Building and Timber Pest Inspection Report

Inspection Date: Fri, 27 Mar 2026

Property Address: 1 Gwynne St, Gwynneville NSW 2500,
Australia

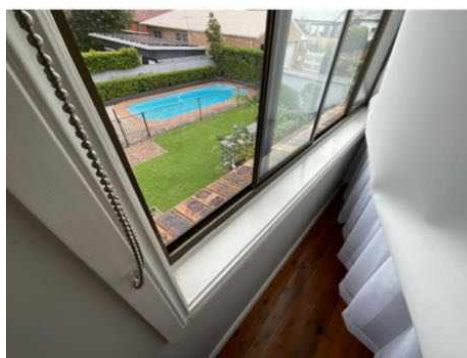
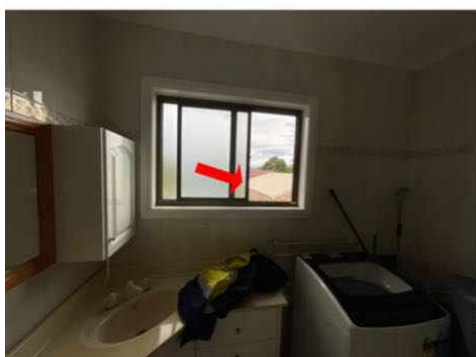
Building: Building 1
 Location: Pictured upstairs windows
 Finding: Window opening restrictors missing.
 Information: These pictured windows are missing window restrictors. The Building Code of Australia rules require all openable windows (where the internal floor is more than 2m above the ground outside) in residential rooms to be fitted with a suitable screen or restrictor. Windows located 1.7m above the floor level do not require protection.

Window restrictors are required where people who are vulnerable to the risk of falling have access to windows. This means all windows above ground level which do not have another fall prevention safety measure in place, such as a balcony or balustrade should have a restrictor.

These need to be added urgently for the safety of all persons.

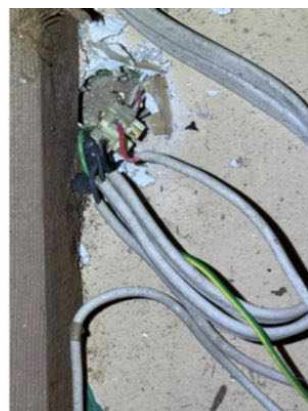
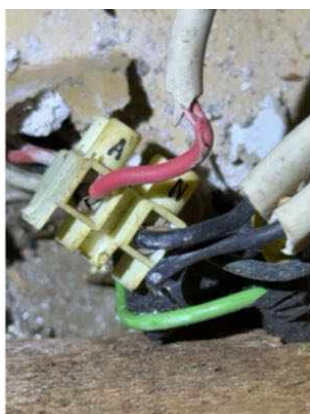
Finding 1.02

Building: Building 1
 Location: Roof Cavity areas
 Finding: Electrical cables missing a junction boxes
 Information: The electrical fittings in this roof area was found to be missing a junction boxes at the time of inspection.

This missing fittings and loose cables does expose electrical works, and may create a safety hazard if there is potential contact with persons in the area.

A Licensed electrician should be appointed to rectify these areas immediately.

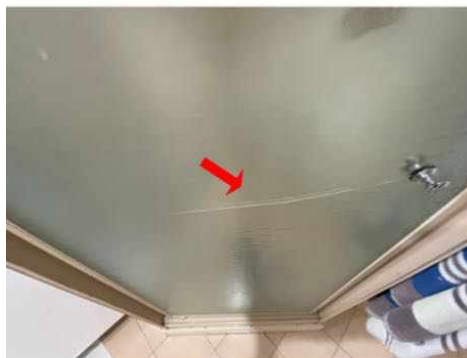
Finding 1.03

Building: Building 1
 Location: Lower Bathrooms
 Finding: Shower screen - Cracked
 Information: Cracks were identified in the shower screen in this bathroom. This is generally the result of impact damage, and is likely to develop further when left unmanaged.

The likelihood of further cracking and shattering is increased exponentially, providing a safety hazard in the area. A qualified glazier is required to repair the screen as soon as possible.

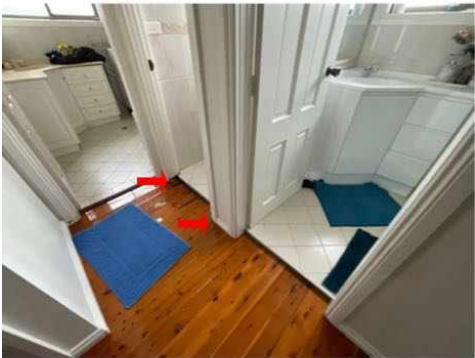
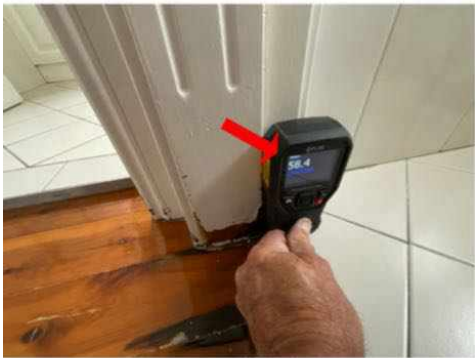
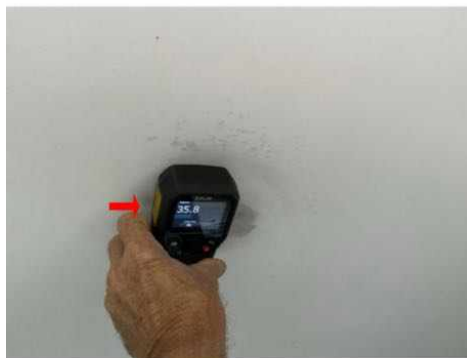
Finding 2.01

| Finding: | Evidence of excessive moisture was present at the time of inspection |
| Information: | Excessive moisture and moisture damage was found in these 5 areas at the time of the inspection. Medium to high readings of up to 87.8 was recorded. |

This high moisture and moisture damage has occurred as a result of leaks from the ensuite roof area, the upper bathrooms through the waterproofing membranes, and in both kitchens and lower bathroom vanity. This moisture can attract termites and produce conditions that promote termite attack, fungal growth and wood decay.

All these areas show moisture damage includes swelling, wood rot and mould (See these defects in this report).

In the upper toilet and ensuite where moisture was travelled under and in walls and flooring areas, structural wood rot to wall and floor framing is likely increasing the

costs of renovations and repairs. This damage can only be assessed once renovations begin as internal wall and floor framing cannot be seen.

Where waterproofing membranes are damaged, very costly repairs are required and quotes should be sought prior to purchase from bathroom renovation companies.

It is highly recommended that quotes be sought for all damaged areas prior to purchase and all plumbing and drainage fixtures and fittings be maintained regularly in order to prevent this excessive moisture damage being present in the internal property in the future.

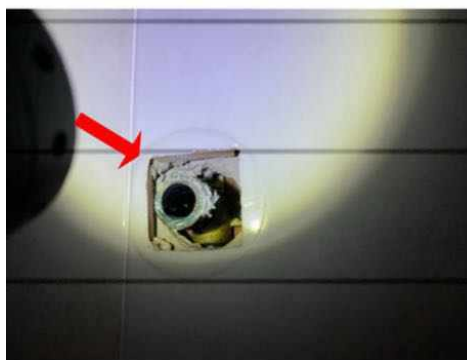
| Finding: | Waterproofing membranes damaged and none evident in ensuite shower |

With older property's where this information is unavailable all wet areas should be monitored. The leaks, water staining and peeling or bubbling of the paint found in the bathrooms indicate these waterproofing membranes have failed.

The ensuite shower wall where the spout is missing, shows no membrane in this area. Other bathroom membranes may also be missing and this can only be determined with an invasive inspection.

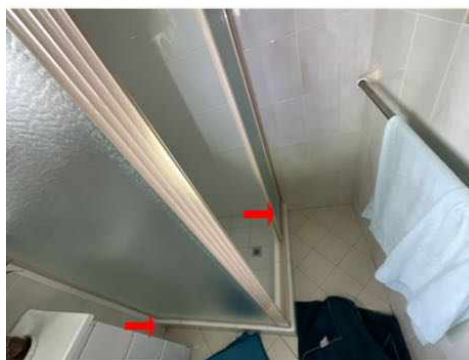
Finding 3.03

| Finding: | Shower screens - Leaking |
| Information: | Leaking was evident to the shower screens at the time of inspection. It is suspected that the leaking has occurred as a result missing sealant. Leaking from the shower , where left unattended, is likely to lead to water damage to adjoining flooring and walls. Such damage can lead to water damage and necessitate extensive remedial works being required. Active water leaks may also create an environment that is susceptible to the formation and development of mould. |

Appointment of a sealant expert is required to repair or replace this missing sealant. Such works should be performed as soon as possible to ensure that no further damage occurs.

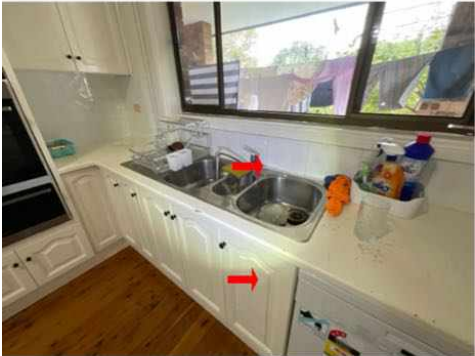
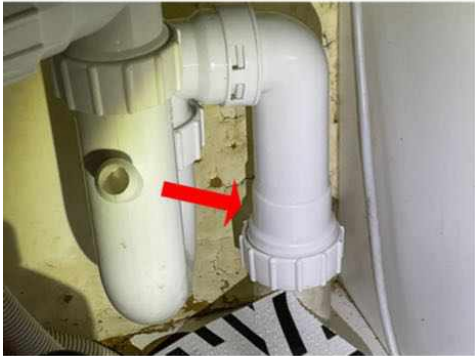
Finding 3.04

| Finding: | Swollen and damaged cabinetry |
| Information: | One vanity and both kitchens cabinetry have been affected by excessive moisture over a prolonged period of time, and have swollen as a result. The structural integrity of swollen building elements cannot be guaranteed, and further damage is possible if these areas are left unmanaged. Both kitchens are extremely damaged, the under sink areas are water damaged with mould present. Very high moisture of 80.1 was recorded under the lower kitchen sink indicating water leaks present. |

Repair or replacement of swollen building elements should be conducted by a qualified carpenter or cabinet maker after a plumber has repaired any leaks.

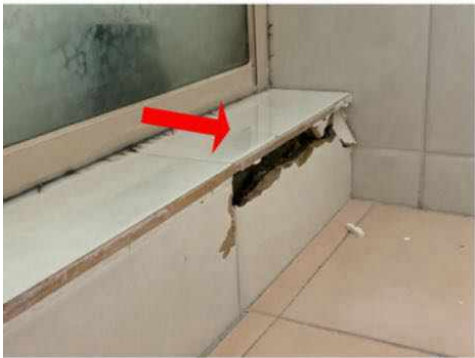
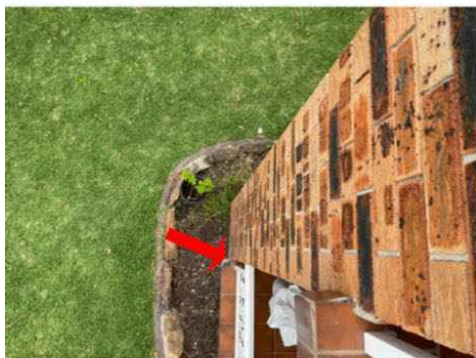
Finding 3.05

| Finding: | Tiles cracked |
| Information: | Cracked tiles were evident in these pictured areas at the time of inspection. It is suspected that this cracking has occurred as a result of minor settlement or impact damage. |

Cracked tiles throughout the household detract from the overall appearance of the affected areas. In wet areas of kitchens and bathrooms, it can lead to water damage of adjoining walls and floors.

Replacement of cracked tiles is recommended as soon as possible. A tiling contractor may be appointed to perform these works. Where cracks become more numerous, contact a licensed building inspector for further investigation.

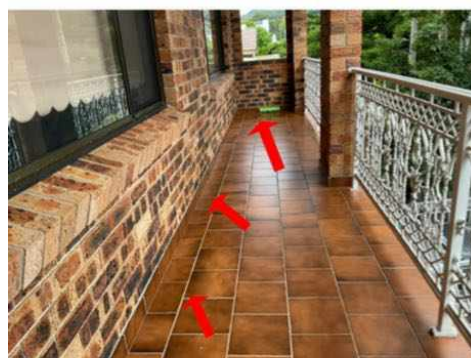
Finding 3.06

| Information: | Drummy tiled areas were identified at the time of inspection. The term 'drummy' refers to tiles that have become detached from their fixing, despite otherwise being in relatively good condition. Such defects are generally caused by physical or moisture damage to the area. Drummy tiled areas may also be a direct result of poor workmanship during the construction process. |

Tiled areas may swell and shrink with changes in air humidity if the area has sustained moisture damage. Any exposure to moisture is capable of causing tiled areas to become drummy and/or cracked over a prolonged period of time. Drummy tiled areas generally require removal and replacement of affected tiles, with adequate sealant and grouting.

Specialist trades are available for these types of services. A registered builder may be required to undertake works if damage is extensive or if secondary building defects have resulted. Otherwise, it is advised that a tiling contractor be appointed to perform works as necessary. Immediate action is recommended to ensure that no further damage is sustained in the affected area.

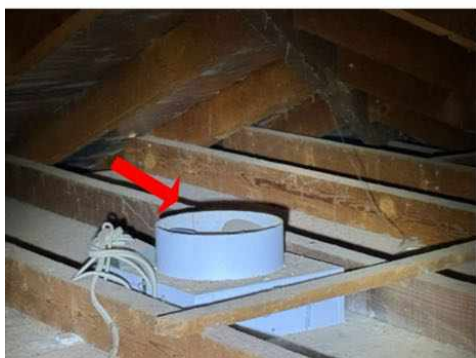
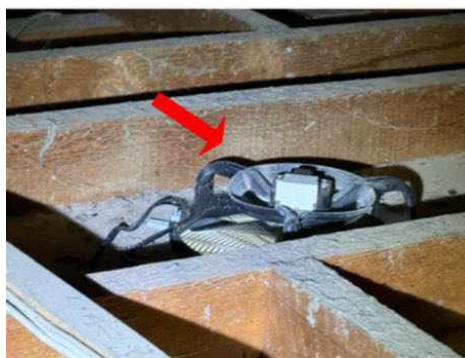
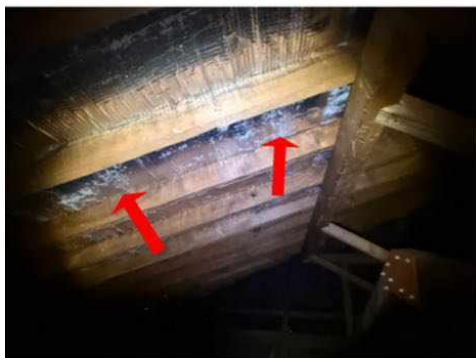
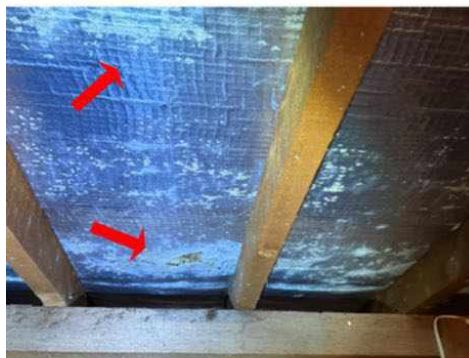
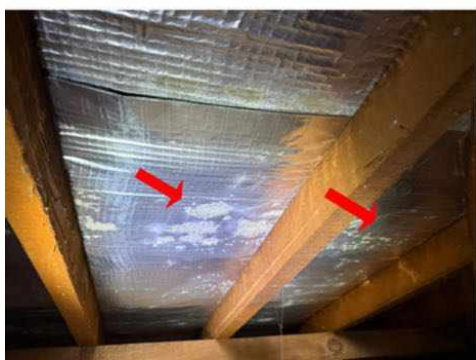
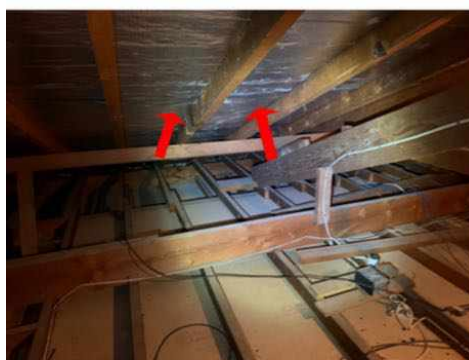
Finding 3.07

| Information: | On inspection of the roof void, it was observed that the exhaust fans to the wet areas do not exhaust directly to the outside of the building, which is required by the National construction code if sarking has been fitted, as it has in this home. This is causing mould development and unhealthy conditions inside the roof void. These fans need to be redirected by a plumber or air conditioning technician into the external environment to stop this mould further developing. |

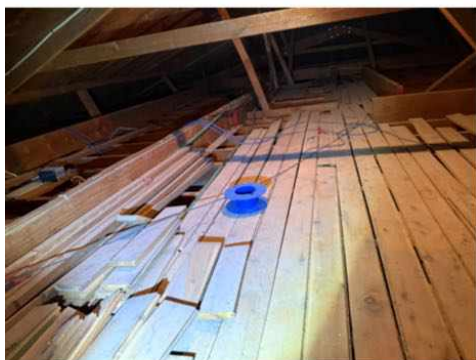
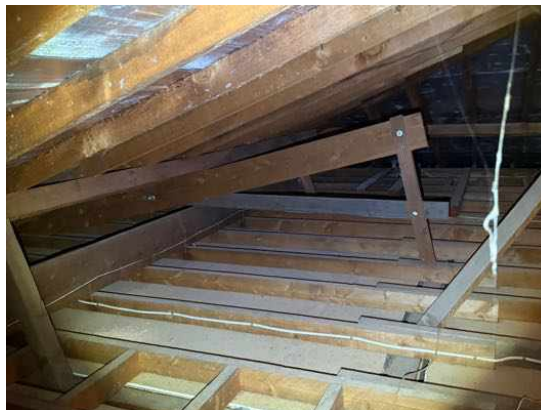
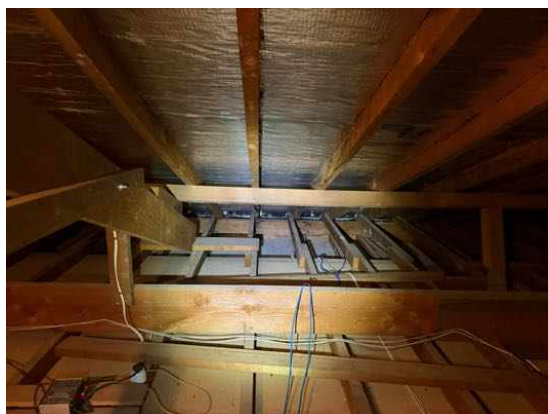
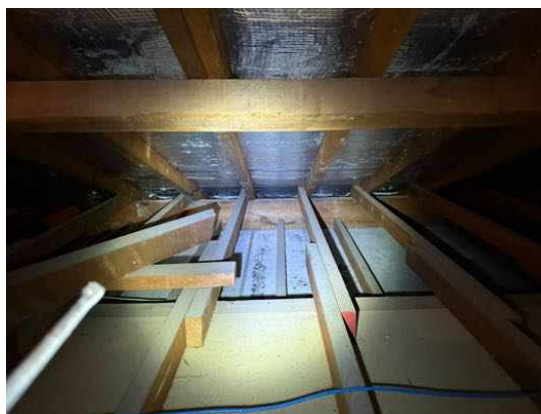
Where insulation is absent, the area does not meet current Australian Standards. Installation of adequate insulation is required and should be conducted as soon as possible.

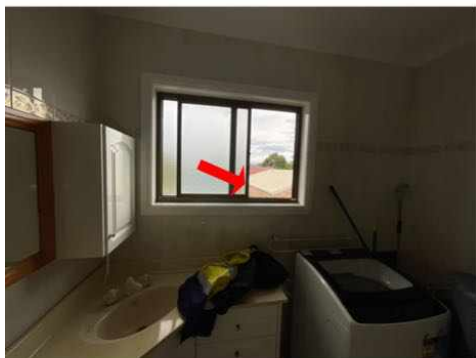
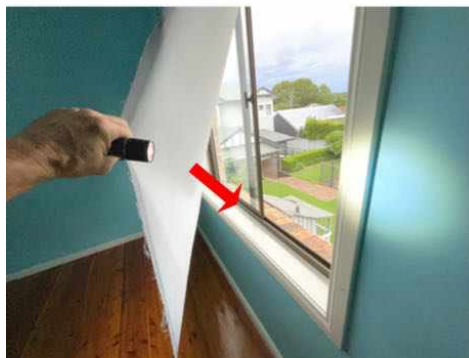
Finding 3.12

Generally, factors such as general age of the building element, general building movement or sometimes a lack of maintenance are the usual causes for this type of defect.

Replacement of window hardware or frame may be required, as well as minor repairs and cleaning. A registered builder or general handy person will be required to repair the affected windows.

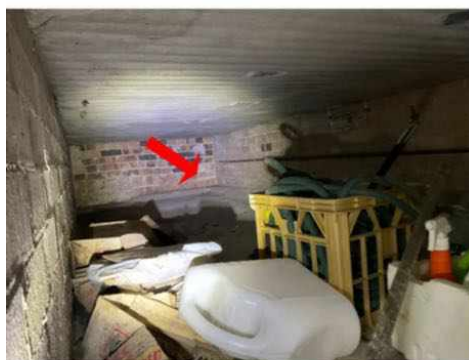
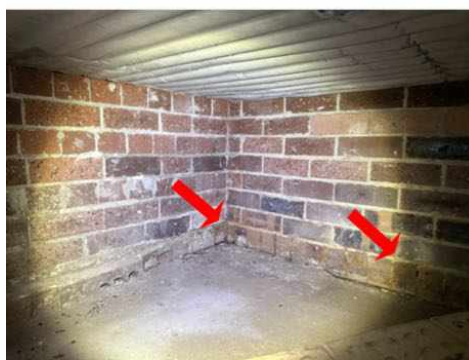
Finding 3.16

The first step in addressing rising damp is to diagnose the cause. The identified cause should be addressed first before addressing the appearance and other defects which have resulted from the rising damp. If the original cause is not resolved, further cases of damp are likely to ensue, resulting in secondary defects.

Consultation with a qualified plumber is advised immediately to identify the cause of the damp and perform remedial works as required.

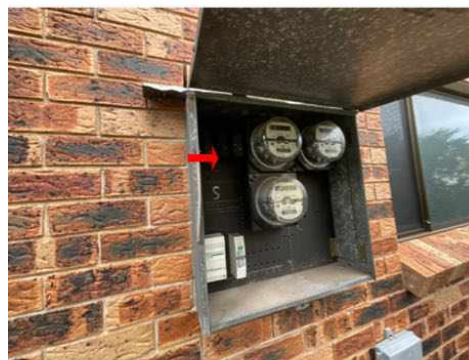
A durable notice should be placed in the switchboard unit to indicate current termite barriers. At the time of inspection, no durable notice was evident and it appeared as though no chemical termite management system has been installed, with no evidence to suggest preventative works taking place since the property was built.

The client may consider gaining further advice from a pest controller as to the costs and procedures involved with a 'chemical' application. It is recommended that obtaining such advice be a short-term priority.

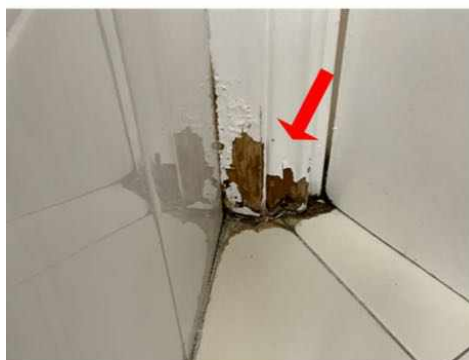
Finding 6.02

In this case, the affected timber element is in a decaying state and will need replacement by a carpenter or licensed builder.

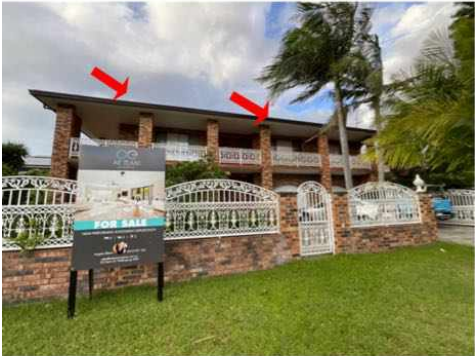
Building: Building 1
 Location: All External Areas
 Finding: Additional Photos - Obstructions and Limitations of EXTERNAL AREAS
 Information: These photographs are an indication of the obstructions and limitations which impeded full inspection of external areas at the time of inspection. These obstructions can hide an array of defects and should be removed to allow full inspection to be

carried out. A re-inspection is recommended once the areas are made accessible.

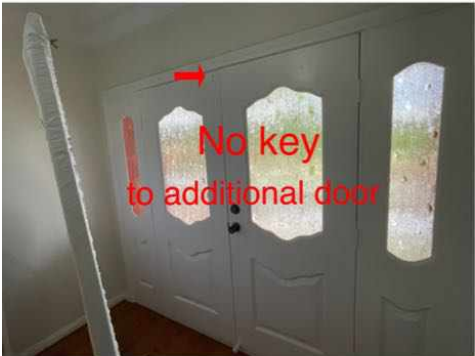
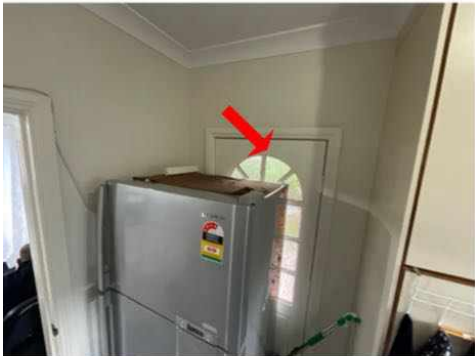
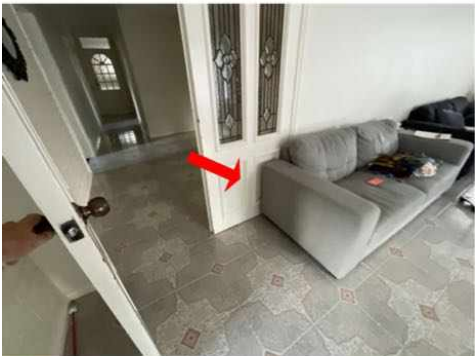
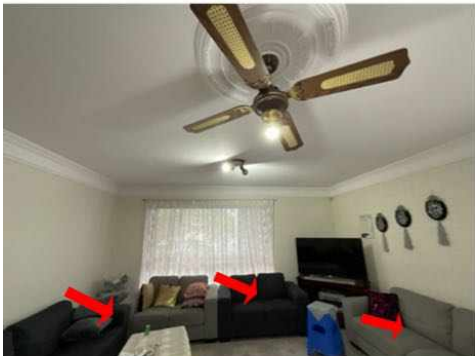
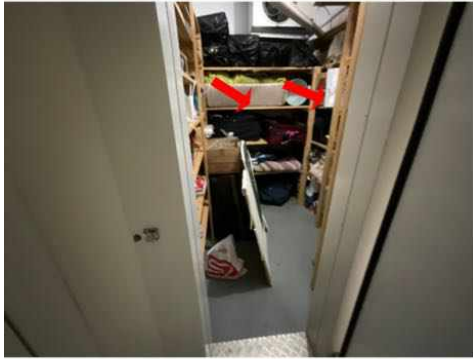
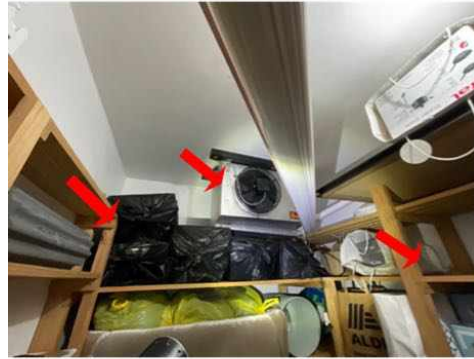
Building: Building 1
Location: All Internal Areas
Finding: Additional Photos - Obstructions and Limitations of INTERNAL AREAS
Information: These photographs are an indication of the obstructions and limitations which impeded full inspection of Internal areas at the time of inspection. These obstructions can hide an array of defects and should be removed to allow full inspection to be carried out. A re-inspection is recommended once the areas are made accessible.

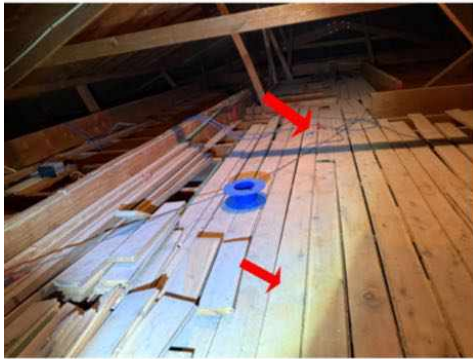
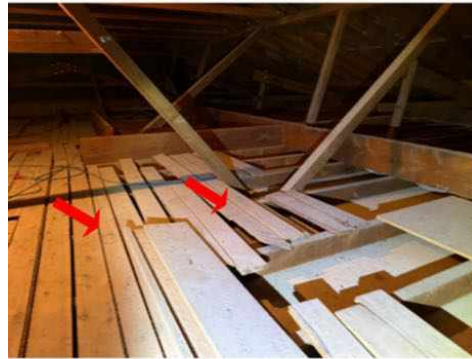
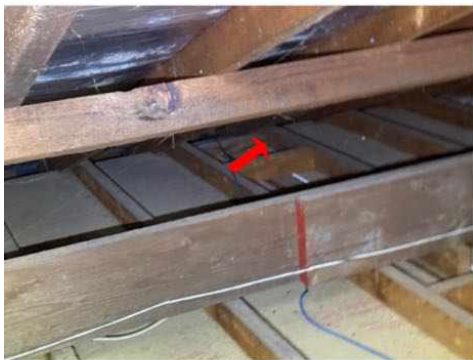
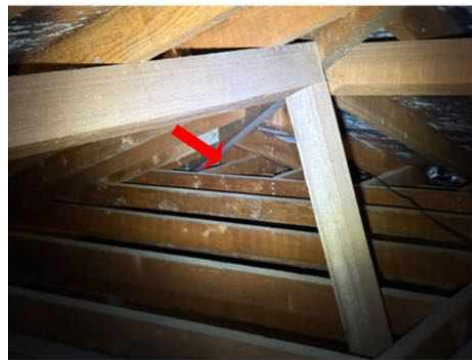
Building: Building 1
 Location: All Roof cavity areas
 Finding: Additional Photos - Obstructions and Limitations of the ROOF CAVITY
 Information: These photographs are an indication of the obstructions and limitations which impeded full inspection of roof cavity areas at the time of inspection. These obstructions can hide an array of defects and should be removed to allow full inspection to be carried out if applicable. A re-inspection is recommended once the areas are made accessible.

The inspection was also limited to areas with an allowable crawl space of 600mm x

600mm, in particular towards the external walls where the roof line diminishes, these areas were not accessible.

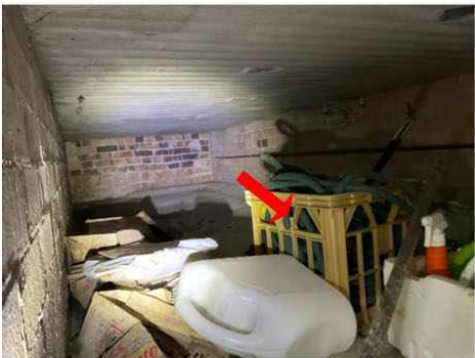
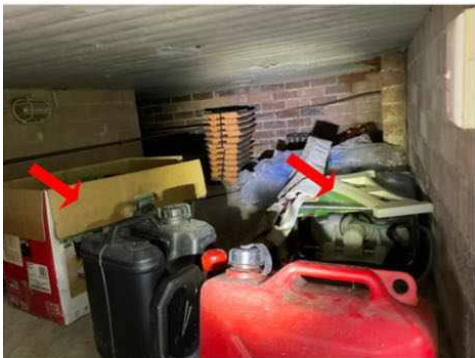
| Finding: | Additional Photos - Obstructions and Limitations of SUBFLOOR AREAS |
| Information: | These photographs are an indication of the obstructions and limitations which impeded full inspection of subfloor areas at the time of inspection. These obstructions can hide an array of defects and should be removed to allow full inspection to be carried out. A re-inspection is recommended once the areas are made accessible. |
