Building and Timber Pest Inspection Report

Inspection Date: Fri, 6 Feb 2026

Property Address: 20 McMullen Ave, Carlingford NSW 2118,
Australia

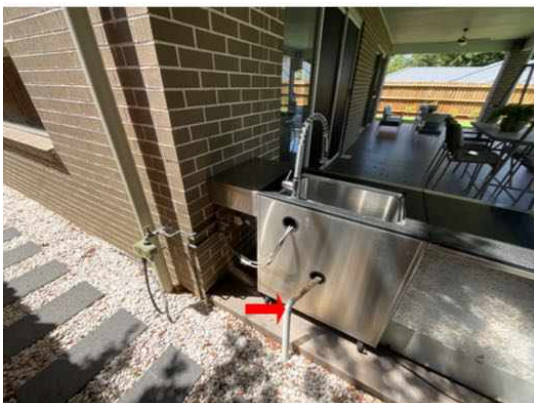
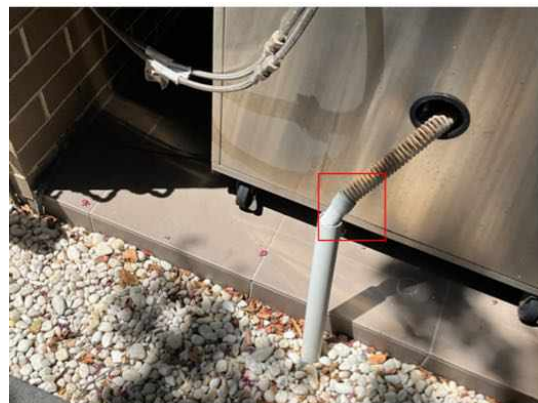
Finding 3.09

Building:	Main Building
Location:	Exterior walls - right side
Finding:	External surfaces — Holes

Whether intentional or not, gaps and holes to external surfaces are susceptible to insect and vermin ingress, as well as allowing water penetration to the cavity wall. As such, associated building elements are likely to deteriorate at an accelerated rate, and major implications are expected if holes around the pipework are left unmanaged.

All excessive holes, gaps or cracks should be adequately filled by a suitable sealant or trimmings as soon as possible to prevent any further damage. Such works may be conducted by a general handyperson or licensed bricklayer.

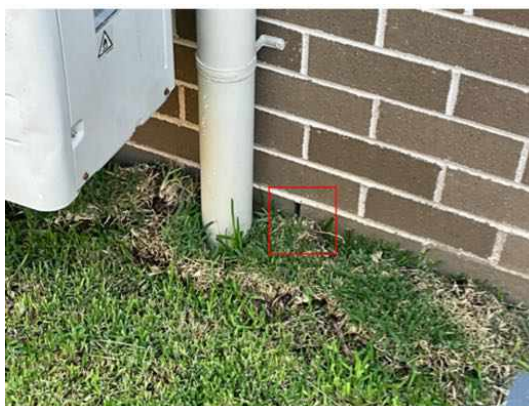
Finding 6.04

Building:	Main Building
Location:	Slab penetrations
Finding:	Service penetrations
Information:	Services into home can allow for concealed termite entry without additional or adequate termite protection.

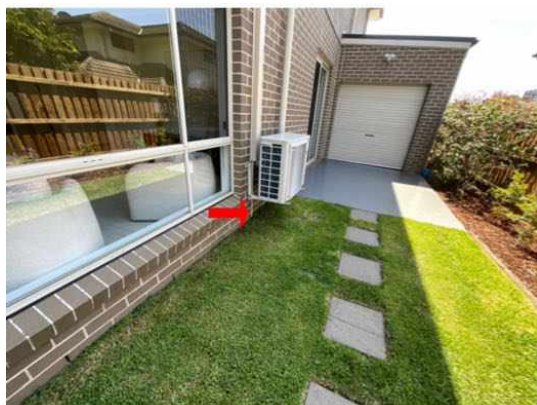
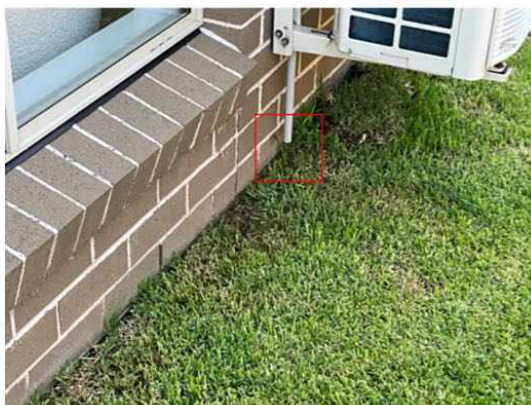
Finding 6.06

Building:	Main Building
Location:	Fencing & Landscaping
Finding:	Building materials in direct ground contact - conducive to termites
Information:	Where timber elements are in direct contact with the ground and consequently moisture or dampness they become conducive to termite activity. Whether timber is used as a building element part of a fencing structure or stored as an unused item they can provide an environment that is attractive to termite infestation.

When met with excessive moisture timber begins to decay and develop wood rot. Any timbers that are in direct contact with external grounds especially if left untreated or non-durable also provide ingress for subterranean termites into that particular element.

The removal of any such materials that may be conducive to termite activity should be removed as soon as possible to minimise the risk of termite attack.

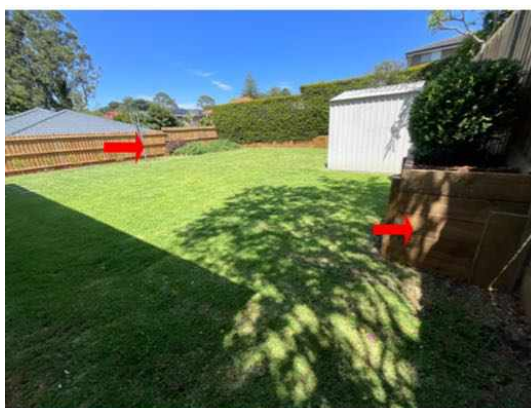
Finding 6.07

Building:	Main Building
Location:	Garden beds

Finding: Garden Beds
 Information: Garden beds were found to be evident in the garden area. These garden beds can include untreated timber, and with a combination of moisture from watering hosing can make conditions conducive to termite activity and termite ingress.

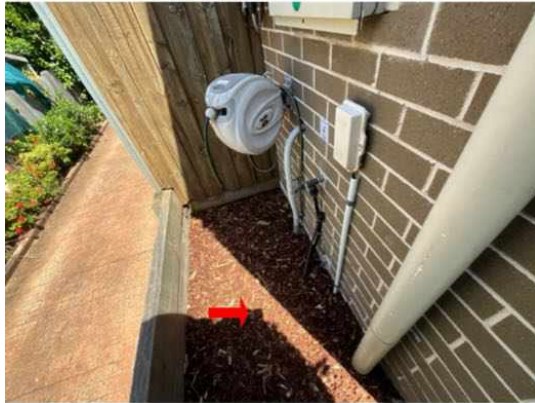
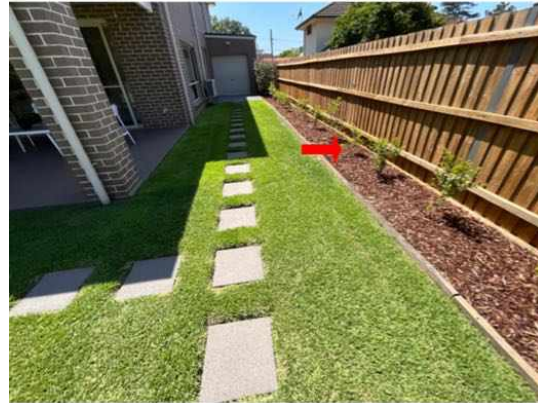
Finding 6.08

Building: Main Building
 Location: External tap
 Finding: Tap - No drain
 Information: The external tap in this area was noted to have no drain at the time of inspection.

This keeps the surrounding surfaces damp while using the tap, which becomes conducive to termite activity.

A licensed plumber must be appointed to ensure an appropriate drain is installed.

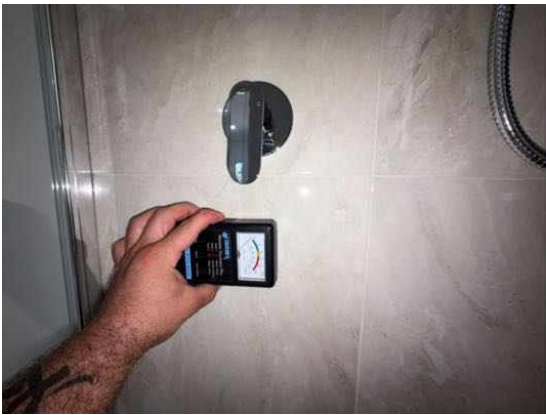
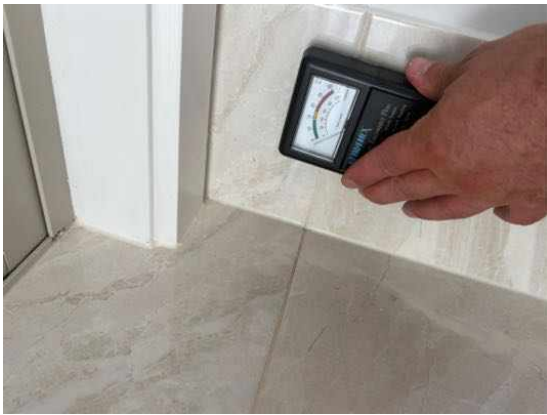
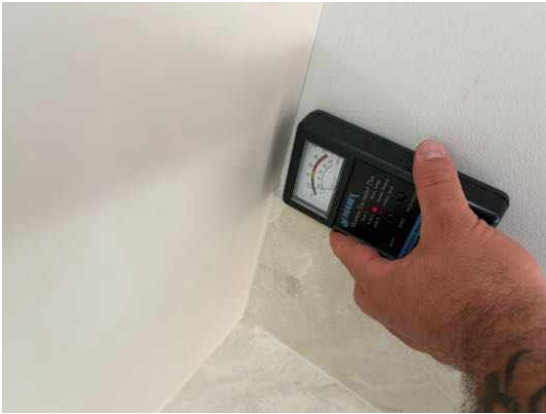
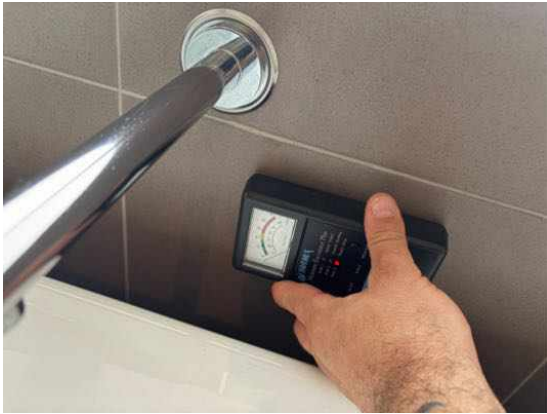
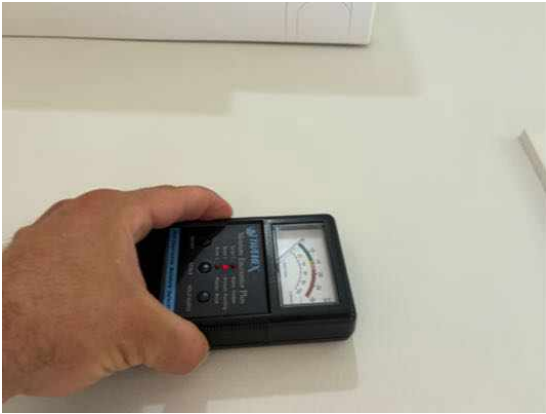
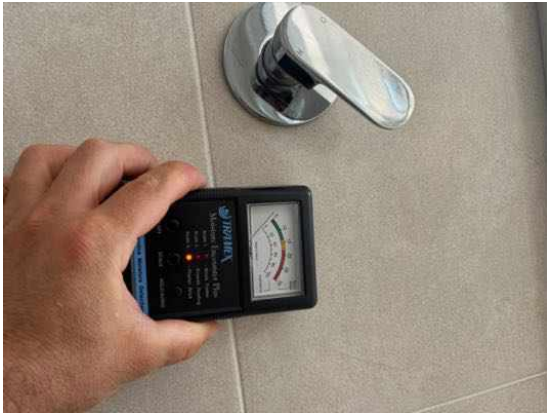
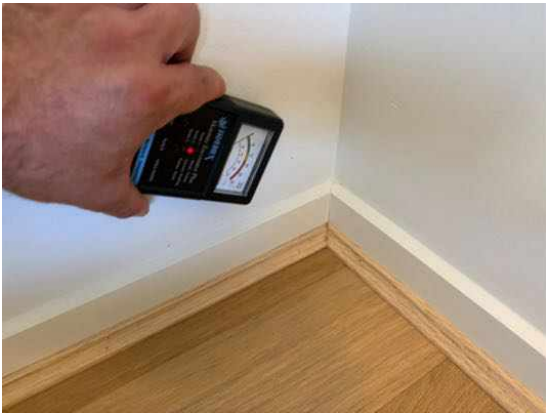
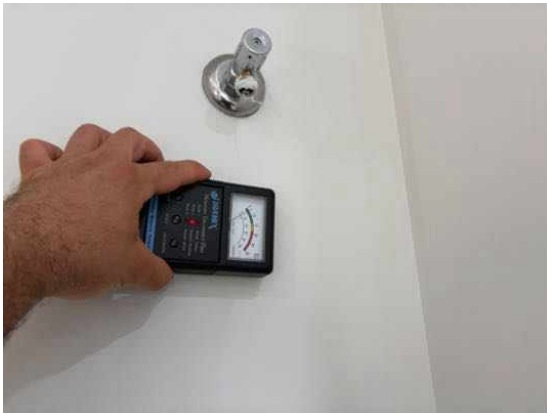
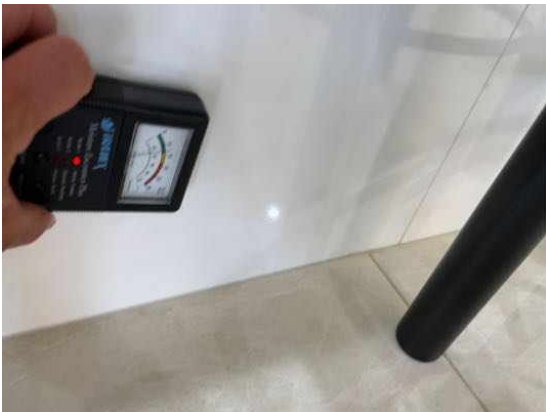
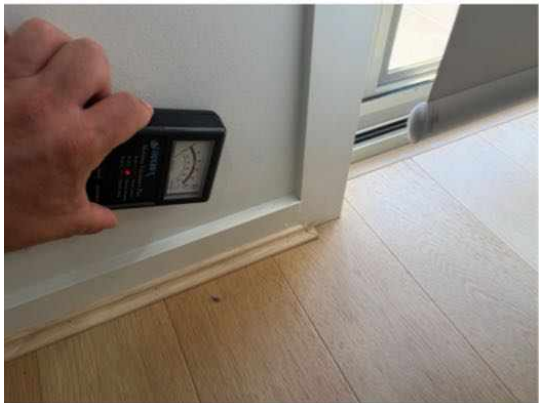
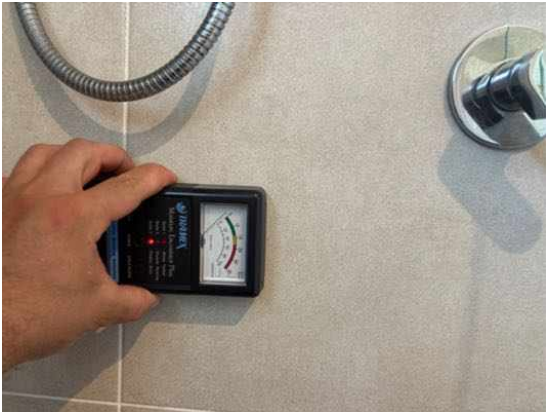
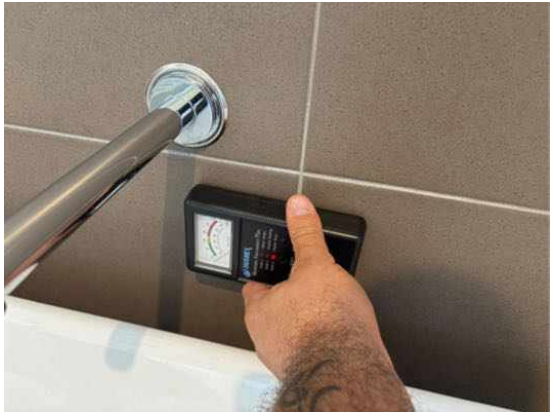
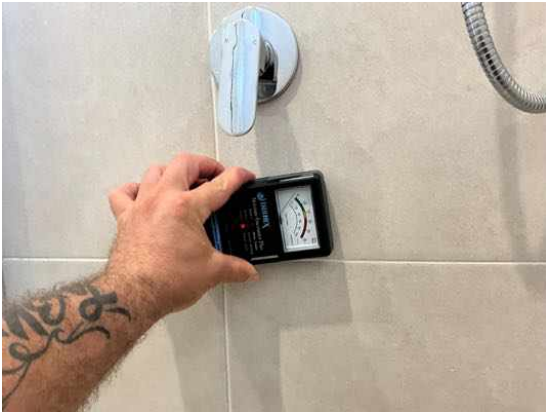
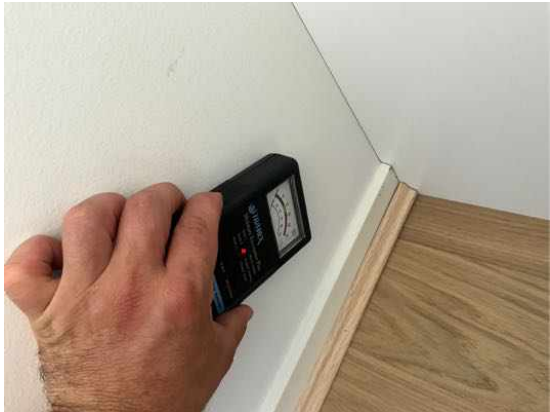
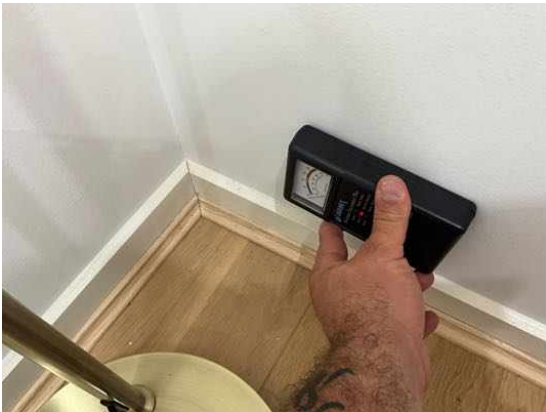
Building: Main Building
Location: All Areas
Finding: Moisture metre
Information: During the inspection the property was checked for moisture using a moisture metre.

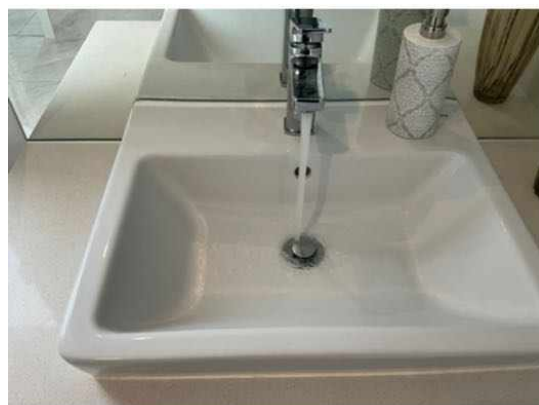
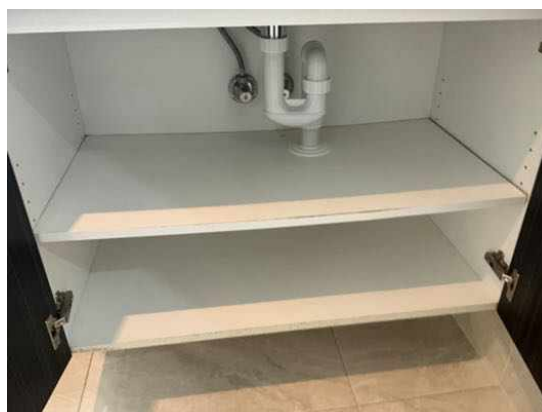
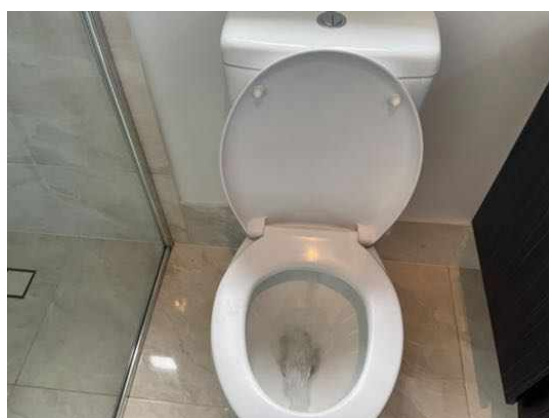
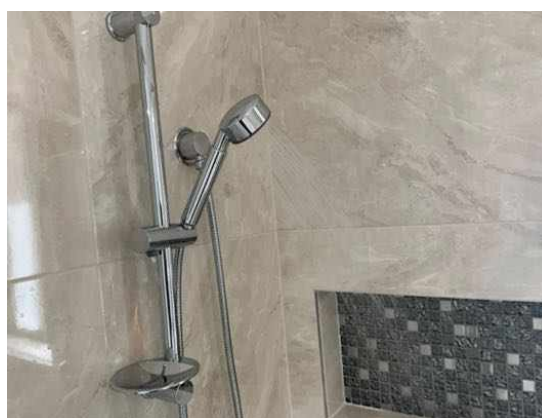
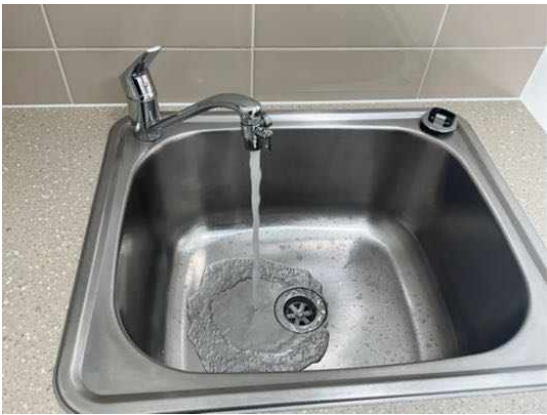
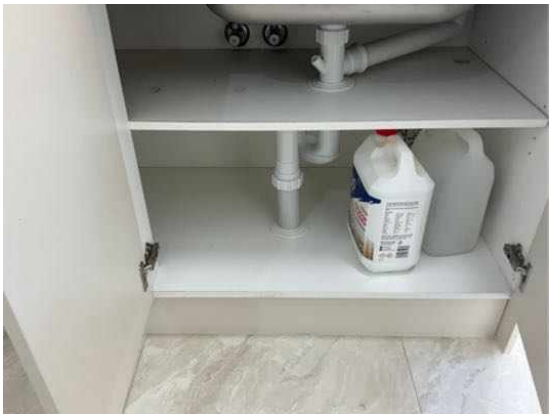
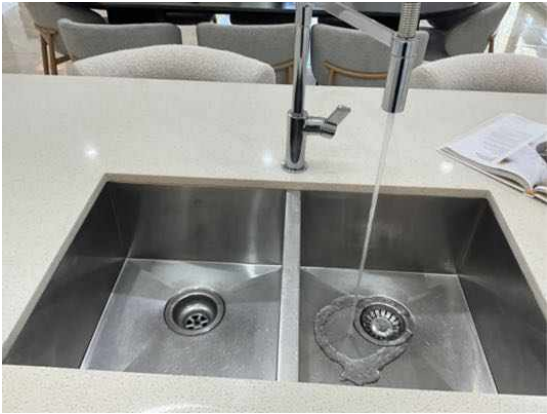
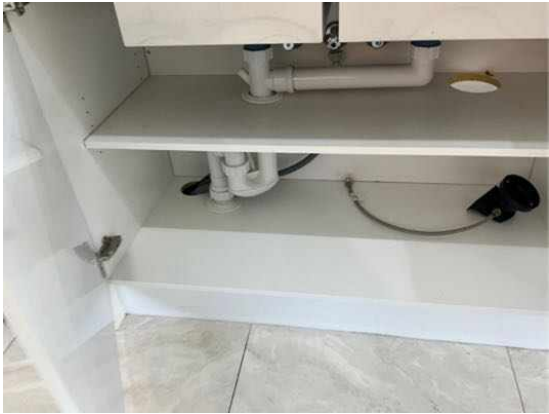
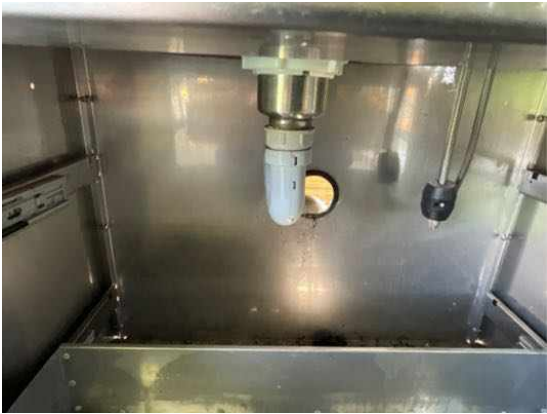
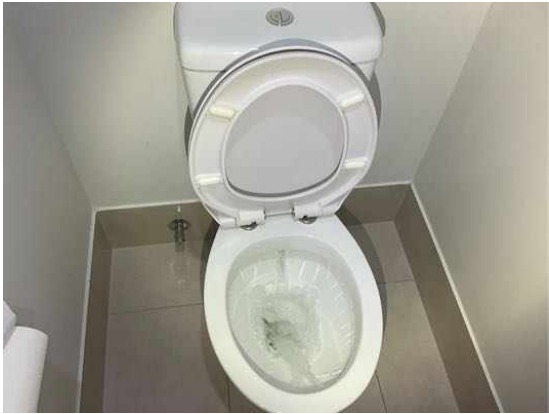
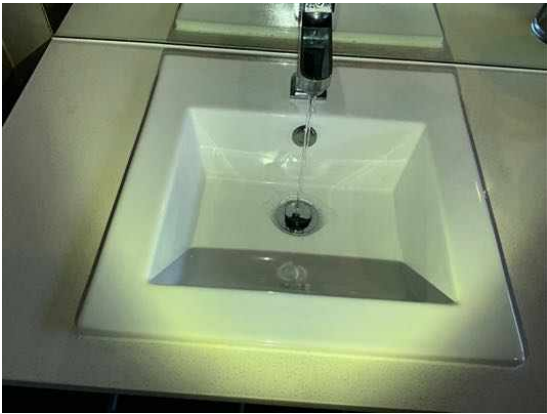
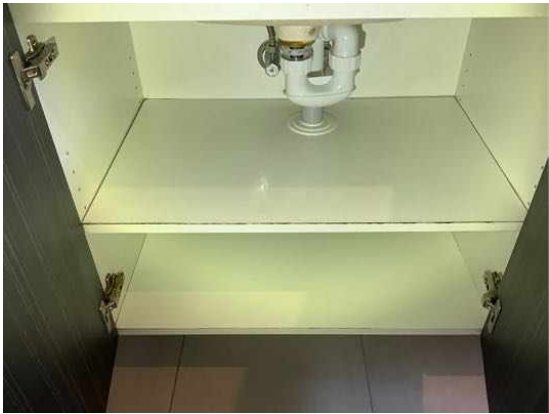
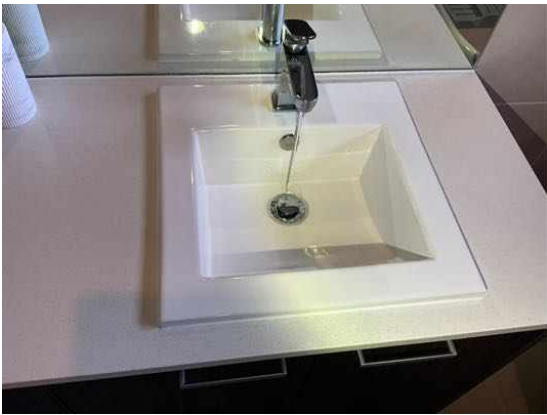
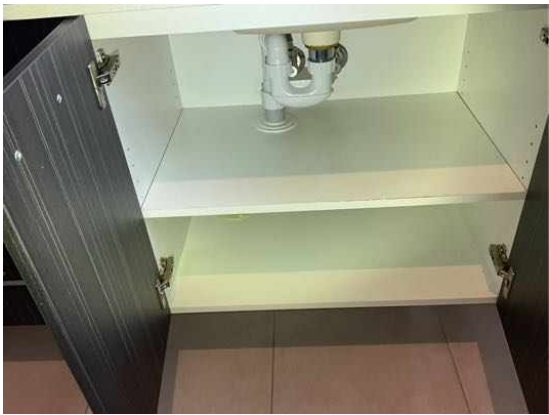
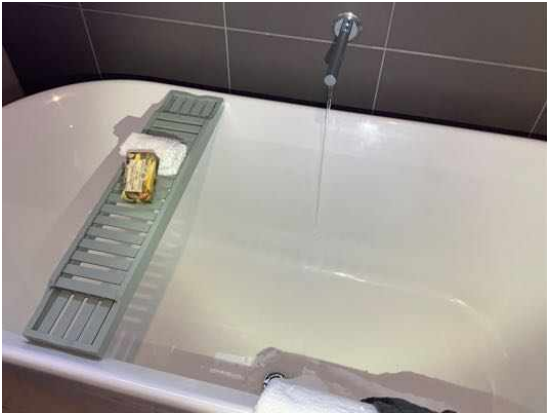
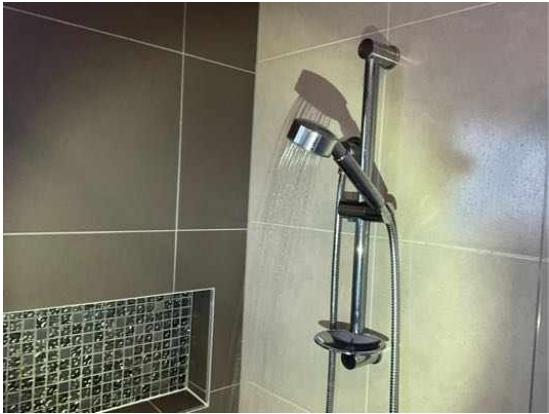
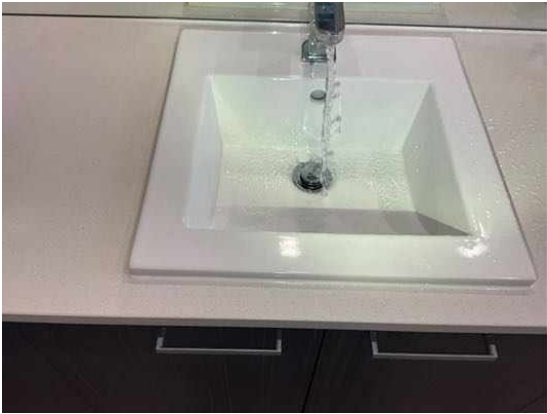
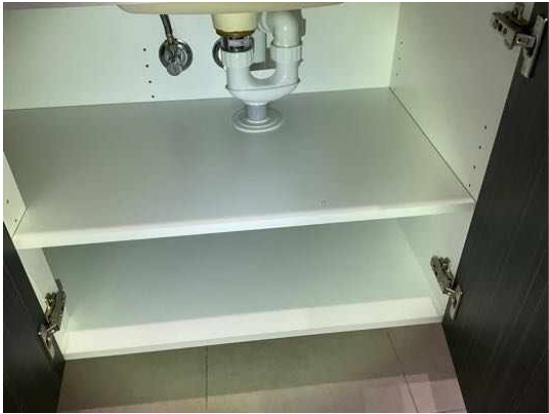
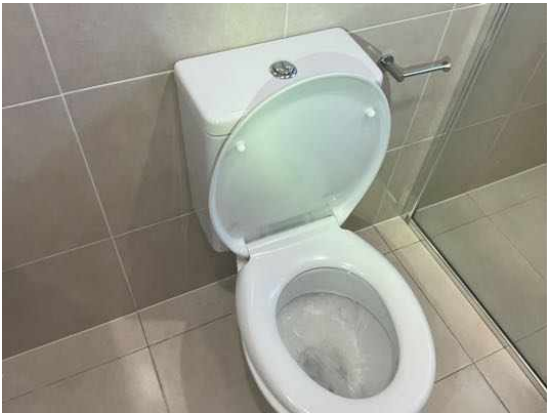
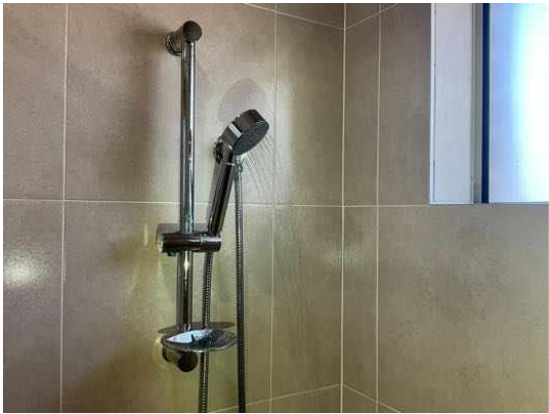
Building: Main Building
Location: All Wet Areas
Finding: Waterproofing
Information:

All taps, mixers and toilets were tested for operation, except for those obstructed. The waterproofing to the shower recess was assessed by checking the walls in and around the shower recess for varying moisture content. There were no significant variations across the tested areas. No sign of recent water damage was evident upon a visual inspection of the surrounding walls, where the visual nature of the inspection was possible.

Consequently, there is no conclusive evidence of any current shower recess leakage other than those which may have already been mentioned earlier in this report. It is reasonable to assume the shower waterproofing is sound. Note that if the shower is not used, or has not been used for some time, moisture readings would not vary significantly and this can lead to erroneous results. It is not possible under the visual inspection criteria (under which a prepurchase inspection is carried out) to categorically determine if there are leaks. If a more accurate assessment is required, a special purpose inspection should be requested. Alternatively, the assumption should be made that the shower may leak.

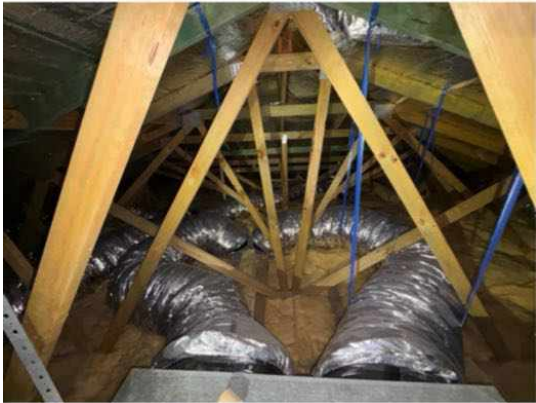
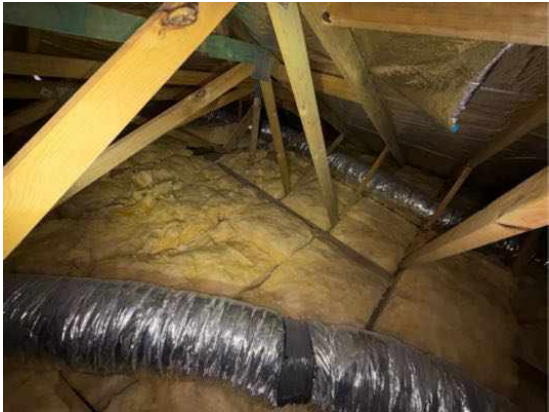
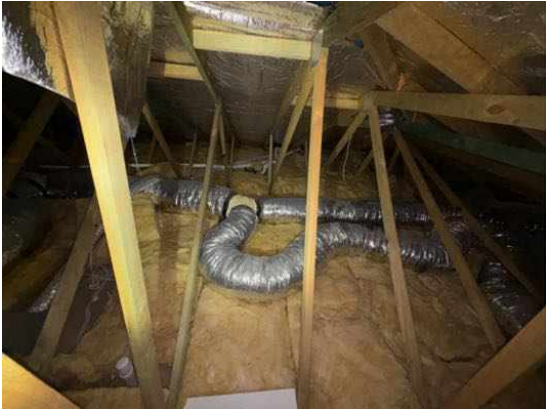
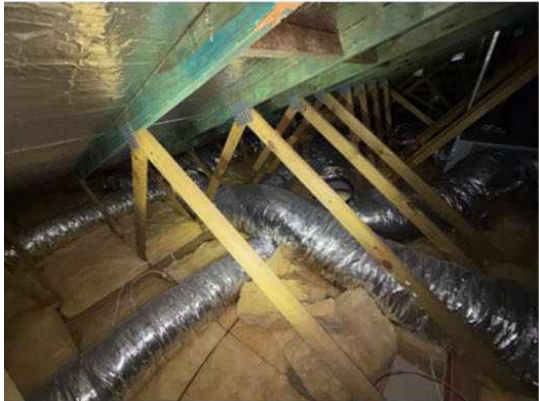
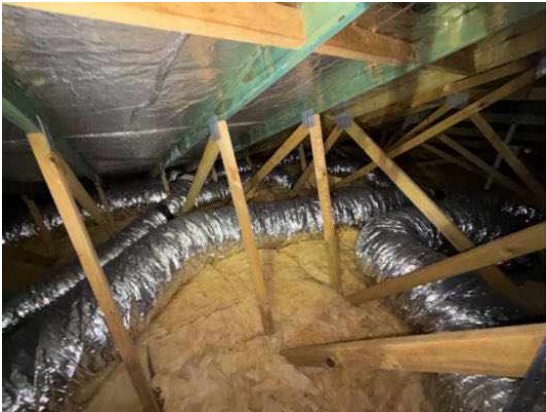
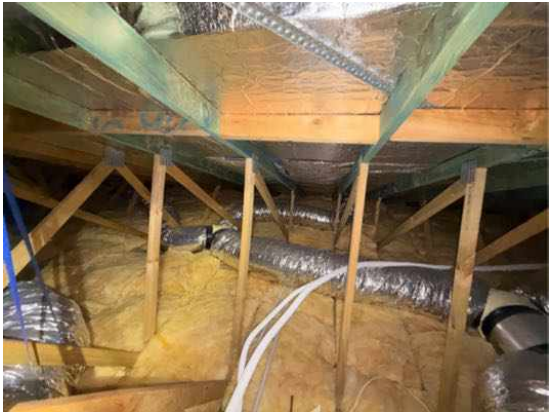
Building: Main Building
Location: Roof Void
Finding: Additional Photos
Information:

Additional photos are provided for your general reference.

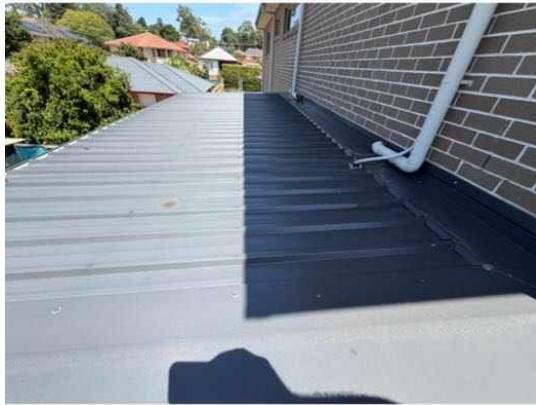
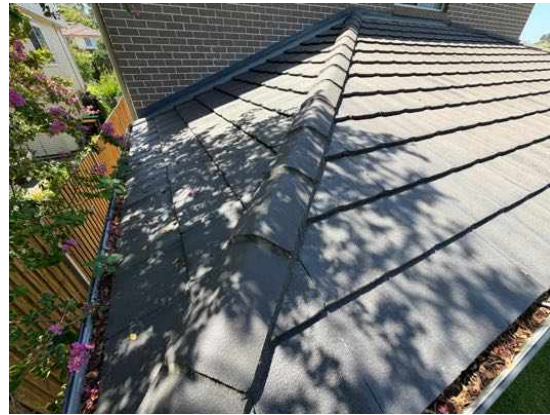
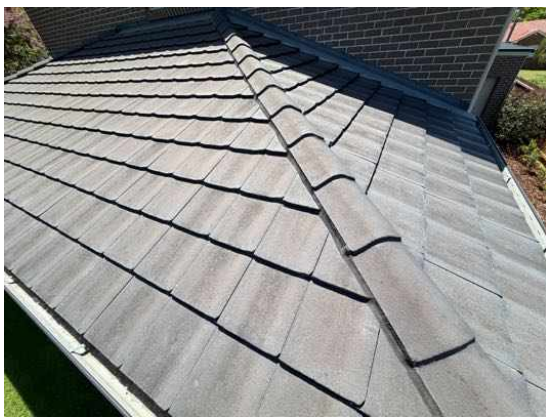
Building: Main Building
Location: Roof Exterior
Finding: Additional Photos
Information:

Additional photos are provided for your general reference.

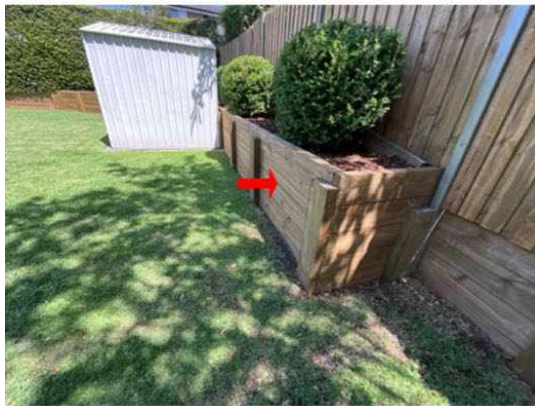
Building: Main Building
 Location: Retaining walls
 Finding: Retaining walls
 Information: At the time of inspection the retaining walls were checked and no defects were observed other than those which May have been mentioned earlier in this report.

AS4349.1-2007 requires all retaining walls in excess of 700mm to be inspected by a licensed and practicing structural engineer.

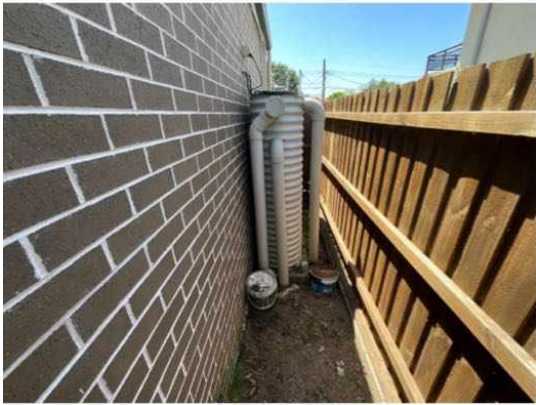
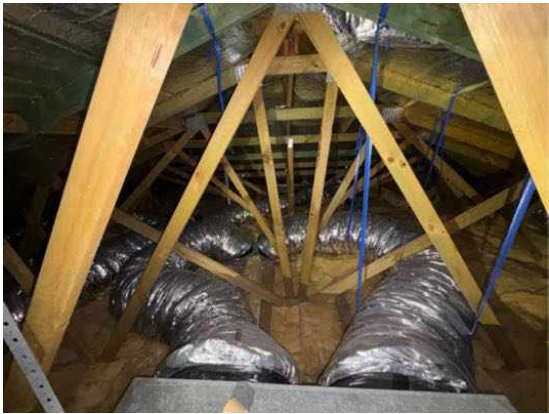
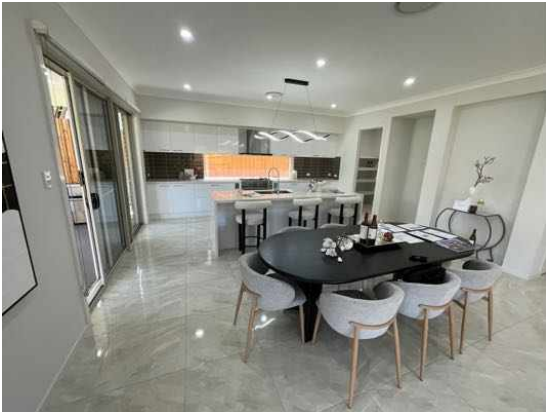
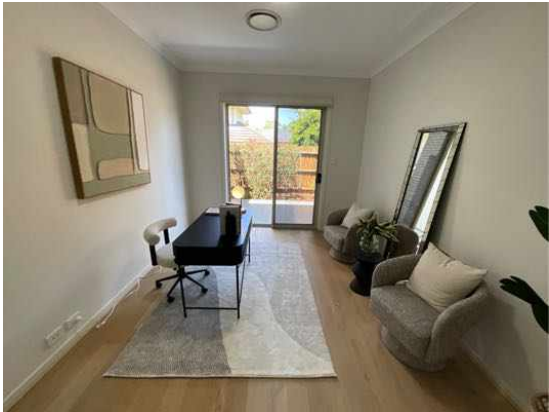
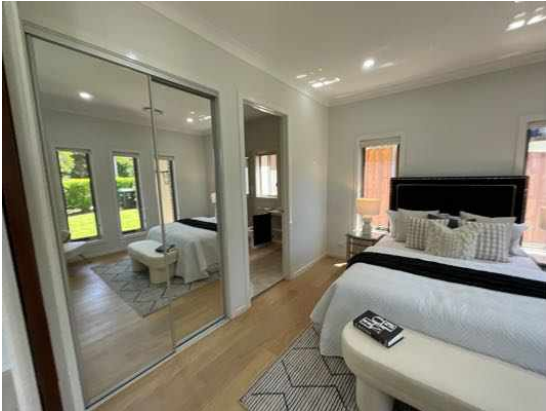
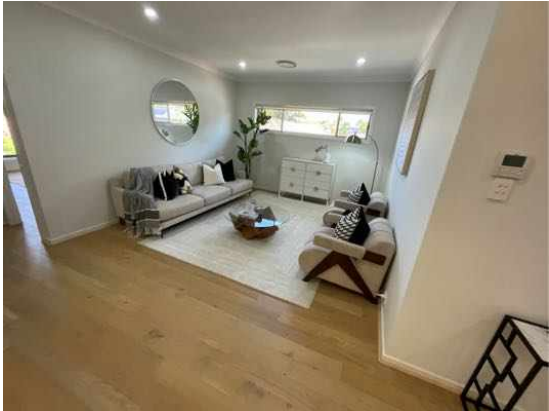
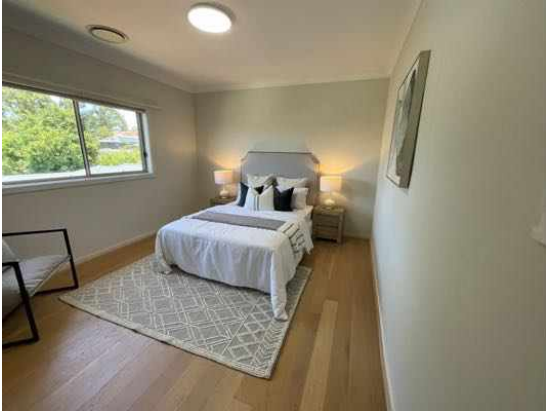
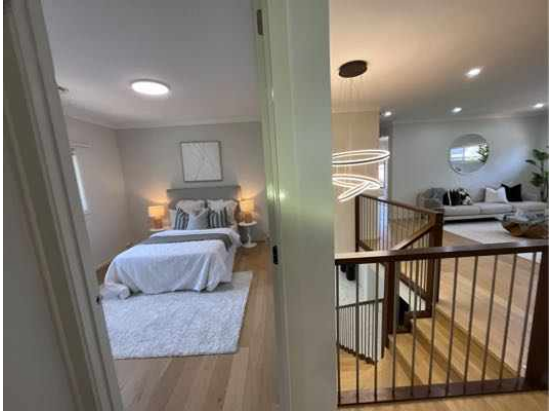
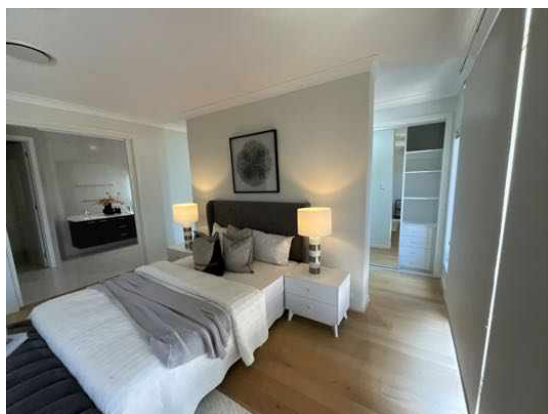
Building: Main Building
 Location: All Areas
 Finding: Additional Photos - Obstructions and Limitations
 Information:

These photographs are an indication of the obstructions and limitations which impeded full inspection of the property at the time of inspection. These obstructions can hide an array of defects and should be removed to allow full inspection to be carried out. A re-inspection is recommended once the areas are made accessible.

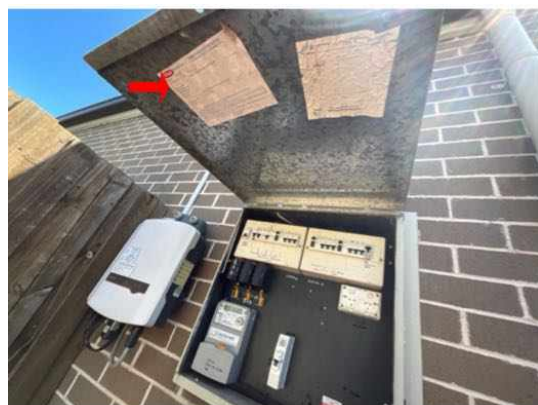
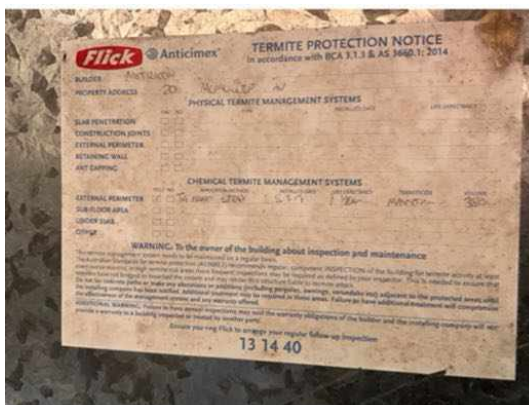
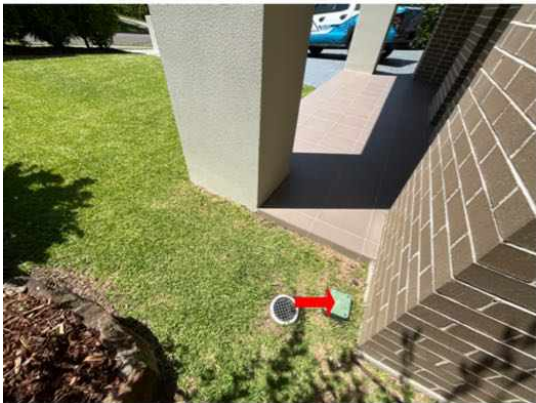
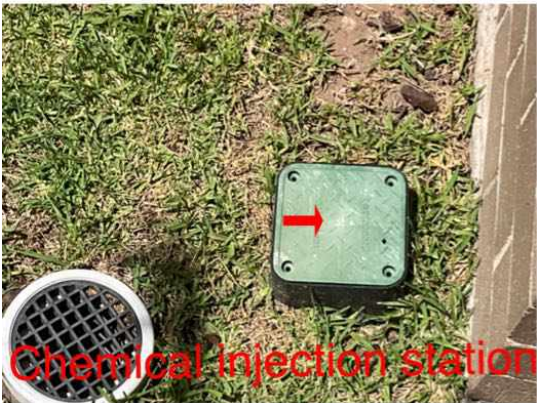
Where a Termite Management System has been identified you should refer to the type of barrier date of installation warranty conditions and any documentation provided by a builder or past owner. Consult the company who installed the barrier to confirm whether the system is still under warranty.

Most chemical termite management systems expire and require replenishment and all physical systems are primarily designed to prevent concealed entry.
