Building Inspection Report

Inspection Date: Thu, 19 Mar 2026

Property Address: 3 Irene Ct, Cheltenham VIC 3192, Australia

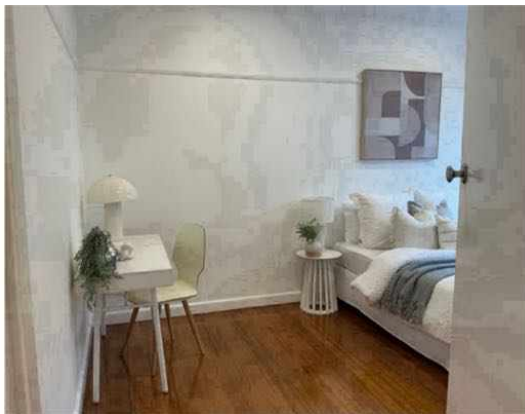
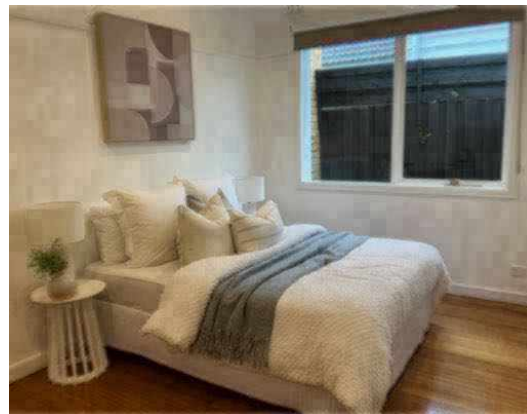
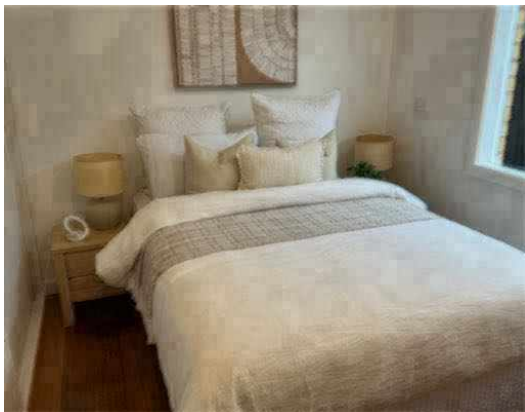
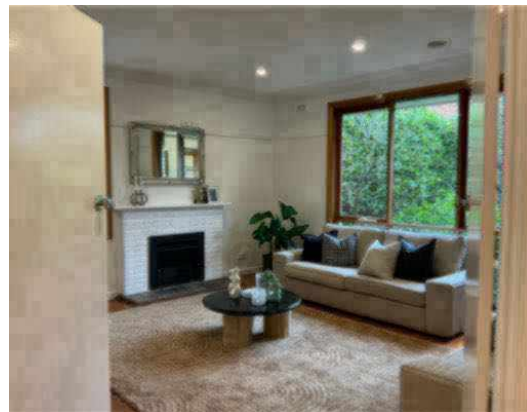
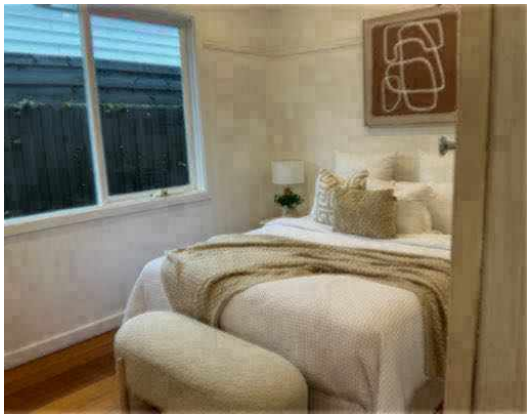
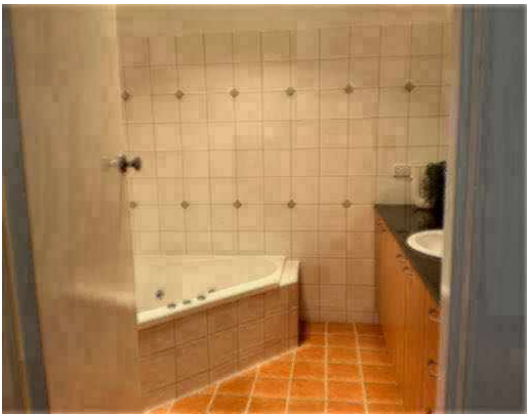
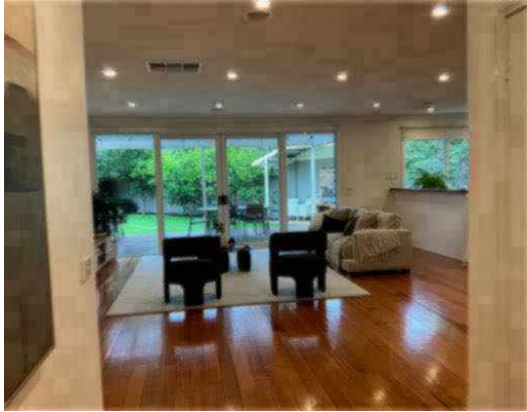
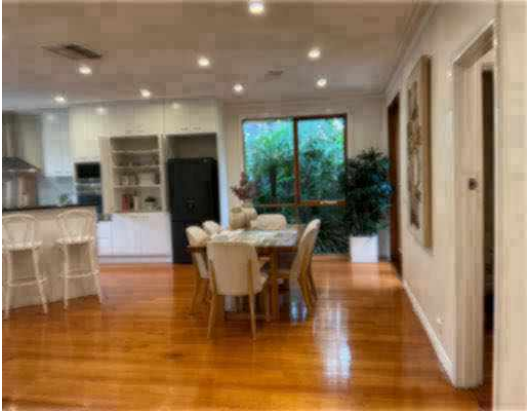
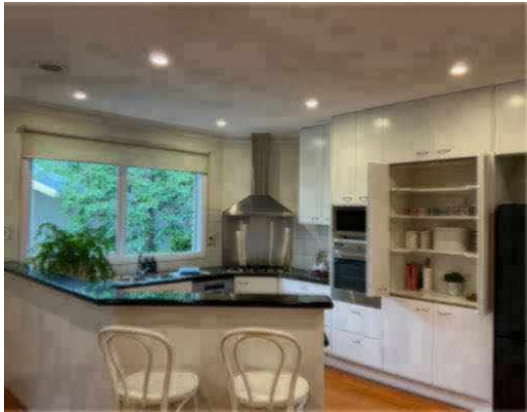
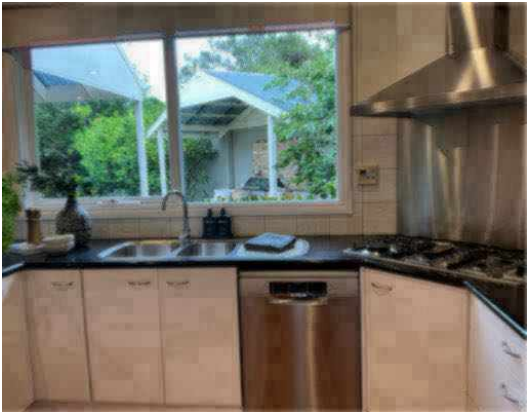
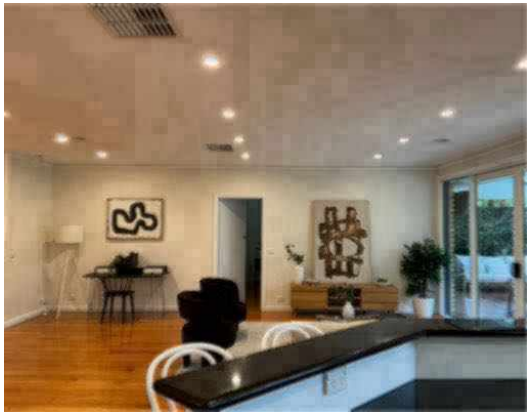
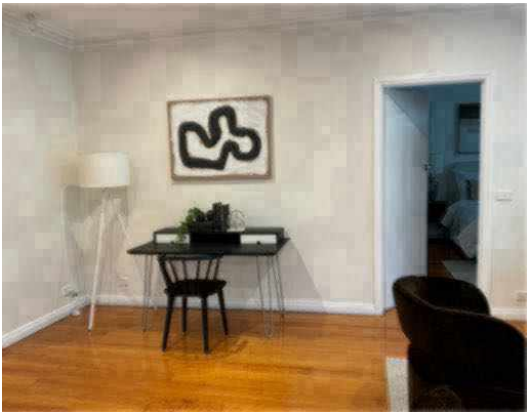
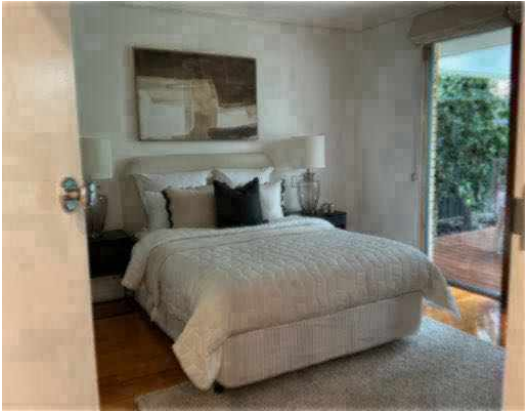
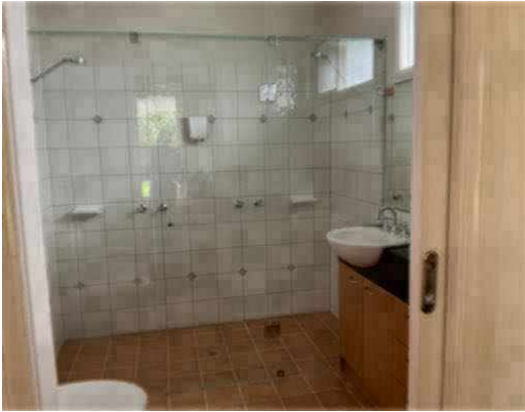
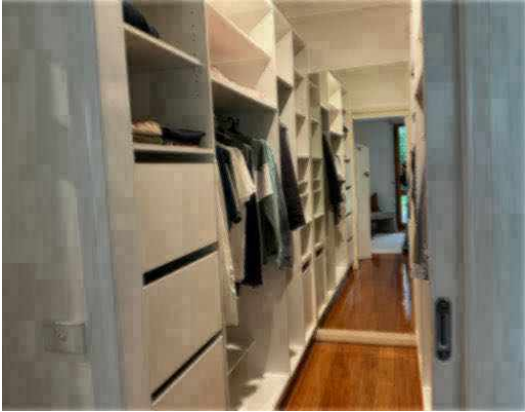
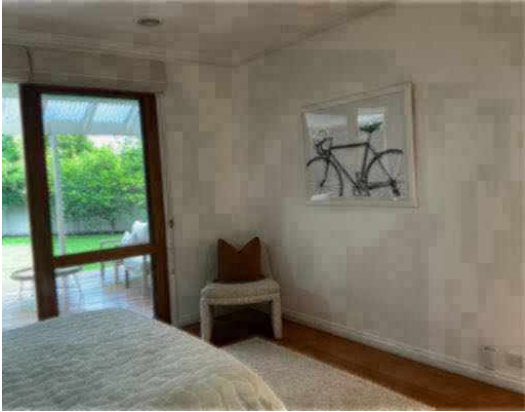
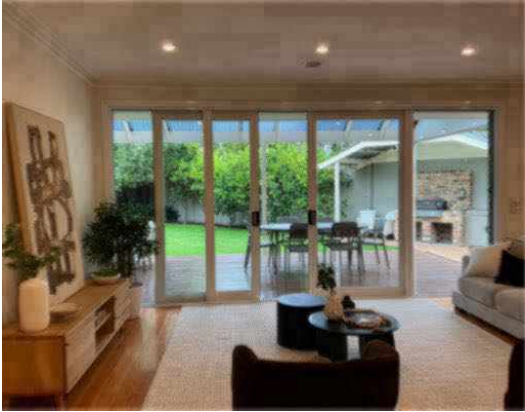
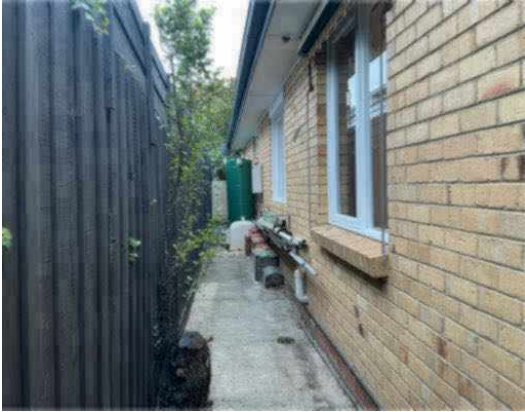
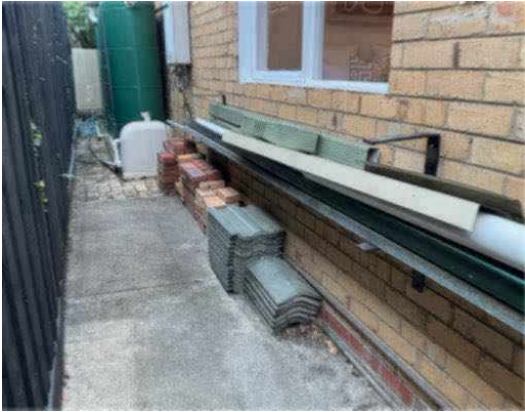
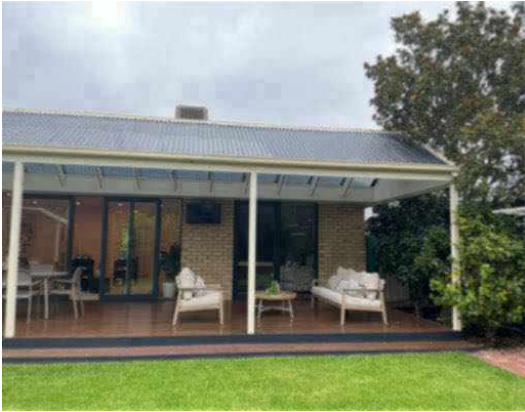
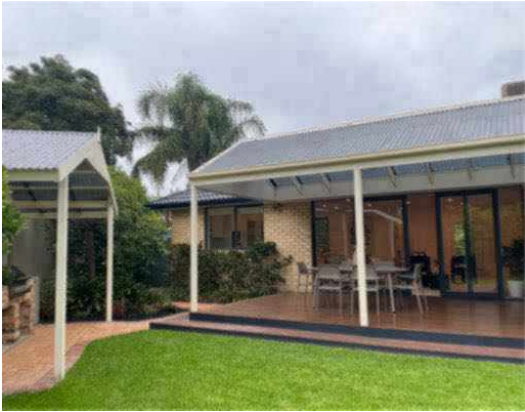
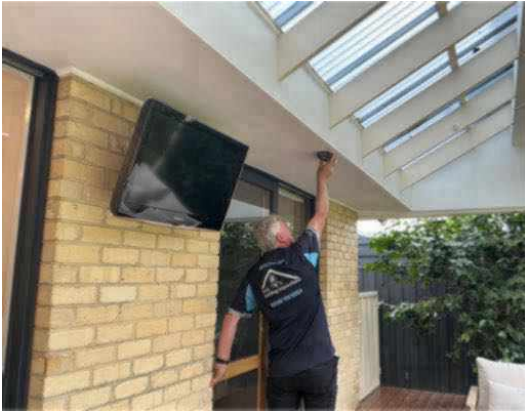
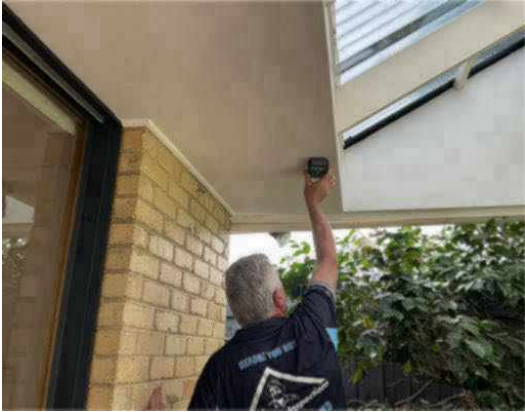
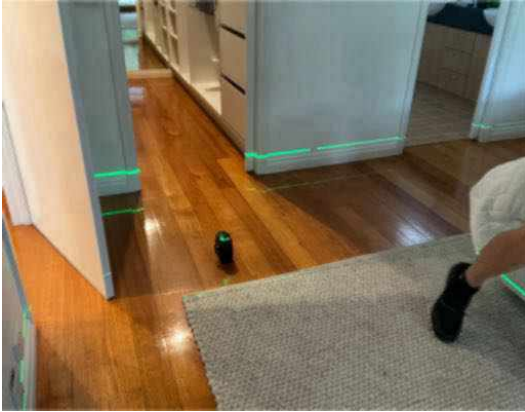
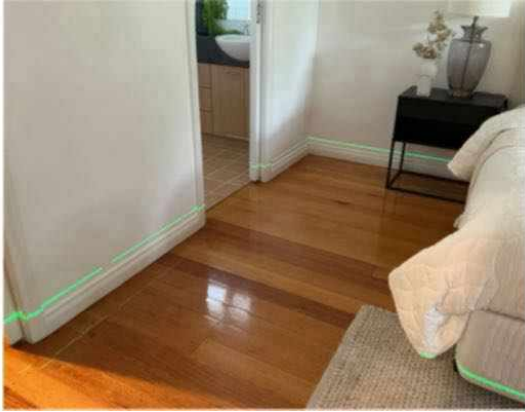
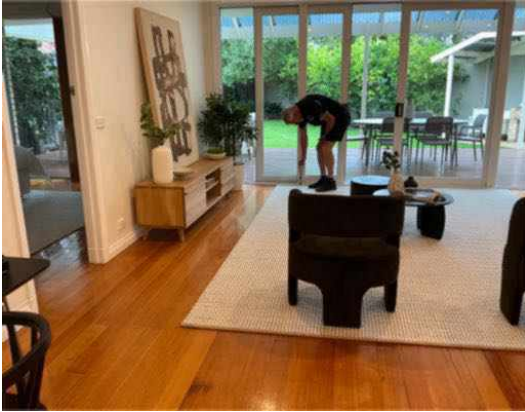
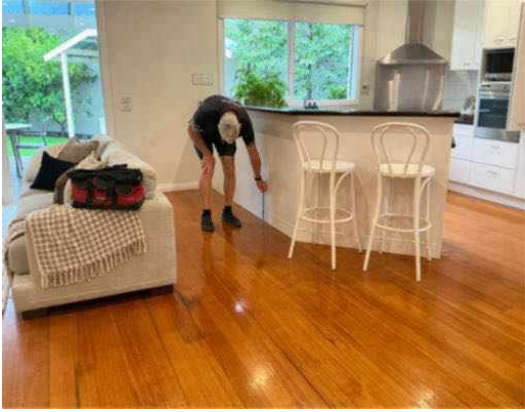
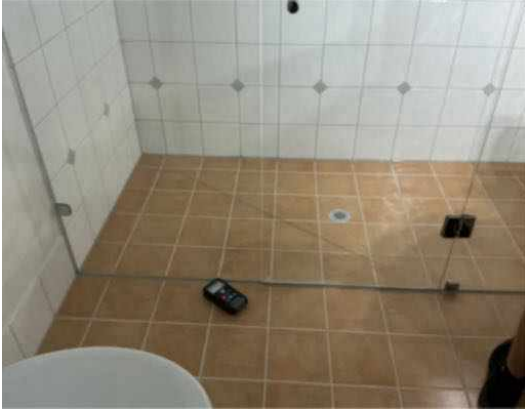
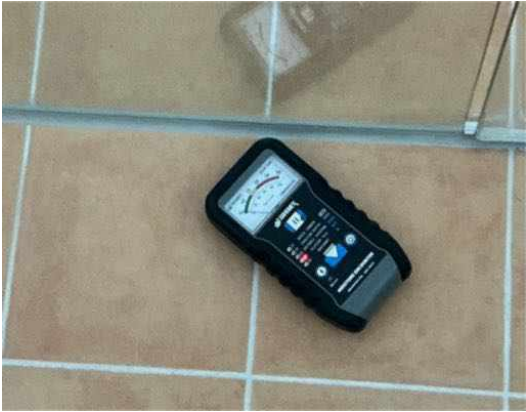
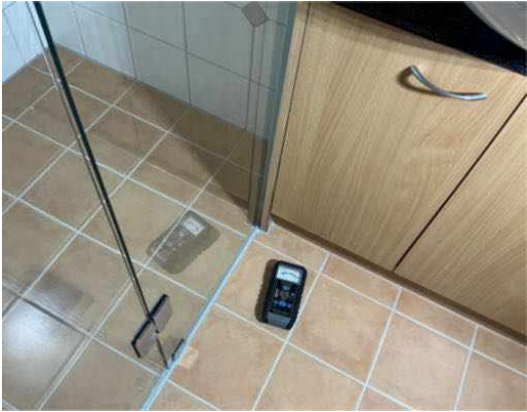
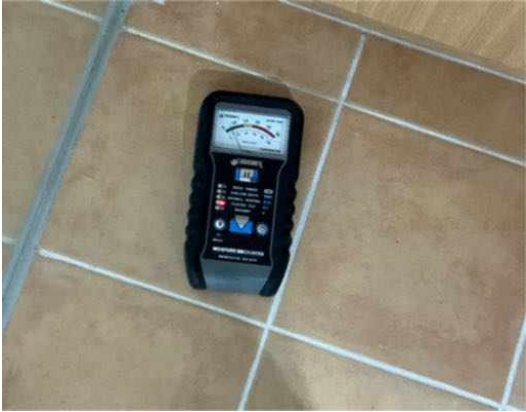
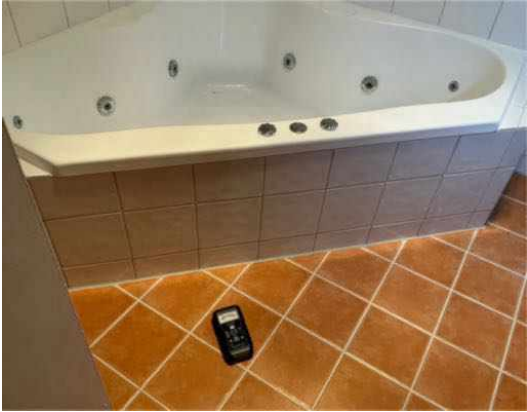
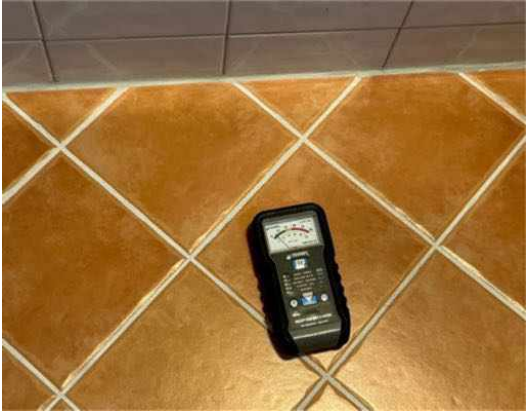
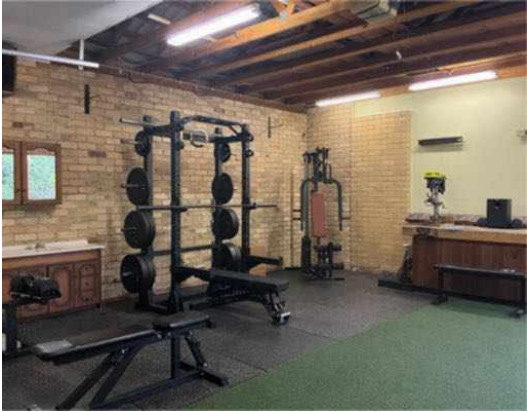
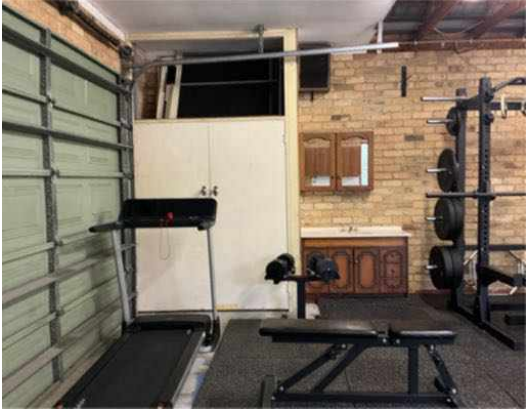
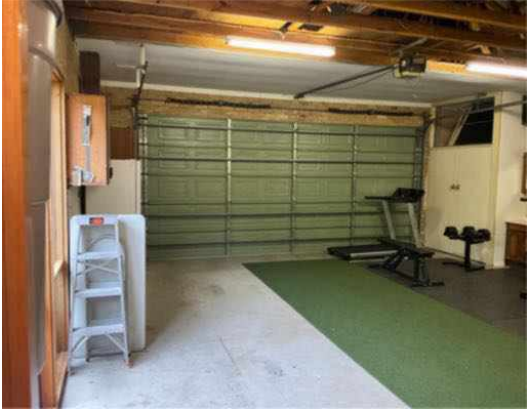
Building: Main Building
Location: All Areas
Finding: Additional Photos and Obstructions and Limitations
Information: These are additional photographs and photographs of the obstructions and limitations inside and outside (furniture, landscaping etc) which may impede full inspection of the property at the time of inspection. These obstructions can hide an array of defects and may be removed to allow full inspection to be carried out. A re-inspection may be made if clients require once the areas are made accessible.

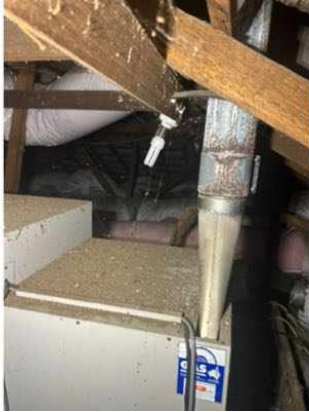
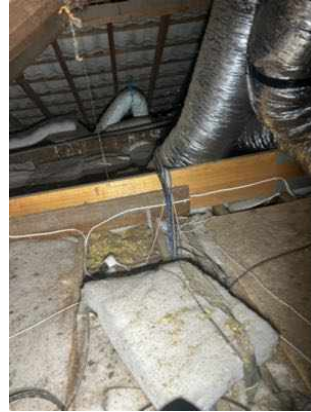
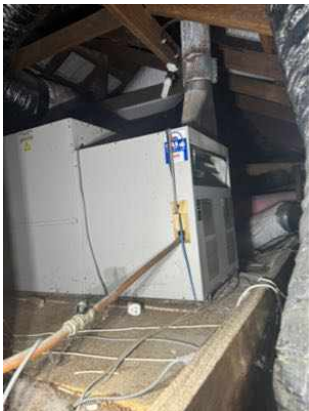
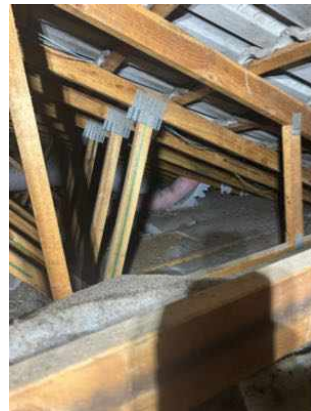
Building: Main Building
Location: All Areas
Finding: Additional Photos - Obstructions and Limitations
Information: These photographs are an indication of the obstructions and limitations which impeded full inspection of the property at the time of inspection. These obstructions can hide an array of defects and should be removed to allow full inspection to be carried out. A re-inspection is recommended once the areas are made accessible.

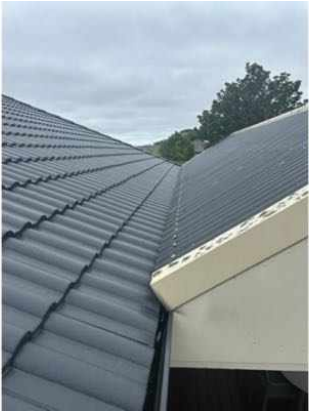
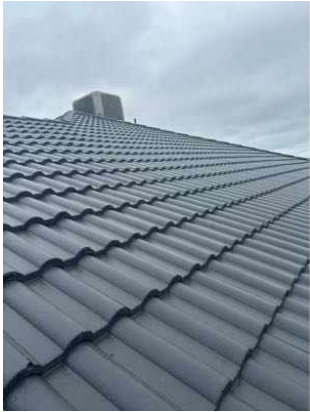
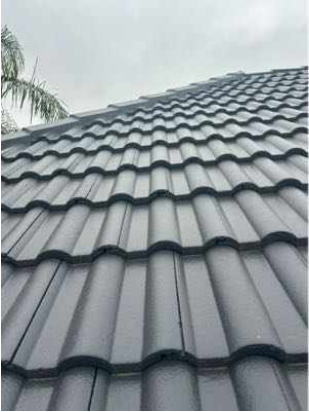
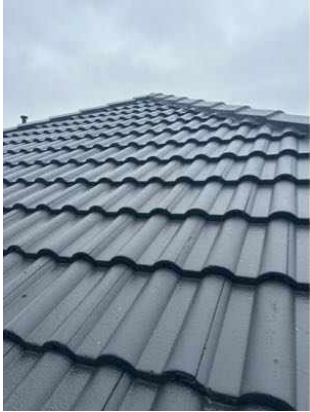
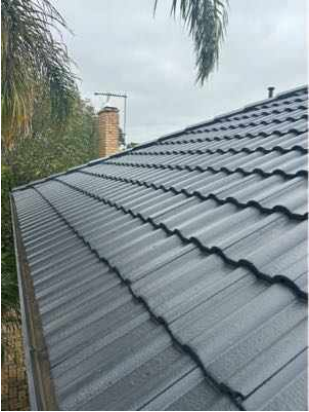
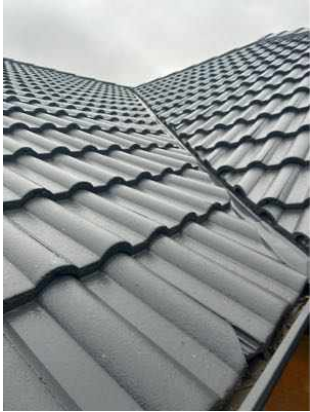
Building: Main Building
Location: Roof Exterior
Finding: Additional Photos
Information: Additional photos are provided for your general reference
