# Building and Timber Pest Inspection Report

Inspection Date: Tue, 10 Feb 2026

Property Address: 19 Cavendish St, CONCORD WEST, NSW,  
2138, Australia

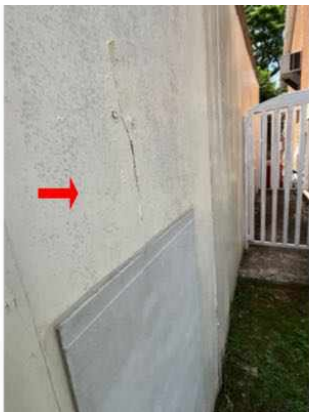
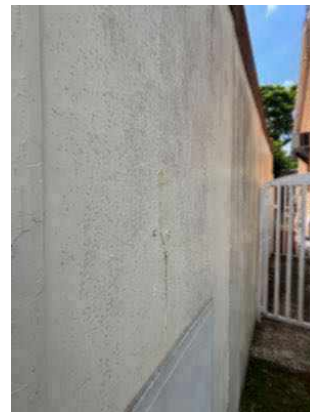
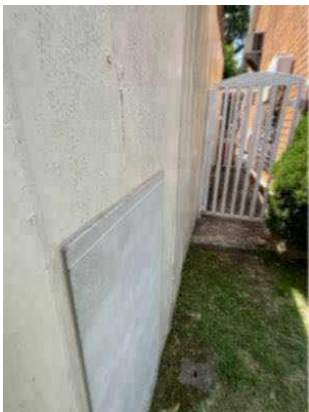
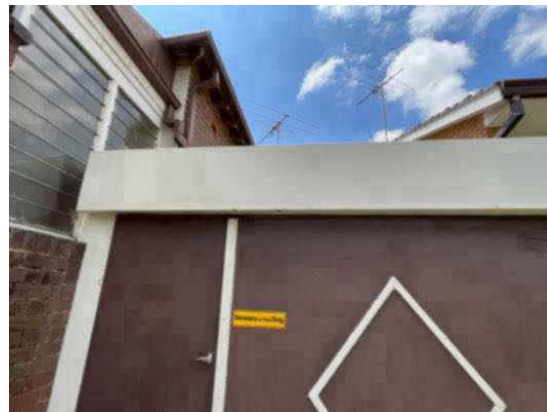
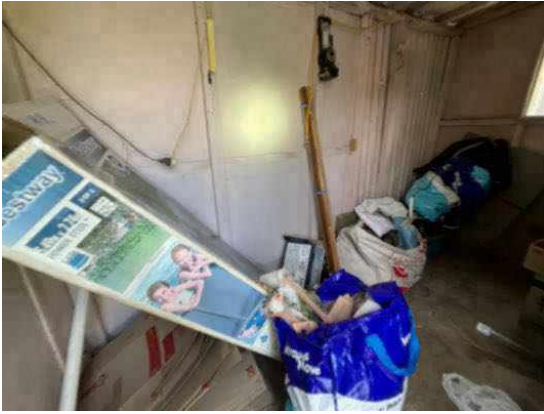
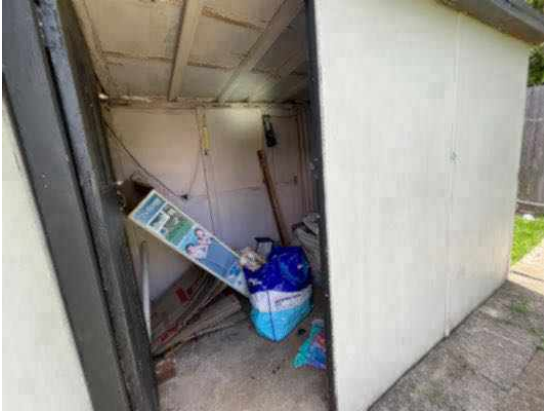
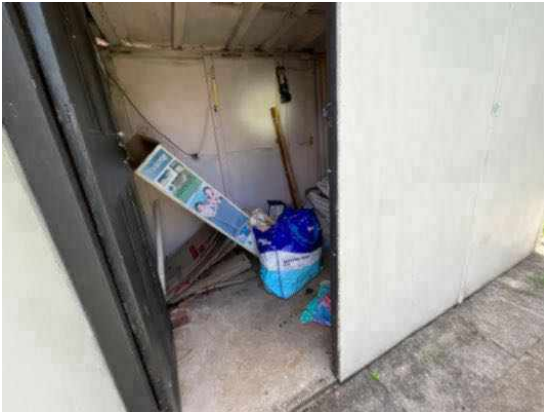
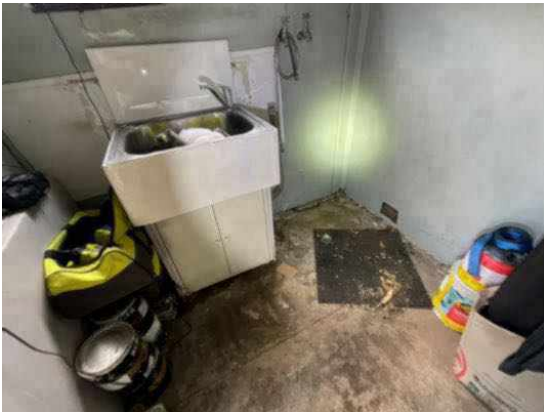
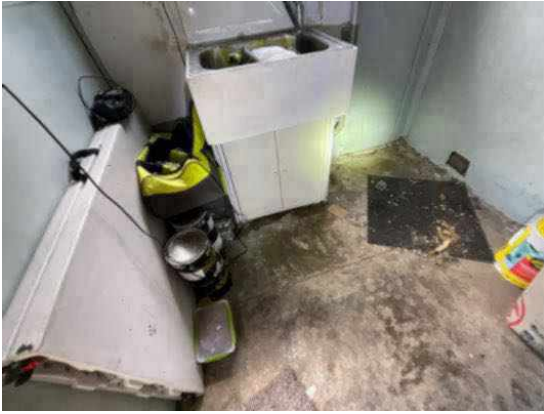
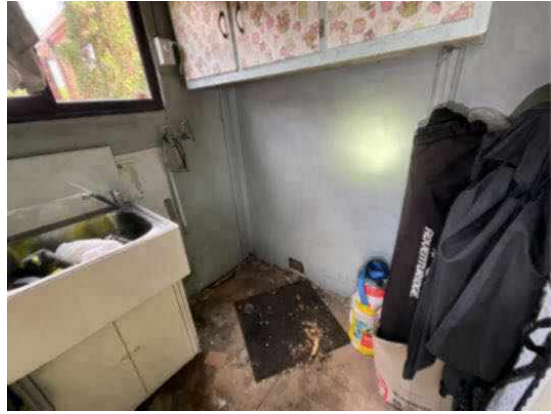
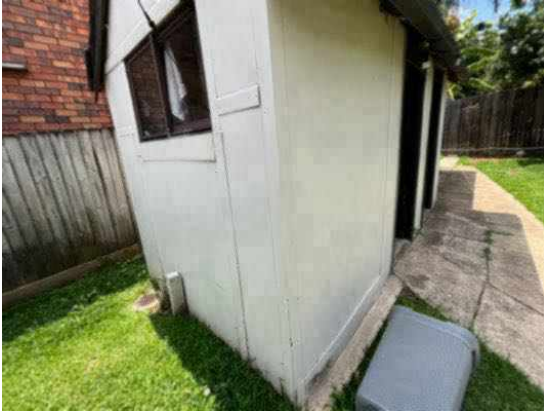
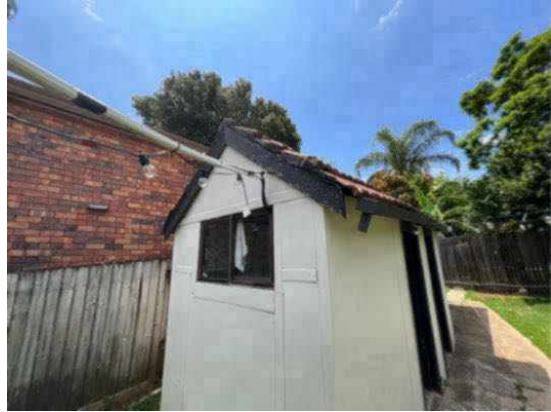
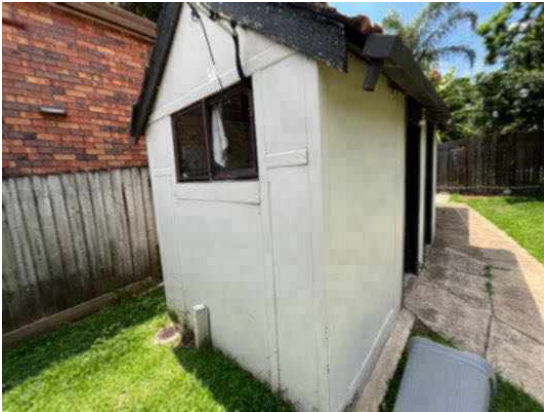
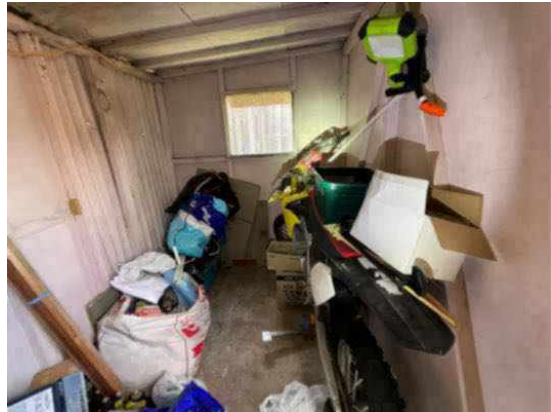
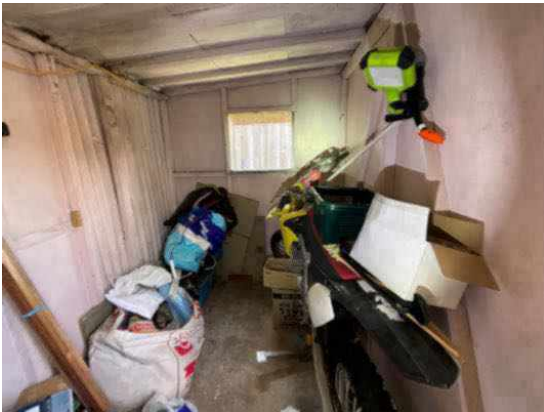
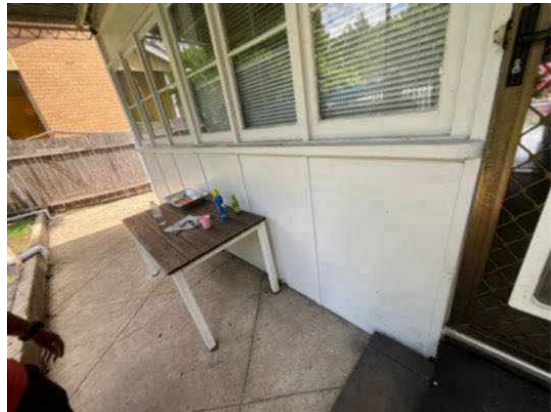
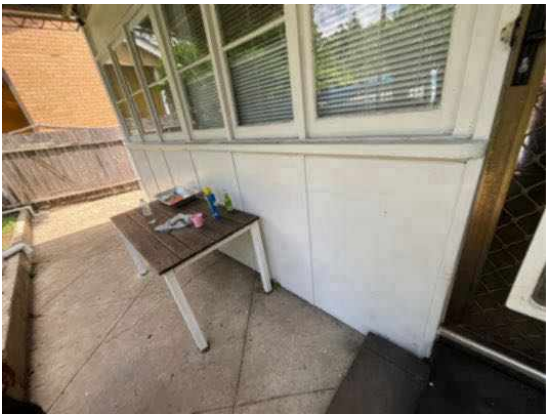
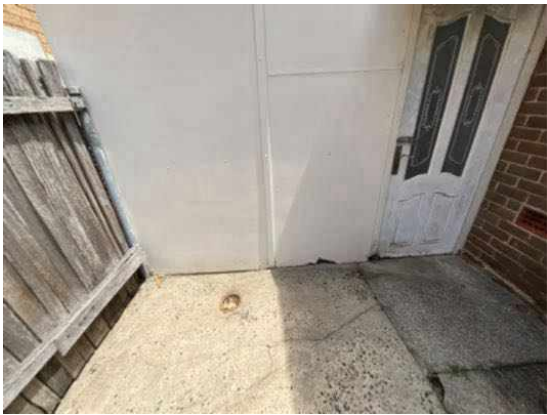
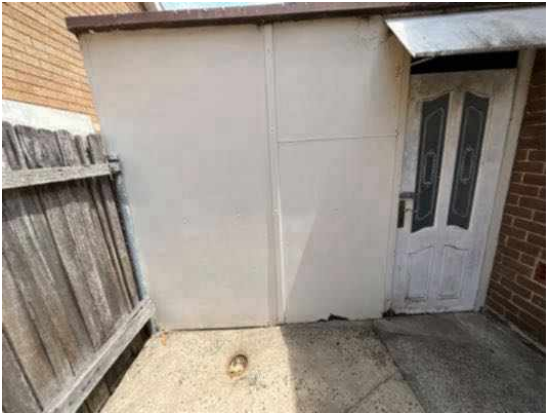
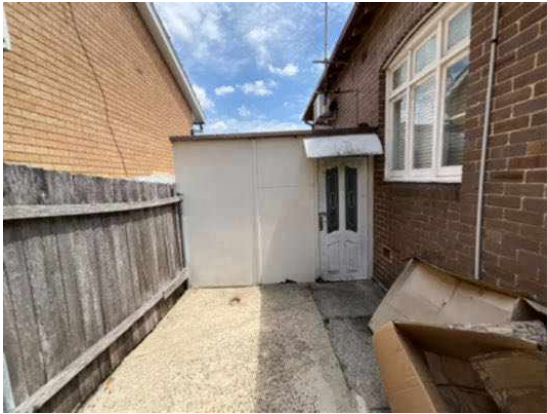
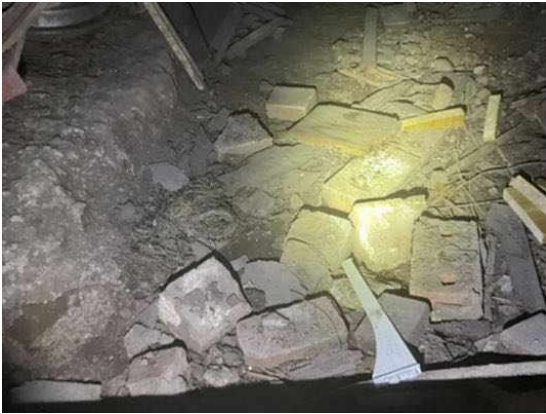
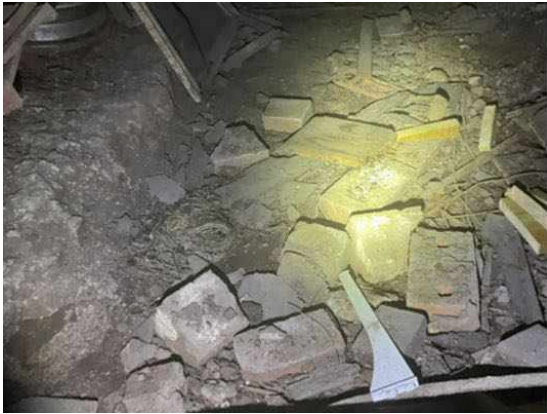
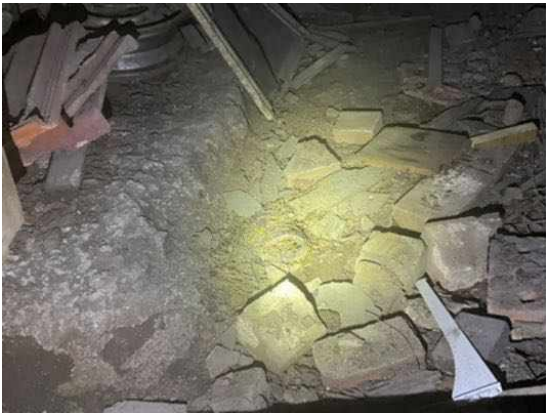
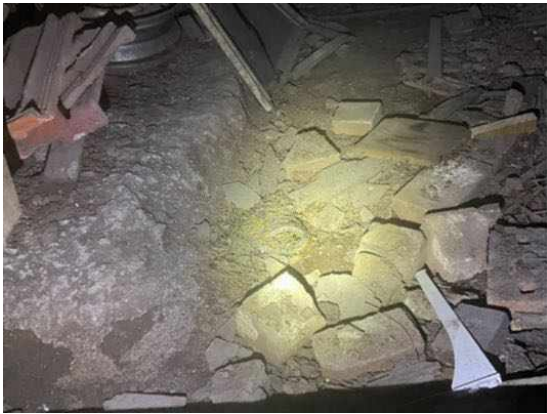
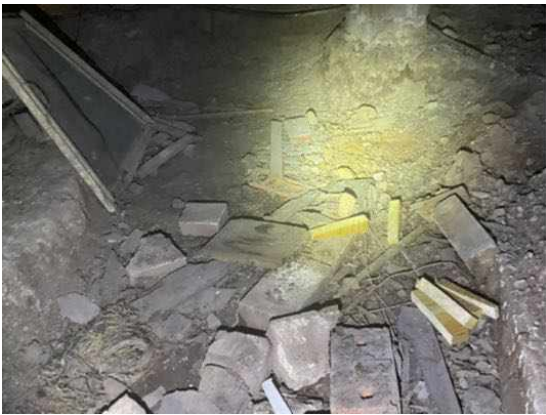
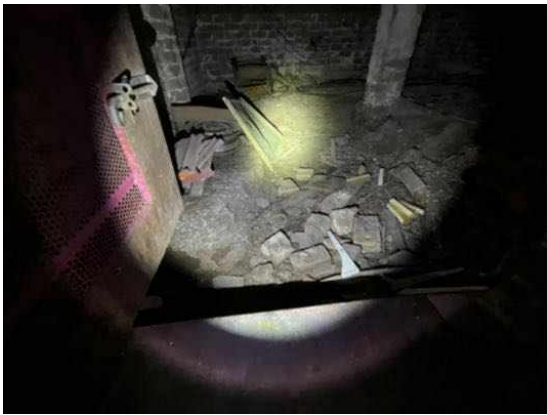
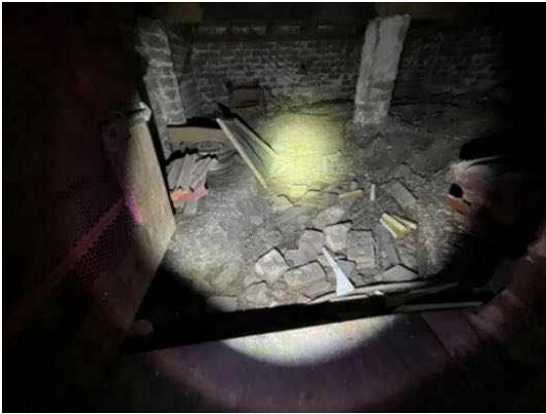
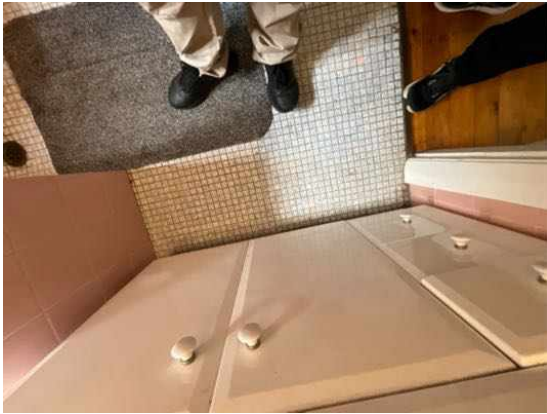
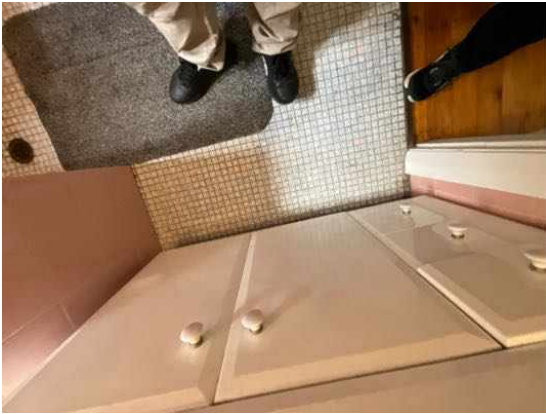
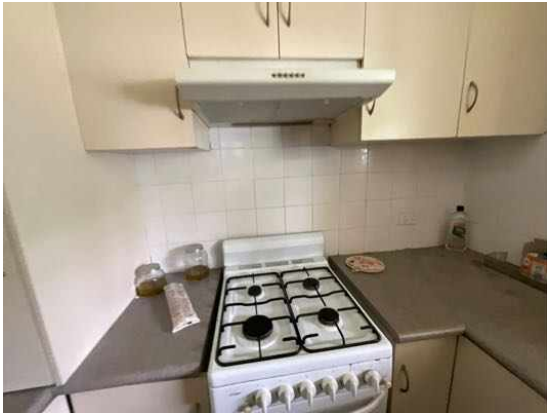
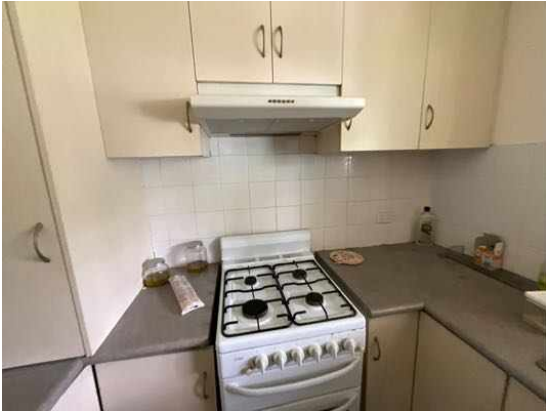
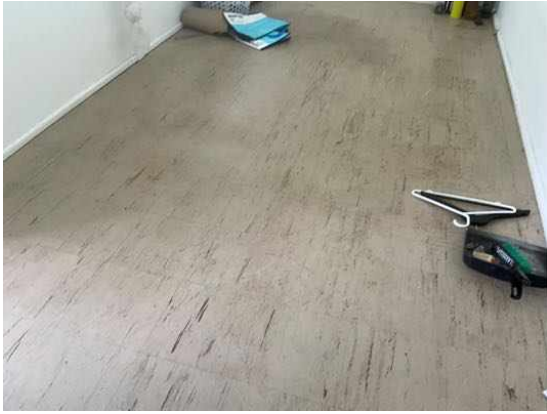
Building:	Main Building
Location:	All Areas
Finding:	Asbestos - Suspected ACM Identified on Site
Information:	Reporting on Asbestos is outside the Scope of this Report. This suspected defect is highlighted as a caution only. We suspect, based on our experience in the building industry, that there is a higher risk of the identified building element containing asbestos.

As Asbestos Reporting is outside the scope of this report, we advise that you consider a separate Asbestos Inspection and Condition Audit, which can include the taking of samples for definitive confirmation of the presence of Asbestos.

In the interim, the client is advised to act with caution, especially when considering any damage to building materials general wear and tear renovations extensions demolition and general maintenance activities due to the suspected presence of Asbestos.

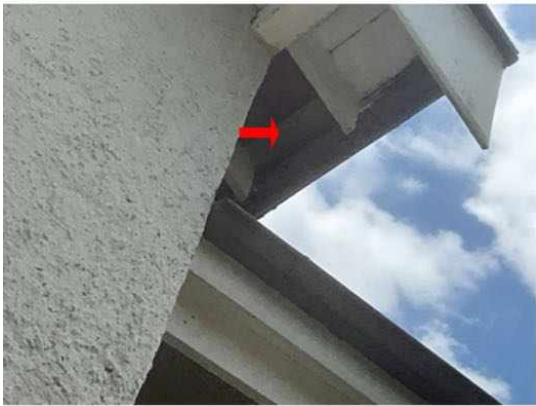
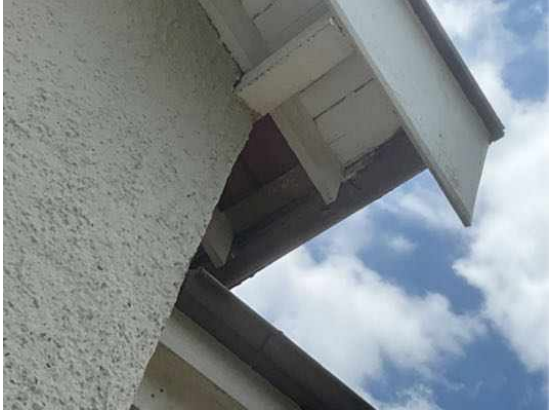
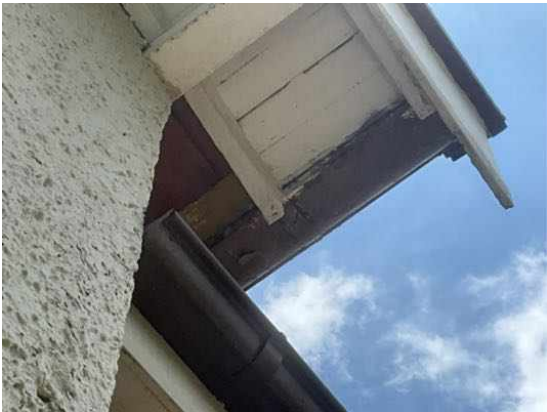
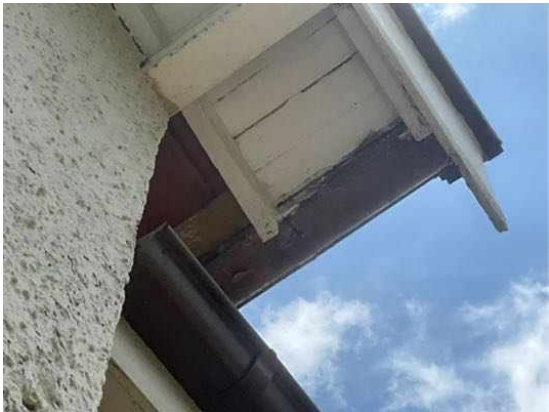
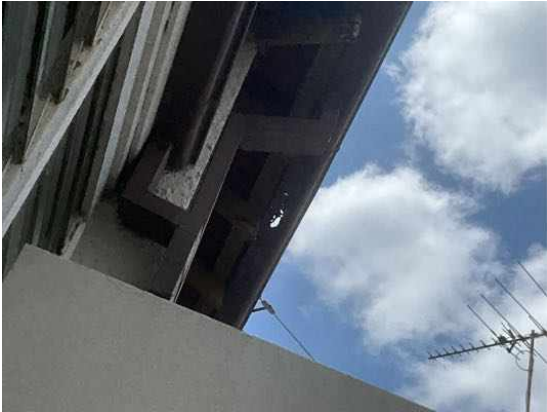
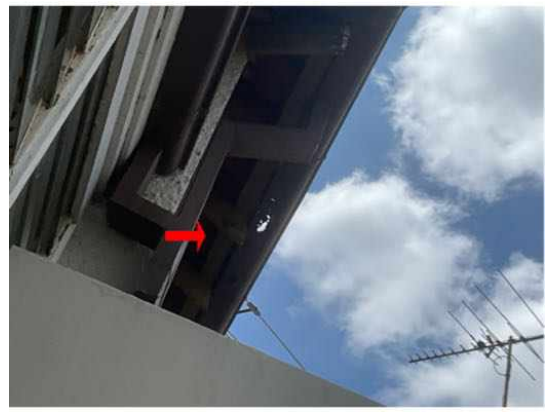
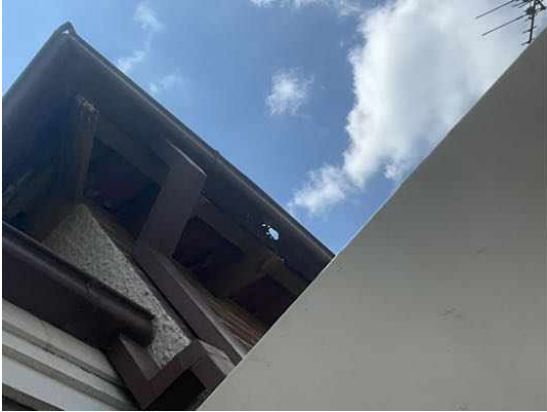
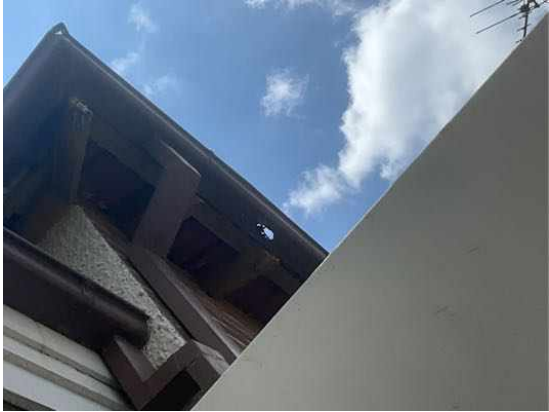
### Finding 2.02

Building:	Main Building
Location:	All Areas
Finding:	Rusty Gutters
Information:	The gutters exhibit signs of rust, including corrosion and discoloration, compromising their functionality and aesthetics.

**Risk:** Rusty gutters pose several risks, including reduced water drainage efficiency, potential water damage to the building's exterior and foundation, and aesthetic degradation. Corrosion weakens the structural integrity of the gutters, making them prone to leaks, cracks, and eventual failure. Inadequate water drainage can lead to water pooling around the foundation, causing erosion, moisture infiltration, and potential structural damage over time. Additionally, rust stains may detract from the curb appeal of the property, impacting its overall appearance and value.

A qualified gutter repair or maintenance professional should be engaged to address the issue. They can assess the extent of rust damage, recommend appropriate repair or replacement options, and perform necessary repairs to restore the functionality and integrity of the gutters. Depending on the severity of the rust, repairs may involve cleaning, sanding, patching, or replacing corroded sections of the gutters. Additionally, they may apply protective coatings or install gutter guards to prevent future rust formation and prolong the lifespan of the gutters. Regular gutter maintenance, including cleaning and inspection, can also help prevent rust and ensure

optimal performance.

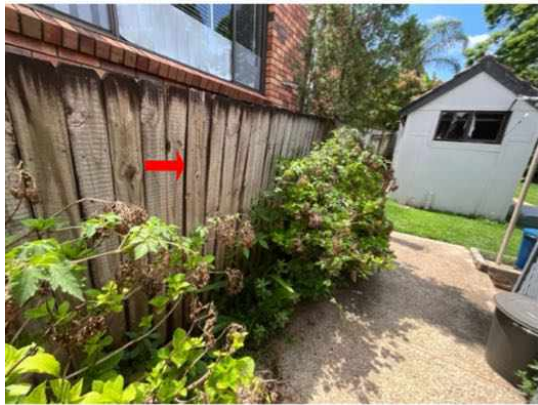
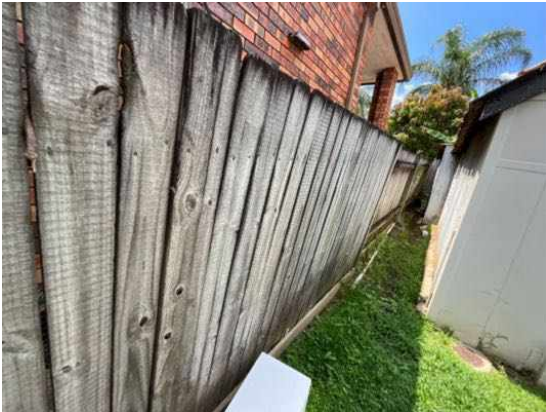
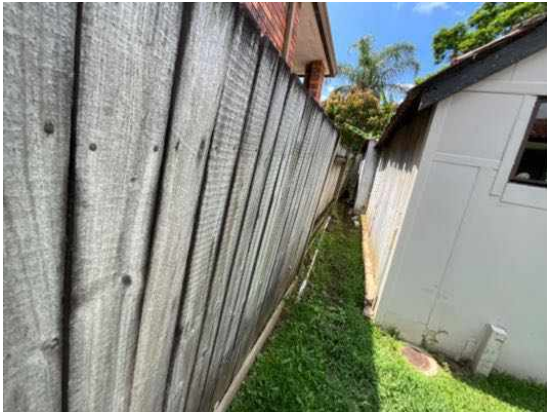
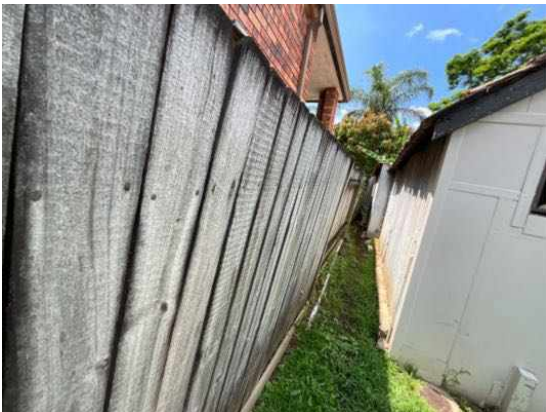
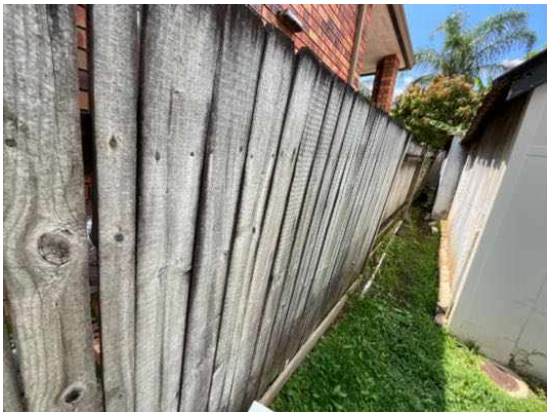
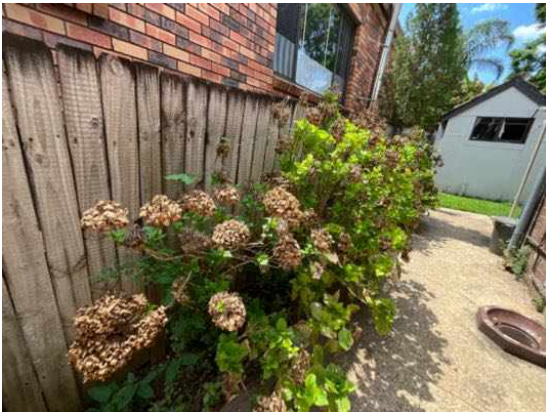
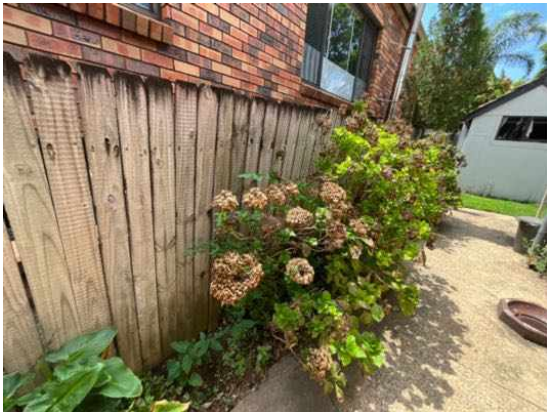
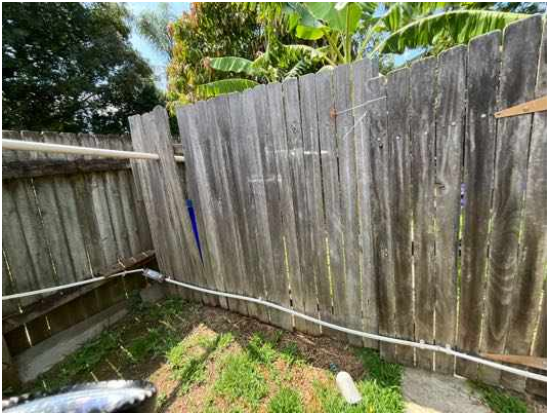
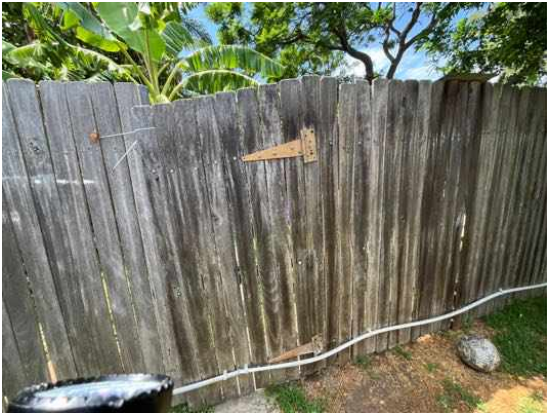
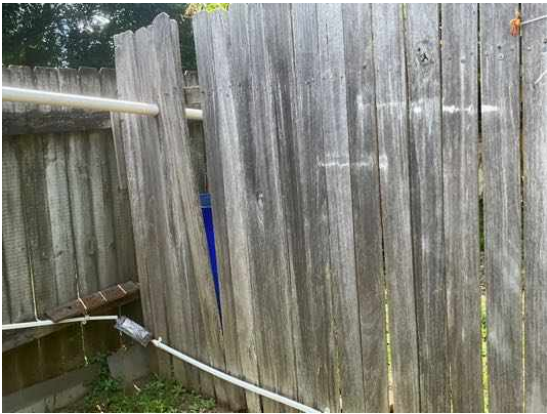
## Finding 2.03

Building:	Main Building
Location:	All Areas
Finding:	Deteriorated fence
Information:	The fence along the property boundary has deteriorated significantly, showing signs of rot, rust, and structural weakness. Several sections are leaning or have become detached, compromising the integrity of the fence and its ability to perform its intended function.

The deteriorated fence poses multiple risks:

1. **Safety Hazard:** The unstable fence may collapse, posing a risk of injury to residents, visitors, and passersby.
2. **Security Concern:** The compromised fence may allow unauthorized access to the property, increasing the risk of theft, vandalism, or trespassing.
3. **Property Damage:** Falling sections of the fence could damage nearby structures, plants, or other property features.
4. **Legal Liability:** If the fence were to fail and cause injury or damage to neighboring properties, the property owner may be held liable.

- **Licensed Fencing Contractor:** A professional fencing contractor should be hired to assess the extent of the damage and either repair or replace the deteriorated sections.
- **Handyman Services:** For minor repairs, a qualified handyman could be engaged to reinforce or repair specific sections of the fence.
- **Landscaper (if the fence is part of a larger garden feature):** If the fence is integrated into the landscape design, a landscaper with experience in fencing could be involved in the repair or replacement process.

It's important to ensure that whoever is hired is experienced and qualified to ensure the fence is restored to a safe and functional condition, compliant with local regulations.

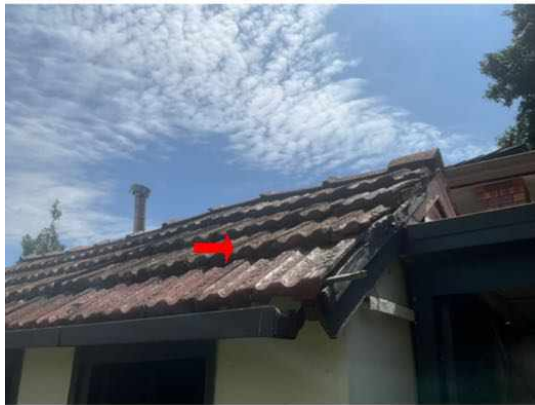
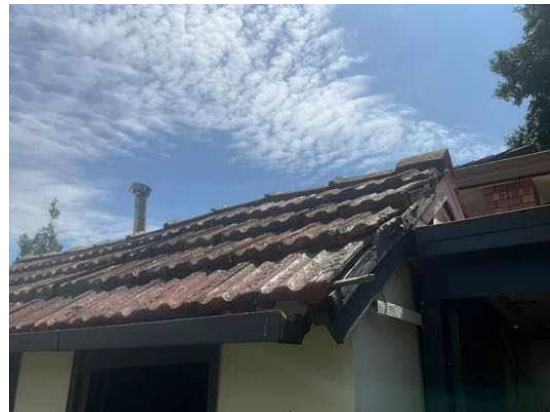
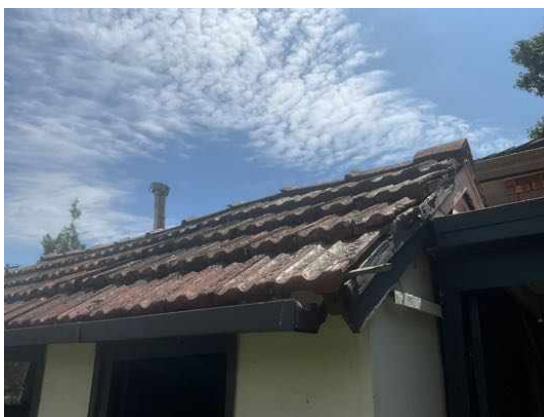
Building: Main Building  
 Location: Shed  
 Finding: Roof Weathered  
 Information: Upon inspection of the exterior roofing, the majority of roof was not in a fair condition. While weathering of the roof is consistent with the age of the property, maintenance works are required.

Isolated areas of mortar have come loose in the valleys and minor cracking is also present. Re-pointing and re-sealing the may be considered as an interim solution by the client to help preserve and extend the life span of the tiles.

Where left unmanaged, deteriorating roof are likely to lead to a number of secondary defects, including minor water leaks and weather exposure to internal roofing structures.

Consultation with a roofing contractor is highly advised to gain advice on cost of remedial works that may be required in the short to medium term. Remedial works are likely to increase the longevity of the exterior roofing structure.

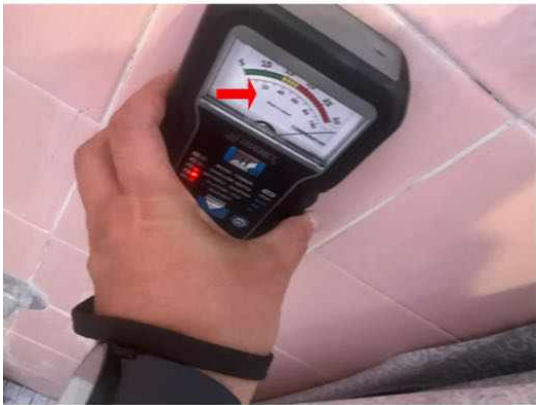
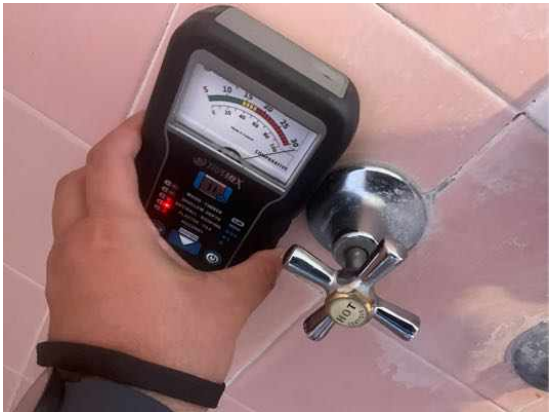
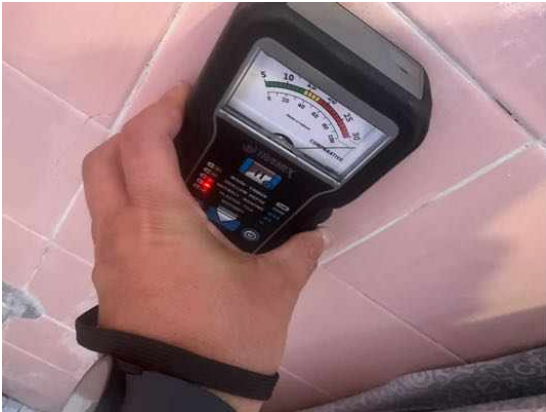
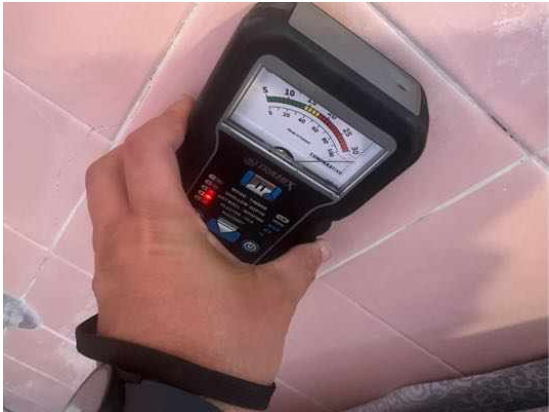
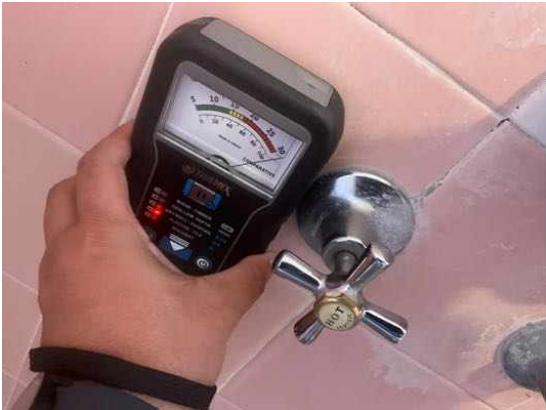
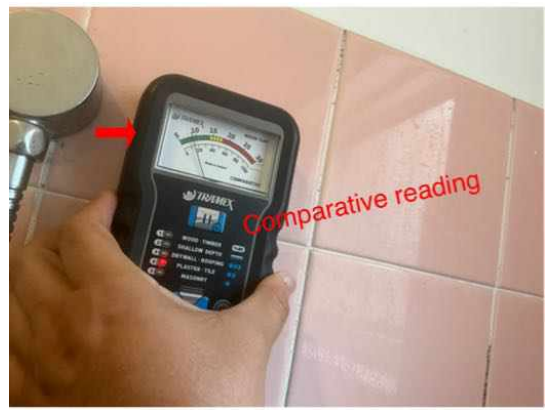
### Finding 2.05

Building: Main Building  
 Location: Bathroom

Finding: Evidence of excessive moisture was present at the time of inspection  
Information: Excessive moisture is present behind the bathroom tiles, indicating a potential water leakage issue within the wall.

The prolonged presence of moisture can lead to mold growth, deteriorate the structure, and create an environment conducive to health hazards. Additionally, it may compromise the adhesive holding the tiles, leading to their detachment.

A licensed plumber or a qualified contractor specializing in water damage remediation should investigate the source of the moisture, fix any leaks, and address the damage. Additionally, replacing affected tiles and ensuring proper waterproofing are crucial to preventing future issues.

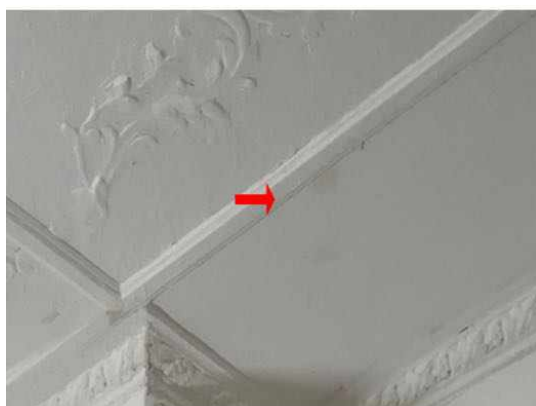
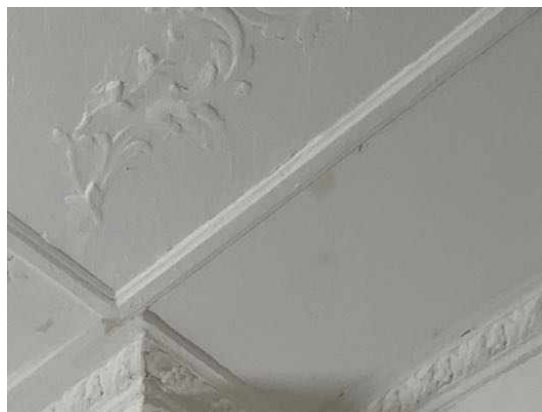
## Finding 2.06

Building:	Main Building
Location:	Bedroom 3
Finding:	Water staining
Information:	Water staining was evident in this area at the time of inspection. Water staining indicates that surfaces have been exposed to excessive moisture over time. The minerals and other elements in the water lead to staining, which may graduate to corrosion and deterioration if left unmanaged.

While mostly an appearance defect, water staining can be indicative of more serious defects, which may be currently concealed by other building elements.

Where water staining is active, a licensed plumber must be consulted to identify the cause of the staining and to provide advice on any reparation works that may be required. Replacement of any broken or damaged structures is advised.

Conversely, where water staining is old and inactive, affected building materials may be repaired or replaced at client discretion. A qualified carpenter or registered builder may be appointed to perform these works.

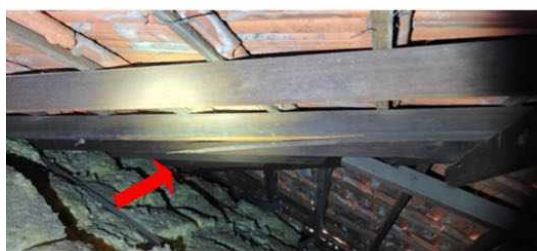
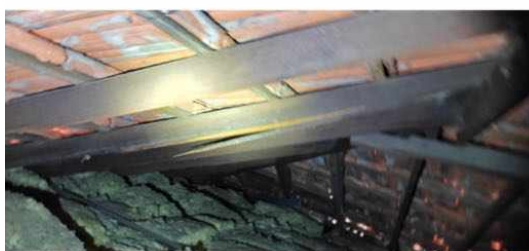
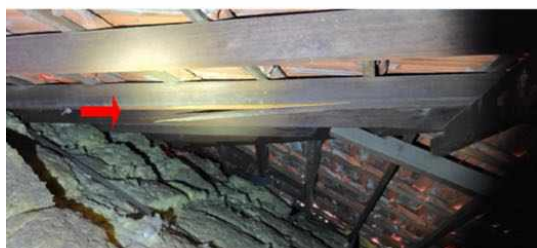
## Finding 2.07

Building:	Main Building
Location:	Roof Void
Finding:	Roof void - Cracked Roof Member
Information:	A timber member of the roof within the roof cavity has sustained a significant crack and splitting, compromising its ability to adequately support roof loads.

The damage impacts the structural integrity of the roof framing system. According to AS 4349.1, such a defect is considered a major structural defect, as it may result in loss of structural strength or stability. Failure to rectify could lead to roof sagging,

deformation, or collapse under load conditions, posing a safety hazard to occupants and risking further property damage.

It is strongly recommended that a licensed structural engineer assess the extent of the defect to determine whether the affected member can be repaired or must be replaced. Rectification should be carried out by a qualified builder or roof truss specialist following the engineer's direction.

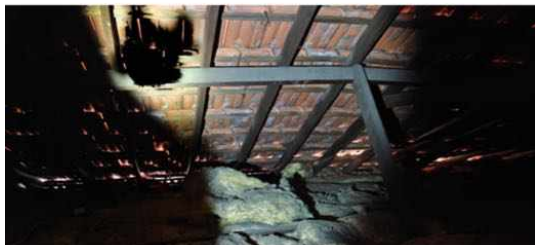
## Finding 2.08

Building:	Main Building
Location:	Roof Void
Finding:	Roof Void - Evidence of batten movement
Information:	Evidence of batten movement and visible daylight through the roof covering was observed from within the roof void. Several roof battens appear to have shifted or become dislodged from their original positions.

This condition compromises the structural integrity of the roof, as battens are essential for supporting roof tiles or sheeting. Movement or displacement can result in roof tile failure, leading to water ingress and potential damage to internal building elements,

including insulation, ceiling linings, and electrical wiring. It also increases the risk of wind uplift or progressive roof failure in severe weather conditions.

A licensed roofing contractor or qualified builder should be engaged urgently to assess the full extent of structural batten movement and carry out remedial works. This may include re-fixing or replacing battens, ensuring all roofing elements are adequately secured, and checking for any related structural damage.

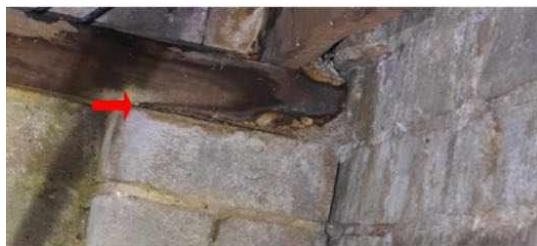
## Finding 2.09

Building:	Main Building
Location:	Subfloor
Finding:	Subfloor- Wood Rot in Bearer and Joist
Information:	The bearer and joist in the subfloor show significant wood rot, which has compromised the structural integrity of the timber. Wood rot typically occurs due to prolonged exposure to moisture, and in this case, it has led to severe decay, weakening the timber and reducing its load-bearing capacity. This deterioration poses a critical risk to the overall stability of the floor structure.

- **Structural Risk:** High risk of structural failure in the affected area due to compromised load-bearing capacity. If left unaddressed, this could lead to sagging, uneven floors, or even collapse in extreme cases.
- **Safety Risk:** Elevated safety risk for occupants, as a weakened subfloor could fail under load, posing a potential hazard.
- **Moisture and Decay Propagation Risk:** The presence of rot in the timber can spread if the source of moisture is not addressed, potentially affecting adjacent timbers and leading to widespread damage.

This defect should be classified as a major defect due to the severe impact on structural integrity and safety. Immediate action is required to rectify the issue and maintain the building's stability.

- **Engage a Licensed Carpenter or Structural Engineer:** A qualified carpenter or structural engineer should assess the extent of the damage and replace the affected bearer and joist. They will ensure the replacement timbers are adequately treated and installed to meet structural standards.
- **Address Moisture Source:** It is critical to identify and eliminate the moisture source contributing to the wood rot. Improving subfloor ventilation, repairing leaks, or installing a moisture barrier may be necessary to prevent future decay.

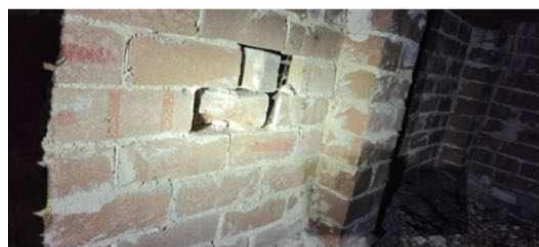
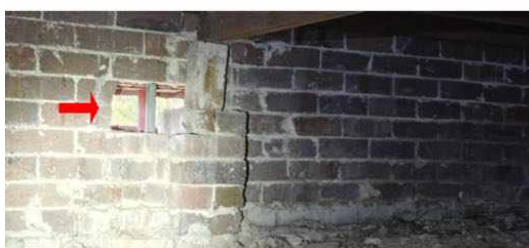
### Finding 2.10

Building:	Main Building
Location:	Subfloor
Finding:	Subfloor - Substandard Works
Information:	Evidence of substandard construction and repair work in the subfloor area. This includes poorly constructed and uneven brick piers, use of inappropriate materials, and a general lack of structural integrity in the support system.

- **\*\*Structural Failure:\*\*** The inadequate support from substandard construction could lead to uneven settling, sagging floors, or even collapse of the structure above.

- **Safety Hazard:** The compromised subfloor structure poses a significant risk of injury to occupants and anyone accessing the subfloor area for maintenance.

- **Further Damage:** Substandard repairs may not effectively address underlying issues, leading to progressive damage and increased repair costs over time.

- **Structural Engineer:** A structural engineer should be consulted to assess the extent of the substandard work and to design an appropriate remediation plan.

- **Professional Contractor:** Following the structural engineer's recommendations, a professional contractor with experience in foundation and subfloor repairs should be hired to perform the necessary corrective work to bring the subfloor up to standard.

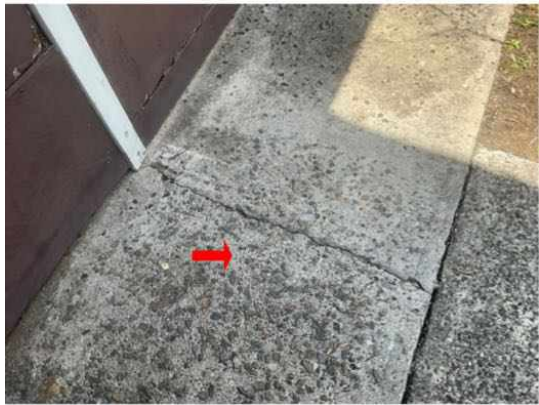
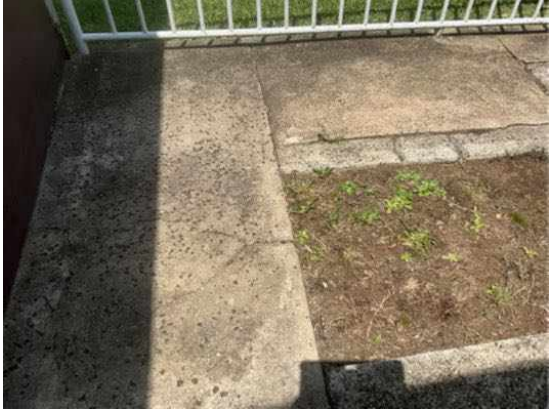
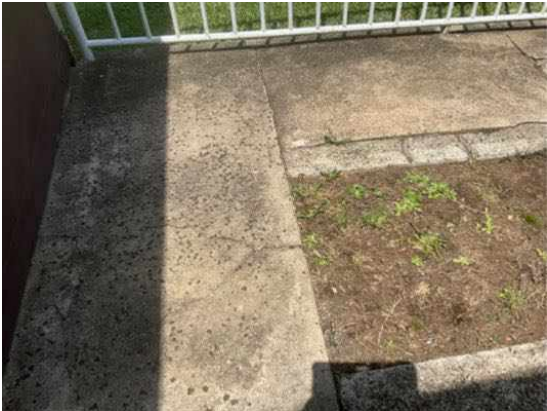
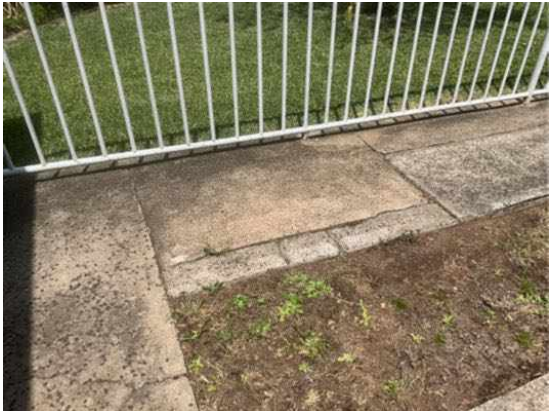
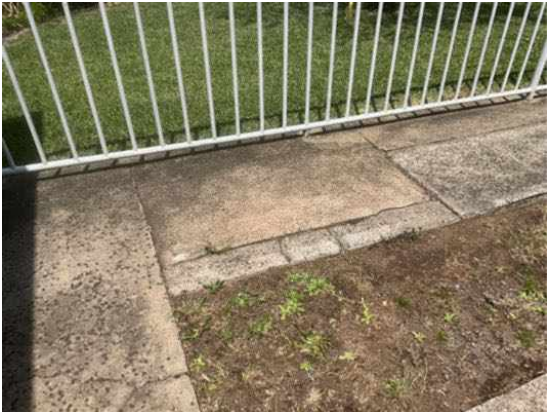
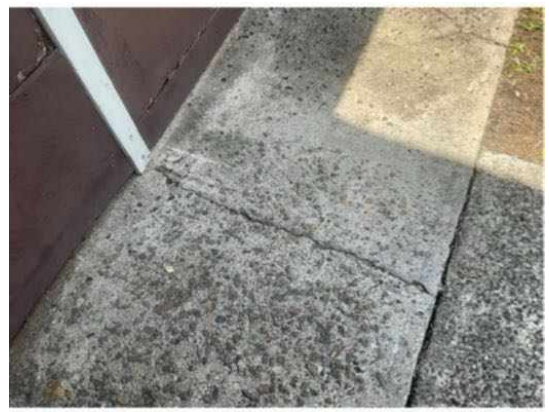
Building:	Main Building
Location:	All Areas
Finding:	Noticeable Cracking in Concrete Slab
Information:	Noticeable cracking has been observed in the concrete slab, failing to meet the required construction and quality standards.

- .
- Cracks are visible on the surface and may extend through the depth of the slab.
- Evidence of improper curing or inadequate reinforcement leading to cracking.

- Compromised structural integrity of the slab, potentially leading to failure under load.
- Water ingress through cracks, causing corrosion of reinforcement and further weakening the structure.
- Potential trip hazards and aesthetic issues, reducing the overall value and safety of the property.
- Increased maintenance and repair costs due to ongoing deterioration.

- A structural engineer should be engaged to assess the extent of the cracking and recommend appropriate repair methods.

- A licensed contractor or concrete repair specialist should carry out the recommended repairs under the guidance of the structural engineer.

A detailed inspection should be conducted post-repair to confirm compliance with the required standards and to ensure that the structural integrity of the concrete slab has been restored.

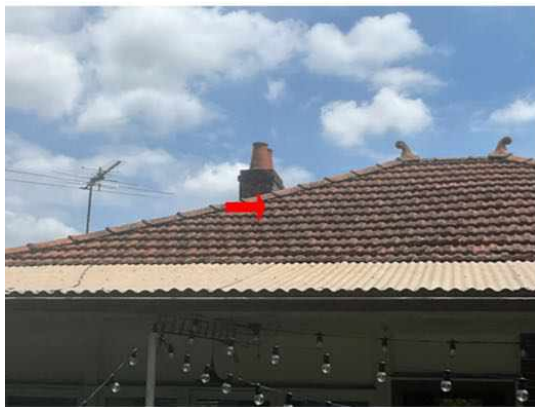
Finding 3.02

Building: Main Building  
 Location: All Areas  
 Finding: Roof Weathered  
 Information: Upon inspection of the exterior roofing, the majority of roof was not in a fair condition. While weathering of the roof is consistent with the age of the property, maintenance works are required.

Isolated areas of mortar have come loose in the valleys and minor cracking is also present. Re-pointing and re-sealing the may be considered as an interim solution by the client to help preserve and extend the life span of the tiles.

Where left unmanaged, deteriorating roof are likely to lead to a number of secondary defects, including minor water leaks and weather exposure to internal roofing structures.

Consultation with a roofing contractor is highly advised to gain advice on cost of remedial works that may be required in the short to medium term. Remedial works are likely to increase the longevity of the exterior roofing structure.

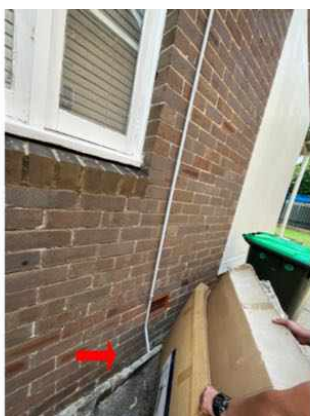
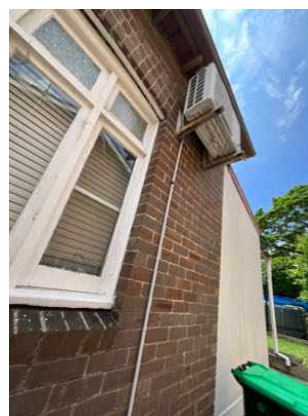
### Finding 3.03

Building: Main Building  
 Location: Exterior walls - right side

Finding: Air conditioner - Disconnected overflow  
 Information: The Air Conditioner (A/C) overflow was found to be disconnected from storm water drainage and is creating excessive moisture in the surrounding area.

Such leaking creates an environment which is conducive to an array of defects, including water damage to associated building elements and the attraction of termite or timber pest infestation.

It is highly recommended that a licensed plumber be appointed to connect the A/C overflow in order to prevent such an environment from being created. These minor works should be carried out as soon as possible.

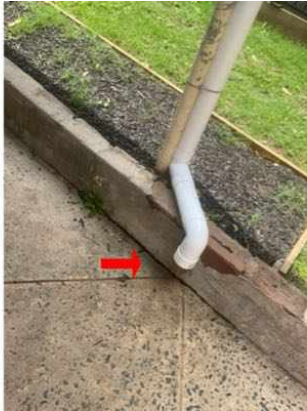
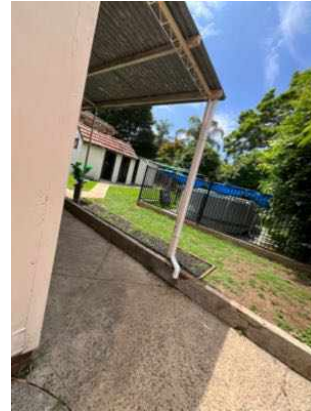
### Finding 3.04

Building: Main Building  
 Location: Pergola  
 Finding: Disconnected downpipe  
 Information: A notable defect with a disconnected downpipe, compromising the efficient drainage of rainwater from the roof. This disconnectivity poses an increased risk of water accumulation, potentially leading to foundation erosion, water damage to the property, and a conducive environment for mold growth.”

1. Foundation Erosion: Accumulated water around the foundation due to the disconnected downpipe can lead to soil erosion, jeopardizing the stability of the property's foundation.
2. Water Damage: Uncontrolled water runoff can result in water penetrating the building envelope, causing interior water damage to walls, ceilings, and other structural components.
3. Mold Growth: The presence of excess moisture provides an ideal environment for mold growth, posing health risks and necessitating costly remediation.

Engage a qualified and licensed roofing or gutter specialist to address the disconnected downpipe. This professional will reconnect the downpipe to ensure proper water drainage, mitigating the associated risks and preserving the integrity of the property.

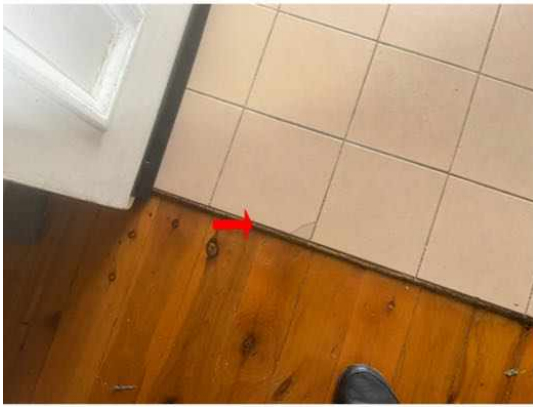
### Finding 3.05

Building: Main Building  
 Location: Front porch  
 Finding: Floor Tile crack  
 Information: A floor tile has a visible crack on the surface.

The damaged tile presents a trip hazard, may lead to cuts if stepped on barefoot, and can allow moisture ingress into the substrate, which may cause further deterioration or loosening of adjacent tiles. It also affects the overall appearance of the floor.

A licensed tiler should be engaged to remove the damaged tile and install a matching replacement. If spare tiles are unavailable, additional remedial work may be required to blend the repair with surrounding finishes.

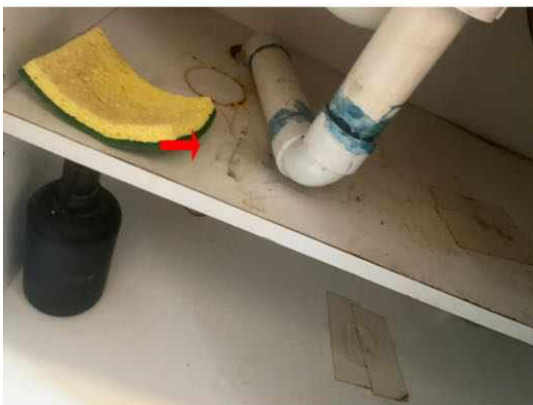
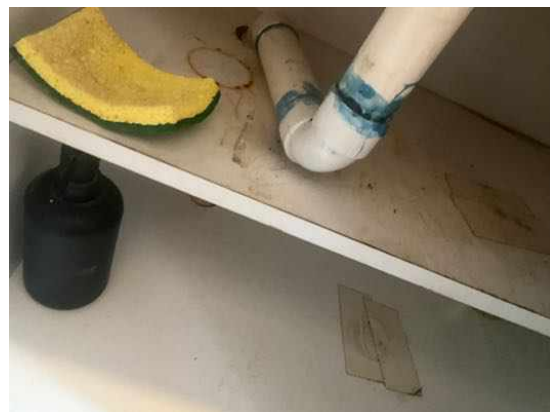
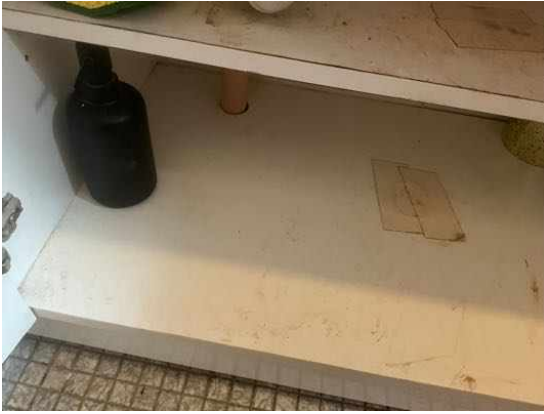
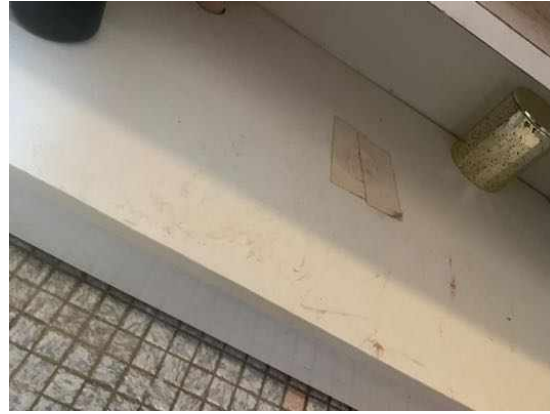
### Finding 3.06

Finding: Water damage / Vanity

Information: "The vanity in the shower area has sustained water damage, resulting in swelling and discoloration of the wood, as well as potential structural issues. This damage compromises both the aesthetic and functional aspects of the vanity."

1. **Carpenter or Woodworker:** They can assess and repair the damage to the vanity, potentially replacing any irreparable parts.
2. **Plumber:** If the water damage is due to plumbing issues, a plumber can fix leaks and ensure there are no further water-related problems.
3. **General Contractor:** If the damage is extensive and affects the surrounding area, a general contractor can coordinate the repair work, including both the vanity and any related structural or cosmetic repairs.
