# Building and Timber Pest Inspection Report

Inspection Date: Tue, 10 Feb 2026

Property Address: 19 Cavendish St, CONCORD WEST, NSW,  
2138, Australia

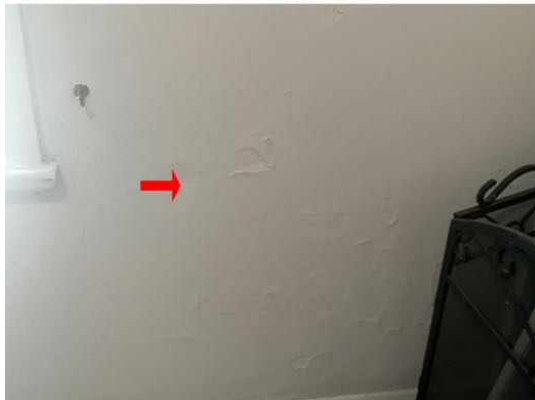
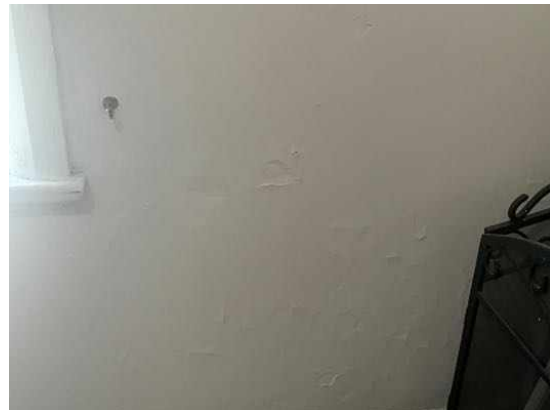
### Finding 3.07

Information: Sections of the paint in this area was found to have deteriorated. Paint deteriorating is generally an indication of excessive moisture in the area that is currently hidden by the painted surface.

The presence of excessive moisture can have major implications on associated building elements if left unattended. While only seemingly minor at this stage, the damage cannot be determined due to the paint, obstructing any further inspection of the damage.

It is highly advised that the affected paint to be cleaned to allow a further, more invasive inspection by a licensed builder/painter. Failure to act on this defect may necessitate major works in the future.

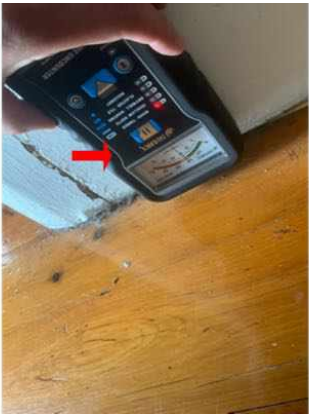
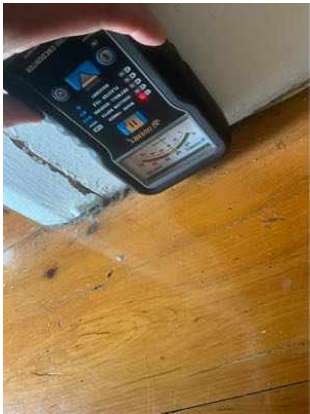
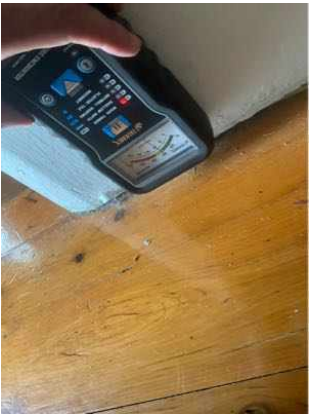
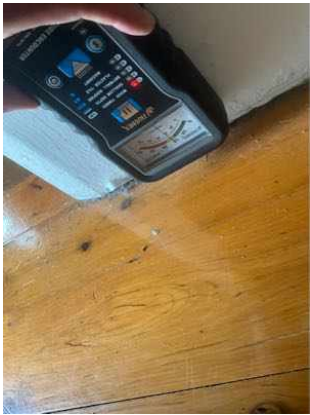
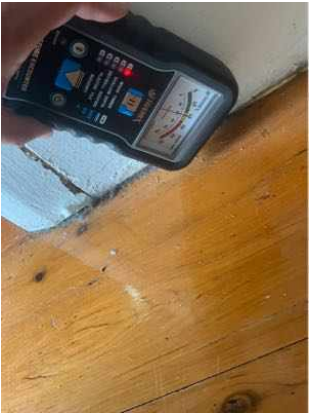
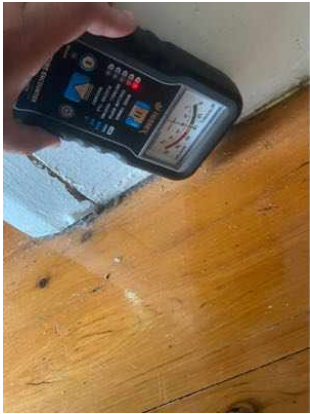
### Finding 3.08

Building:	Main Building
Location:	All Areas
Finding:	Excessive Moisture – Skirting Boards
Information:	At the time of inspection, excessive moisture readings were detected to the skirting boards. This condition is inconsistent with normal dry internal conditions and indicates ongoing or intermittent moisture exposure to the wall base and adjoining building elements.

- Rising damp due to an ineffective or bridged damp-proof course (DPC)
- Moisture ingress from external ground levels, inadequate falls, or poor drainage
- Plumbing leaks within walls or adjacent wet areas
- Prolonged condensation or poor ventilation

- Deterioration of skirting boards and wall linings
- Potential mould growth affecting indoor air quality

- Concealed damage to framing and finishes if left unaddressed

Further investigation by a licensed builder and/or plumber is recommended to determine the source of moisture. Rectification may include improving drainage, addressing damp-proofing, repairing leaks, and replacing affected materials once moisture issues are resolved.

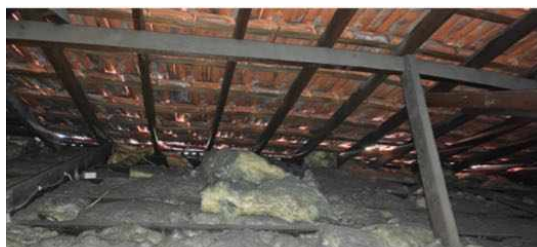
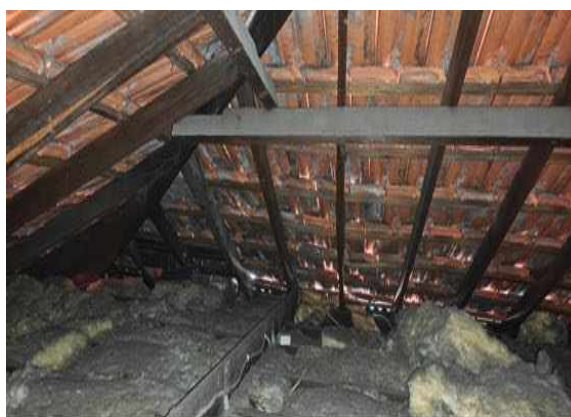
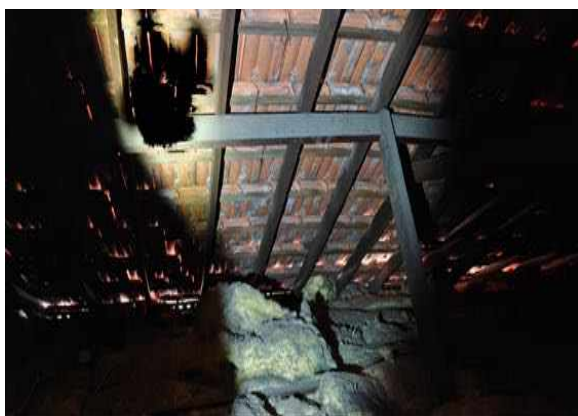
**Finding 3.09**

Location:	Roof Void
Finding:	Sarking - Missing
Information:	Sarking is missing under the roof sheeting. Sarking acts as an insulator that helps with noise reduction and protects against water penetration. Sarking plays a key role in the operation and function of the overall roofing structure and its performance.

Although not a requirement at the time of construction, replacement of any missing building element is advisable (although this can be quite expensive to do after the time of construction). Where sarking is missing, regular inspections of the roof tiles for cracking and potential moisture penetration is required.

Sarking may be retrospectively fitted by a registered builder at the discretion of the client.

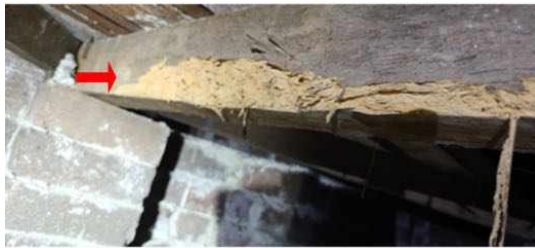
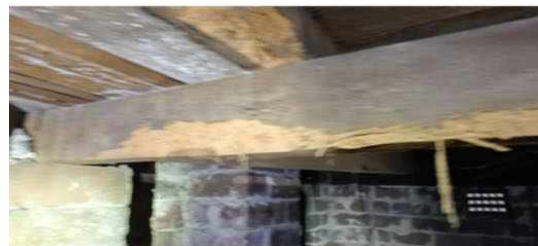
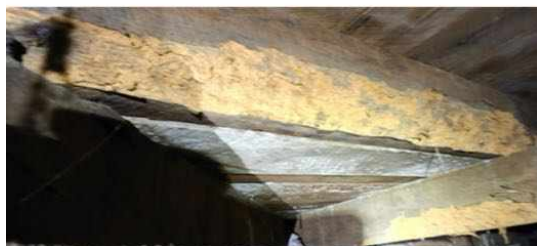
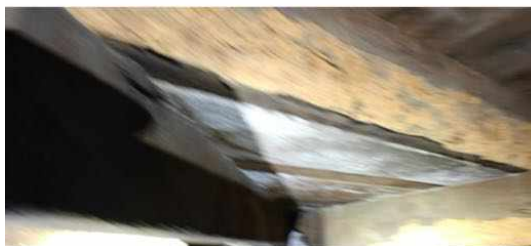
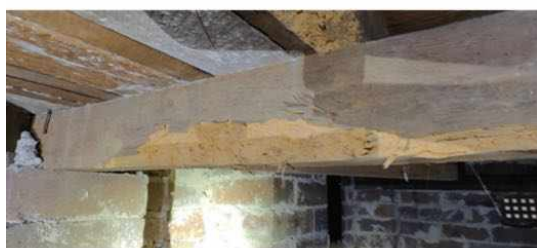
Building:	Main Building
Location:	Subfloor
Finding:	Suspected timber pest damage - subfloor
Information:	Suspected timber pest damage has been detected in the subfloor, compromising the structural integrity of the building's foundation.

The presence of Suspected timber pest damage increases the risk of further structural deterioration, weakening the subfloor and potentially causing instability in the entire structure. If left unaddressed, this may lead to severe structural issues, compromising safety and necessitating extensive repairs.

A licensed pest control professional should conduct a thorough & invasive inspection to assess the extent of damage. Subsequently, a qualified contractor experienced in subfloor repairs should be engaged to address and rectify the damage. Swift action is crucial to prevent further harm and ensure the long-term stability of the building.

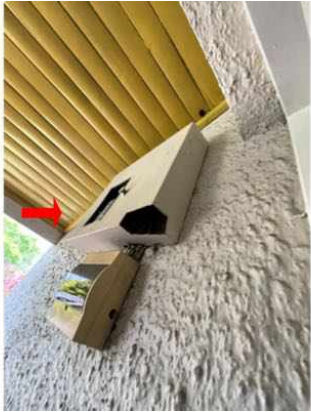
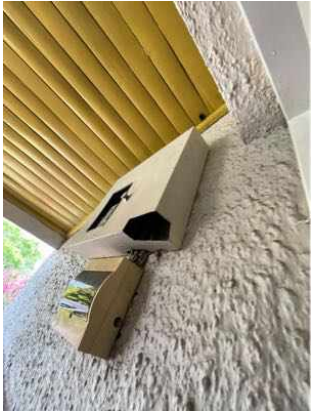
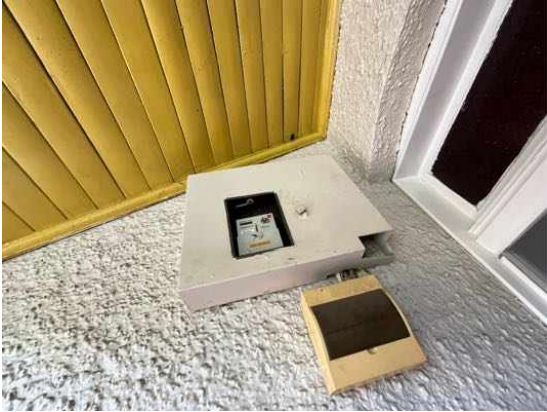
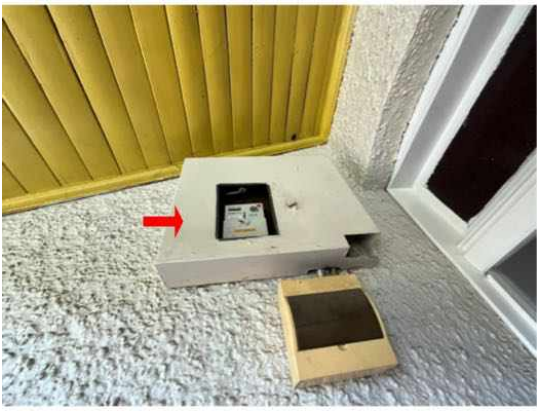
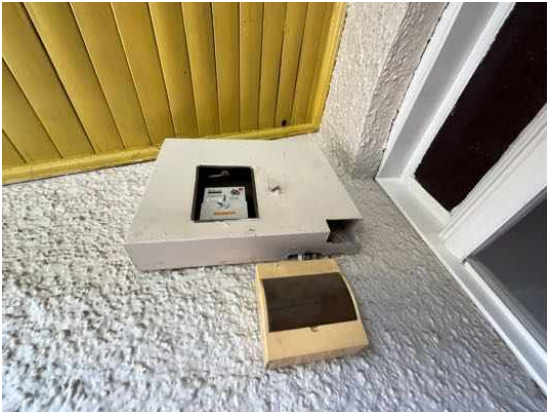
### Finding 6.01

Building:	Main Building
Location:	Front porch
Finding:	No Evidence of Termite Management System - Durable notice / Legible Sticker
Information:	The application of a pre & post-construction chemical termite barrier is highly recommended for all properties. Such barriers are highly effective in preventing termite attack on any timber building elements throughout the property.

A durable notice was not placed in the switchboard unit to indicate current termite barriers is legible at the time of inspection.

Client must seek further information from the vendor or real estate agent if the conditions of termite management systems were maintained.

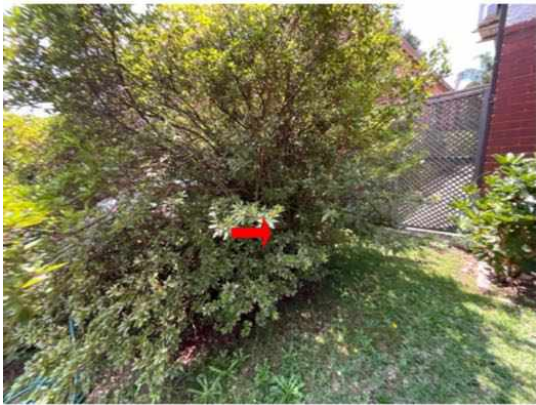
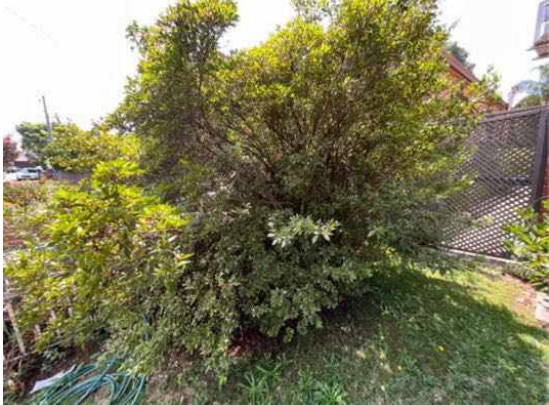
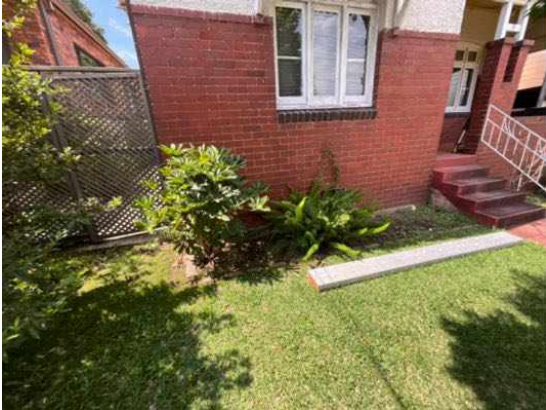
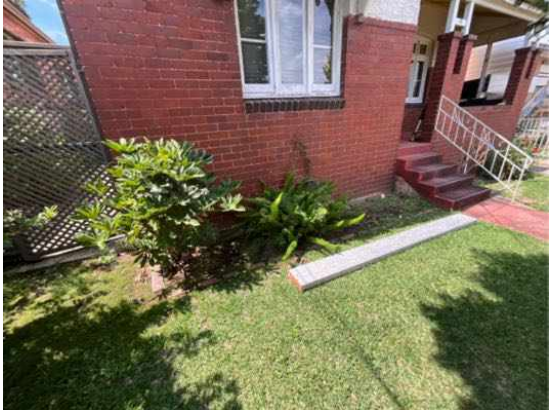
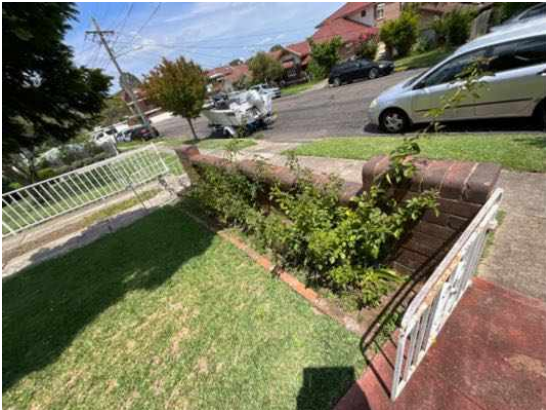
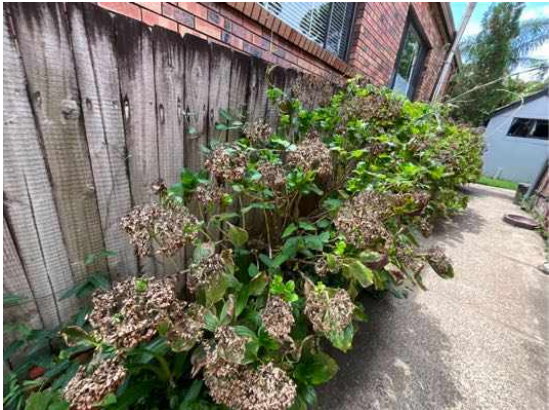
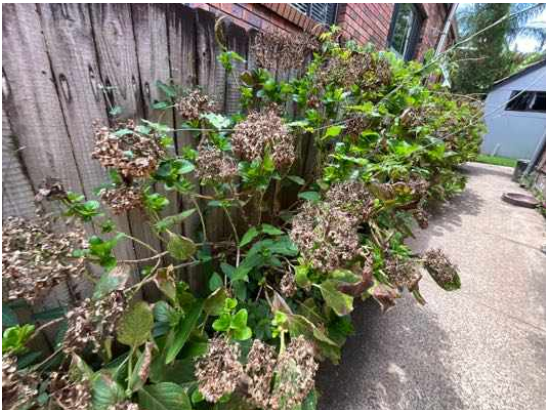
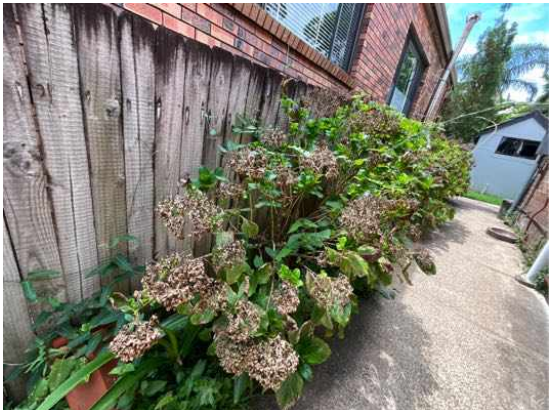
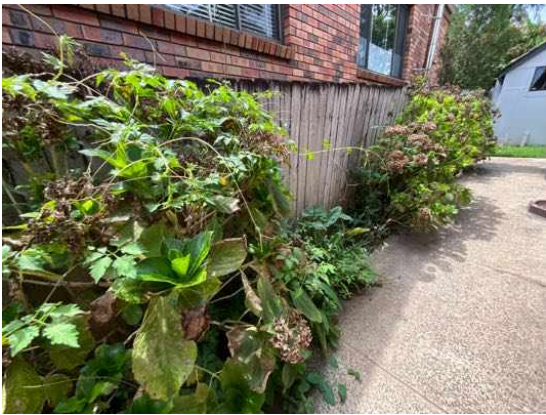
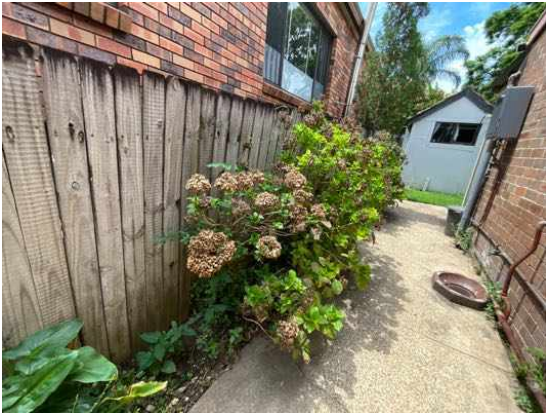
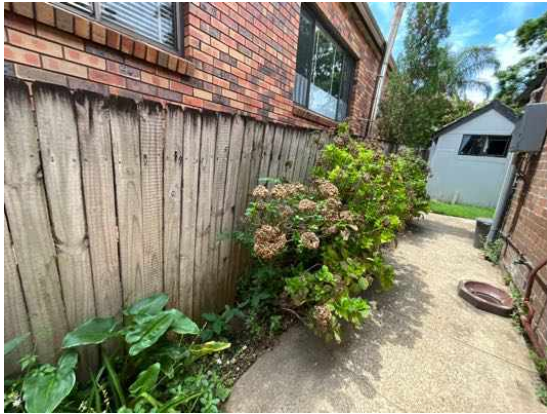
**Finding 6.02**

Building: Main Building  
Location: All Areas  
Finding: Dense vegetation around a property can increase the risk of termite infestation  
Information: The presence of dense vegetation around a property can increase the risk of termite infestation, as it provides a conducive environment for them. To address this, consider maintaining a clear space between the vegetation and your home. If you suspect a termite issue, it's advisable to consult with a licensed pest control professional for inspection and treatment.

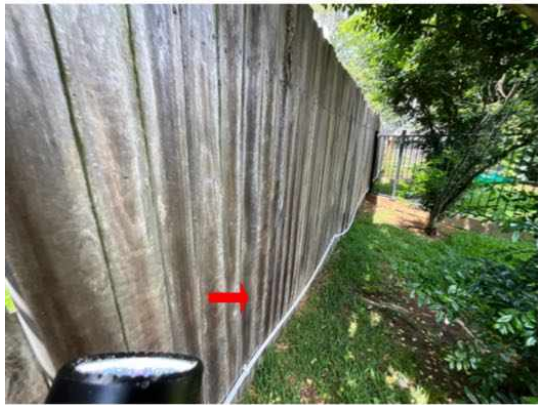
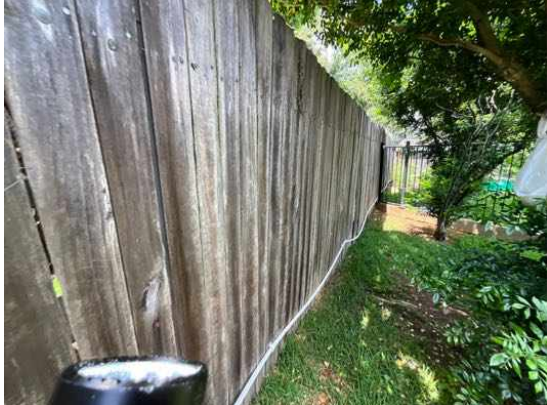
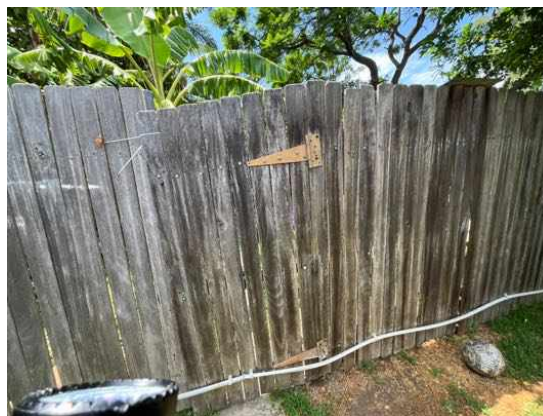
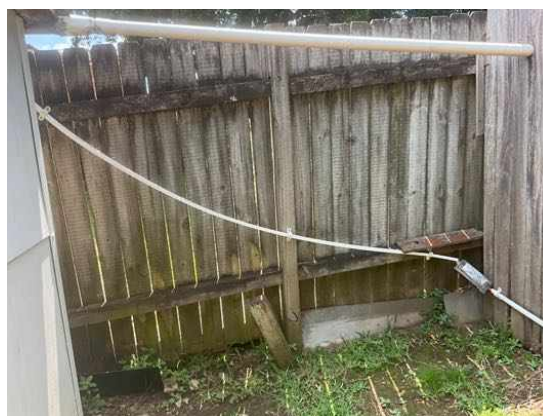
**Finding 6.03**

Building: Main Building  
 Location: All Areas  
 Finding: Timber on ground / conducive conditions to termite damage  
 Information: Timber on the ground is indeed conducive to termite damage. Termites are known to thrive in moist environments, and wood in contact with soil or moisture is more susceptible to infestation.

To prevent this, it's important to keep timber elevated and away from direct ground contact. Regular inspections and proper termite control measures are also essential to protect your wooden structures from termite damage.

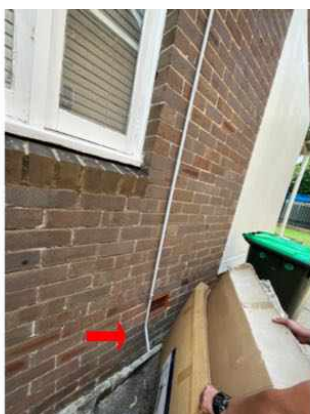
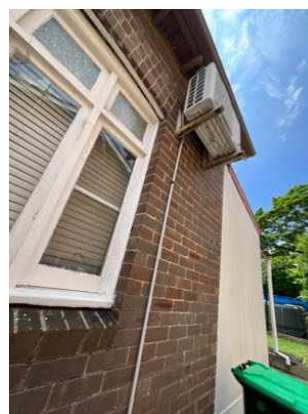
### Finding 6.04

Building:	Main Building
Location:	Exterior walls - right side
Finding:	Aircon - Excessive moisture conducive condition near Air-conditioner
Information:	<p>Excessive moisture near an air conditioner can indeed create conducive conditions for termites. Termites are attracted to damp and decaying wood, which can be found in areas with high moisture levels. To fix this issue:</p> <ol style="list-style-type: none"> <li>1. Fix Leaks: Check for any leaks or condensation around your air conditioning unit. Repair any damaged pipes, drains, or insulation that may be causing moisture buildup.</li> <li>2. Proper Drainage: Ensure that your air conditioner has proper drainage. Make sure the condensate drain line is clear and directed away from your home's foundation.</li> <li>3. Ventilation: Improve ventilation around the unit. Ensure that the area is well-ventilated to reduce humidity levels.</li> <li>4. Regular Maintenance: Schedule regular maintenance for your air conditioning system. This can help prevent leaks and ensure</li> </ol>

5. Please consult a HVAC Technician: HVAC (Heating, Ventilation, and Air Conditioning) technicians are trained to diagnose and

repair a wide range of air conditioning problems. They can handle issues with the cooling system, refrigerant, electrical components, and more.

6. Consult an appropriate and Qualified Professional: For severe moisture issues or persistent termite problems, consult with a

pest control professional who can provide targeted solutions.

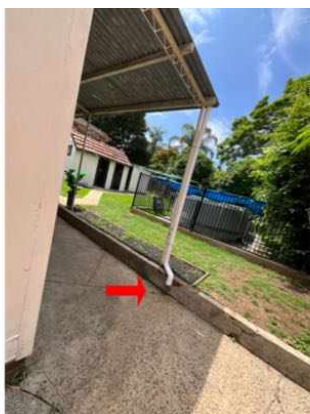
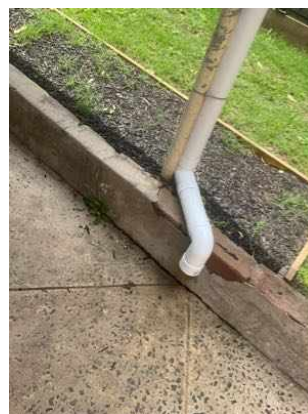
Building:	Main Building
Location:	Pergola
Finding:	Downpipes not connected- Conducive conditions for timber pest
Information:	Unconnected downpipes can indeed pose a risk for attracting termites, as they provide a source of moisture near a building's foundation. Termites are attracted to moisture and wood, so it's important to address this issue to prevent potential infestations. Connecting downpipes to the stormwater system or ensuring proper drainage away from the building can help mitigate this a licensed plumber is the most qualified professional to handle plumbing-related tasks, including connecting downpipes to the stormwater system. They have the necessary expertise and tools to ensure proper installation.

Please remember that proper installation is essential to ensure effective drainage and prevent future issues, so it's often best to hire a qualified professional, especially for complex or extensive downpipe installations.

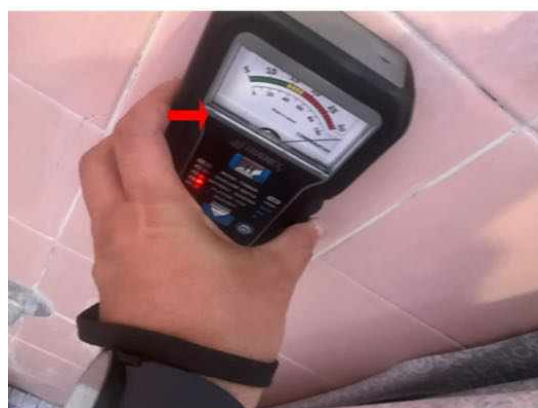
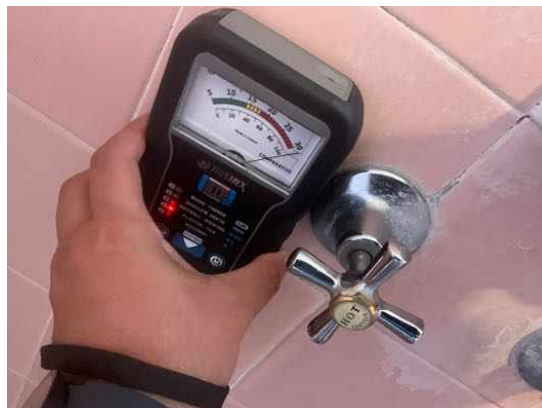
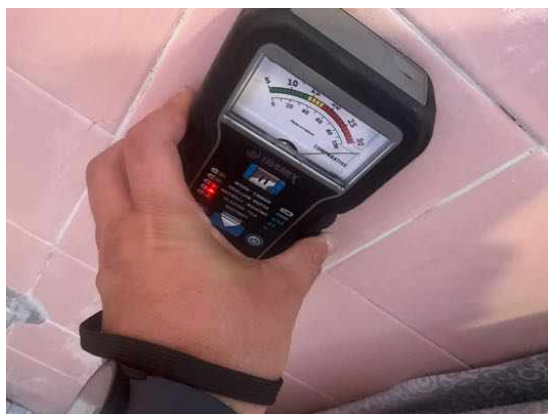
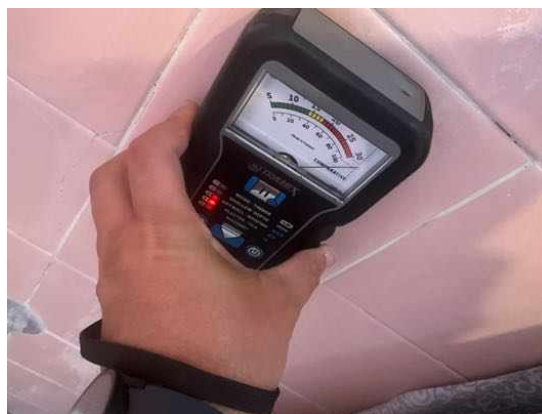
### Finding 6.06

Building:	Main Building
Location:	Bathroom
Finding:	Excessive moisture - Conducive to Timber pest
Information:	Excessive moisture can attract termites and produce conditions that promote fungal growth and wood decay.

Excessive moisture is generally caused by deteriorated inadequate or missing roof drainage leaking plumbing pipes or fixtures poorly plumbed HWS overflows or condenser units and poor site drainage.

If mould growth has been found there may be environmental biological or health issues involved. In these cases an appropriately qualified inspector should also be contacted.

Prior to any remedial works being performed a qualified plumber should be appointed to further inspect the property and to identify the cause of the excessive moisture. Works to remove affected building elements may then be necessary and should be performed by an appropriate tradesperson.

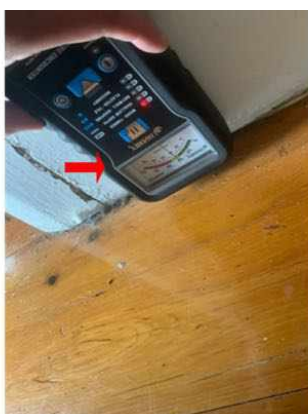
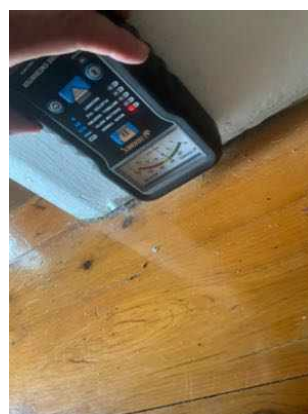
### Finding 6.07

Building:	Main Building
Location:	All Areas
Finding:	Excessive moisture - Conducive to Timber pest
Information:	Excessive moisture can attract termites and produce conditions that promote fungal growth and wood decay.

Excessive moisture is generally caused by deteriorated inadequate or missing roof drainage leaking plumbing pipes or fixtures poorly plumbed HWS overflows or condenser units and poor site drainage.

If mould growth has been found there may be environmental biological or health issues involved. In these cases an appropriately qualified inspector should also be contacted.

Prior to any remedial works being performed a qualified plumber should be appointed to further inspect the property and to identify the cause of the excessive moisture. Works to remove affected building elements may then be necessary and should be performed by an appropriate tradesperson.

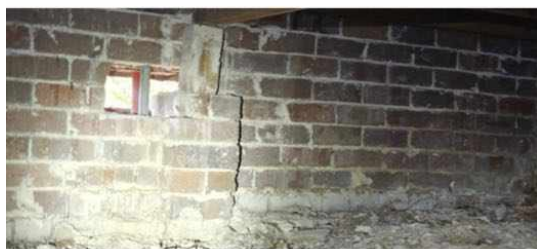
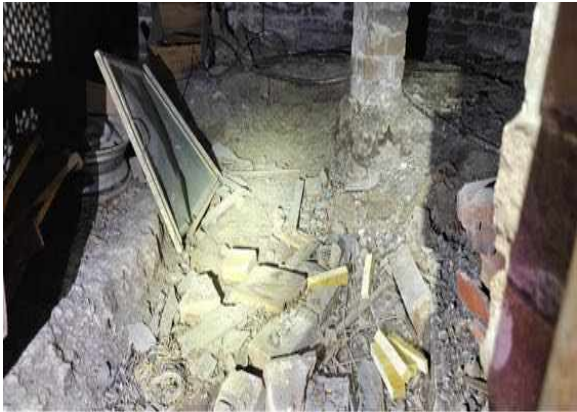
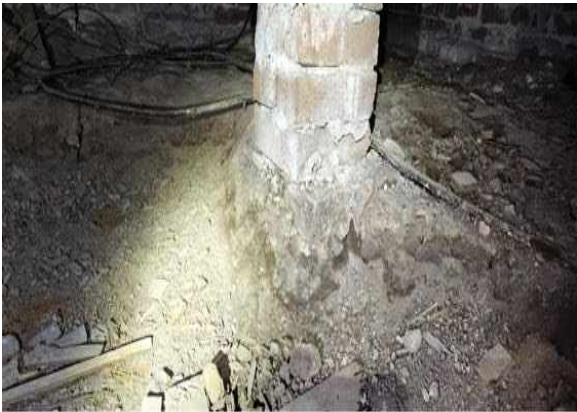
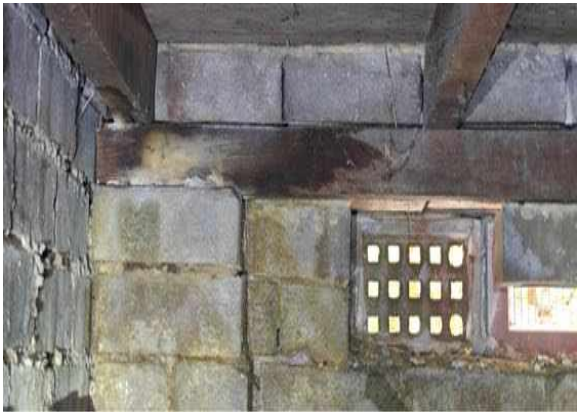
### Finding 6.08

Location: Subfloor  
Finding: Subfloor - poor ventilation, inadequate site drainage, water stains, and no ant caps  
Information: The subfloor lacks adequate ventilation, suffers from inadequate site drainage, exhibits water stains, and lacks ant caps, creating conducive conditions for timber pests such as termites.

Risk: The combination of poor ventilation, inadequate drainage, water stains, and absence of ant caps significantly increases the risk of timber pest infestations. Termites are attracted to moist environments and can thrive in subfloors with high humidity levels and water damage. The lack of proper ventilation and drainage exacerbates moisture retention, providing an ideal habitat for timber pests to establish colonies and cause extensive damage to the subfloor structure. Additionally, water stains indicate previous or ongoing moisture issues, which further attract timber pests and contribute to the deterioration of timber materials.

A licensed pest control professional specializing in timber pest management should be consulted to assess the extent of the infestation and develop a comprehensive treatment plan. They can implement strategies to eliminate existing timber pests, such as termites and prevent future infestations by addressing underlying moisture issues. Additionally, a qualified contractor or builder may be needed to improve subfloor ventilation, enhance site drainage, repair water-damaged areas, and install ant caps to prevent pest entry points. Regular inspections and maintenance are essential to ensure ongoing protection against timber pests and maintain the structural integrity of the subfloor.

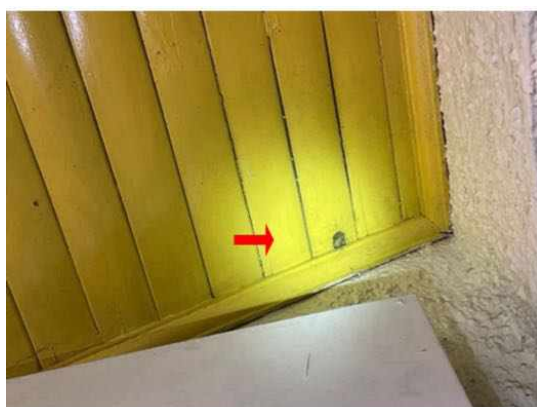
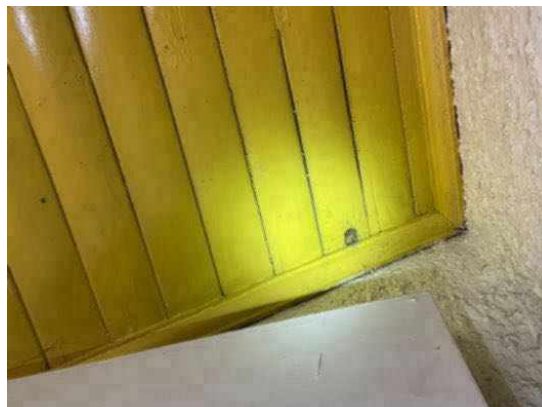
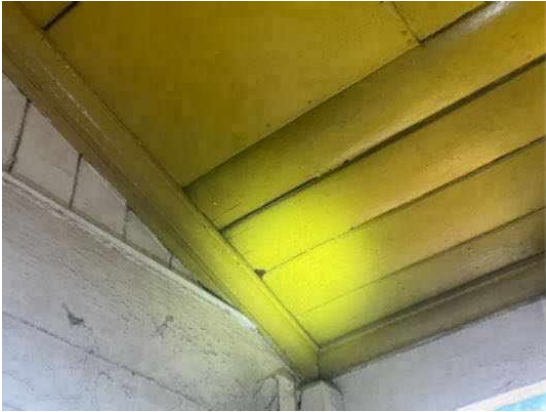
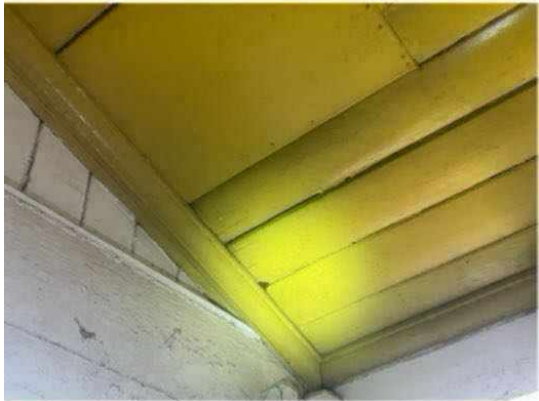
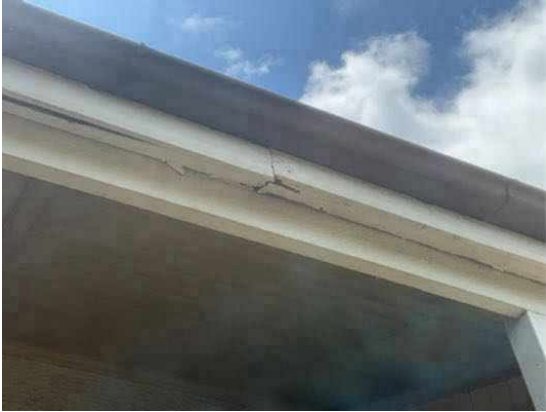
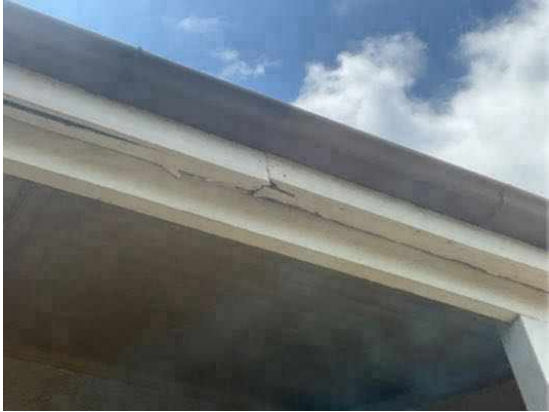
### Finding 7.01

Building:	Main Building
Location:	All Areas
Finding:	Wood rot
Information:	This building element shows evidence of wood rot. Wood rot, also known as Fungal Decay, occurs when timbers and other cellulose building materials are exposed to damp conditions on an ongoing basis. This could be the result of exposure to weathering over a prolonged period of time, or the attraction of excessive moisture from other abutting building materials. Contributing factors also include poor air ventilation in the area.

Wood rot is often associated with general damp problems and is evidenced by a 'musty' smell or mould and mildew occurring on surfaces. If left unmanaged, damp conditions can lead to further health problems and the decay of timbers will continue.

Early intervention and regular maintenance, particularly of exterior timbers, will prolong the useful life of these building elements. Prior to any works being performed, the cause of the moisture that has created the visible wood rot should be identified and addressed in a suitable manner. Replacement of affected timbers may then be a necessary step in protecting surrounding building elements from such deterioration.

A qualified plumber may be appointed to assess the cause of excessive moisture and to provide advice on any remedial works as required. A qualified carpenter or registered builder may also be required to replace affected building materials.

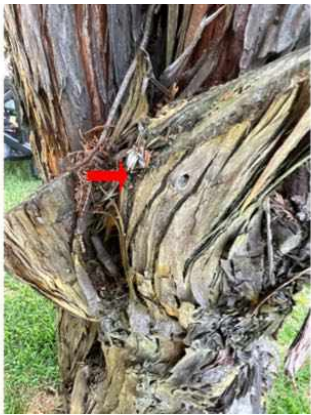
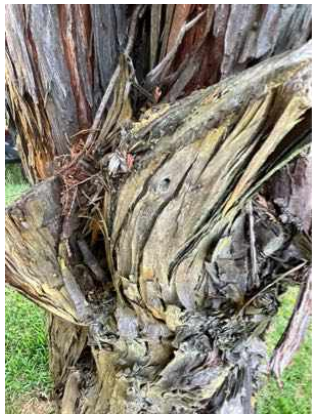
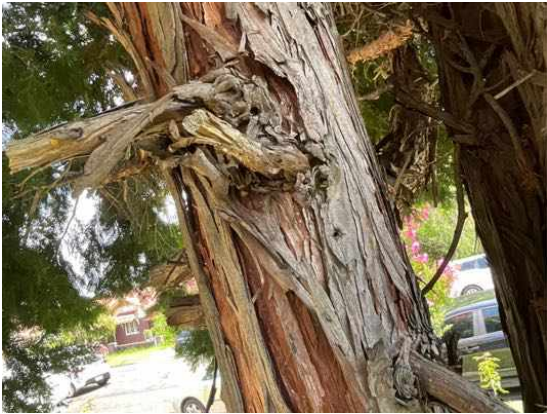
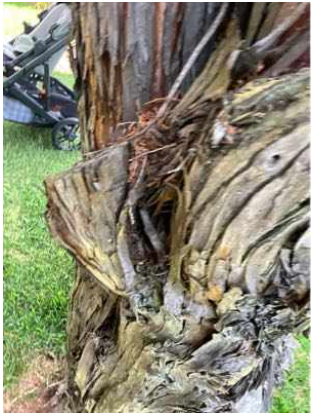
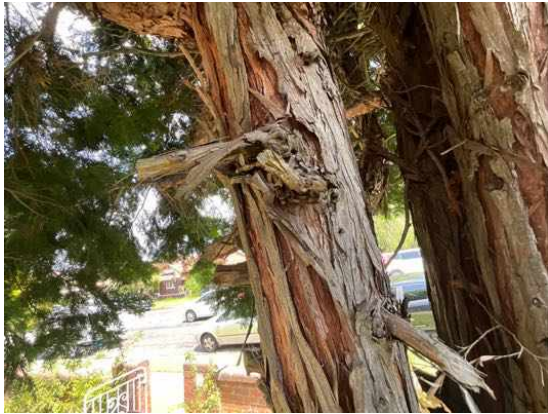
## Evidence of wood borer activity and/or damage

- Engage a qualified arborist to assess the structural integrity of the tree and arrange for safe removal if required.
- If the tree is within falling distance of a building, fence, or utility infrastructure, urgent removal is recommended.
- Regular site monitoring is advised for surrounding trees to detect any early signs of similar pest activity.
