Building and Timber Pest Inspection Report

Inspection Date: Wed, 28 Jan 2026

Property Address: 11/41 Victoria St, Werrington NSW 2747,
Australia

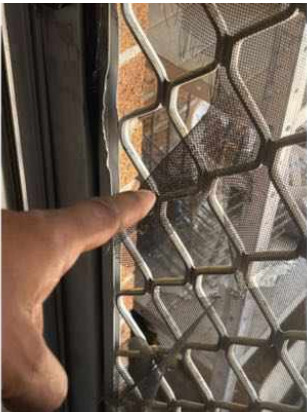
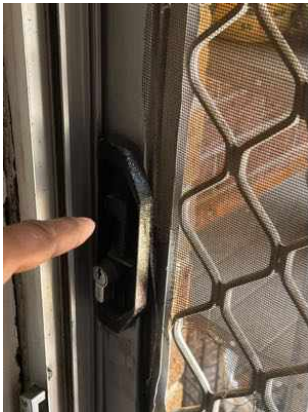
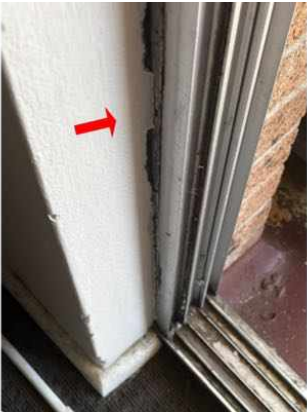
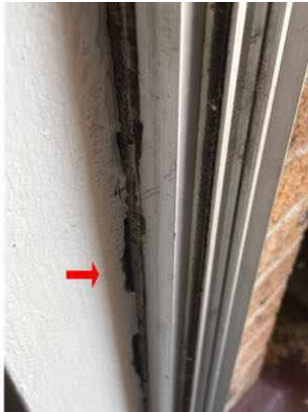
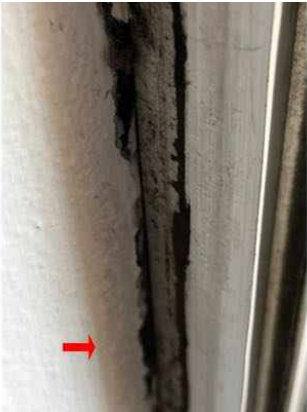
| Finding: | Flyscreens - Deteriorated/ Door not Locking |

It is advised that all missing building elements be replaced in order to ensure the full function of all building structures.

A general handy-person/ Licensed Doors and window installer may be appointed to replace flyscreens at the discretion of the client.

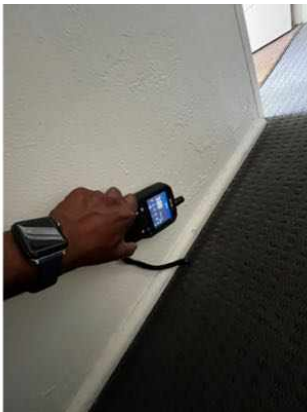
Finding 2.03

Building: Main Building
 Location: Bathroom walls/ Laundry walls
 Finding: High Moisture Readings - Evidence of high moisture was present during Inspection.
 Information: All areas of dwellings are checked with particular attention paid to wet areas which were closely assessed to check for moisture levels of moisture and temperature anomalies.

It is highly recommended that all plumbing and drainage fixtures and fittings be maintained regularly in order to prevent excessive moisture being present in the external / internal property.

It is highly advised to consult a Licensed Plumber to inspect and remedy the situation.

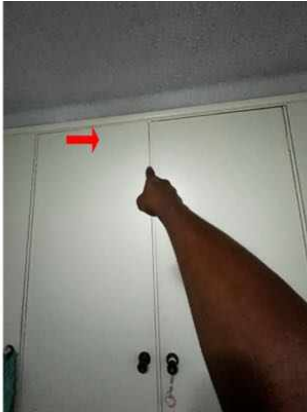
A door that binds to associated door frame may have several causes, ranging from minor defects, such as poor installation of the door or deteriorated hinges.

A qualified carpenter or general handyperson should be appointed to perform minor rectification works at client discretion.

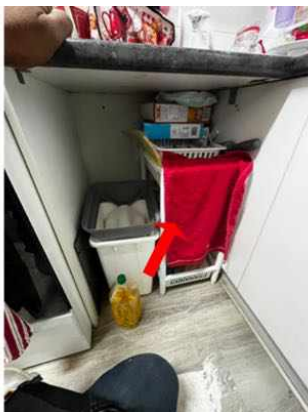
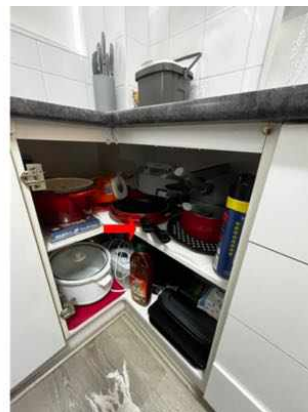
Live Timber Pest Activity

No evidence was found

Timber Pest Damage

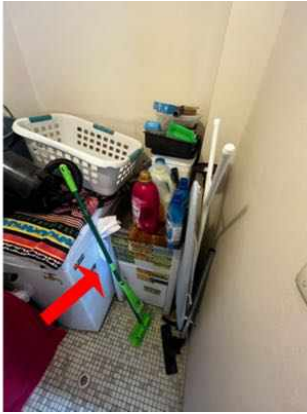
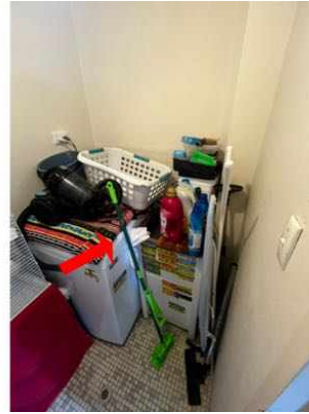
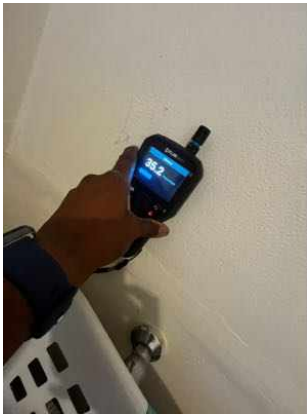
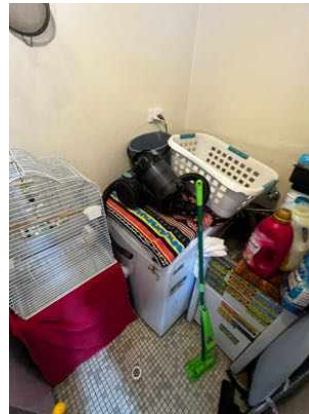
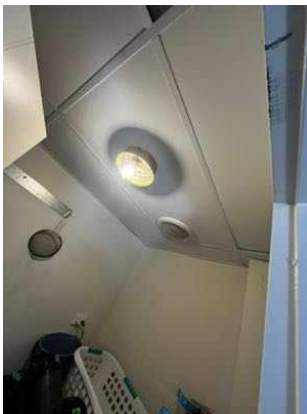
These obstructions can hide an array of defects and should be removed to allow full inspection to be carried out.

A re-inspection is recommended once the areas are made accessible.

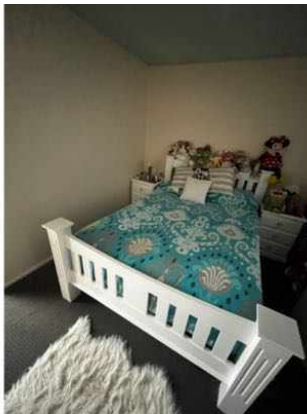
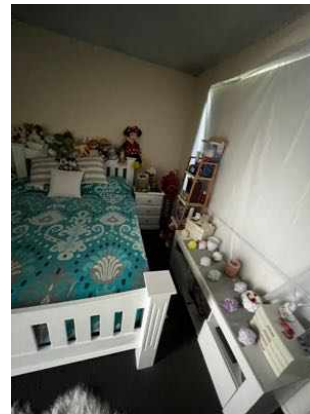
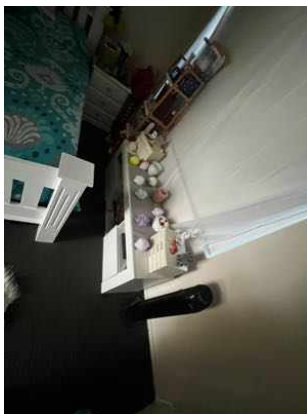
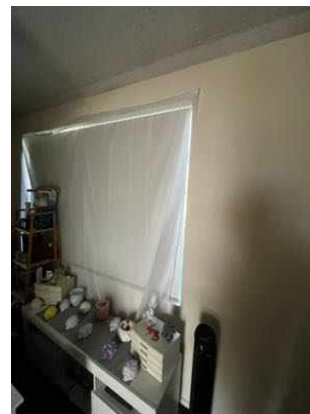
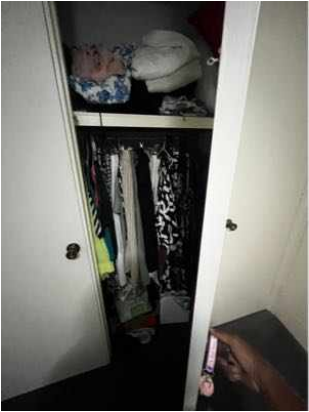
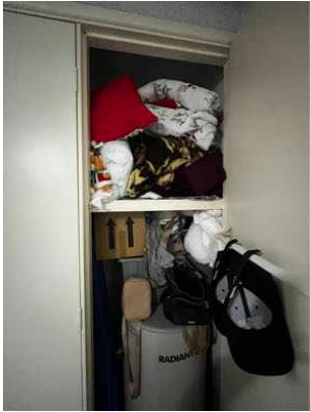
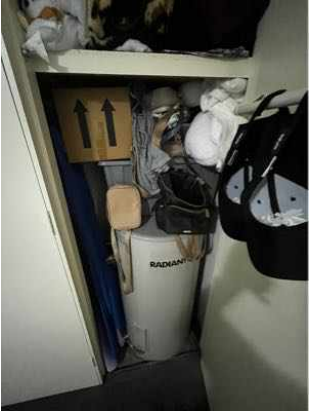
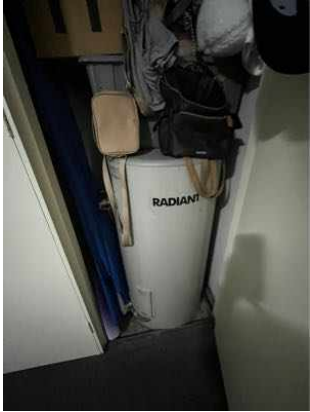
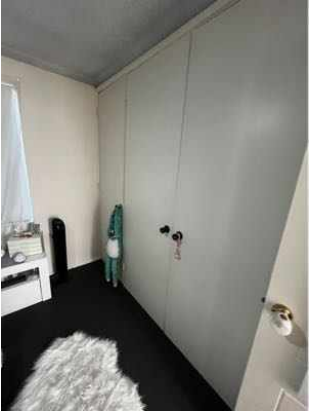
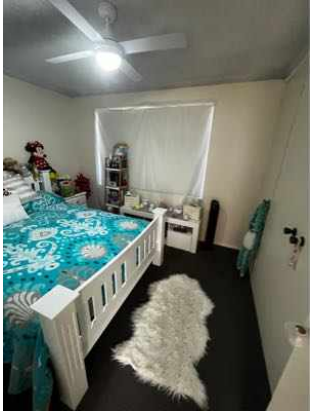
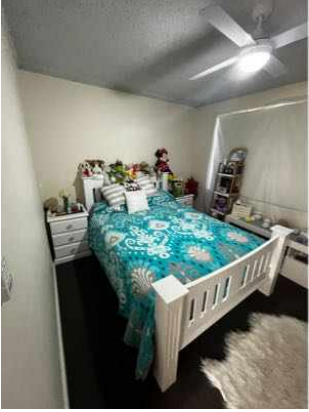
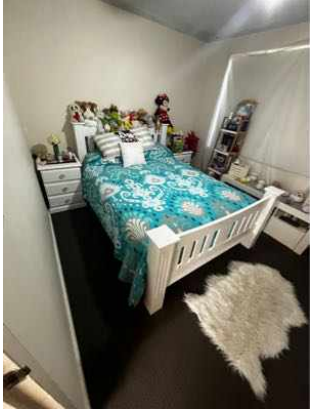
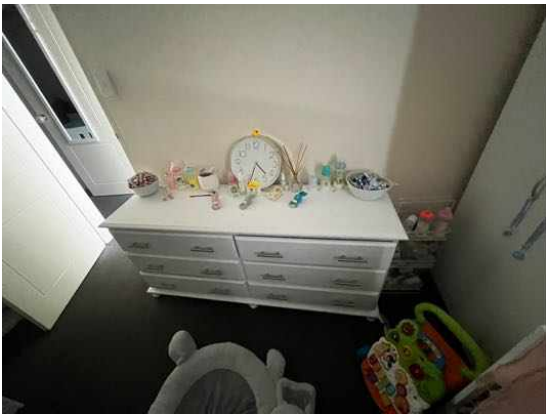
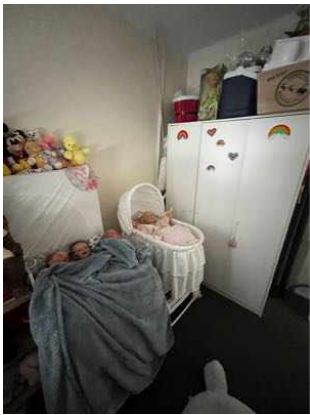
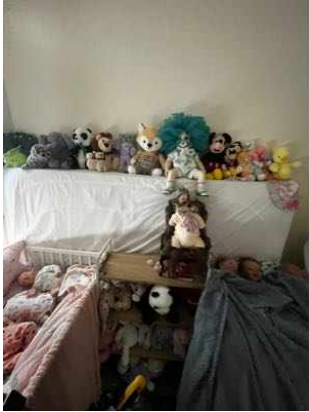
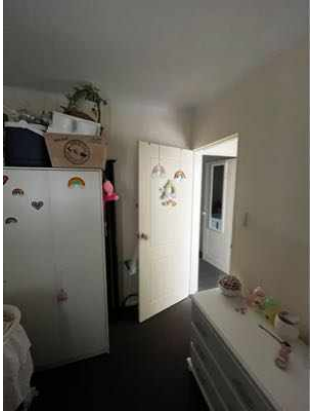
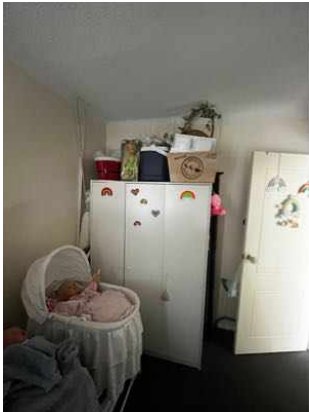
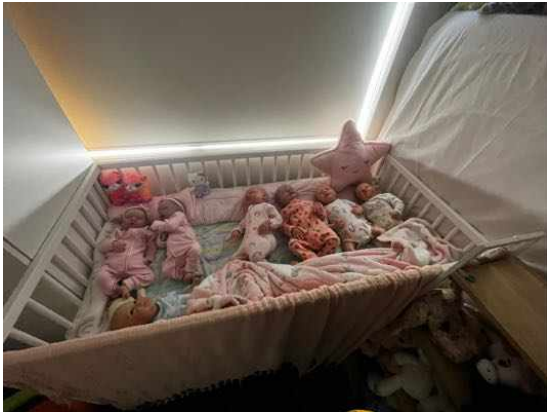
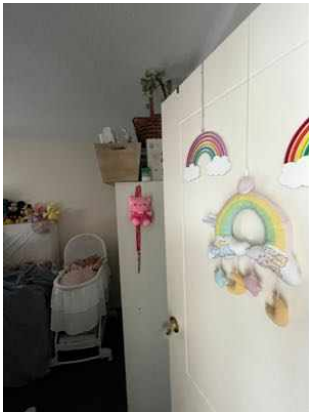
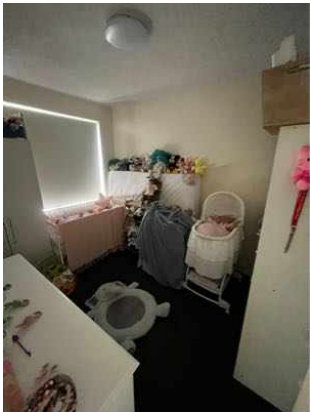
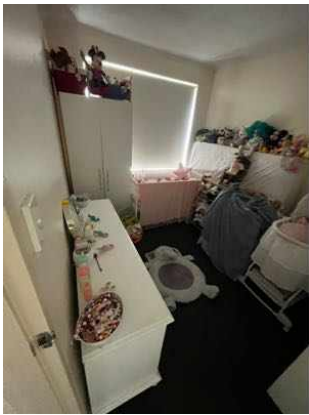
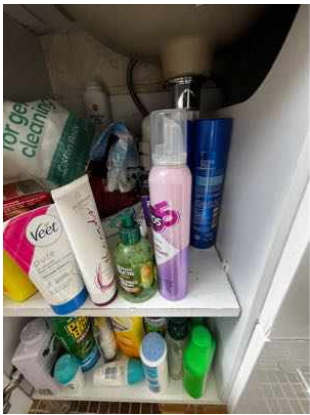
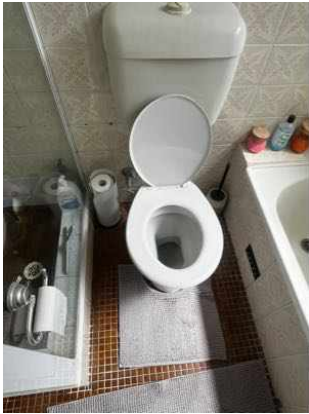
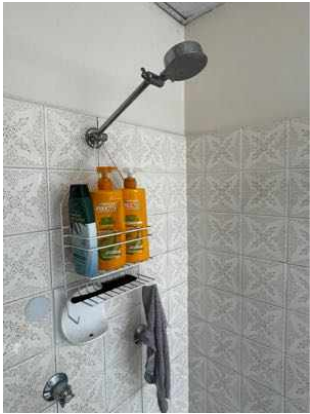
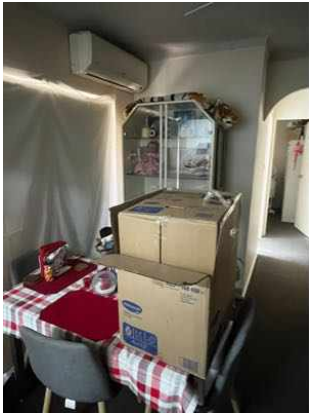
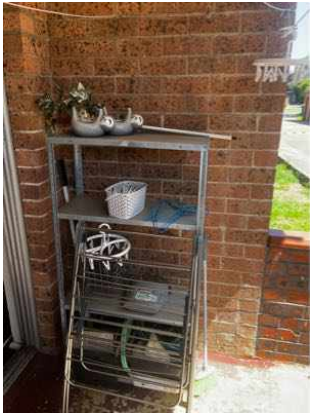
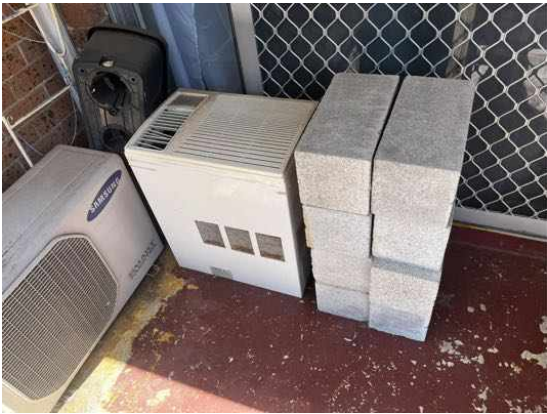
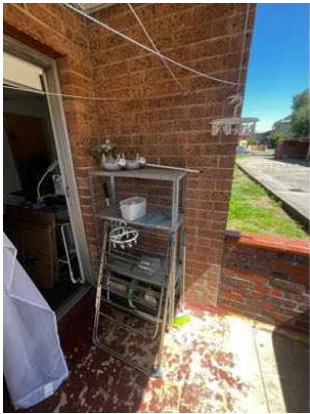
Finding: Additional Photos - Obstructions and Limitations

Information: These photographs are an indication of the obstructions and limitations which impeded full inspection of the property at the time of inspection. These obstructions can hide an array of defects and should be removed to allow full inspection to be carried out. A re-inspection is recommended once the areas are made accessible.

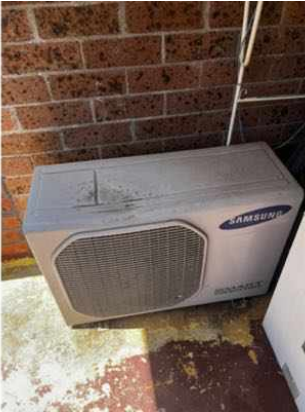
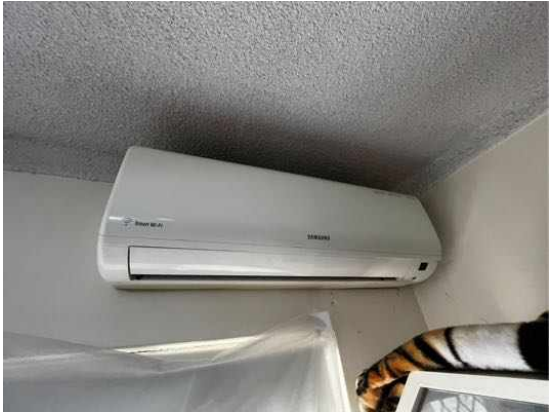
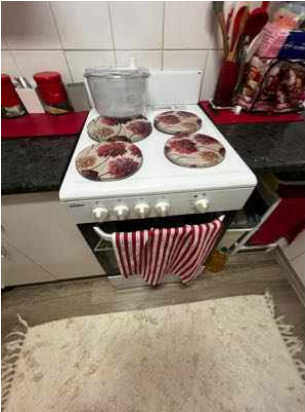
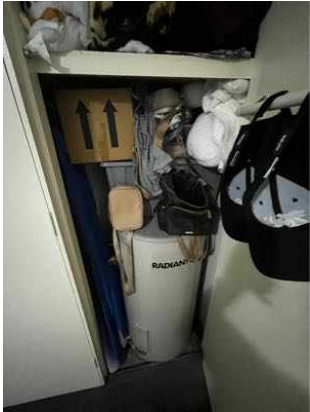
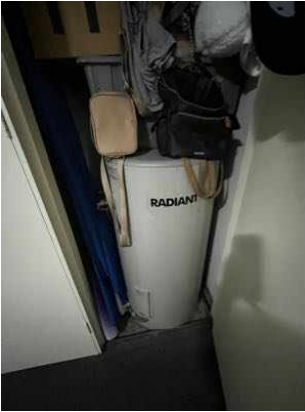
Building: Main Building
 Location: All Areas
 Finding: Plumbing/electrical/gas/aircon/appliances/pool equipment/fire safety etc
 Information: Plumbing and electrical inspections are outside the scope of the building inspection and must be conducted by a Licensed and registered Trades person.

It is highly recommended that the client makes immediate arrangements to have the gas appliances checked by a licensed gas plumber to ensure that the appliances are

We recommend all other installations be checked also.

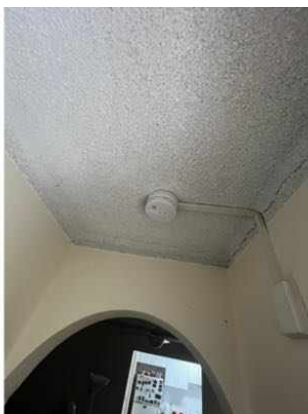
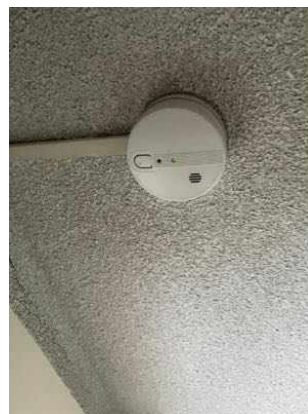
Building: Main Building
Location: All Internal Areas

Additionally, it is advised that all smoke detectors be tested by the homeowner on a monthly basis.

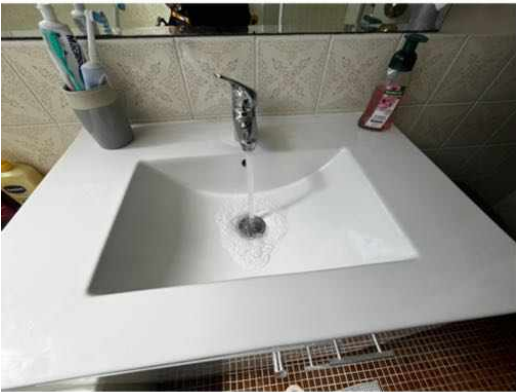
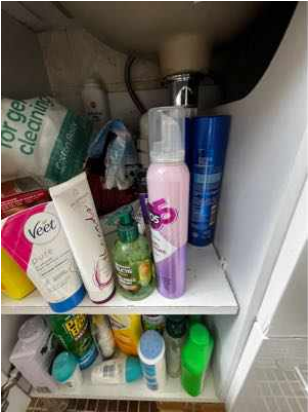
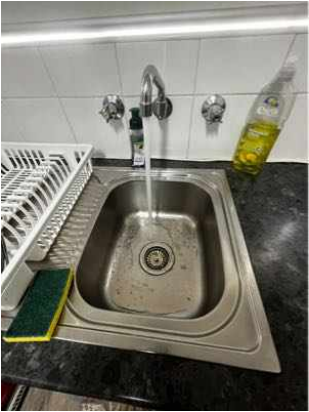
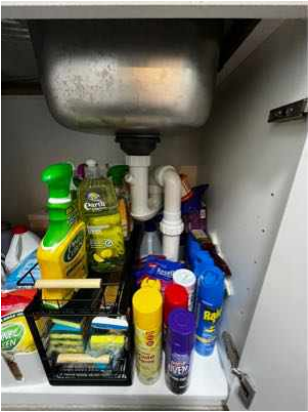
Building: Main Building
 Location: Kitchen/ Bathroom
 Finding: Cabinetry Plumbing - Kitchen/ Bathroom
 Information: All cupboards where sinks and basins with drainage plumbing were inspected and no evidence of leaks were present at the time of inspection.

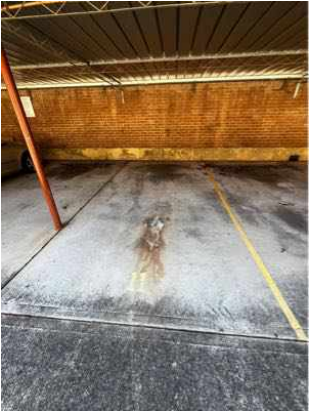
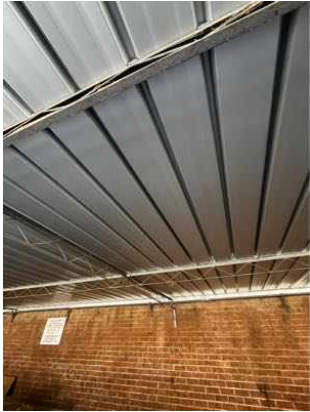
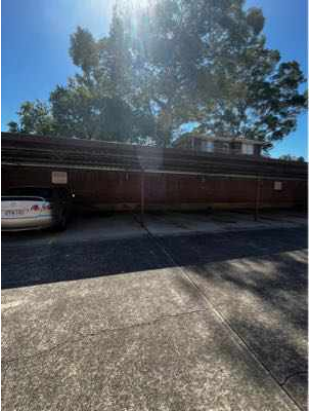
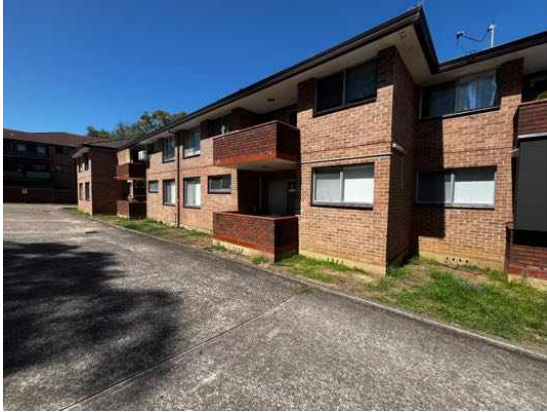
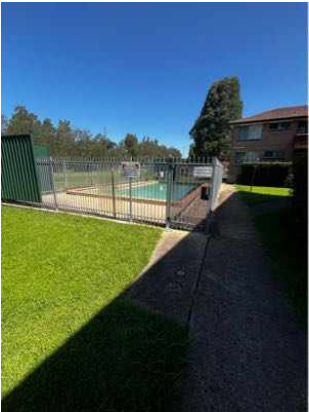
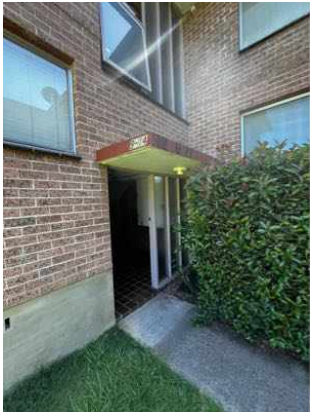
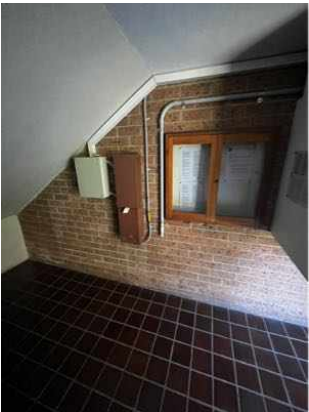
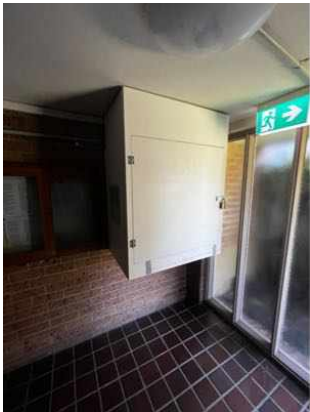
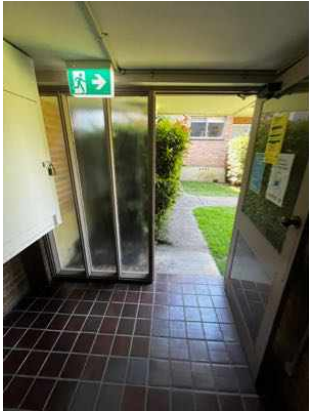
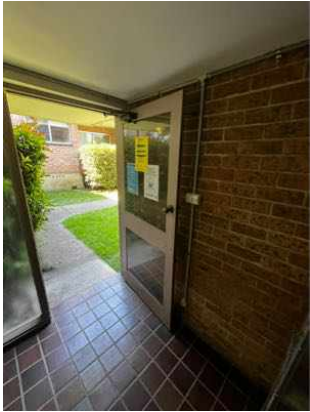
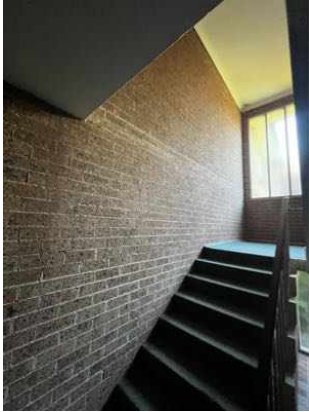
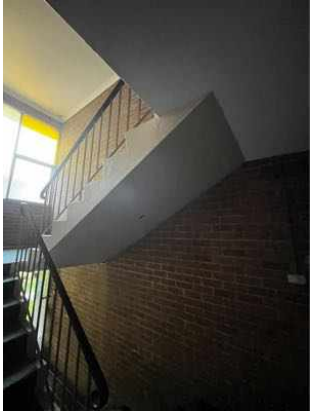
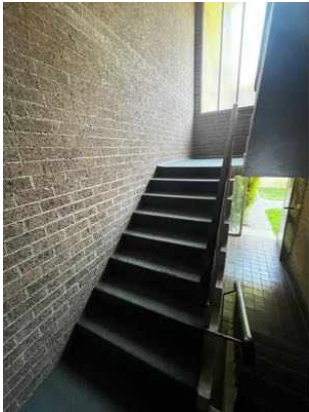
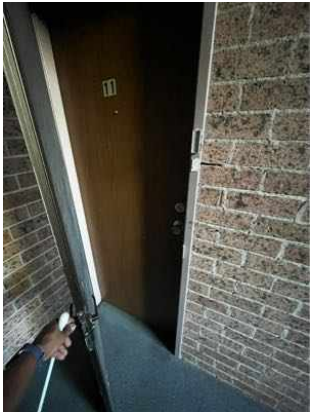
Building: Main Building
 Location: Common Areas/ Car space/Cage
 Finding: Additional Photos
 Information: Additional photos are provided for your general reference
