# Building and Timber Pest Inspection Report

Inspection Date: Tue, 24 Feb 2026

Property Address: 1 Burraneer St, Leumeah NSW 2560,  
Australia

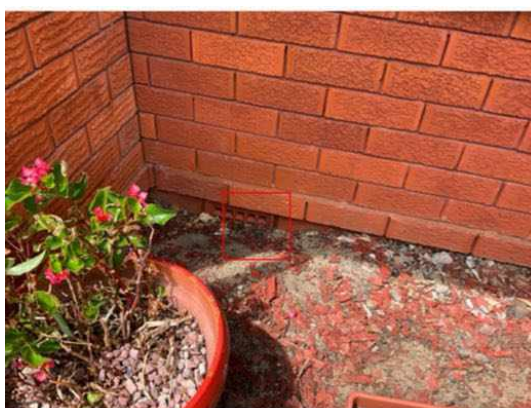
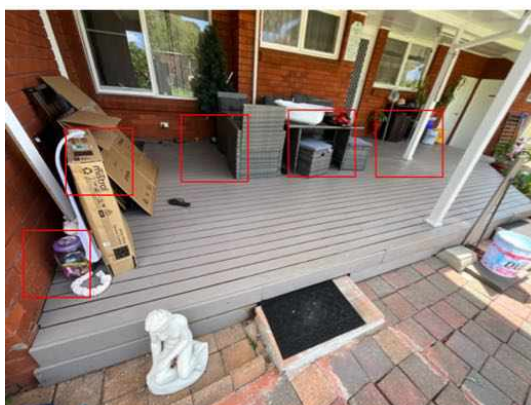
#### Finding 3.01

Building: Main Building  
 Location: Multiple areas  
 Finding: Air vents - Blocked or inadequate  
 Information: It was noted at the time of inspection that the subfloor area lacks adequate ventilation.

The cause of this inadequate ventilation is the state of the air vents to the subfloor area. Where air vents are insufficient in number or are blocked, either fully or partially, subfloor ventilation is decreased.

A well ventilated subfloor aids in maintaining dry conditions, preventing secondary damage such as wood rot and pest activity, as well as preventing the development of mould/fungi and mildew (which can lead to major respiratory issues or safety hazards for occupants, particularly the elderly, the very young and those with existing illnesses).

All air vents should be cleared of blockages to promote adequate air flow to the area. Where ventilation is still insufficient, retrospective installation of air vents may be required. Appointment of a licensed builder may be required to perform these works as necessary.

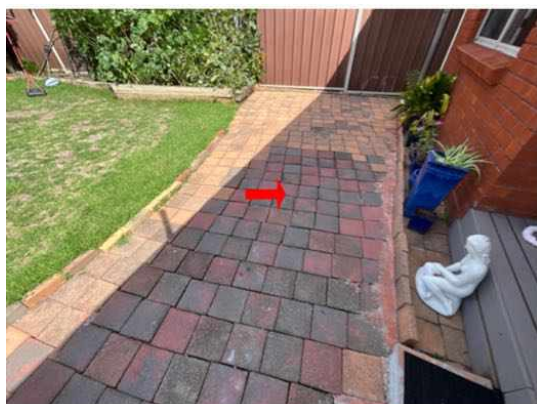
### Finding 3.02

Sections of the external paved area are uneven, which may develop into a trip hazard. It appears as though the area has been subject to rough installation, or that paving sections have lifted due to movements in the foundation.

Left unmanaged, the May develop into a safety hazard due to trip and fall.

Re-paving of the area is required to remedy this situation. Further consultation with a specialist concreter is advised.

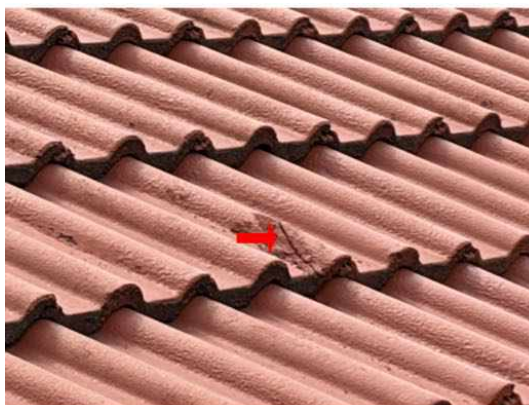
### Finding 3.03

Building:	Main Building
Location:	Roof Exterior
Finding:	Cracked roof tile - Sealed (defective)
Information:	Cracked roofing tile was noted to have been sealed. This handyman work appears to have been completed to a substandard level and does not comply with regular building practices. Further deterioration will inevitably cause cracking at the seal allowing moisture penetration.

All cracked or damaged tiles must be replaced rather than repaired.

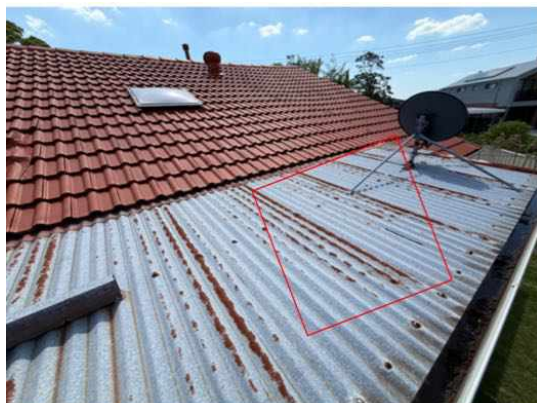
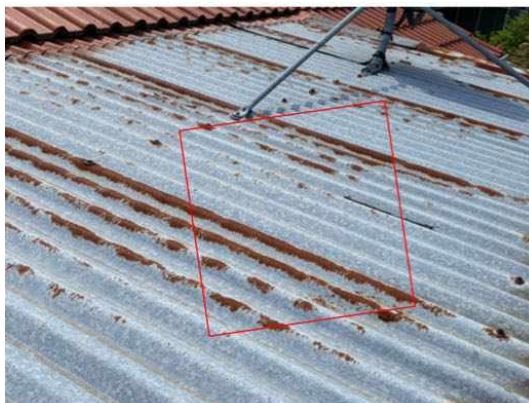
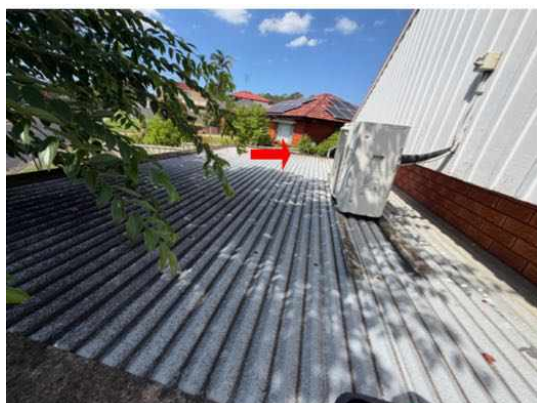
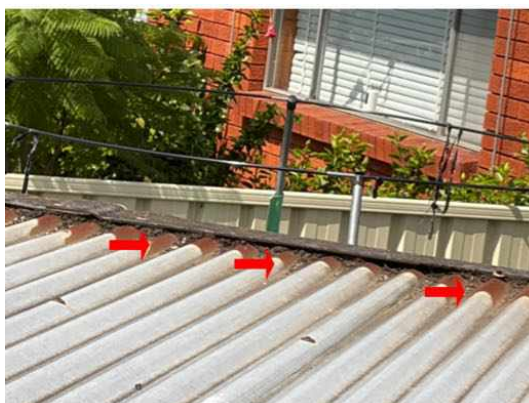
Building:	Main Building
Location:	Carport , alfresco
Finding:	Roof sheets - Rusted
Information:	Metal roofs generally comprise numerous individual sheets, which join and overlap. These intersections are particularly prone to lift at the edge and consequently rust at these points.

Upon inspection of the exterior roofing structure, evidence of rust to these sections was identified. If left unmanaged, these degrading joins can allow water ingress to the internal roofing structures, potentially leading to secondary damage of building elements. Accelerated deterioration of the roofing sheets and any associated building elements is also likely to occur.

A roofing contractor should be appointed immediately to assess the damage to the roofing sheets and to perform remedial works as necessary. Works may include replacement of severely affected roofing sheets or minor works such as the application of rust-retardant surface protectors.

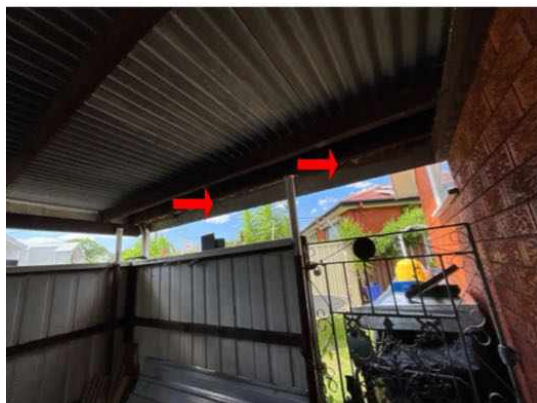
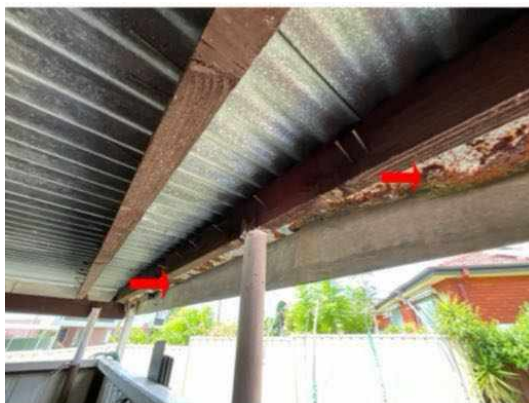
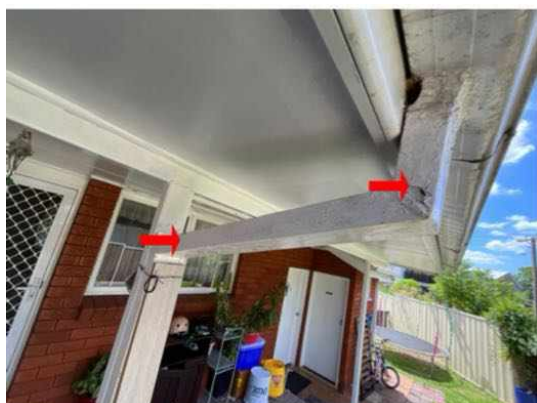
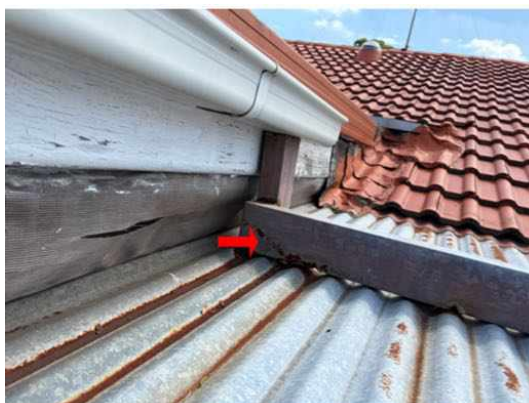
### Finding 3.06

Building:	Main Building
Location:	Multiple areas
Finding:	Roof plumbing - Rusted or corroded
Information:	The roof plumbing has areas of rust and corrosion. It is suspected that this has been caused by blockages, resulting in pooling or standing water, that have prematurely rusted elements of the roof plumbing.

Rusted roof plumbing will generally develop holes and leaks that can affect other building elements with poor drainage of storm water. Poorly drained roof areas will also lead to damp conditions surrounding the base perimeter of the building which, if left unmanaged, can lead to a range of secondary building defects.

Repair and/or replacement of rusted roof plumbing is highly required in order to reinstate the roof drainage system to a fully operational level. To further maintain these areas, gutters should be cleaned frequently, allowing the avoidance of any partial blockages.

A licensed plumber or specialist roof restoration company should be appointed to undertake these works. It is advised that such works be completed as soon as possible to prevent any further damage and deterioration.

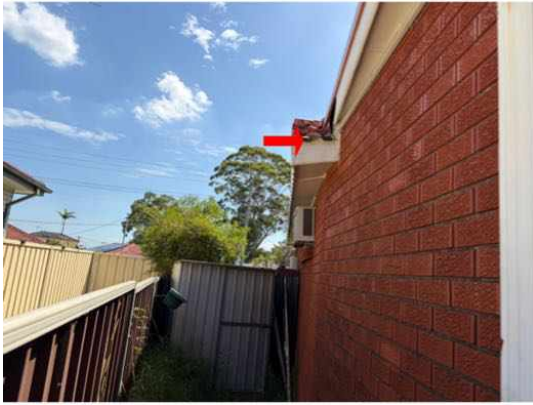
### Finding 3.07

Building:	Main Building
Location:	Roof Exterior RHS
Finding:	Roof plumbing - Missing
Information:	Some sections of the roof are not adequately drained via gutters and downpipes. Gutters and downpipes that are not installed adequately are likely to result in excessively damp conditions against the exterior surfaces and around the base perimeter of the building.

Excessive moisture creates an environment which accelerates the deterioration of building elements in the area, as well as being conducive to termite and pest infestation. Such an environment is likely to necessitate repair and/or replacement of building elements, which are prone to sustaining wood rot, rust or corrosion.

A roofing plumber should be appointed as soon as possible to install relevant roof plumbing materials.

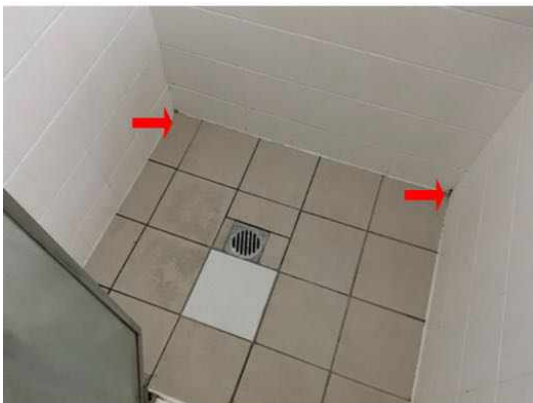
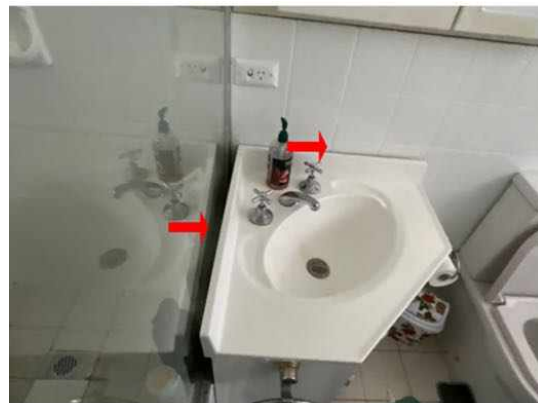
### Finding 3.08

Building:	Main Building
Location:	All Wet Areas
Finding:	Sealant and grouting - Missing or damaged
Information:

It was noted on inspection that sealant or grout is degraded to this area.

Different materials and floor areas move at different rates, generally causing cracking to grout or sealant at this point. A flexible sealant is required to allow for expected expansion and contraction, while keeping the joint water tight and protective of all associated building materials.

Flexible and mould resistant materials should be applied to affected areas to prevent any subsequent water damage that is likely to occur. Regular maintenance and replacement of damage or missing or damaged sealant and grout is highly recommended to the wet areas, as this is a regular wear and tear defect. Sealant and grouting in areas that come into regular contact with water should be maintained for the long term care of your property.

A sealant specialist should be appointed to complete these works as soon as possible.

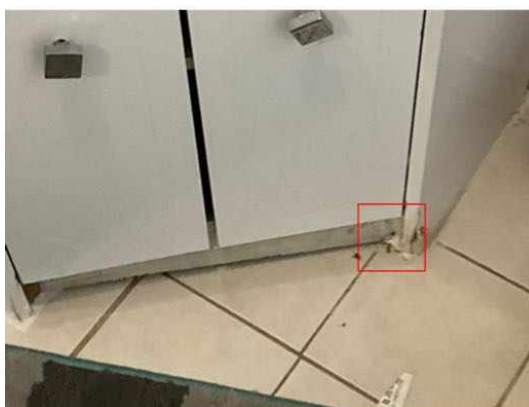
### Finding 3.09

Building:	Main Building
Location:	Bathroom
Finding:	Cupboard/vanity - Swollen/Water Damaged
Information:	Water damage was identified inside the vanity/cupboards in this area and it was also found to be swollen. Water damaged/swollen building elements generally indicate that the building materials have been affected by excessive moisture over a prolonged period of time, and have swollen as a result. A licensed plumber should be engaged to assess where the moisture is coming from and carry out any rectification as soon as possible. Replacement of the vanity/cupboards is also advised by a licensed cabinetmaker.

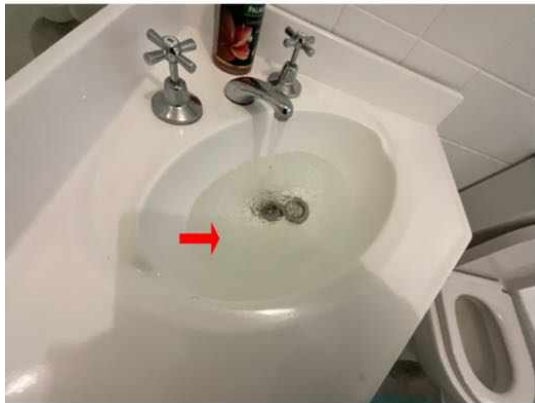
### Finding 3.10

Building:	Main Building
Location:	Bathroom
Finding:	Sink/basin - slow draining
Information:	The sink/basin drain appeared to be partially blocked at the time of inspection. Blockages here are usually caused by hair and other debris. If left unmanaged, a lack of general maintenance may lead to the development of more significant defects, such as water damage to surrounding building materials.

A licensed plumber should be appointed to remove the blockage at the client discretion.

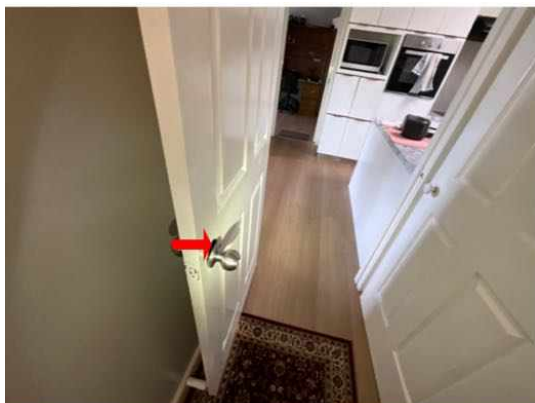
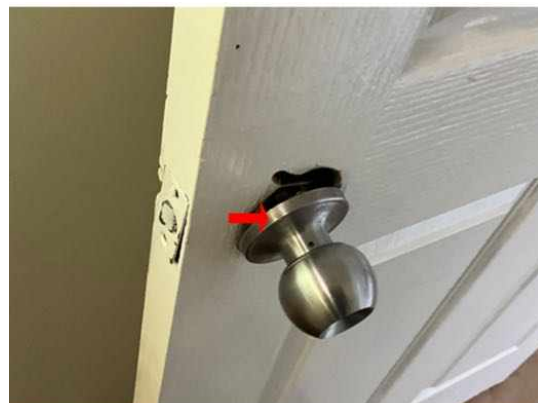
### Finding 3.11

Building:	Main Building
Location:	Hallway
Finding:	Building element - Damaged
Information:	Breakage occurs generally when the building materials have either aged and decayed, or as a result of damage (accidental or deliberate).

Repair and/or replacement of broken elements is advised to ensure that additional secondary defects do not arise as a consequence. Such works are necessary, as all building elements play a key role in the operation and function of the overall structure and its performance.

A relevant tradesperson should be appointed to repair or replace the affected building element prior to any subsequent damage being caused.

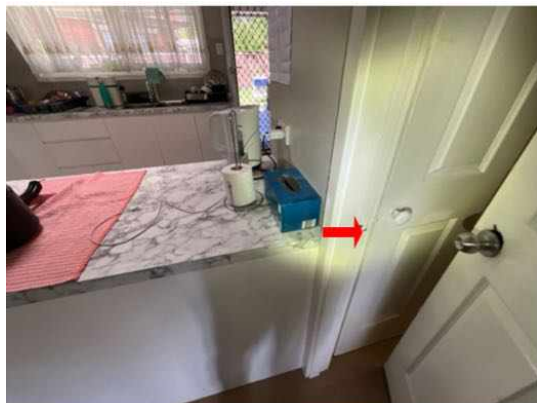
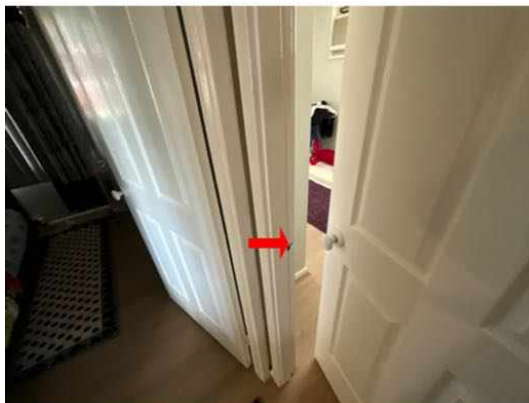
### Finding 3.12

This is a common defect and is expected in a property of this age, whether being due to substandard installation or general deterioration of the door hardware.

Readjustment of the striker plate is recommended at client discretion. Works such as these can be completed by a general handyman or qualified carpenter.

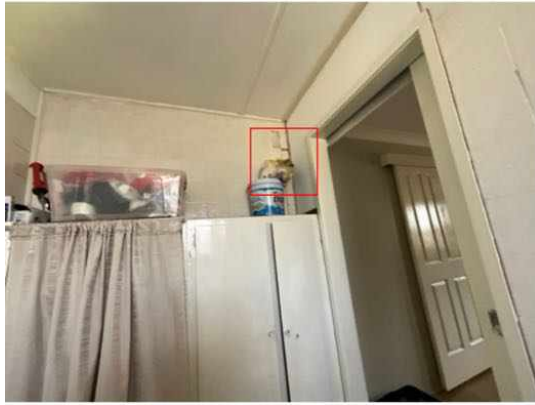
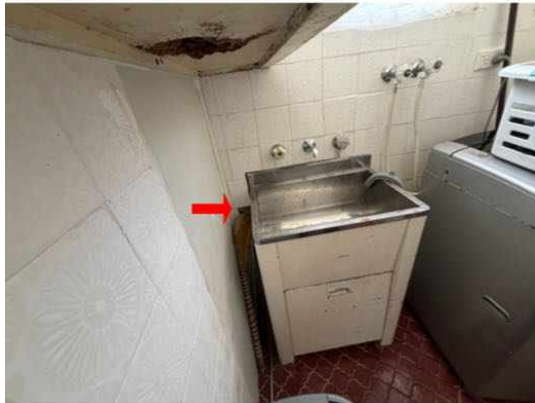
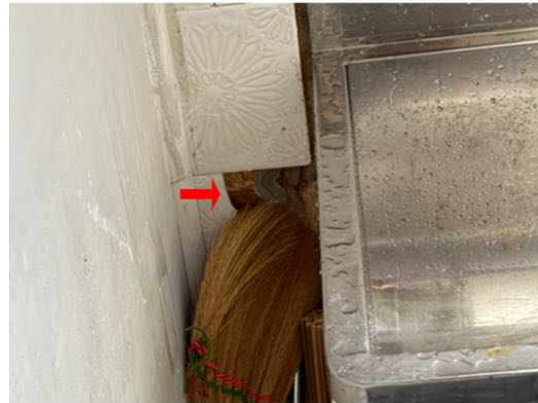
### Finding 3.13

Building: Main Building  
 Location: Laundry  
 Finding: Tiles - Damaged  
 Information: Damage was evident to the tiling in this area at the time of inspection.

If left unmanaged, water penetration to these areas may lead to subsequent water damage, which is likely necessitate repair work to affected building elements.

A tiling contractor should be appointed to ensure that no further water damage occurs. The re-application of silicone and grouting throughout remaining tile work is also advised, to further protect the area against water penetration.

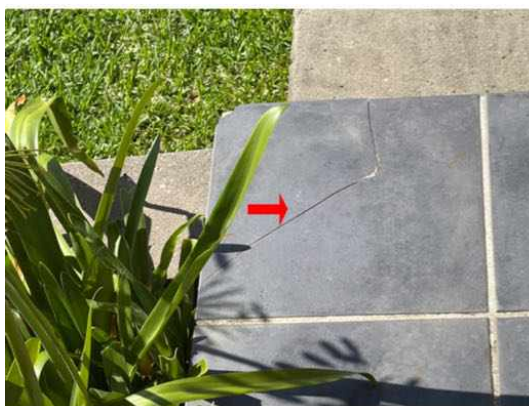
### Finding 3.14

Building: Main Building  
 Location: Porch  
 Finding: Cracked floor tiles  
 Information:

Cracking in the floor tiles was evident in this area at the time of inspection. It is suspected that this cracking has occurred as a result of minor settlement or shrinkage.

Cracked tiles throughout the household detract from the overall appearance of the affected areas however it is unlikely to create or lead to any secondary defects.

While not considered a matter of urgency, replacement of cracked floor tiles is recommended at the clients discretion. A licensed tiling contractor may be appointed to perform these works. Where cracks become more numerous, contact a licensed building inspector for further investigation.

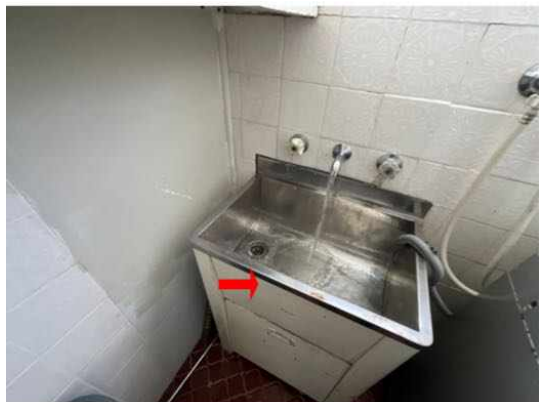
### Finding 3.15

Building: Main Building  
 Location: Laundry  
 Finding: Fitting or fixture - Loose sink  
 Information:

The laundry sink in this area is loose and can be moved with minimal force applied by hand. The sink should be fixed firmly to the wall and/or floor.

If left unmanaged, the sink may move and cause damage to pipes, fitting and finishes.

A licensed plumber should be appointed to perform these rectification works.

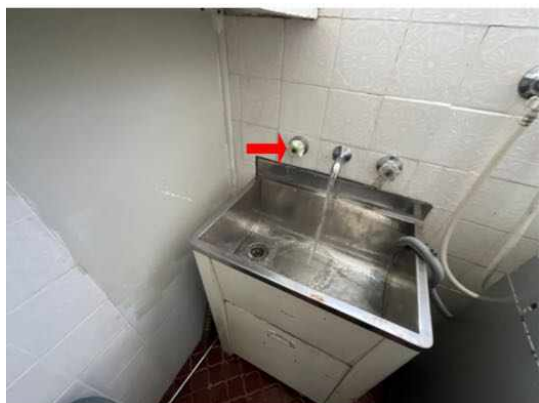
### Finding 3.16

Building: Main Building  
 Location: Laundry  
 Finding: Plumbing fitting or fixture - Loose  
 Information:

The fitting in this area is loose and requires adjustment to tighten.

If left unmanaged, the fitting may further deteriorate, causing potential for the development of other minor secondary defects.

A licensed plumber should be appointed to perform these rectification works at discretion of the client.

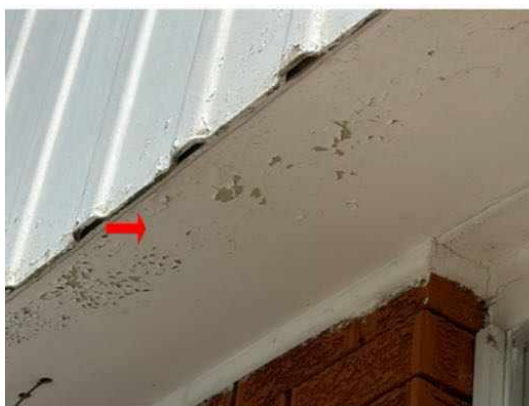
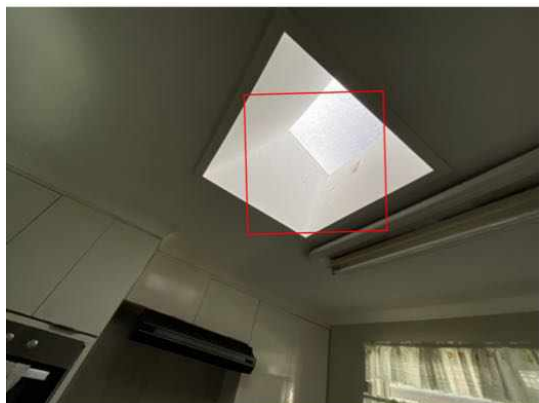
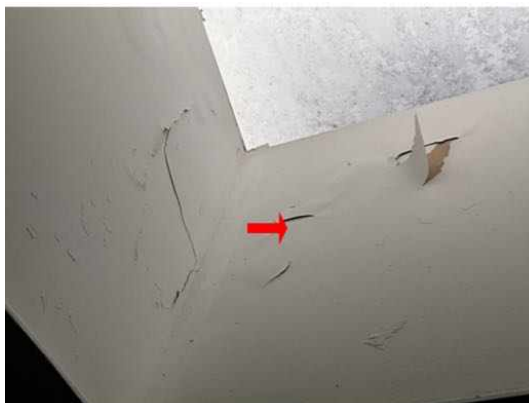
### Finding 3.17

Building:	Main Building
Location:	Multiple areas
Finding:	Paint cracking and peeling
Information:	Cracking and ultimately flaking of paint can occur for a variety of reasons. Often these failures are due to the fact that the paint has inadequate adhesion and flexibility, both common problems with lower quality exterior flat paints.

When timber is involved, moisture intrusion results in swelling of the wood surface followed by contraction as the wood dries. The expansion and contraction cycles, can result in cracking and subsequent paint failure by flaking and peeling.

Cracking and flaking can also result when paint is applied too thinly due to overspreading (higher-than-recommended spread rate) or excessive thinning. These practices tend to diminish the paint's final film thickness, so that it is more vulnerable to cracking and flaking.

Inadequate surface preparation can also cause these failures, especially when paint is applied to bare wood or a very porous surface without first applying a primer.

A qualified painter should be appointed to rectify the problem.

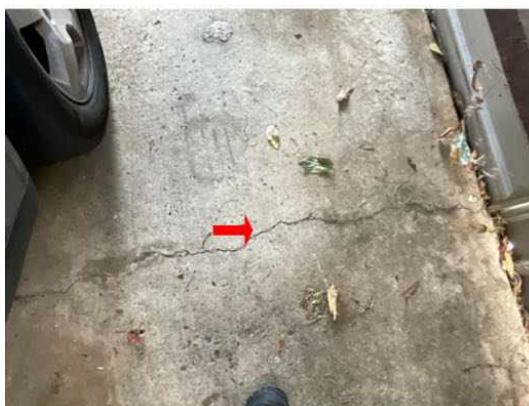
### Finding 3.18

Building:	Main Building
Location:	Carport
Finding:	Cracking - External Concrete Paving Damage Category 0 - Hairline (less than 1mm)
Information:	Hairline cracks were identified in external concrete paving. Hairline cracks are very minor in nature and generally are only ever an appearance defect. To be classified as a Category 0 or hairline crack, the crack width would be less than 0.3mm. While such cracking may be noticeable in some cases, it is common and does not indicate any structural damage.

Generally the cause of a hairline crack in existing concrete paving such as driveways and pathways is indicative of the expansion and contraction of the concrete. Such causes are generally due to environmental factors, such as moisture levels, weather conditions, root systems of nearby trees or the soil types on which they are laid.

Hairline cracks may also be due to poor original installation of the concrete. Factors such as poor compaction of the sub surface and/or inadequate reinforcing of the slab may create cracking and other secondary defects.

Monitoring of all cracking should be conducted frequently. Always contact a building inspector should cracks widen, lengthen, or become more numerous.

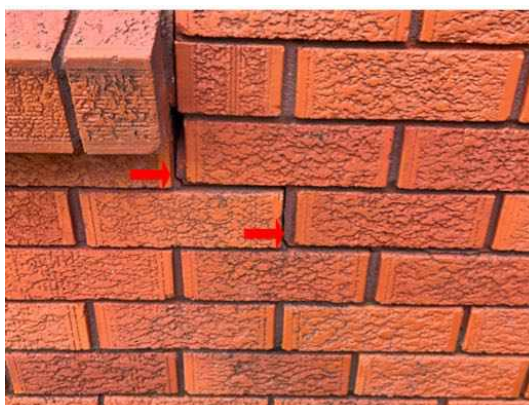
### Finding 3.19

Building:	Main Building
Location:	Front left corner
Finding:	Brickwork - Step cracking
Information:	Step cracking was identified to the brickwork in this area at the time of inspection. Step cracking, which is similar to other forms of cracking, has a variety of possible causes. However, the most common is the subsidence of adjacent footings.

Step cracking is a relatively common defect, and is most likely to occur adjacent to windows, doors and other openings. Mortar failure in the gaps between affected bricks indicates the stresses and tensions affecting the wall.

The degree of damage falls within Category 1, described as fine cracks, which are less than 1.0mm in width limit, and that do not need repair.

Damage of this category is not considered a defect for rectification.

Minor step cracking can be used as a warning sign to address factors causing stress to the wall, which can include the effect of surrounding trees, water leaks, soil erosion, or even the presence of reactive soils in the surrounding area. Always contact your building inspector should cracks widen, lengthen, or become more numerous.

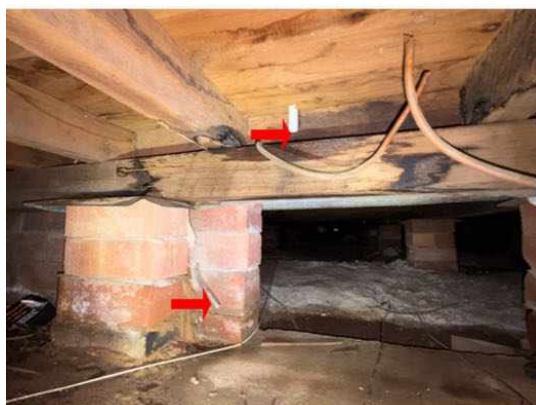
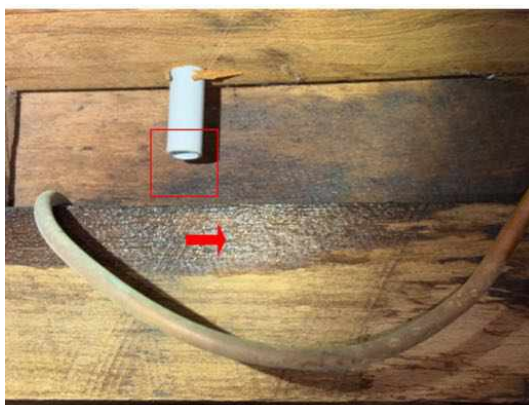
These damp conditions can lead to secondary defects such as rot, rust or corrosion of associated building elements, the formation of fungal decay, or even the creation of potential slip hazards. When coupled with poor site drainage, pooling of water may also attract termite activity to this area.

It is highly recommended that a licensed plumber be appointed to install adequate drainage to the overflow. These works will ensure that the area remains dry and free of any secondary defects.

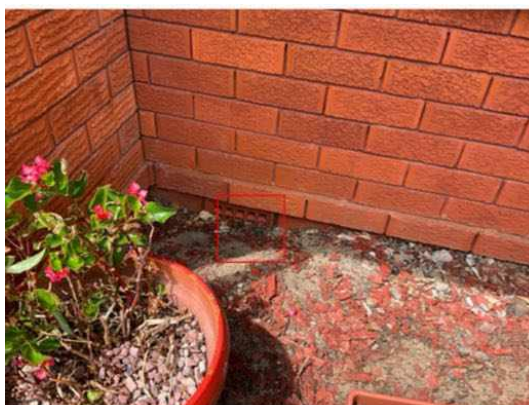
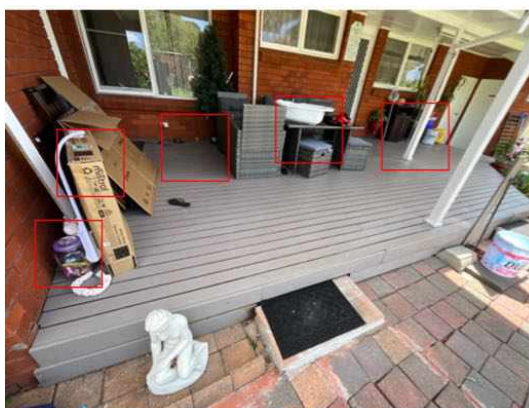
### Finding 6.02

Building:	Main Building
Location:	Multiple areas
Finding:	Air vents - Blocked or inadequate
Information:	It was noted at the time of inspection that the subfloor area lacks adequate ventilation. The cause of this inadequate ventilation is the state of the air vents to the subfloor

A well ventilated subfloor aids in maintaining dry conditions, preventing secondary damage such as wood rot and pest activity, as well as preventing the development of mould/fungi and mildew (which can lead to major respiratory issues or safety hazards for occupants, particularly the elderly, the very young and those with existing illnesses).

All air vents should be cleared of blockages to promote adequate air flow to the area. Where ventilation is still insufficient, retrospective installation of air vents may be required. Appointment of a licensed builder may be required to perform these works as necessary.

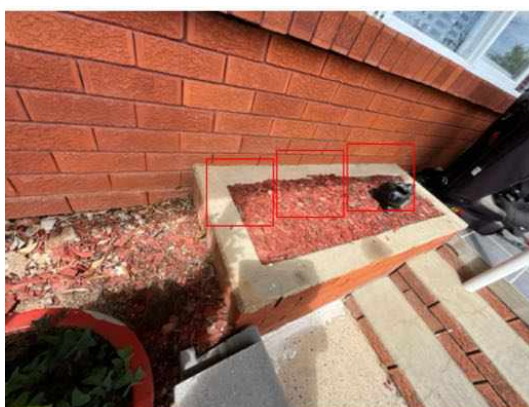
Damp proof course (DPC) is a barrier of impervious material built into a wall or pier to prevent moisture from moving to any part of the building. Where external ground levels are built up over this barrier ingress is provided for moisture from the exterior grounds into the base brickwork or other building material and allowed to rise.

Such conditions attract termites into these damp areas which is likely to lead to infestation if left untreated.

While retrospective fitting of DPC is considered to be impractical works are required in order to prevent the extraction of moisture from the external environment into exterior brickwork or wall materials. Landscaping or re-paving of external grounds may be considered by the client. Regular annual inspections are strongly advised.

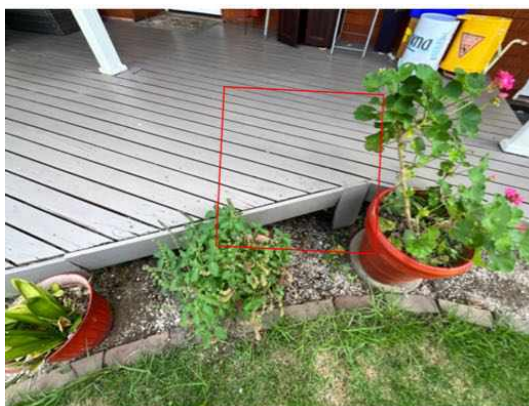
Building:	Main Building
Location:	Fencing & Landscaping
Finding:	Building materials in direct ground contact - conducive to termites
Information:	Where timber elements are in direct contact with the ground and consequently moisture or dampness they become conducive to termite activity. Whether timber is used as a building element part of a fencing structure or stored as an unused item they can provide an environment that is attractive to termite infestation.

When met with excessive moisture timber begins to decay and develop wood rot. Any timbers that are in direct contact with external grounds especially if left untreated or non-durable also provide ingress for subterranean termites into that particular element.

The removal of any such materials that may be conducive to termite activity should be removed as soon as possible to minimise the risk of termite attack.

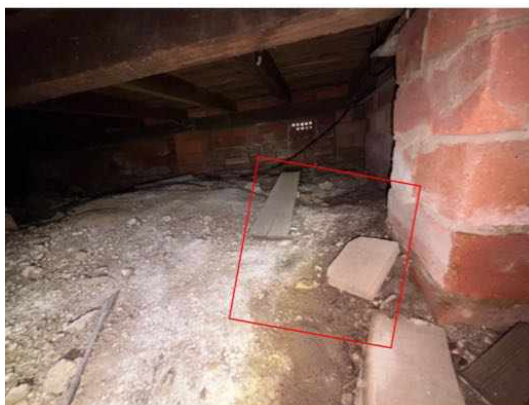
### Finding 6.06

Building:	Main Building
Location:	Subfloor
Finding:	Stored timbers - subfloor space or external area
Information:	The storing of timbers in the subfloor space or around the external property increases the risk of termite activity being present. As they are likely to come into contact with weather conditions or excessive moisture wood rot is likely to develop on timbers that are not treated.

It is highly recommended that any stored timbers be immediately removed from areas in which they may attract any termite / timber pest attack. Minimisation of risk / prevention of termite attack is far more adequate than dealing with the presence of termite activity.

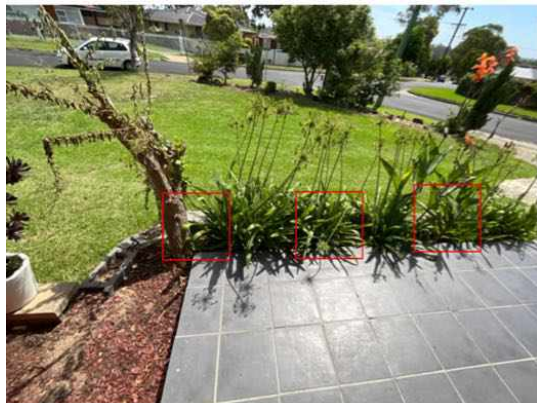
Building:	Main Building
Location:	Porch
Finding:	Vegetation - Abutting property

Information: Vegetation against external wall may have an invasive root system. If there are weak points in the brick work or concrete slab, it is possible for the roots to gain entry into these areas. Once the roots have gained entry, it is possible for termites to gain concealed entry via these roots. It is recommended to remove the vegetation and root system where possible.

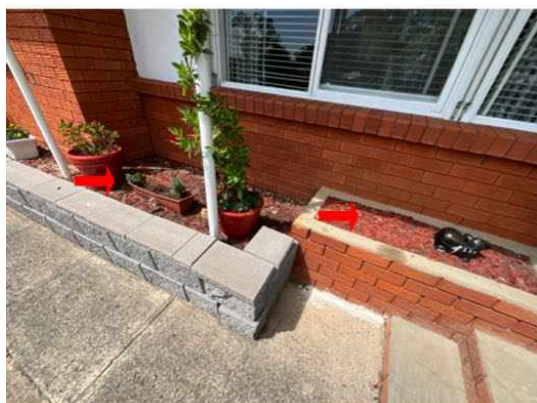
Finding: Garden Beds

Information: Garden beds were found to be evident in the garden area. These garden beds can include untreated timber, and with a combination of moisture from watering hosing can make conditions conducive to termite activity and termite ingress.

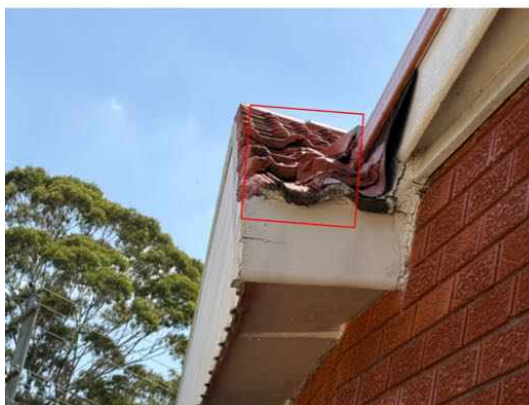
Finding: Roof plumbing - Missing

Information: Some sections of the roof are not adequately drained via gutters and downpipes. Gutters and downpipes that are not installed adequately are likely to result in excessively damp conditions against the exterior surfaces and around the base

Excessive moisture creates an environment which accelerates the deterioration of building elements in the area, as well as being conducive to termite and pest infestation. Such an environment is likely to necessitate repair and/or replacement of building elements, which are prone to sustaining wood rot, rust or corrosion.

A roofing plumber should be appointed as soon as possible to install relevant roof plumbing materials.

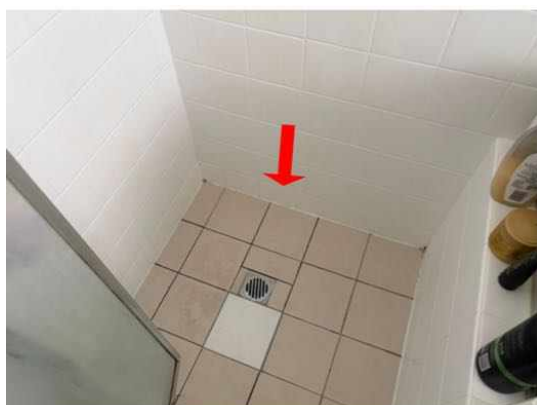
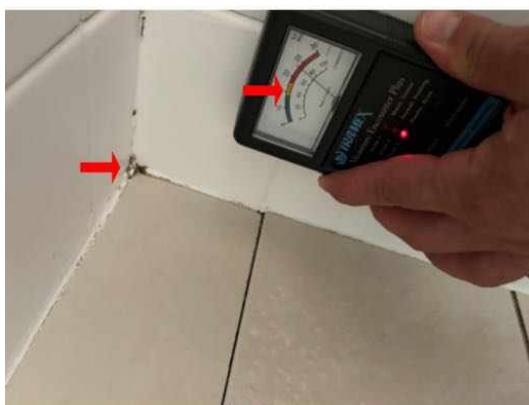
### Finding 6.12

Building:	Main Building
Location:	Bathroom
Finding:	Shower damp - Sealant and grout
Information:	Damp is evident to the lower 400mm of wall to the shower alcove. This defect is quite common, and is suspected to have been caused by moisture permeating or leaching through the grouting and sealant in this area, which shows evidence of deterioration. Leaking pipes within the wall is also a possible cause however this seems unlikely in this instance as there is no moisture build up around the taps or transferring to the other side of the wall. There appears to be no sealant around the tap spindles which may be a small contributing factor.

Unmanaged damp in the shower recess is likely to facilitate the formation and development of mould and fungi growth, decaying associated building materials and compromising their structural integrity of associated elements. It is important to address damp conditions, as the World Health Organisation notes that excess moisture leads - on almost all indoor materials - to growth of microbes such as moulds, fungi and bacteria, which subsequently emit spores and other matter into the indoor air. Exposure to these contaminants is associated with a wide range of

respiratory and other health-related problems. Damp conditions also create a conducive environment for termite infestation.

Consultation with a bathroom sealant specialist is advised immediately to identify the cause of damp and to perform remedial works as required.

Always ensure that sealant and grout is in good condition to prevent any moisture issues occurring in the future.

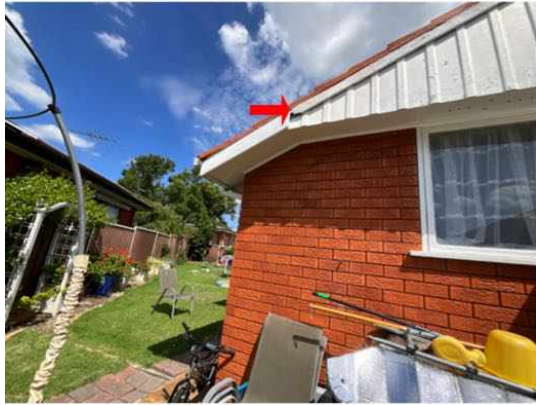
### Finding 7.01

Building:	Main Building
Location:	Fascias
Finding:	Fascias - Wood rot/decay
Information:	Wood rot was found to be affecting fascias and barges in this area, evidenced by the presence of mould on the surface in some areas. Wood rot, also known as Fungal Decay, occurs when timbers and other cellulose building materials are exposed to damp conditions on an ongoing basis.

It is likely that this wood rot has developed as a result of faults in the roof plumbing, creating excessive moisture in this areas. Otherwise frequent exposure to rain and other weather conditions also make fascias and barges susceptible to accelerated deterioration.

Early intervention and regular maintenance will prolong the useful life of these building elements. Prior to any works being performed, the cause of the moisture that has created the visible wood rot should be identified and addressed in a suitable manner.

It is advised that a roof plumber be appointed to inspect all roof plumbing and subsequently identify the cause of the wood rot. Replacement of affected fascias and barges may then be a necessary step in protecting surrounding building elements from such deterioration.

A licensed plumber may be appointed to assess the cause of excessive moisture and to provide advice on any remedial works as required. A licensed carpenter may also be required to replace affected building materials.

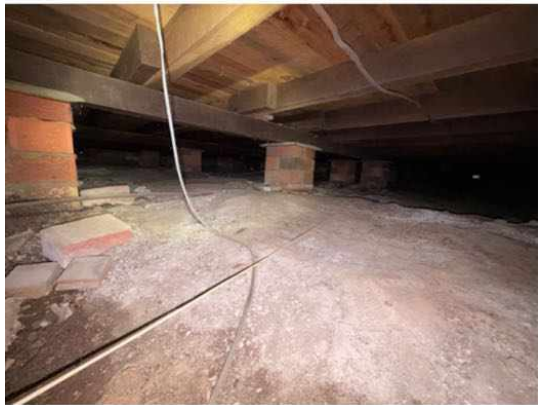
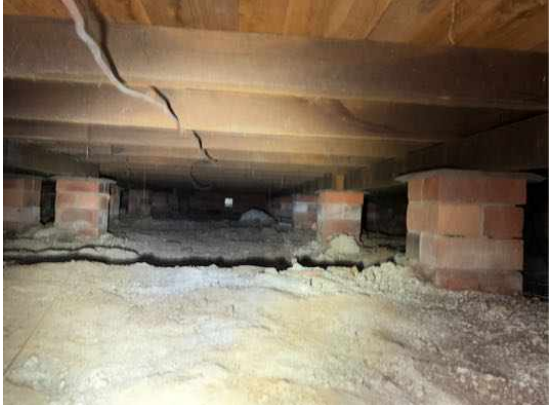
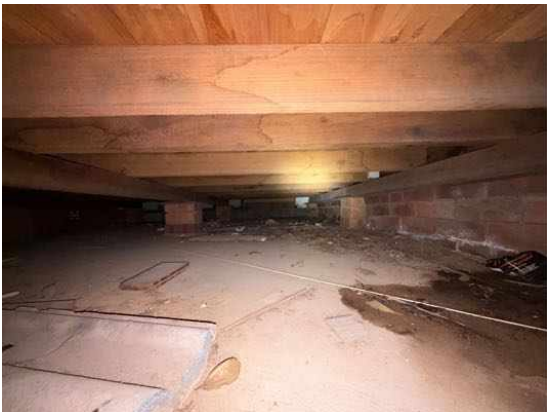
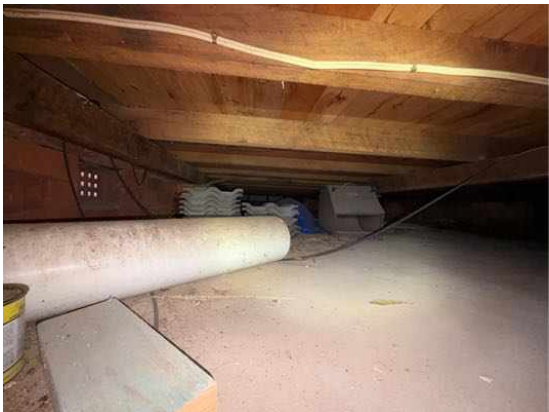
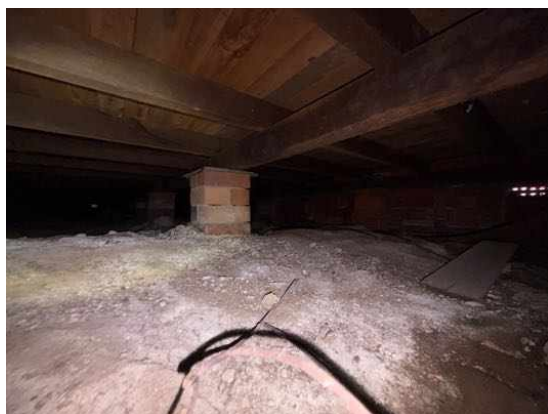
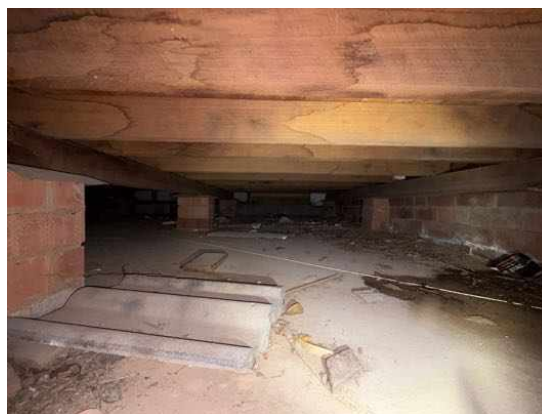
Finding: Additional Photos

Information: Additional photos are provided for your general reference.

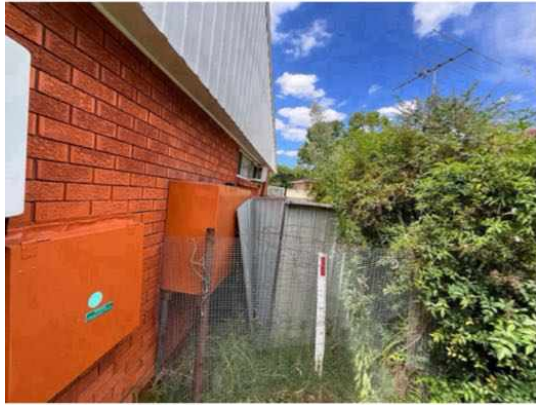
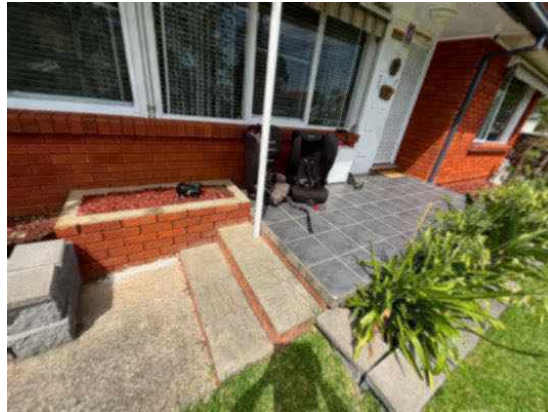
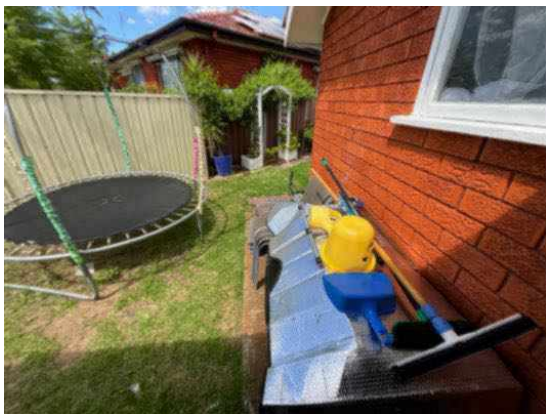
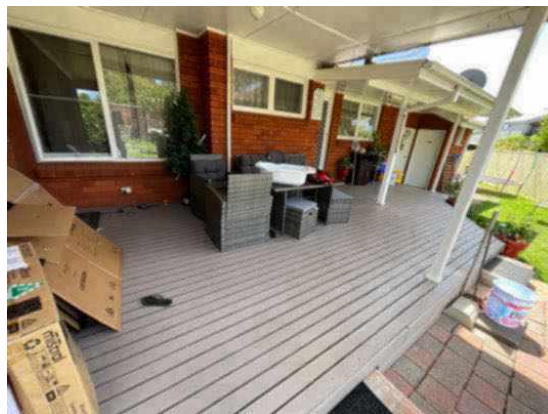
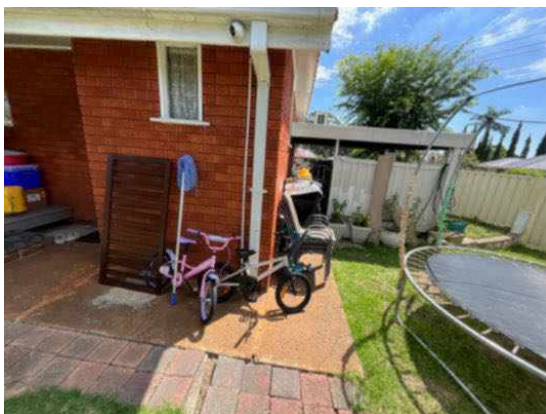
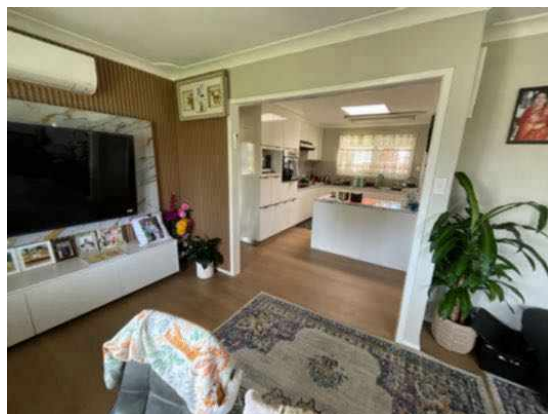
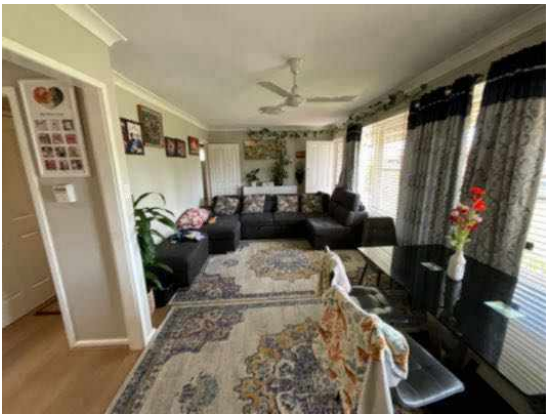
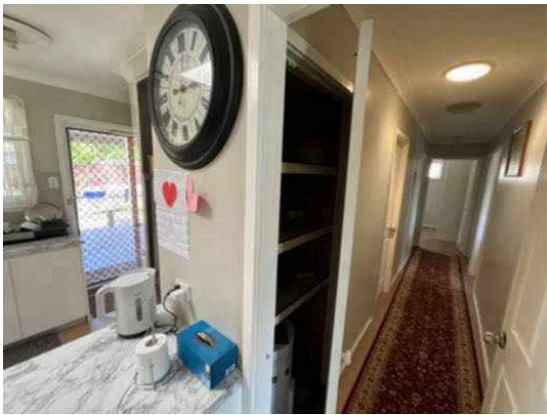
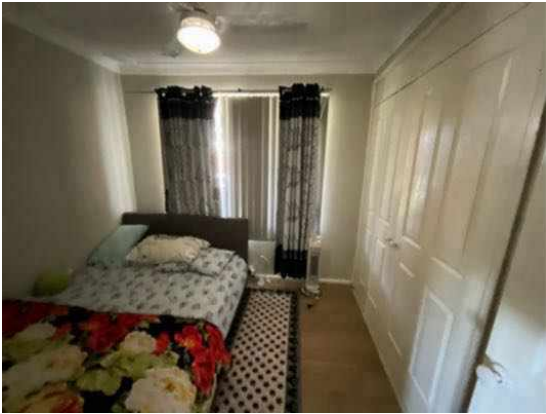
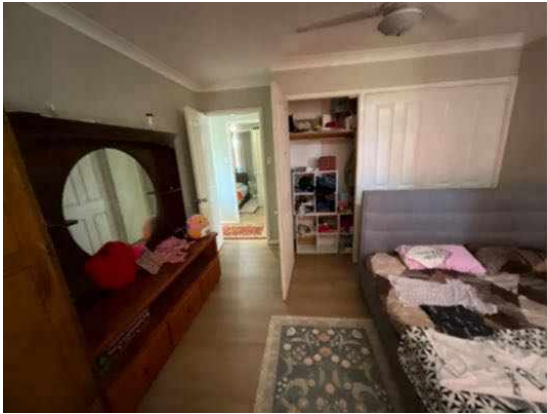
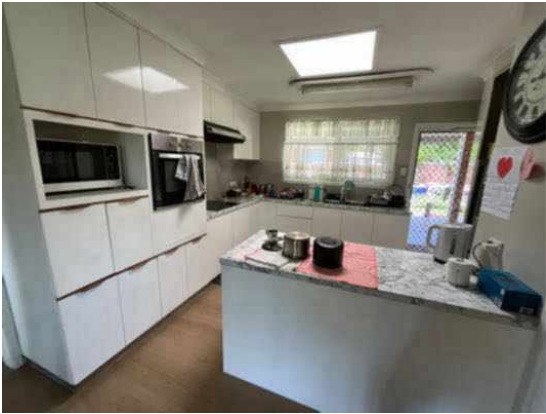
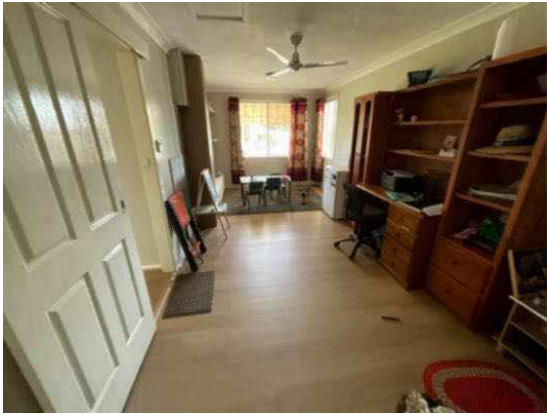
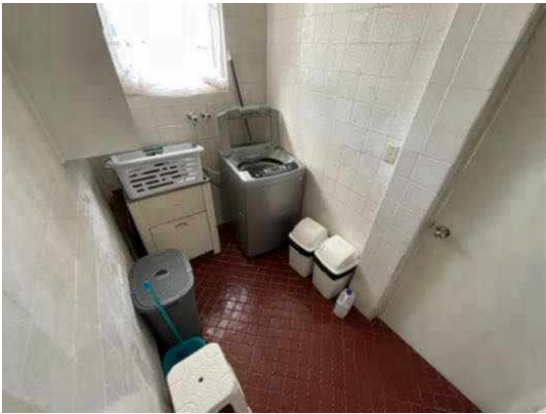
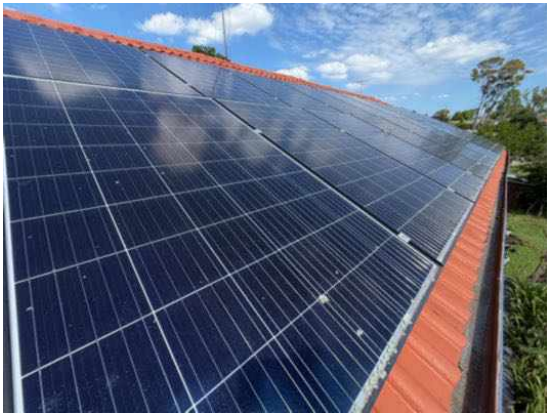
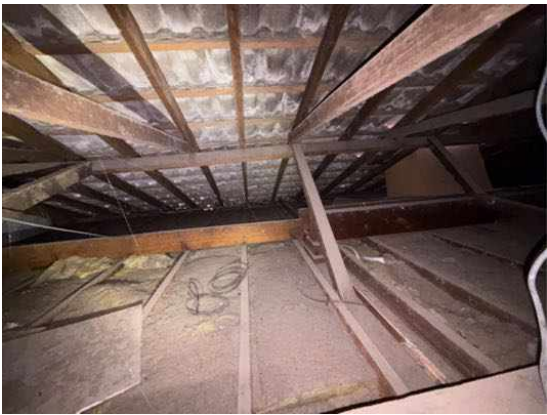
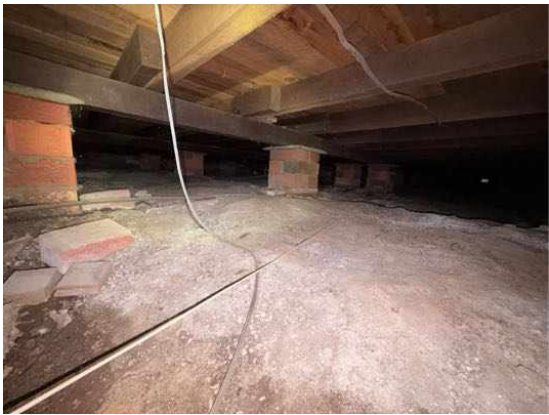
Building: Main Building  
Location: All Areas  
Finding: Additional Photos - Obstructions and Limitations  
Information:

These photographs are an indication of the obstructions and limitations which impeded full inspection of the property at the time of inspection. These obstructions can hide an array of defects and should be removed to allow full inspection to be carried out. A re-inspection is recommended once the areas are made accessible.
