Building and Timber Pest Inspection Report

Inspection Date: Sat, 7 Mar 2026

Property Address: 11 Ellerstone Ct, Kellyville NSW 2155,
Australia

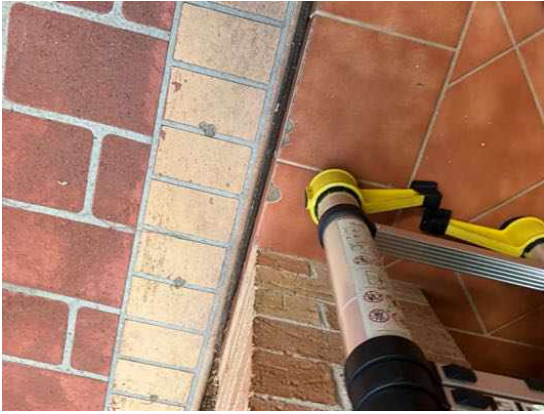
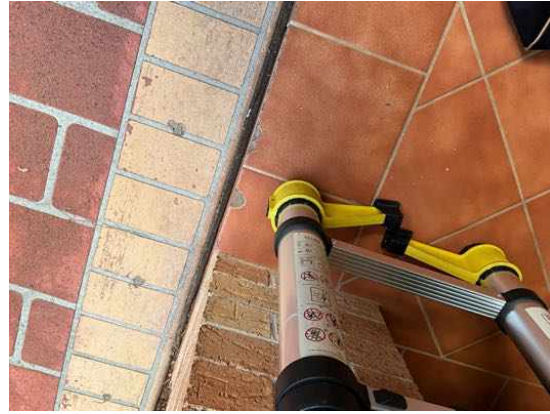
Finding 3.02

Finding: Crack in concrete slab - Category 0

Information: A crack coded as Category 0 was identified in the slab. A Category 0 crack is described as a hairline crack, representing insignificant movement of slab from level.

The approximate width of the crack to be considered Category 0 is 0.3mm, or change in offset of less than 8mm when a 3m straight edge is placed over the defect.

No rectification is required at this time. However, all cracking should be monitored over a 12 month period to identify any further damage in the area.

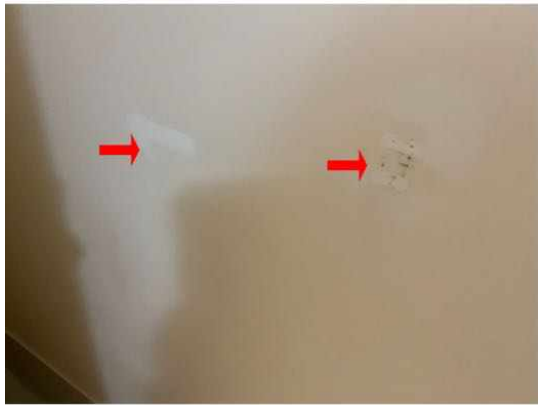
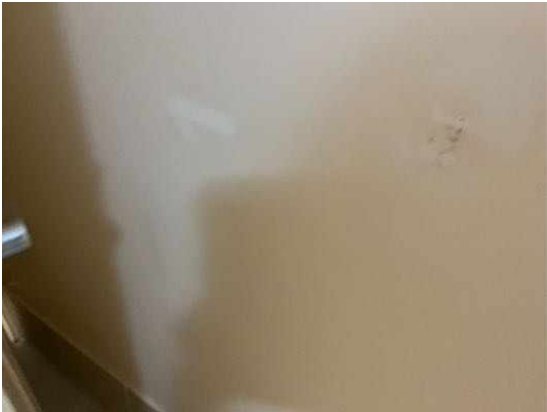
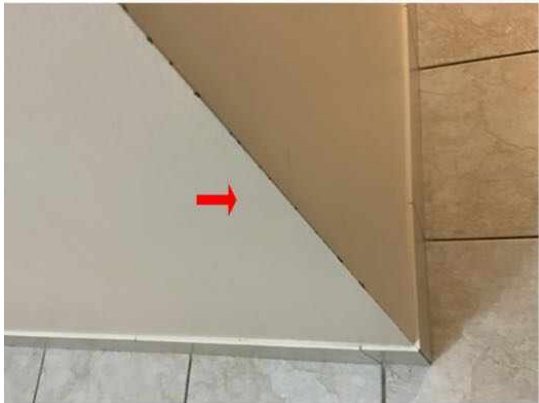
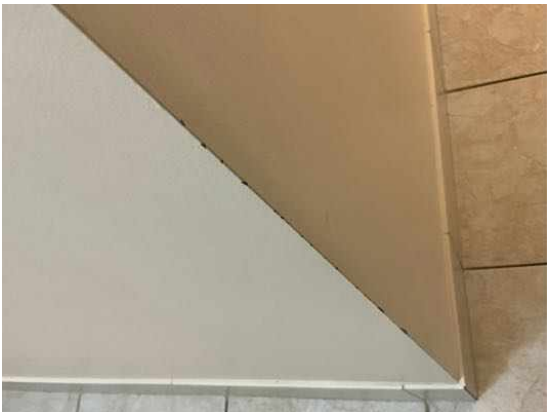
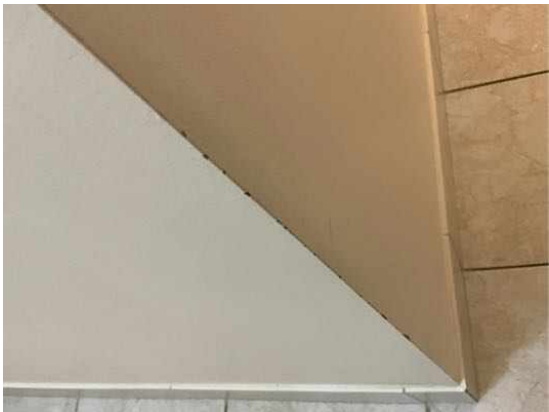
Finding 3.09

Building: Main Building
 Location: All Areas
 Finding: Paint surface - Scratches
 Information: Scratches have been identified on the paint surface, detracting from the overall appearance and quality of the painted surface.

1. Aesthetic Degradation: Scratches mar the appearance of the painted surface, diminishing its visual appeal and potentially lowering property value.
2. Corrosion Vulnerability: Exposed areas of bare metal due to scratched paint are susceptible to corrosion, leading to structural damage and compromised durability.
3. Environmental Hazards: Scratched paint can release hazardous chemicals into the environment, posing risks to both human health and the ecosystem.

A qualified painter should address the issue promptly to repair the scratched paint. Depending on the severity of the scratches, repair options may include sanding, priming, and repainting the affected area to restore the integrity and appearance of the paint surface.

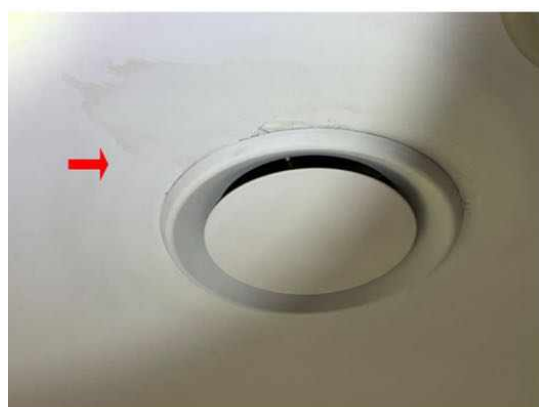
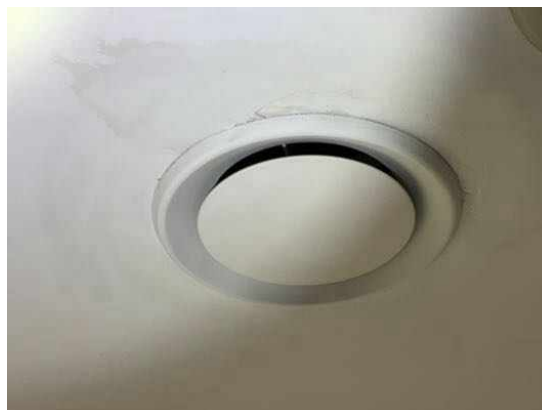
Building:	Main Building
Location:	All Areas
Finding:	Condensation stains near vents
Information:	Condensation stains near vents in a roof cavity can indicate potential moisture issues that, if not addressed, could lead to mold growth, structural damage, and decreased insulation effectiveness. Here are the risks and steps to fix it:

1. ****Mold Growth****: Persistent moisture can create an environment conducive to mold growth, which can affect indoor air quality and cause health problems.
2. ****Structural Damage****: Over time, moisture can weaken the wooden structure, leading to rot and compromised structural integrity.

3. **Insulation Damage**: Moisture can reduce the effectiveness of insulation, leading to higher energy costs and reduced comfort.

1. **Identify the Source**: Determine where the moisture is coming from. This could be due to poor ventilation, leaks in the roof, or condensation from HVAC ducts.
2. **Improve Ventilation**: Ensure that the attic or roof cavity is well-ventilated. This can be done by installing additional vents or improving existing ones.
3. **Seal Ducts**: Make sure HVAC ducts are properly sealed to prevent condensation from forming on their surfaces.
4. **Insulate Ducts**: Insulating ducts can reduce the temperature difference between the air inside the duct and the surrounding air, which can reduce condensation.
5. **Check for Leaks**: Inspect the roof and any penetrations (e.g., vents, chimneys) for leaks and repair as needed.

1. **Roofing Contractors**: For leaks and structural issues in the roof.
2. **HVAC Professionals**: For duct insulation and sealing issues.
3. **Insulation Specialists**: For improving attic or roof cavity insulation.
4. **General Contractors**: For overall assessment and coordination of different repairs.

It's recommended to have a professional inspect the area to determine the exact cause and scope of the issue. They can provide specific recommendations and solutions based on the condition observed.

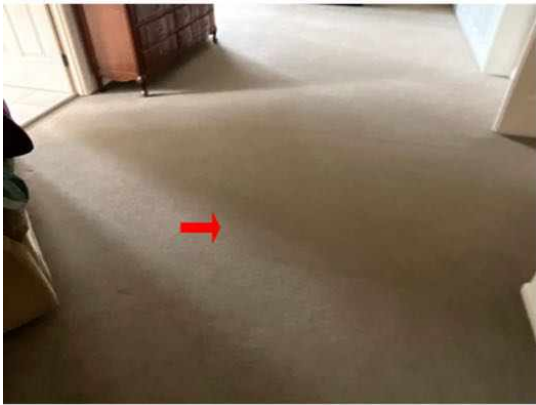
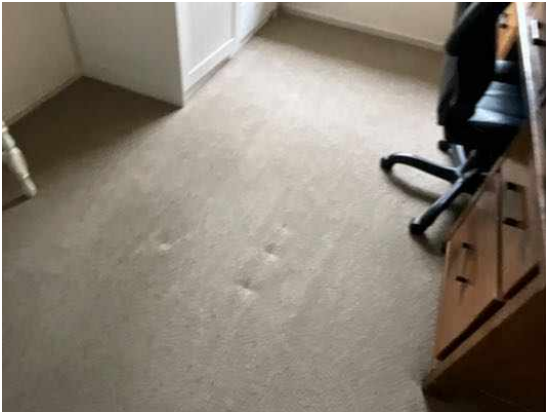
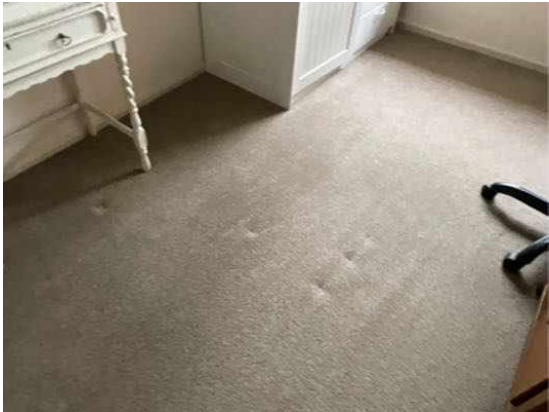
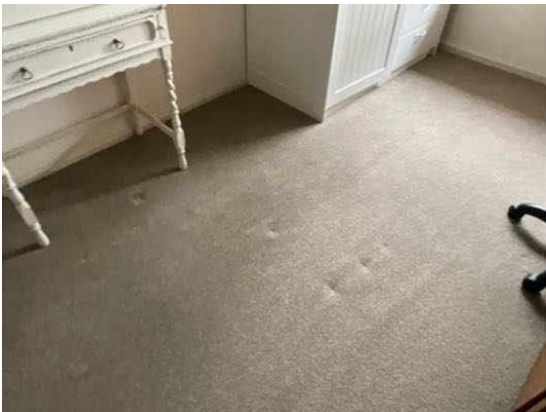
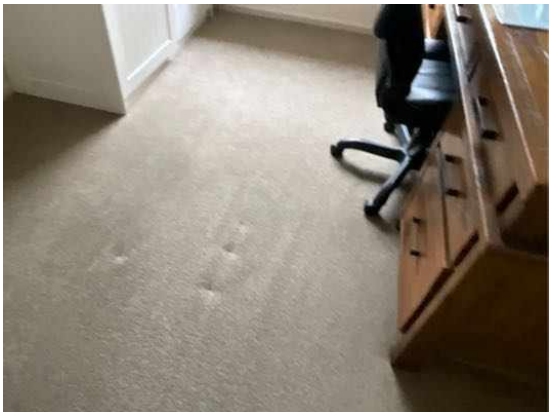
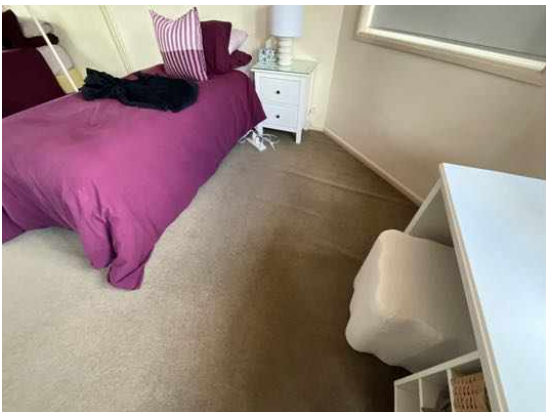
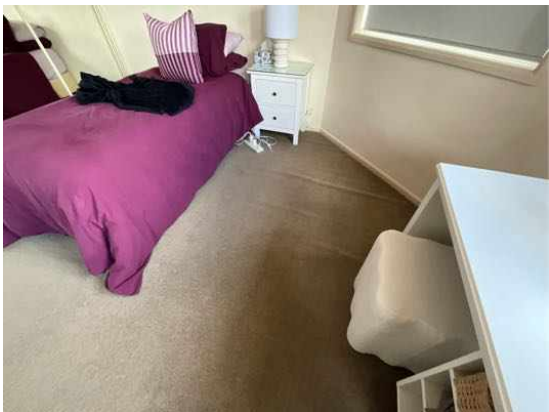
Finding 3.12

Building:	Main Building
Location:	All Areas
Finding:	carpet exhibits visible signs of aging
Information:	Carpets are exhibiting visible signs of aging, including fraying edges, faded colors, and flattened fibers, diminishing their aesthetic appeal and functional quality.
Risk:	The risk associated with aging carpets includes diminished appearance, decreased comfort, potential tripping hazards due to frayed edges, and a negative impact on indoor air quality if fibers begin to degrade and release particles into the air.
Who can fix it:	Professional carpet cleaning and restoration services can address issues such as deep cleaning to rejuvenate colors, repairing frayed edges, and restoring fibers. Additionally, replacing the carpets entirely may be necessary in severe cases of aging or damage beyond repair.

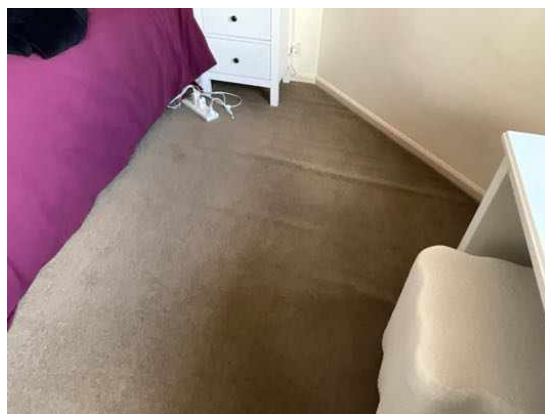
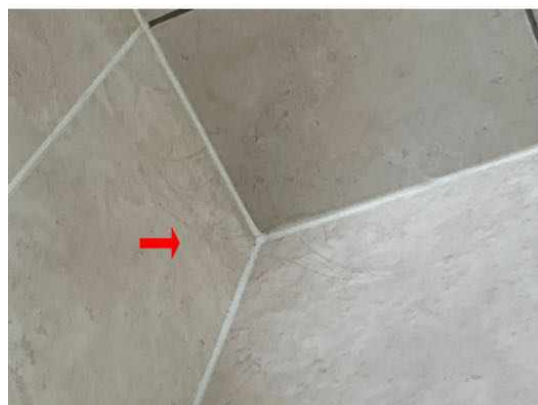
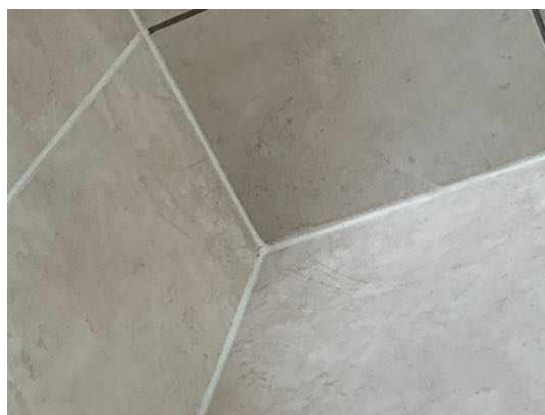
Finding 3.13

Information: Visible surface scratches were observed, While this is primarily a cosmetic defect, it can negatively impact the visual appeal and reduce the durability of the tile glaze over time.

A qualified tiler or handyman should assess the extent of the damage. Minor scratches may be polished or concealed with appropriate tile repair products, while deeper scratches may require tile replacement to restore the original finish.

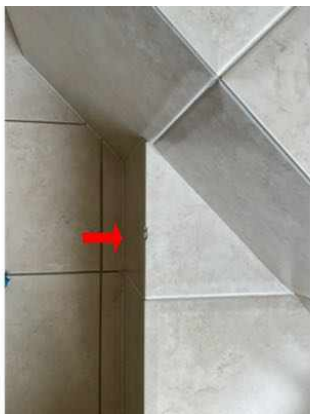
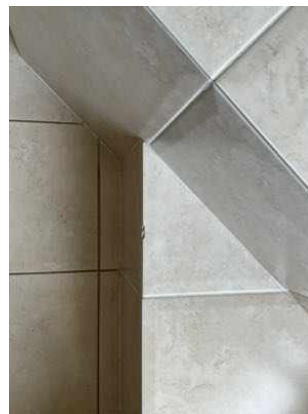
- Injury Risk: The sharp edge of the chipped tile can cause cuts if someone accidentally steps on or touches it.
- Water Damage Risk: If the chipped area becomes larger, water may seep through,

- Tiler or Handyman: A professional tiler or a handyman should be contacted to replace the chipped tile or, if feasible, repair it to prevent further damage or injury.

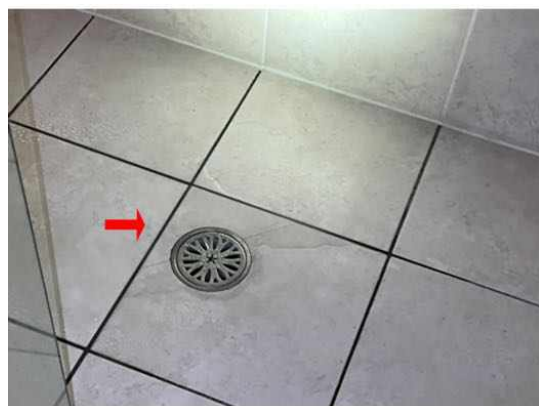
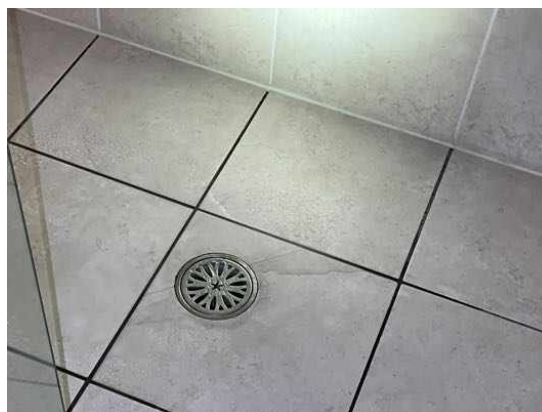
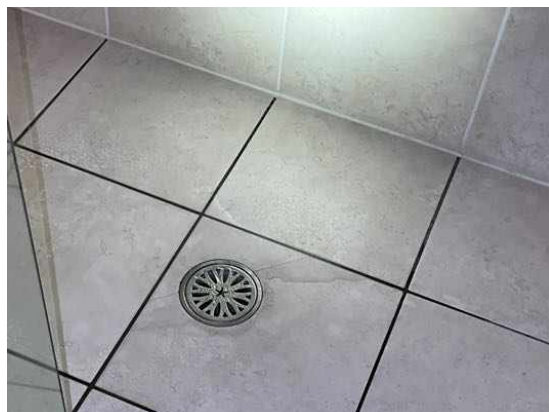
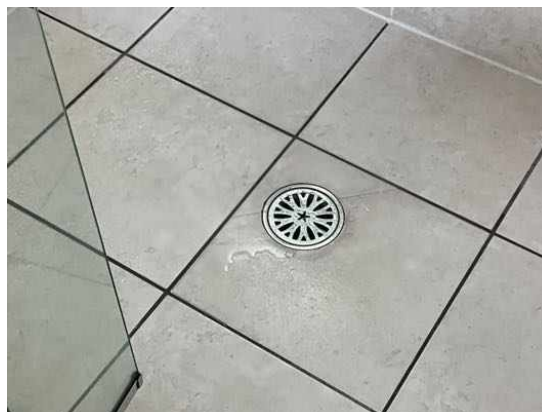
Finding 3.16

Building:	Main Building
Location:	Ensuite
Finding:	Shower base - Water pooling
Information:	Evidence of water pooling around the floor waste in the shower recess was noticed at the time of inspection. It is suspected that this excessive moisture is attributed to insufficient fall in the shower floor tiles.

This pooling is minor overall but is still considered unsatisfactory, as standard tiling practices would not permit this situation to occur. Pooling water around floor wastes can create a slip hazard in extreme cases and create conditions that are conducive to mould growth over time. Where left unmanaged, the degradation of sealant and grouting is also likely to occur, possibly necessitating further repair works.

Remedial works may involve some sections of tiling and flooring repair and replacement. A tiling contractor or bathroom specialist should be appointed to provide further advice on reparation options and to perform works as necessary.

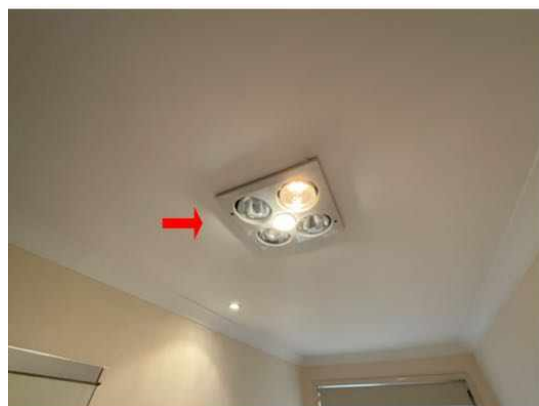
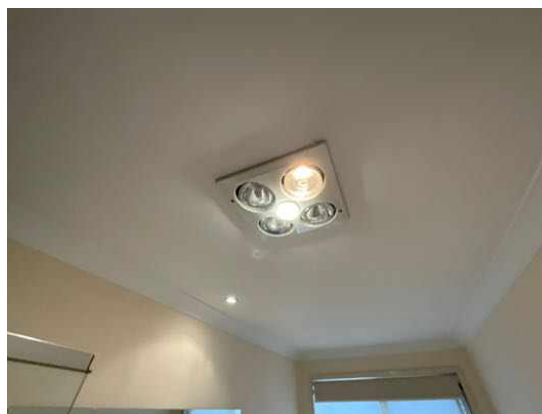
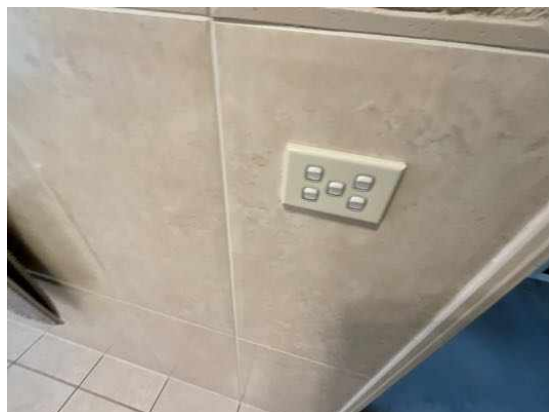
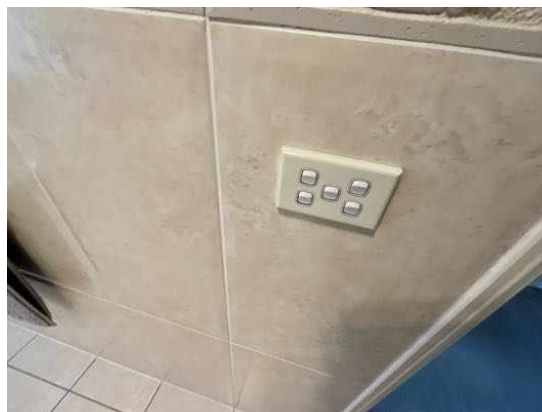
Finding 3.17

Building:	Main Building
Location:	Bathroom
Finding:	Heating light in exhaust fan not working / operating
Information:	"The heating light in the exhaust fan is not operating, failing to provide the intended heating function."

A qualified electrician or HVAC technician can fix the issue by inspecting the heating element, wiring, and controls to identify and repair any faults or damages.

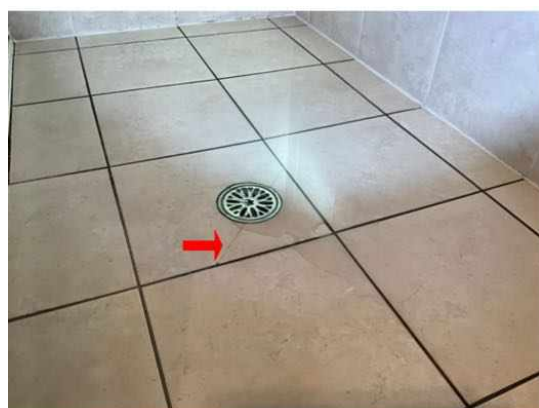
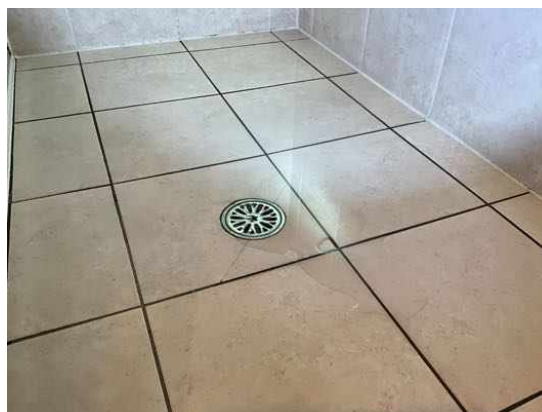
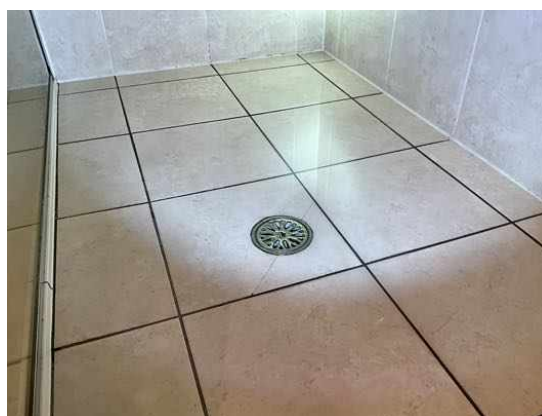
This pooling is minor overall but is still considered unsatisfactory, as standard tiling practices would not permit this situation to occur. Pooling water around floor wastes can create a slip hazard in extreme cases and create conditions that are conducive to mould growth over time. Where left unmanaged, the degradation of sealant and grouting is also likely to occur, possibly necessitating further repair works.

Remedial works may involve some sections of tiling and flooring repair and replacement. A tiling contractor or bathroom specialist should be appointed to provide further advice on reparation options and to perform works as necessary.

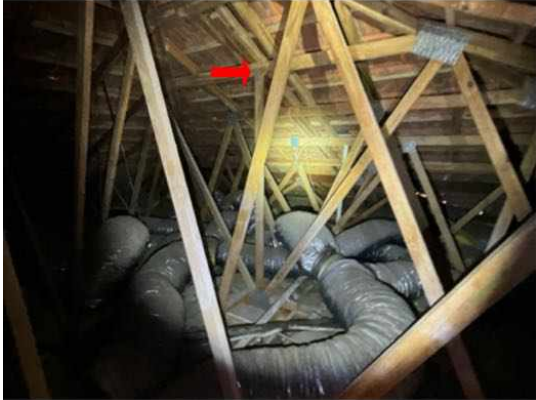
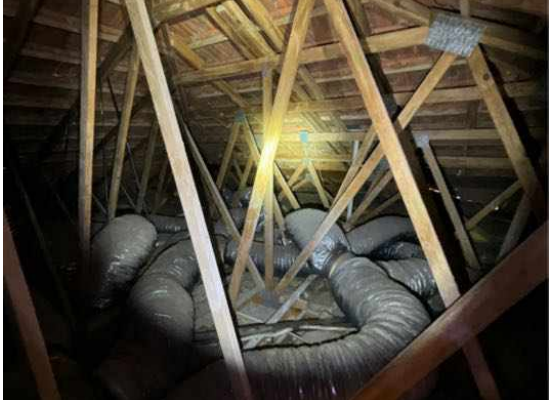
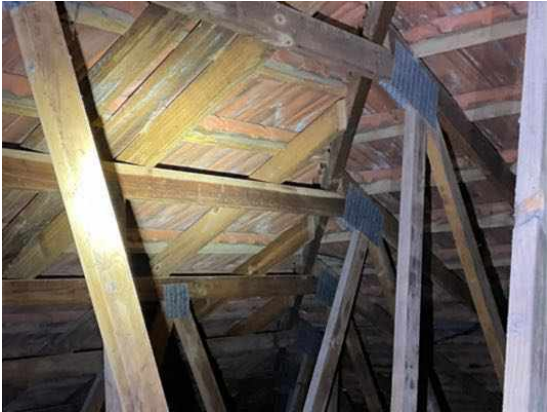
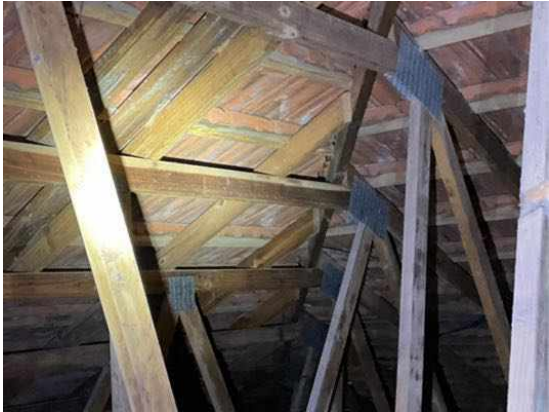
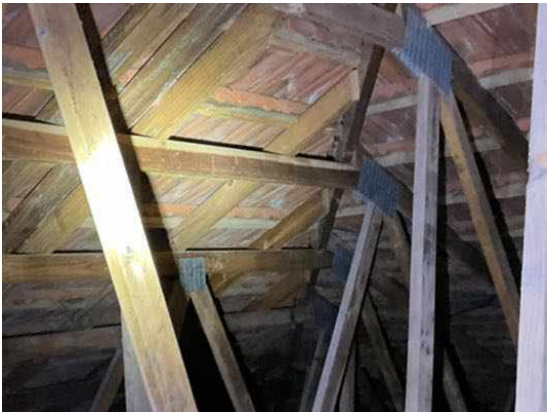
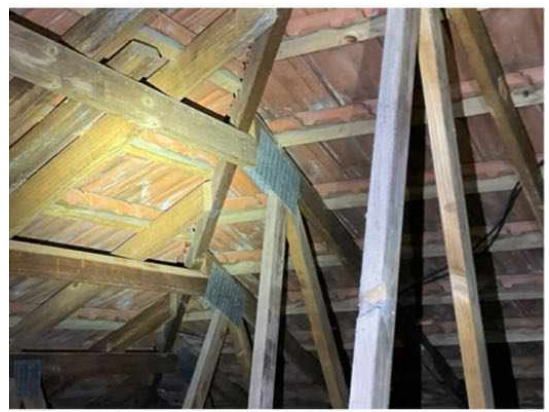
Building: Main Building
 Location: Roof Void
 Finding: Sarking - Missing
 Information: Sarking is missing under the roof sheeting. Sarking acts as an insulator that helps with noise reduction and protects against water penetration. Sarking plays a key role in the operation and function of the overall roofing structure and its performance.

Although not a requirement at the time of construction, replacement of any missing building element is advisable (although this can be quite expensive to do after the time of construction). Where sarking is missing, regular inspections of the roof tiles for cracking and potential moisture penetration is required.

Sarking may be retrospectively fitted by a registered builder at the discretion of the client.

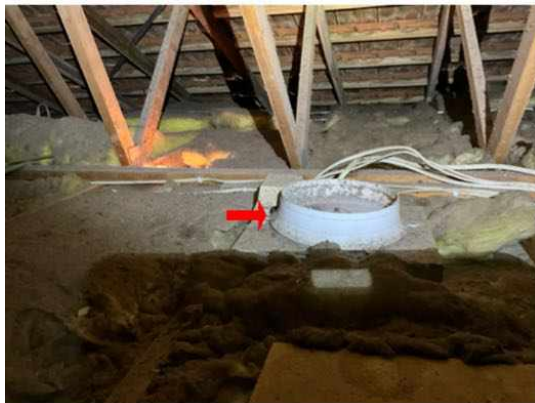
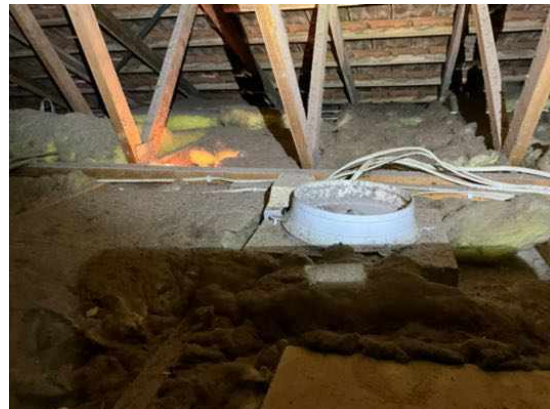
Finding 3.22

Building: Main Building
Location: Roof Void

Finding: Exhaust fan not vented out
 Information: The exhaust fan located within the roof void is not appropriately ducted to the external atmosphere and is currently discharging moist air directly into the roof space. This is considered a defect under AS 4349.1, as it does not meet the minimum standard of residential building performance expected under normal residential building practices.

This condition may lead to excessive condensation within the roof void, increasing the risk of mould growth, deterioration of insulation, timber decay, and overall reduced durability of building elements. It may also result in poor indoor air quality, potentially affecting occupant health.

It is recommended that the exhaust fan be modified by a licensed HVAC contractor or qualified builder, ensuring it is properly ducted to discharge externally in accordance with manufacturer specifications, the National Construction Code (NCC), and applicable Australian Standards.

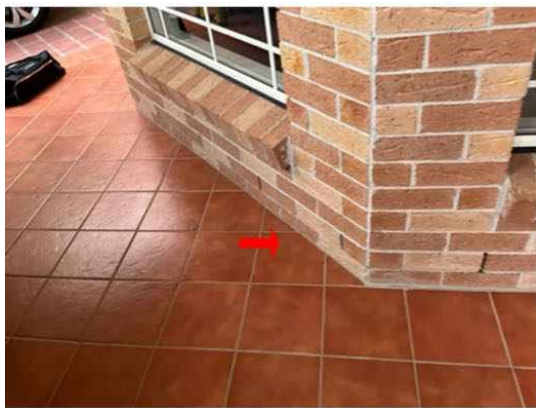
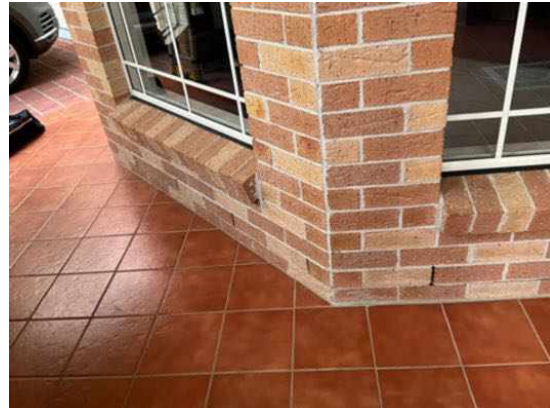
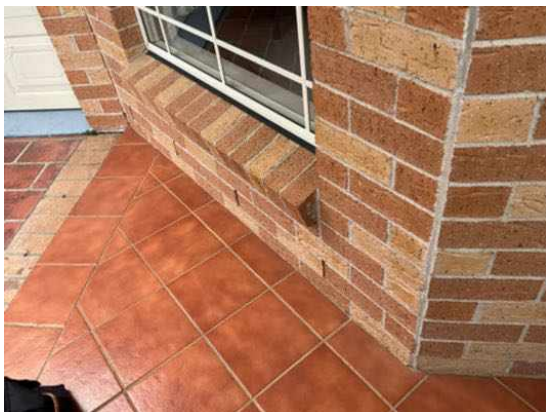
If the slab edge is not properly exposed there is a high risk of termite attack. Sometimes, in order to determine the type of slab, a suitably qualified person such as an architect or builder may be required to consult the construction plans.

Where the slab edge cannot be properly inspected, it is highly recommended that termite or timber pest inspections be carried out every 6-12 months to aid protection of the property against infestation.

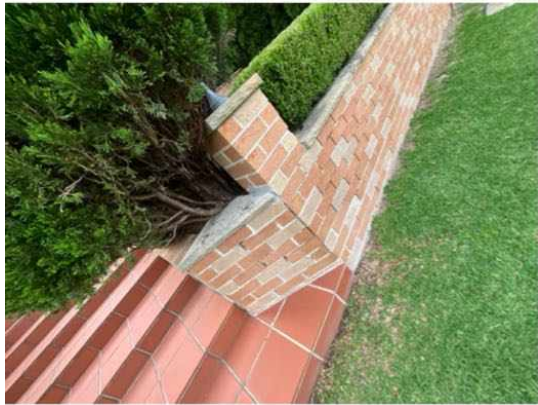
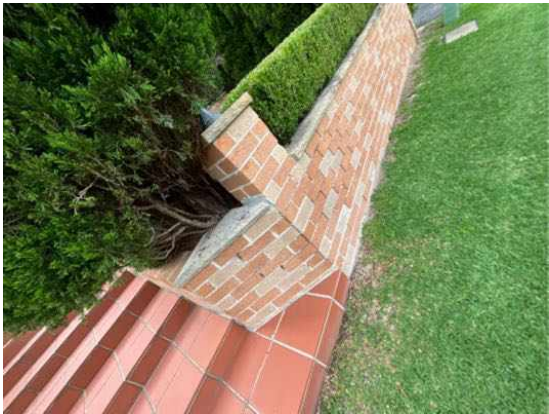
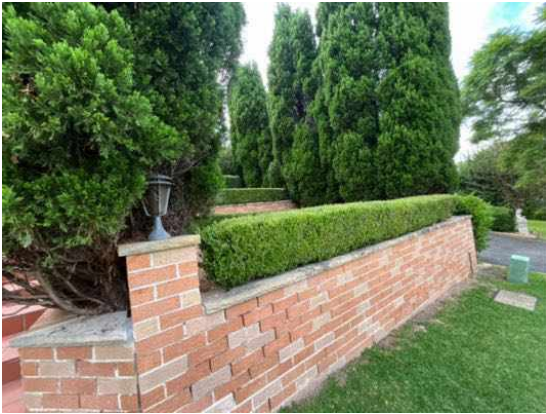
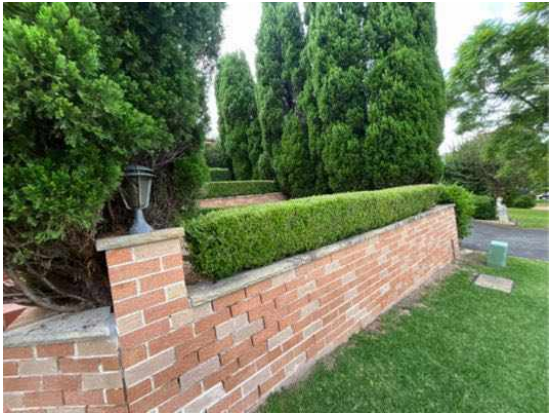
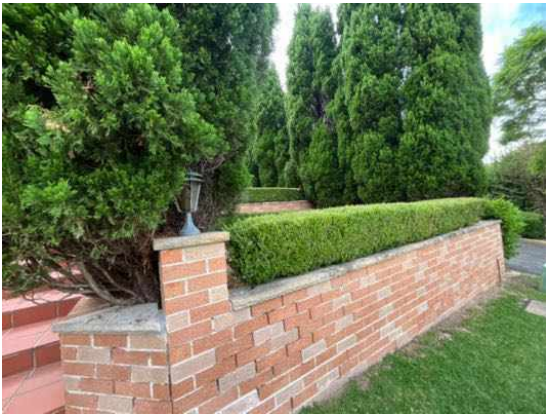
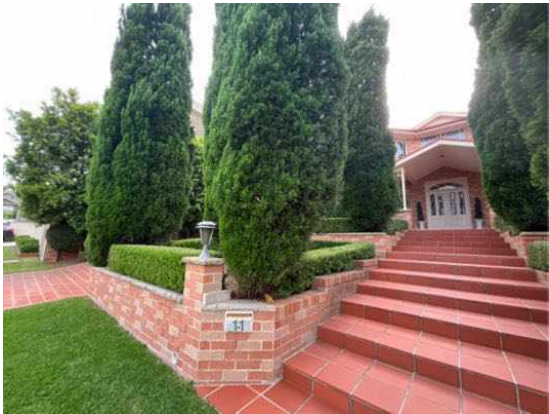
Finding 6.02

Building: Main Building
Location: All Areas
Finding: Dense vegetation around a property can increase the risk of termite infestation
Information: The presence of dense vegetation around a property can increase the risk of termite infestation, as it provides a conducive environment for them. To address this, consider maintaining a clear space between the vegetation and your home. If you suspect a termite issue, it's advisable to consult with a licensed pest control professional for inspection and treatment.

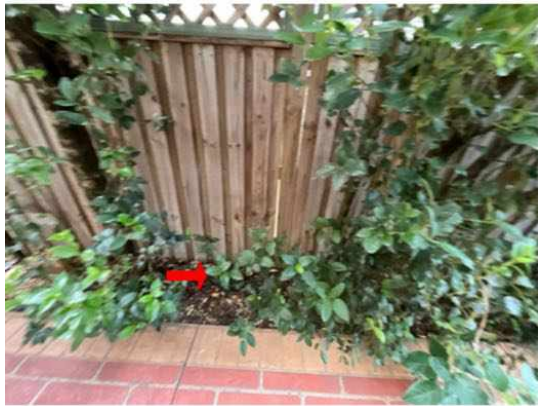
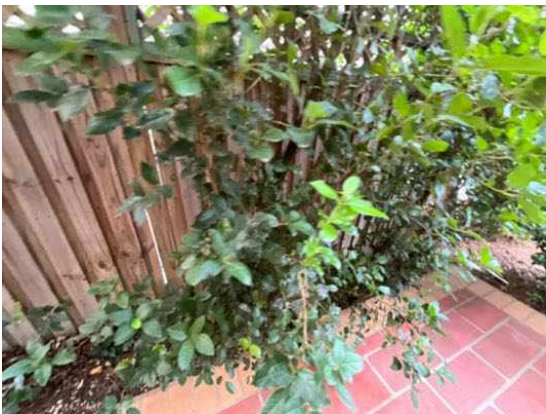
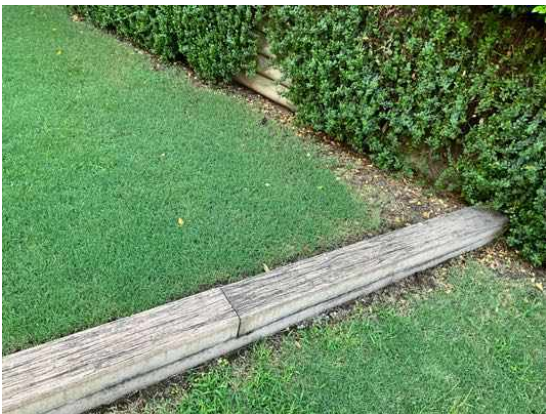
Finding 6.03

Building:	Main Building
Location:	All Areas
Finding:	Timber on ground / conducive conditions to termite damage
Information:	Timber on the ground is indeed conducive to termite damage. Termites are known to thrive in moist environments, and wood in contact with soil or moisture is more susceptible to infestation.

To prevent this, it's important to keep timber elevated and away from direct ground contact. Regular inspections and proper termite control measures are also essential to protect your wooden structures from termite damage.

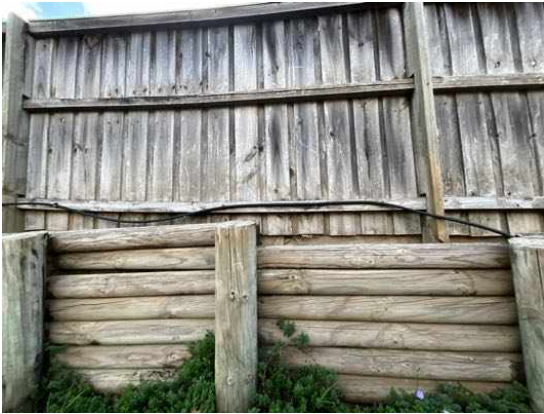
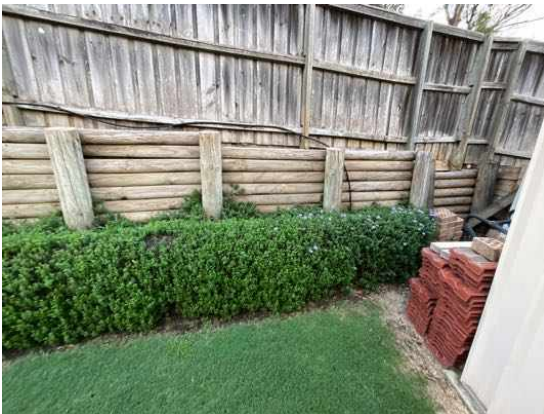
Finding 6.04

Building:	Main Building
Location:	All Areas
Finding:	Bridging or Obstruction Conducive environment for Termites
Information:	Bridging of termite barriers occurs when termites bridge (usually by building a mud tunnel) a termite barrier or inspection zone or where termites have a passage, allowing them to bridge the barrier.

Recommended moving obstructions away from the external walls for further and future inspections.

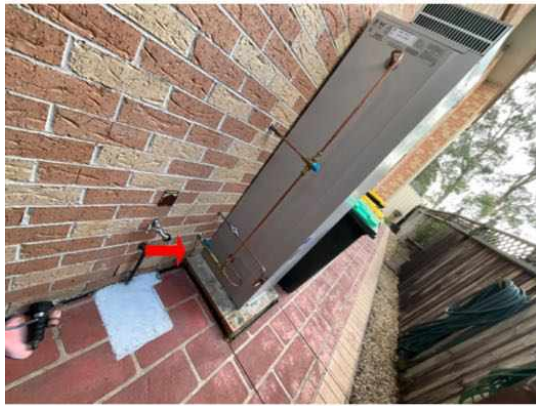
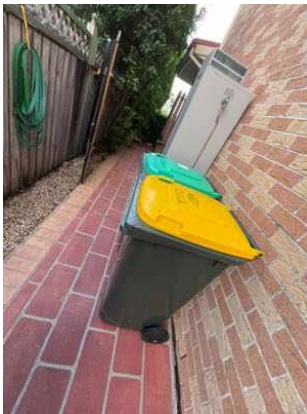
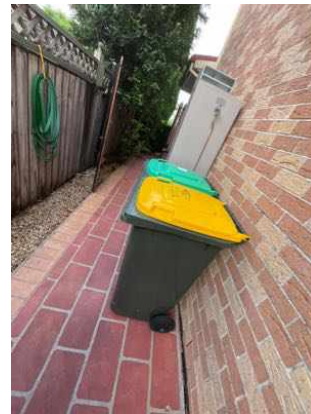
Finding 6.05

Building:	Main Building
Location:	All Areas
Finding:	No Drain under tap
Information:	There is no drain installed under the tap, leading to water accumulation and creating conducive conditions for timber pests. This defect needs immediate attention to prevent potential damage and pest infestation.

1. Water Accumulation: Without proper drainage, water can accumulate around the base of the tap, leading to persistent dampness in the surrounding area.
2. Timber Pest Infestation: The damp environment created by standing water is highly conducive to timber pests, such as termites and wood borers, which thrive in moist conditions and can cause significant damage to wooden structures.
3. Structural Damage: Prolonged exposure to moisture can lead to wood rot and

deterioration of structural timber, compromising the integrity of the building.

4. Health Hazards: Persistent dampness can also promote mold and mildew growth, posing health risks to occupants.

5. Aesthetic Damage: Water stains and damage to finishes and materials around the tap area can detract from the appearance of the building and lead to costly repairs.

A licensed plumber or a qualified building contractor can address this defect by:

1. Assessment: Evaluating the area to determine the best approach for installing a proper drainage system under the tap.
2. Installation: Installing a drain that effectively channels water away from the base of the tap, preventing water accumulation and dampness.
3. Repair and Prevention: Inspecting and repairing any existing water damage and implementing measures to prevent future water accumulation and pest infestations.

By addressing this issue promptly, you can mitigate the risks associated with water accumulation and timber pest infestation, ensuring the longevity and safety of the building.

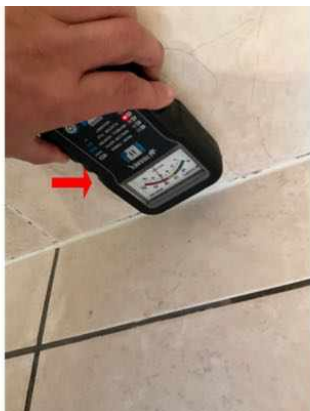
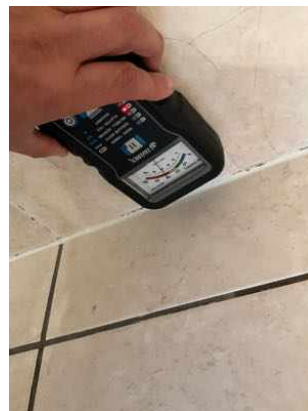
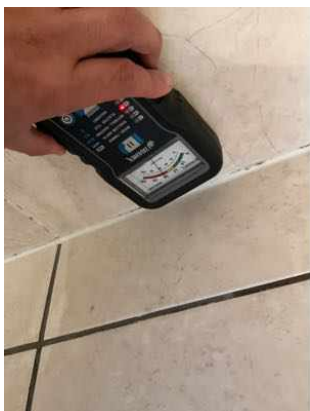
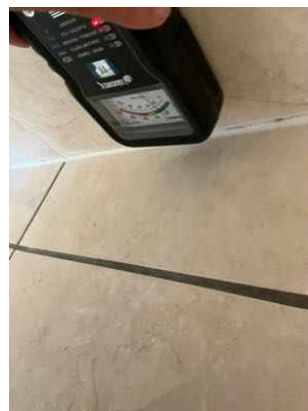
Building:	Main Building
Location:	Bathroom
Finding:	Excessive moisture - Conducive to Timber pest
Information:	Excessive moisture can attract termites and produce conditions that promote fungal growth and wood decay.

Excessive moisture is generally caused by deteriorated inadequate or missing roof drainage leaking plumbing pipes or fixtures poorly plumbed HWS overflows or condenser units and poor site drainage.

If mould growth has been found there may be environmental biological or health issues involved. In these cases an appropriately qualified inspector should also be

contacted.

Prior to any remedial works being performed a qualified plumber should be appointed to further inspect the property and to identify the cause of the excessive moisture. Works to remove affected building elements may then be necessary and should be performed by an appropriate tradesperson.

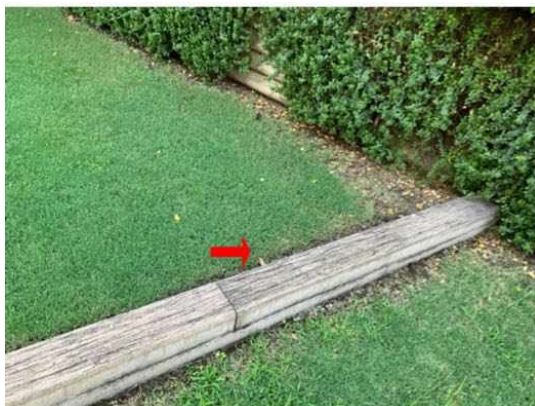
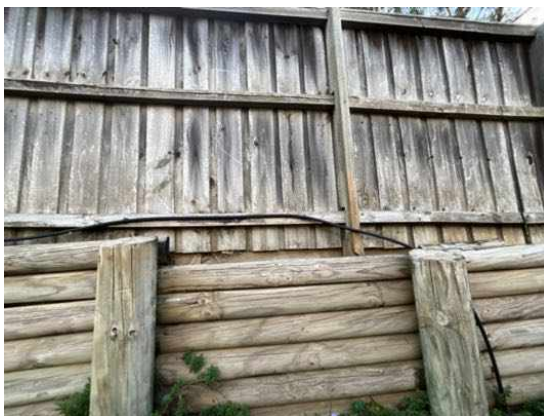
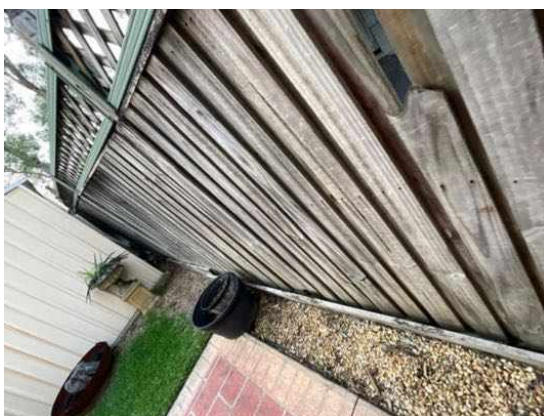
Finding 7.01

Building:	Main Building
Location:	All Areas
Finding:	Wood rot
Information:	This building element shows evidence of wood rot. Wood rot, also known as Fungal Decay, occurs when timbers and other cellulose building materials are exposed to damp conditions on an ongoing basis. This could be the result of exposure to weathering over a prolonged period of time, or the attraction of excessive moisture from other abutting building materials. Contributing factors also include poor air ventilation in the area.

Wood rot is often associated with general damp problems and is evidenced by a

'musty' smell or mould and mildew occurring on surfaces. If left unmanaged, damp conditions can lead to further health problems and the decay of timbers will continue.

Early intervention and regular maintenance, particularly of exterior timbers, will prolong the useful life of these building elements. Prior to any works being performed, the cause of the moisture that has created the visible wood rot should be identified and addressed in a suitable manner. Replacement of affected timbers may then be a necessary step in protecting surrounding building elements from such deterioration.

A qualified plumber may be appointed to assess the cause of excessive moisture and to provide advice on any remedial works as required. A qualified carpenter or registered builder may also be required to replace affected building materials.
