Building and Timber Pest Inspection Report

Inspection Date: Sat, 7 Mar 2026

Property Address: 11 Ellerstone Ct, Kellyville NSW 2155,
Australia

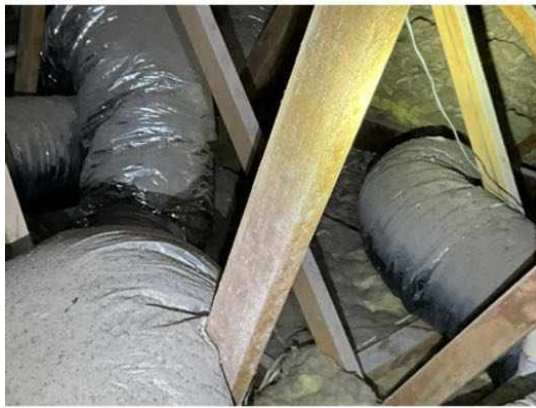
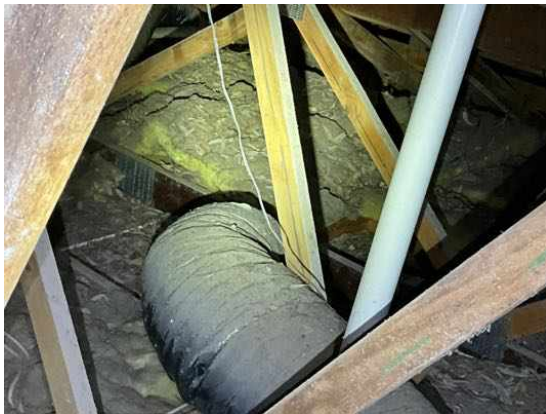
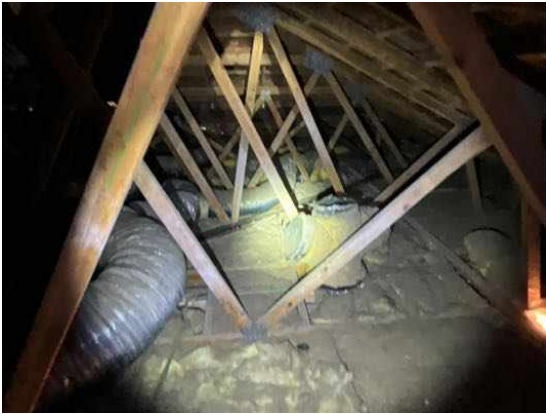
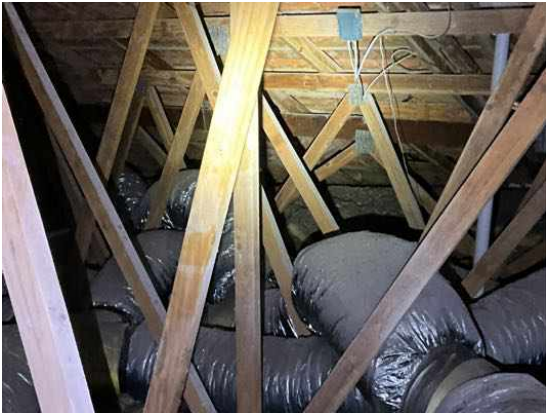
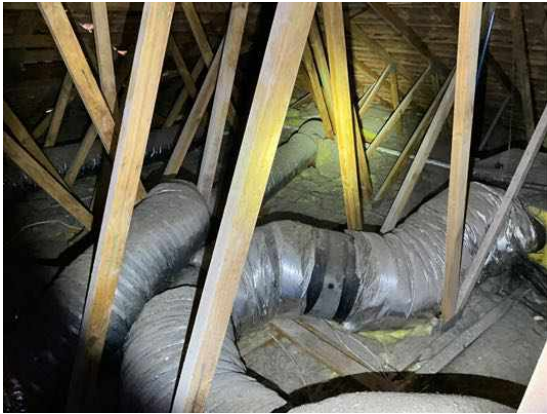
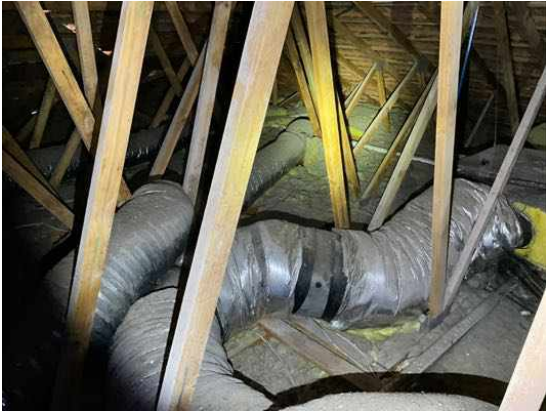
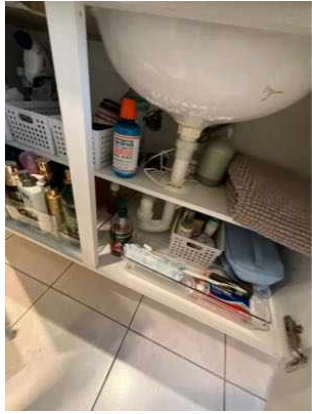
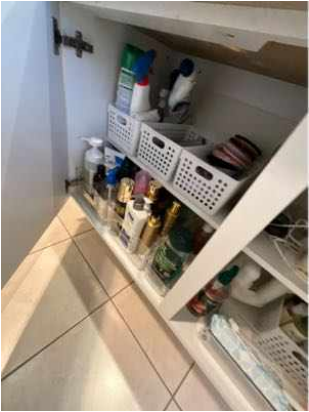
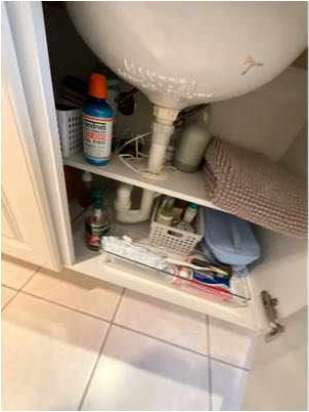
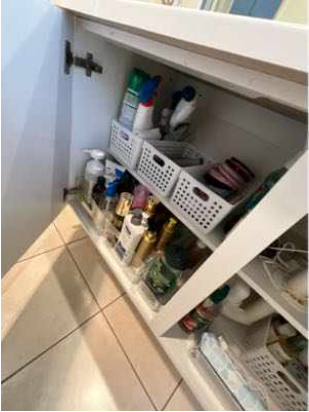
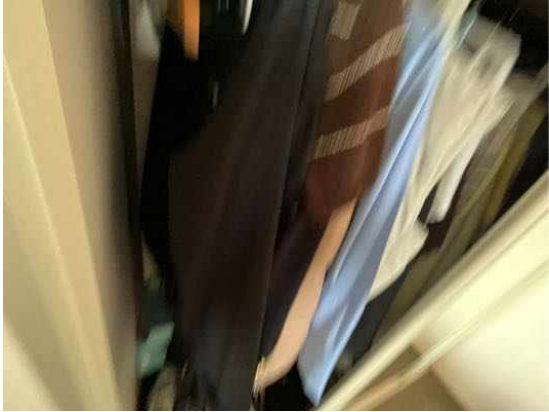
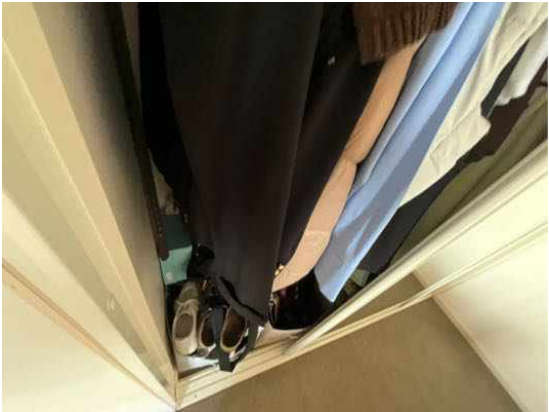
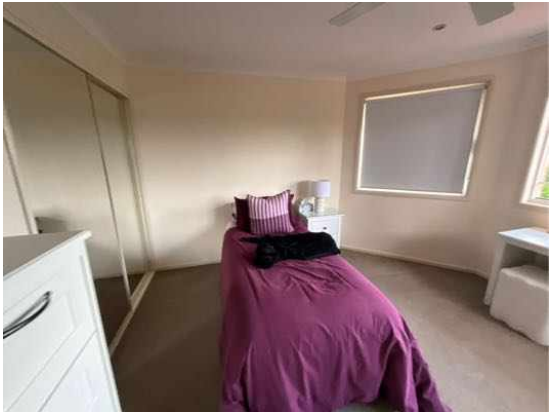
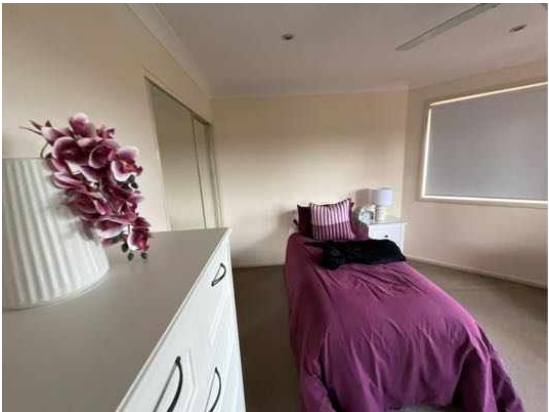
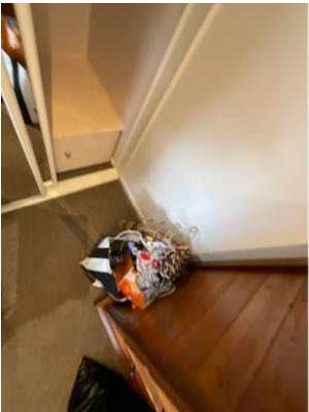
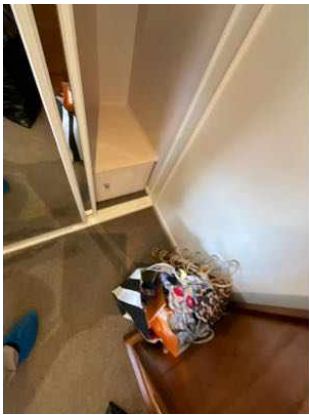
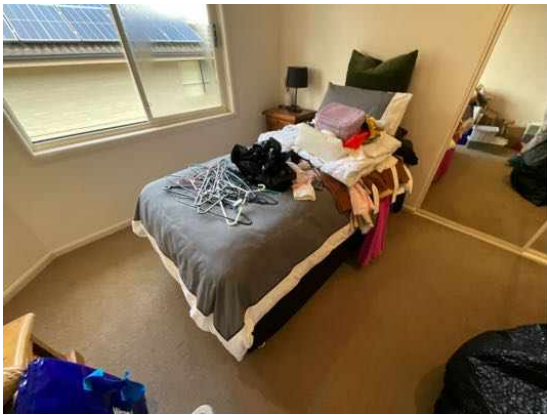
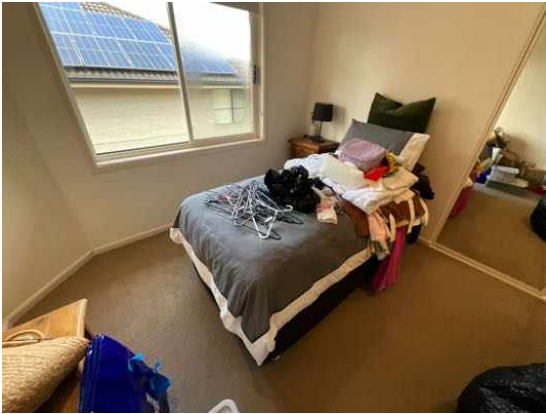
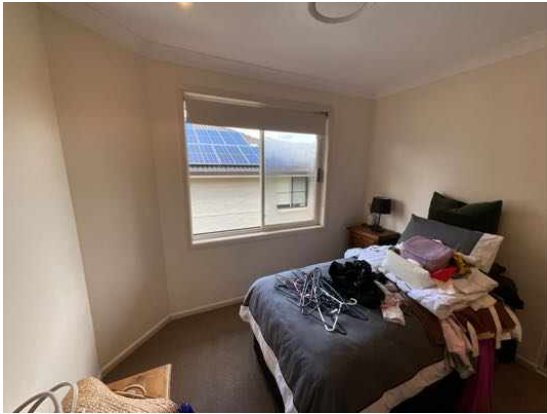
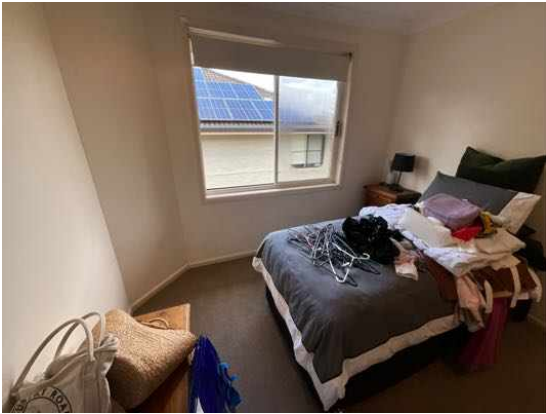
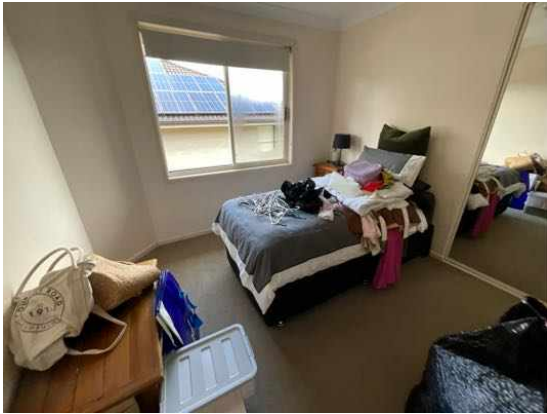
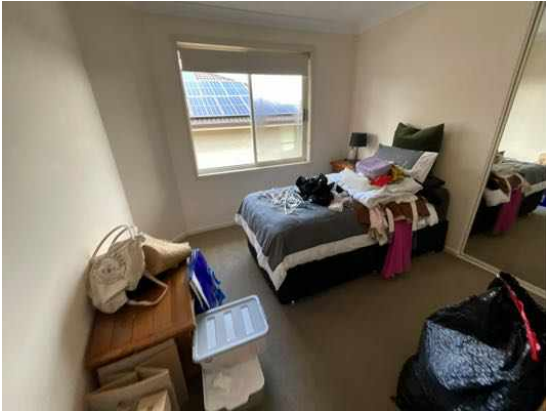
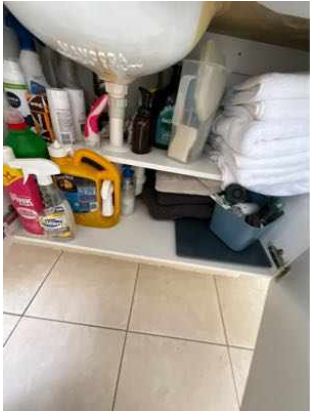
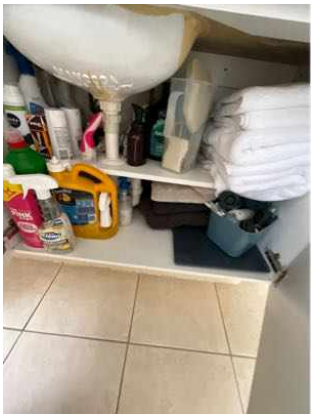
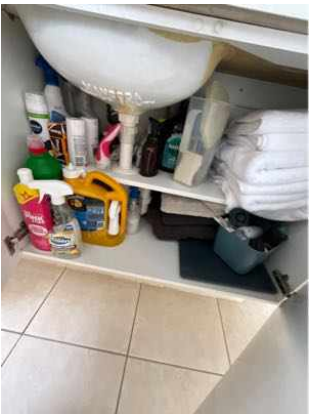
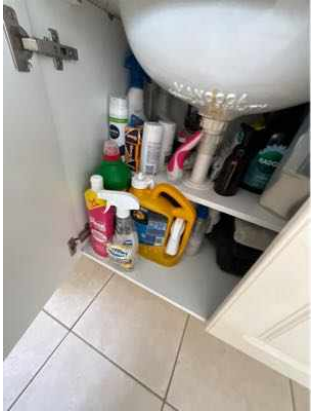
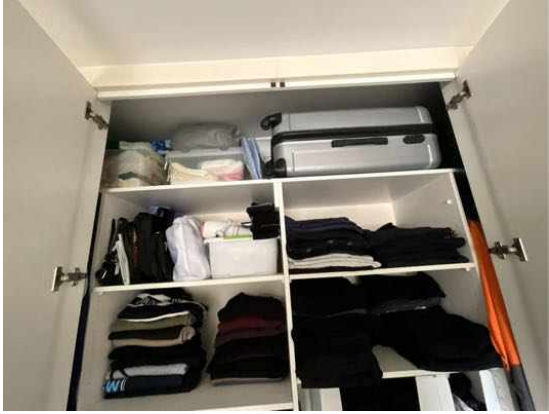
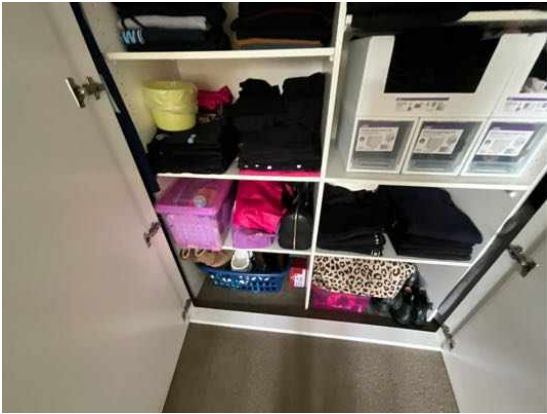
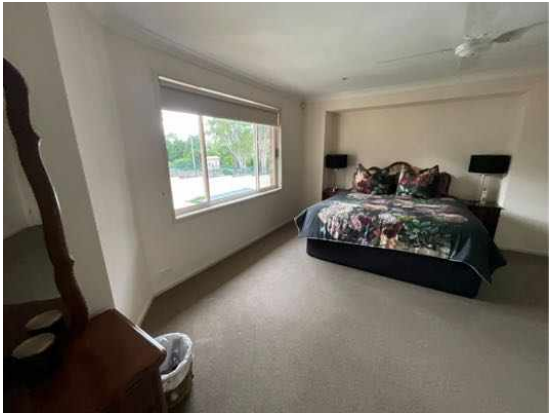
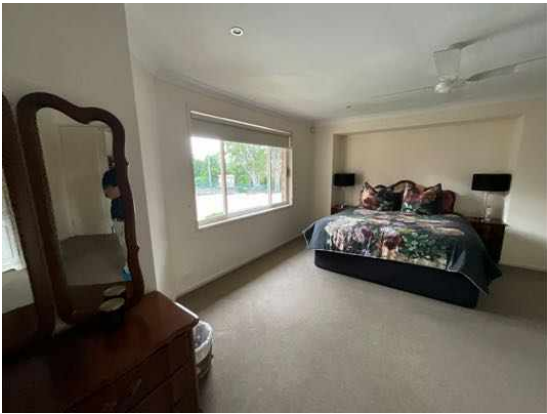
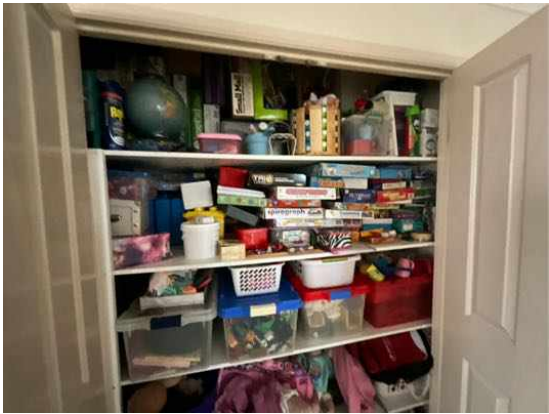
Building: Main Building
Location: All Areas
Finding: Additional Photos - Obstructions and Limitations
Information: These photographs are an indication of the obstructions and limitations which impeded full inspection of the property at the time of inspection. These obstructions can hide an array of defects and should be removed to allow full inspection to be carried out. A re-inspection is recommended once the areas are made accessible.

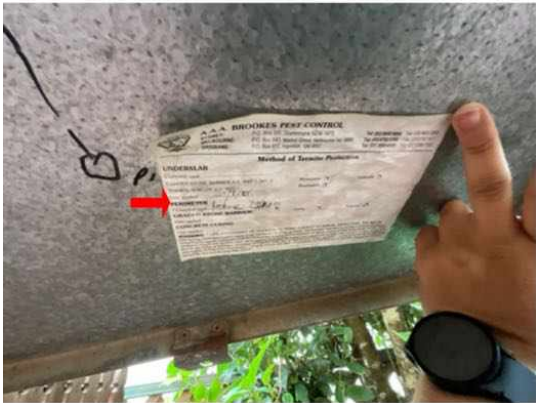
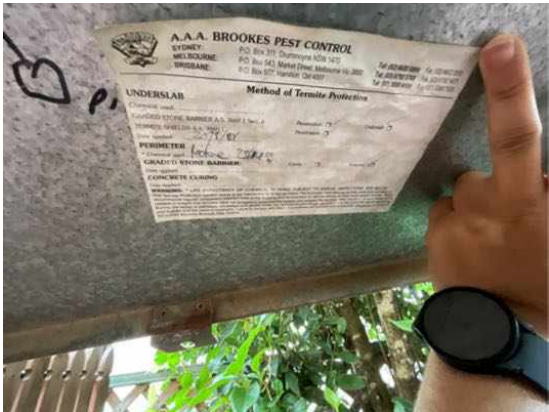
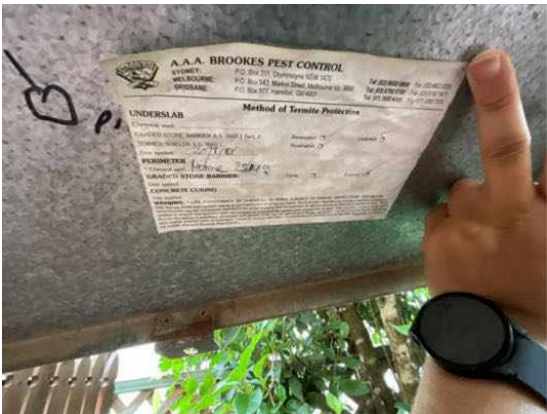
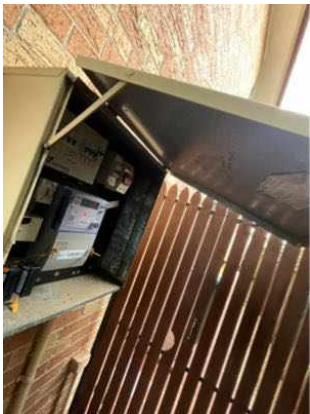
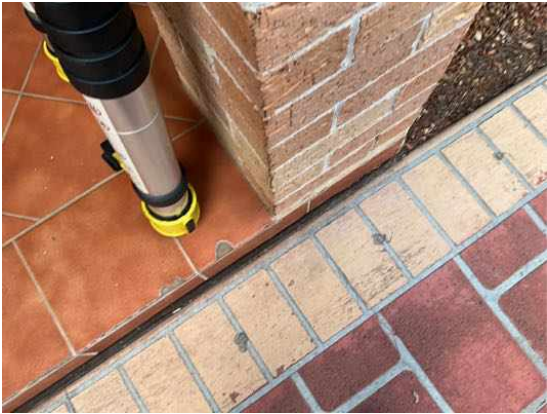
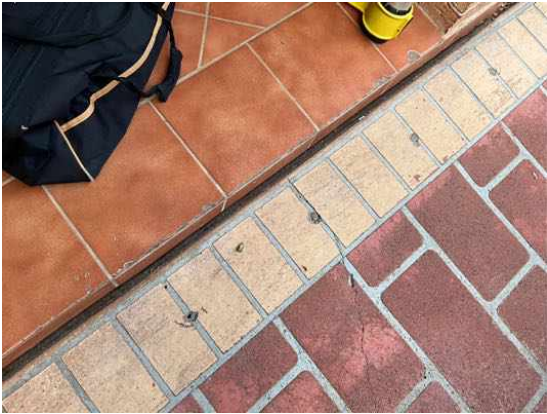
Building: Main Building
Location: Exterior walls - right side
Finding: Evidence of Termite Management System - Durable notice / Legible Sticker - seek further information
Information: The application of a pre & post-construction chemical termite barrier is highly recommended for all properties. Such barriers are highly effective in preventing termite attack on any timber building elements throughout the property.

A durable notice placed in the switchboard unit to indicate termite barriers at the time of inspection.

Client must seek further information from the vendor or real estate agent if the conditions of termite management systems were maintained as per the label or seek advise from licensed pest controller.
