# Building and Timber Pest Inspection Report

Inspection Date: Fri, 23 Jan 2026

Property Address: 20 Onslow St, Nerang QLD 4211, Australia

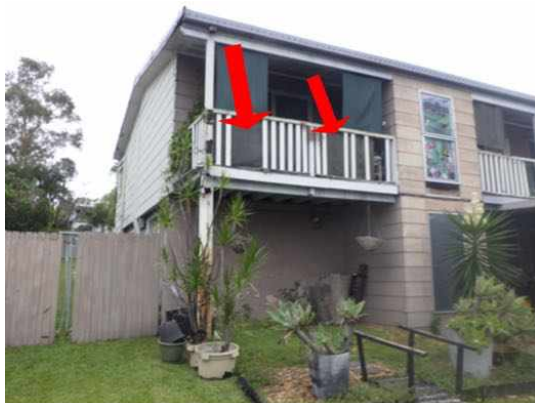
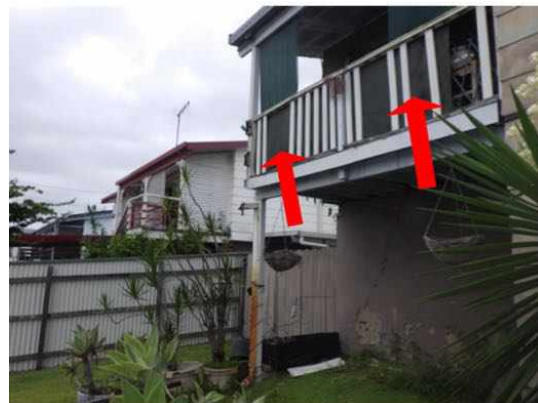
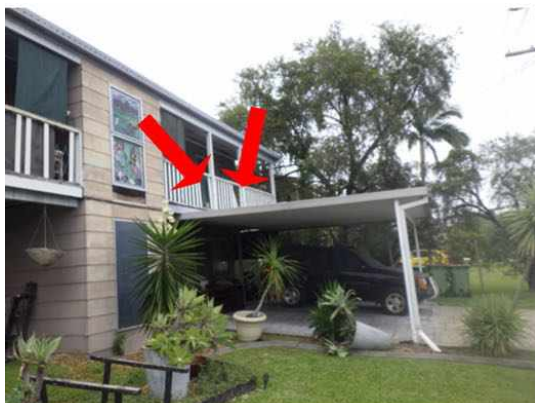
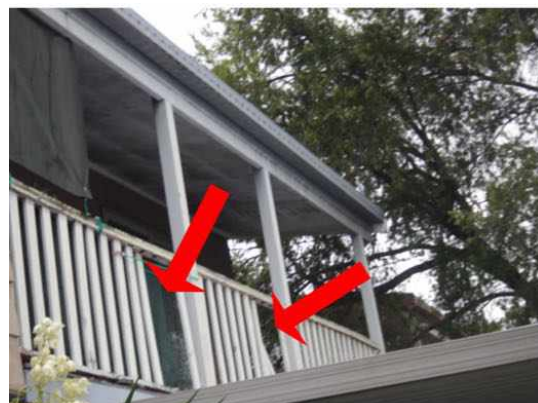
Building: Main Building  
 Location: Balconies > Front  
 Finding: Balustrade - Deteriorated  
 Information: It was noted at the time of inspection that sections of the balustrade to the front balcony areas have deteriorated. Typically balustrading deteriorates due to age and or wear, rot and or rust which is generally expected for a structure of this age, due to prolonged exposure to weather conditions. Sometimes inadequate installation or maintenance can be to blame.

If left unattended, it is likely that further damage will occur. It is suspected that repair of several elements of the balustrade may be required however replacement may be a consideration of the client also.

A licensed builder should be appointed to provide further advice and perform rectification works as necessary.

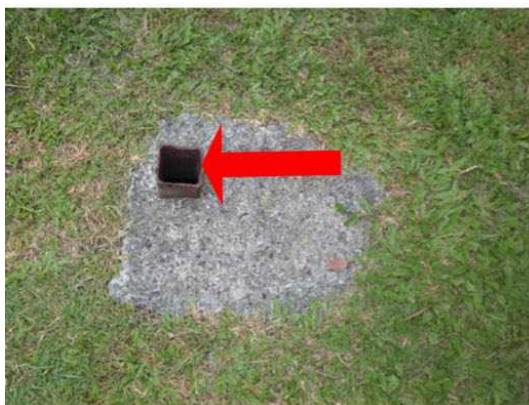
#### Finding 1.02

Building: Main Building  
 Location: Yard - Back > Centre Left  
 Finding: Exposed - Sharp Metal  
 Information: At the time of inspection it was noted there was exposed sharp box section metal protruding above the finished ground surface at the rear of the property.

It appears the box section metal may be from a previously removed fixtures or fittings.

A licensed carpenter or general handyman could be engaged to cut the metal below surface level and or fit protective cover plates.

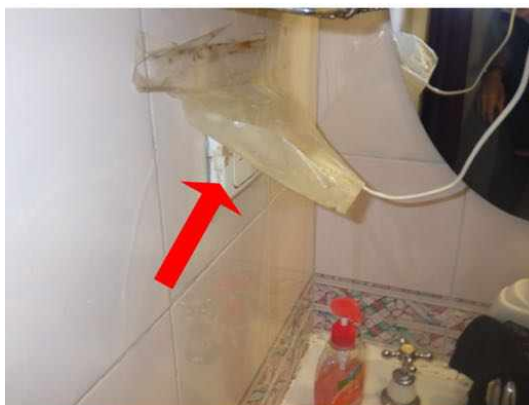
### Finding 1.03

Building: Main Building  
 Location: Bathroom 2 > Front Left  
 Finding: Electrical switch exposed  
 Information: An exposed electrical switch was observed in the ground floor bathroom area. Exposed electrical switches in bathroom or wet areas represent a potential safety hazard including for personal contact.

A licensed electrician should be engaged as a matter of priority to confirm the electrical switch as compliant with electrical installation regulations.

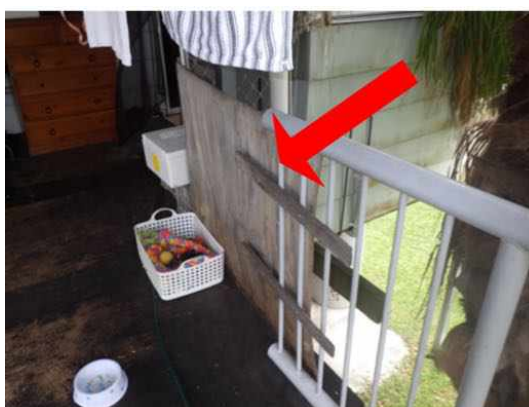
## Finding 1.04

Building:	Main Building
Location:	Alfresco > Centre Left
Finding:	Balustrade - Deteriorated
Information:	It was noted at the time of inspection that sections of the balustrade to the alfresco area show signs of rudimentary repair or have deteriorated. Typically balustrading deteriorates due to age and or wear, rot and or rust which is generally expected for a structure of this age, due to prolonged exposure to weather conditions. Sometimes inadequate installation or maintenance can be to blame.

A licensed carpenter could be appointed to perform rectification works as necessary.

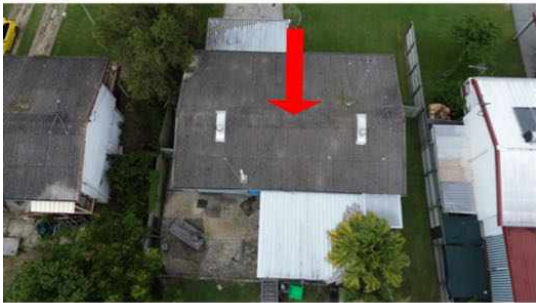
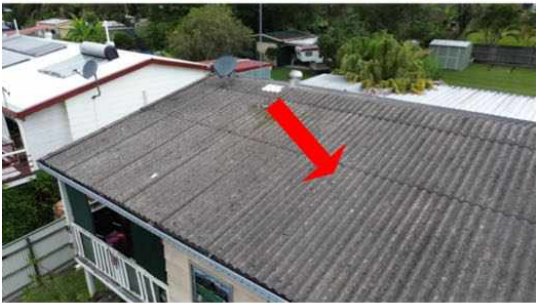
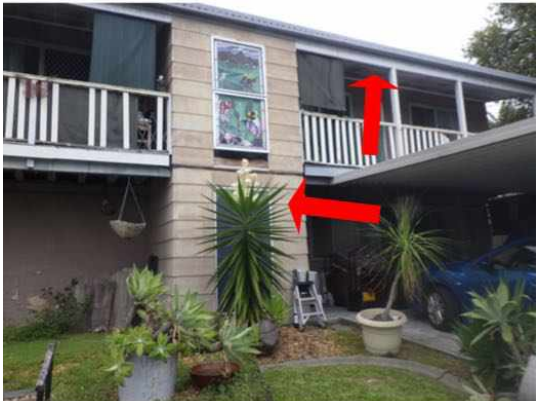
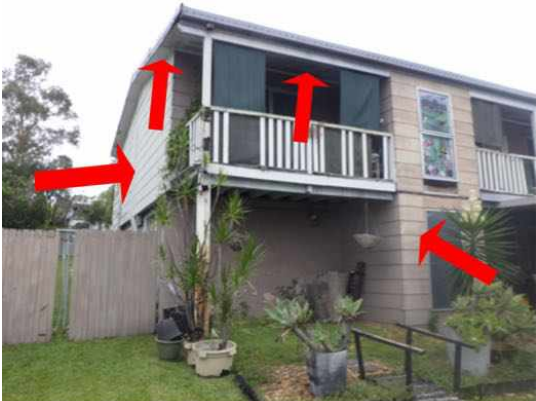
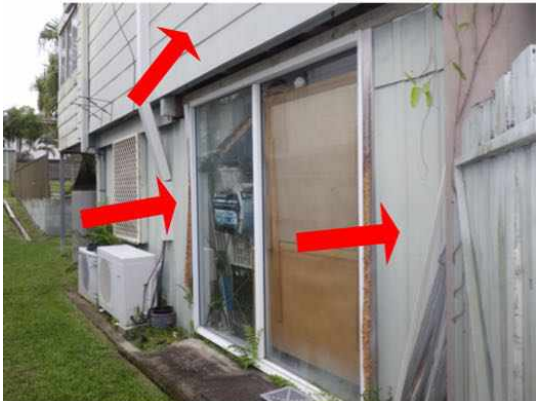
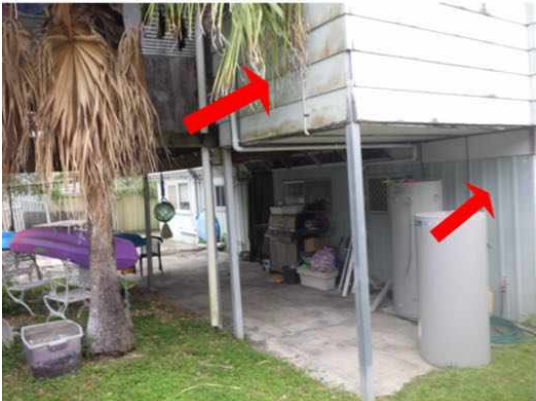
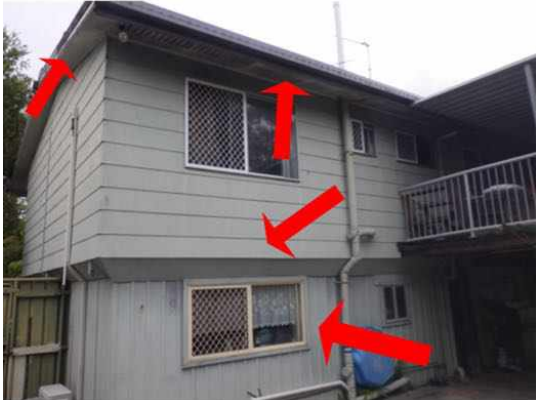
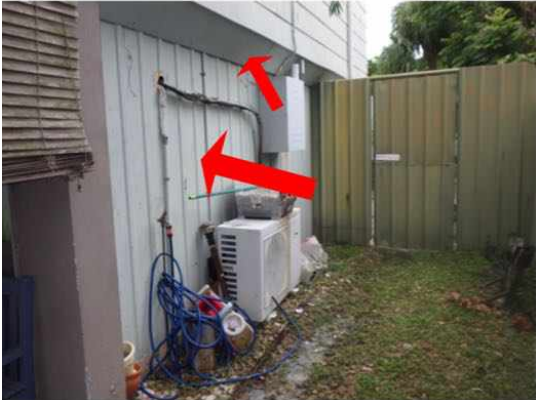
## Finding 1.05

Building:	Main Building
Location:	External Areas > Existing
Finding:	Asbestos - Suspected ACM Identified on Site
Information:	At the time of inspection it was suspected that external area wall cladding, roof sheeting and eaves linings may be of asbestos containing materials.

Reporting on Asbestos is outside the Scope of this Report. This suspected defect is highlighted as a caution only. We suspect, based on our experience in the building industry, that there is a higher risk of the identified building materials containing asbestos.

As Asbestos Reporting is outside the scope of this report, we advise that you consider a separate Asbestos Inspection and Condition Audit, which can include the taking of samples for definitive confirmation of the presence of Asbestos.

In the interim, the client is advised to act with caution, especially when considering any damage to building materials general wear and tear renovations extensions demolition and general maintenance activities due to the suspected presence of Asbestos.

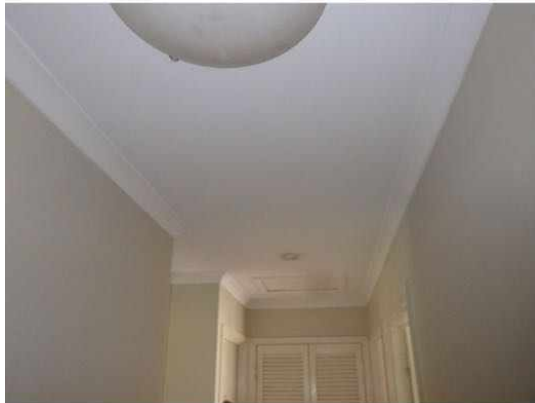
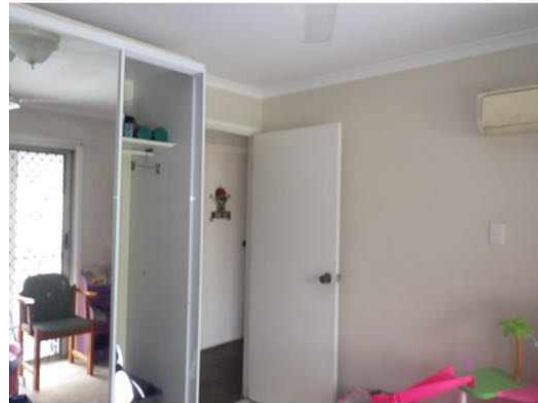
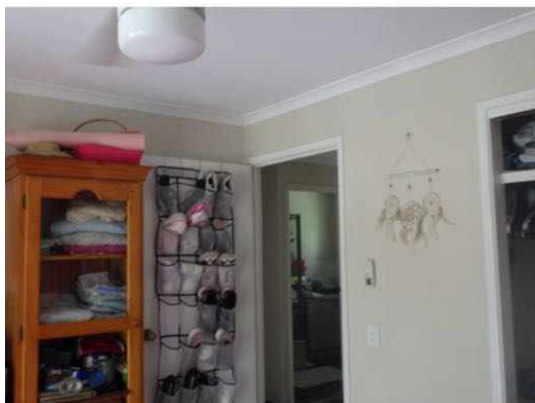
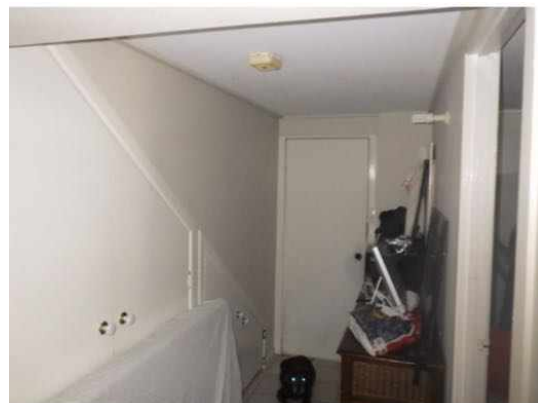
Finding 1.06

Building: Main Building  
 Location: Internal Areas > Existing  
 Finding: Smoke Detectors and Alarms  
 Information: At the time of inspection it was noted there was no interconnected photoelectric smoke detectors installed in the hallways or any of the bedrooms.

Please note that this defect is highlighted as a caution only. We suspect, based on our experience in the building industry, that the absence of smoke detectors, or their poor condition, should be addressed as a matter of urgency to improve occupant safety.

A qualified electrician should be engaged to install photoelectric smoke detectors and provide certification documentation to confirm smoke detector types, locations and compliance.

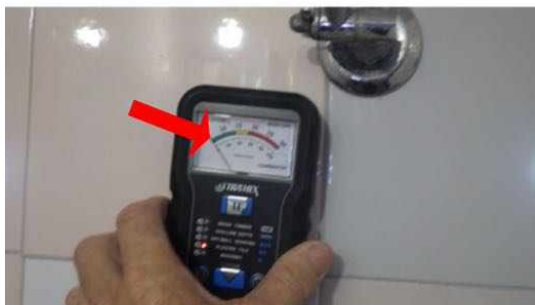
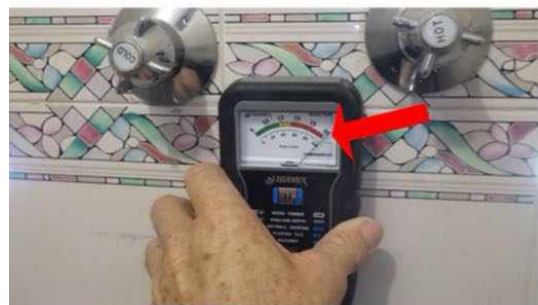
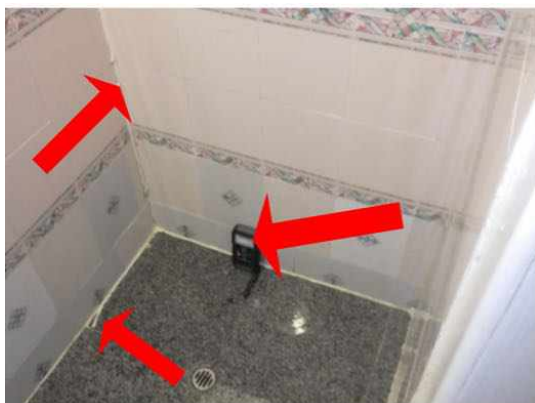
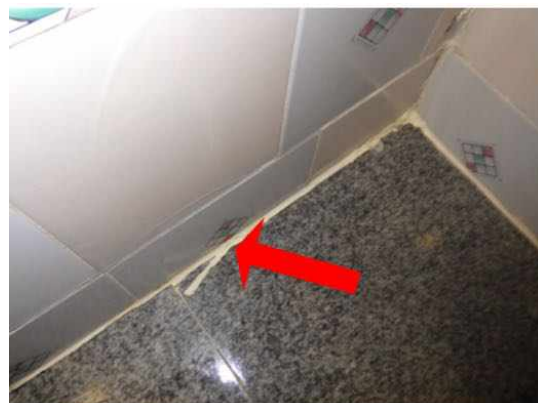
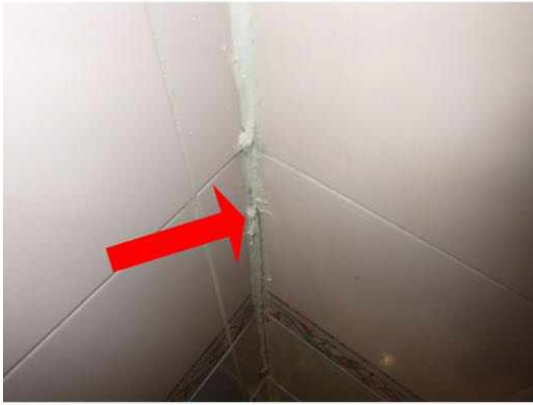
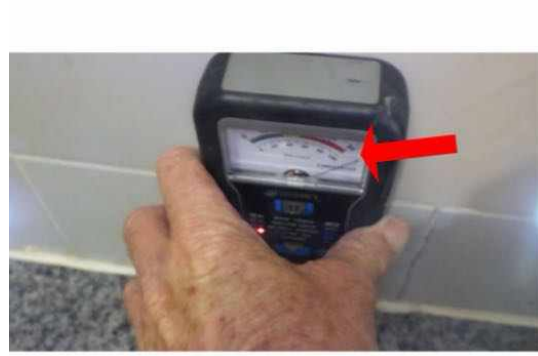
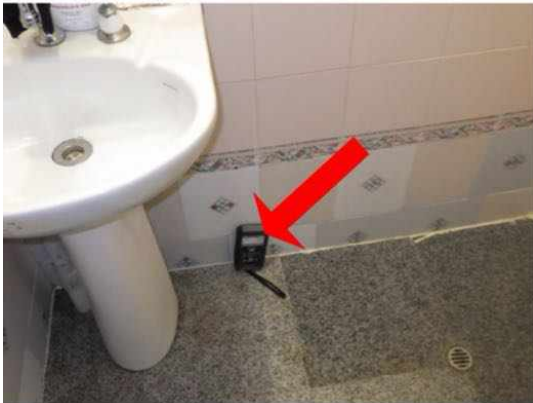
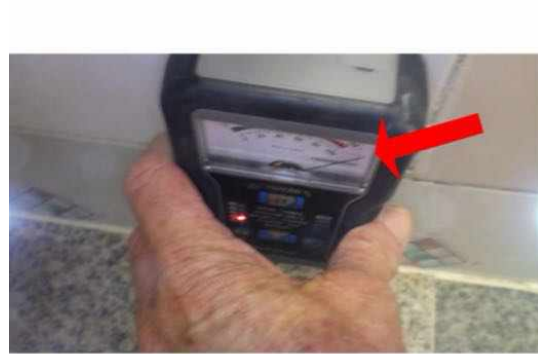
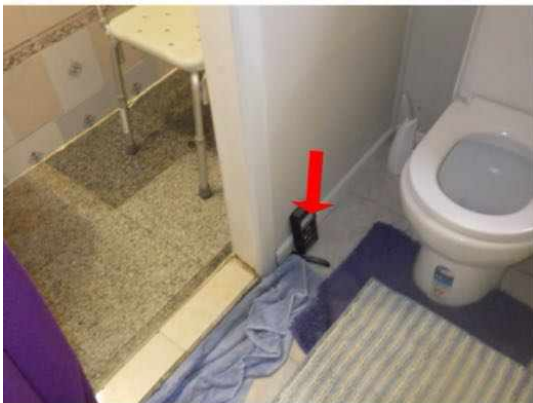
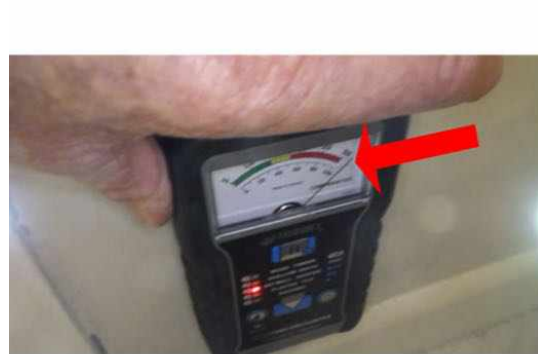
### Finding 2.01

Finding: Shower - Leaking

Information: The ground floor bathroom shower area showed evidence of deterioration and registered elevated moisture level readings to the lower wall areas of the shower cubicle at the time of inspection, with the elevated moisture level readings transferring to the opposite side of the walls which would indicate the shower is leaking.

It is suspected that the leaking has occurred as a result of general ageing of the building elements and deterioration of sealants and grout.

Leaking from the shower area, where left unattended, is likely to lead to water damage to adjoining flooring and walls. Such damage can lead to water damage and necessitate extensive remedial works being required. Active water leaks may also create an environment that is susceptible to the formation and development of mould and /or timber termite activity.

Appointment of a licensed builder or shower area specialist will be required to repair or replace the shower area. Such works should be performed as soon as possible to ensure that no further damage occurs.

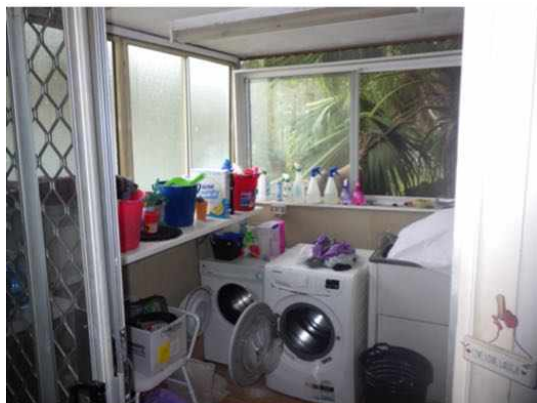
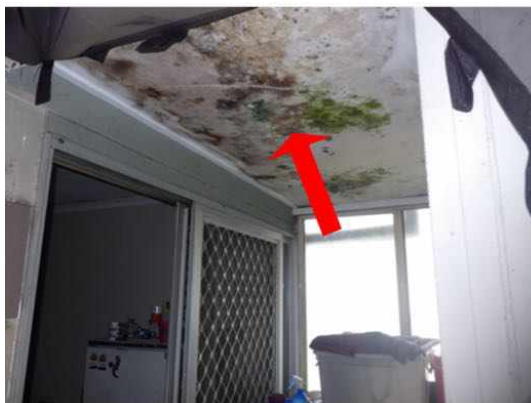
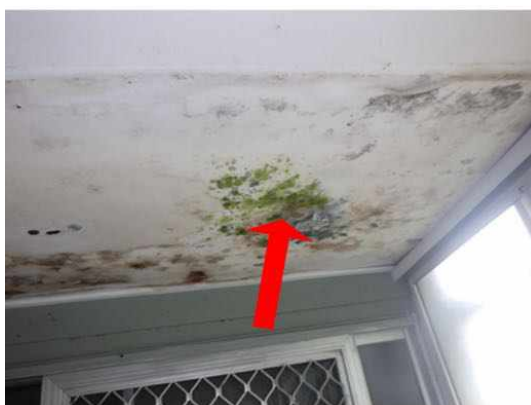
## Finding 2.02

Building: Main Building  
 Location: Laundry > Front  
 Finding: Ceiling - Water damaged  
 Information: At the time of inspection there was water staining and mould growth to the upper level laundry area ceiling linings.

Water damage to the ceiling lining is generally an indication of excessive moisture being present in the roof void, usually via a leak to the roof covering.

Where water damage is evident to the ceiling, the primary requirement is to identify and rectify the source of the leak. A roofing plumber should be appointed as soon as

possible to identify the leak and perform rectification works as necessary, ensuring the water damage is restricted.

Once the leak is repaired, consultation with relevant tradespeople, including plasterers and painters, is advised. Rectification works may include replacement of ceiling lining or minor repainting, depending on the extent of the damage.

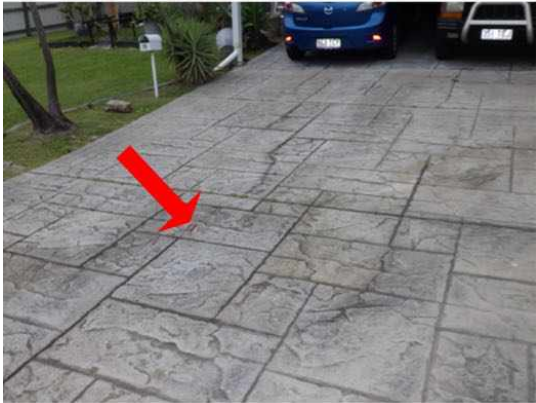
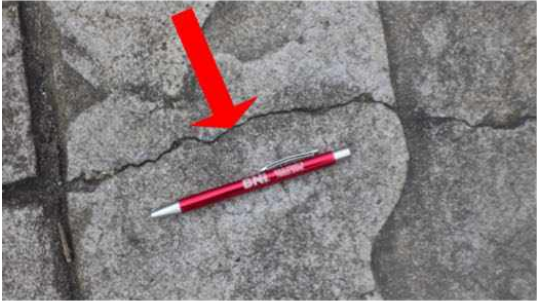
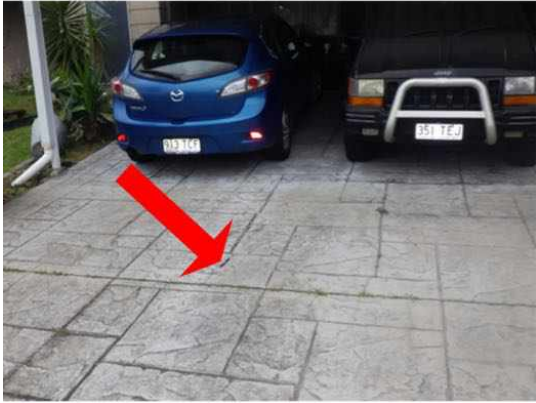
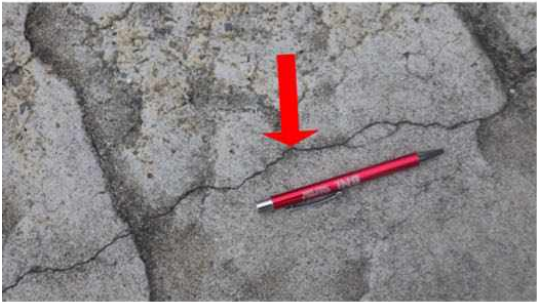
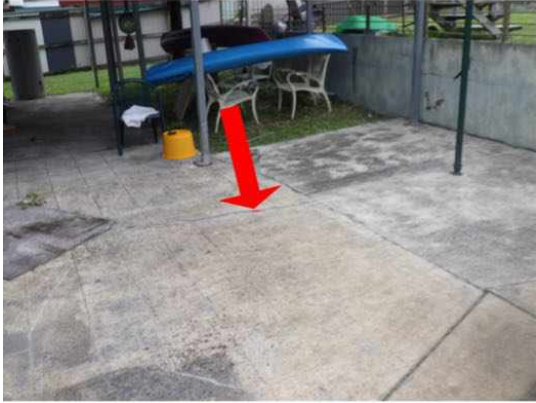
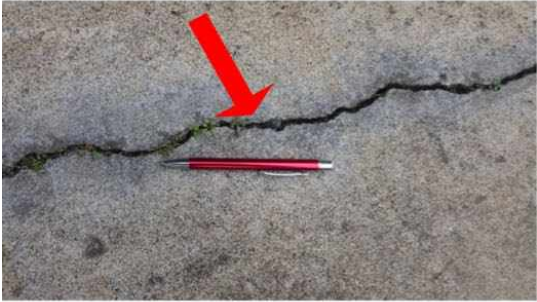
### Finding 3.01

Building: Main Building  
 Location: Driveway > Ground Level  
 Finding: Cracking in concrete slab - Category 1  
 Information: Cracking coded as Category 1 was identified in the driveway and footpaths concrete slabs (as per example photos). A Category 1 crack is described as a fine but noticeable crack, with the slab at an otherwise reasonable level.

To be considered Category 1, the approximate width of the crack is less than 1.0mm, or a less than 10mm change in offset when a 3m straight edge is placed over the defect.

Category 1 cracks should be monitored for a period of 12 months. At the end of the monitoring period, identified cracks that are rated greater than Category 2 are considered defects, and require rectification.

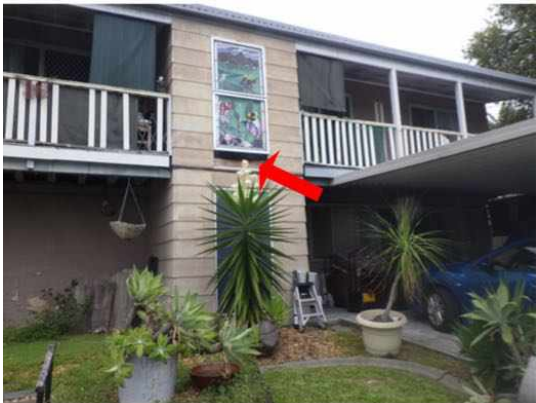
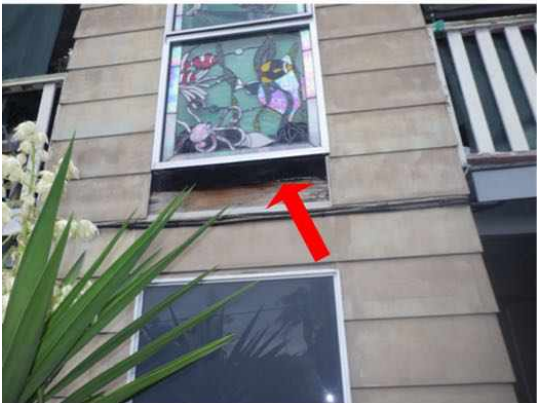
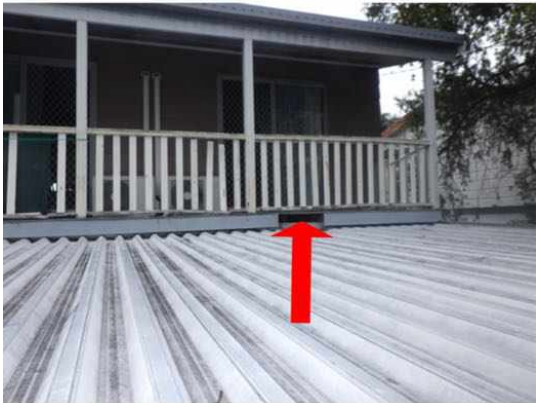
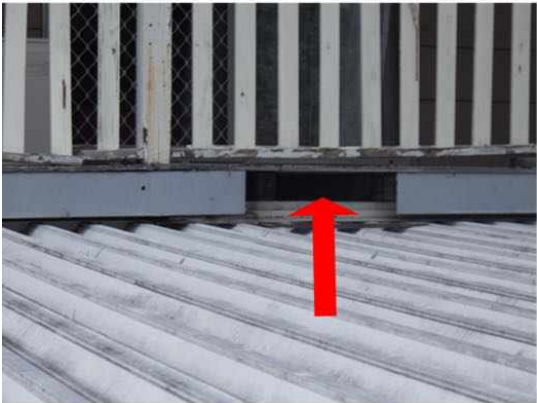
**Finding 3.02**

Building: Main Building  
 Location: Exterior walls - front > Centre  
 Finding: Weatherboard Damaged  
 Information: There was areas of damaged or missing hardiplank weatherboard cladding to external walls at the time of inspection.

A qualified carpenter or general handyman could be engaged to undertake repair work.

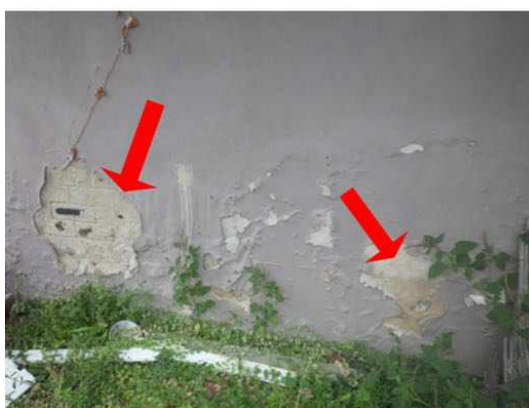
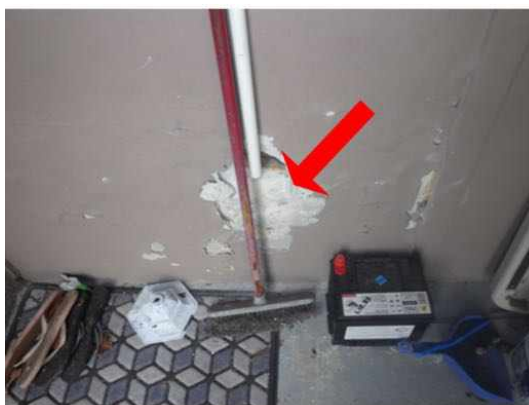
**Finding 3.03**

Building: Main Building  
 Location: Exterior walls - front > Front Left, Centre  
 Finding: Render Damaged  
 Information: At the time of inspection it was noted that there was chipped and broken render areas to the brick walls at the front of the property.

The chipped or broken render appears consistent with impact damage and/or exposure to moisture.

A qualified solid plasterer should be engaged to undertake repair work as required.

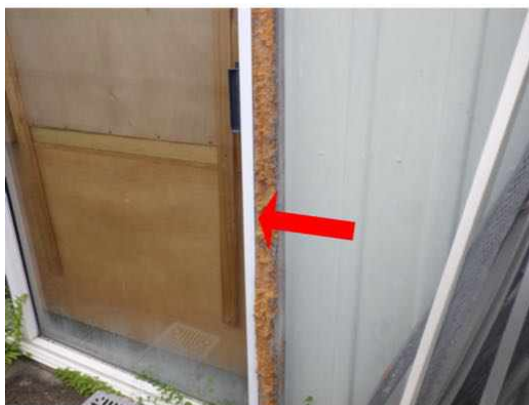
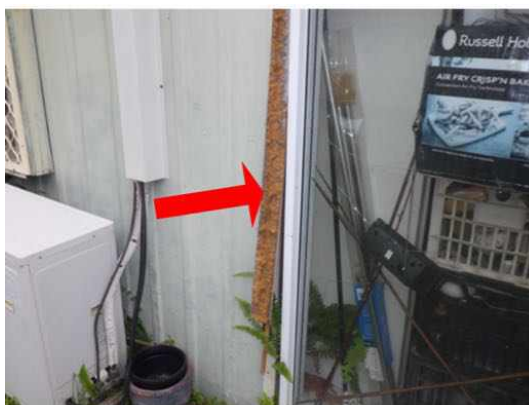
### Finding 3.04

Building: Main Building  
 Location: Exterior walls - left side > Centre Left  
 Finding: Wood Rot  
 Information: At the time of inspection an area of the MDF timber facing board to the exterior wall cladding showed signs significant deterioration or wood rot. The wood rot /damage appears to be caused from excessive moisture and/or unsuitable building materials.

The client could engage a qualified carpenter or general handyman to undertake repair work.

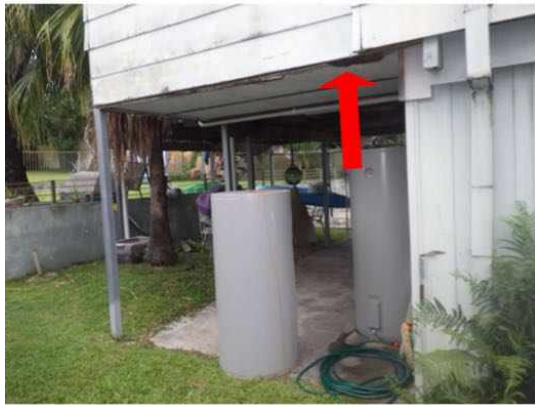
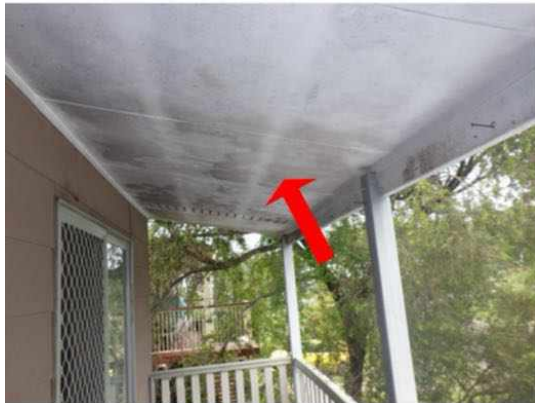
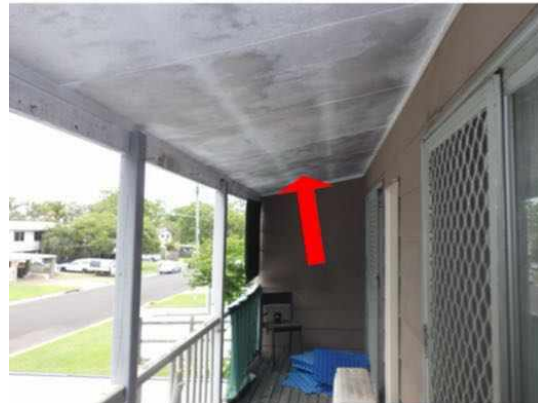
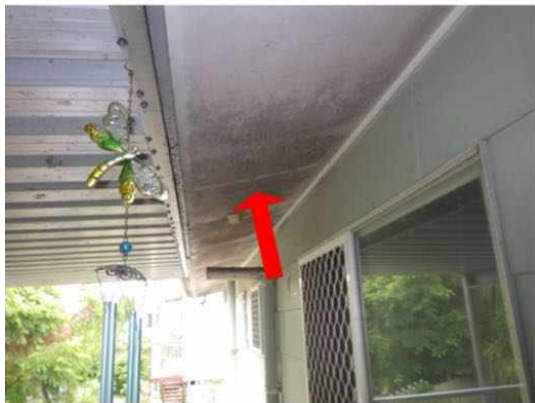
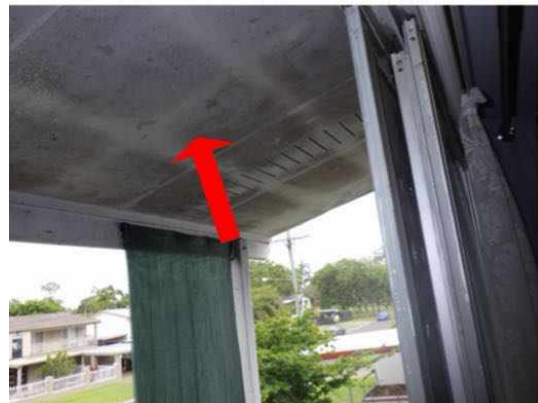
### Finding 3.05

Finding: Eaves - Damaged

Information: At the time of inspection the eaves around the exterior property were found to have suffered deterioration, damage and/or have been affected by surface mould in a number of areas (as per example photos). The damage may have been sustained as a result of a number of possible causes, including poor roof drainage, leaking roof plumbing or minor impact damage.

The damage and surface mould to the eave sheathing in these areas detracts from the appearance of the structure.

Where eaves show moderate to severe damage, remedial works may be required. Where water damage is suspected as being the underlying cause, appointment of a licensed plumber is advised as a matter of urgency to identify the source of the water leak.

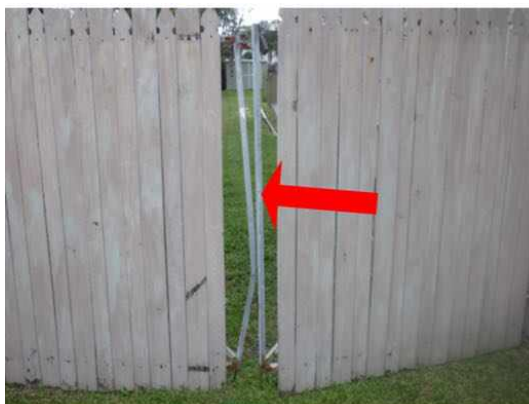
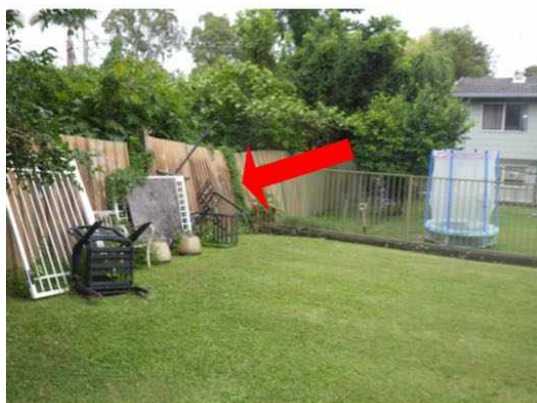
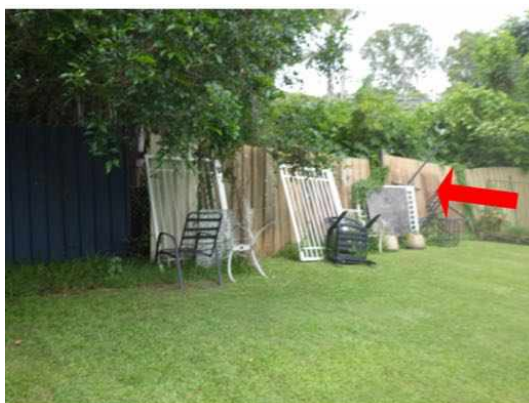
### Finding 3.06

Building: Main Building  
 Location: Yard > Existing  
 Finding: Fencing - Deteriorated  
 Information: It was noted at the time of inspection that sections of the fencing and gates to the front left and right side of the property have deteriorated (as per example photos). Typically fencing deteriorates due to age and or wear, rot and or rust which is generally expected for a structure of this age, due to prolonged exposure to weather conditions. Sometimes inadequate installation or maintenance can be to blame.

If left unattended, it is likely that further damage will occur. It is suspected that repair of several elements of the fencing may be required however replacement may be a

A licensed fencing contractor should be appointed to provide further advice and perform rectification works as necessary.

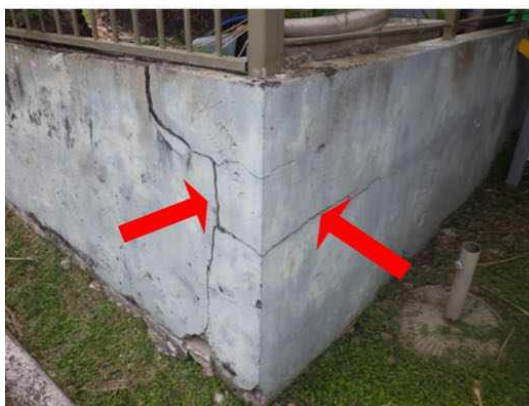
### Finding 3.07

Building:	Main Building
Location:	Yard - Back > Centre
Finding:	Retaining wall - Deteriorated
Information:	The rendered brick retaining wall to the rear of the property showed evidence of cracking and movement at the time of inspection. The level of cracking is considered category 2 - 3 which will require repair.

Deteriorated retaining walls may be a result of substandard construction, poor site drainage or unmanaged stormwater flows.

A licensed brick layer or brick retaining wall installer could be appointed to repair or replace the wall, at the discretion of the client.

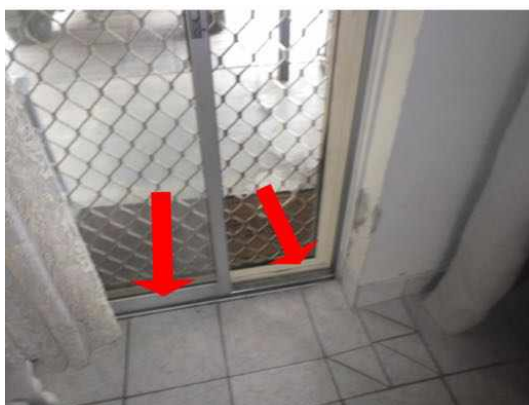
### Finding 3.08

Building:	Main Building
Location:	Utilities Room 1 > Front
Finding:	Door - Stiff to slide
Information:	The aluminium sliding door and security screen door to the ground floor utilities room 1 area were stiff to open and difficult to operate at the time of the inspection. Doors provide ventilation to the adjoining area and should be at a fully operational level to ensure user comfort. Restricted function of the door may also pose as a potential safety hazard if required for emergency egress from the building.

Generally, factors such as general age of the building element and a lack of maintenance are the usual causes for this type of defect.

An aluminium sliding door service agent will be required to repair the affected doors.

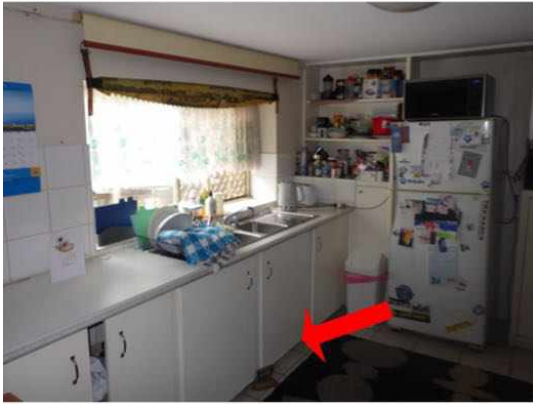
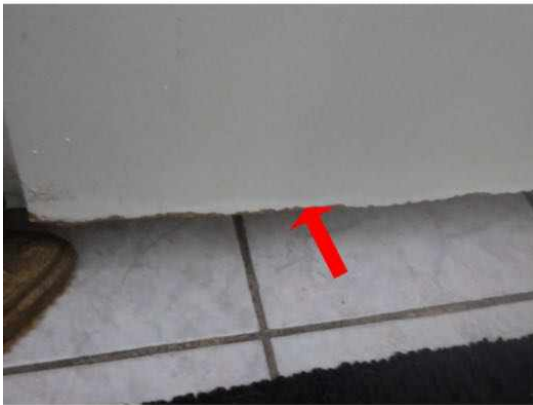
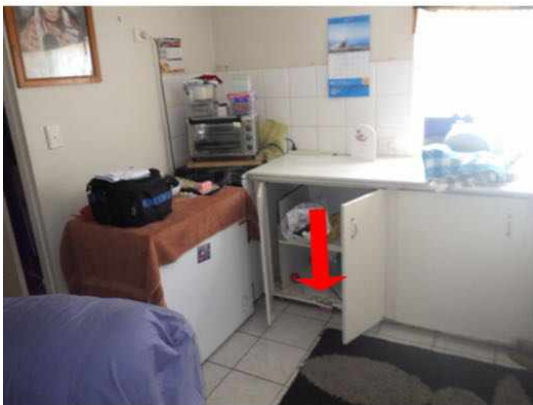
### Finding 3.09

Building:	Main Building
Location:	Kitchenette > Existing
Finding:	Cabinetry - Deterioration
Information:	At the time of inspection the kitchenette cabinetry showed signs of deterioration. The level of damage appears consistent with exposure to moisture or general wear and

A qualified cabinet maker or general handyman could be engaged to undertake repair works at the clients discretion.

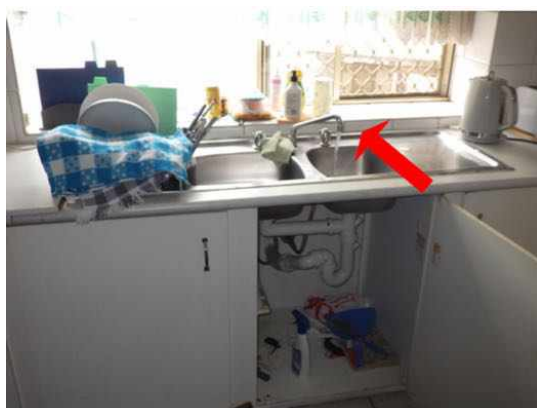
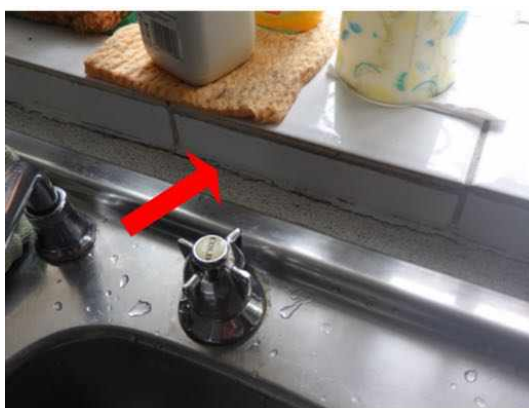
**Finding 3.10**

Building: Main Building  
 Location: Kitchenette > Rear  
 Finding: Kitchen Bench -Sealant  
 Information: It was noted on inspection that sealant is deteriorated or missing from the kitchen bench / tiled splash back intersection. It is important this area is sealed to prevent

moisture or liquids penetrating the generally unsealed edges. Sealant also prevents vermin from accessing and or nesting in these areas.

A flexible sealant is required to allow for expected expansion and contraction, while keeping the joint water tight and protective of all associated building materials.

A sealant specialist or tiling contractor should be appointed to complete these works as soon as possible.

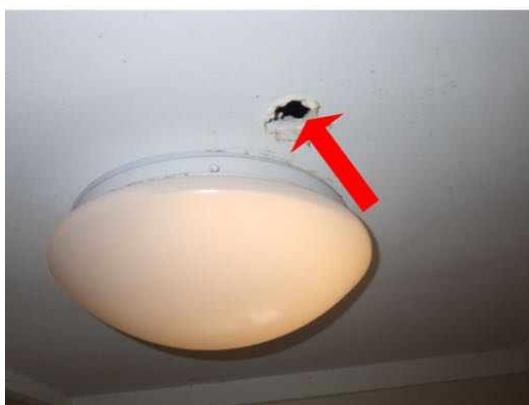
### Finding 3.11

Building:	Main Building
Location:	Toilet (WC) > Centre
Finding:	Internal ceiling - Hole
Information:	A hole was identified in the ground floor WC area ceiling. It is suspected that the hole is from a previously removed fixture or fitting.

All excessive holes, gaps or cracks should be adequately filled by a suitable sealant or trimmings as soon as possible to prevent any further damage. Such works may be conducted by a general handyperson or licensed painter.

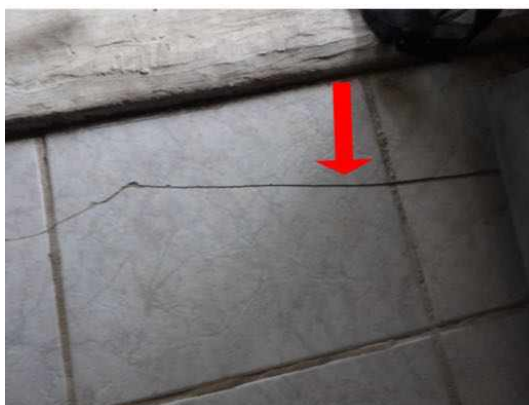
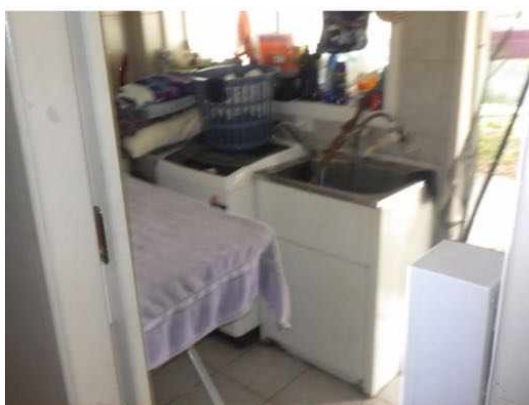
### Finding 3.12

Building: Main Building  
 Location: Laundry > Rear Right  
 Finding: Tile - Cracked  
 Information: Cracked tiles to the ground floor laundry area were identified at the time of inspection. Such defects are generally caused by impact. Cracked or broken tiled areas may also be a direct result of poor workmanship during the construction process.

A tiling contractor could be appointed to perform repair works at the clients discretion.

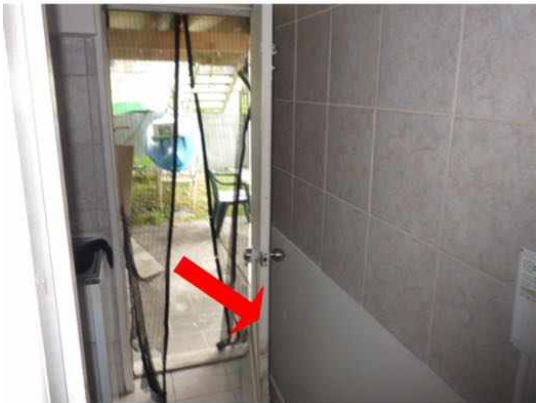
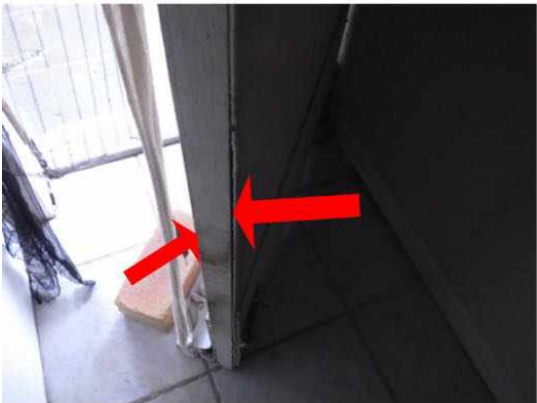
### Finding 3.13

Building: Main Building  
 Location: Laundry > Rear Right  
 Finding: Damaged Door  
 Information: The ground floor laundry external door has suffered damage to the front edge.

Damage occurs generally when the building materials have aged and decayed, but may be indicative of impact damage.

A qualified carpenter or general handyman could be appointed to repair/replace the door at the clients discretion.

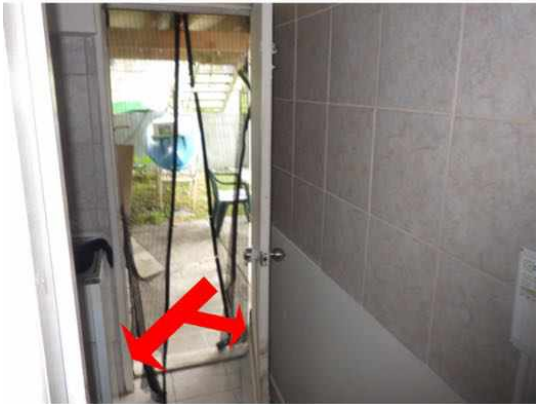
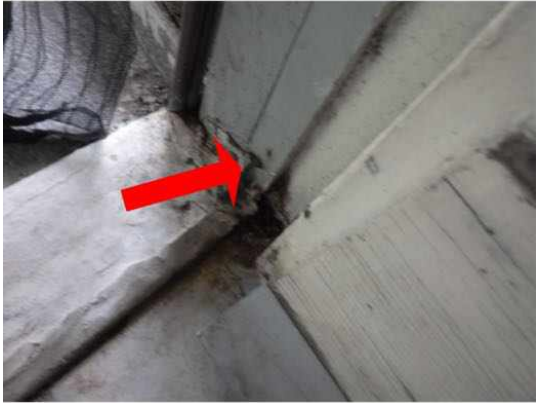
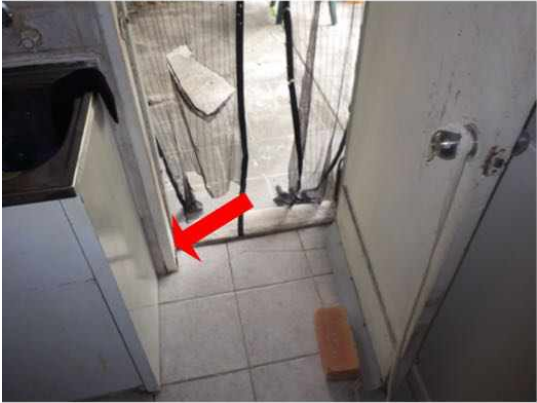
**Finding 3.14**

Building: Main Building  
Location: Laundry > Rear Right  
Finding: Architraves Damaged  
Information: At the time of inspection the exterior door frame and timber architraves in the ground floor laundry showed signs of damage or deterioration. The deterioration appears consistent with moisture exposure.

A qualified carpenter or general handyman could be engaged to repair or replace the timber architraves as required.

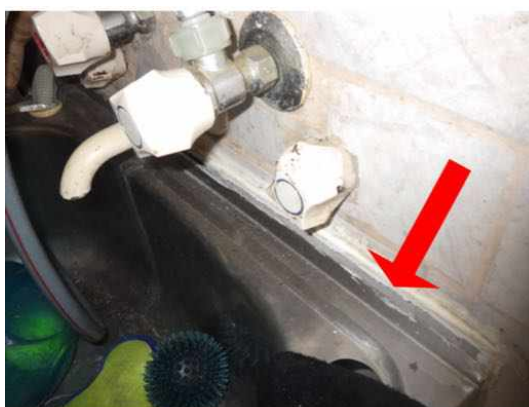
### Finding 3.15

Building: Main Building  
 Location: Laundry > Centre,Rear  
 Finding: Sealant - Deteriorated  
 Information: It was noted on inspection that sealant has deteriorated to the ground floor laundry tub /tiled wall intersection. Sealant is used to protect gaps and crevices in building materials to ensure that they are water-tight and prevent water penetration to the associated structure

A sealant specialist or general handyman should be appointed to complete repair work.

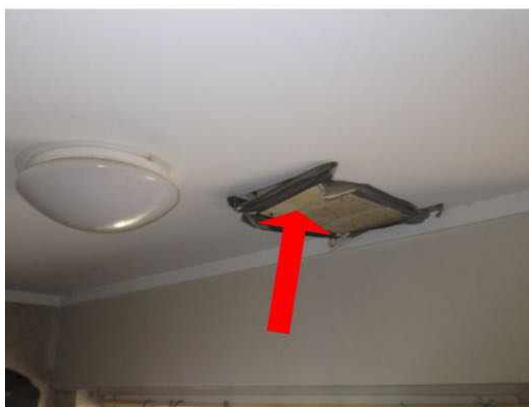
### Finding 3.16

Building: Main Building  
 Location: Laundry > Centre  
 Finding: Vent Cover  
 Information: At the time of inspection it was noted the ceiling space ventilation panel in the ground floor laundry area was hanging loosely.

A general handyman could be engaged to replace the damaged vent cover.

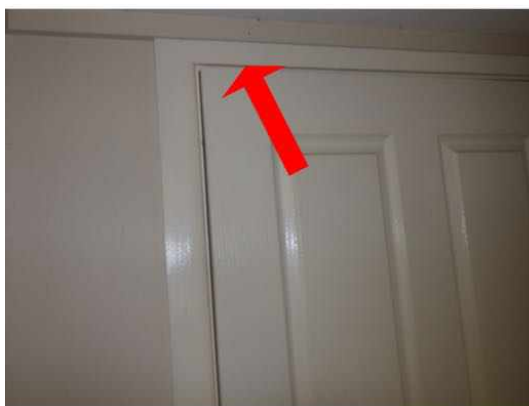
### Finding 3.17

Building: Main Building  
 Location: Utilities Room 2 > Front  
 Finding: Door - Binding/Jamming  
 Information: Binding and/or jamming of the utilities room 2 door on the door frame was evident during standard operation. This defect inhibits the functionality of affected door as well as creating potential for secondary defects to associated building elements, such as damage to the door framing.

A door that binds to the associated door frame or sill may have several causes, such as poor installation of the door or deteriorated hinges.

A qualified carpenter or general handyperson could be appointed to perform minor rectification works at client discretion.

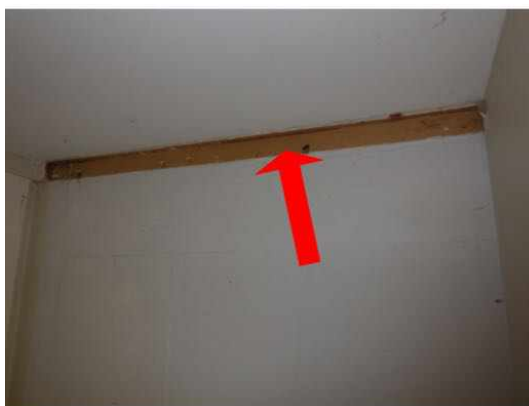
### Finding 3.18

Building: Main Building  
 Location: Utilities Room 2 > Front Left  
 Finding: Timber Trim - Missing  
 Information: At the time of inspection it was observed there was a section of timber trim missing from the internal wall/ ceiling linings internal corner in utilities room 2. It is important these gaps or areas are sealed with an appropriate trim to prevent pest and/or vermin activity or nesting.

A qualified carpenter or general handyman could be engaged to replace any missing timber trims.

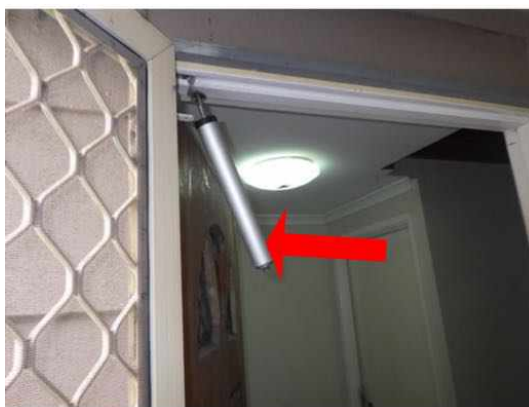
### Finding 3.19

Building: Main Building  
 Location: Entry > Front  
 Finding: Door - Closer  
 Information: The door closer to the entry area security door was found to be detached and/or broken at the time of inspection. Breakage occurs generally when the building materials have aged and decayed, but may be indicative of impact damage (accidental or deliberate).

A general handyman could be appointed to repair or replace the door closer at the client's discretion.

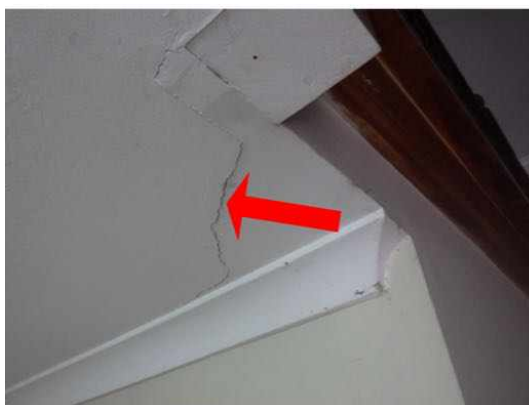
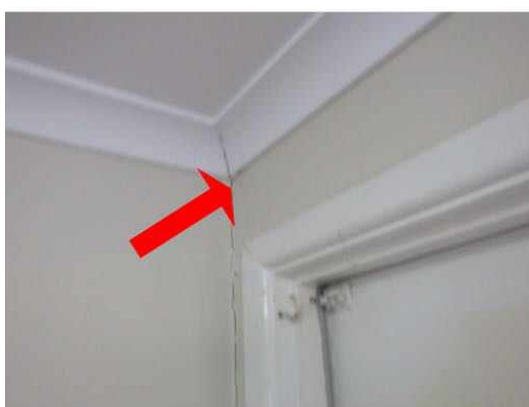
### Finding 3.20

Building: Main Building  
 Location: Entry > Centre Right  
 Finding: Cracking - Ceiling  
 Information: There is cracking to an area of the entry area ceiling and wall lining.

The cracking appears minor in nature and is generally only ever an appearance defect. While such cracking may be noticeable in some cases, it is quite common and does not indicate any structural damage.

Cracking of this nature can generally be repaired with minor sanding, filling and/or repainting. Such works should be performed by a qualified painter or a general handyman.

Monitoring of all cracking should be conducted frequently. Always contact a building inspector should cracks widen, lengthen, or become more numerous.

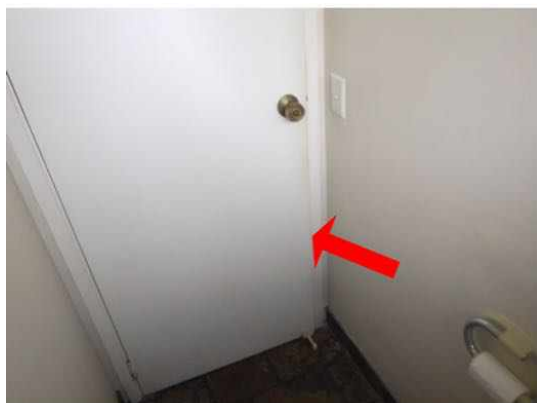
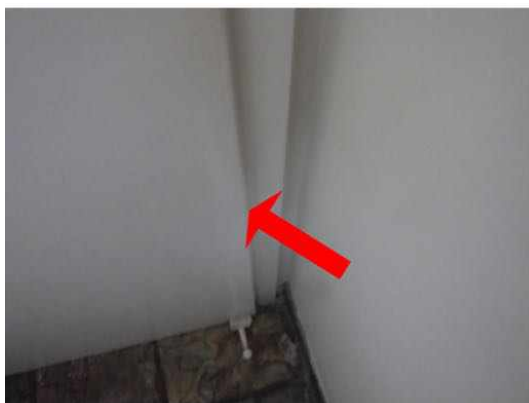
### Finding 3.31

Building:	Main Building
Location:	Toilet (WC) > Existing
Finding:	Wear and Tear
Information:	At the time of inspection the upper level WC interior showed signs of minor cracking and/or scuffing to floors and walls.

The level of damage appears consistent with general deterioration and/or wear and tear.

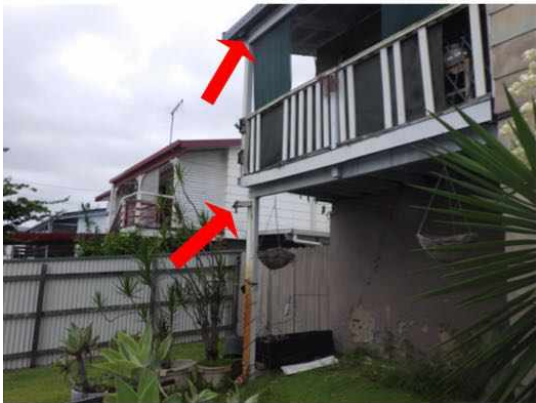
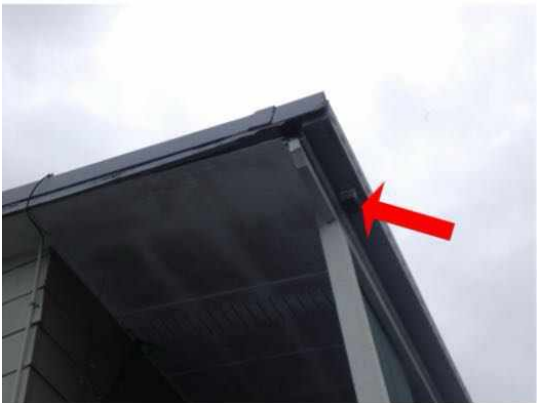
### Finding 6.02

Building:	Main Building
Location:	Exterior walls - front > Front Left
Finding:	Stormwater pipe - Damaged
Information:	The down pipe to the front left side exterior wall of the building has suffered damage and has detached from the exterior wall and/or roof gutter.

Where roof plumbing doesn't drain adequately, the area at the base perimeter can become excessively damp, potentially creating an environment that is susceptible to rust and corrosion of surrounding building elements, as well as attracting termites and other pests.

It is recommended that a licensed plumber be appointed to repair the down pipe as necessary.

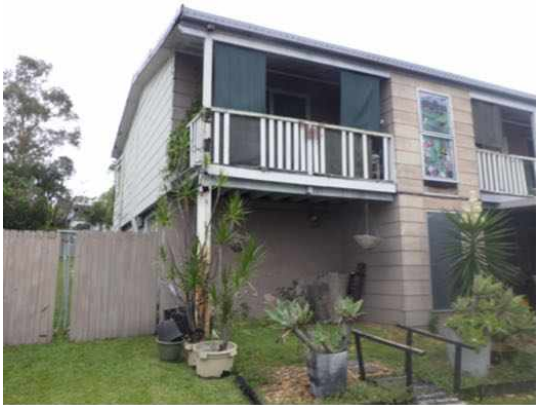
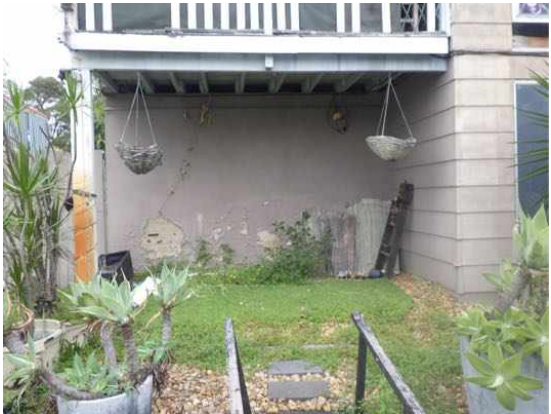
**Finding 6.03**

Building: Main Building  
Location: Exterior walls > Existing  
Finding: Stored Items  
Information: At the time of inspection there was stored items against the external walls in all areas of the property (as per example photos).

These stored items severely limit full inspection of the area and are likely to conceal timber termite pest and or vermin activity.

It is highly recommended the items are removed to allow for complete inspection of the area.
