# Building and Timber Pest Inspection Report

Inspection Date: Fri, 23 Jan 2026

Property Address: 20 Onslow St, Nerang QLD 4211, Australia

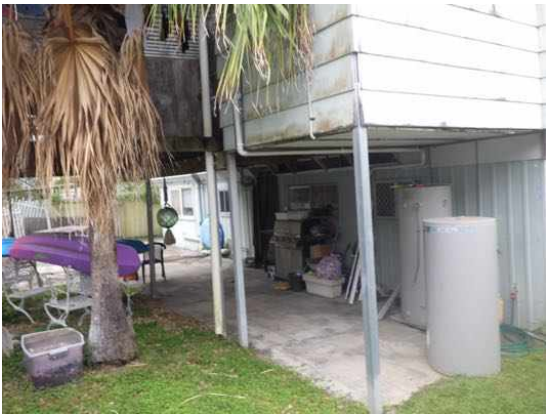
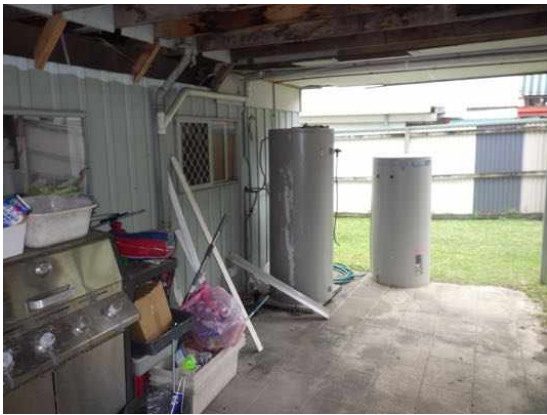
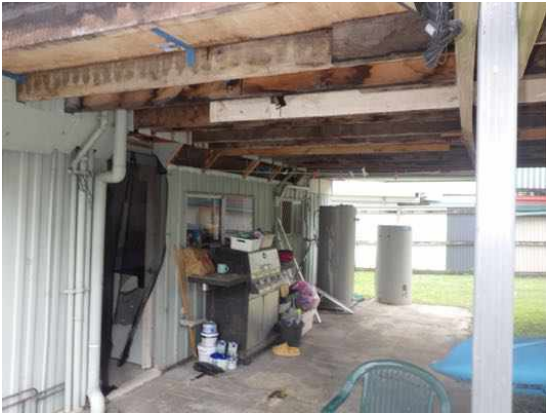
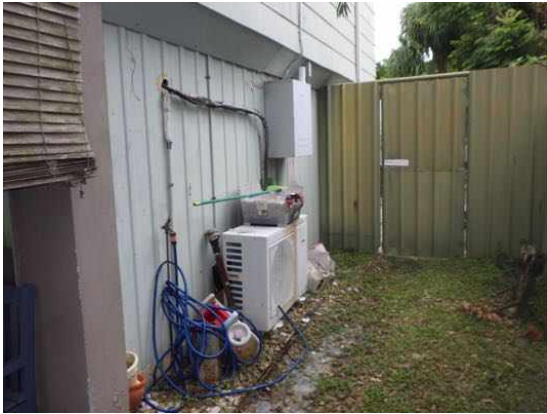
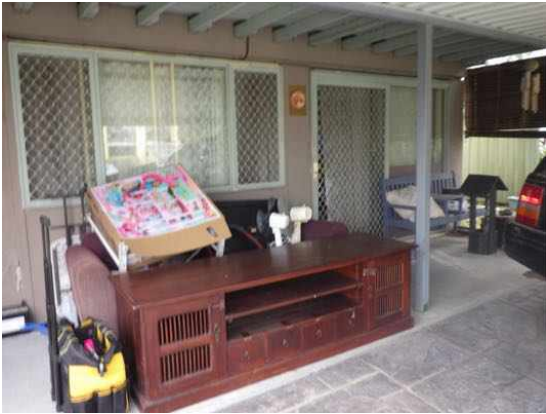
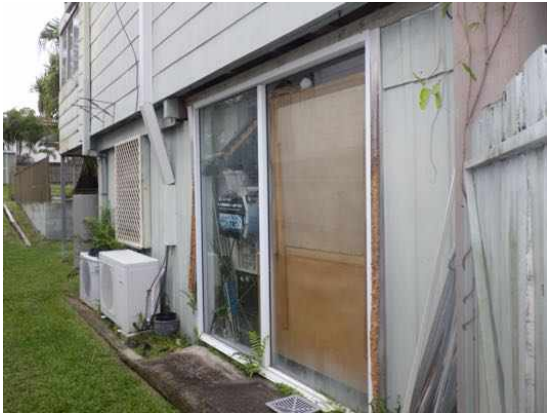
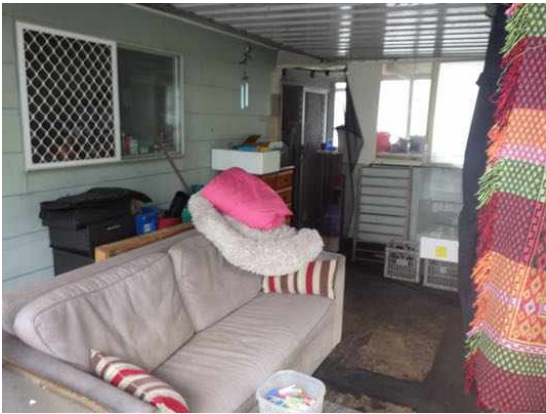
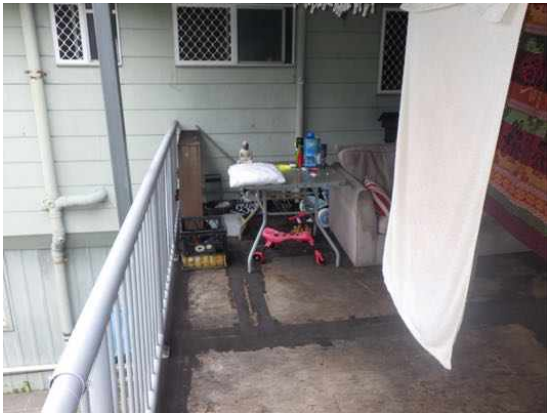
Finding 6.04

Building:	Main Building
Location:	Exterior walls - rear > Rear Left
Finding:	Stormwater downpipes
Information:	The down pipes to the roof area at the rear of the property are not connected to the stormwater drainage on the site. This disconnection negatively impacts the functional capacity of the downpipes and the surrounding ground area.

Where roof plumbing doesn't drain as required, the area at the base perimeter can become excessively damp, potentially creating an environment that is susceptible to flooding and rust or corrosion of surrounding building elements, as well as attracting termites and other pests.

It is recommended that a licensed plumber be appointed to further inspect and to extend the down pipes to the properties stormwater line as necessary.

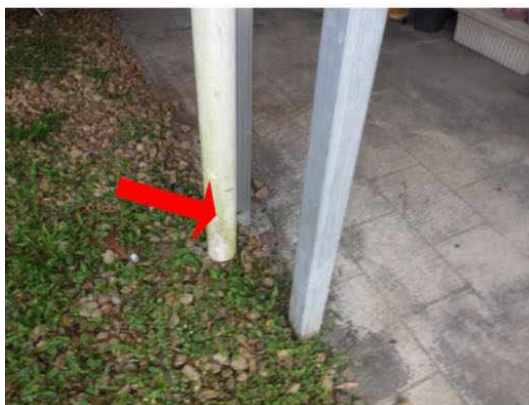
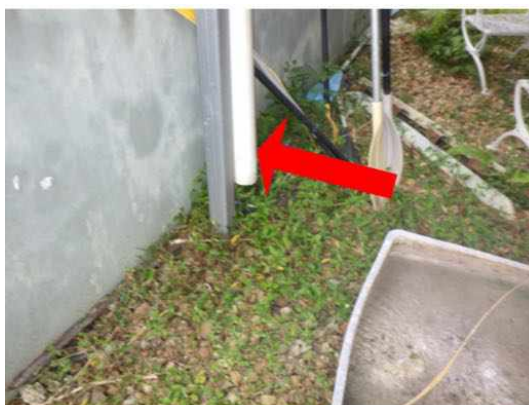
### Finding 6.05

Building:	Main Building
Location:	Exterior walls - rear > Centre Left
Finding:	Overflow - Not plumbed for drainage
Information:	The hot water system overflow is not plumbed or connected to suitable drainage, which can result in the surrounding area becoming excessively damp. These damp conditions can lead to secondary defects such as rot, rust or corrosion of associated

building elements, the formation of fungal decay, or even the creation of potential slip hazards. When coupled with poor site drainage, pooling of water may also attract termite activity to this area. It is highly recommended that a qualified plumber be appointed to install adequate drainage to the overflow. These works will ensure that the area remains dry and free of any secondary defects.

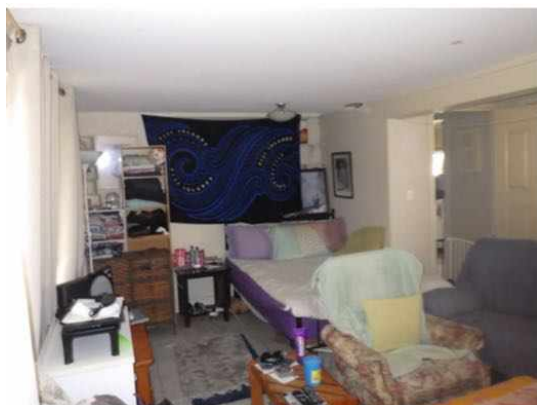
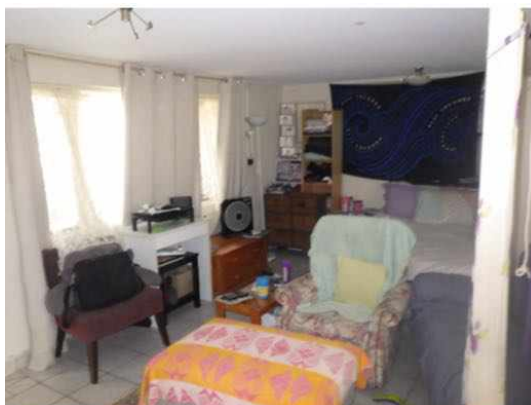
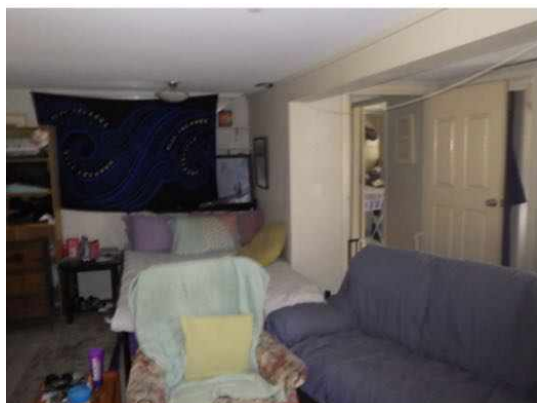
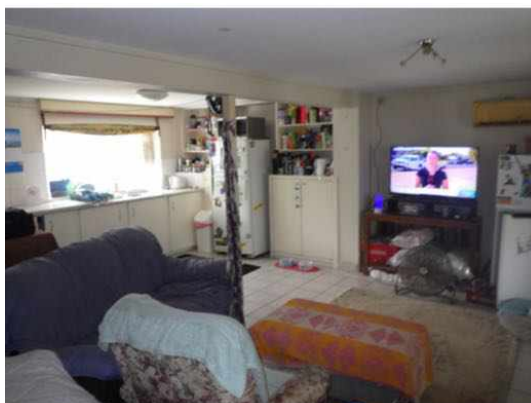
Building: Main Building  
 Location: Utilities Room 1 > Existing  
 Finding: Obstructions and Limitations Internal Areas  
 Information: These photographs are an indication of the obstructions and limitations which impeded full inspection of the ground floor utilities room 1 area at the time of inspection. These obstructions can hide an array of defects and should be removed to allow full inspection to be carried out. A re-inspection is recommended once the areas are made accessible.

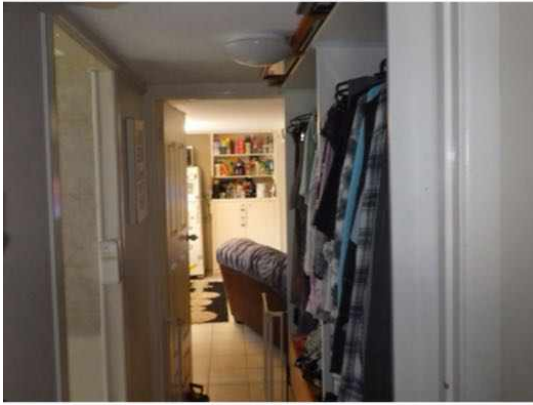
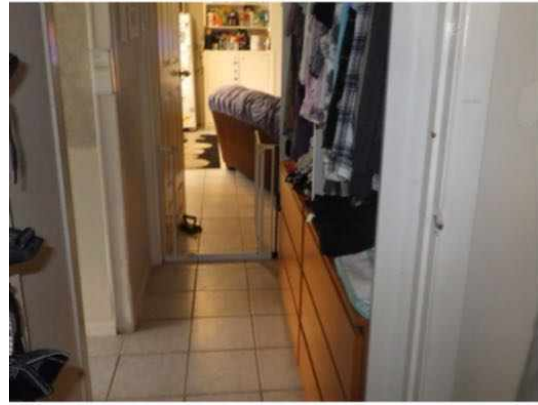
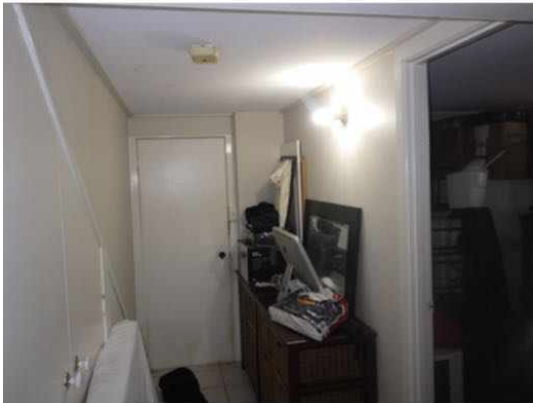
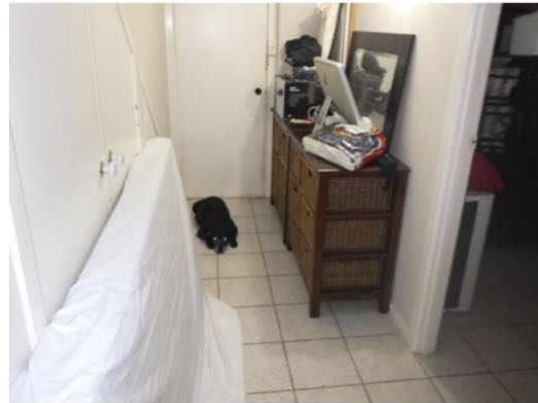
Building: Main Building  
 Location: Hallway 2  
 Finding: No obvious defect  
 Information: No obvious defects found at the time of inspection.

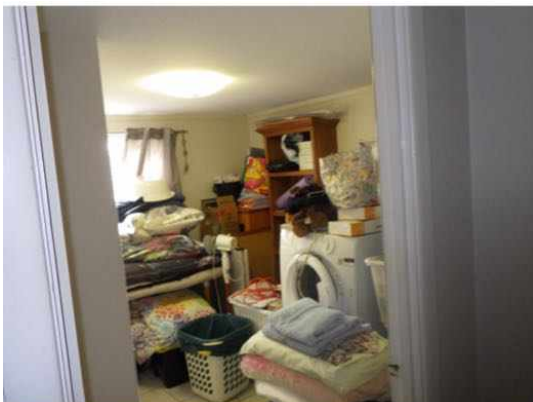
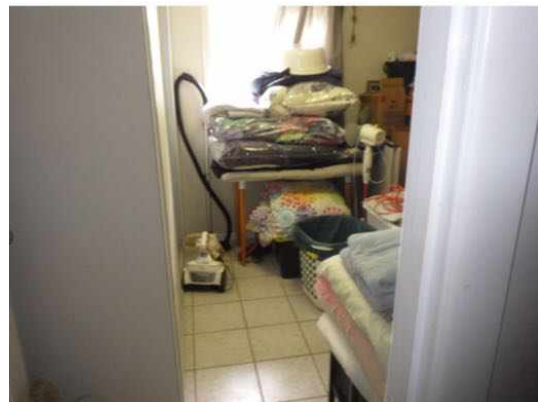
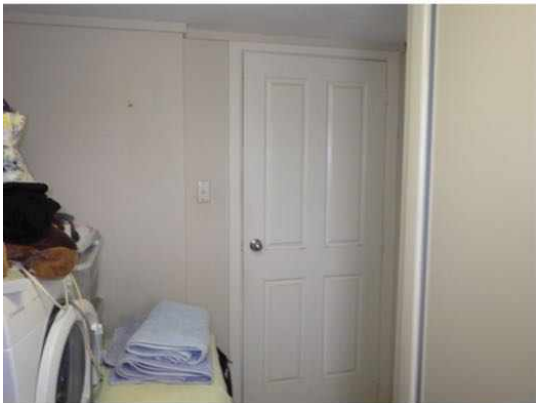
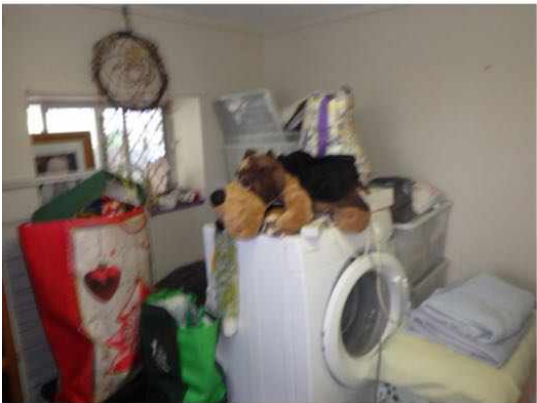
Building: Main Building  
 Location: Utilities Room 2 > Existing  
 Finding: Obstructions and Limitations Internal Areas  
 Information: These photographs are an indication of the obstructions and limitations which impeded full inspection of the ground floor utilities room 2 internal area at the time of inspection. These obstructions can hide an array of defects and should be removed to allow full inspection to be carried out. A re-inspection is recommended once the areas are made accessible.

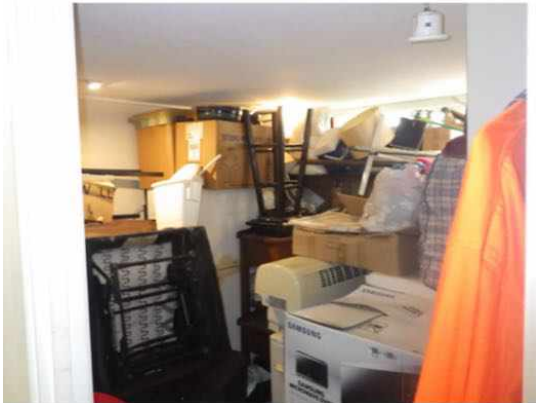
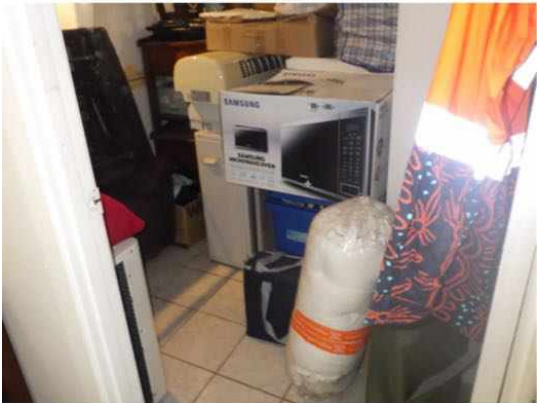
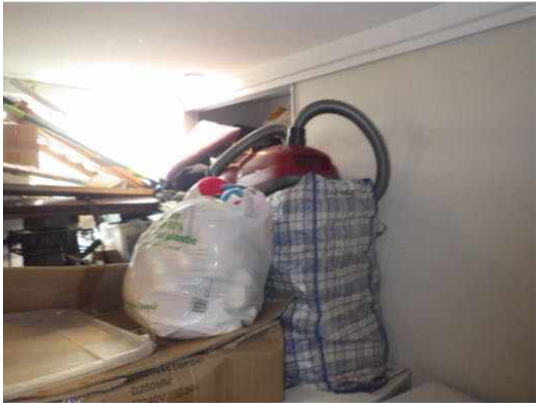
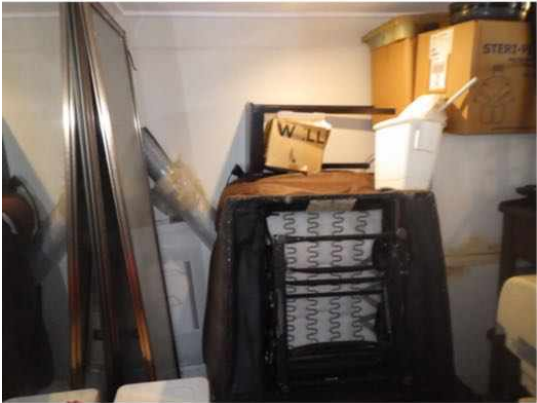
Building: Main Building  
Location: Utilities Room 3 > Existing  
Finding: Obstructions and Limitations Internal Areas  
Information: These photographs are an indication of the obstructions and limitations which impeded full inspection of the ground floor utilities room 3 internal areas at the time of inspection. These obstructions can hide an array of defects and should be removed to allow full inspection to be carried out. A re-inspection is recommended once the areas are made accessible.

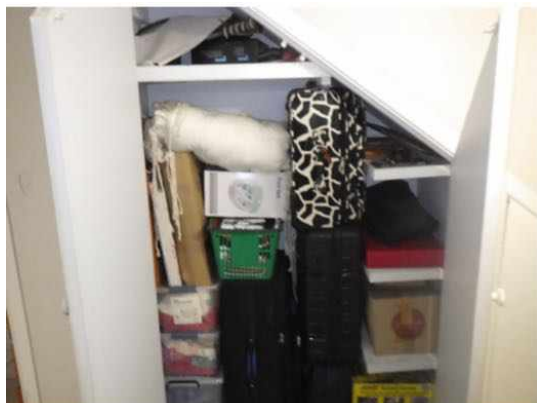
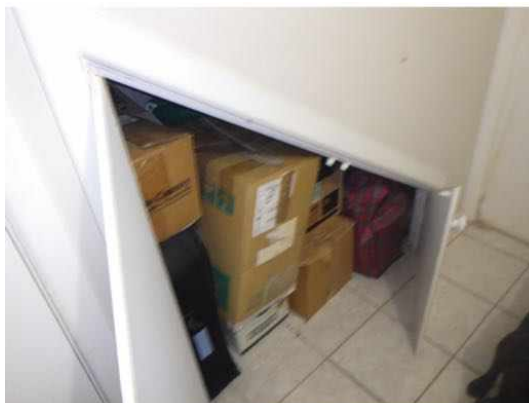
Building: Main Building  
 Location: Under Stair Void or Storeroom > Existing  
 Finding: Obstructions and Limitations Internal Areas  
 Information: These photographs are an indication of the obstructions and limitations which impeded full inspection of the ground floor under stair storage areas at the time of inspection. These obstructions can hide an array of defects and should be removed to allow full inspection to be carried out. A re-inspection is recommended once the areas are made accessible.

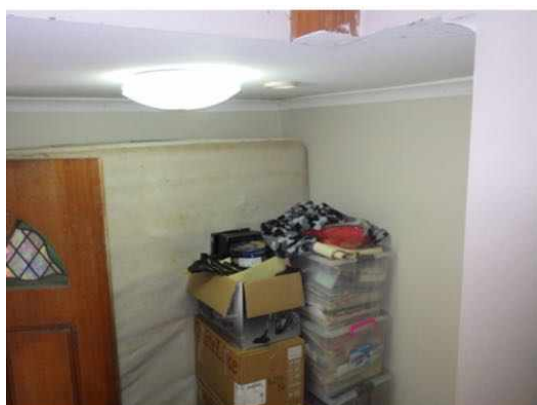
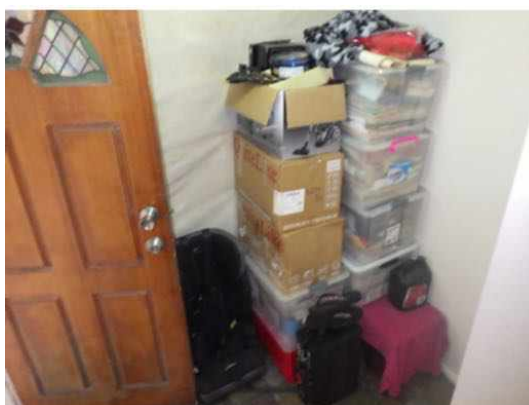
Building: Main Building  
 Location: Entry > Existing  
 Finding: Obstructions and Limitations Internal Areas  
 Information: These photographs are an indication of the obstructions and limitations which impeded full inspection of the entry internal area at the time of inspection. These obstructions can hide an array of defects and should be removed to allow full inspection to be carried out. A re-inspection is recommended once the areas are made accessible.

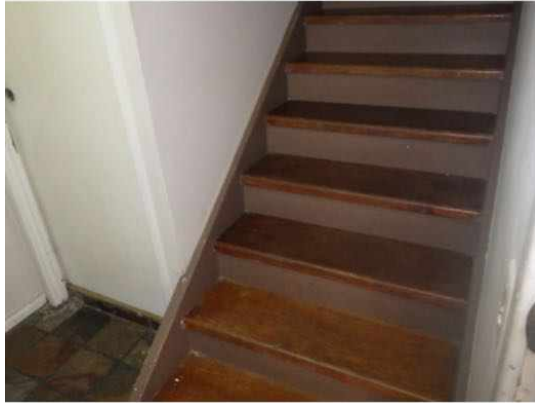
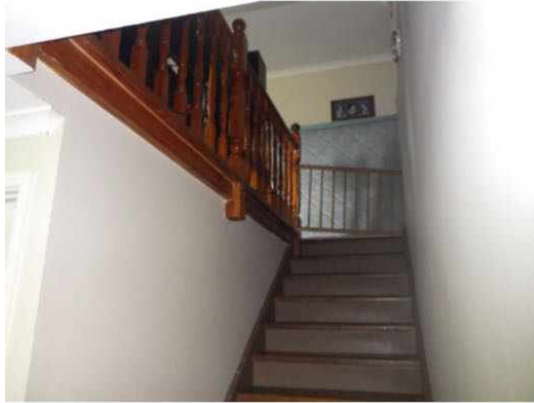
Building: Main Building  
Location: Stairs - Internal  
Finding: No obvious defect  
Information: No obvious defects found at the time of inspection.

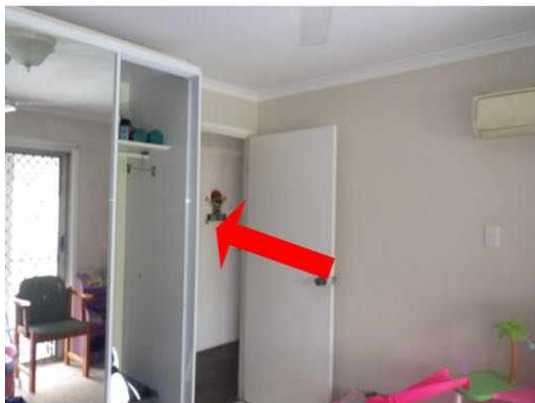
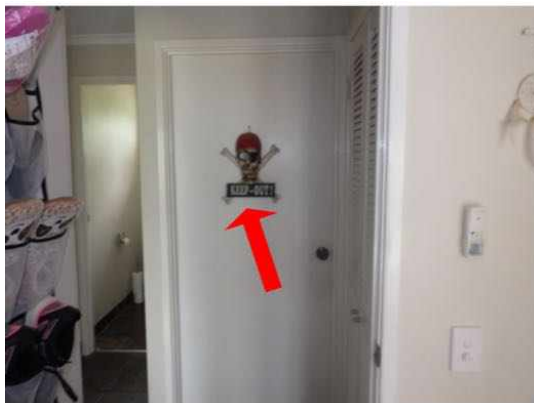
Building: Main Building  
Location: Bedroom 3 > Existing  
Finding: No Access  
Information: At the time of inspection access was denied to the bedroom 3 interior, due to a sleeping shift worker.

No inspection of the bedroom 3 internal area was undertaken.

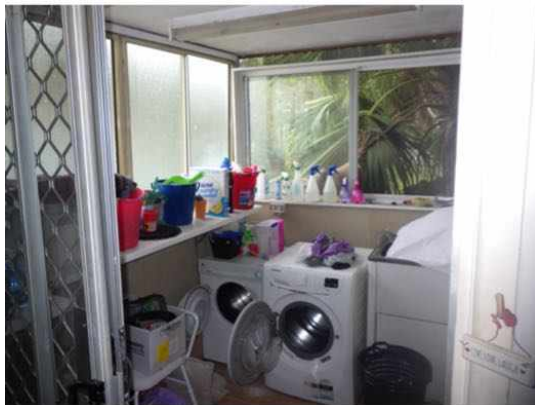
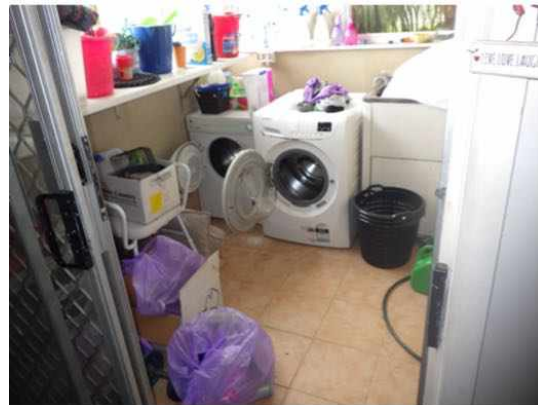
Building: Main Building  
Location: Laundry > Existing  
Finding: Obstructions and Limitations Internal Areas  
Information: These photographs are an indication of the obstructions and limitations which impeded full inspection of the upper level internal areas at the time of inspection.

These obstructions can hide an array of defects and should be removed to allow full inspection to be carried out. A re-inspection is recommended once the areas are made accessible.

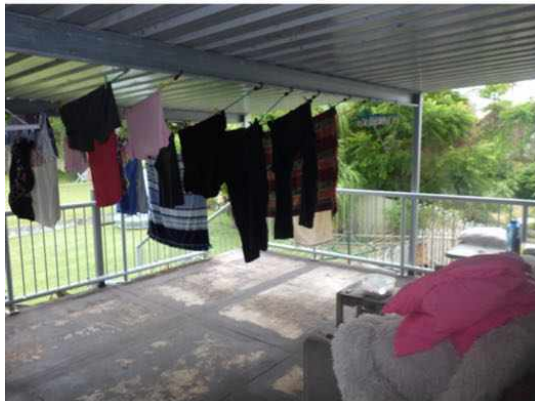
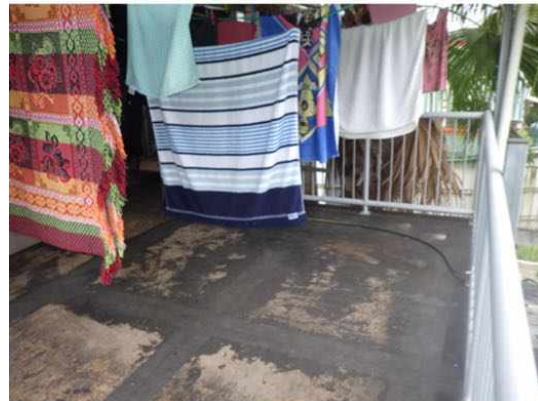
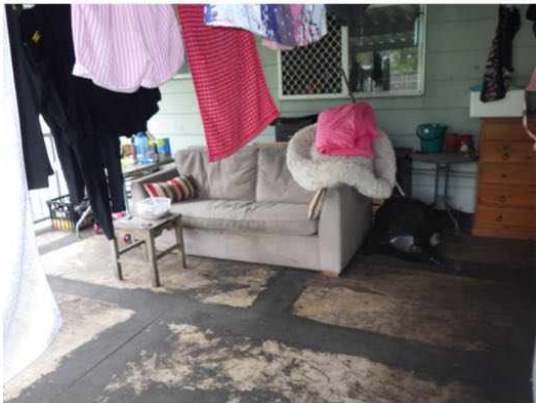
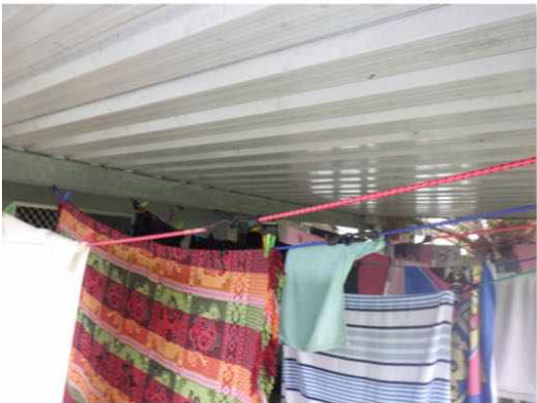
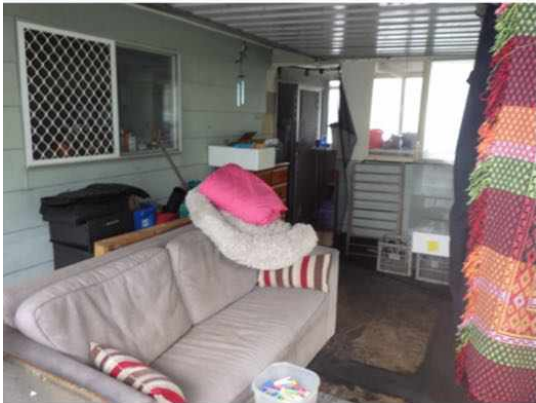
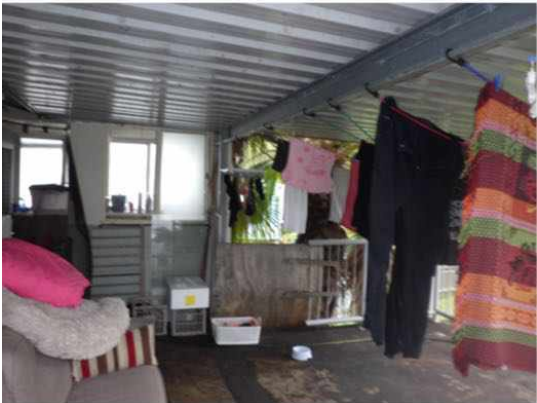
Building: Main Building  
 Location: Alfresco > Existing  
 Finding: Obstructions and Limitations External Areas  
 Information: These photographs are an indication of the obstructions and limitations which impeded full inspection of the alfresco area at the time of inspection. These obstructions can hide an array of defects and should be removed to allow full inspection to be carried out. A re-inspection is recommended once the areas are made accessible.

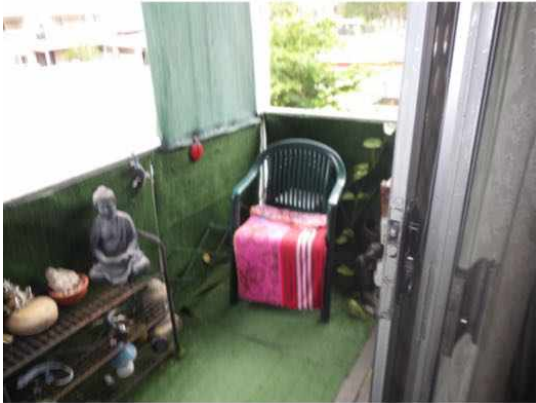
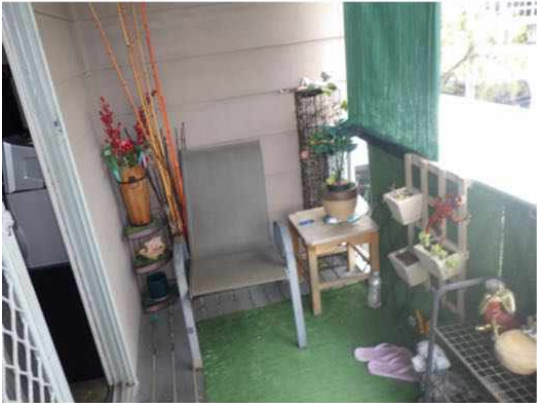
Building: Main Building  
 Location: Balcony > Existing  
 Finding: Obstructions and Limitations External Areas  
 Information: These photographs are an indication of the obstructions and limitations which impeded full inspection of the external balcony area at the time of inspection. These obstructions can hide an array of defects and should be removed to allow full inspection to be carried out. A re-inspection is recommended once the areas are made accessible.

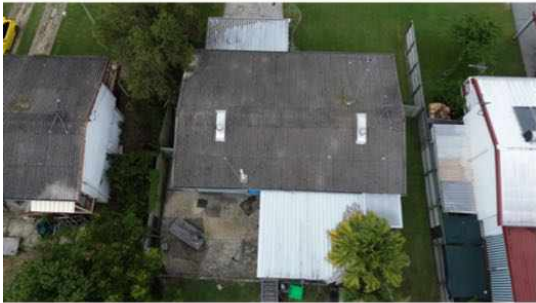
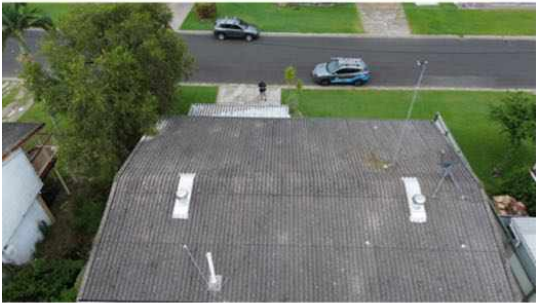
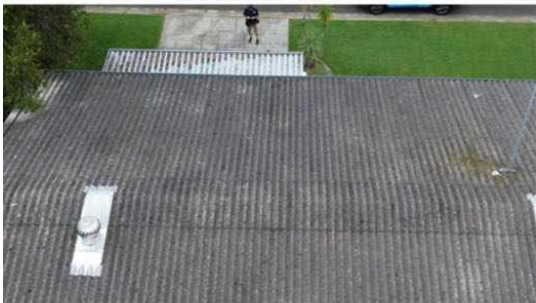
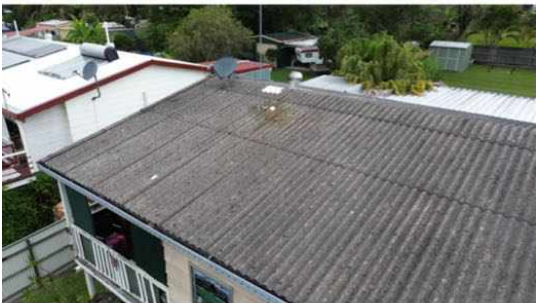
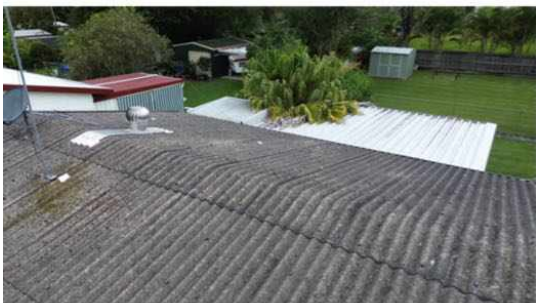
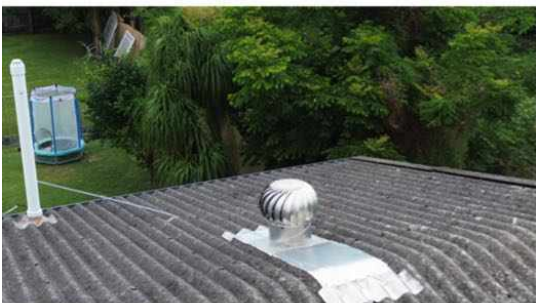
Building: Main Building  
Location: Roof Exterior > Existing  
Finding: Roof Photos  
Information: Roof area photos were taken with the DJI Mini 3 Drone flown over the roof at the time of inspection.

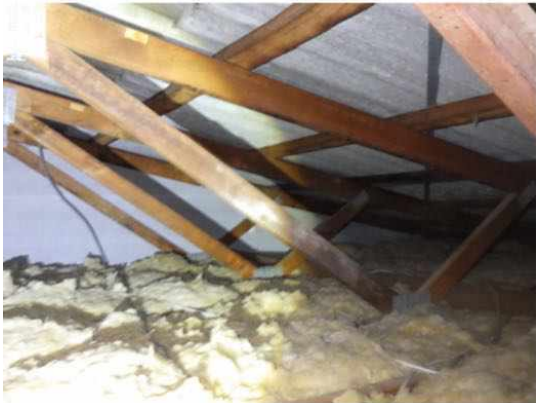
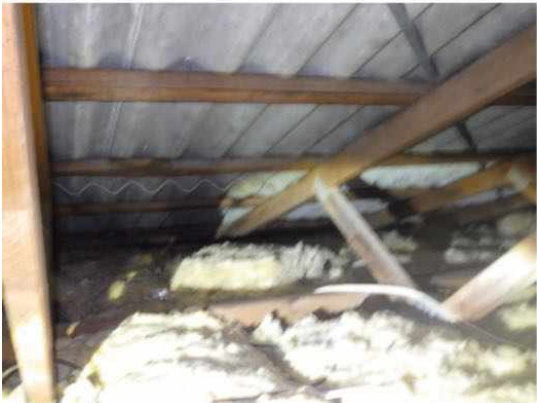
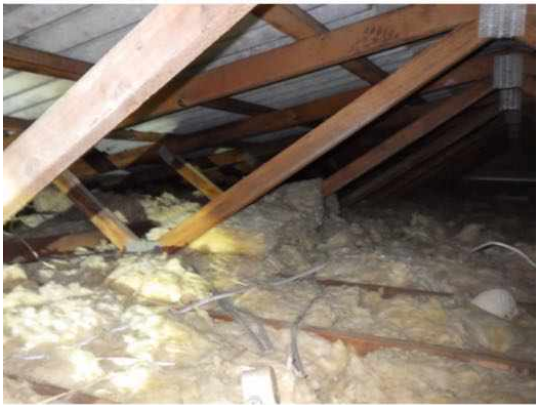
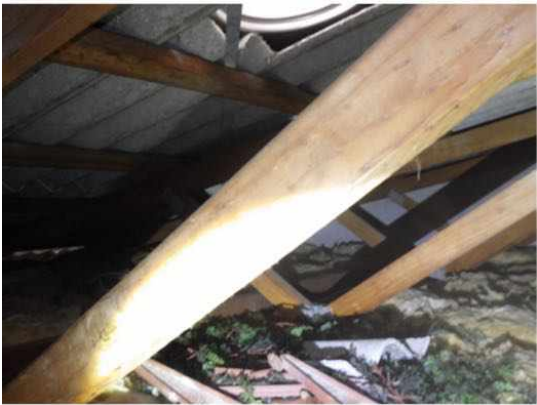
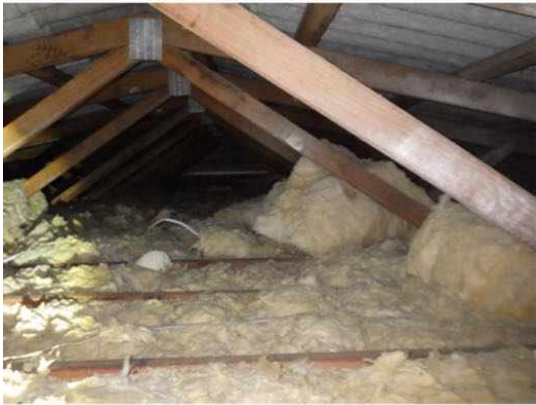
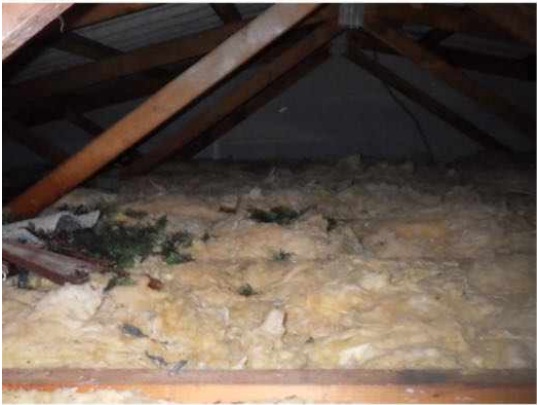
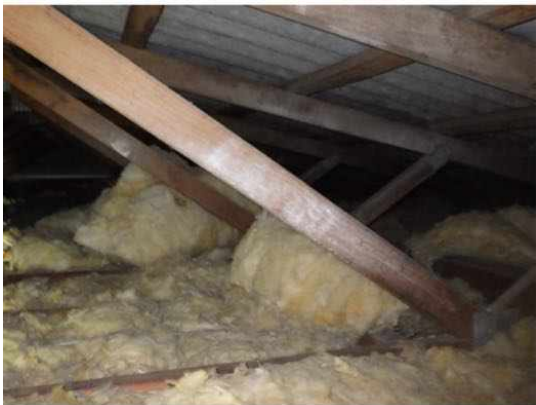
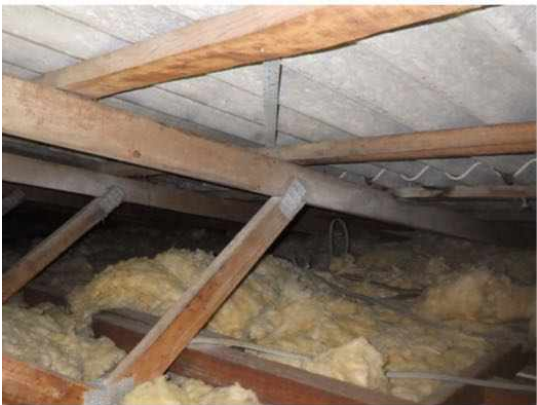
Building: Main Building  
Location: Attic > Existing  
Finding: Additional Photos  
Information: Additional photos are provided for your general reference

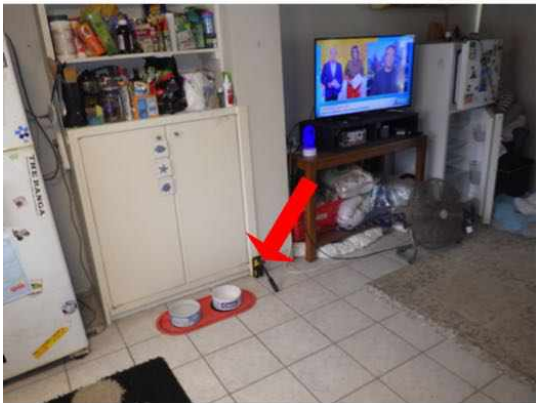
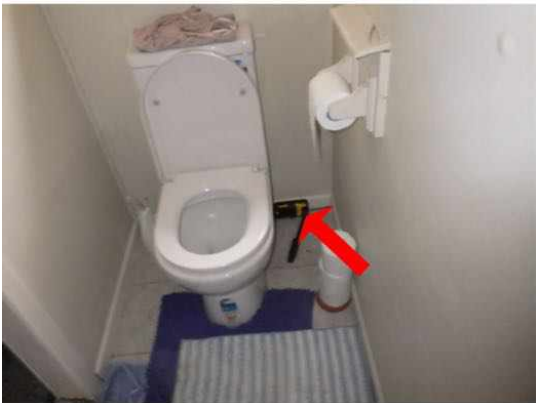
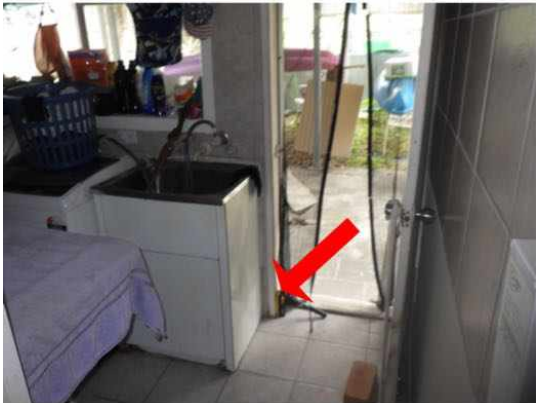
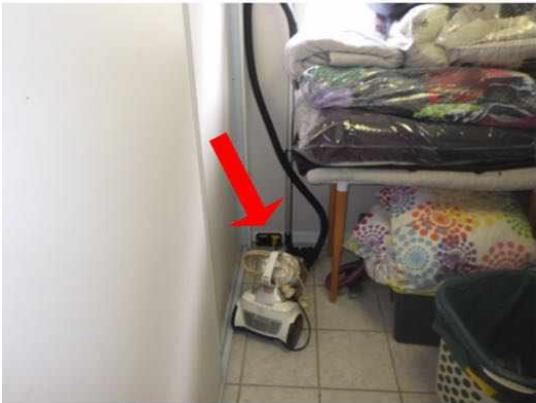
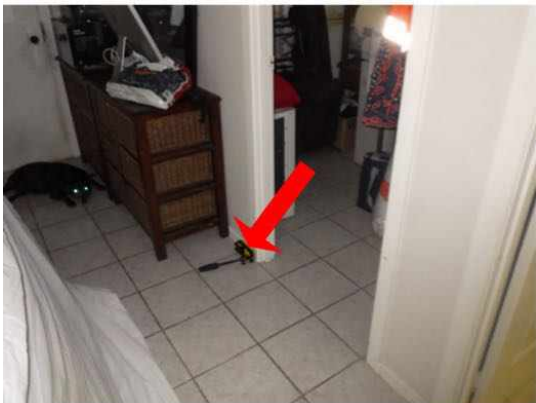
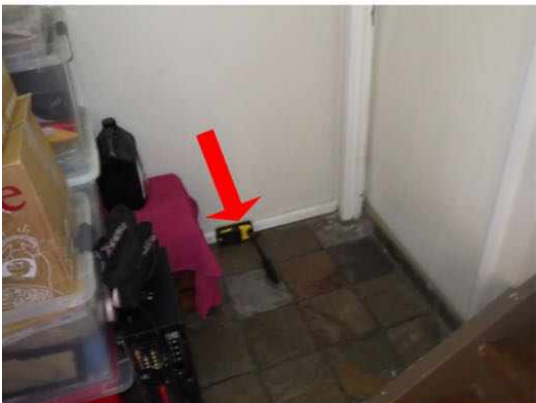
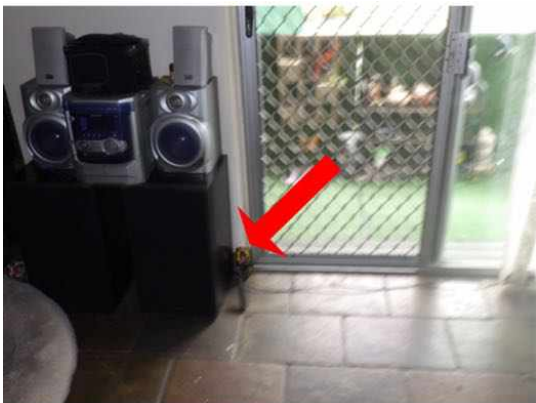
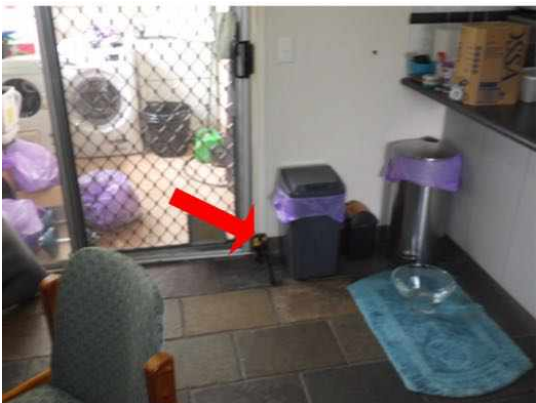
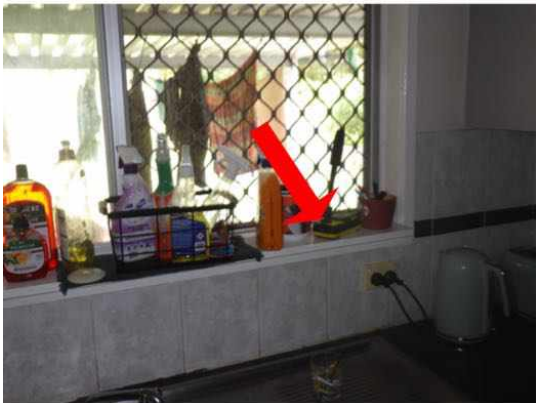
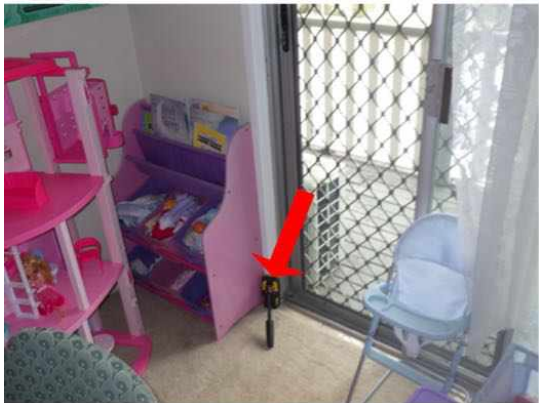
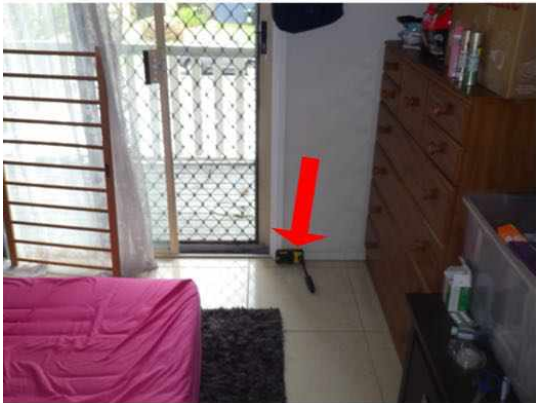
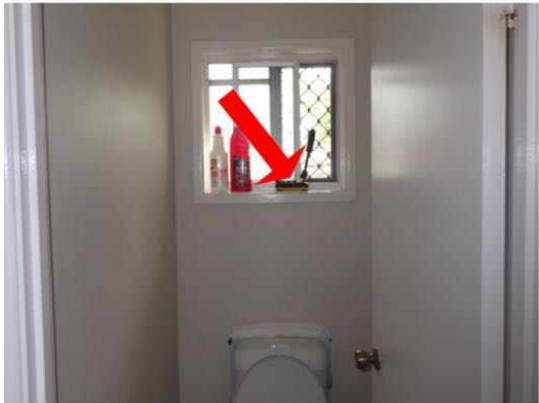
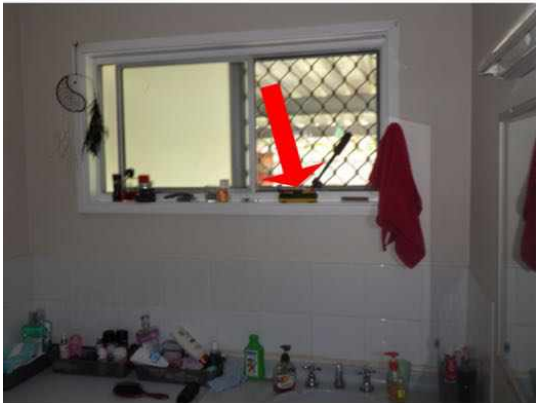
Building: Main Building  
Location: Internal Areas  
Finding: Termitracker  
Information: The termitracker itracker was positioned randomly to internal wall, timber skirting and window frame areas checking for signs of termite activity.

No activity was recorded at the time of inspection.

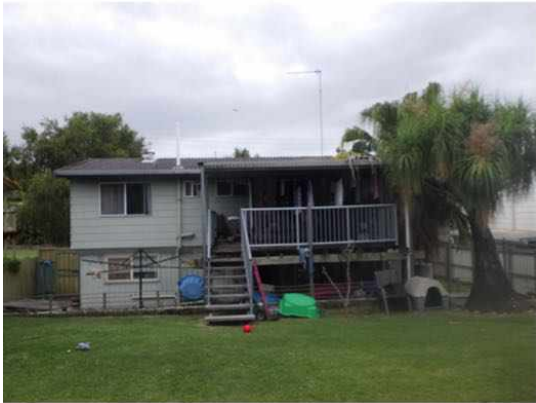
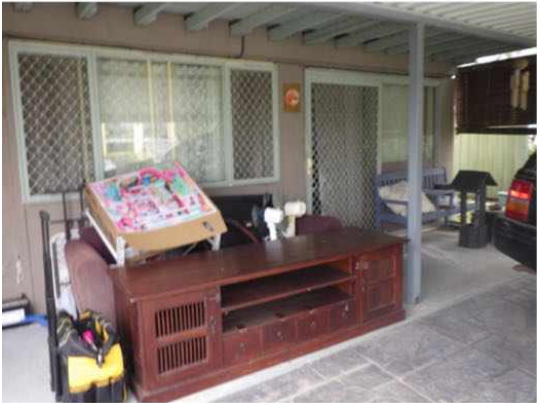
Building: Main Building  
 Location: External Areas > Existing  
 Finding: Building Compliance  
 Information: At the time of inspection it was noted there has been building extension works and/or renovation/alteration works to the dwelling.

It is highly recommended that the seller provides the relevant approval information, or a search of the Local Council and QBCC records be made to determine what approvals have been granted for the extension, alterations and/or renovation works to the property.
