# Building and Timber Pest Inspection Report

Inspection Date: Wed, 25 Mar 2026

Property Address: 14 Taylors Road, Silverdale NSW 2752

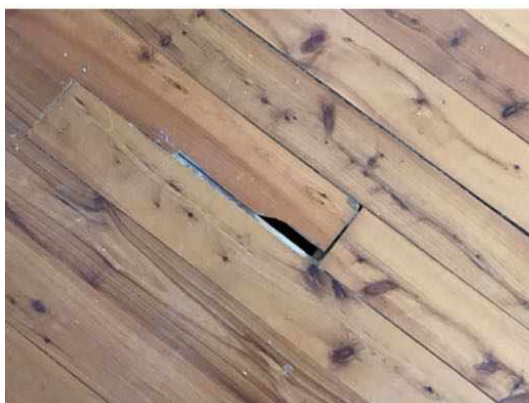
Building:	Main Building
Location:	Living Room > Upstairs
Finding:	Flooring – Damaged Timber Floorboard (Safety Hazard).
Information:	Observation:

A timber floorboard was observed to be damaged at an upstairs location, with a section chipped away resulting in a localised hole within the board. While the extent of physical damage appears minor, the defect is situated within a commonly trafficked area.

Due to its location and the presence of an uneven surface and hole, the defect presents a potential trip hazard to occupants and visitors. This increases the risk of slips, trips, or falls, particularly in low-light conditions or where the defect may not be immediately visible. If left unaddressed, the damage may worsen with continued use, potentially leading to further deterioration of the surrounding flooring and an increased safety risk.

It is recommended that the damaged section of flooring be repaired as a priority to eliminate the trip hazard. Rectification may involve repair, patching, or replacement of the affected floorboard by a suitably qualified flooring contractor or carpenter. Works should ensure the finished surface is level, secure, and free from defects.

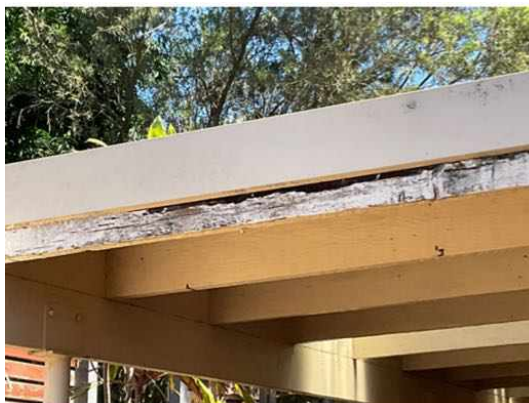
### Finding 2.01

Building: Main Building  
 Location: Pergola  
 Finding: Major Defect – Timber Decay to Pergola Roof Structure  
 Information:

Evidence of timber decay consistent with fungal rot was identified to sections of the roof rafters within the rear pergola at the time of inspection. The affected timbers exhibited deterioration indicative of prolonged moisture exposure. This condition typically develops where timber remains damp over extended periods, allowing fungal activity to break down the structural fibres.

In this instance, the decay appears likely associated with ongoing exposure to weather elements, including rain penetration and general environmental conditions. Contributing factors may include inadequate sealing, lack of protective coatings, and/or insufficient maintenance of exposed timber components.

Given the structural role of rafters, the presence of decay is considered a significant defect requiring attention.

- A suitably qualified and licensed carpenter or building contractor should be engaged to carry out a detailed assessment of the pergola structure to determine the full extent of deterioration.
- All decayed or structurally compromised timber members should be repaired or replaced as necessary to restore structural integrity.
- Any contributing moisture sources should be identified and rectified, which may include improving drainage, weatherproofing, or protective finishes.
- Exposed timbers should be appropriately sealed, painted, or treated to reduce future moisture ingress and prolong service life.

Timely remediation is recommended to prevent further deterioration and potential safety risks associated with structural weakening.

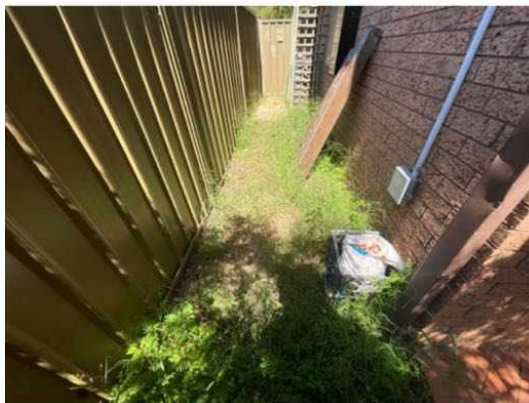
### Finding 3.01

Building: Main Building  
 Location: Exterior - left side  
 Finding: Site/Yard Drainage – Below Average.  
 Information: Defect – Below Average Site Drainage

Site drainage in the inspected areas appears to be below average, with no surface drains observed at the time of inspection. Ground surfaces and paved areas adjacent to the building do not appear to be adequately graded to facilitate effective surface water runoff.

- A licensed plumber and/or landscaping contractor should be engaged to:
  - Evaluate the current site grading and surface runoff conditions
  - Install or upgrade surface water drainage (e.g. strip drains, spoon drains, grated channels) as required
  - Improve grading around the building to ensure water flows away from the structure

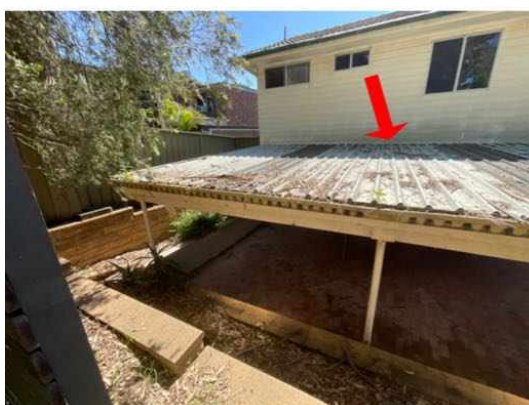
**Finding 3.04**

Building: Main Building  
Location: Pergola  
Finding: Roof Plumbing – Missing Flashings (Minor Defect)  
Information: Observation:

Rectification is not considered urgent; however, installation of suitable flashings is recommended to improve weatherproofing. A licensed roofing plumber may be engaged to assess the junction and install appropriate flashing in accordance with standard building practices. Investigation and rectification may be undertaken at the client's discretion.

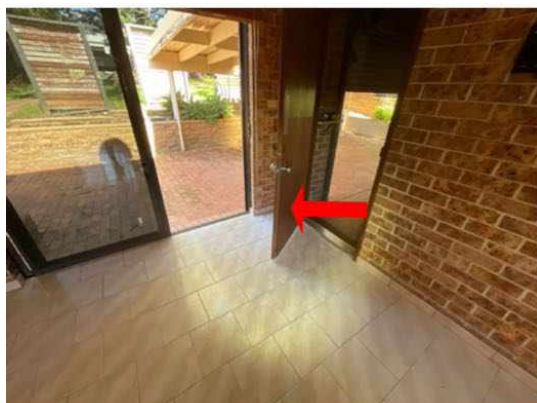
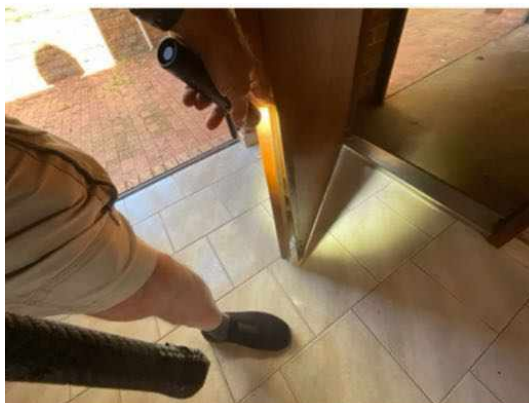
### Finding 3.05

Building: Main Building

It is also recommended that doors, particularly those exposed to moisture (e.g., bathroom or laundry areas), be maintained through periodic sealing or painting to

extend their service life and maintain functionality.

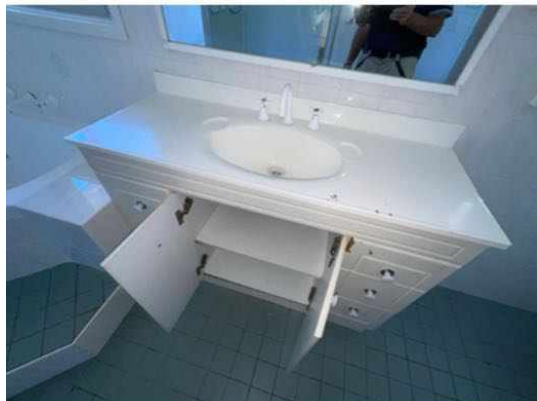
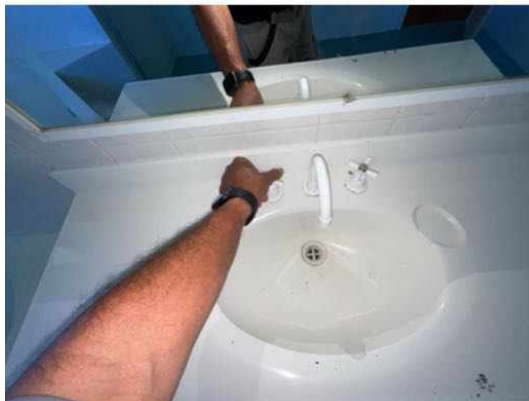
The assessment was limited to functional testing of the tap at the time of inspection. No dismantling of fixtures or investigation of concealed pipework was undertaken. The exact cause of failure and the condition of internal components or associated plumbing connections could not be fully determined without further specialist inspection.

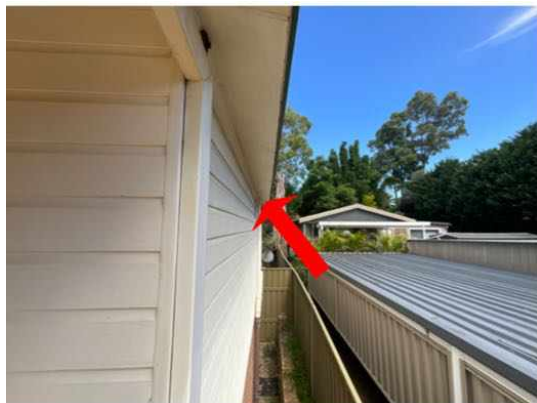
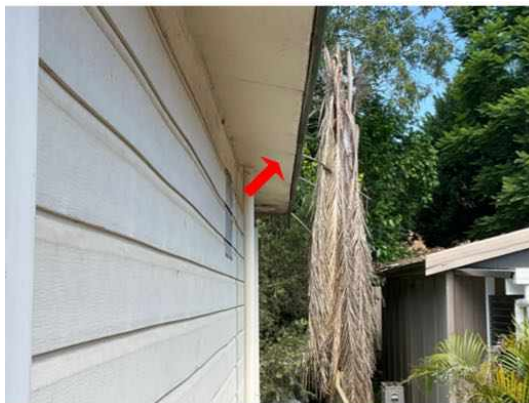
### Finding 3.08

Building: Main Building  
 Location: Eaves  
 Finding: Eaves - Sagging.  
 Information: Sagging Eaves – Maintenance Required

- Minor rectification works are recommended. A qualified carpenter or general handyman should be appointed to reinstate and secure the eaves to ensure proper function and alignment.
- Early maintenance will help prevent more costly repairs from developing over time.

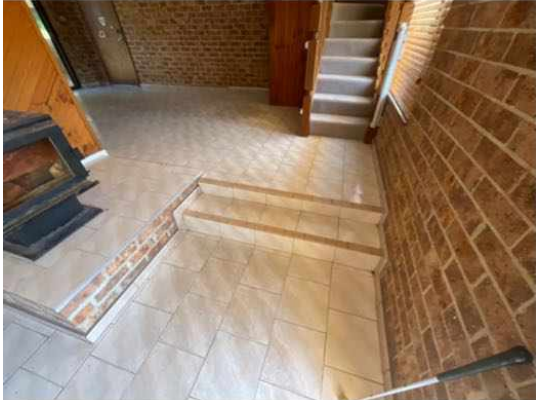
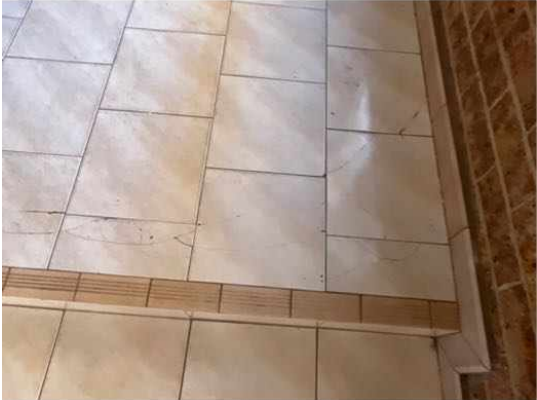
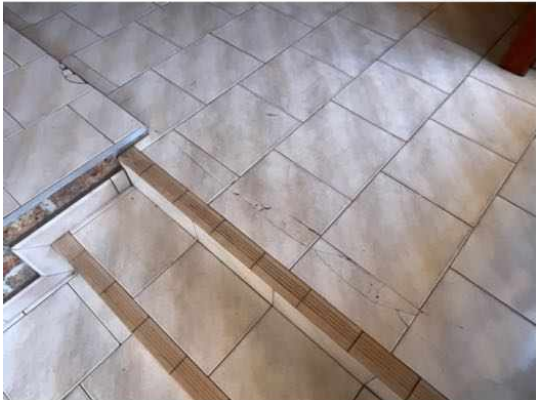
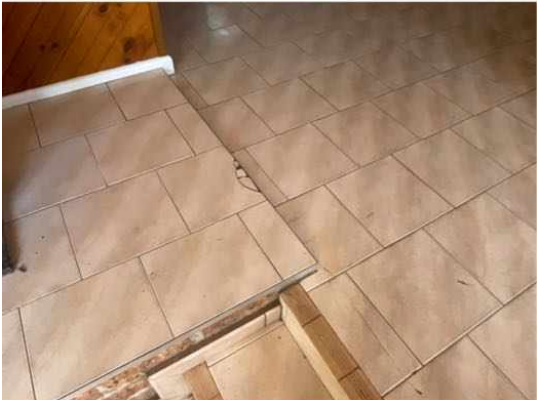
### Finding 3.09

Building:	Main Building
Location:	Foyer
Finding:	Floor Tiles – Cracked (Minor Defect).
Information:	Observation:

The inspection was limited to visual assessment only. No invasive investigation of the tile substrate, bedding, or subfloor structure was carried out. Accordingly, the underlying cause of the cracking could not be conclusively determined at the time of inspection.

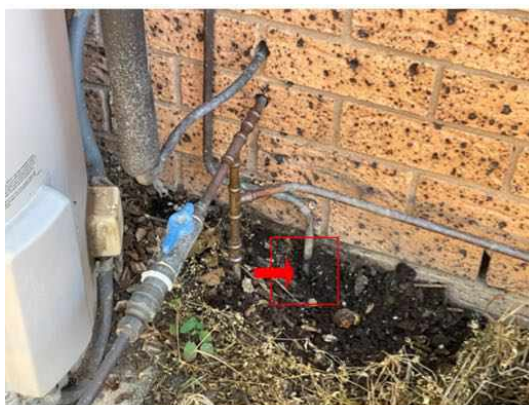
### Finding 6.03

Building:	Main Building
Location:	All External Areas
Finding:	Overflow Management – Risk of Termite Activity..
Information:	Observation: Water Pooling from HWS and Air Conditioning Overflows

It is highly recommended that all overflows from the HWS and air conditioning units be redirected away from the building, preferably via fixed drainage or extension piping, to prevent water accumulation near the structure.

These minor corrective works should be undertaken promptly to minimise the risk of both termite ingress and potential structural damage due to ongoing moisture exposure.

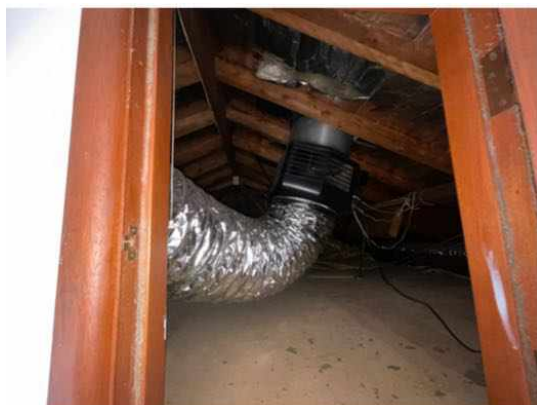
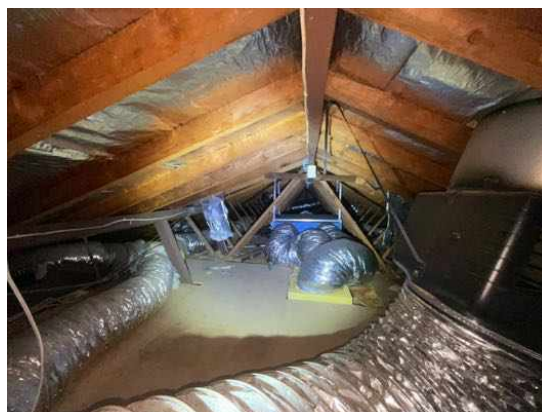
Building:	Main Building
Location:	Roof Void
Finding:	Roof Void – Limited Accessibility..
Information:	Observation:

Installation of an additional manhole is recommended to facilitate a re-inspection and enable a more thorough assessment of the roof void in the future. This will help ensure that all structural elements and concealed areas are properly evaluated.

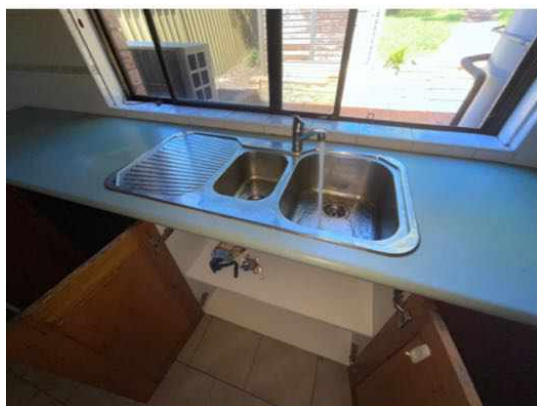
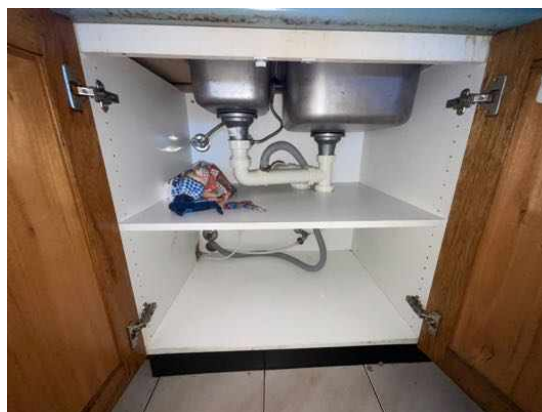
Building: Main Building  
 Location: Kitchen  
 Finding: Kitchen Sink – Overall Condition & Recommendations.  
 Information: Observations:

- Further monitoring and testing are recommended once the tap(s) are in constant use, to identify any drainage issues or signs of slow leaks not evident during the limited inspection.
- For long-term property care, it is advised that sealant and grouting in water-exposed areas be regularly inspected and maintained. A sealant specialist or tiling contractor may be engaged to carry out these works where necessary.

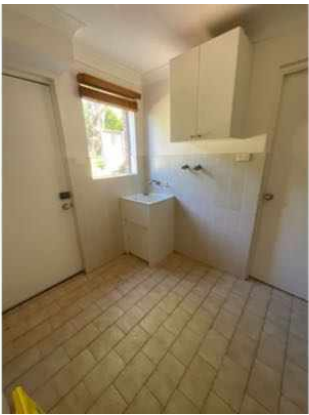
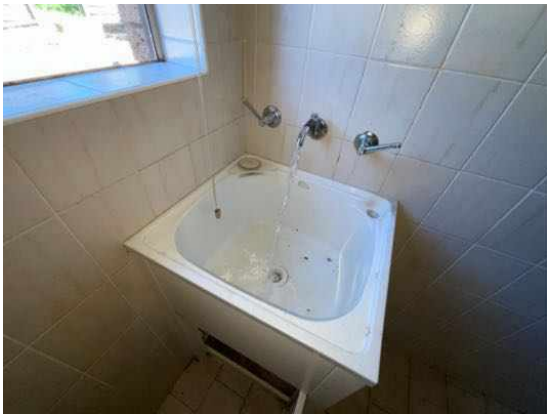
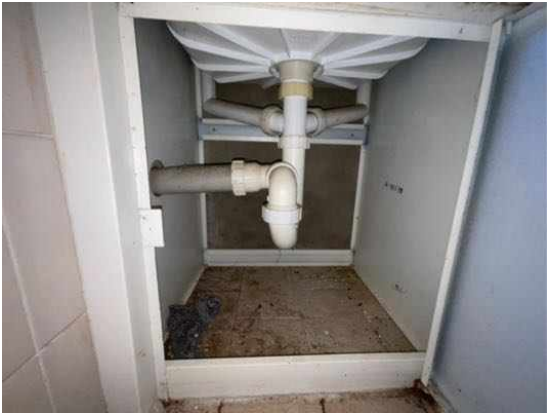
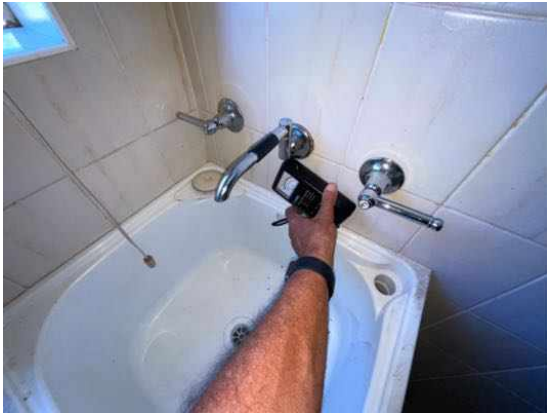
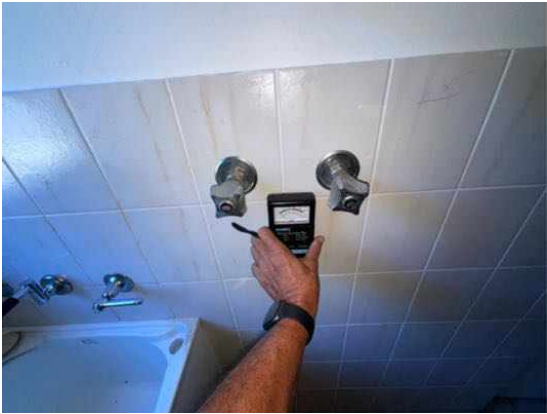
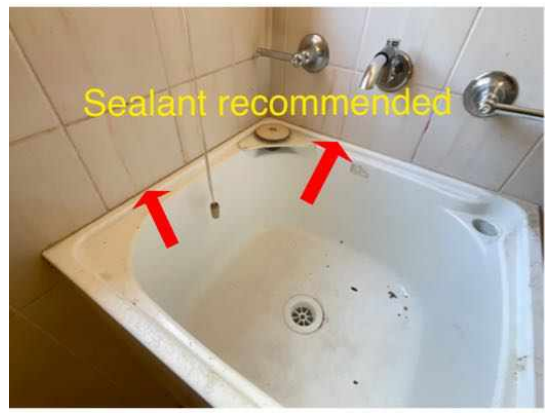
Building: Main Building  
 Location: Laundry  
 Finding: Laundry - Taps/Plumbing/Drainage.  
 Information: Observation: Laundry Tub – Taps, Plumbing, and Cabinetry

- Further monitoring or testing is recommended once the taps are placed into regular use, to ensure no leaks develop over time and that the drainage system continues to perform adequately.
- Flexible and mould-resistant sealant should be applied to junctions between the basin and the wall to prevent water ingress that may lead to damage.
- Regular maintenance and prompt replacement of missing or deteriorated sealant is highly recommended, as this is a common wear-and-tear issue.
- Sealant and grouting in wet areas should be maintained as part of the long-term care and upkeep of the property.
- Where required, a sealant specialist or qualified tiling contractor should be appointed to carry out remedial sealing works.

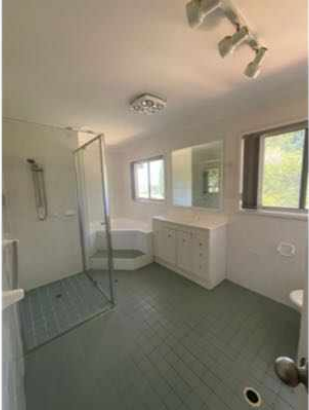
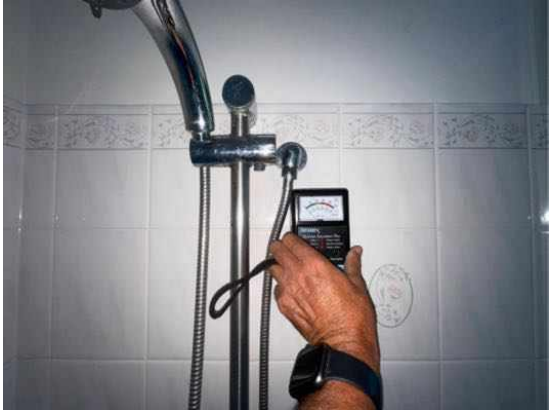
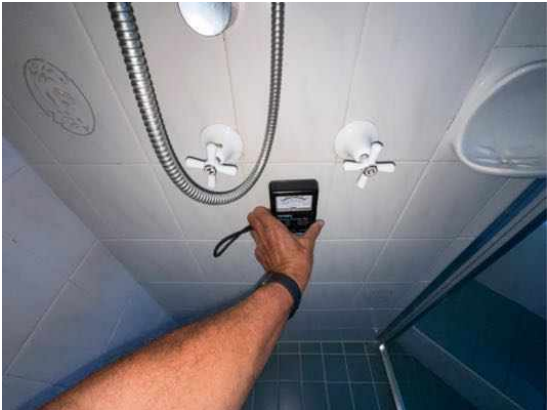
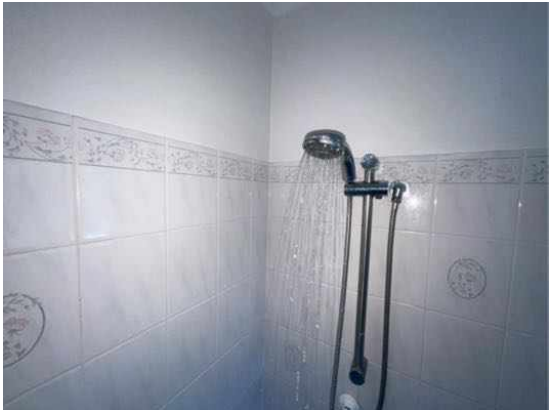
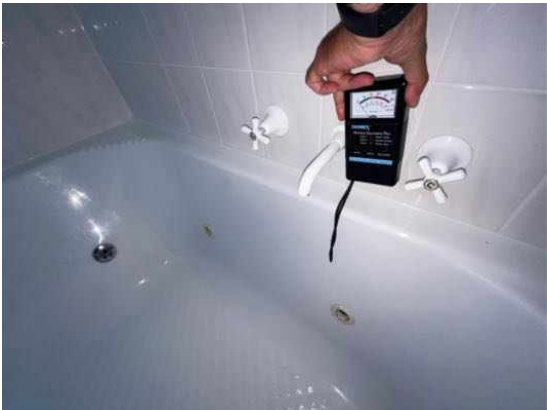
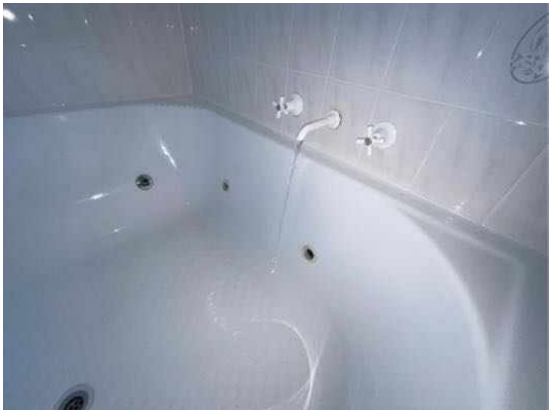
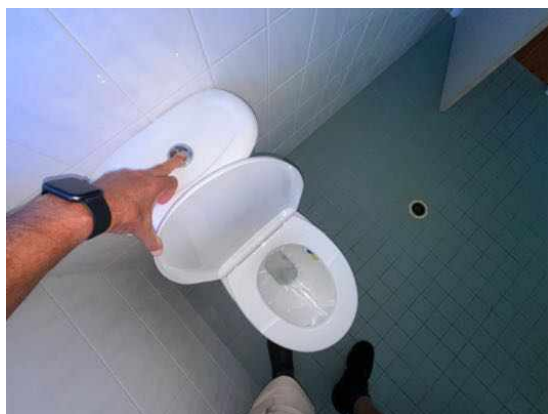
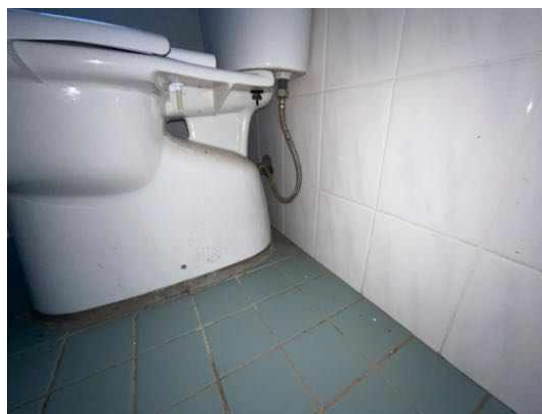
Building: Main Building  
 Location: Ensuite  
 Finding: Wet Areas - Bathroom(s) - Overall Condition & Recommendations.  
 Information: Overall Condition & Recommendations

- Floor waste was found to be clear and free of blockages at the time of inspection. Further monitoring is advised after consistent use to identify any drainage issues or buildup requiring cleaning.

- No elevated moisture readings were detected around the tap fittings or behind the shower walls (as viewed from adjacent rooms), suggesting no active plumbing leaks at the time of inspection.

- Elevated moisture readings were found in the lower shower walls, which is a common occurrence with certain tile types that naturally absorb more moisture. This should be monitored over time.

- Sealing of grout and tiles is recommended to prevent moisture buildup and mould growth in damp areas such as showers.
- The condition of grout appeared to be serviceable

- No leaks were observed during flushing. The toilet operated normally, and the toilet pan appeared to be securely fixed to the floor.

- Basin(s) were water tested and inspected, with no leaks or blockages identified in the plumbing or drainage system at the time of inspection.
- Further monitoring is recommended after the basin(s) are placed under regular use to confirm ongoing performance and cleanliness.
- No visible water damage was observed to the vanity cabinetry at the time of inspection.

- Flood testing of the shower recess is recommended. This may reveal inadequacies in the waterproofing or shower screens, which could lead to water damage in surrounding areas.

- Grout in wall and/or floor junctions may crack and deteriorate over time. It is recommended to remove any rigid grout from junctions and replace with flexible, mould-resistant sealant in accordance with best building practices.

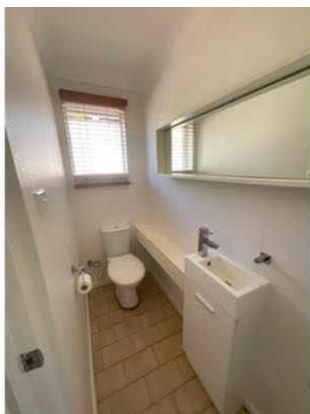
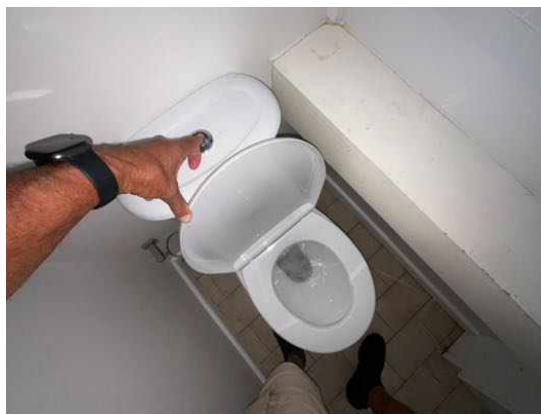
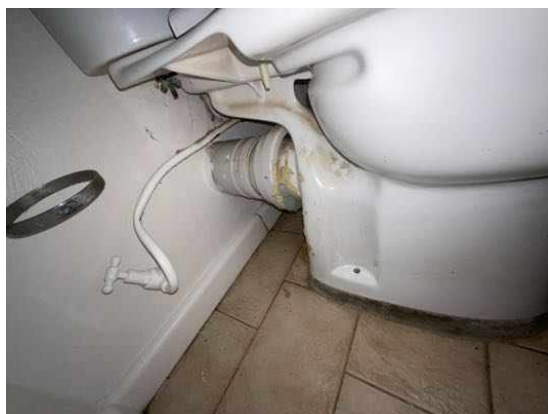
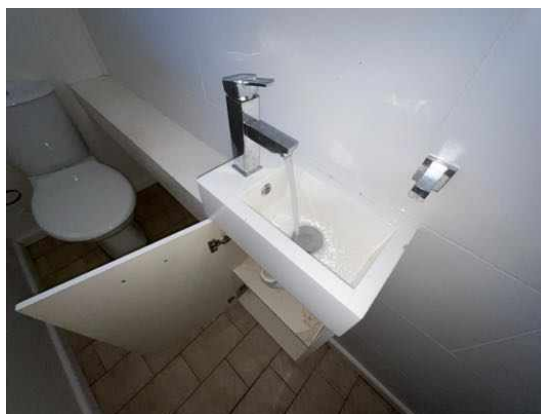
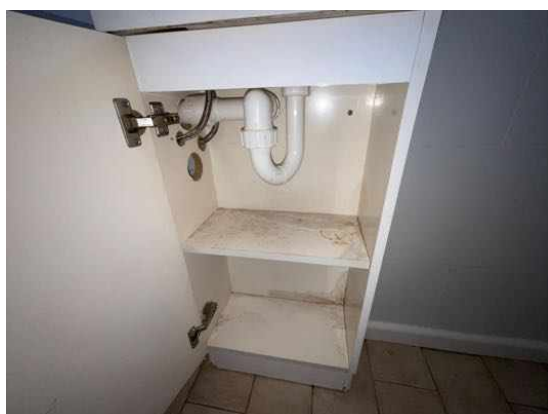
Building: Main Building  
 Location: All Areas  
 Finding: Water Pressure – Observation Only.  
 Information: During the inspection, water pressure appeared to be within a normal operating range based on a basic functional check. However, this observation was made without the use of pressure testing equipment and does not constitute an assessment by a licensed plumber.

It is strongly recommended that a Licensed Plumber be engaged to conduct a comprehensive assessment of the plumbing system to verify its functionality, check for any underlying issues, and confirm compliance with current regulations and standards.
