Building Inspection Report

Inspection Date: Tue, 27 Jan 2026

Property Address: unit 2/142 Pound Rd, Hampton Park VIC
3976, Australia

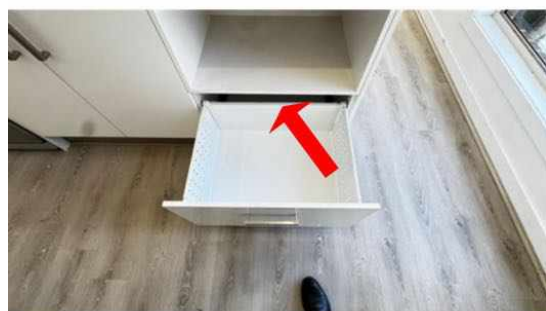
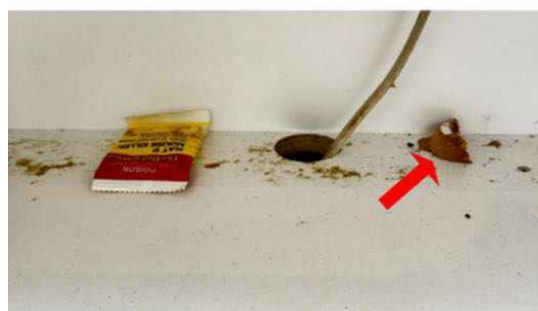
Defects 3.01

Building: Main Building
 Location: Kitchen
 Finding: Cabinets - Poor Installation & Detailing
 Information: Cabinets were observed to have poor installation and detailing. These issues affect both the visual appearance and functional performance of the cabinetry.

This may be due to inadequate installation techniques, misalignment during installation, use of incorrect fixings or poor craftsmanship.

When practical, a qualified cabinetmaker or qualified carpenter should be engaged to address these detailing issues. Prompt action will help ensure proper fit, finish, and durability of the cabinetry.

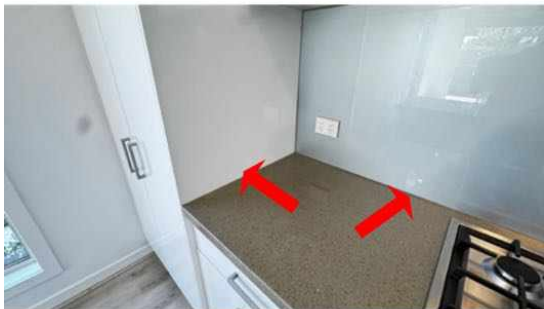
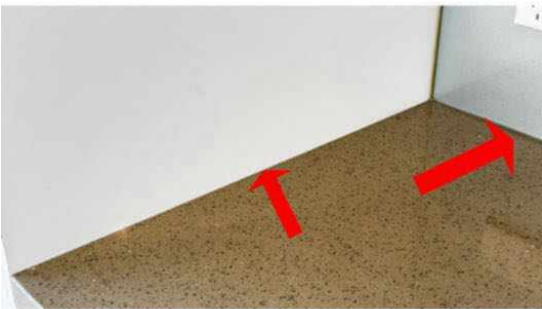
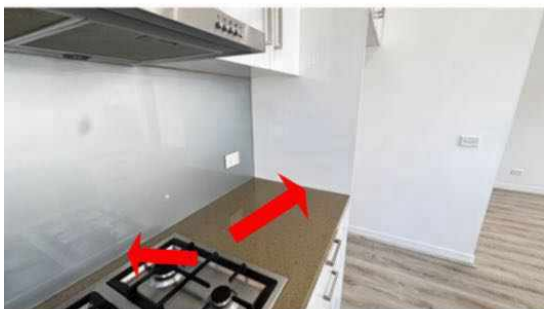
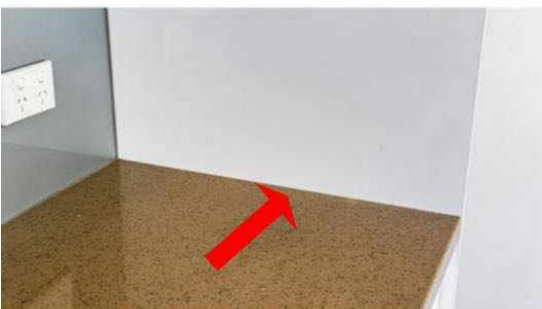
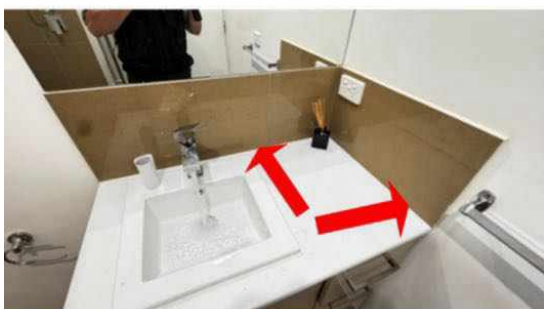
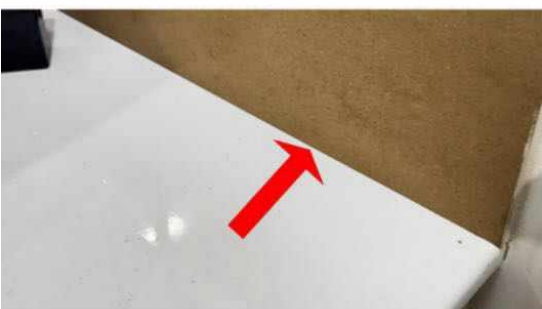
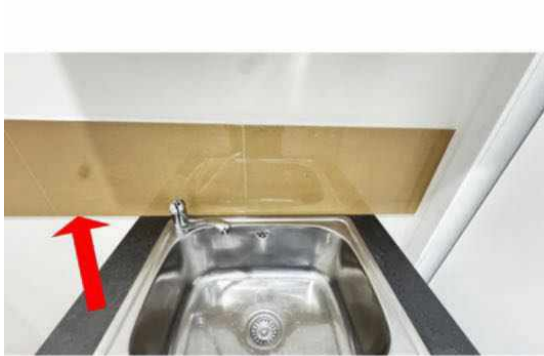
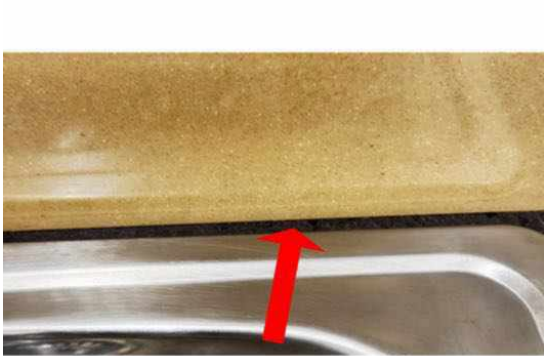
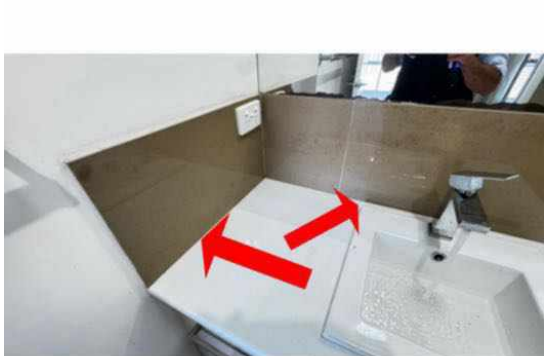
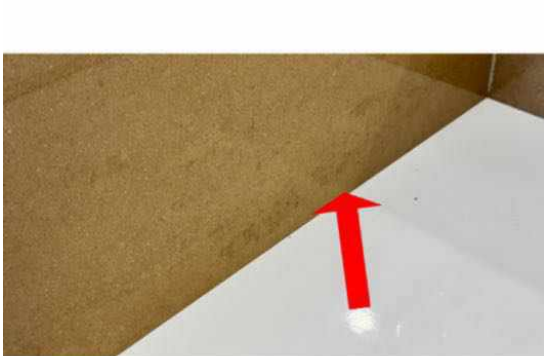
Defects 3.02

Building: Main Building
 Location: Kitchen, laundry, bathroom 1, bathroom 2 >
 Finding: Sealant - Missing
 Information: The inspection identified sealant that is missing in this area. Missing sealant can allow moisture ingress, promote mould growth, and reduce the durability and hygiene of

This may have been caused by age-related deterioration of the original sealant, lack of installation or lack of routine maintenance and re-sealing.

A qualified tiler or competent handy man should be engaged immediately to apply new, compliant sealant. Properly maintained sealant will prevent water ingress, maintain hygiene, and extend the life of adjacent building elements.

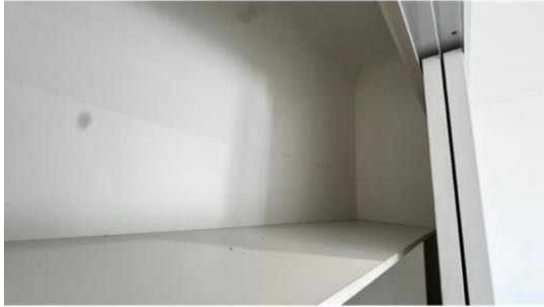
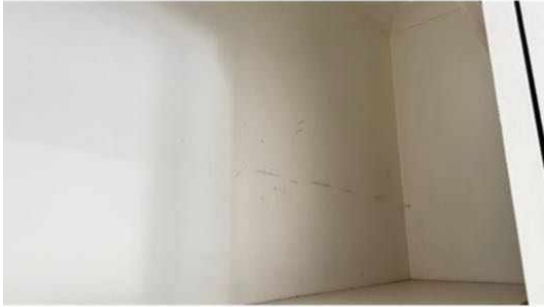
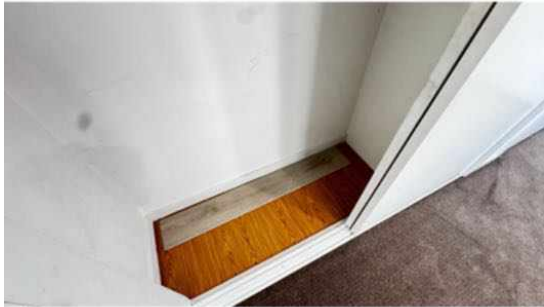
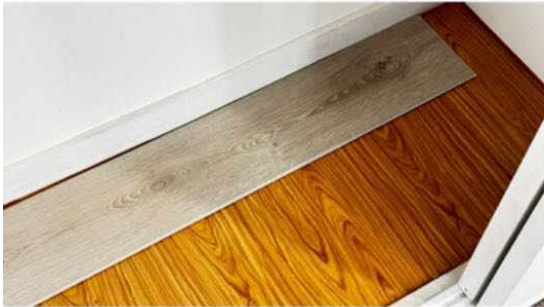
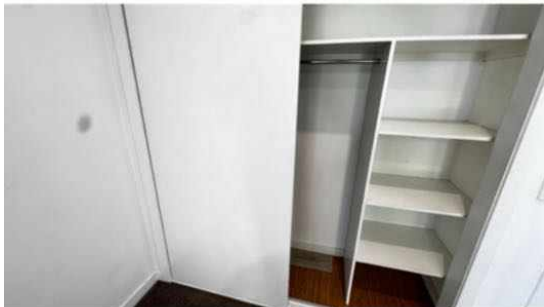
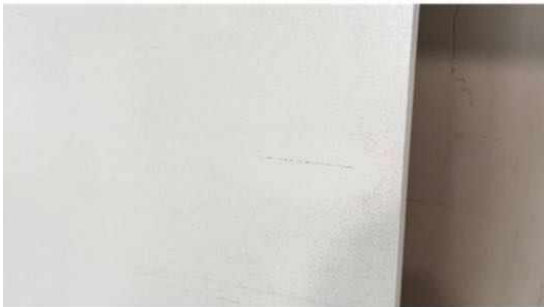
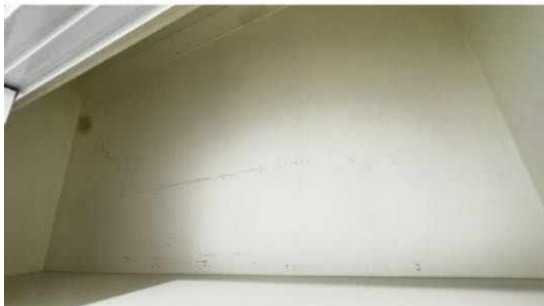
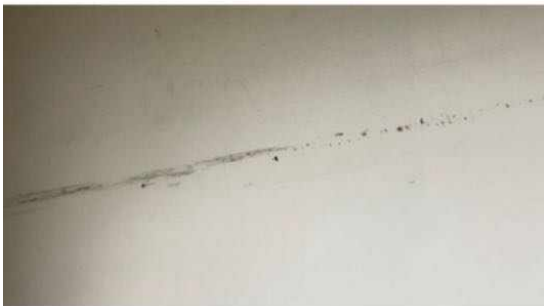
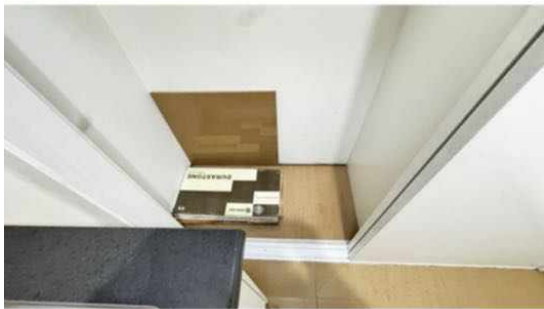
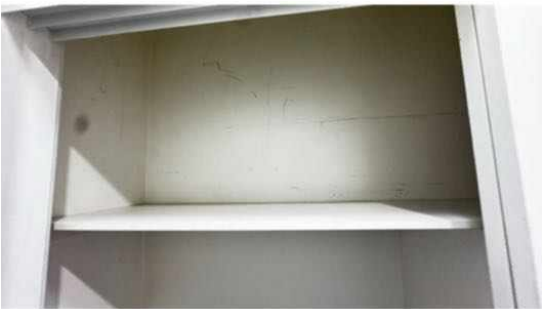
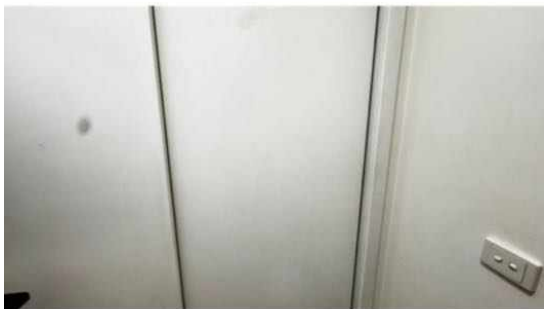
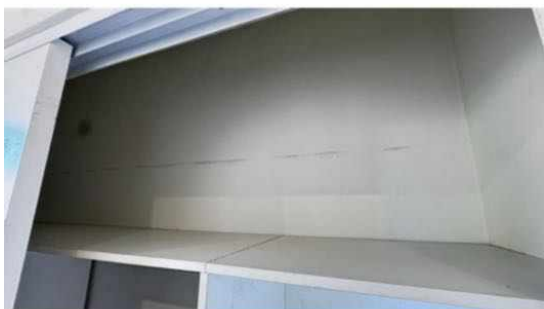
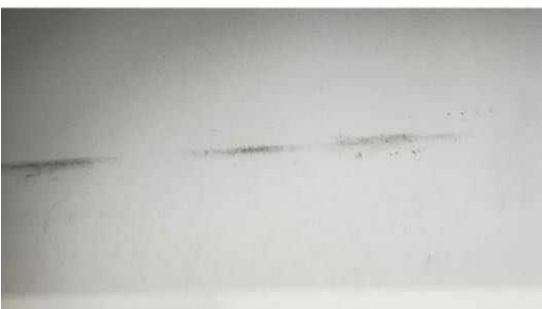
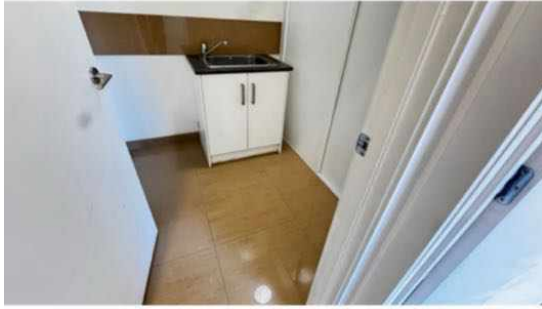
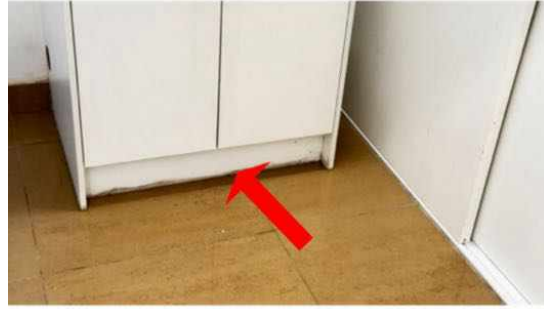
Defects 3.03

Building: Main Building
Location: All Areas >
Finding: Walls - Scuff Marks

Information: The walls were inspected for paint condition, and discolouration was observed. While primarily a cosmetic issue, deteriorated paint may indicate poor surface preparation, or age-related wear.

Possible causes include age-related wear and impact damage.

A qualified painter should be engaged when practical to prepare and repaint affected areas. Addressing paint deterioration improves aesthetics and protects wall materials from further wear.

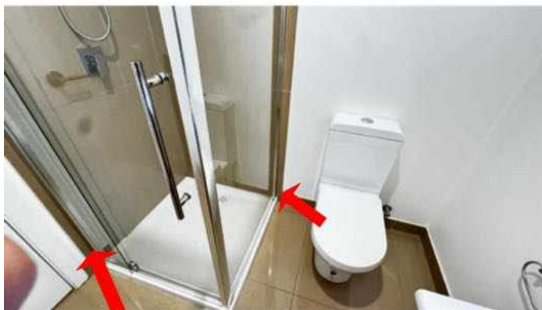
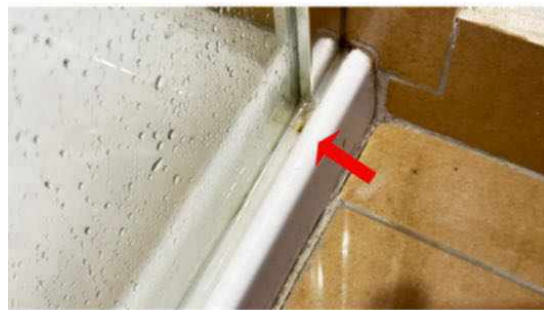
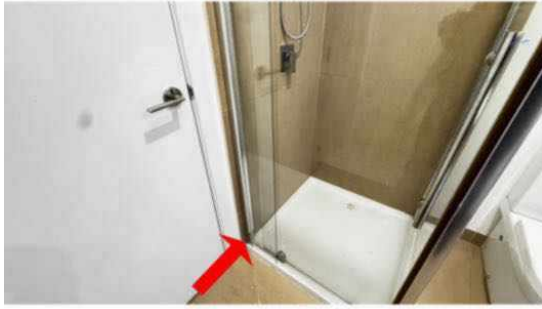
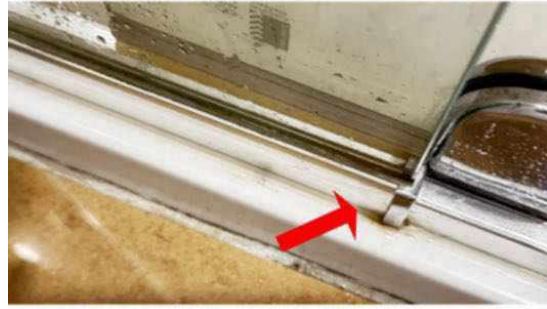
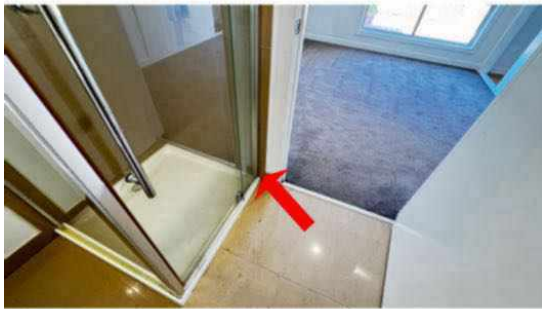
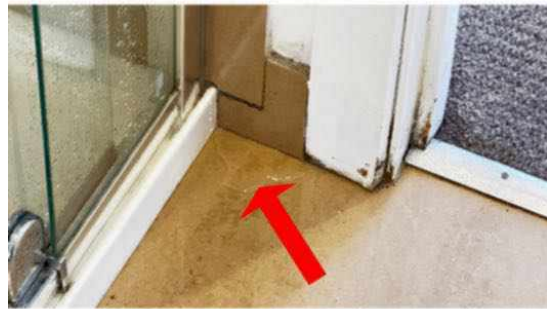
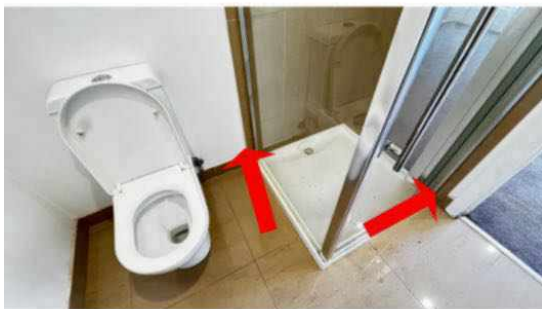
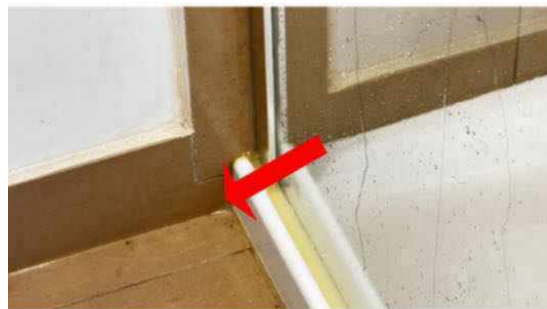
Defects 3.04

Building:	Main Building
Location:	Bathroom 1 & Bathroom 2 >
Finding:	Shower Screen - Leaking - Inadequate Sealant
Information:	The shower screen in this area was inspected, and water leakage was observed, which appears to be caused by inadequate or deteriorated sealant at joints and connections.

Defective sealant can allow water to escape the shower enclosure, leading to damage of surrounding floor finishes, wall linings, and potentially underlying structures. Prolonged leakage may also promote mould growth and compromise hygiene.

This condition may result from poor original installation, age-related deterioration of the sealant, or lack of maintenance.

A licensed plumber, qualified tiler, or bathroom specialist should be engaged immediately to remove any deteriorated sealant and reapply a compliant, waterproof seal. Prompt rectification will prevent water damage, maintain hygiene, and ensure the shower functions as intended.

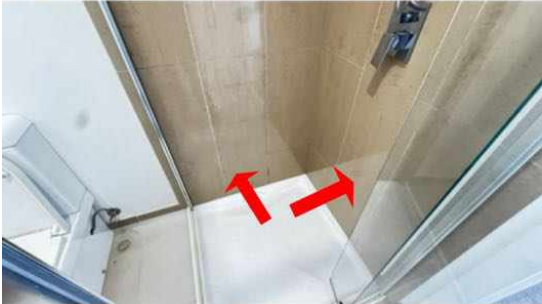
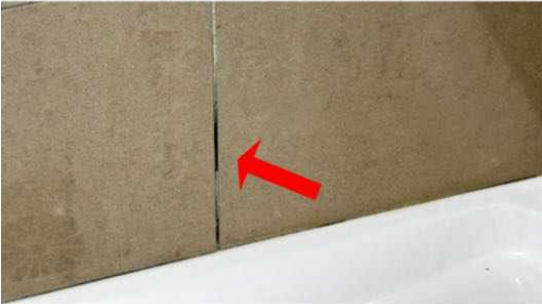
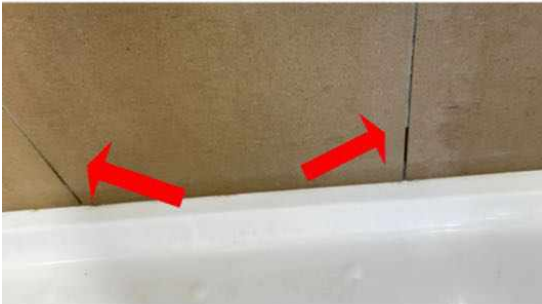
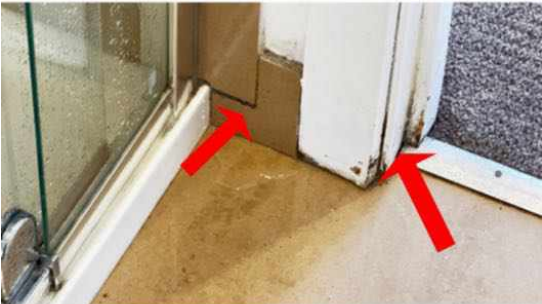
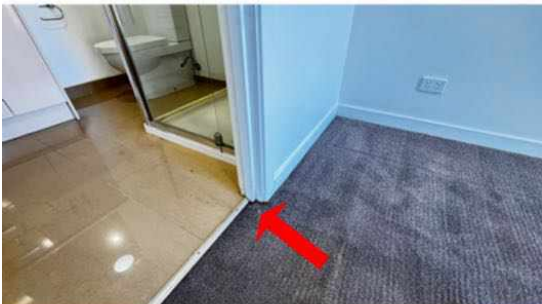
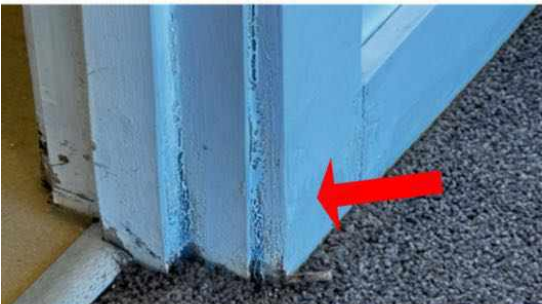
Defects 3.05

Building:	Main Building
Location:	Bathroom 2
Finding:	Shower Damp - To Be Monitored & Epoxy Grout
Information:	Damp is evident to the lower wall to the shower alcove and acceptable level moisture reading were found to the reverse side of the shower. Moisture readings were not found to the wall adjacent to the shower.

Damp (or structural damp) refers to the presence of unwanted moisture in the structure of a building, either as the result of intrusion from outside, or condensation from within the structure. In the shower area, internal water leaks or other sources of excessive moisture are generally the cause of damp.

It is advised to engage an epoxy grout specialist to remove and replace the grout with epoxy grout and install epoxy to all floor wall corner joints.

Always ensure that sealant and grout is in good condition to prevent any moisture issues occurring in the future

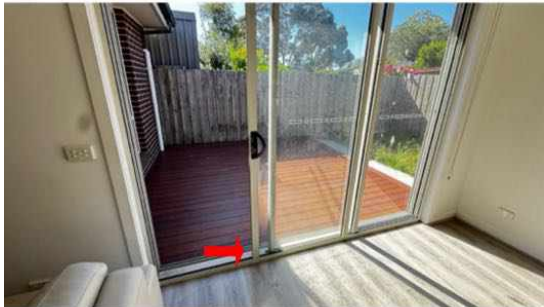
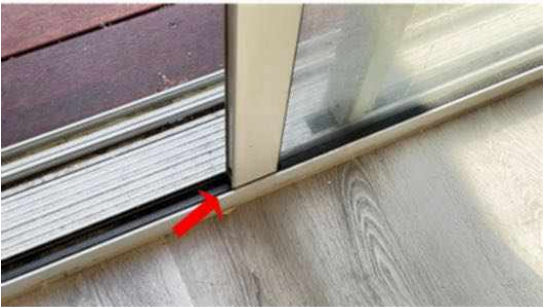
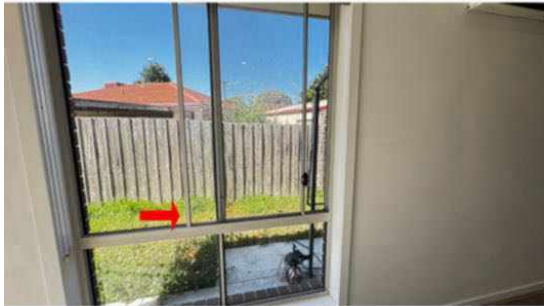
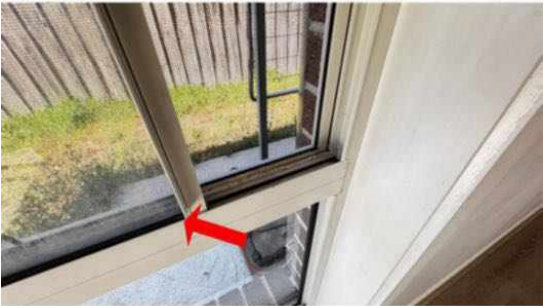
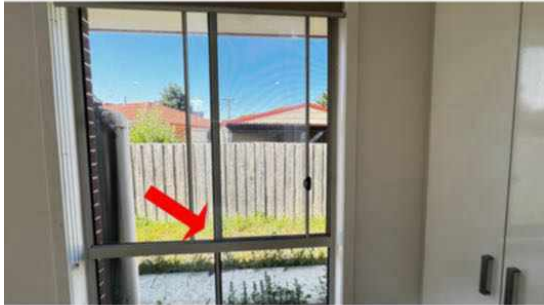
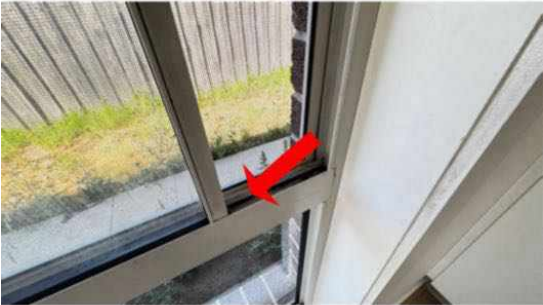
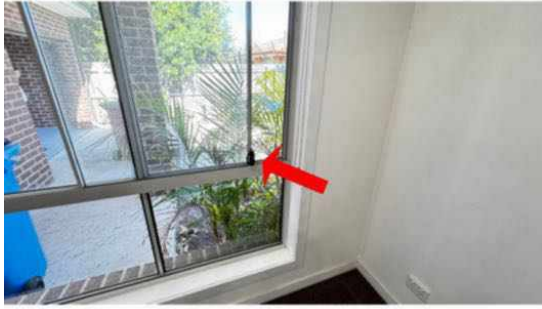
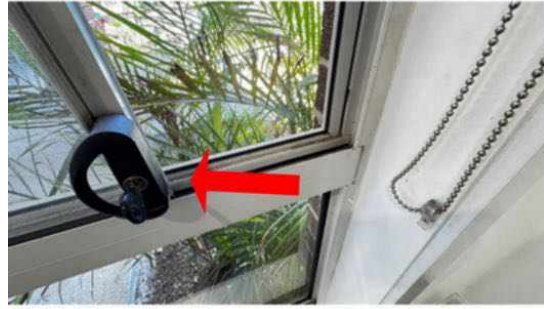
Defects 3.06

Building: Main Building
Location: Lounge room, bedroom 1, bedroom 2 >
Finding: Windows - Stiff To Open

Windows were observed to be stiff to open in this area. The stiffness can make the window difficult to operate, reduce usability, and may increase the risk of damage if force is applied.

Possible causes include misalignment, worn hardware, or buildup of debris.

It is recommended that the building owners engage a window specialist or registered builder immediately to assess the window and adjust, repair, or service it to restore smooth operation.

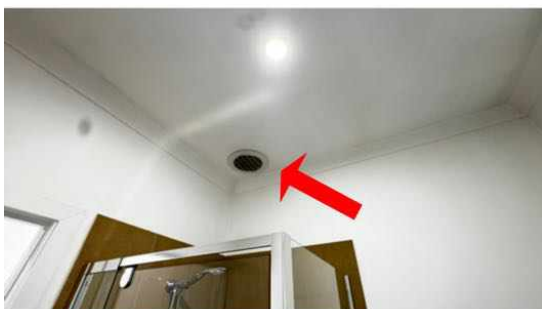
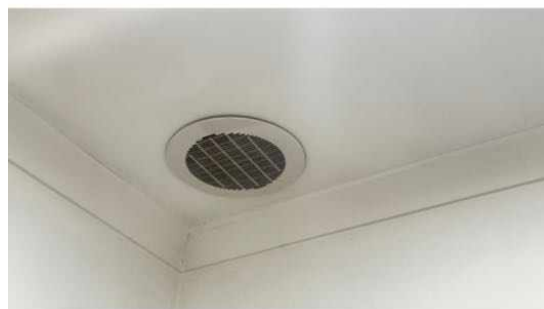
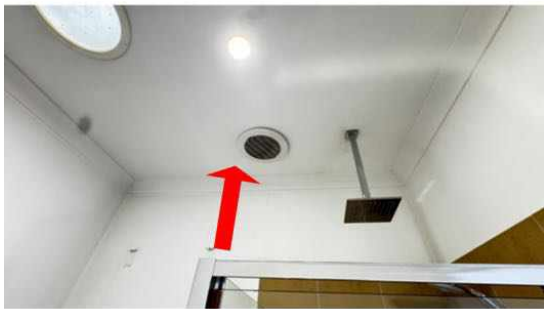
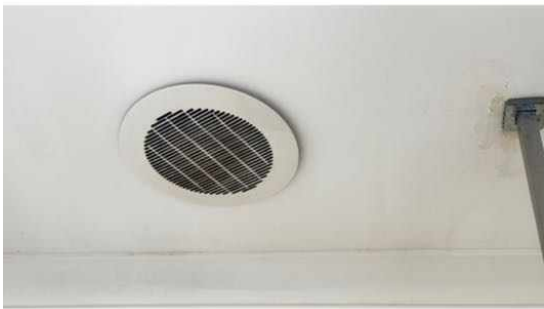
Defects 3.07

Building:	Main Building
Location:	Bathroom 1 & bathroom 2
Finding:	Bathroom Ventilation - Not Operational
Information:	Ventilation systems in the bathroom were observed to be not operational during the inspection. Inadequate ventilation can reduce air circulation, increase humidity, promote condensation and mould growth, and affect indoor air quality and occupant comfort.

This may be due to blocked, damaged, or malfunctioning vents, fans, or ducting, poor installation, age-related deterioration, or lack of routine maintenance.

When practical, a licensed electrician should be engaged to inspect and repair or replace the ventilation systems. This may include cleaning blocked ducts, repairing or replacing faulty fans, or installing new ventilation units. Prompt action will help improve air quality and reduce condensation and mould risk.

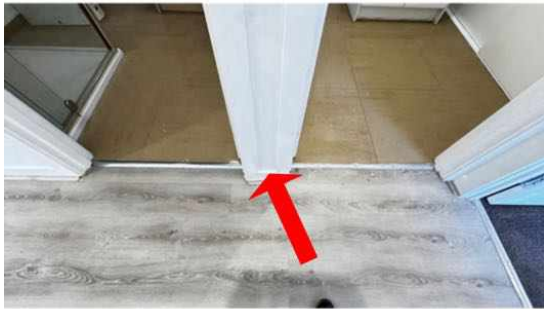
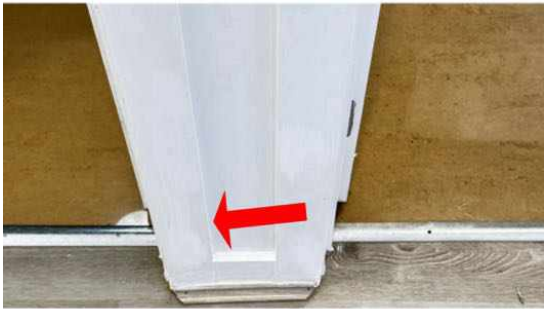
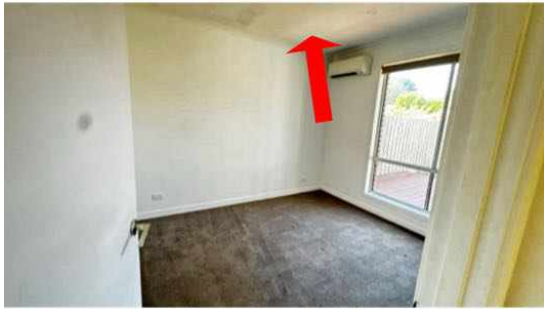
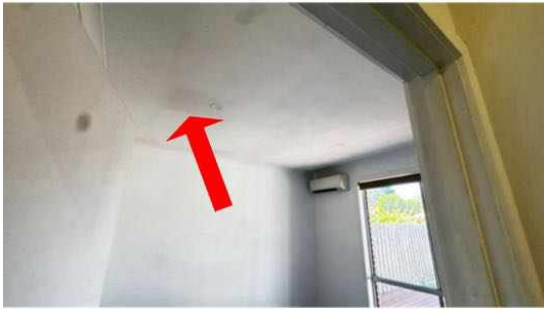
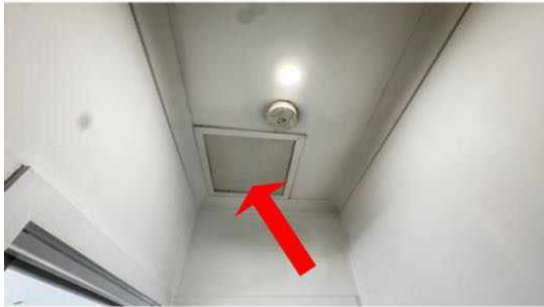
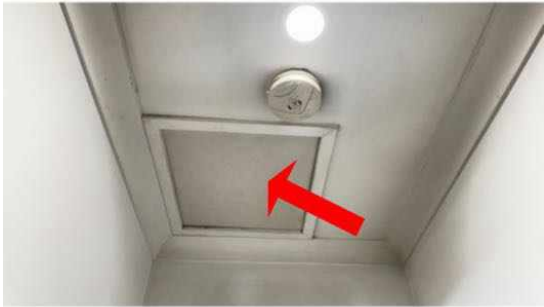
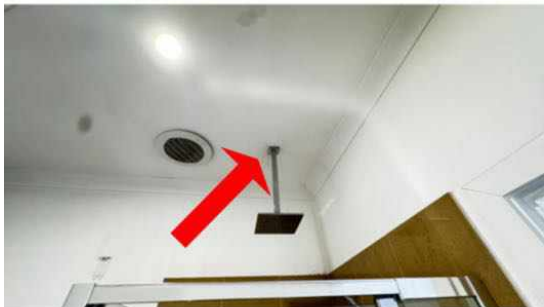
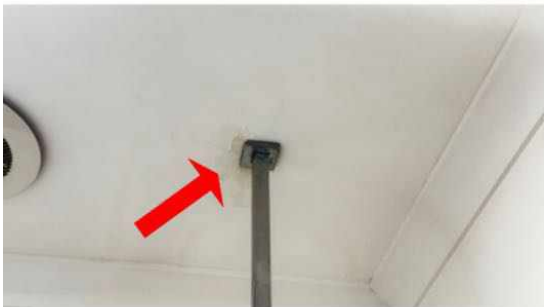
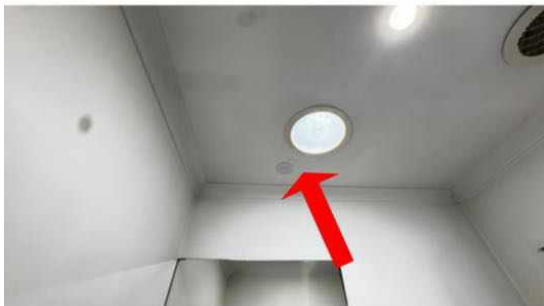
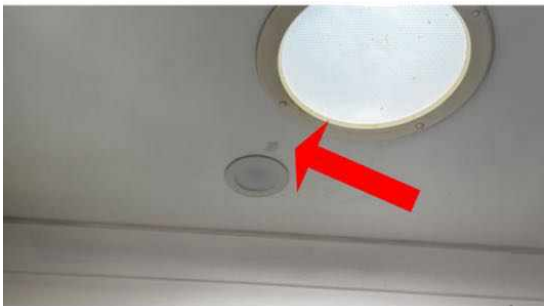
Defects 3.08

Building: Main Building
Location: All Areas
Finding: Paint Finishes Discolouration
Information: The ceilings & walls were inspected for paint condition, and discolouration was observed in this area.

While primarily a cosmetic issue, the affected paint may indicate age-related wear, poor surface preparation, or previous repairs.

When practical, a qualified painter should be engaged to prepare and repaint the affected areas. Addressing paint deterioration will improve the appearance of the ceilings and help protect the surfaces from further wear.

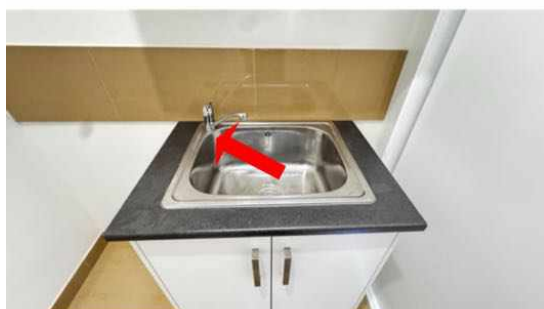
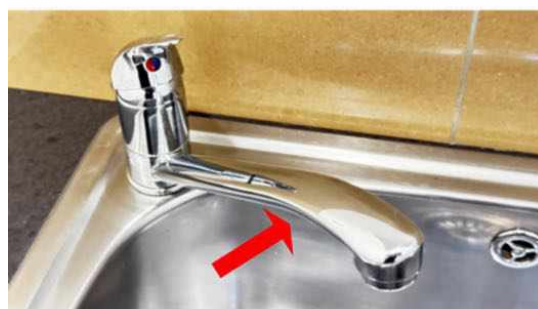
Defects 3.09

Building: Main Building
 Location: Laundry >
 Finding: Laundry Taps - Not Operational
 Information: Laundry taps were observed to be not operational during the inspection. Non-functional taps can affect hygiene, cause water damage to surrounding surfaces, and may increase the risk of mould, damage to cabinetry, and structural deterioration.

This may be due to age-related wear, loose or improper installation, corrosion or failure of internal components, impact or mechanical stress, or other plumbing issues such as faulty connections.

A licensed plumber should be engaged immediately to inspect, repair or replace the non-operational taps. This may include tightening or replacing fittings, repairing leaks, and ensuring secure installation. Prompt action will help prevent further water damage, maintain hygiene, and ensure safe operation.

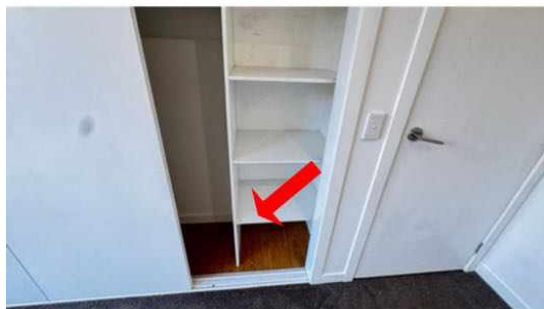
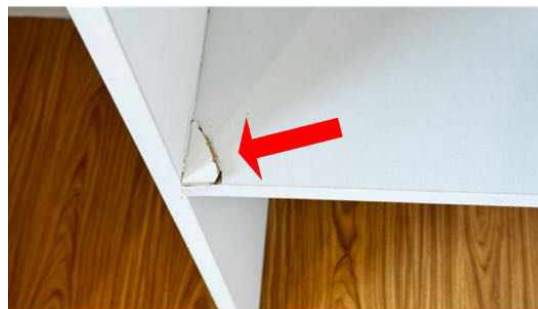
Defects 3.10

Building: Main Building
 Location: Bedroom 2
 Finding: Cabinets - Damaged
 Information: Visible damage was noted to cabinet units, affecting both their appearance and functionality. If left unaddressed, the damage may worsen over time.

This damage may result from impact during installation or use, moisture exposure, poor-quality materials or finishes, or inadequate installation and protection during construction. *No elevated moisture levels were detected at the time of inspection.

When practical, a qualified cabinetmaker should be engaged to repair or replace the damaged components to restore proper function and appearance.

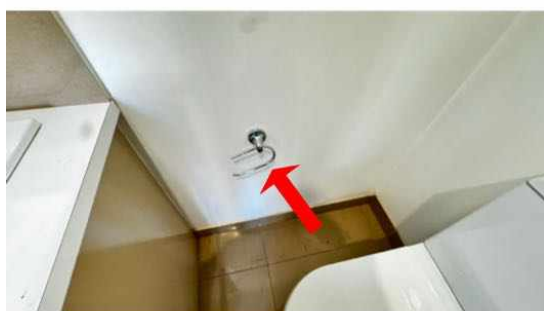
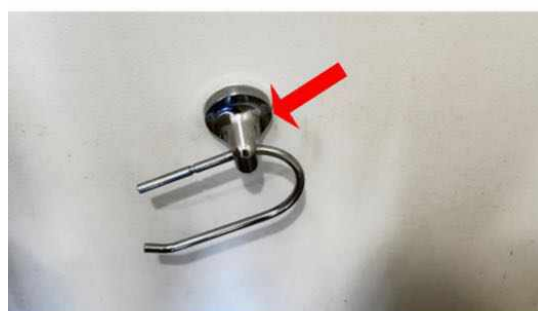
Defects 3.11

Building:	Main Building
Location:	Toilet (WC) >
Finding:	Toilet Roll Holder - Loose
Information:	Toilet roll holders were observed to be loose or inadequately secured to walls, moving when light pressure was applied in this area. This reduces usability and may cause further damage if not addressed.

Common causes include incorrect or inadequate fixings, use of anchors unsuitable for the wall type, movement of the wall or timber substrate, wear from repeated use, or improper installation.

If left unresolved, the fitting may detach, damage wall finishes, or cause progressive deterioration of both fittings and surrounding surfaces.

A qualified carpenter or experienced handyman should be engaged immediately to securely refix or replace the fitting using appropriate fixings and methods for the wall type. The fittings should be monitored over time to ensure they remain secure.

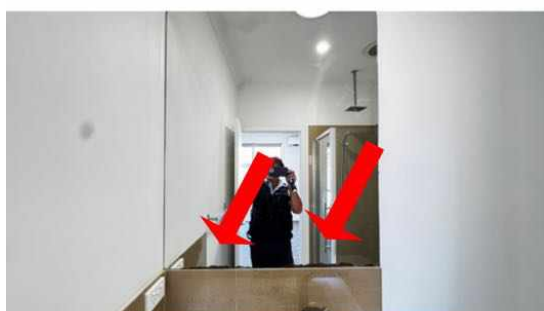
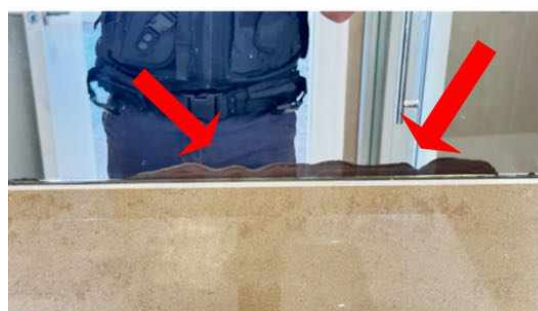
Defects 3.12

Building:	Main Building
Location:	Bathroom 2

Finding: Bathroom Mirrors - Edge Deterioration
Information: Mirrors were observed to have edge deterioration in this area. Damaged mirrors can be a safety hazard due to sharp edges, reduce visual appeal, and affect functional use.

This may be due to age-related wear, poor installation, or exposure to moisture causing edge damage.

A qualified glazier or bathroom specialist should be engaged without delay to inspect and repair or replace the damaged mirrors. This may include replacing affected mirrors, securing the mounting, and ensuring edges are properly sealed. Prompt action will help prevent injury, restore functionality, and maintain appearance.

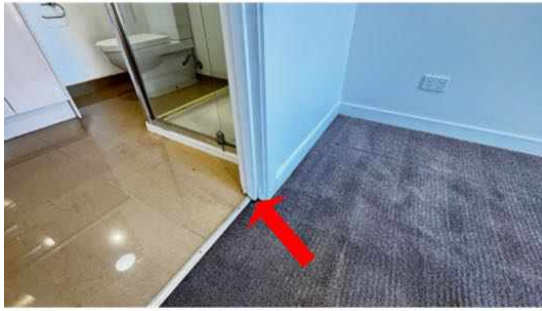
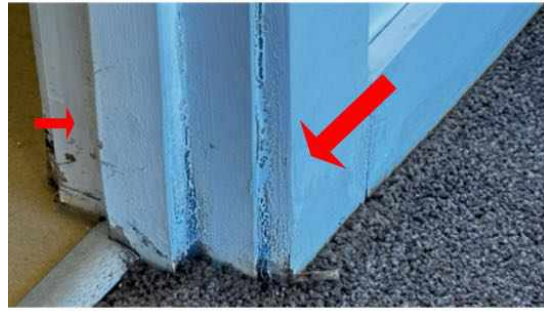
Defects 3.13

Building: Main Building
Location: Bathroom 2 >
Finding: Architraves & Skirting Boards - Swelling
Information: During the inspection, swelling was observed to the skirting boards in these affected areas. Swelling of timber or composite finishes is commonly associated with moisture exposure and may lead to distortion, deterioration, or loss of adhesion if left unaddressed.

The condition may have been caused by moisture ingress from historic plumbing leaks, condensation, or previous water overflow from the Laundry area.

It is recommended that a licensed builder be engaged when practical to investigate the source of moisture, assess the extent of damage, and carry out repairs or replacement as required to prevent further deterioration.

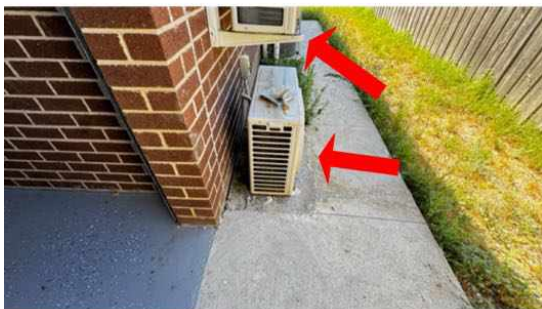
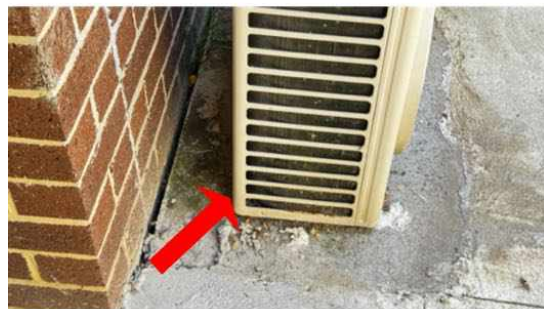
Defects 3.14

Building:	Main Building
Location:	All External Areas >
Finding:	AC Condensate Drain - Not Connected To Storm Water
Information:	The air conditioning condensate drain in this area was observed to be disconnected from stormwater drainage.

When condensate is not properly directed to a stormwater outlet, water can accumulate around the building or air conditioning unit, creating damp conditions that may lead to secondary defects such as timber rot, corrosion of nearby metal components, mould growth, or slippery surfaces. Prolonged pooling of water may also attract termites and contribute to long-term deterioration of surrounding building elements.

A qualified HVAC technician or licensed plumber should be engaged immediately to connect the condensate drain to a suitable stormwater outlet. Prompt rectification will ensure proper drainage, protect the building fabric, and reduce potential health and safety risks.

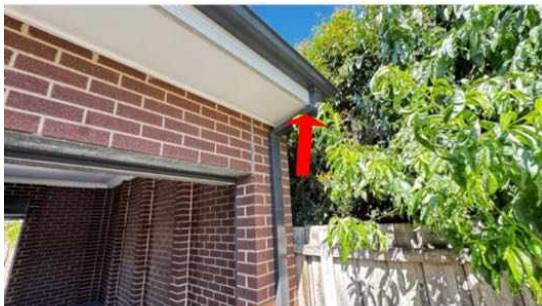
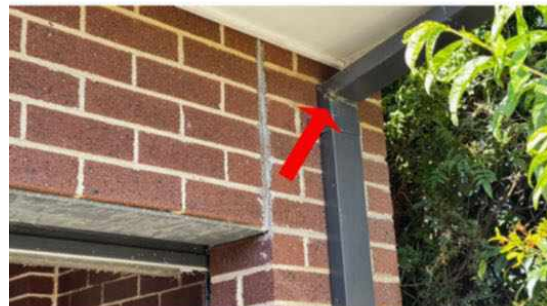
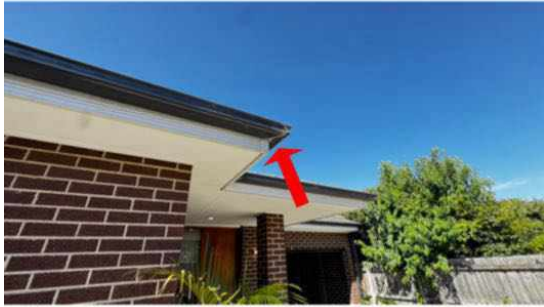
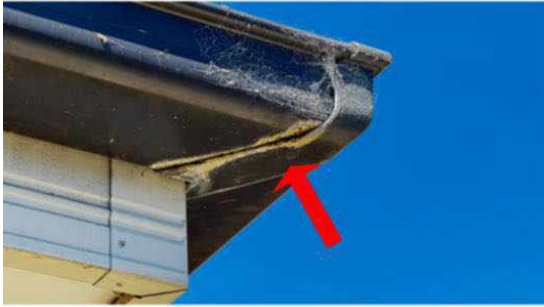
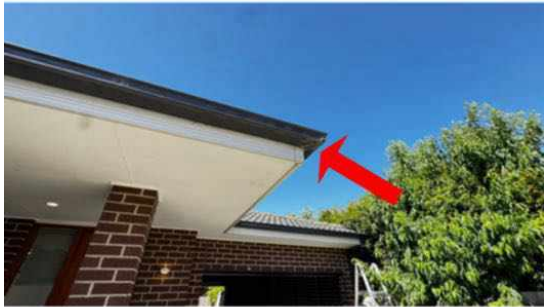
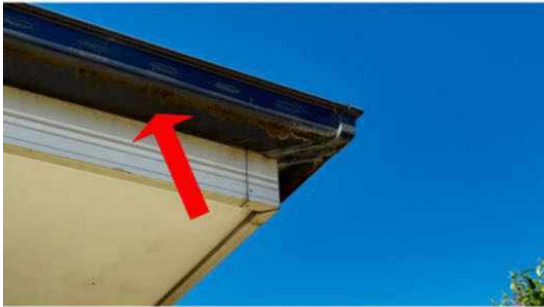
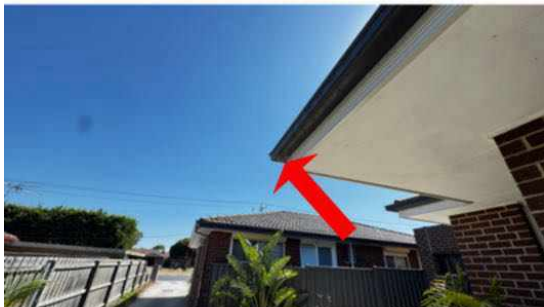
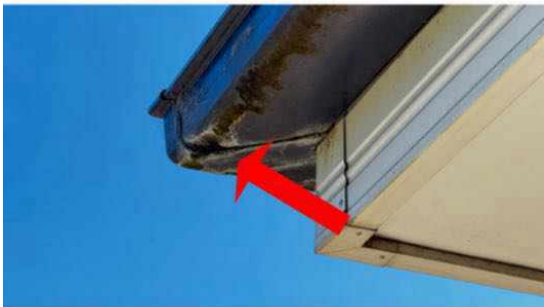
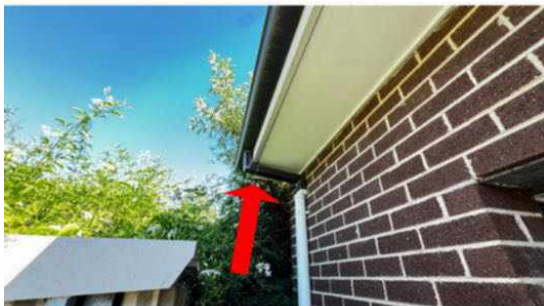
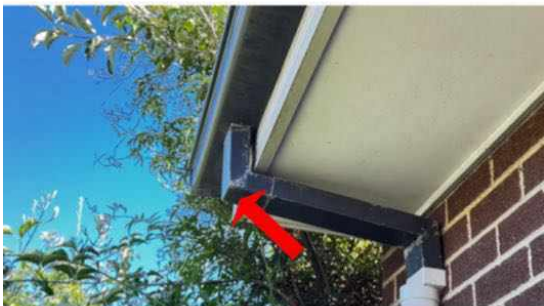
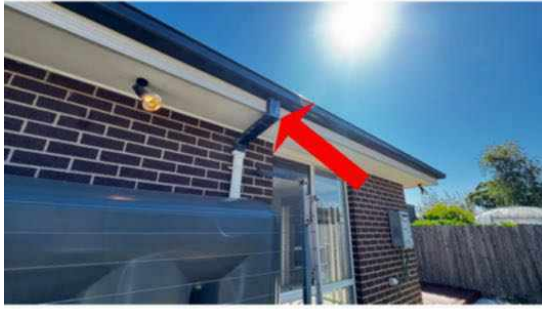
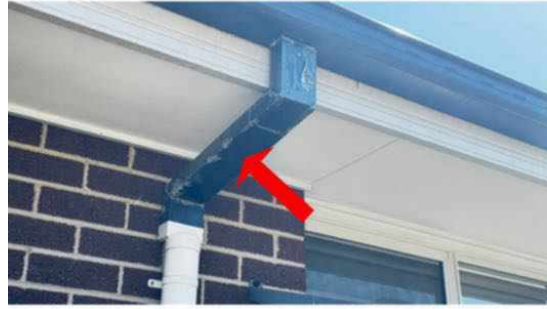
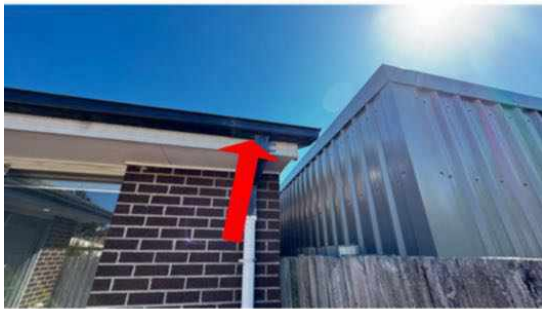
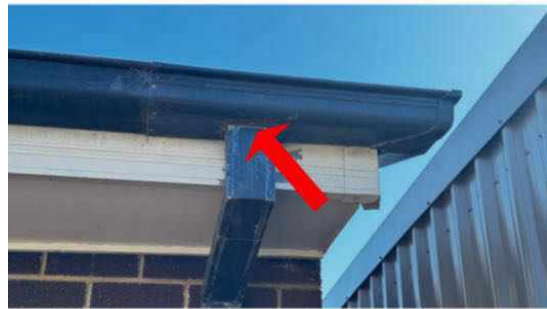
Defects 3.15

Building:	Main Building
Location:	All External Areas >
Finding:	Roof Plumbing - Rusted & Corroded
Information:	The roof plumbing has areas of rust and corrosion. It is suspected that this has been caused by blockages, resulting in pooling or standing water, that have prematurely rusted elements of the roof plumbing.

Rusted roof plumbing will generally develop holes and leaks that can affect other building elements with poor drainage of storm water. Poorly drained roof areas will also lead to damp conditions surrounding the base perimeter of the building which, if left unmanaged, can lead to a range of secondary building defects.

Repair and/or replacement of rusted roof plumbing is required in order to reinstate the roof drainage system to a fully operational level. To further maintain these areas, gutters should be cleaned frequently, allowing the avoidance of any partial blockages.

A licensed plumber or specialist roof restoration company should be appointed to undertake these works. It is advised that such works be completed as soon as possible to prevent any further damage and deterioration.

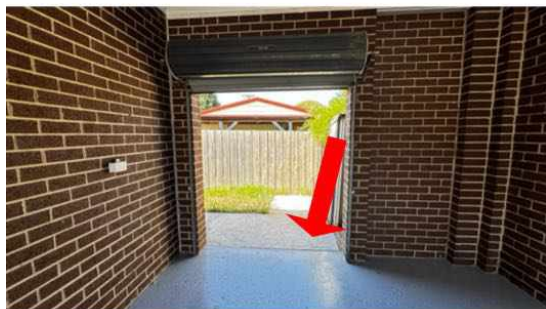
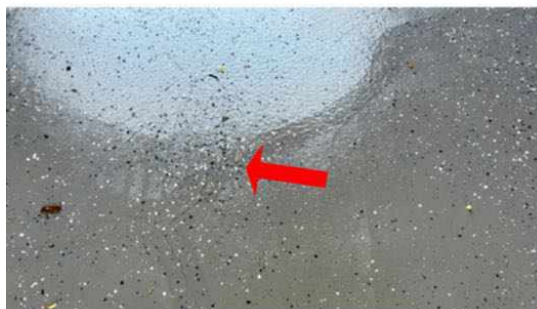
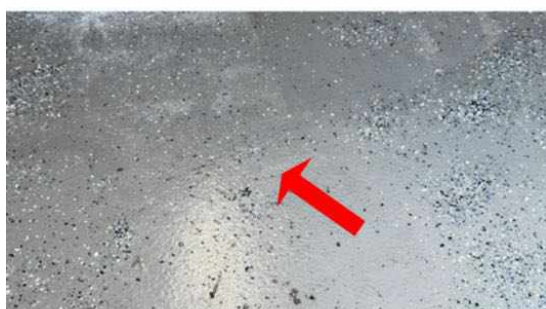
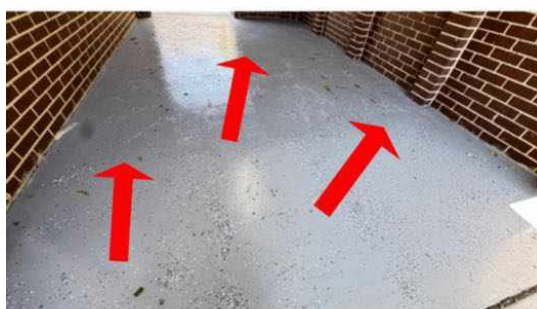
Defects 3.16

Building:	Main Building
Location:	Garage
Finding:	Concrete - Minor Cracking & Surface Imperfections
Information:	Concrete surfaces were visually inspected in this area. Cracking, surface settlement, and minor unevenness were observed. While these defects do not currently compromise structural safety, they may affect long-term durability, appearance, and vehicle access.

These issues may be caused by age-related wear, soil movement or settlement beneath the surface, possible tree root intrusion, or inadequate original construction or reinforcement.

A qualified concreter should be engaged when practical to repair or resurface affected areas. Prompt rectification will restore a smooth surface, improve appearance, and prevent further deterioration.

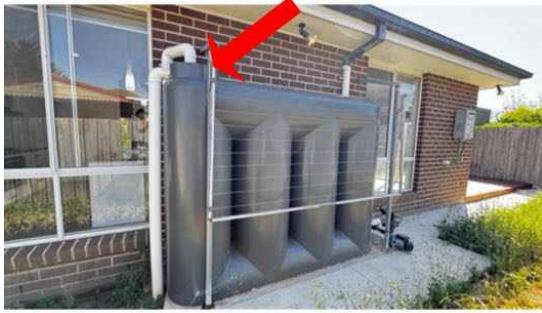
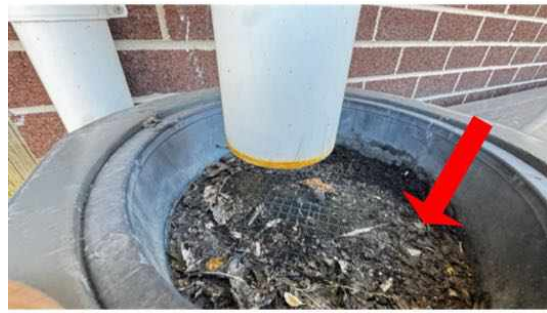
Defects 3.17

Building:	Main Building
Location:	All External Areas > Rear
Finding:	Rainwater Tank - Leaf Strainer Blocked
Information:	The leaf strainer on the rainwater tank is blocked with leaves and debris, restricting the flow of water into the tank. This is located at the inlet on top of the rainwater tank.

This has likely occurred due to a build-up of leaves and debris from the roof and gutters. A blocked leaf strainer may cause water to overflow, back up into gutters, or discharge uncontrolled around the tank and building.

A licensed plumber or competent hand man is required to clean and clear the leaf strainer. This should be attended to immediately to allow proper water flow and prevent overflow or damage.

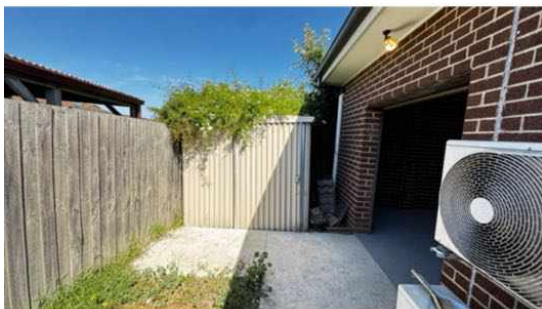
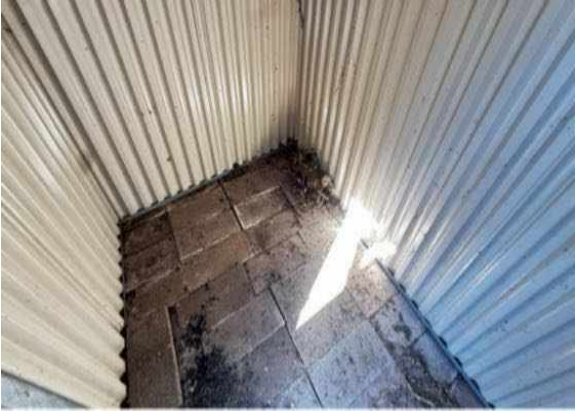
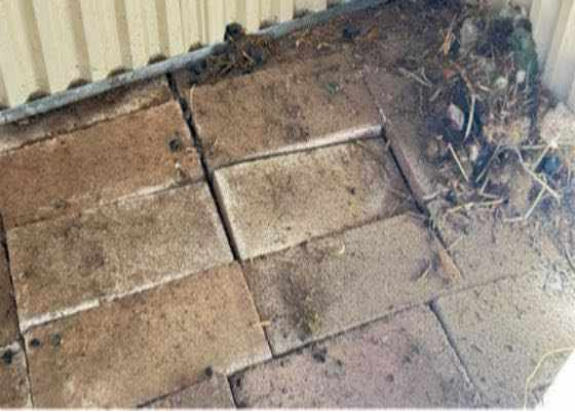
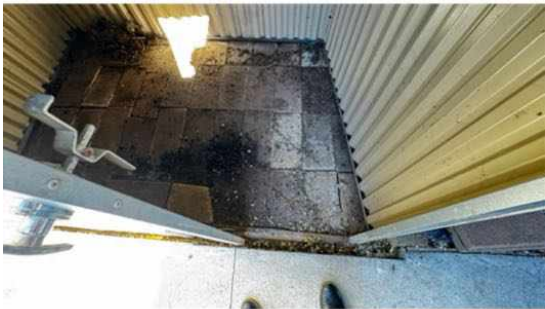
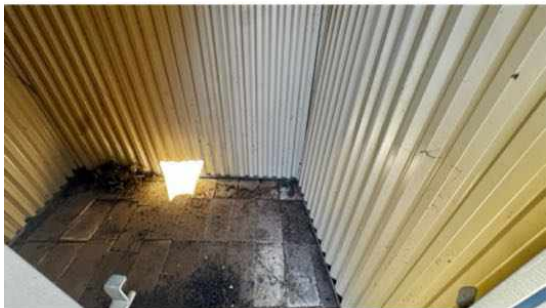
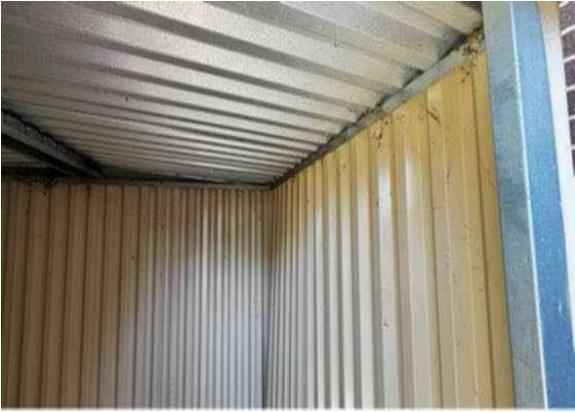
Defects 3.18

Building: Main Building
 Location: All External Areas > Rear
 Finding: Garden Shed - General Condition
 Information: The garden shed was inspected visually. The shed structure shows signs of age-related deterioration, including corrosion of roofing and walls and weathered components.

The shed does not appear to compromise the primary dwelling structure but may reduce usability, weatherproofing, and amenity. This deterioration is likely due to age, exposure to weather, and a lack of regular maintenance.

When practical, a competent hand man should be engaged to repair or replace damaged, missing, or weathered components. Rectification will restore functionality, durability, and weatherproofing of the shed.

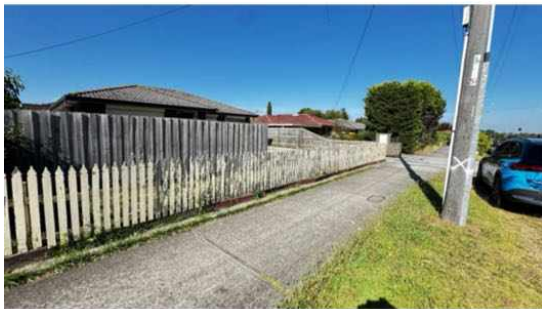
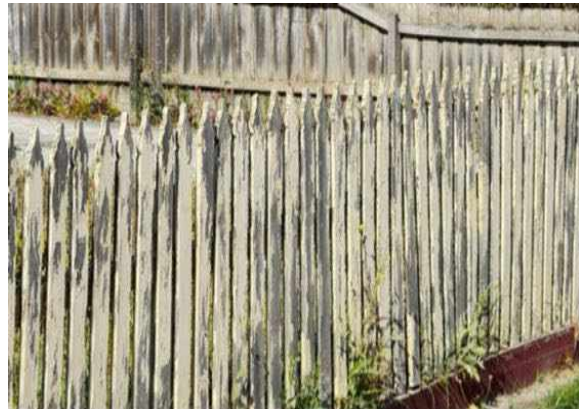
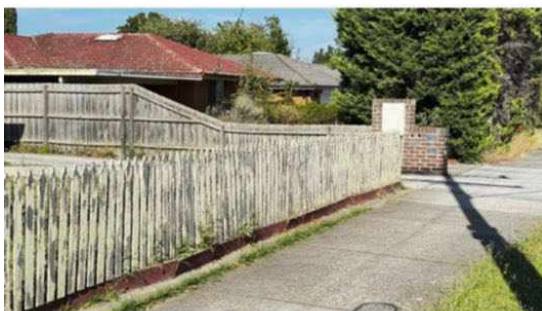
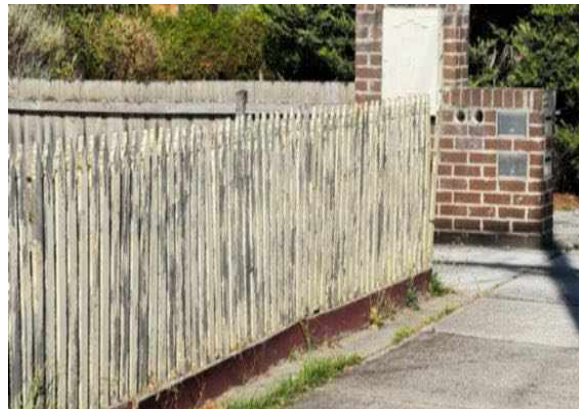
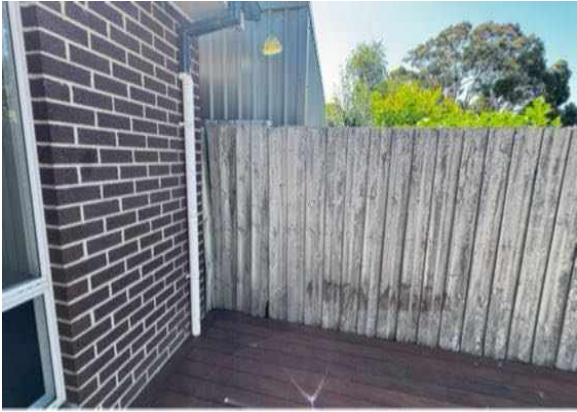
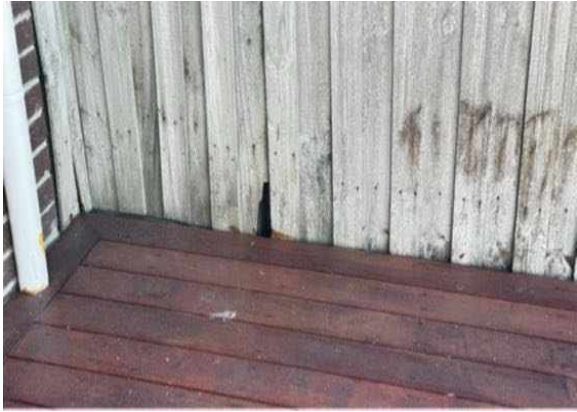
Defects 3.19

Building: Main Building
Location: Fencing All Areas
Finding: Fencing - Deteriated
Information: Timber fencing was inspected and deterioration was observed in this area. Deteriorated fencing can compromise structural stability, reduce privacy, and may allow pest ingress or accelerated decay if left unaddressed.

Possible causes include age-related timber decay, prolonged exposure to moisture or sunlight, poor maintenance, or impact damage.

When practical, a qualified carpenter or fencing specialist should be engaged to repair or replace affected sections, and a qualified painter should be engaged to restore protective finishes. Prompt rectification will maintain structural performance, improve appearance, and extend the lifespan of the fencing.
