Building Inspection Report

Inspection Date: Tue, 27 Jan 2026

Property Address: unit 2/142 Pound Rd, Hampton Park VIC
3976, Australia

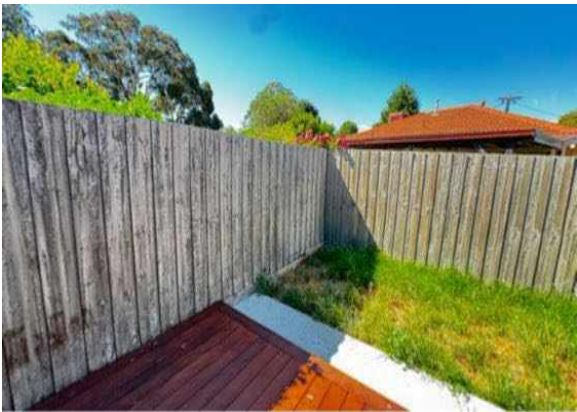
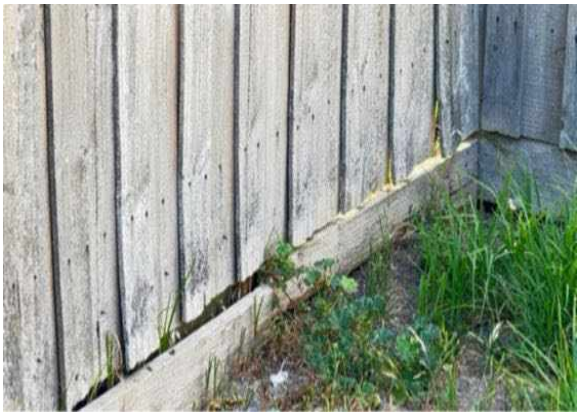
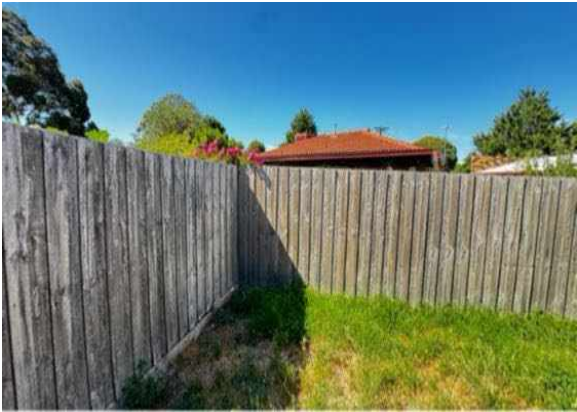
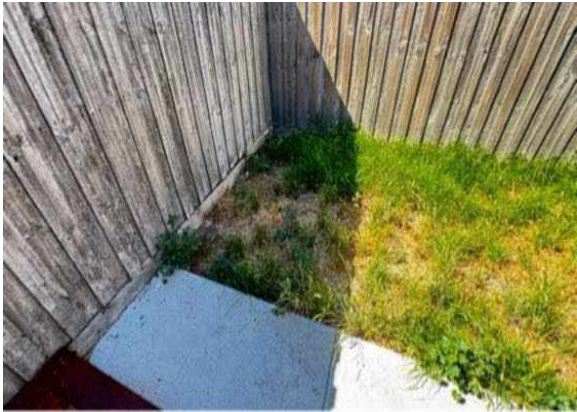
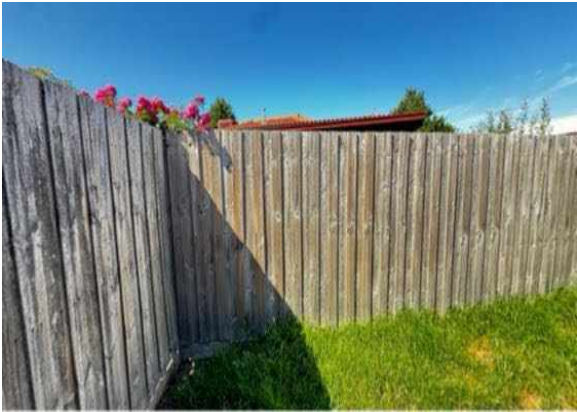
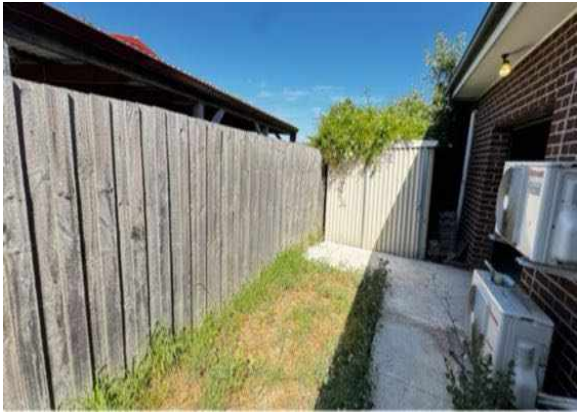
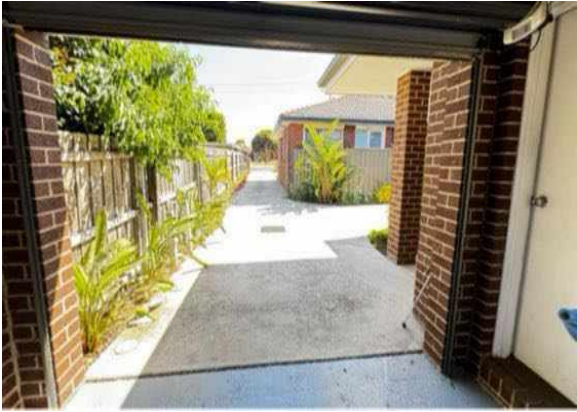
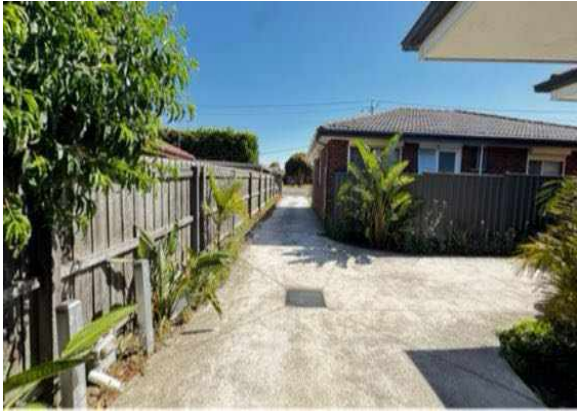
Defects 3.19

Possible causes include age-related timber decay, prolonged exposure to moisture or sunlight, poor maintenance, or impact damage.

When practical, a qualified carpenter or fencing specialist should be engaged to repair or replace affected sections, and a qualified painter should be engaged to restore protective finishes. Prompt rectification will maintain structural performance, improve appearance, and extend the lifespan of the fencing.

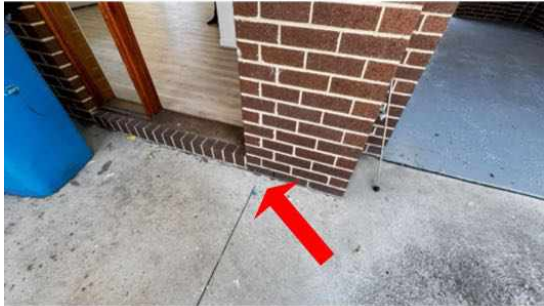
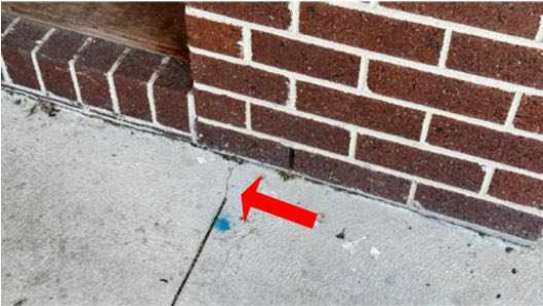
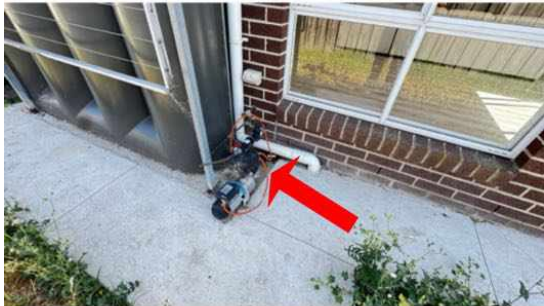
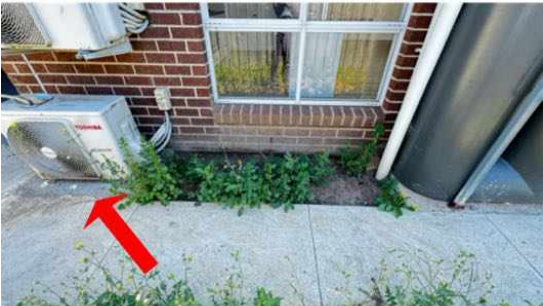
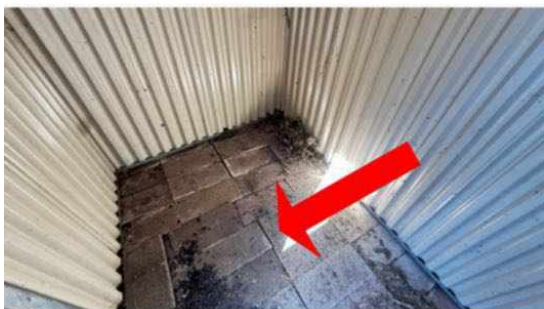
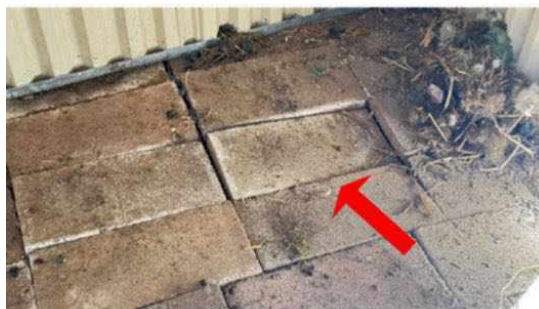
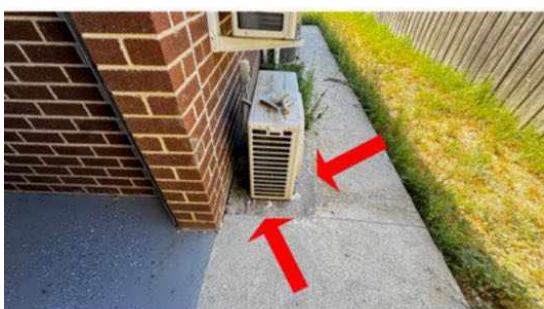
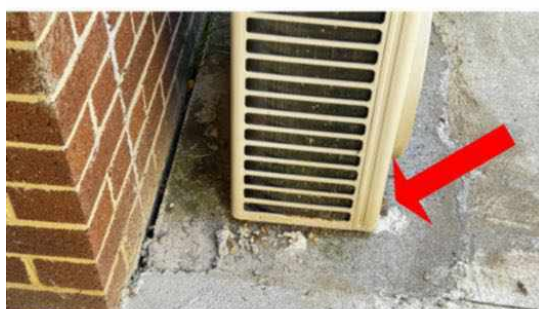
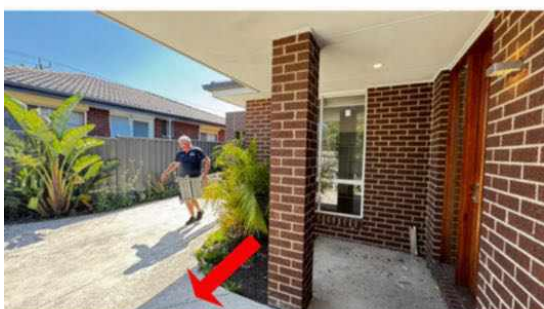
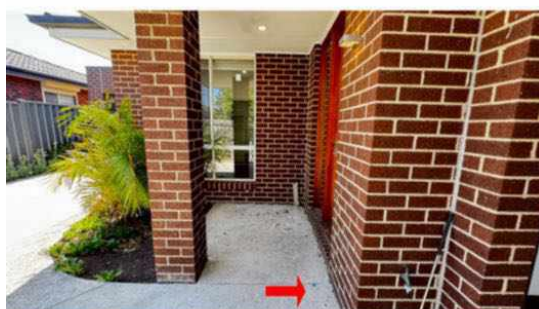
Defects 3.20

Building: Main Building
Location: All External Areas >
Finding: Paving - Minor Cracking
Information:

The external paved areas were visually inspected. Minor cracking, uneven surfaces, and general wear were observed in this area. These defects do not currently affect structural safety but may reduce durability, appearance, and safe pedestrian access.

This may be caused by age-related deterioration of concrete, pavers, or other materials, soil movement or settlement beneath paved surfaces, tree root intrusion or erosion, or inadequate original installation or sub-base compaction.

A qualified landscaper should be engaged as soon as possible to repair or resurface sections as required. Rectification will restore even surfaces, reduce trip hazards, and improve the serviceability and appearance of the paved areas.

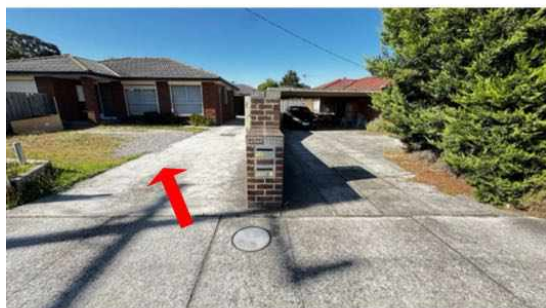
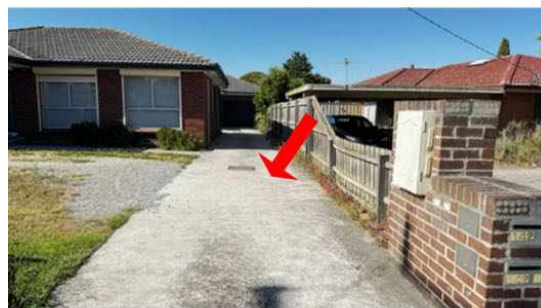
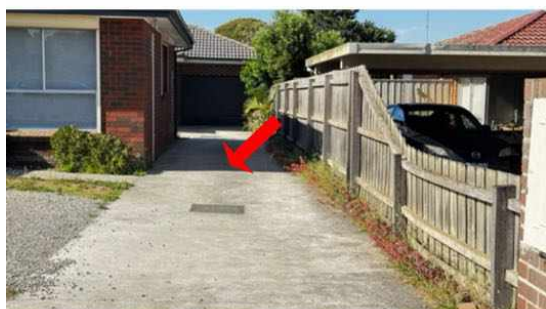
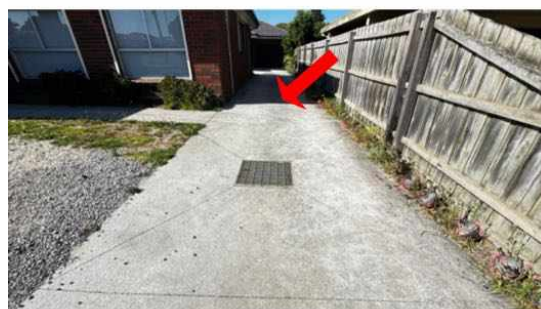
Defects 3.21

Building: Main Building
 Location: Driveway >
 Finding: Driveway - Minor Cracking & Surface Imperfections
 Information: The external driveway was visually inspected. Minor cracking, surface settlement, and minor unevenness was observed in this area. While these defects do not currently compromise structural safety, they may affect long-term durability, appearance, and vehicle access.

These issues may be caused by age-related wear, soil movement or settlement beneath the driveway, possible tree root intrusion, or inadequate original construction or reinforcement.

A qualified concreter should be engaged when practical to repair or resurface affected areas. Prompt rectification will restore a smooth surface, improve appearance, and prevent further deterioration.

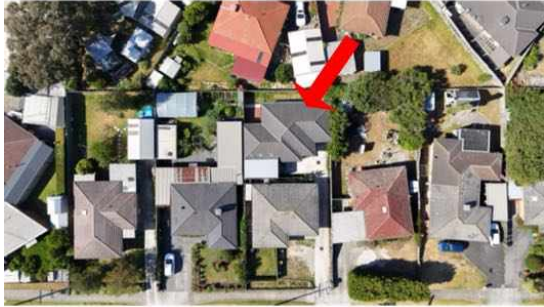
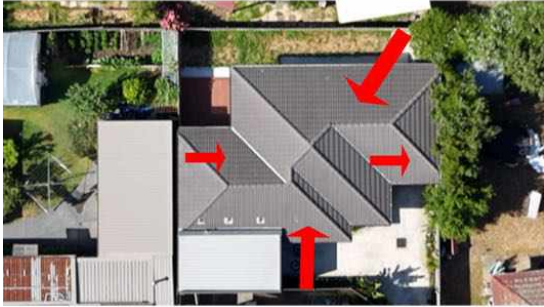
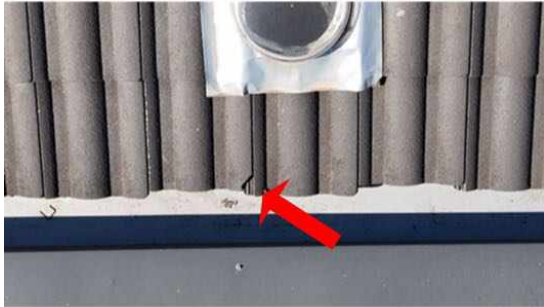
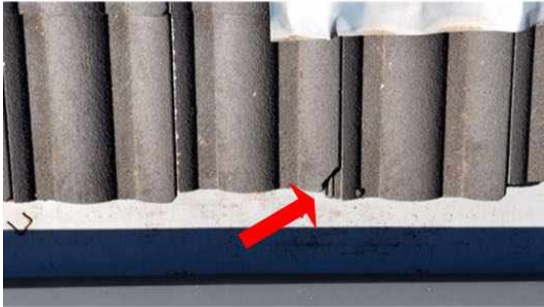
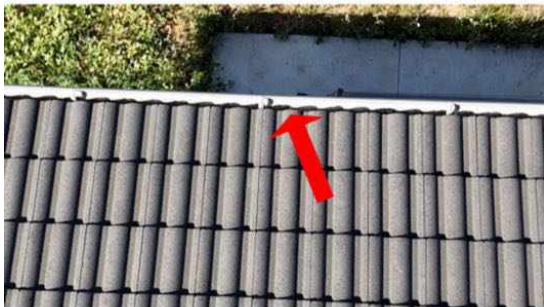
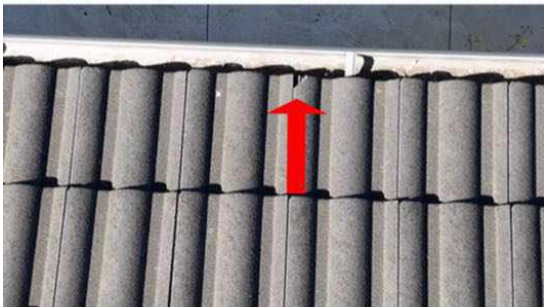
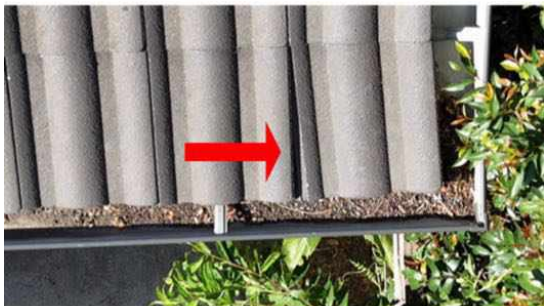
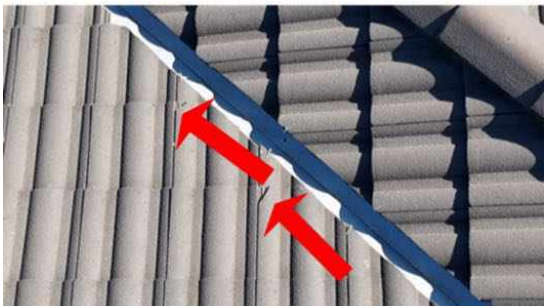
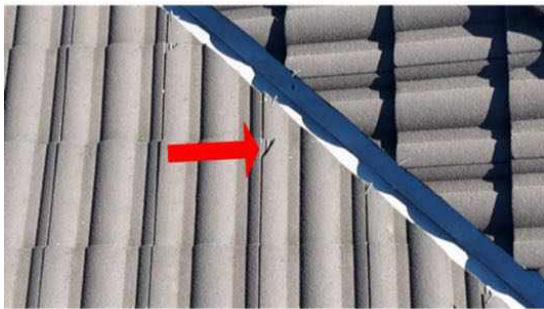
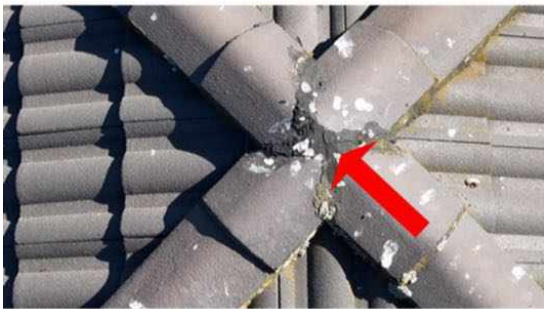
Defects 3.22

Building:	Main Building
Location:	Roof Exterior
Finding:	Roof Plumbing - Roof Tiles Cracked
Information:	Roof tiles in this area are cracked and may no longer provide full protection. The issue is observed across the roof surface where damaged tiles are present.

This has likely occurred due to impact, weathering, or poor installation. Cracked tiles may allow water to penetrate, causing leaks, water damage to internal structures, or deterioration of surrounding tiles.

A licensed roof plumber is required to inspect and repair or replace the cracked tiles in this area. This should be rectified immediately to prevent water ingress and further damage.

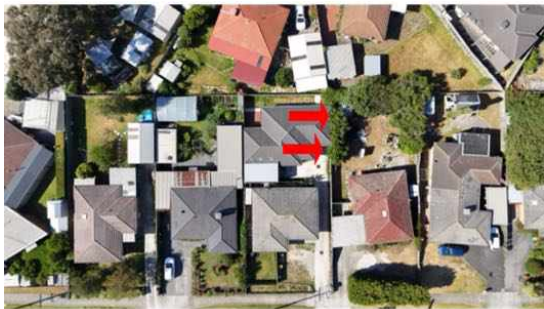
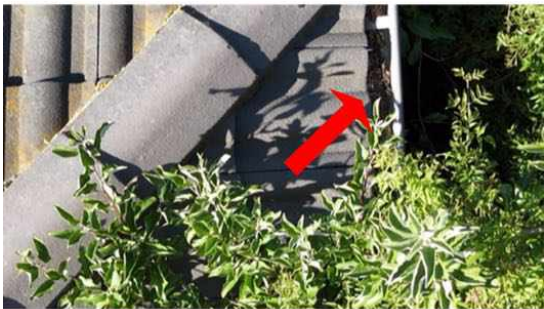
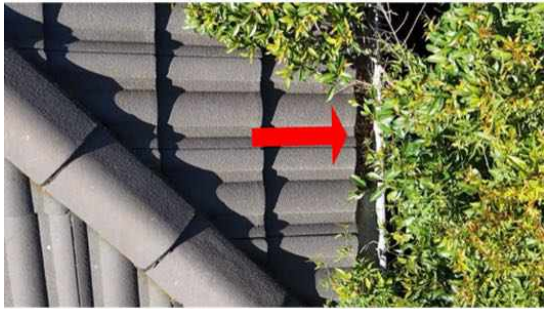
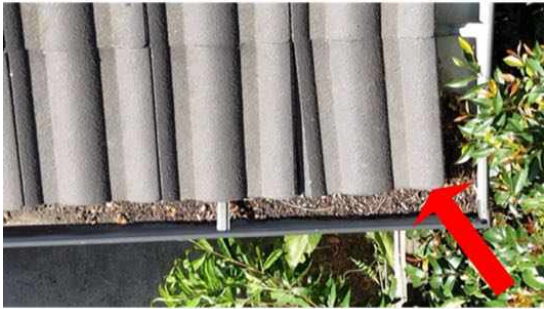
Defects 3.23

Building: Main Building
Location: Roof Exterior
Finding: Roof Plumbing - Gutters Blocked
Information: Gutters in this area are blocked and not allowing water to flow freely. The issue is observed along the gutter runs where leaves, debris, or other obstructions have accumulated.

This has likely occurred due to lack of maintenance or build-up of debris over time. Blocked gutters may cause water to overflow, damage the roof, walls, or foundations, and increase the risk of erosion or water ingress.

A licensed roof plumber or competent handy man is required to inspect and clear the blocked gutters in this area. This should be rectified immediately to ensure water drains correctly and to prevent potential damage to the building.

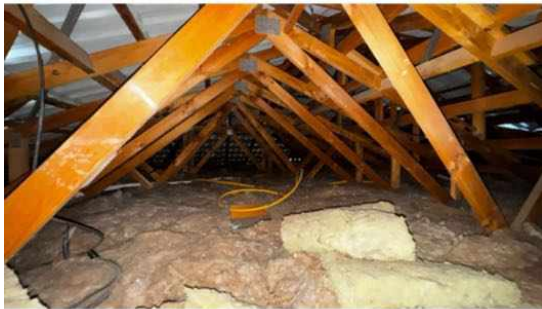
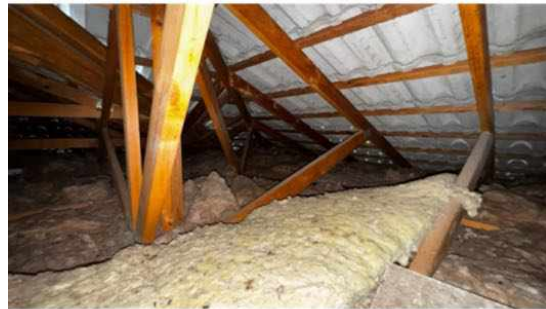
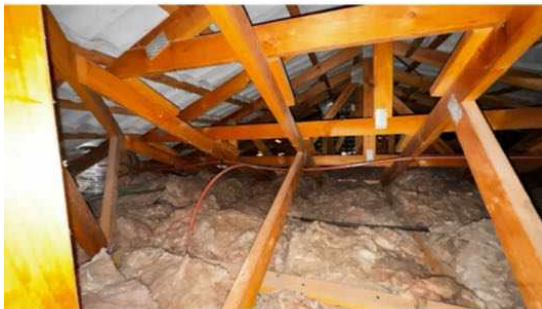
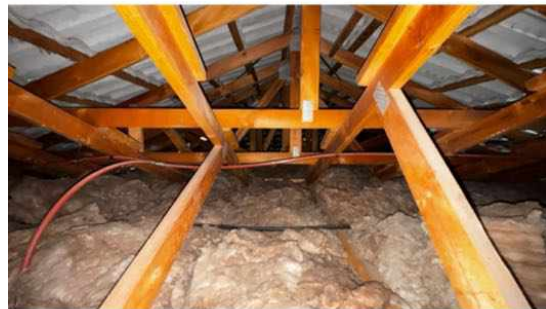
Noted Item

Building: Main Building
Location: Roof Void
Finding: Roof Void - Limited Access
Information: Limited access to the roof void was present due to facts including but not limited to, limited access, insulation, Air condition Unit & ducting, obstructions or placement of insulation and or sarking, for this reason complete access to the roof void was not possible.

A visual inspection was carried out from accessible areas only, recommend installing another access hatch in a more accessible area for a re-inspection.

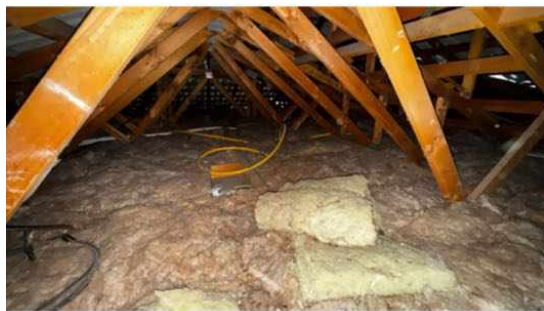
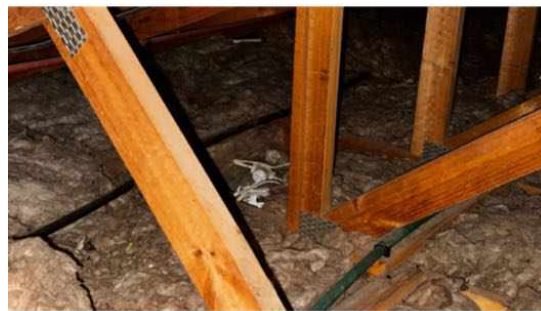
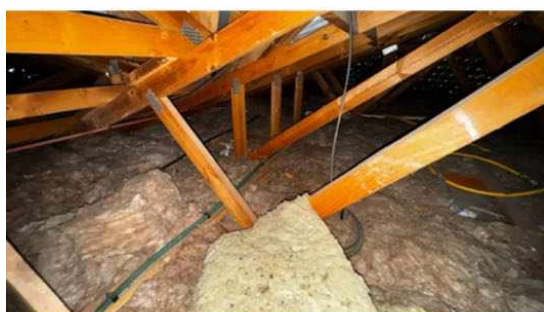
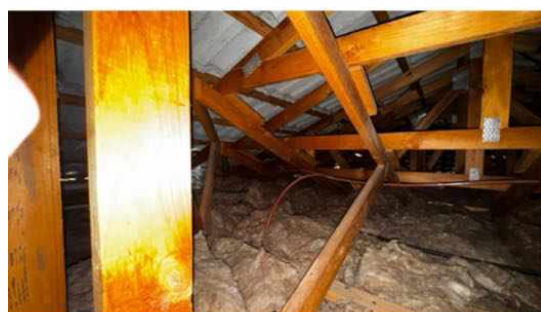
NOTE: Unless all insulation is removed from the roof space a full inspection is never possible, timber pest or termite activity and/or damage may not be visible.

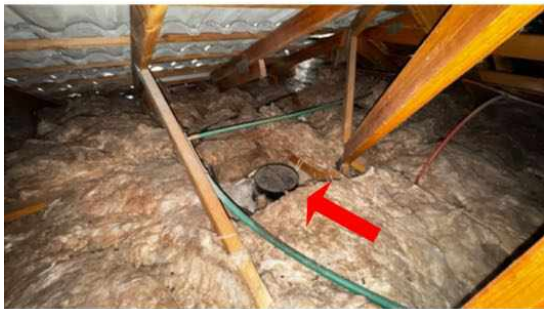
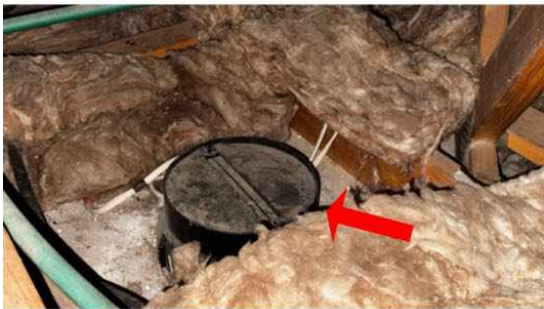
Building: Main Building
Location: Roof Void >
Finding: Roof Void - Exhaust Fans Not Ducted To Atmosphere
Information: The exhaust fans in the roof void are not ducted to the atmosphere. The issue is observed where fan outlets discharge directly into the roof space instead of venting outside.

This has likely occurred due to incomplete installation or missing ducting. Unducted fans may cause moisture buildup, condensation, and potential damage to insulation, ceiling linings, or timber, increasing the risk of mould growth and structural deterioration.

A licensed HVAC technician or licensed roof plumber is required to install proper ducting to vent the exhaust fans to the atmosphere. This should be rectified immediately to prevent moisture-related damage and maintain the performance of the ventilation system.

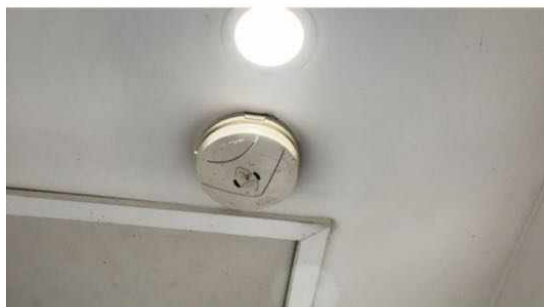
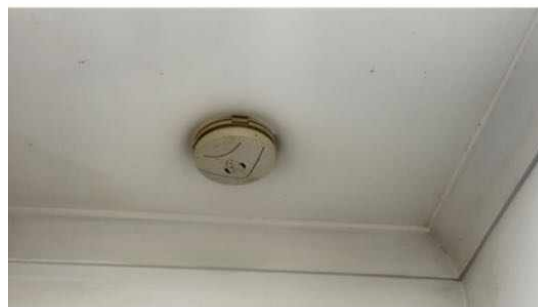
Building: Main Building
 Location: All Internal Areas
 Finding: Smoke Detectors - Advisory
 Information: During the inspection, smoke detectors were noted for advisory purposes only. The operation, age, type, and compliance of smoke detectors could not be fully verified as part of this inspection.

Smoke detectors are critical life-safety devices, and non-compliant, outdated, or non-operational units may not provide adequate warning in the event of a fire.

It is recommended that a licensed electrician be engaged immediately to test, service, and upgrade smoke detectors as required to ensure correct operation and compliance with current safety requirements.

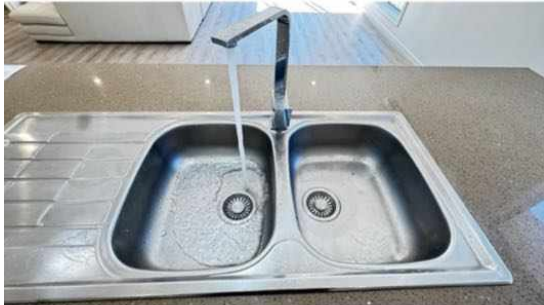
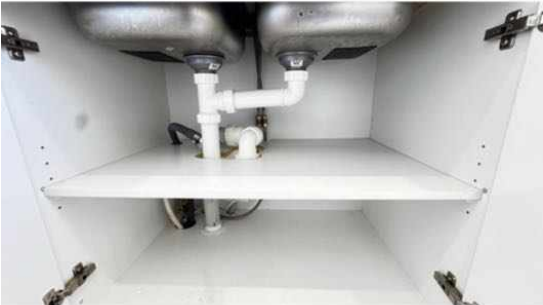
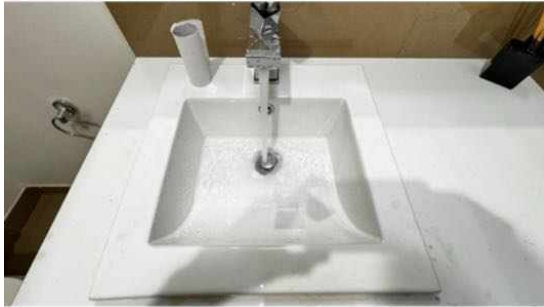
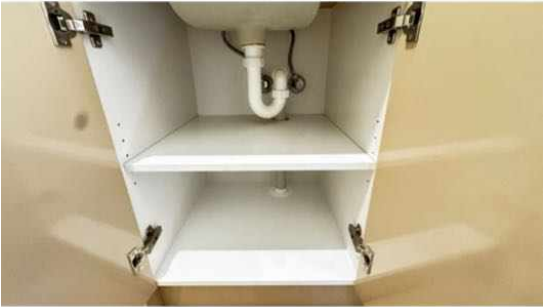
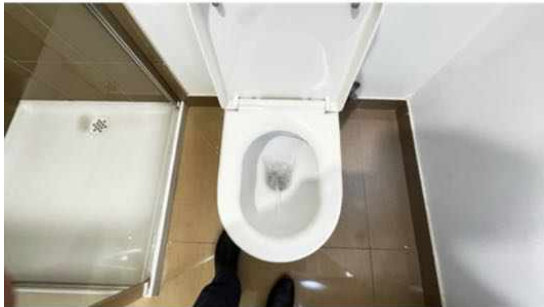
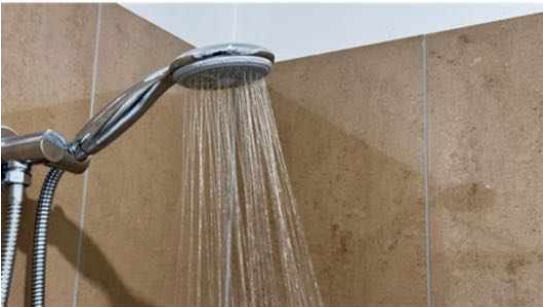
Building: Main Building
 Location: All Internal Areas
 Finding: Water Supply & Drainage - Shower, Basins, Toilets, & Plumbing Fixtures
 Information: The shower recess was tested, and no visible water penetration to surrounding areas was observed at the time of inspection, except where noted as a separate defect elsewhere in this report. Water appeared to flow freely toward the floor waste. Moisture detected to the shower walls is documented separately in the report. The shower floor waste appeared clear during inspection.

Flushing the toilet revealed no visible leaks, and the fixture appeared to operate normally unless otherwise noted as a separate defect. No water damage was observed to the vanity unit unless specifically stated elsewhere in the report. Basins, bathtubs, laundry tubs, vanities, and sinks were tested and inspected with no evidence of leaks, blockages, or drainage issues at the time of inspection unless otherwise noted. All internal taps and shower heads were tested with no leaks observed, unless documented as a separate defect.

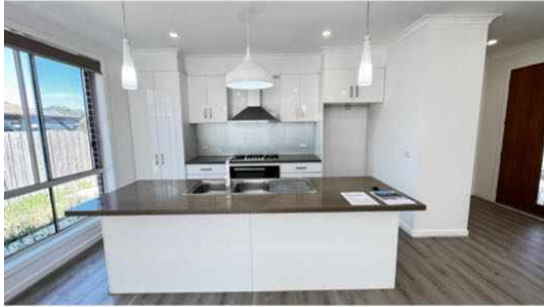
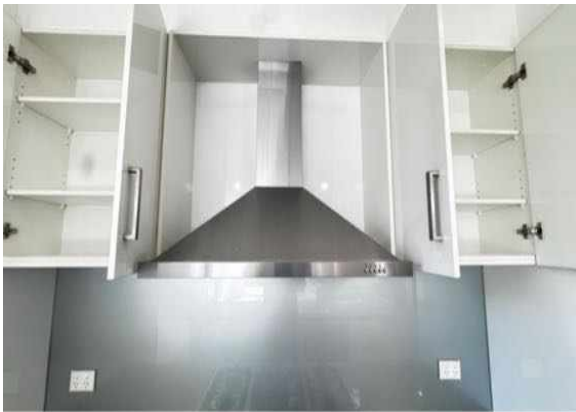
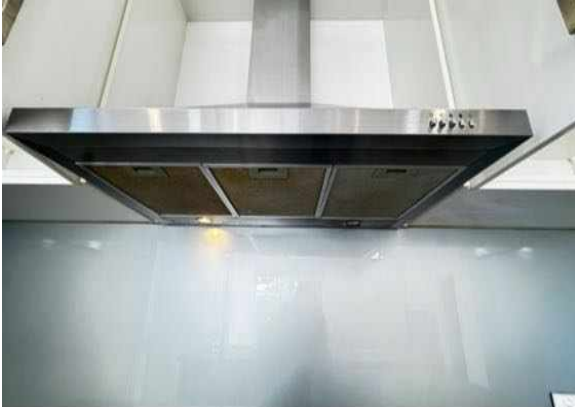
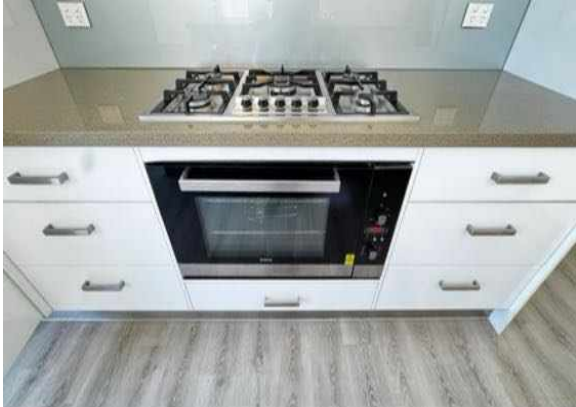
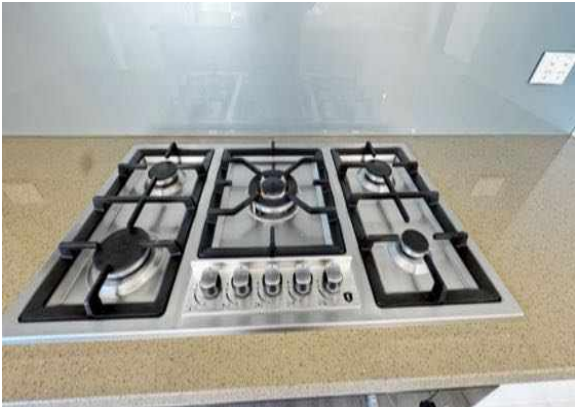
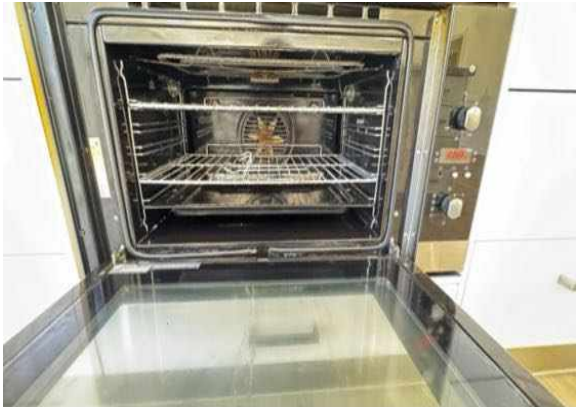
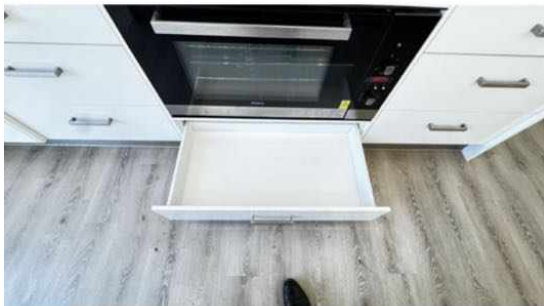
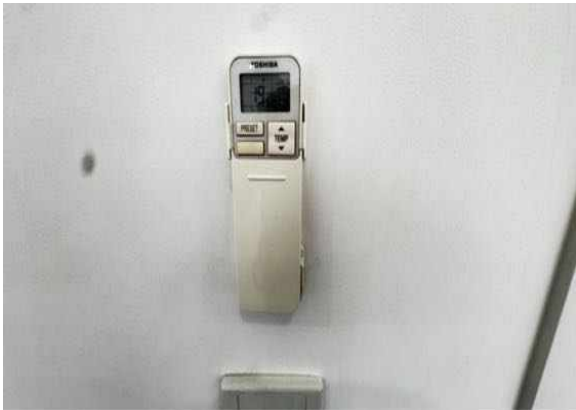
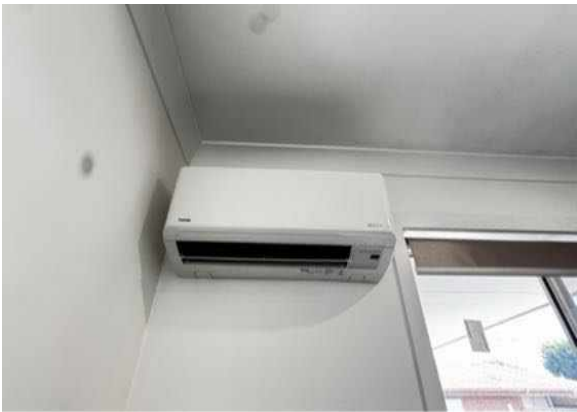
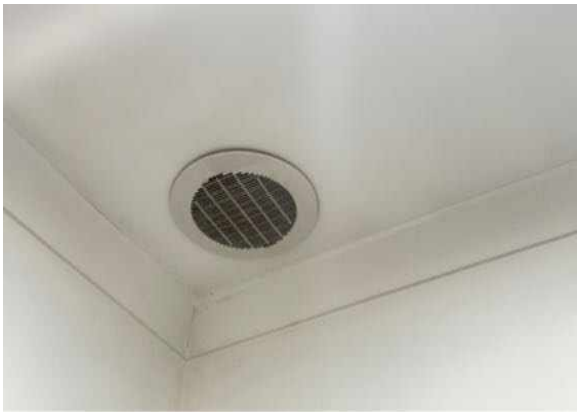
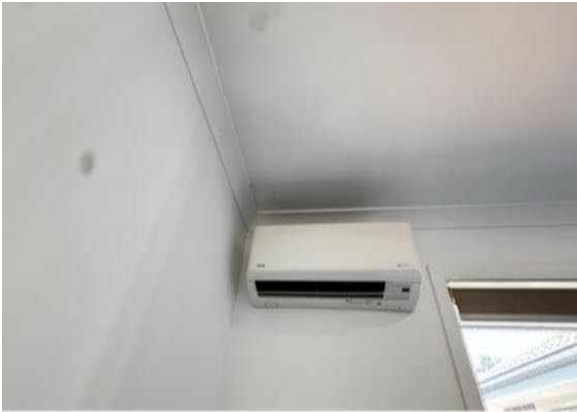
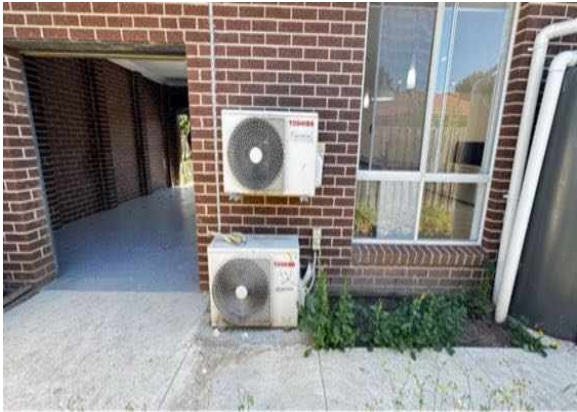
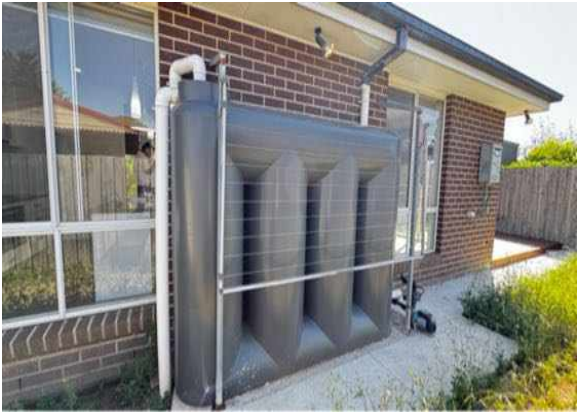
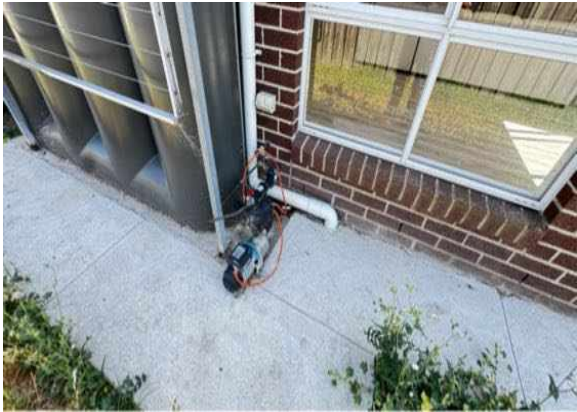
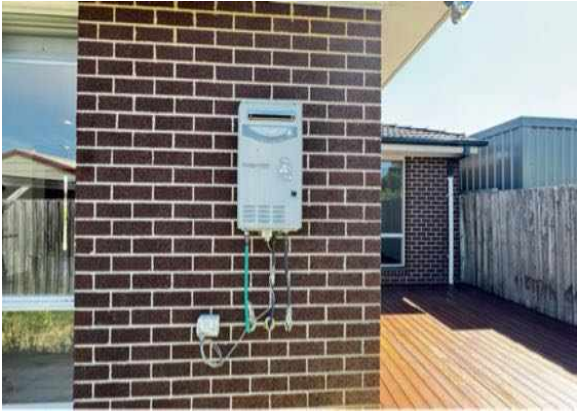
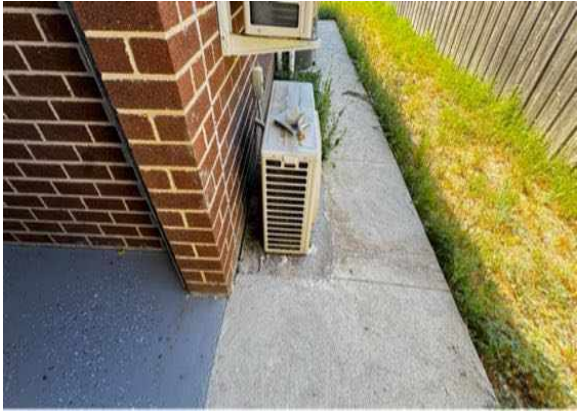
Appliances may be worn, damaged, or malfunctioning. Electrical or gas appliances can pose serious safety hazards if incorrectly installed or maintained.

Observations and images of appliances are for informational purposes only and do not form part of the formal building inspection.

Service, repair, or replace equipment as necessary, particularly where service history or warranty coverage is unknown.

Inspect any water, gas, or electrical connections associated with appliances to ensure safety and compliance.

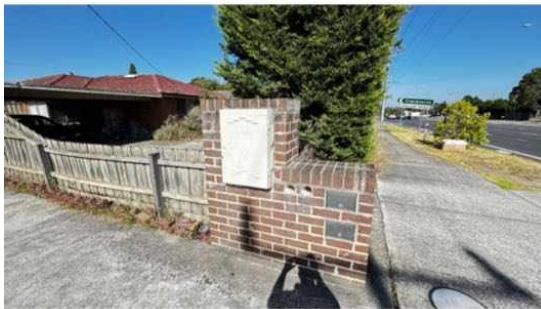
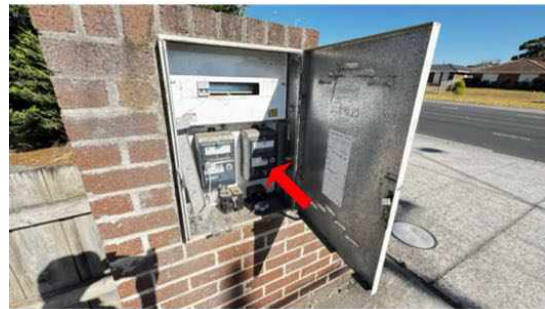
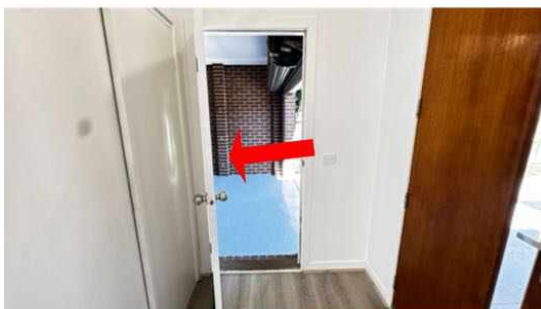
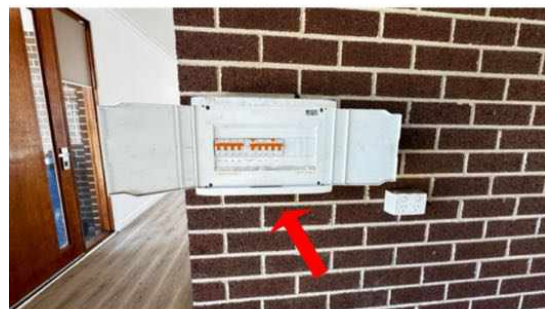
(AS 4349.1-2007: Electrical Switchboard & meter inspections are for your information only, as functional testing is outside the scope of a standard pre-purchase building inspection.)

For full compliance and safety verification, a licensed electrician should be engaged to inspect the switchboard, test all circuits, and ensure all components are functioning correctly. This will help maintain electrical safety and prevent potential hazards.

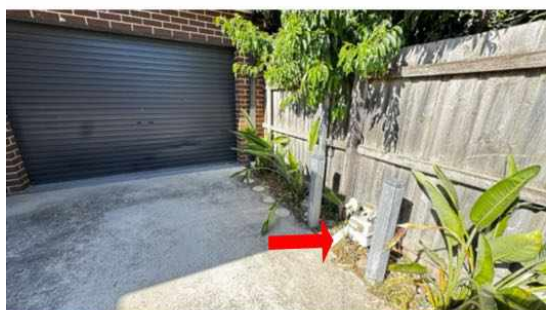
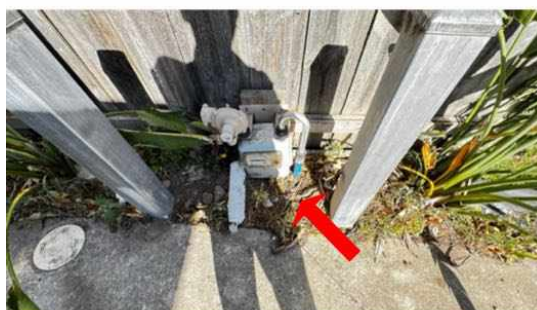
Gas meters can be affected over time by age, environmental exposure, or accidental impact, which may lead to corrosion, physical damage, leakage, or non-compliance with current regulations. Regular checks are recommended to ensure ongoing safe operation.

(AS 4349.1–2007: Gas meter images are for your information only, as functional testing is outside the scope of a standard pre-purchase building inspection.)

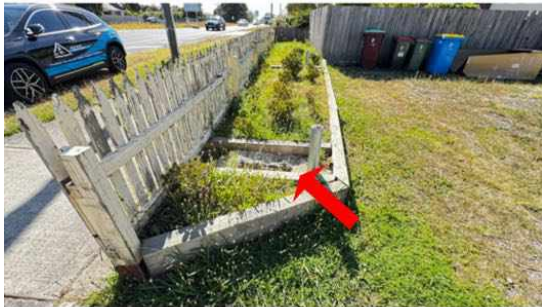
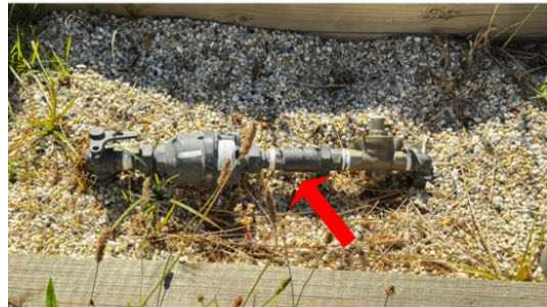
Building:	Main Building
Location:	All External Areas
Finding:	Water Meter - Location For Your Information Only
Information:	The water meter was photographed at the time of the inspection. The meter is included for reference & location purposes only.

Water meters can be affected over time by age, environmental exposure, accidental impact, or poor maintenance. Potential issues could include leaks, corrosion, or malfunction that may impact water supply or cause water damage.

It is recommended that a licensed plumber carry out routine inspections and maintenance to ensure continued safe and compliant operation. Observations are for informational purposes only and do not form part of a full safety or compliance inspection.

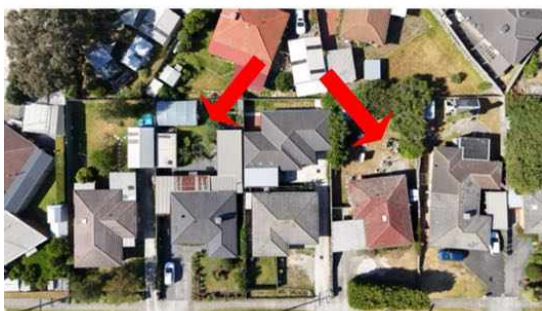
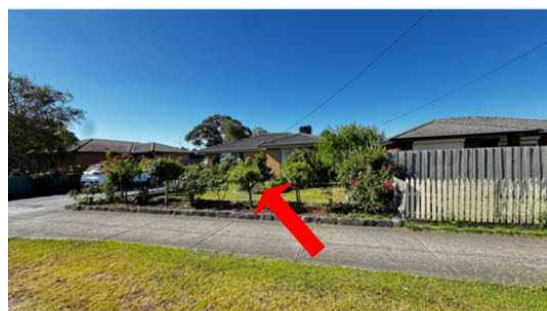
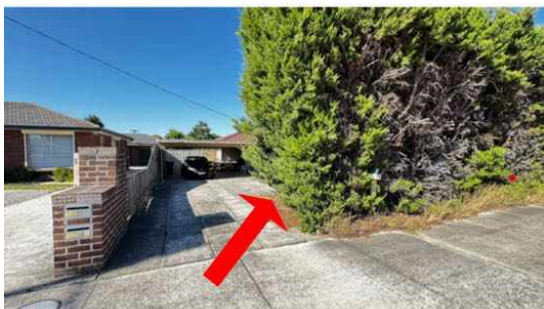
(AS 4349.1–2007: inspection of neighbouring properties is not included in standard pre-purchase building inspections; this statement is for your information only.)

Recommendation: For concerns regarding noise, encroachments, or structural issues affecting neighbouring properties, it is recommended to engage relevant specialists (e.g., acoustic consultant, building surveyor, or a registered builder) and/or contact the local council.

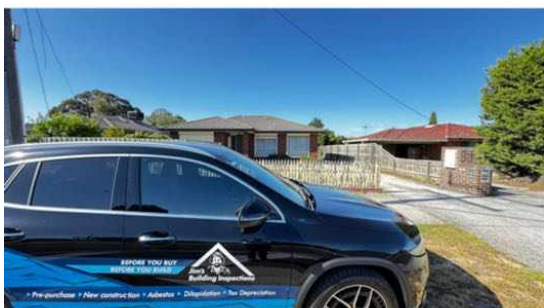
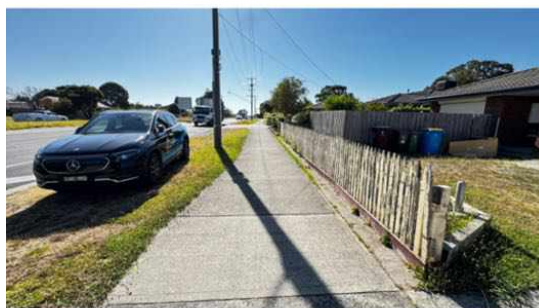
During the inspection, minor cracking, surface wear, or uneven sections were observed on footpaths or crossovers. Some accessible metal components, such as street signage or grates, showed signs of rust or deterioration. Debris accumulation and vegetation encroachment were also noted around council infrastructure. Access or visibility was limited to certain council-owned assets.

These areas should be monitored, and for detailed assessment, maintenance, or compliance verification, the relevant local council authority should be contacted immediately. Regular monitoring of adjacent council assets is recommended to ensure ongoing safety and proper maintenance.

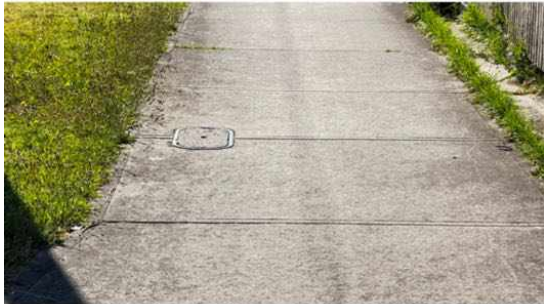
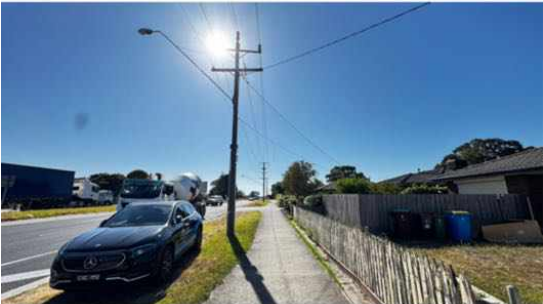
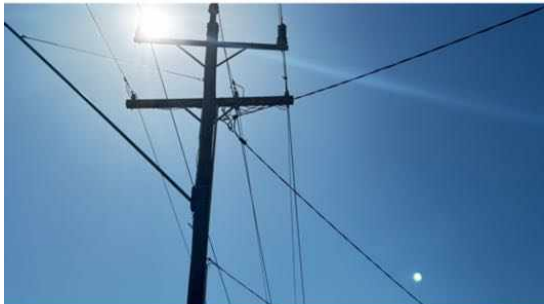
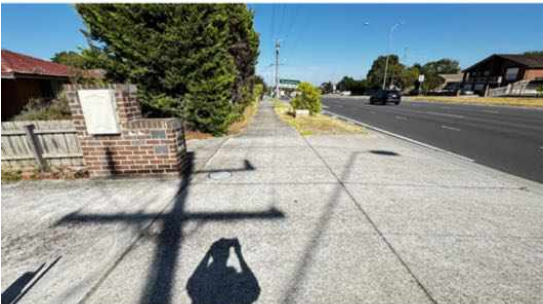
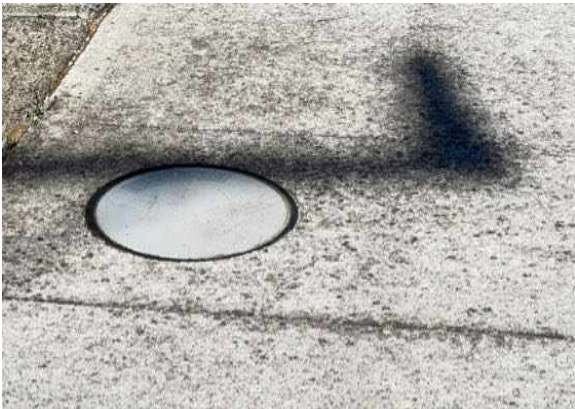
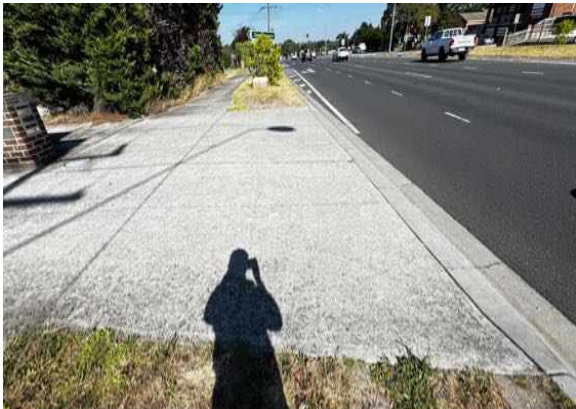
Building: Main Building
Location: All Areas
Finding: Additional Photos - Common Property
Information: Additional photos are provided for your general reference and are to be discussed with your building inspector.
