Building Inspection Report

Inspection Date: Tue, 27 Jan 2026

Property Address: unit 2/142 Pound Rd, Hampton Park VIC
3976, Australia

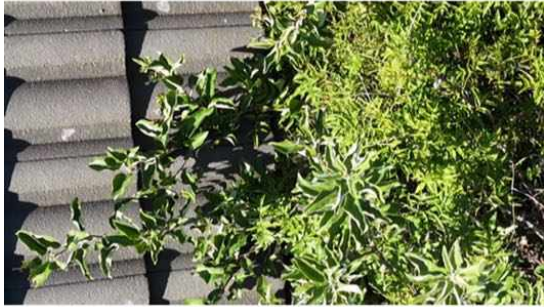
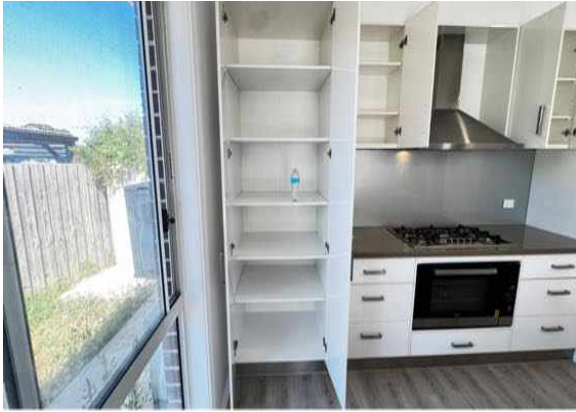
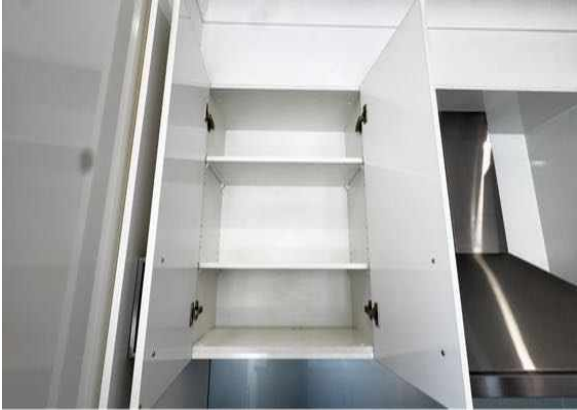
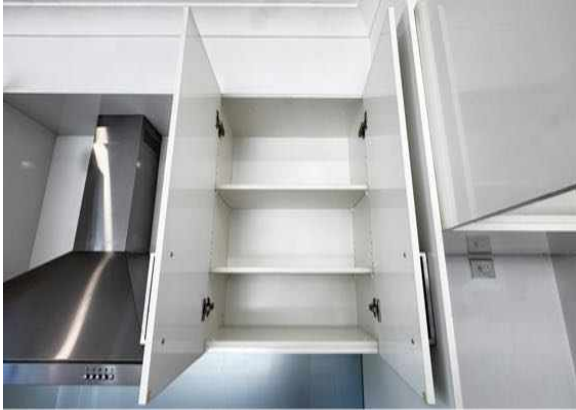
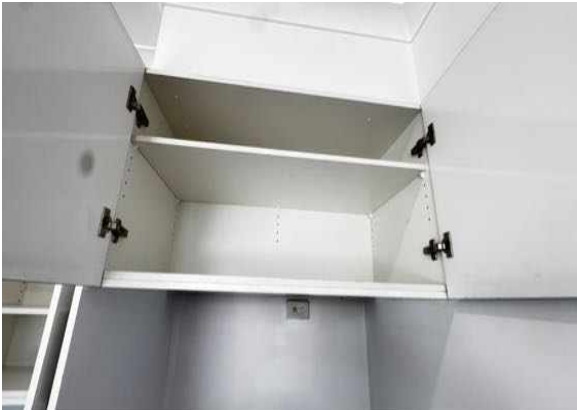
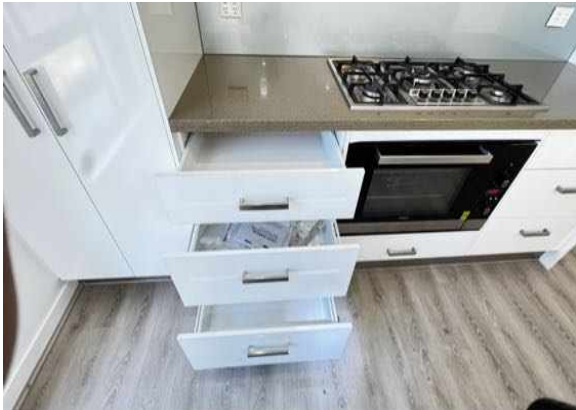
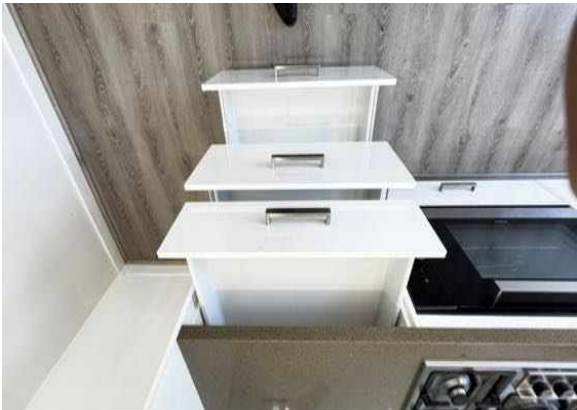
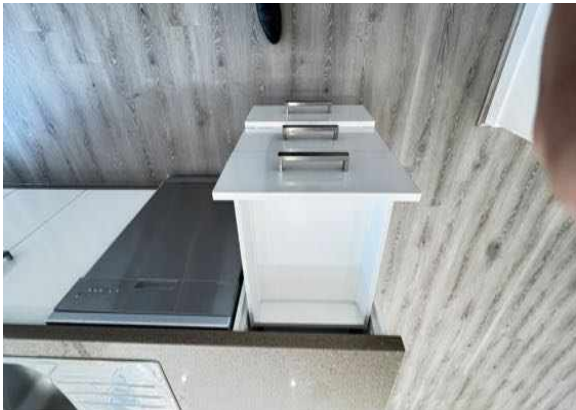
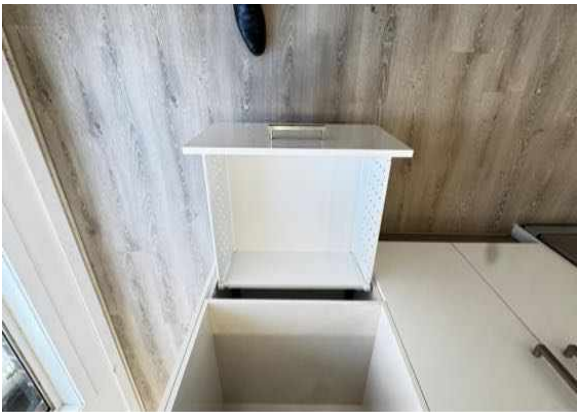
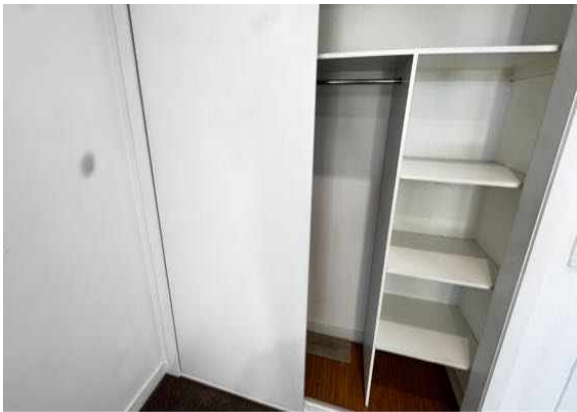
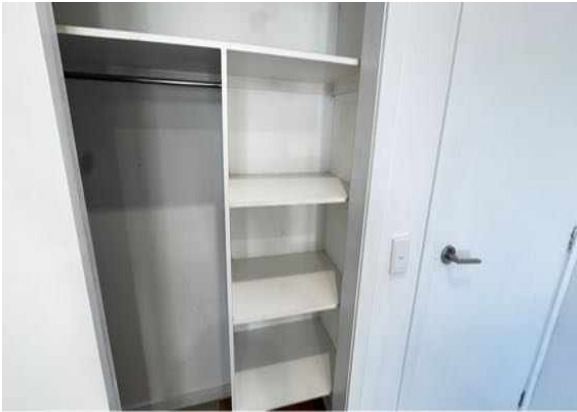
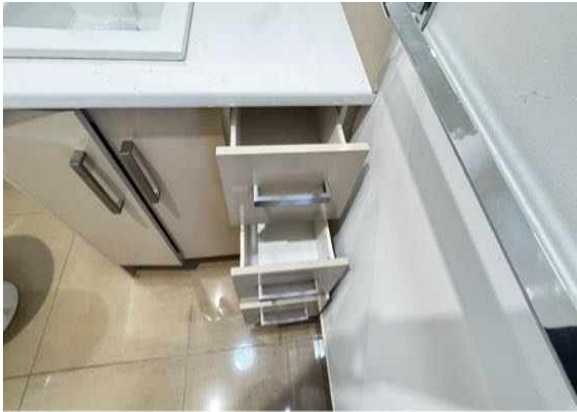
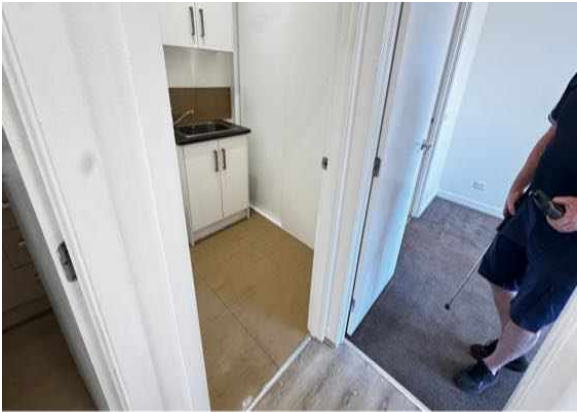
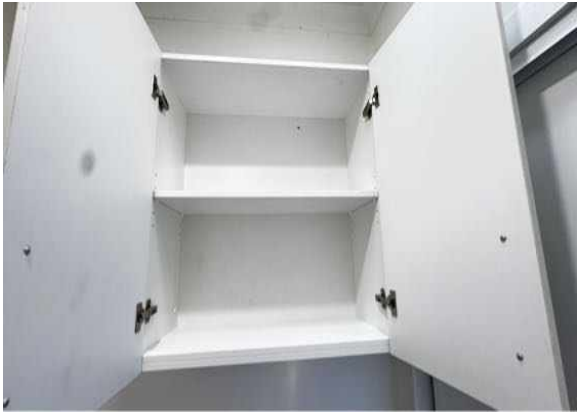
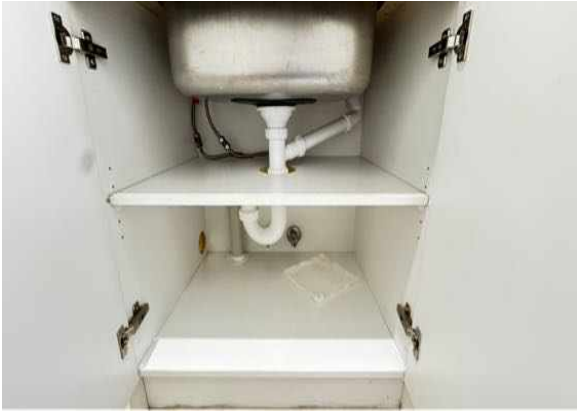
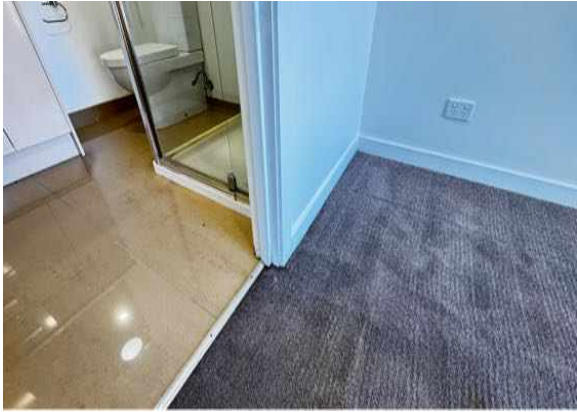
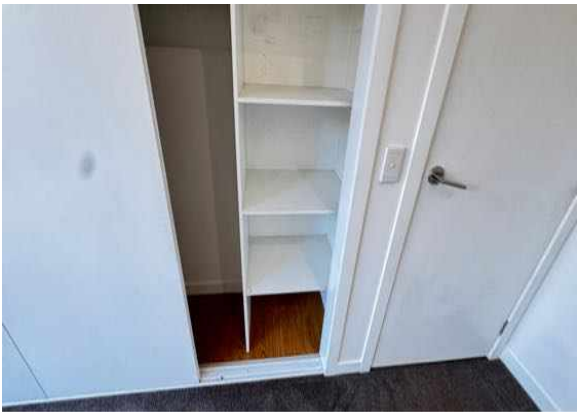
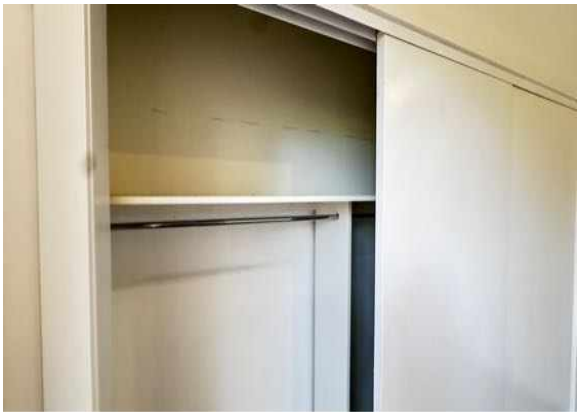
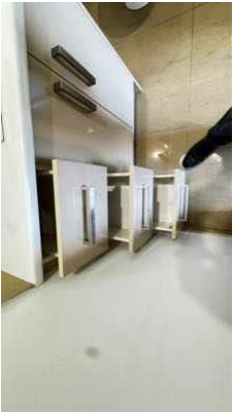
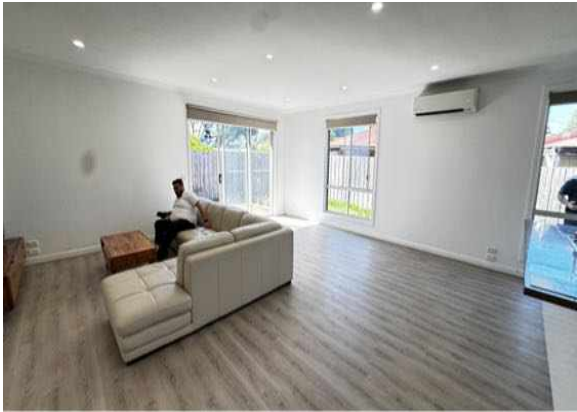
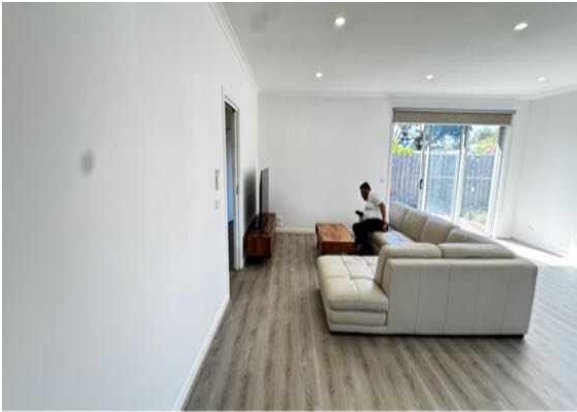
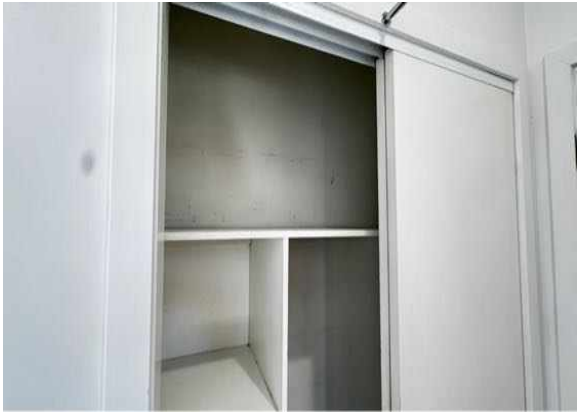
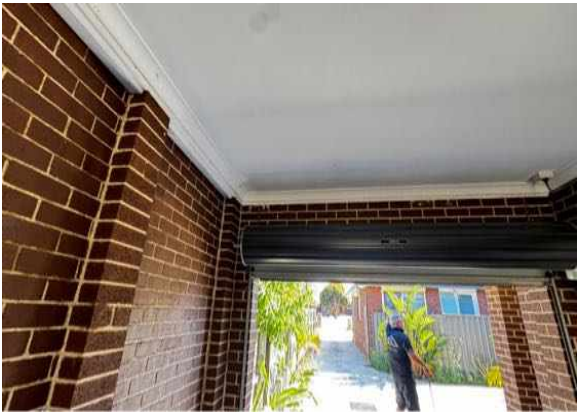
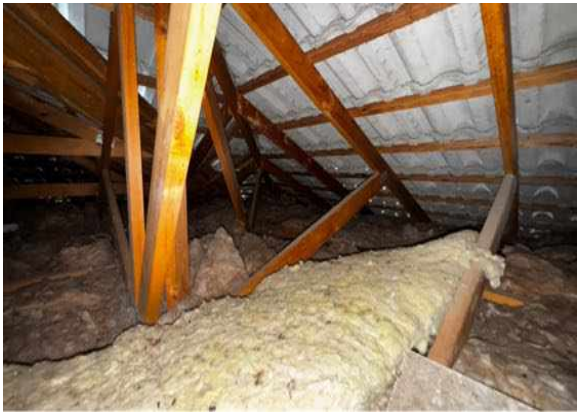
It is important to note that these restrictions can conceal a wide range of building defects, including but not limited to:

Structural damage such as cracking or movement in walls, floors, or ceilings.

Pest activity such as termites or timber decay.

Electrical, plumbing, or safety hazards.

Because these areas could not be visually assessed, no comment can be made on their condition within this report.

It is strongly recommended that obstructions be removed and concealed areas made fully accessible immediately. A re-inspection should then be carried out to allow a complete assessment of the property's condition. This is particularly important prior to purchase, as defects in concealed areas can carry significant rectification costs.
