Building and Timber Pest Inspection Report

Inspection Date: Thu, 19 Feb 2026

Property Address: 30 Aloomba St, Chadstone VIC 3148,
Australia

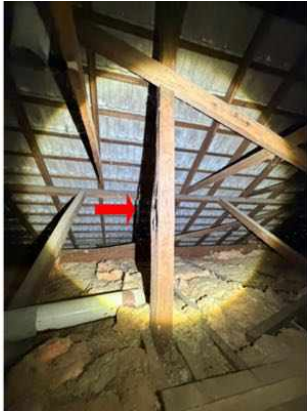
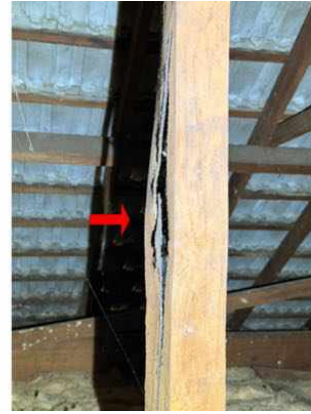
This defect may compromise the roof framing's ability to transfer loads correctly and could lead to further movement, distortion, or localized structural failure over time (major defect).

Arrange prompt assessment by a qualified structural engineer or licensed carpenter, and complete appropriate repairs/replacement and re-supporting as required.

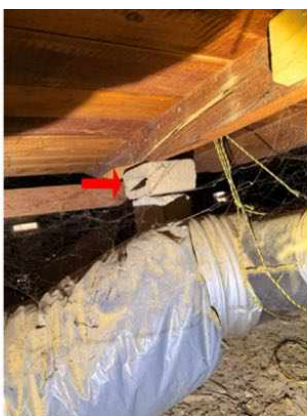
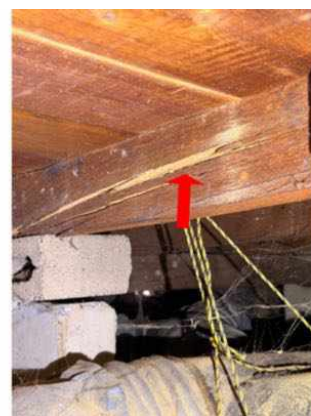
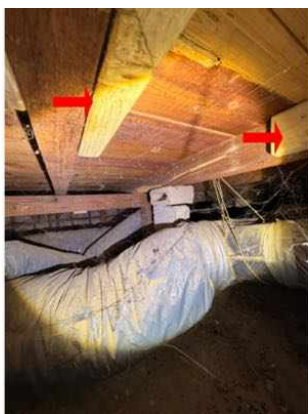
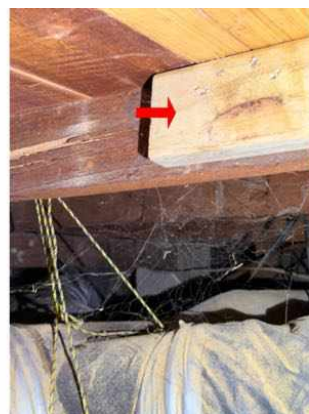
Finding 2.02

Building:	Main Building
Location:	Subfloor
Finding:	Major Defect – Subfloor Structure
Information:	Temporary floor packers were observed supporting a split and previously repaired floor bearer within the subfloor area. The floor bearer shows visible longitudinal splitting, and the support appears improvised rather than a permanent structural solution.

Temporary packers and a compromised floor bearer may not provide adequate long-term load support. This condition can lead to further structural movement, uneven floors, and potential deterioration of the building's structural integrity.

A licensed builder or structural engineer should be engaged to assess the adequacy of the existing support system. Permanent rectification, including proper structural support and repair or replacement of the affected floor bearer, is recommended as a matter of priority.

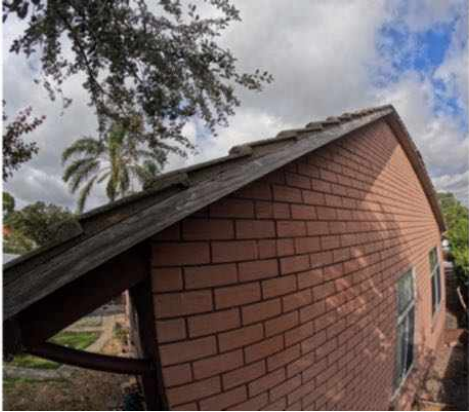
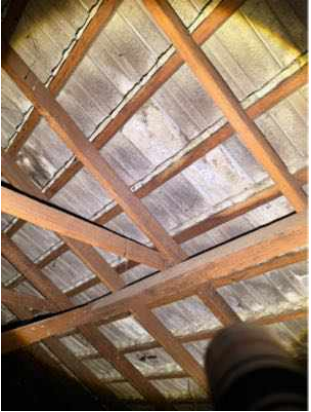
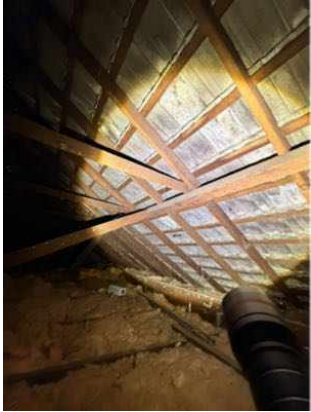
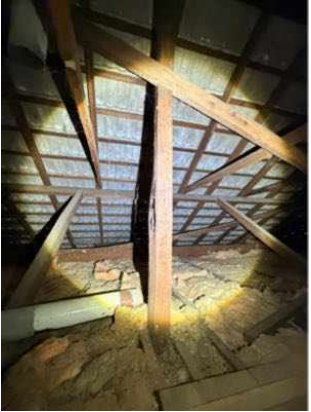
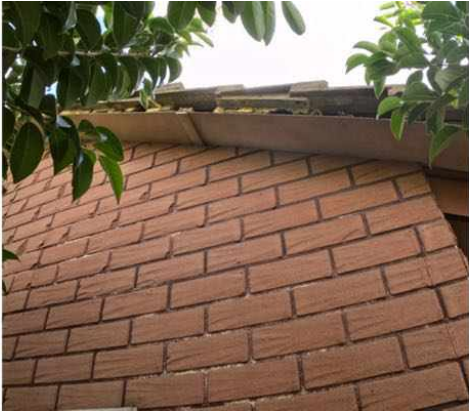
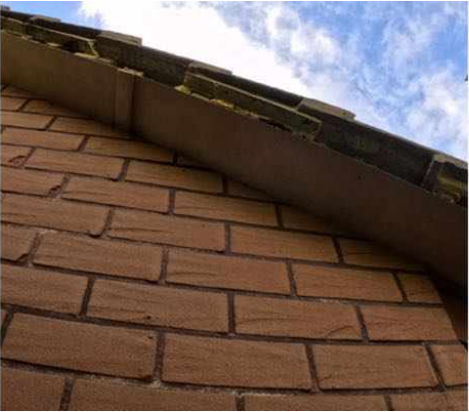
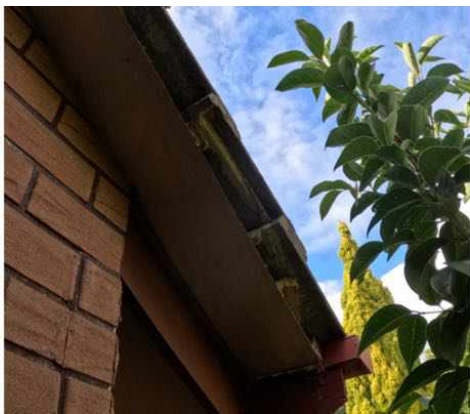
Building: Main Building
 Location: Roof Exterior
 Finding: Roof tiles - Weathered
 Information: Upon inspection of the exterior roofing, the majority of roof tiles were considered to be in a fair condition. While weathering of the tiles is consistent with the age of the property, maintenance works are required.

Isolated areas of mortar have come loose in the valleys and minor cracking is also present. Re-pointing and re-sealing the may be considered as an interim solution by the client to help preserve and extend the life span of the tiles.

Where left unmanaged, deteriorating roof tiles are likely to lead to a number of secondary defects, including minor water leaks and weather exposure to internal roofing structures.

Efflorescence was observed on the underside of the roofing material. This is identified by the white, powdery staining that forms when moisture within the material dissolves salts, which are then carried to the surface and deposited as the water evaporates.

While efflorescence itself is not structurally damaging, it indicates that moisture is penetrating or accumulating in the roof covering. If left unaddressed, ongoing moisture exposure may contribute to deterioration of roofing materials and encourage timber decay or corrosion of fixings.

It is recommended to monitor the area for signs of active leaks and ensure roof drainage and ventilation are adequate. If moisture ingress persists, a licensed roofing contractor should be engaged to investigate and carry out necessary rectification works.

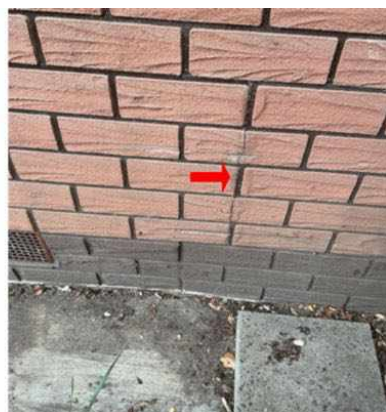
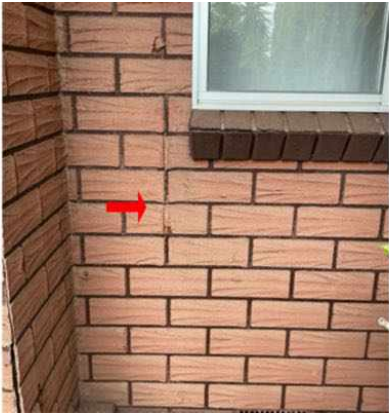
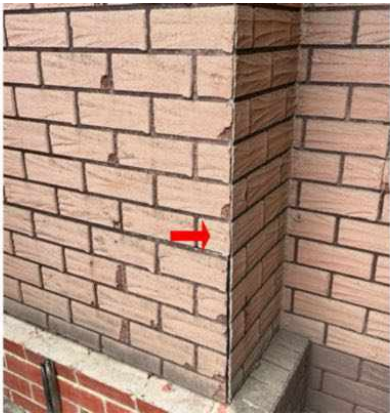
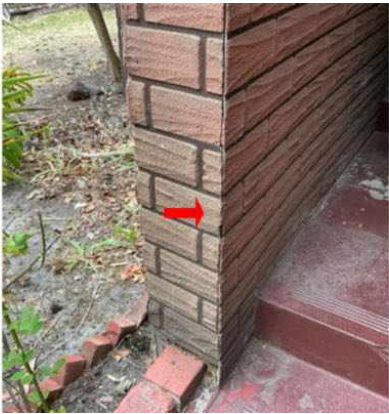
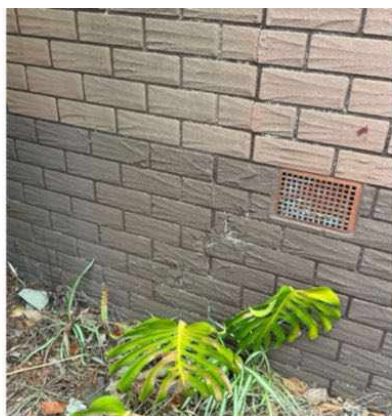
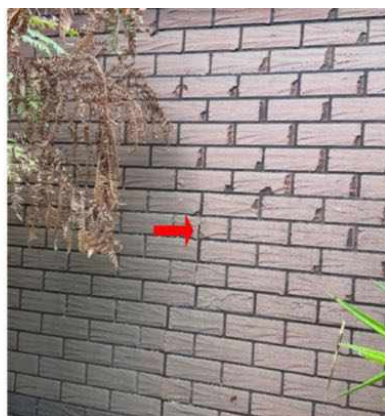
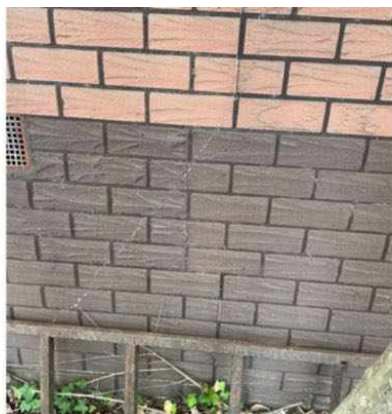
Finding 3.03

Building:	Main Building
Location:	Walls
Finding:	External wall cladding – cracking observed (various locations)
Information:	Cracking was noted to the external wall cladding at multiple areas around the property. This may be associated with minor building movement/settlement and normal thermal expansion and contraction.

While generally considered a minor defect, cracking may allow moisture entry and progressive deterioration if left unattended. Due to the less common cladding profile/finish, matching materials and completing repairs may be more difficult and potentially higher cost than standard cladding systems.

Engage a qualified builder/renderer to assess the extent and cause of cracking and to provide a repair method and cost estimate (including matching). Client is advised to factor potential repair costs into their overall purchase decision.

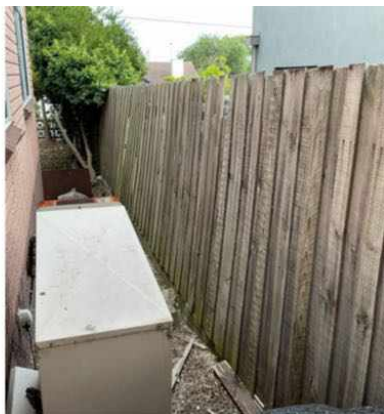
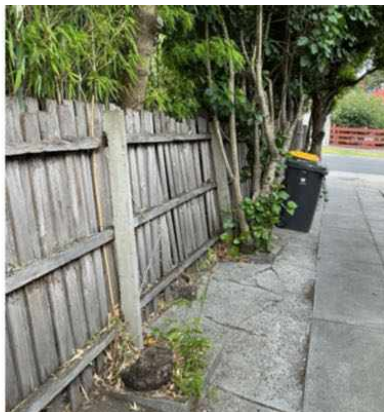
Finding 3.04

Information: Sections of the fence were observed to be leaning and out of alignment. This may be due to footing movement, poor anchoring, or gradual deterioration over time. Although no immediate structural failure was noted, the leaning condition may worsen and could eventually compromise stability or appearance.

Recommend monitoring the fence over time. If further movement occurs or stability becomes a concern, engage a qualified fencing contractor or builder to assess and undertake appropriate rectification work.

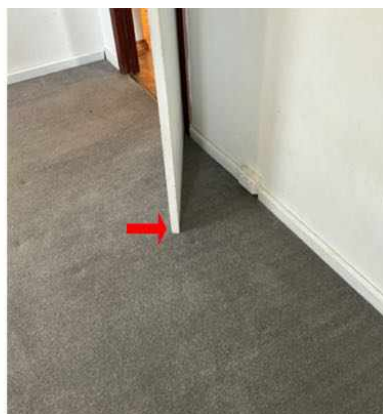
Finding 3.05

Building:	Main Building
Location:	Bedroom
Finding:	Door stop - Missing
Information:	The door stop is missing or is inadequate to stop the door handle from damaging the wall. Although some building elements may seem irrelevant or unnecessary, all building elements play a key role in the operation and function of the overall structure and its performance.

Re-installation or replacement of the door stop is advised as soon as possible to prevent any subsequent damage to the door or associated structures. A general handyman may be appointed to perform these works at client discretion.

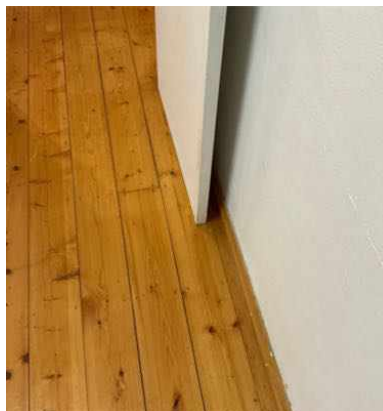
Finding 3.07

Finding: Door stop - Missing

Information: The door stop is missing or is inadequate to stop the door handle from damaging the wall. Although some building elements may seem irrelevant or unnecessary, all

building elements play a key role in the operation and function of the overall structure and its performance.

Re-installation or replacement of the door stop is advised as soon as possible to prevent any subsequent damage to the door or associated structures. A general handyman may be appointed to perform these works at client discretion.

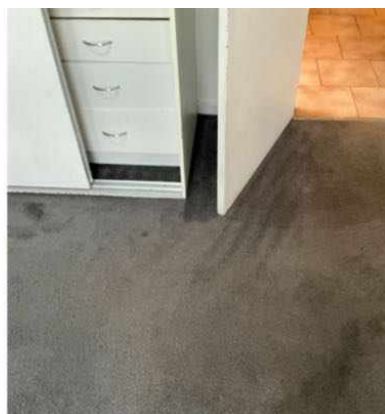
Finding 3.08

Building:	Main Building
Location:	Bedroom 3
Finding:	Door - Binding/jamming
Information:	Binding and/or jamming of this door is evident during standard operation. This defect inhibits the functionality of the affected door as well as creating potential for secondary defects to associated building elements, such as damage to the floor covering.

A door that binds to flooring or to the associated door frame may have several causes, ranging from minor defects, such as poor installation of the door or deteriorated hinges, through to major structural issues, such as damage to subfloor structures.

Where door binding/jamming appears to indicate major structural issues, a registered builder specialising in re-stumping should be appointed to provide an estimate on the cost of rectification.

For minor causes, a qualified carpenter or general handyman should be appointed to perform minor rectification works at client discretion.

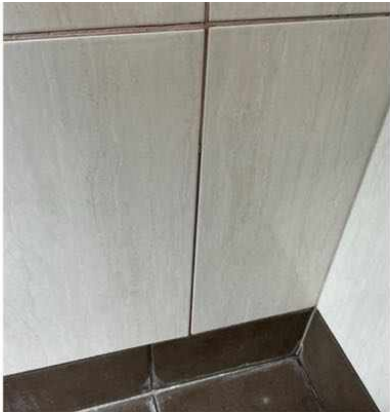
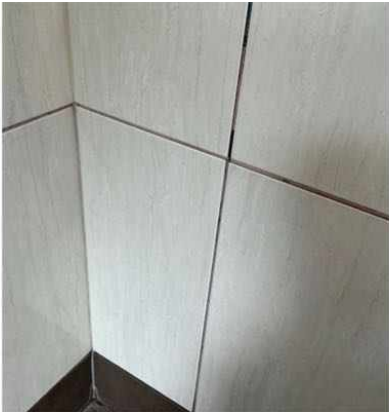
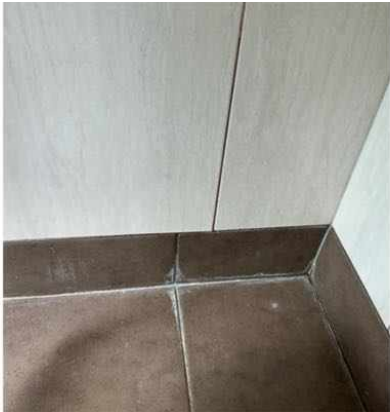
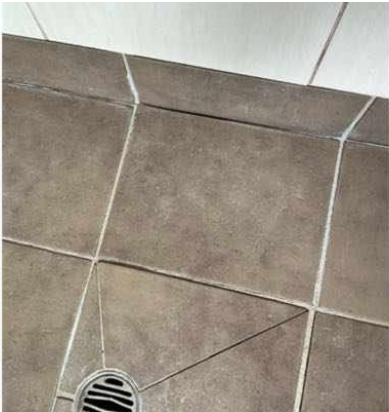
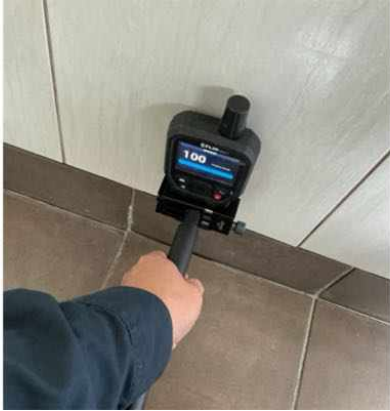
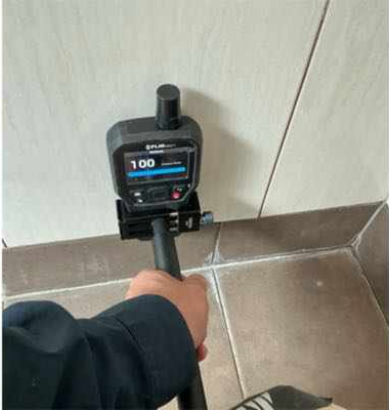
Prolonged exposure to moisture may lead to substrate damage, tile movement, mould growth, or further breakdown of the waterproofing system if not addressed.

Engage a qualified tiler or damp-proofing specialist to remove deteriorated grout/sealant and properly reseal all affected areas to prevent further moisture ingress.

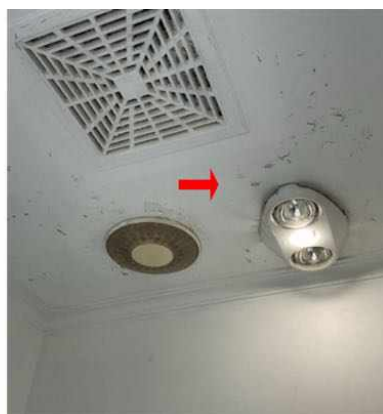
Finding 3.11

Building: Main Building
 Location: Bathroom
 Finding: Peeling paint was observed to the bathroom ceiling finish. Condensation
 Information: Peeling paint was observed to the bathroom ceiling finish.

This is commonly associated with ongoing high humidity/condensation and may indicate intermittent moisture exposure, which can lead to further paint failure and potential mould growth over time.

Improve ventilation (confirm exhaust fan is present and operating) and have the ceiling surface prepared and repainted with a suitable bathroom-grade moisture-resistant system after confirming no active moisture source is present.

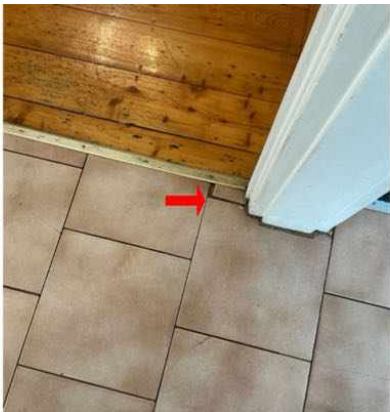
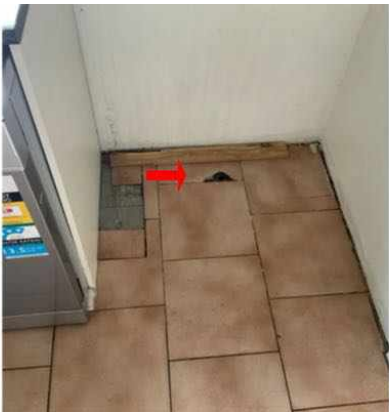
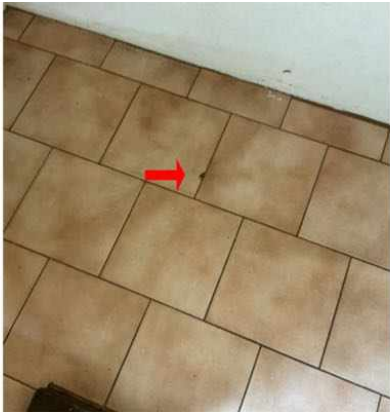
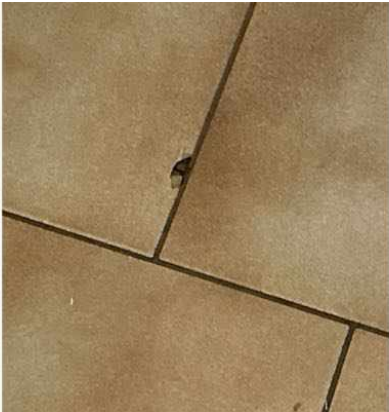
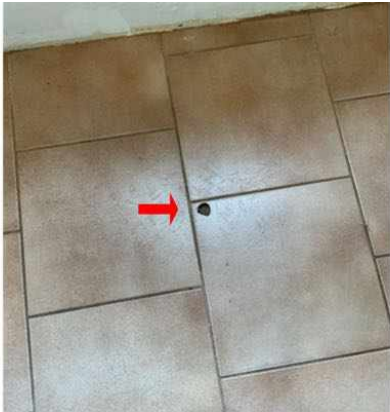
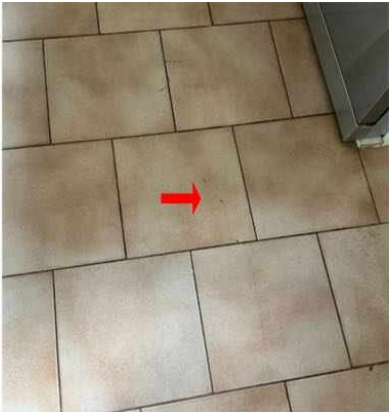
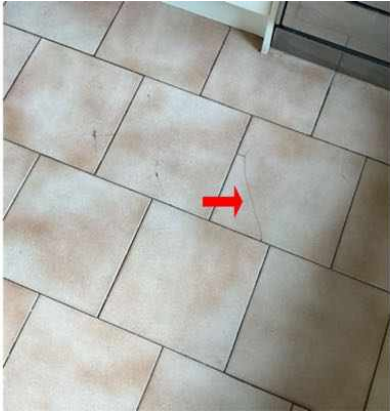
Building: Main Building
 Location: All Areas
 Finding: Damaged Floor Tile
 Information: damaged floor tile was observed in the property. This type of damage is typically caused by the impact of a heavy object.

It is recommended to engage a licensed tiling contractor to replace the affected tile and restore the surface to its original condition for both safety and aesthetic purposes.

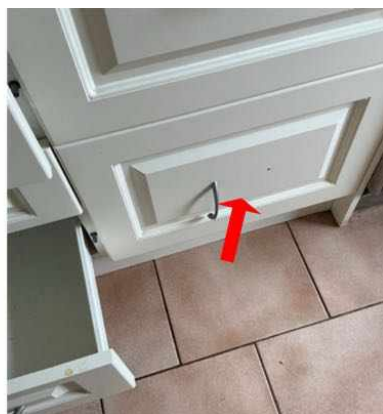
Finding 3.13

Building: Main Building
 Location: Kitchen
 Finding: Fitting or fixture - Loose
 Information: The fitting in this area is loose and requires adjustment to tighten.

If left unmanaged, the fitting may further deteriorate, causing potential for the development of other minor secondary defects.

A relevant tradesperson should be appointed to perform these rectification works at discretion of the client.

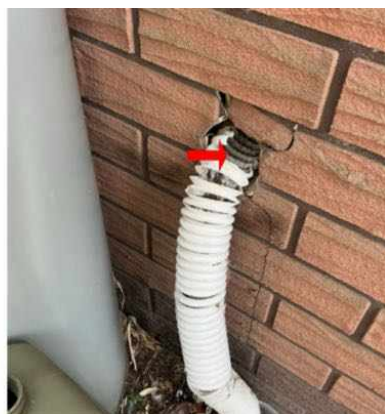
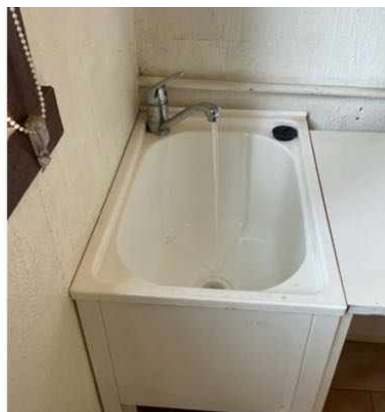
Finding 3.14

Building: Main Building
 Location: Laundry
 Finding: Broken pipe
 Information: When the laundry tap was turned on, water was observed leaking from a damaged external drain/pipe. This ongoing leakage can raise moisture levels in the surrounding area, which may adversely affect the footing/foundation over time, and may also allow moisture to enter the wall cavity and cause concealed damage. The elevated moisture conditions are also conducive to termite activity.

Engage a licensed plumber to investigate and repair/replace the damaged pipework and confirm all joints/connections are watertight. After repairs, monitor the area for continued dampness and consider further investigation (and a timber pest assessment if concerns persist) to check for any moisture-related damage or termite risk.

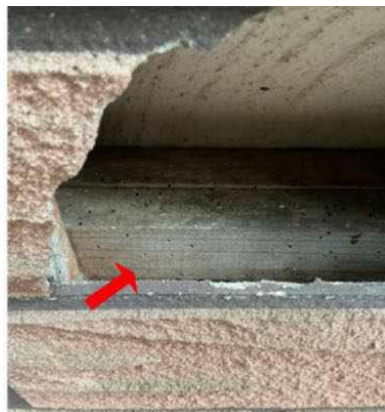
Building:	Main Building
Location:	Walls
Finding:	External wall cladding hole with timber borer damage
Information:	An opening/hole was noted in the external wall cladding, exposing internal timber. The exposed timber shows evidence consistent with wood borer activity (multiple small pin-holes).

The damaged timber may continue to deteriorate and the opening may allow moisture and pest/termite entry into the wall cavity.

Arrange a licensed timber pest inspector to assess the extent of borer activity and recommend treatment/rectification, then repair/replace affected timber as required and reinstate the cladding to fully close and seal the opening.

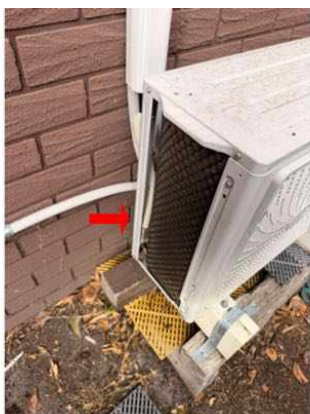
Building:	Main Building
Location:	Hot water/aircon unit(s)
Finding:	The air conditioning overflow pipe is not properly connected and discharges directly into the soil adjacent to the building.
Information:	This creates a conducive condition for termite activity by providing a constant moisture source near the structure. It may also lead to soil erosion, mould growth, or damage to nearby building materials.

The overflow should be redirected to an appropriate discharge point—such as a stormwater connection or designated drainage area—away from the building foundation, in accordance with plumbing and termite management standards.

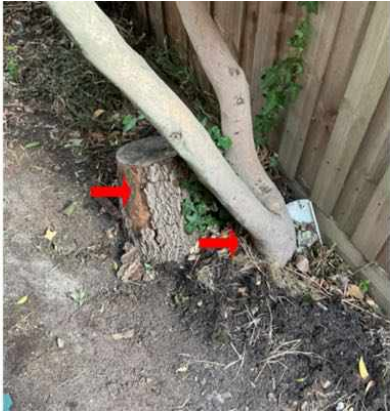
Finding 6.03

Building:	Yard
Location:	Yard
Finding:	Large trees/stumps within 30m of house
Information:	There are a number of large trees/stumps within 30m of the house which may contain natural termite activity. It is important to monitor these areas to ensure no natural activity is allowed to progress into the main house.

Regular inspections are recommended. Consider test drilling any large trees.

A pest controller can be contacted to carry out such testing at the owners discretion.

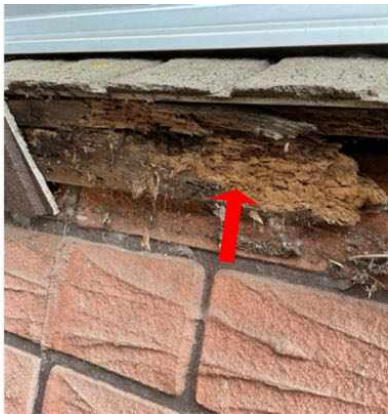
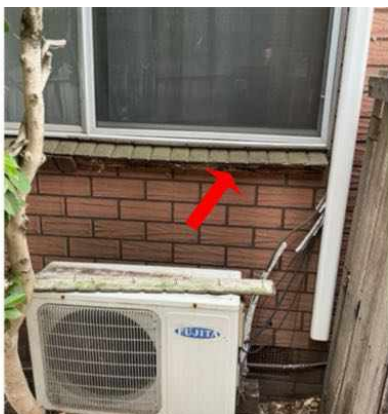
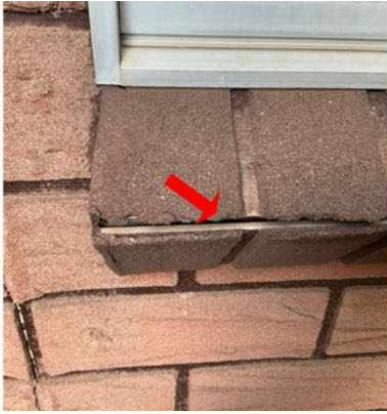
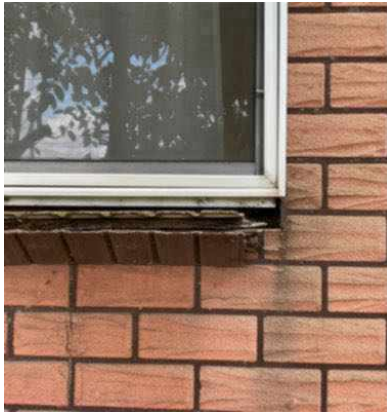
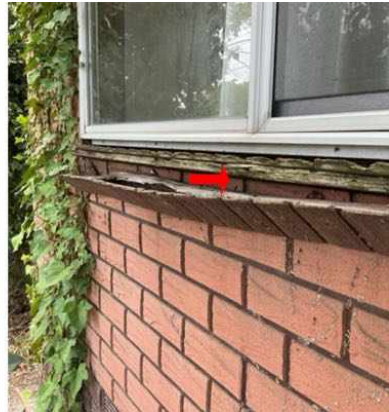
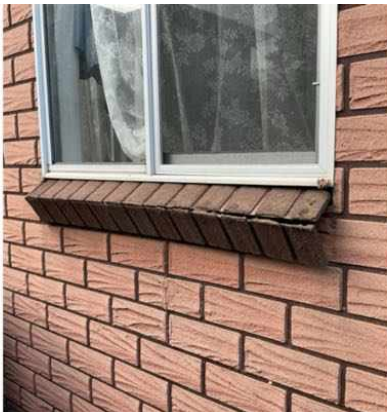
Finding 7.01

Building:	Main Building
Location:	Walls
Finding:	Window sill / lower cladding—severe deterioration and wood decay
Information:	The window sill/lower cladding shows severe damage with advanced timber decay, likely due to prolonged moisture exposure.

Deteriorated cladding can allow further moisture entry and progressive decay, and rectification may be costly even if not currently structural.

Engage a qualified carpenter/builder to replace the deteriorated sections and investigate/rectify the moisture source contributing to the decay, and factor the likely repair cost into your purchase decision.

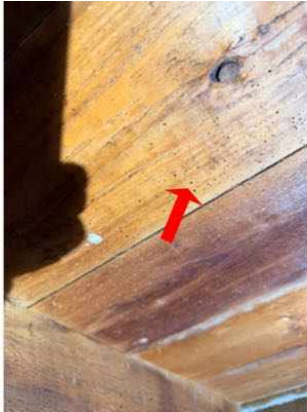
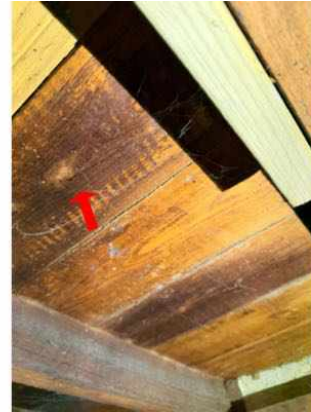
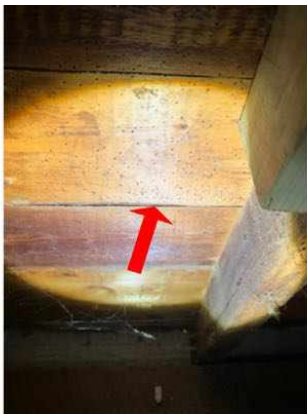
Finding 8.01

Building:	Main Building
Location:	Subfloor
Finding:	Evidence of wood borer activity identified
Information:	Wood borers small beetles that colonise in exposed timber elements are a common timber pest that are regularly mistaken for termites. Although wood borer activity is generally not detrimental to the affected timber they may lead to serious damage and necessitate replacement of certain building elements if left unattended.

The other commonly known borer the Anobium borer is more likely to attack floorboards and may cause severe structural damage to flooring areas.

As no live wood borer activity was identified treatment is not required at this time. Replacement of affected timbers may be considered by the client for superficial reasons.

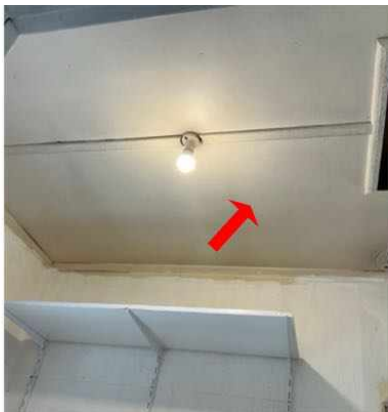
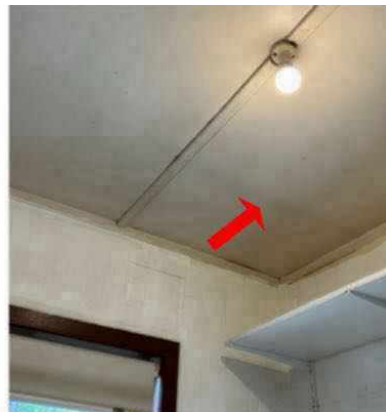
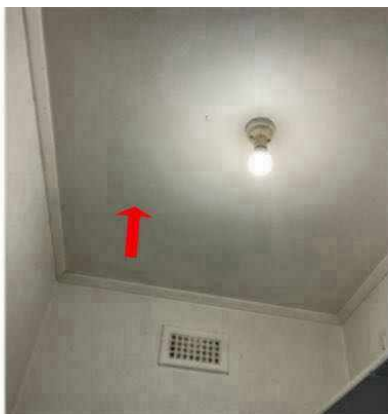
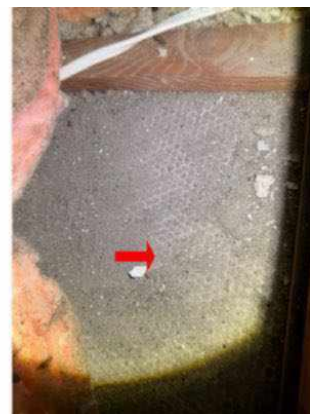
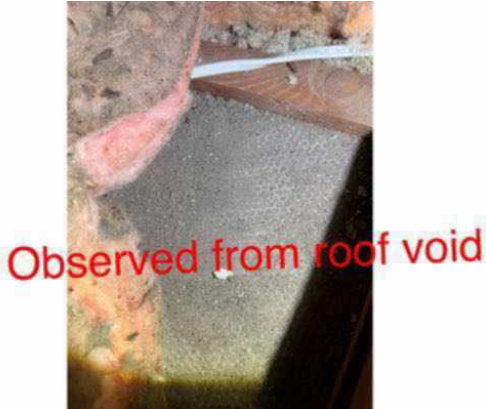
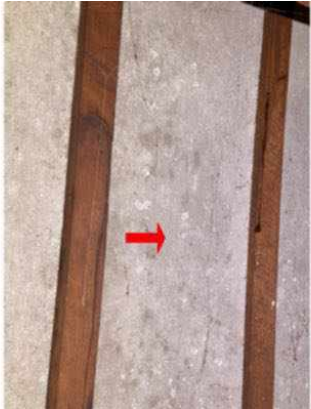
Building: Main Building
Location: Laundry, roof void
Finding: Asbestos - Suspected ACM Identified on Site
Information: Reporting on Asbestos is outside the Scope of this Report. This suspected defect is highlighted as a caution only. We suspect, based on our experience in the building industry, that there is a higher risk of the identified building element containing asbestos.

As Asbestos Reporting is outside the scope of this report, we advise that you consider a separate Asbestos Inspection and Condition Audit, which can include the taking of samples for definitive confirmation of the presence of Asbestos.

In the interim, the client is advised to act with caution, especially when considering any damage to building materials general wear and tear renovations extensions demolition and general maintenance activities due to the suspected presence of Asbestos.

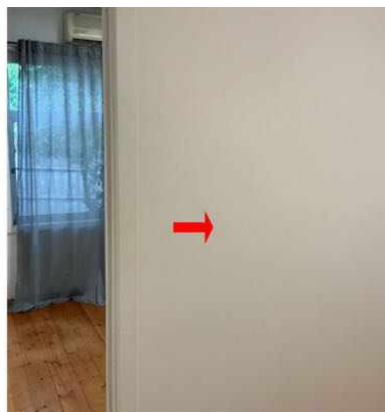
Building: Main Building
 Location: Living Room
 Finding: For your information
 Information: This is provided for your information only. No immediate action is required at the time of inspection; however, monitoring or future attention may be beneficial depending on use, condition, or preferences.

If the wall is not adequately supported, differential movement may occur, which can lead to settlement and cracking over time.

Monitor the wall for any signs of movement (e.g., noticeable settlement, new or widening cracks, sticking doors/windows). If movement is observed, engage a qualified builder/structural engineer promptly to assess and carry out repairs as required.

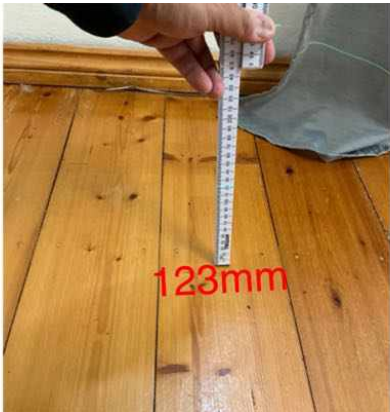
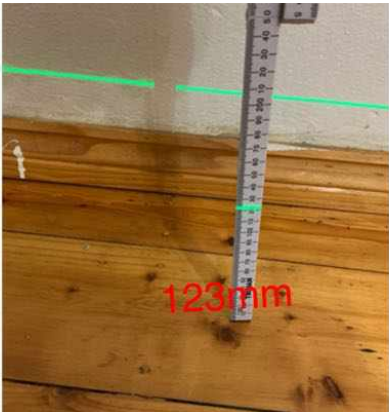
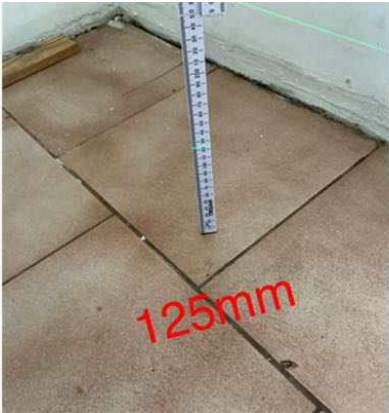
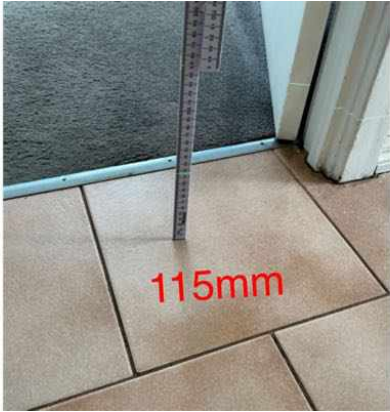
Building:	Main Building
Location:	All Areas
Finding:	floor unevenness - v4
Information:	The standard laser level was positioned 125 mm above the floor, as shown in the photo. The measured floor deviation across the room ranges from the lowest point to the highest point by approximately 10mm

Considering the age of the property and no visible significant cracks were observed at time of inspection. This degree of settlement is generally within an acceptable range for a building of its era. However, for buyers who have higher expectations regarding floor levelness or sensitivity to uneven floors, it should be noted that restumping or re-leveling can involve a considerable cost. This should be taken into account when planning the overall purchase budget.

For further information or investigation, contact a licensed builder for cost estimation and a structural engineer to assess the extent of settlement and the condition of the stumps.

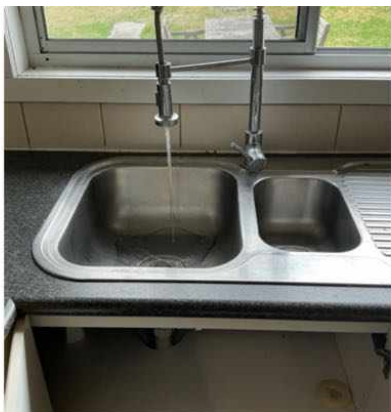
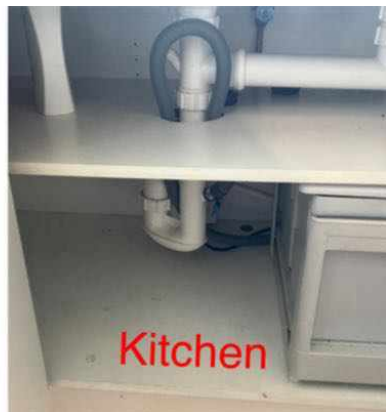
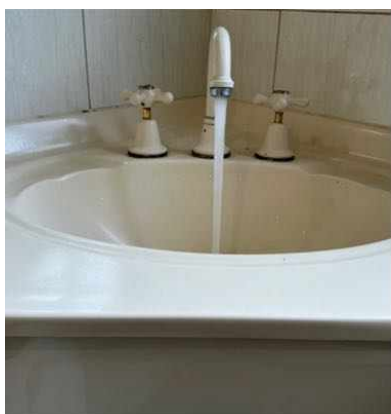
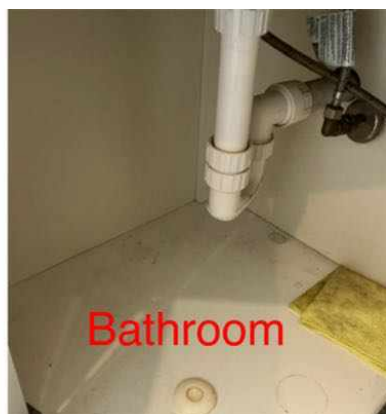
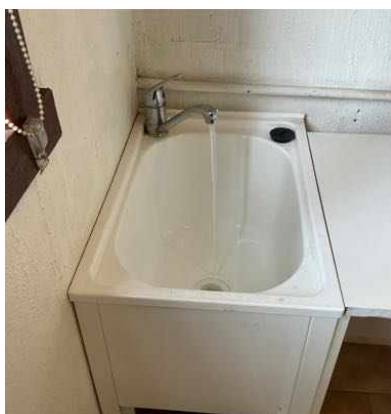
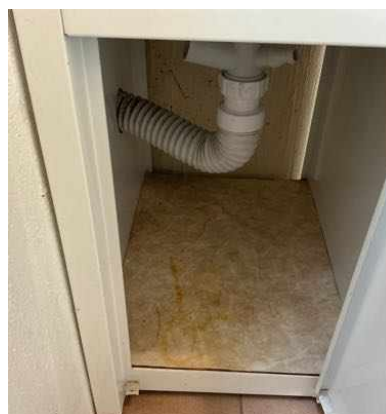
Building: Main Building
Location: Cabinetry plumbing
Finding: For your information
Information: Cabinetry plumbing - No leaks evident

All cupboards where sinks and basins with drainage plumbing were inspected and no evidence of leaks were present at the time of inspection.

For your information only no remedial works are required at the time of inspection.

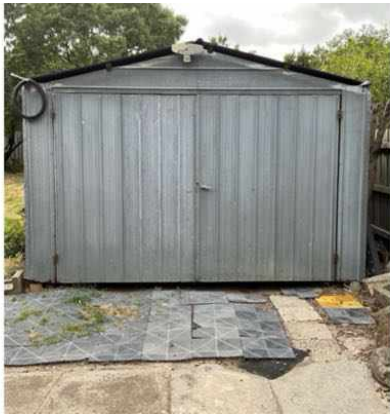
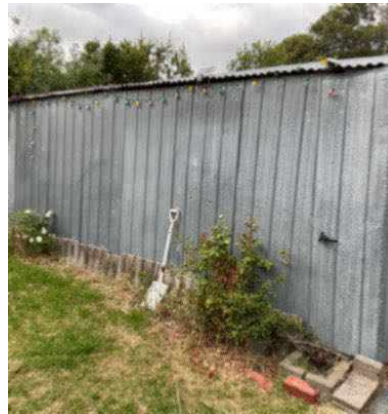
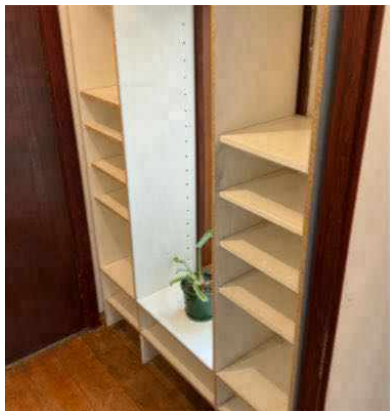
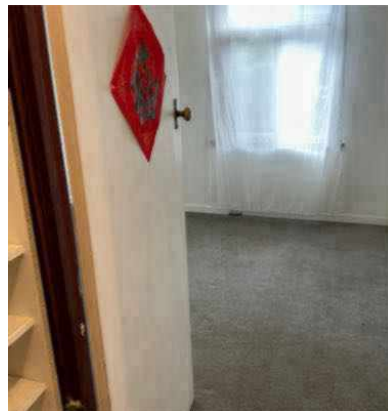
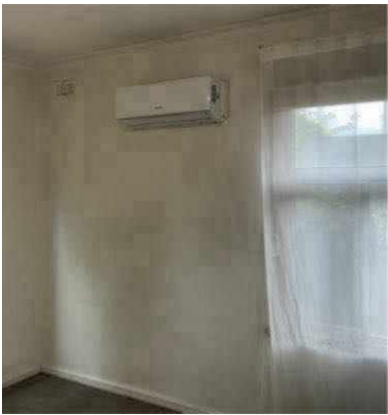
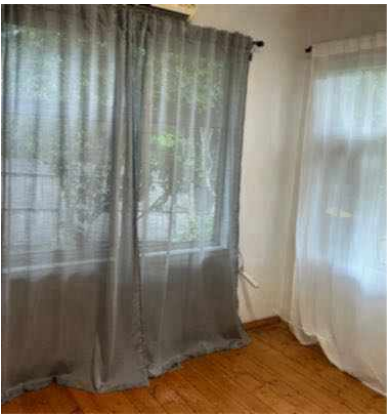
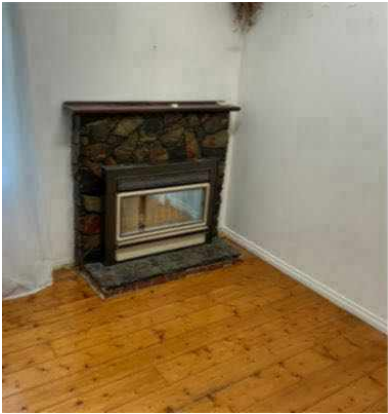
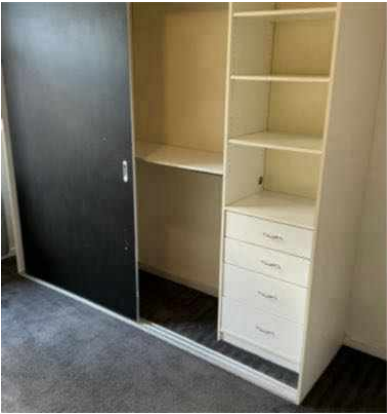
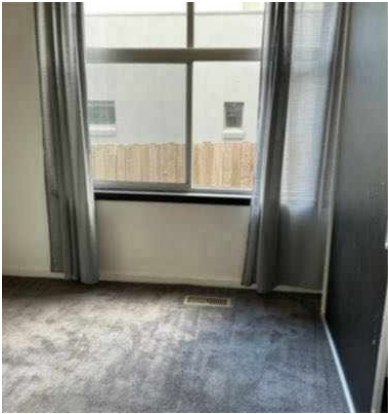
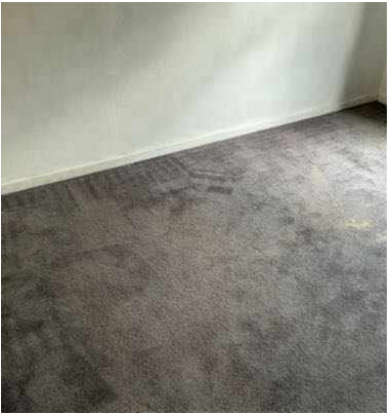
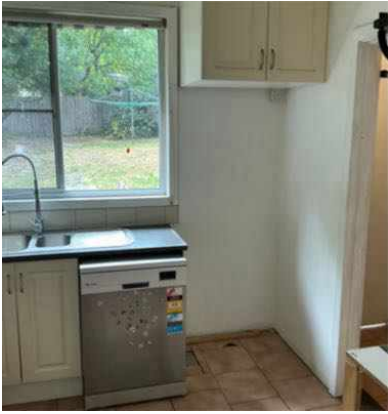
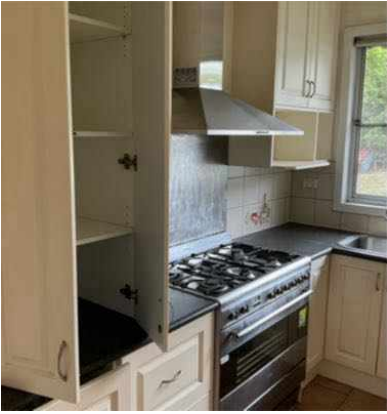
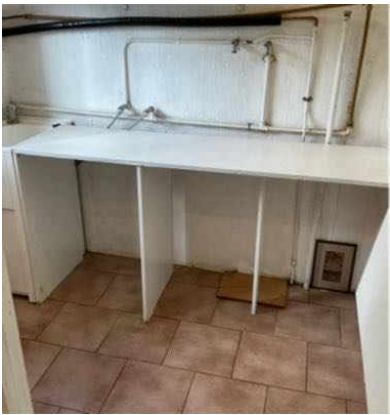
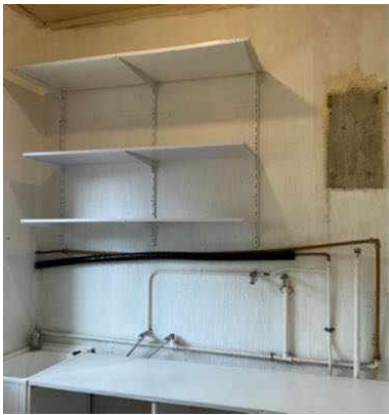
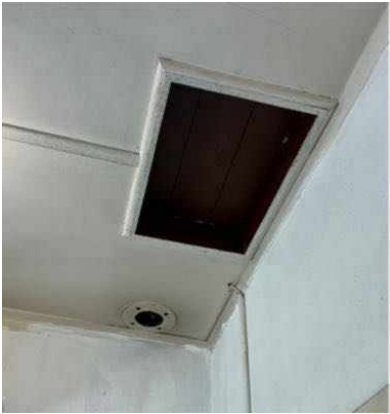
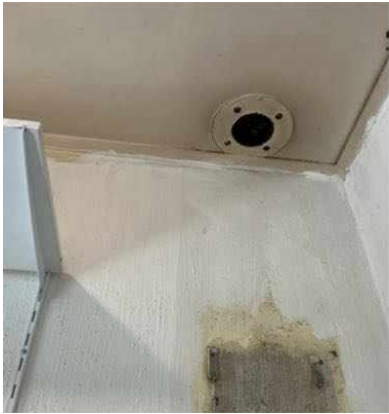
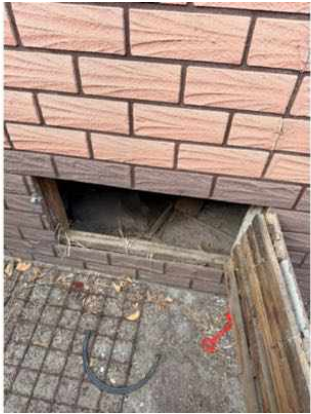
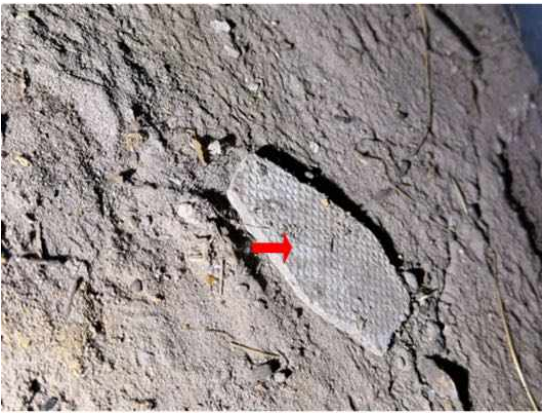
Building: Main Building
Location: All Areas
Finding: Additional Photos - Obstructions and Limitations
Information: These photographs are an indication of the obstructions and limitations which impeded full inspection of the property at the time of inspection. These obstructions can hide an array of defects and should be removed to allow full inspection to be carried out. A re-inspection is recommended once the areas are made accessible. Arrows and highlights have been included to identify minor defects. The purchaser can discuss further with the building inspector.
