## Building Inspection Report

Inspection Date: Thu, 22 Jan 2026

Property Address: 19A Gloucester Ave, MERRYLANDS, NSW,  
2160, Australia

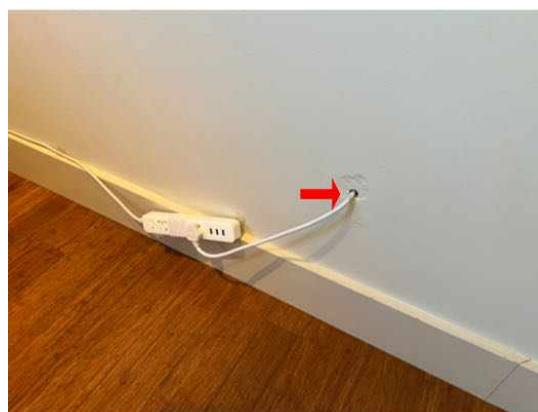
Building:	Main Building
Location:	Bedroom 4
Finding:	Exposed Electrical Cable to Internal Wall
Information:	An exposed electrical cable was observed protruding from the internal wall surface, with a power board connected externally.

Exposed electrical wiring presents a potential safety hazard, as it increases the risk of electric shock, accidental damage to the cable, and non-compliant electrical installation practices. The absence of a proper wall plate or conduit protection means the wiring is vulnerable to mechanical damage and does not appear to meet current electrical safety standards.

It is recommended that this issue be rectified as a priority by a licensed electrician. The cable should be correctly terminated within an approved outlet, conduit, or wall plate to ensure compliance and to eliminate potential safety risks. Repairs should be undertaken as soon as practicable.

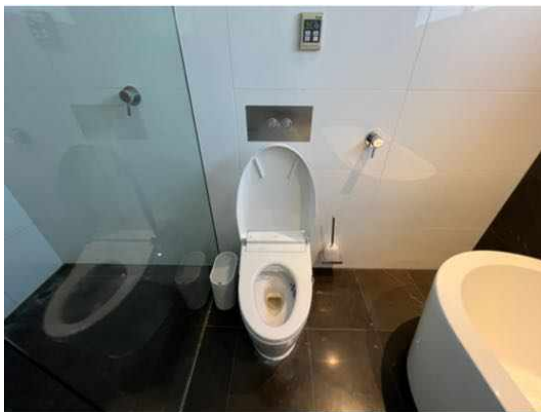
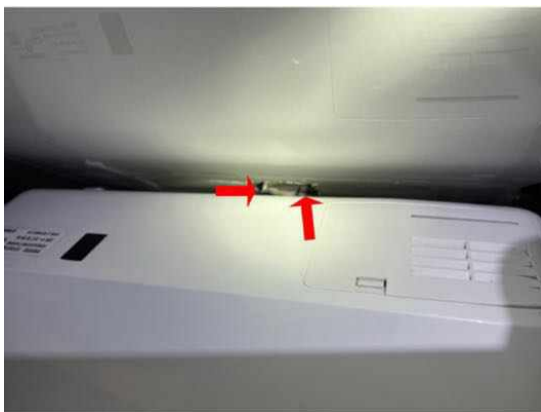
Building:	Main Building
Location:	Bathroom 2
Finding:	Unsecured Electrical Wiring Behind Toilet
Information:	An electrical cable was observed unsecured and inadequately protected behind the toilet cistern.

is present in close proximity to plumbing fixtures and moisture-prone surfaces.

Unsecured electrical wiring poses a potential safety risk, particularly within wet areas. The lack of proper fixing, mechanical protection, or enclosure increases the risk of damage to the cable, potential electric shock, and does not appear to comply with current electrical safety standards. The location behind the toilet also restricts visibility and access, increasing the likelihood of the issue remaining unnoticed.

It is recommended that this matter be rectified as a priority by a licensed electrician. The wiring should be properly secured, enclosed, and terminated in accordance with current electrical regulations to eliminate safety risks. Repairs should be carried out as soon as practicable.

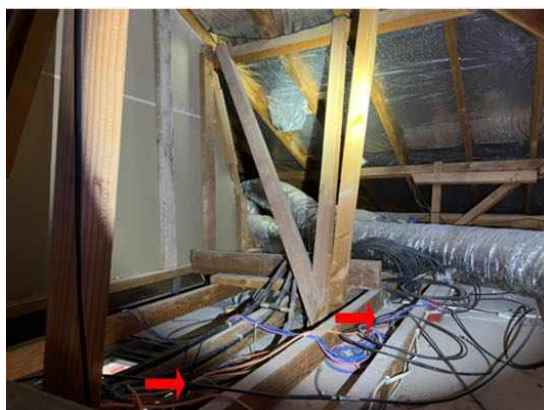
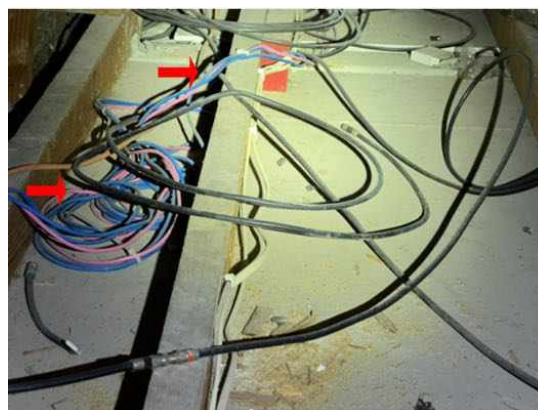
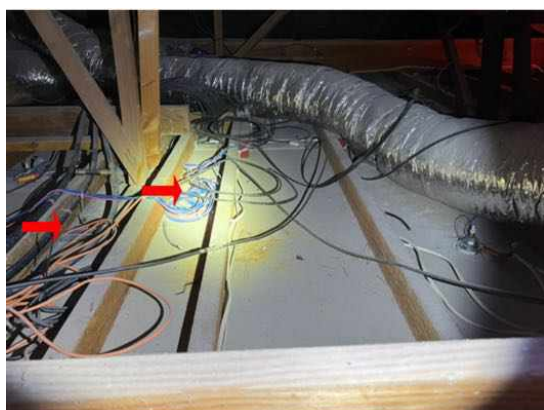
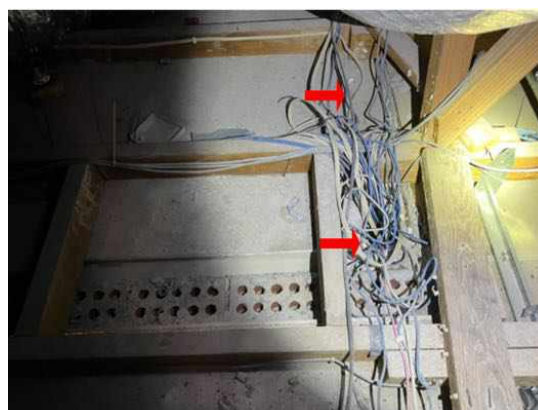
Building:	Main Building
Location:	Roof Void
Finding:	Unsafe Electrical Wiring in Roof Void
Information:	Electrical wiring was observed within the roof void that is not adequately supported, secured, or neatly run.

Electrical wiring that is loosely run, poorly supported, or inadequately fixed presents a potential safety hazard. Improperly installed wiring may be subject to mechanical damage, abrasion, or stress over time, increasing the risk of electrical faults, short circuits, or fire. The condition observed does not appear to meet acceptable installation practices for roof void wiring.

It is recommended that a licensed electrician be engaged as a priority to assess and rectify the wiring installation. The wiring should be properly supported, secured, and installed in accordance with current electrical safety standards to reduce the risk of damage and potential fire or electrical hazards.

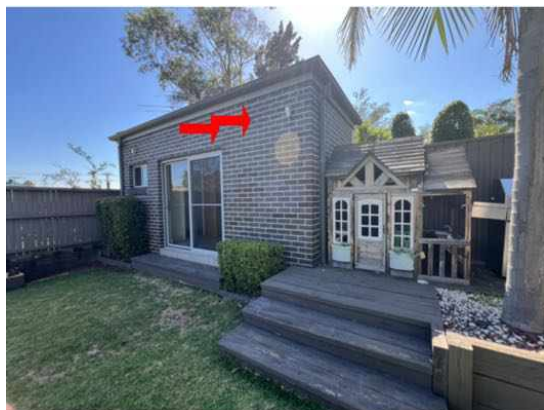
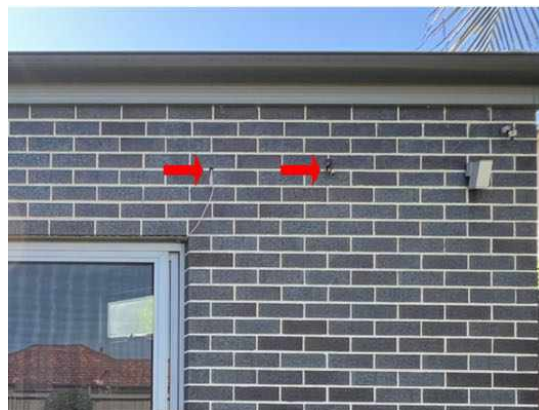
Building:	Out Building
Location:	Exterior walls - front
Finding:	Electrical – Unsecured External Cabling
Information:	Electrical cabling was observed hanging loose on the external brick wall of the dwelling. The cabling appears to exit the wall without appropriate mechanical protection, termination, or secure fixing, leaving it exposed to the weather and physical damage. The exact purpose of the cable could not be confirmed at the time of inspection.

This condition is considered an electrical safety hazard as unsecured and exposed

cabling may deteriorate due to UV exposure, moisture ingress, or accidental contact, increasing the risk of electrical faults or shock. It is recommended that a licensed electrician assess the installation and either correctly terminate, remove, or securely fix and protect the cabling in accordance with current electrical standards. This should be addressed as soon as practicable to reduce potential safety risks.

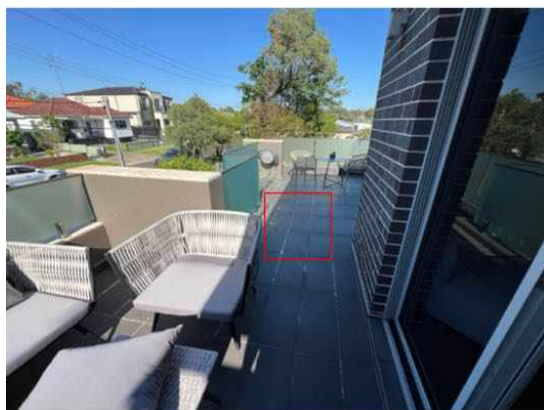
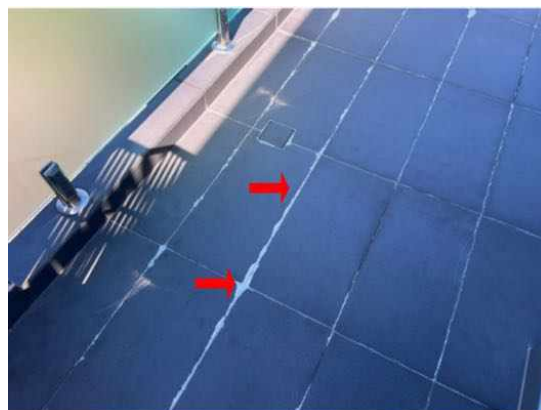
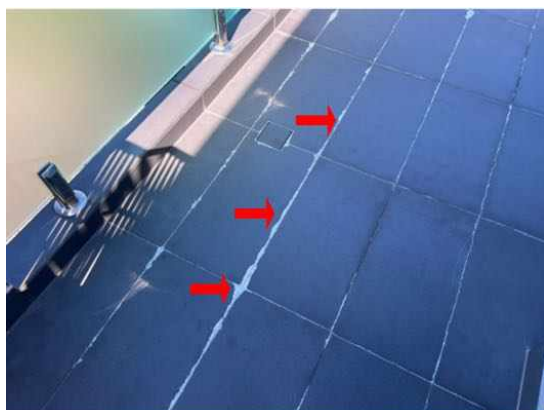
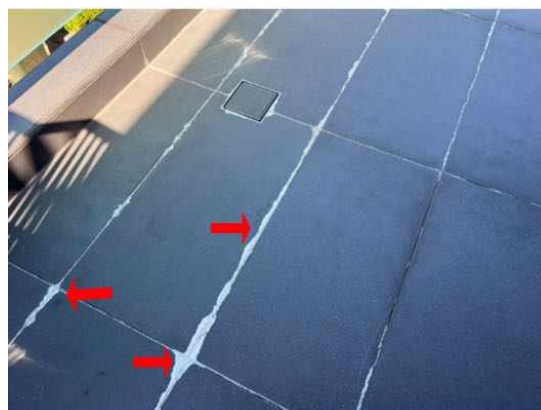
Building:	Main Building
Location:	Front Elevation
Finding:	Deteriorated / Cracked Grout to Main Bedroom Balcony Tiles
Information:	Cracking and deterioration were observed to the grout joints between tiles to the main bedroom balcony floor.

Grout to external tiled areas is subject to thermal movement, weather exposure, and normal ageing. Where grout becomes cracked or deteriorated, it may allow moisture penetration beneath the tiles, which can lead to loosening of tiles and potential waterproofing issues over time if left unaddressed.

It is recommended that the affected grout be raked out and regouted, or resealed with a suitable flexible external-grade grout or sealant as part of routine maintenance. Ongoing monitoring is advised to ensure the condition does not worsen or result in tile movement or water ingress.

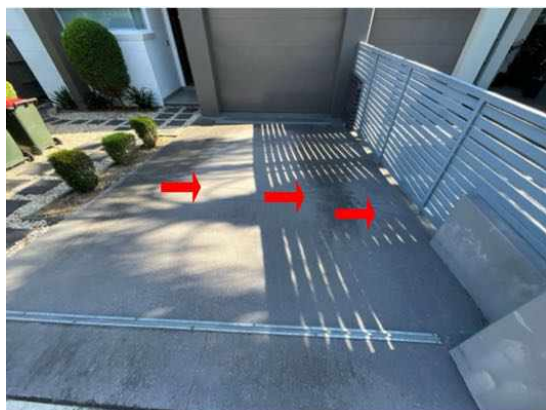
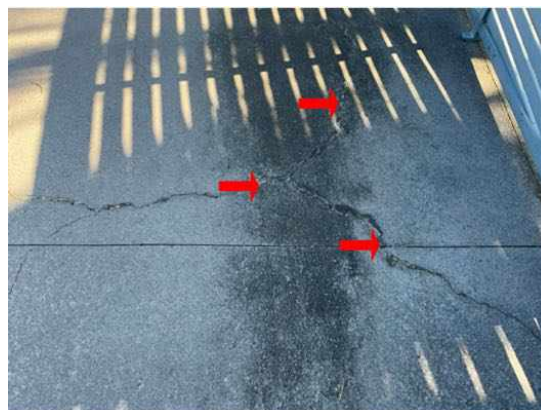
Building:	Main Building
Location:	Driveway
Finding:	Cracking to Concrete Driveway
Information:	Cracking was observed to the concrete driveway surface. The cracking appears to be shrinkage and/or movement related and is evident across sections of the driveway slab.

The cracking is located within the driveway leading to the garage, including areas adjacent to the boundary fencing and garage entry.

Concrete cracking can occur due to ground movement, moisture variation, thermal expansion and contraction, inadequate control joints, or general ageing of the material. While the cracking observed appears to be minor to moderate in nature at the time of inspection, it may allow moisture ingress over time, which can contribute to further deterioration of the concrete and potential unevenness if left unaddressed.

It is recommended that the cracks be monitored and sealed as a minimum to reduce water penetration. If cracking worsens, becomes uneven, or presents a trip hazard, further assessment and repairs by a suitably qualified concreter should be undertaken.

Rectification should be considered within a reasonable timeframe to prevent further deterioration.

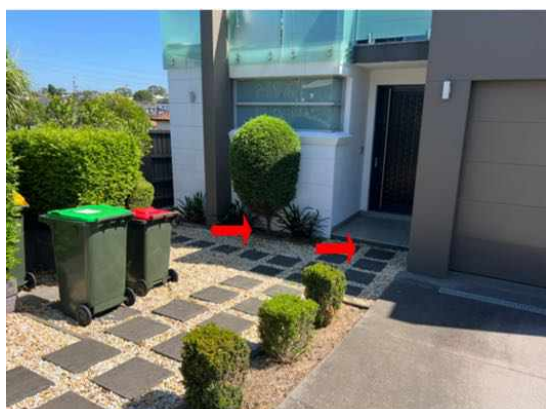
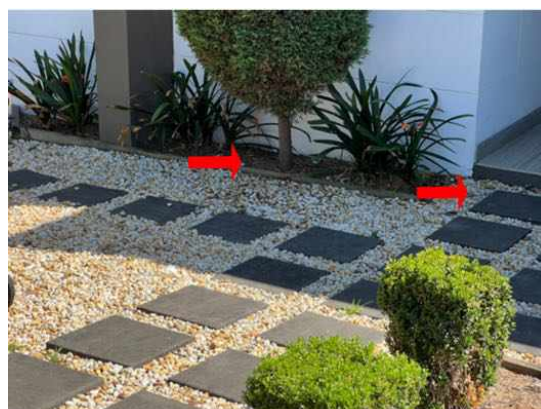
Building:	Main Building
Location:	Yard - Front
Finding:	Site drainage - Inadequate
Information:	The site drainage in this area was found to be inadequate at the time of inspection, creating potential for subsequent water damage to associated building elements.

It is important that water does not lie against the base of walls; surrounding paths and ground levels should be sloped to drain water away from walls. Downpipes should not discharge stormwater onto lower walls or plinths. Stormwater should be carried away by large, regularly cleaned drains. Ground levels may need to be lowered to expose a buried DPC.

Where site drainage is inadequate, installation of an Agricultural (Aggie) Drain may be required. A qualified plumber should be appointed to further inspect the property and perform any remedial works as necessary. Water damage and secondary defects are likely to occur if left unmanaged.

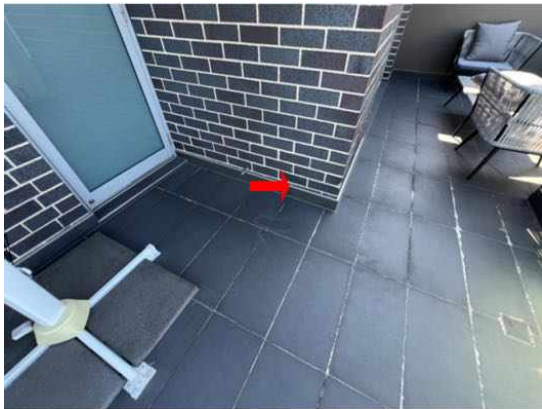
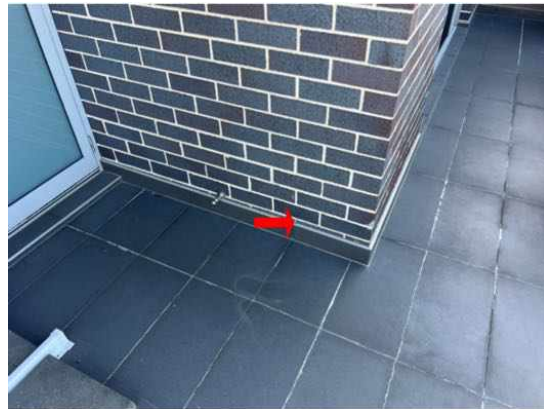
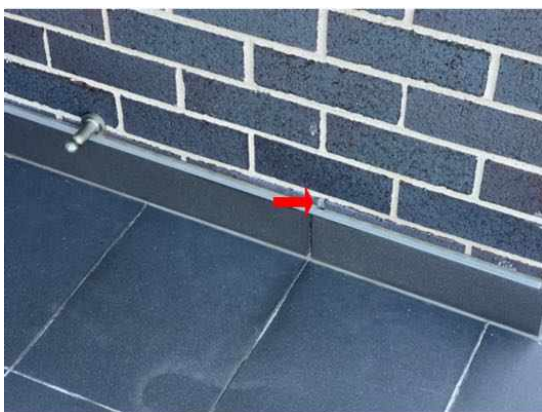
Building: Main Building  
 Location: Balcony - Master bedroom  
 Finding: Weep holes - Blocked  
 Information: It was noted during the time of inspection that some of the weep holes to the brickwork were blocked. Weep holes are designed to allow water from leaks or seepages in brickwork to be directed to the external environment, prior to entering the wall cavity or associated building materials. Weep holes should therefore be kept clean and free of debris or blockages.

Blocked weep holes are likely to result in the presence of excessive moisture within the brickwork and associated structures, creating potential for water damage and moisture problems.

Depending on the nature of the blockage, the homeowner may be able to undertake remedial works to remove blockages. Alternatively, appointment of a registered builder may be required to remove blockages. Preventative works are necessary in ensuring the structural integrity of the affected brickwork and should be performed as soon as possible.

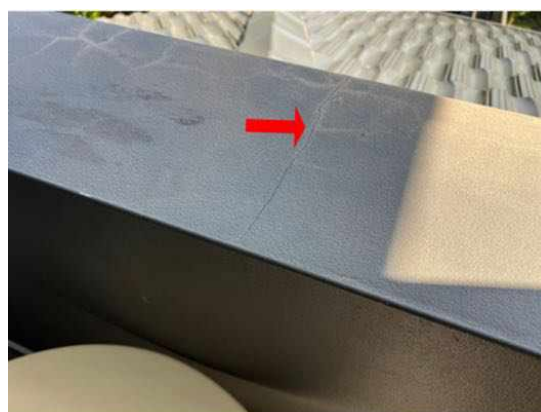
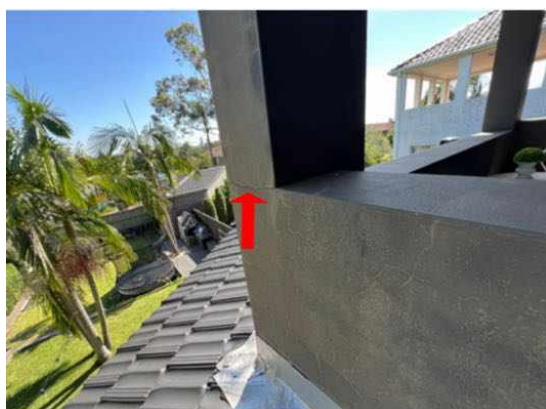
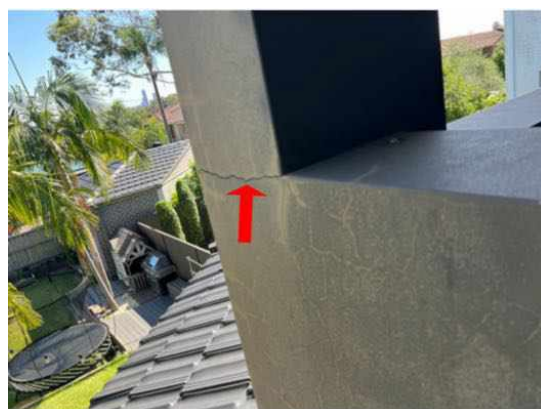
Building: Main Building  
 Location: Balcony - Bedroom 2

Finding: Cracking to Bedroom 2 Balcony Walls

Information: Cracking was observed to the rendered masonry surfaces forming the Bedroom 2 balcony walls. The cracking appears to be hairline to minor in width and is typical of movement or shrinkage within rendered finishes.

The cracking is located along sections of the balcony wall, including the top edge and vertical wall surfaces adjacent to the balcony area of Bedroom 2.

Rendered masonry elements are susceptible to cracking due to thermal movement, differential movement between materials, building settlement, or shrinkage of the render over time. While the cracking observed is minor at the time of inspection and does not appear to be structural in nature, it may allow moisture penetration if left unsealed, particularly given the exposed nature of balcony areas.

It is recommended that the cracks be monitored and sealed with an appropriate flexible exterior sealant and redecorated as required to maintain weather resistance. If cracking increases in width, length, or becomes recurrent after repairs, further assessment by a suitably qualified builder or structural engineer may be warranted. Repairs should be carried out within a reasonable timeframe as part of ongoing maintenance.

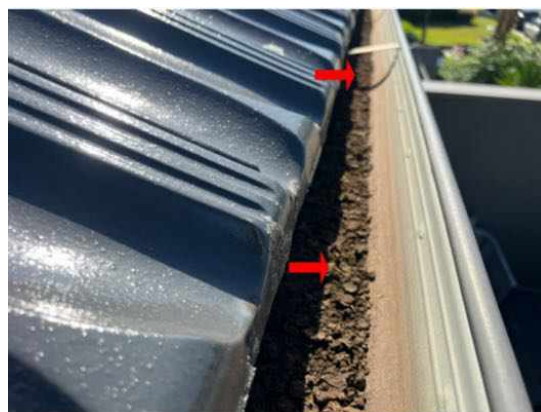
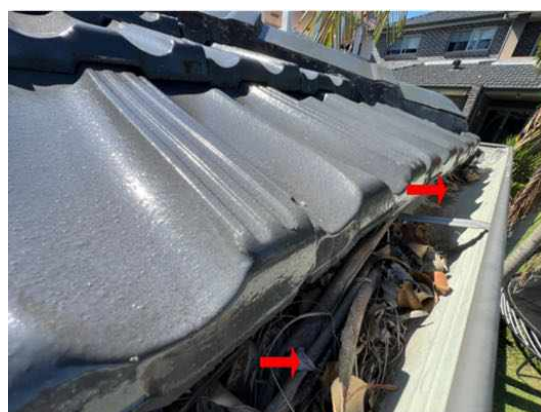
Location: Roof Exterior  
 Finding: Debris Accumulation to Gutters  
 Information: Accumulated debris was observed within sections of the roof gutters at the time of inspection.

Debris accumulation within gutters can restrict the free flow of rainwater, increasing the risk of water overflow, which may lead to moisture damage to fascia boards, eaves, and external wall surfaces. Prolonged blockage can also contribute to premature deterioration of the guttering system.

It is recommended that the gutters be cleaned and cleared of debris as part of routine property maintenance. Ongoing periodic cleaning is advised, particularly in areas subject to leaf litter, to ensure the guttering system continues to function as intended.

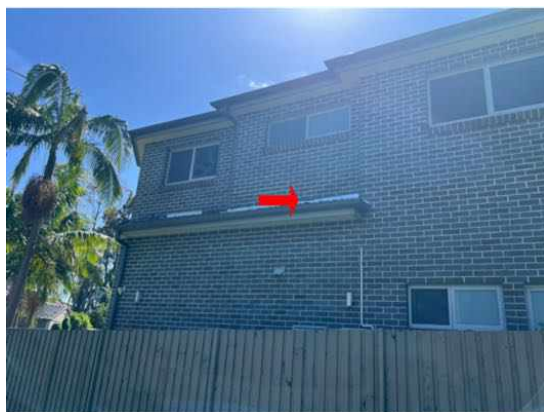
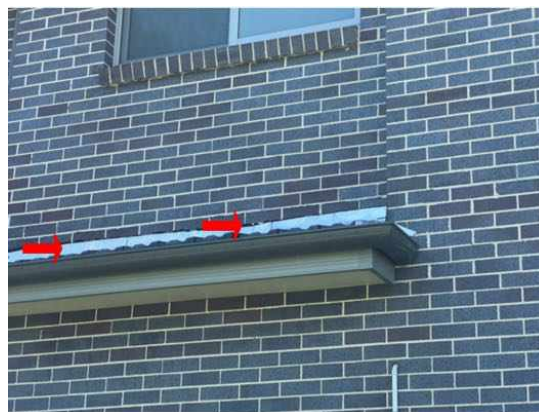
Building: Main Building  
 Location: Roof Exterior  
 Finding: Roof plumbing - Loose flashing  
 Information: Metal and other material flashings are applied to seals and intersections between roof

coverings and building elements. They are designed to aid in weatherproofing of roof joints, and require regular inspection and maintenance as they are more subject to rust-related deterioration.

The flashing in this section of the exterior roofing appears to have come loose from its original fixing. It is suspected that this minor defect has occurred as a result of general deterioration over time.

Re-fixing and potential replacement of certain areas of flashing is advised to promote adequate roof drainage and protection from water penetration. Failure to perform these works may result in water damage and accelerated deterioration of associated building elements.

A roofing contractor or roofing plumber should be appointed as soon as possible to restore the flashing to a fully operational state.

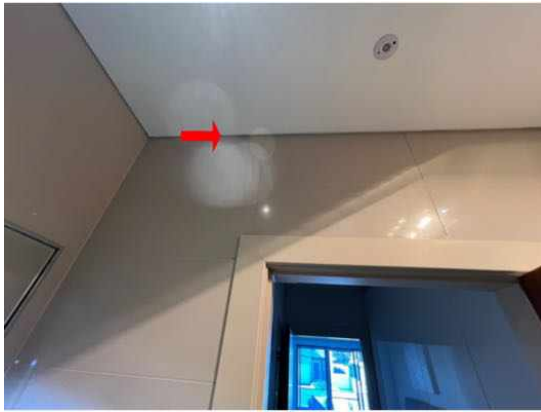
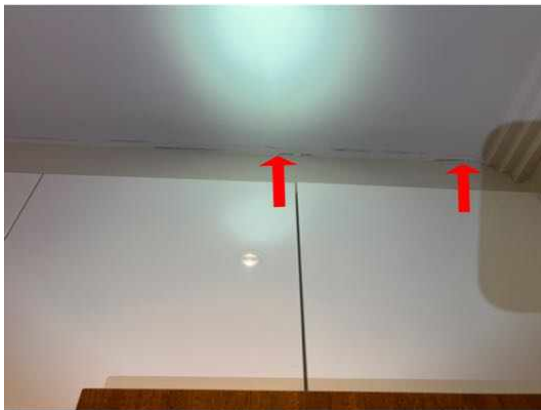
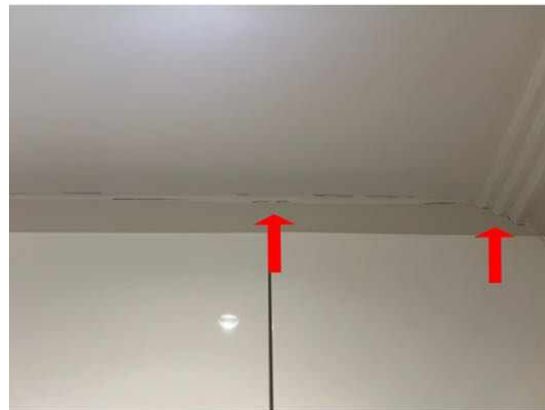
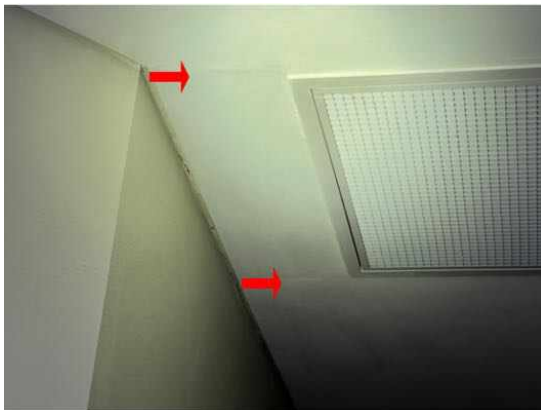
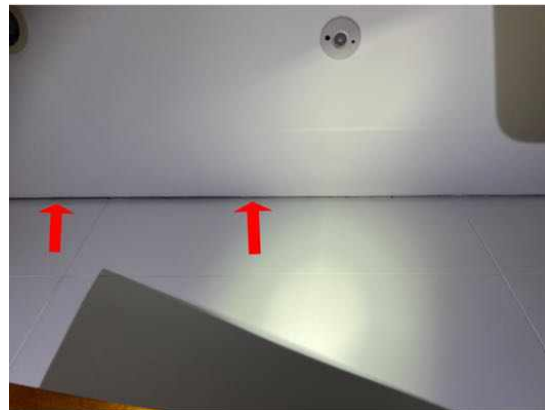
Building:	Main Building
Location:	All Internal Areas
Finding:	Hairline Cracking to Upstairs Ceilings
Information:	Hairline cracking was observed to the ceiling linings in the upstairs areas of the dwelling.

The cracking is located along ceiling junctions and joint lines, including areas adjacent to cornices.

Hairline cracking to plasterboard ceilings is common and typically results from minor building movement, thermal expansion and contraction, or natural settlement over time. The cracking observed is cosmetic in nature and does not appear to indicate a structural issue at the time of inspection.

No immediate action is required other than ongoing monitoring. If the cracking increases in width, length, or is accompanied by sagging, staining, or moisture-related indicators, further assessment by a suitably qualified tradesperson or building

professional may be warranted.

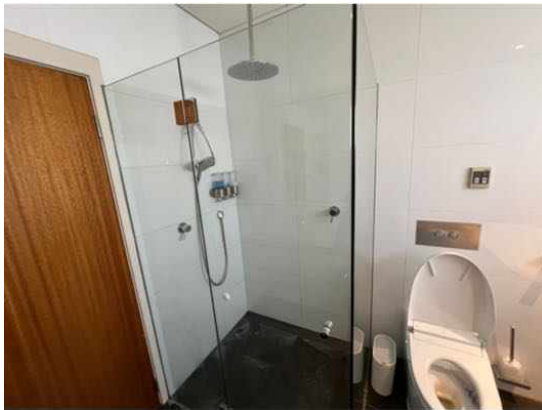
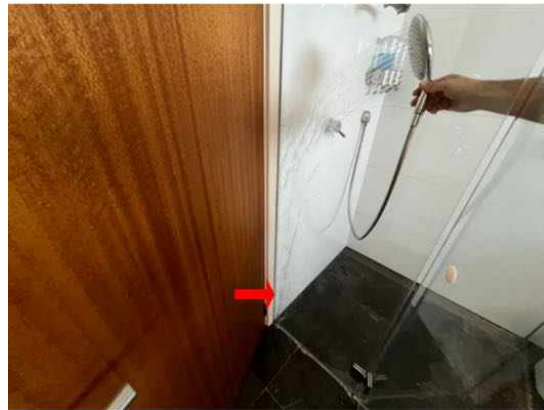
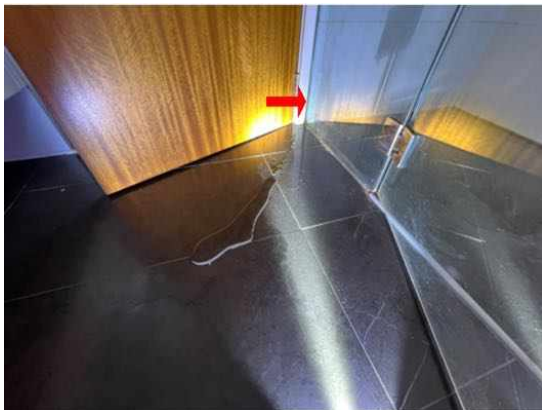
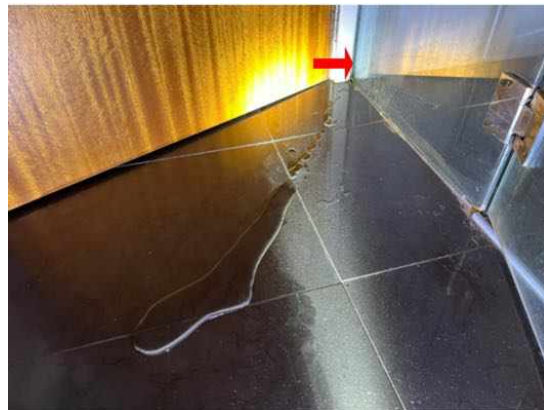
Building: Main Building  
 Location: Bathroom 2  
 Finding: Water Leakage at Shower Screen  
 Information: Water leakage was observed escaping past the shower screen and onto the bathroom floor during operation of the shower.

The leakage is occurring at the base and junctions of the shower screen, including areas adjacent to the bathroom door and surrounding floor tiles.

Shower screens are required to effectively contain water within the shower recess. Where water escapes beyond the screen, it can lead to moisture exposure of adjacent floor finishes, wall linings, and joinery. Ongoing leakage may contribute to deterioration of finishes, increased slip risk, and potential moisture-related damage if left unaddressed.

It is recommended that the shower screen seals, alignment, and installation be assessed and rectified by a suitably qualified glazier or bathroom contractor. Repairs should be carried out promptly to ensure the shower screen effectively contains water and to prevent further moisture-related issues.

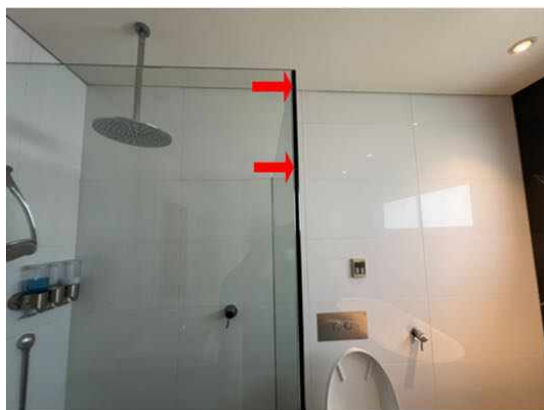
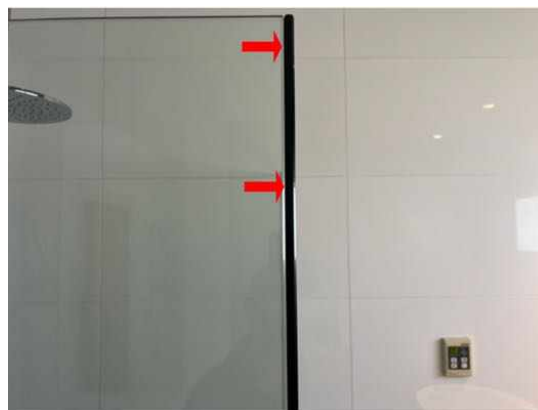
Building:	Main Building
Location:	Bathroom 2
Finding:	Shower Screen Panel Grinding at Upper Section
Information:	The shower screen panel was observed grinding and making contact at the upper section during operation.

at the top indicates misalignment, inadequate clearances, or installation tolerances that may place stress on the glass and associated fixings. If left unrectified, this condition may increase the risk of damage to the shower screen, hardware wear, or potential glass failure over time.

It is recommended that the shower screen alignment be assessed and adjusted by a suitably qualified glazier or bathroom contractor. Rectification should be undertaken to ensure smooth operation and to prevent further wear or potential damage.

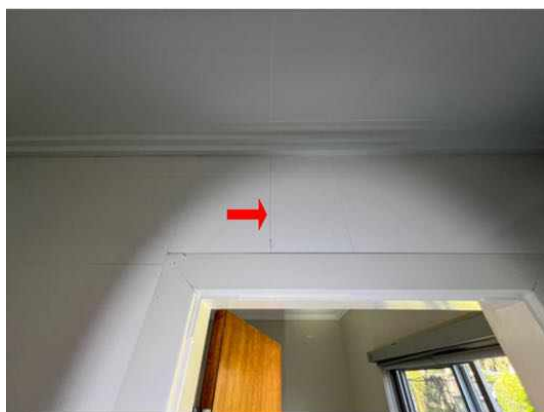
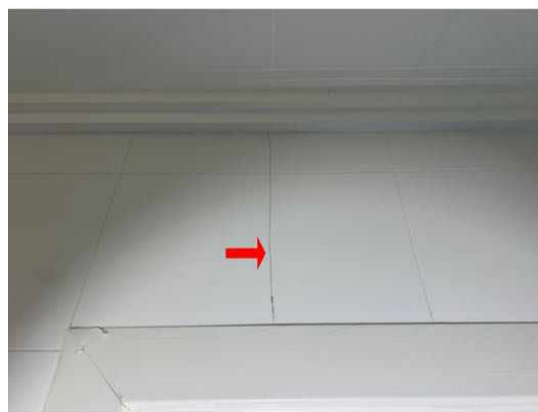
### Defects 3.22

Building:	Out Building
Location:	Living Room
Finding:	Minor Defect – Cracking to Internal Walls
Information:	Hairline cracking was observed to the internal wall linings within the outbuilding. The cracking is primarily located along vertical joints and internal corners of the plasterboard walls and extends from near the ceiling down the wall surface. The cracks appear fine in nature and consistent with minor movement, shrinkage of materials, or normal settlement rather than a structural failure.

At the time of inspection, the cracking was considered a minor defect and cosmetic in nature. While not uncommon in outbuildings, particularly where different construction methods or foundations may be used, these cracks can detract from presentation and may widen over time if left unattended. It is recommended that the cracks be monitored for any signs of progression. Cosmetic repairs, including filling, sanding, and repainting, can be undertaken by a suitably qualified tradesperson as part of routine maintenance, preferably after allowing time to confirm the cracking is stable.

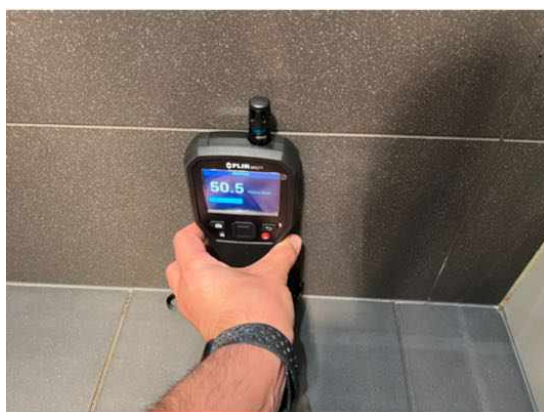
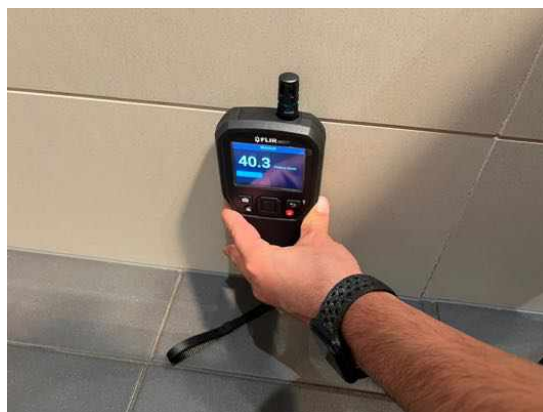
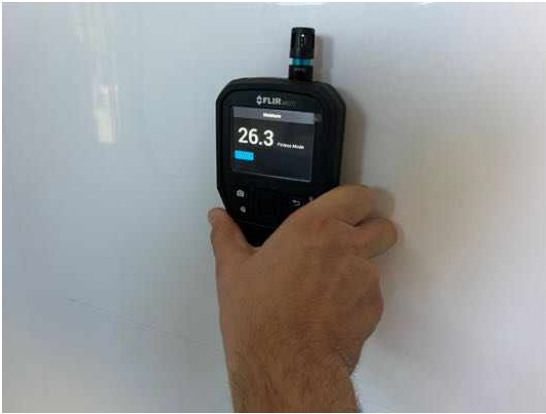
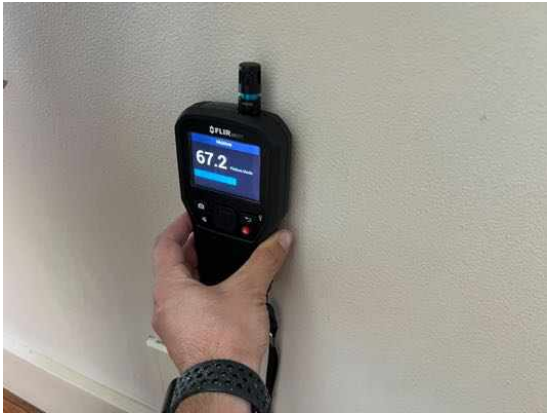
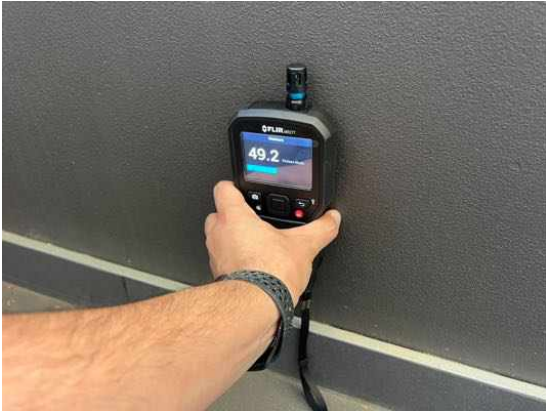
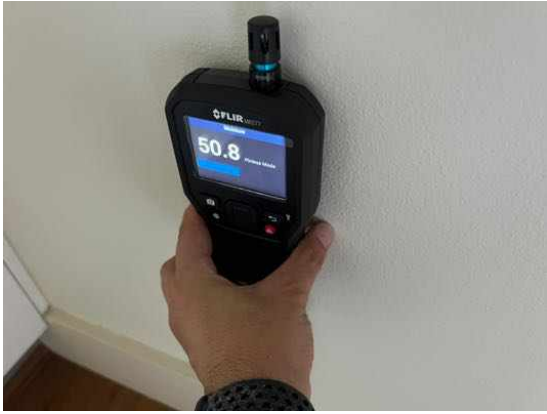
Building: Main Building  
Location: All Areas  
Finding: Moisture metre readings  
Information: Moisture testing was undertaken to selected accessible internal surfaces using a non-invasive moisture meter at the time of inspection. Readings obtained provide an indicative assessment only and are intended as a guide to assist in identifying areas that may warrant further investigation.

No invasive testing was carried out, and moisture readings can be influenced by a range of factors including material type, surface finishes, environmental conditions, and recent use of wet areas. As such, the results are provided for information purposes only and do not constitute a definitive assessment of concealed moisture conditions. Concealed defects may exist that were not evident at the time of inspection.

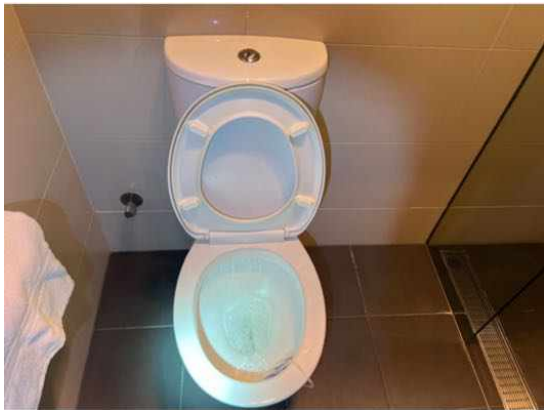
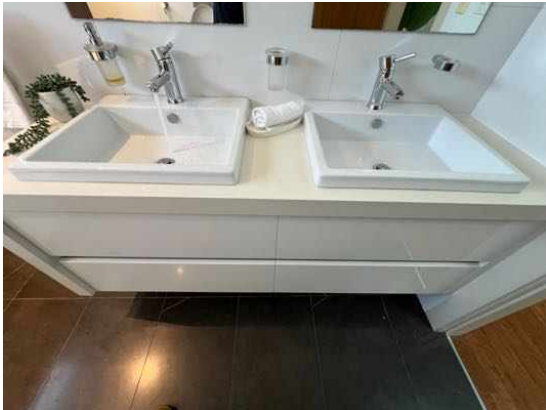
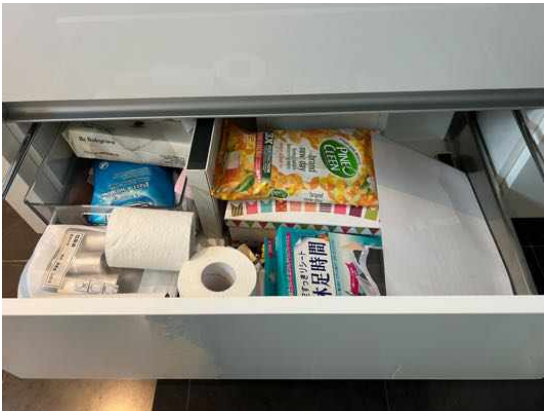
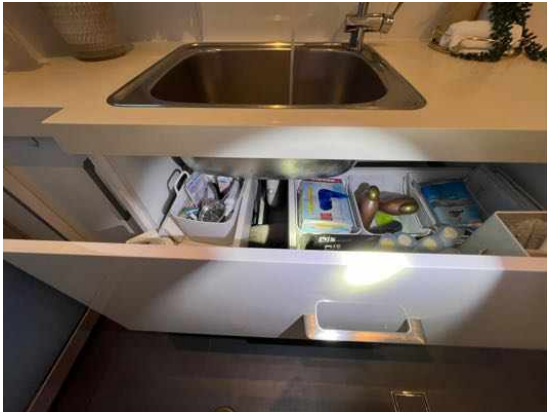
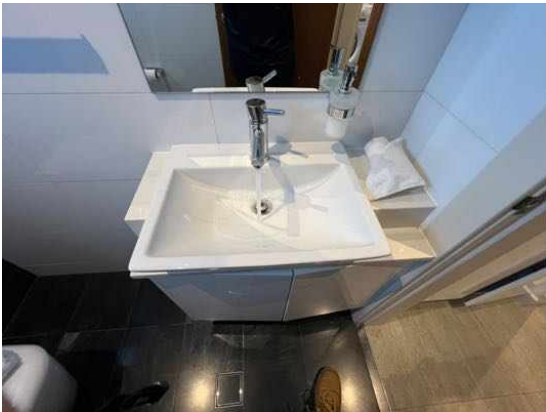
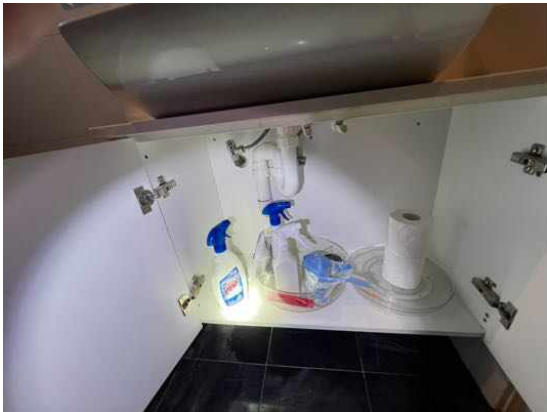
Building: Main Building  
Location: All Wet Areas  
Finding: Waterproofing  
Information: All taps, mixers, and toilets were tested for correct operation, except where access was restricted. The shower recess waterproofing was assessed by conducting non-invasive moisture readings to the walls in and around the shower recess. No abnormal or significant moisture variations were detected within the areas tested. In addition, a visual inspection of the surrounding wall surfaces did not reveal any visible signs of recent or ongoing water damage where inspection was possible.

Based on the above observations, there is no conclusive evidence to suggest the presence of an active shower recess leak at the time of inspection, other than any issues already identified elsewhere in this report. It is therefore reasonable to assume that the shower waterproofing is currently performing as intended. However, it should be noted that if the shower has not been used for an extended period prior to the inspection, moisture readings may not accurately reflect underlying conditions and may result in misleading outcomes. As this inspection is limited to visual and non-invasive methods in accordance with pre-purchase inspection standards, it is not possible to definitively confirm the absence of leaks. If a higher level of certainty is required, a specialist invasive inspection is recommended.

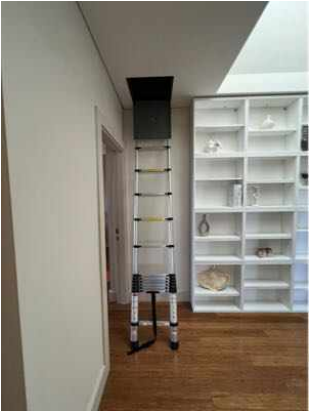
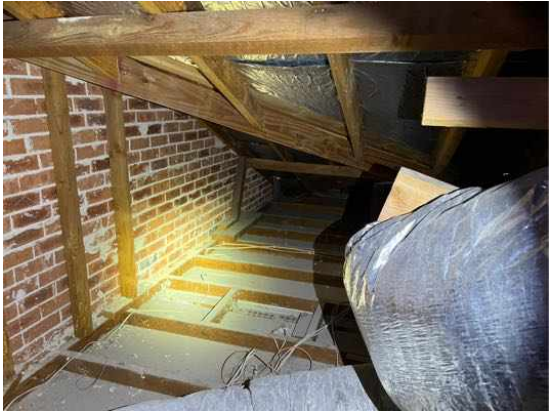
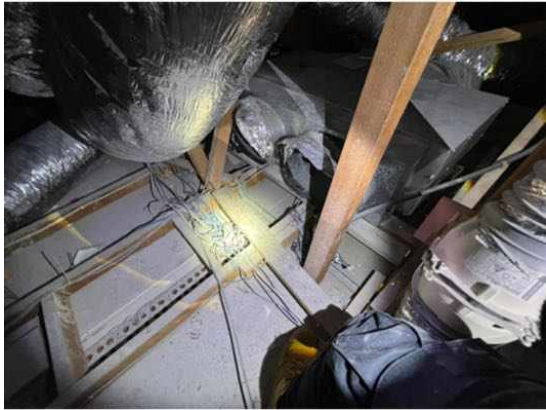
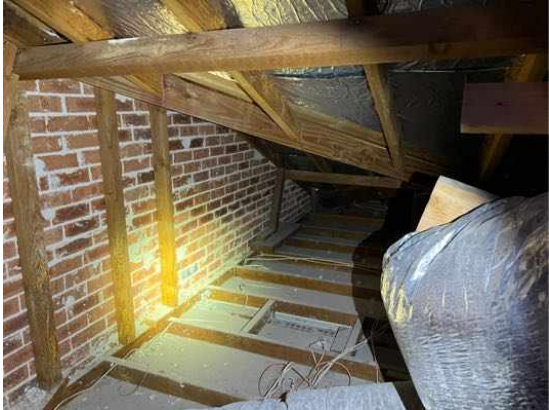
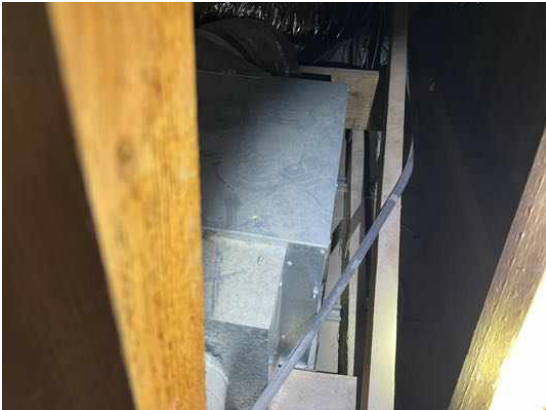
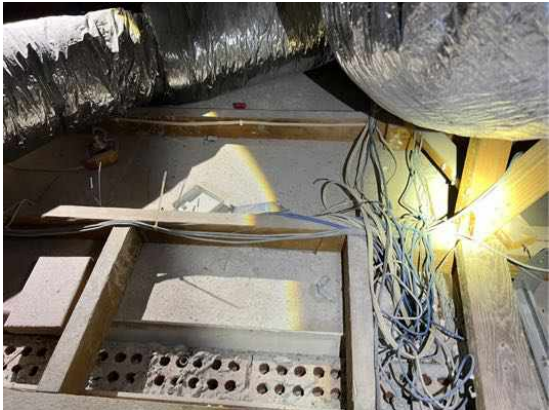
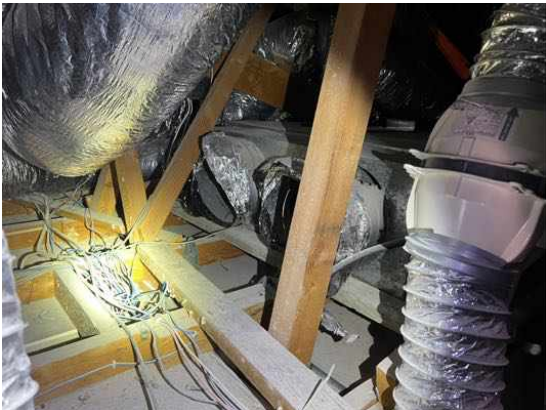
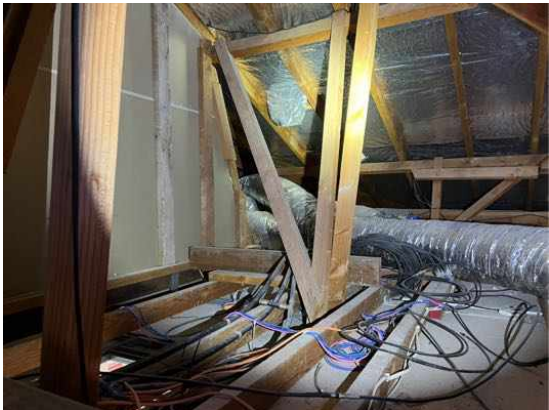
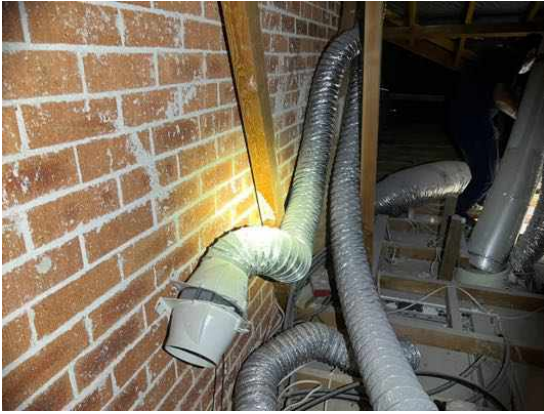
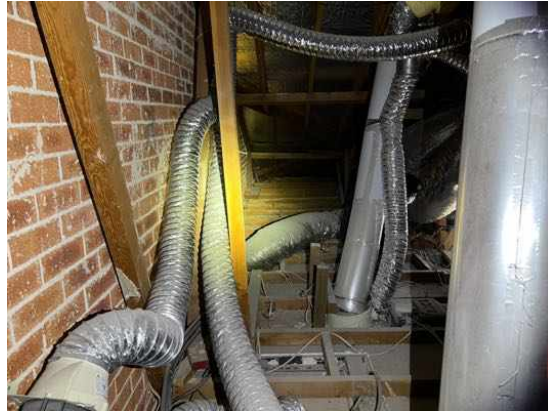
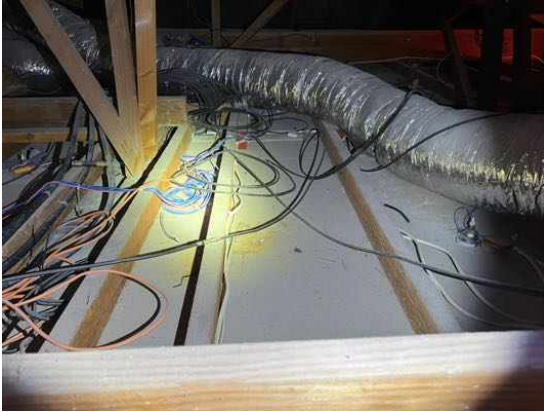
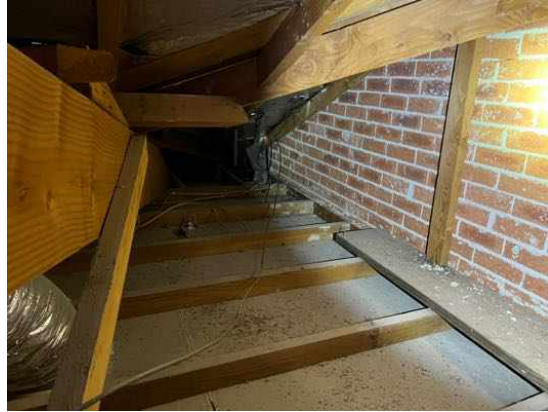
Building: Main Building  
Location: All Wet Areas  
Finding: Roof void additional photos  
Information: Additional photos are provided for your reference.
