## Building Inspection Report

Inspection Date: Thu, 22 Jan 2026

Property Address: 19A Gloucester Ave, MERRYLANDS, NSW,  
2160, Australia

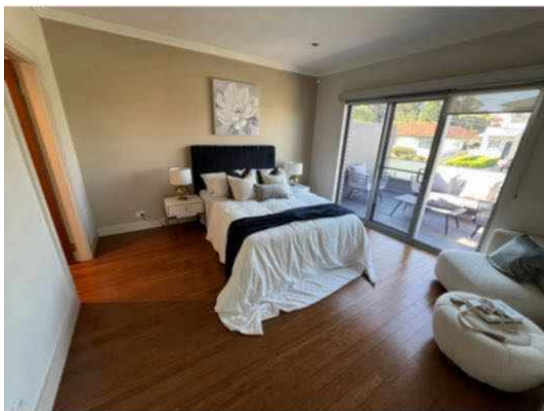
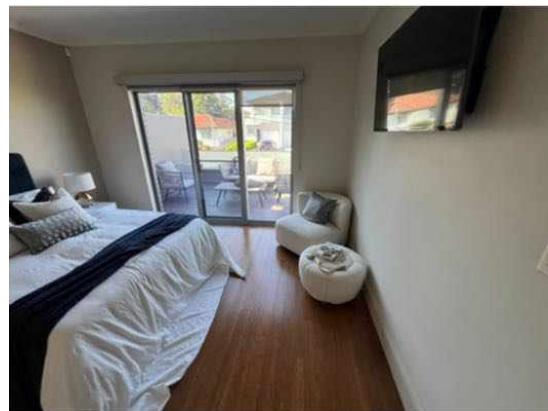
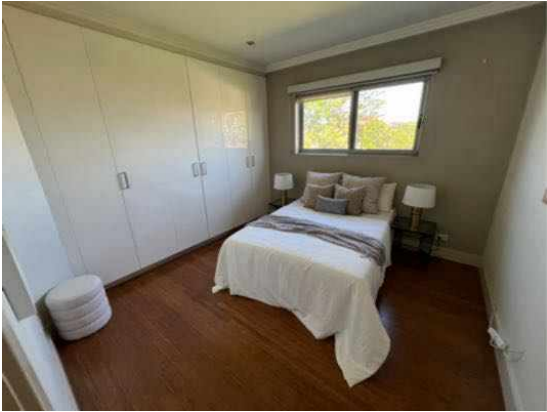
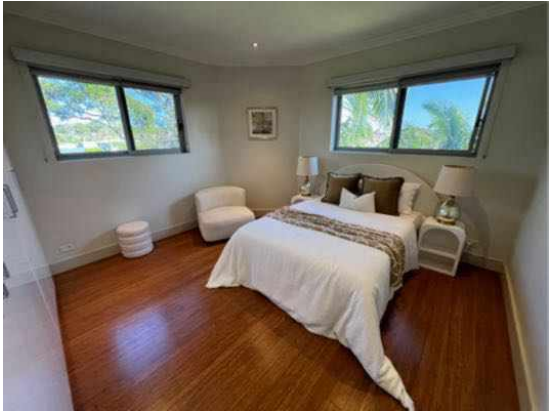
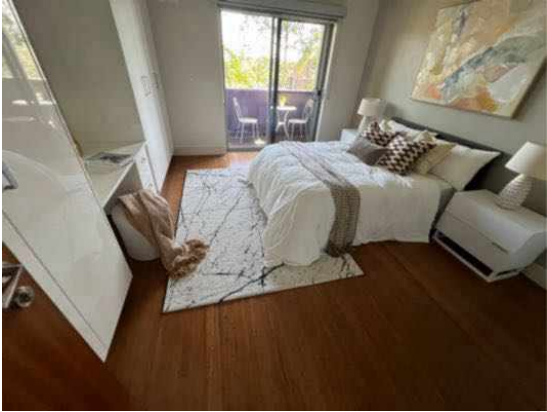
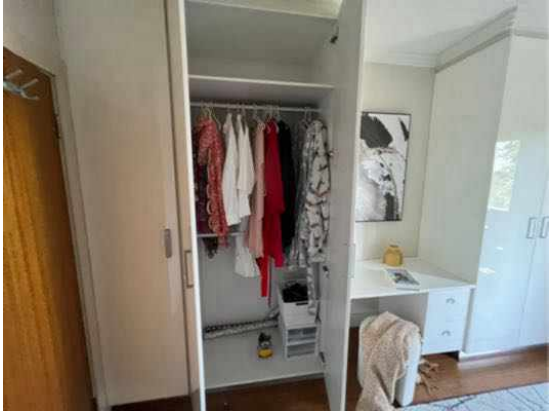
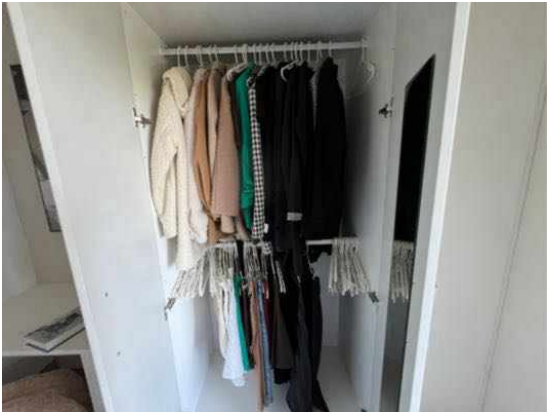
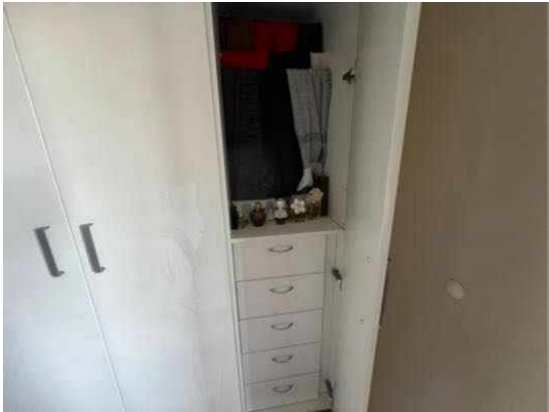
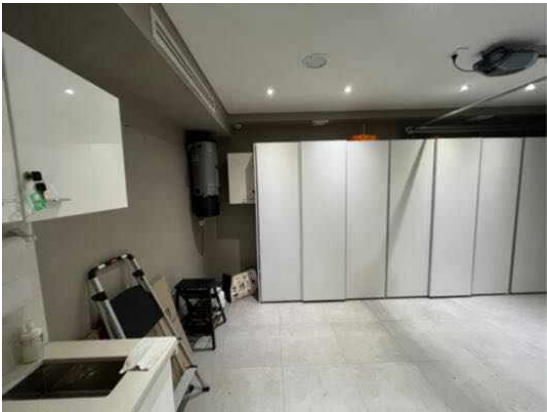
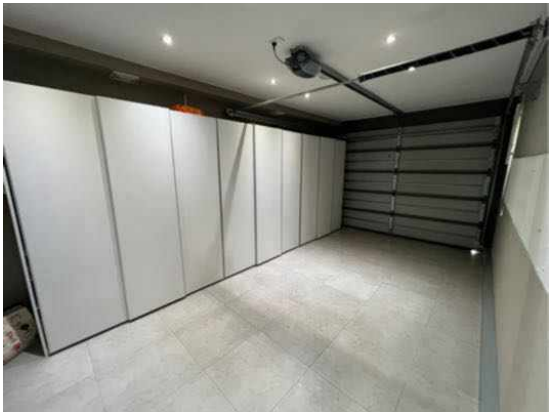
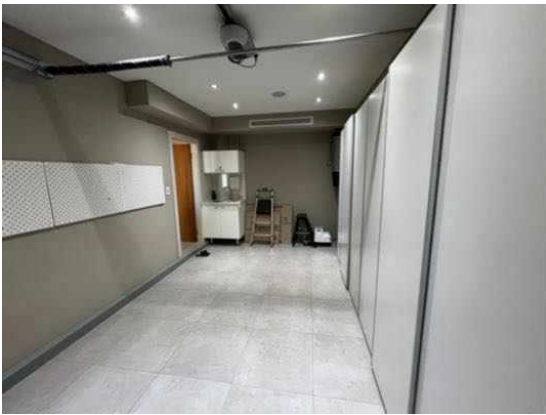
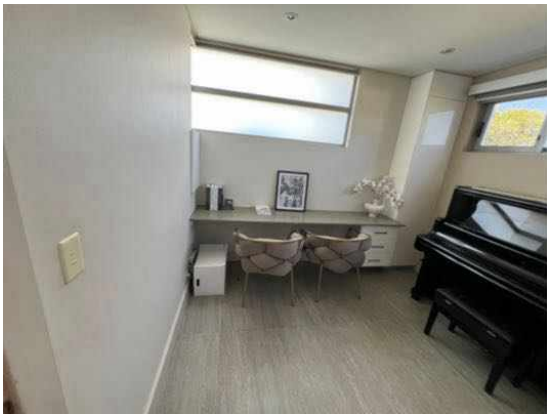
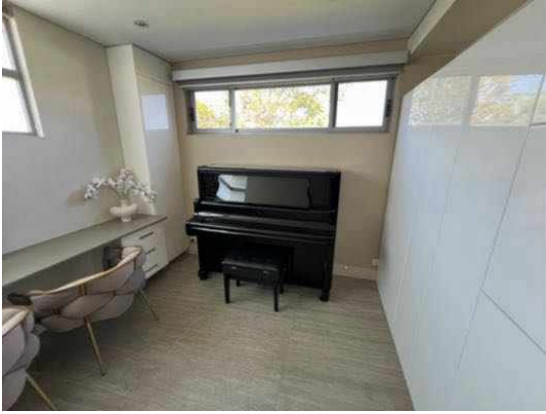
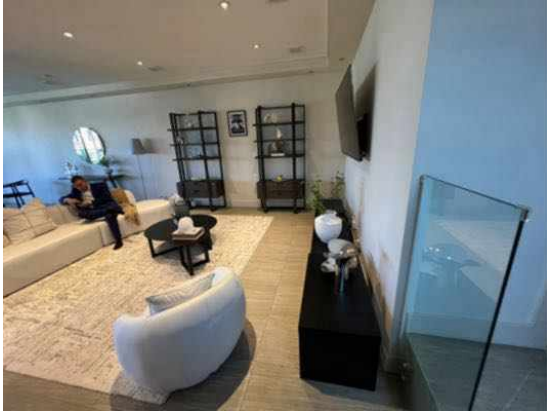
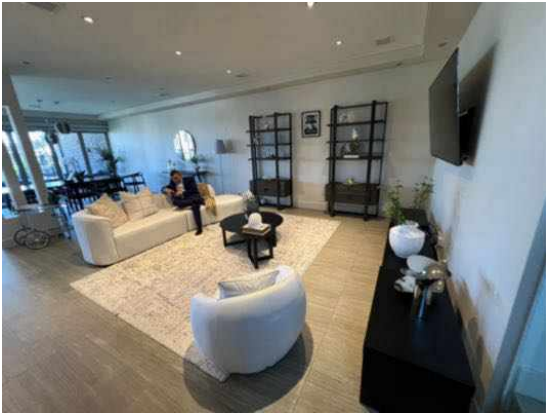
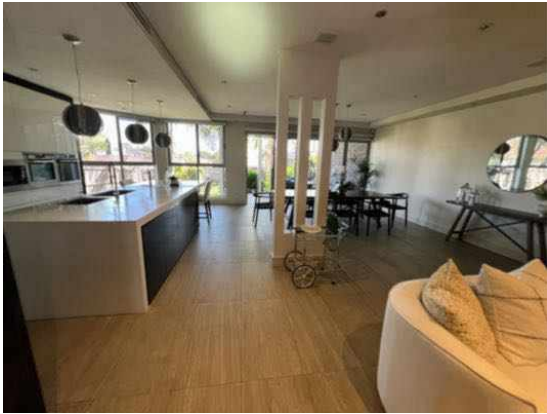
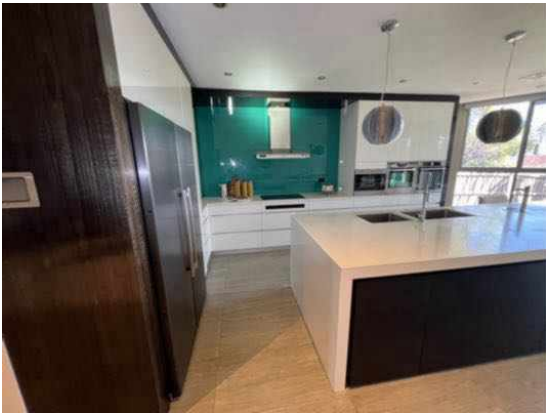
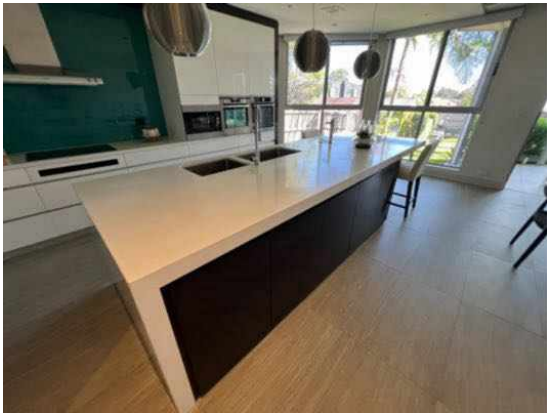
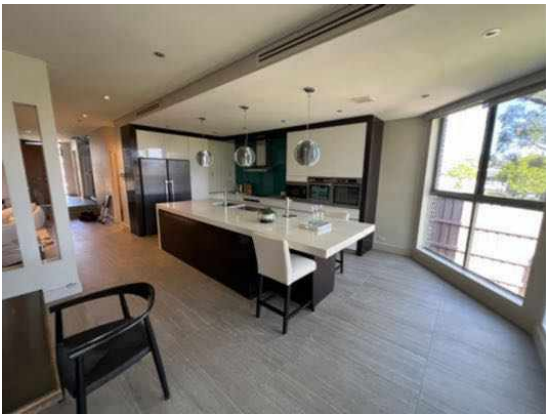
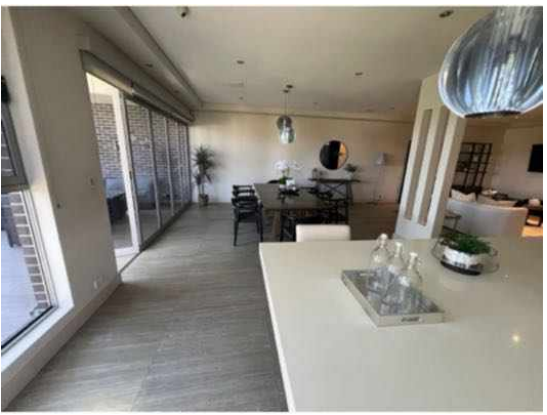
Building: Main Building  
 Location: All Internal Areas  
 Finding: Additional Photos - Obstructions and Limitations  
 Information: These photographs are an indication of the obstructions and limitations which impeded full inspection of the property at the time of inspection. These obstructions can hide an array of defects and should be removed to allow full inspection to be carried out. A re-inspection is recommended once the areas are made accessible.

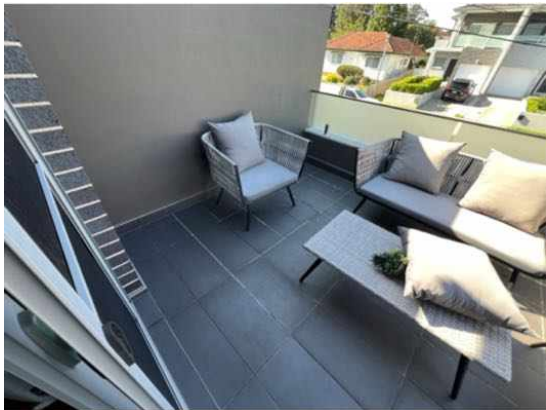
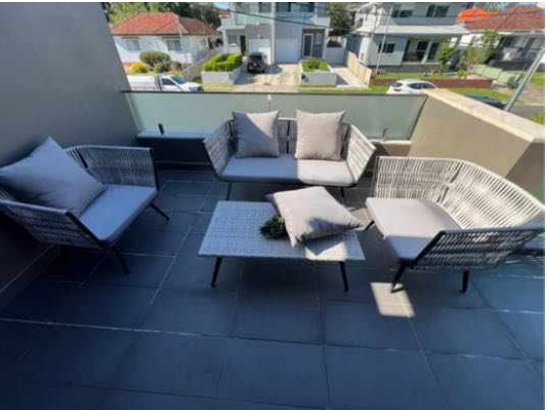
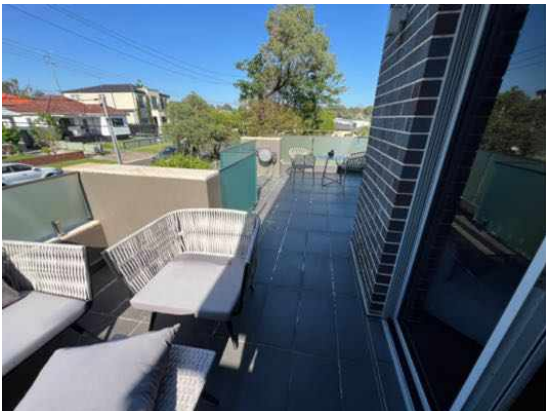
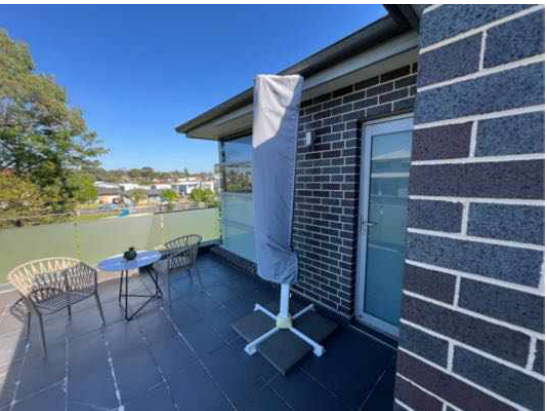
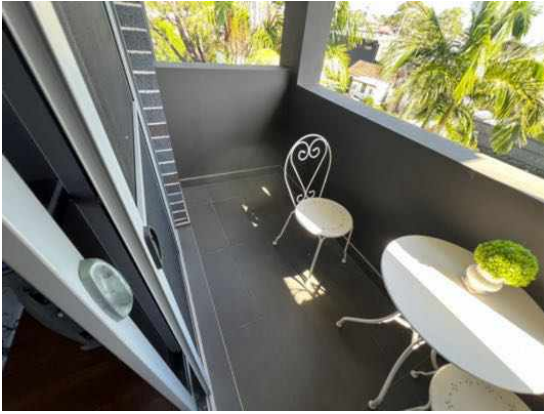
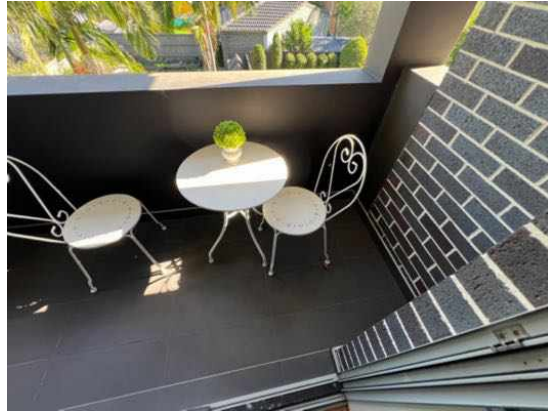
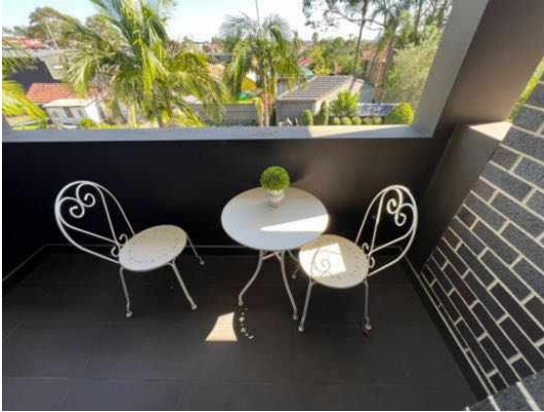
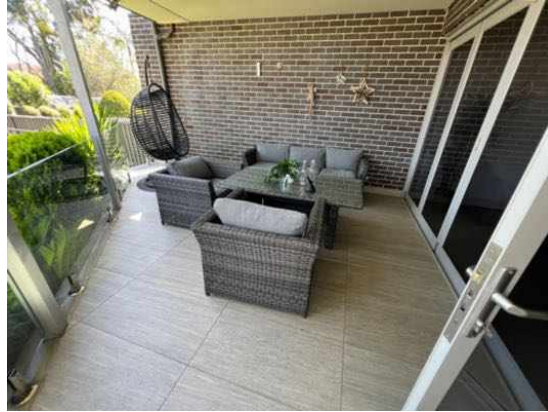
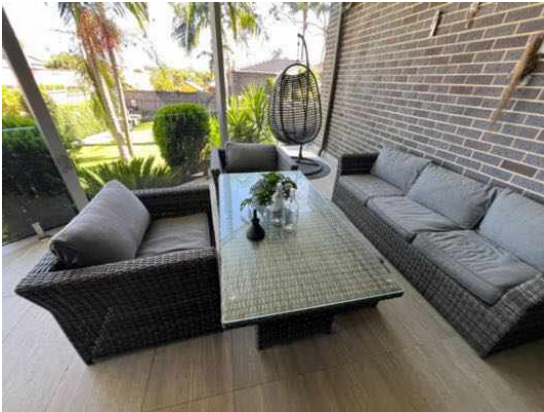
Building: Main Building  
Location: All External Areas  
Finding: Additional Photos - Obstructions and Limitations  
Information: These photographs are an indication of the obstructions and limitations which impeded full inspection of the property at the time of inspection. These obstructions can hide an array of defects and should be removed to allow full inspection to be carried out. A re-inspection is recommended once the areas are made accessible.

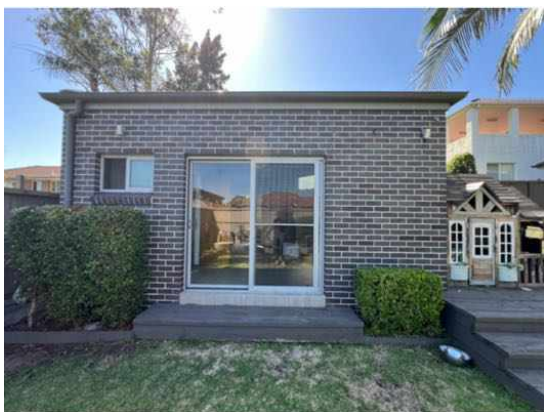
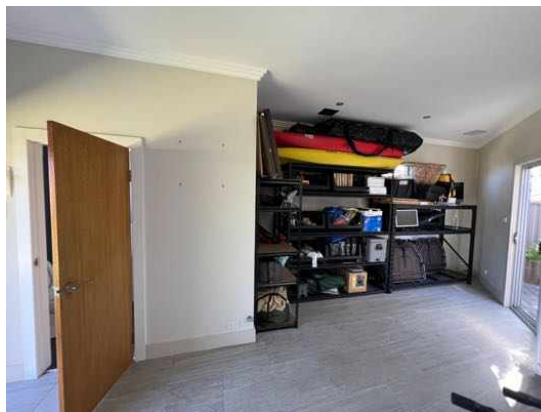
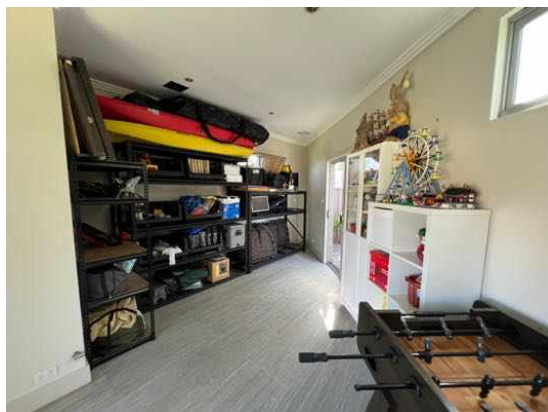
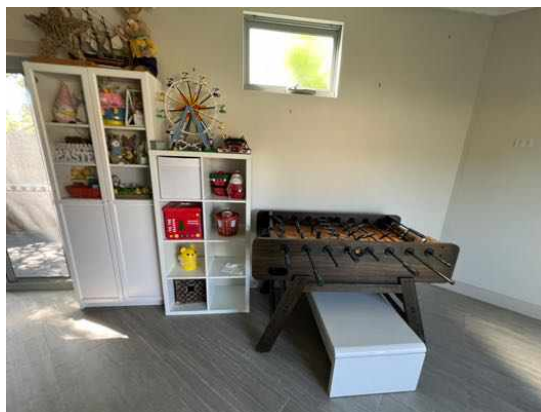
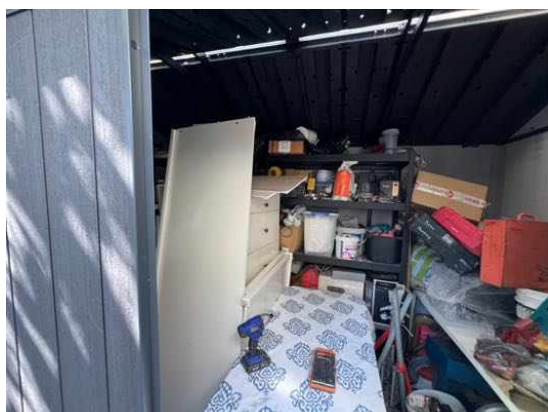
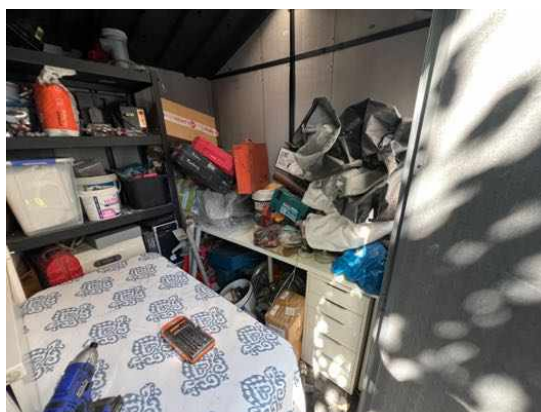
Building:	Out Building
Location:	All Internal Areas
Finding:	Additional Photos - Obstructions and Limitations
Information:	These photographs are an indication of the obstructions and limitations which impeded full inspection of the property at the time of inspection. These obstructions can hide an array of defects and should be removed to allow full inspection to be carried out. A re-inspection is recommended once the areas are made accessible.

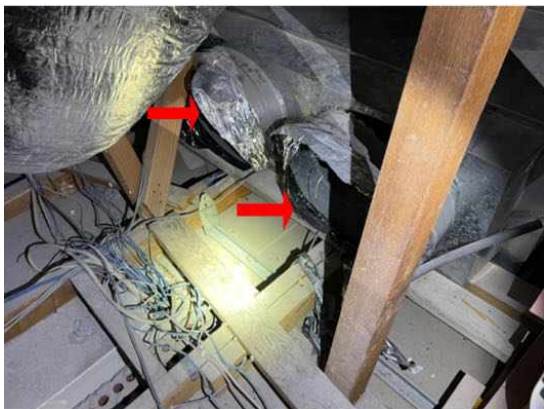
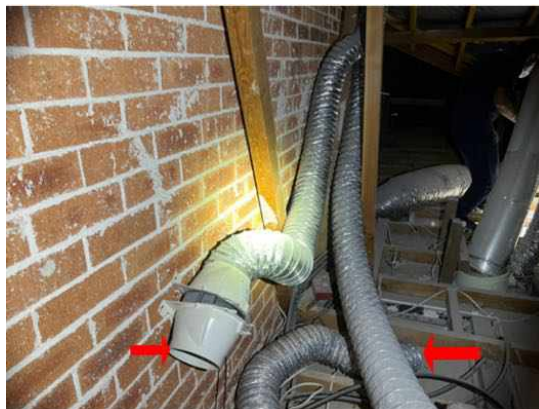
Building:	Main Building
Location:	Roof Void
Finding:	Disconnected / Redundant Air Conditioning Ducting in Roof Void
Information:	Disconnected and non-operational ducting was observed within the roof void, which appears to be associated with a previous or redundant air conditioning system.

The ducting is located within accessible areas of the roof void, including sections that are not connected to any active air conditioning unit or outlet.

Disconnected or redundant ductwork within roof spaces may reduce system efficiency if part of an active installation, or may indicate incomplete removal of a previous system. Loose or unsupported ducting can also obstruct access within the roof void and may be subject to damage over time. Due to the non-invasive nature of the inspection, it was not possible to confirm whether the ducting forms part of an active system or is associated with a decommissioned unit.

It is recommended that the ducting be assessed by a suitably qualified air conditioning

contractor. Any redundant ductwork should be properly removed, or active ducting reconnected and secured as required. Rectification should be undertaken as part of general maintenance or prior to future system use.

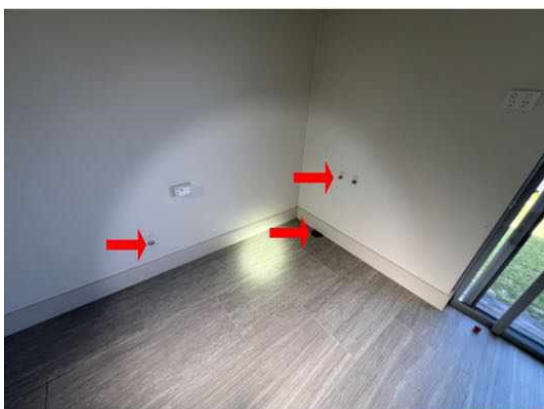
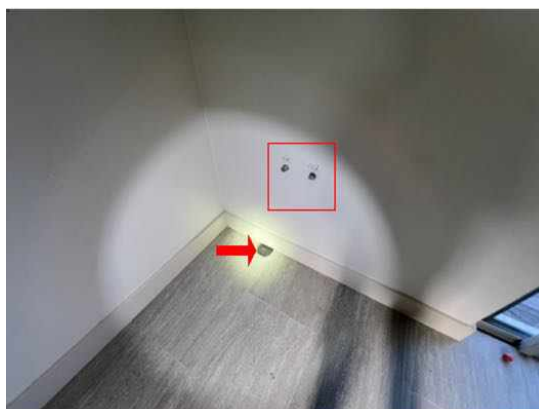
Building: Out Building  
 Location: Living Room  
 Finding: Exposed / Unfinished Plumbing and Gas Services  
 Information: Exposed and unfinished service points, including hot and cold water outlets, gas connection point(s), and a floor waste, were observed within an internal room of the dwelling. These services appear incomplete, with no fixtures installed and the surrounding wall and floor areas not fully made good at the time of inspection.

While no active leaks or gas odours were detected at the time of inspection, the exposed and unfinished nature of these services represents a minor defect due to the potential for damage, debris ingress, and safety concerns if the services are inadvertently disturbed. It is recommended that a licensed plumber and licensed gas fitter assess these service points and either properly cap, secure, or complete the installation as intended. Rectification should be carried out within a reasonable timeframe.
