Building and Timber Pest Inspection Report

Inspection Date: Thu, 5 Mar 2026

Property Address: 32/538 Woodville Rd, Guildford NSW 2161,
Australia

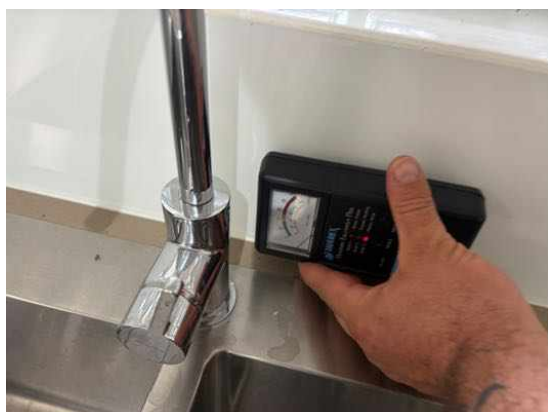
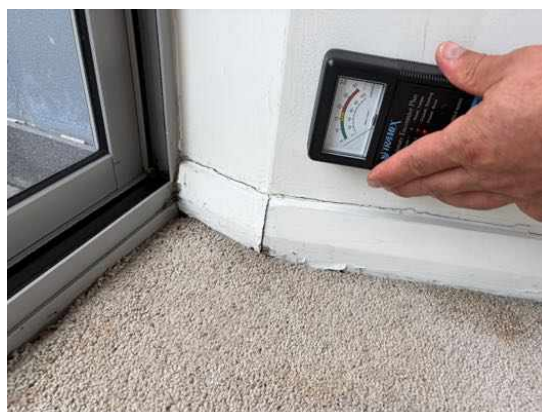
Building: Main Building
 Location: All Wet Areas
 Finding: Waterproofing
 Information:

Consequently, there is no conclusive evidence of any current shower recess leakage other than those which may have already been mentioned earlier in this report. It is reasonable to assume the shower waterproofing is sound. Note that if the shower is not used, or has not been used for some time, moisture readings would not vary significantly and this can lead to erroneous results. It is not possible under the visual inspection criteria (under which a prepurchase inspection is carried out) to categorically determine if there are leaks. If a more accurate assessment is required, a special purpose inspection should be requested. Alternatively, the assumption should be made that the shower may leak.

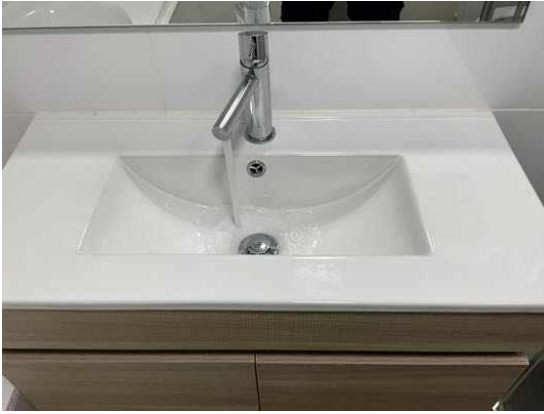
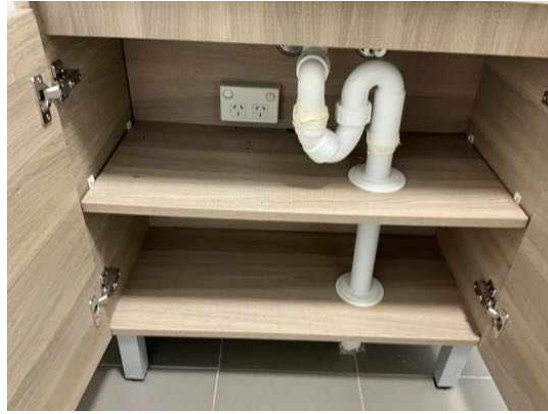
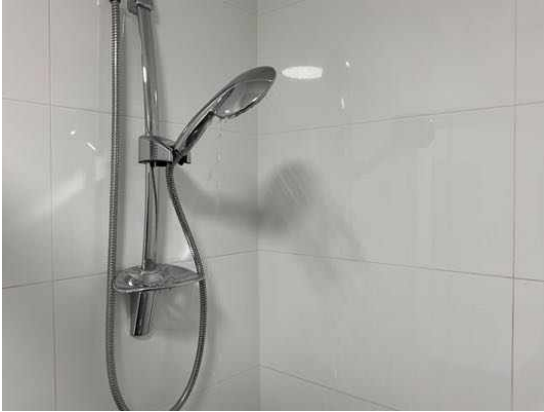
Building:	Main Building
Location:	Plumbing/electrical/gas/aircon/appliances/pool equipment/fire safety etc
Finding:	Plumbing & Electrical
Information:	Plumbing and electrical inspections including appliances are outside the scope of the building inspection and must be conducted by a Licensed and registered Trades person. It is highly recommended that the client makes immediate arrangements to have the gas appliances checked by a licensed gas plumber to ensure that the appliances are working safely and efficiently. We recommend all other installations be checked also. Whilst we note and comment of visually apparent defects that present during the building inspection, legislation requires the checking and documenting of compliance for plumbing and electrical requirements be done by licensed electrician and plumbers respectively to ensure they are functioning correctly.

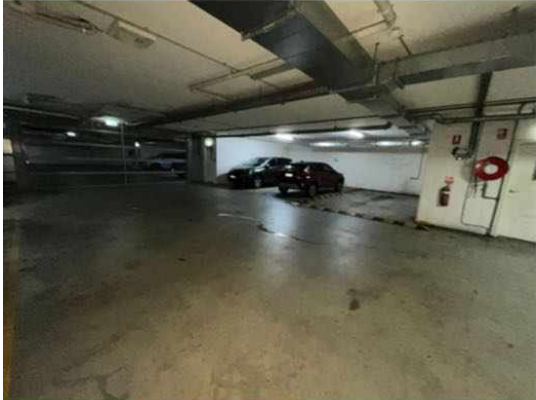
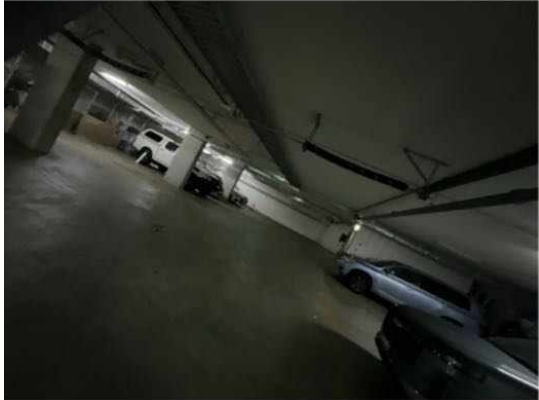
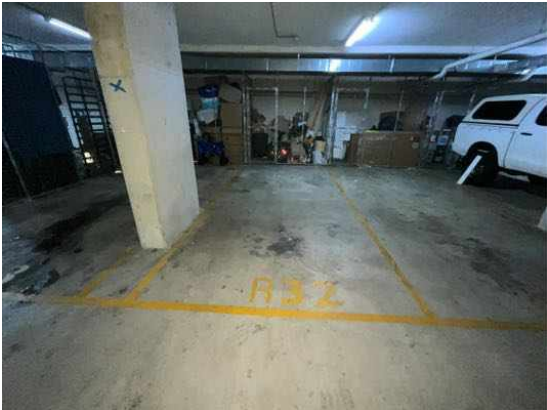
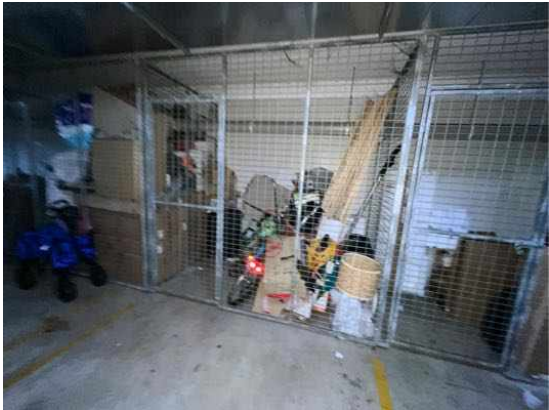
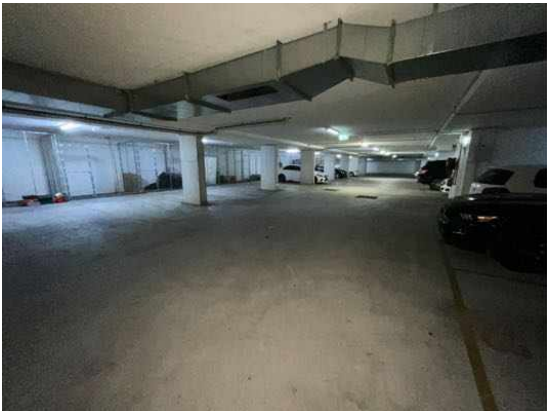
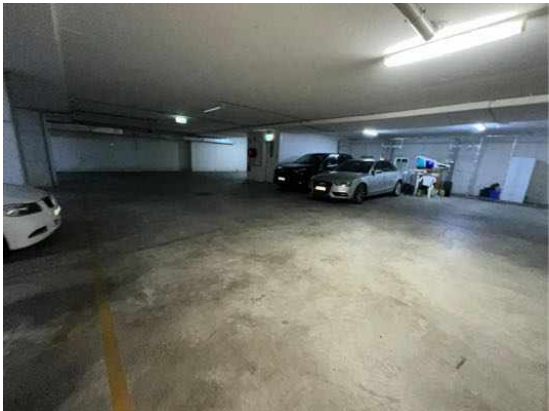
Building:	Main Building
Location:	Garage
Finding:	Additional Photos- Garage
Information:	Additional photos are provided for your general reference. Arrows may have been included to highlight areas of importance. Please discuss these photos with your building consultant for clarification.

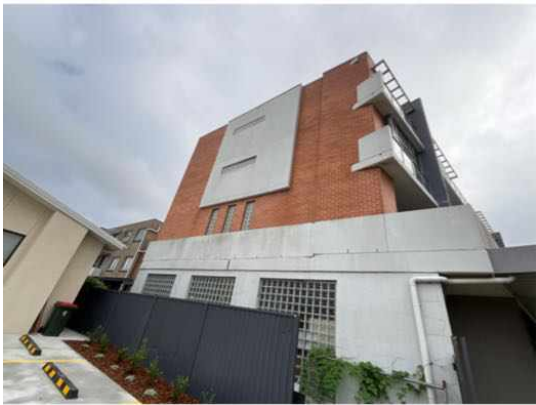
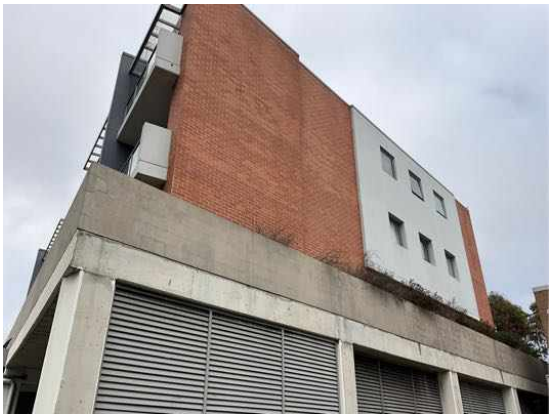
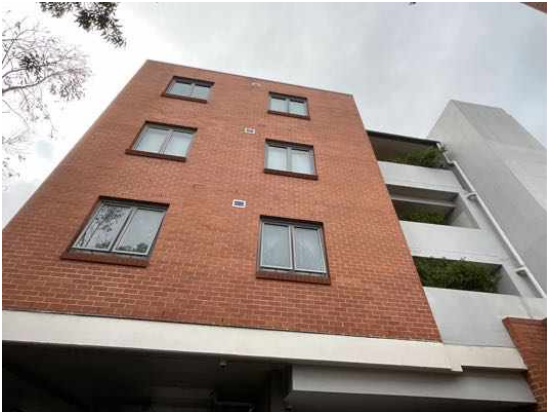
Building: Main Building
Location: Exterior
Finding: Additional Photos
Information:

Additional photos are provided for your general reference.

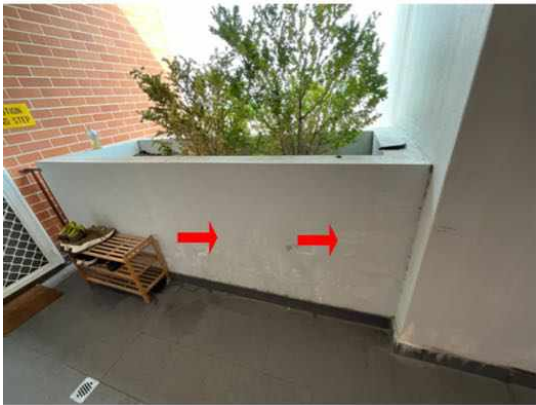
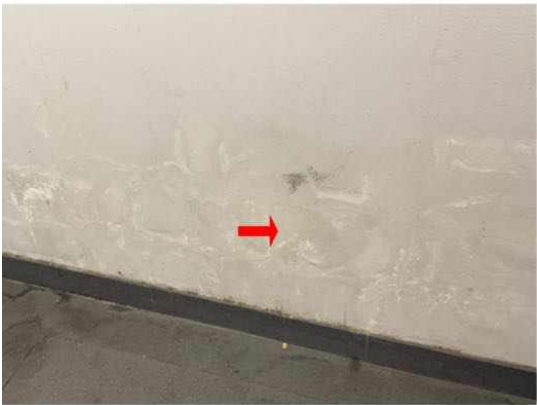
Building: Main Building
 Location: Other common areas
 Finding: Additional Photos
 Information: Additional photos are provided for your general reference.
