# Building and Timber Pest Inspection Report

Inspection Date: Tue, 10 Feb 2026

Property Address: 25 Birkdale Terrace, West Wodonga VIC  
3690, Australia

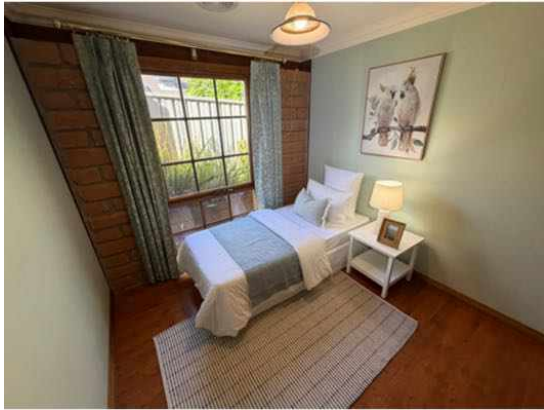
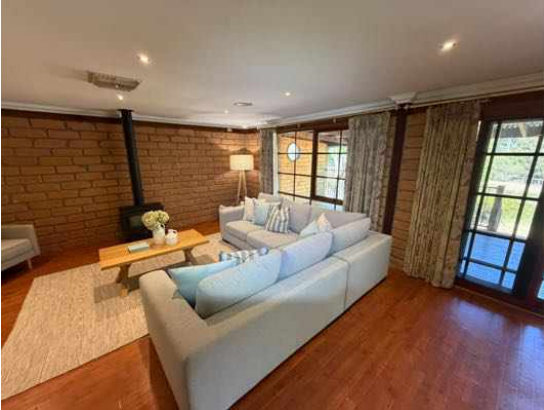
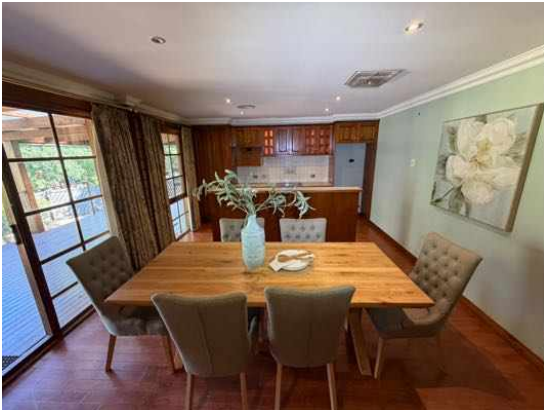
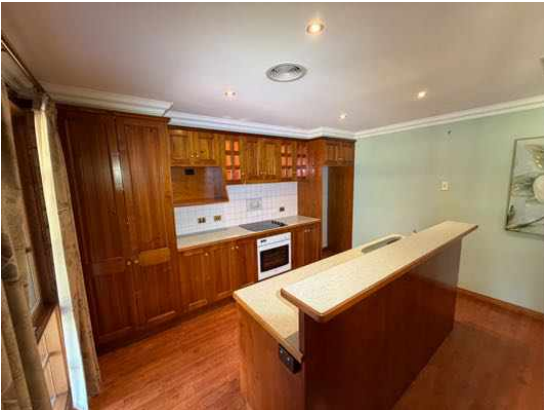
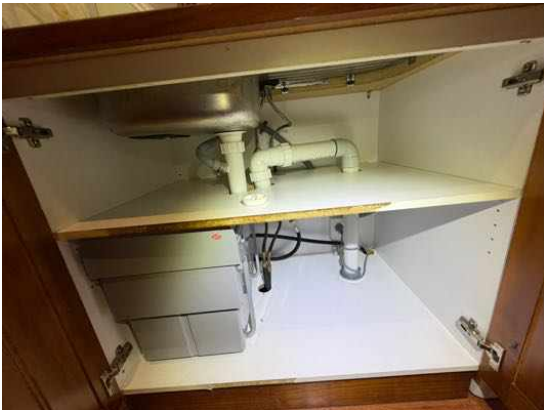
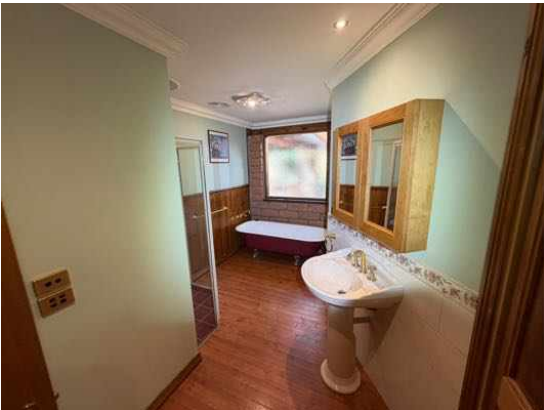
Building: Main Building  
Location: All Areas  
Finding: Additional Photos - Obstructions and Limitations  
Information: These photographs are an indication of the obstructions and limitations which impeded full inspection of the property at the time of inspection. These obstructions can hide an array of defects and should be removed to allow full inspection to be carried out. A re-inspection is recommended once the areas are made accessible.

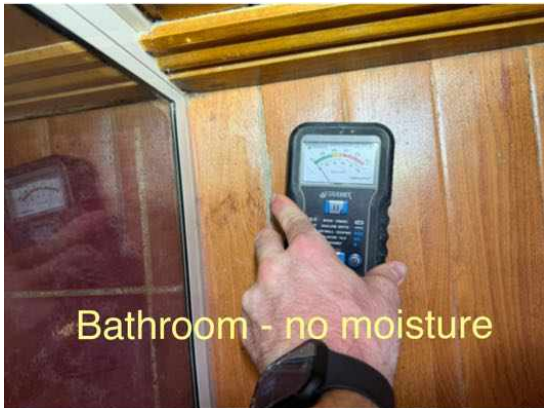
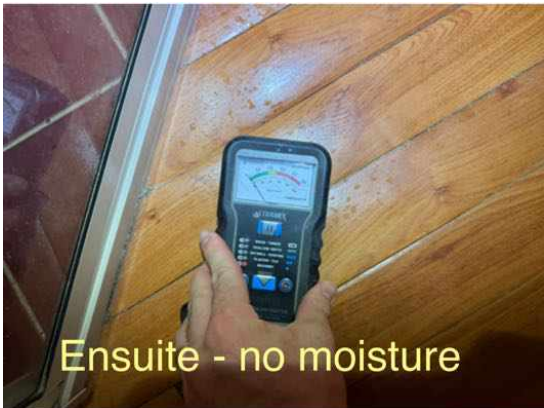
Building: Main Building  
 Location: Eave, Verandah, Hallway  
 Finding: Water Staining Present  
 Information: It appears that water staining was present at but not limited to, the hallway ceiling, front timber eave, outside the shower areas and rear patio beam. Potential causes of leaking include deteriorated roof cladding or damaged plumbing fittings and fixtures. No high moisture was evident in these areas at the time of inspection.

It is recommended that the client monitor these areas and engage a licensed plumber, should the leak persist or return.
