Building and Timber Pest Inspection Report

Inspection Date: Sat, 28 Feb 2026

Property Address: 2/510 Butson Ave, South Albury NSW 2640,
Australia

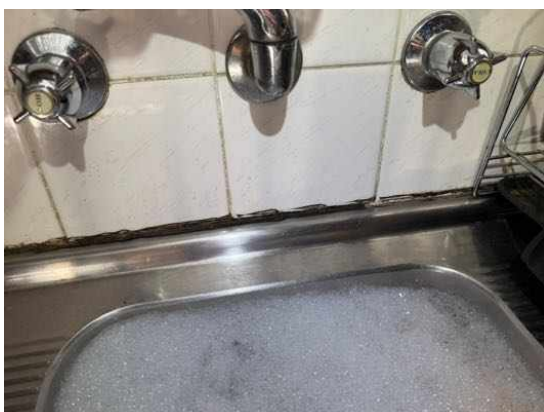
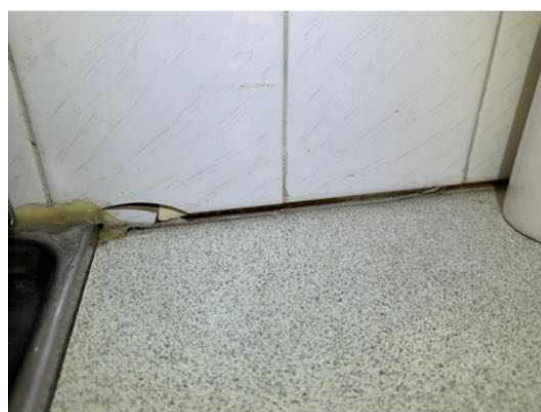
Finding 3.04

| Finding: | Cracking - External & Internal |

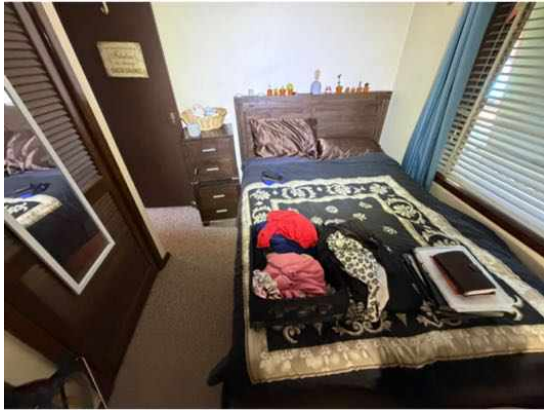
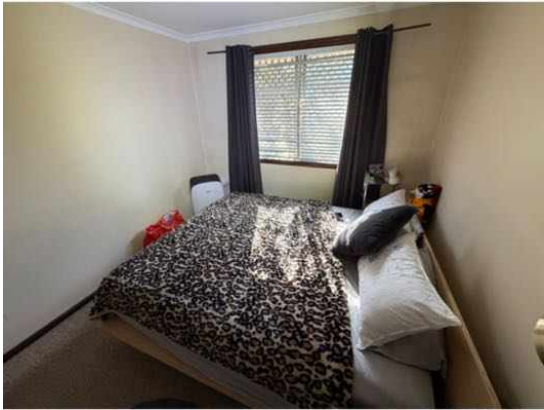
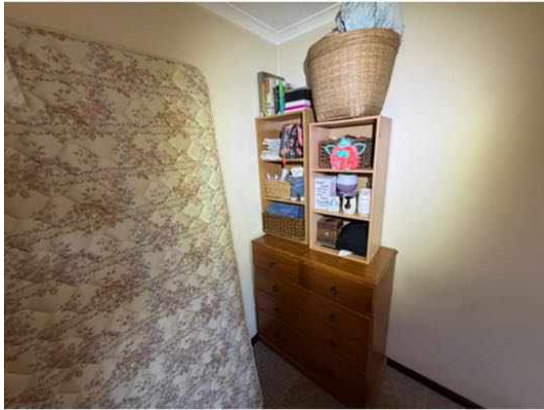
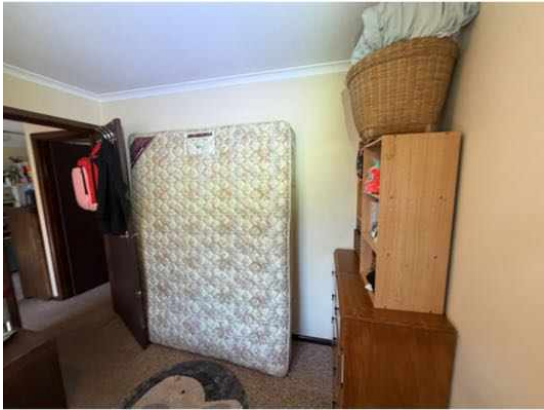
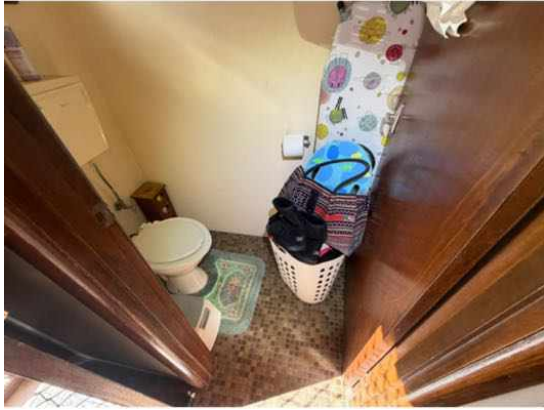
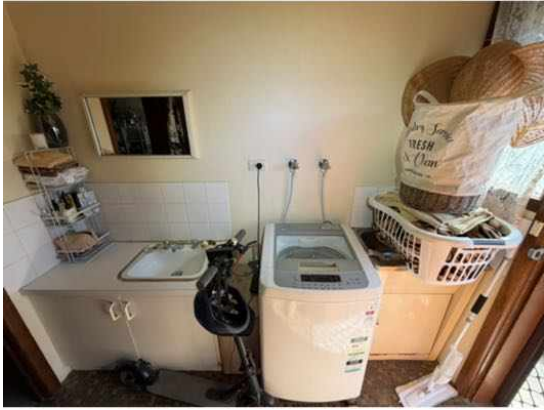
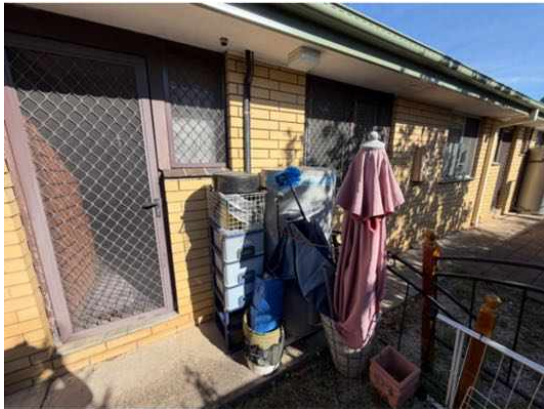
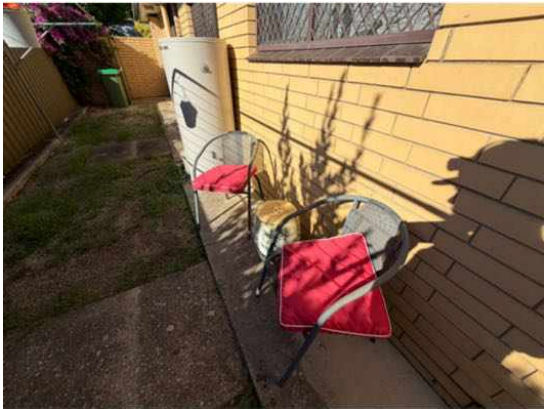
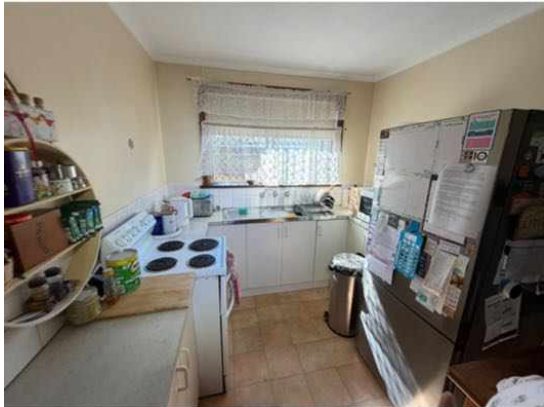
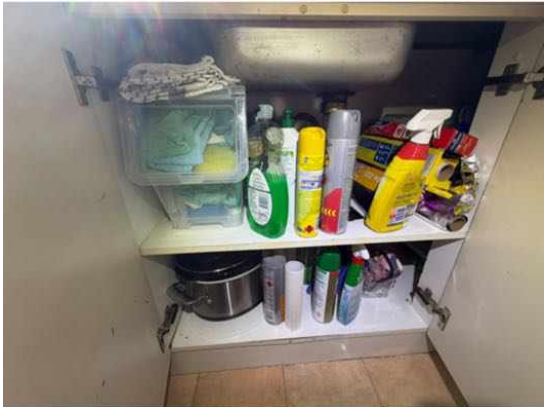
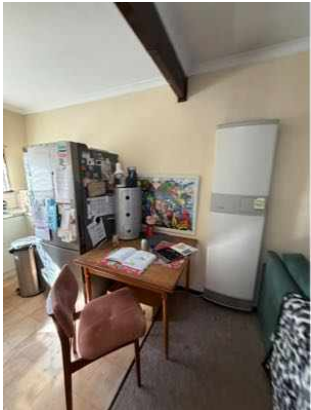
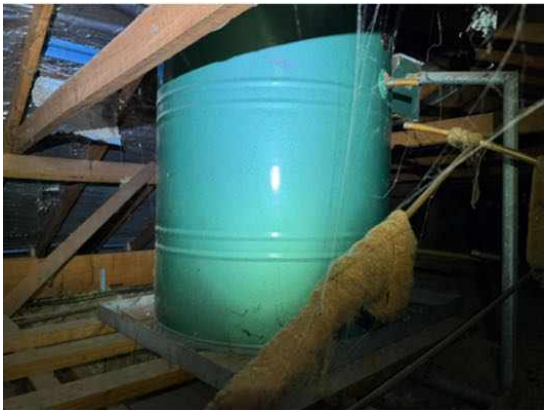
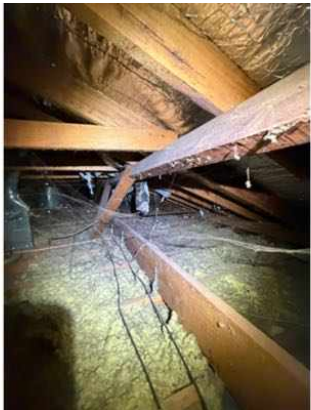
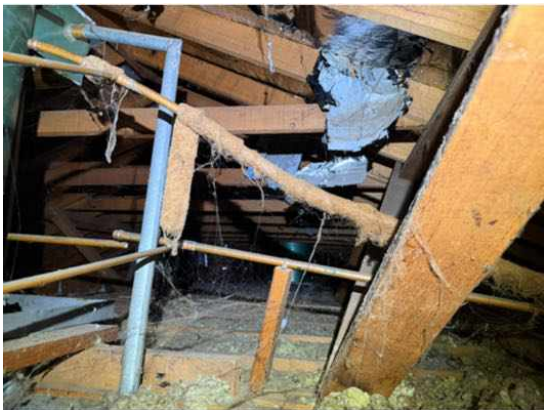
Building: Main Building
Location: All Areas
Finding: Additional Photos - Obstructions and Limitations
Information: These photographs are an indication of the obstructions and limitations which impeded full inspection of the property at the time of inspection. These obstructions can hide an array of defects and should be removed to allow full inspection to be carried out. A re-inspection is recommended once the areas are made accessible.
