Building and Timber Pest Inspection Report

Inspection Date: Thu, 5 Feb 2026

Property Address: 159 Leicester St, Fitzroy VIC 3065, Australia

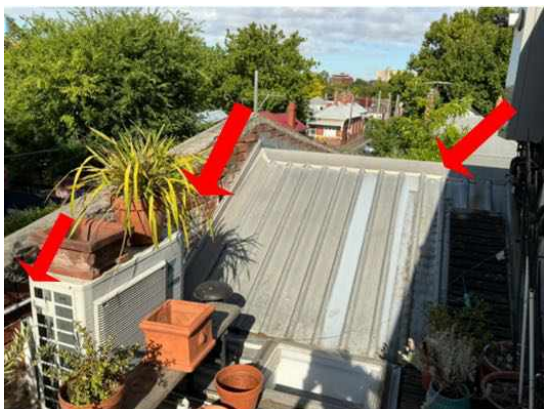
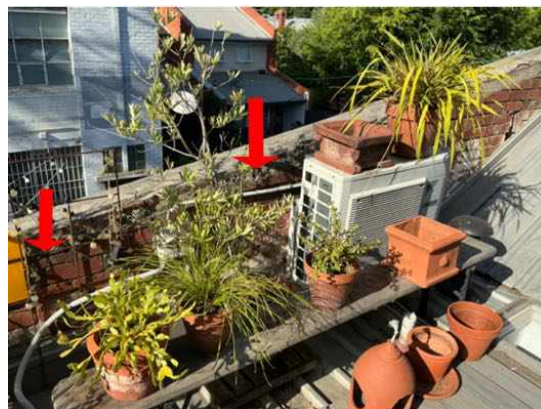
Building: Main Building
 Location: Study/Outside
 Finding: Fall Hazard/ Study/ Outside
 Information: During the inspection, it was observed that guardrails are installed on the perimeter of the building. This poses a significant risk of individuals falling from a height exceeding three metres.

The construction of the guardrails must be carried out by a Registered Builder or Carpenter.

It is strongly recommended that this matter be addressed as expeditiously as possible.

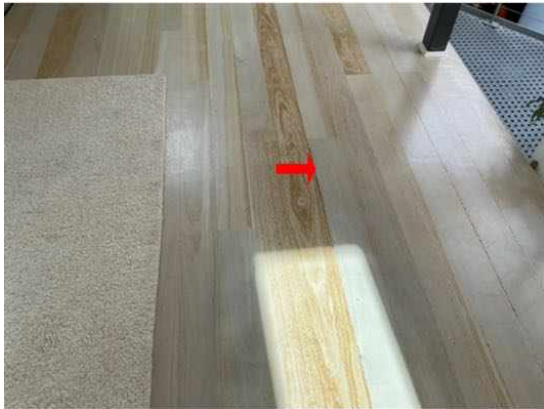
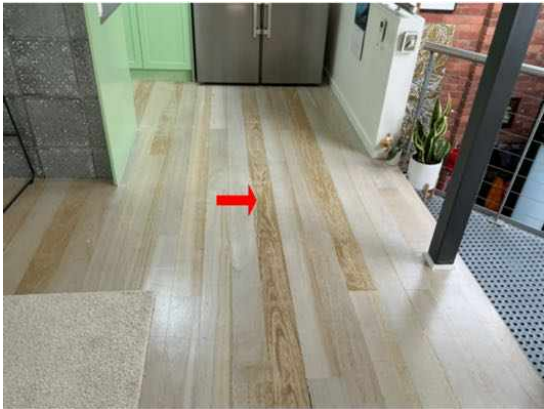
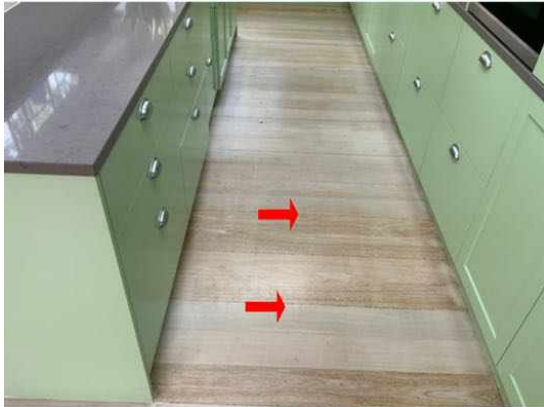
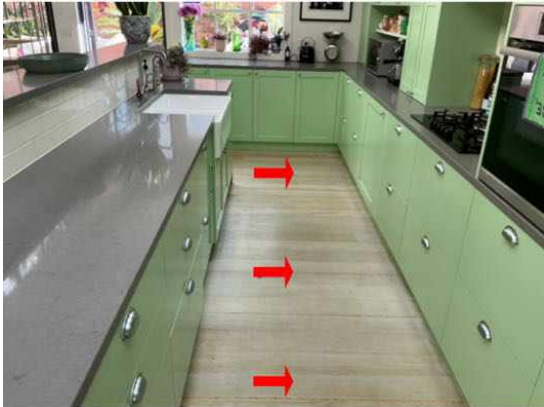
If left unmanaged, deteriorating laminated flooring is likely to result in several secondary defects, including minor trip hazards.

Consultation with a flooring contractor is highly recommended to obtain advice on the cost of remedial works that may be required in the short to medium term. However, complete changes of flooring are ultimately up to the client's discretion.

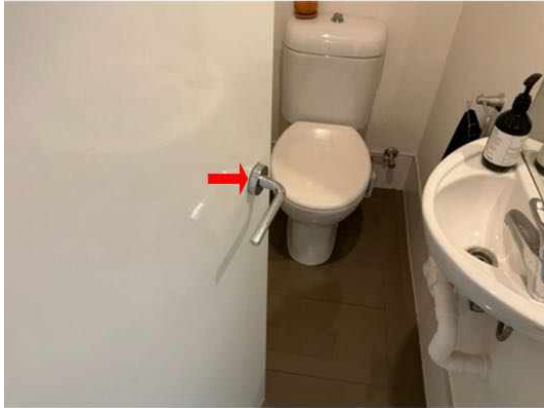
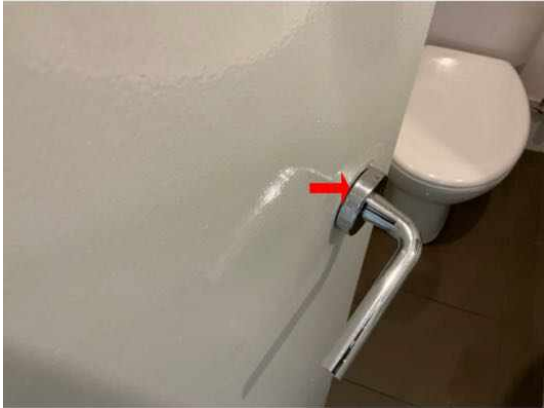
Finding 3.09

Building: Main Building
Location: Toilet (WC)
Finding: Door handle - loose
Information: During the inspection, a loose door handle was identified. While this may appear minor, it compromises the door’s functionality and poses a potential safety hazard being locked inside.

A General Handyperson or Carpenter should be appointed to rectify the issue at the client’s discretion. If left unattended, further functional impairment is likely to occur.

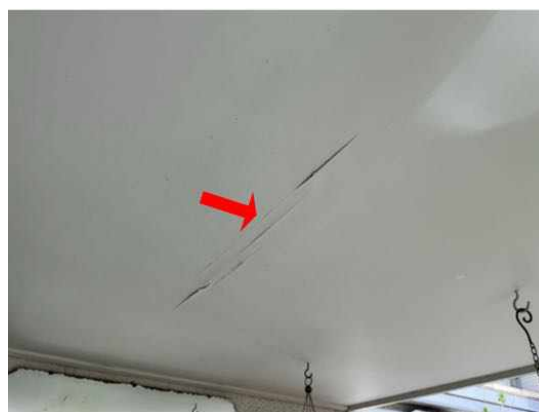
Finding 3.10

Building:	Main Building
Location:	Verandah
Finding:	Ceiling - Water Damage
Information:	Water Damage to ceiling linings in this area was evident at the time of inspection. Water damage indicates that surfaces have been exposed to excessive moisture over time.

While mostly an appearance defect, water damage can be indicative of more serious defects, which may be currently concealed by interior ceilings.

Where water damage is active, a Licensed Plumber must be consulted to identify the cause of the damage and to provide advice on any reparation works that may be required. Replacement of any damaged structures is advised.

Conversely, where water damage is old and inactive, affected building materials may be repaired or replaced at client discretion.

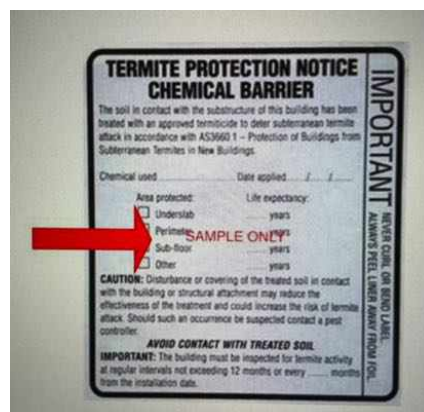
Information: The application of a post-construction chemical termite barrier is highly recommended for all properties, particularly if live termite activity has been found on the site previously. Such barriers are highly effective in preventing termite attack on any timber building elements throughout the property.

A durable notice should be placed in the switchboard unit to indicate current termite barriers. At the time of inspection, it appeared as though no termite management system has been installed, with no evidence to suggest preventative works taking place.

The client may consider gaining further advice from a pest controller as to the costs and procedures involved with this application. It is recommended that obtaining such advice be a short-term priority.

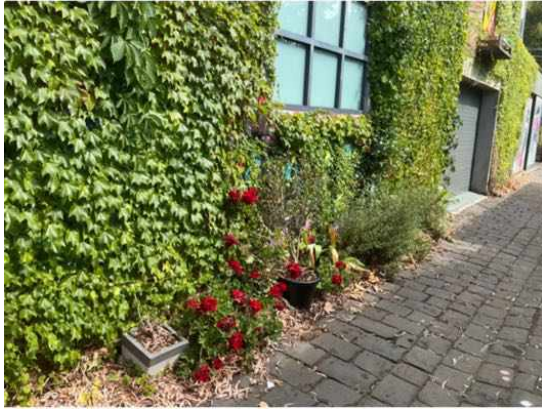
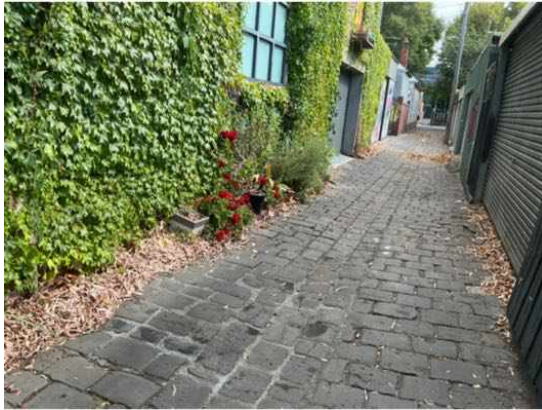
Finding 6.02

Finding: Garden Beds - Conditions Conducive to Termite Attack

Information: Garden beds were found to be evident in close proximity to the building. Garden beds immediately adjacent to the perimeter of the building block the visual inspection of these areas, providing a concealed termite entry point.

Garden beds can include untreated timber and a combination of moisture from watering, which produce conditions conducive to termite activity and ingress.

Further advice from a Timber Pest Technician is required to ensure appropriate Termite Management systems are implemented.

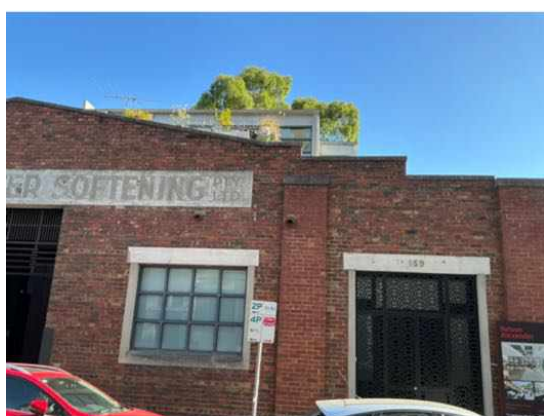
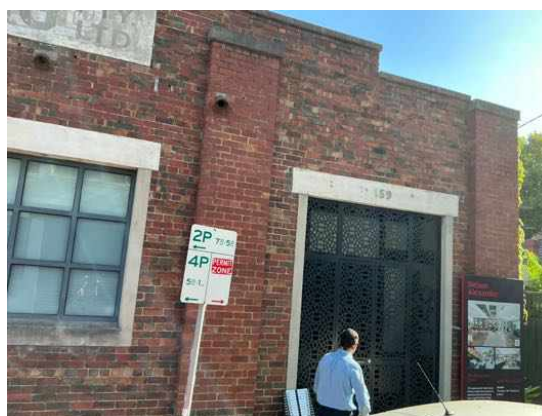
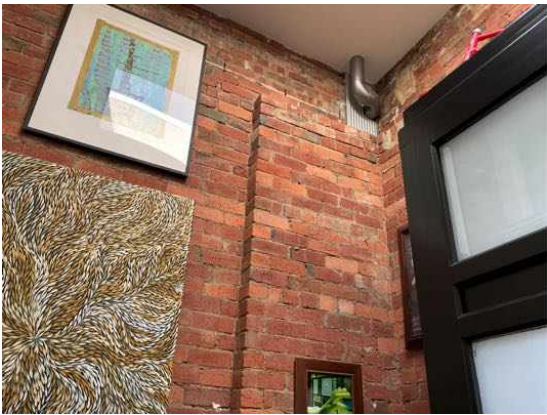
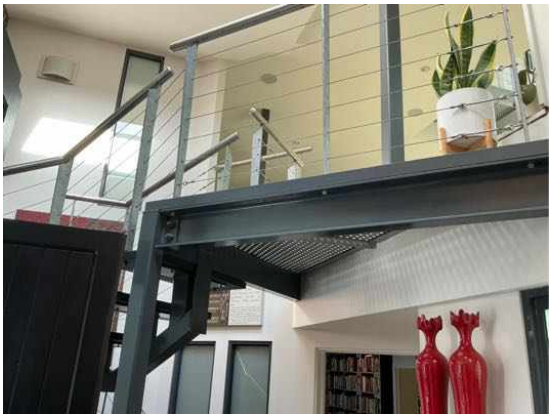
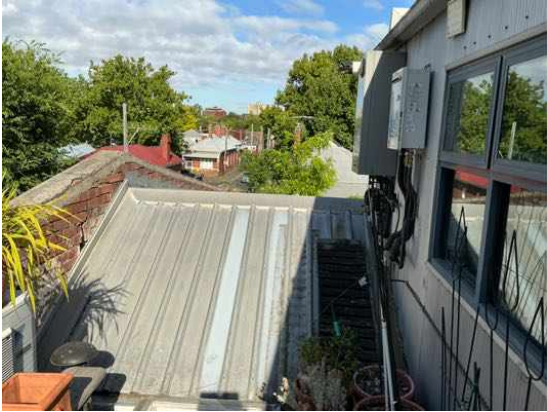
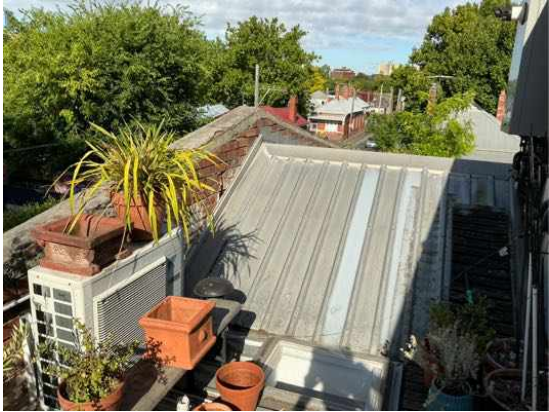
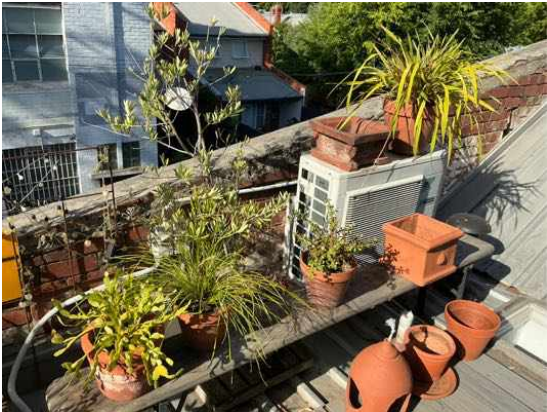
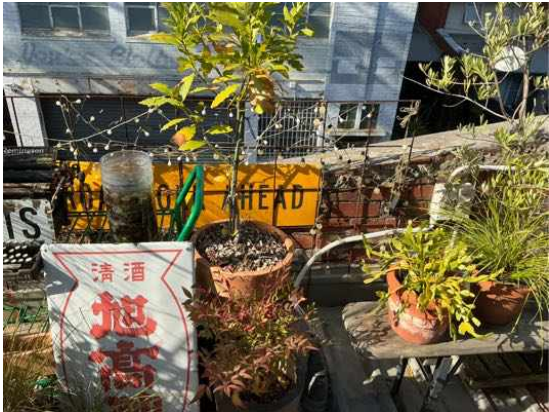
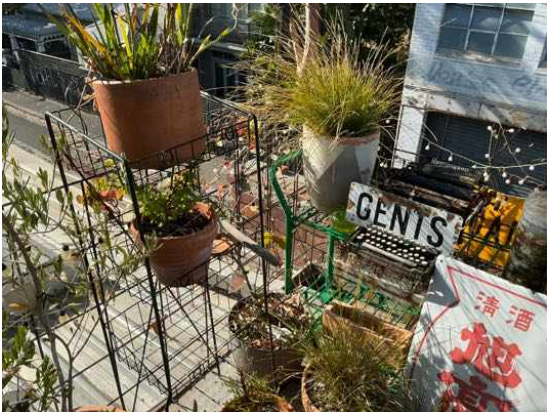
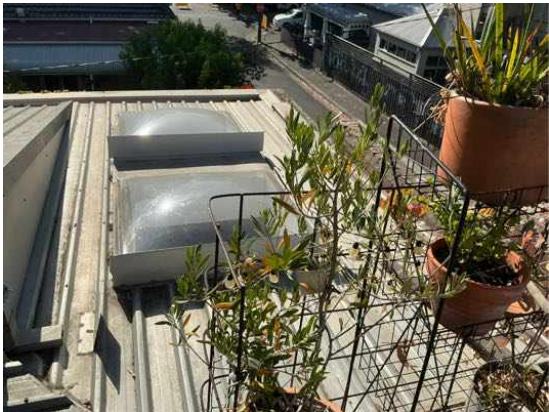
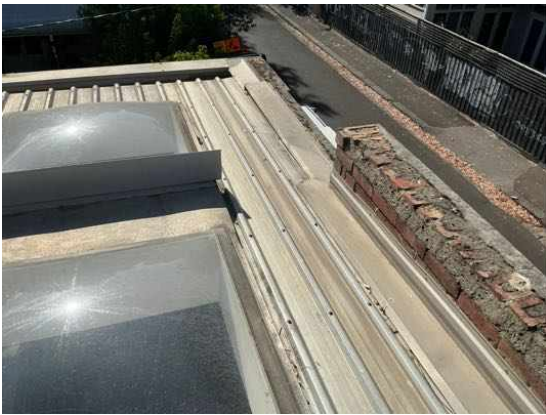
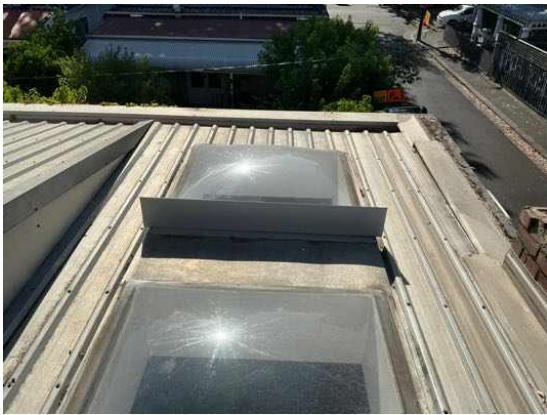
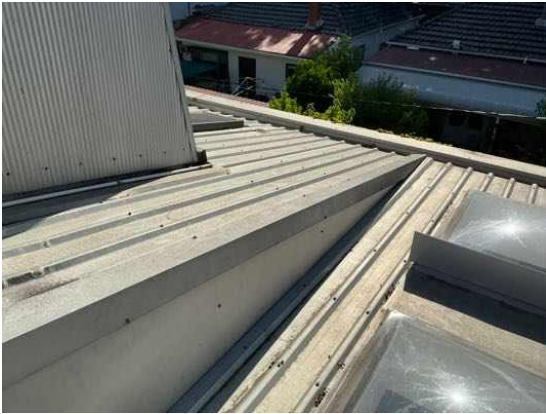
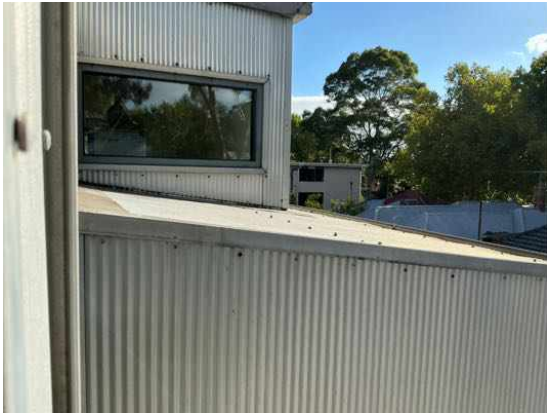
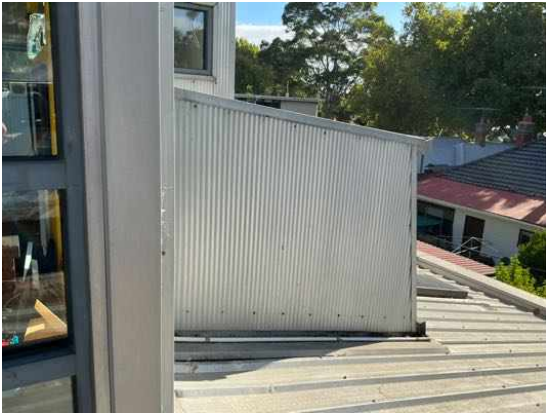
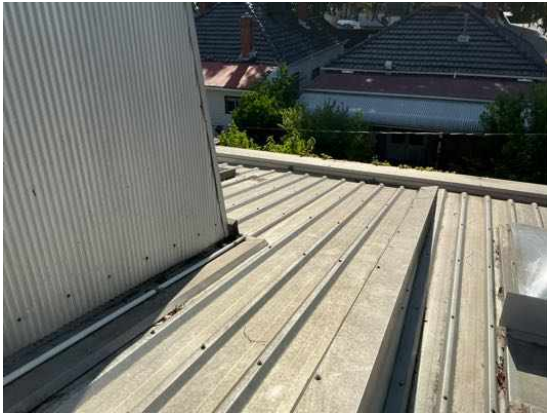
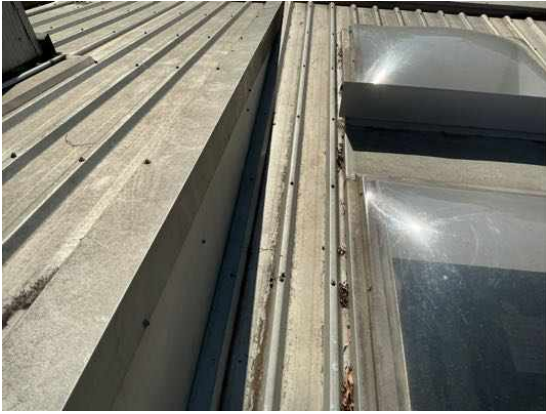
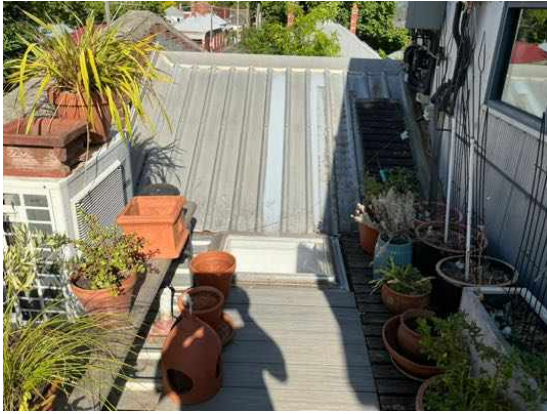
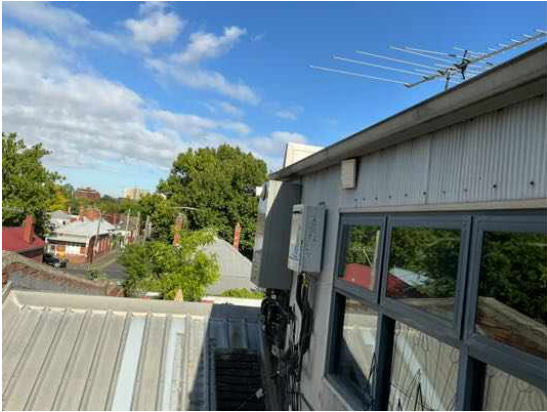
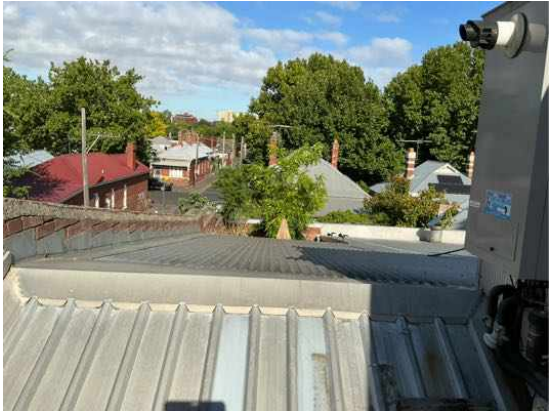
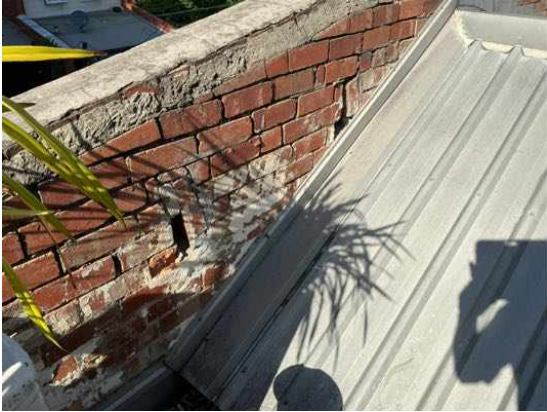
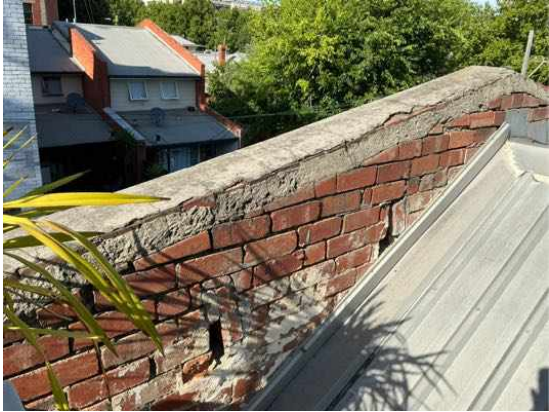
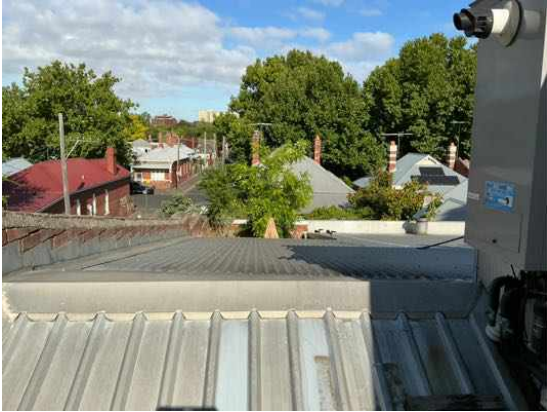
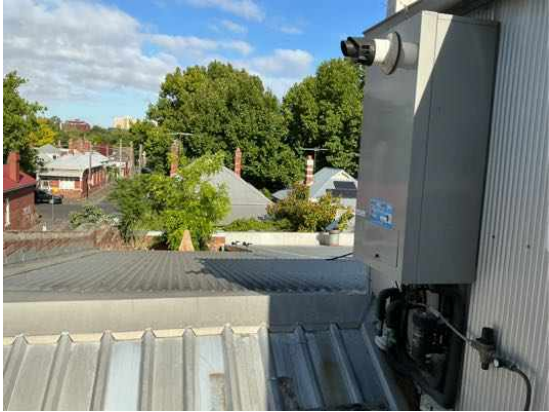
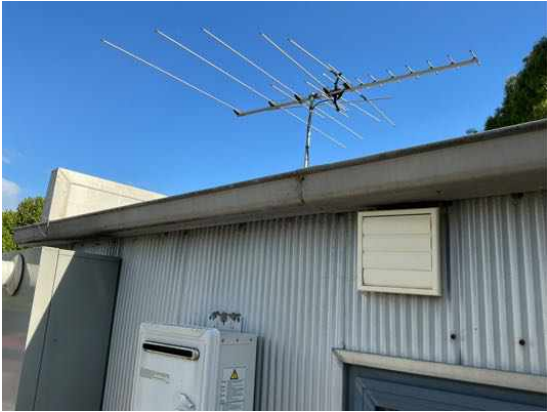
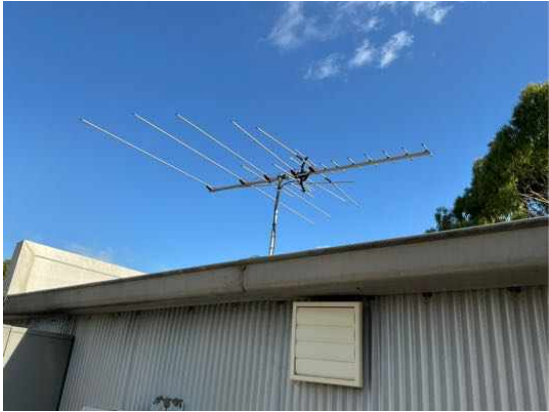
Noted Item

Building:	Main Building
Location:	All Areas
Finding:	Additional Photos - Obstructions and Limitations
Information:	These photographs are an indication of the obstructions and limitations which impeded full inspection of the property at the time of inspection. These obstructions can hide an array of defects and should be removed to allow full inspection to be carried out. A re-inspection is recommended once the areas are made accessible.

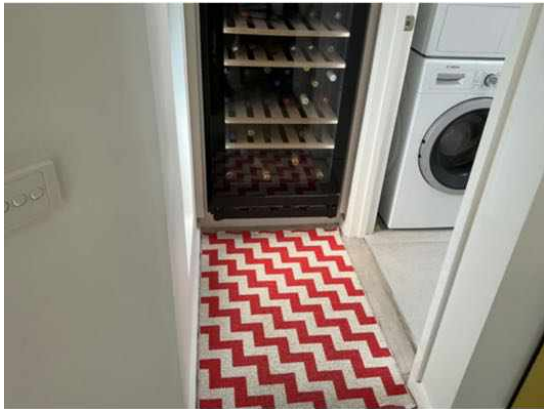
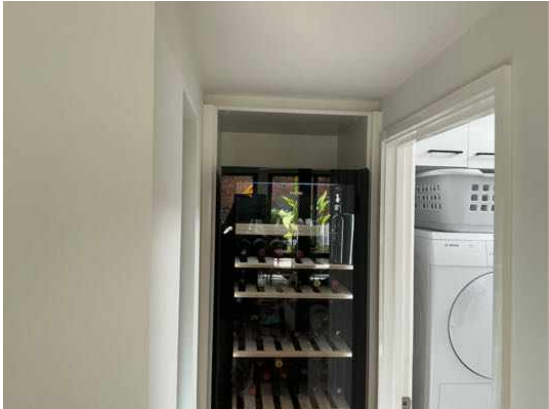
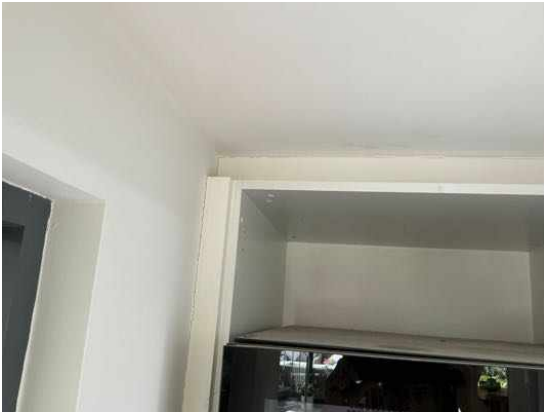
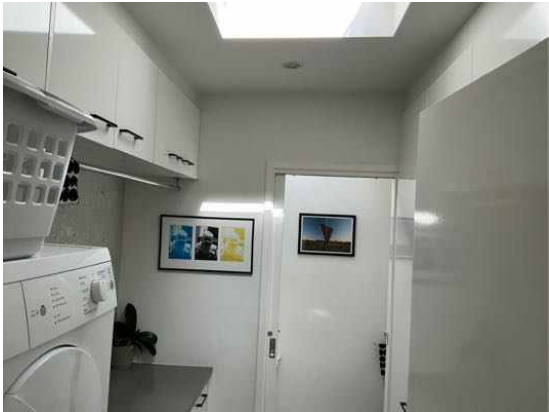
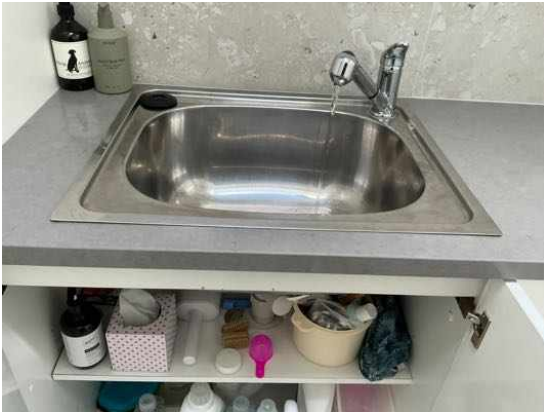
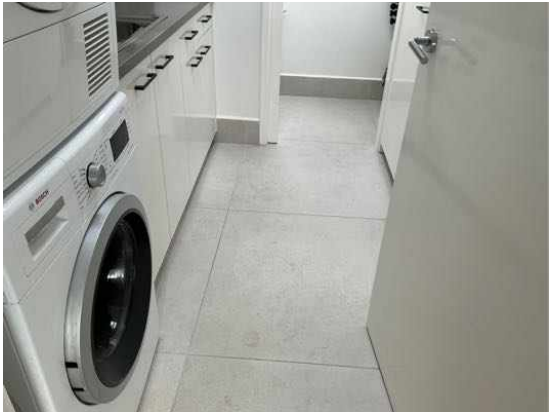
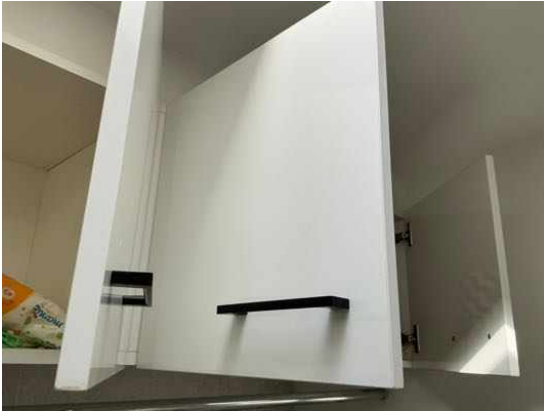
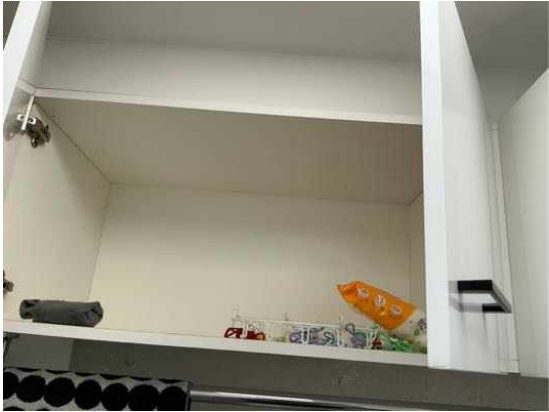
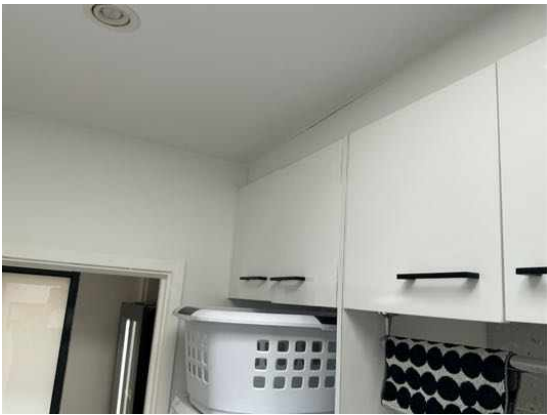
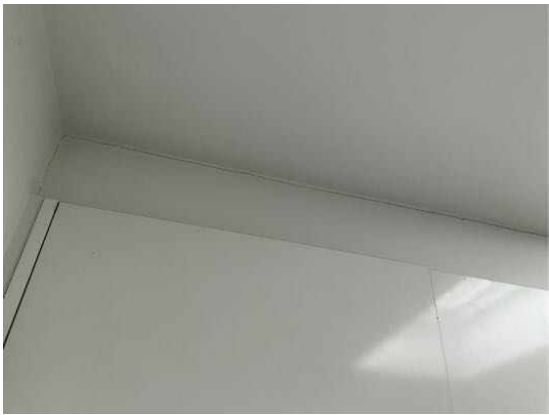
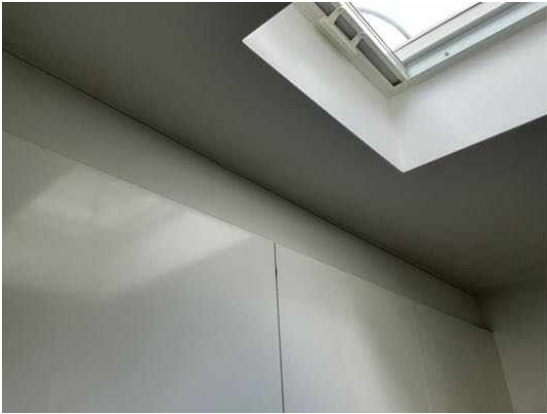
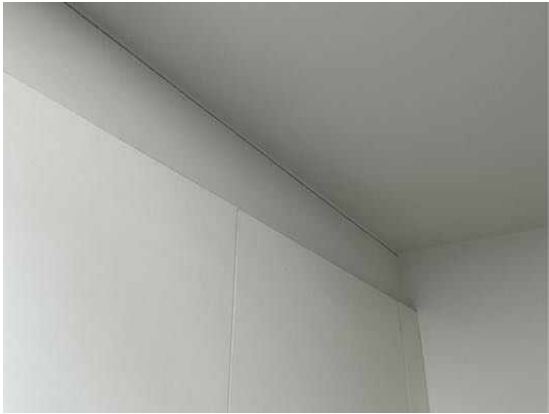
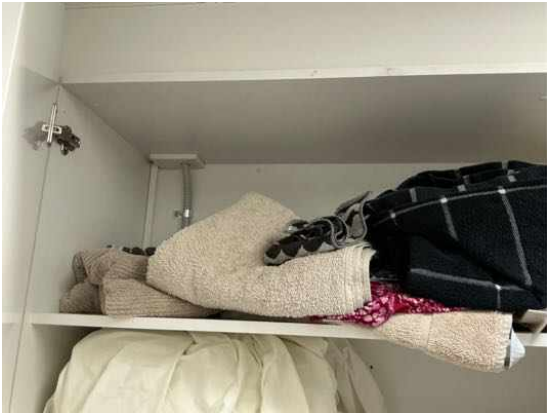
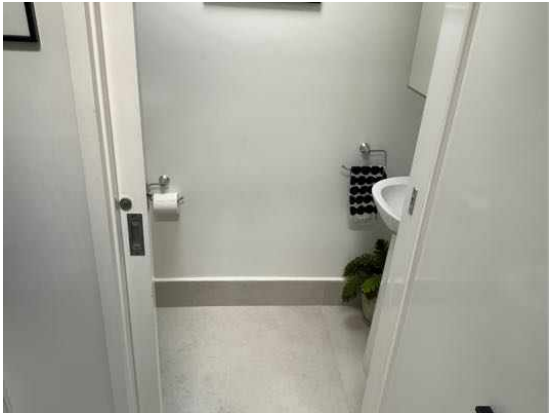
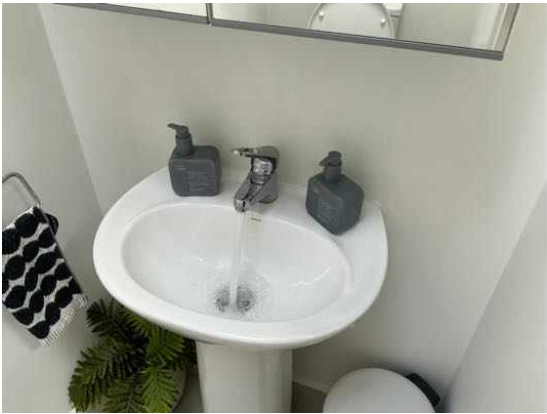
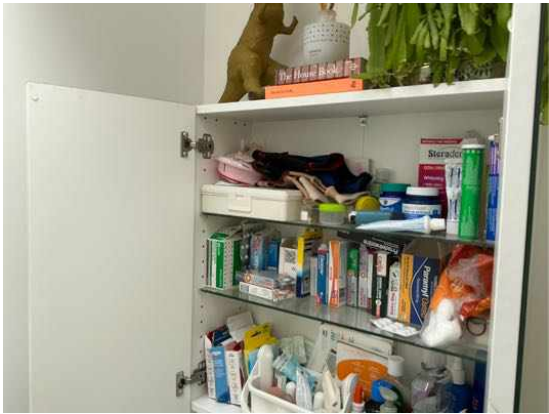
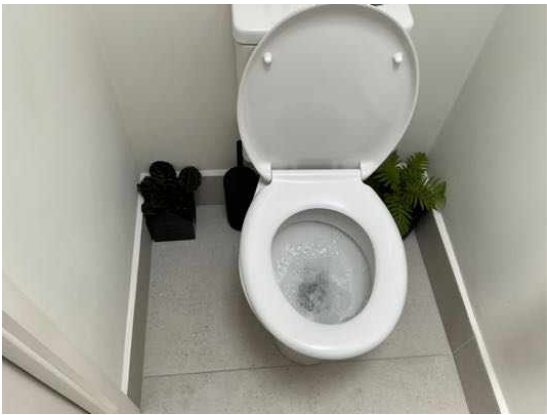
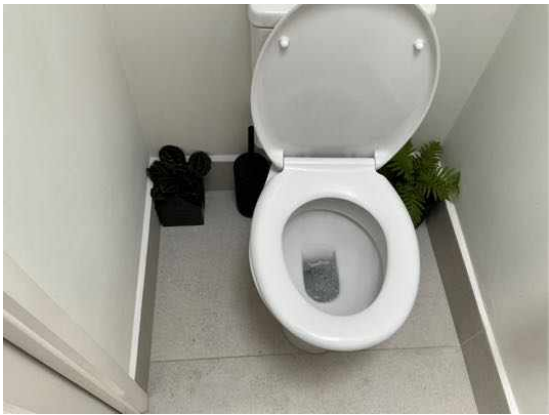
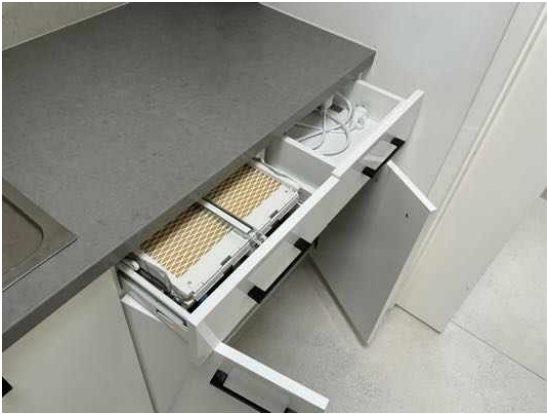
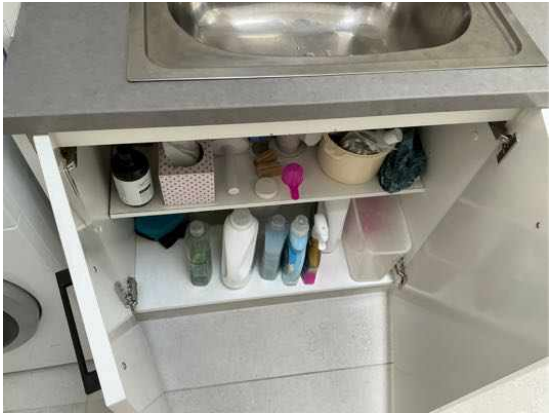
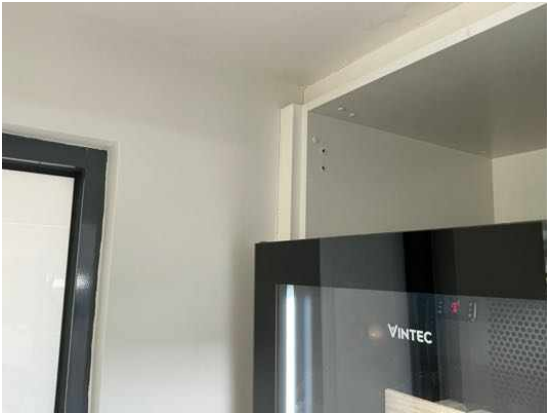
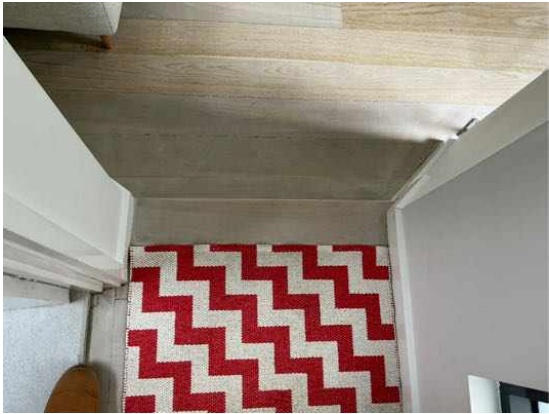
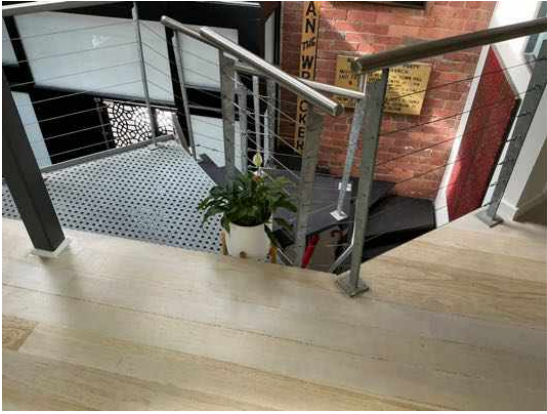
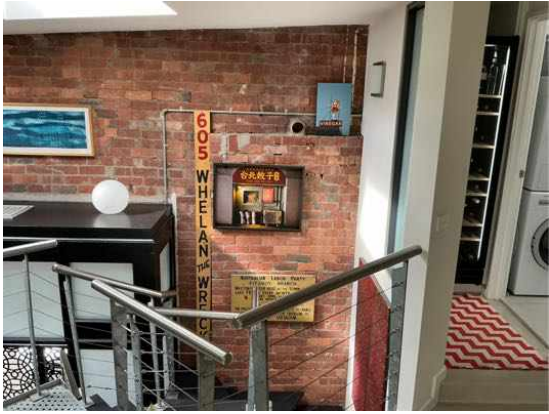
Building:	Main Building
Location:	All Areas
Finding:	Additional Photos - Obstructions and Limitations
Information:	These photographs are an indication of the obstructions and limitations which impeded full inspection of the property at the time of inspection. These obstructions can hide an array of defects and should be removed to allow full inspection to be carried out. A re-inspection is recommended once the areas are made accessible.
