Building and Timber Pest Inspection Report

Inspection Date: Thu, 5 Feb 2026

Property Address: 159 Leicester St, Fitzroy VIC 3065, Australia

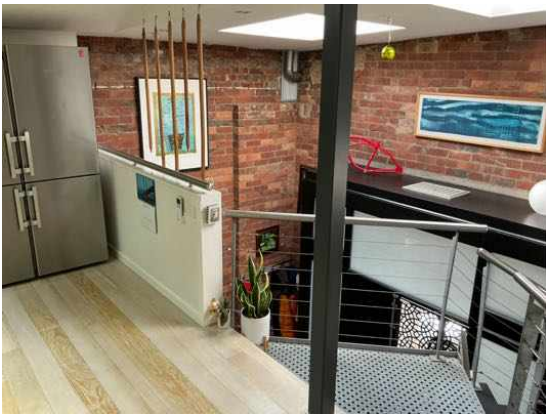
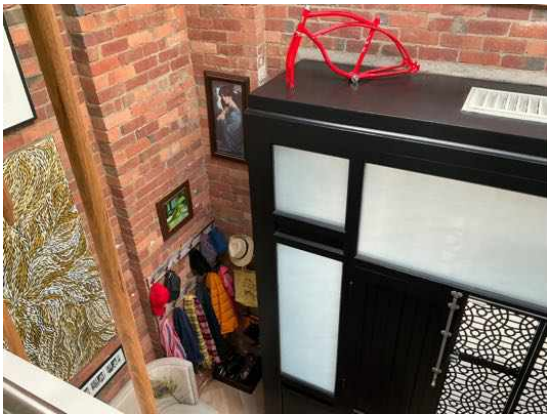
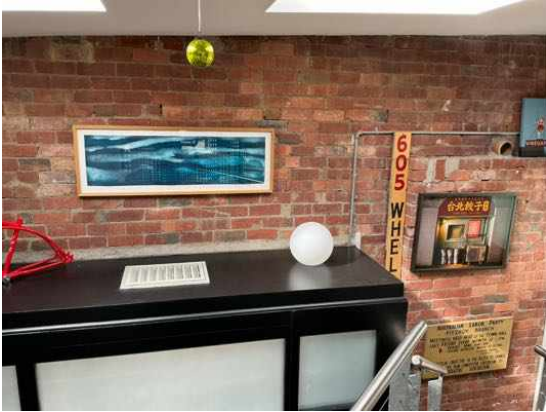
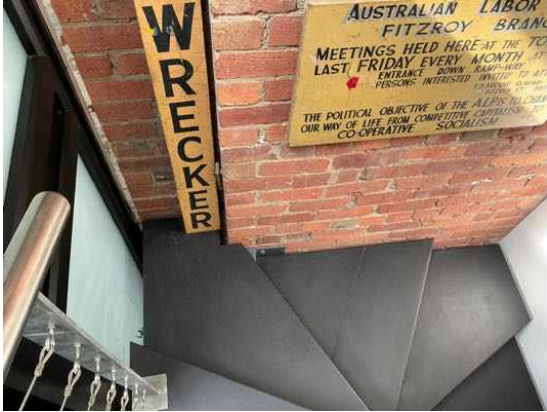
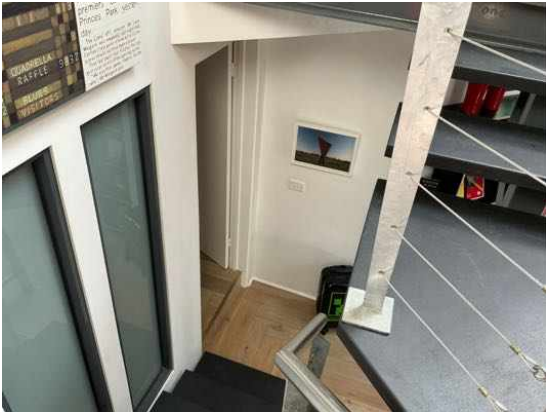
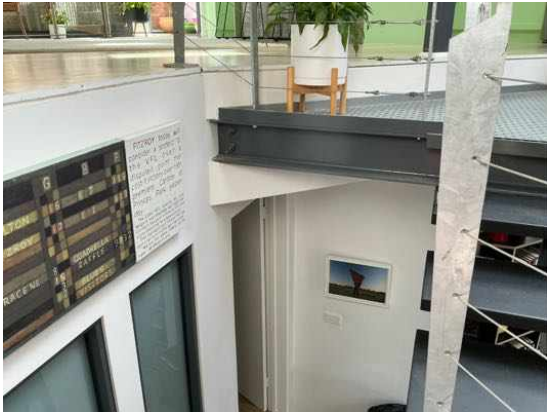
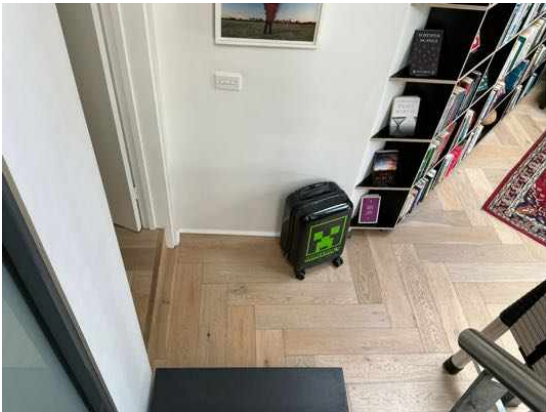
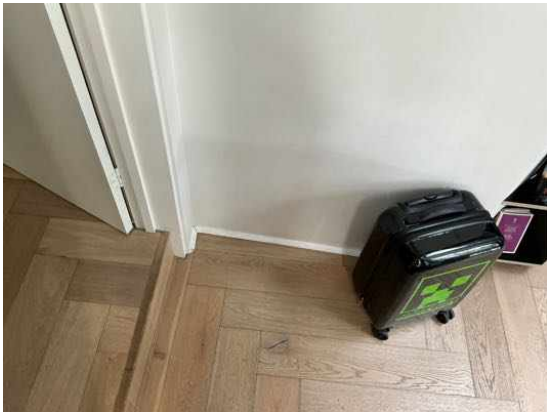
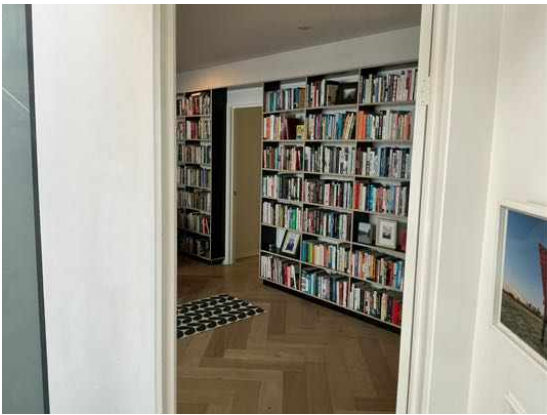
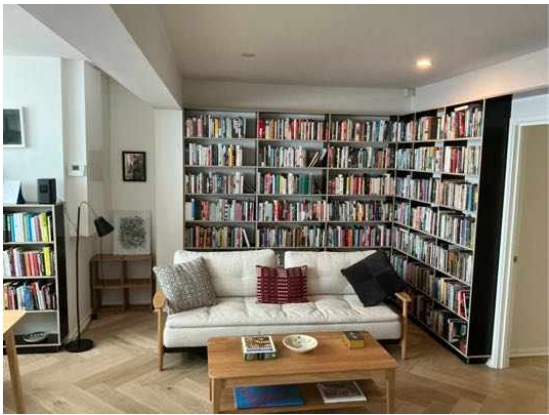
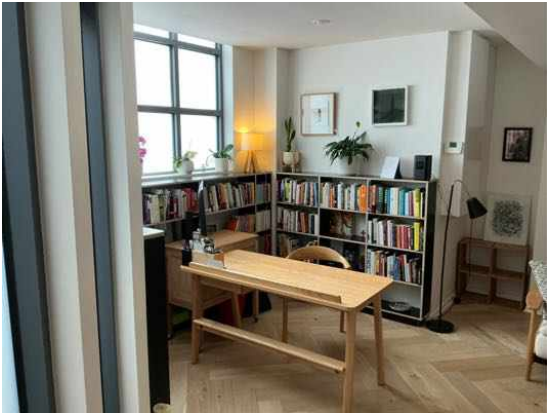
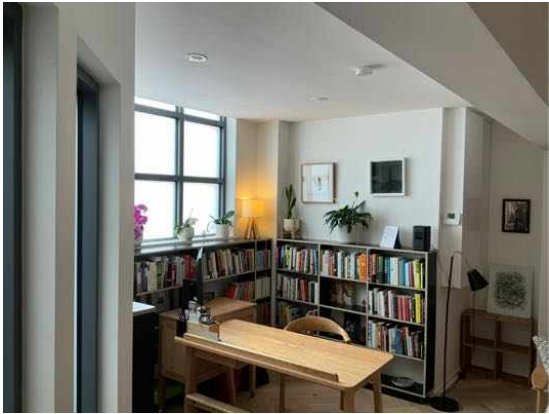
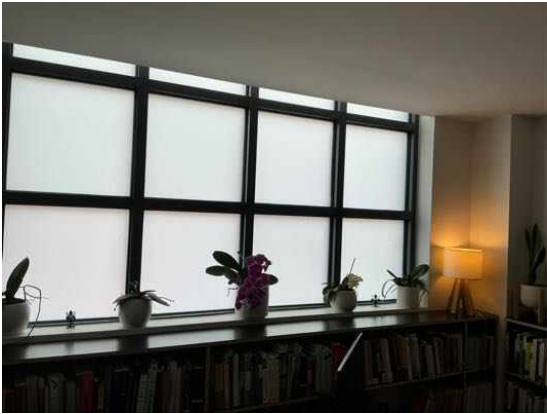
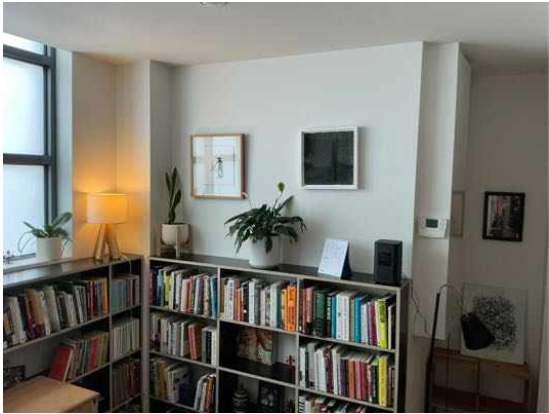
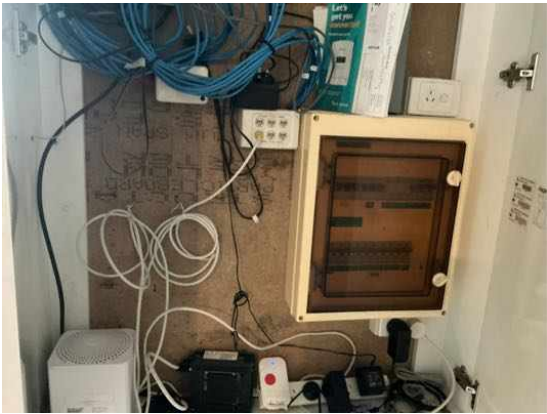
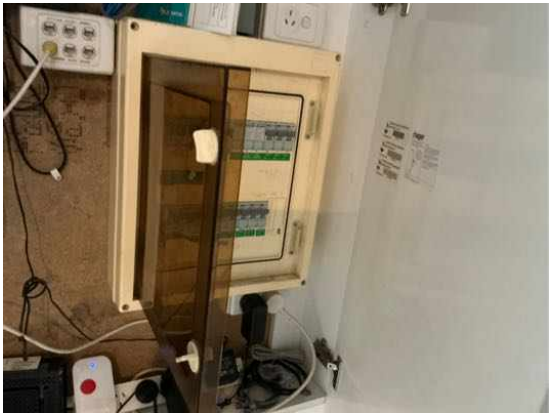
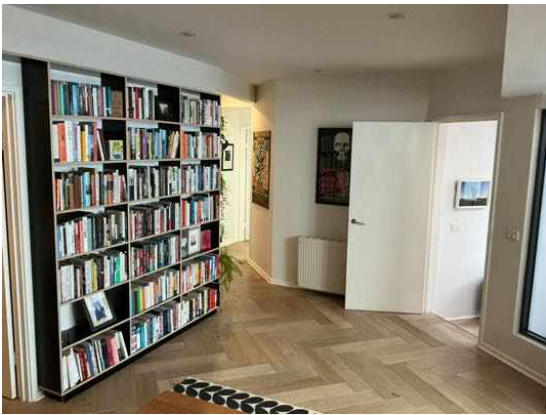
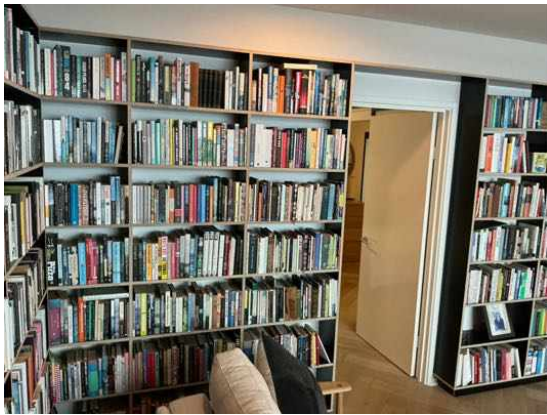
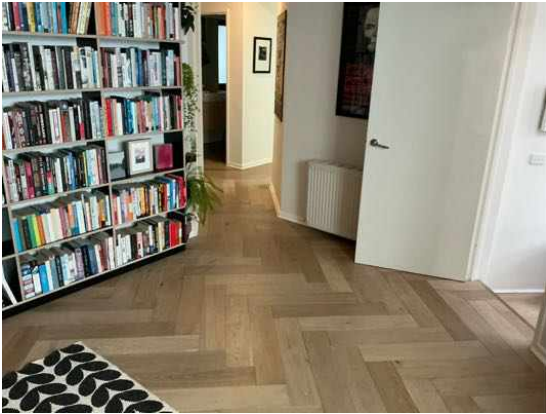
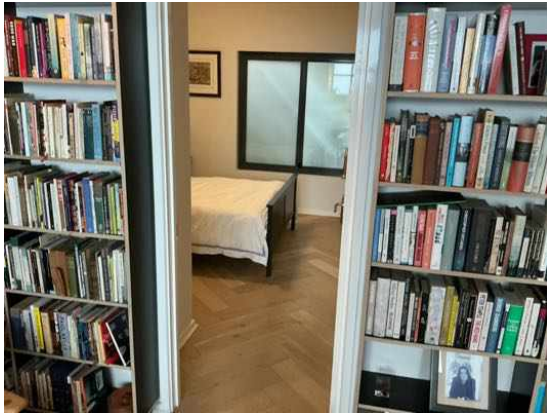
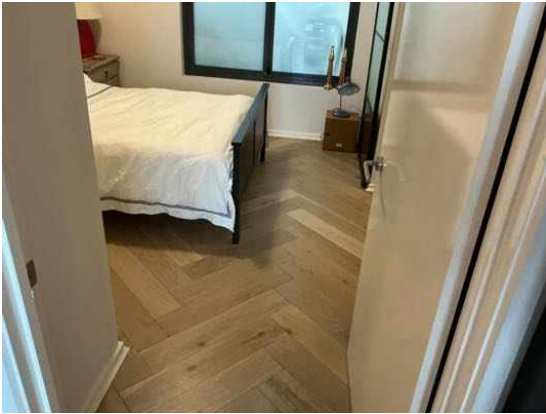
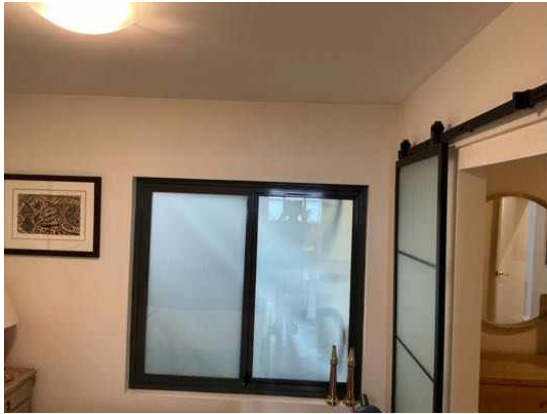
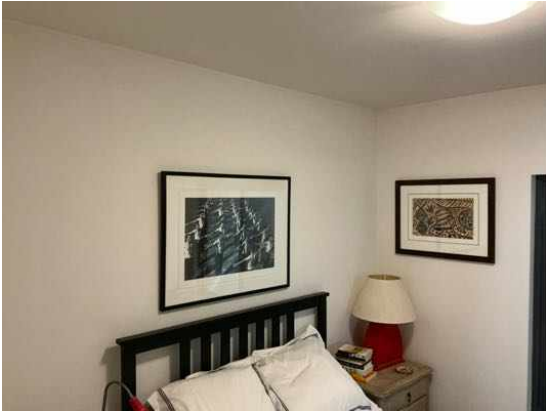
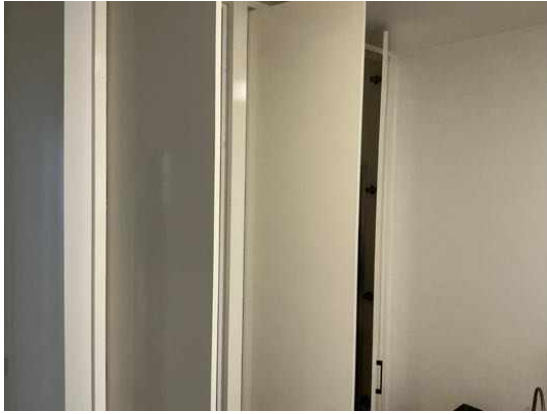
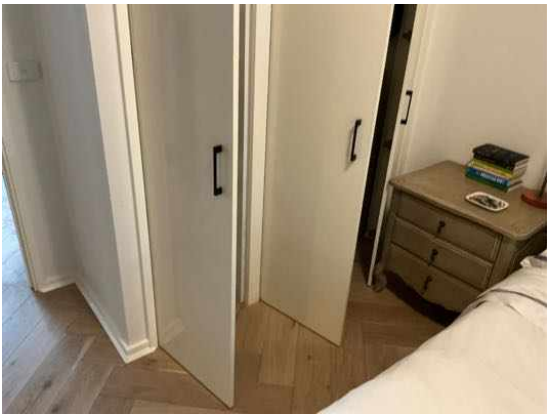
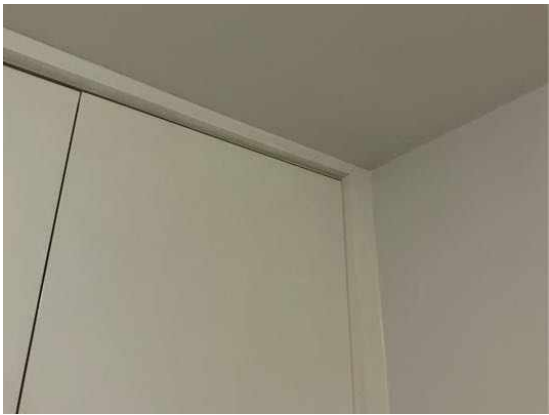
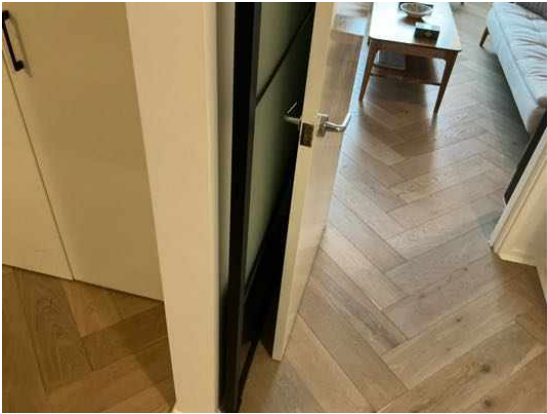
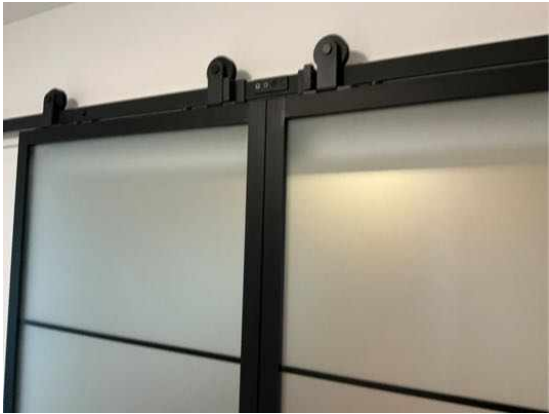
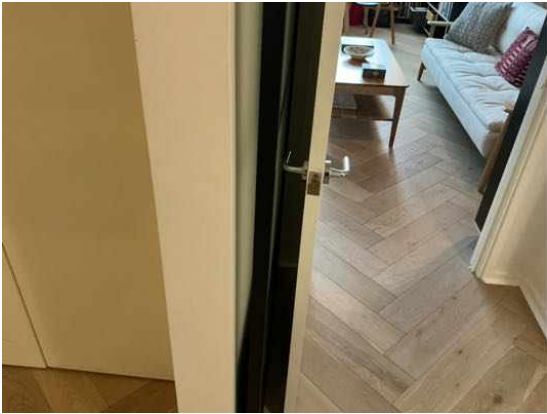
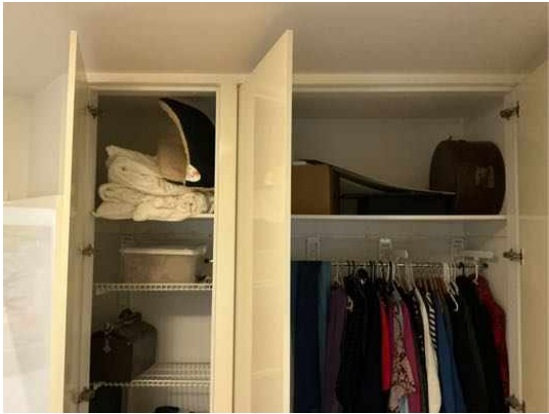
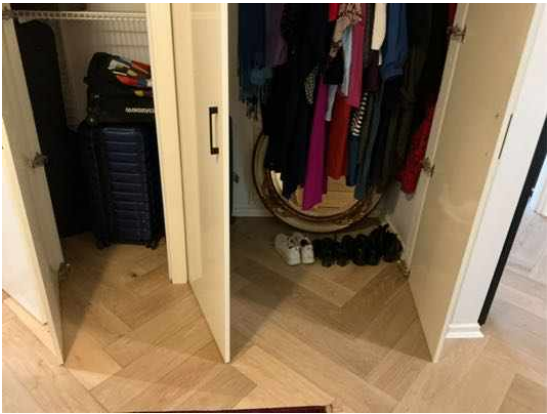
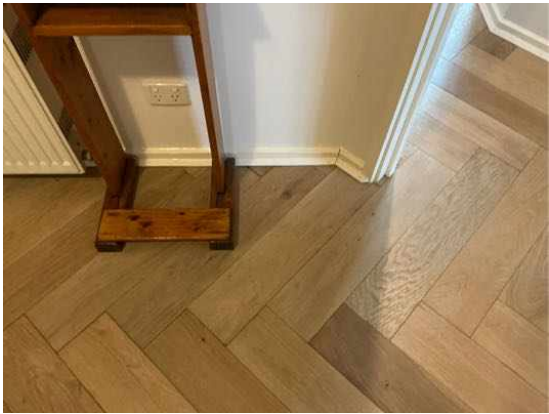
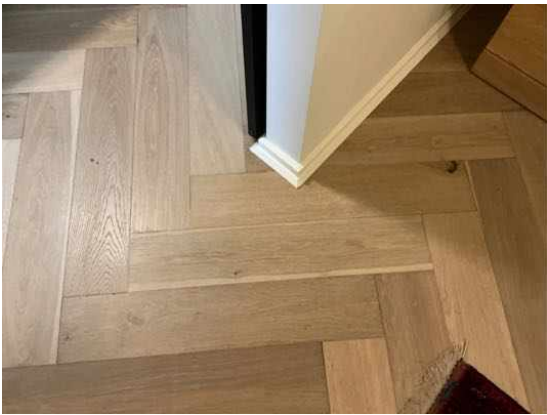
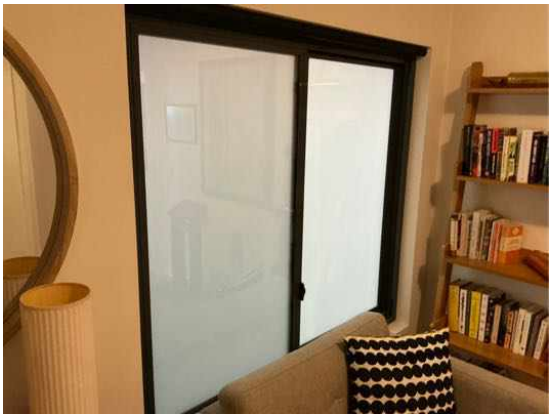
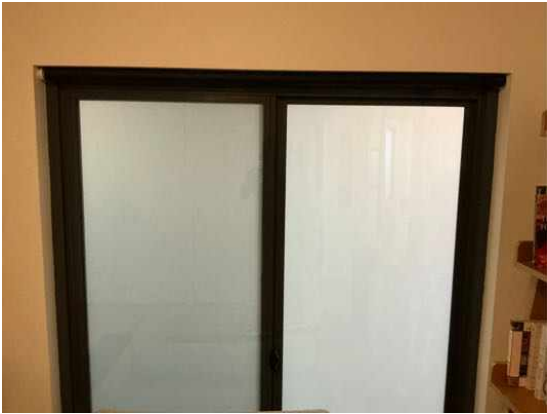
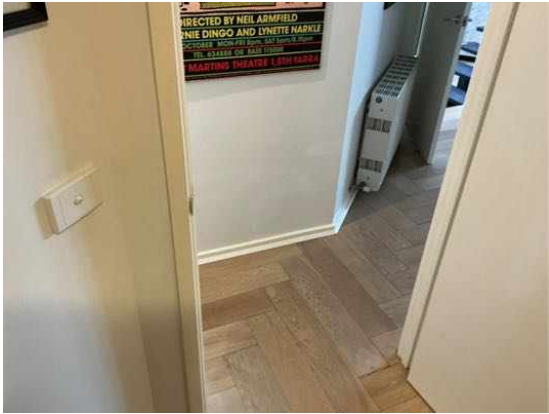
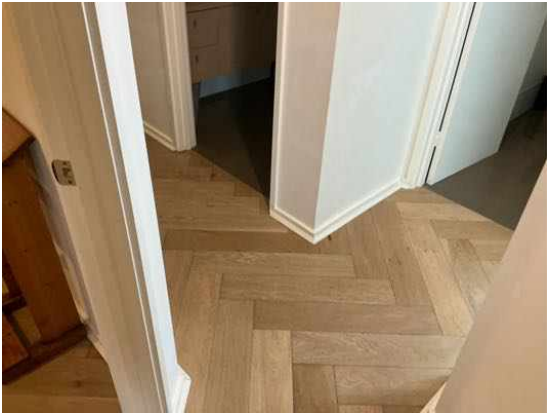
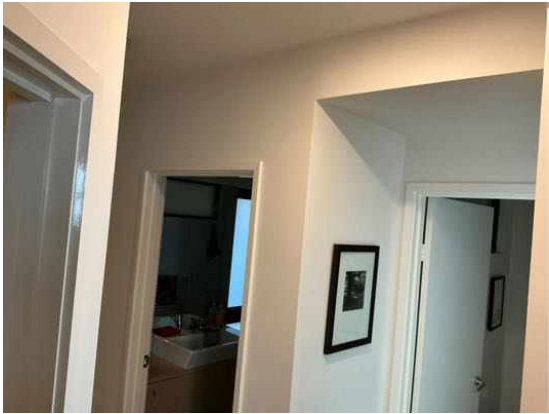
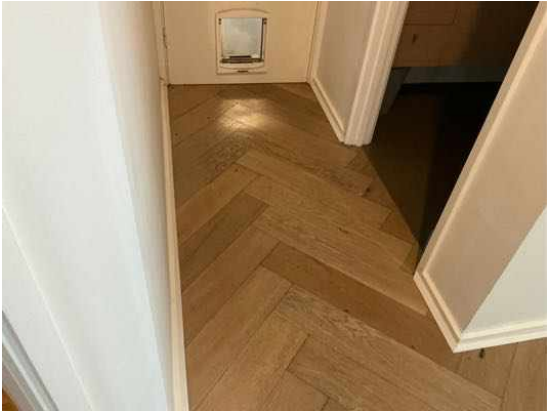
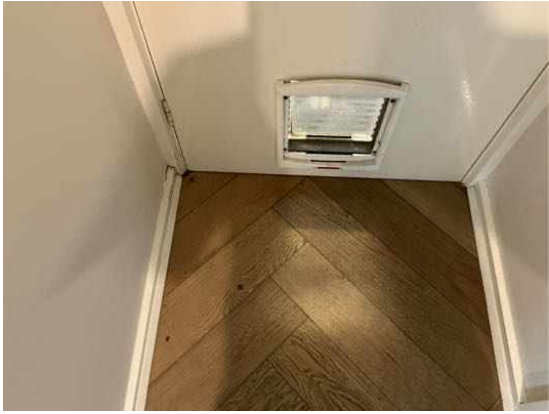
Building:	Main Building
Location:	All Areas
Finding:	Additional Photos - Obstructions and Limitations
Information:	These photographs are an indication of the obstructions and limitations which impeded full inspection of the property at the time of inspection. These obstructions can hide an array of defects and should be removed to allow full inspection to be carried out. A re-inspection is recommended once the areas are made accessible.
