Building and Timber Pest Inspection Report VR

Inspection Date: Mon, 12 Jan 2026

Property Address: 4 Grevillea St, Ormiston QLD 4160,
Australia

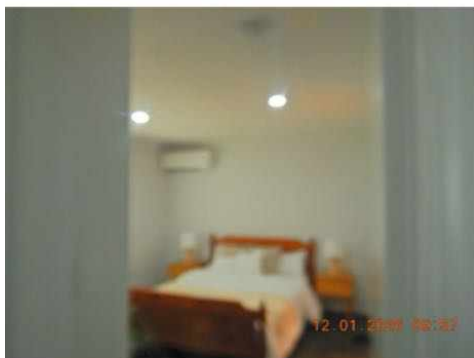
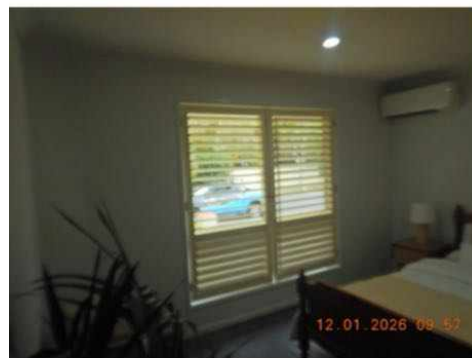
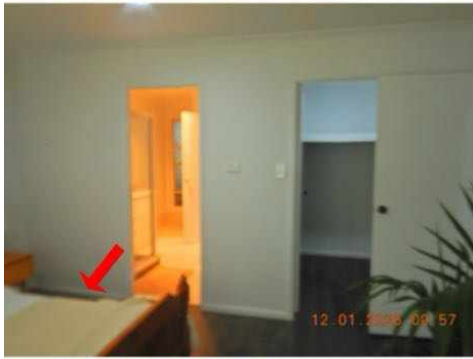
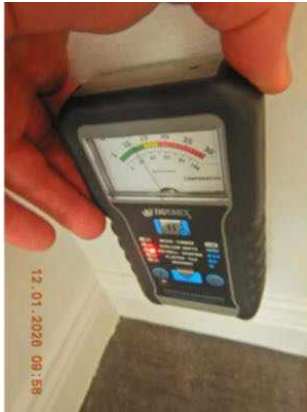
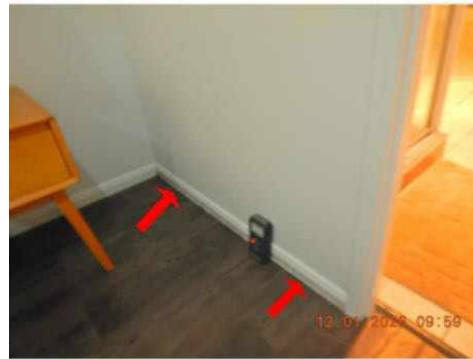
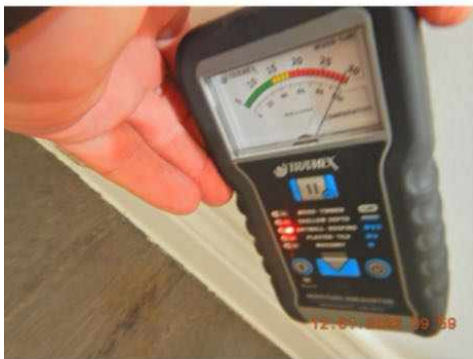
Building: Main Building
Location: Bedroom - Master > Rear Right
Finding: moisture meter readings
Information: There was a high moisture meter reading of between 22/30 % in the master bedroom/ ensuite shower wall area, with identified movement and moisture damage in the base of this wall at the time of this inspection. This can be caused by water ingress into the wall cavity from external sources or a possible plumbing leak . Wet areas can also have a potential failure to the water proofing membrane causing potential water issues. A licensed plumbing contractor or waterproofing contractor should inspect this area and report .

Termatrack radar readings taken in this area indicated NO termite activity at the time of this inspection.

Repair works may be required to the wall framing in this area.

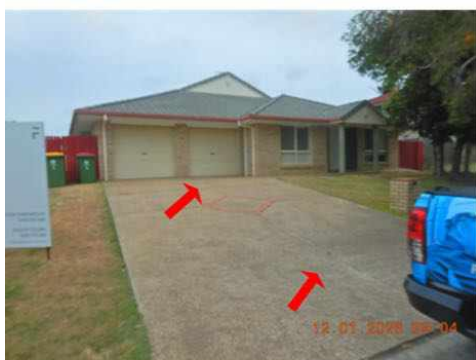
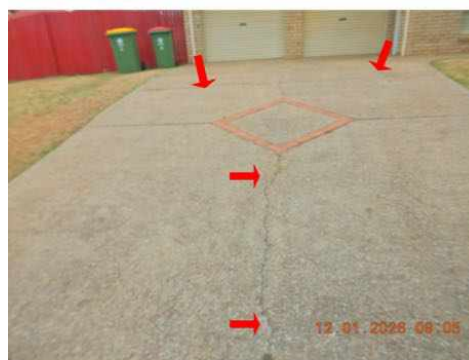
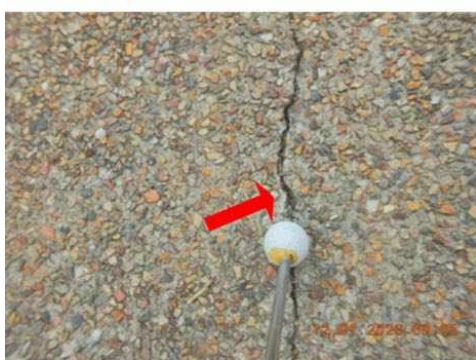
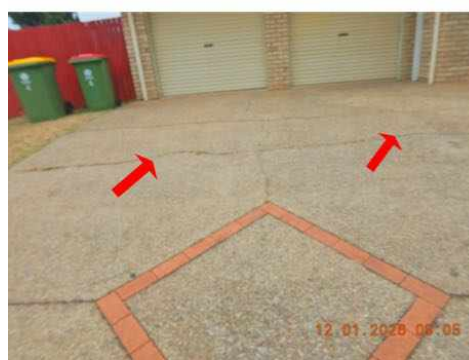
Finding 3.01

Building:	Main Building
Location:	Driveway > All Areas
Finding:	Cracking - External Concrete Paving Damage Category 2 - Distinct (less than 3mm)
Information:	Distinct cracks were identified in external driveway concrete paving. Distinct cracks are generally found in older concrete paving, and may also present as a trip hazard as consequence of an uneven or curved surface.

General age and expected deterioration of the paved areas is a common cause of this type of cracking. However, expansion and contraction of the slab may also have occurred due to environmental factors. Such factors include variable moisture and weather conditions, the presence of trees and their roots having a settling or lifting affect on the soil, or the effect of load bearing, e.g. heavy vehicles over a sustained period of time.

Cracking to this degree may also be due to poor original installation of the concrete. Factors such as poor compaction of the sub surface and/or inadequate reinforcing of the slab may create cracking and other secondary defects.

Repairs are likely to be required to prevent further cracking and to reduce hazards associated with cracking, such as tripping. Monitoring of all cracking should be conducted frequently. Always contact a building inspector should cracks widen, lengthen, or become more numerous.

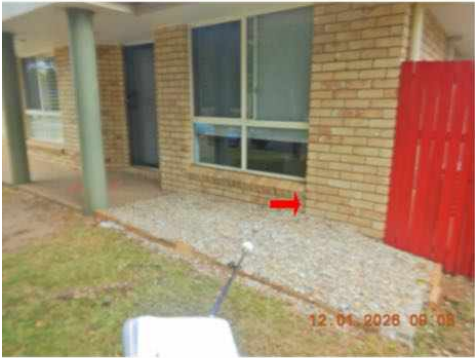
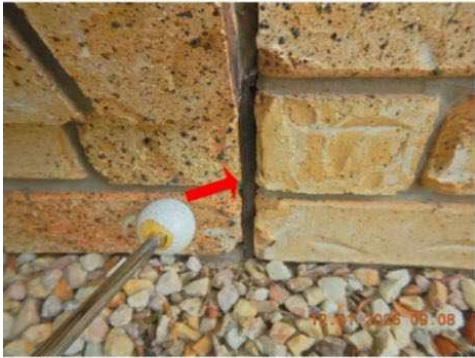
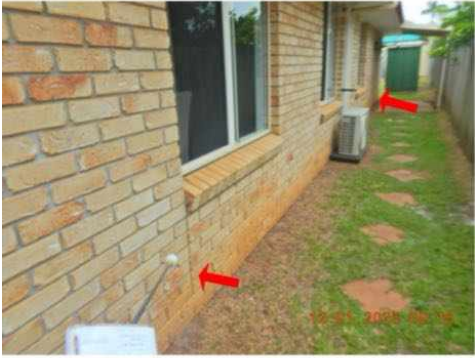
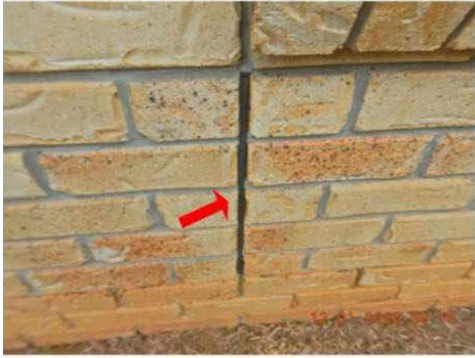
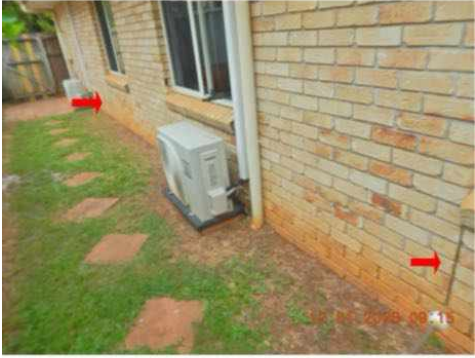
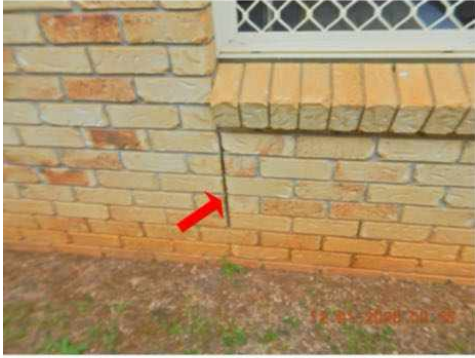
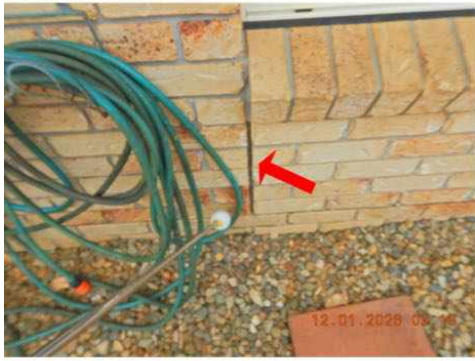
Finding 3.02

Building:	Main Building
Location:	Exterior walls > All Areas
Finding:	Masonry expansion joints not silicon sealed
Information:	Masonry wall expansion joints throughout this property were found to not be silicon sealed at the time of this inspection.

An appropriate flexible external grade sealant should be installed as per Australian standards .

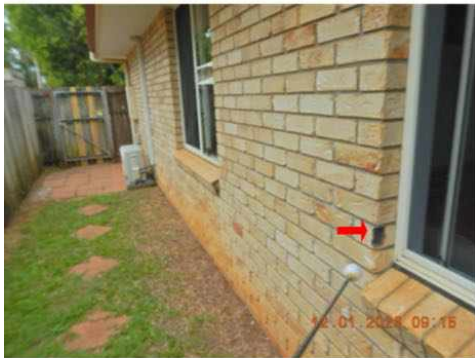
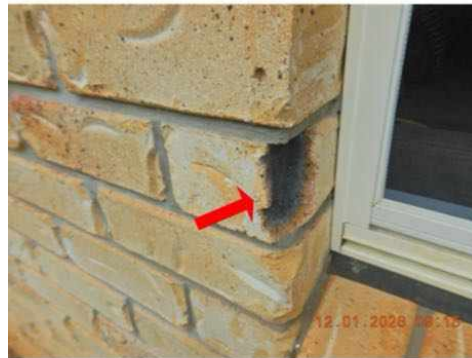
Finding 3.03

Building: Main Building
 Location: Exterior walls - right side > Centre
 Finding: Impact damage to brickwork
 Information: There is suspected minor impact damage to the right side family room brickwork that can be repaired at the clients discretion .

A bricklayer contractor or handyman can complete this job.

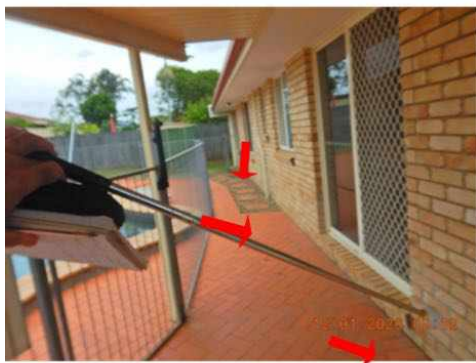
Finding 3.04

Building: Main Building
 Location: Pool Area > Rear
 Finding: Concrete / paved paths fall towards the building.
 Information: The rear pool paving and pathway on this property has been installed with fall back towards the rear of this building .

This MAY allow unwanted moisture penetration into areas of this building under severe weather conditions, and there were no obvious yard drains identified in this area.

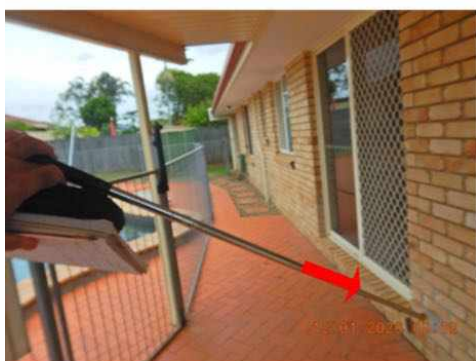
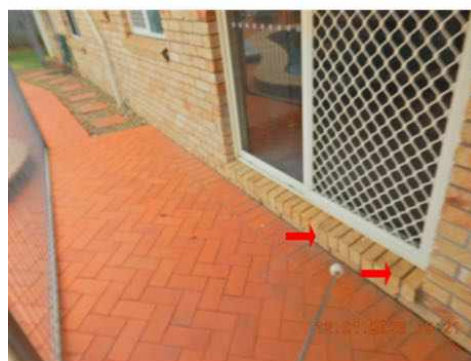
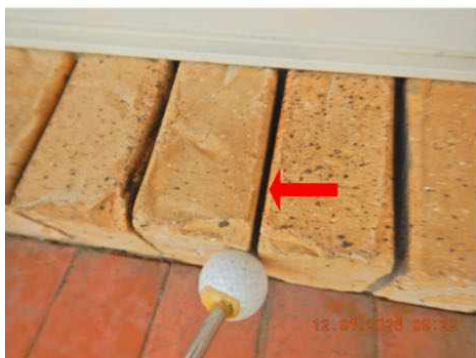
Finding 3.05

Building: Main Building
Location: Exterior walls - rear > Rear
Finding: Mortar - Deterioration
Information: The mortar to areas of the rear rumpus room sliding glass door brick sill was found to be in a deteriorating condition, and will require minor repair work.

This is suspected to be caused from salt water from the pool area.

Mortar deterioration can be attended to by a handyperson where areas of deterioration are localised and easily accessible. Otherwise, consultation with a roofing contractor is advised where greater works are required.

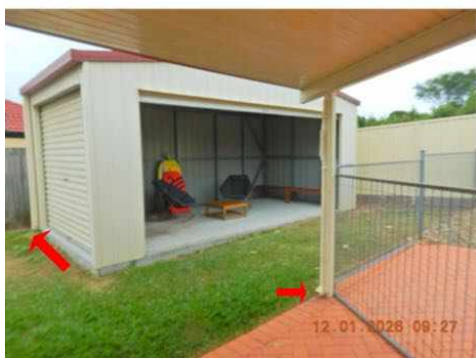
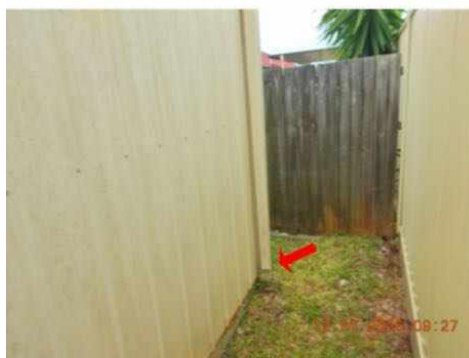
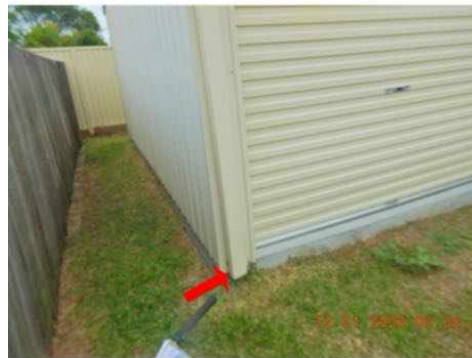
Finding 3.06

Information: The down pipes to the rear alfresco and detached garden shed in this property are not connected to the storm water line to the street. At present the down pipes are depositing water to the ground, this may over a period of time contribute to possible subsidence and structural foundation issues and may contribute to the development of mould and mildew, as well as being conducive to termite activity.

This is also conducive to termite activity.

The services of a licensed plumbing contractor could be engaged to carry out this task.

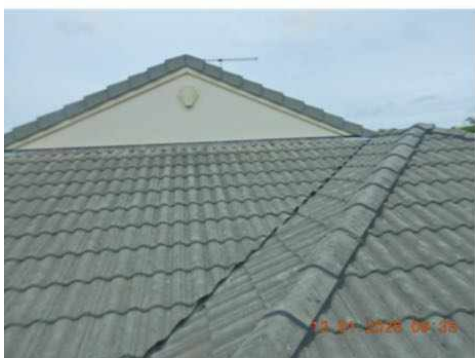
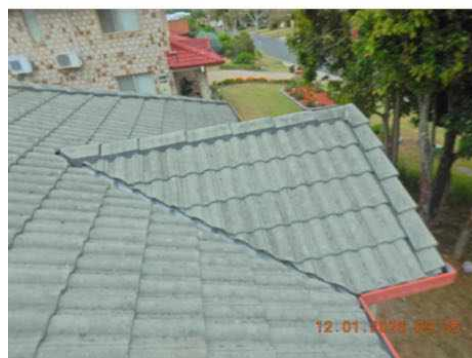
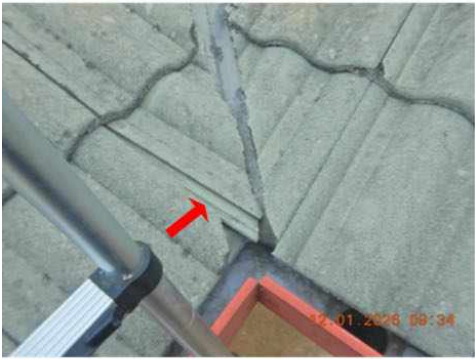
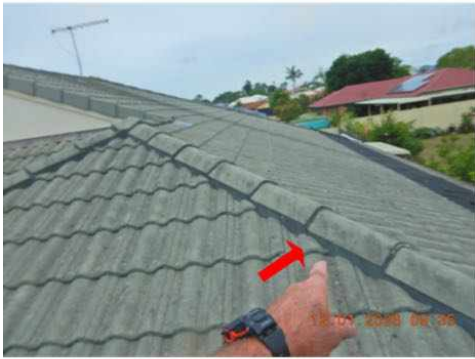
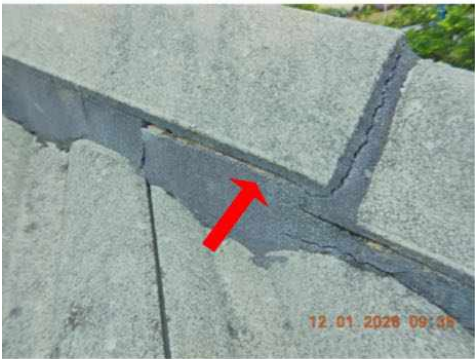
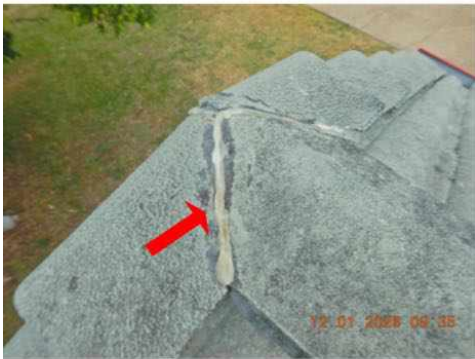
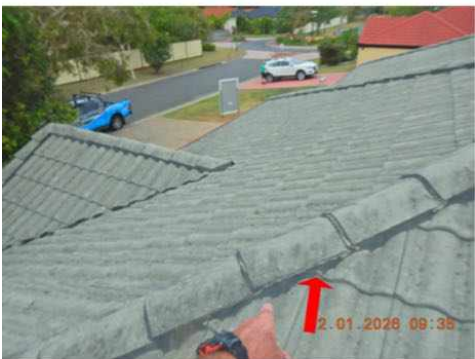
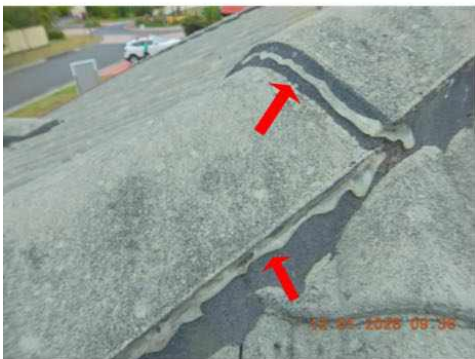
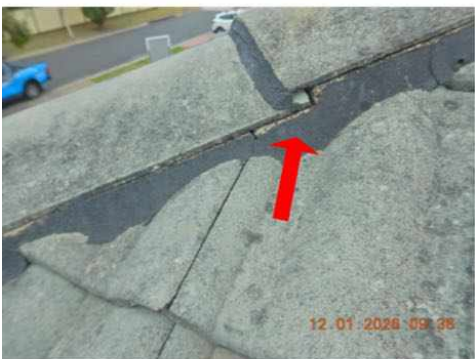
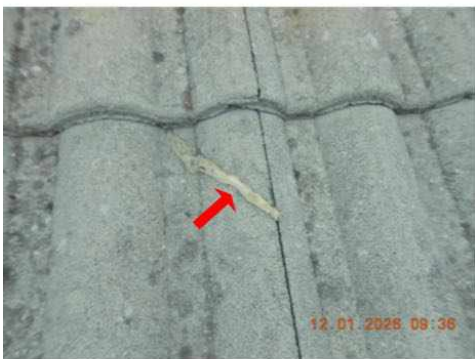
Finding 3.07

Building:	Main Building
Location:	Roof Exterior > All Areas
Finding:	Roof tiles - Weathered
Information:	Upon inspection of the exterior roofing, the majority of roof tiles were considered to be in a fair condition. While weathering of the tiles is consistent with the age of the property, maintenance works are required.

Isolated areas of mortar have come loose in the valleys and minor cracking is also present. Re-pointing and re-sealing the roof tiles may be considered as an interim solution by the client to help preserve and extend the life span of the tiles.

Where left unmanaged, deteriorating roof tiles are likely to lead to a number of secondary defects, including minor water leaks and weather exposure to internal roofing structures.

Consultation with a roofing contractor is highly advised to gain advice on cost of remedial works that may be required in the short to medium term. Remedial works are likely to increase the longevity of the exterior roofing structure.

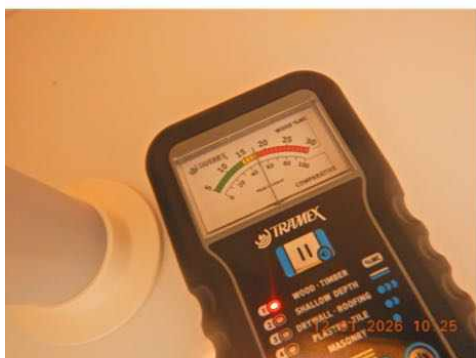
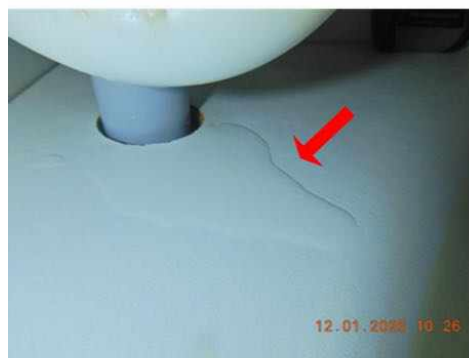
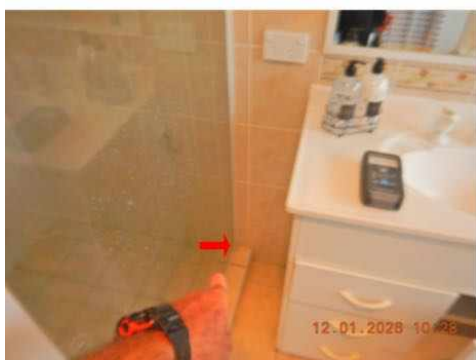
Finding 3.13

Building:	Main Building
Location:	Bathroom > Centre
Finding:	Tiles - Cracked or damaged
Information:	Minor Cracking was evident to the main bathroom floor tiling in this area at the time of inspection. While the cracking appears to be minor, this area is frequently exposed to water, allowing potential for water penetration into adjoining sections of walls or flooring.

If left unmanaged, water penetration to these areas may lead to subsequent water damage, which is likely necessitate repair work to affected building elements.

A tiling contractor should be appointed to ensure that no further water damage occurs. The re-application of silicone and grouting throughout remaining tile work is also advised, to further protect the area against water penetration.

Where water penetration has led to water damage, appointment of a relevant tradesperson may be required to repair damaged building elements.

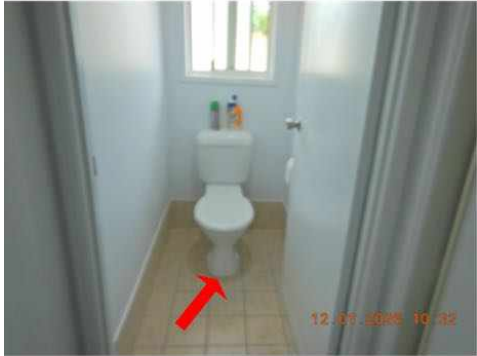
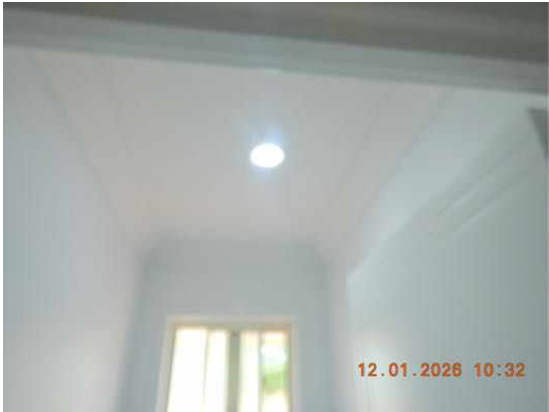
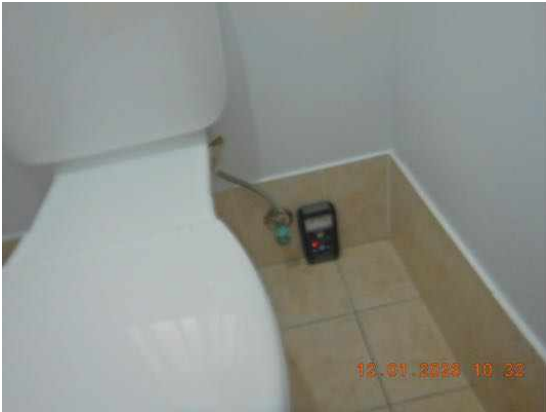
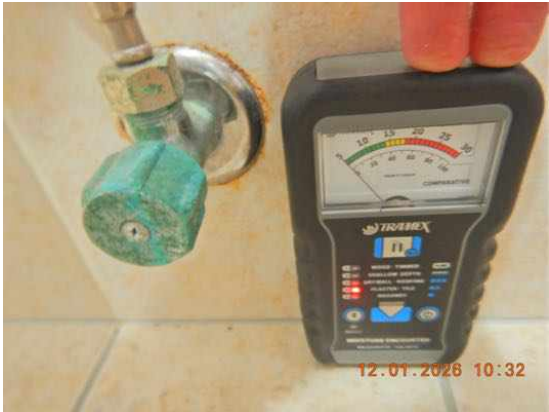
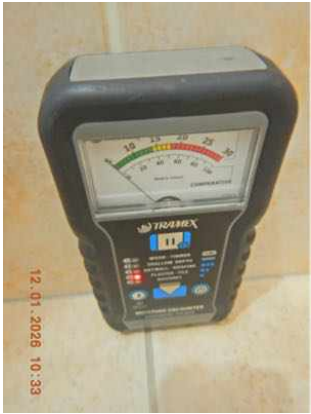
Finding 3.15

Building: Main Building
Location: Toilet (WC) > Rear
Finding: Toilet pan not secured correctly
Information: The main toilet pan was found to be loose and not secured to the floor correctly at the time of this inspection.

This may pose a potential safety hazard to anyone who may be using this unit if the unit moves or breaks when used.

There has been NO silicon sealant installed under the toilet pan, and there is minor movement in the pan.

Installation of an adequate silicone sealant will reduce the minor movement in the toilet pan.

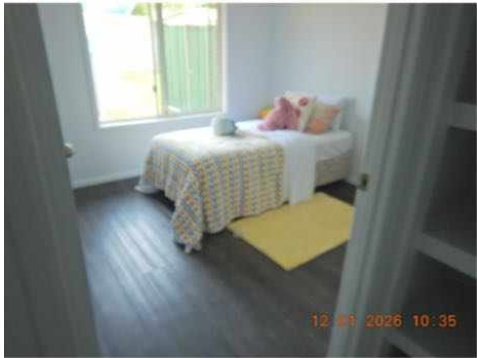
Finding 3.16

Building: Main Building
Location: Bedroom 3 > Front Right
Finding: Robe door damaged
Information: The bedroom-3 robe sliding door in this room was found to have sustained impact damage to the back face and will require repair or replacement.

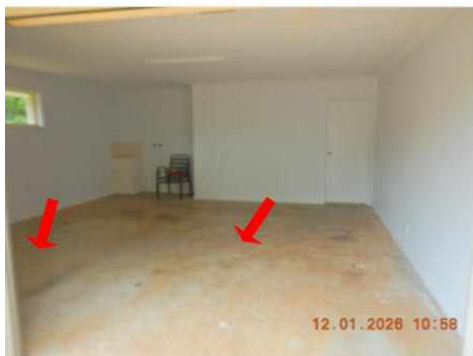
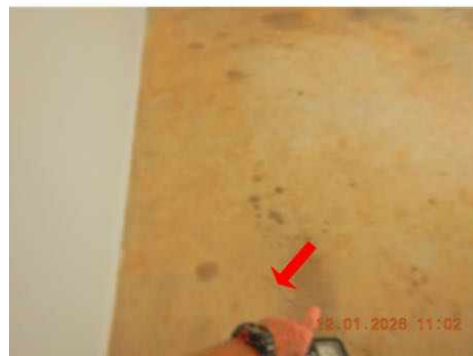
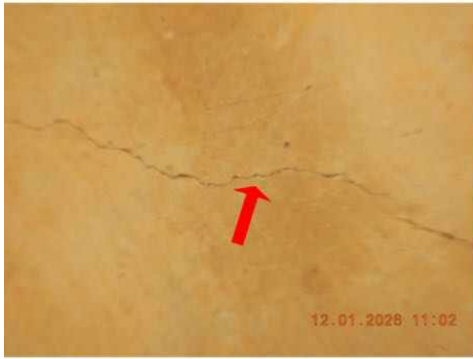
Finding 3.18

Building: Main Building
 Location: Garage > All Areas
 Finding: Crack in concrete slab - Category 1
 Information: Minor cracking coded as Category 1 was identified in the garage area slab. A Category 1 crack is described as a fine but noticeable crack, with the slab at an otherwise reasonable level.

To be considered Category 1, the approximate width of the crack is less than 1.0mm, or a less than 10mm change in offset when a 3m straight edge is placed over the defect.

Category 1 cracks should be monitored for a period of 12 months. At the end of the monitoring period, identified cracks that are rated greater than Category 2 are considered defects, and require rectification.

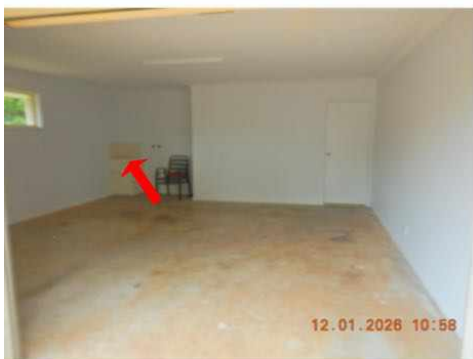
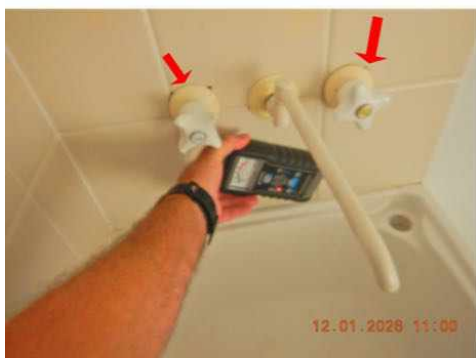
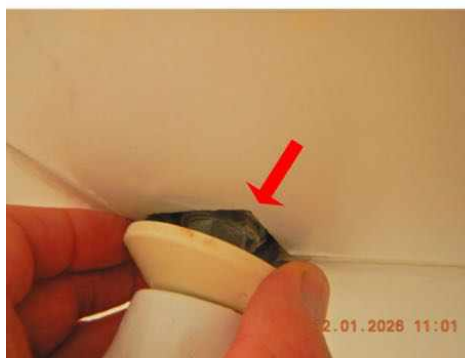
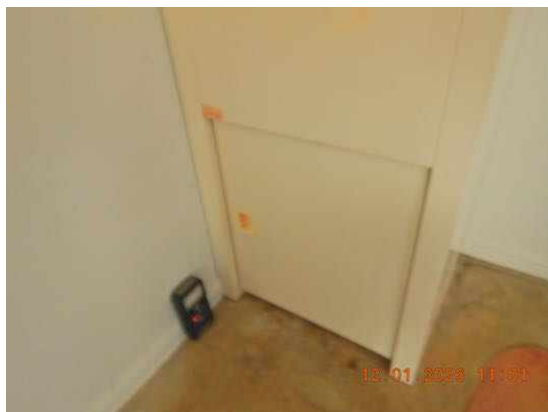
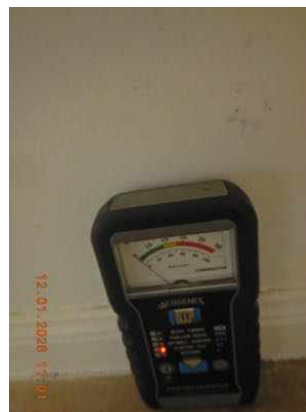
Finding 3.19

Building: Main Building
 Location: Garage/ Laundry > Rear Left
 Finding: Tap bodies not sealed in wall cavity
 Information: The garage /laundry wall taps were found to not be sealed in the wall cavity at the time of this inspection.

This will allow unwanted moisture penetration into the wall and floor cavity and may cause unwanted moisture damage to occurring to other areas of this building.

Installation of an appropriate sanitary grade sealant to all tap areas should be completed as soon as possible to reduce the risk of any further moisture damage occurring.

A plumbing contractor or handyman could complete the job.

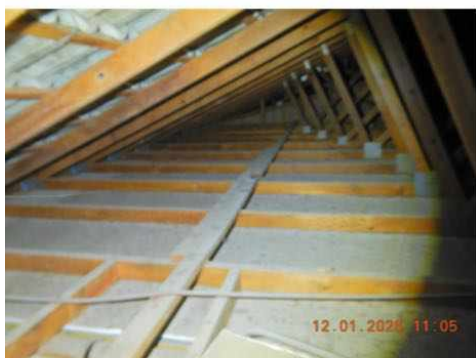
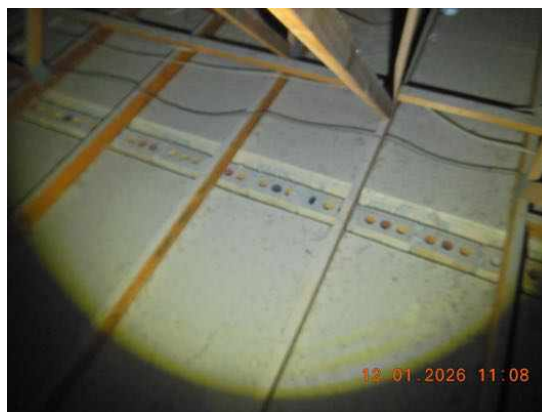
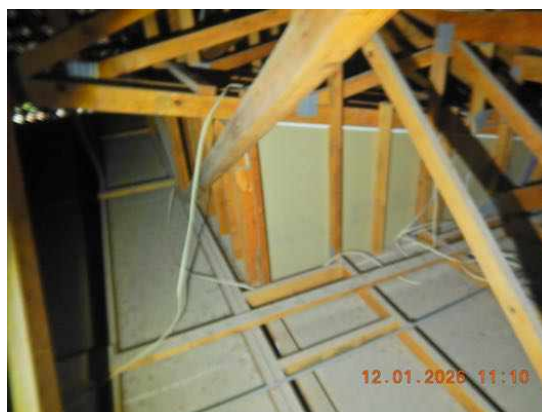
Finding 3.20

Building:	Main Building
Location:	Roof Void > All Areas
Finding:	Insulation - Missing
Information:	Upon inspection of the roof void it was noted that insulation is not present.

Where insulation is absent, the area does not meet current Australian Standards. Installation of adequate insulation is recommended and should be conducted at the client's discretion.

Ceiling Insulation was not required to be installed under the building code at the time of this buildings construction .

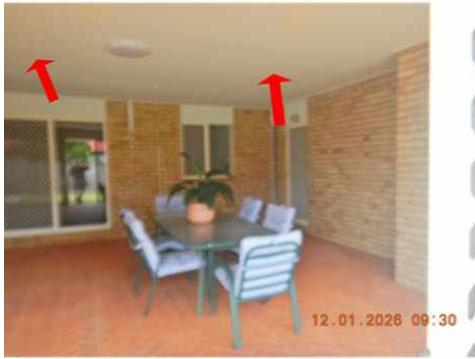
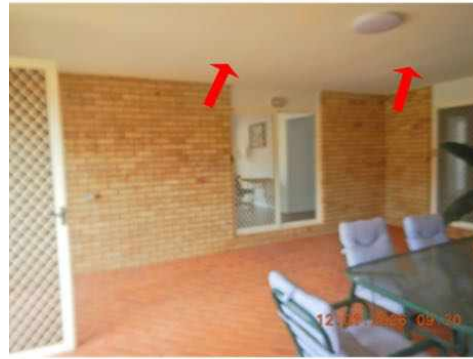
Finding 3.21

Building:	Main Building
Location:	Alfresco > All Areas
Finding:	Ceiling - Sagging
Information:	Sections of the alfresco ceiling were found to have minor sagging at the time of inspection. Sagging to the fixed ceiling structure generally indicates that the building materials have swollen, due to contact with water, or that fixings (e.g. nails or glue) have become loose and require reattachment.

Where minor sagging is evident, comparatively minor works, such as re-gluing of ceiling sheets, may be required. Such works may be performed by relevant tradespeople, such as plasterers and painters. Where excessive moisture has caused the roofing structure to swell and sag, the source of the water leak should primarily be identified prior to any remedial works being performed.

The appropriate action should be taken by the client as soon as possible to ensure that any potential further damage is limited.

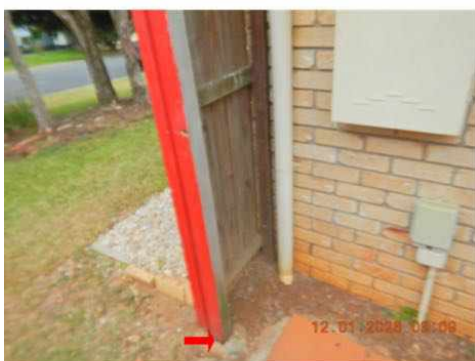
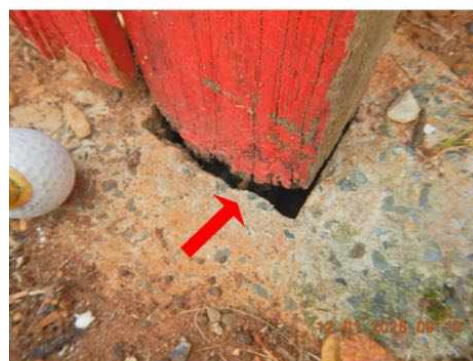
Finding 3.22

Finding: Fencing - Deteriorated

Information: It was noted at the time of inspection that sections of the timber fencing throughout the property have deteriorated. Typically fencing deteriorates due to age and or wear, rot and or rust which is generally expected for a structure of this age, due to prolonged exposure to weather conditions. Sometimes inadequate installation or maintenance can be to blame.

If left unattended, it is likely that further damage will occur. It is suspected that repair of several elements of the fencing may be required however replacement may be a consideration of the client also.

A licensed fencing contractor should be appointed to provide further advice and perform rectification works as necessary.

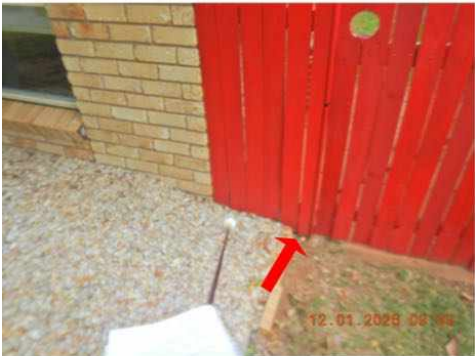
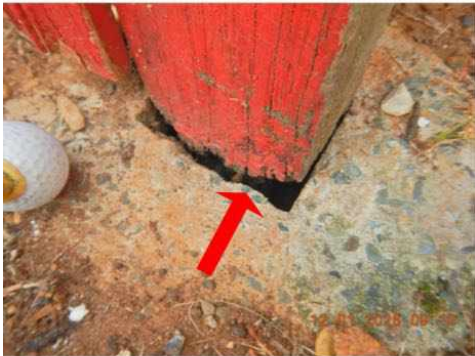
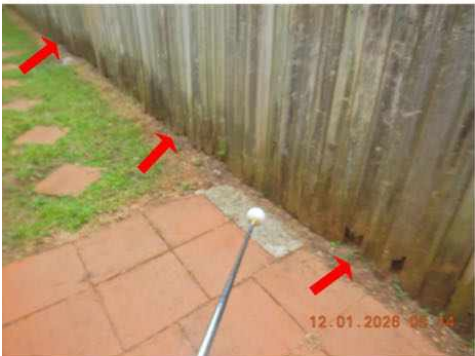
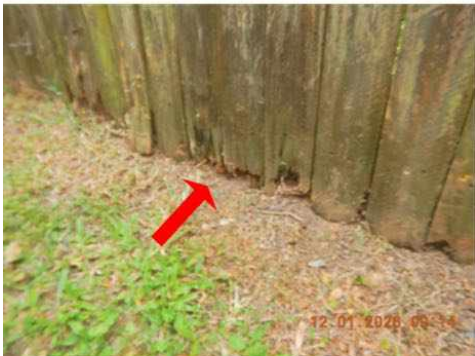
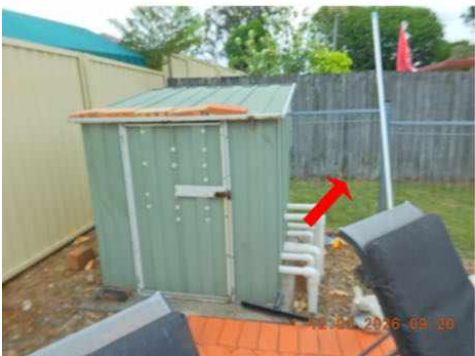
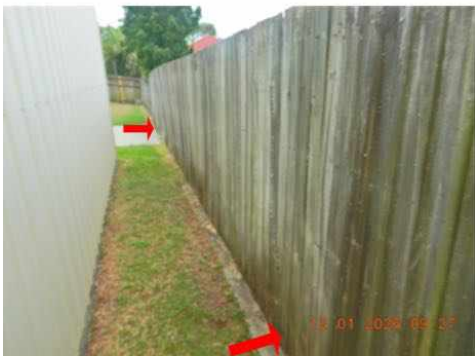
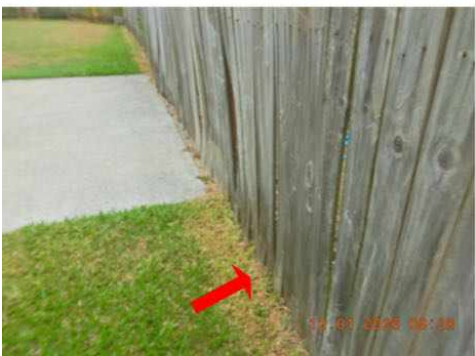
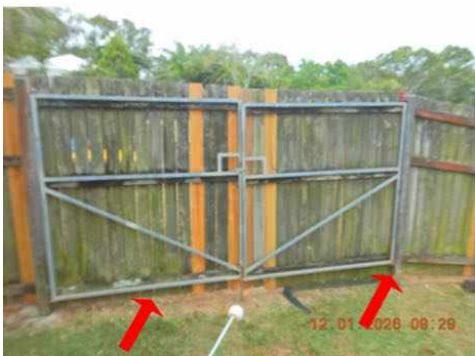
Finding 7.01

Building:	Main Building
Location:	Yard > All Areas
Finding:	Fungal decay - present (widespread)
Information:	Fungal decay was identified to most timber fence areas in this property at the time of this inspection.

In this case, fungal decay appears to have become widespread and is likely to have affected any adjoining timber elements/structures. The widespread development of fungal decay is likely to have heavily impacted the structural integrity and tensile strength of the affected timber elements and the associated structure.

Timbers affected by widespread fungal decay should be replaced immediately. The cause of the moisture that has led to the development of such decay should also be identified and dealt with in an appropriate manner.

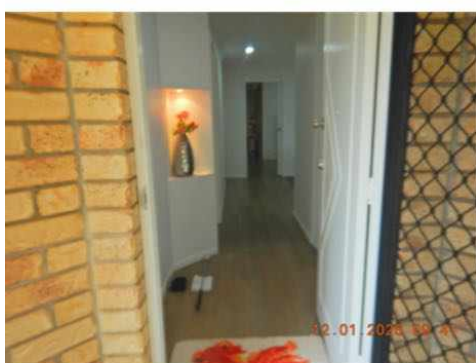
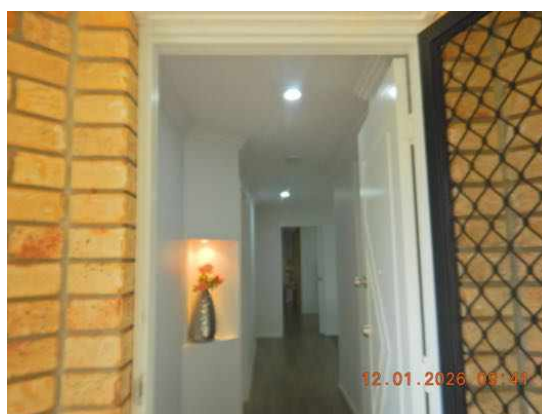
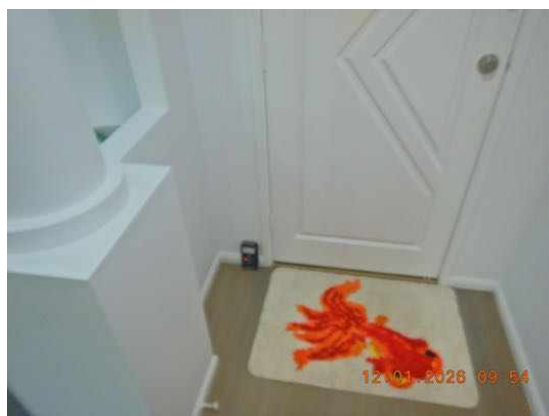
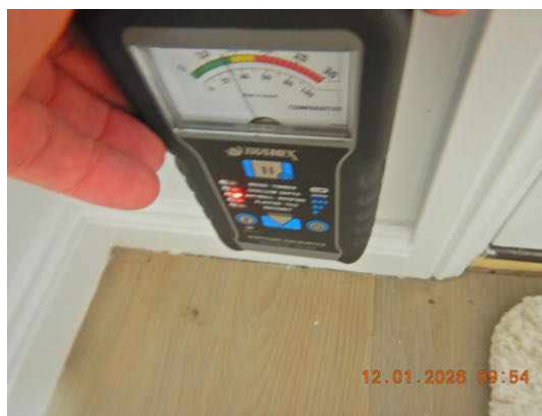
Building: Main Building
 Location: Entry > All Areas
 Finding: No obvious defects identified
 Information: There were no obvious defects found in the main front entry area on a visual inspection at this time.

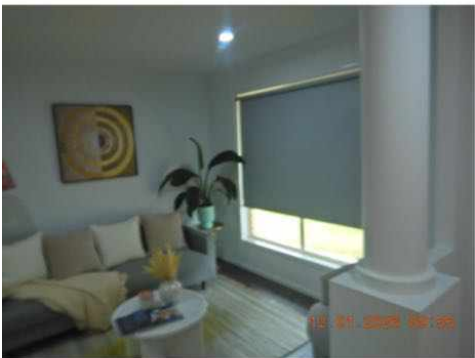
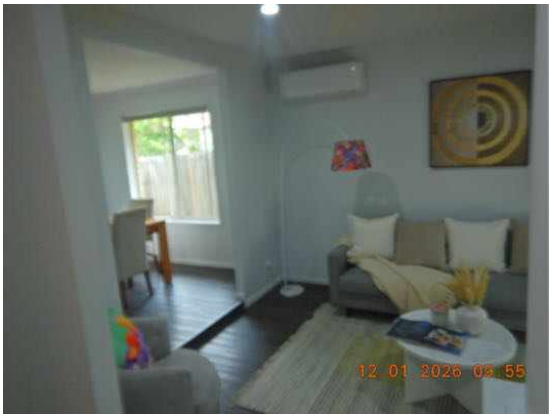
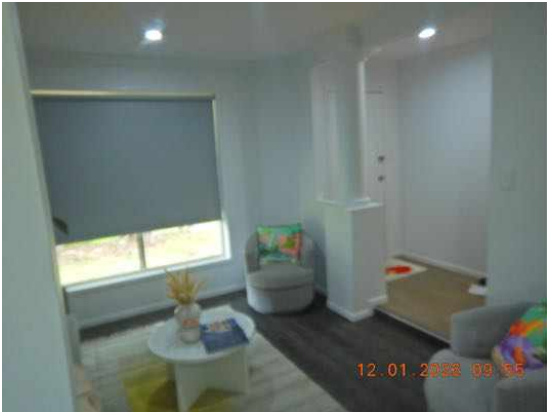
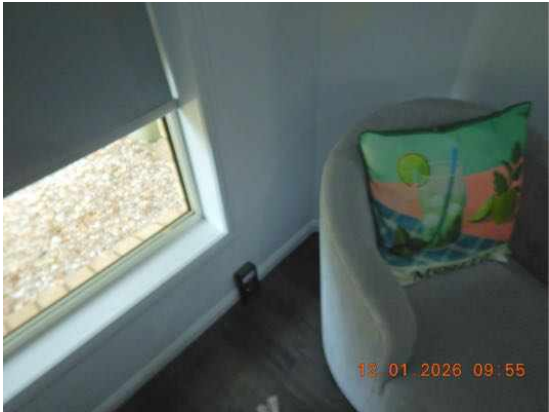
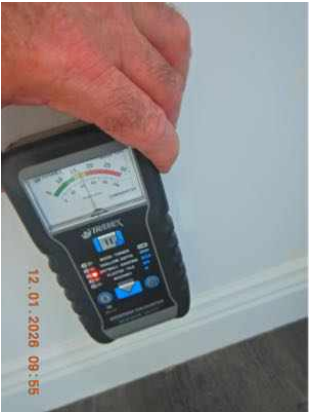
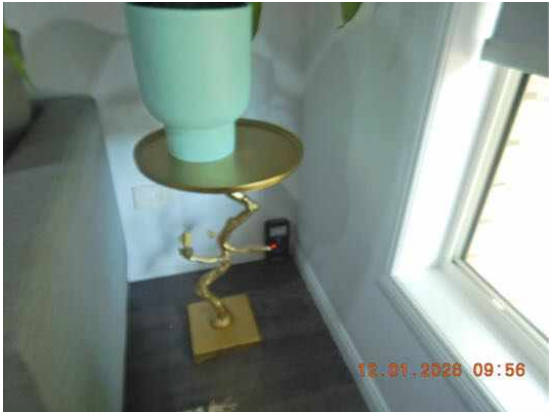
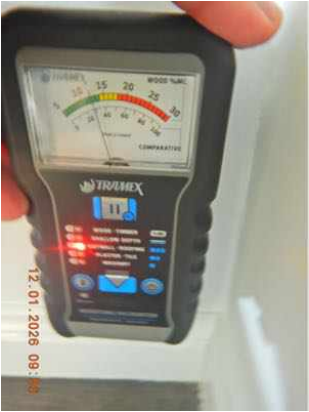
Noted Item

Building: Main Building
 Location: Living Room > All Areas
 Finding: No obvious defects identified
 Information: There were no obvious defects found in the living room on a visual inspection at this time.

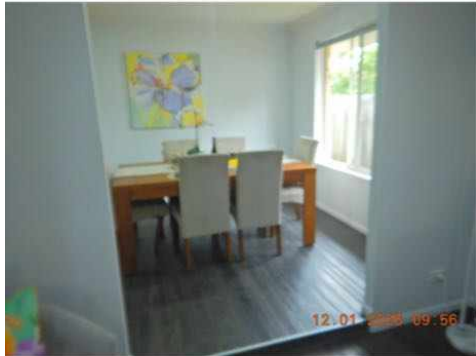
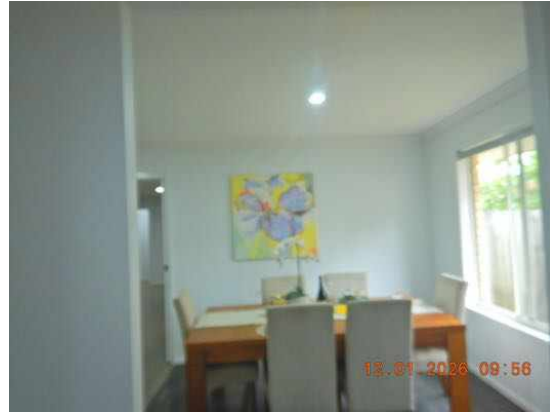
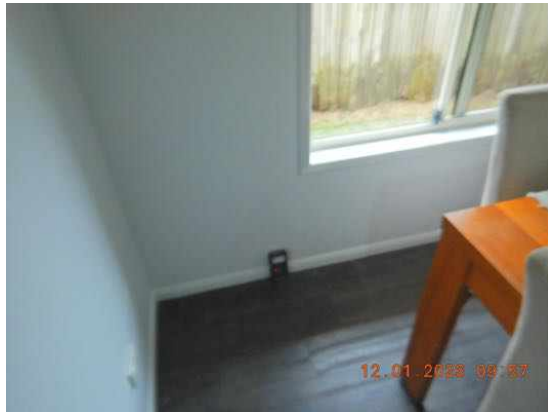
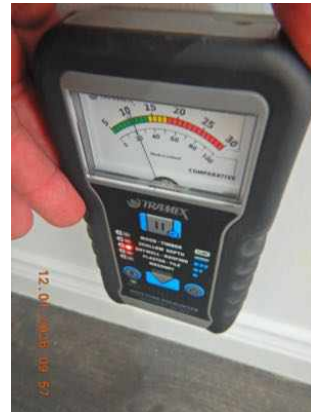
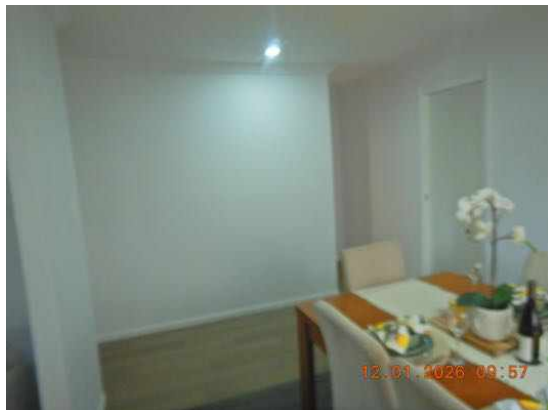
Noted Item

Building: Main Building
 Location: Dining Room > All Areas
 Finding: No obvious defects identified
 Information: There were no obvious defects found in the dining room on a visual inspection at this time.

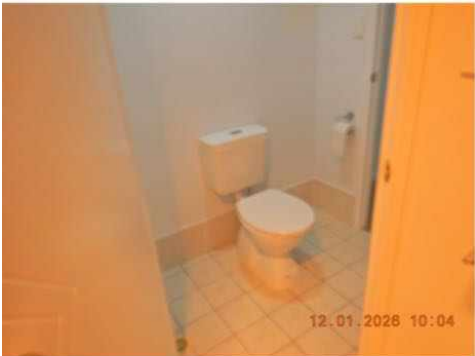
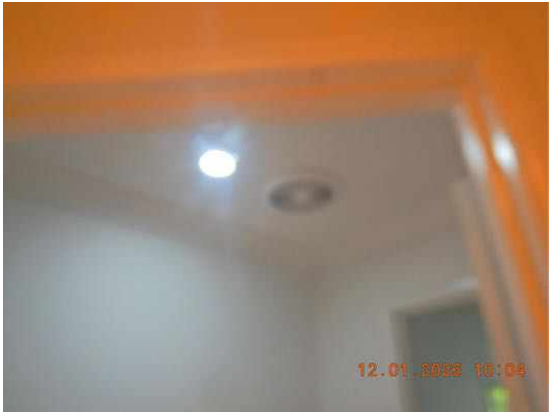
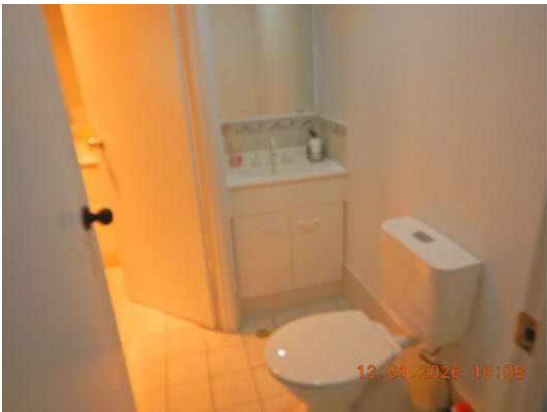
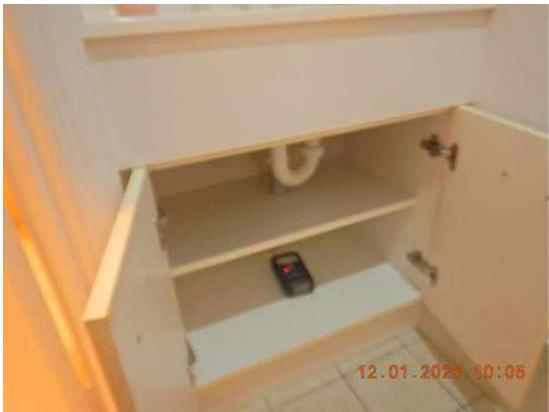
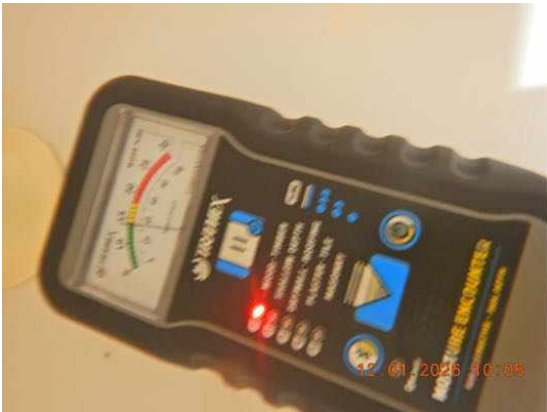
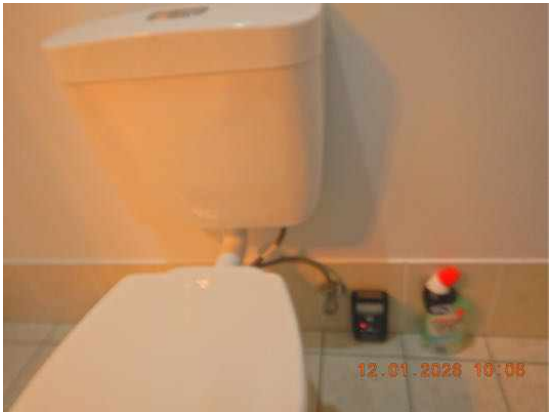
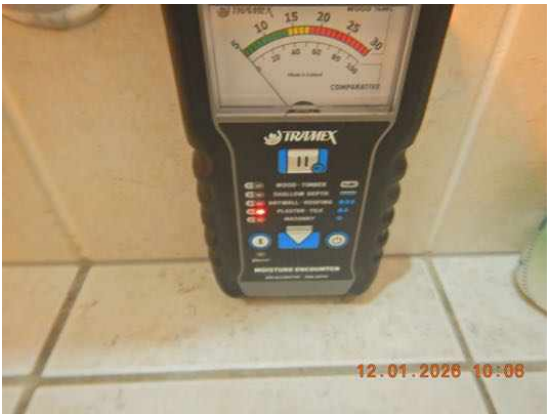
Noted Item

Building: Main Building
 Location: Toilet (WC) > All Areas
 Finding: No obvious defects identified
 Information: There were no obvious defects found in the toilet room on a visual inspection at this

time.

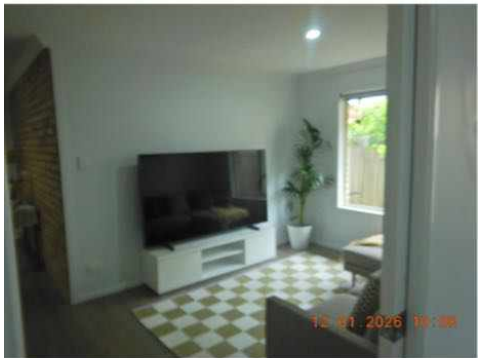
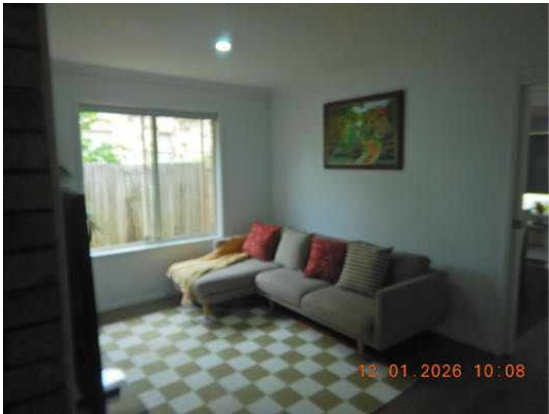
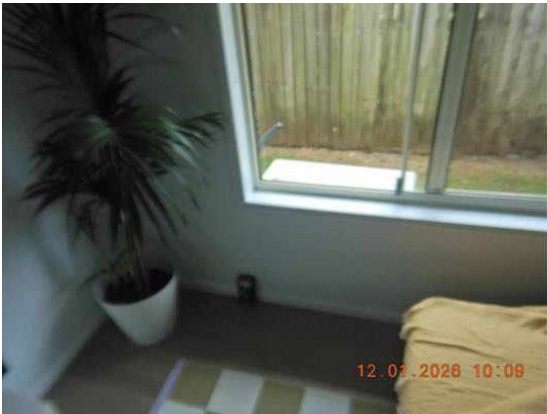
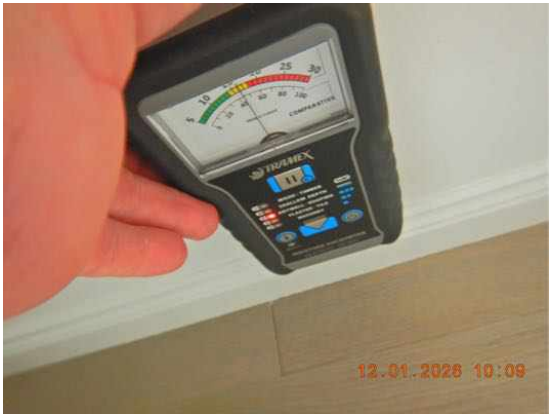
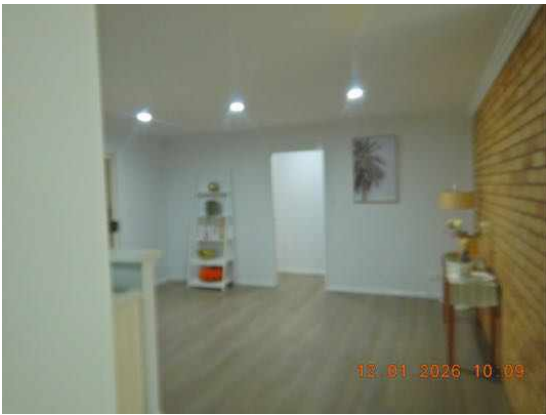
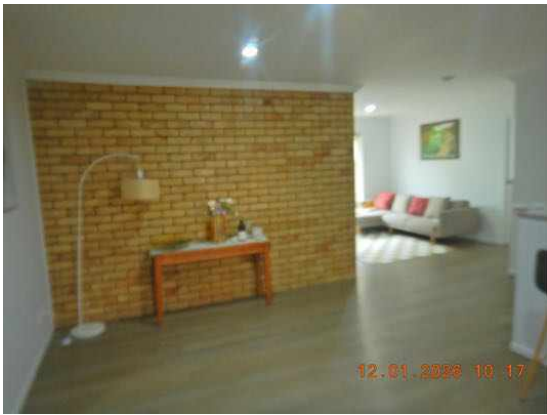
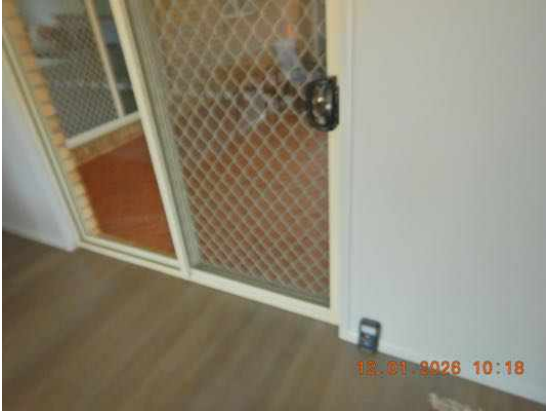
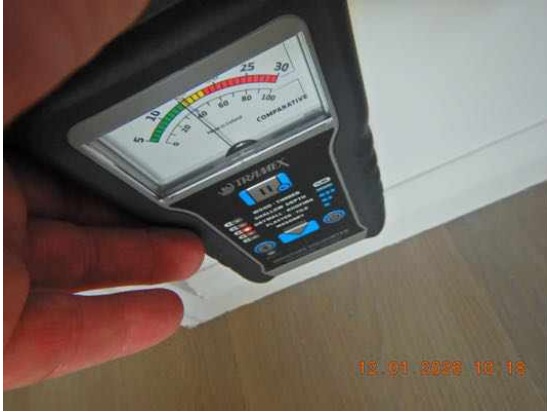
Noted Item

Building: Main Building
Location: Family / Meals Room > All Areas
Finding: No obvious defects identified
Information: There were no obvious defects found in the family/meals areas on a visual inspection at this time.
