Building and Timber Pest Inspection Report VR

Inspection Date: Mon, 12 Jan 2026

Property Address: 4 Grevillea St, Ormiston QLD 4160,
Australia

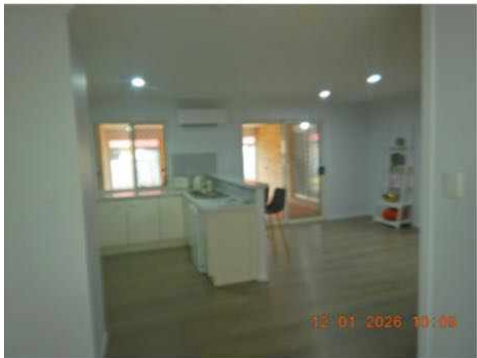
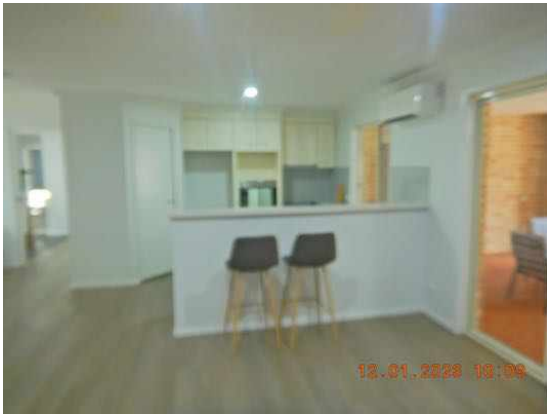
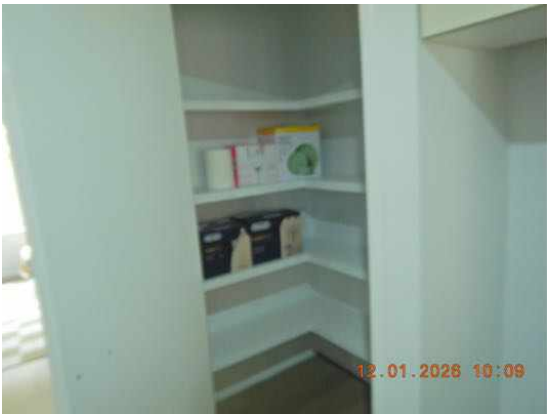
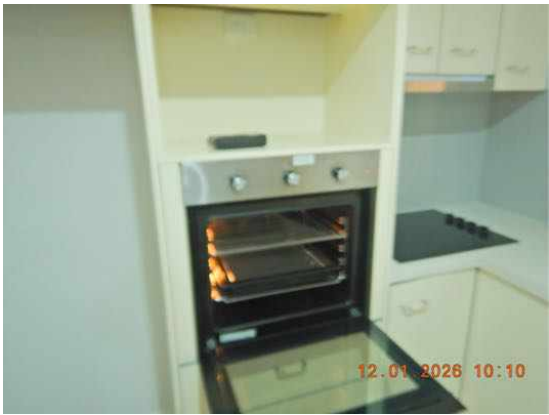
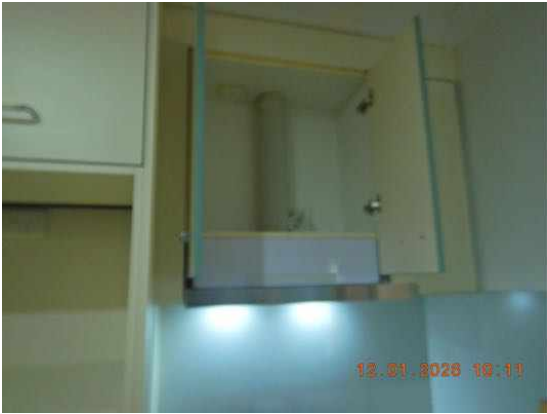
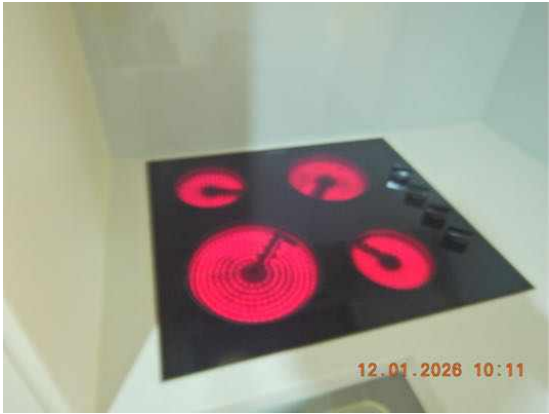
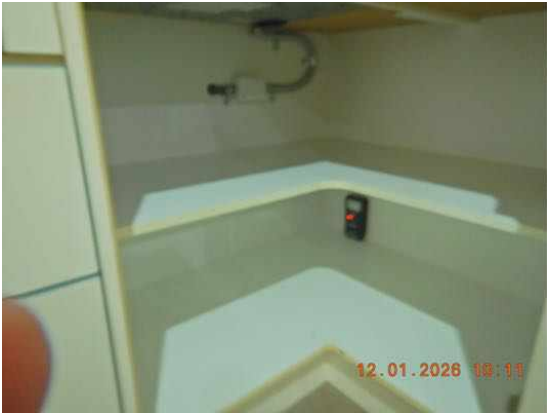
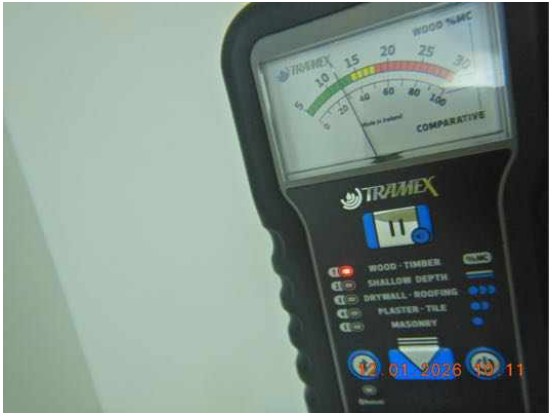
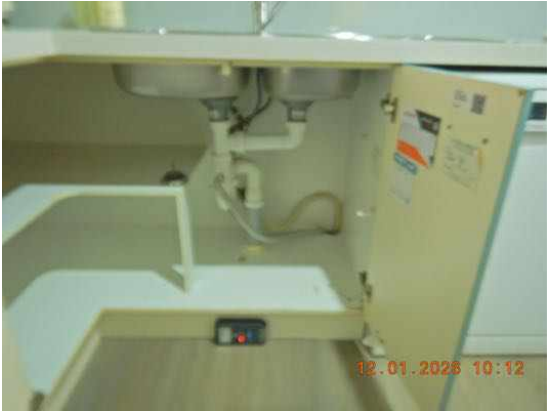
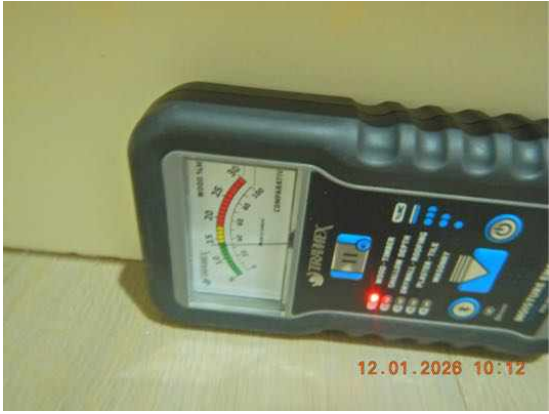
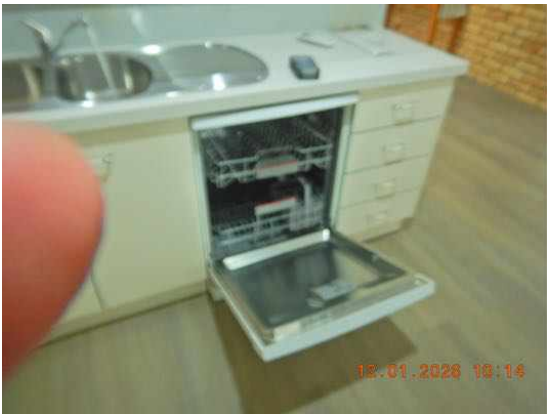
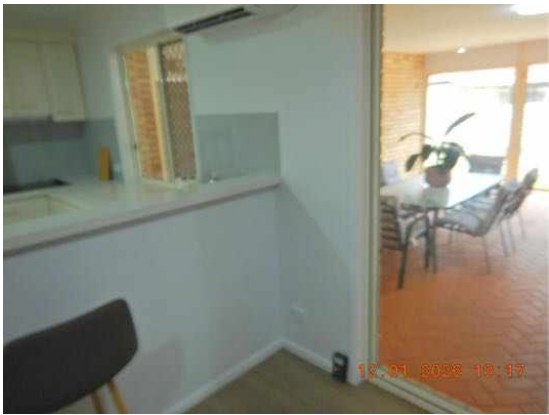
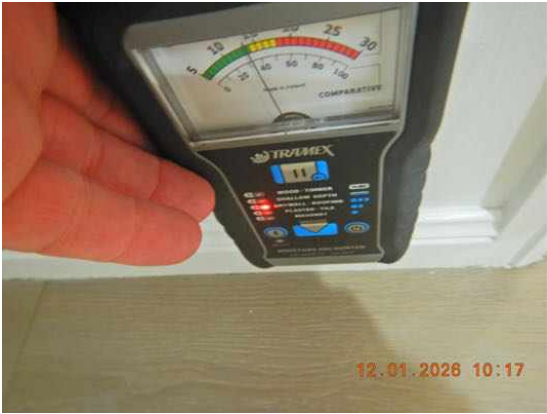
Noted Item

Building: Main Building
 Location: Kitchen > All Areas
 Finding: No obvious defects identified
 Information: There were no obvious defects found in the kitchen area on a visual inspection at this time.

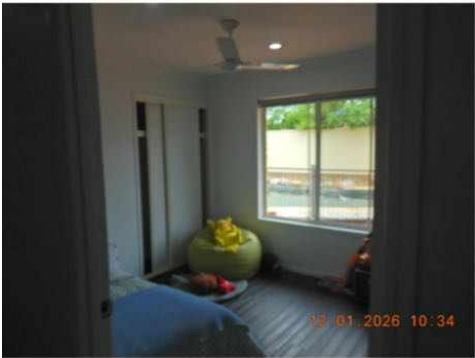
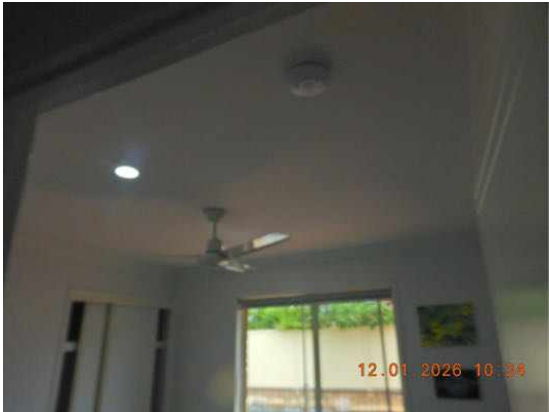
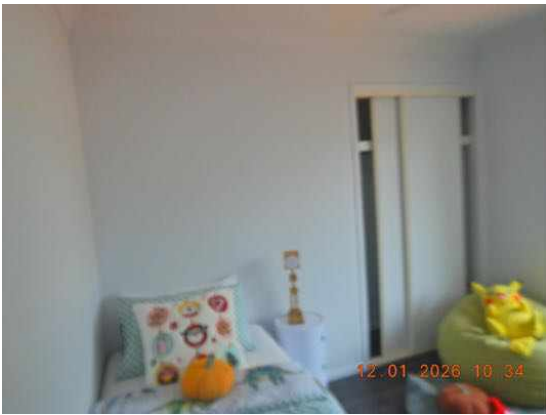
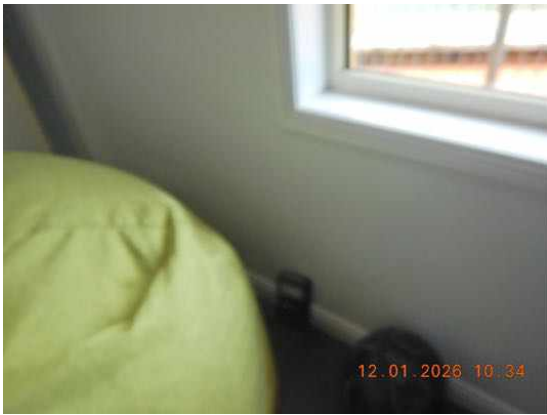
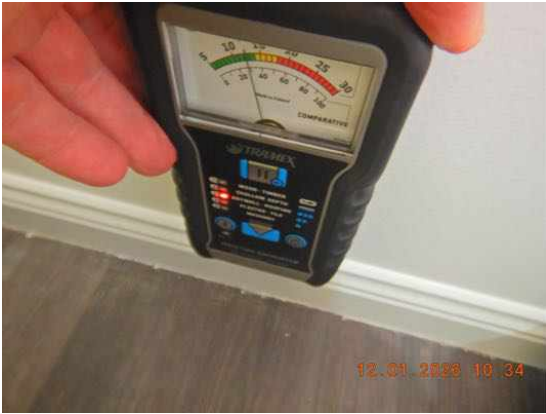
Building: Main Building
Location: Bedroom 4 > All Areas
Finding: No obvious defects identified
Information: There were no obvious defects found in bedroom-4 on a visual inspection at this time.

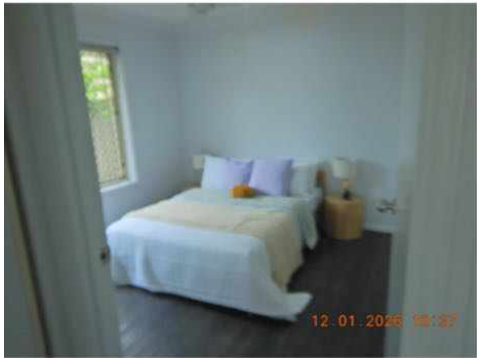
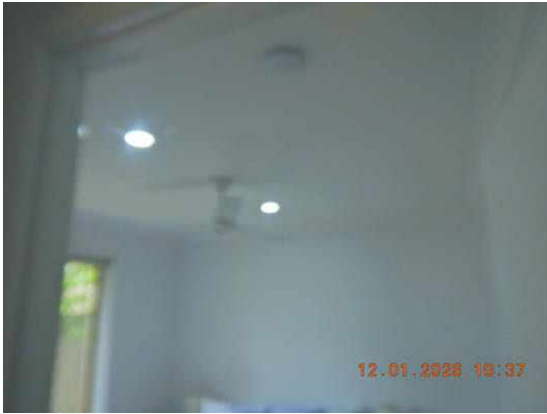
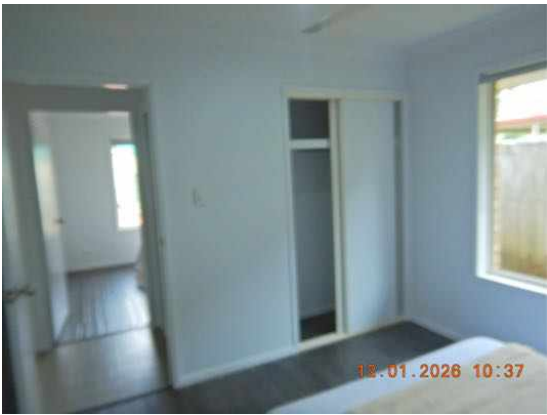
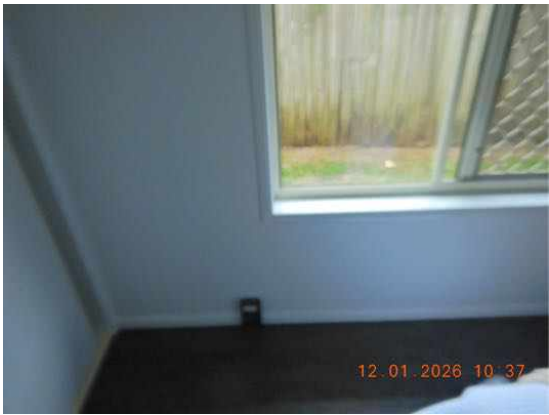
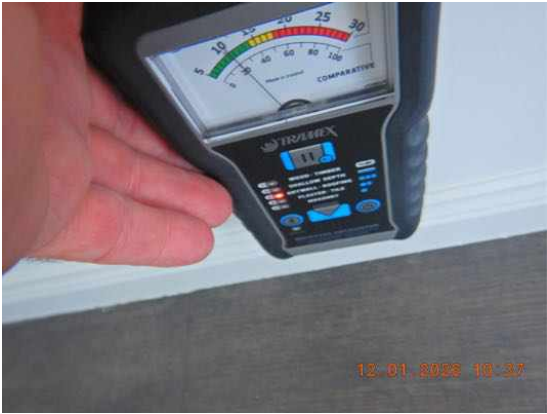
Building: Main Building
Location: Bedroom 2 > All Areas
Finding: No obvious defects identified
Information: There were no obvious defects found in bedroom-2 on a visual inspection at this time.

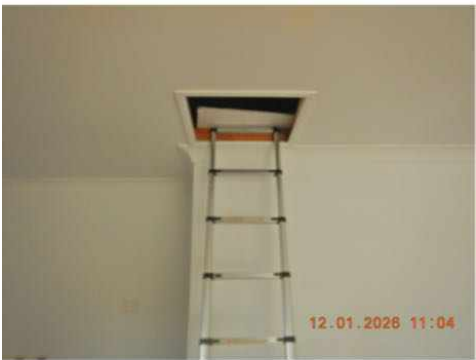
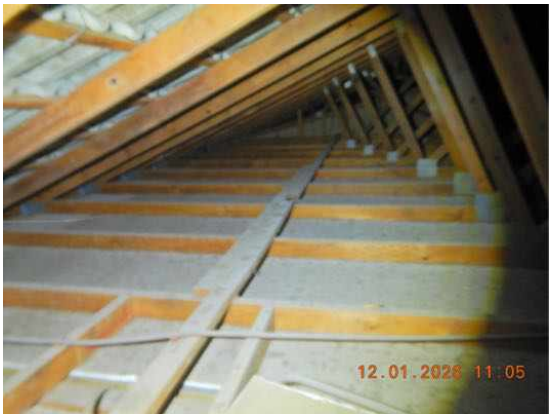
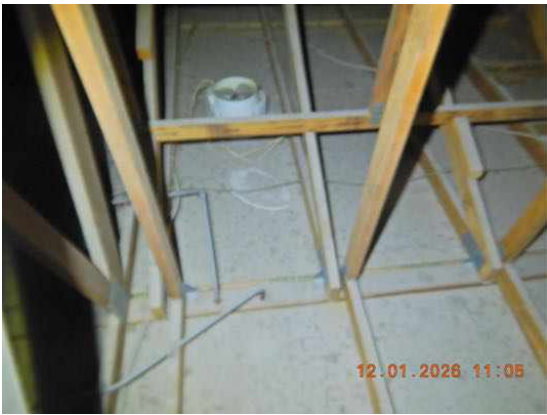
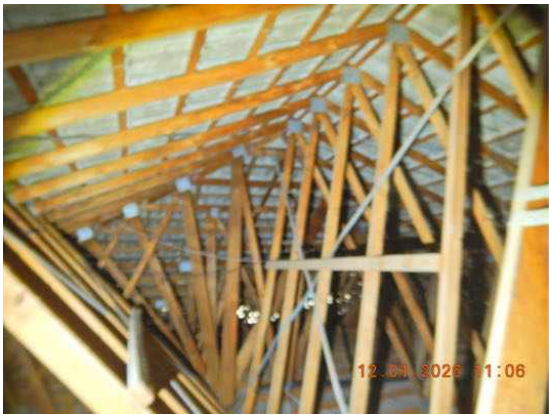
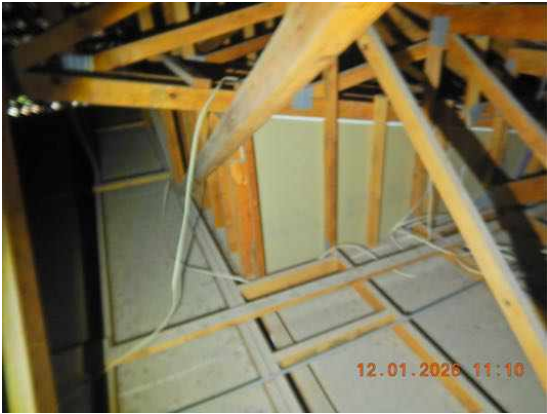
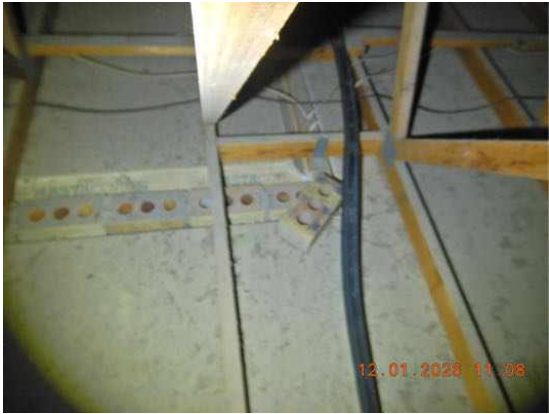
Building: Main Building
 Location: Roof Void > All Areas
 Finding: Roof void Inspected
 Information: The roof void was inspected for timber pest activity.

No Evidence of timber pest activity was identified at the time of this inspection.
