Building and Timber Pest Inspection Report

Inspection Date: Thu, 9 Apr 2026

Property Address: 9 Alverna St, Rooty Hill NSW 2766,
Australia

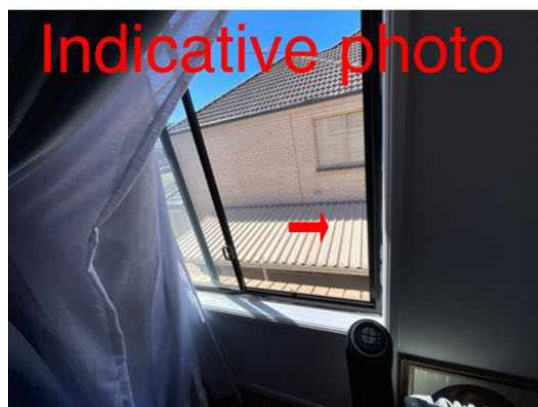
Building:	Main Building
Location:	Upstairs Windows
Finding:	Window restrictions - Missing
Information:	Window restrictors were found to be missing.

Windows need to be locked at 12.5cm when the devices are engaged. The safety devices must be robust and child proof. The alternative is security screens such as bars or grills on the windows so long as they have gaps no bigger than 12.5cm. Flyscreens do not comply unless they are the reinforced security type and capable of resisting the very strong outward pressure which would prevent a child falling through. The laws apply to openable windows in a building within 1700mm of the internal floor and if the internal floor is more than 2m above the ground floor outside.

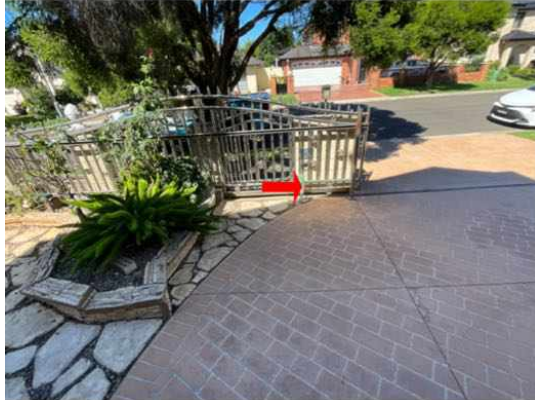
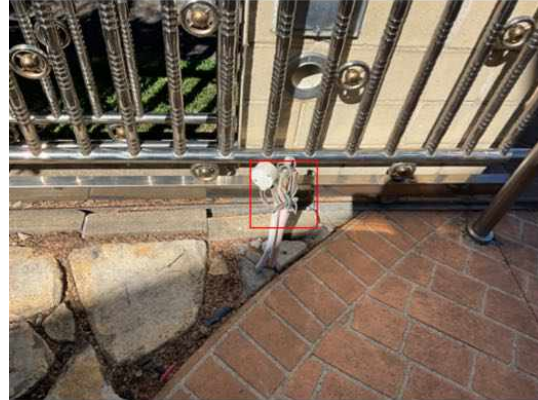
Finding 1.02

Building:	Main Building
Location:	Driveway
Finding:	Electrical wiring - Exposed/Messy
Information:	Instances of exposed wiring, messy wiring, not in junction boxes or unprotected with electrical tape was identified in this area at the time of inspection.

We highly recommend that a licensed electrician be engaged to check this area and make safe all exposed wiring before any further inspections or works are carried out.

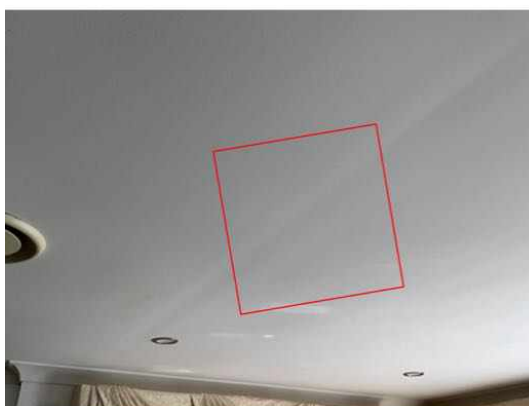
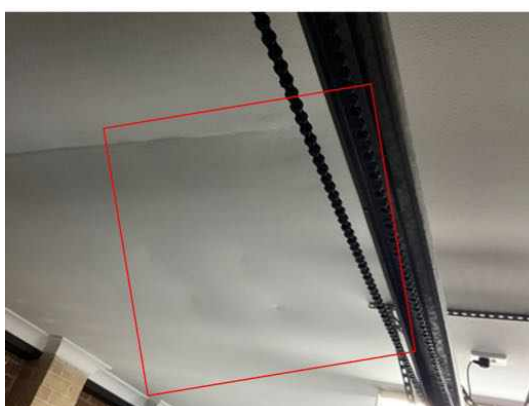
Building:	Main Building
Location:	Dining Room, garage
Finding:	Ceiling - Sagging
Information:	Sections of the ceiling were found to be sagging at the time of inspection. Sagging to the fixed ceiling structure generally indicates that the building materials have swollen, due to contact with water, or that fixings (e.g. nails or glue) have become loose and require reattachment.

Where minor sagging is evident, comparatively minor works, such as re-gluing of ceiling sheets, may be required. Such works may be performed by relevant tradespeople, such as plasterers and painters. Where excessive moisture has caused the roofing structure to swell and sag, the source of the water leak should primarily be identified prior to any remedial works being performed.

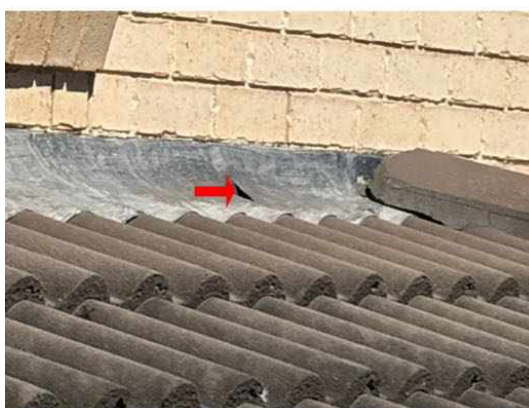
Finding 3.02

Building:	Main Building
Location:	Dining Room

Finding: Roof plumbing - Flashing cracked
 Information: Water leaks generally occur when a particular area of the property is not weather or water tight. Cracks were evident to the roof flashing in this area at the time of inspection.

Regardless of the location, if left unmanaged, even minor leaks can lead to serious damage of associated building elements, potentially resulting in the need for replacement of building materials. Damage to ceilings, wood rot, mould and other hazards, such as electrical hazards, may also arise if left unmanaged.

Further inspection and repair by a roof specialist or a licensed roof plumber is advised to adequately rectify the potential leak.

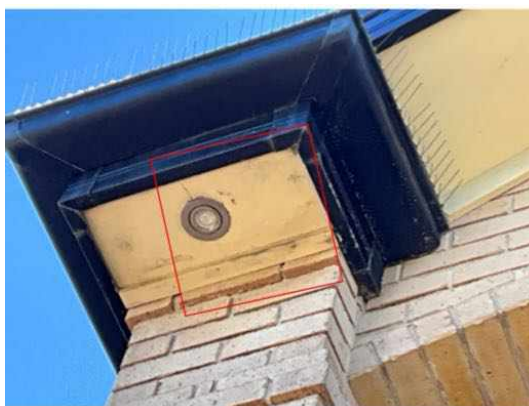
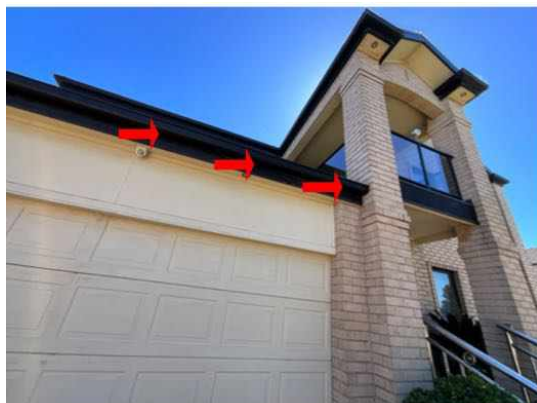
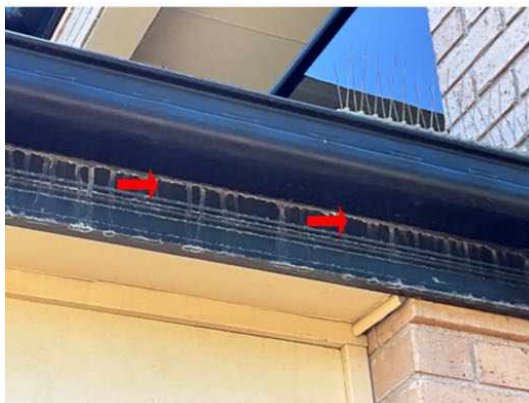
Finding 3.03

Building: Main Building
 Location: Front Elevation
 Finding: Eaves/Roof plumbing -- water damages
 Information: Water damage is generally an indication of excessive moisture being present, usually via a leak. It is suspected that gutter blockages causing stormwater to backflow into the eaves causing water damages. This is additionally conducive to termite activity due to the damp conditions.

Where water damage is evident, the primary requirement is to identify and rectify the source of the leak. Gutters must be kept clear of any blockages moving forward. A roofing plumber should be appointed for further assessment if the problem persists.

Once the leak is repaired, consultation with relevant tradespeople, including carpenters, plasterers and painters, is advised.

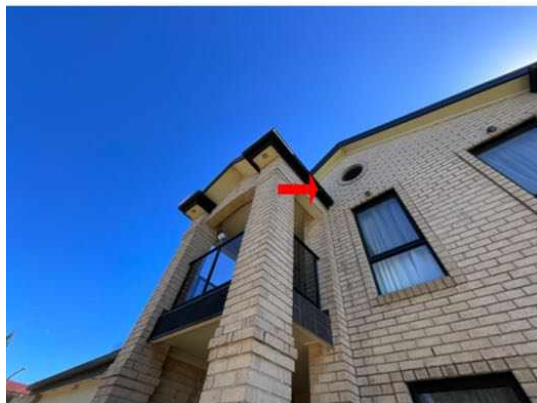
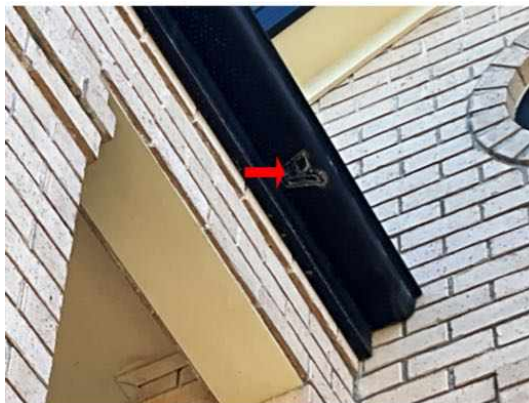
Finding 3.04

Building:	Main Building
Location:	Front Elevation
Finding:	Stormwater drain - Not connected
Information:	The roof plumbing is not adequately connected to stormwater drainage on the site. This disconnection negatively impacts the functional capacity of the roof plumbing.

Where roof plumbing doesn't drain adequately, the area at the base perimeter can become excessively damp, potentially creating an environment that is susceptible to rust and corrosion of surrounding building elements, as well as attracting termites and other pests.

It is highly recommended that a plumber be appointed to further inspect the area and to install adequate drainage equipment where necessary.

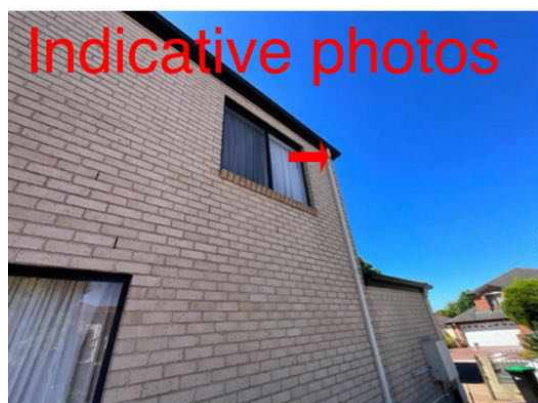
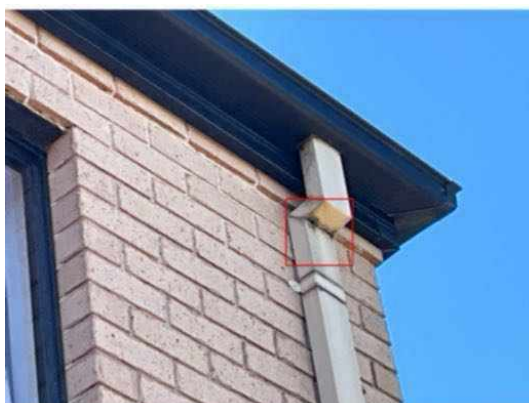
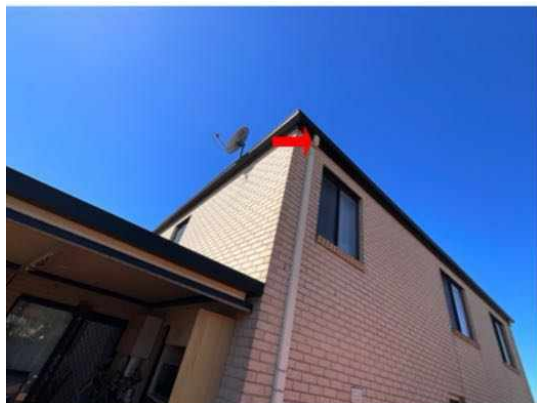
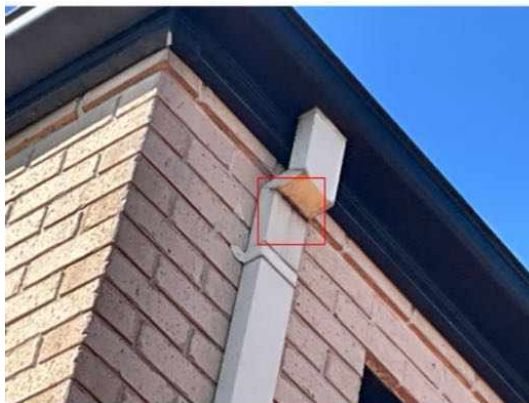
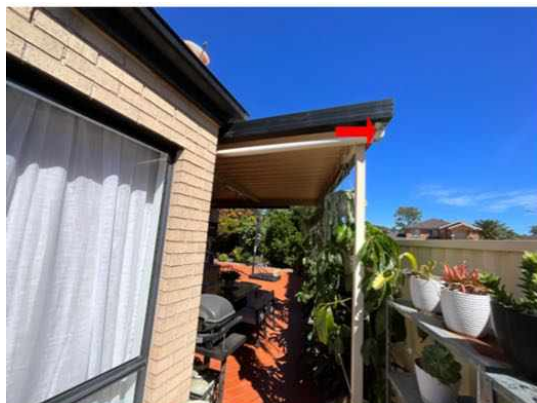
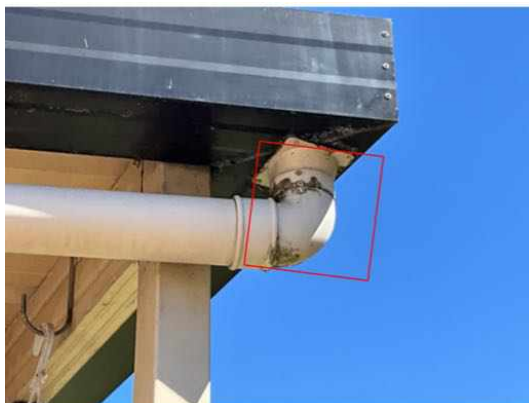
Finding 3.05

Building:	Main Building
Location:	Multiple areas of roof plumbing
Finding:	Water leak - External
Information:	Water leaks were found to be present to exterior plumbing work. Leaks are generally caused by deterioration of the plumbing elements over time, due to exposure to weather conditions, but may have also been caused by minor impact damage.

Such leaking creates damp conditions in the affected area, causing potential for water pooling and subsequent water damage if left unattended. These conditions may also attract termite attack, particularly if the area is subject to minimal levels of sun throughout daylight hours.

It is highly advised that a licensed plumber be appointed to rectify any water leaks that may be present. Areas of repair and replacement of plumbing fittings and fixtures may be required and, as such, a quotation should be sought.

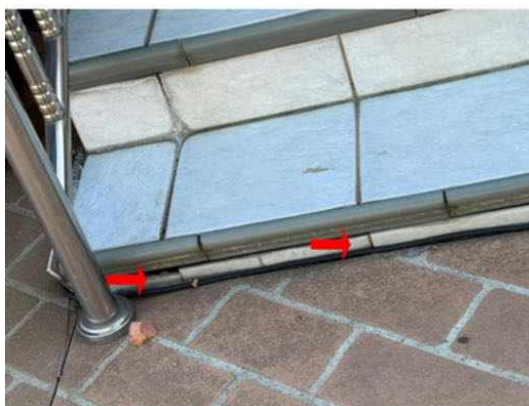
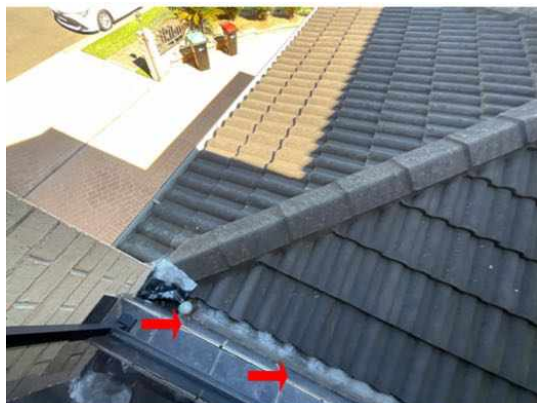
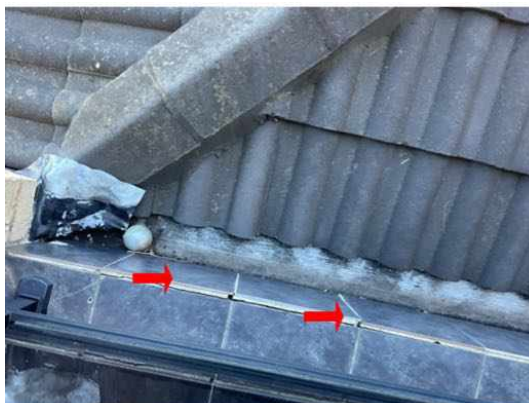
Finding 3.06

Building:	Main Building
Location:	Porch, balcony
Finding:	Tiles - Drummy
Information:	Drummy tiled areas were identified at the time of inspection. The term 'drummy' refers to tiles that have become detached from their fixing, despite otherwise being in relatively good condition. Such defects are generally caused by physical or moisture damage to the area. Drummy tiled areas may also be a direct result of poor workmanship during the construction process.

Tiled areas may swell and shrink with changes in air humidity if the area has sustained moisture damage. Any exposure to moisture is capable of causing tiled areas to become drummy and/or cracked over a prolonged period of time. Drummy tiled areas generally require removal and replacement of affected tiles, with adequate sealant and grouting.

Specialist trades are available for these types of services. A licensed tiling contractor may be appointed to perform works as necessary.

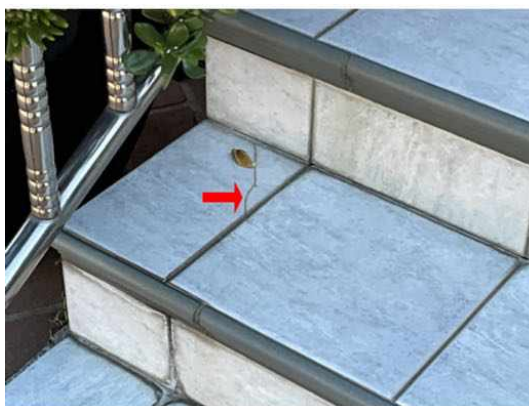
Finding 3.07

Building: Main Building
 Location: Porch
 Finding: Cracked floor tiles
 Information:

Cracking in the floor tiles was evident in this area at the time of inspection. It is suspected that this cracking has occurred as a result of minor settlement or shrinkage.

Cracked tiles throughout the household detract from the overall appearance of the affected areas however it is unlikely to create or lead to any secondary defects.

While not considered a matter of urgency, replacement of cracked floor tiles is recommended at the clients discretion. A licensed tiling contractor may be appointed to perform these works. Where cracks become more numerous, contact a licensed building inspector for further investigation.

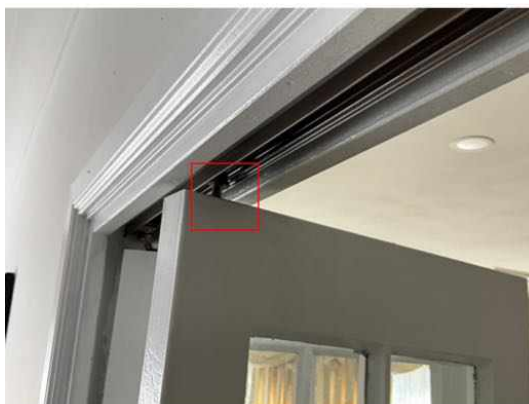
The door in this area was jammed and difficult to slide along the associated tracks at the time of the inspection. Restricted function of the affected door may pose as a potential safety hazard if required for emergency egress from the building.

maintenance are the usual causes for this type of defect.

Replacement of door hardware or tracks may be required, as well as minor repairs and cleaning. A licensed carpet will be required to repair the affected doors.

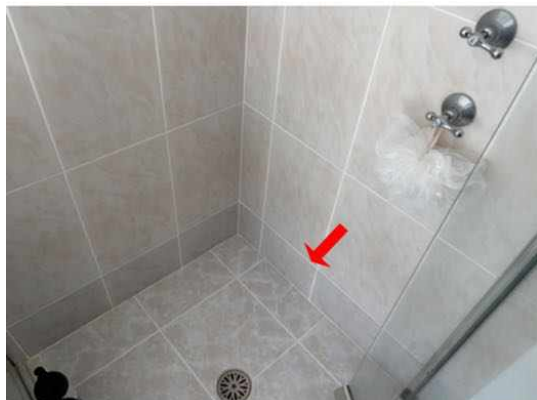
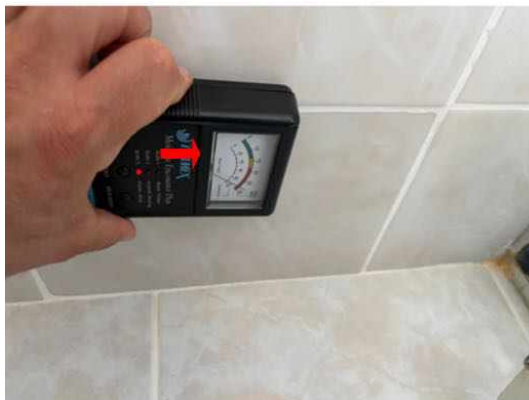
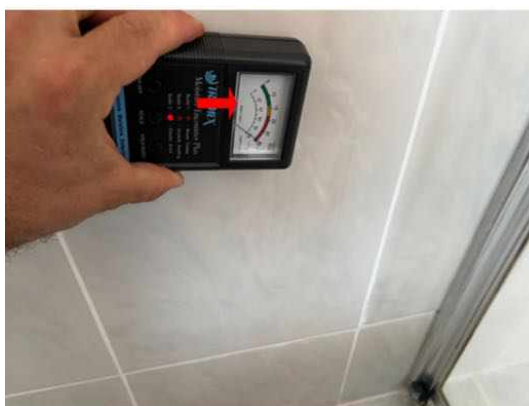
Finding 3.10

Building:	Main Building
Location:	Ensuite, bathroom
Finding:	Shower damp - Monitor
Information:	Damp is evident to the lower 400mm of wall to the shower alcove. There is no high reading around the taps nor are there high readings transferring to the other side of the wall. Sealant appears to have been repaired recently and both sealant and grout appear in acceptable condition at present.

This defect is quite common, and is suspected to have been caused by moisture permeating or leaching through the grouting and perhaps gaps in the sealant prior to repair.

Monitoring the area is advised and if any visual signs of excessive moisture appear (peeling paint, mould) then consultation with a qualified plumber or bathroom specialist

would be advised to identify the cause of damp and to perform remedial works as required.

Always ensure that sealant and grout is in good condition to prevent any moisture issues occurring in the future.

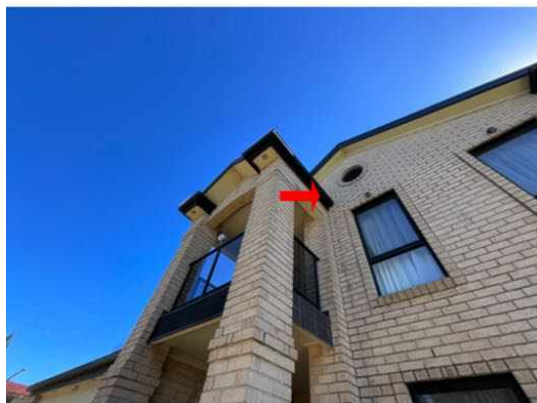
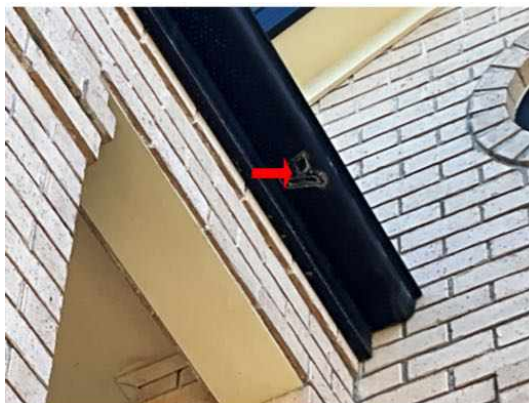
Where roof plumbing doesn't drain adequately, the area at the base perimeter can become excessively damp, potentially creating an environment that is susceptible to rust and corrosion of surrounding building elements, as well as attracting termites and other pests.

It is highly recommended that a plumber be appointed to further inspect the area and to install adequate drainage equipment where necessary.

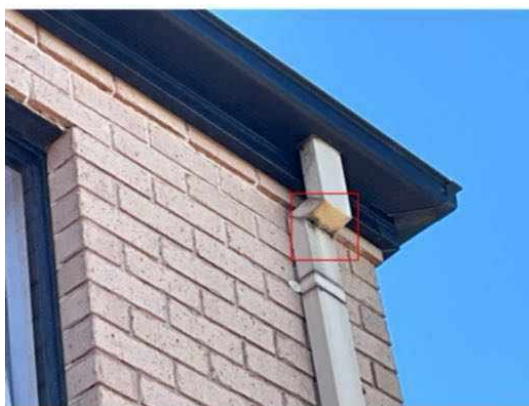
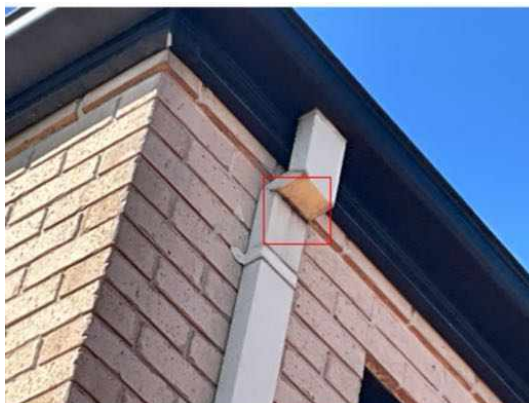
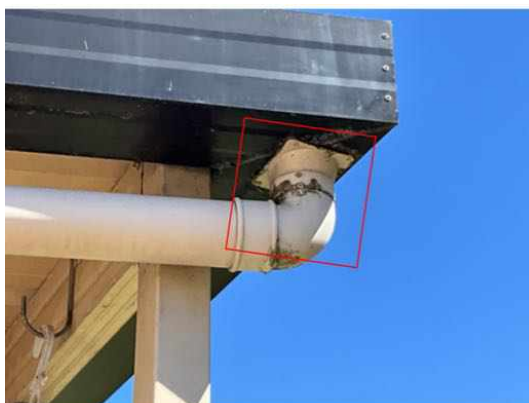
Finding 6.02

Building:	Main Building
Location:	Multiple areas of roof plumbing
Finding:	Water leak - External
Information:	Water leaks were found to be present to exterior plumbing work. Leaks are generally caused by deterioration of the plumbing elements over time, due to exposure to weather conditions, but may have also been caused by minor impact damage.

Such leaking creates damp conditions in the affected area, causing potential for water pooling and subsequent water damage if left unattended. These conditions may also attract termite attack, particularly if the area is subject to minimal levels of sun throughout daylight hours.

It is highly advised that a licensed plumber be appointed to rectify any water leaks that may be present. Areas of repair and replacement of plumbing fittings and fixtures may be required and, as such, a quotation should be sought.

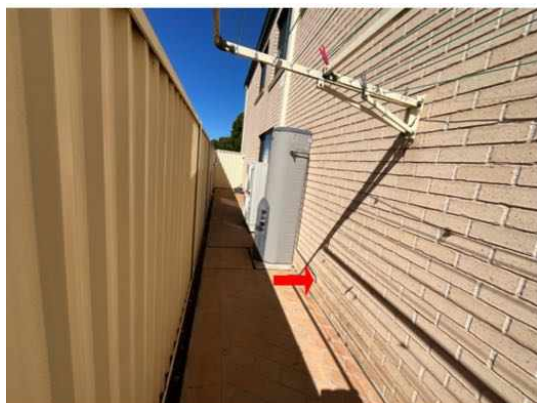
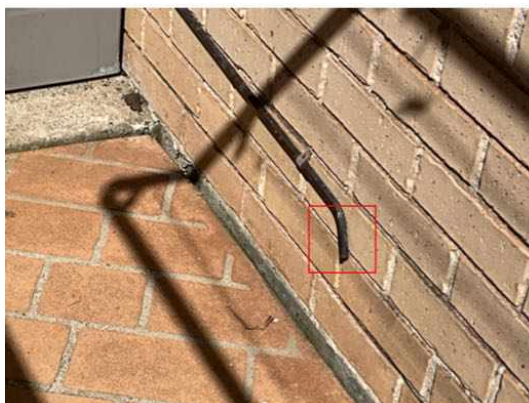
These damp conditions can lead to secondary defects such as rot, rust or corrosion of associated building elements, the formation of fungal decay, or even the creation of potential slip hazards. When coupled with poor site drainage, pooling of water may also attract termite activity to this area.

It is highly recommended that a licensed plumber be appointed to install adequate drainage to the overflow. These works will ensure that the area remains dry and free of any secondary defects.

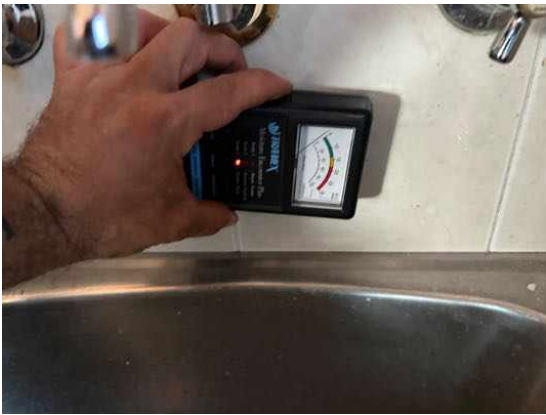
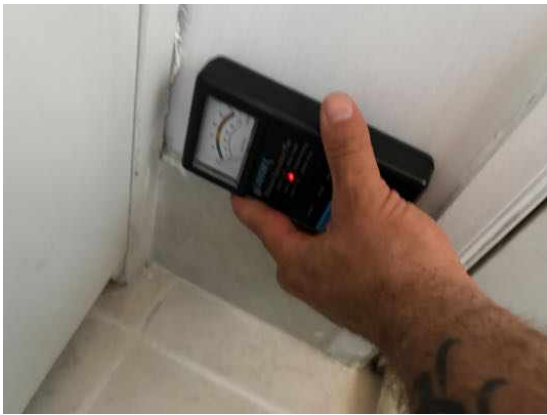
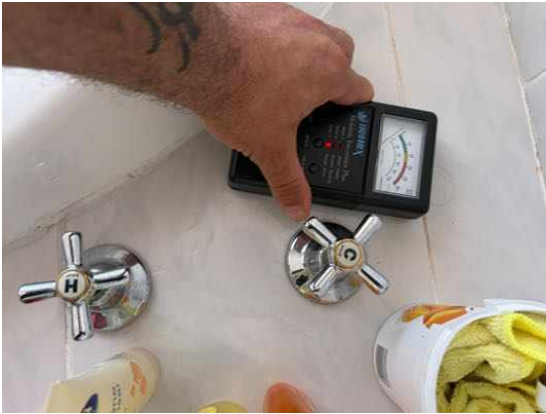
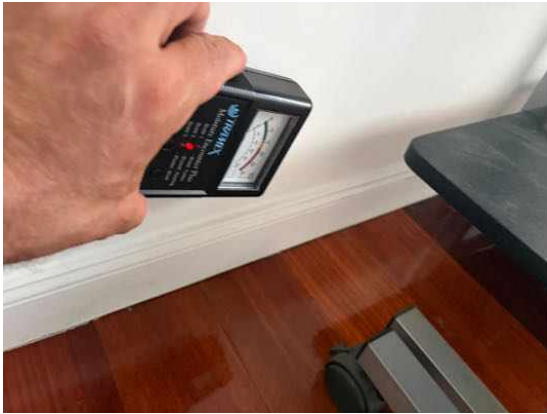
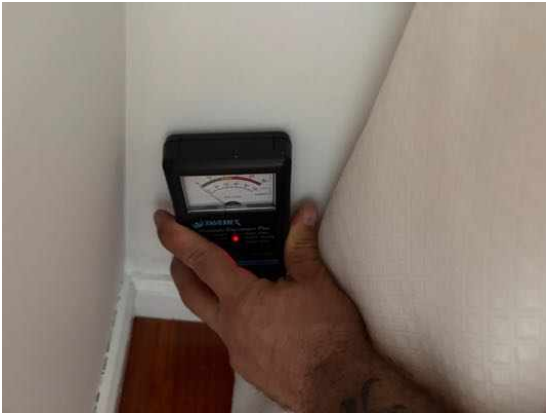
Building: Main Building
Location: All Areas
Finding: Moisture metre
Information: During the inspection the property was checked for moisture using a moisture metre.

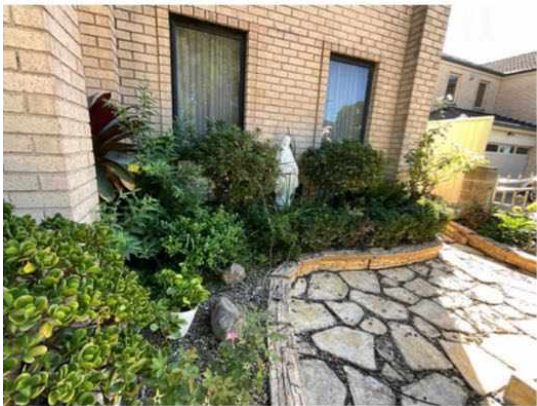
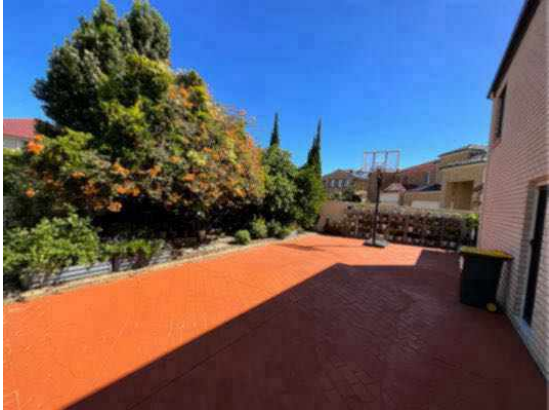
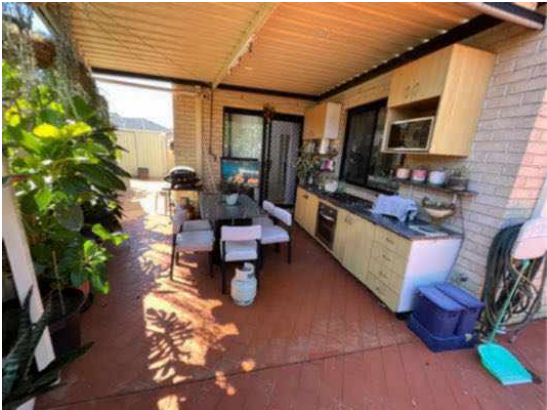
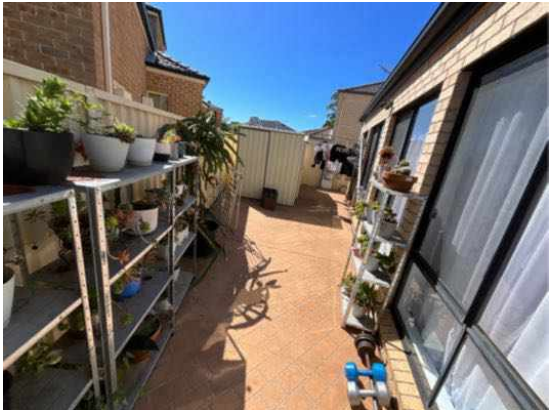
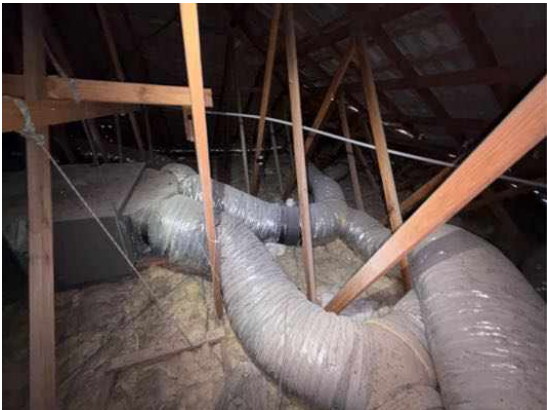
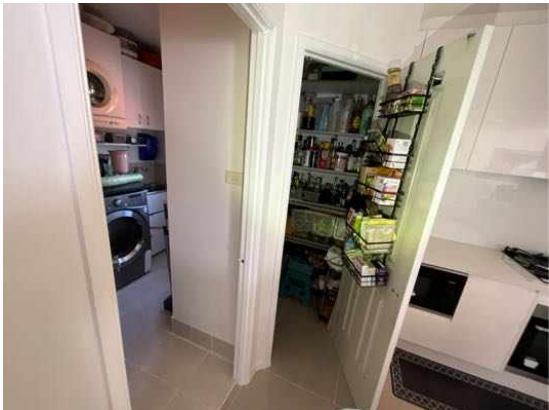
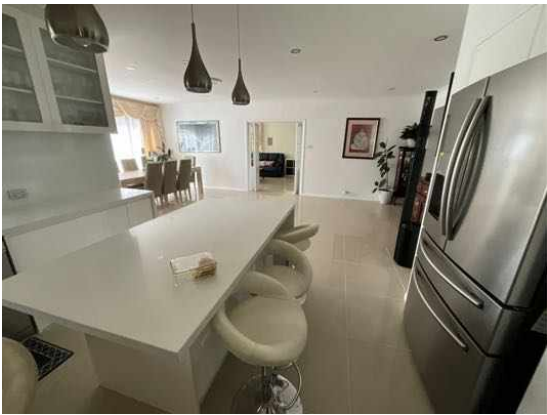
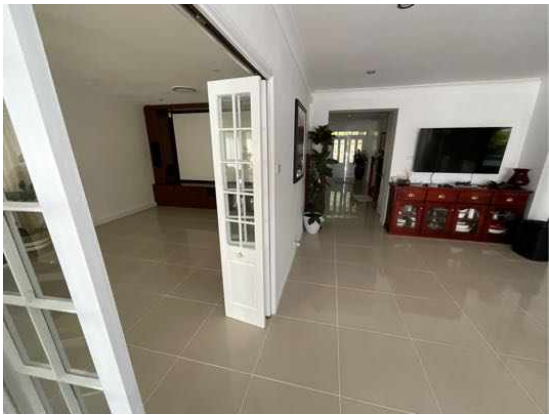
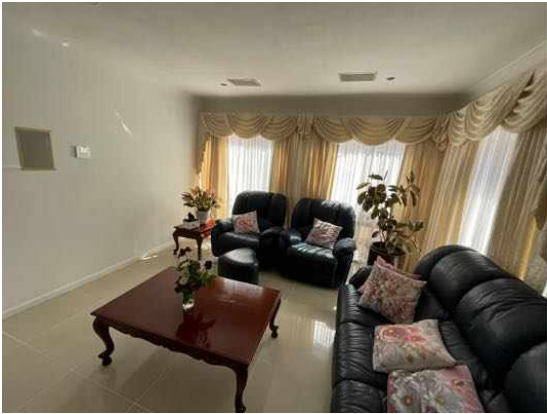
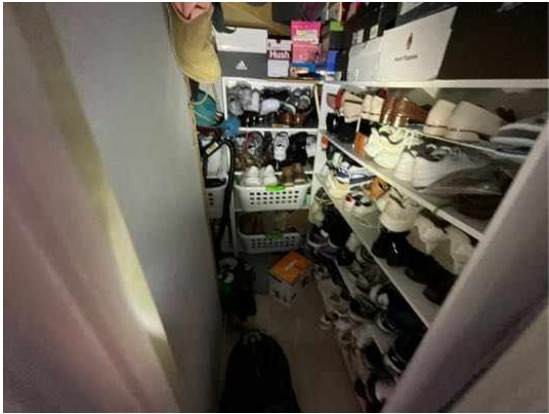
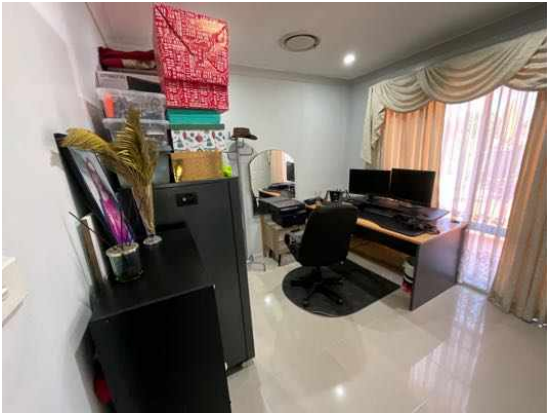
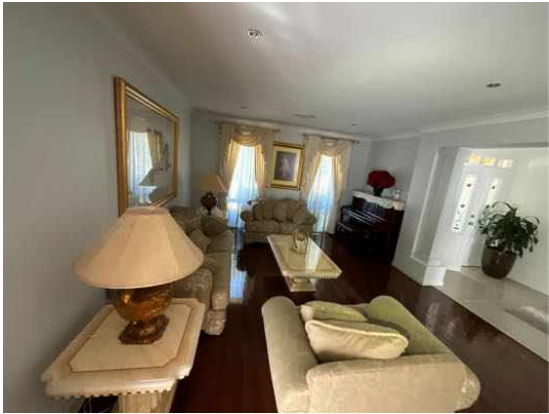
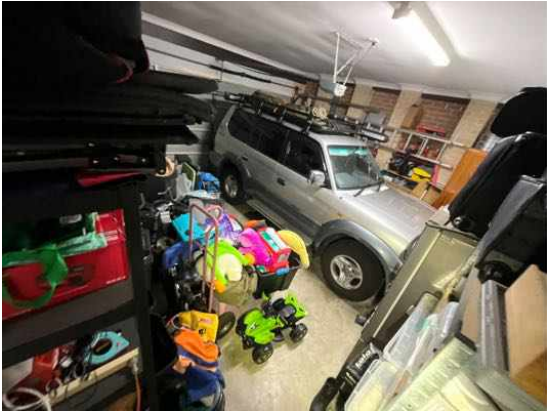
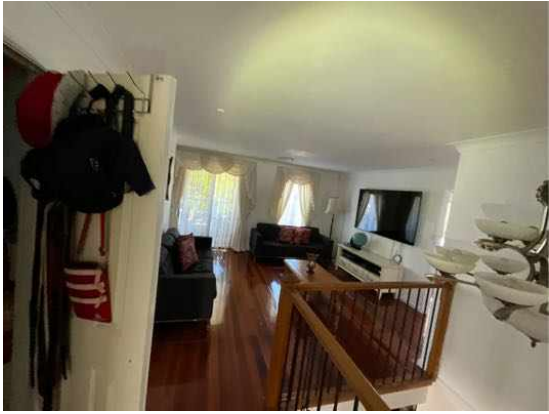
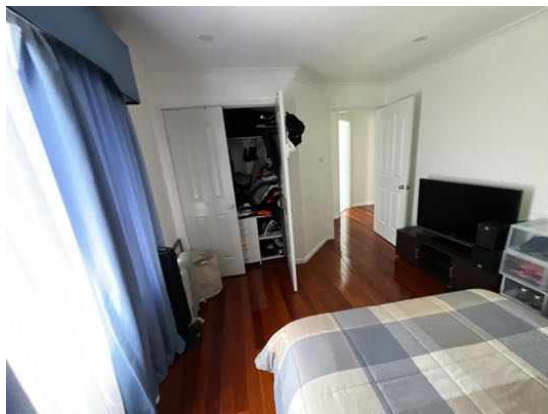
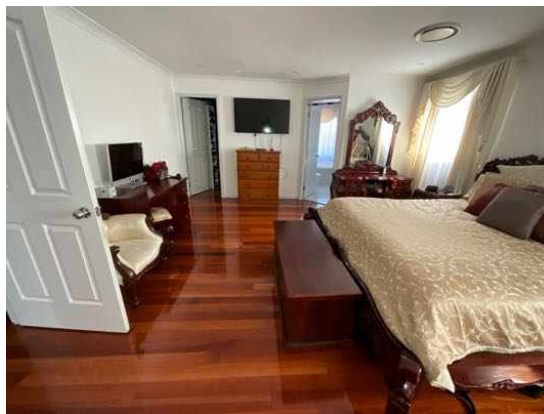
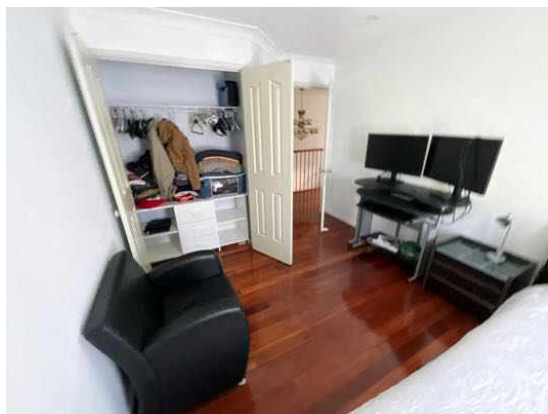
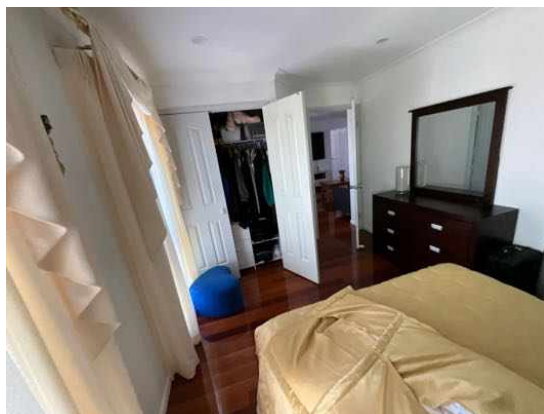
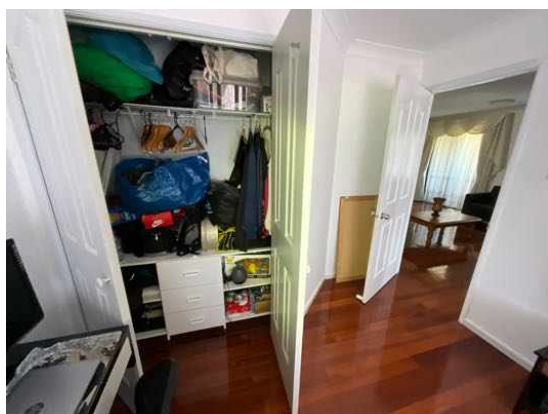
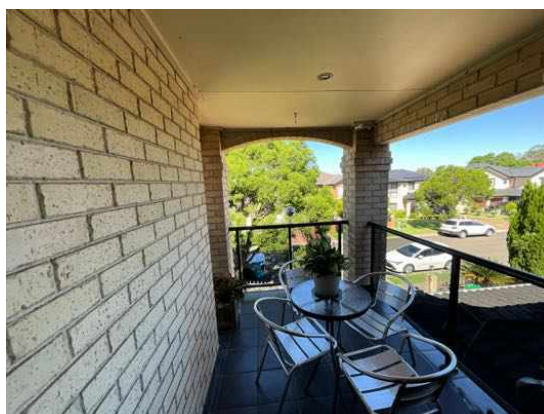
Building: Main Building
Location: All Areas
Finding: Additional Photos - Obstructions and Limitations
Information:

These photographs are an indication of the obstructions and limitations which impeded full inspection of the property at the time of inspection. These obstructions can hide an array of defects and should be removed to allow full inspection to be carried out. A re-inspection is recommended once the areas are made accessible.

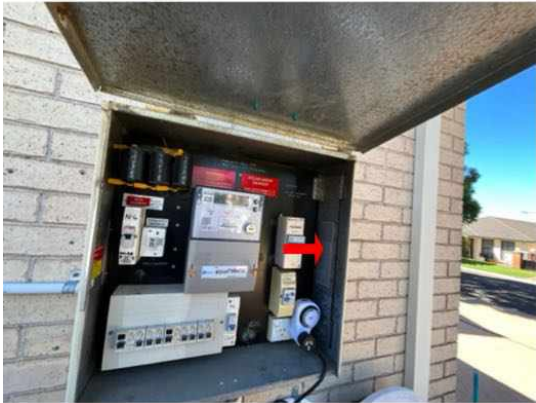
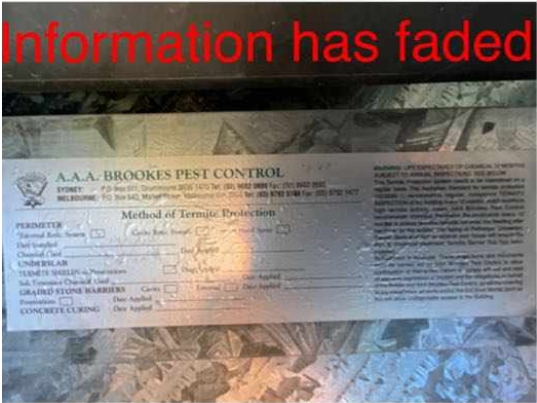
The following items were noted as - Evidence of a previous termite management program

Where a Termite Management System has been identified you should refer to the type of barrier date of installation warranty conditions and any documentation provided by a builder or past owner. Consult the company who installed the barrier to confirm whether the system is still under warranty.

Most chemical termite management systems expire and require replenishment and all physical systems are primarily designed to prevent concealed entry.
