# Building and Timber Pest Inspection Report

Inspection Date: Wed, 11 Mar 2026

Property Address: 131 Doonside Cres, Woodcroft NSW 2767,  
Australia

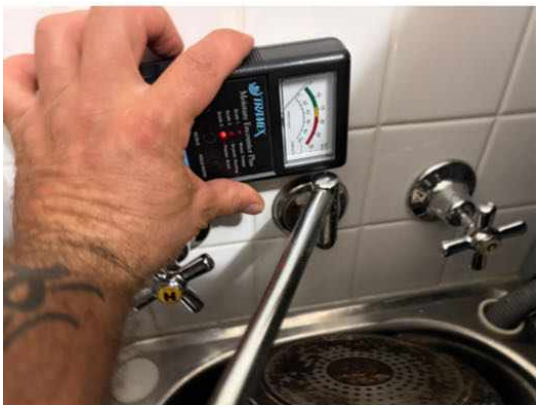
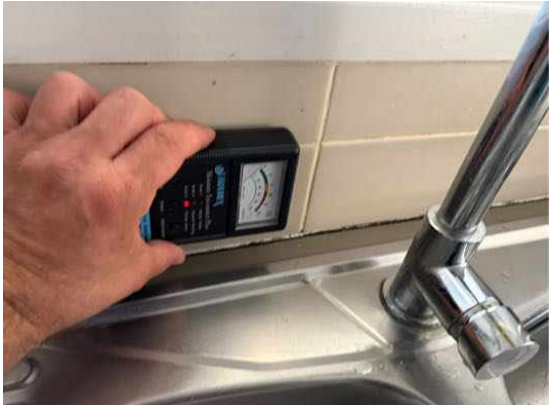
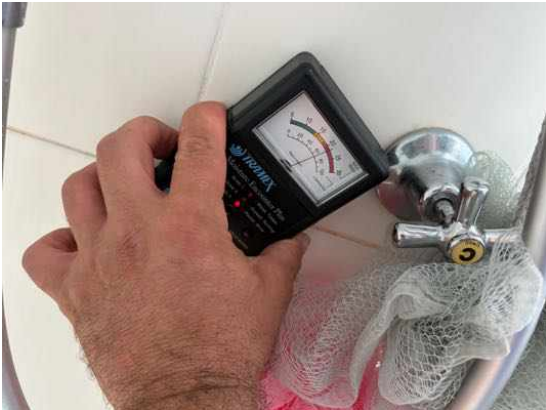
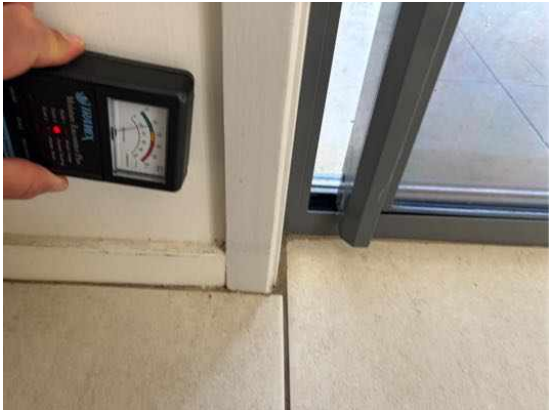
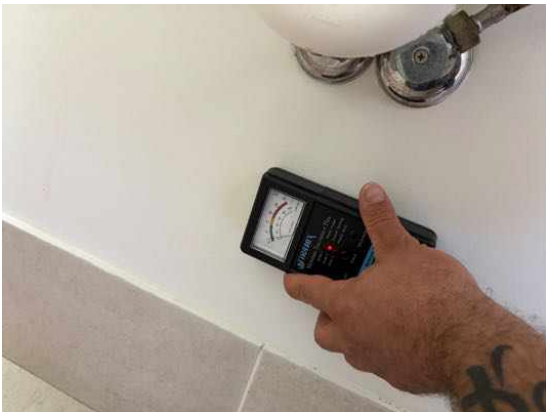
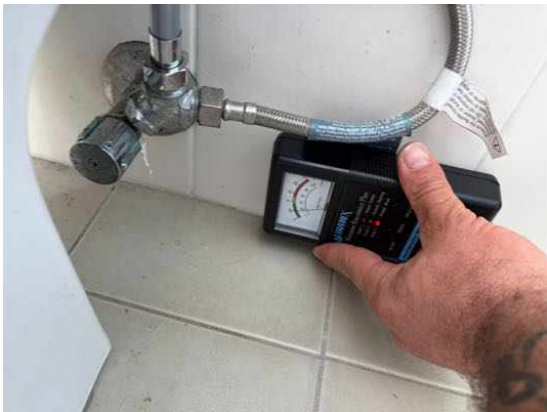
Building: Main Building  
Location: All Areas  
Finding: Moisture metre  
Information: During the inspection the property was checked for moisture using a moisture metre.

This is for information only.

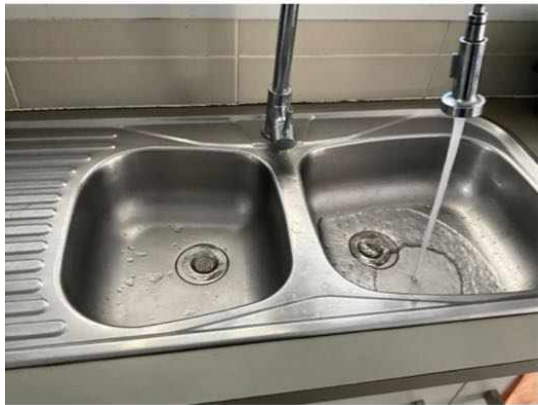
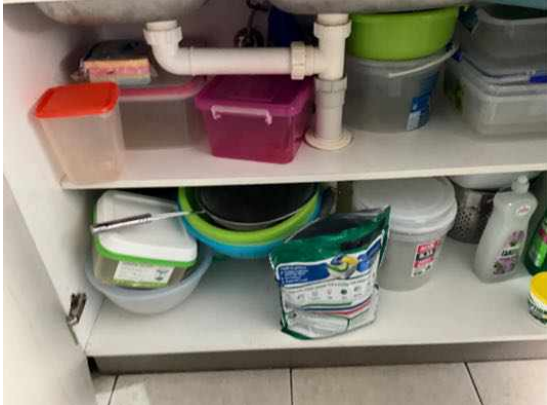
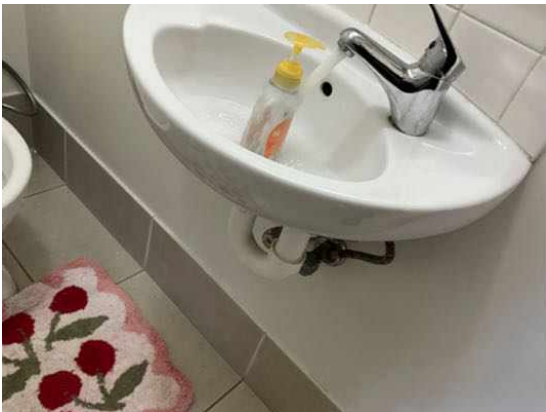
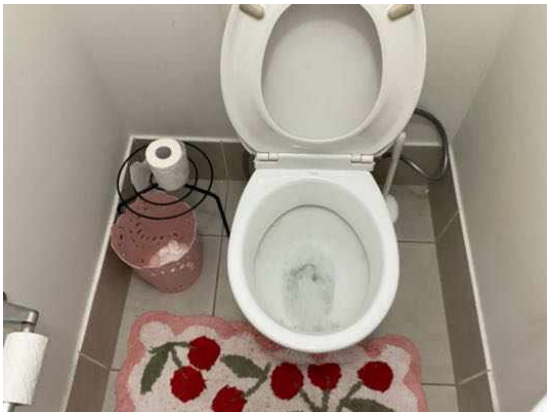
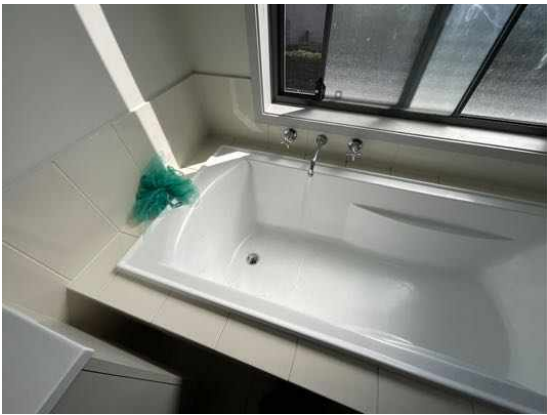
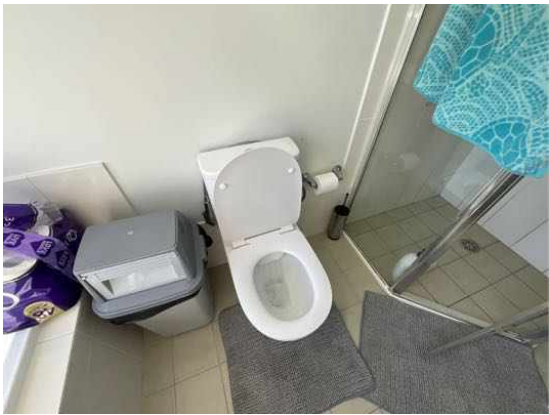
Building: Main Building  
Location: All Wet Areas  
Finding: Additional Photos  
Information:

Additional photos are provided for your general reference.

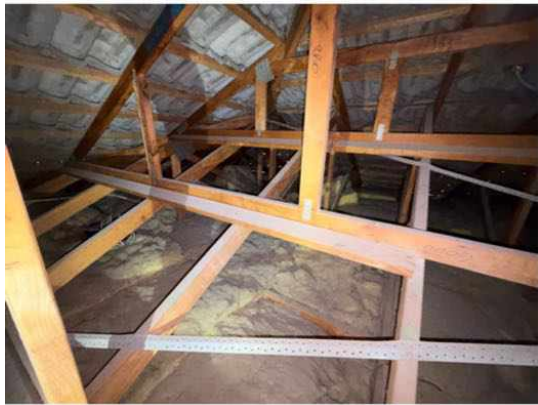
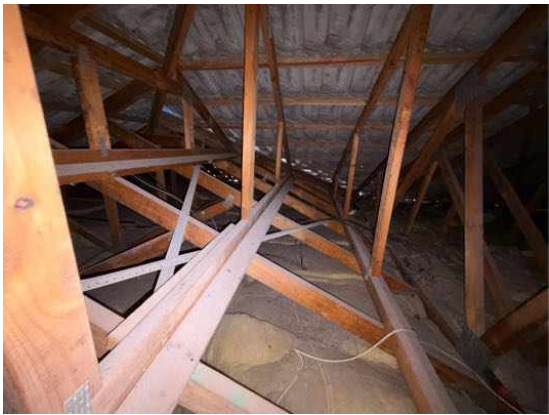
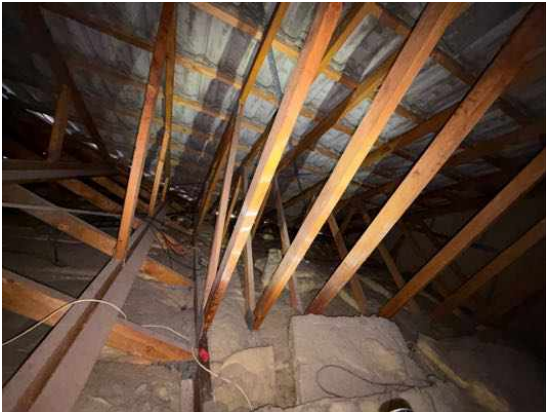
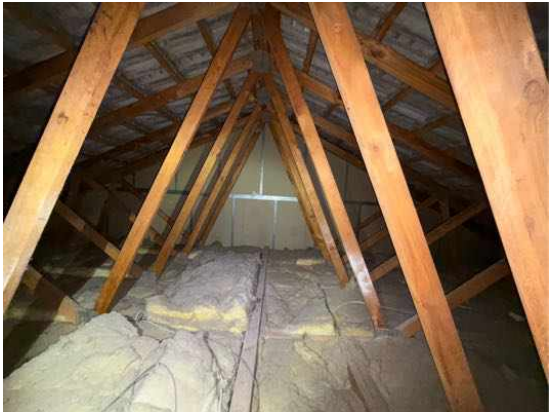
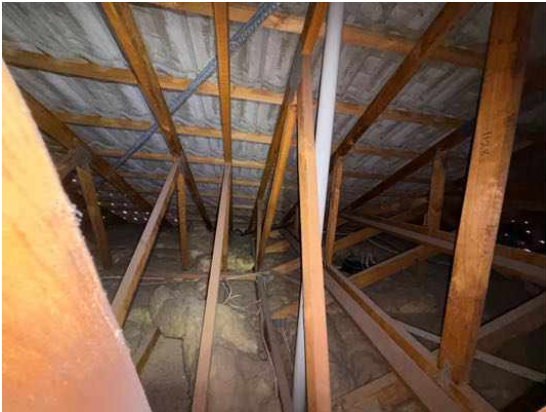
Building: Main Building  
Location: Roof Void  
Finding: Additional Photos  
Information:

Additional photos are provided for your general reference.

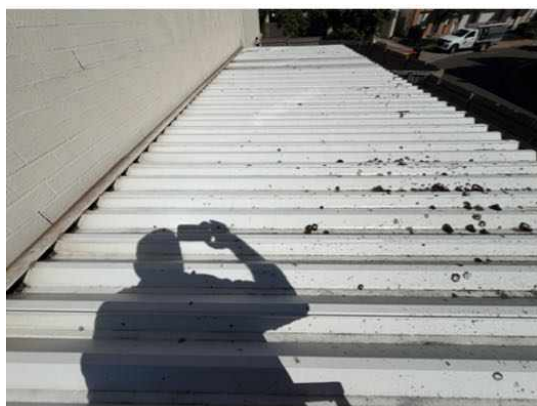
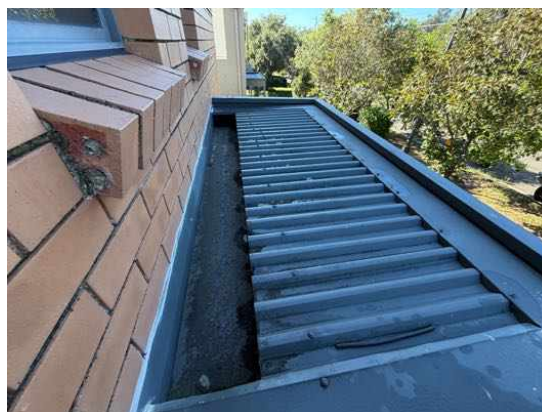
Building: Main Building  
Location: Roof Exterior  
Finding: Additional Photos  
Information:

Additional photos are provided for your general reference.

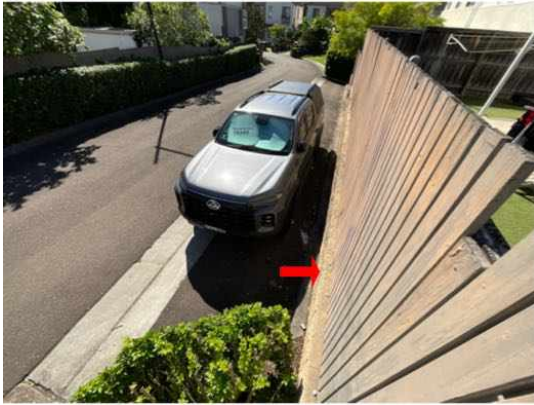
Building: Main Building  
 Location: Retaining walls  
 Finding: Retaining walls  
 Information: At the time of inspection the retaining walls were checked and no defects were observed other than those which May have been mentioned earlier in this report.

AS4349.1-2007 requires all retaining walls in excess of 700mm to be inspected by a licensed and practicing structural engineer.

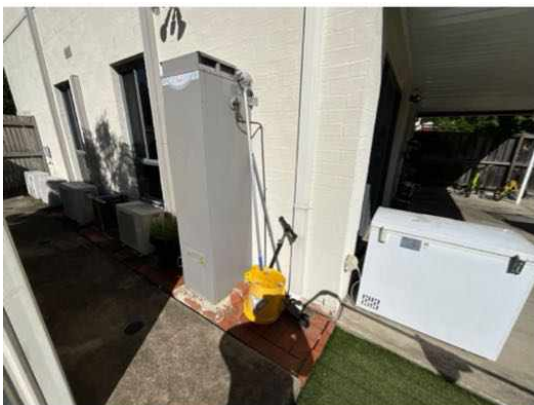
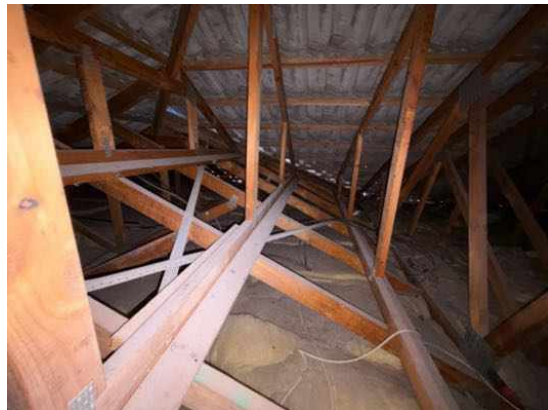
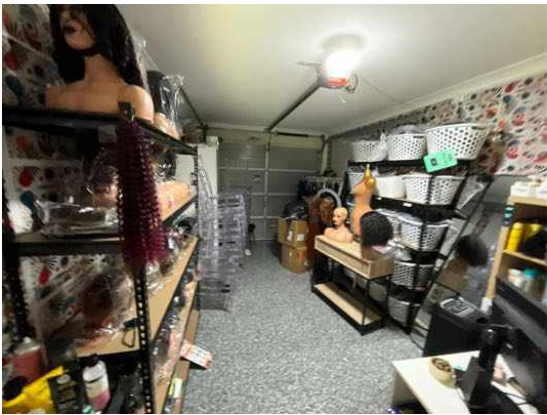
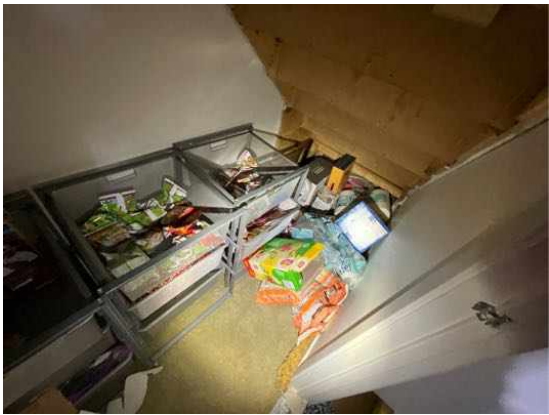
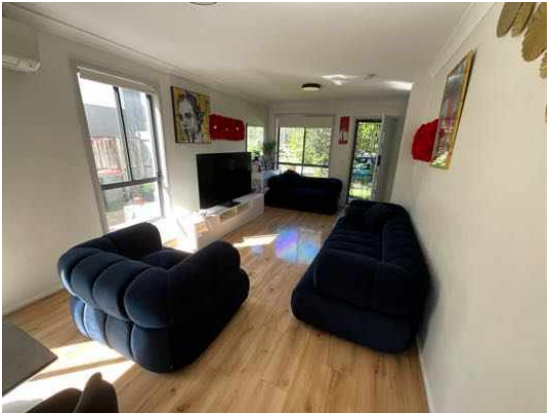
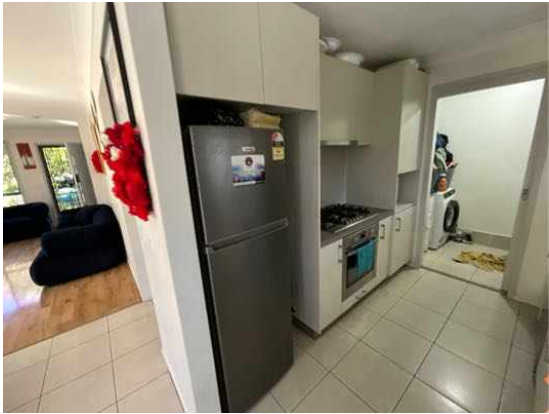
Building: Main Building  
 Location: All Areas  
 Finding: Additional Photos - Obstructions and Limitations  
 Information:

These photographs are an indication of the obstructions and limitations which impeded full inspection of the property at the time of inspection. These obstructions can hide an array of defects and should be removed to allow full inspection to be carried out. A re-inspection is recommended once the areas are made accessible.

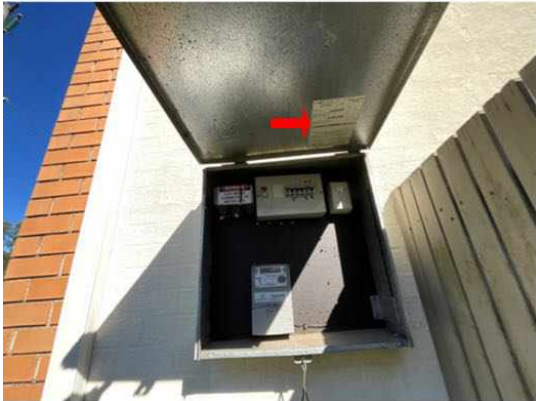
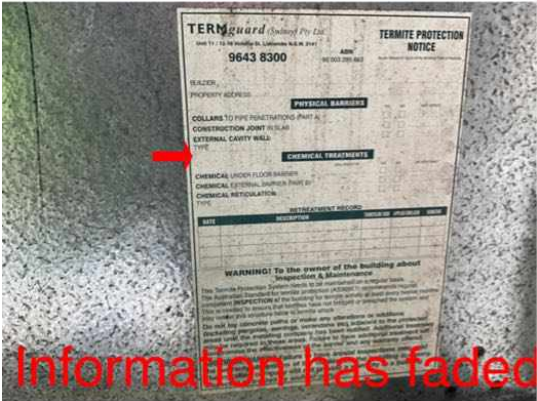
Information has faded

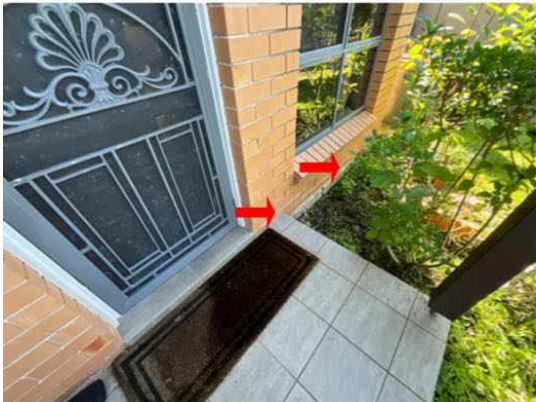
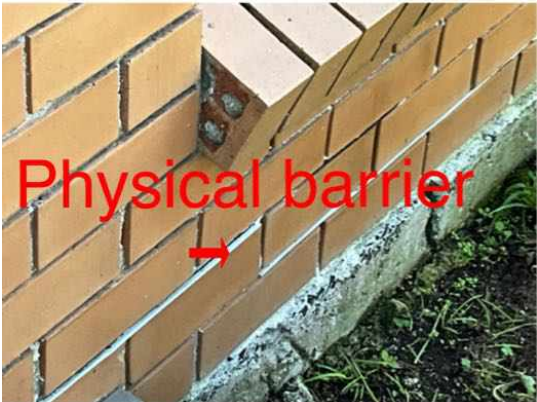
Physical barrier
