## Building Inspection Report

Inspection Date: Thu, 22 Jan 2026

Property Address: 41 Orelia Ave, Orelia WA 6167, Australia

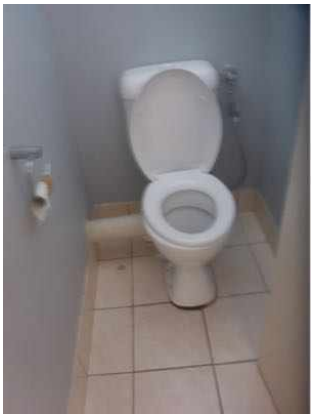
Building: Main Building  
Location: Internal Areas > Existing  
Finding: Plumbing & Electrical  
Information: At the time of inspection majority electrical & Plumbing fittings were working.
