Building and Timber Pest Inspection Report

Inspection Date: Wed, 11 Feb 2026

Property Address: 29 Roseby St, Marrickville NSW 2204,
Australia

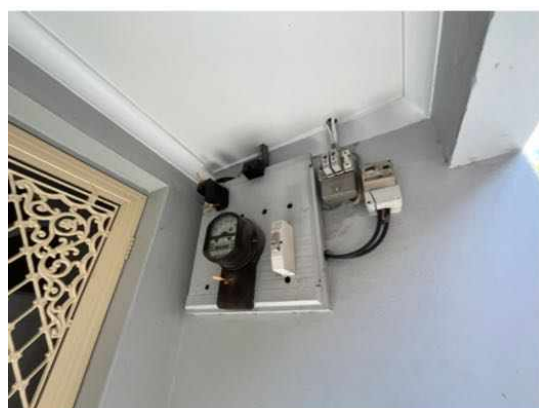
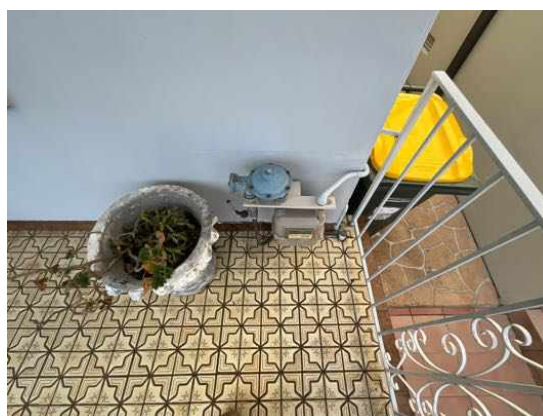
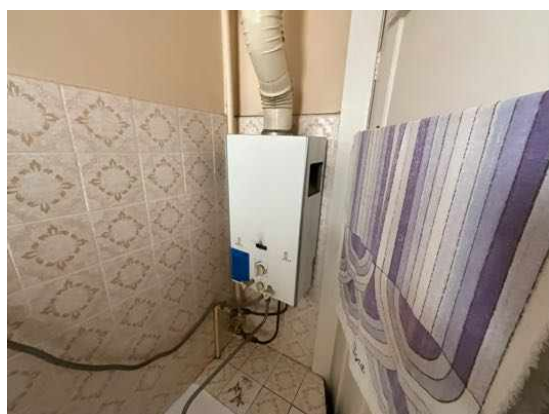
Building: Main Building
Location: All Areas
Finding: Photos Added
Information: Additional photos are provided for your general reference.

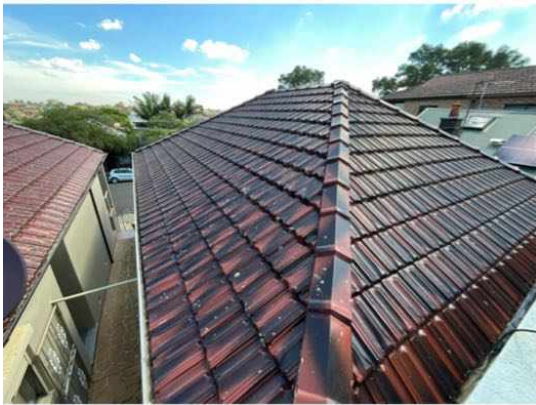
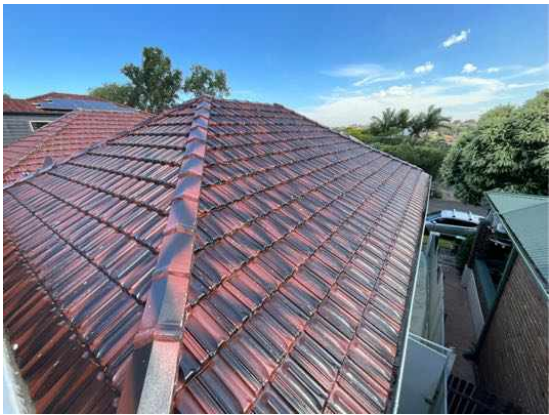
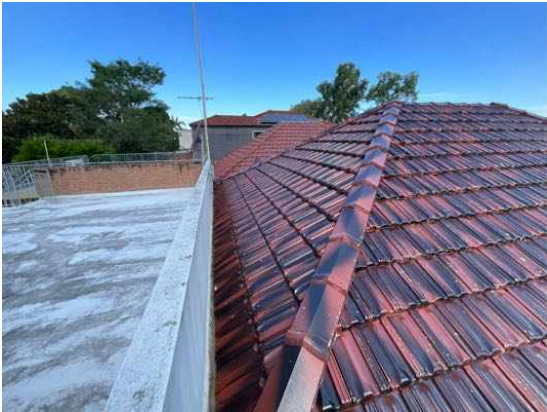
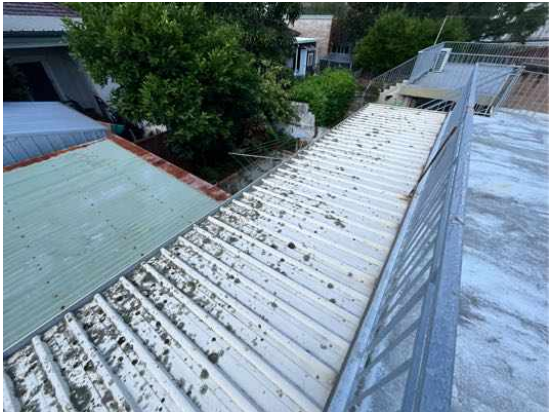
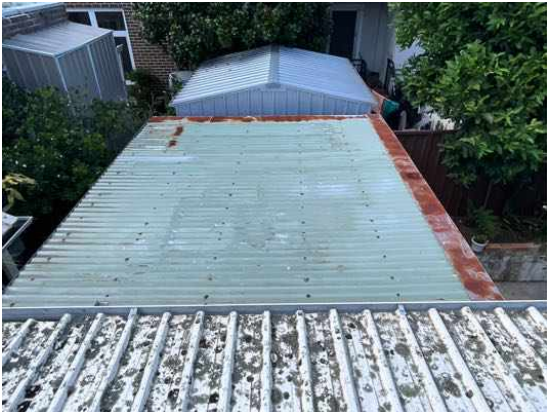
Building: Main Building
Location: Roof Exterior
Finding: Photos Added
Information: Additional photos are provided for your general reference.
