Building Inspection Report

Inspection Date: Thu, 9 Apr 2026

Property Address: 53 Mary St, Unley SA 5061, Australia

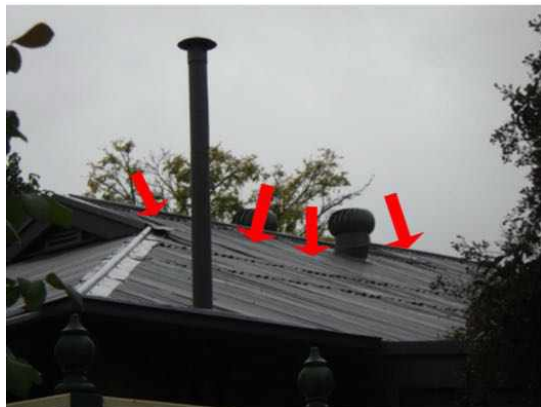
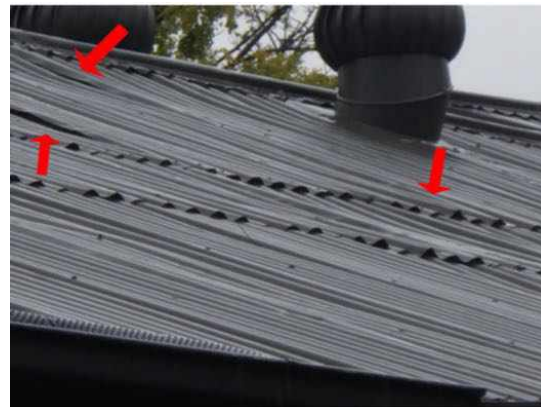
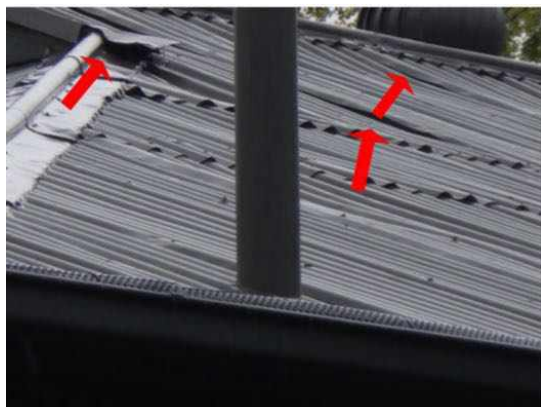
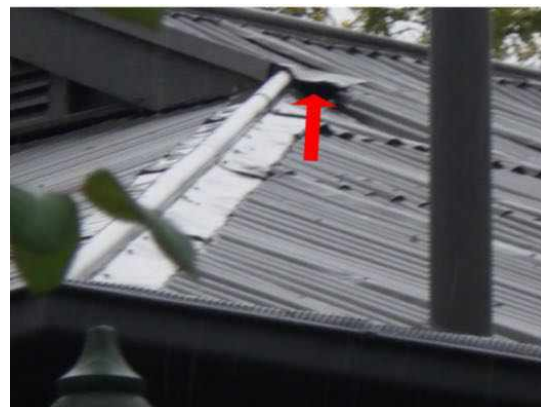
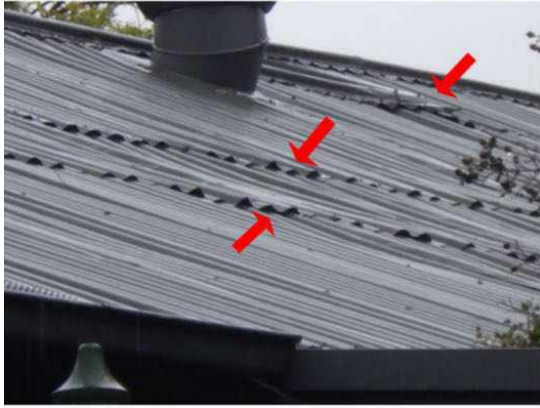
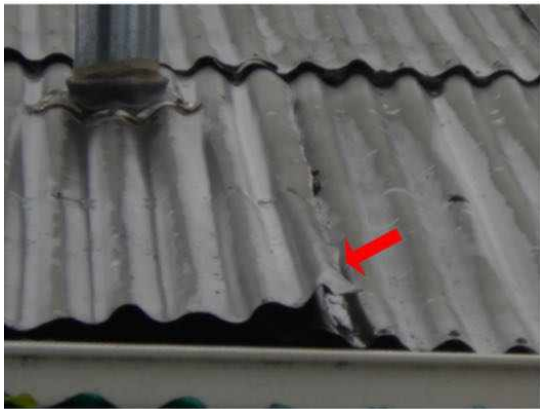
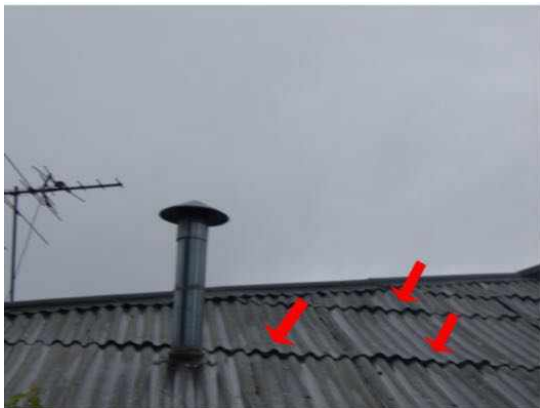
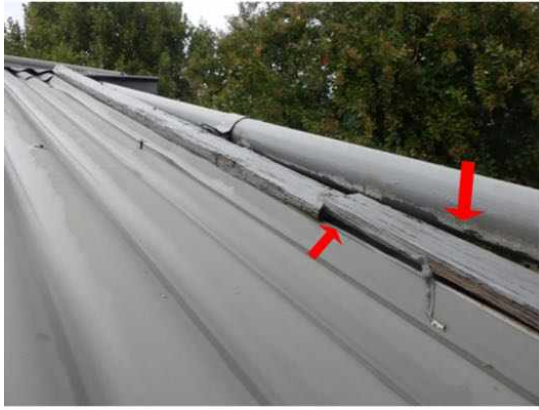
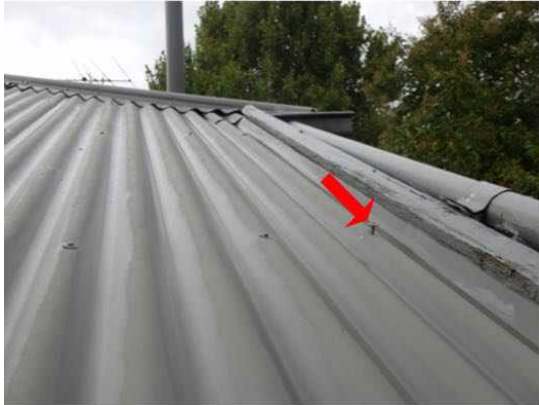
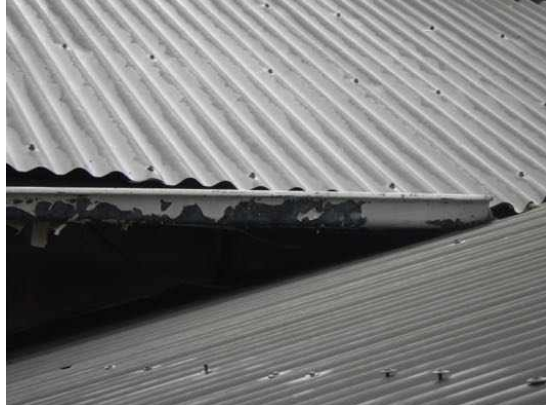
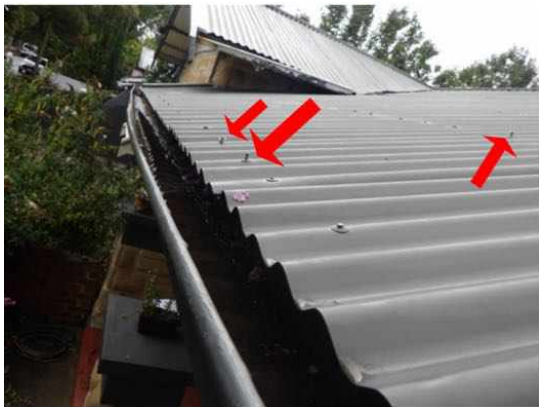
Defects 2.01

Building: Building 1
Location: All External Areas
Finding: Roof sheets - Not secure / Loose from its original fixing
Information: Upon inspection of the exterior roofing it was found that the roof sheets have not been adequately secured to the adjoining roof structure.

Loose roof sheets are susceptible to water penetration, exposing the surrounding associated area to internal roof leaks and water damage.

Adequate fixing of all loose roof sheets should be conducted as soon as possible to ensure no further damage is incurred during the construction process. The builder on site should be notified of this defect as soon as possible in order to engage the appropriate tradesperson to perform necessary works.

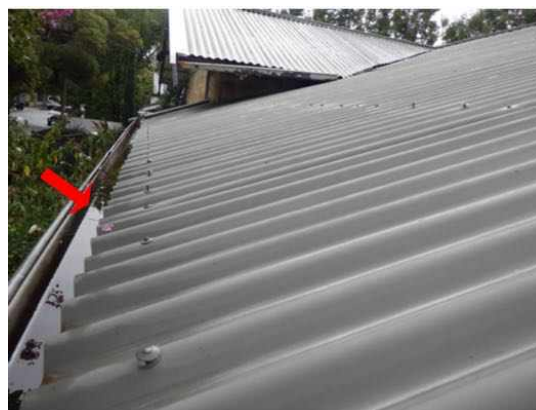
Defects 2.02

Building:	Building 1
Location:	All External Areas
Finding:	Gutters - Blocked
Information:	At the time of inspection it was noticed that gutters were blocked in few sections around the property. Gutters have to be cleaned in regular intervals.

Blocked gutters are likely to lead to high levels of moisture in the affected areas. Such moisture will not only cause rust and decay of the associated building materials, but can also provide conditions that are conducive to termite and timber pest activity. Blockages in gutters should therefore be removed immediately to ensure dry conditions are maintained.

Consult a Licensed Plumber for further specific advice on remedial works that may be required. In the interim, it is highly advised that blocked gutters be removed by the homeowner or a general handyperson as a matter of urgency.

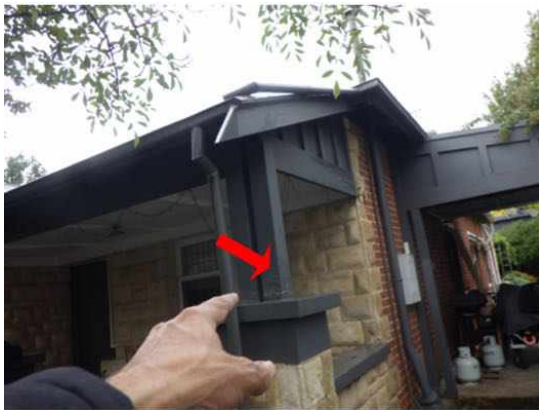
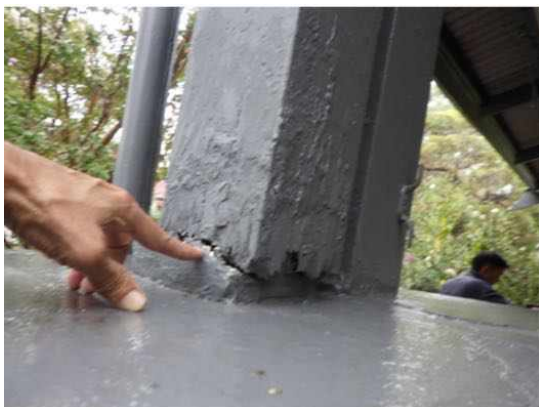
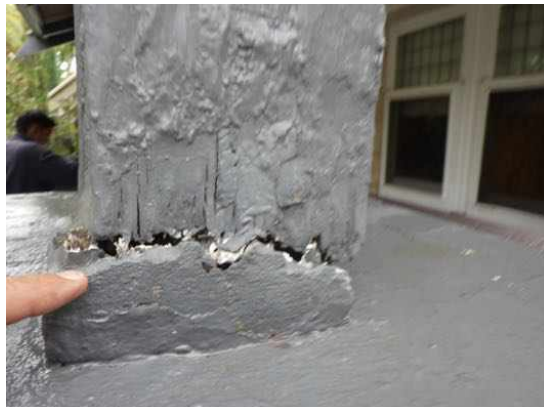
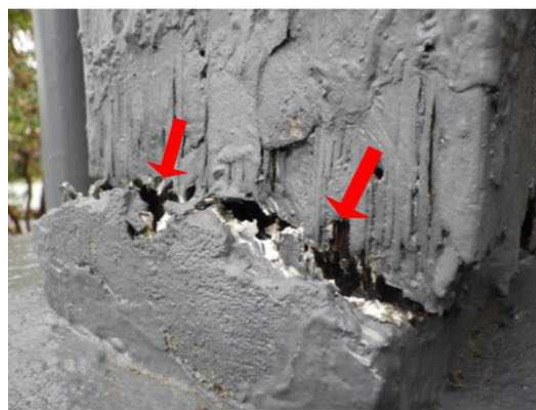
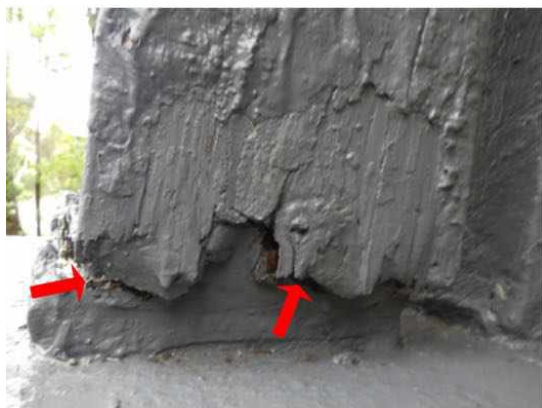
Defects 2.03

Building:	Building 1
Location:	All External Areas
Finding:	Entry Area - Post - Wood Rot / Damaged
Information:	At the time of inspection it was noticed that this building element shows evidence of wood rot and result of that structural integrity has been compromised . Wood rot, also known as Fungal Decay, occurs when timbers and other cellulose building materials are exposed to damp conditions on an ongoing basis. This could be the result of exposure to weathering over a prolonged period of time, or the attraction of excessive

moisture from other abutting building materials. Contributing factors also include poor air ventilation in the area.

Wood rot is often associated with general damp problems and is evidenced by a 'musty' smell or mould and mildew occurring on surfaces. If left unmanaged, damp conditions can lead to further health problems and the decay of timbers will continue.

Early intervention and regular maintenance, particularly of exterior timbers, will prolong the useful life of these building elements. Prior to any works being performed, the cause of the moisture that has created the visible wood rot should be identified and addressed in a suitable manner. Replacement of affected timbers may then be a necessary step in protecting surrounding building elements from such deterioration.

A qualified plumber may be appointed to assess the cause of excessive moisture and to provide advice on any remedial works as required. A qualified carpenter or registered builder may also be required to replace affected building materials.

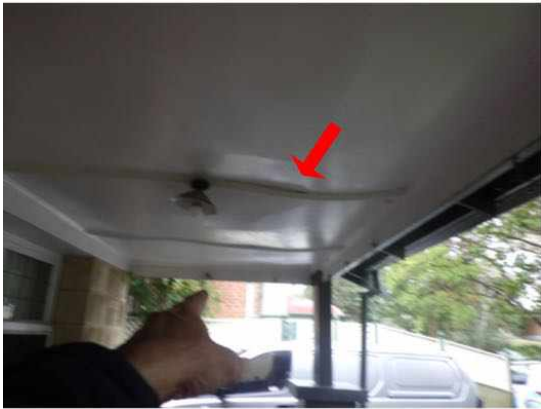
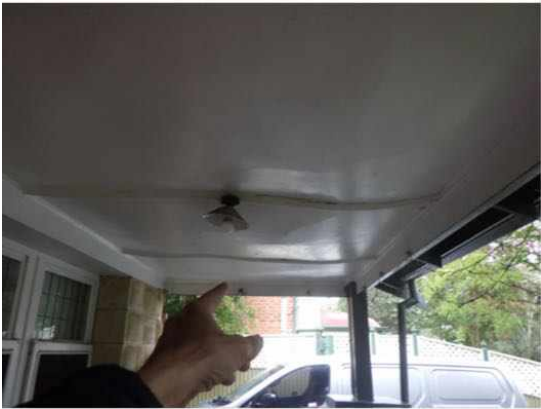
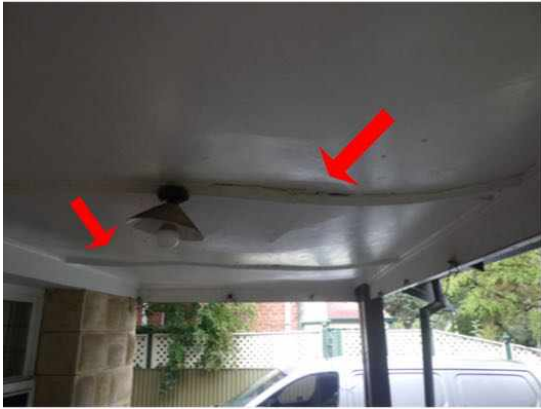
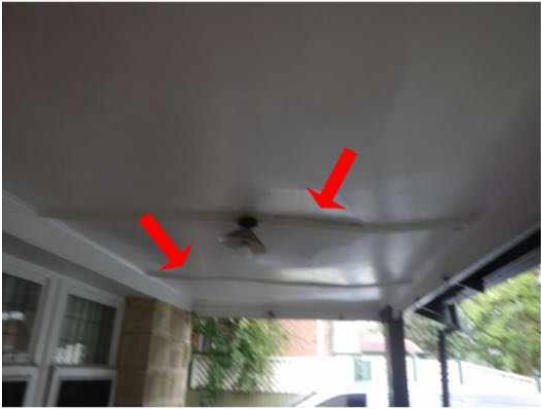
Defects 2.04

Building:	Building 1
Location:	All External Areas
Finding:	Porch Ceiling - Sagging
Information:	At the time of inspection it was noticed that sections of the ceiling were found to be sagging in this entry / porch area. Sagging to the fixed ceiling structure generally indicates that the building materials have swollen, due to contact with water, or that fixings (e.g. nails or glue) have become loose and require reattachment.

In some cases, sagging ceiling linings may also indicate that there are structural issues, causing surfaces to warp, twist or sag. Where sagging appears to be major, appointment of a structural engineer is advised to further inspect the property and identify the source and rectification works required.

Where minor sagging is evident, comparatively minor works, such as re-gluing of ceiling sheets, may be required. Such works may be performed by relevant tradespeople, such as plasterers and painters. Where excessive moisture has caused the roofing structure to swell and sag, the source of the water leak should primarily be identified prior to any remedial works being performed.

The appropriate action should be taken by the client as soon as possible to ensure that any potential further damage is limited.

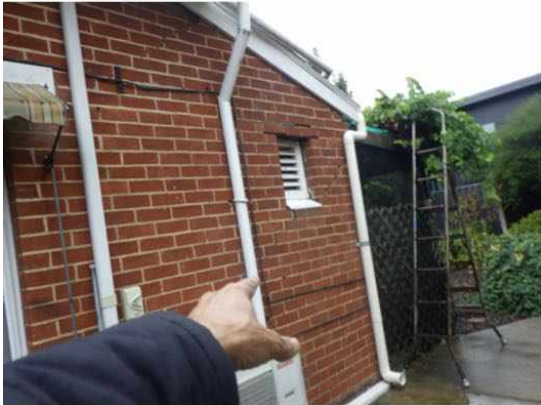
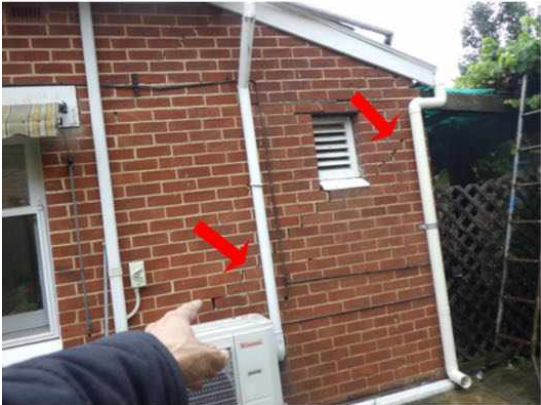
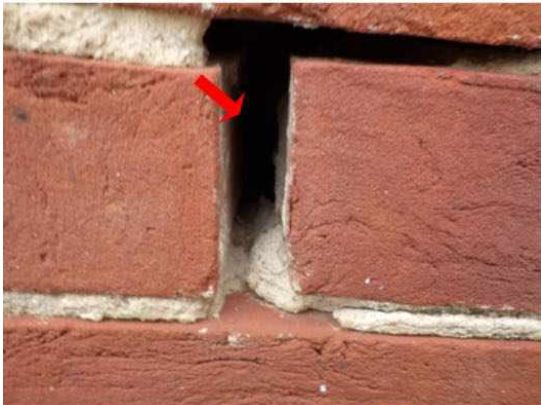
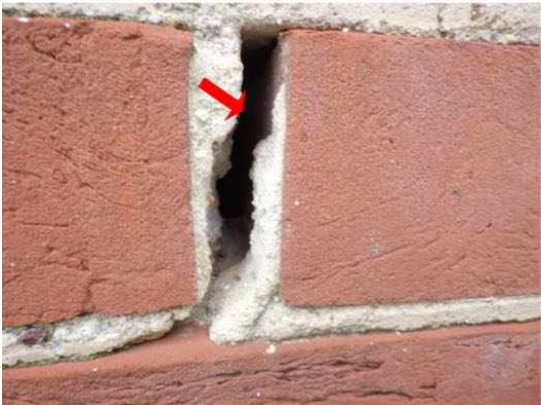
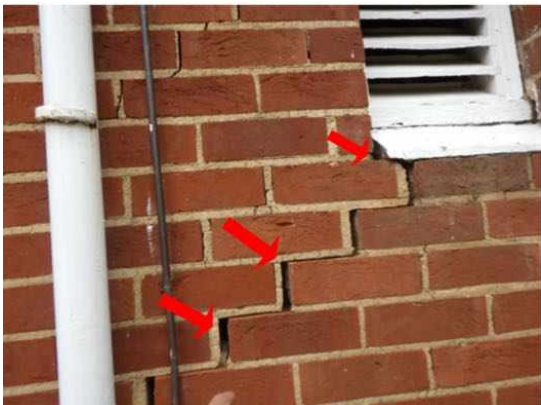
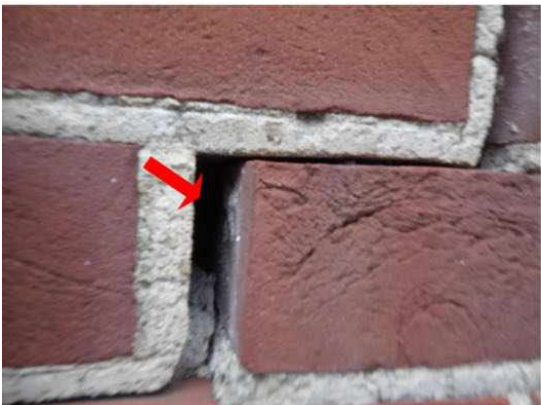
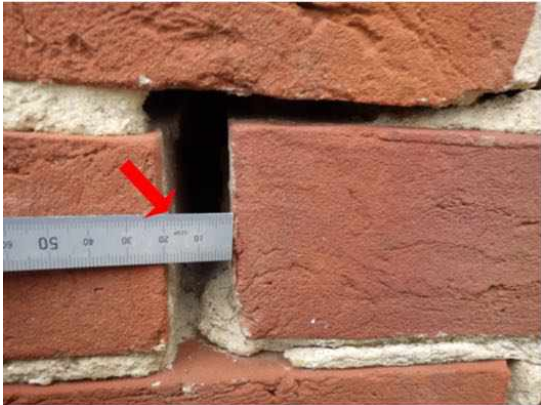
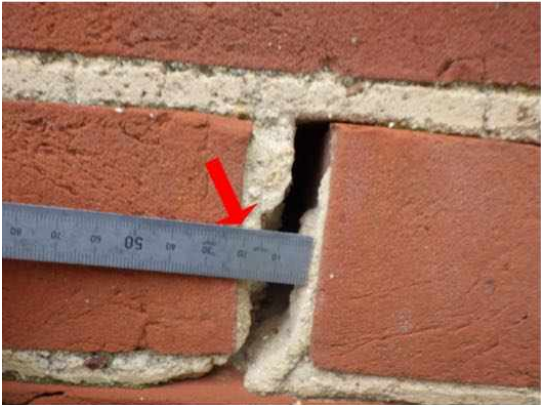
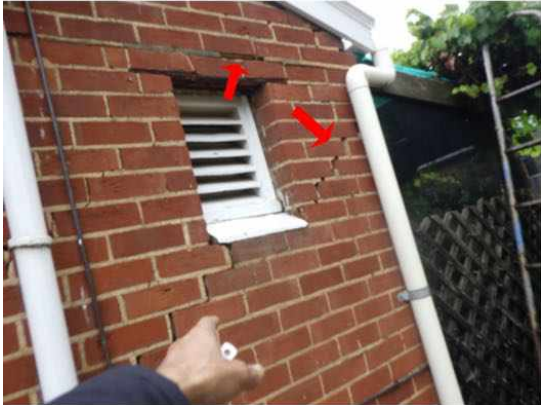
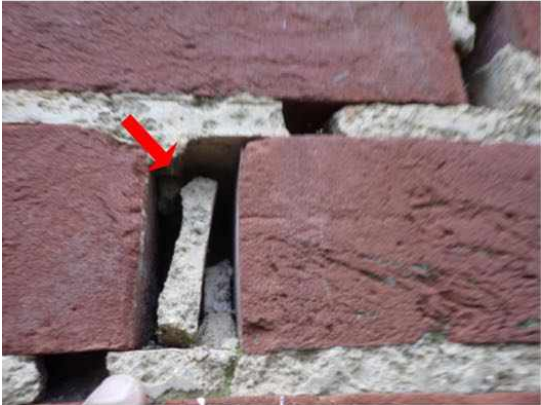
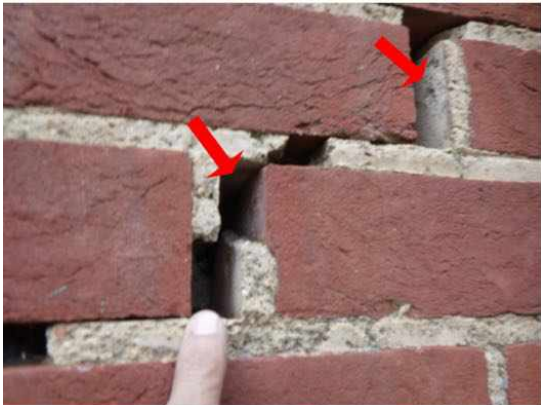
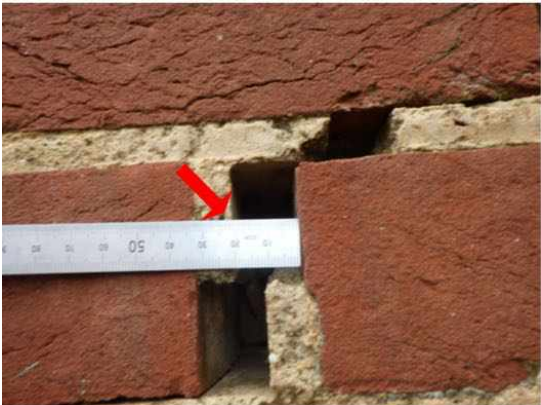
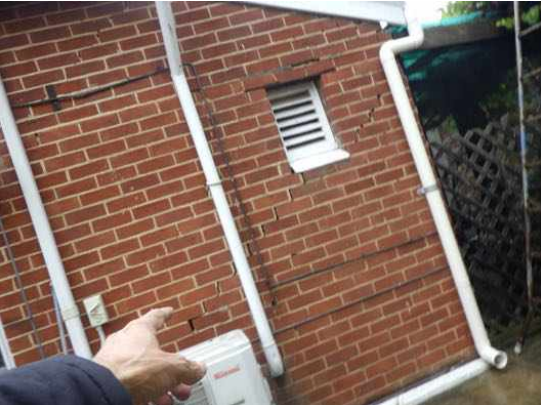
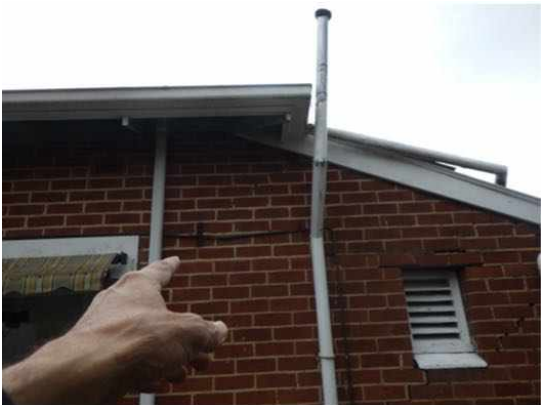
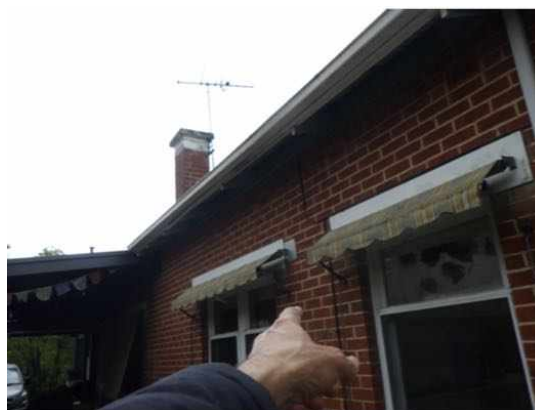
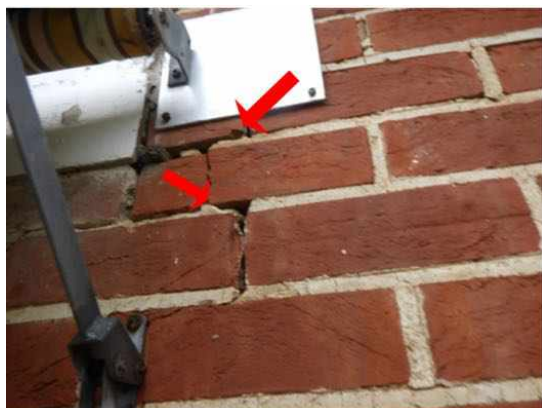
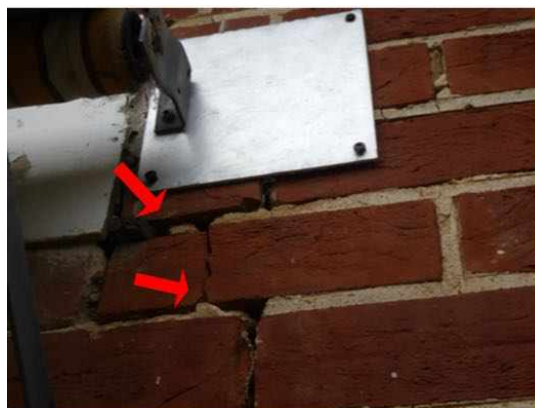
Defects 2.05

Building: Building 1
Location: All External Areas
Finding: Brickwork - Cracking [Repair required]
Information: Major cracking was identified to the brickwork in this area. Cracks of this type are likely to have been caused by minor expected movement of building elements, but may also have a structural cause that is more significant.

A crack of this size may be repaired by extensive filling. Additionally, further remedial works to associated building elements, such as eave sheeting or external door frames, is likely to be required.

A qualified bricklayer should be contacted immediately to estimate and perform repair and restoration works. Consultation with a structural engineer may be required where structural instability is found to be the underlying cause of the cracking.

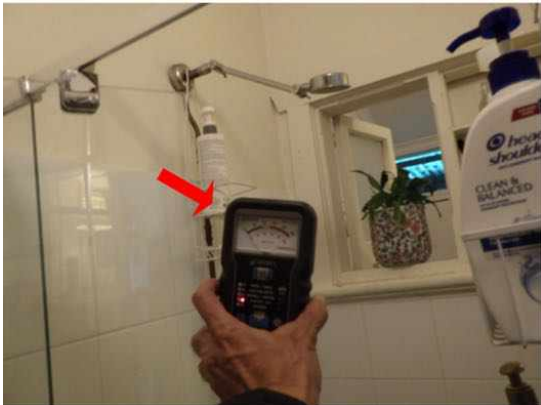
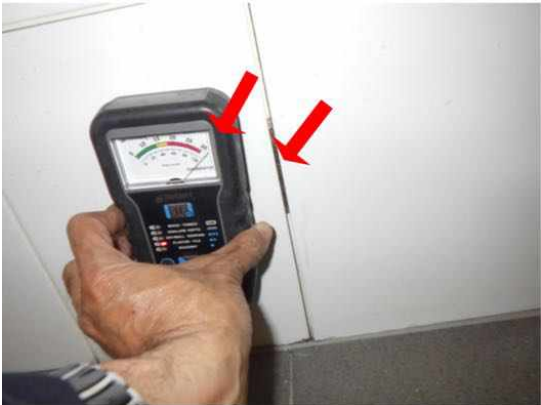
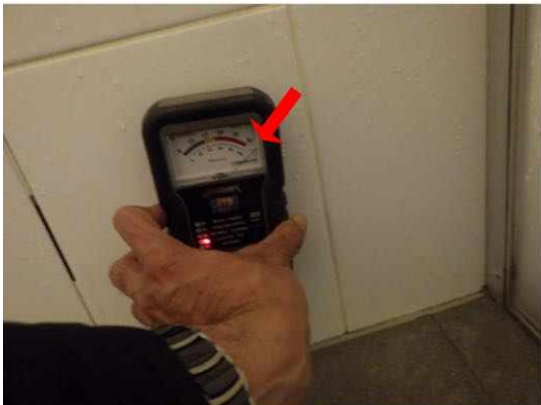
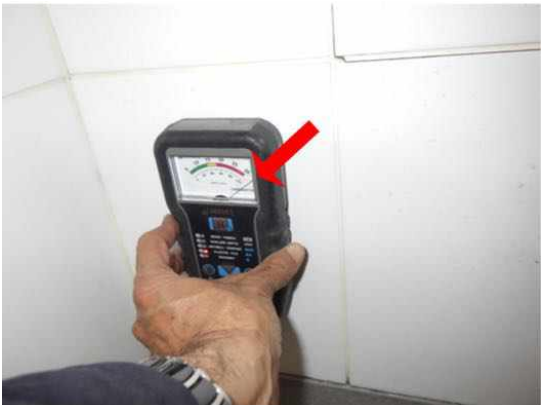
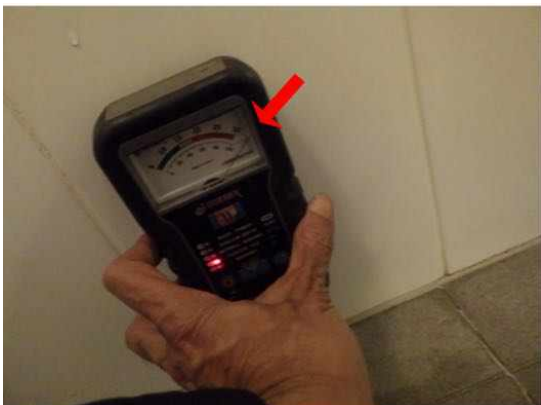
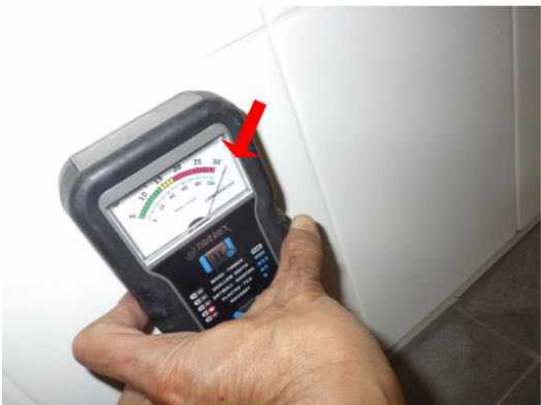
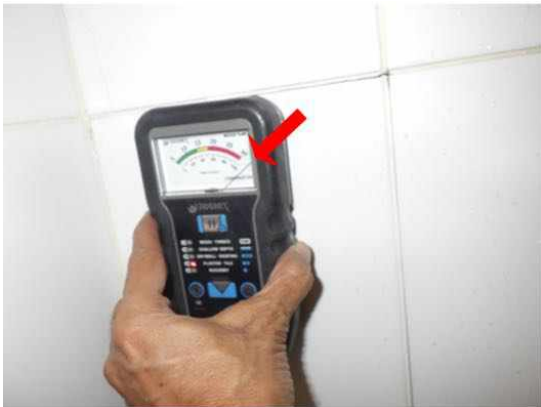
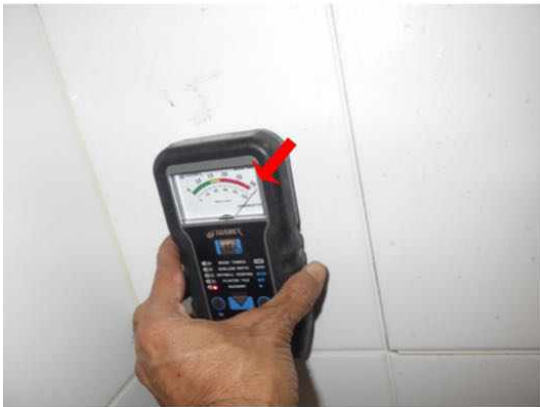
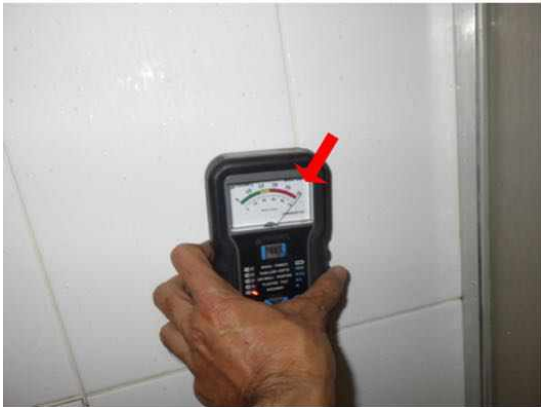
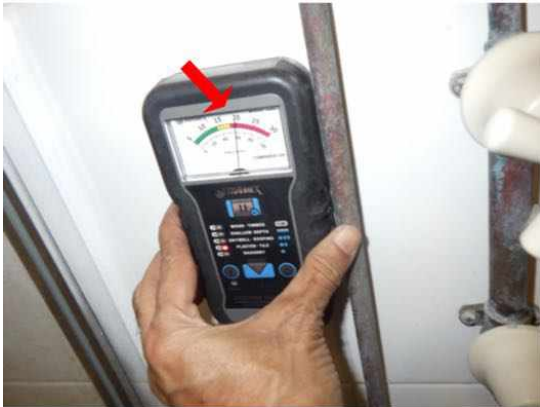
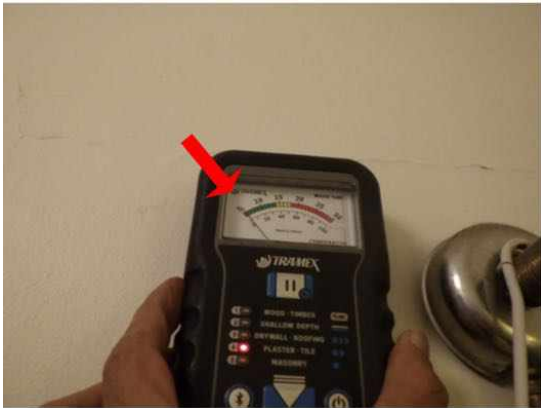
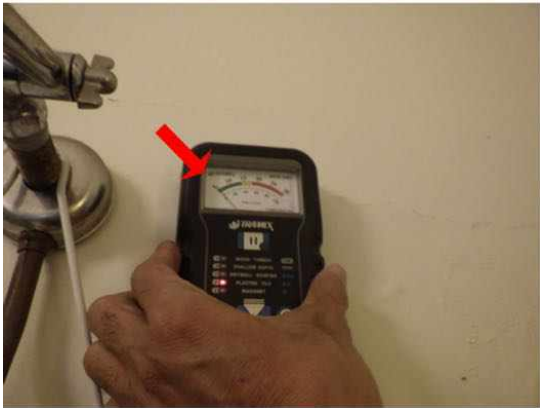
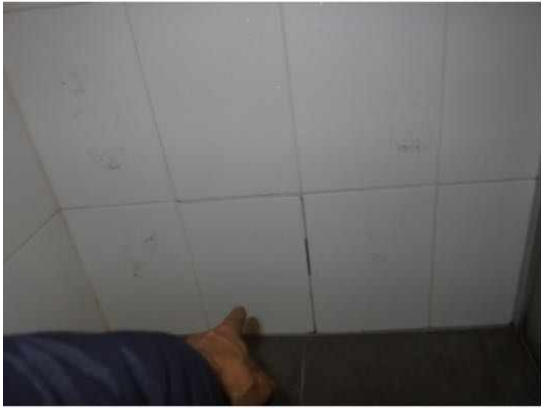
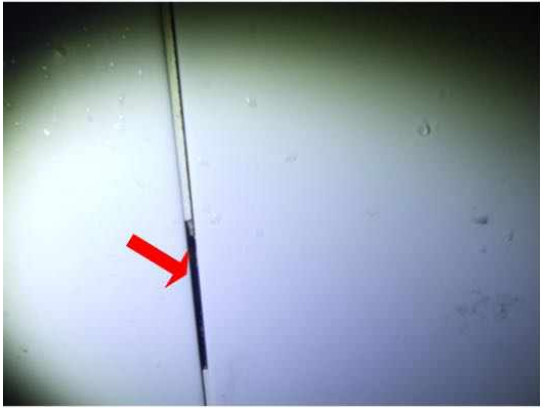
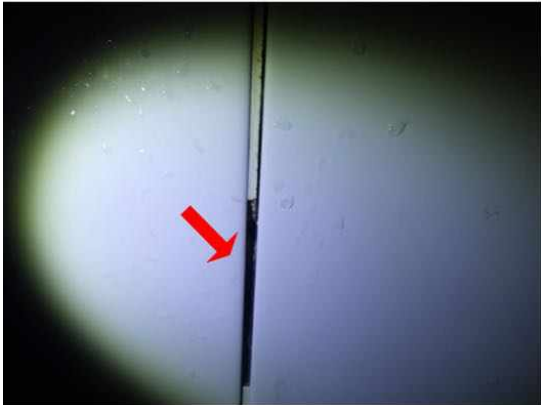
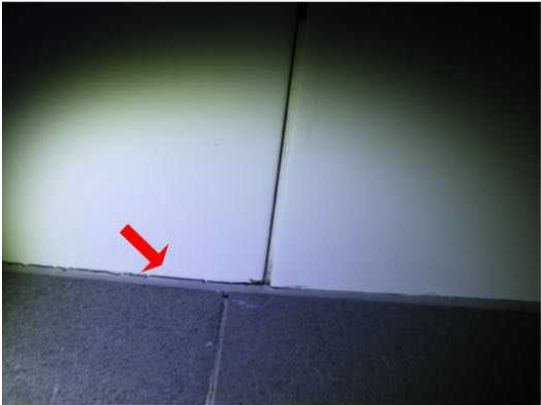
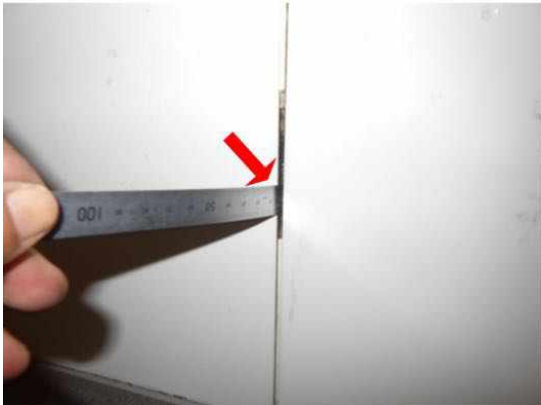
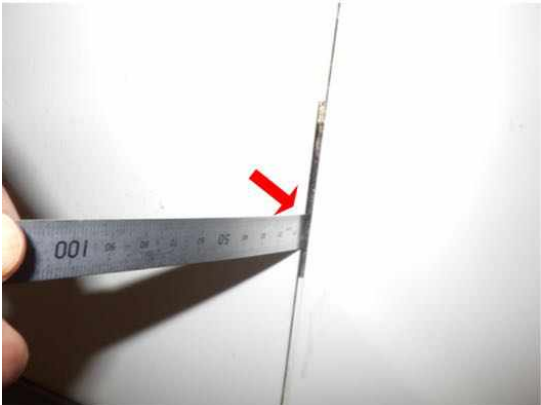
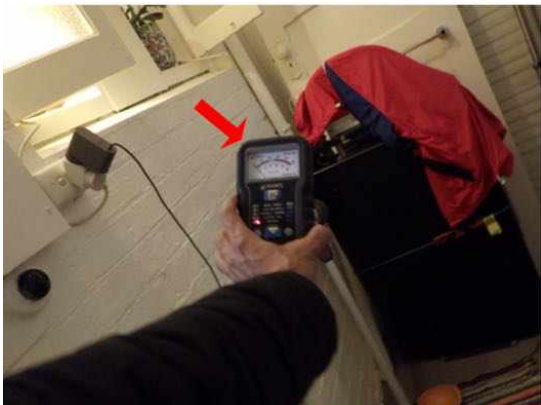
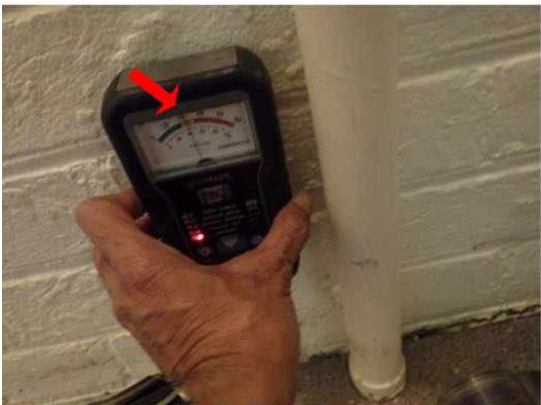
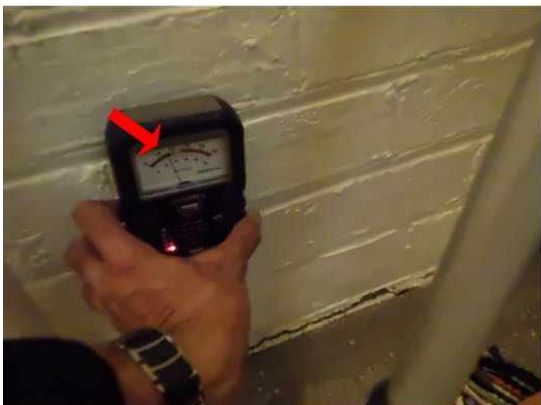
Defects 2.06

Building:	Building 1
Location:	Bathroom
Finding:	Shower Alcove - Damp & Grout deteriorated & Moisture transferring to other side of the walls
Information:	Damp is evident to the lower 400mm approximately of wall to the shower alcove. This defect is quite common, and is suspected to have been caused by moisture permeating through the grouting in this area, which shows evidence of deterioration. Leaking pipes within the adjoining wall is also a possible cause.

Apart from that at the time of inspection it was also noticed that evidence of grout deteriorated in this shower alcove area and moisture is transferring to other side of the walls.

Damp (or structural damp) refers to the presence of unwanted moisture in the structure of a building, either as the result of intrusion from outside, or condensation from within the structure. In the shower area, internal water leaks or other sources of excessive moisture are generally the cause of damp.

Unmanaged damp in the shower recess is likely to facilitate the formation and development of mould and fungi growth, decaying associated building materials and compromising their structural integrity. Exposure to these contaminants is associated with a wide range of respiratory and other health-related problems.

Consultation with a qualified plumber or bathroom specialist is advised immediately to identify the cause of damp and to perform remedial works as required. Where excessive mould growth is present, further inspection by a specialist environmental health inspector should also be considered.

Always ensure that sealant and grout is in good condition to prevent any moisture issues occurring in the future.

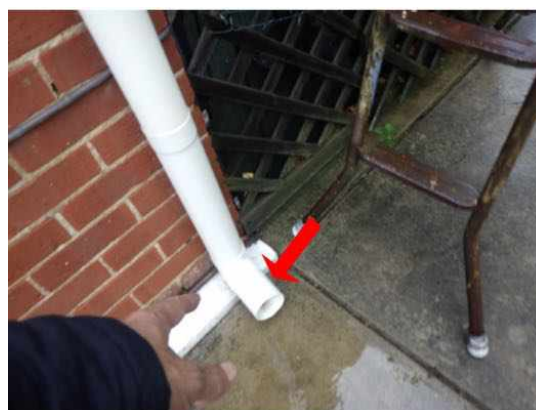
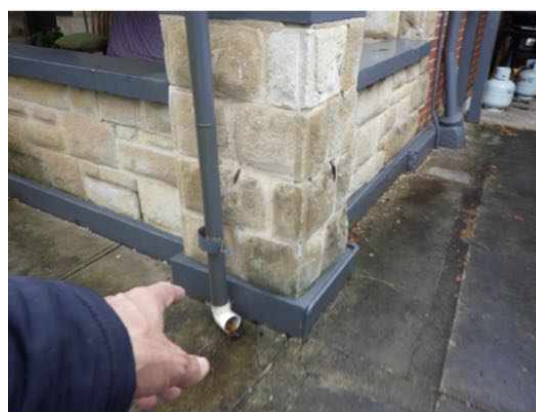
Defects 2.07

Building:	Building 1
Location:	All External Areas
Finding:	Site drainage - Inadequate
Information:	The site drainage in this area was found to be inadequate at the time of inspection, creating potential for subsequent water damage to associated building elements.

It is important that water does not lie against the base of walls; surrounding paths and ground levels should be sloped to drain water away from walls. Downpipes should not discharge stormwater onto lower walls or plinths. Stormwater should be carried away by large, regularly cleaned drains. Ground levels may need to be lowered to expose a buried DPC.

Where site drainage is inadequate, installation of an Agricultural (Aggie) Drain may be required. A qualified plumber should be appointed to further inspect the property and perform any remedial works as necessary. Water damage and secondary defects are likely to occur if left unmanaged.

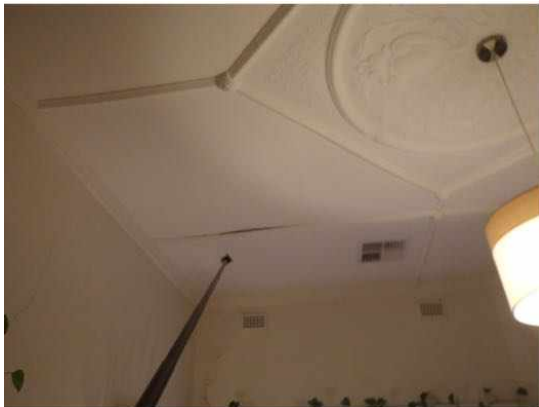
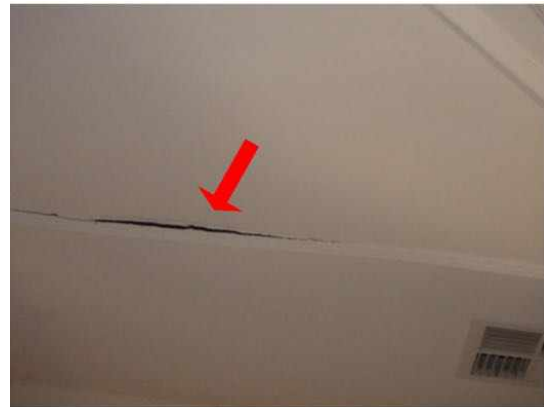
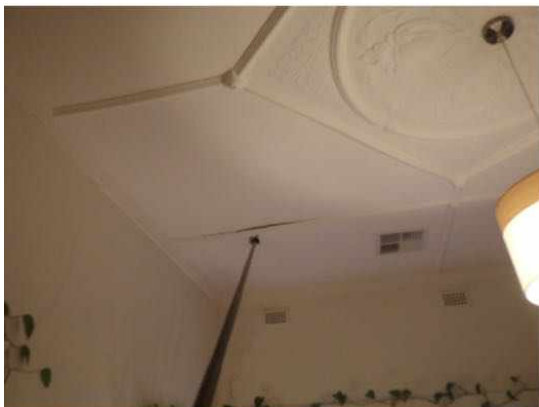
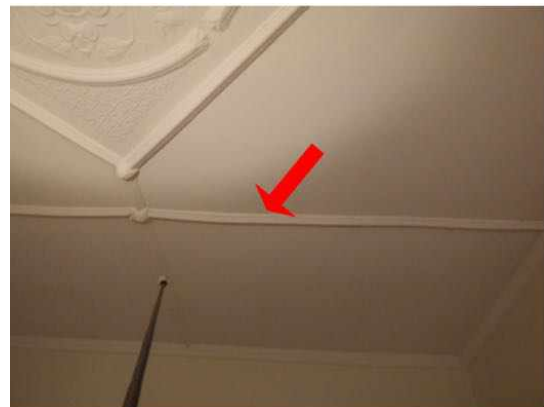
Defects 2.09

Building:	Building 1
Location:	All Internal Areas
Finding:	Internal Ceiling - Sagging
Information:	Sections of the ceiling were found to be sagging at the time of inspection. Sagging to the fixed ceiling structure generally indicates that the building materials have swollen, due to contact with water, or that fixings (e.g. nails or glue) have become loose and require reattachment.

In some cases, sagging ceiling linings may also indicate that there are structural issues, causing surfaces to warp, twist or sag. Where sagging appears to be major, appointment of a structural engineer is advised to further inspect the property and identify the source and rectification works required.

Where minor sagging is evident, comparatively minor works, such as re-gluing of ceiling sheets, may be required. Such works may be performed by relevant tradespeople, such as plasterers and painters. Where excessive moisture has caused the roofing structure to swell and sag, the source of the water leak should primarily be identified prior to any remedial works being performed.

The appropriate action should be taken by the client as soon as possible to ensure that any potential further damage is limited.

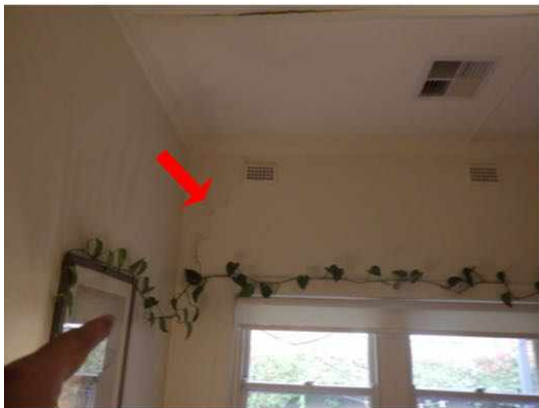
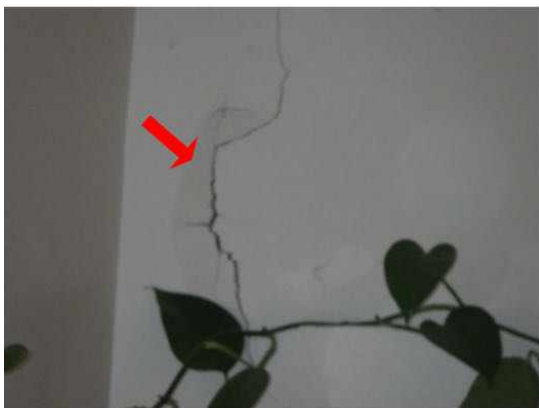
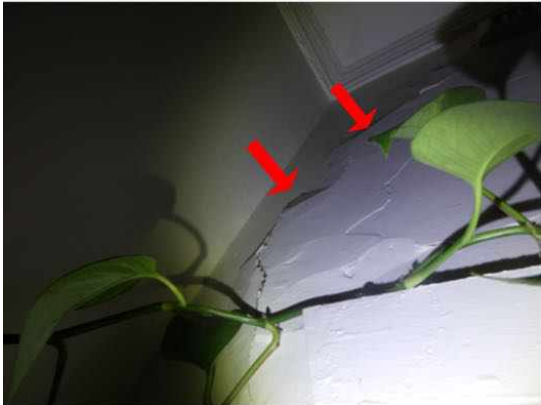
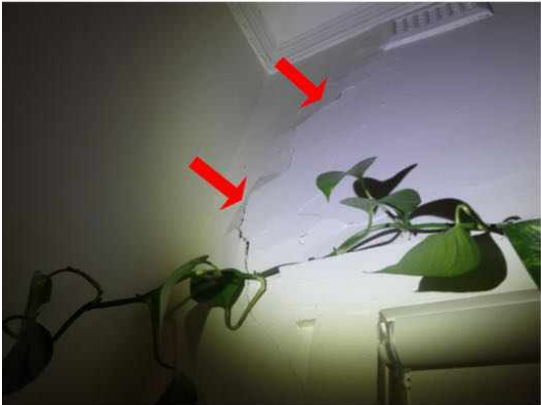
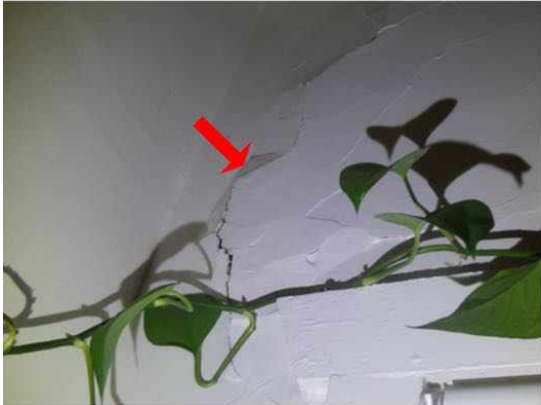
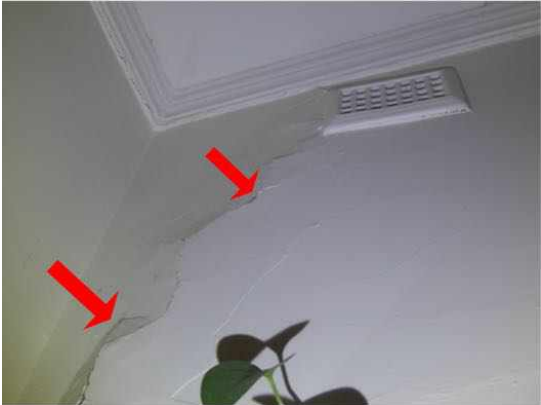
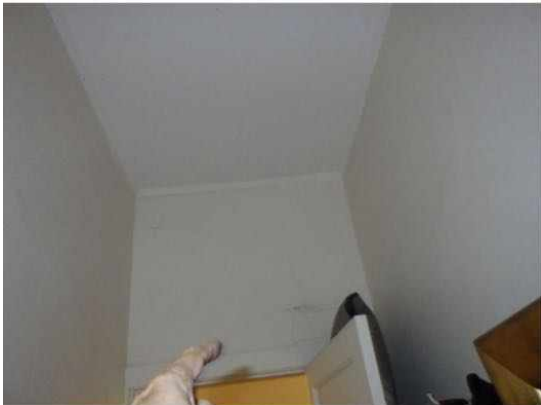
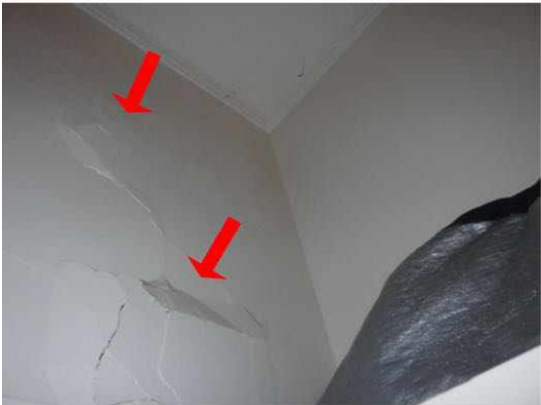
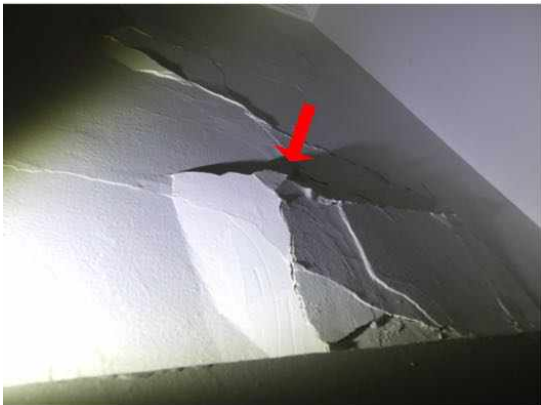
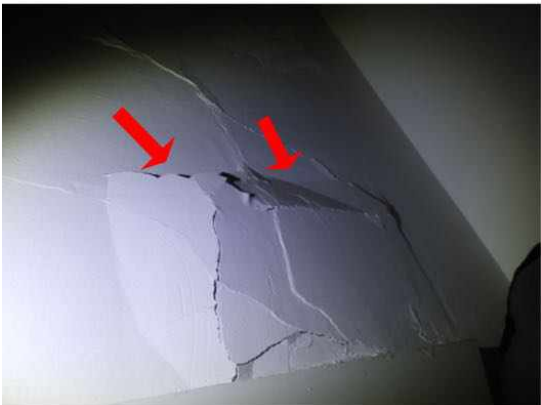
Defects 2.10

The most common causes of plaster failure are physical damage and moisture damage. Moisture causes plaster to swell and shrink as the humidity of the air changes, or as a consequence of leaks, which can be enough to create drumminess or cracking.

Drummy plaster generally needs chemical re-adhesion or to be screwed back to the substrate, with minor consequent patching and painting required.

Ensure that the general environment is free of moisture and humidity to aid in the prevention of drummy plaster and plaster damage. Appointment of a qualified plasterer is advised as soon as possible in order to complete remedial works as necessary.
