Building Inspection Report

Inspection Date: Thu, 9 Apr 2026

Property Address: 53 Mary St, Unley SA 5061, Australia

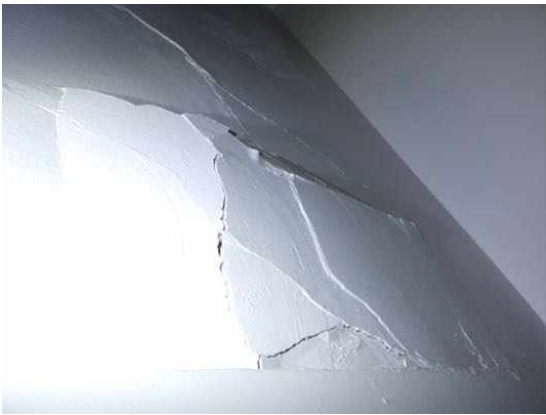
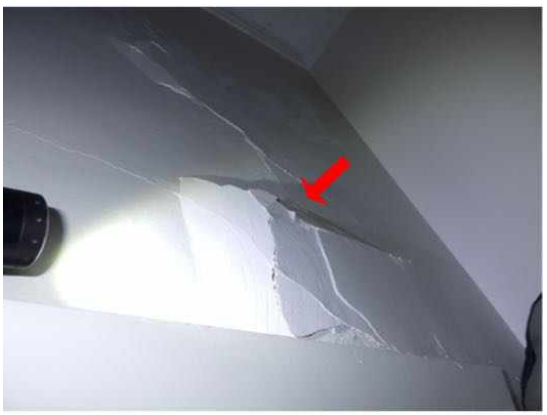
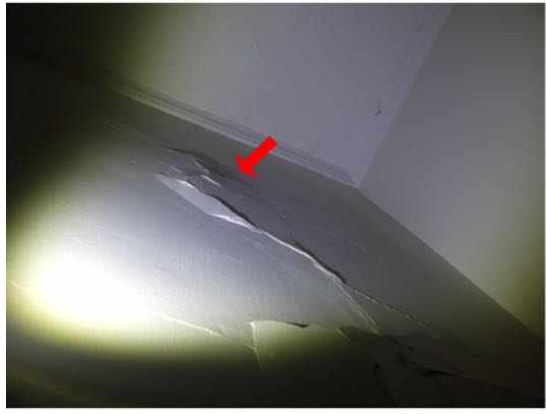
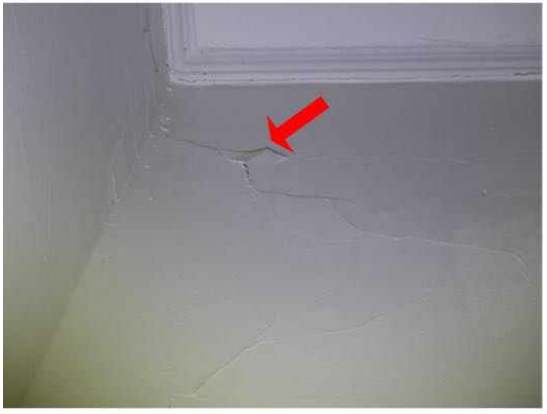
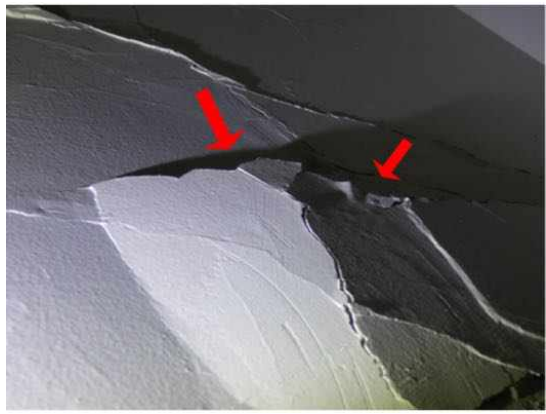
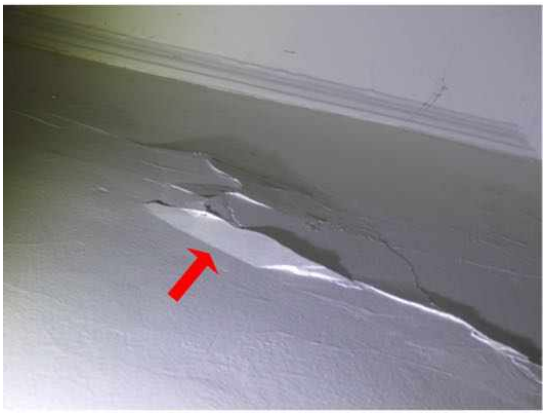
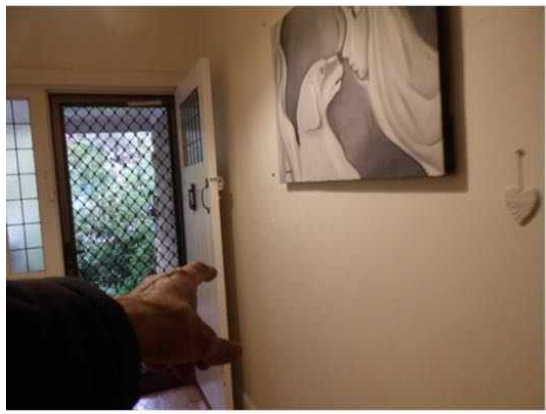
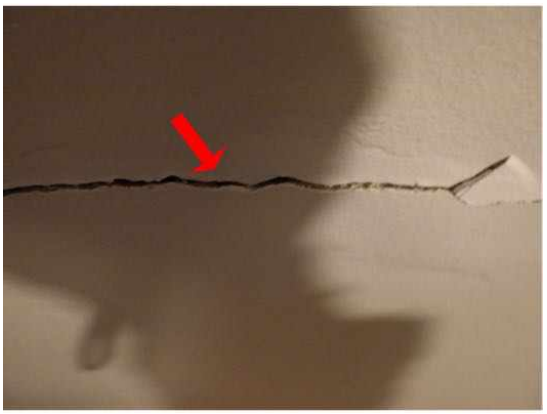
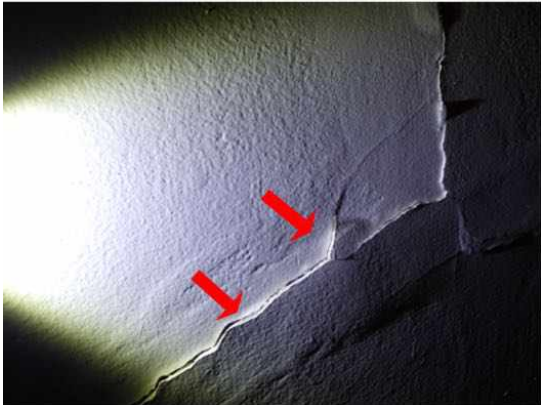
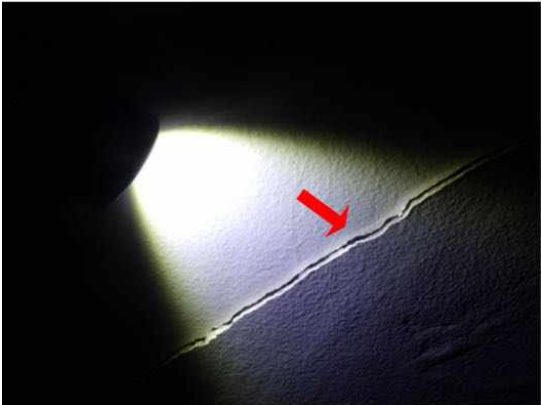
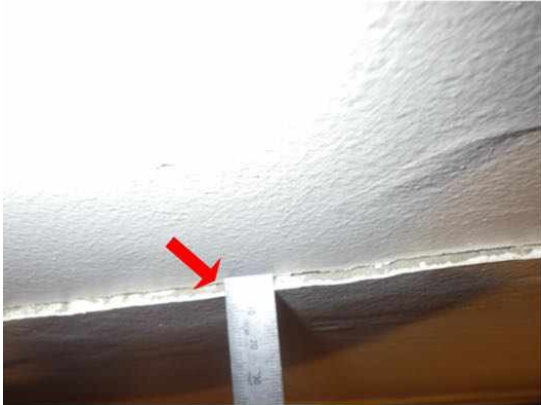
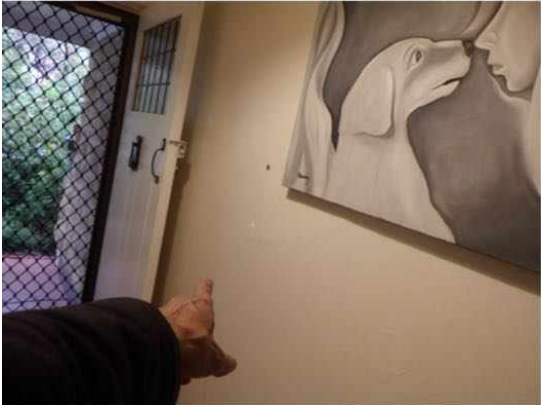
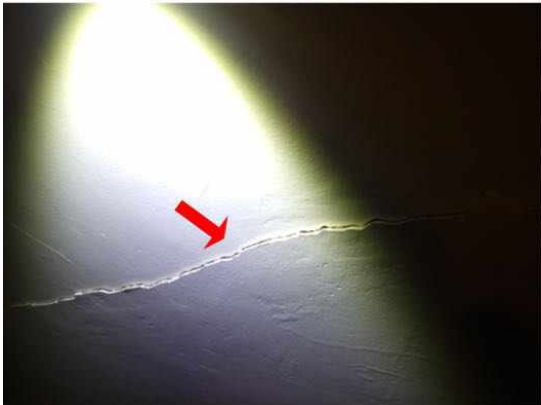
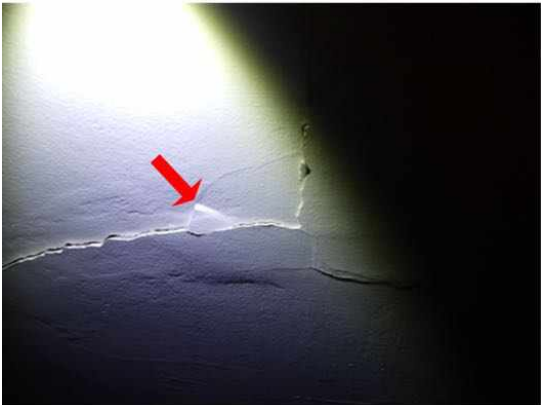
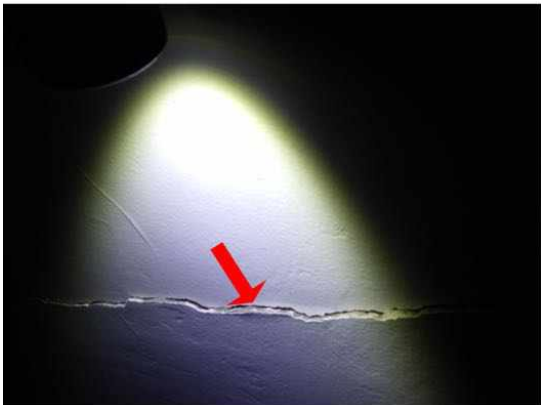
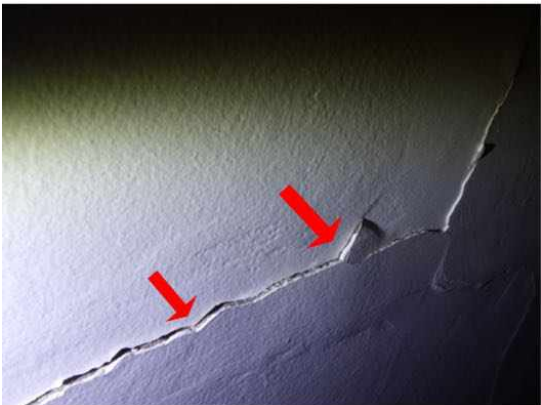
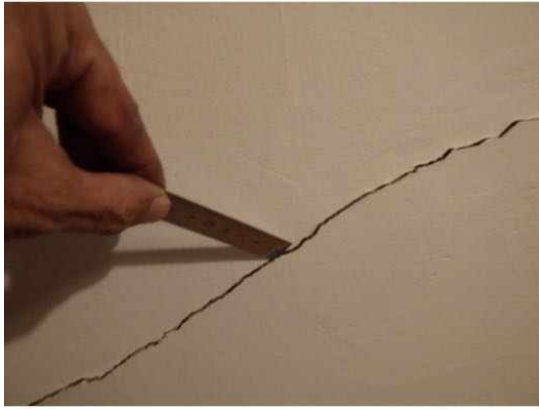
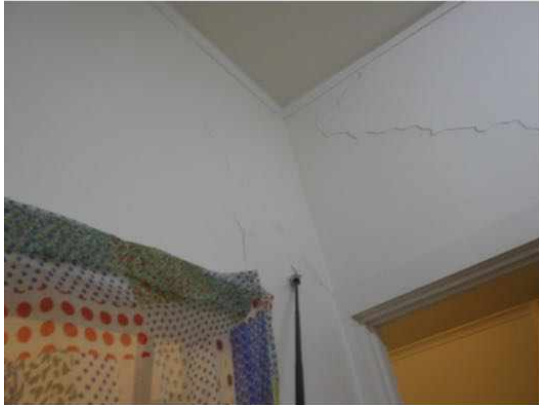
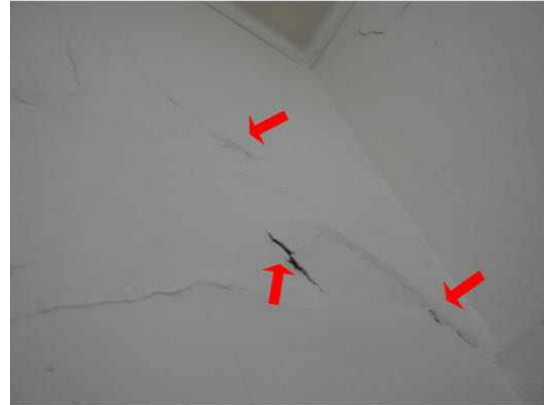
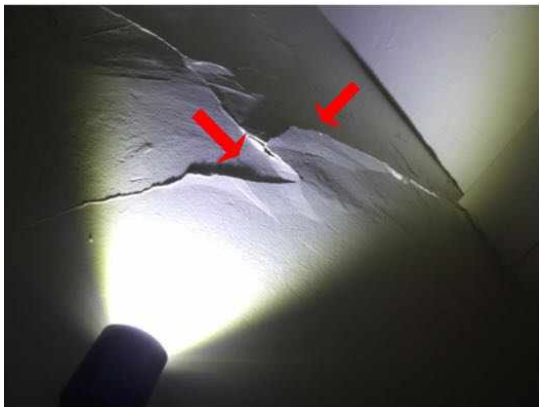
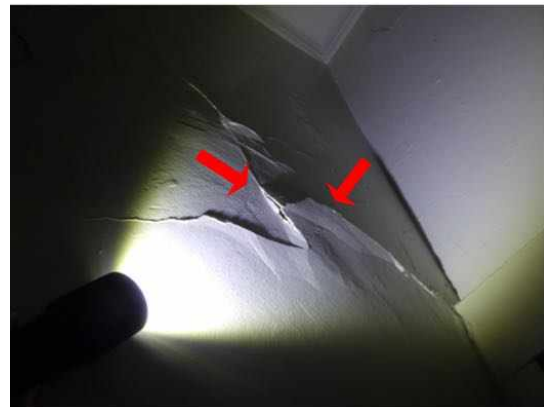
Defects 2.10

The most common causes of plaster failure are physical damage and moisture damage. Moisture causes plaster to swell and shrink as the humidity of the air changes, or as a consequence of leaks, which can be enough to create drumminess or cracking.

Ensure that the general environment is free of moisture and humidity to aid in the prevention of drummy plaster and plaster damage. Appointment of a qualified plasterer is advised as soon as possible in order to complete remedial works as necessary.

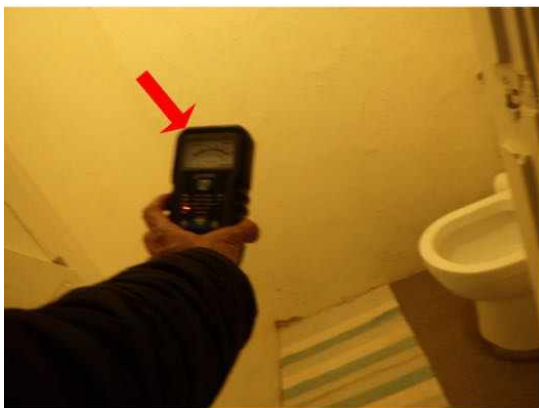
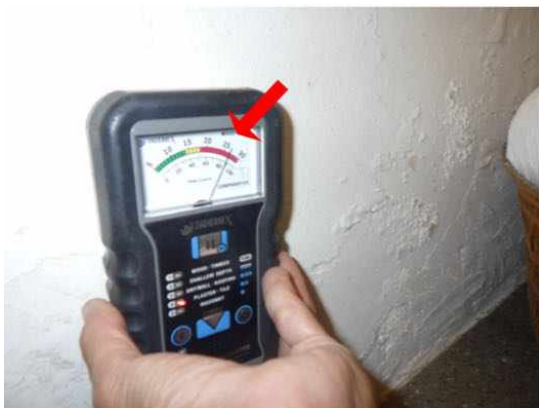
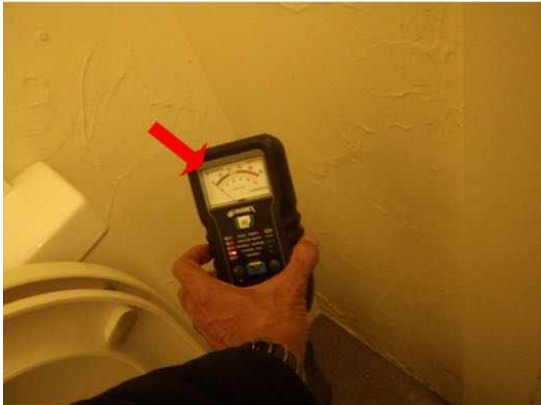
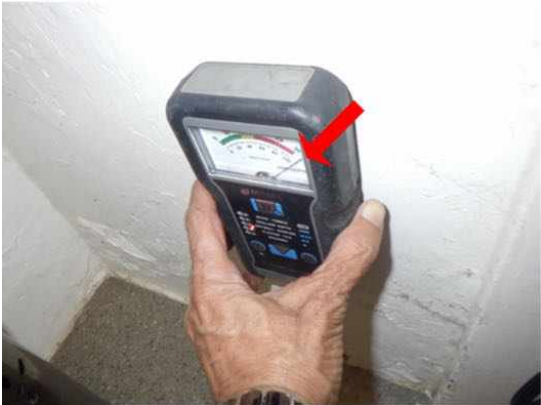
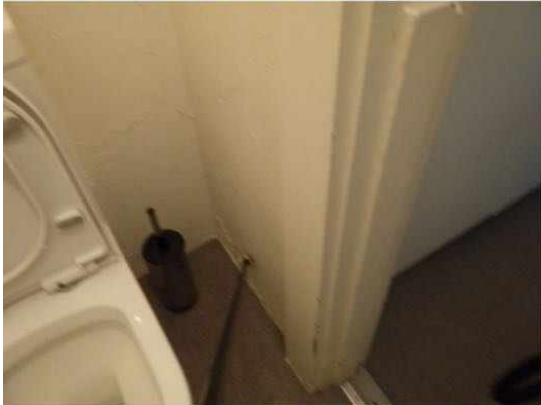
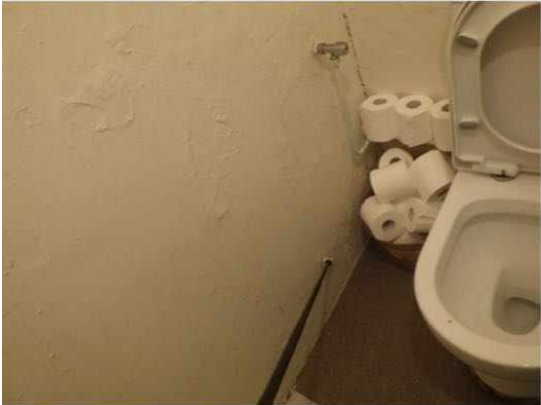
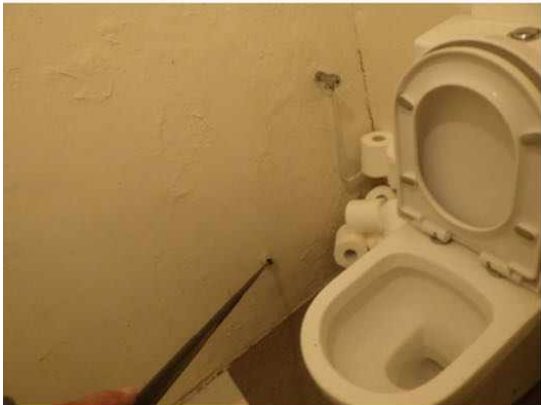
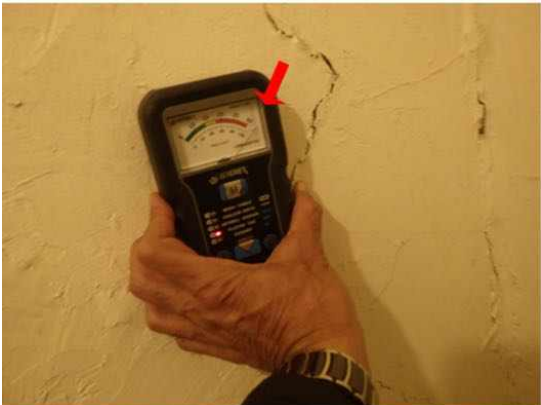
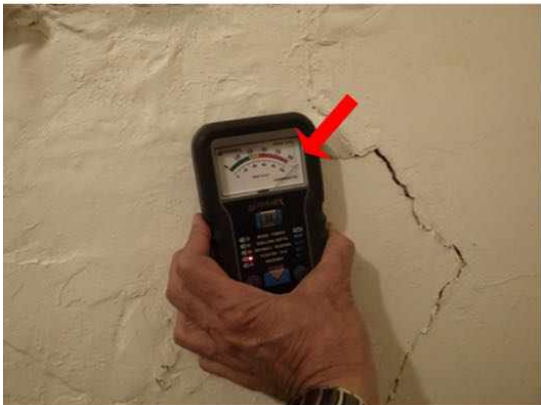
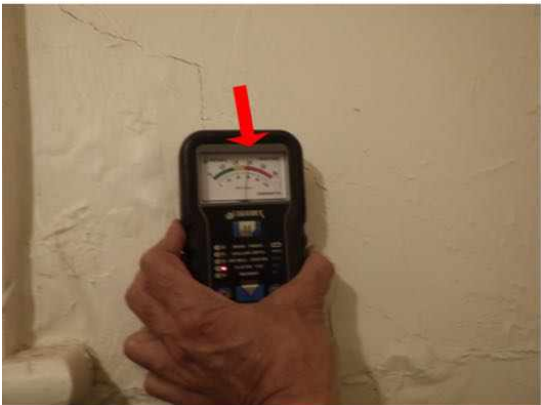
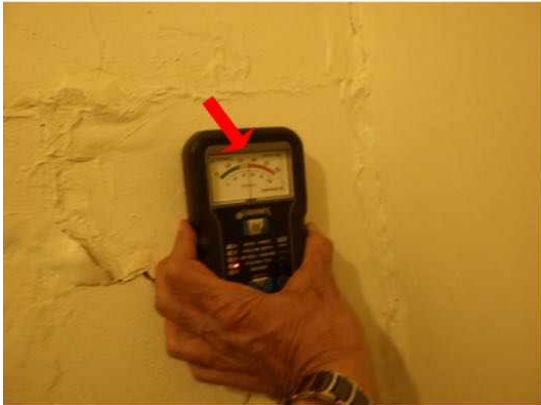
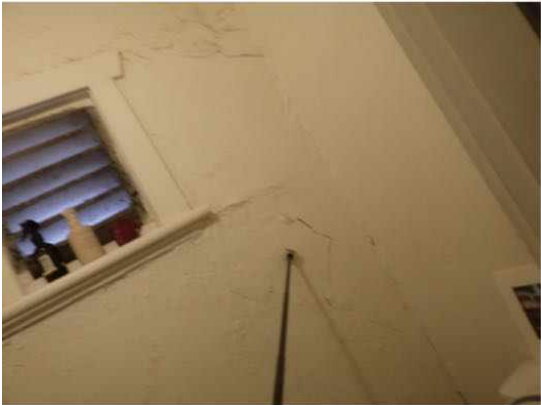
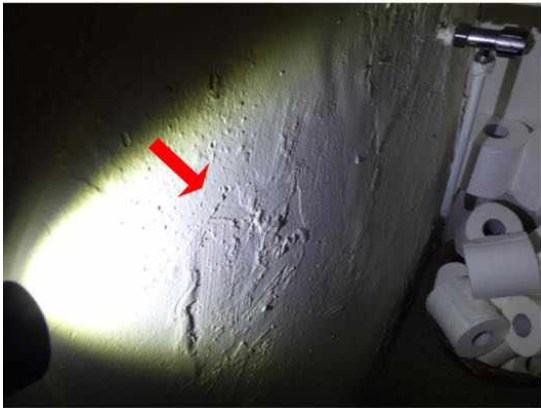
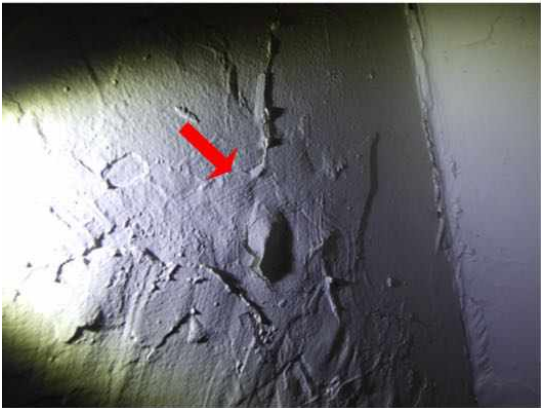
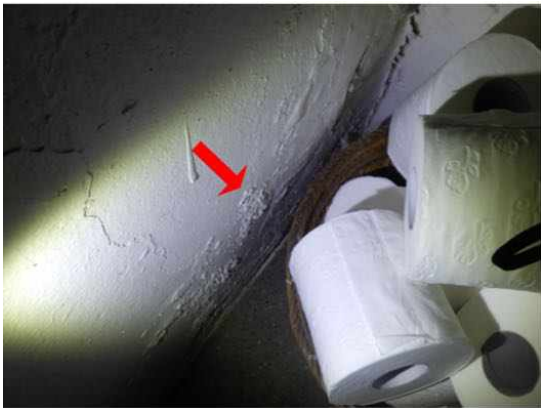
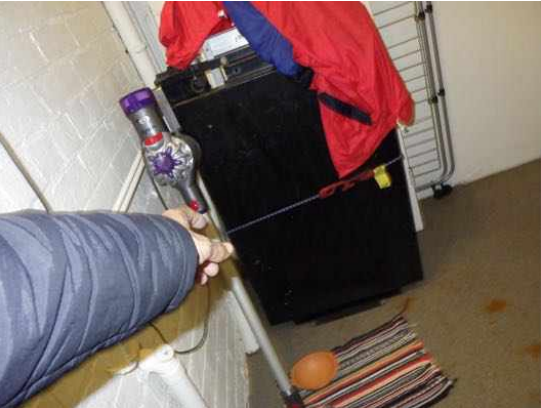
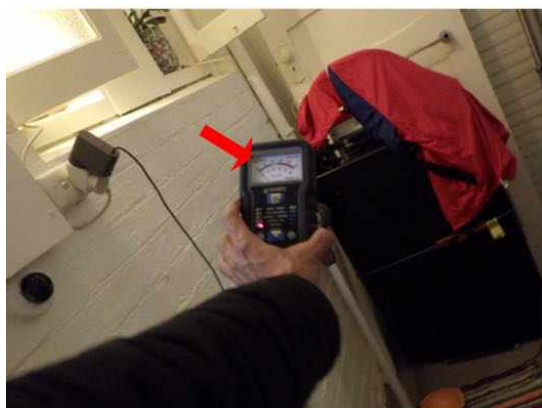
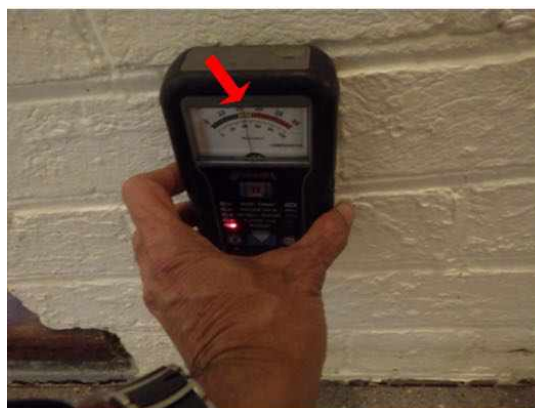
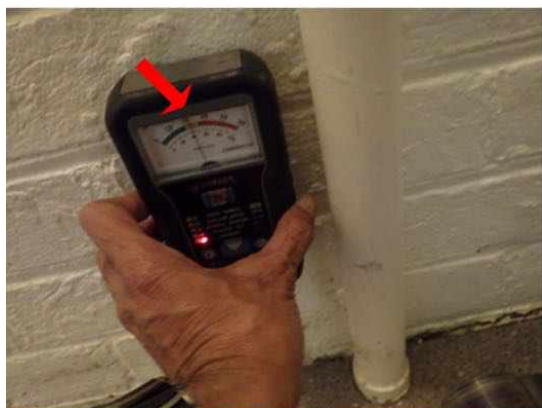
Defects 2.11

Building:	Building 1
Location:	All Internal Areas
Finding:	Internal walls - Damp
Information:	At the time of inspection it was noticed that high moisture readings were noted in few sections of internal walls around the property .

Damp (or structural damp) refers to the presence of unwanted moisture in the structure of a building, either as the result of intrusion from outside, or condensation from within the structure. Generally, structural damp is caused by rain penetration, rising damp, and leaks from plumbing pipes.

Unmanaged damp facilitates the formation and development of mould, fungi growth and wood rot, decaying associated building materials and compromising their structural integrity. Damage to finishes is also likely to occur, including lifting, bubbling, peeling and staining of paint, plaster and wallpaper.

The first step in addressing damp is to diagnose the cause. The identified cause should be addressed first prior to repairing the appearance and other defects which have resulted from the rising damp. If the original cause is not resolved, further cases of damp are likely to ensue, resulting in secondary defects.

Consultation with a qualified plumber is advised immediately to identify the cause of damp and perform remedial works as required. Where excessive mould growth is present, further inspection by a specialist environmental health inspector should also be considered.

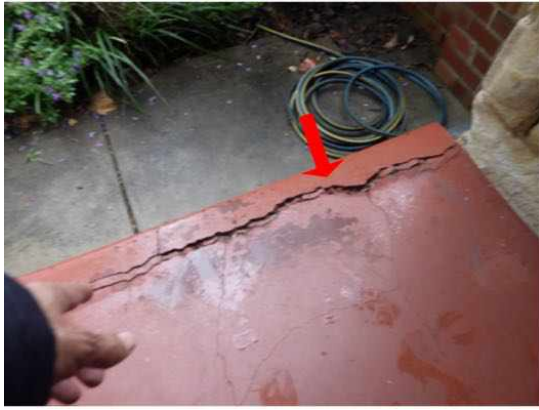
Defects 3.01

Building:	Building 1
Location:	All External Areas
Finding:	Building element - Damaged
Information:	At the time of inspection it was noticed that evidence of paving damaged in this entry area.

Breakage occurs generally when the building materials have either aged and decayed, or as a result of damage (accidental or deliberate).

Repair and/or replacement of broken elements is advised to ensure that additional secondary defects do not arise as a consequence. Such works are necessary, as all building elements play a key role in the operation and function of the overall structure and its performance.

A relevant tradesperson should be appointed to repair or replace the affected building element prior to any subsequent damage being caused.

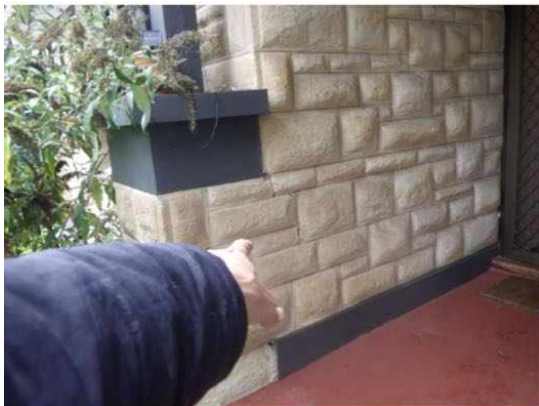
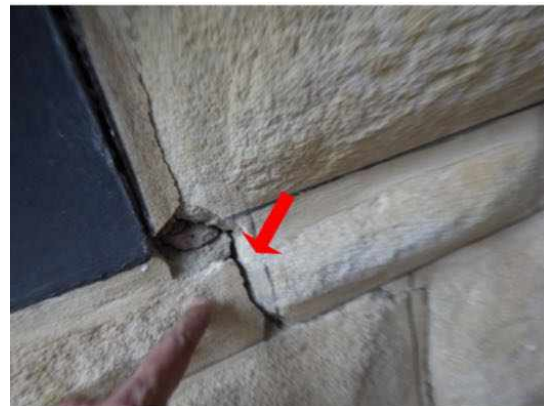
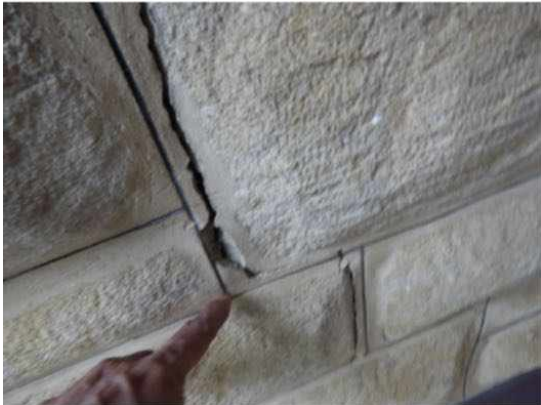
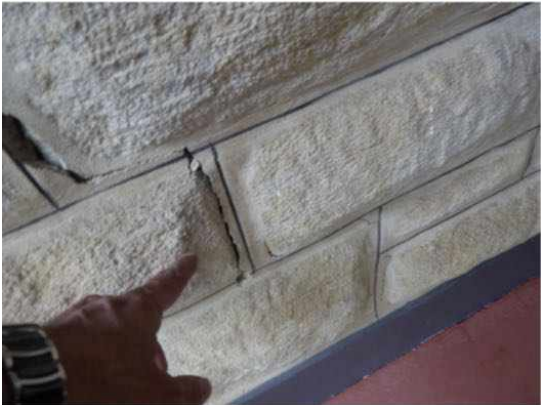
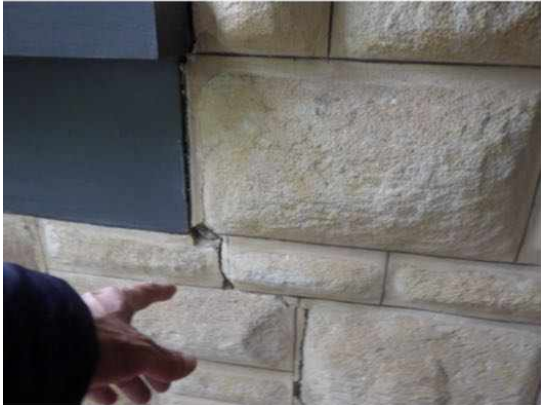
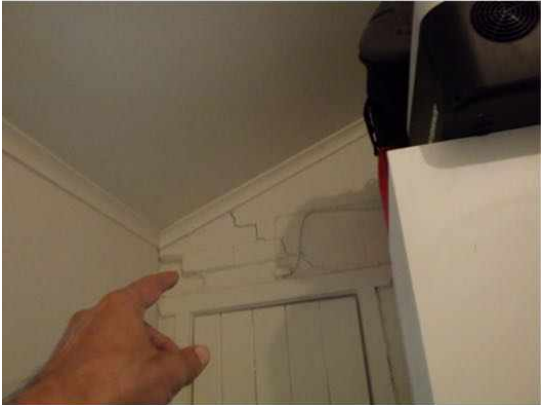
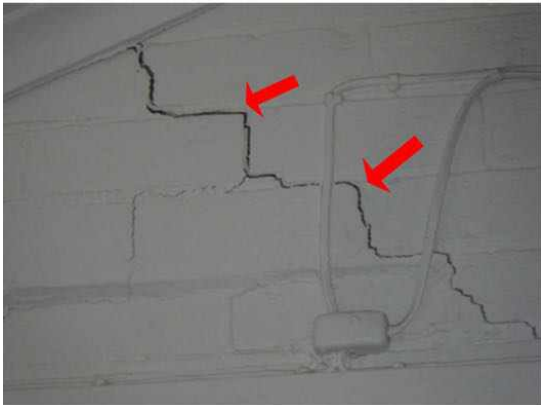
Defects 3.02

Building:	Building 1
Location:	All Areas
Finding:	Brickwork - Step cracking
Information:	Step cracking was identified to the brickwork in this area at the time of inspection. Step cracking, which is similar to other forms of cracking, has a variety of possible causes. However, the most common is the subsidence of adjacent footings.

Step cracking is a relatively common defect, and is most likely to occur adjacent to windows, doors and other openings. Mortar failure in the gaps between affected bricks indicates the stresses and tensions affecting the wall.

Where step cracking is extensive or severe, the client is advised to consult a structural engineer. Minor step cracking can be used as a warning sign to address factors causing stress to the wall, which can include the effect of surrounding trees, water leaks, soil erosion, or even the presence of reactive soils in the surrounding area.

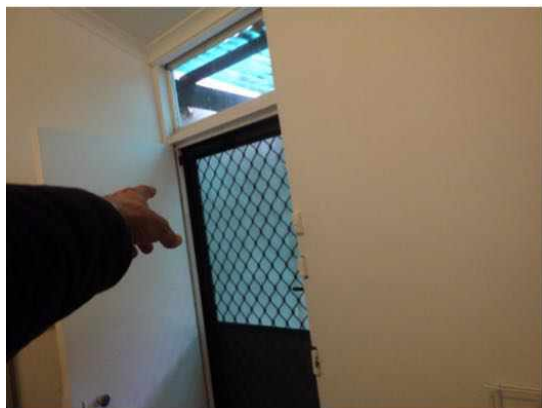
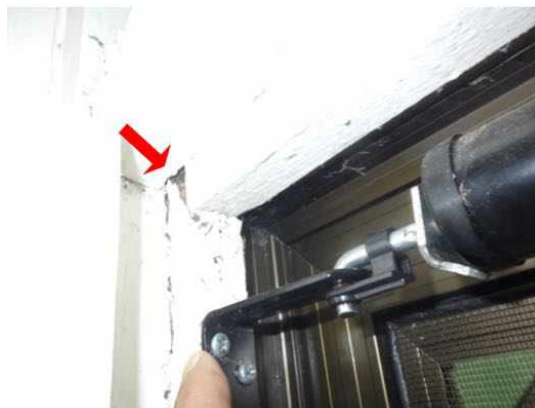
Defects 3.03

Building: Building 1
Location: All Internal Areas
Finding: Building element - Broken
Information: Breakage occurs generally when the building materials have either aged and decayed, or as a result of damage (accidental or deliberate).

Repair and/or replacement of broken elements is advised to ensure that additional secondary defects do not arise as a consequence. Such works are necessary, as all building elements play a key role in the operation and function of the overall structure and its performance.

A relevant tradesperson should be appointed to repair or replace the affected building element prior to any subsequent damage being caused.

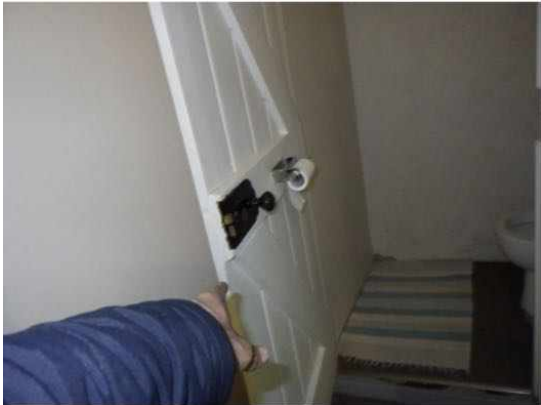
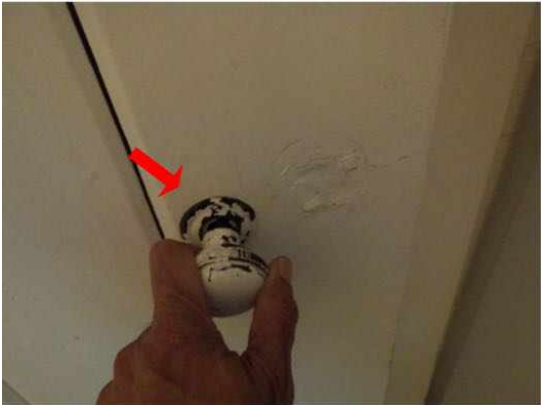
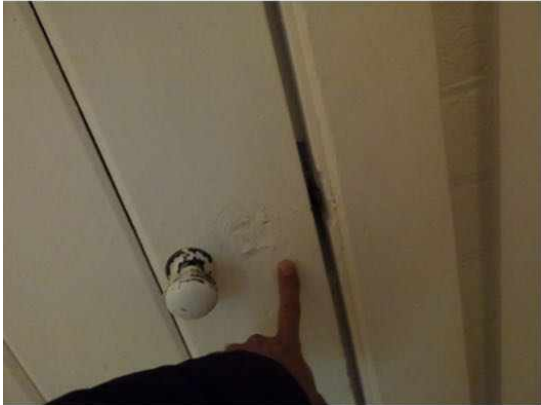
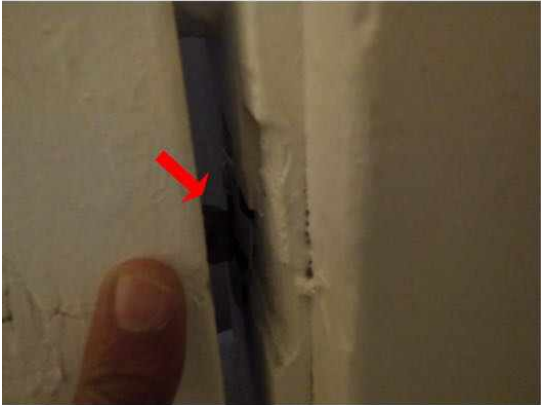
Defects 3.04

Building:	Building 1
Location:	All Internal Areas
Finding:	Door handle - Not latching
Information:	It was noted that the door in this area was not latching during operation at the time of inspection. Whilst detracting from the functionality of this building element, this minor defect may also be a security risk, and may therefore have serious implications if left unattended.

It is suspected that this defect has occurred due to minor issues with the associated hinges. Such damage is identified as general wear and tear, which is expected for building elements of this age.

A qualified carpenter or general handyperson may be appointed to perform rectification works as necessary, at client discretion. If left unattended, further functional impairment is likely to occur.

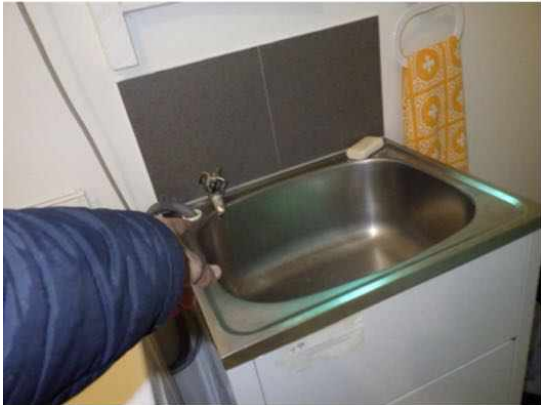
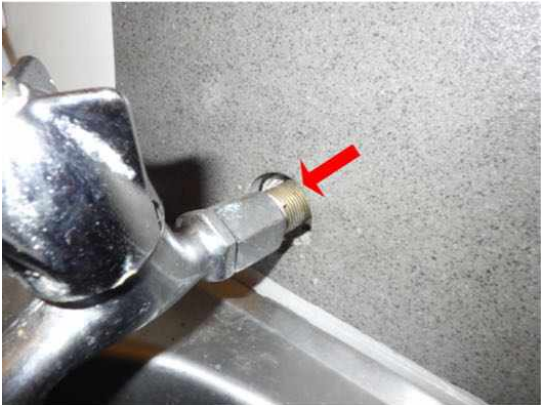
Defects 3.05

Building: Building 1
Location: All Internal Areas
Finding: Grout - Missing
Information: Grout is missing in this laundry area. Grout is used to protect gaps and crevices in building materials to ensure that they are water-tight and prevent water penetration to the associated structures.

Where grout is missing, a tiling contractor should be appointed immediately to apply grout and re-apply any silicone where necessary. Failure to do so is likely to lead to water damage to the surrounding area.

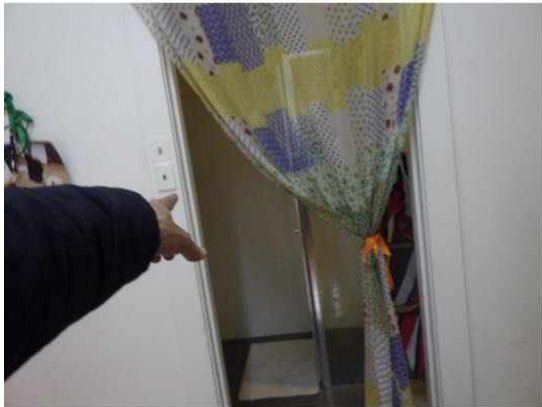
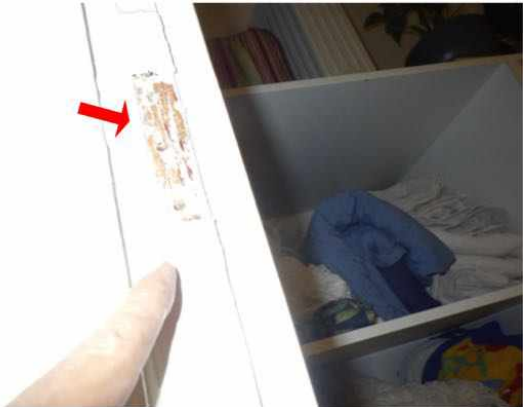
Defects 3.06

Building: Building 1
Location: All Internal Areas
Finding: Building element - Missing
Information: At the time of inspection it was noticed door is missing from this bathroom area. Although some building elements may seem irrelevant or unnecessary, all building elements play a key role in the operation and function of the overall structure and its performance.

Replacement of any missing building element should be conducted as soon as possible to ensure that no damage or functional issues occur to associated building materials.

The appropriate tradesperson should be appointed as soon as possible to replace the missing building element.

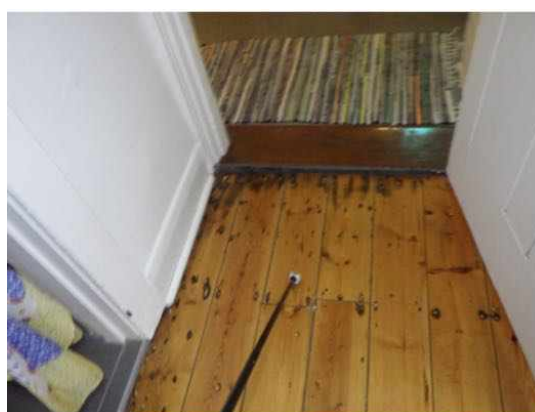
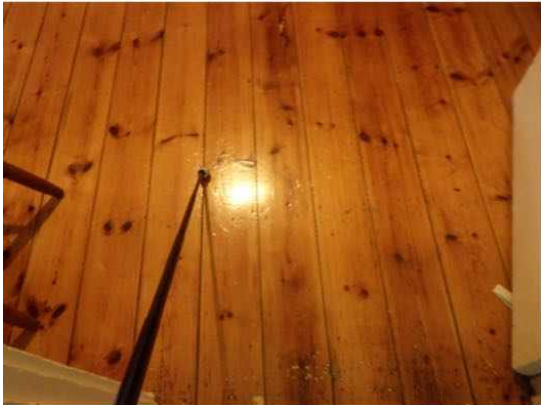
Defects 3.07

Bouncy floors generally indicate that the floorboards or the subfloor structures are coming loose from the joists that they are installed on. Bouncy flooring may also be the result of gaps between flooring and stumps or joist structures, which require packing.

The client is advised to seek quotations for required repairs from a Registered Builder specialising in re-stumping. The potential resolution may range from packing gaps in subfloor structures through to replacement of subfloors stumps and refixing of flooring.

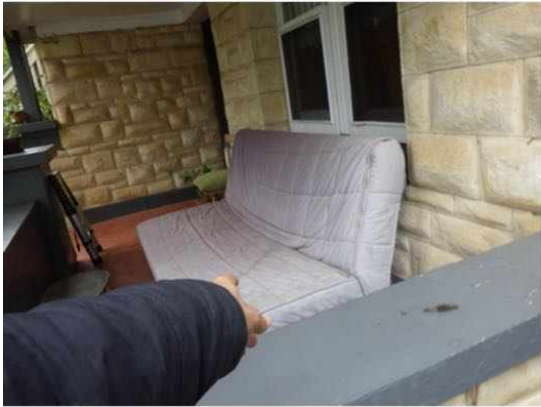
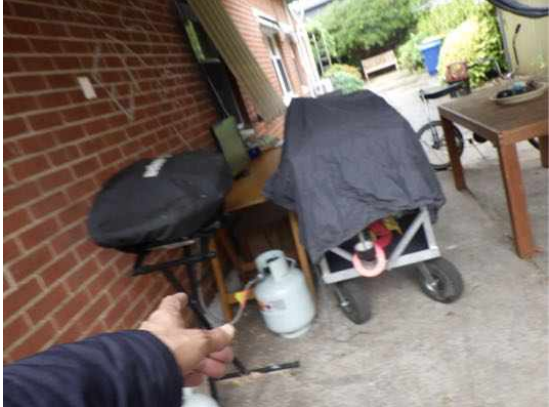
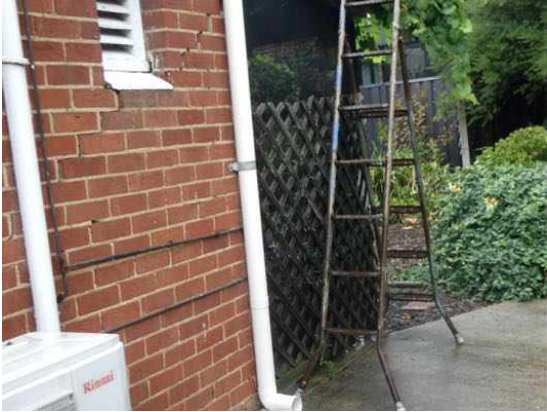
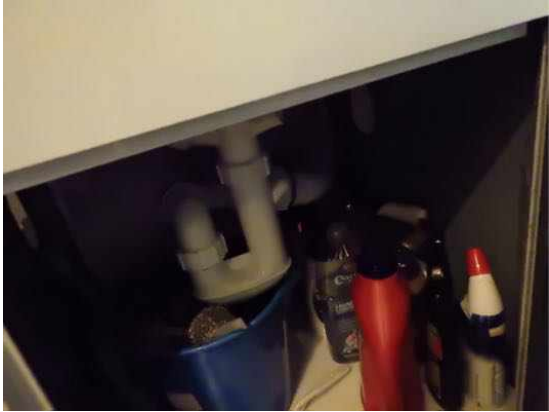
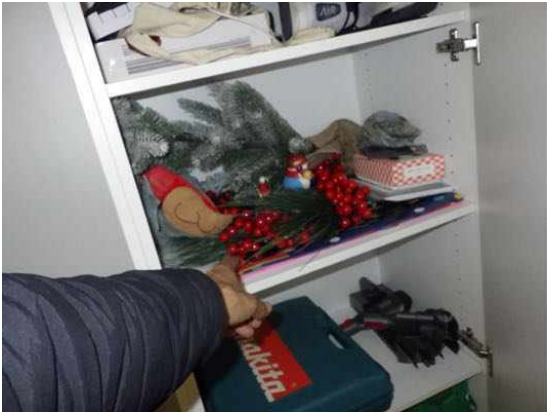
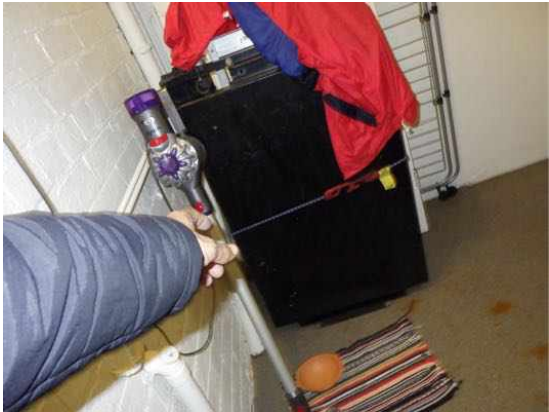
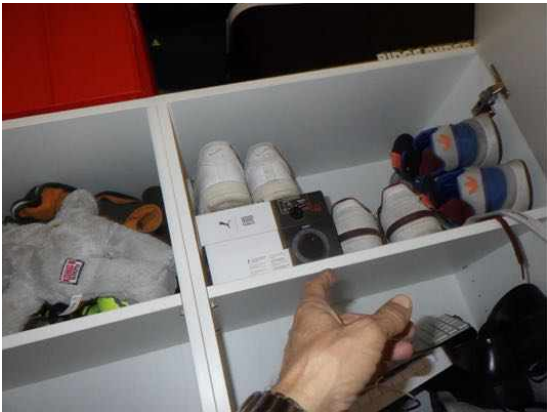
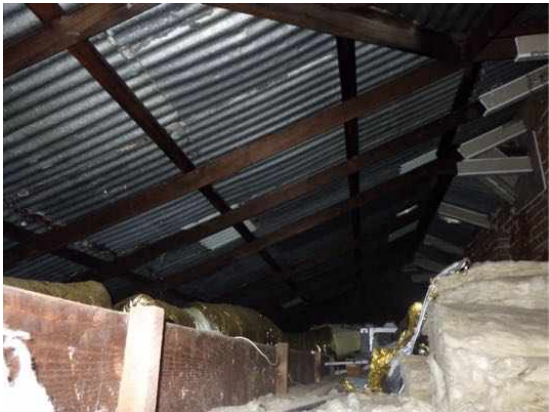
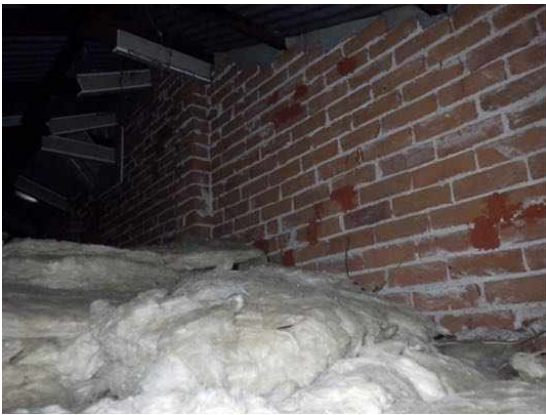
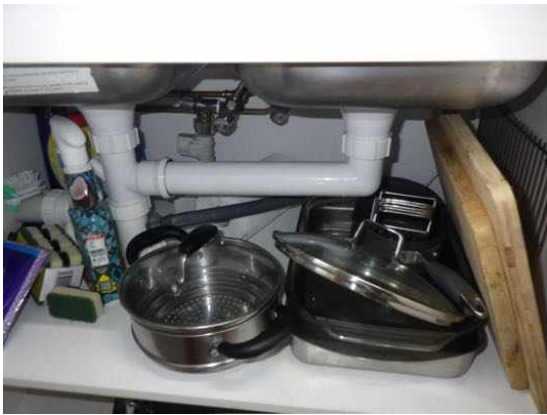
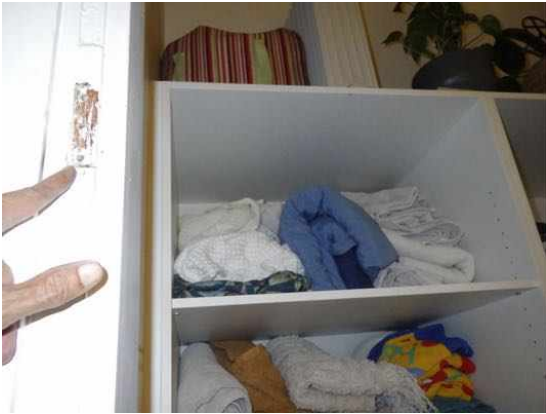
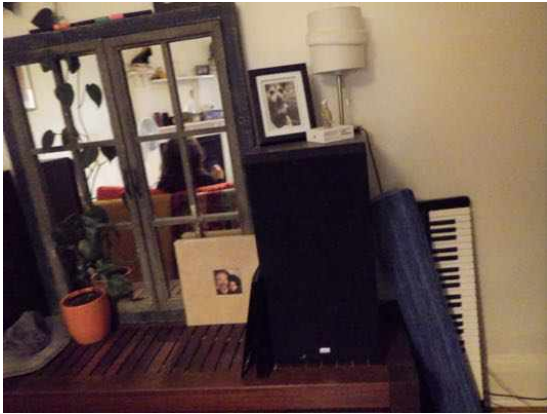
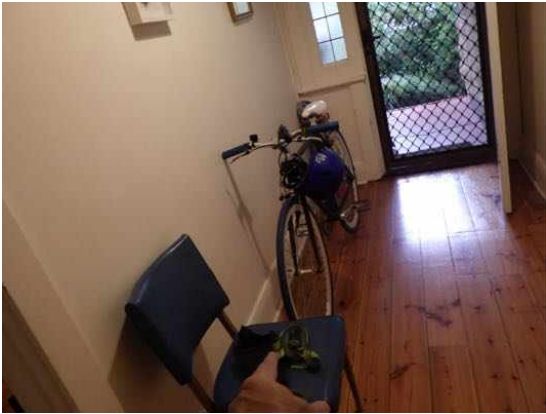
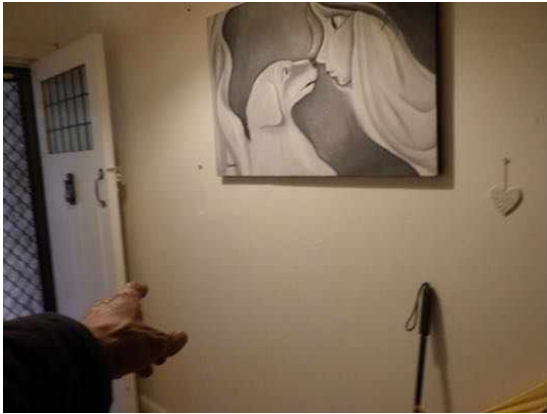
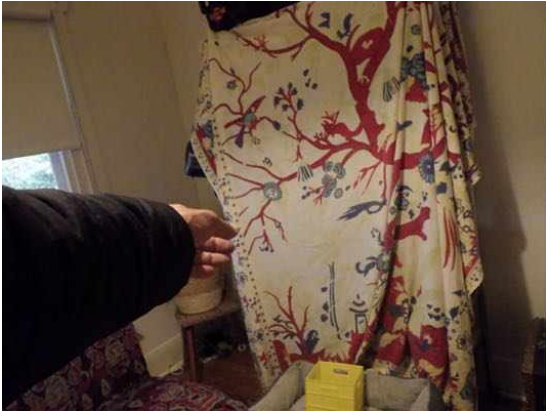
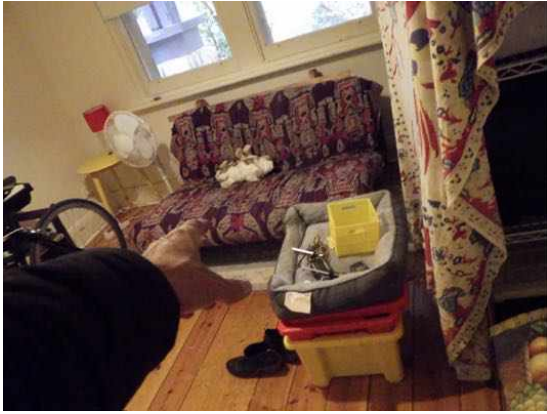
Building: Building 1
 Location: All Areas
 Finding: Additional Photos - Obstructions and Limitations
 Information: These photographs are an indication of the obstructions and limitations which impeded full inspection of the property at the time of inspection. These obstructions can hide an array of defects and should be removed to allow full inspection to be carried out. A re-inspection is recommended once the areas are made accessible.
