Building Inspection Report

Inspection Date: Thu, 9 Apr 2026

Property Address: 53 Mary St, Unley SA 5061, Australia

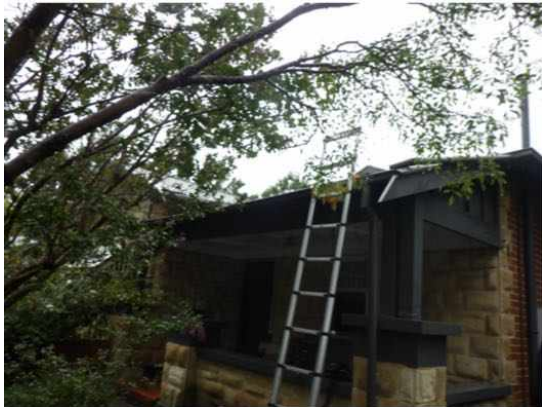
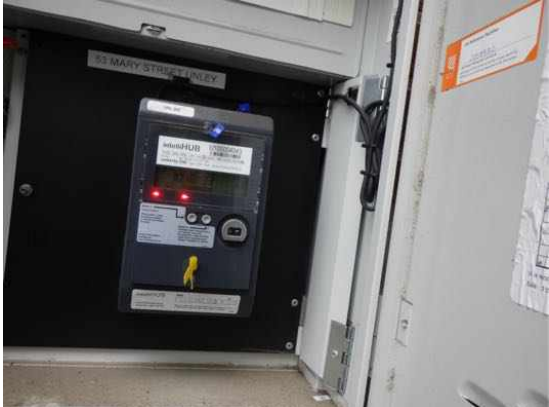
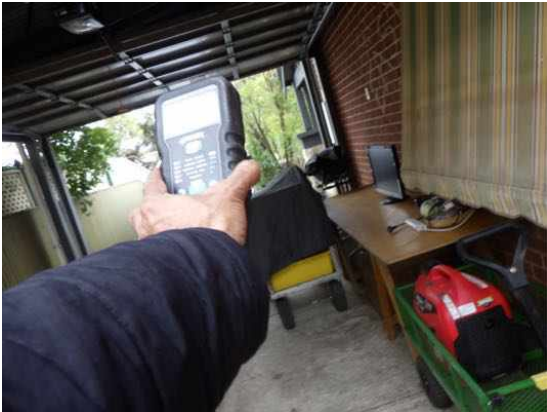
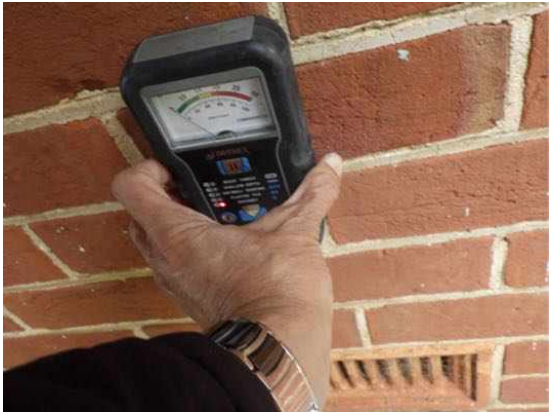
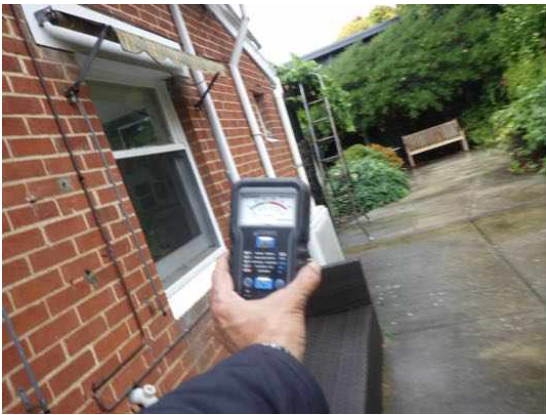
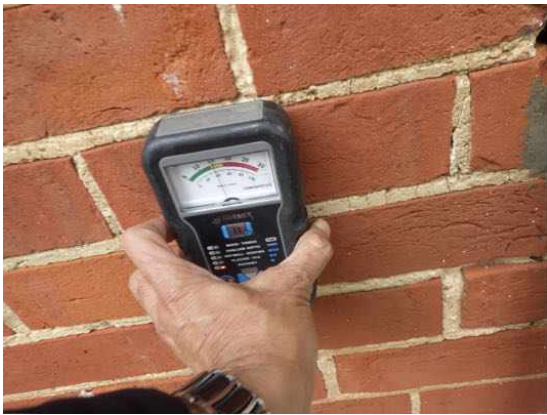
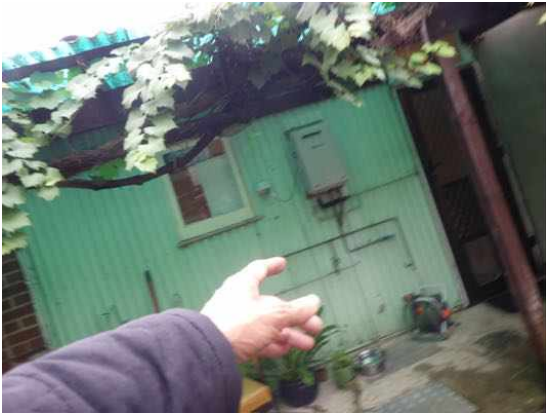
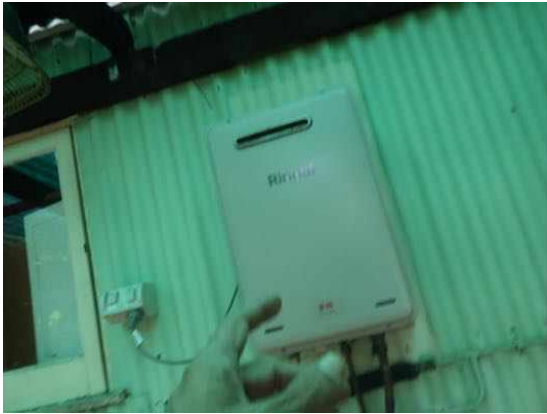
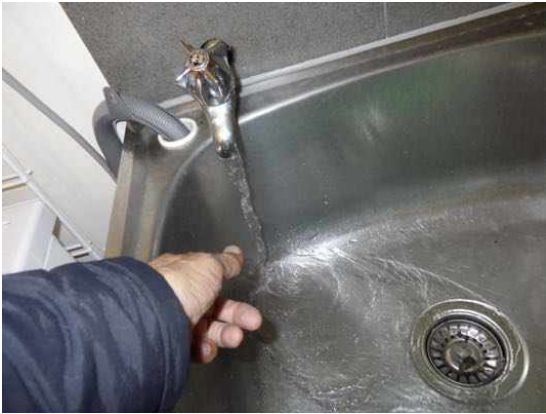
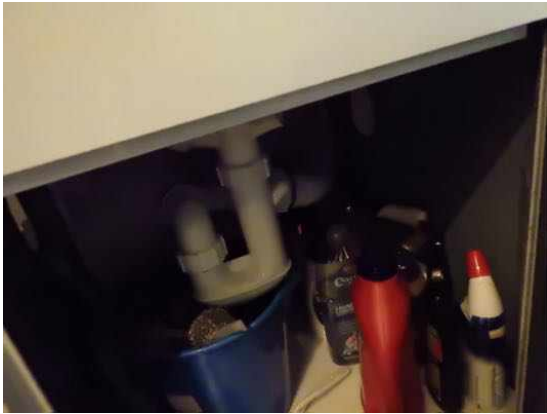
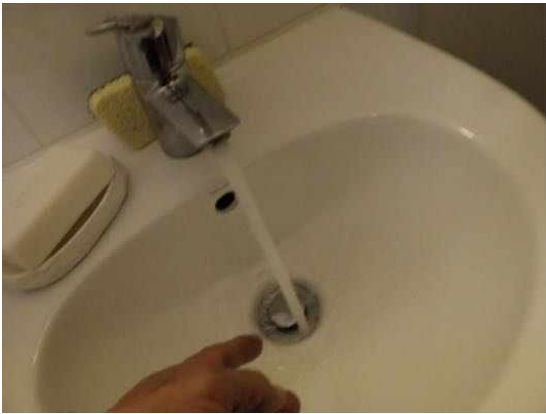
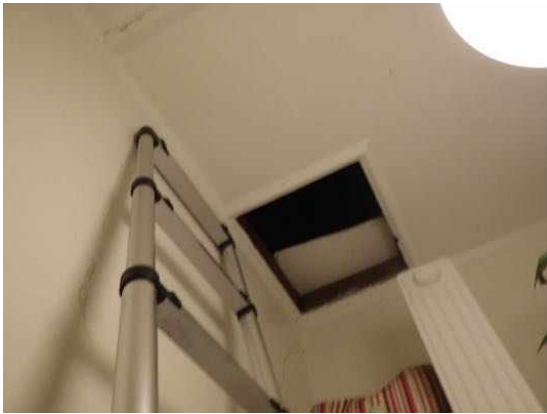
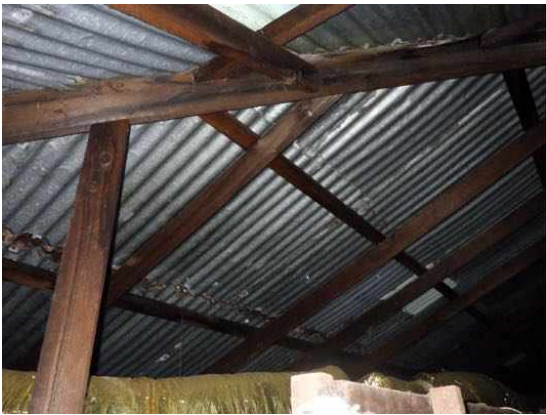
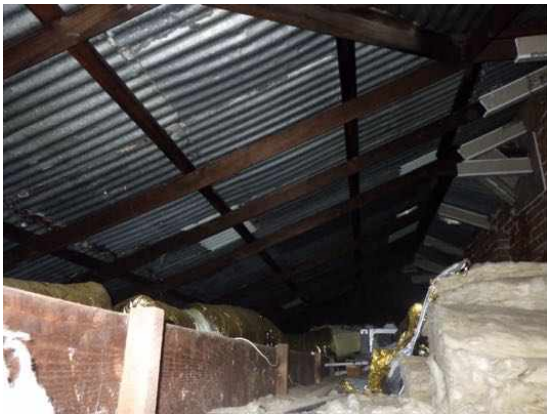
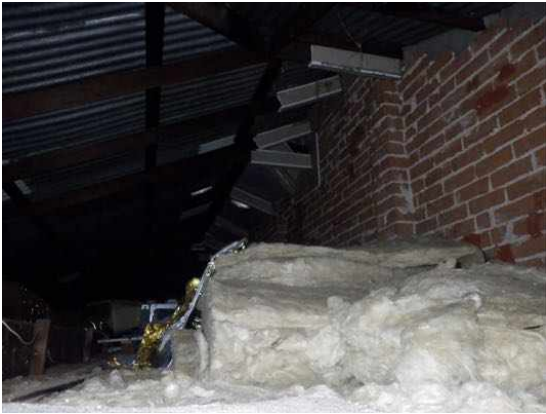
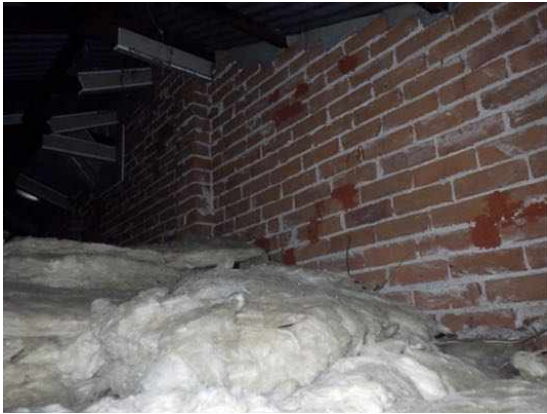
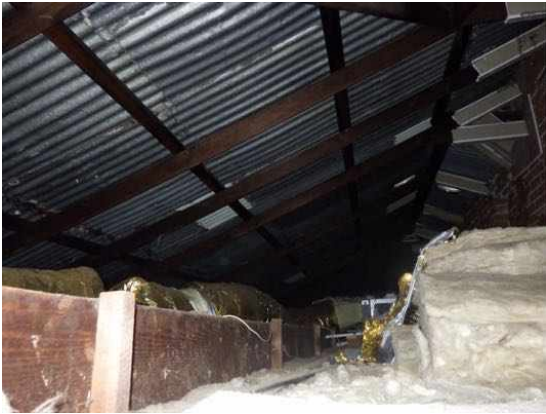
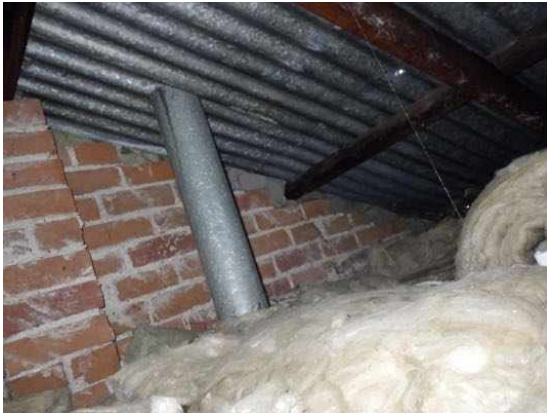
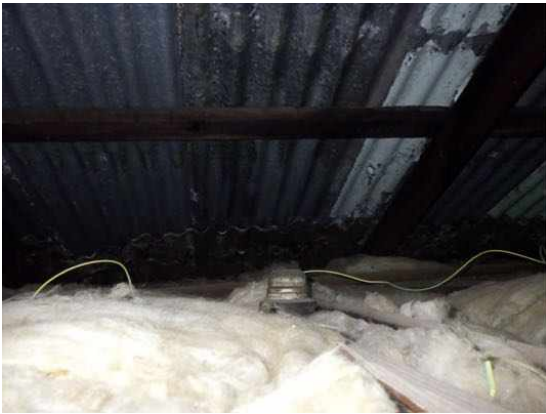
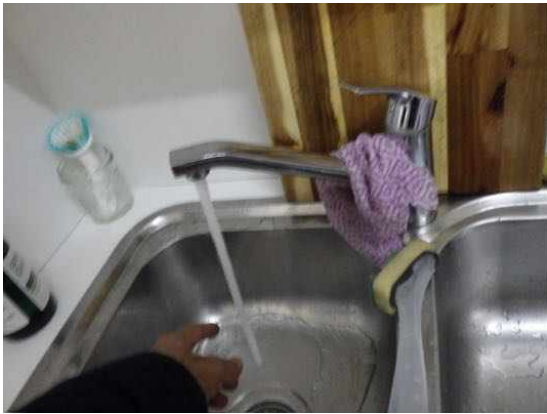
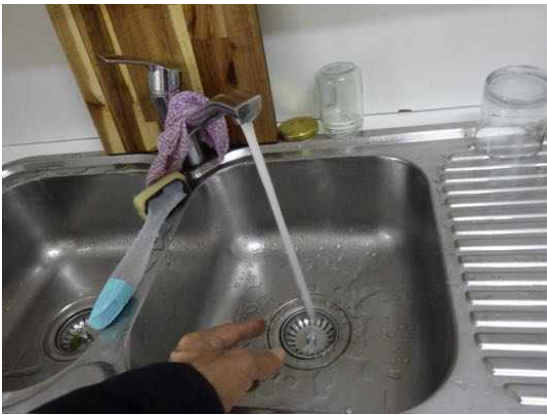
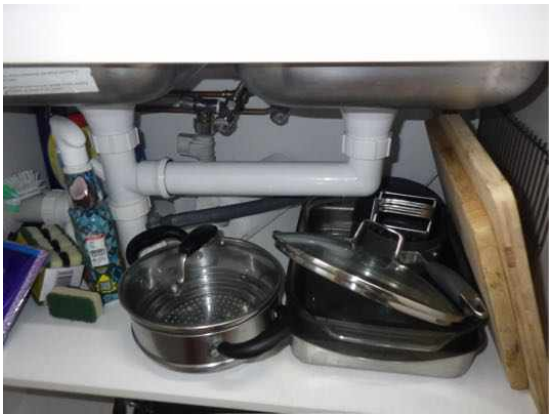
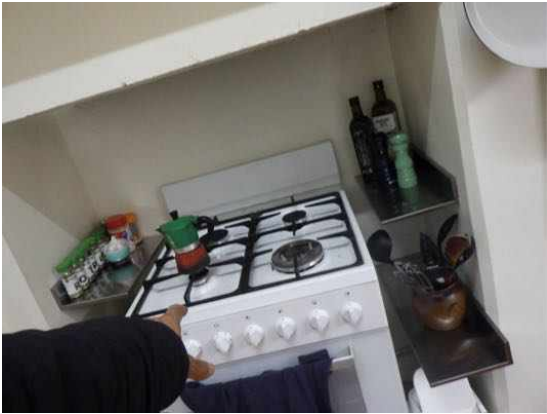
Building: Building 1
Location: All Areas
Finding: Additional Photos
Information: Additional photos are provided for your general reference
