## Building Inspection Report

Inspection Date: Wed, 1 Apr 2026

Property Address: 58 London St, Bentleigh VIC 3204, Australia

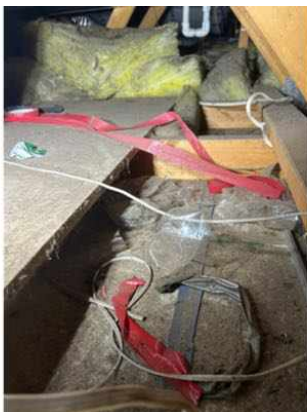
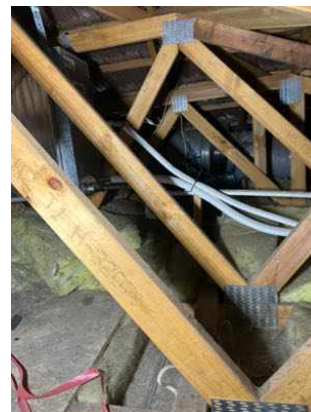
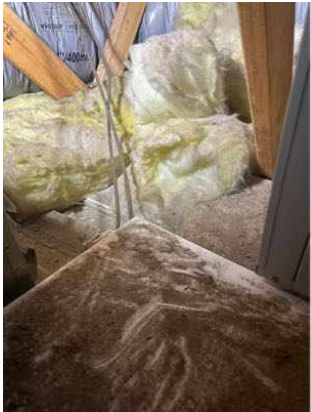
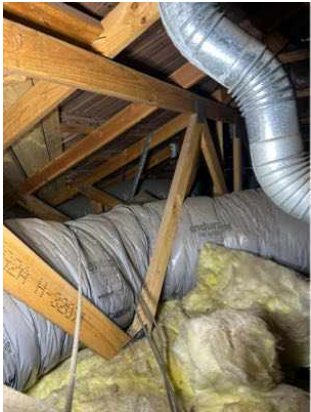
### Defects 3.11

Building:	Main Building
Location:	Roof Void
Finding:	Insulation - Inadequate
Information:	Upon inspection of the roof void it was noted that there is a lack of adequate insulation.

The level of insulation in the property does not meet current Australian Standards. Installation of adequate insulation is required and should be conducted as soon as possible.

Caution should be exercised when accessing the roof void. Do not attempt to stand on the framework to the underside of the trusses and be aware there is a potential for electric shock if contact is made with exposed or faulty electrical wiring.

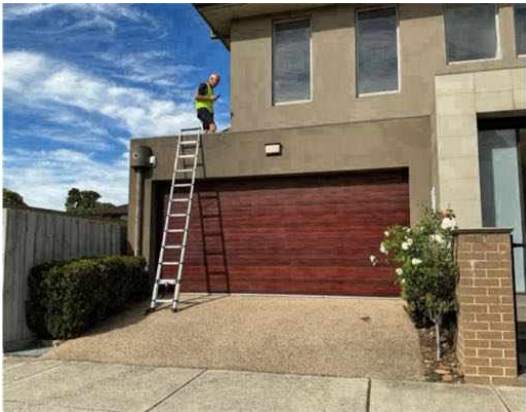
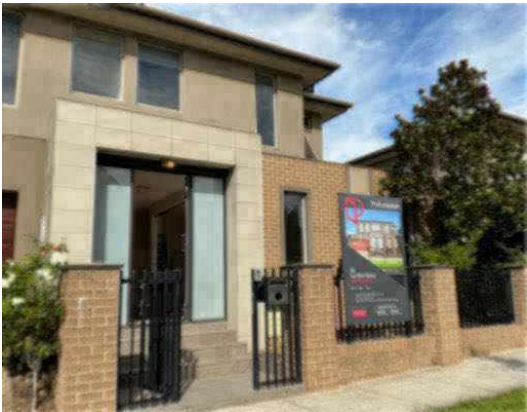
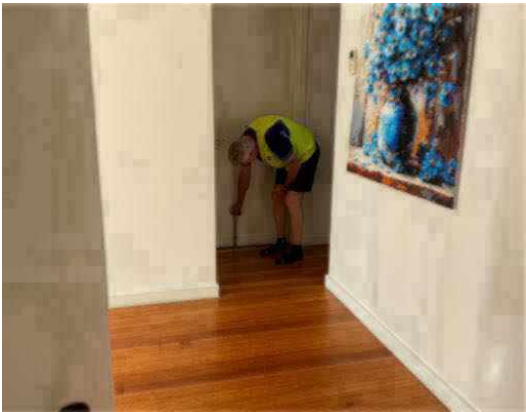
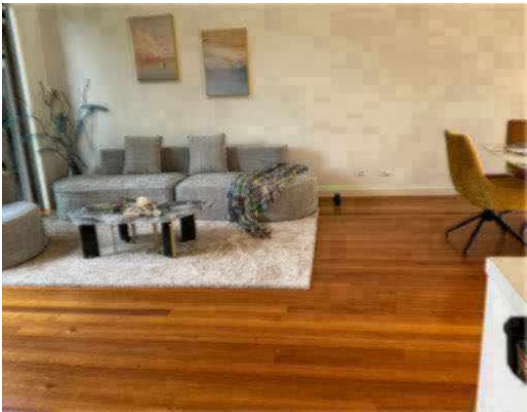
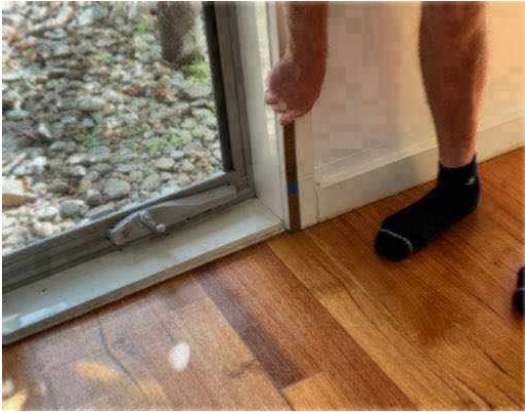
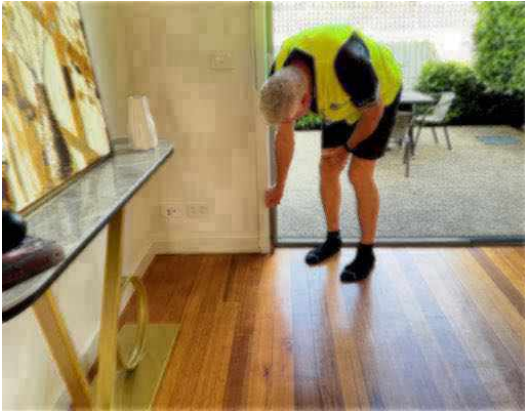
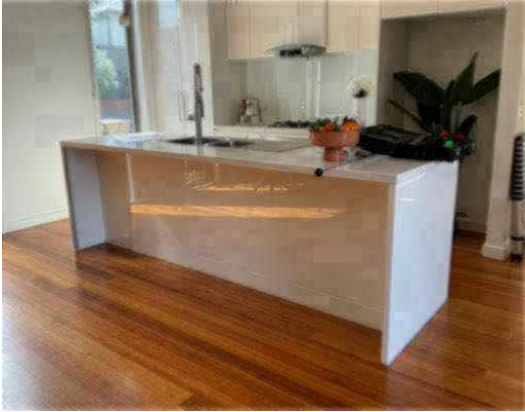
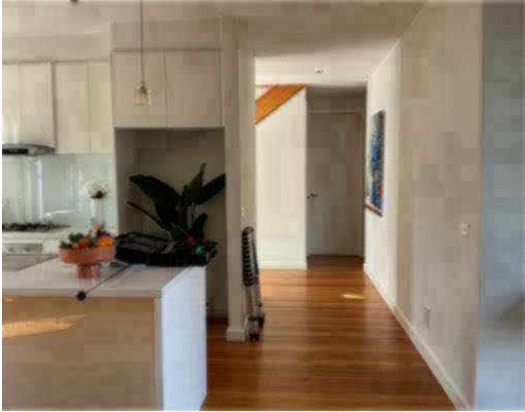
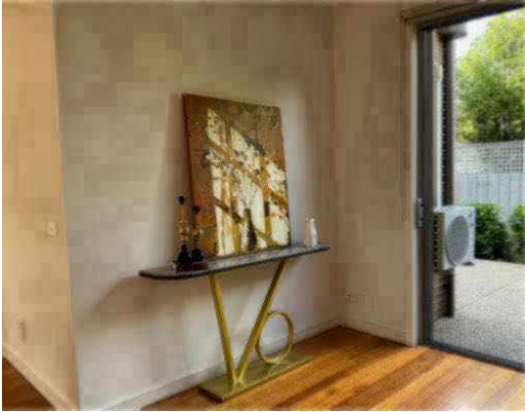
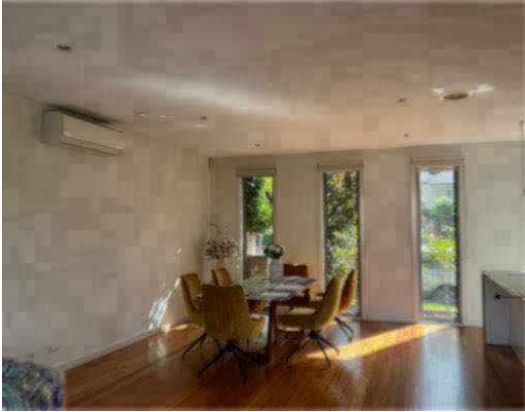
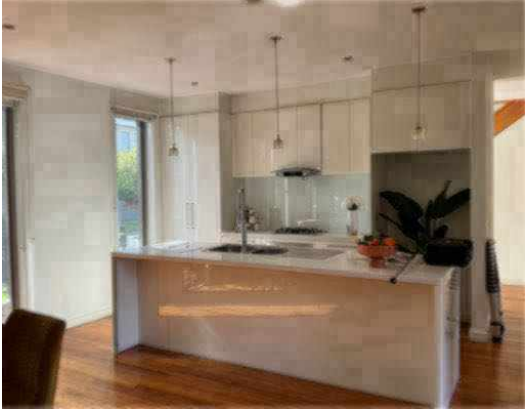
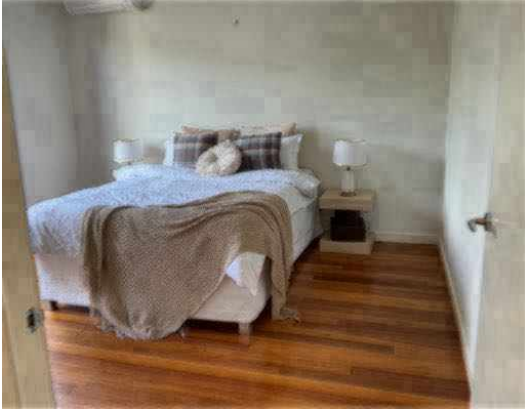
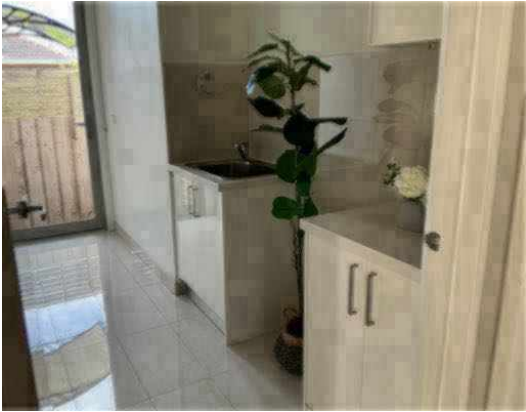
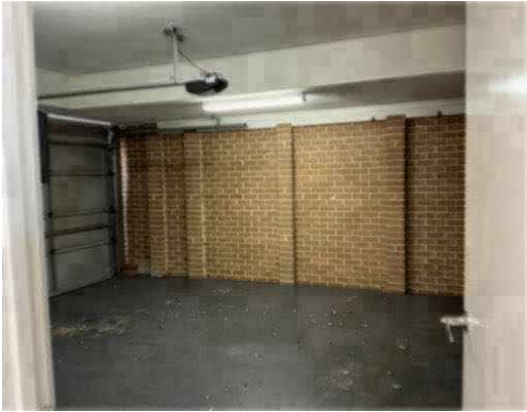
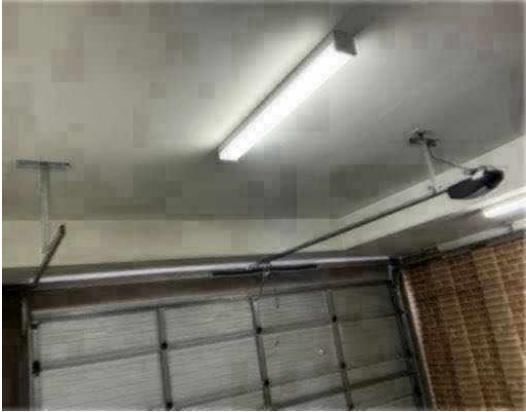
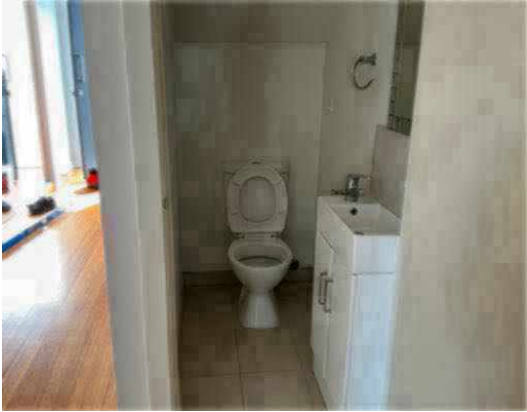
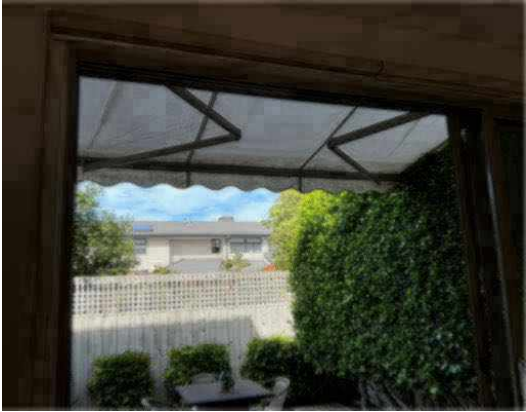
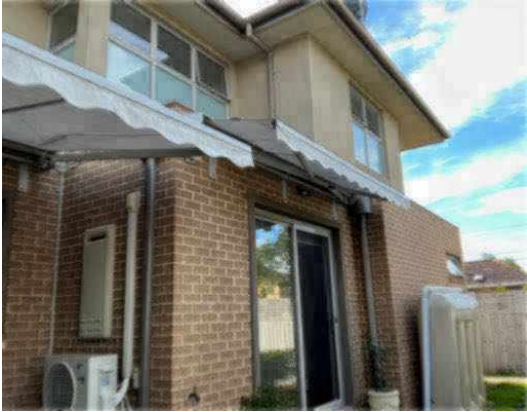
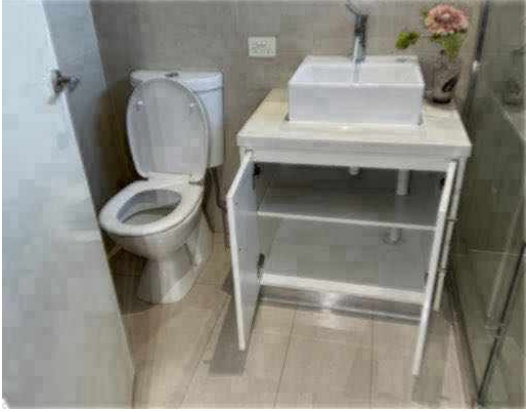
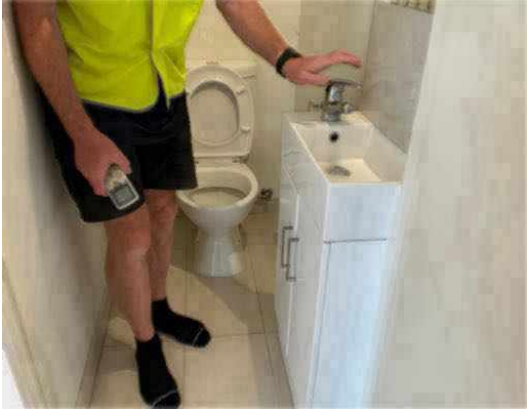
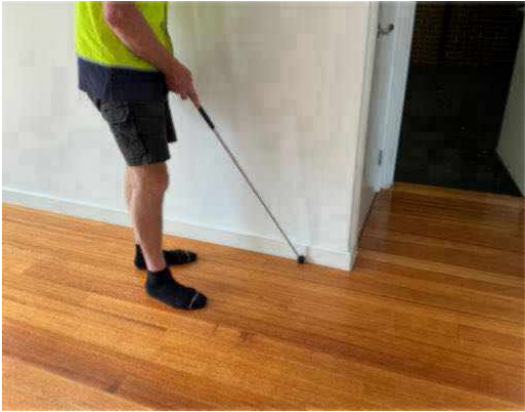
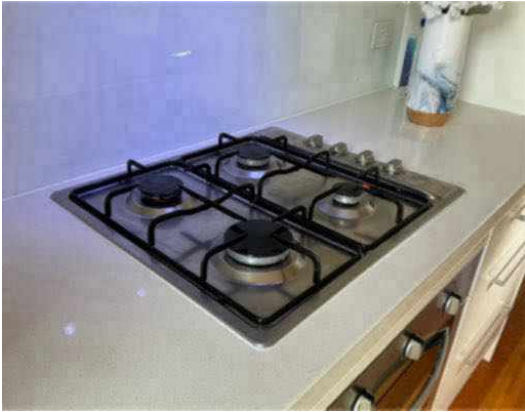
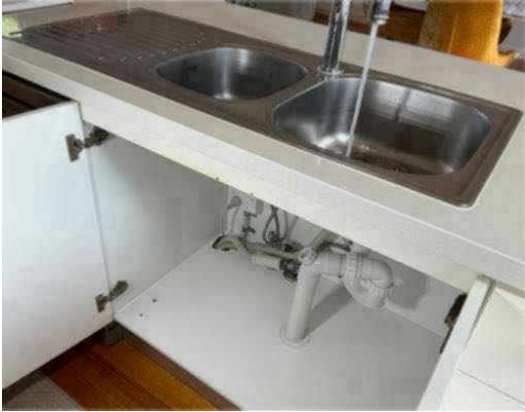
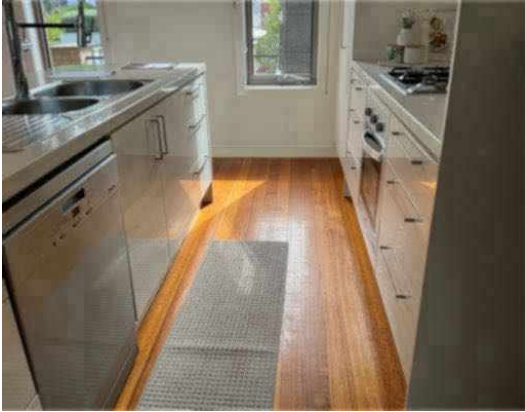
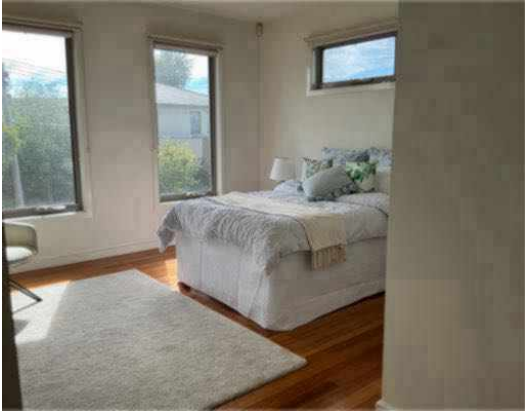
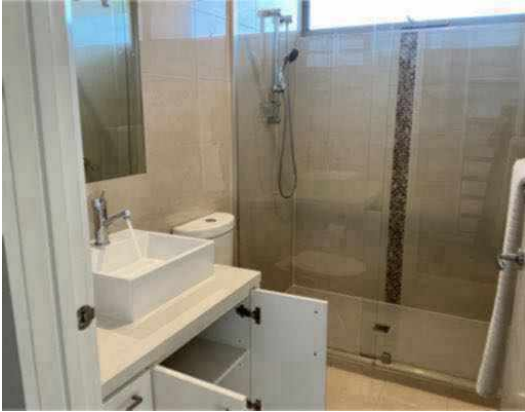
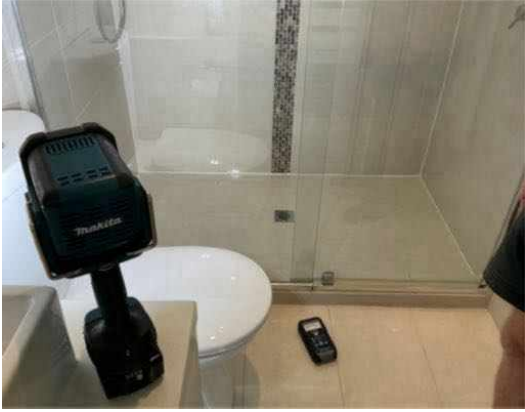
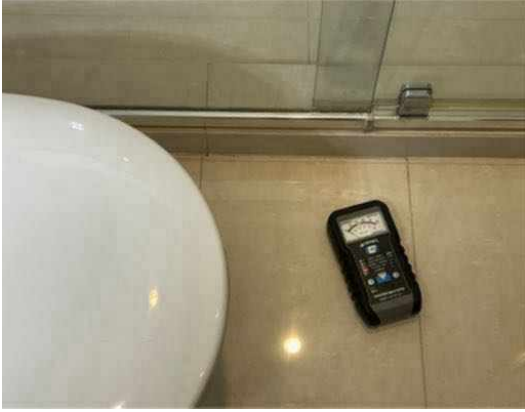
#### Noted Item

Building: Carport  
Location: All Areas  
Finding: Additional Photos and Obstructions and Limitations  
Information: These are additional photographs and photographs of the obstructions and limitations inside and outside (furniture, landscaping etc) which may impede full inspection of the property at the time of inspection. These obstructions can hide an array of defects and may be removed to allow full inspection to be carried out. A re-inspection may be made if clients require once the areas are made accessible.

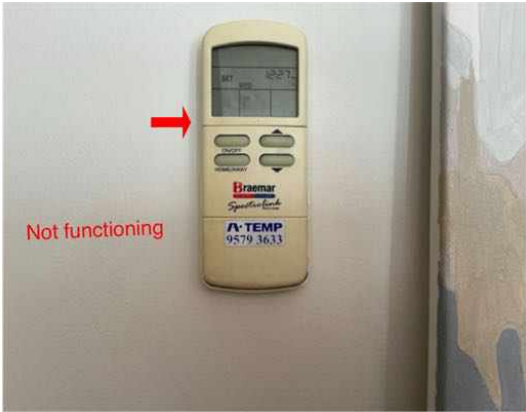
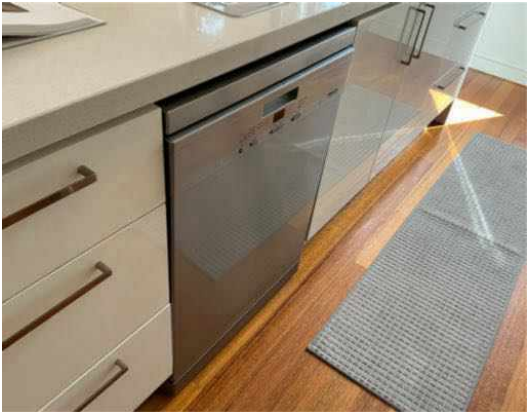
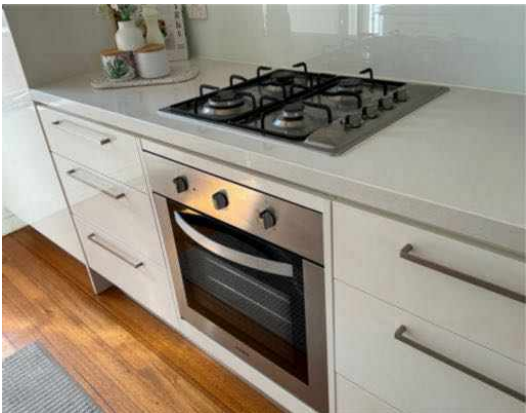
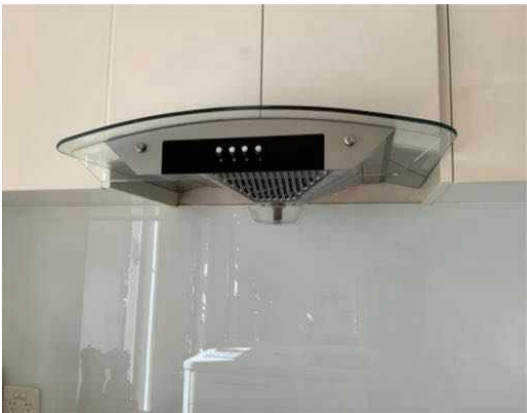
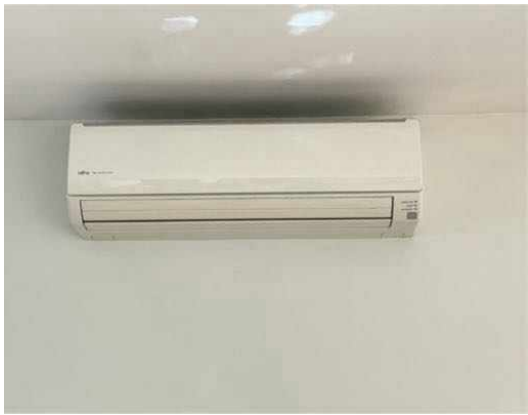
Building: Main Building  
 Location: All appliances  
 Finding: Warranty - Expired  
 Information: Where appliances are beyond their warranty period, the owner should be prepared to meet the cost of replacement or repair of the item at any time. The operation of the appliance can not be guaranteed and further inspection by an appropriately qualified tradesperson may be required.

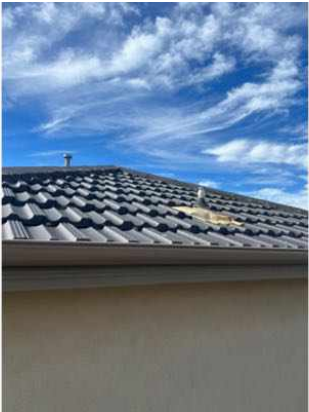
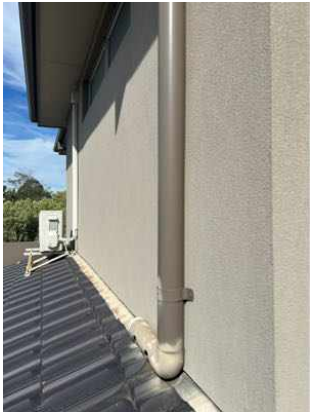
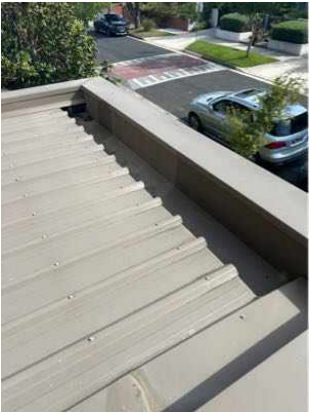
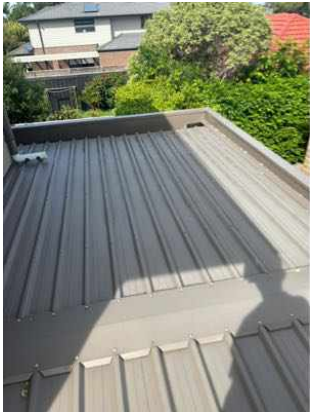
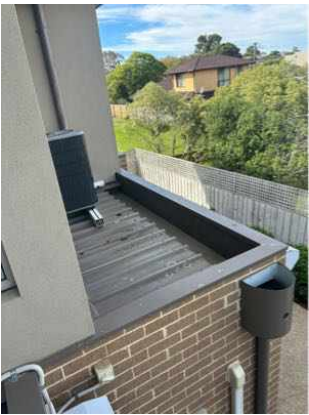
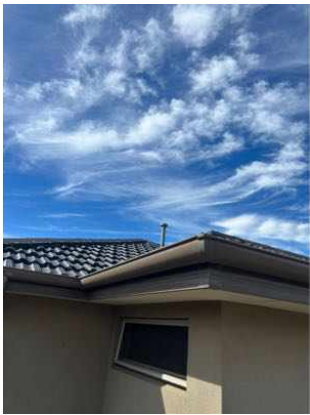
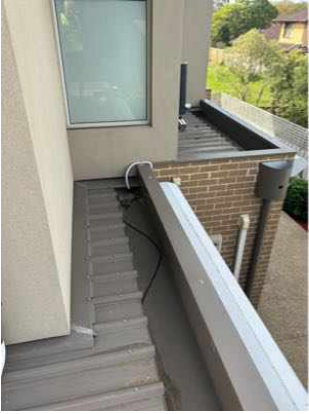
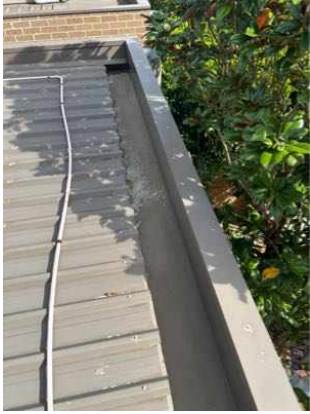
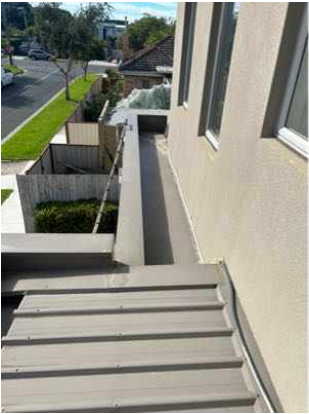
Building: Main Building  
Location: Roof Exterior  
Finding: Additional Photos  
Information: Additional photos are provided for your general reference
