Building Inspection Report

Inspection Date: Fri, 16 Jan 2026

Property Address: 58-60 Mariners Reef Rd, MARYBOROUGH,
VIC, 3465, Australia

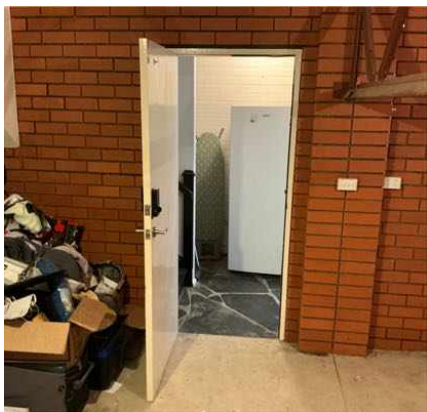
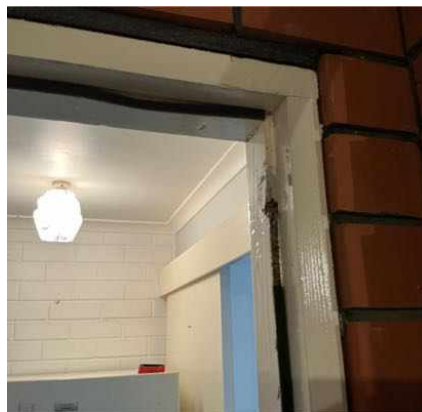
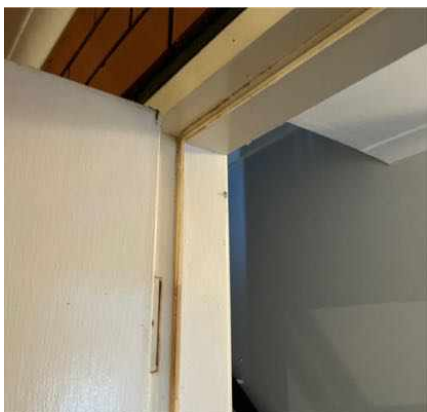
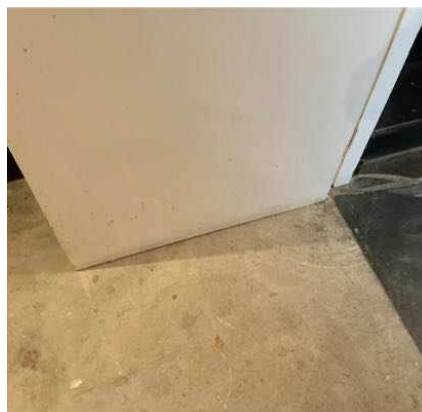
Defects 3.02

Building:	Main Building
Location:	All Internal Areas
Finding:	Missing or Damaged Door Stops
Information:	Several door stops were observed to be either missing or damaged throughout the property. Door stops serve a critical function in protecting walls, skirting boards, doors, and surrounding fixtures from impact damage caused by the door swinging too far.

- Risk of damage to walls, architraves, and door hardware due to uncontrolled door movement.
- Repetitive contact may result in indentations, chipped paint, or structural cracking.
- Reduced functionality and premature wear to doors and frames.

- Engage a qualified tradesperson or handyperson to install or replace door stops where required.
- Ensure the selected stops are appropriate for the type and swing of the door (e.g.

- Check nearby surfaces and door components for any damage already caused, and carry out repairs as needed.

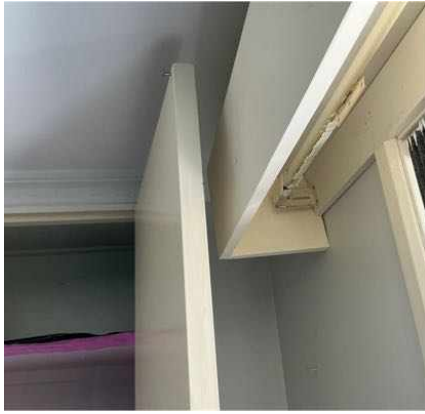
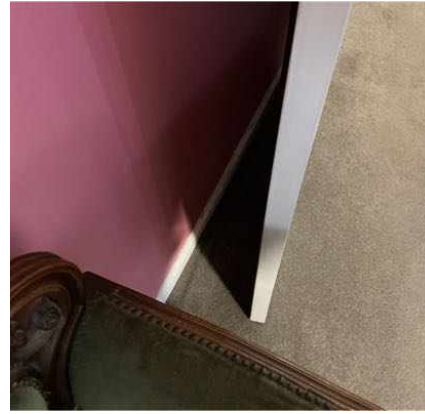
Defects 3.03

Building:	Main Building
Location:	Internal Areas
Finding:	Internal Doors Binding on Carpet
Information:	During the inspection, it was observed that one or more internal doors were binding at the base due to contact with the carpet. This condition restricts proper door operation and places undue pressure on the floor covering.

- Restricted door operation and reduced functionality.
- Increased risk of damage to carpet fibres and floor finishes.
- Potential for accelerated wear to door edges and door hardware.
- Reduced overall finish quality and usability of the affected areas.

This condition affects normal usability and finish quality and should be rectified to prevent ongoing damage and ensure proper door operation throughout the dwelling.

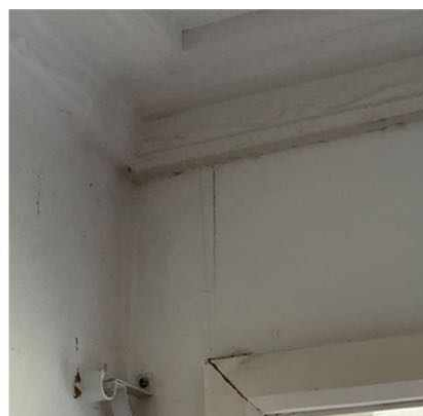
Defects 3.04

Building: Main Building
Location: Internal Areas
Finding: Cracking to Internal Wall Linings
Information: Cracking was observed to internal wall linings during the inspection. These types of cracks are generally considered common and are typically the result of natural building movement, age-related wear, thermal expansion and contraction, or minor installation-related issues in plasterboard or supporting framing members.

The cracking noted is typical of minor building movement and does not currently present as structural. Regular monitoring and cosmetic repair will assist in preserving the internal presentation and allow early intervention if future issues arise.

- Engage a qualified plasterer to repair cracks and consider installing expansion joints if necessary to accommodate ongoing building movement.
- Arrange for repainting by a qualified painter following any plaster repairs.
- Monitor cracks over time for signs of progression (e.g. widening, lengthening, or new cracks forming).
- If deterioration continues or operational issues with doors/windows arise, seek further assessment from a building inspector or structural engineer.

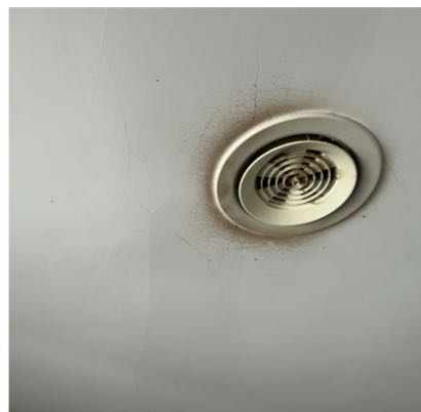
Defects 3.05

Building:	Main Building
Location:	Entry
Finding:	Cracking and Staining to Ceiling Finishes Adjacent to Heating Duct
Information:	At the time of inspection, cracking to the ceiling lining and paint finish was observed in the vicinity of the heating duct within the entry area. Localised brown discolouration and staining were also present around the duct penetration. The cracking appears to radiate from and around the duct opening, indicating movement, thermal expansion, or moisture-related stress to the ceiling lining at this location.

- The cracking indicates ongoing movement or stress to the ceiling lining, which may continue to worsen over time.
- The staining suggests possible past or current moisture presence, condensation, or air leakage around the duct penetration.
- If moisture is present, there is an increased risk of ceiling lining deterioration, mould growth, and hidden damage to framing or insulation.
- The condition reduces the overall presentation of the entry area and may indicate broader performance issues with duct sealing or roof space moisture control.

In summary, the cracking and staining around the heating duct indicate ceiling lining distress and possible moisture or air leakage concerns, and rectification is recommended to prevent further deterioration and restore the ceiling to a stable and durable condition.

- The duct penetration should be inspected to confirm whether moisture, condensation, or air leakage is occurring.
- Any gaps around the duct should be properly sealed to prevent air and moisture transfer.
- The affected ceiling area should be repaired by a qualified tradesperson, including stabilising the substrate, re-finishing, and repainting.

- If moisture is confirmed, further investigation of roof space ventilation, insulation, and duct insulation may be required.

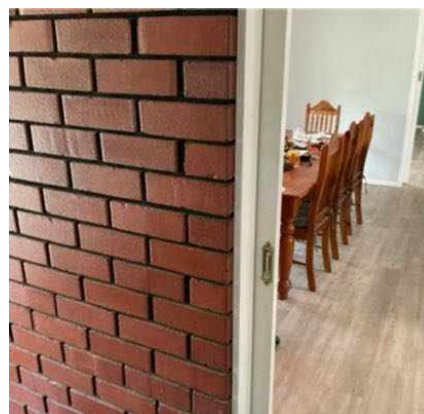
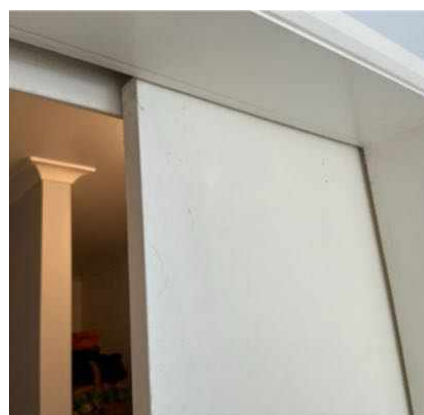
Defects 3.06

Building:	Main Building
Location:	Dining Room & Laundry
Finding:	Internal Sliding Door - Stiff
Information:	During the inspection, one or more internal sliding doors were noted to operate stiffly or not slide smoothly along their tracks. This condition is commonly caused by minor misalignment, debris accumulation within the tracks, or deterioration of rollers and fittings over time.

- Reduced ease of use and impaired door functionality.
- Increased wear to door tracks, rollers, or fittings if left unaddressed.
- Possible difficulty achieving full closure, affecting privacy or security.

- Clean and inspect the upper and lower tracks to remove dust or debris.
- Lubricate all moving components to improve operation.
- Engage a qualified carpenter or handyman to adjust, realign, or replace worn rollers and fittings as required.

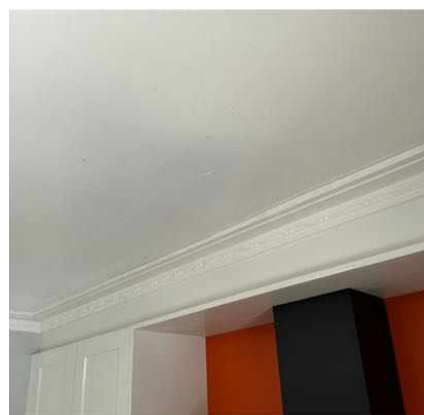
Defects 3.07

This type of ceiling deformation is commonly seen in areas where ceiling spans are wide or exposed to environmental movement and should be addressed to maintain finish quality and prevent future damage.

- Rectify the sag by reinforcing or adjusting ceiling support as necessary and reattaching or replacing the affected cornice.
- Monitor the area for signs of worsening sag or plaster cracking if immediate repair is not undertaken.

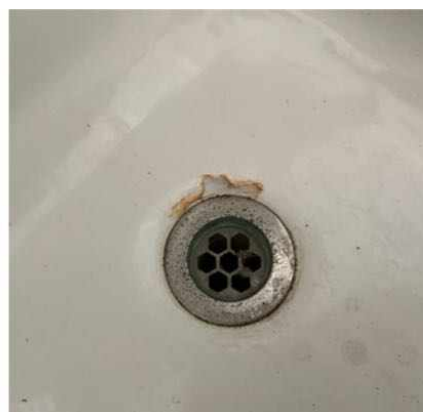
In summary, the peeling enamel around the bath waste area represents an active deterioration issue that will continue to worsen if not addressed, and rectification is recommended to restore durability, hygiene, and functional performance.

- A qualified bathroom or resurfacing contractor should assess the bathtub to determine whether professional re-enamelling or replacement is required.
- Any loose or unstable enamel should be removed prior to repair to prevent ongoing failure of the surrounding coating.
- The area should be restored to a smooth, sealed, and waterproof finish suitable for wet-area use.

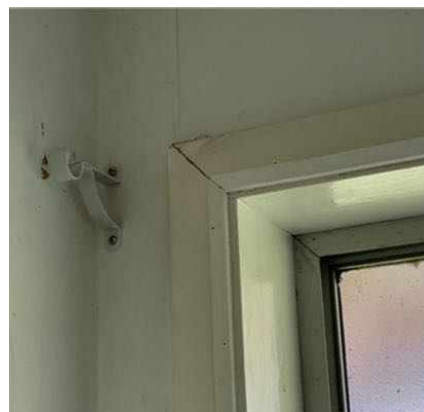
Defects 3.11

Building:	Main Building
Location:	Bathroom
Finding:	Cracking to Painted Architraves and Skirting Boards
Information:	Cracks were observed opening up in various sections of the painted architraves and skirting boards. These cracks may be associated with minor building movement, timber shrinkage, or inadequate surface preparation prior to painting.

This condition is not uncommon following recent painting, particularly in timber joinery, and is typically considered a maintenance item unless associated with significant structural movement.

- Engage a qualified painter or builder to assess the extent of cracking and undertake necessary repairs, which may include filling, sanding, and repainting affected areas.
- Monitor for any signs of worsening or recurring movement over time.

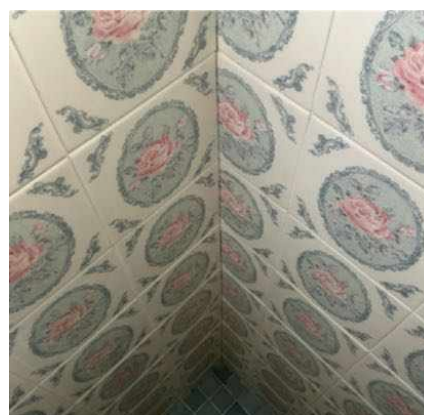
Defects 3.12

Building:	Main Building
Location:	Shower
Finding:	Missing Sealant to Shower Intersection Joints
Information:	At the time of inspection, it was observed that the shower intersection joints (including wall-to-wall and wall-to-floor junctions) have not been sealed with flexible waterproof sealant. Although this installation method was commonly accepted at the time the dwelling was constructed, it does not align with current best practice for wet area detailing. The absence of sealant leaves these junctions vulnerable to water penetration during normal shower use.

In summary, the absence of caulking to the shower intersection joints represents an increased risk of concealed water ingress and progressive damage, and rectification is recommended to improve moisture control, durability, and long-term performance of the wet area.

- A licensed bathroom contractor should assess the shower area for evidence of moisture ingress or waterproofing compromise.
- All intersection joints should be professionally cleaned, dried, and sealed using a suitable flexible waterproof sealant designed for wet areas.
- If moisture damage is identified, further investigation of the underlying waterproofing system may be required.

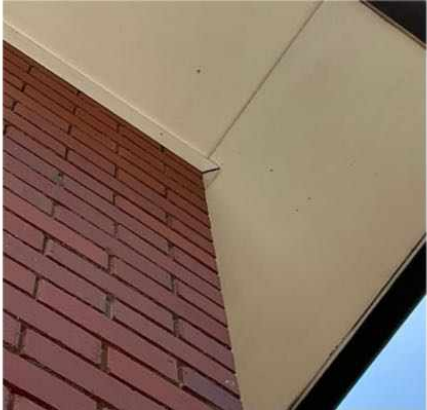
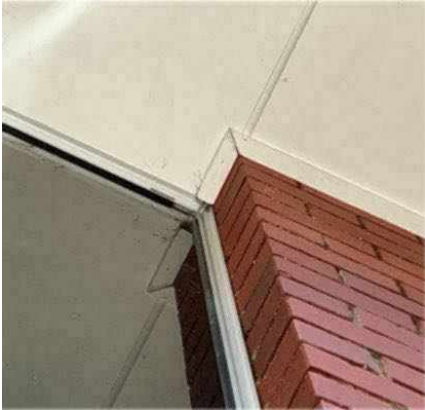
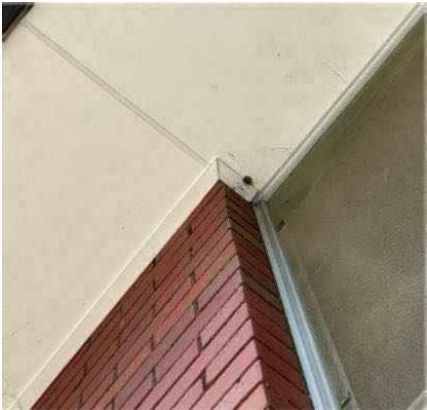
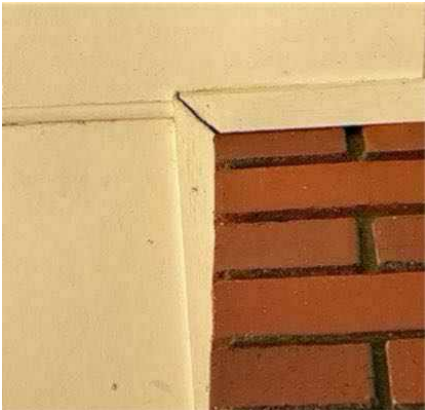
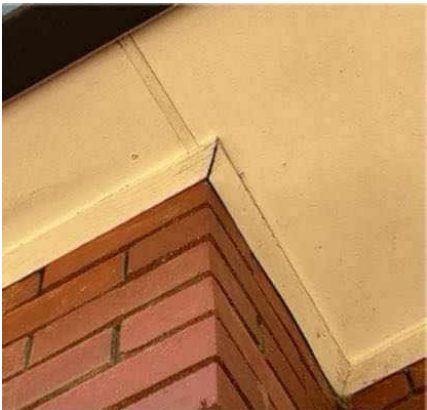
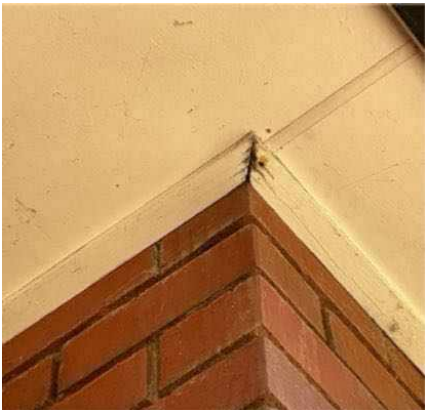
Defects 3.13

Building:	Main Building
Location:	All External Areas
Finding:	Cracking and Separation of Timber Quad Moldings at Eaves
Information:	During the inspection, cracking and separation was noted at the mitre joints of timber quad moldings installed around the eaves in multiple locations. This condition is common in aging properties and is typically associated with natural movement and environmental exposure over time.

The separation observed is consistent with typical age-related wear and environmental exposure, and is considered a maintenance item rather than a structural concern. Prompt attention will help prevent moisture-related deterioration and preserve the external appearance of the property.

- Repaint affected areas with a high-quality, weatherproof coating to protect from further weathering.
- Monitor repaired areas as part of routine exterior maintenance, particularly following seasonal changes or heavy rain events.

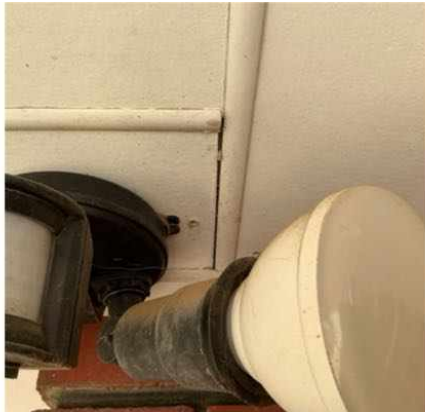
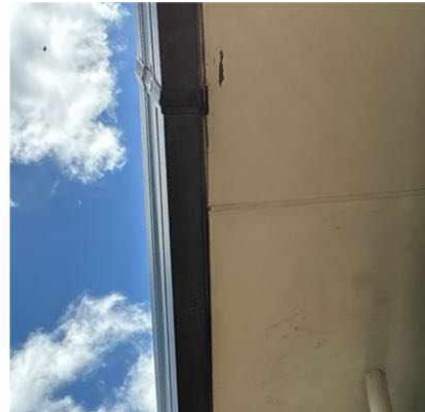
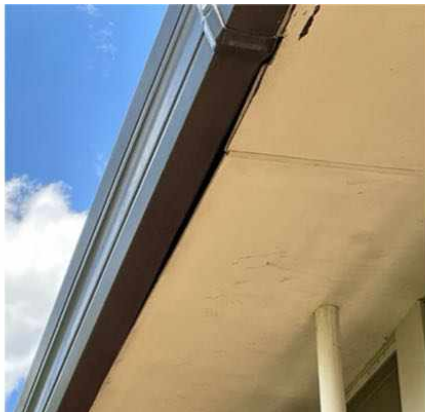
Defects 3.14

In summary, the separation of the eave lining from the joining strips and gutter/fascia represents a progressive durability and weather-resistance defect that will continue to worsen if left unaddressed, and rectification is recommended to restore enclosure integrity, protect the roof space, and maintain the long-term performance of the building envelope.

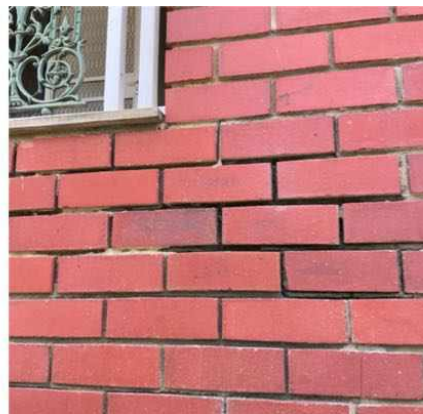
Defects 3.15

Building:	Main Building
Location:	Facade Near Garage
Finding:	Deteriorated Mortar Bedding to Brickwork
Information:	During the inspection, sections of mortar bedding to the brickwork were observed to be deteriorated in various areas. Mortar plays a critical role in bonding bricks together, maintaining wall stability, and providing a weather-resistant seal against moisture ingress. The level of deterioration observed is generally consistent with the age and construction type of the dwelling; however, it still represents a material defect that requires maintenance.

In summary, while the mortar deterioration is consistent with the age of the dwelling, it represents a progressive maintenance defect that will continue to worsen if not addressed, and rectification is recommended to preserve the structural integrity, durability, and long-term performance of the masonry walls.

- A qualified bricklayer should be engaged to carry out repointing to all affected areas by removing loose or deteriorated mortar and replacing it with compatible mortar.
- If deterioration is widespread or located in elevated or difficult-to-access areas, a registered builder should be engaged to manage the rectification works.
- Where brick displacement, significant cracking, or wall distortion is observed, a structural engineer should be consulted to assess potential underlying movement.
- Contributing moisture sources, including drainage, roof drainage systems, and flashing details, should be reviewed and improved where required to reduce future deterioration.
- Ongoing periodic inspection and maintenance of brickwork should be undertaken to prevent recurrence.

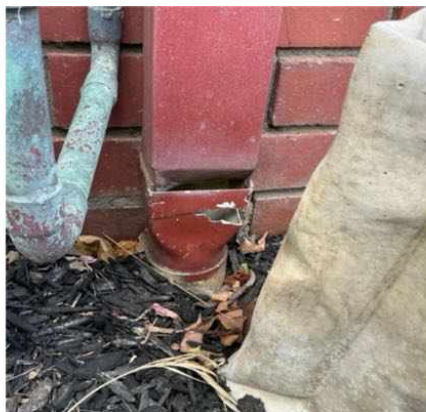
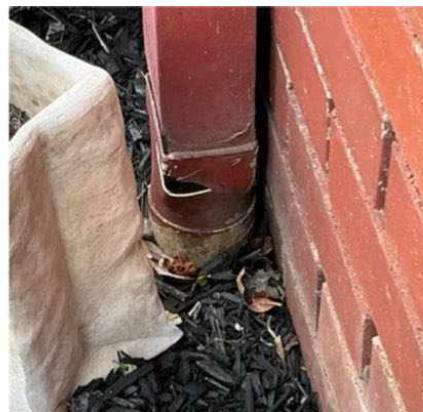
In summary, one or more downpipes were not properly connected to the stormwater system. Rectification is recommended to ensure rainwater is discharged effectively and to prevent potential moisture-related issues around the dwelling.

- Engage a licensed plumber to extend all affected downpipes and ensure proper connection to the stormwater system.
- Confirm system performance during rainfall to verify that stormwater is being effectively discharged away from the structure.
- Monitor surrounding areas for signs of pooling, erosion, or excess moisture following rectification.

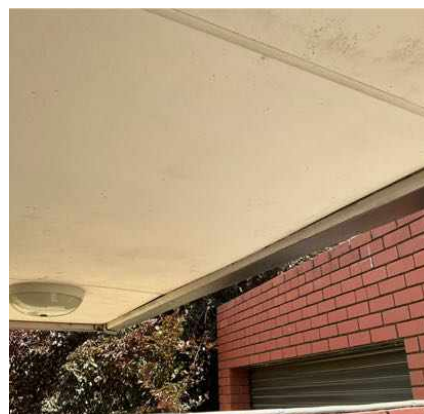
Defects 3.19

The observed sagging and makeshift fixing of the eave sheets indicate material degradation and improper support, which is consistent with age-related wear in older properties. These conditions present both visual and functional issues that, if left unaddressed, may worsen over time. Prompt attention from a qualified tradesperson is recommended to restore the integrity of the eave structures and prevent further deterioration or associated damage.

- Engage a suitably qualified carpenter or handyperson to inspect and secure or replace the affected eave sheets.
- Assess the condition of the underlying fascia boards and roof framing to identify any structural deterioration or rot.
- Review the condition and functionality of the guttering system to ensure it is not contributing to water damage in eave areas.
- Ensure all eave linings are adequately supported and fixed in accordance with current construction standards.
- Consider repainting or resealing the eaves once repaired to improve durability and visual presentation.

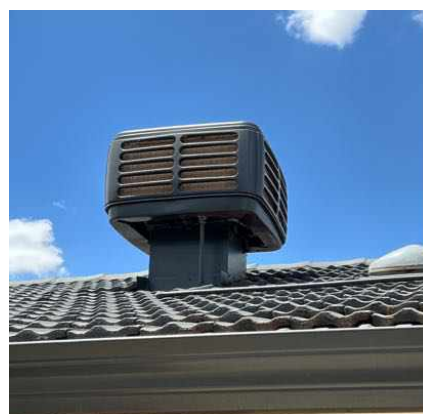
Defects 3.20

Building:	Main Building
Location:	Roof Exterior
Finding:	Evaporative Cooler Overflow Discharging Into Sanitary Vent
Information:	At the time of inspection, the roof-mounted evaporative cooling system was observed to have its overflow pipe connected into a vertical sanitary vent pipe. Based on the visible pipe configuration, the overflow discharge appears to enter the sanitary plumbing system rather than being directed to a stormwater or approved external discharge point.

In summary, the evaporative cooler overflow appears to discharge into a sanitary vent pipe, which is not considered best practice and may represent a plumbing compliance and hygiene concern. Rectification is recommended to ensure correct discharge, prevent cross-contamination, and maintain safe system operation.

- A licensed plumber should confirm the termination point of the evaporative cooler overflow pipe
- The overflow should be redirected to an approved stormwater discharge point with an appropriate air gap
- Any direct sanitary connections should be removed and made compliant
- The cooling system should be checked for internal contamination or odour issues if this configuration has been in place long-term

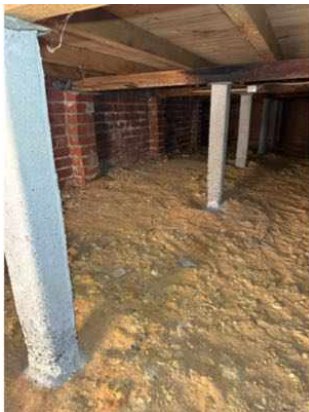
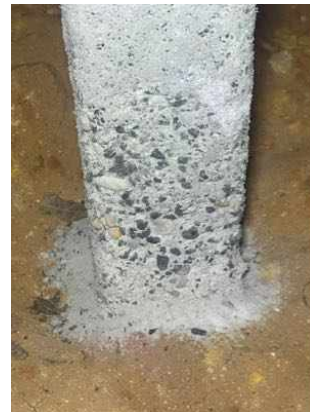
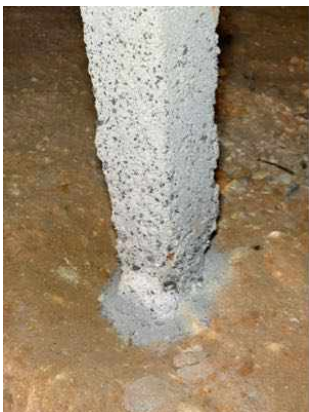
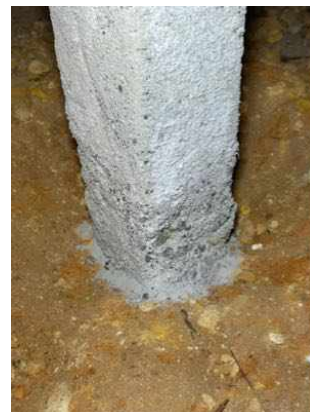
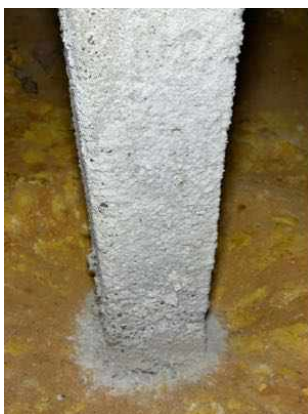
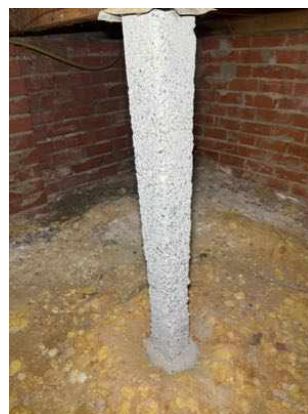
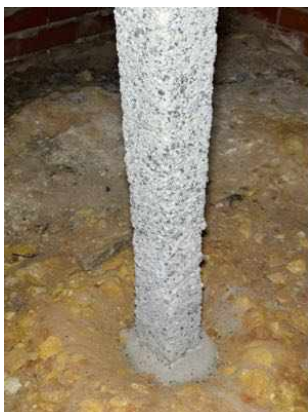
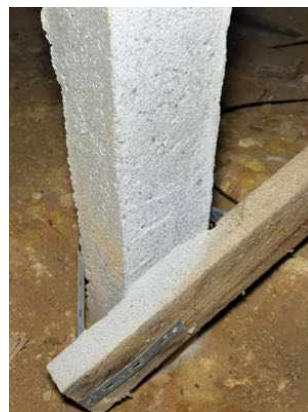
Defects 3.22

In summary, the observed concrete stump deterioration at the ground interface represents a significant durability concern that may compromise long-term structural performance if not addressed.

- A licensed structural engineer or qualified building professional should assess the structural adequacy of the affected stumps.
- Subfloor drainage and ventilation should be reviewed to reduce ongoing moisture exposure.
- Allow for potential stump remediation or replacement works when considering future maintenance or purchase negotiations.

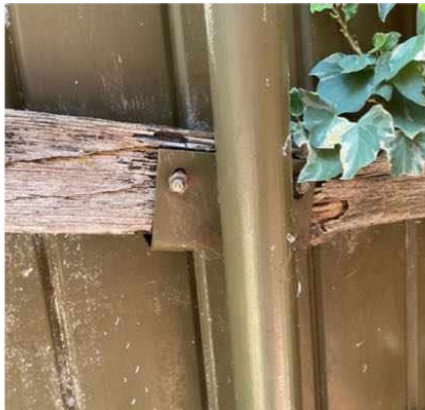
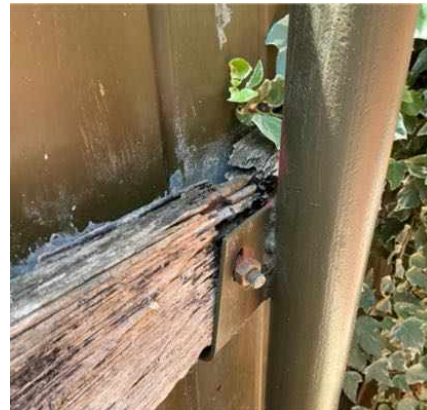
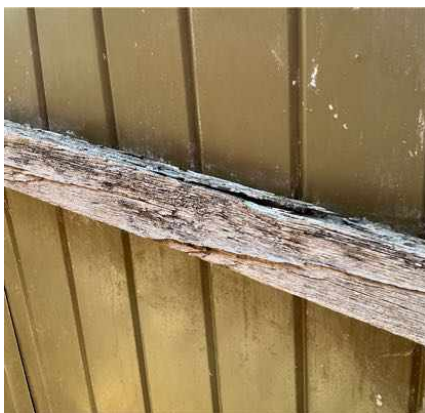
Defects 3.23

Building:	Main Building
Location:	Right-hand Fence
Finding:	Deteriorated Timber Railings with Timber Decay
Information:	The timber railings were observed to be in a deteriorated condition, with multiple defects including failed joints at rail connections, general misalignment, and visible timber decay. Sections of the railings display surface breakdown, softening, and loss of section, consistent with prolonged moisture exposure and lack of ongoing maintenance. In some areas, the railings no longer appear to provide reliable structural performance or effective containment.

- Reduced structural stability of the railing system
- Timber decay further compromises strength and long-term durability
- Increased safety risk where the railings are relied upon as a barrier or support
- Favourable conditions for termite activity and continued biological deterioration
- Negative impact on property presentation and perceived condition
- Ongoing deterioration may result in higher future repair or replacement costs

The observed deterioration and timber decay to the timber railings should be addressed to reinstate structural function, improve safety, enhance appearance, and prevent continued degradation of the railing system.

- Engage a qualified carpenter or builder to assess the condition and extent of timber decay within the railings
- Remove and replace all decayed and structurally compromised railing members
- Reconstruct failed rail joints and reinstate correct alignment and fixing
- Identify and rectify moisture sources contributing to timber decay
- Apply suitable protective coatings or sealants to reduce future weather-related deterioration
- Confirm the railing installation complies with relevant safety and regulatory requirements

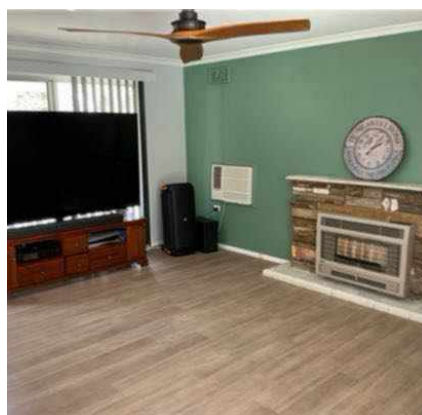
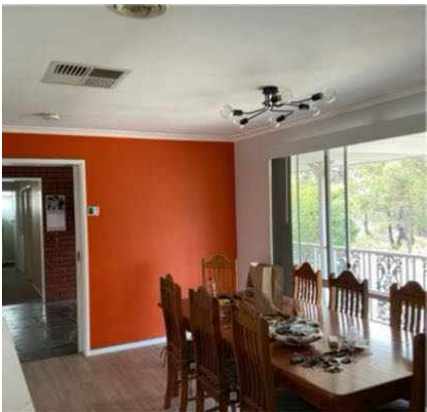
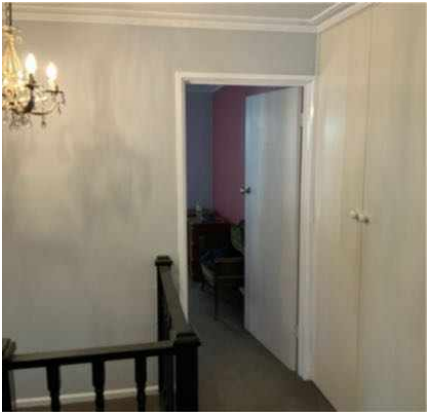
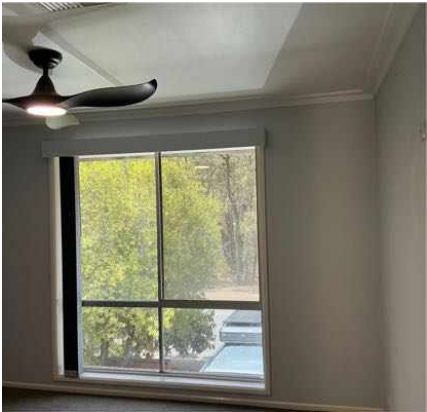
Building:	Main Building
Location:	All Internal Areas
Finding:	Rooms - recently painted
Information:	It appears that certain areas of the house have recently been repainted, enhancing the overall appearance of the property. While fresh paint can provide a clean and aesthetically pleasing finish, it is important to recognize that it may also be used to conceal underlying issues, such as repair work, structural cracks, or other surface imperfections. Without further investigation, it is difficult to ascertain whether the painted areas are purely cosmetic or indicative of deeper concerns.

- Keep an eye on repainted areas to check for signs of cracks re-emerging. Take note

of any changes in width, length, or frequency of cracks, as these can be indicative of underlying movement or stress.

- If cracks worsen or show significant progression, consult a licensed building inspector or structural engineer to conduct a comprehensive assessment. A professional evaluation will help determine the root cause of the movement and provide guidance on necessary repairs.

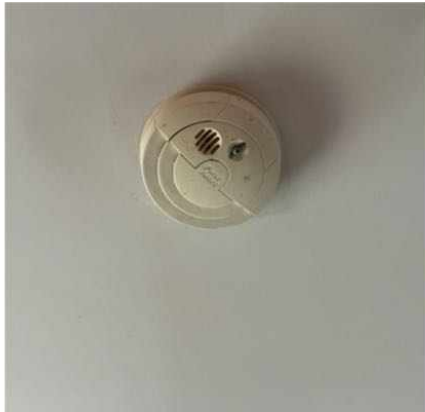
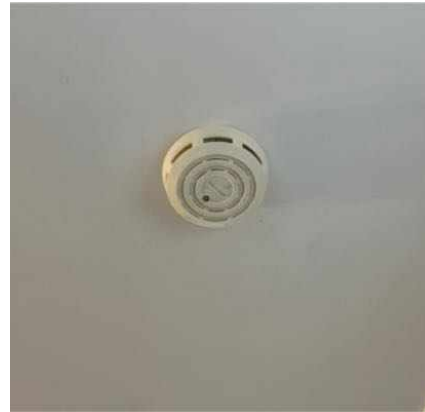
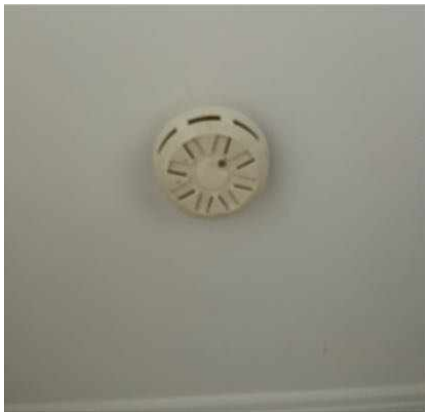
Building:	Main Building
Location:	All Internal Areas
Finding:	Smoke Detector Compliance Not Assessed
Information:	The inspection and reporting on the presence, function, and compliance of smoke detectors—whether battery-operated or hard-wired—fall outside the formal scope of this pre-purchase building inspection. However, general observations regarding smoke alarm coverage or deficiencies are noted for the client's awareness.

- Following settlement, the client should engage a licensed electrician or fire safety professional to:
 - Inspect all existing smoke detectors for compliance, functionality, and correct placement.
 - Install new or additional units where necessary, ensuring compliance with AS 3786 and state-based legislation.
- For optimal fire safety, ensure smoke detectors are:
 - Interconnected where required.
 - Positioned in all sleeping areas and paths of travel as per current regulations.
 - Maintained according to manufacturer instructions and replaced every 10 years.
 - Tested monthly, with annual battery replacement where applicable.

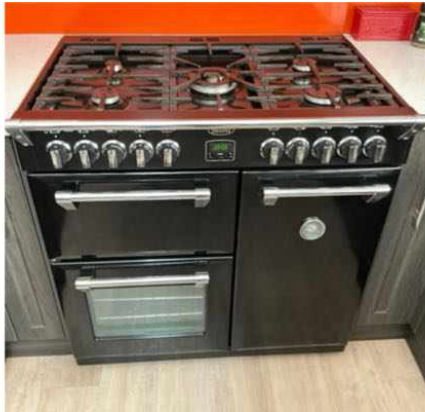
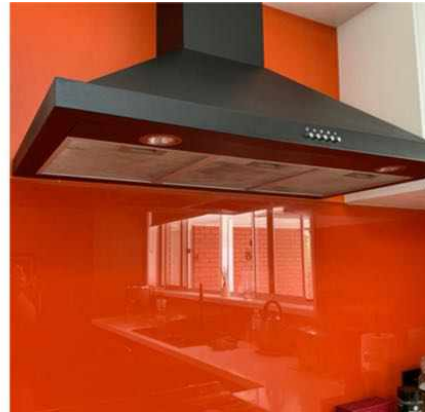
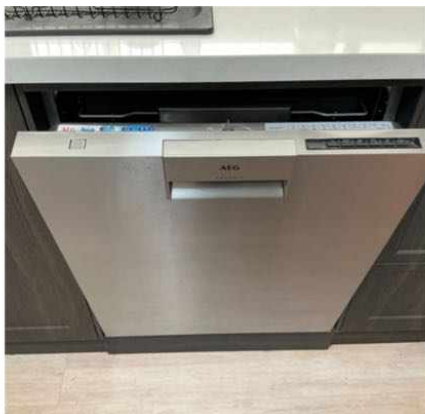
Building: Main Building
 Location: Kitchen
 Finding: Condition of Installed Appliances - Operational
 Information: At the time of inspection, the installed appliances—including the oven, cooktop, rangehood, and dishwasher—were checked for basic operational function. All appliances powered on and responded as expected to standard user inputs, indicating they are in working condition.

- Appliances appear to be functioning as intended at the time of inspection.
- No obvious signs of damage, malfunction, or missing components were observed.

- Engage a licensed electrician or appliance technician to conduct a safety check of all appliances, particularly if installation dates, service history, or compliance documentation are unknown.

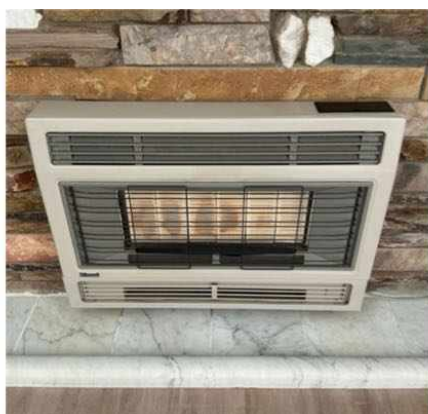
Building:	Main Building
Location:	Lounge Room
Finding:	Servicing and Safety of Gas Wall Heaters
Information:	It is strongly advised that all gas wall heaters within the property are regularly serviced and maintained by a licensed and registered plumber. Over time, gas appliances can become inefficient or develop faults, which may lead to serious safety hazards such as carbon monoxide leaks, fire risk, or poor combustion efficiency.

- Engage a licensed and registered plumber to carry out a full service and safety inspection of all gas wall heaters prior to use.
- Ensure future servicing is completed in accordance with manufacturer specifications and gas safety regulations.
- Install a carbon monoxide detector in all rooms containing gas heaters for added safety and peace of mind.

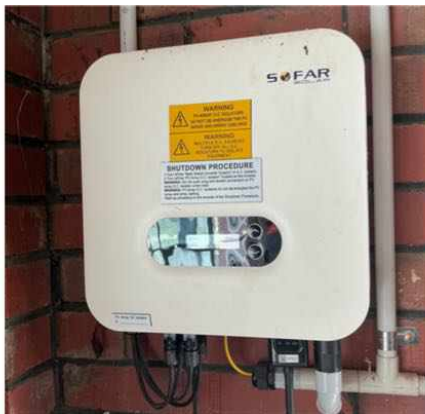
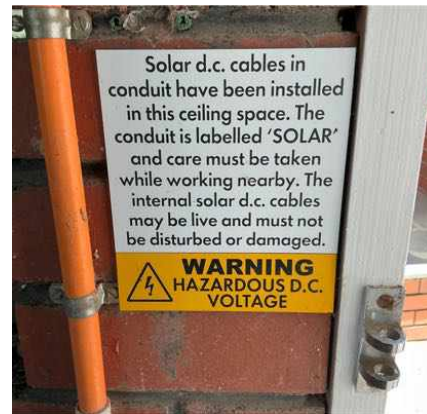
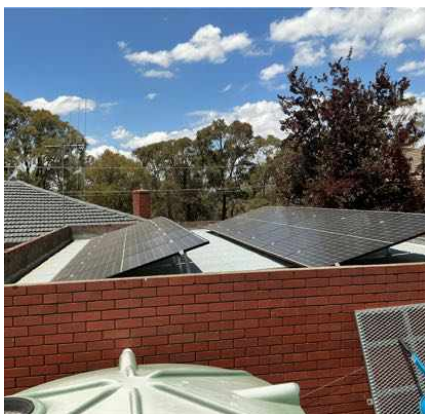
Building:	Main Building
Location:	Garage
Finding:	Photovoltaic (PV) Solar Panel System – Limitations and Considerations
Information:	A rooftop PV solar panel system was present at the time of inspection. While the installation appeared intact from a visual standpoint, no assessment was made regarding its electrical compliance, inverter performance, or energy output. The inspection of solar power systems is outside the scope of a standard building inspection.

- Panels, wiring, isolators, and inverters may degrade over time or fail without regular servicing.
- Safety risks such as arc faults, exposed wiring, or non-compliant isolators may go

- Engage a Clean Energy Council (CEC) accredited electrician or solar technician to inspect the entire system for safety, compliance, and performance.
- Confirm that the system meets the requirements of AS/NZS 5033:2021 and AS/NZS 4777.1:2016.
- Ensure the inverter is functioning correctly and that appropriate system documentation is available.

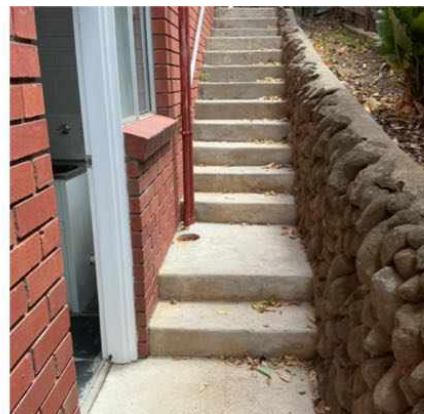
Building: Main Building
Location: Right-hand Side

Finding: Potential Surface Water Ingress Risk to Laundry Doorway
Information: At the time of inspection, the external concrete path and stair configuration along the right-hand side of the dwelling was observed to direct surface water toward the laundry doorway. The finished surface levels appear relatively flat in this area, with limited visible fall away from the doorway opening. Although no active water ingress was observed at the time of inspection, the layout presents a potential risk during periods of heavy rainfall.

It cannot be confirmed under dry inspection conditions whether water enters the laundry; however, the configuration indicates that water may track toward the doorway threshold when significant rainfall occurs.

- Potential for surface water to enter the laundry during heavy or wind-driven rainfall events
- Increased risk of moisture damage to internal floor finishes, wall linings, and door framing
- Ongoing exposure may contribute to mould growth and material deterioration
- Moisture ingress may occur intermittently and remain unnoticed until damage becomes established

- The area should be monitored during rainfall to confirm whether water enters the laundry
- If water ingress is observed, drainage falls should be corrected to direct water away from the doorway
- Consider installation of a surface drain, threshold barrier, or regrading of the concrete path if required
- Any moisture affected internal finishes should be assessed if ingress is confirmed

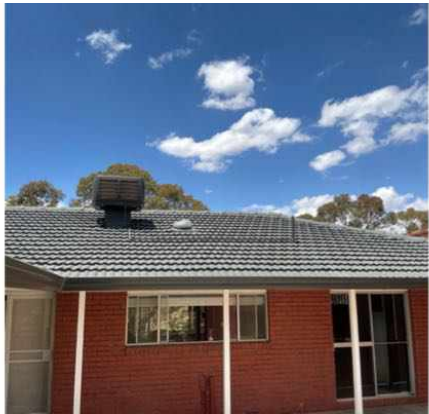
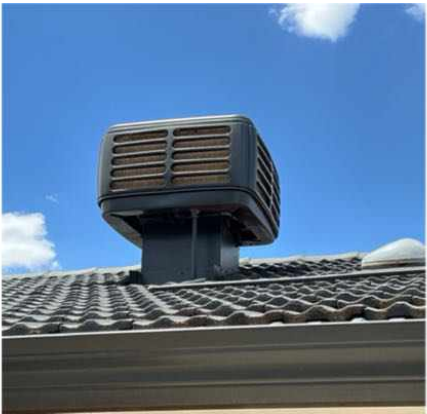
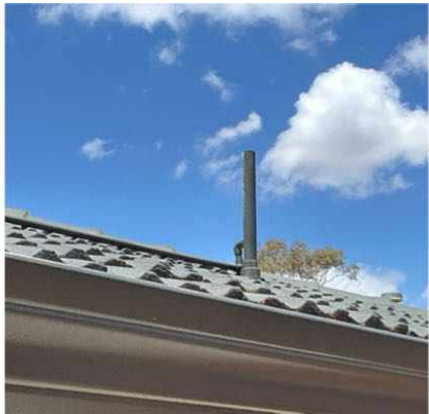
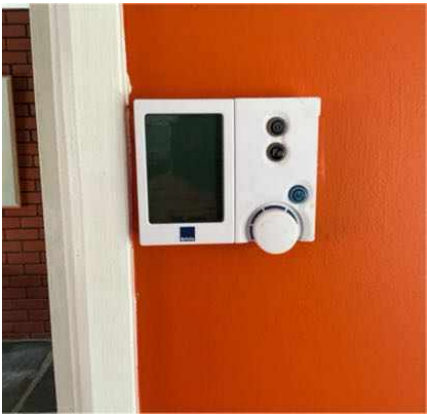
Building:	Main Building
Location:	Roof Exterior
Finding:	Evaporative Air Conditioning System and Ductwork
Information:	An evaporative air conditioning unit was observed installed at roof level, with associated ductwork located within the roof space. The system and ducting were visually inspected only where accessible. No obvious defects were identified at the time of inspection; however, the operational performance, internal condition of the unit, duct integrity, airflow balance, and overall efficiency could not be assessed as part of a standard building inspection.

- The system may not be operating efficiently if routine servicing and maintenance have not been carried out.
- Ductwork located within the roof space may deteriorate over time due to heat, dust accumulation, or physical disturbance, potentially reducing airflow performance.
- Undetected issues such as internal corrosion, worn components, water supply faults, or air leaks may affect system reliability and cooling effectiveness.
- If the system is nearing the end of its service life, repair or replacement costs may be

- Engage a licensed HVAC technician or evaporative cooling specialist to carry out a full operational inspection and service of the system.
- Confirm the condition and integrity of ductwork, including connections, supports, and insulation.
- Verify the age of the unit, service history, and availability of replacement parts.
- Allow for ongoing maintenance as part of normal ownership to maintain system performance and longevity.

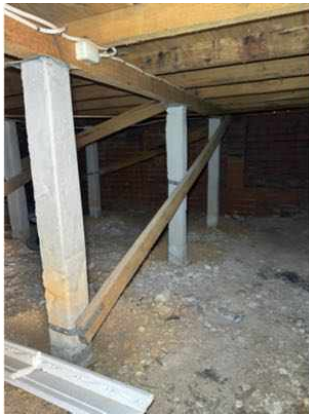
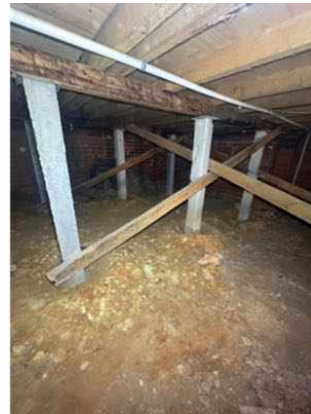
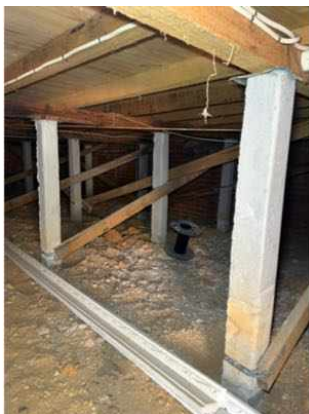
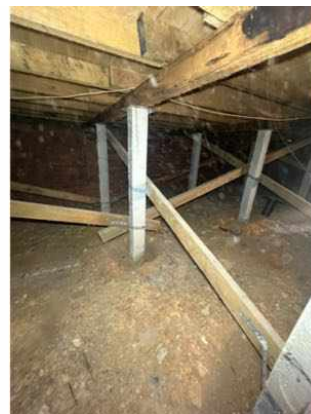
Building:	Main Building
Location:	Subfloor
Finding:	Concrete Stumps – Remaining Subfloor Supports
Information:	During inspection of the remaining concrete stumps within the subfloor, these supports were observed to be in comparatively better condition than the previously noted deteriorated stumps. The concrete surfaces appear generally intact with no significant visible surface breakdown, aggregate exposure, or powdering at the ground interface. The stumps were also observed to be supported by timber bracing, which currently assists in maintaining alignment and load distribution.

While the visible condition of these stumps is notably improved relative to the deteriorated stumps, the presence of bracing indicates that these supports have likely required stabilisation due to past or ongoing structural movement or settlement. The bracing appears functional at the time of inspection but should be regarded as a temporary or supplementary support measure rather than a permanent structural solution.

- These stumps are currently providing more reliable support than the deteriorated stumps
- The presence of bracing indicates past or potential movement within the subfloor structure
- Bracing is not a permanent substitute for compliant structural support
- There remains a risk of future movement if underlying footing or soil conditions change
- Structural performance is dependent on both stump integrity and ground stability

- Engage a qualified structural contractor or engineer to assess the adequacy of stump condition and bracing arrangement
- Confirm whether the bracing is temporary or intended as a permanent support system
- Monitor for signs of movement including cracking, floor unevenness, or door misalignment
- Consider allowance for future underpinning or restumping works if movement or deterioration progresses
