Building and Timber Pest Inspection Report

Inspection Date: Sat, 14 Feb 2026

Property Address: 20/300C Burns Bay Rd, Lane Cove NSW
2066, Australia

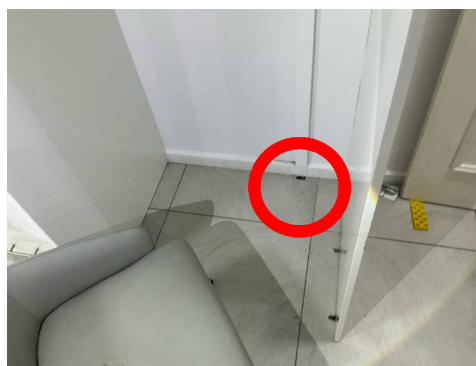
Finding: Electrical Wires - Exposed

Information: During the inspection, exposed electrical wires were noted. This condition poses a significant safety hazard, as it increases the risk of electrical shock, short circuits, and potential fire. It is imperative that a qualified electrician addresses this issue immediately by properly insulating the exposed wires and ensuring all electrical connections comply with safety standards. Prompt action will mitigate the risks associated with exposed wiring and maintain the safety and integrity of the property's electrical system.

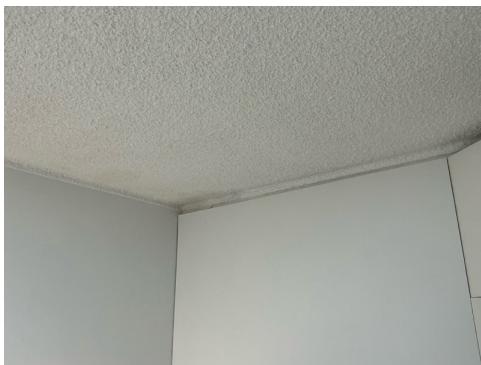
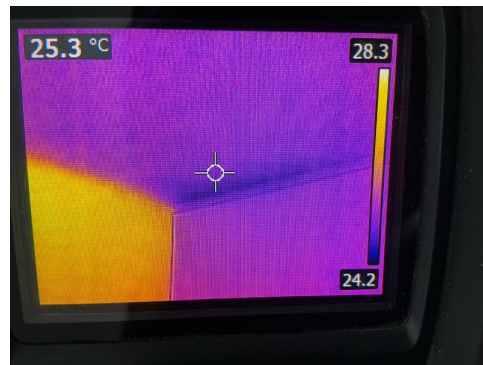
Finding 2.01

Finding: Active Moisture – Ceiling Areas (Bedrooms and Closet)

At the time of inspection, active moisture was detected to the ceiling areas within both bedrooms and the adjoining closet. Thermal imaging and moisture testing identified temperature differentials and elevated moisture readings consistent with ongoing water ingress. Visible signs of dampness and discolouration were also noted to ceiling surfaces.

The presence of active moisture indicates that the issue is current and not historical. If left unaddressed, continued water penetration may result in deterioration of plasterboard, mould growth, insulation damage, and potential structural timber decay.

Immediate investigation and rectification are required. As this appears to be associated with building elements that may fall under common property (such as roofing, external walls, or plumbing services), the client is strongly advised to notify and involve Strata Management without delay. A licensed plumber and/or roofing contractor should be engaged to identify and rectify the source of ingress, followed by appropriate repairs to affected internal finishes once the leak has been fully resolved.

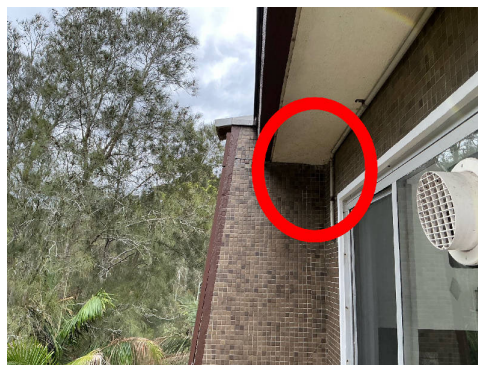
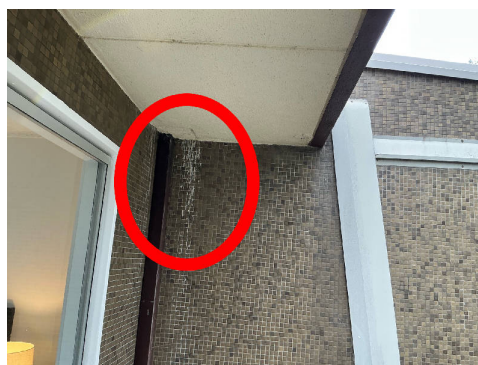
Finding 3.02

Building: Main Building
Location: Balcony
Finding: Eaves - Water stained

Water staining to eaves linings in this area was evident at the time of inspection. Water staining indicates that surfaces have been exposed to excessive moisture over time. The minerals and other elements in the water lead to staining, which may graduate to corrosion and deterioration if left unmanaged.

While mostly an appearance defect, water staining can be indicative of more serious defects, which may be currently concealed by interior ceilings.

Where water staining is active, a licensed plumber must be consulted to identify the cause of the staining and to provide advice on any reparation works that may be required. Replacement of any damaged structures is advised. The client is advised to engage strata management as well.

Conversely, where water staining is old and inactive, affected building materials may be repaired or replaced at client discretion.

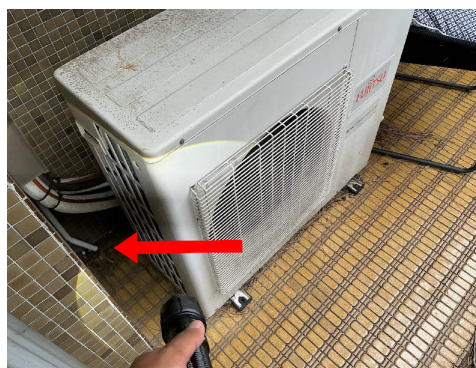
**Finding 3.03**

Finding: Air conditioner - Disconnected overflow

Information: The Air Conditioner (A/C) overflow was found to be disconnected from storm water drainage and is creating excessive moisture in the surrounding area.

Such leaking creates an environment which is conducive to an array of defects, including water damage to associated building elements and the attraction of termite or timber pest infestation.

It is highly recommended that a licensed plumber be appointed to connect the A/C overflow in order to prevent such an environment from being created. These minor works should be carried out as soon as possible.

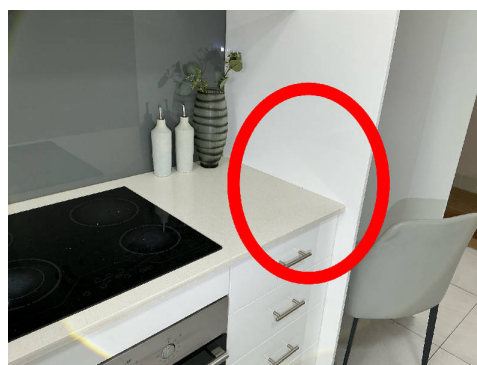
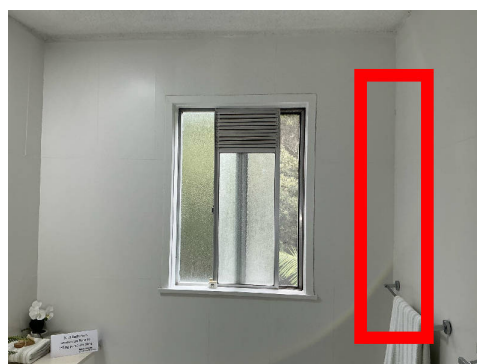
Finding 3.04

Finding: Sealant and Grouting - Missing or Damaged

It was noted on inspection that sealant or grout is degraded/missing to these areas.

Different materials and floor areas move at different rates, generally causing cracking to grout or sealant at this point. A flexible sealant is required to allow for expected expansion and contraction, while keeping the joint water tight and protective of all associated building materials.

Flexible and mould resistant materials should be applied to affected areas to prevent any subsequent water damage that is likely to occur. Regular maintenance and replacement of damage or missing or damaged sealant and grout is highly recommended to the wet areas, as this is a regular wear and tear defect. Sealant and grouting in areas that come into regular contact with water should be maintained for the long term care of your property.

A sealant specialist or tiling contractor should be appointed to complete these works as soon as possible

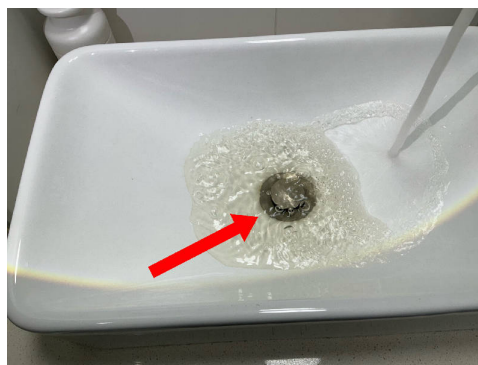
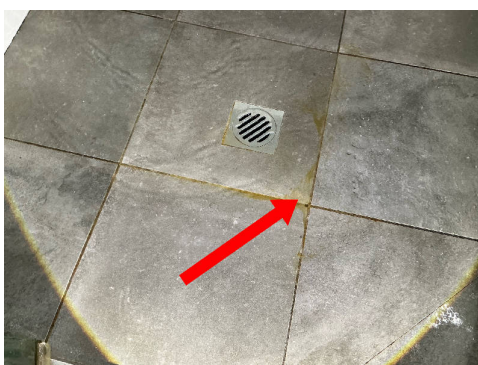
Finding 3.05

Finding: Tap - Rust in water

Information: The water emitting from the tap in this area is rusty-coloured and undiluted. It is suspected that this is a direct result of the erosion and deterioration of associated pipework, which is contaminating the water as it passes through the affected sections.

While this is a common defect and is relatively expected in a property of this age and condition, eroding pipework can have damaging implications to associated building elements if left unmanaged.

Replacement of this pipework appears to be necessary. A licensed plumber should be appointed to further inspect the pipework and provide any remedial works as required.

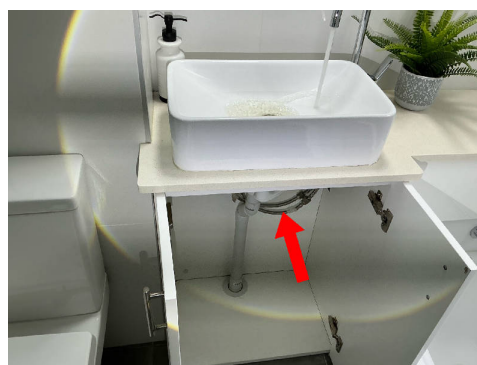
Finding 3.06

Finding: Minor Corrosion to Plumbing Pipes and Cabinet Water Damage

Information: At the time of inspection, minor corrosion was noted to sections of the older copper plumbing pipes beneath the bathroom basin. The corrosion and surface oxidation appear consistent with age-related deterioration and possible past minor leakage. Associated minor water damage and deterioration were observed to the internal cabinet surfaces, including staining and swelling to the base panels.

No active leak was detected at the time of inspection; however, corrosion of this nature can weaken pipe integrity over time and may result in future leakage if left unaddressed.

The client is advised to consider upgrading the older plumbing pipework with new compliant materials to minimise the risk of future leaks. In addition, due to the moisture-related deterioration noted to the cabinet, replacement of the affected bathroom cabinet is recommended to prevent further deterioration.

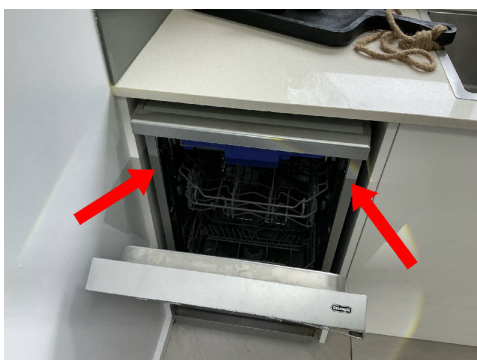
Finding 3.07

At the time of the inspection, it was noted that the dishwasher in this area was not securely installed and appeared to be loose. This improper installation requires prompt attention to ensure the appliance is correctly fitted and stable. If left unmanaged, the condition of the fitting may worsen over time, potentially leading to further deterioration and the development of additional minor defects. These secondary issues could affect both the dishwasher itself and the surrounding cabinetry or flooring.

A loose dishwasher may produce excessive noise and vibration during operation, which can be both disruptive and uncomfortable for occupants. The lack of secure installation may also place strain on the dishwasher's components, potentially reducing the lifespan of the appliance and leading to more significant repairs or maintenance needs in the future.

It is strongly recommended that a qualified plumber be appointed to carry out the necessary rectification work. Ensuring the dishwasher is securely installed will improve its performance, reduce noise and vibration, and prevent further damage to the surrounding area. The client should engage a professional plumber to complete these repairs, ensuring the appliance operates efficiently and safely.

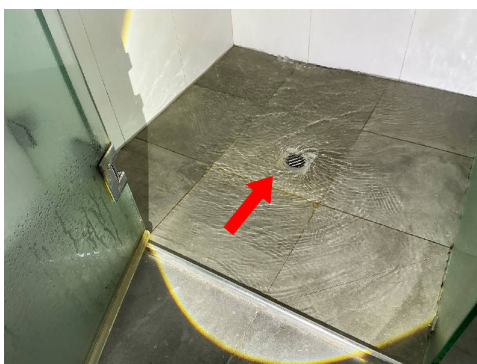
**Finding 3.08**

Building:	Main Building
Location:	Bathroom
Finding:	Shower Drainage – Slow Discharge and Inadequate Falls

Information: At the time of inspection, water within the shower area was observed to drain very slowly, resulting in pooling around the floor waste. In addition, the floor gradient appears inadequate, as water was not effectively directed toward the drain and was noted to remain ponded on the tiled surface.

Slow drainage may be caused by a partial blockage within the waste line, build-up of debris, or inadequate pipe fall. The insufficient floor slope (falls) toward the waste can further contribute to standing water, increasing the risk of long-term moisture retention, deterioration of grout and sealant, mould growth, and potential waterproofing failure if left unaddressed.

The client is advised to engage a licensed plumber to inspect and rectify the drainage issue, including clearing any blockage and assessing the adequacy of the waste connection. If the floor falls are confirmed to be non-compliant or insufficient, further rectification works by a suitably qualified tradesperson may be required to ensure proper drainage and prevent ongoing water pooling.

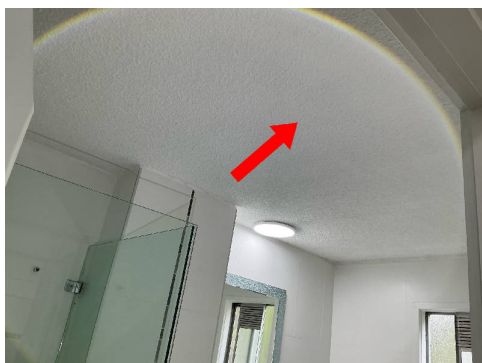
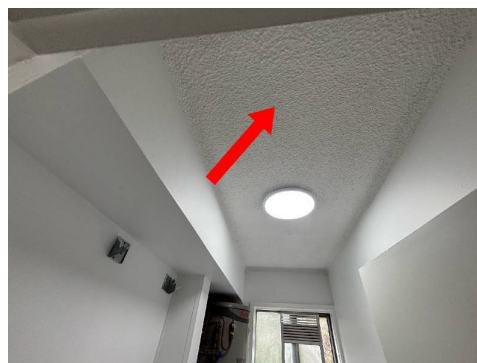
Finding 3.09

Finding: Exhaust fan - Missing

Information: An exhaust fan has not been installed in this area. Missing exhaust fans may lead to the development of more significant defects such as moisture damage to surrounding building materials from inadequate ventilation. Inadequate ventilation in internal areas creates an environment that is conducive to the formation and development of mould and other respiratory hazards. It is highly advised that a licensed electrician be appointed to retrospectively install an exhaust fan. Failure to perform works to aid the ventilation of the area may lead to the development of these secondary defects.

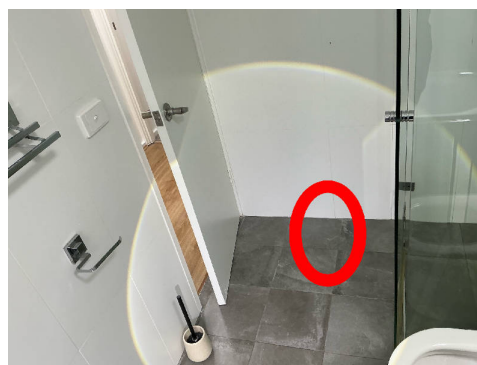
Finding 3.10

Finding: Door Stopper(s) - Missing

Information: At the time of inspection, it was noted that a door stopper was missing in this area.

The absence of a door stopper can lead to potential damage to the door, wall, or surrounding finishes, as the door may swing open too far and impact the wall or adjacent objects. Over time, this can cause dents, scuffs, or even structural damage to the wall or door. It is recommended that a door stopper be installed to prevent further damage and ensure the protection of both the door and the surrounding area.

The client is advised to engage services of a handyman to install the door stopper.

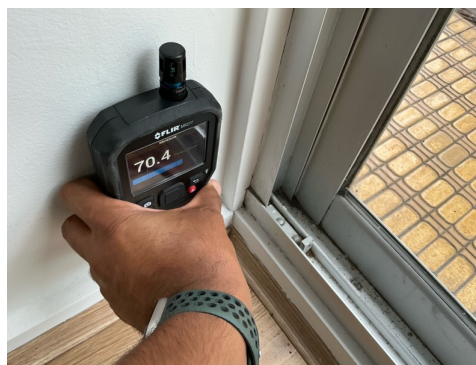
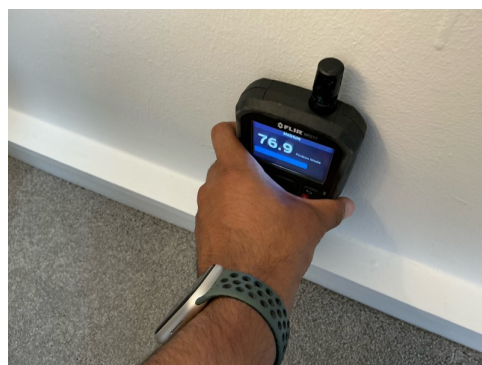
Finding 3.11

Finding: Excessive Moisture - Walls

Information: Excessive moisture was observed in the walls at the time of inspection, indicating potential underlying issues that could be contributing to this condition.

One possible cause is rising damp, where moisture from the ground seeps up through the brickwork due to a compromised waterproofing. Another potential factor could be water ingress from faulty, leaking or blocked gutters, roof and downpipes, which may be allowing water to overflow and penetrate the wall.

The client is advised to engage services of a professional plumber and strata management to fix the issue of roof leaks and also monitor the area over 12 months for any further deterioration.

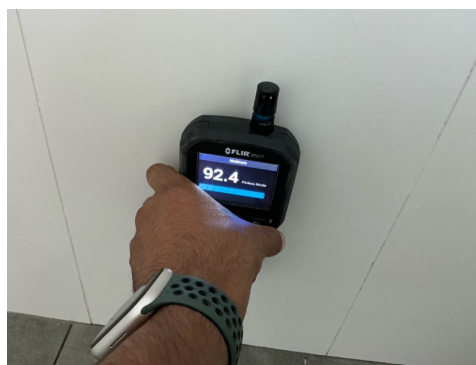
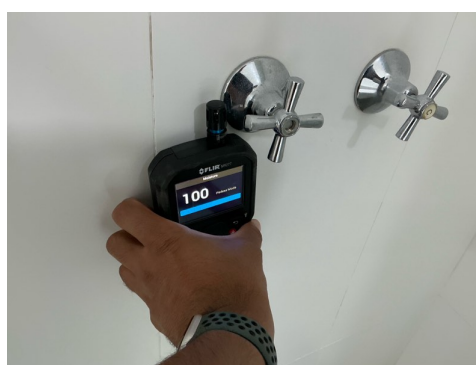
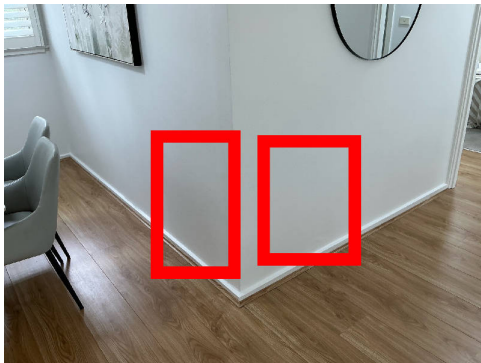
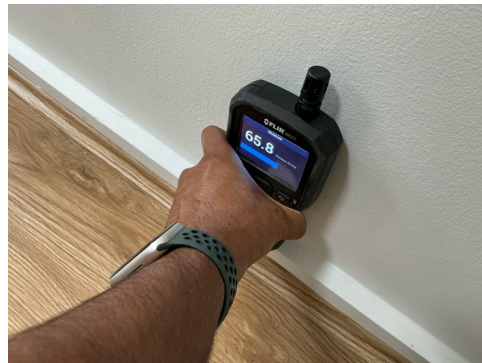
Finding 3.12

Information: At the time of inspection, elevated moisture levels were detected on the wall adjacent to the shower area. While no visible water damage or deterioration was noted, the presence of moisture suggests possible seepage or condensation associated with regular shower use.

At this stage, no immediate action is required. However, the area should be monitored over the next 12 months for any signs of deterioration such as staining, bubbling paint, or mould growth. It should be noted that moisture ingress of this nature does not generally resolve without intervention, and at some point remedial works are likely to be required. Should conditions worsen, the client is advised to engage services of a licensed plumber or waterproofing specialist to rectify the issue of moisture before this minor defect turns into major defect.

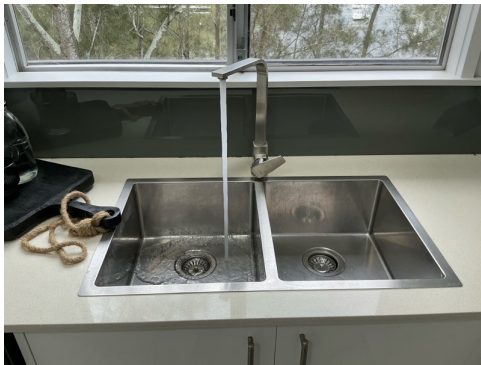
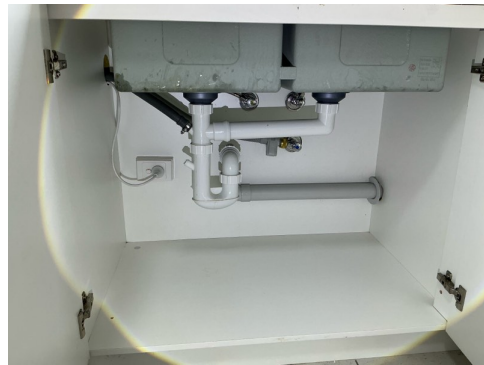
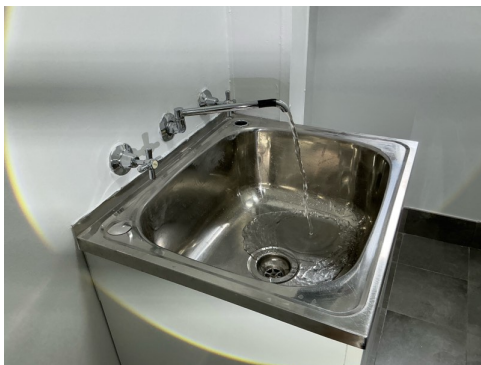
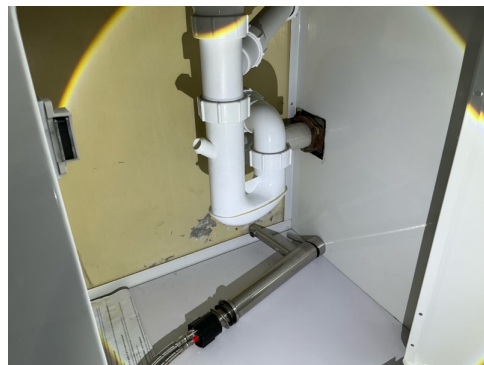
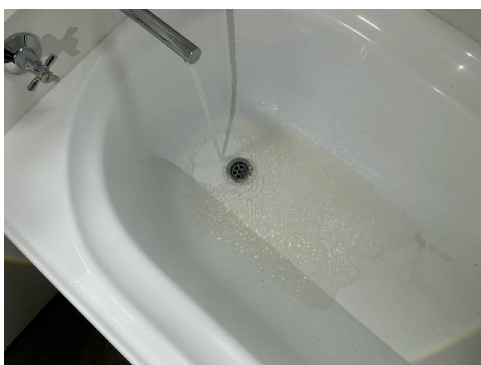
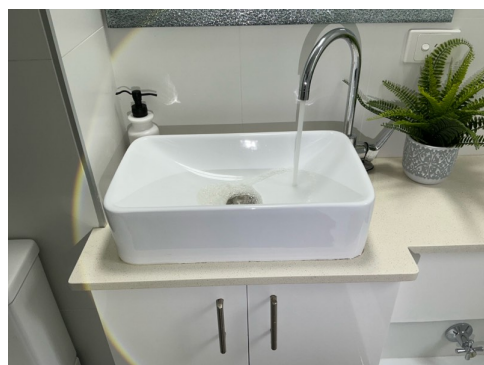
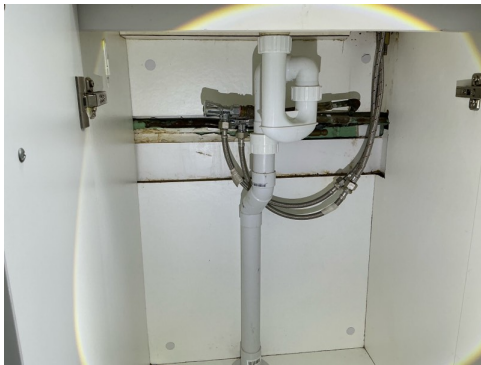
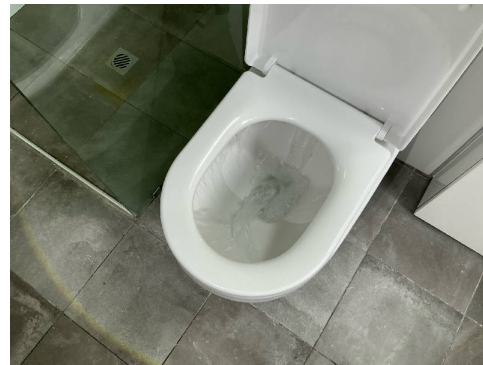
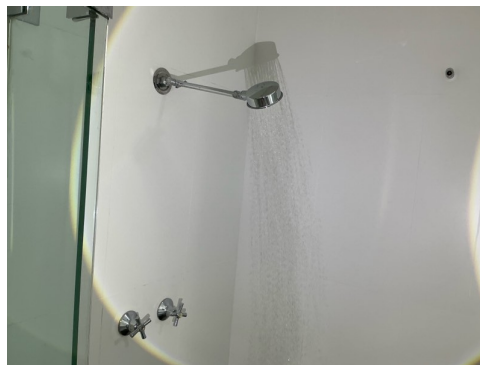
Information: During the inspection, all accessible taps, drainage systems, and toilets were tested for water flow and drainage efficiency, and checked for any visible signs of leakage. At the time of the inspection, no issues were noted in these areas. Unless highlighted in a separate defect statement, no immediate remedial work appears necessary. Supporting images may be found in the additional photos section for reference.

It is important to note that while a visual inspection of cupboards and cabinetry beneath sinks and vanities was undertaken, stored personal items and fixtures presented obstructions that limited full visibility of the internal areas. As per standard inspection practices, inspectors are not permitted to move or disturb personal belongings during the inspection process. Therefore, only visible and accessible sections were inspected, and concealed water damage or plumbing defects may not have been detected.

Given this, a re-inspection is recommended after all obstructions have been cleared to allow for a comprehensive assessment of these areas. Regular maintenance and monitoring of plumbing and drainage systems is also advised to ensure ongoing functionality and early detection of potential issues.

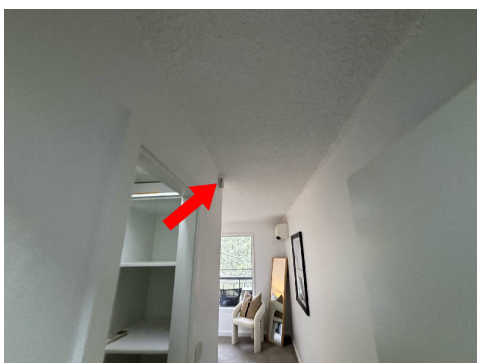
Building: Main Building
Location: All Areas
Finding: Smoke Detectors and Alarms

The reporting on smoke detectors or alarms, including hard-wired smoke detection systems and their compliance with legislative requirements, falls outside the scope of this inspection report. However, based on our experience in the building industry, we feel it is important to highlight the absence or poor condition of smoke detectors as a significant safety concern. While this observation is included as a cautionary note, addressing the presence and condition of smoke detectors should be considered an urgent priority to enhance the safety of the building's occupants.

It is strongly recommended that a further inspection and advisory service be undertaken to assess the sufficiency, type, and location of smoke detectors throughout the property. This should also include testing the functionality of all devices to ensure they are operational and compliant with relevant safety standards. Greater fire safety and detection requirements, including specific placement and type of smoke detectors, apply to commercial buildings, which should be reviewed based on building use and local regulations.

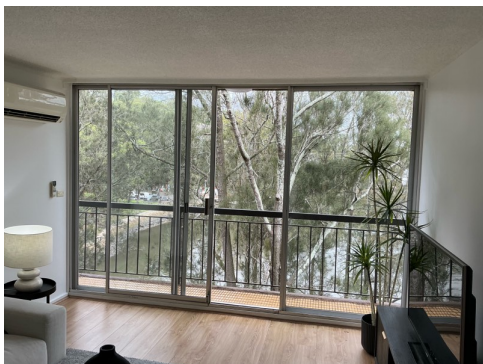
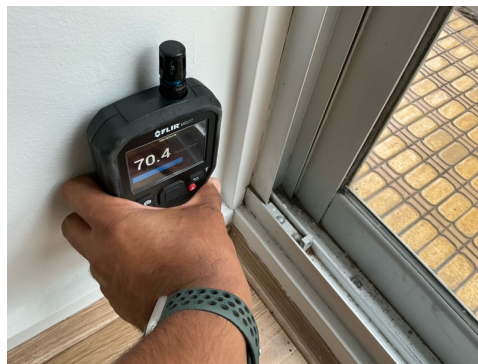
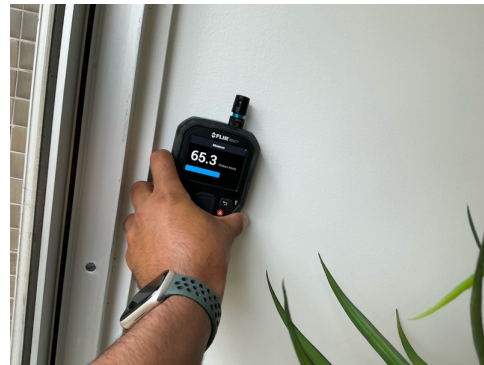
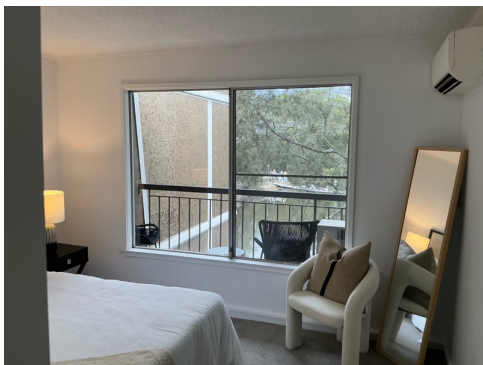
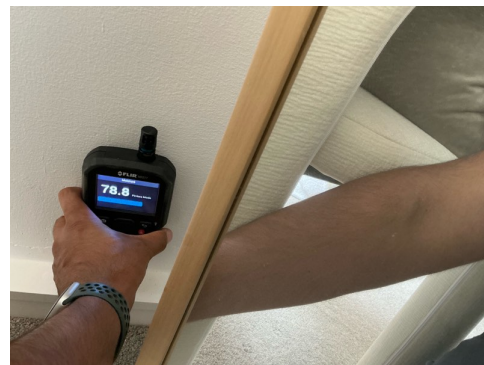
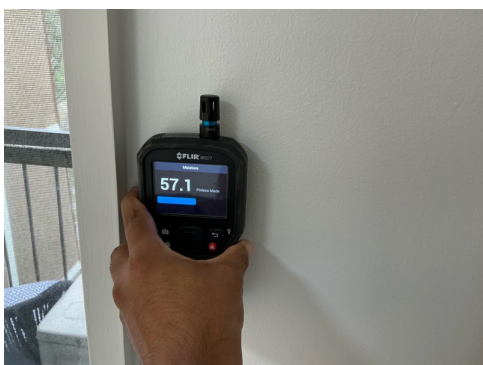
Finding: Additional Photos - Moisture Meter Readings

Information: Additional moisture meter reading photos have been provided for the property to offer further clarity on areas tested during the inspection. These photos are intended to give a visual reference for the specific locations where moisture levels were measured, as indicated by the red arrows in the images. These readings were taken at the time of the inspection to assess any potential moisture-related issues within the property. Any defects related to moisture that were identified during the inspection have been separately mentioned in the defect statements within the report.

For further clarification or additional information regarding the moisture readings, the client is encouraged to contact the building inspector directly. Regular monitoring of moisture-prone areas is recommended to ensure any emerging concerns are addressed promptly, particularly during wetter seasons or in high-humidity conditions.

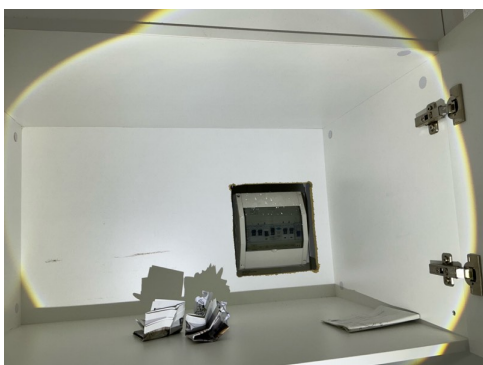
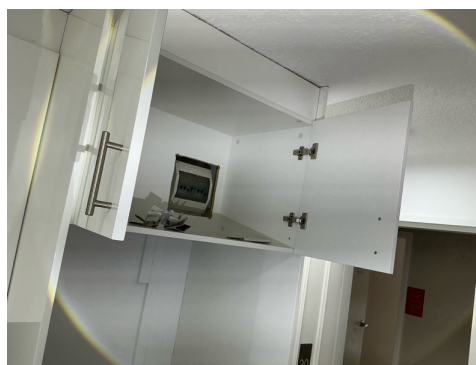
Building: Main Building
Location: Kitchen
Finding: Electrical Meter Box
Information: Electrical meter box is located in kitchen cabinets

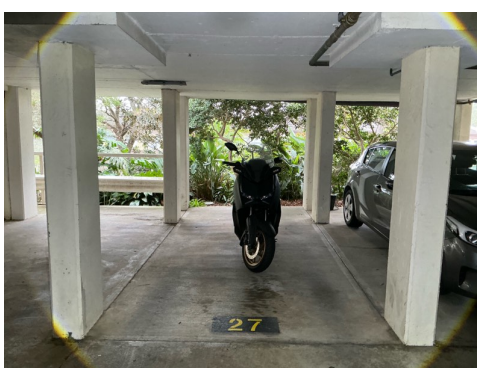
Building: Main Building
Location: Basement
Finding: Allocated Car Spaces & Storage Room

Information: The accompanying photos are provided for your general reference, showcasing the current condition of the car parking spots and storage rooms as observed at the time of inspection. It is important to note that these images are meant to serve as a visual snapshot of the property's features at the time of the assessment. However, the client is strongly advised to confirm all allocations, such as car parking spots, storage rooms, and any associated rights or access, within the terms of the contract. Verifying these allocations through the contract ensures clarity and avoids potential disputes regarding ownership or usage. The photos included are intended to give an overview of the designated areas, but the final details should always be cross-referenced with the contractual agreements for accuracy and completeness.

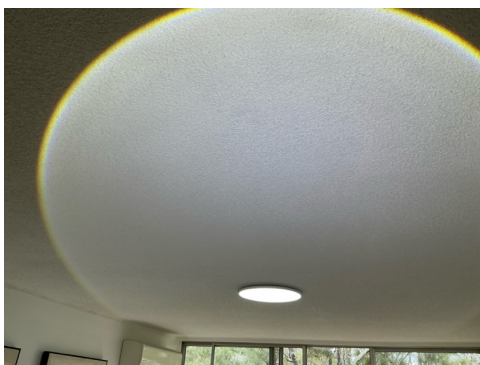
Information: Some older buildings may contain asbestos-containing materials (ACM) within walls, ceilings, flooring, eaves, or other building components. Asbestos was commonly used in construction materials prior to the late 1980s.

The client is advised to consult with the building or strata management to confirm whether any asbestos materials remain on the property and to verify if removal or management procedures have been undertaken in accordance with current safety regulations.

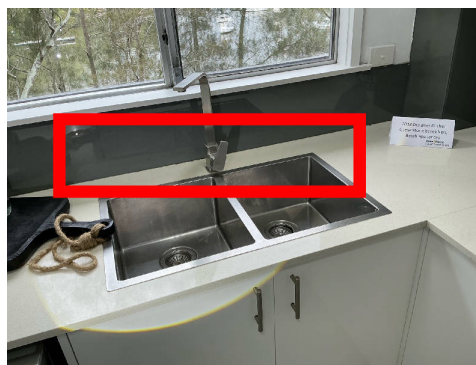
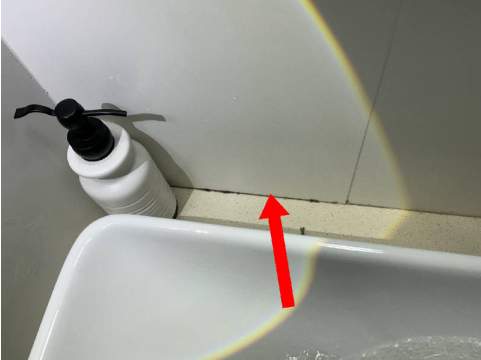
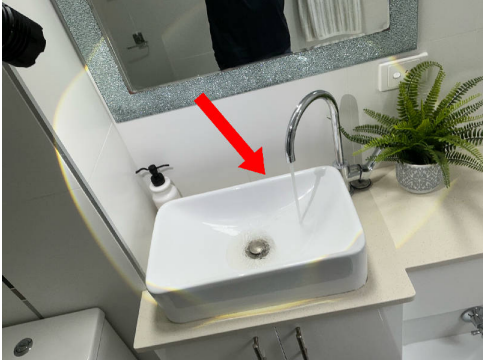
Information: At the time of inspection, mould growth was observed on the sealant within the wet areas, indicating prolonged moisture exposure and inadequate ventilation. Mould can deteriorate the integrity of the sealant over time and pose hygiene concerns.

The affected sealant should be removed and replaced with a high-quality mould-resistant silicone, and the area should be thoroughly cleaned and treated to remove existing mould. Adequate ventilation should be maintained to prevent recurrence.
