Building and Timber Pest Inspection Report

Inspection Date: Tue, 17 Feb 2026

Property Address: 14 Gallina Dr, Spring Farm NSW 2570,
Australia

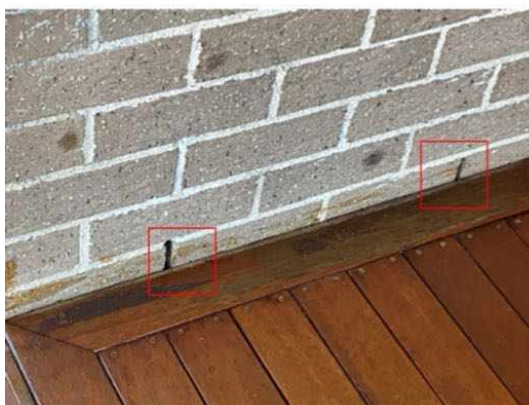
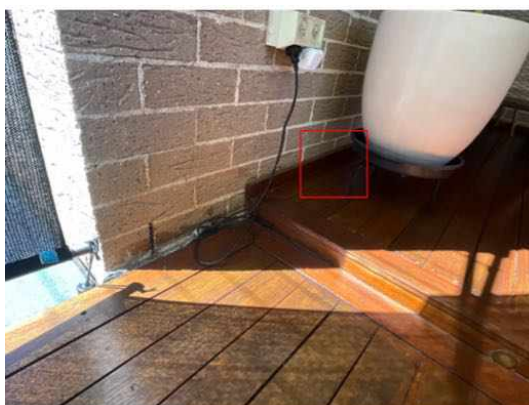
Finding 6.02

Building:	Main Building
Location:	Fencing & Landscaping
Finding:	Building materials in direct ground contact - conducive to termites
Information:	Where timber elements are in direct contact with the ground and consequently moisture or dampness they become conducive to termite activity. Whether timber is used as a building element part of a fencing structure or stored as an unused item they can provide an environment that is attractive to termite infestation.

When met with excessive moisture timber begins to decay and develop wood rot. Any timbers that are in direct contact with external grounds especially if left untreated or non-durable also provide ingress for subterranean termites into that particular element.

The removal of any such materials that may be conducive to termite activity should be removed as soon as possible to minimise the risk of termite attack.

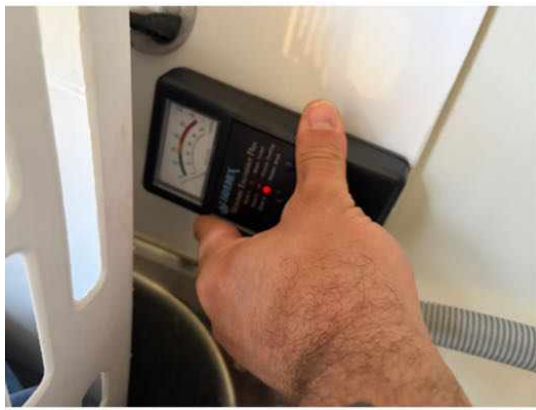
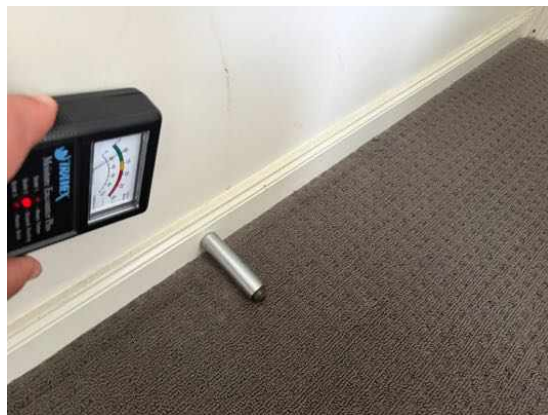
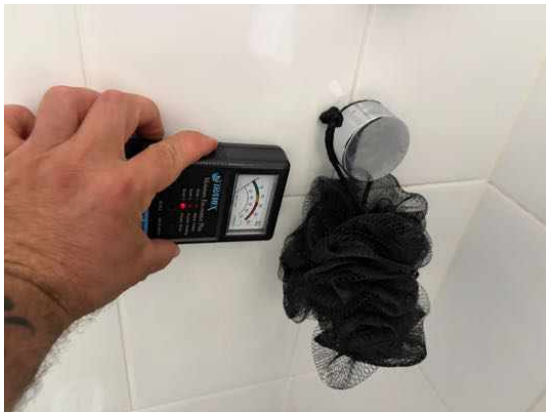
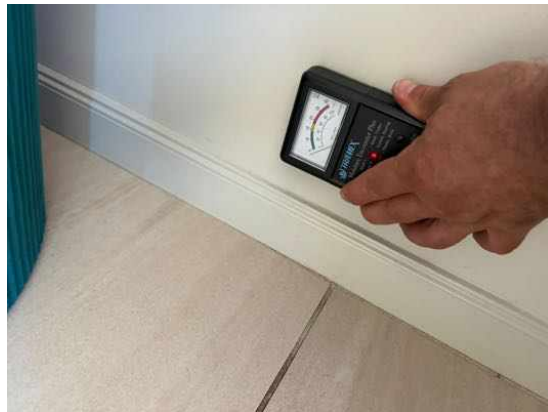
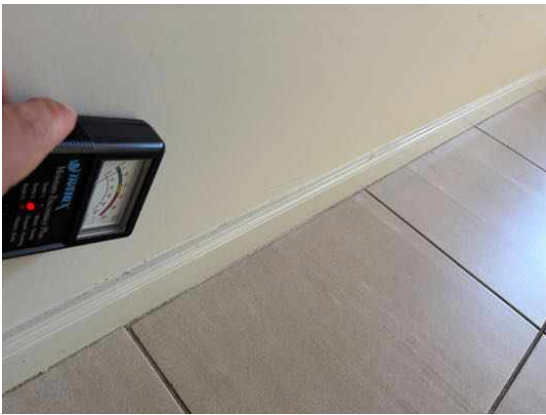
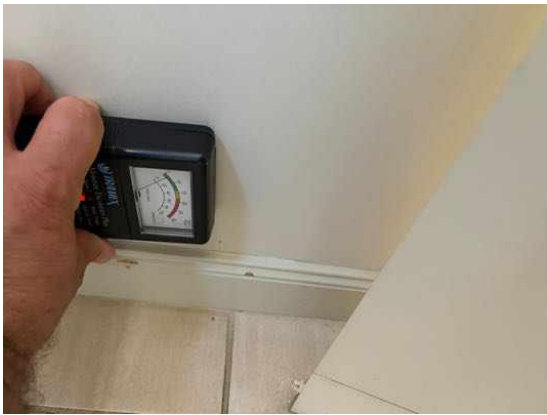
Building: Main Building
Location: All Areas
Finding: Moisture metre
Information: During the inspection the property was checked for moisture using a moisture metre.

This is for information only.

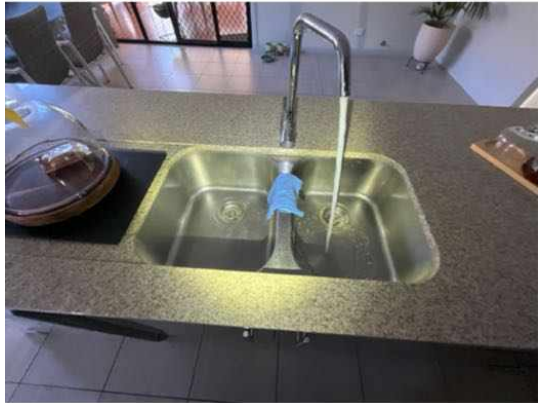
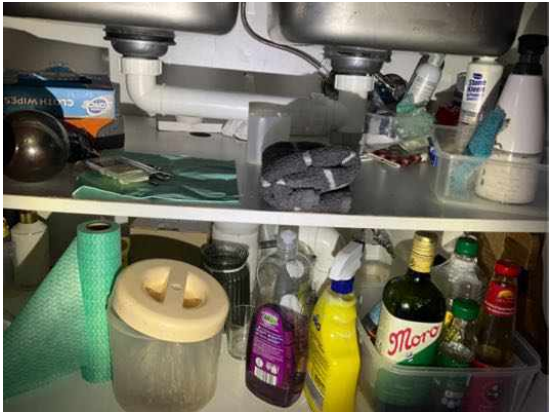
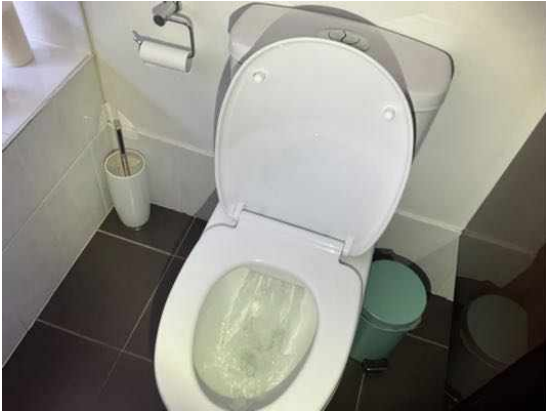
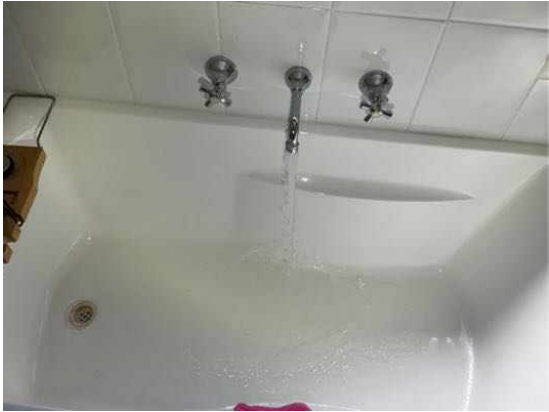
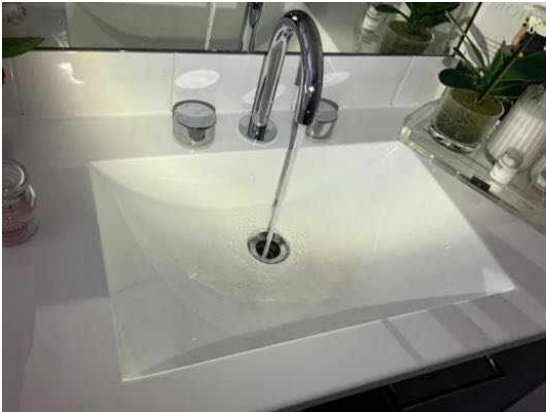
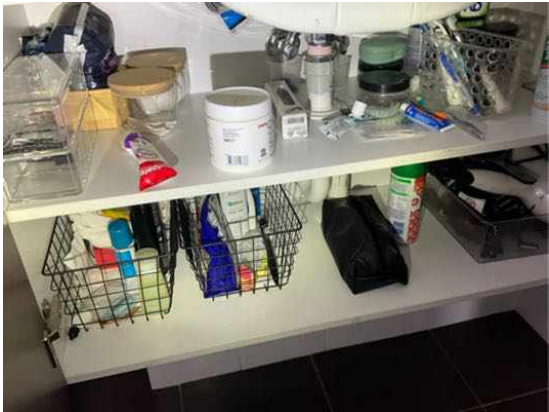
Noted Item

Building: Main Building
Location: All Wet Areas
Finding: Additional Photos
Information:

Additional photos are provided for your general reference.

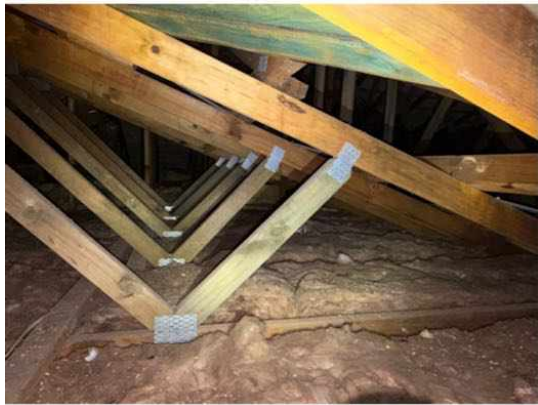
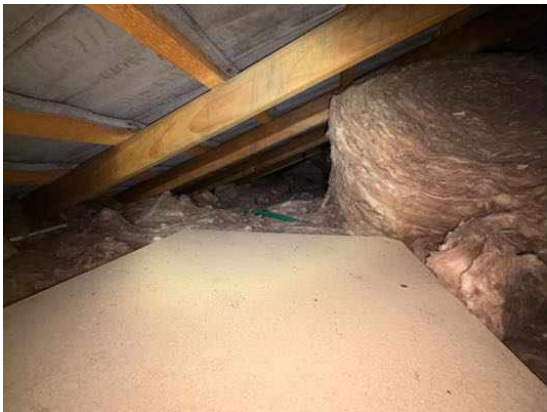
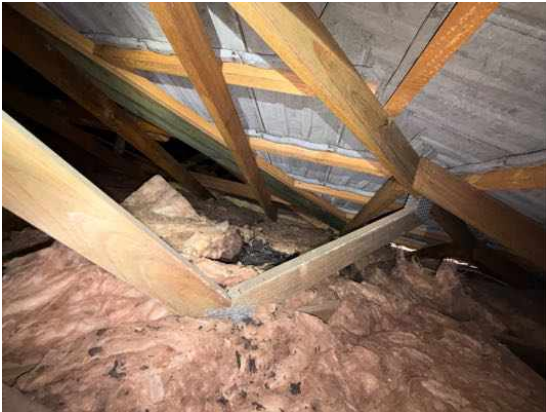
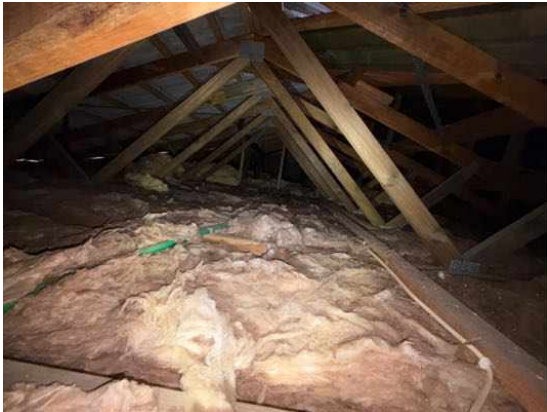
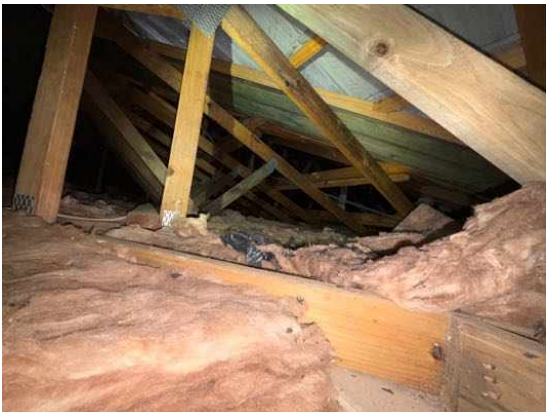
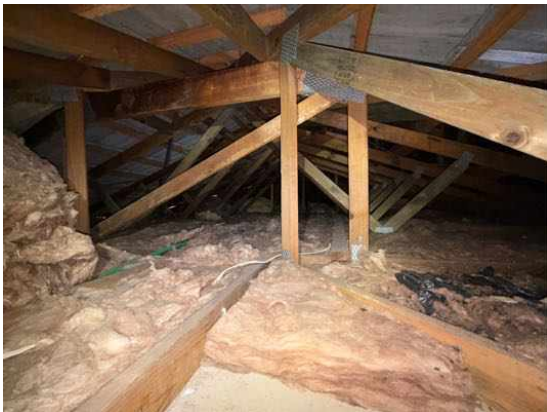
Noted Item

Building: Main Building
Location: Roof Void
Finding: Additional Photos
Information:

Additional photos are provided for your general reference.

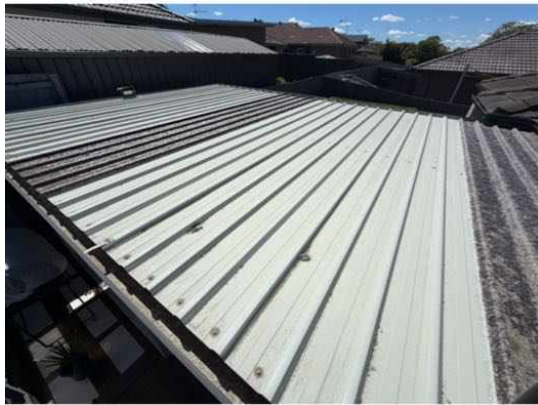
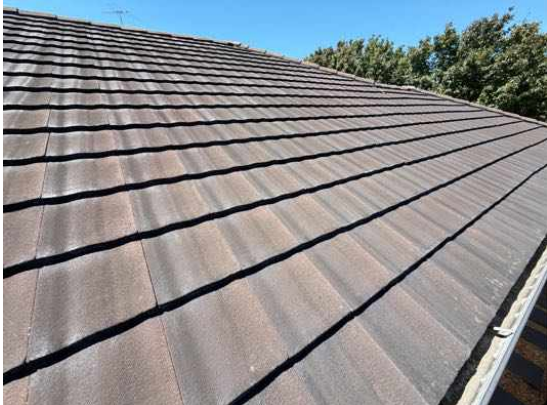
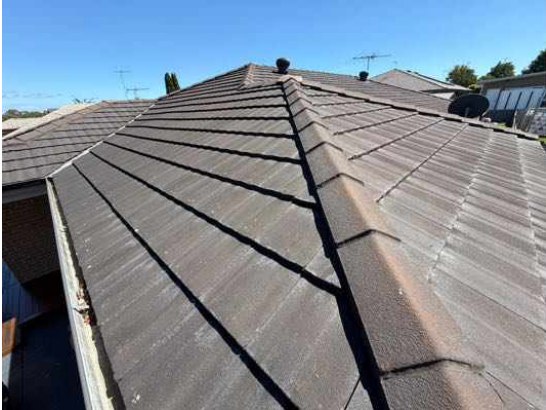
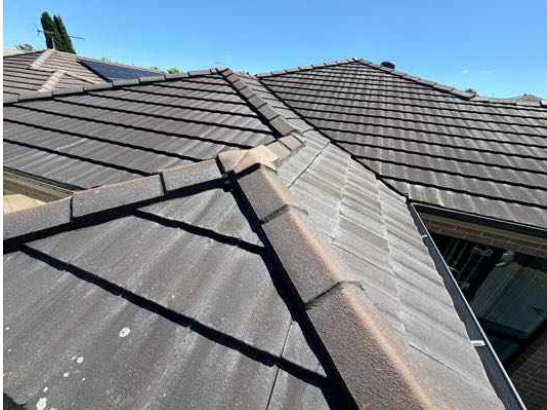
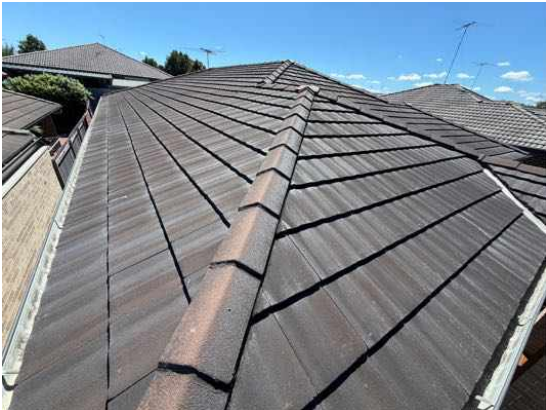
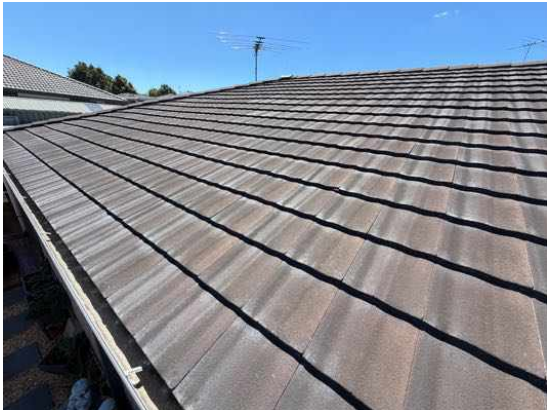
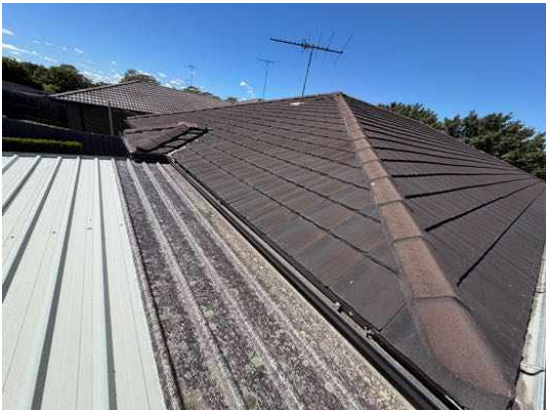
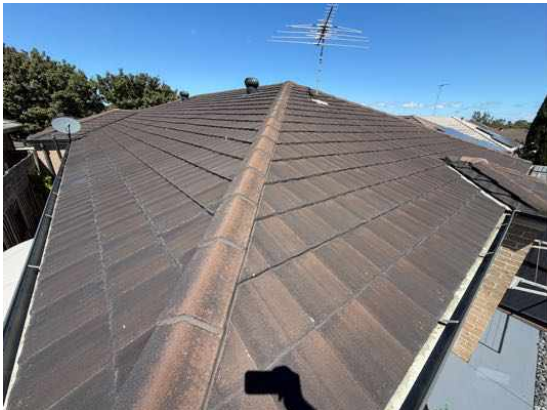
Building: Main Building
Location: Roof Exterior
Finding: Additional Photos
Information:

Additional photos are provided for your general reference.

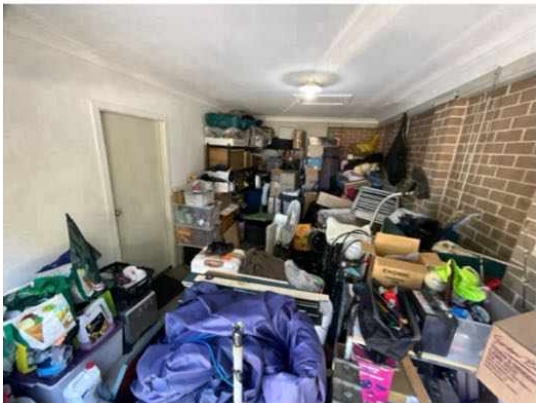
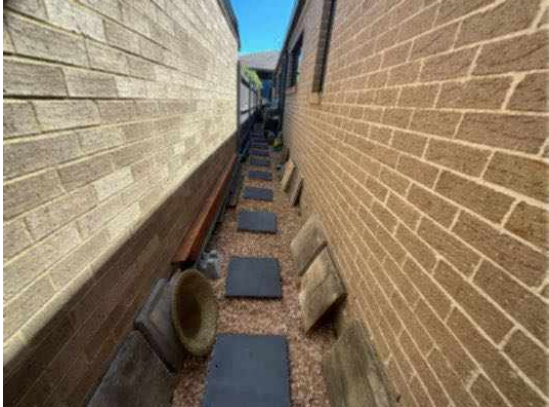
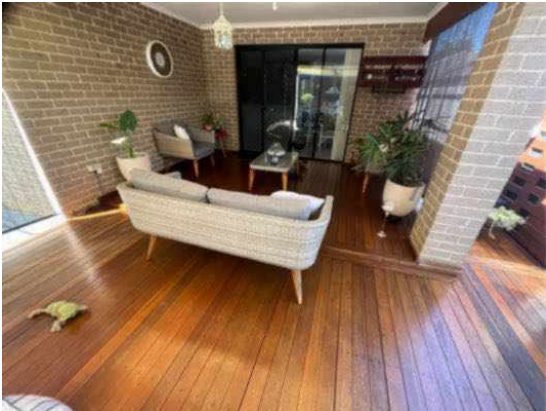
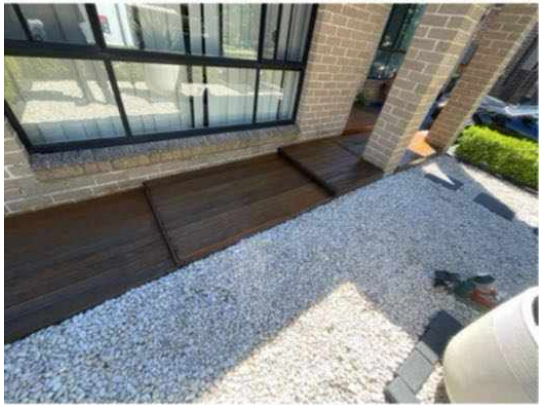
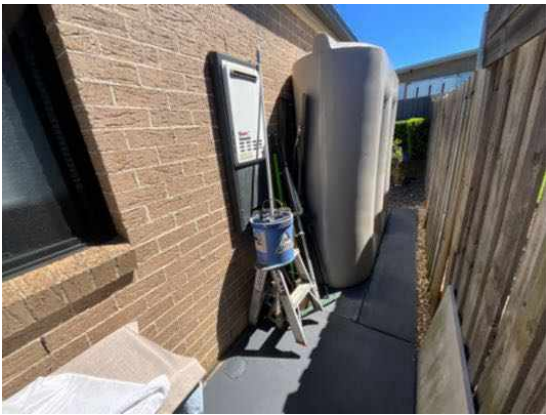
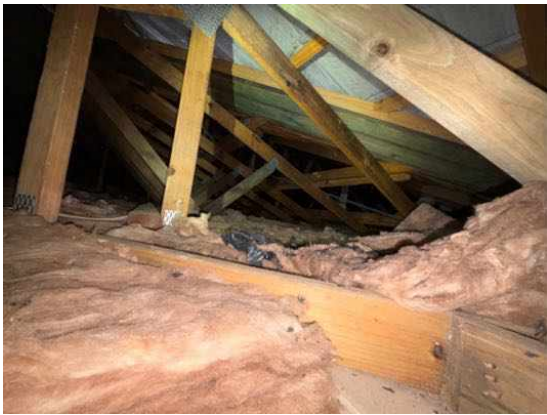
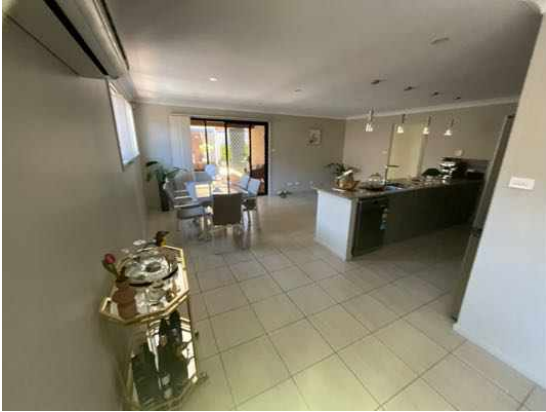
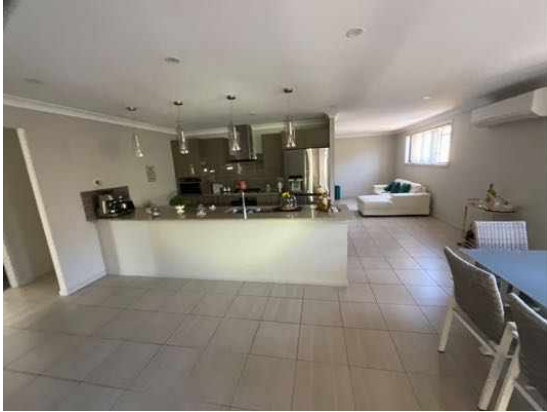
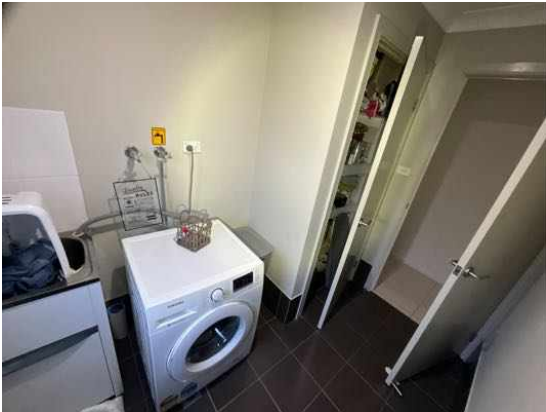
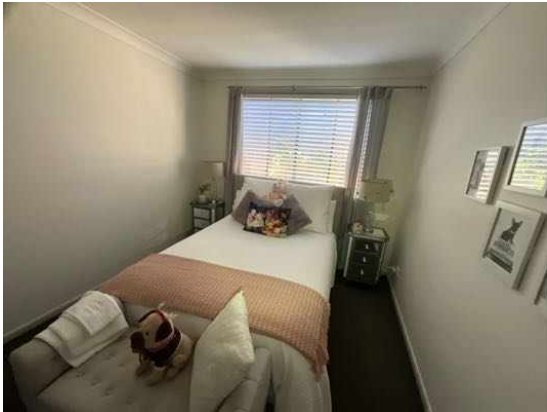
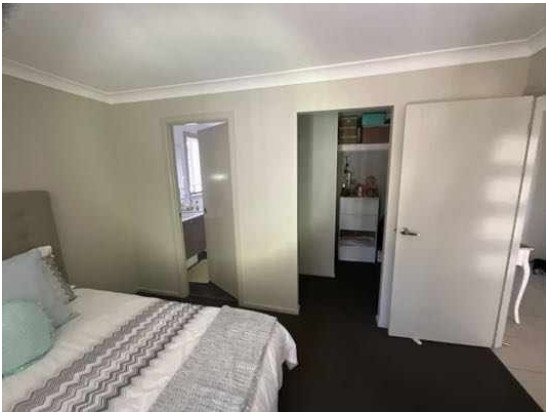
Building: Main Building
Location: All Areas
Finding: Additional Photos - Obstructions and Limitations
Information:

These photographs are an indication of the obstructions and limitations which impeded full inspection of the property at the time of inspection. These obstructions can hide an array of defects and should be removed to allow full inspection to be carried out. A re-inspection is recommended once the areas are made accessible.

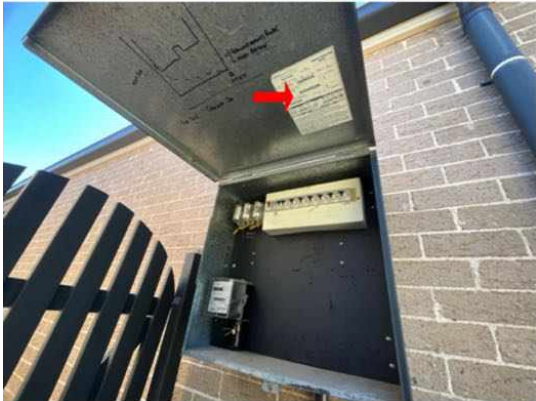
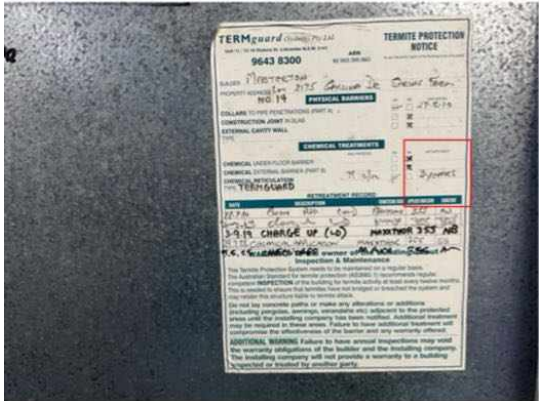
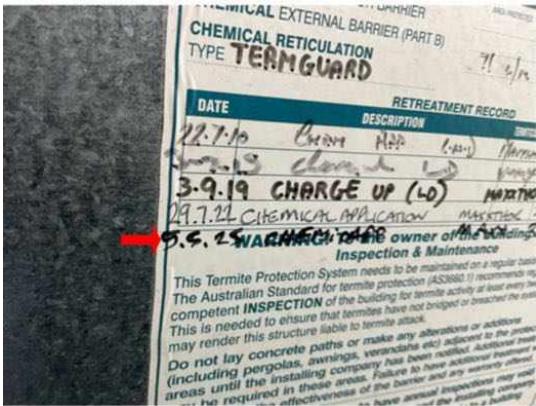
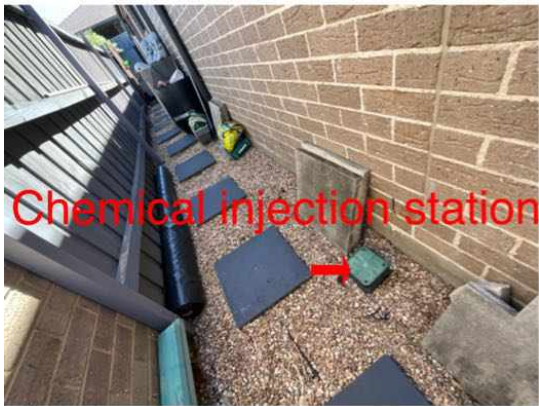
The following items were noted as - Evidence of a previous termite management program

Where a Termite Management System has been identified you should refer to the type of barrier date of installation warranty conditions and any documentation provided by a builder or past owner. Consult the company who installed the barrier to confirm whether the system is still under warranty.

Most chemical termite management systems expire and require replenishment and all physical systems are primarily designed to prevent concealed entry.
