## Building Inspection Report

Inspection Date: Thu, 22 Jan 2026

Property Address: 361 Waterfall Gully Rd, Rosebud VIC 3939,  
Australia

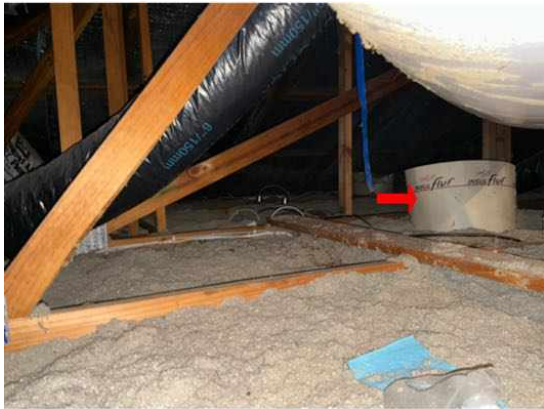
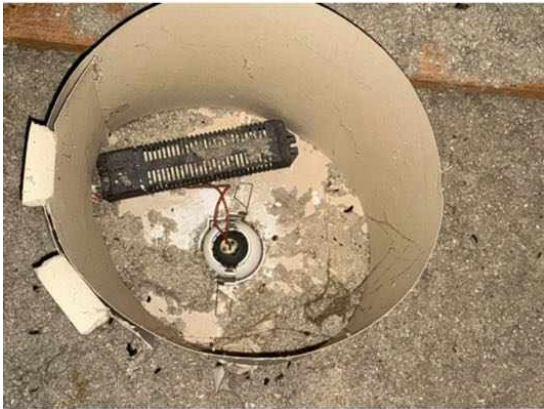
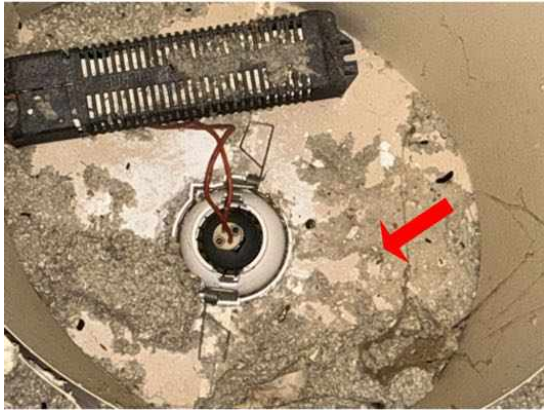
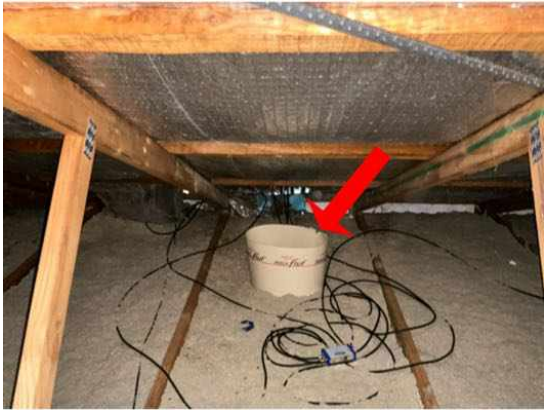
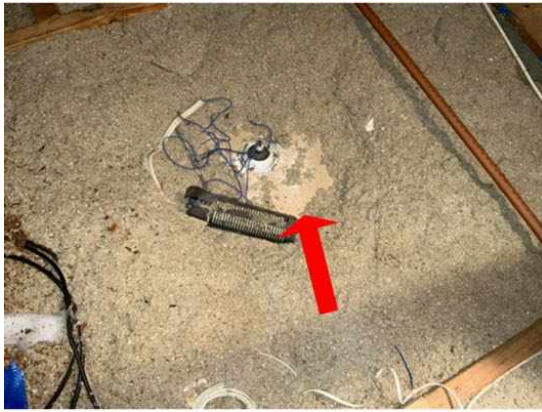
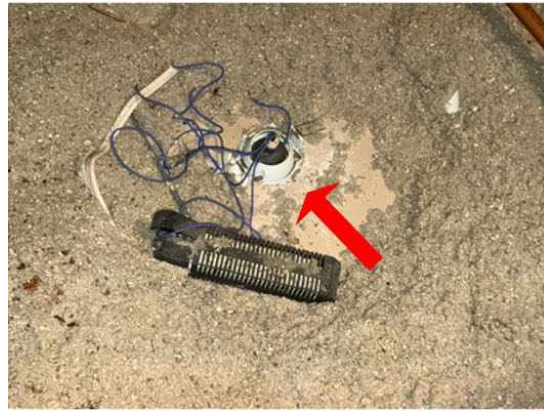
#### Defects 1.01

Building: Main Building  
Location: Roof Void >  
Finding: Roof Void - Electrical - Downlight Fittings Wrapped With Debris  
Information: Downlight fittings within the roof space were observed to be covered with debris. This is an unsafe condition, as combustible materials in close proximity to light fittings can increase the risk of overheating and fire.

This condition may have resulted from insulation contact.

A licensed electrician should be engaged immediately to remove the debris and assess the downlight installation. The fitting should be made safe, which may include installing an appropriate fire-rated downlight cover or replacing the fitting to ensure safe operation and reduce fire risk.

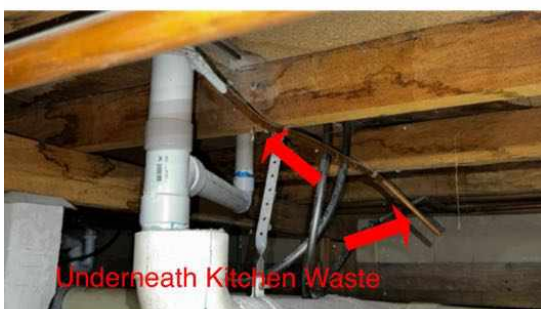
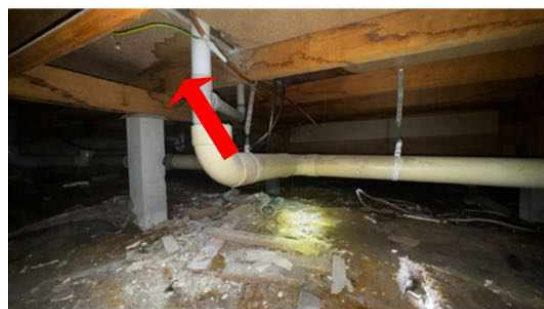
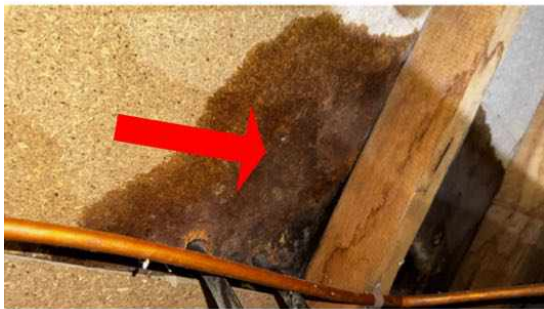
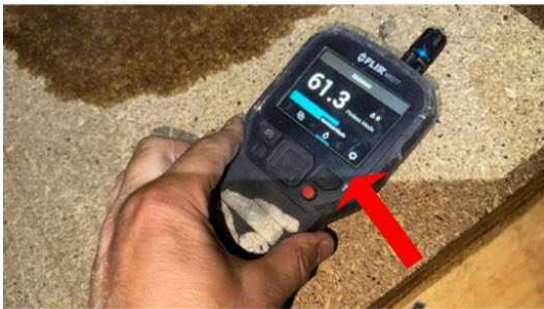
### Defects 2.01

Building:	Main Building
Location:	Subfloor - Kitchen Sink Waste
Finding:	Water Leak - Sub Floor - Flooring
Information:	A water leak was observed in the subfloor with damp timber framing, wet floor materials, and staining indicating ongoing moisture exposure.

The leak is likely caused by a faulty waterproofing systems or plumbing defect allowing water to penetrate the subfloor. If not addressed, this may lead to timber decay, mould growth, structural damage, and potential termite activity.

A licensed plumber should be engaged immediately to locate and repair the source of the leak, and a carpenter or builder may be needed to inspect and repair any affected structural elements. Immediate action is recommended to prevent further deterioration and maintain structural integrity.

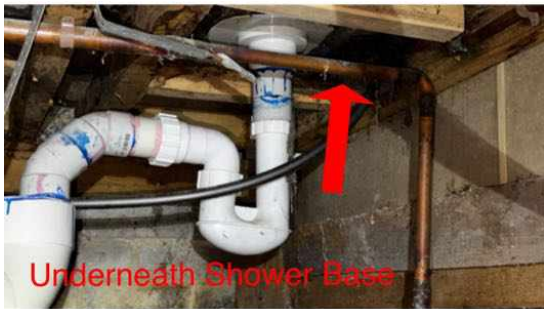
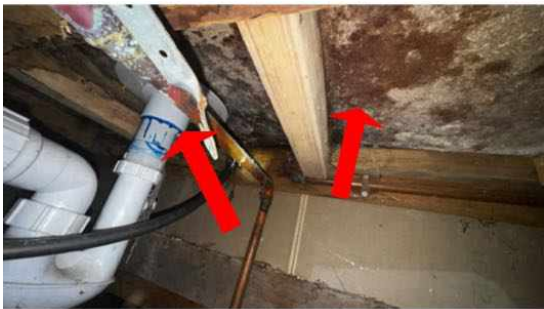
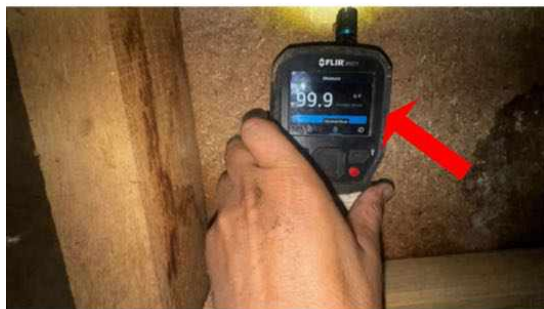
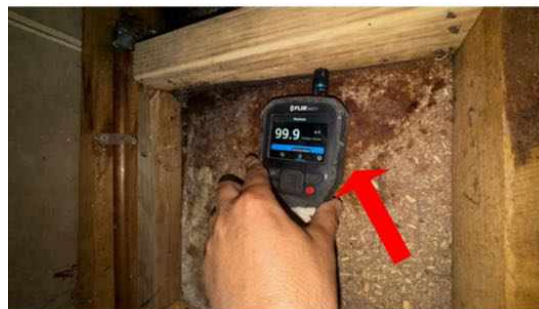
**Defects 2.02**

Building: Main Building  
Location: Subfloor - Master Shower  
Finding: Water Leak - Sub Floor - Flooring  
Information: A water leak was observed in the subfloor with damp timber framing, wet floor materials, and staining indicating ongoing moisture exposure.

The leak is likely caused by a faulty waterproofing systems or plumbing defect allowing water to penetrate the subfloor. If not addressed, this may lead to timber decay, mould growth, structural damage, and potential termite activity.

A licensed plumber should be engaged immediately to locate and repair the source of the leak, and a carpenter or builder may be needed to inspect and repair any affected structural elements. Immediate action is recommended to prevent further deterioration and maintain structural integrity.

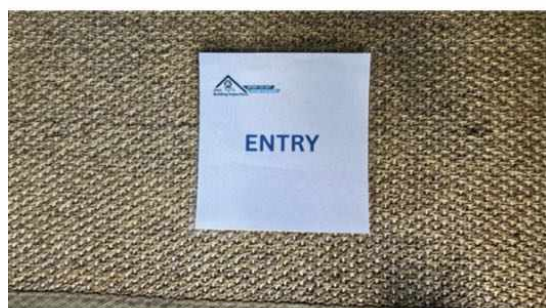
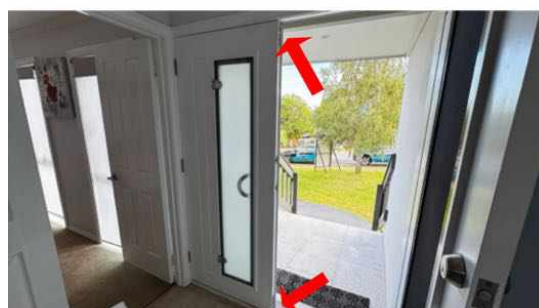
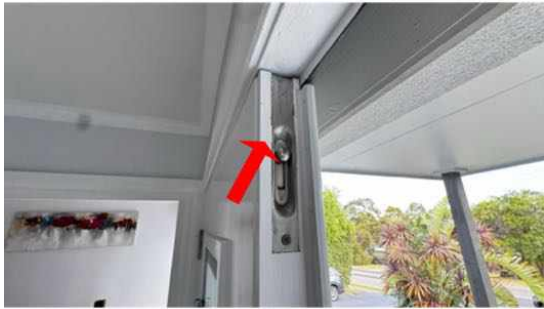
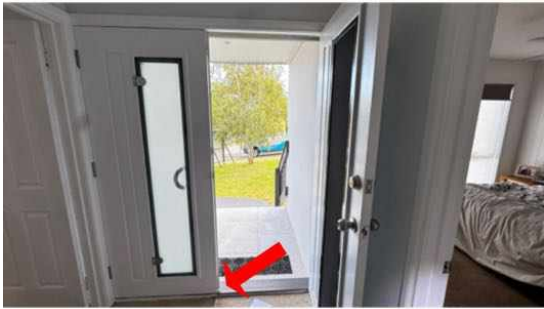
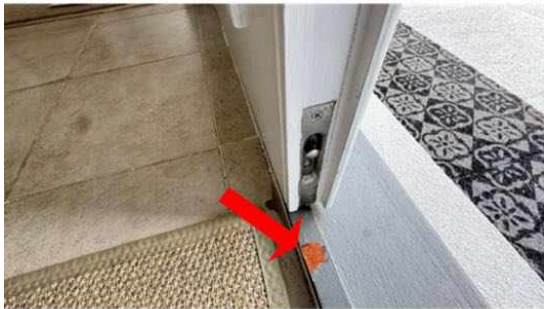
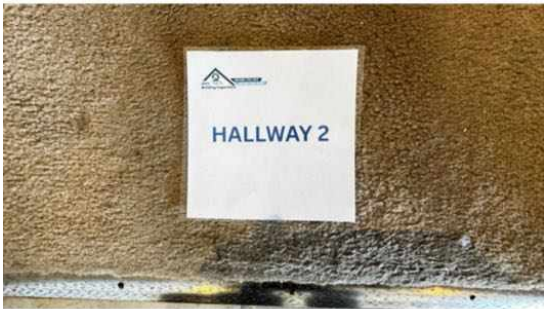
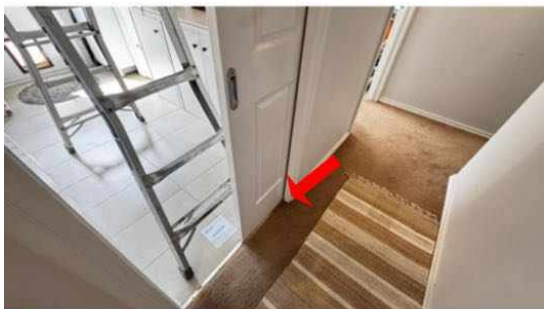
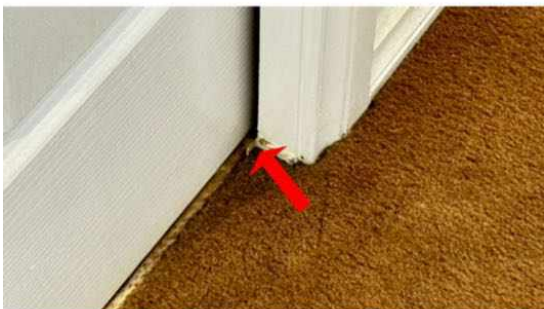
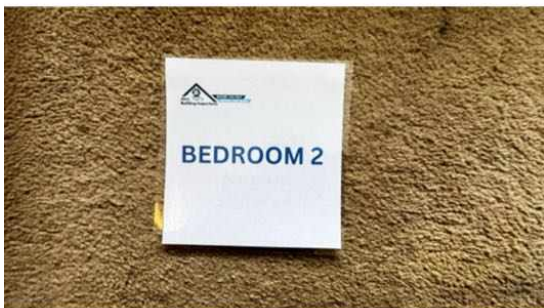
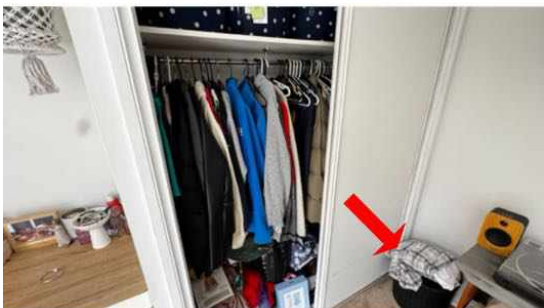
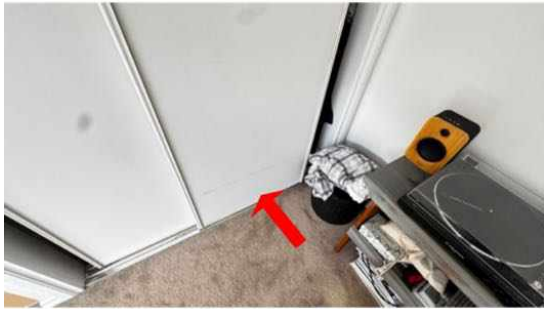
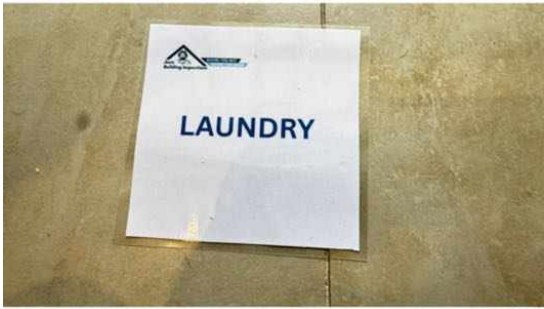
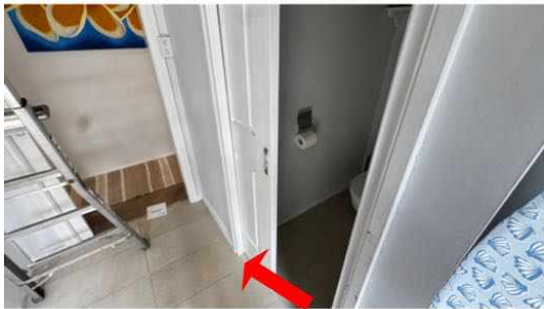
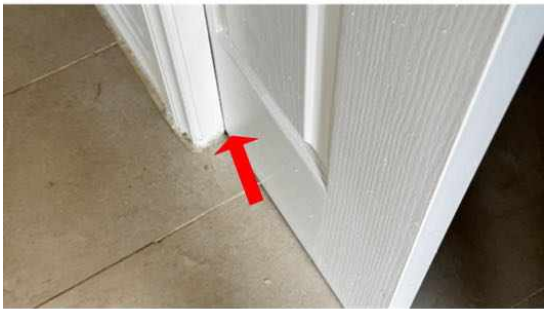
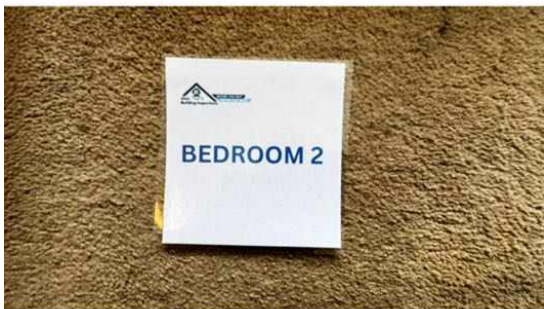
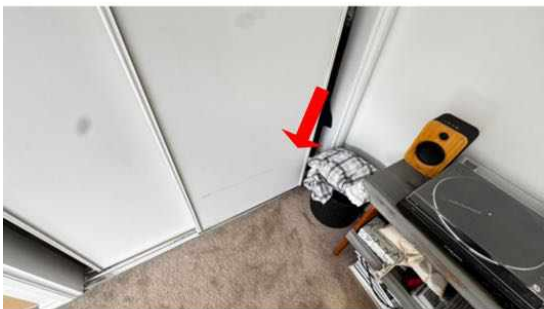
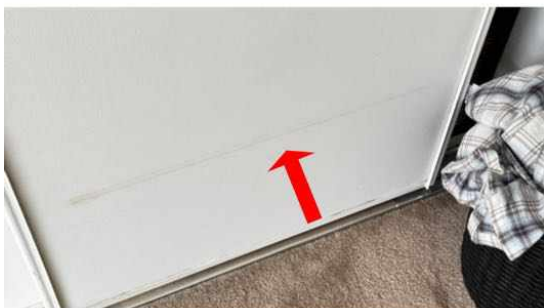
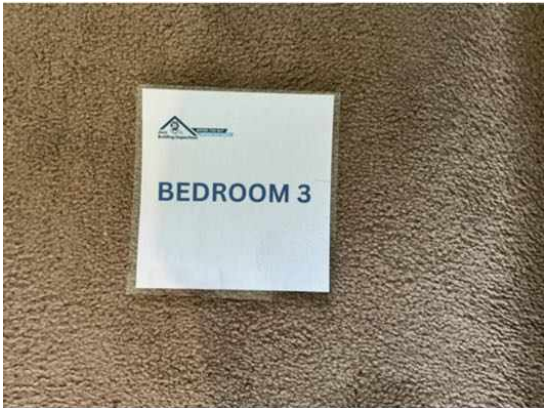
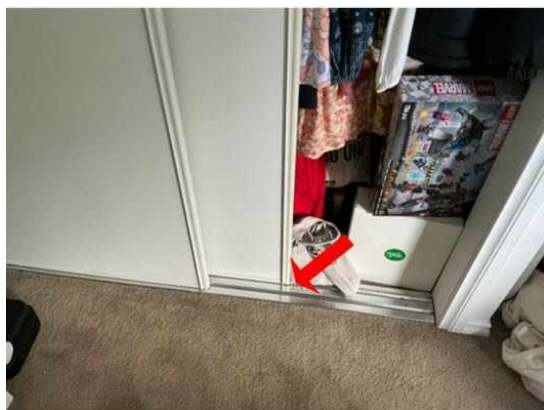
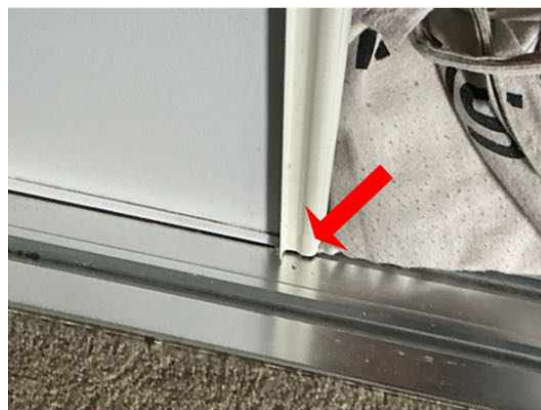
### Defects 3.01

Building:	Main Building
Location:	All Areas
Finding:	Doors - Doors Binding
Information:	Binding or jamming of the door was observed in this area. This affects door functionality and may cause secondary damage to surrounding building elements, such as floor coverings.

Binding can result from minor issues, including poor installation, worn hinges, or misalignment, or from more significant structural problems, such as subfloor movement or damage.

When practical, a qualified carpenter should be engaged to inspect and carry out necessary repairs. If the door continues to bind after repair, or if further movement is observed, a registered builder or structural engineer should be engaged immediately to inspect for underlying structural issues.

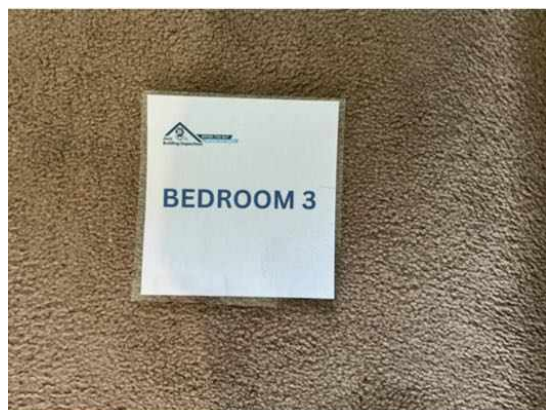
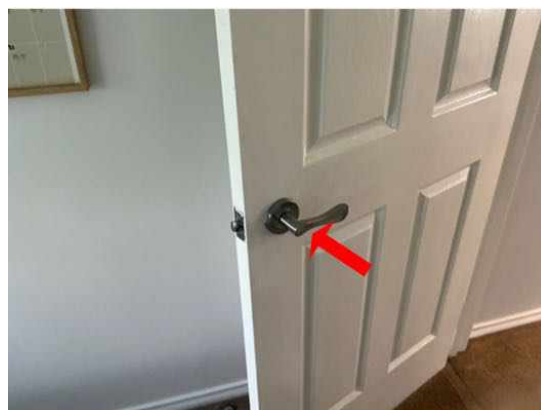
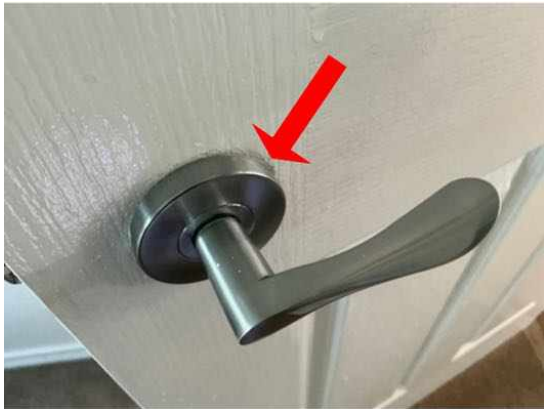
### Defects 3.02

Finding: Doors - Loose Door Handles

Information: The inspection identified loose door handles in this area. Loose door hardware can affect door operation, making opening and closing difficult and reducing overall functionality.

The issue appears to be caused by wear and tear, corrosion, improper installation, or impact damage.

A qualified carpenter or door specialist should be engaged immediately to repair, replace, or adjust the loose handles. Prompt rectification will ensure doors operate smoothly and maintain functionality.

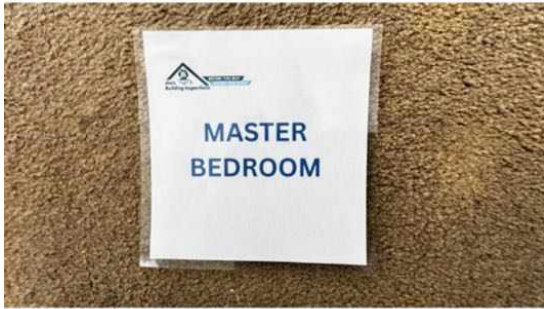
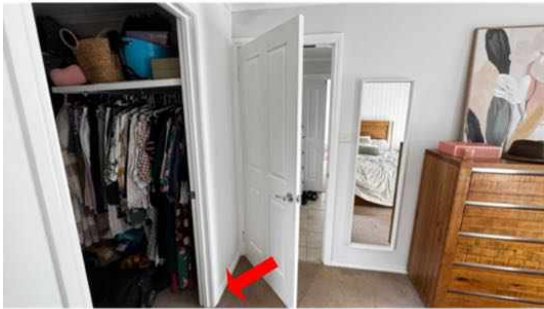
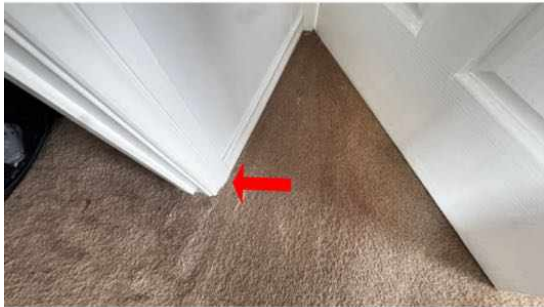
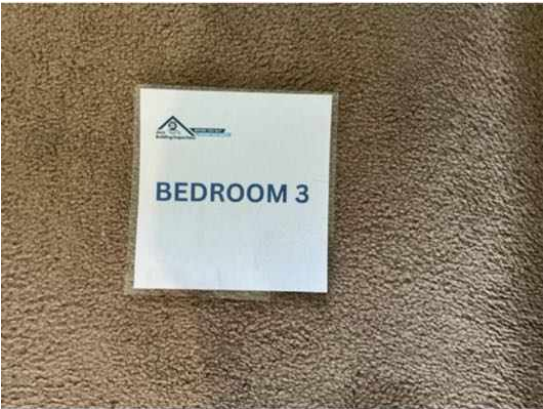
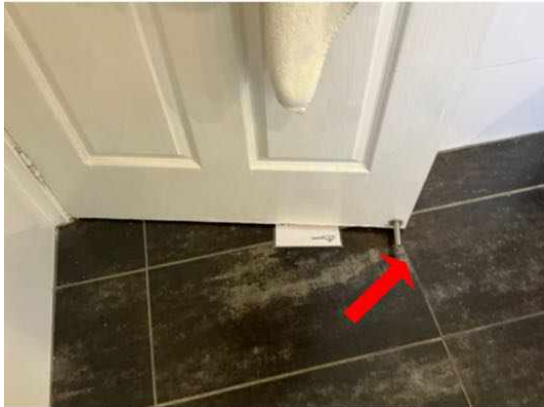
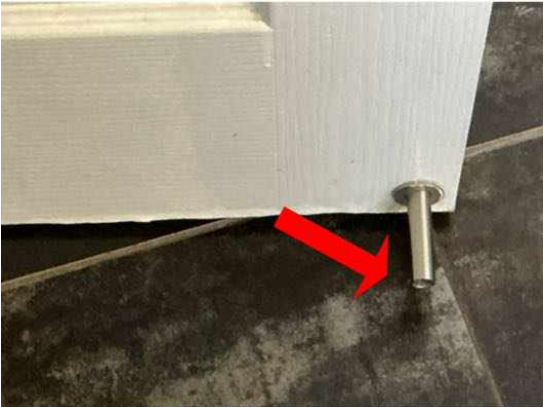
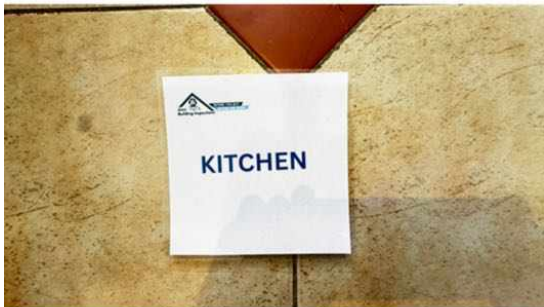
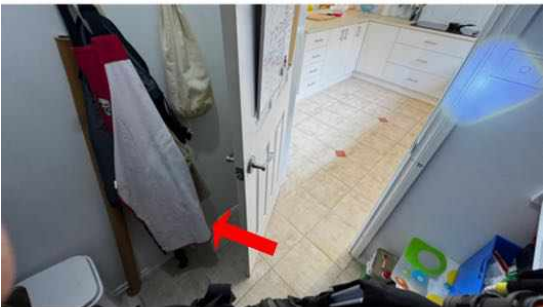
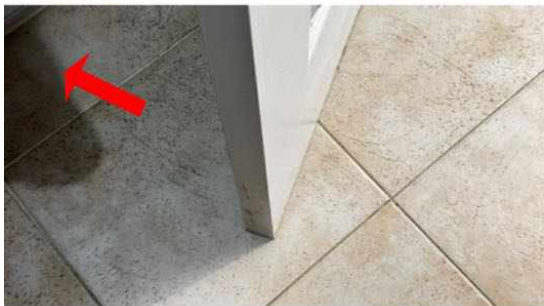
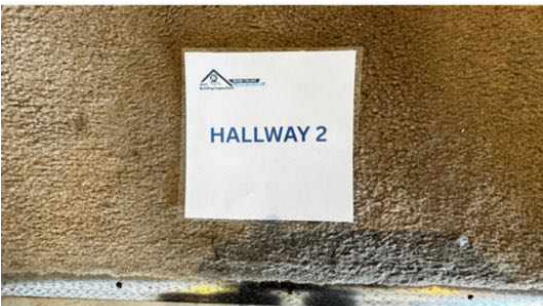
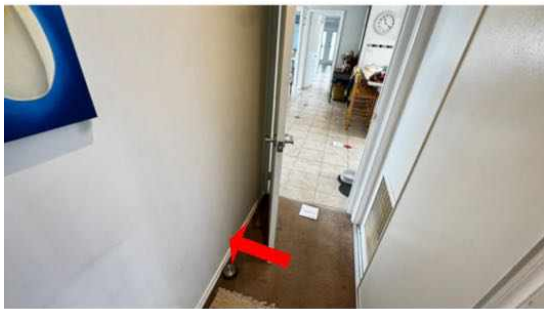
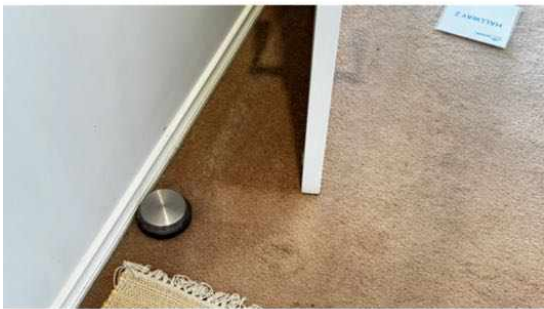
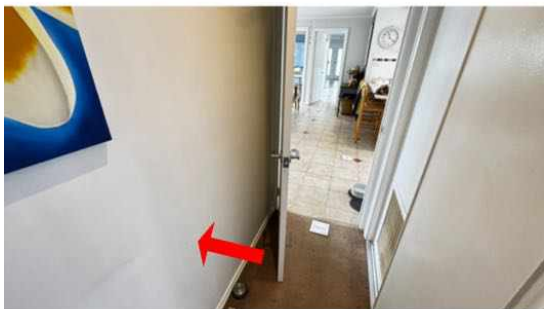
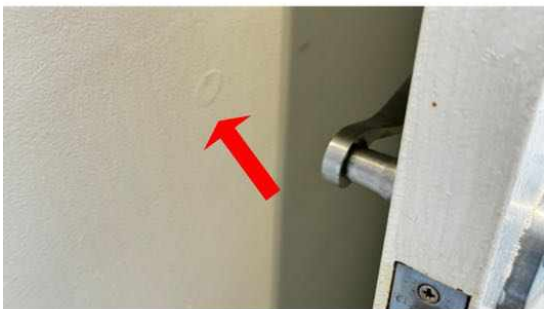
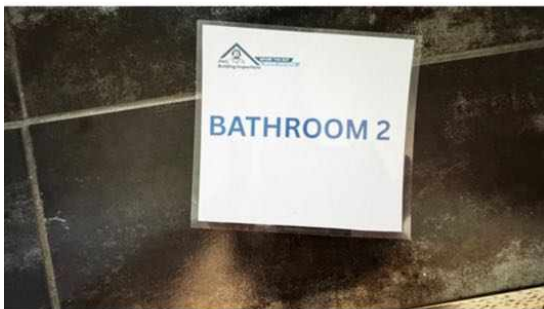
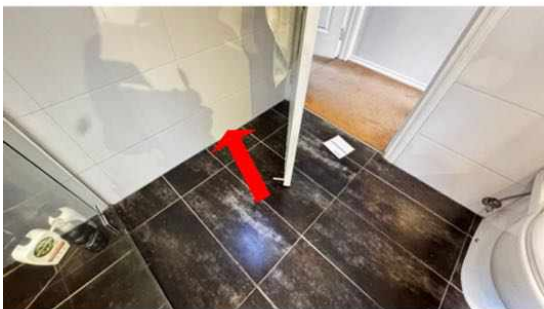
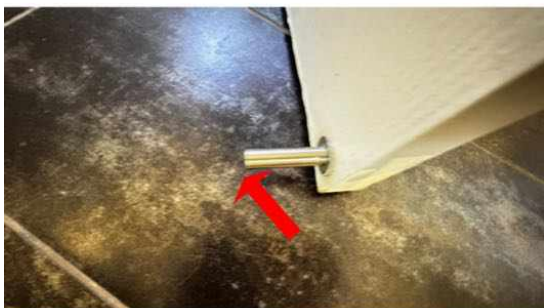
**Defects 3.03**

Building: Main Building  
Location: All Areas >  
Finding: Doors - Missing Door Stops  
Information: The inspection identified missing door stops in this area. Missing door stops can lead to damage to walls or doors and may impair the proper operation of the doors.

The absence of door stops may be due to them not being installed during construction or having been removed after installation.

It is recommended that a qualified carpenter or competent handyman be engaged promptly to install the missing door stops. Correct installation will protect doors and walls and ensure proper door functionality.

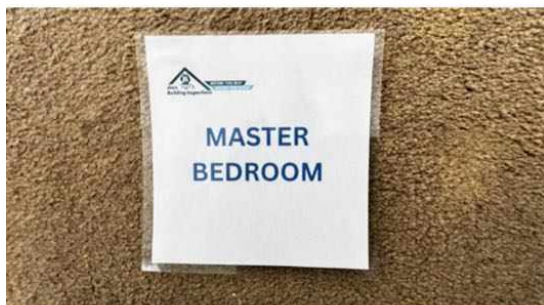
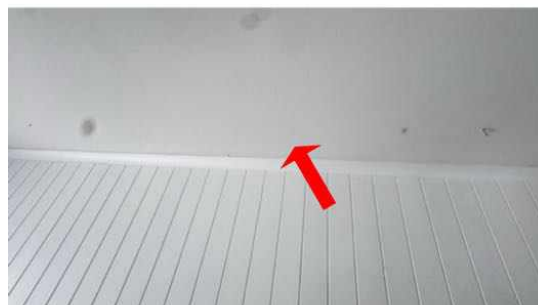
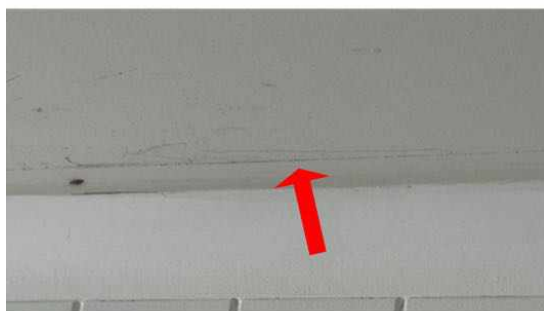
Defects 3.04

Building: Main Building  
Location: All Areas >  
Finding: Ceilings - Paint Finishes Discolouration  
Information: The ceilings were inspected for paint condition, and discolouration and uneven finishes were observed in this area. While primarily a cosmetic issue, the affected paint may indicate age-related wear, poor surface preparation, or previous repairs.

This may be due to age-related degradation of paint layers, poor application or surface preparation, or previous patching with incompatible paint.

When practical, a qualified painter should be engaged to prepare and repaint the affected areas. Addressing paint deterioration will improve the appearance of the ceilings and help protect the surfaces from further wear.

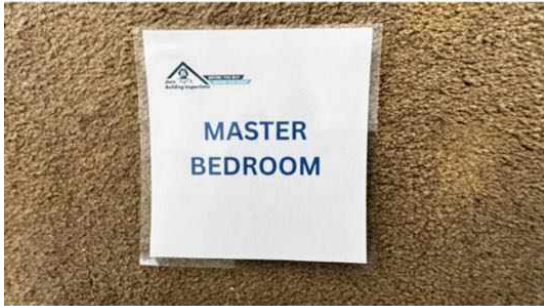
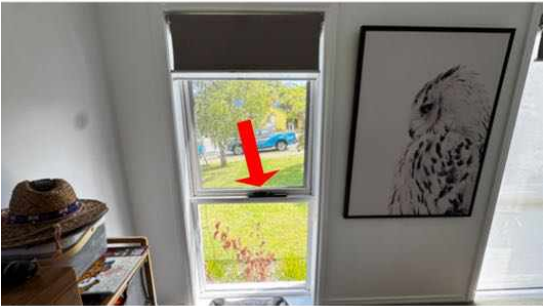
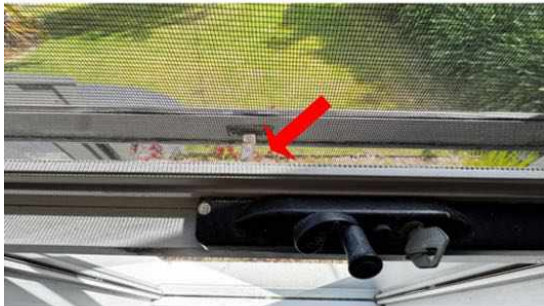
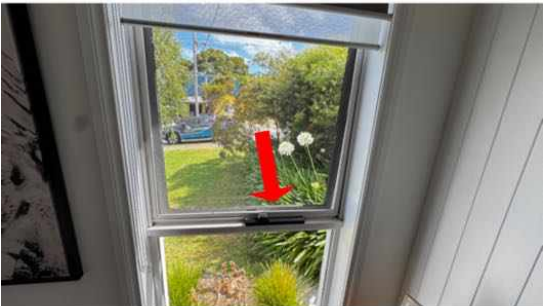
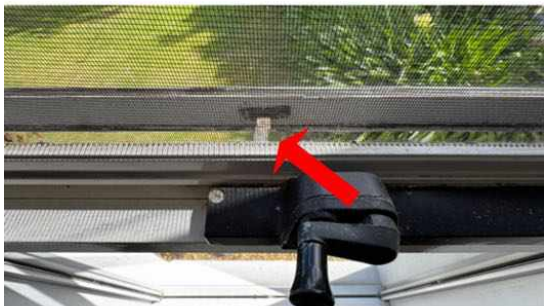
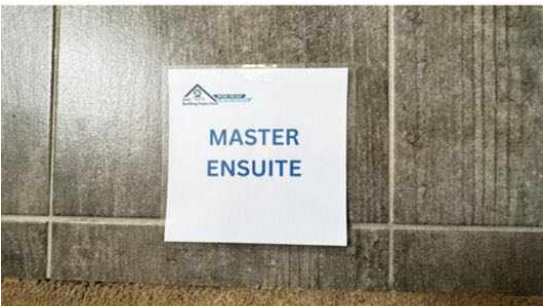
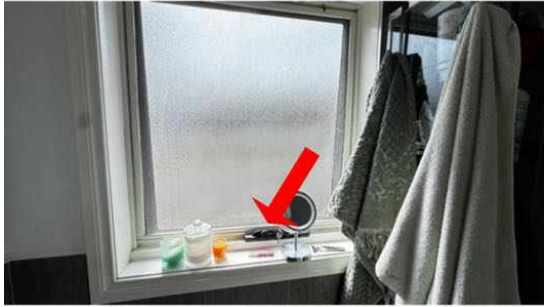
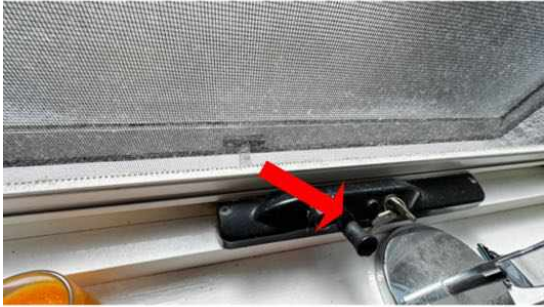
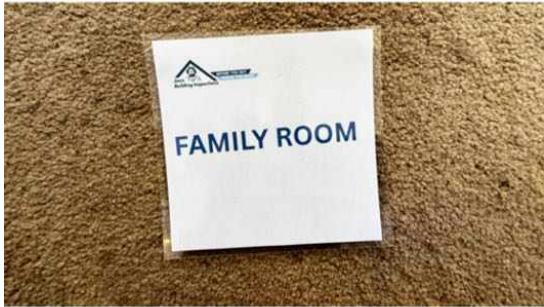
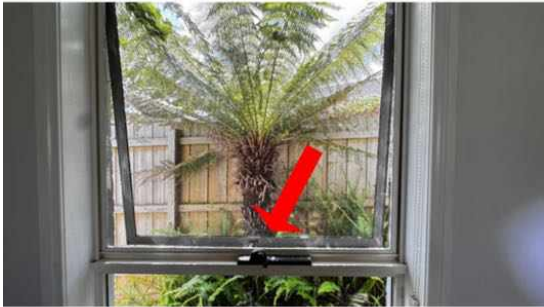
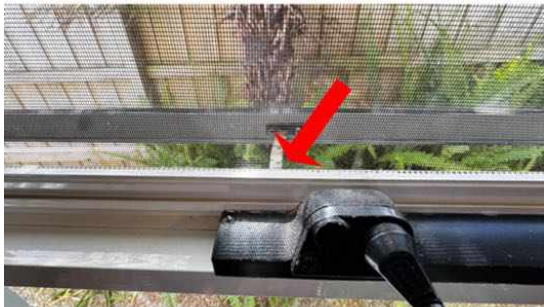
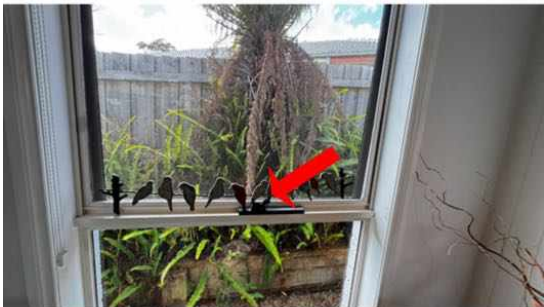
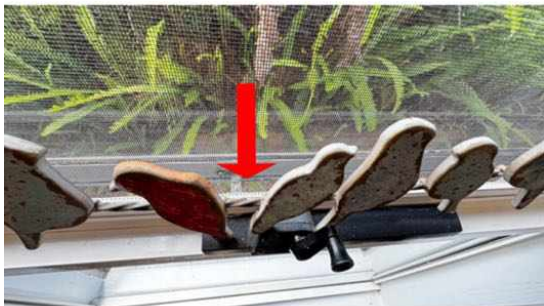
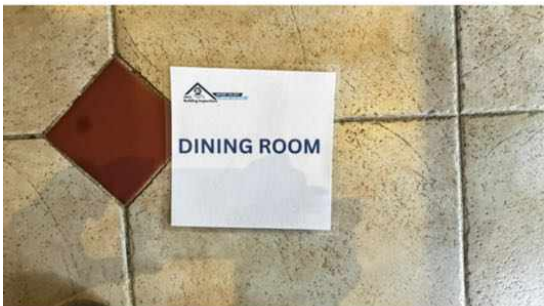
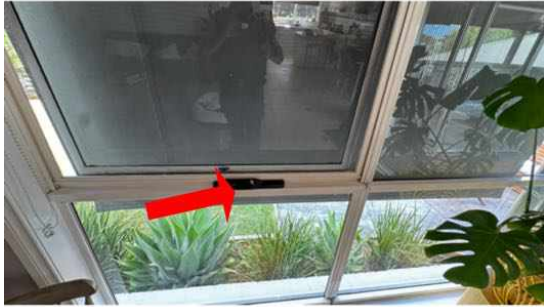
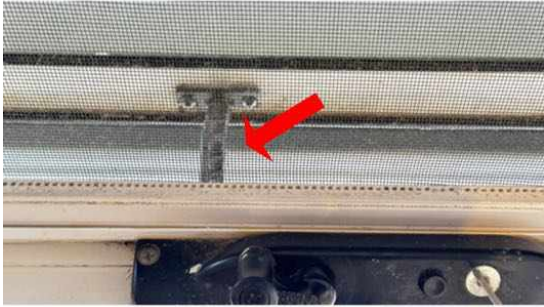
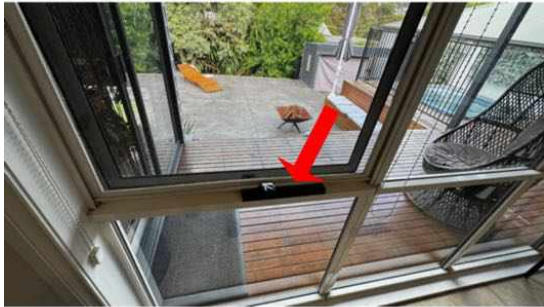
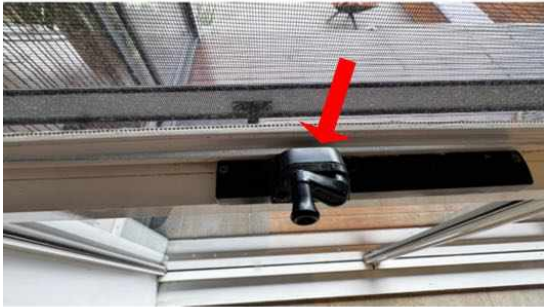
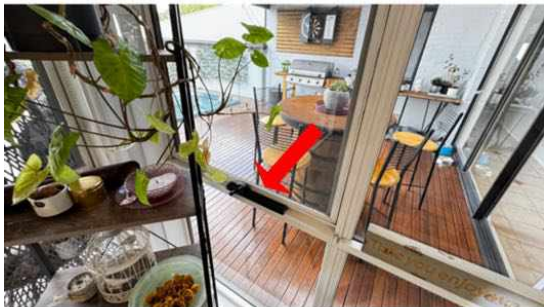
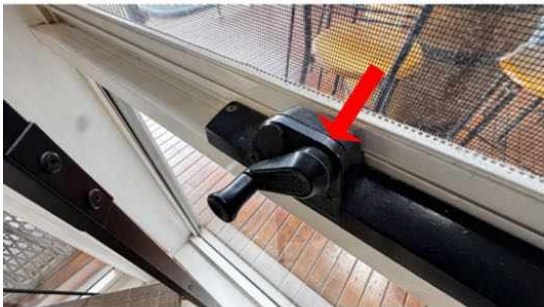
### Defects 3.05

Building: Main Building  
Location: All Areas >  
Finding: Windows - Stiff To Open  
Information: Windows were observed to be stiff to open in this area. The stiffness can make the window difficult to operate, reduce usability, and may increase the risk of damage if force is applied.

Possible causes include misalignment, worn hardware, or buildup of debris.

It is recommended that the building owners engage a window specialist or registered builder immediately to assess the window and adjust, repair, or service it to restore smooth operation.

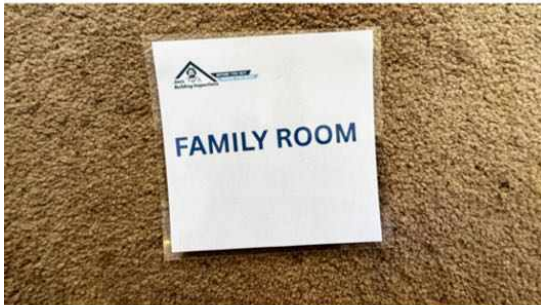
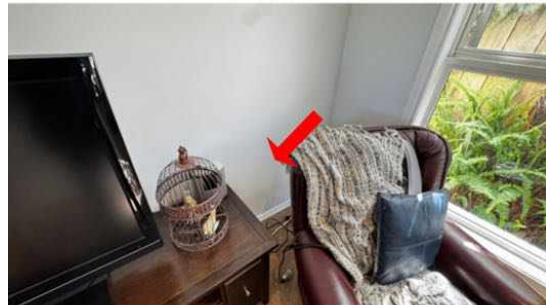
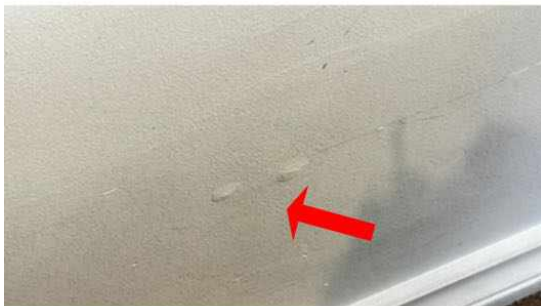
**Defects 3.06**

Building: Main Building  
Location: All Areas  
Finding: Walls - Nails Popping  
Information: The walls were inspected and evidence of nail popping (where nails or screws have worked loose) was observed. This is generally a cosmetic issue, although repeated occurrences may indicate minor movement of the framing or shrinkage of materials.

Possible causes include timber framing shrinkage or seasonal expansion/contraction, slight building settlement causing movement of fixings or inadequate or failing fixings during original construction.

A licensed plastering contractor should be engaged immediately to reset or replace loose fasteners, patch affected areas, and repaint as required. Although nail popping does not typically affect structural integrity, addressing it will maintain wall appearance and prevent further minor damage.

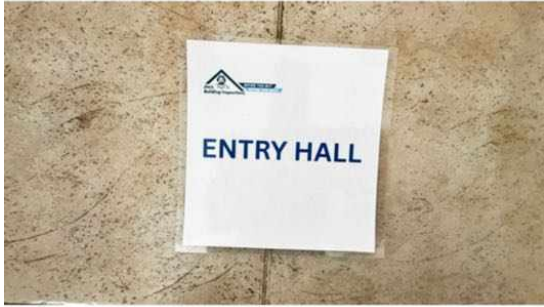
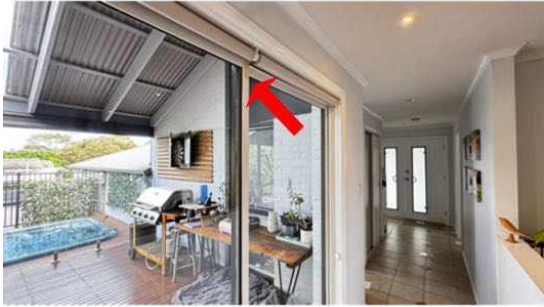
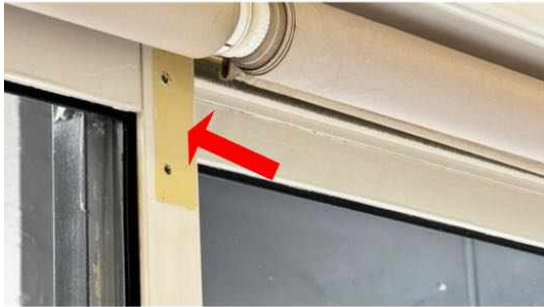
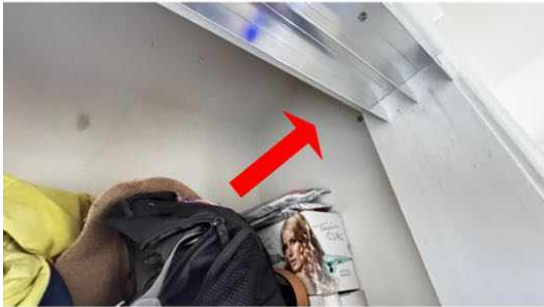
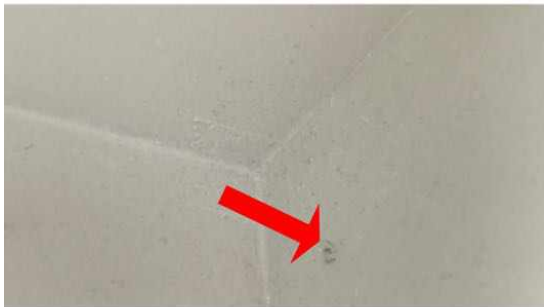
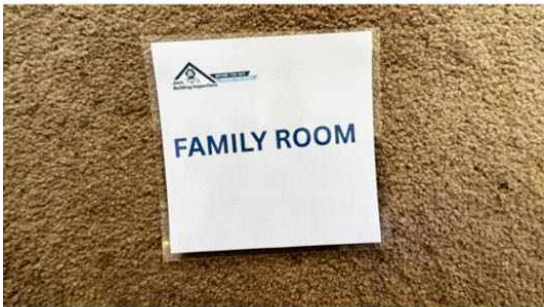
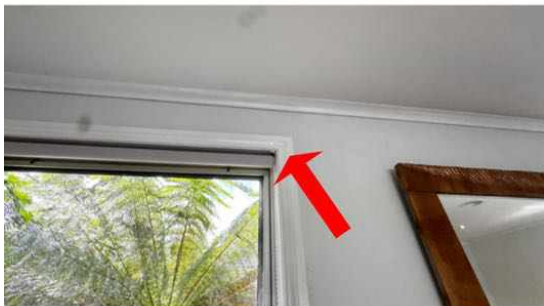
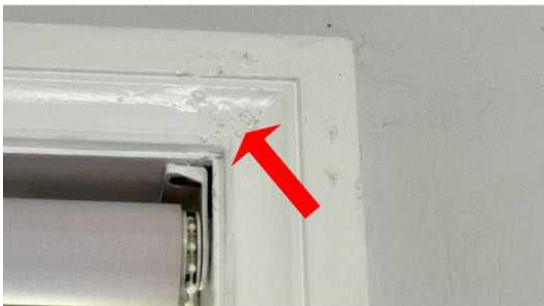
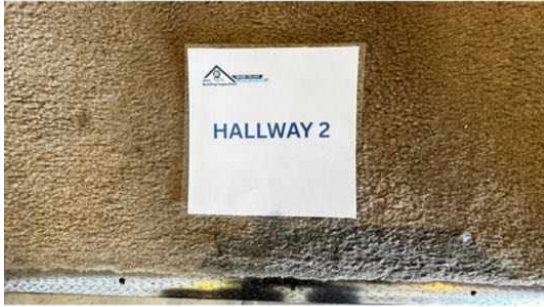
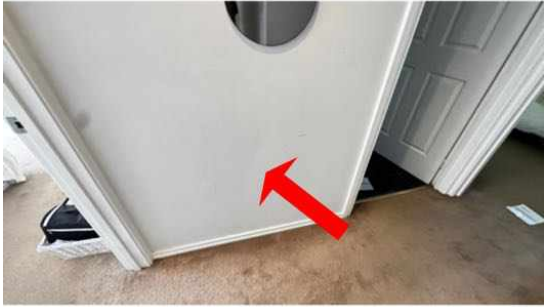
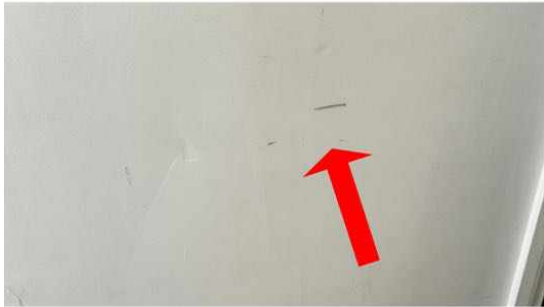
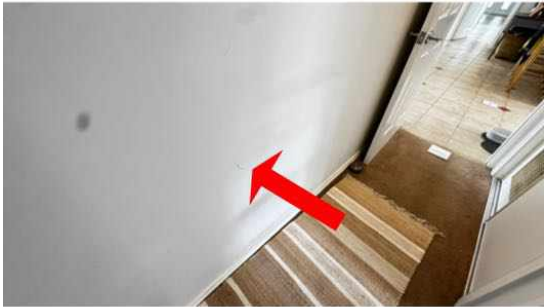
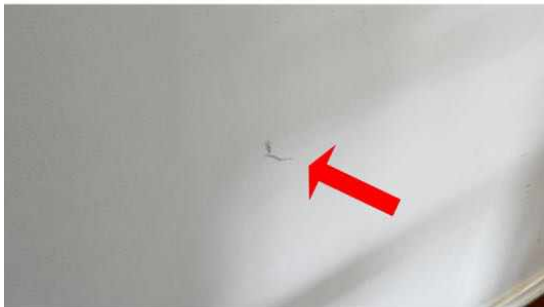
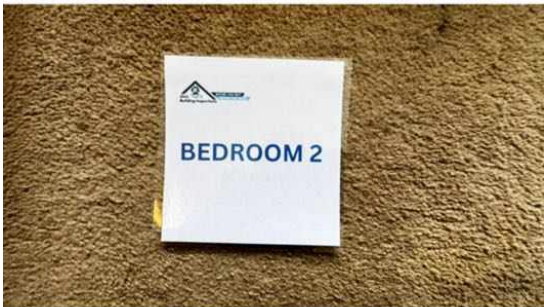
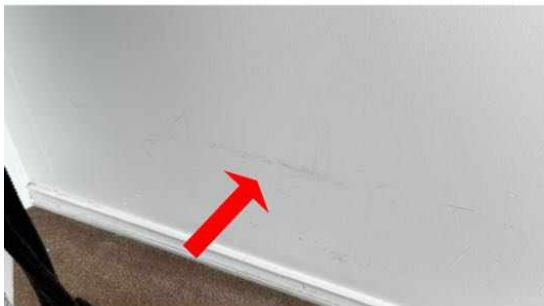
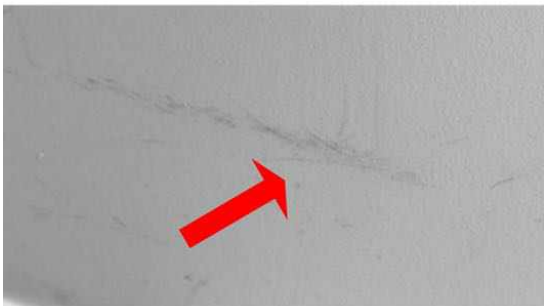
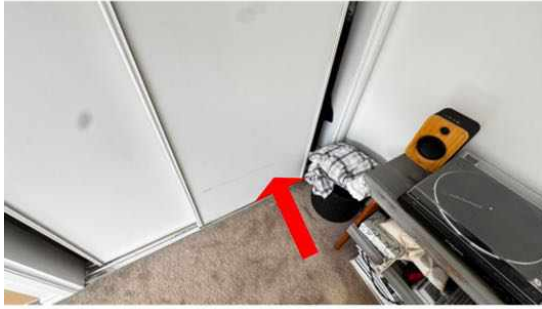
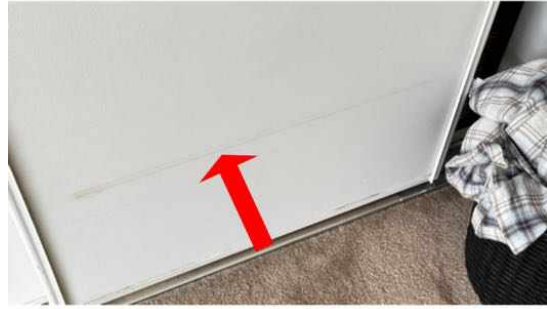
### Defects 3.07

Building:	Main Building
Location:	All Areas
Finding:	Walls - Paint Finishes Discolouration
Information:	The walls were inspected for paint condition, and discolouration was observed in this area.

While primarily a cosmetic issue, the affected paint may indicate age-related wear, poor surface preparation, or previous repairs.

When practical, a qualified painter should be engaged to prepare and repaint the affected areas. Addressing paint deterioration will improve the appearance of the ceilings and help protect the surfaces from further wear.

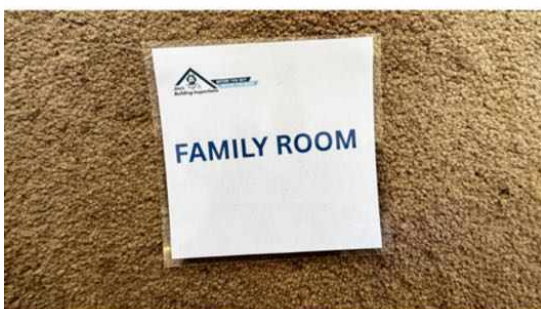
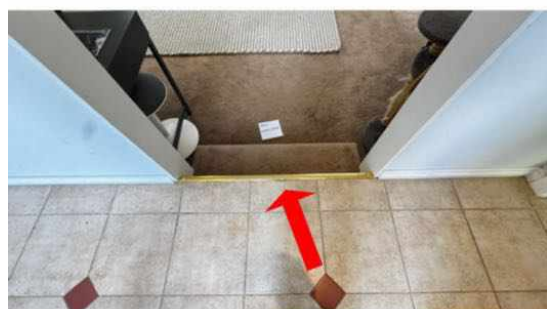
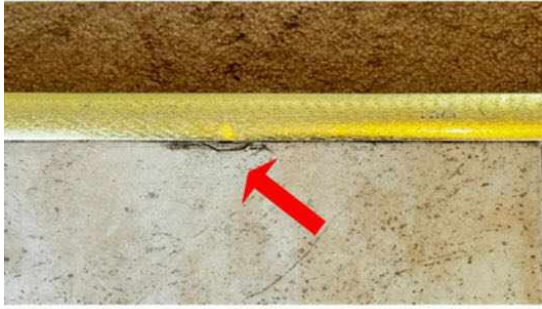
### Defects 3.08

Finding: Floor Tiles - Cracked

Information: Cracked floor tiles were observed in this area. Cracked tiles can affect the aesthetic appearance, create trip hazards, and allow moisture to penetrate underlying substrates, potentially leading to water damage or deterioration of adhesives and substrates.

Possible causes include impact damage, age-related wear, movement or settlement of the substrate, or poor installation practices.

When practical, a qualified tiler should be engaged to assess and replace all damaged tiles, repair or prepare the substrate if required, and restore the finished surface. Prompt attention will maintain durability, prevent water ingress, and improve appearance.

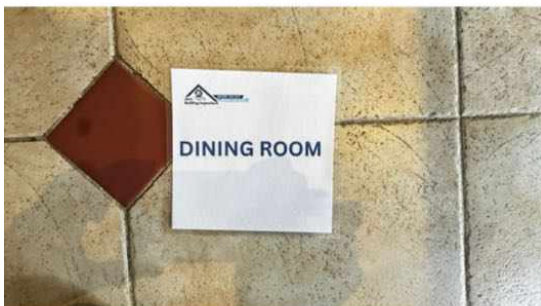
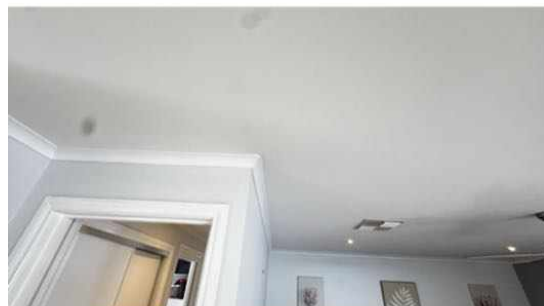
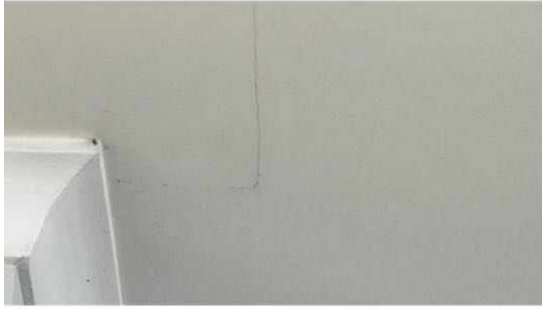
### Defects 3.09

Building:	Main Building
Location:	All Areas
Finding:	Ceilings - Plaster Cracking
Information:	The ceilings were inspected and cracking in the plaster was observed in this area. Cracks can affect the appearance of the ceilings and may worsen over time if left unaddressed.

When practical, a qualified plastering contractor should be engaged to assess and repair the cracked plaster. Prompt action will improve the appearance of the ceilings and help prevent further deterioration.

Cracking should be monitored over time to determine whether movement is ongoing. Where cracks are purely cosmetic, patching and repainting by a qualified plasterer may be undertaken as part of routine maintenance. If cracks widen, reappear after repairs, or are accompanied by other structural signs, further investigation by a registered builder or structural engineer is recommended immediately.

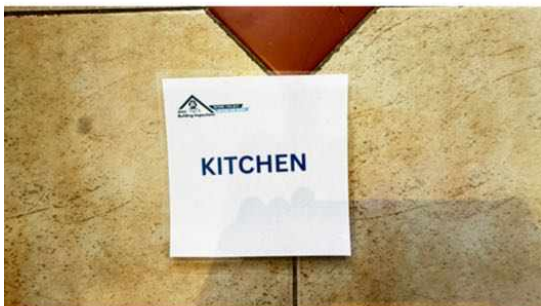
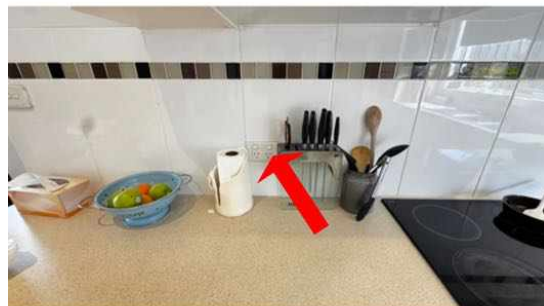
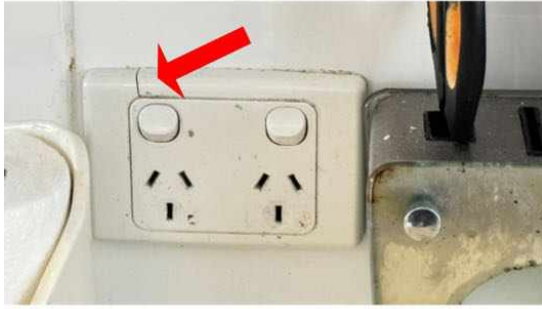
### Defects 3.10

Finding: Electrical - Damaged GPO

Information: A general power outlet (GPO) was observed to be damaged in this area. Damaged GPOs can result in poor electrical connections, increase the risk of electric shock, and may prevent safe use of electrical appliances.

The damage may have been caused by physical impact, age-related wear, loose connections, or exposure to environmental factors.

A licensed electrician should be engaged immediately to inspect and repair or replace the damaged GPO. Prompt rectification will ensure safe operation and reduce the risk of electrical hazards.
