## Building Inspection Report

Inspection Date: Thu, 22 Jan 2026

Property Address: 361 Waterfall Gully Rd, Rosebud VIC 3939,  
Australia

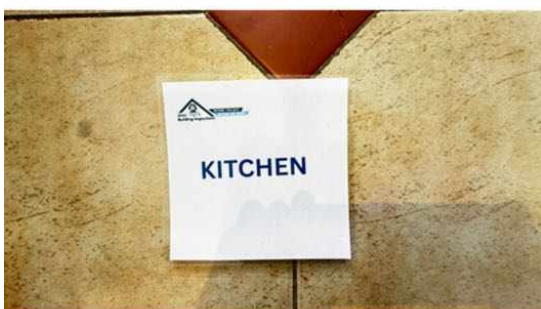
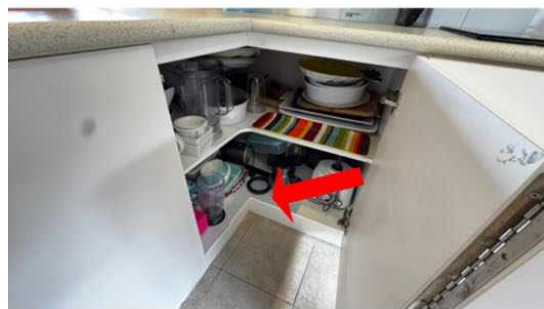
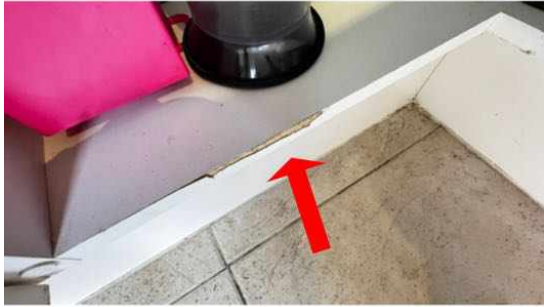
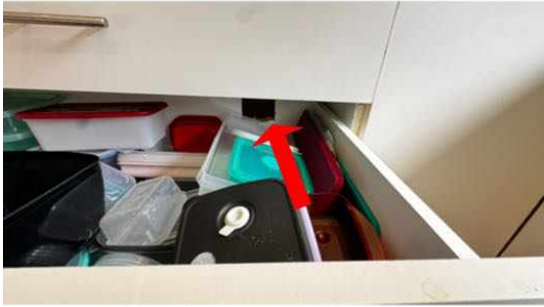
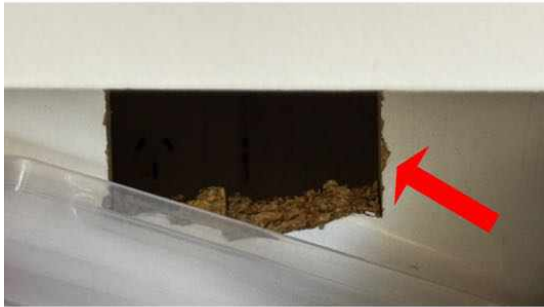
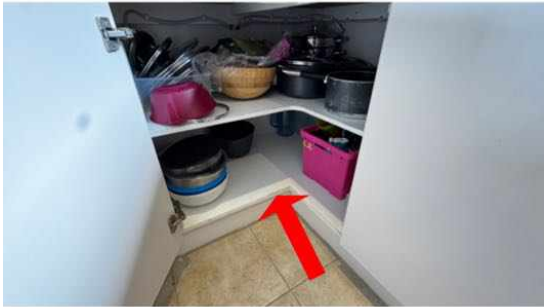
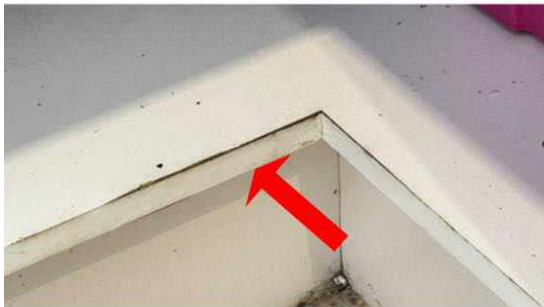
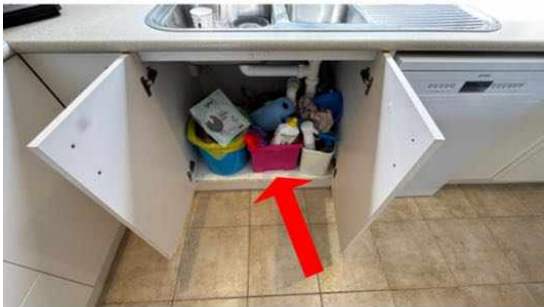
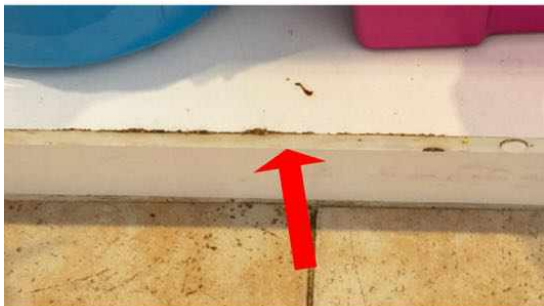
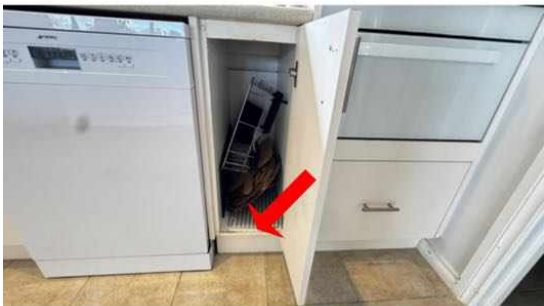
### Defects 3.11

Building:	Main Building
Location:	Kitchen
Finding:	Kitchen - Cabinets - Damaged
Information:	The inspection identified kitchen cabinets with visible damage. Defective cabinets can compromise usability, hygiene, and, over time, may deteriorate further if exposed to moisture.

The issue may be caused by age-related material deterioration, poor installation practices or impact damage from daily use.

A licensed carpenter, joiner, or kitchen specialist should be engaged immediately to assess, repair, or replace the affected cabinets. Remedial works may include re-gluing, re-sealing, replacing damaged sections, or full replacement if structural integrity is compromised. Prompt rectification will restore functionality, prevent further deterioration, and maintain hygiene and appearance.

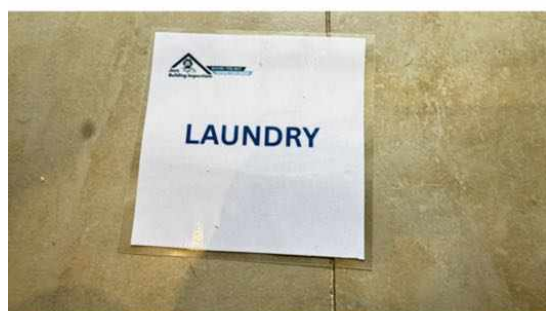
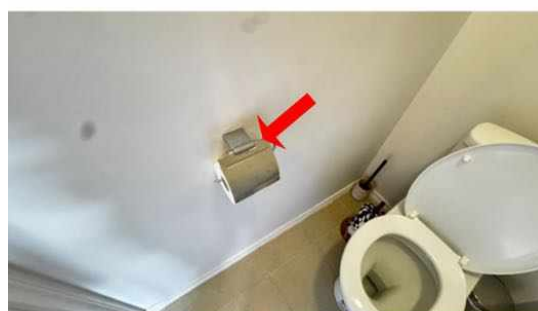
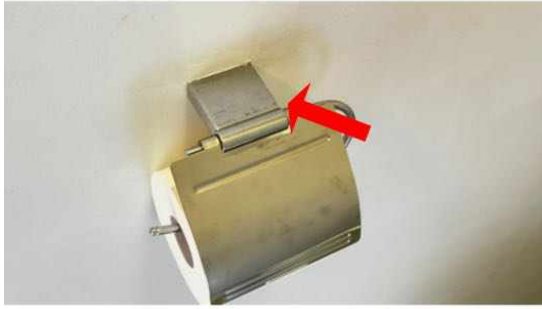
### Defects 3.12

Building:	Main Building
Location:	Laundry >
Finding:	Bathroom Fittings - Loose
Information:	Bathroom fittings were observed to be loose and inadequately secured to walls in this area, moving when light pressure was applied. This reduces usability and may cause further damage if not addressed.

Common causes include incorrect or inadequate fixings, use of anchors unsuitable for the wall type, movement of the wall or timber substrate, wear from repeated use, or improper installation.

If left unresolved, loose fittings may detach, damage wall finishes, or cause progressive deterioration of both fittings and surrounding surfaces.

When practical, a qualified carpenter or experienced handyman should be engaged to securely refix or replace all loose fittings using appropriate fixings and methods for the wall type. The fittings should be monitored over time to ensure they remain secure.

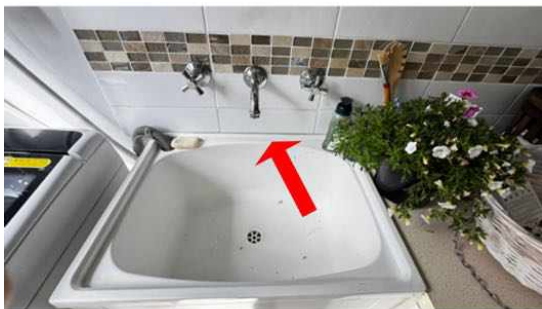
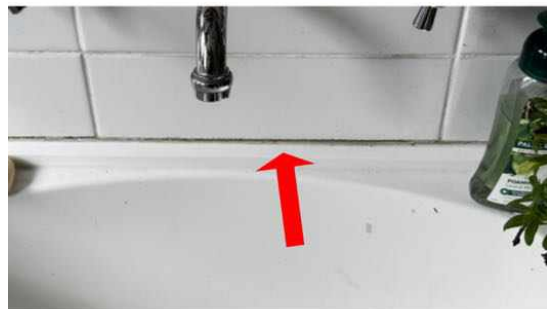
### Defects 3.13

Finding: Laundry - Sealant Missing

Information: The inspection identified sealant in the laundry that is missing. Missing sealant can allow moisture ingress, promote mould growth, and reduce the durability and hygiene of tiled surfaces and joinery.

This may have been caused by lack of routine maintenance and sealing.

A qualified tiler or competent handy man should be engaged immediately to apply new, compliant sealant materials. Properly maintained sealant will prevent water ingress, maintain hygiene, and extend the life of adjacent surfaces.

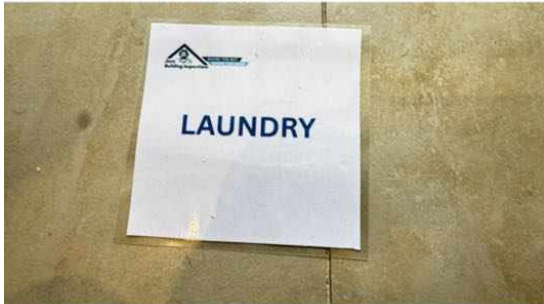
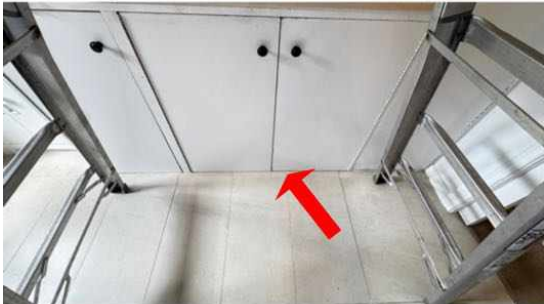
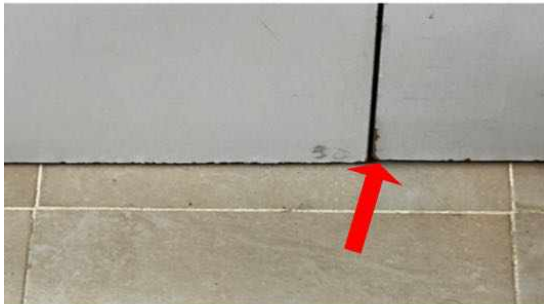
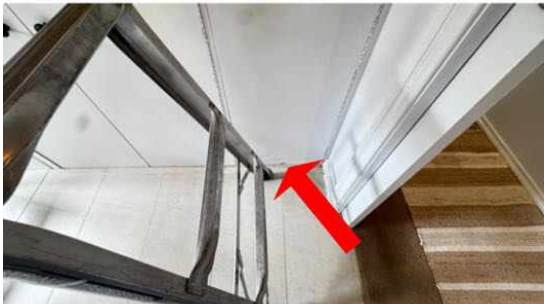
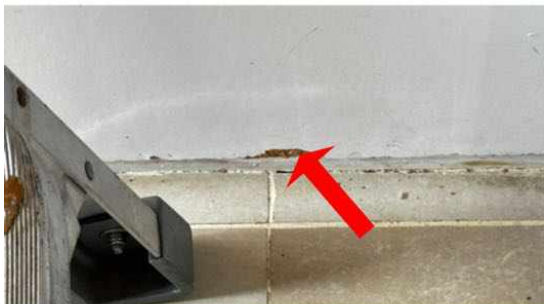
### Defects 3.14

Finding: Cabinets - Damaged

Information: Visible damage was noted to cabinet units, affecting both their appearance and functionality. If left unaddressed, the damage may worsen over time.

This damage may result from impact during installation or use, moisture exposure,

poor-quality materials or finishes, or inadequate installation and protection during construction. \*No elevated moisture levels were detected at the time of inspection.

When practical, a qualified cabinetmaker should be engaged to repair or replace the damaged components to restore proper function and appearance.

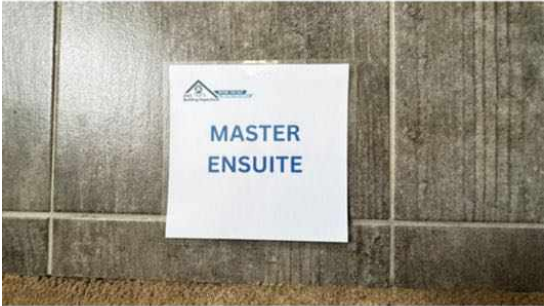
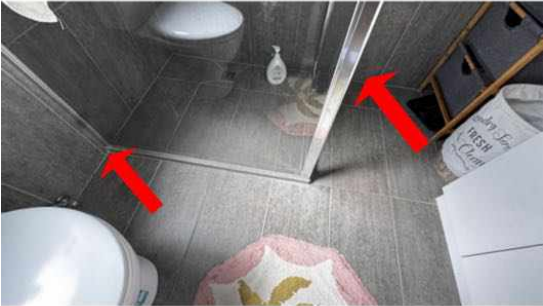
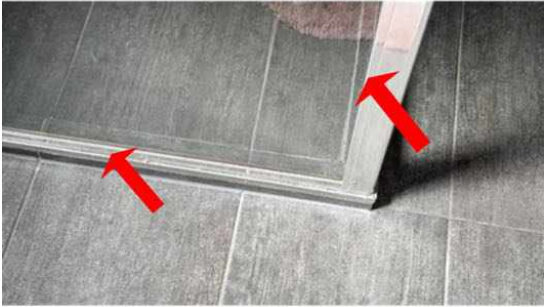
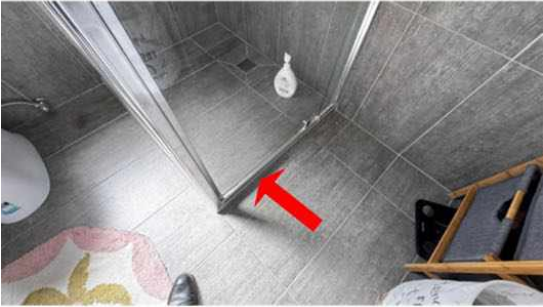
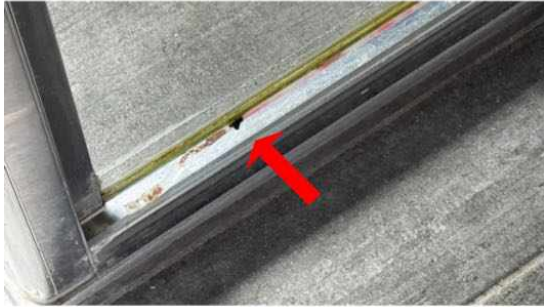
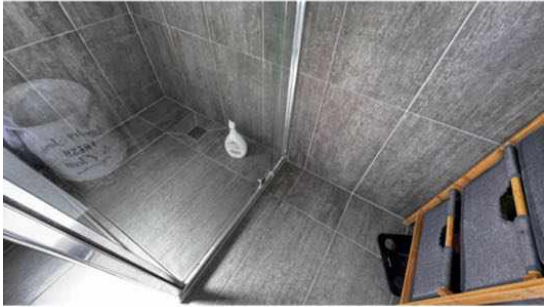
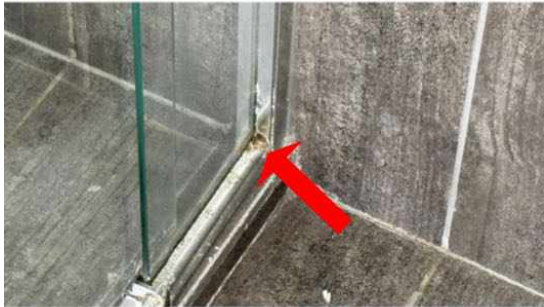
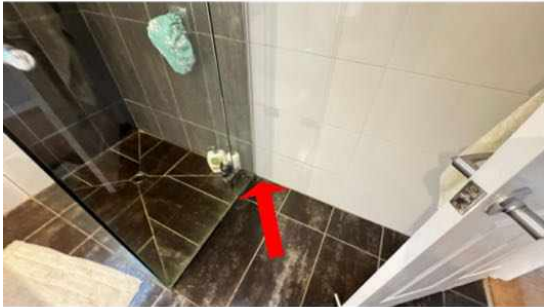
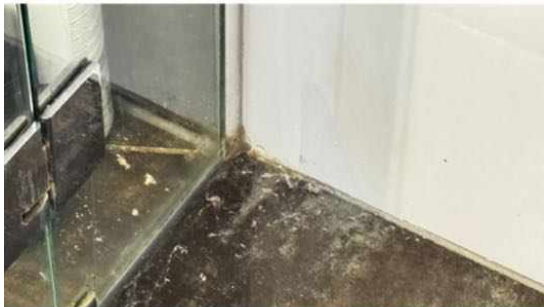
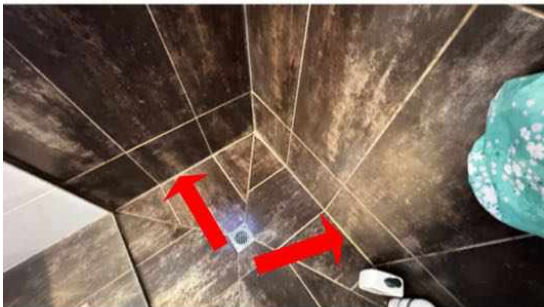
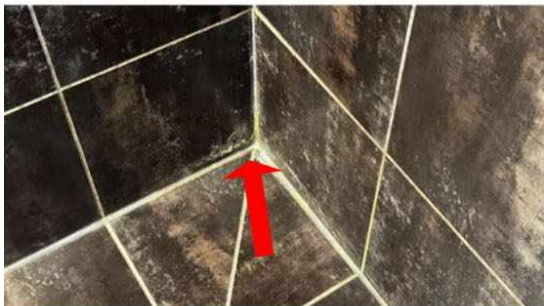
**Defects 3.15**

Building:	Main Building
Location:	Ensuite & Bathroom 2
Finding:	Caulking - Inadequate - Floor To Wall Junctions
Information:	Inadequate and poorly applied caulking was observed at the floor-wall junction in this

area, with gaps, deterioration, and irregular application reducing the effectiveness of the sealant barrier. These deficiencies will allow water to penetrate beneath floor coverings or into surrounding building materials, particularly in wet areas.

Common causes include uneven or insufficient sealant application, use of inappropriate or low-quality products, movement of adjoining surfaces, age-related deterioration, or poor surface preparation affecting adhesion.

If left unaddressed, moisture may penetrate subfloor or floor/wall materials, potentially causing swelling, mould growth, deterioration of finishes, and progressive widening of gaps. \*Note no elevated moisture levels were detected at the time of inspection.

A qualified tradesperson, such as a tiler or caulking specialist, should be engaged promptly to remove any failed sealant and apply a compliant, flexible sealant to ensure a continuous moisture barrier. The area should be monitored over time for further movement or degradation.

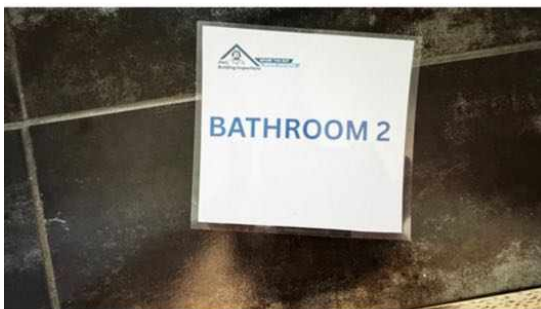
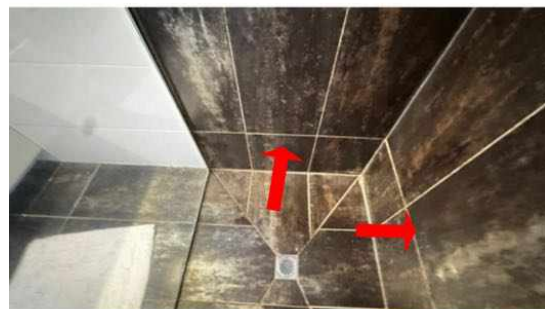
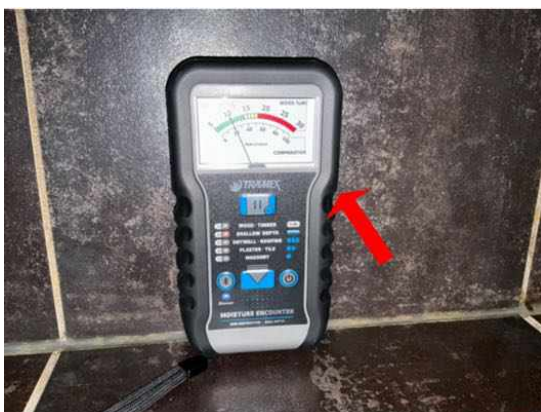
Defects 3.16

Building: Main Building  
 Location: Bathroom 2 >  
 Finding: Shower Damp - To Be Monitored & Epoxy Grout  
 Information: Damp is evident to the lower wall to the shower alcove and acceptable level moisture reading were found to the reverse side of the shower. Moisture readings were not found to the wall adjacent to the shower.

Damp (or structural damp) refers to the presence of unwanted moisture in the structure of a building, either as the result of intrusion from outside, or condensation from within the structure. In the shower area, internal water leaks or other sources of excessive moisture are generally the cause of damp.

It is advised to engage an epoxy grout specialist to remove and replace the grout with epoxy grout and install epoxy to all floor wall corner joints.

Always ensure that sealant and grout is in good condition to prevent any moisture issues occurring in the future

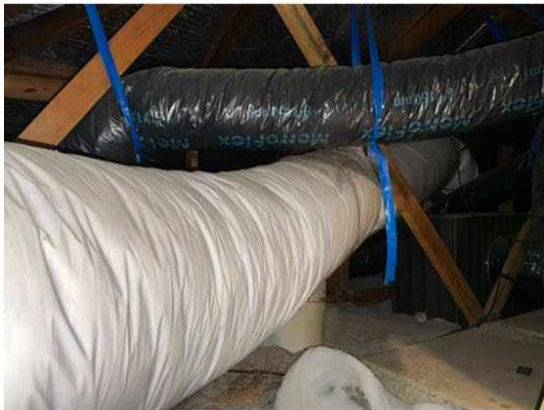
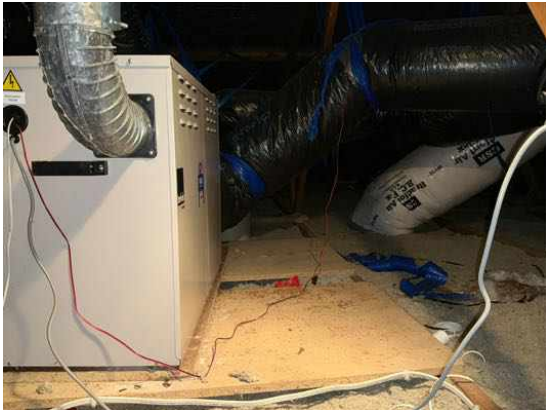
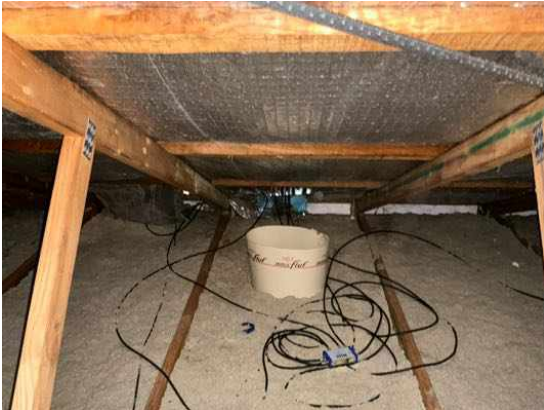
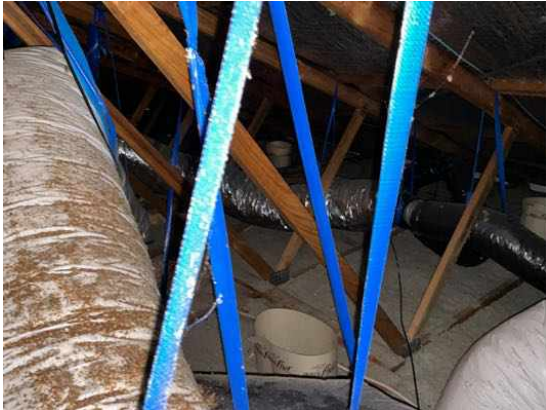
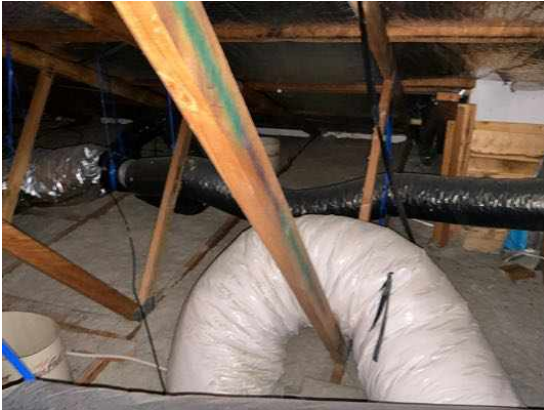
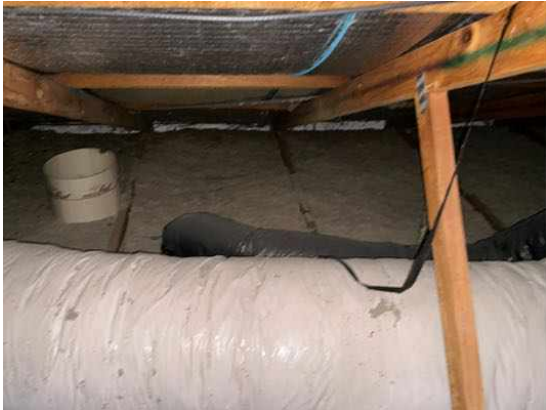
### Defects 3.17

Building: Main Building  
 Location: Roof Void  
 Finding: Roof Void - Limited Access

Information: Limited access to the roof void was present due to facts including but not limited to, limited access, insulation, Air condition Unit & ducting, obstructions or placement of insulation and or sarking, for this reason complete access to the roof void was not possible.

A visual inspection was carried out from accessible areas only, recommend installing another access hatch in a more accessible area for a re-inspection.

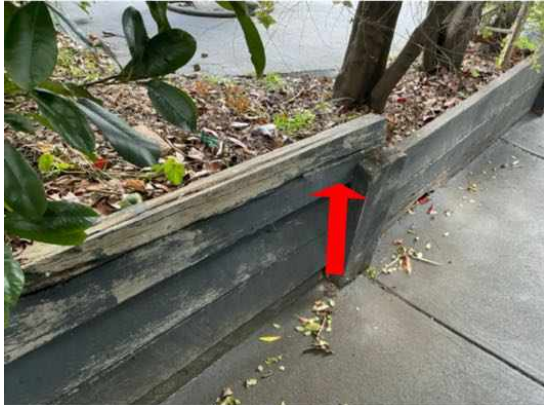
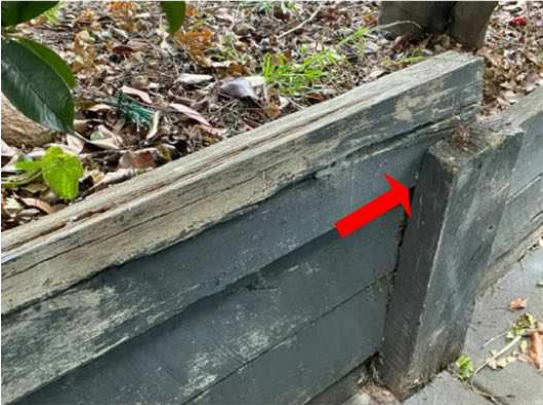
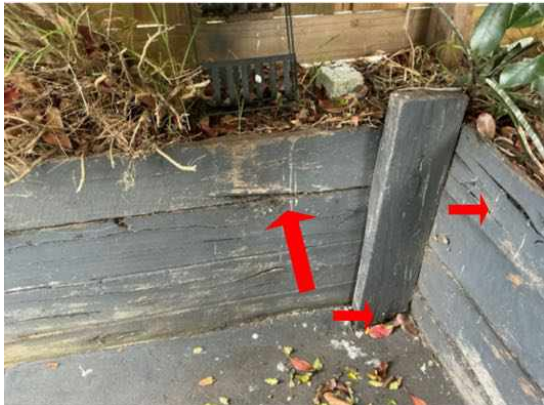
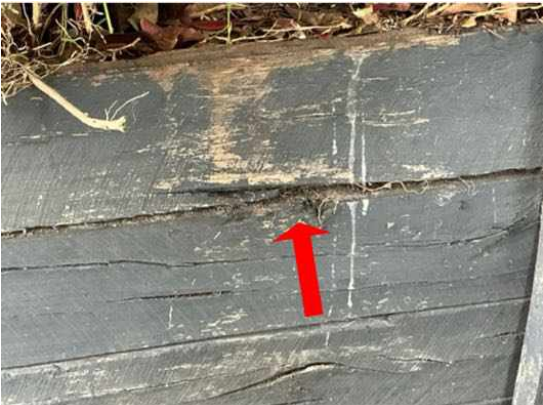
### Defects 3.19

Finding: External Timber - Timber Rot

Information: Timber elements including wall claddings, timber rails & posts, landscaping timbers, and other external timber surfaces were inspected and show signs of rot, decay and fungal attack in these areas. Softening, discoloration, splitting, and moisture penetration indicate ongoing timber degradation.

This is likely caused by prolonged moisture exposure, inadequate protective coatings or maintenance, direct contact with soil or water, or poor detailing that traps water or limits ventilation.

If left unaddressed, the affected timber may lose structural integrity, leading to progressive decay, potential collapse of walls, decks, or landscaping features, mould growth, and reduced durability and appearance of the building exterior.

A registered builder or timber specialist should inspect the affected areas immediately to determine the extent of damage. Damaged timbers should be repaired or replaced, protective treatments applied, and drainage or detailing corrected to prevent recurrence. Ongoing monitoring and urgent remedial action are required to prevent further deterioration.

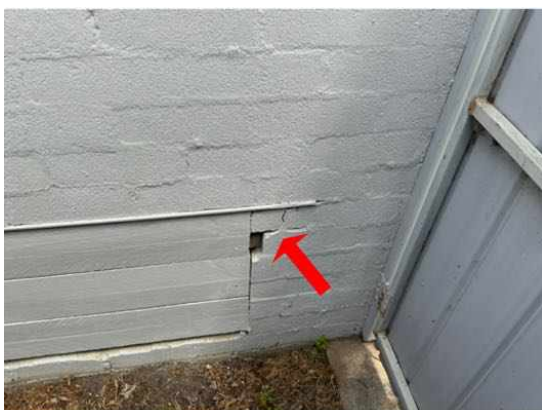
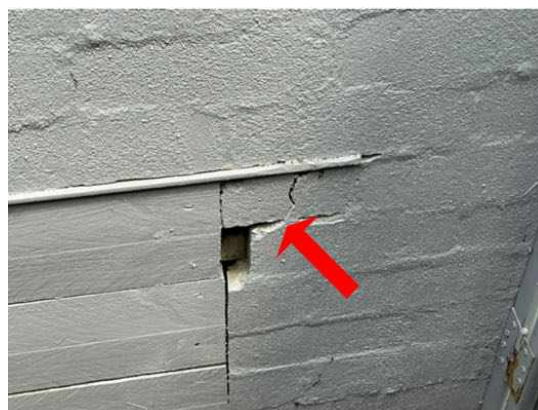
### Defects 3.20

Building:	Main Building
Location:	All External Areas >
Finding:	External Walls - Minor Cracking To Wall Claddings
Information:	Minor cracking was observed to the external walls in this area. The cracking appeared superficial and did not indicate significant structural movement; however, such cracking can allow moisture ingress if left unaddressed.

The cracking is likely due to building movement or minor settlement.

When practical, a registered builder should assess and repair the cracking, which may include sealing and repainting. The area should be monitored, and any increase in cracking or signs of movement should be further investigated immediately by a Structural Engineer.

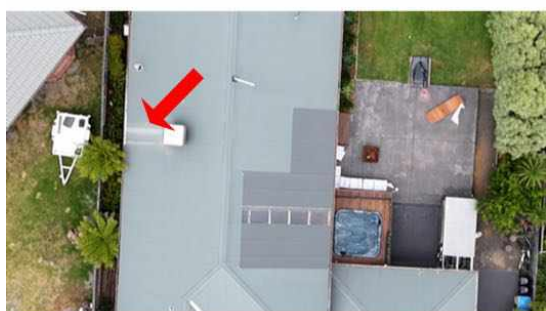
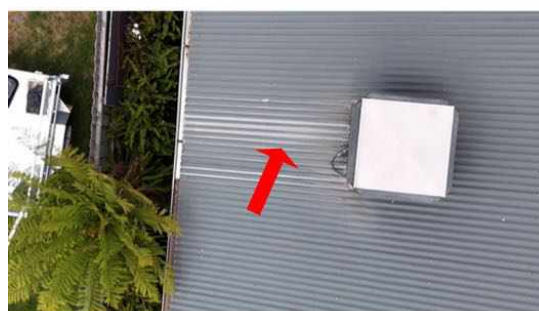
### Defects 3.21

Building:	Main Building
Location:	All External Areas >
Finding:	AC Condensate Drain - Not Connected To Storm Water
Information:	The air conditioning condensate drain in this area was observed to be disconnected from stormwater drainage.

When condensate is not properly directed to a stormwater outlet, water can accumulate around the building or air conditioning unit, creating damp conditions that may lead to secondary defects such as timber rot, corrosion of nearby metal components, mould growth, or slippery surfaces. Prolonged pooling of water may also attract termites and contribute to long-term deterioration of surrounding building elements.

A qualified HVAC technician or licensed plumber should be engaged immediately to connect the condensate drain to a suitable stormwater outlet. Prompt rectification will ensure proper drainage, protect the building fabric, and reduce potential health and safety risks.

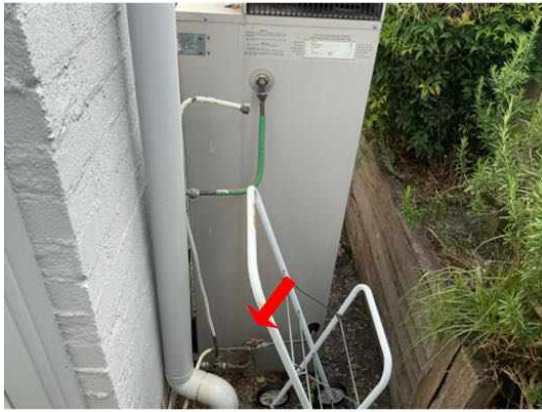
## Defects 3.22

Building:	Main Building
Location:	All External Areas >
Finding:	HWS - (T&P) Valve Not Connected To Storm Water
Information:	The Hot Water System (HWS) Temperature & Pressure Relief (T&P) valve discharge pipe was observed to be disconnected from stormwater drainage.

When not properly connected, discharged water can create damp conditions around the HWS, potentially leading to secondary defects such as timber rot, corrosion of nearby metal components, mould growth, or slip hazards. Prolonged exposure to moisture in this area may also attract termite activity and contribute to long-term deterioration of surrounding building elements.

A licensed plumber should be engaged immediately to connect the T&P discharge pipe to a suitable stormwater outlet or floor waste. Prompt rectification will ensure safe operation of the HWS, protect surrounding structures, and reduce potential health and safety risks.

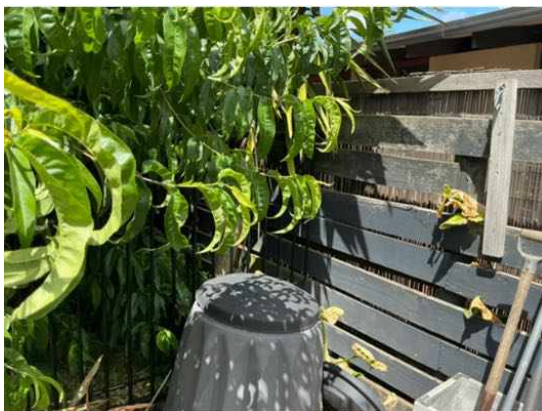
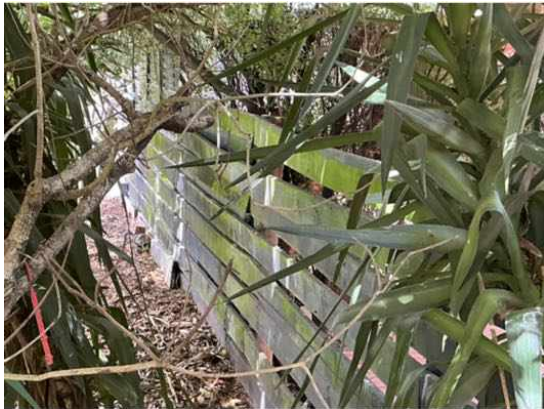
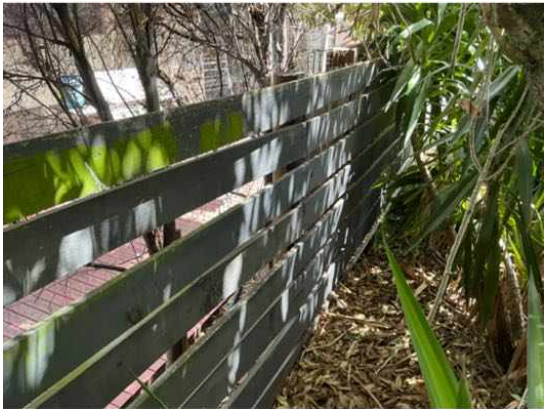
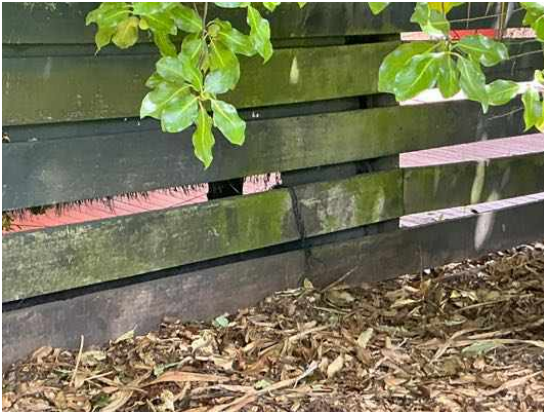
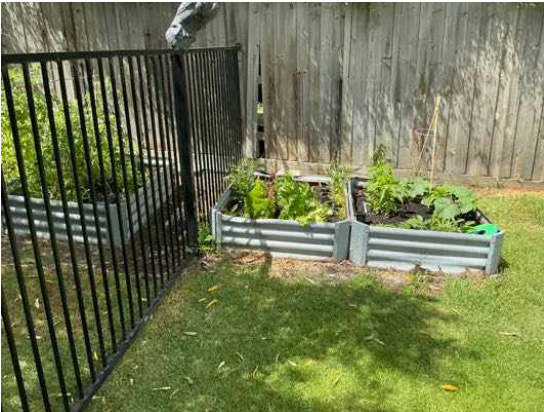
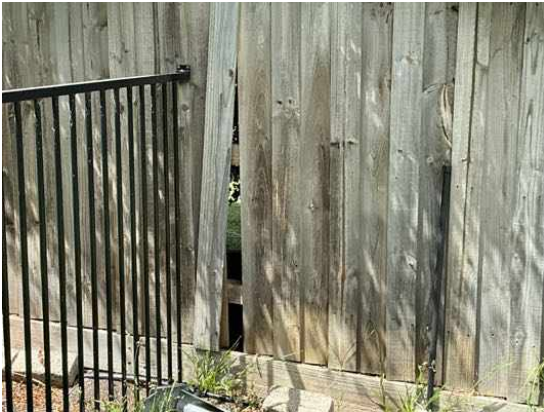
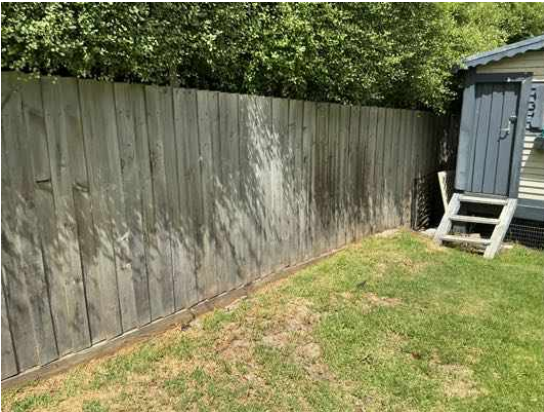
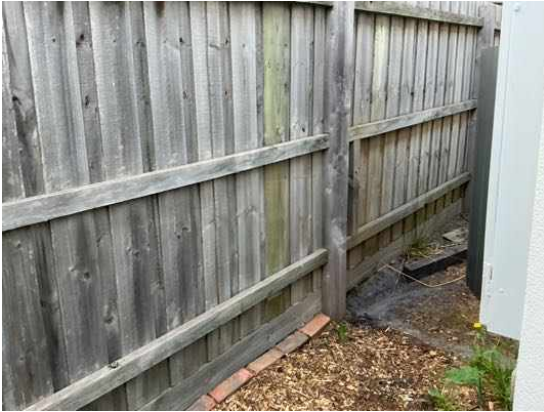
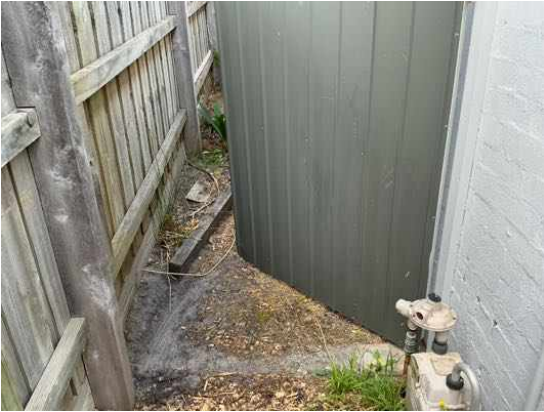
### Defects 3.23

Building:	Main Building
Location:	Fencing All Areas
Finding:	Fencing - Deteriated
Information:	Timber fencing was inspected and deterioration was observed in this area. Deteriorated fencing can compromise structural stability, reduce privacy, and may allow pest ingress or accelerated decay if left unaddressed.

Possible causes include age-related timber decay, prolonged exposure to moisture or sunlight, poor maintenance, or impact damage.

When practical, a qualified carpenter or fencing specialist should be engaged to repair or replace affected sections, and a qualified painter should be engaged to restore protective finishes. Prompt rectification will maintain structural performance, improve appearance, and extend the lifespan of the fencing.

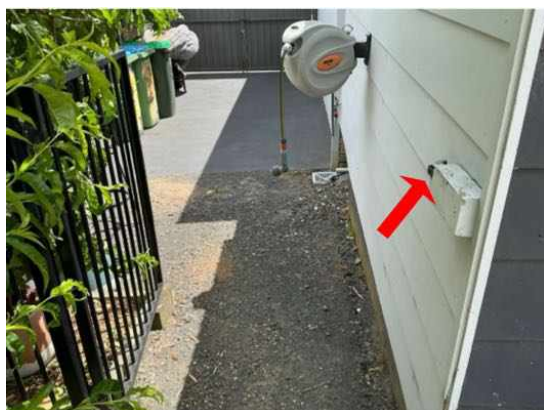
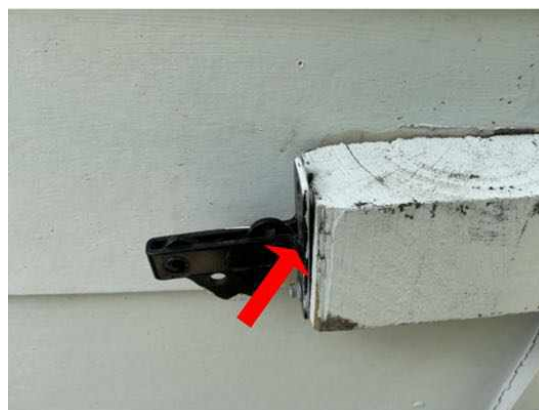
Defects 3.24

Building: Main Building  
 Location: All External Areas  
 Finding: Gates - Gate Binding  
 Information: Binding or jamming of the gate was observed in this area. This affects functionality and may cause secondary damage to surrounding building elements.

Binding can result from minor issues, including poor installation, worn hinges, or misalignment.

When practical, a qualified carpenter should be engaged to inspect and carry out necessary repairs.

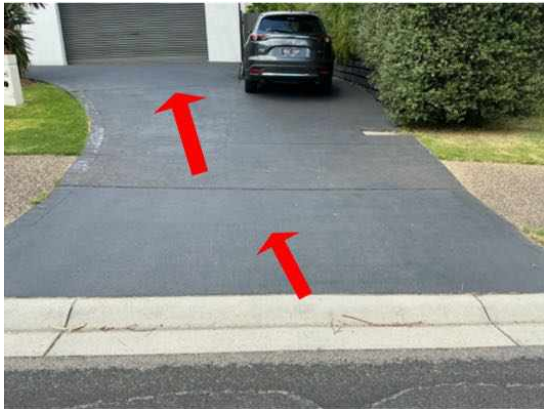
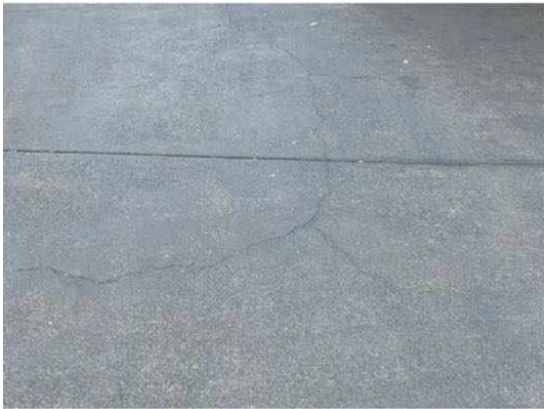
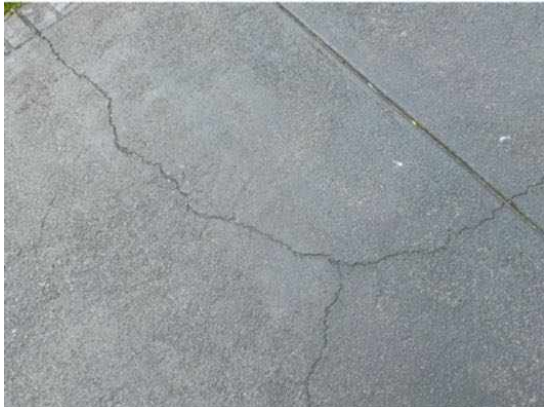
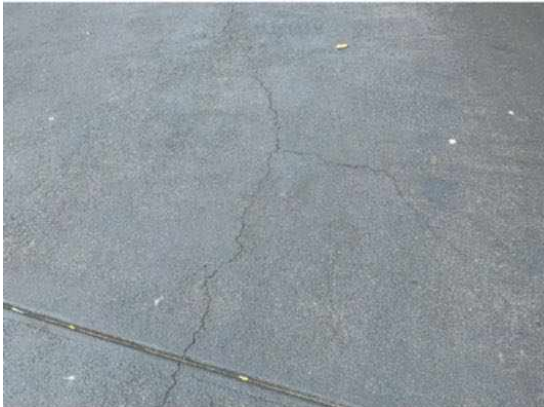
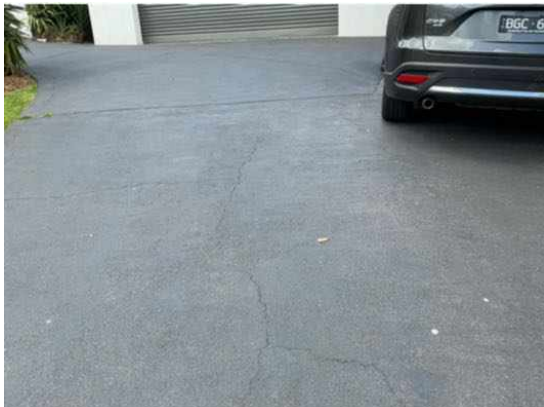
### Defects 3.25

Building: Main Building  
 Location: Driveway >  
 Finding: Driveway - Minor Cracking & Surface Imperfections  
 Information: The external driveway was visually inspected. Minor cracking, surface settlement, and minor unevenness was observed in this area. While these defects do not currently compromise structural safety, they may affect long-term durability, appearance, and vehicle access.

These issues may be caused by age-related wear, soil movement or settlement beneath the driveway, possible tree root intrusion, or inadequate original construction or reinforcement.

A qualified concreter should be engaged when practical to repair or resurface affected areas. Prompt rectification will restore a smooth surface, improve appearance, and prevent further deterioration.

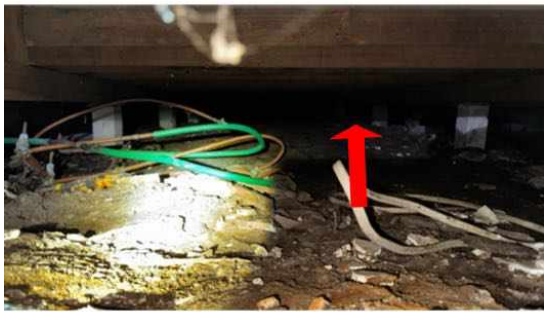
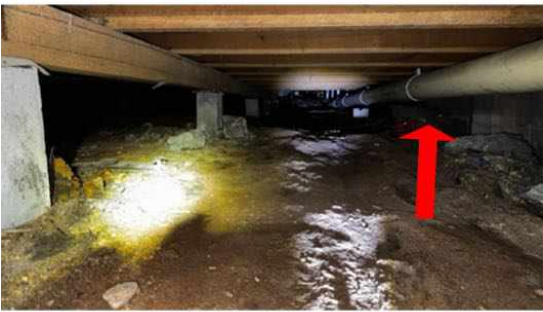
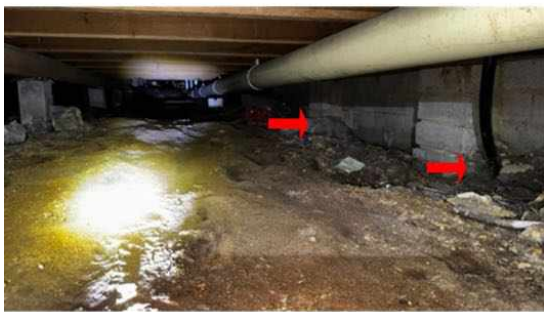
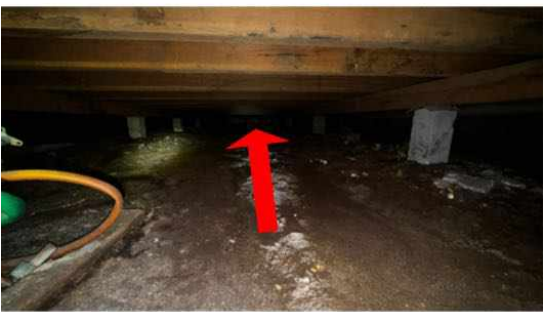
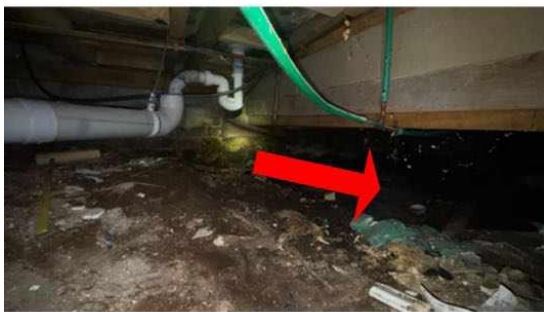
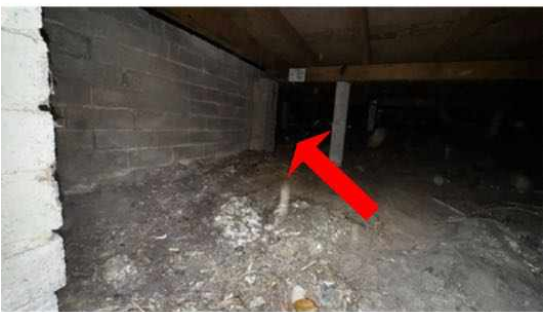
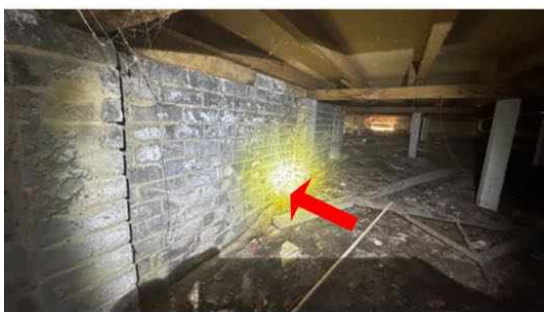
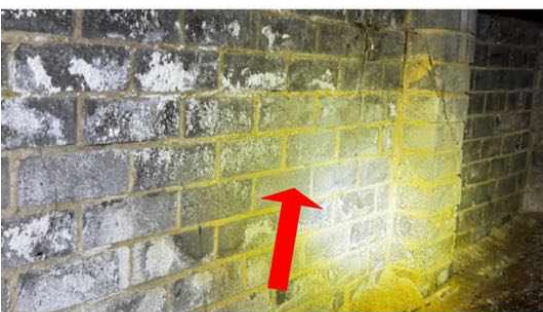
**Defects 3.26**

Building: Main Building  
Location: Subfloor >  
Finding: Sub - Floor - Excessive Moisture Identified  
Information: Excessive moisture can attract termites and produce conditions that promote fungal growth and wood decay.

Excessive moisture is generally caused by deteriorated or leaking plumbing pipes or excessive subfloor moisture to the subfloor where a qualified plumber or a mechanical ventilation specialist should be engaged to further inspect the property to identify the cause of the excessive moisture and carry out any necessary repairs.

This is advised to be carried out as soon as possible.

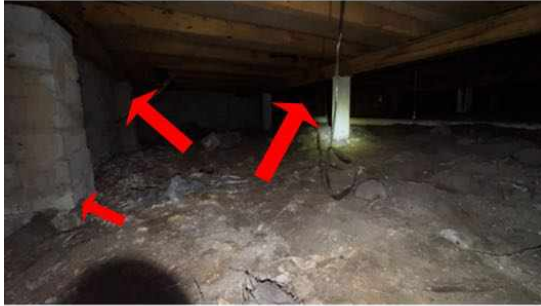
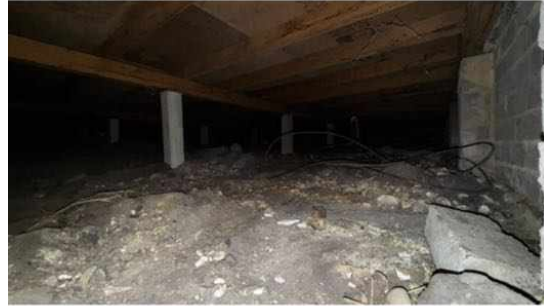
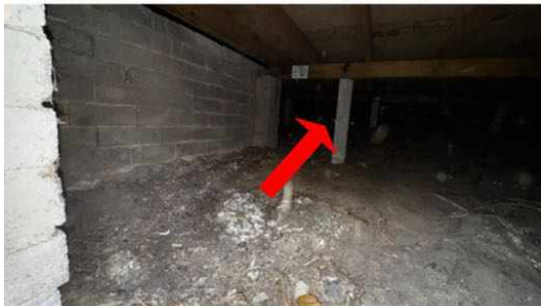
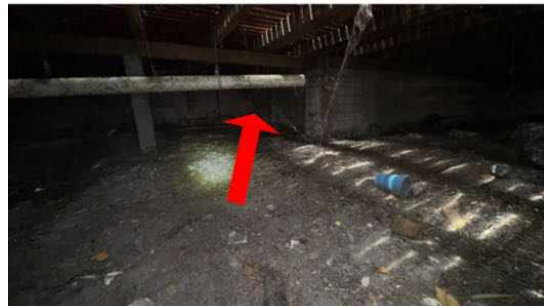
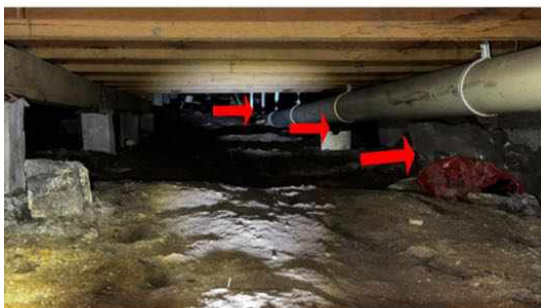
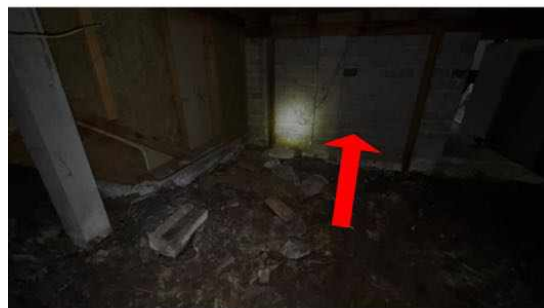
### Defects 3.27

Information: It was noted at the time of inspection that the subfloor area lacks adequate ventilation. Ventilation can be restricted by a variety of minor defects, including obstructions in the subfloor space, a lack of vents or a low clearance, no mechanical ventilation and insufficient external site drainage.

A well ventilated subfloor aids in maintaining dry conditions, preventing secondary damage such as wood rot and pest activity, as well as preventing the development of mould and mildew (which can lead to respiratory safety hazards for occupants).

Where ventilation is substandard it is usually caused by factors such as failure to install adequate vents during construction subsequent building works or earth and vegetation covering over vents low subfloor clearance and items or debris in the subfloor restricting airflow.

The initial step in improving ventilation is to ensure that the subfloor area is free of any debris or stored items. Where ventilation is still inadequate, it is advised to ensure that all vents are clear of blockages, additional vents may be installed and external surface and subsurface drainage is reviewed.

The client may also consider mechanical ventilation (powered fans) to improve subfloor airflow. Remedial works should be conducted as a matter of urgency to protect against the development of potentially harmful subfloor conditions.

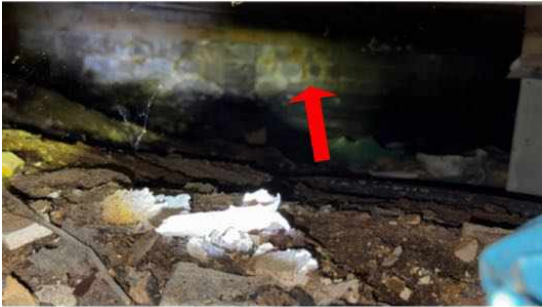
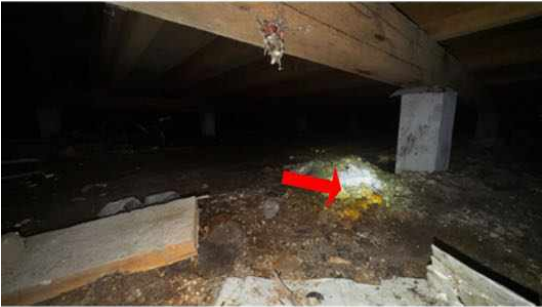
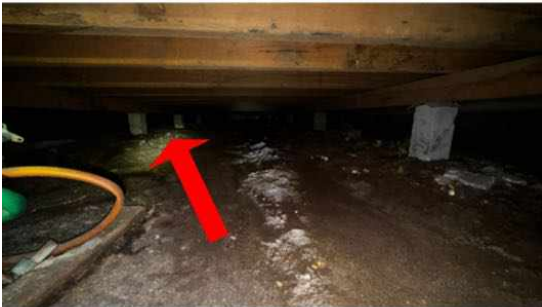
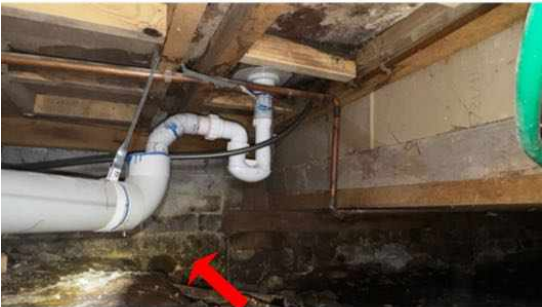
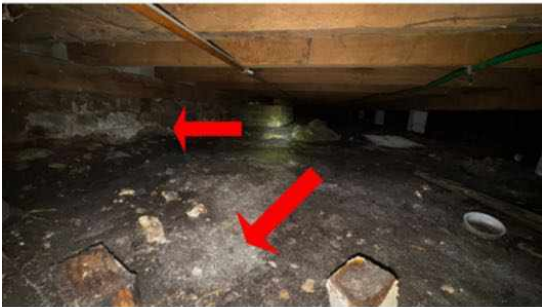
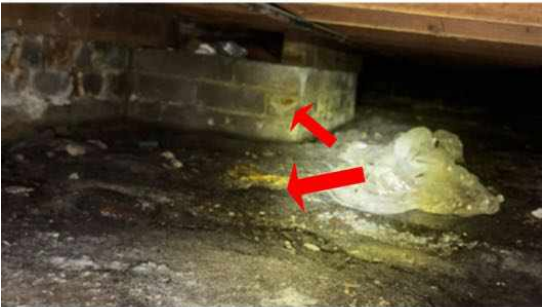
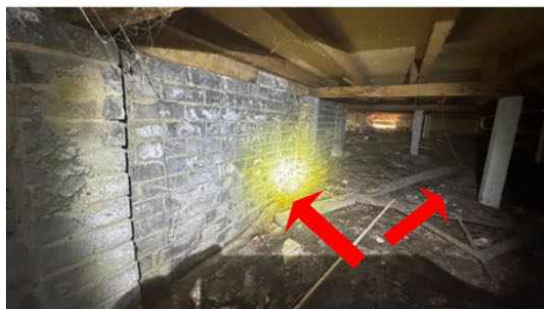
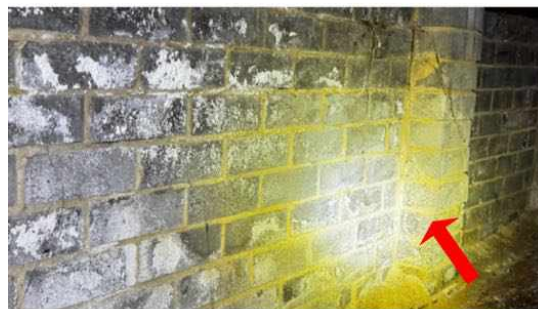
### Defects 3.28

Building:	Main Building
Location:	Subfloor
Finding:	Sub Floor - Suspected Mould
Information:	Suspected mould growth was observed in the subfloor in this area.

conditions. Mould can damage building materials, reduce indoor air quality, and pose health risks to occupants.

A registered builder or mould remediation specialist is required to inspect the subfloor, identify the source of moisture, and remediate the mould. Works may include removal of affected materials and treatment of surfaces. This should be rectified immediately to prevent further damage and health risks.

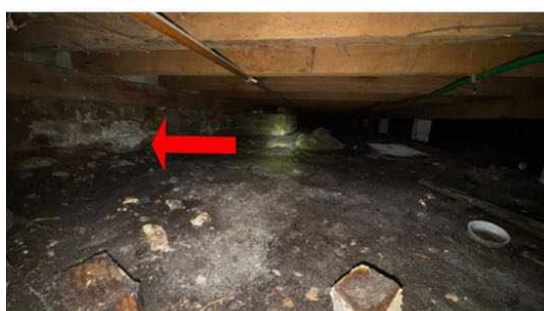
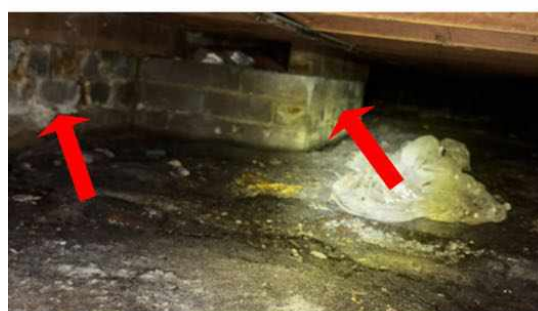
### Defects 3.29

Building:	Main Building
Location:	Subfloor
Finding:	Sub - Floor - Rising Damp
Information:	Evidence of rising damp was observed in the subfloor area. Rising damp occurs when moisture from the ground travels upward through walls or flooring, which can lead to timber decay, corrosion of metal components, mould growth, and deterioration of finishes if not addressed promptly.

This condition is typically caused by inadequate or failed damp-proofing, poor ventilation in the subfloor, or prolonged exposure to ground moisture.

A registered builder or qualified waterproofing specialist should be engaged immediately to assess the extent of rising damp, determine the underlying cause, and implement appropriate remedial measures. Early intervention will help prevent further structural damage, deterioration of materials, and potential health hazards from mould.

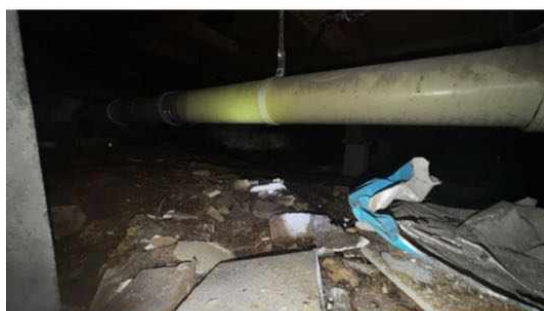
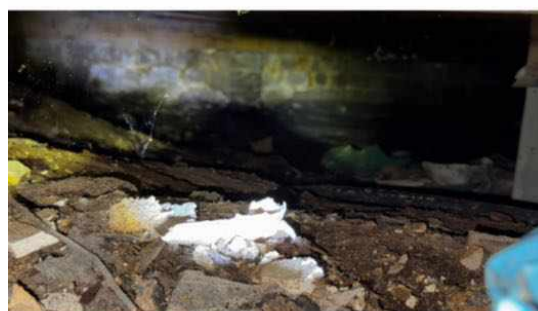
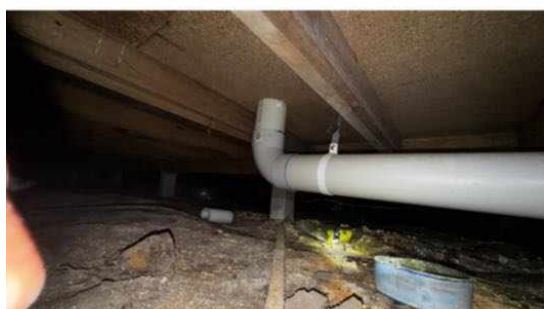
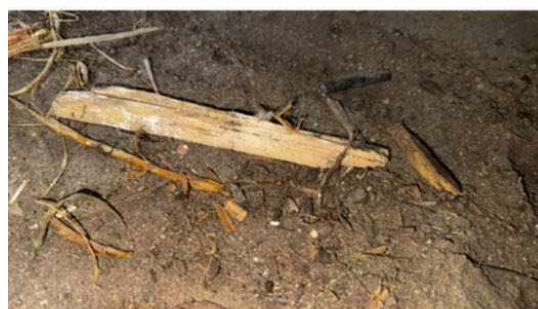
### Defects 3.30

Building:	Main Building
Location:	Subfloor
Finding:	Sub - Floor - Stored Items, Rubbish & Debris

**Information:** The subfloor was observed to contain stored items, rubbish, and debris. The issue is present where clutter restricts access and covers surfaces beneath the building.

This has likely occurred due to accumulation of materials over time or inadequate cleaning. Excess items can conceal defects, restrict inspections and maintenance, increase pest activity, and create fire or safety hazards.

This observation is provided for information only. When practical, a competent handyman should be engaged to remove all rubbish and clear access to ensure safe inspection, maintenance, and ongoing monitoring of the subfloor.
