## Building Inspection Report

Inspection Date: Thu, 22 Jan 2026

Property Address: 361 Waterfall Gully Rd, Rosebud VIC 3939,  
Australia

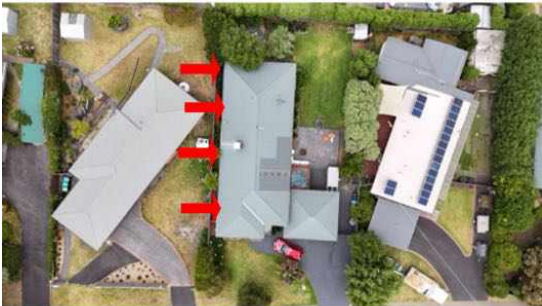
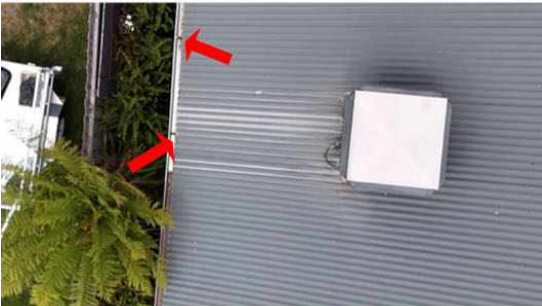
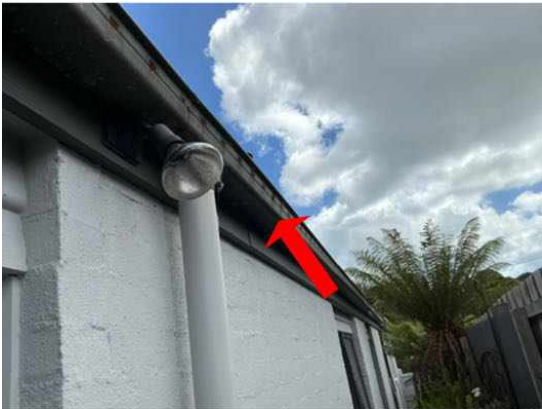
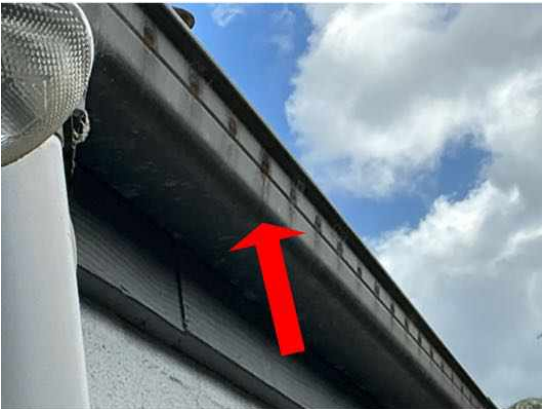
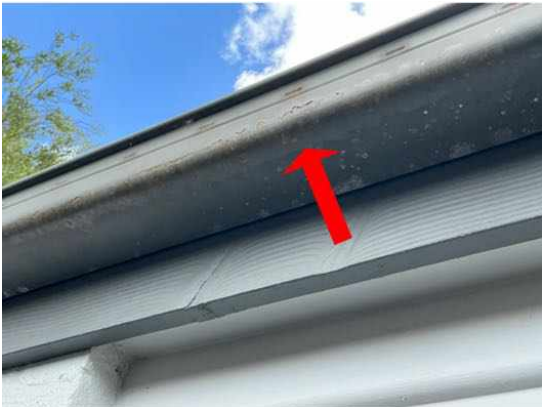
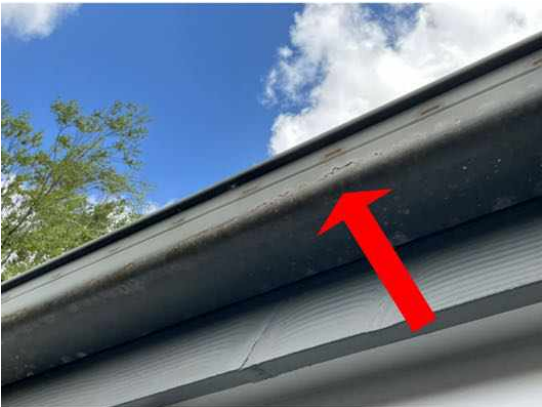
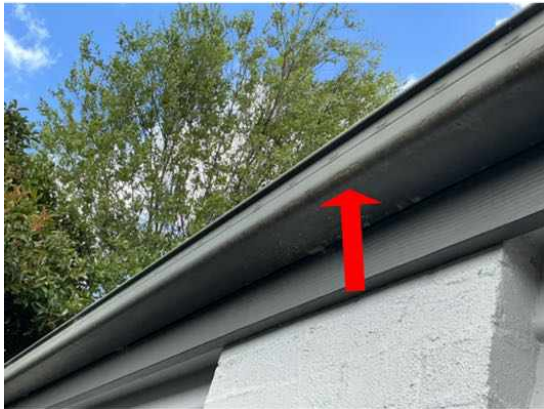
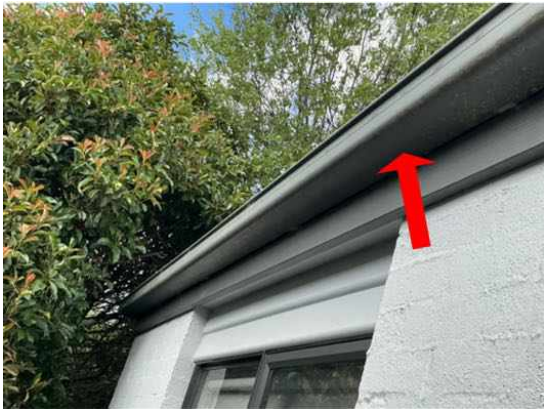
### Defects 3.31

**Finding:** Roof Plumbing - Rusted & Corroded

**Information:** The roof plumbing has areas of rust and corrosion. It is suspected that this has been caused by blockages, resulting in pooling or standing water, that have prematurely rusted elements of the roof plumbing.

Rusted roof plumbing will generally develop holes and leaks that can affect other building elements with poor drainage of storm water. Poorly drained roof areas will also lead to damp conditions surrounding the base perimeter of the building which, if

left unmanaged, can lead to a range of secondary building defects.

Repair and/or replacement of rusted roof plumbing is required in order to reinstate the roof drainage system to a fully operational level. To further maintain these areas, gutters should be cleaned frequently, allowing the avoidance of any partial blockages.

A licensed plumber or specialist roof restoration company should be appointed to undertake these works. It is advised that such works be completed as soon as possible to prevent any further damage and deterioration.

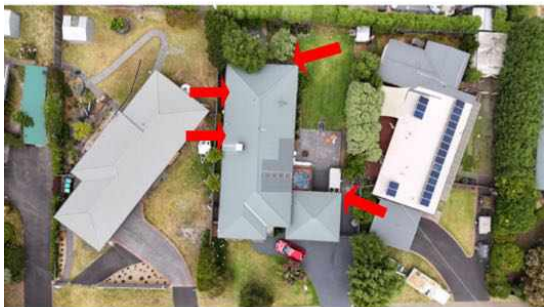
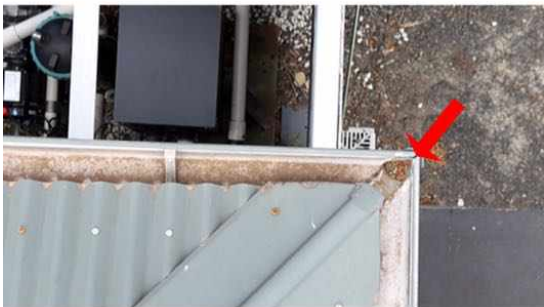
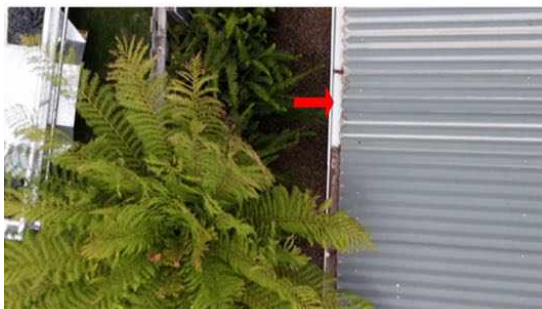
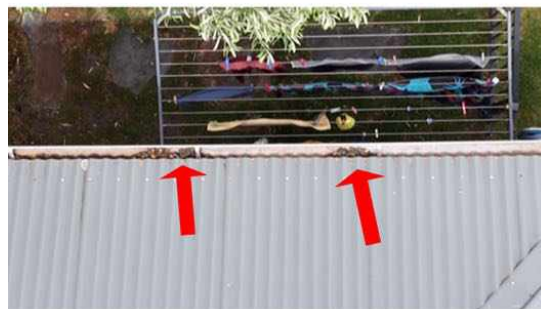
**Defects 3.32**

Building: Main Building  
 Location: Roof Exterior  
 Finding: Roof Plumbing - Gutters Blocked  
 Information: Gutters in this area are blocked and not allowing water to flow freely. The issue is observed along the gutter runs where leaves, debris, or other obstructions have accumulated.

This has likely occurred due to lack of maintenance or build-up of debris over time. Blocked gutters may cause water to overflow, damage the roof, walls, or foundations, and increase the risk of erosion or water ingress.

A licensed roof plumber or competent handy man is required to inspect and clear the blocked gutters in this area. This should be rectified immediately to ensure water drains correctly and to prevent potential damage to the building.

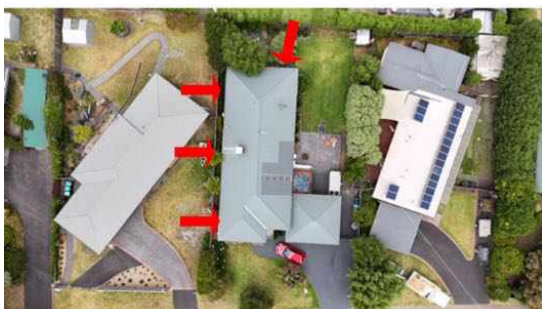
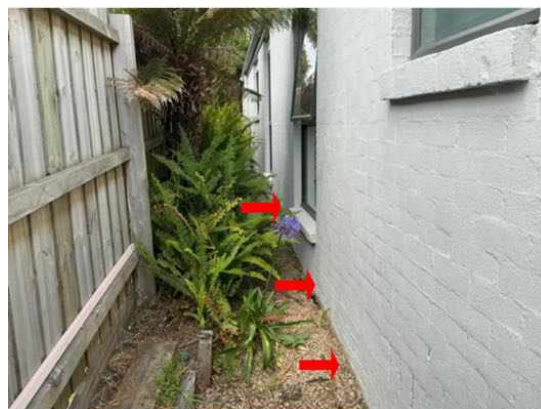
### Defects 3.33

Finding: Site Drainage - Inadequate

Information: The overall site drainage was observed to be inadequate at the time of inspection. Poor drainage can cause water to pond near external walls, increasing the risk of rising damp, foundation movement, timber decay, and deterioration of associated building elements.

Ground levels should slope away from the dwelling to direct water from walls and footings. Downpipes must be properly connected to the stormwater system and should not discharge directly onto walls, paving, or plinths. Stormwater should be directed away from the property through adequately sized and maintained drains. Where ground levels are too high and cover the damp-proof course (DPC), lowering the levels may be necessary to expose the DPC and allow effective drainage.

A licensed plumber should be engaged promptly to investigate and recommend suitable remedial works, which may include the installation of an agricultural (aggie) drain or other site drainage improvements. Immediate action is strongly recommended, as inadequate drainage can lead to progressive water damage and secondary building defects over time.

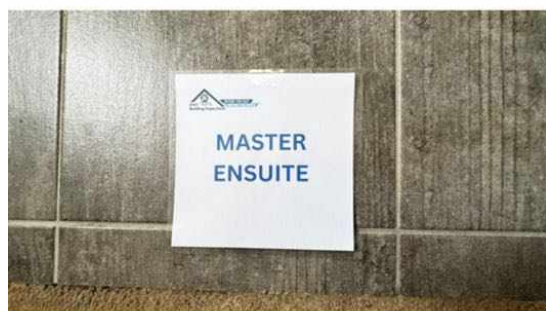
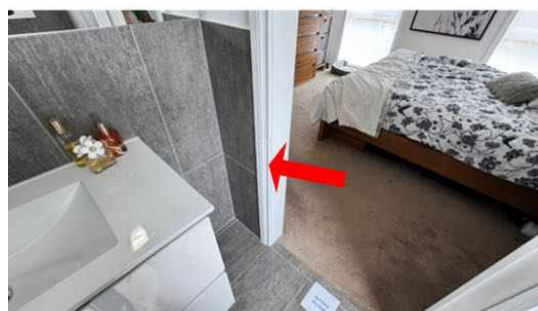
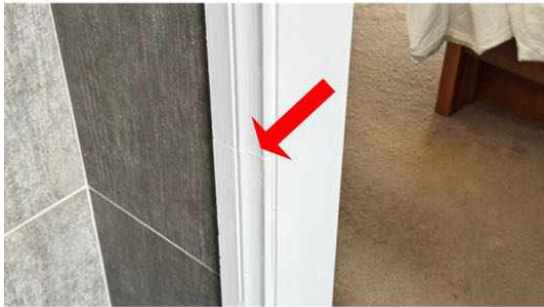
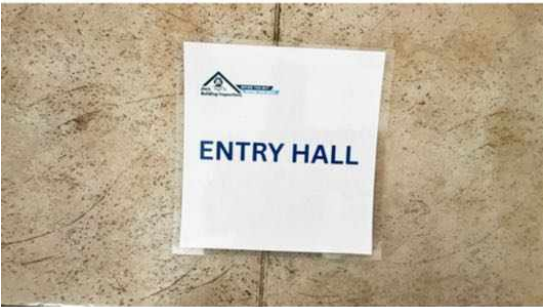
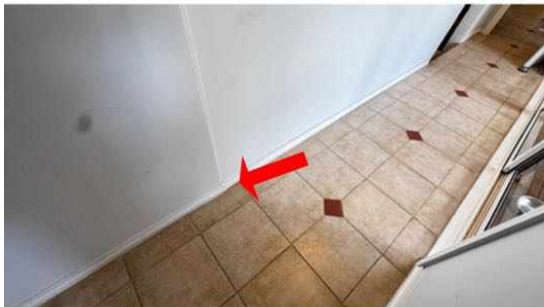
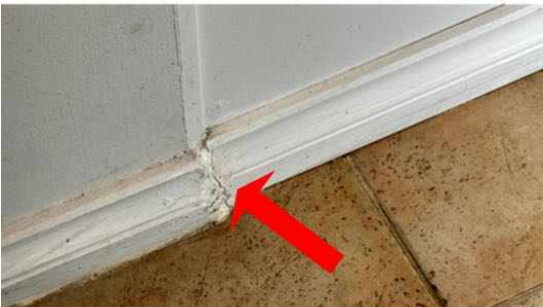
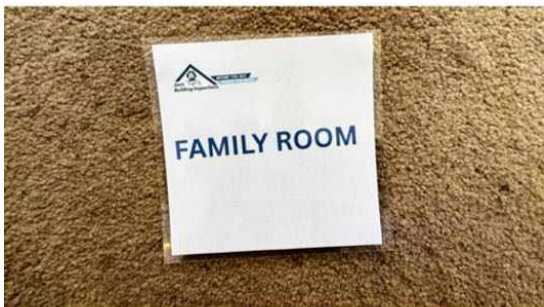
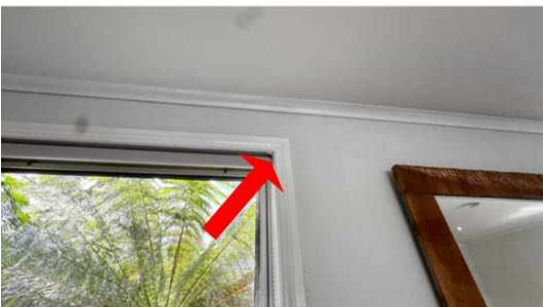
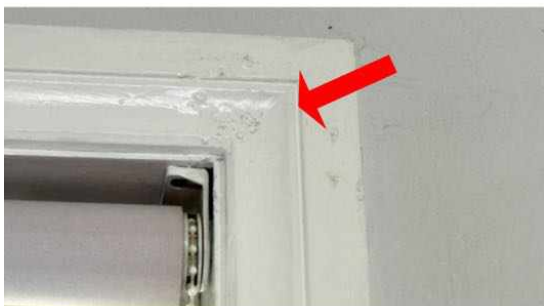
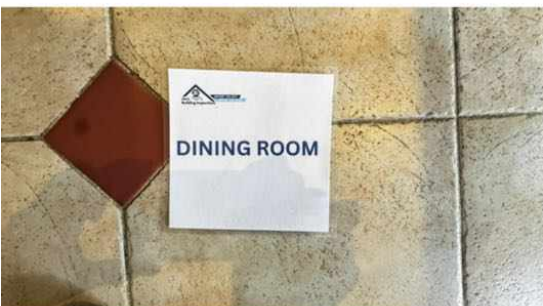
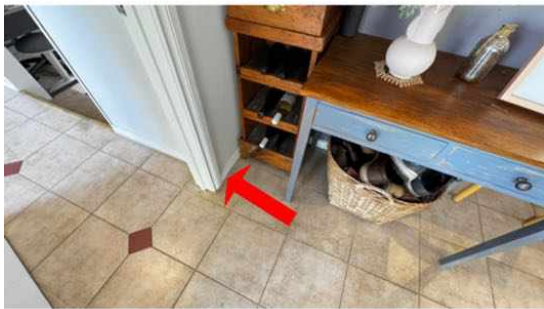
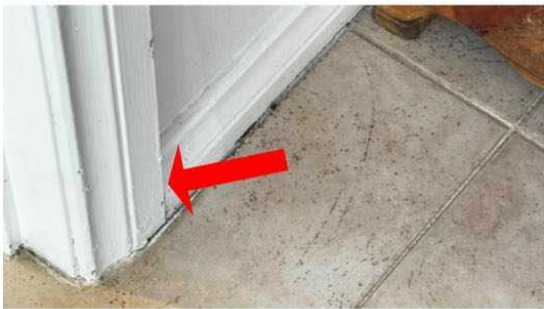
Building:	Main Building
Location:	All Areas
Finding:	Architraves & Skirting Boards - Minor Movement
Information:	Minor movement was noted in the architraves and skirting boards in this area, with small gaps at joints, slight separations from adjoining surfaces, and minor cracking in paint and sealant. This movement appears superficial and is generally related to normal timber behaviour or minor building settlement.

Common causes include seasonal timber shrinkage or expansion, slight building settlement, historic moisture or thermal movement, or insufficient fixing during installation. While largely cosmetic, these gaps and cracks can affect the appearance of finishes. If left unaddressed, minor deterioration may continue over time.

When practical, a qualified painter should be engaged to fill and repaint affected areas, to restore a neat finish.

Ongoing monitoring is advised, especially after seasonal changes. If movement worsens, a structural engineer should be consulted immediately to assess and recommend any necessary repairs.

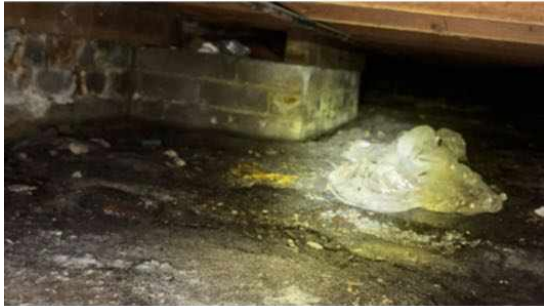
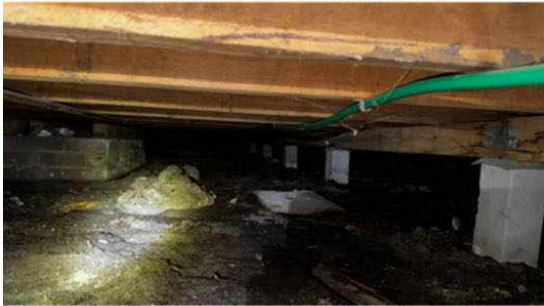
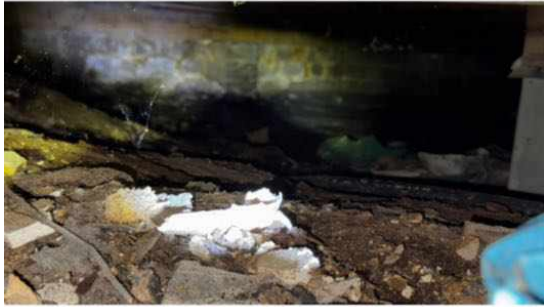
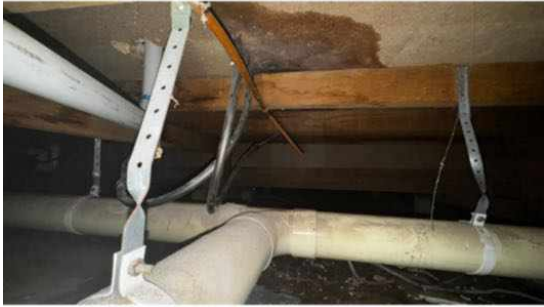
Building: Main Building  
Location: Subfloor  
Finding: Sub Floor - Limited Access  
Information: The subfloor area was observed to have restricted, limited and difficult access. The issue is present where limited space and obstacles prevent safe entry and movement beneath the building.

This has likely occurred due to inadequate access points. Poor access can impede inspections, maintenance, and timely identification of structural, pest, or service issues, increasing long-term repair costs and safety risks.

A registered builder is required to assess and improve subfloor access. This should be addressed as soon as possible to ensure safe entry, proper inspection, and maintenance of the subfloor.

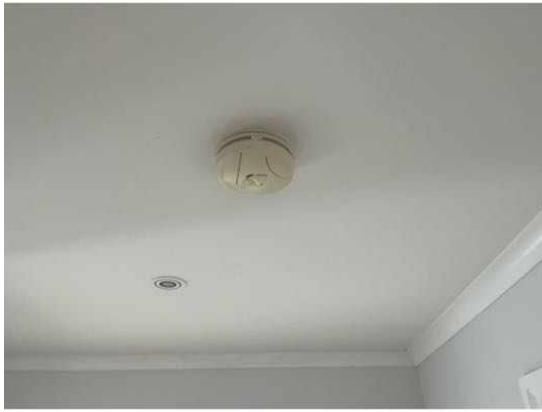
Building: Main Building  
Location: All Internal Areas  
Finding: Smoke Detectors - Advisory  
Information: During the inspection, smoke detectors were noted for advisory purposes only. The operation, age, type, and compliance of smoke detectors could not be fully verified as part of this inspection.

Smoke detectors are critical life-safety devices, and non-compliant, outdated, or non-operational units may not provide adequate warning in the event of a fire.

It is recommended that a licensed electrician be engaged immediately to test, service, and upgrade smoke detectors as required to ensure correct operation and compliance with current safety requirements.

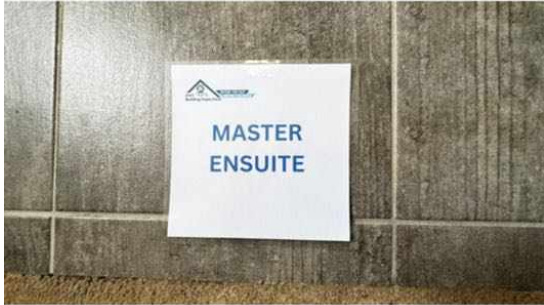
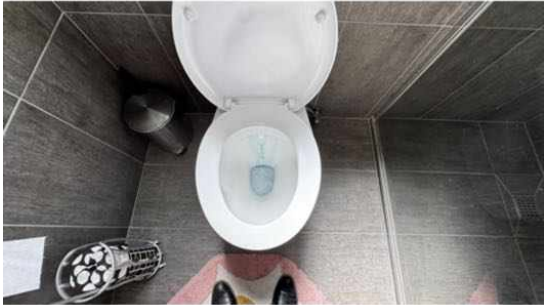
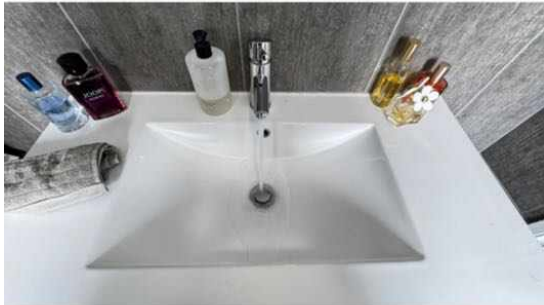
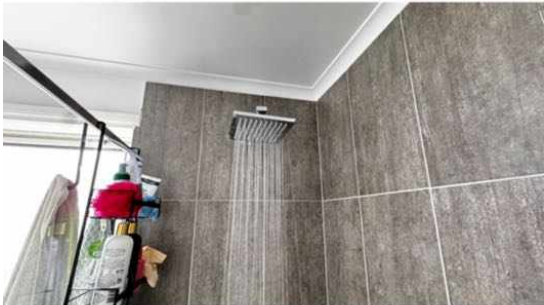
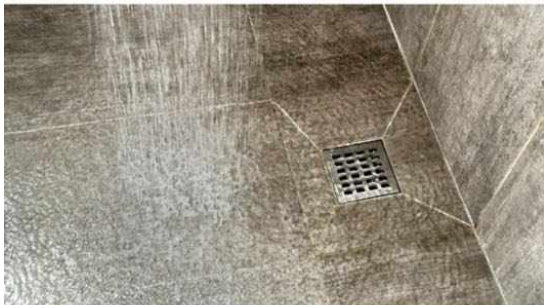
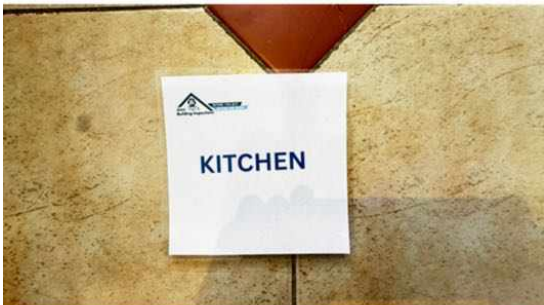
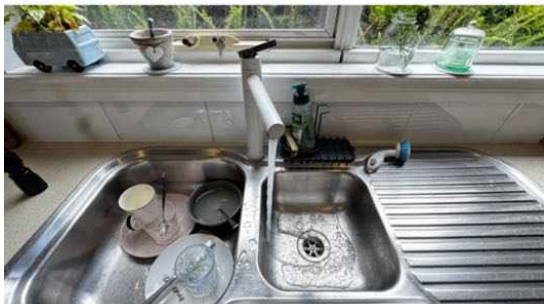
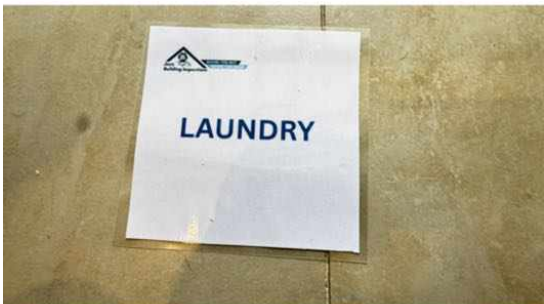
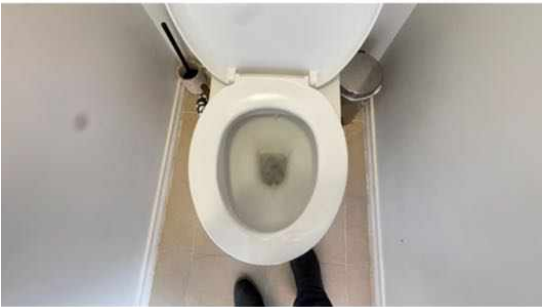
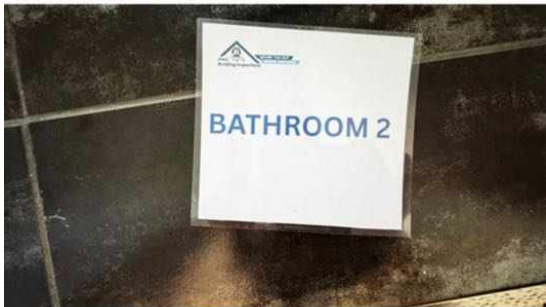
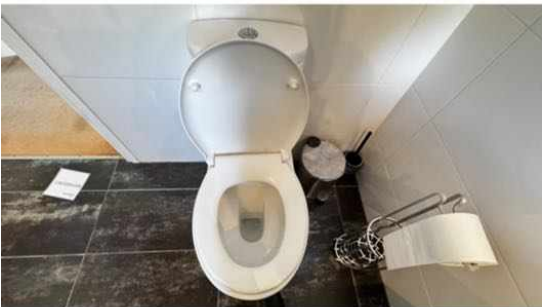
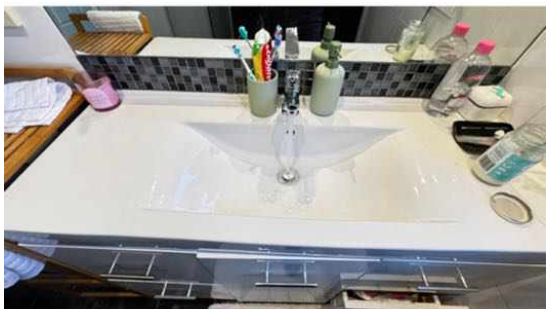
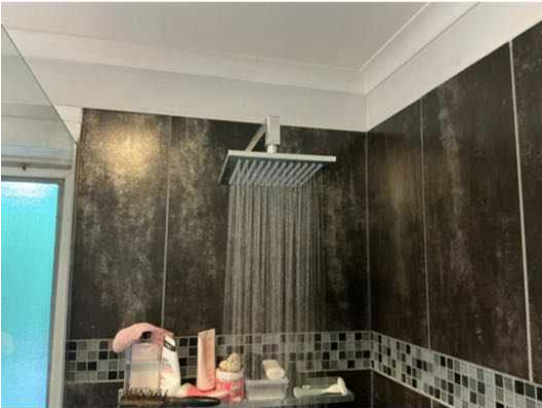
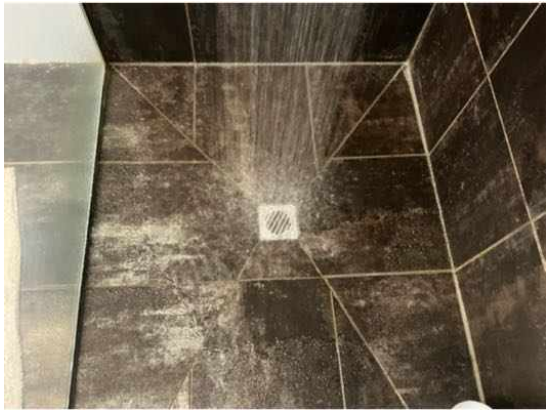
Building: Main Building  
 Location: All Internal Areas  
 Finding: Water Supply & Drainage - Shower, Basins, Toilets, & Plumbing Fixtures  
 Information: The shower recess was tested, and no visible water penetration to surrounding areas was observed at the time of inspection, except where noted as a separate defect elsewhere in this report. Water appeared to flow freely toward the floor waste. Moisture detected to the shower walls is documented separately in the report. The shower floor waste appeared clear during inspection.

Flushing the toilet revealed no visible leaks, and the fixture appeared to operate normally unless otherwise noted as a separate defect. No water damage was observed to the vanity unit unless specifically stated elsewhere in the report. Basins, bathtubs, laundry tubs, vanities, and sinks were tested and inspected with no evidence of leaks, blockages, or drainage issues at the time of inspection unless otherwise noted. All internal taps and shower heads were tested with no leaks observed, unless documented as a separate defect.

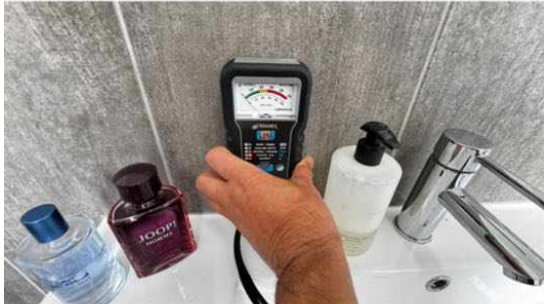
Building: Main Building  
Location: All Areas Interior & Exterior  
Finding: Moisture Levels - Advisory - No Elevated Moisture Levels Present  
Information: At the time of inspection, no elevated moisture levels were detected in these areas. Moisture readings were taken (using a Tramex Moisture Meter) and non-invasive testing methods and reflect conditions present at the time of inspection only. This item is noted for advisory purposes and should not be relied upon as a guarantee that moisture issues are not present elsewhere or may not occur in the future.

It is important to note that moisture levels can fluctuate due to weather conditions, plumbing usage, seasonal changes, or intermittent leaks. Concealed moisture within wall cavities, subfloor areas, or other inaccessible locations may not be detected during a visual or limited moisture assessment.

Ongoing monitoring of the property is recommended, and further investigation by a qualified tradesperson should be considered if signs of water ingress, dampness, staining, mould growth, or material deterioration become apparent.

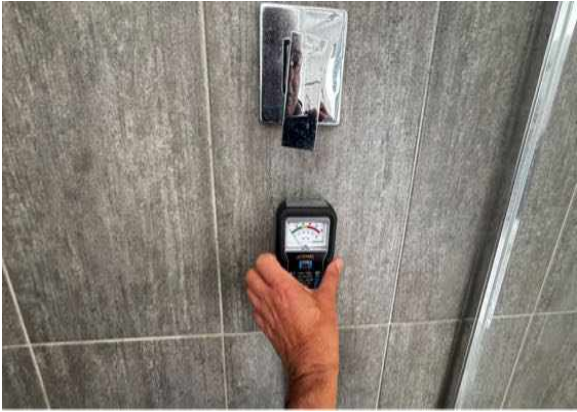
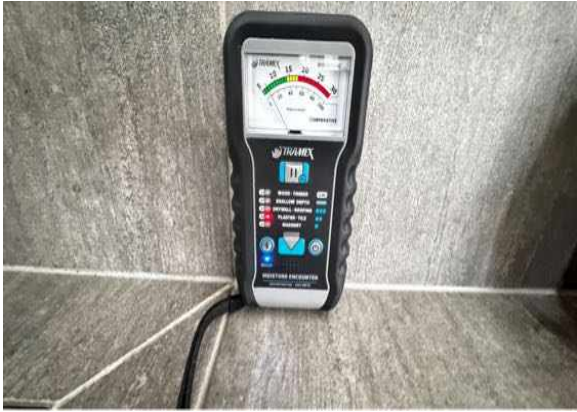
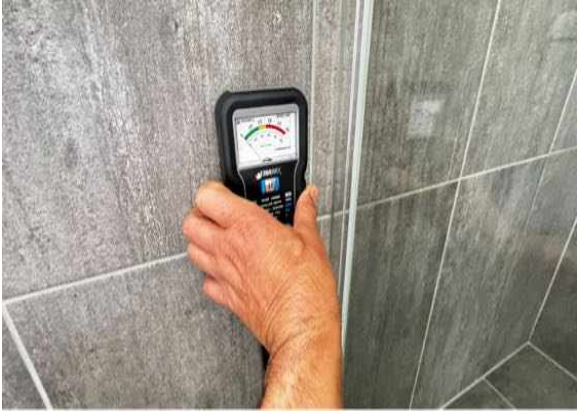
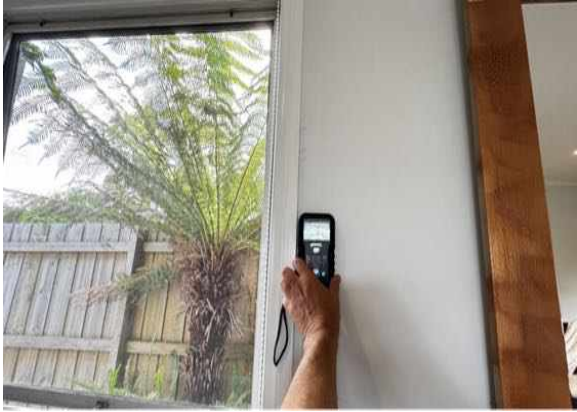
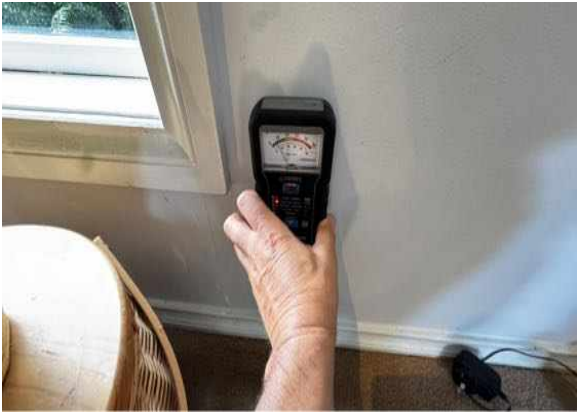
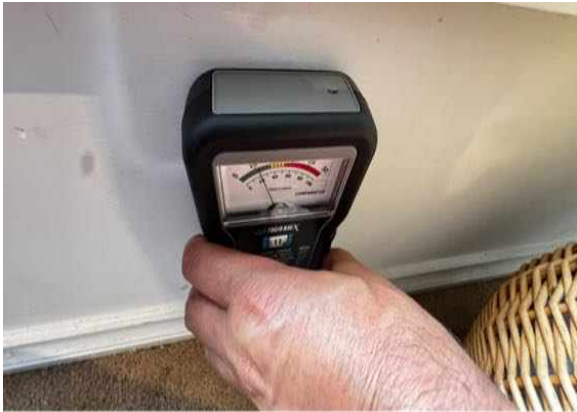
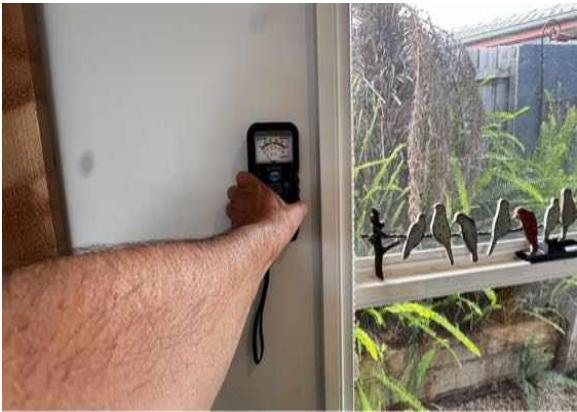
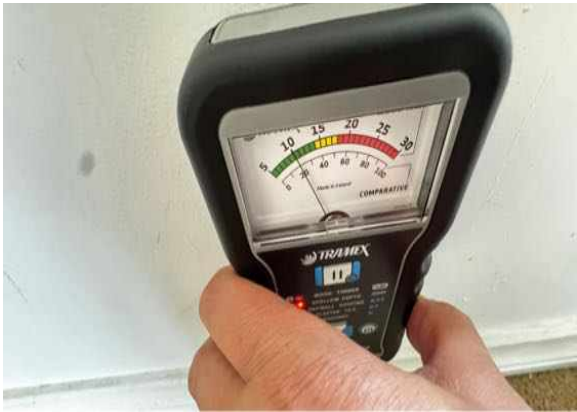
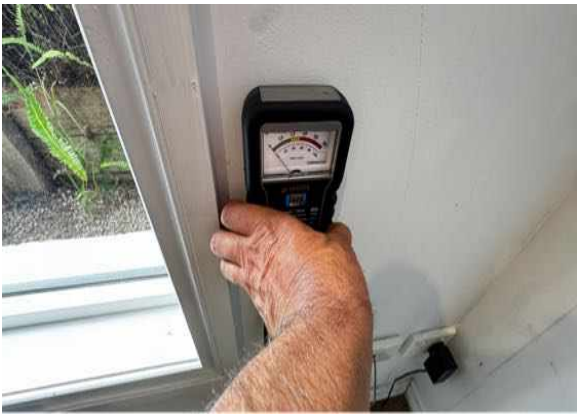
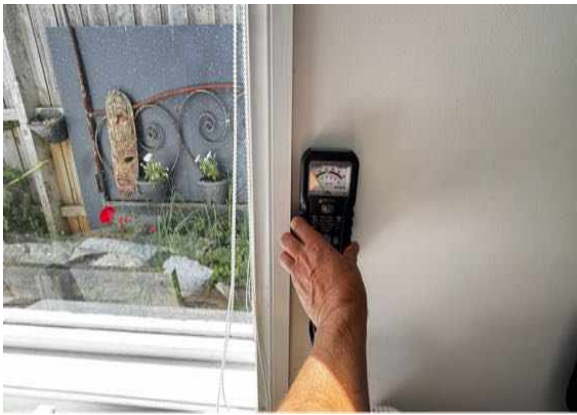
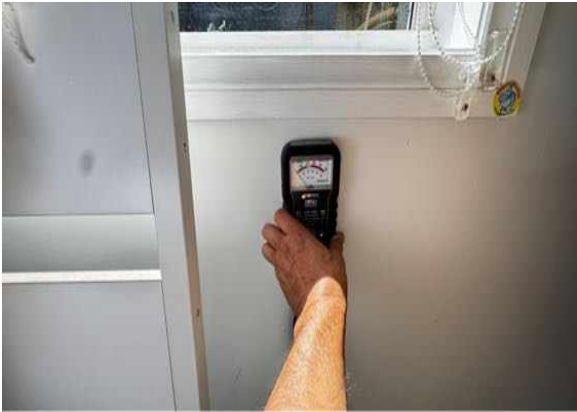
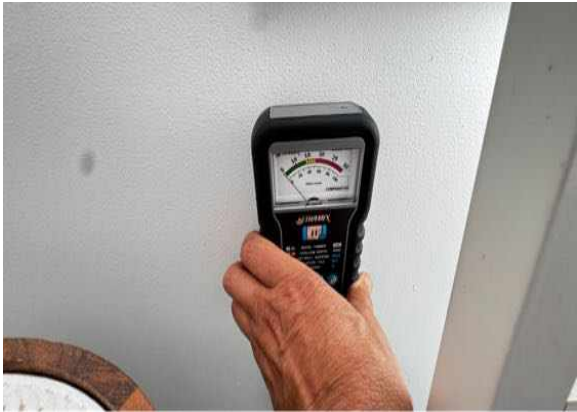
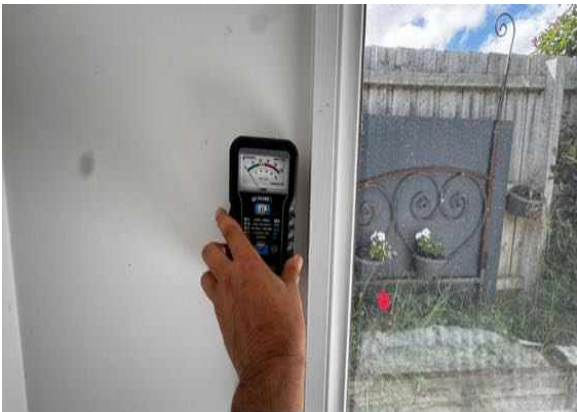
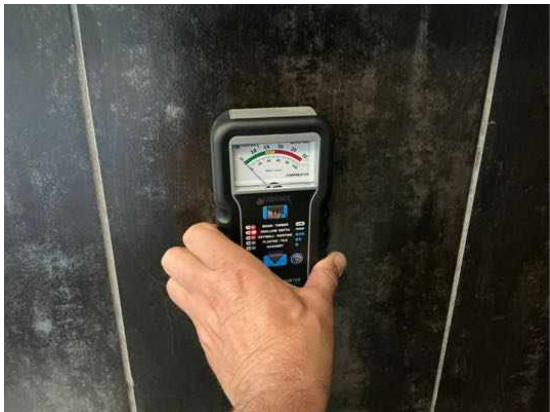
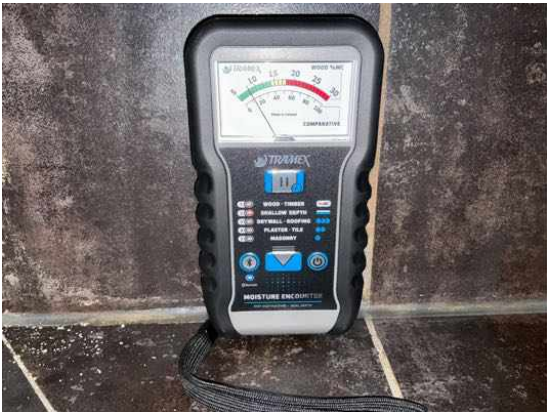
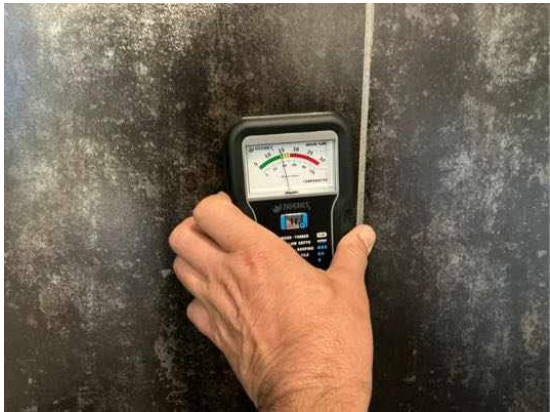
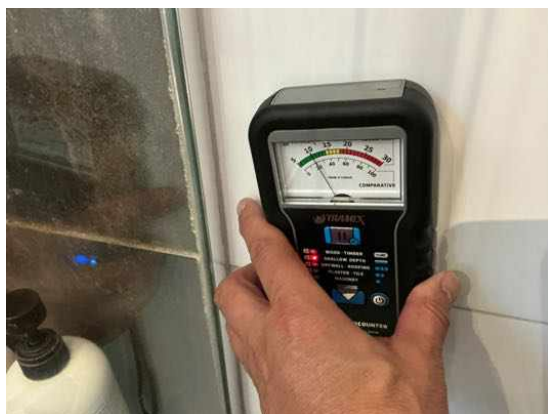
Building: Main Building  
 Location: All Areas Interior & Exterior  
 Finding: Thermal Scanning & Diagnostic - Advisory - No Elevated Moisture Levels Present  
 Information: During the inspection, a thermal imaging camera was utilised as a non-invasive diagnostic tool to assist in identifying potential irregularities associated with moisture ingress, heat loss, insulation deficiencies, or concealed building defects. Thermal imaging detects surface temperature variations that may indicate abnormal conditions within building elements.

Any thermal anomalies identified during the inspection were further assessed where accessible using visual inspection methods and moisture testing. It is noted that thermal imaging is an indicative tool only and does not confirm the presence of defects or moisture without supporting evidence.

Due to the concealed nature of building construction and the limitations inherent in non-invasive inspection methods, the absence of significant thermal anomalies at the time of inspection does not guarantee that concealed defects or moisture issues are not present. Ongoing monitoring and further investigation are recommended should concerns arise.

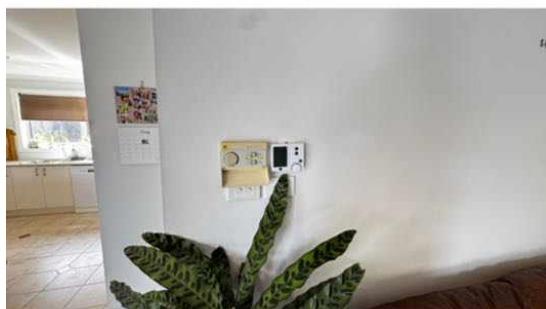
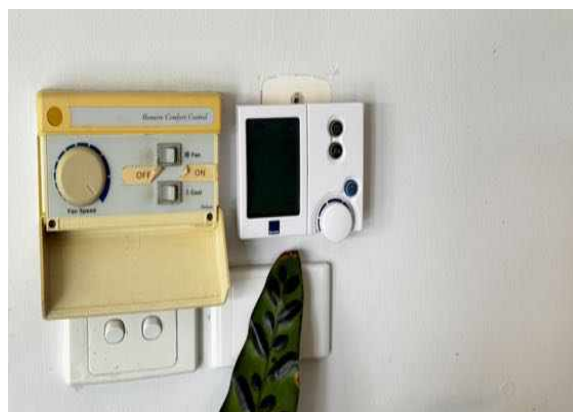
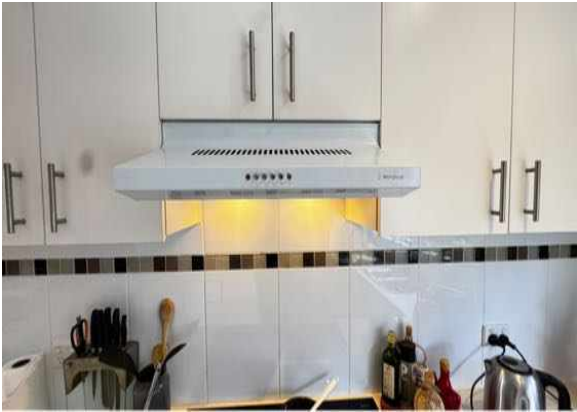
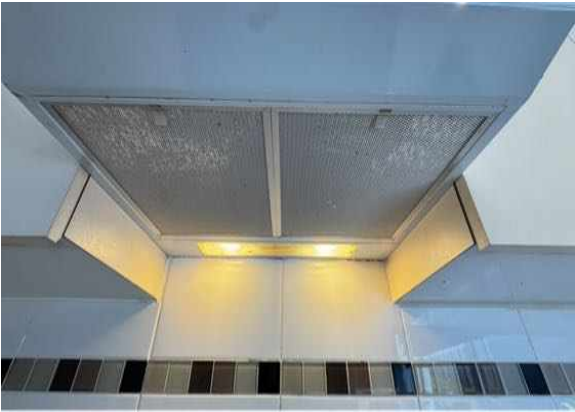
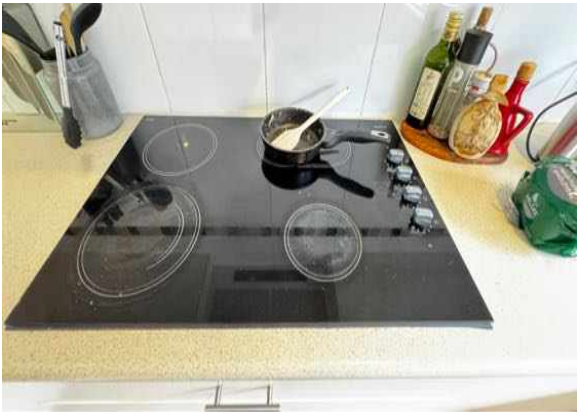
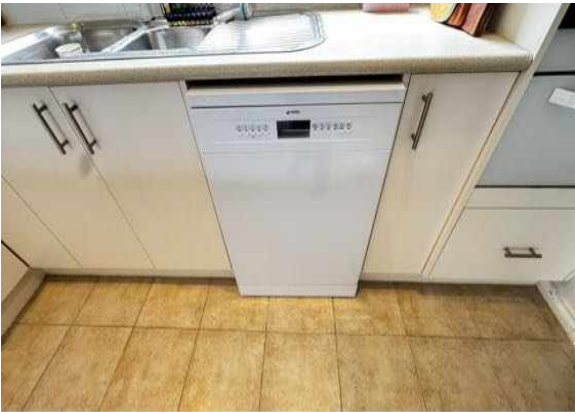
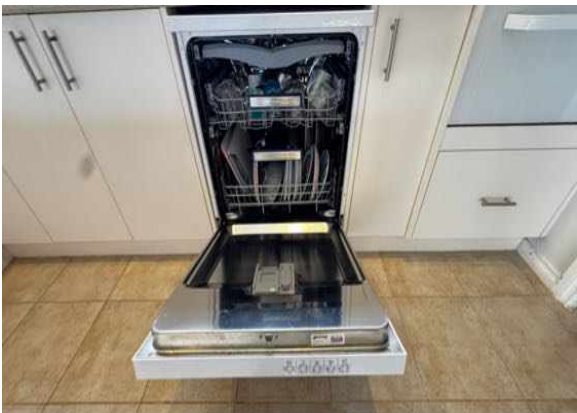
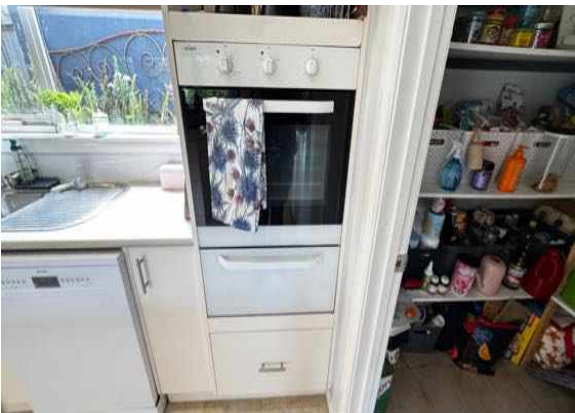
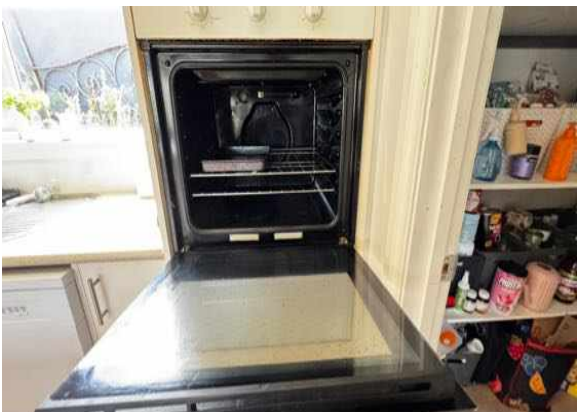
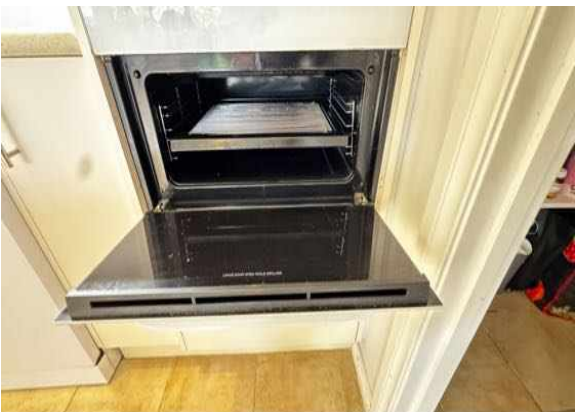
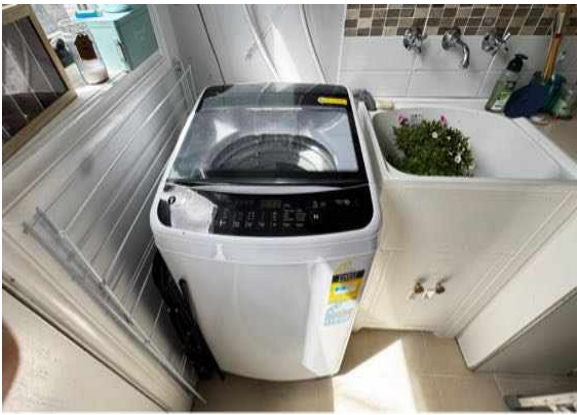
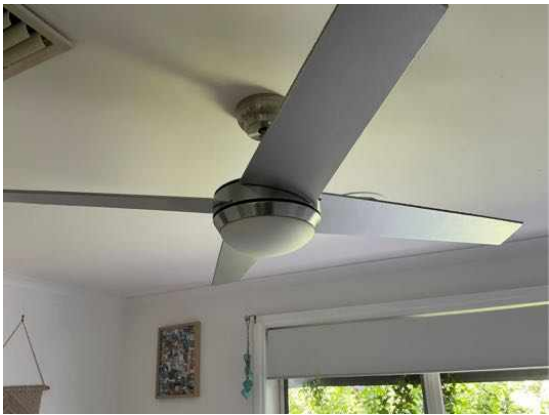
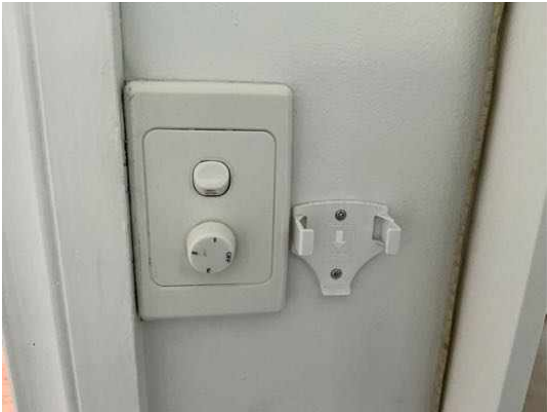
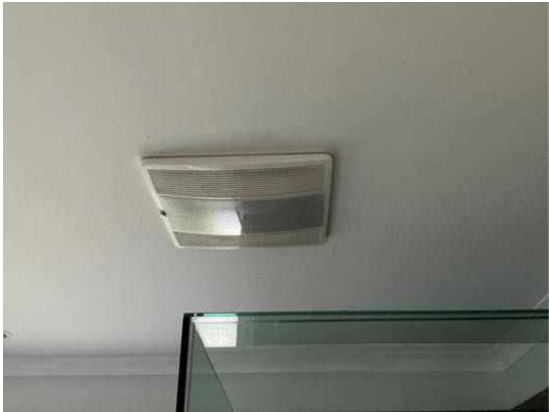
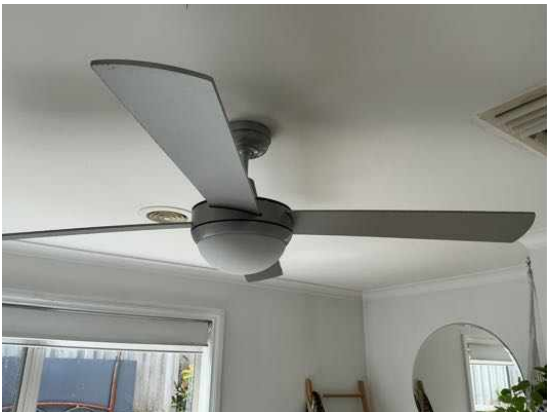
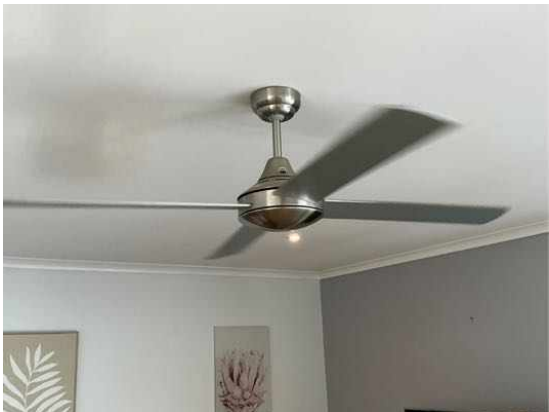
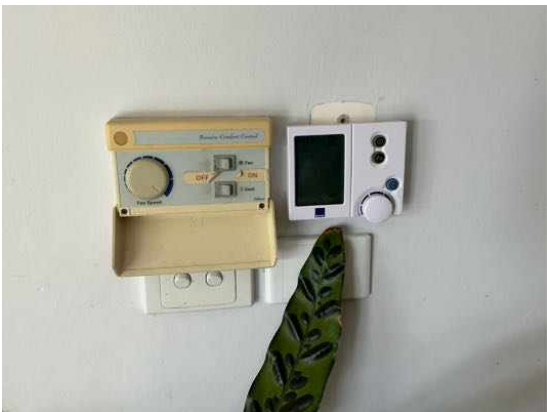
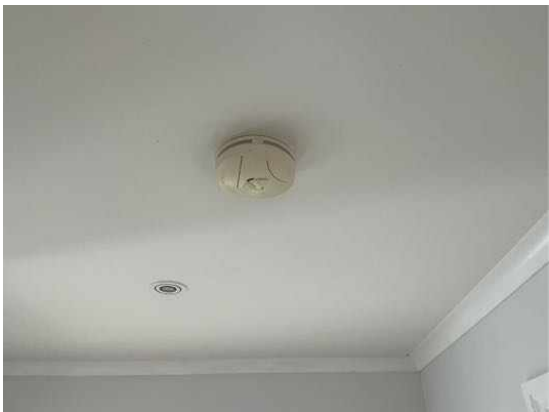
Building: Main Building  
 Location: All Areas, Interior & Exterior  
 Finding: Appliances, Heating & Cooling Systems, Mechanical Systems, Plumbing, Electrical, Fireplaces - Advisory  
 Information: The inspection did not include testing, operation, safety, or assessment of any installed or portable appliances or mechanical systems. This includes, but is not limited to, ovens, cooktops, microwaves, rangehoods, dishwashers, ducted vacuum systems, air-conditioning units, heating systems, hot water services, ceiling fans, exhaust fans, intercoms, security systems, fireplaces, and solid fuel heaters.

Where appliances are beyond their warranty period, the owner should be prepared for potential costs of repair or replacement at any time. The operation of these appliances cannot be guaranteed, and further inspection by a licensed tradesperson may be required. Many appliances are only covered by limited manufacturer or installer warranties. Confirming warranty status is strongly recommended prior to purchase, as out-of-warranty items may require servicing, replacement, or certification by a qualified technician.

Appliances may be worn, damaged, or malfunctioning. Electrical or gas appliances can pose serious safety hazards if incorrectly installed or maintained.

Service, repair, or replace equipment as necessary, particularly where service history or warranty coverage is unknown.

Inspect any water, gas, or electrical connections associated with appliances to ensure safety and compliance.

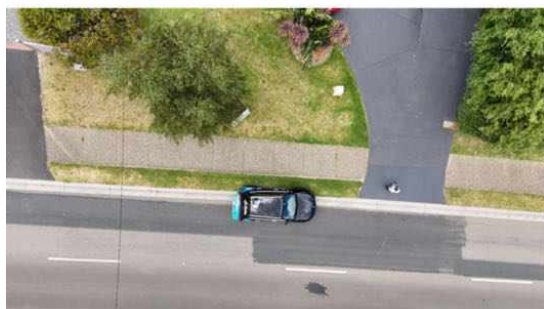
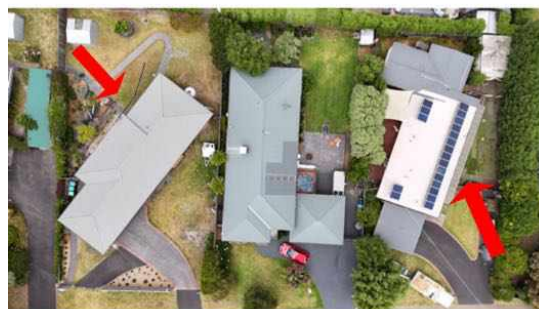
During the inspection, minor cracking, surface wear, or uneven sections were observed on footpaths or crossovers. Some accessible metal components, such as street signage or grates, showed signs of rust or deterioration. Debris accumulation and vegetation encroachment were also noted around council infrastructure. Access or visibility was limited to certain council-owned assets.

immediately. Regular monitoring of adjacent council assets is recommended to ensure ongoing safety and proper maintenance.

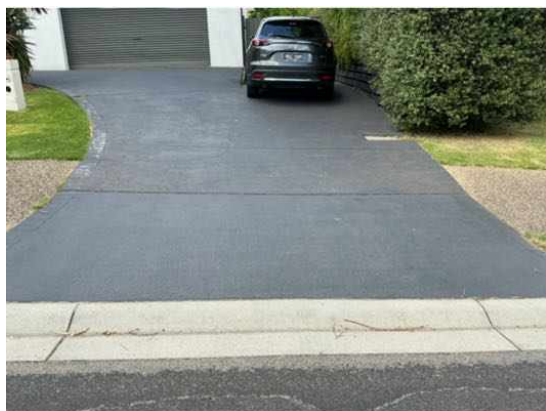
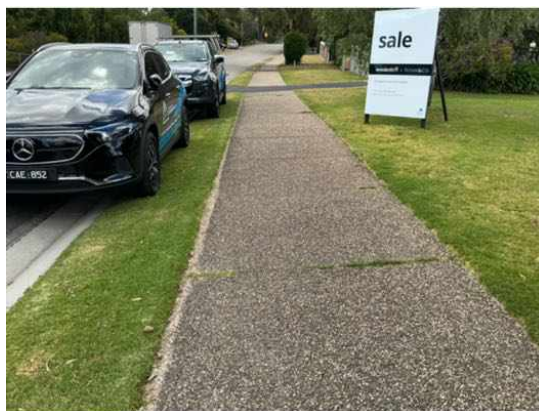
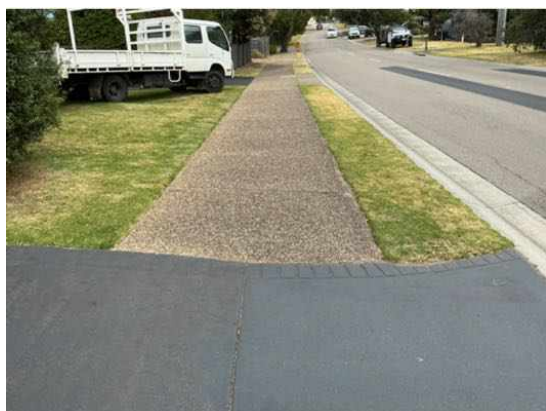
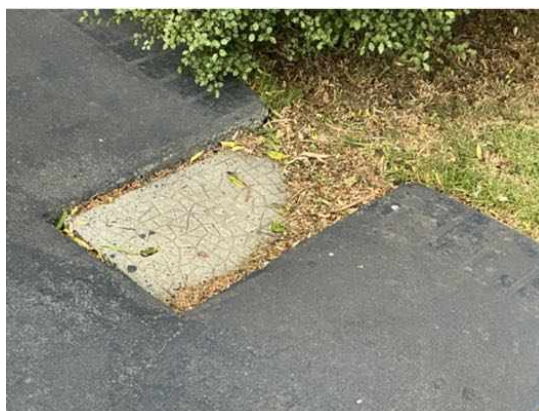
Building:	
Location:	All Areas
Finding:	Additional Photos - Obstructions & Limitations
Information:	These photographs provide evidence of obstructions and restrictions that prevented full access to certain areas of the property at the time of inspection. Such obstructions may include stored goods, furniture, floor coverings, stored building materials, dense vegetation, vehicles, or fixed finishes.

Because these areas could not be visually assessed, no comment can be made on their condition within this report.

It is strongly recommended that obstructions be removed and concealed areas made fully accessible immediately. A re-inspection should then be carried out to allow a complete assessment of the property's condition. This is particularly important prior to purchase, as defects in concealed areas can carry significant rectification costs.
