Building and Timber Pest Inspection Report

Inspection Date: Mon, 19 Jan 2026

Property Address: 4 Park Ln, Wodonga VIC 3690, Australia

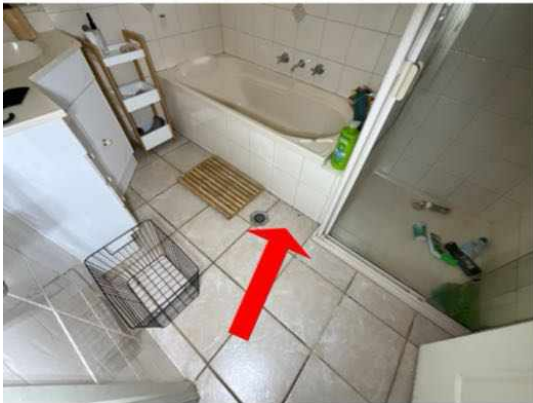
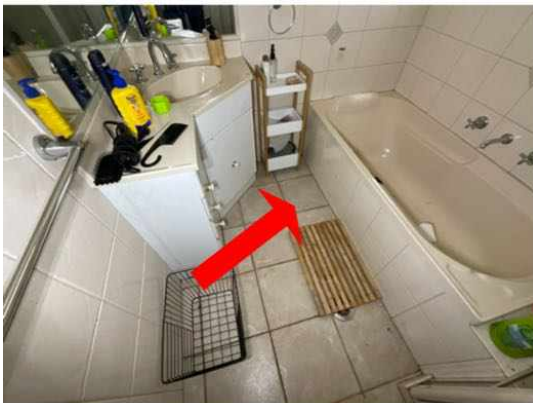
Finding 3.02

Building:	Building 1
Location:	Ensuite
Finding:	Wall Tiles- Cracked
Information:	Cracked tiles within the household detract from the overall appearance of the affected areas, as well as creating potential for water penetration to adjoining building elements. If left unmanaged, water damage may occur as a result of constant water penetration over a prolonged period of time.

While not considered a matter of urgency, replacement of tiles is advised as a solution. A Tiling Contractor may be appointed to perform these works at client discretion.

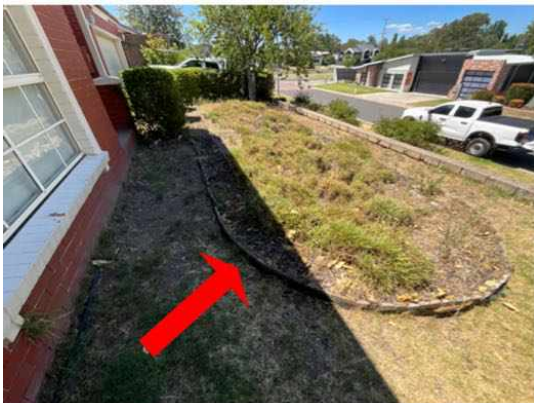
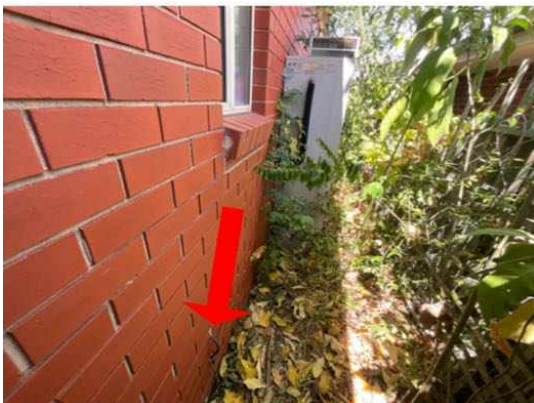
A durable notice should be placed in the switchboard unit to indicate current termite barriers. At the time of inspection, it appeared as though no termite management system has been installed, with no evidence to suggest preventative works taking place.

The client may consider gaining further advice from a pest controller as to the costs and procedures involved with this application. It is recommended that obtaining such advice be a short-term priority.
