Building and Timber Pest Inspection Report

Inspection Date: Mon, 12 Jan 2026

Property Address: 17 Kobina Avenue Glenmore Park NSW
2745

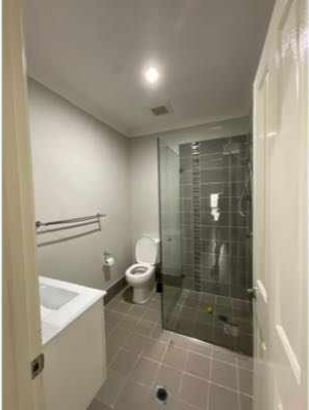
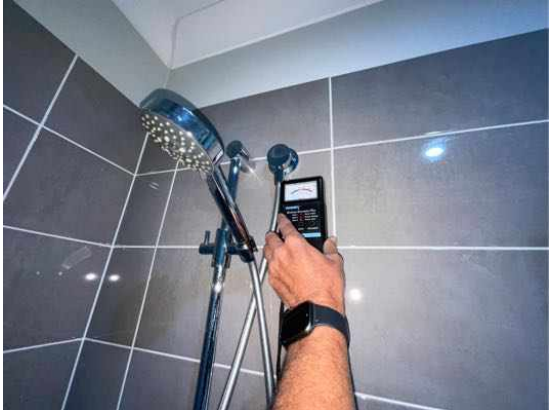
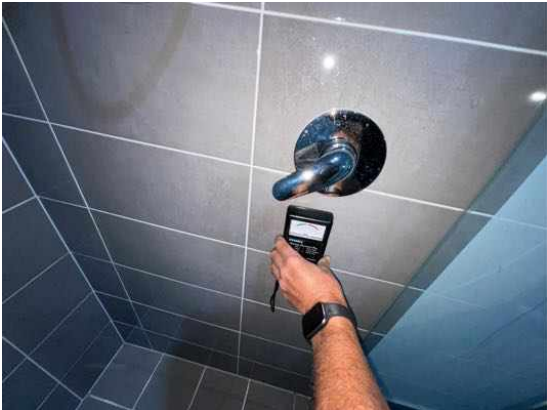
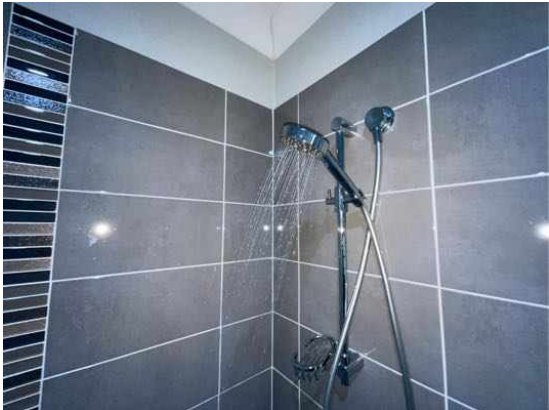
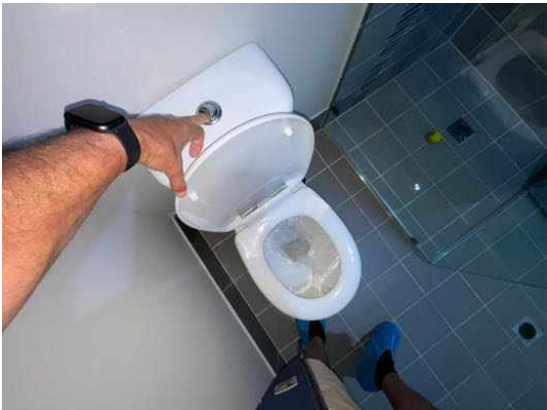
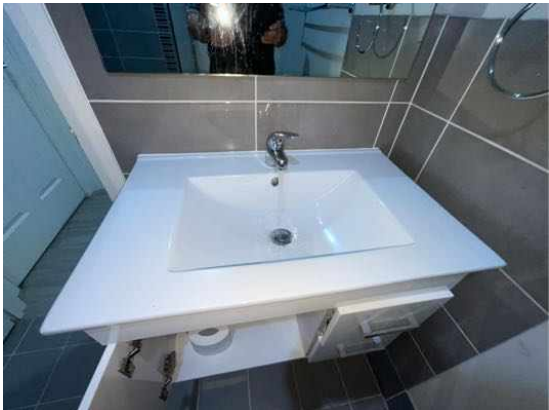
Building: Main Building
 Location: Powder Room
 Finding: Wet Areas - Bathroom(s) - Overall Condition & Recommendations.
 Information: Overall Condition & Recommendations

It is not possible under the visual inspection criteria of a standard pre-purchase report to categorically determine if leaks are present. If a more detailed or accurate assessment is required, a special-purpose inspection should be undertaken.

Alternatively, the assumption should be made that leakage may occur, particularly where historical or environmental conditions are conducive. The visual nature of this inspection cannot detect issues concealed behind wall/floor linings or cabinetry, and invasive investigation may be necessary to confirm the true condition of adjacent or hidden structures.

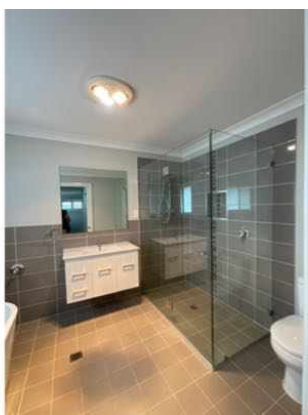
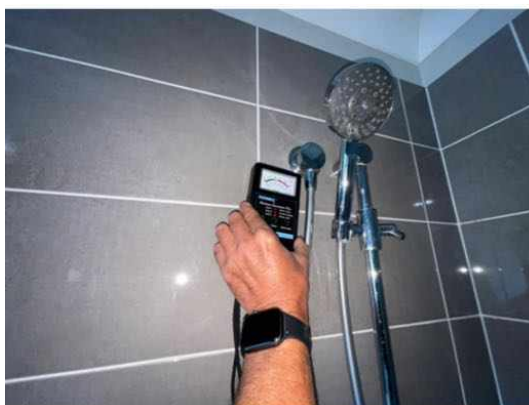
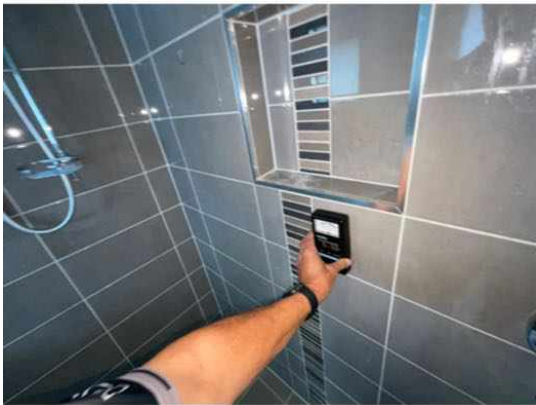
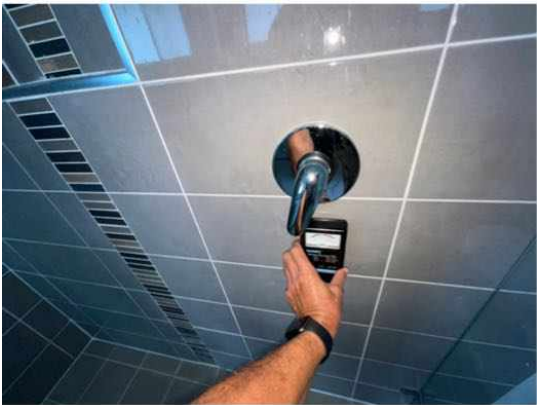
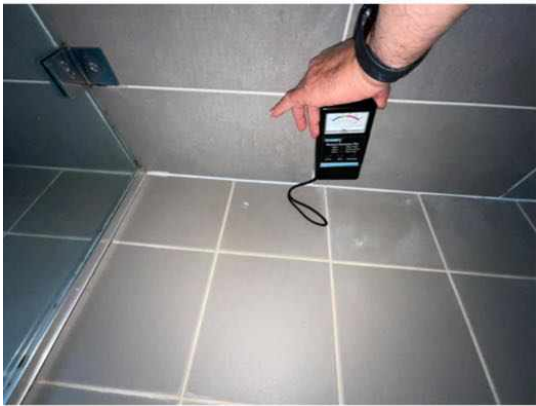
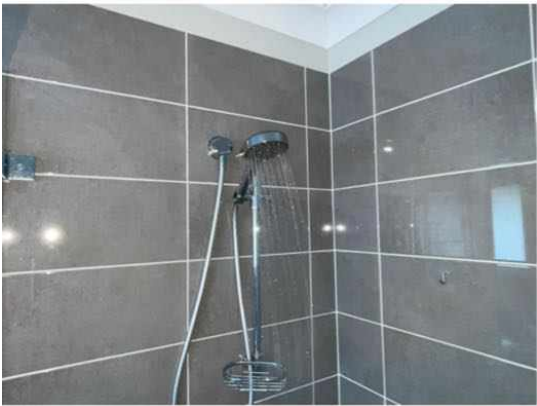
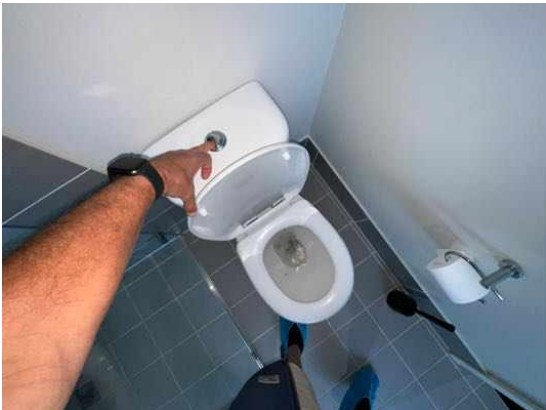
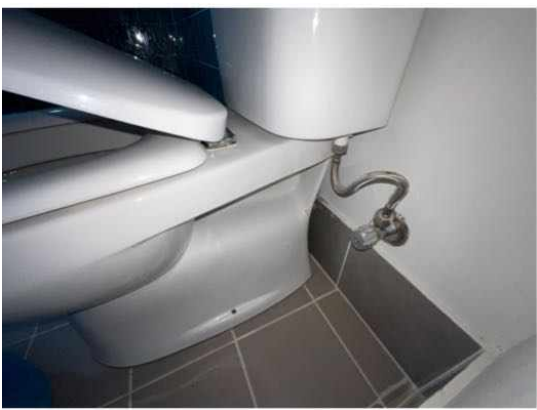
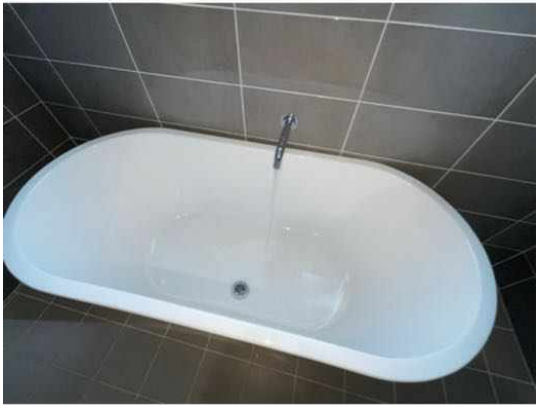
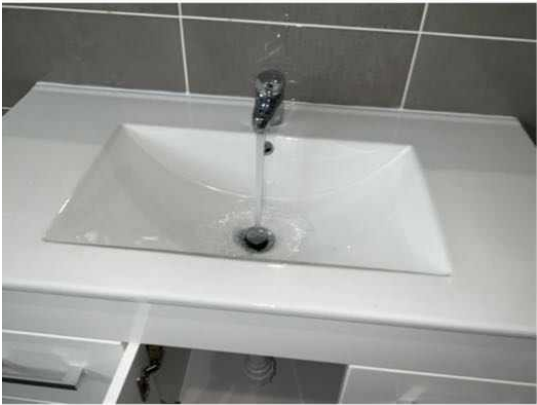
Building: Main Building
 Location: Ensuite
 Finding: Wet Areas - Bathroom(s) - Overall Condition & Recommendations.
 Information: Overall Condition & Recommendations

It is not possible under the visual inspection criteria of a standard pre-purchase report to categorically determine if leaks are present. If a more detailed or accurate assessment is required, a special-purpose inspection should be undertaken.

Alternatively, the assumption should be made that leakage may occur, particularly where historical or environmental conditions are conducive. The visual nature of this inspection cannot detect issues concealed behind wall/floor linings or cabinetry, and invasive investigation may be necessary to confirm the true condition of adjacent or hidden structures.

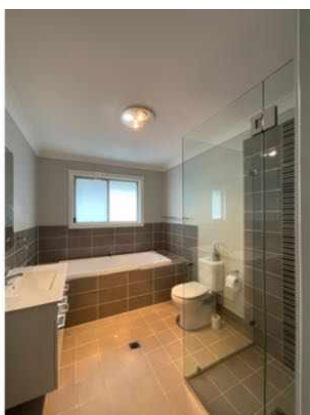
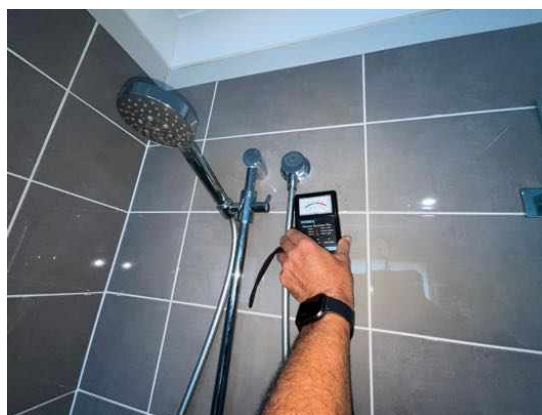
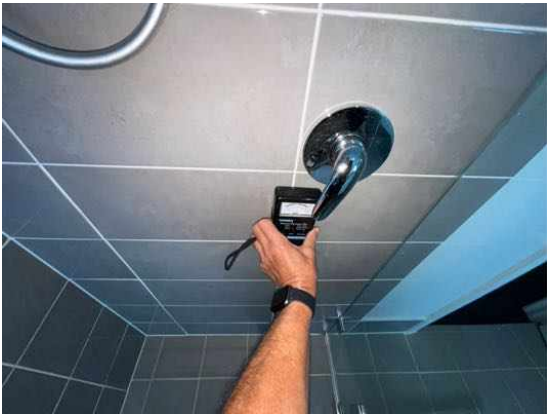
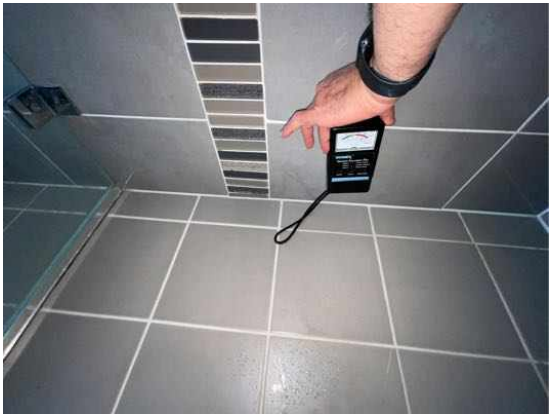
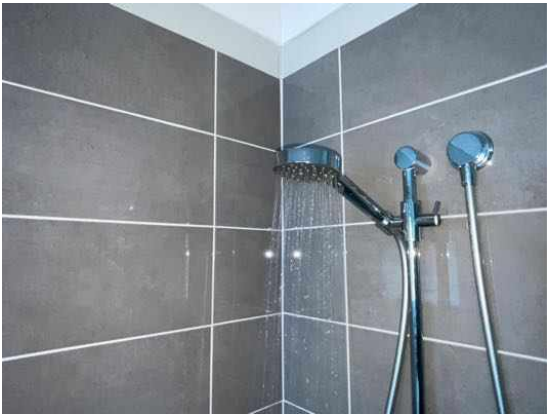
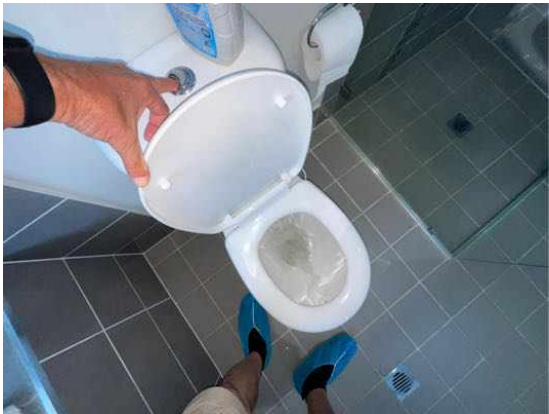
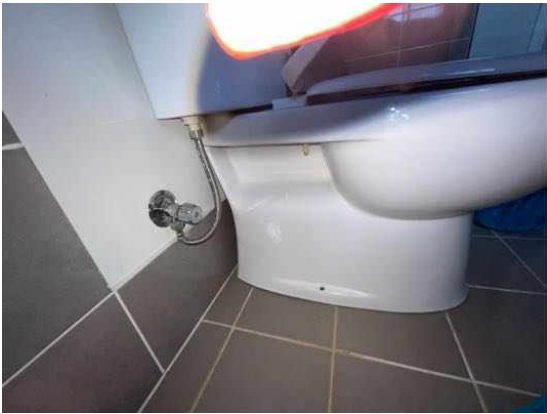
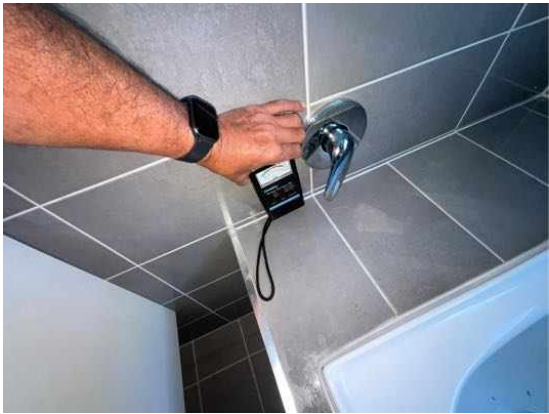
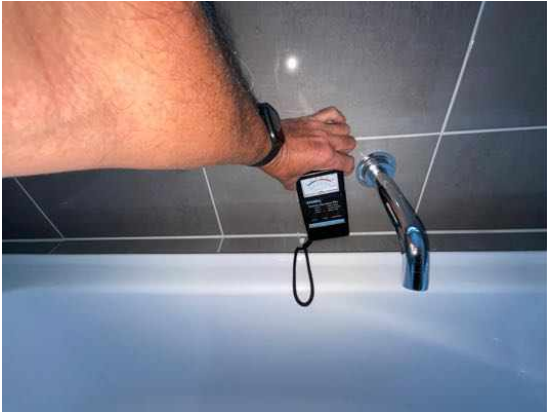
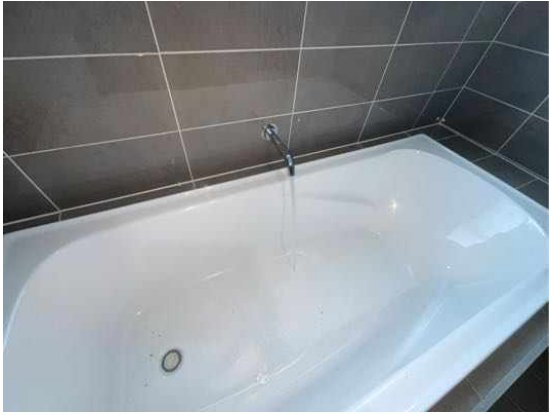
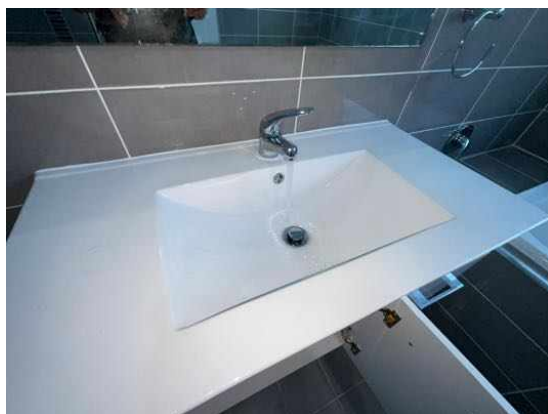
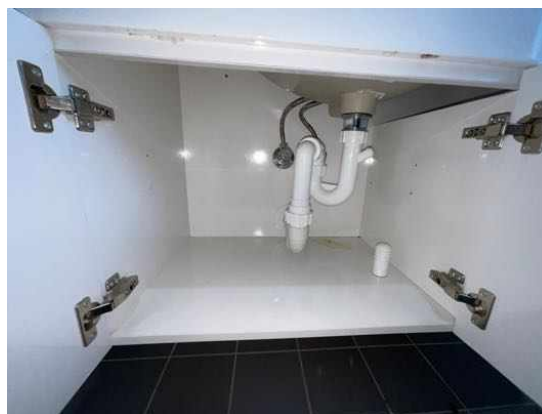
Building: Main Building
 Location: Bathroom
 Finding: Wet Areas - Bathroom(s) - Overall Condition & Recommendations.
 Information: Overall Condition & Recommendations

It is not possible under the visual inspection criteria of a standard pre-purchase report to categorically determine if leaks are present. If a more detailed or accurate assessment is required, a special-purpose inspection should be undertaken.

Alternatively, the assumption should be made that leakage may occur, particularly where historical or environmental conditions are conducive. The visual nature of this inspection cannot detect issues concealed behind wall/floor linings or cabinetry, and invasive investigation may be necessary to confirm the true condition of adjacent or hidden structures.

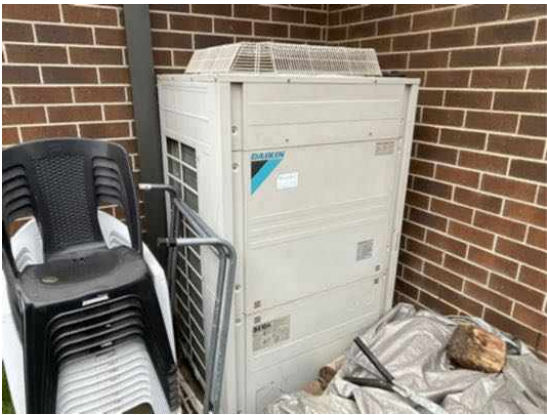
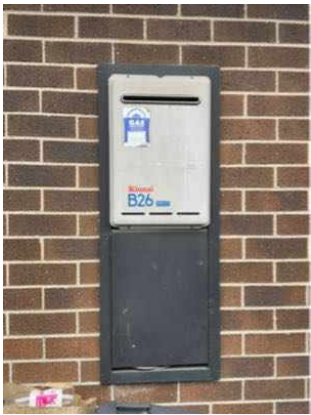
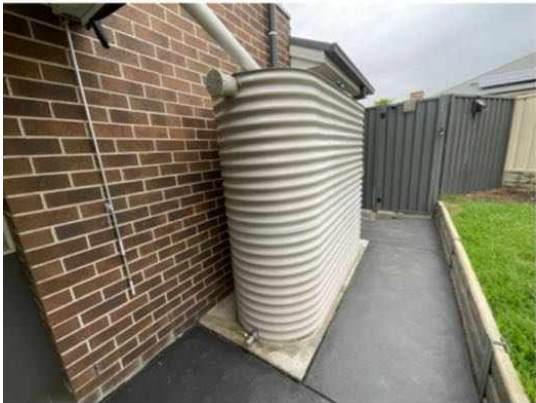
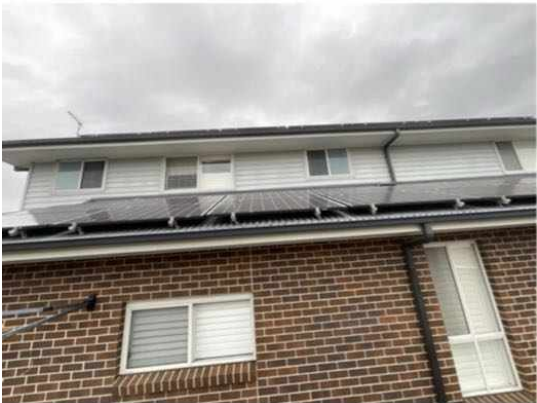
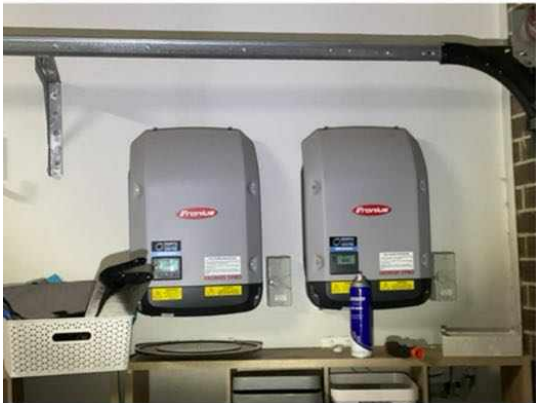
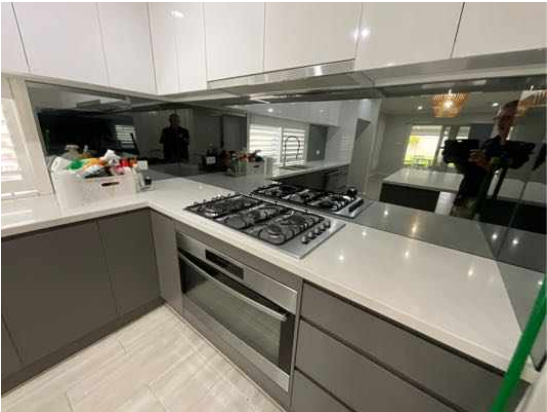
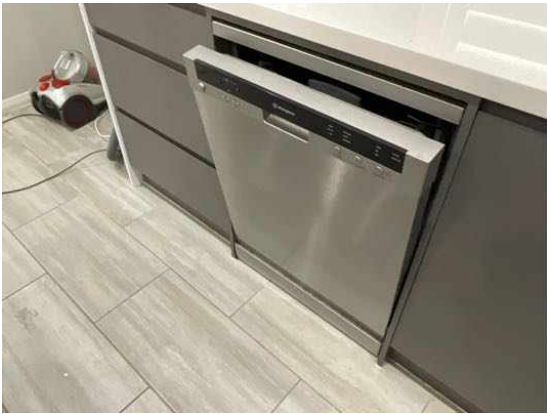
Building: Main Building
 Location: All Areas
 Finding: Plumbing, Electrical & Gas Installations – Scope and Recommendations.
 Information: Plumbing and electrical inspections fall outside the scope of this building inspection and must be carried out by appropriately licensed and registered tradespersons.

- Any gas appliances (if applicable) must be inspected by a licensed gas plumber to confirm they are operating safely and efficiently.
- We also recommend that all other plumbing and electrical installations be thoroughly checked by qualified professionals to ensure they are functioning correctly and meet current safety and compliance standards.

While this inspection includes observations of visually apparent defects relating to plumbing and electrical elements, it does not assess compliance with current regulations. Legislation requires that any such assessment be undertaken and documented by licensed electricians and plumbers.

Additional photos have been supplied with this report for your general reference.

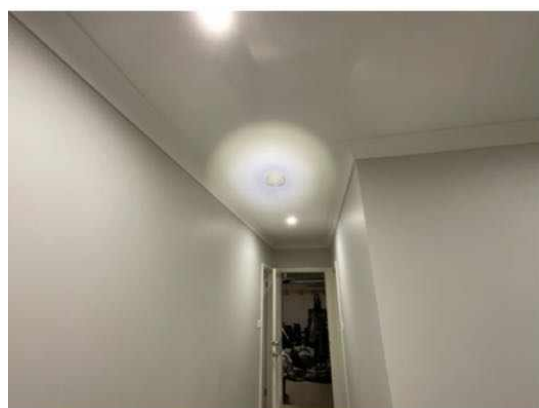
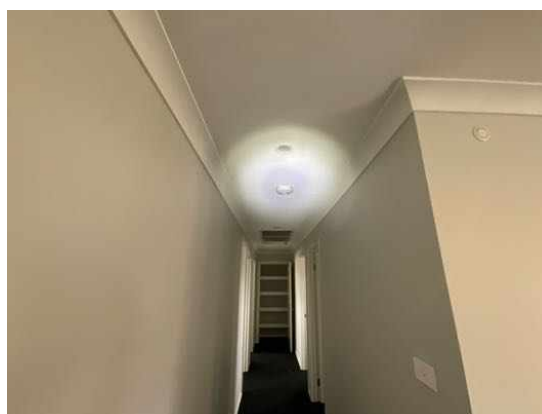
Building:	Main Building
Location:	All Areas
Finding:	Smoke Detectors / Alarms.
Information:	Reporting on the presence, type, location, or compliance of smoke detectors or alarms, including hard-wired smoke detection systems and their legislative requirements, is outside the scope of this inspection report.

To ensure compliance and safety, further inspection and/or advisory services from a qualified specialist are recommended. These services can confirm the sufficiency, type, location, and functionality of all smoke detection devices within the property.

- All smoke detectors be tested monthly by the homeowner.
- All systems comply with the requirements of AS 3786 and any applicable state-based legislation.

Failure to comply with these requirements may pose a serious risk to occupant safety.

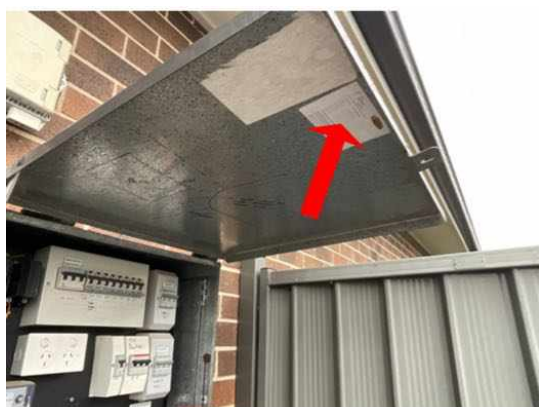
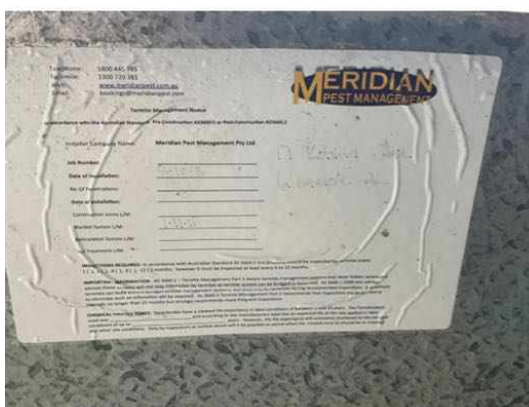
Building: Main Building
 Location: All Areas
 Finding: Termite Management System – Previous Barrier Noted..
 Information: Observation:

At the time of inspection, evidence of a previous termite management system was noted, indicated by the presence of a durable notice affixed to the electrical switchboard.

- The installation of a termite management system is strongly recommended for all properties, particularly those with timber building elements. These systems provide a proactive defence against termite attack and are effective in minimising the risk of concealed termite entry and structural damage.

- The client is advised to contact the pest control provider listed on the durable notice (if identifiable) to obtain further information regarding:
- The type of system installed (e.g., chemical barrier, baiting system, or physical barrier)
- The installation date
- Any warranty conditions, service history, or ongoing maintenance requirements
- If no reliable information can be obtained, or if the existing system is found to be outdated or non-functional, it is recommended that a new termite management system be installed by a licensed pest control professional.
