Building and Timber Pest Inspection Report

Inspection Date: Mon, 23 Mar 2026

Property Address: 114 Hindmarsh St, Cranebrook NSW 2749,
Australia

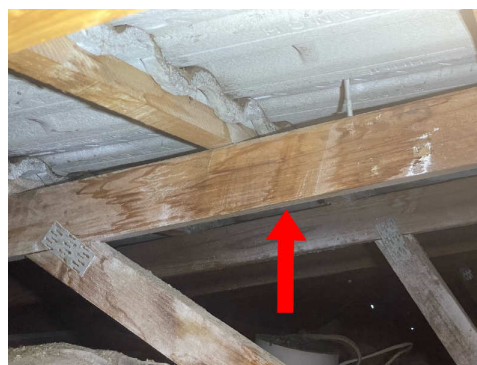
Finding 2.01

Finding: Roof Framing – Water Staining Beneath Solar Panel Fixings

Information: During the roof inspection, water staining was observed to sections of the timber framing beneath the solar panel fixing screws. The staining appears consistent with past or ongoing moisture entry at or around the roof penetrations associated with the solar panel installation.

This condition may indicate that the fixings, seals, or flashing details around the solar panel mounting points are not fully weatherproof, allowing water to track through the roof covering and affect the underlying timber members. Continued moisture ingress can contribute to deterioration of timber elements, damage to surrounding materials, and possible concealed defects if not addressed.

A suitably qualified roofing contractor and/or licensed solar installer should be engaged to assess the solar panel fixing penetrations and carry out repairs as required. The affected timber framing should also be monitored and further investigated if signs of active leakage, deterioration, or moisture persistence are identified.

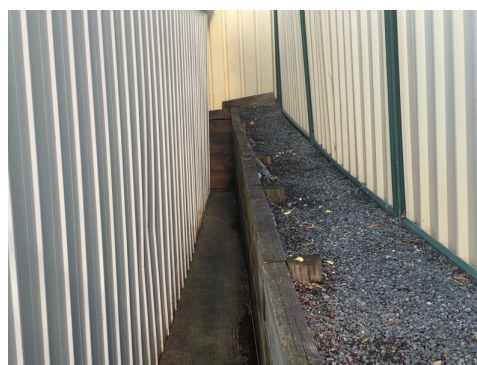
Finding 2.02

Information: During the inspection, the timber retaining wall was observed to be significantly out of plumb and leaning from its intended vertical alignment. The extent of the movement suggests that the wall may no longer be performing as intended and that visible deformation has occurred over time.

A retaining wall that is significantly leaning may indicate structural movement, inadequate support, deterioration of timber components, excessive soil pressure, poor drainage, or a combination of these factors. If left unattended, this condition may lead to further movement, loss of retaining function, and possible localised collapse of the wall and retained ground.

A suitably qualified contractor or structural engineer should be engaged to assess the retaining wall and determine the extent of movement and any necessary remedial works. This defect should be treated as a significant issue and addressed without delay.

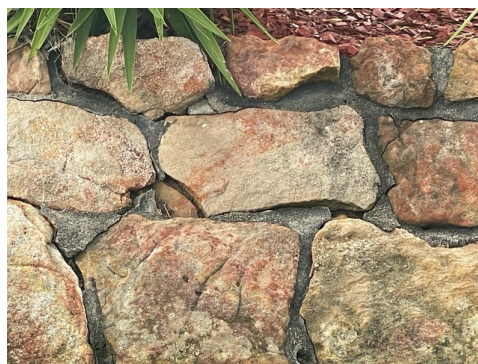
Finding 3.01

Building: Main Building
Location: Front Elevation
Finding: Stone retaining wall - Deteriorated mortar joints

The stone retaining wall located within the external landscaped area of the property was observed to have deteriorated mortar joints in several sections. The issue was more evident along the upper and exposed wall surfaces where the mortar has worn away between the stones.

The mortar joints were found to be cracked, eroded, and in some places missing, which reduces the bond strength between stones and exposes the wall to moisture entry. While the overall alignment of the wall remains satisfactory, the deterioration affects both the visual presentation and long-term durability.

The likely cause of the deterioration is prolonged exposure to weather conditions such as rain, sun, and temperature variations over time. These environmental factors gradually weaken the mortar matrix, leading to surface erosion and separation. No movement or displacement was noted at the time of inspection, indicating the wall's structure remains stable.

It is recommended that the property owner engage a qualified stonemason or landscaper to repoint and repair the affected mortar joints. Using compatible mortar materials and workmanship appropriate for stone construction will ensure durability and consistent appearance.

Although the condition is considered minor at this stage, early intervention will help prevent further weathering and potential water penetration that may eventually compromise the wall's structural performance. Regular maintenance of stone retaining walls is advised to prolong service life and maintain an acceptable standard of appearance.

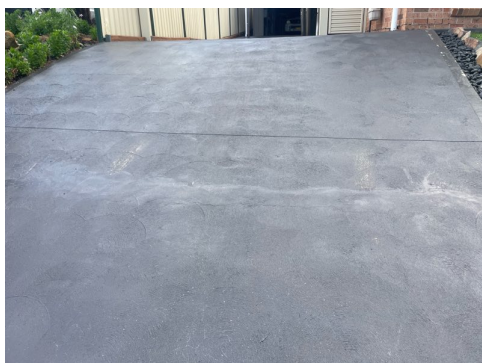
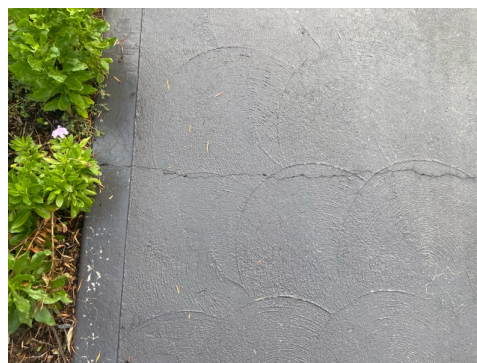
Finding 3.02

Finding: Crack in concrete slab - Category 1

Information: A crack coded as Category 1 was identified in the slab. A Category 1 crack is described as a fine but noticeable crack, with the slab at an otherwise reasonable level.

To be considered Category 1, the approximate width of the crack is less than 1.0mm, or a less than 10mm change in offset when a 3m straight edge is placed over the defect.

Category 1 cracks should be monitored for a period of 12 months. At the end of the monitoring period, identified cracks that are rated greater than Category 2 are considered defects, and require rectification.

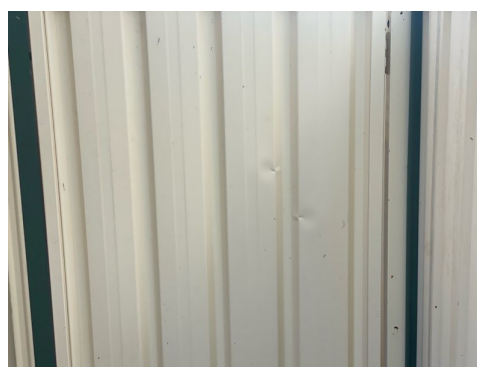
Finding 3.04

Building: Main Building
Location: Fencing
Finding: Perimeter Fence – Impact Damage

Information: During inspection, the perimeter fence, constructed from a steel frame with corrugated steel infill panels, was noted to have sustained damage due to an impact load. The affected section shows distortion and misalignment, with visible bending that reduces both its presentation and structural integrity.

The damaged area appears consistent with force applied directly to the panels and frame. This has resulted in an uneven surface and compromised finish, detracting from the overall appearance of the boundary structure.

This defect was identified along the perimeter fence during the inspection. It is recommended that a competent contractor be engaged to assess the extent of the damage and carry out necessary repairs or replacement to restore the fence to a serviceable and presentable condition.

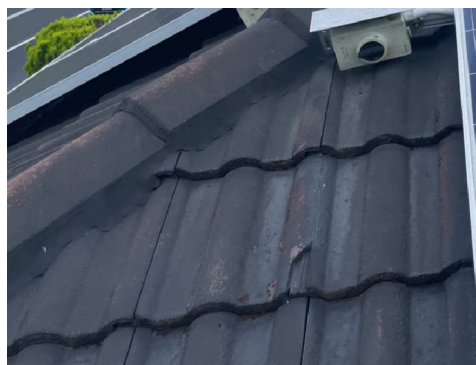
Finding 3.05

Finding: Roof tiles - Broken

Information: Upon inspection of the exterior roof covering, broken roofing tiles were identified. Broken and friable roof tiles are generally the result of ageing and weathering of what is essentially a porous material.

If left to further deteriorate, broken and brittle roof tiles are likely to lead to water penetration via the roof into the ceiling space, causing secondary damage to ceiling linings, insulation and roof structures. Broken roof tiles are also likely to detract from the effectiveness of the roof drainage system, creating potential for secondary damage to the exterior roof covering and roof plumbing.

Replacement of broken tiles is required and should be performed by a roofing contractor as soon as possible.

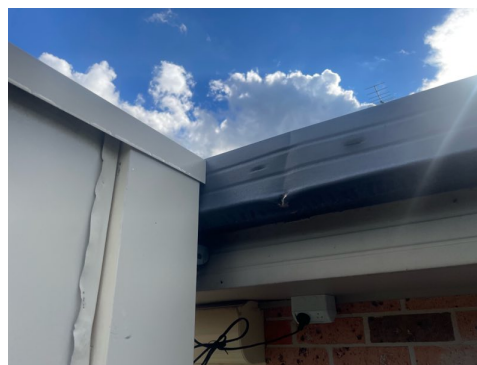
Finding 3.06

Finding: Damaged Gutters

Information: The damaged gutter at the corner junction was observed during the inspection. This issue was identified as the gutter no longer functions as intended, showing signs of deterioration that may affect stormwater drainage.

The defect is located at the corner junction of the roofline, where water flow is most concentrated. If the damage is not rectified in a timely manner, it may cause overflow and moisture ingress, leading to potential secondary defects in surrounding building elements.

It is recommended that a licensed roofing or guttering contractor be engaged to carry out the repair or replacement. Addressing this issue promptly will ensure the guttering system remains functional and helps protect the property from future water damage.

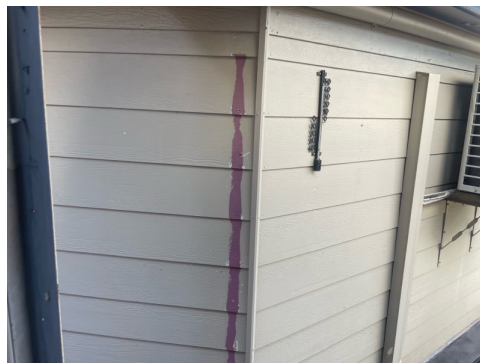
Finding 3.07

Finding: Exterior Paint – Deterioration

Information: During the inspection, the exterior paintwork to sections of the dwelling was noted to be deteriorated. Localised areas showed flaking, peeling, and fading, particularly on the front and side elevations.

This condition is considered a minor defect, as it mainly affects the visual appearance of the property rather than the structural integrity. However, deterioration of the paint finish can, over time, reduce the level of protection provided to the underlying surfaces.

It is recommended that routine maintenance be carried out by a qualified painter or tradesperson to prepare and repaint the affected areas. Regular upkeep of external paintwork helps preserve the building's appearance and maintain protection against weathering.

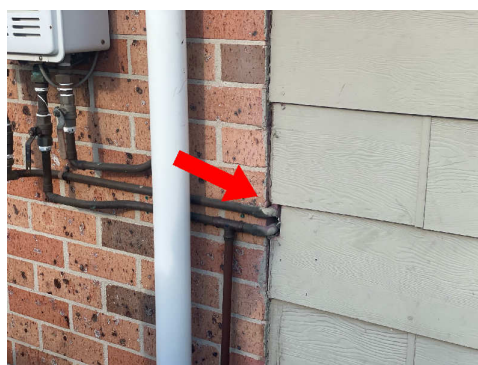
Finding 3.08

Building: Main Building
Location: Exterior walls - right side
Finding: Sealant – Damaged / Displaced

During the inspection, sections of sealant were noted to be damaged, deteriorated, or displaced from the joint. The sealant no longer appeared continuous or properly bonded along the affected junction, leaving parts of the joint insufficiently sealed.

Sealants are used to close and protect joints against the entry of water, moisture, dust, and air, and damaged or detached sealant can reduce the effectiveness of that junction over time. Where left unattended, this condition may contribute to moisture ingress, deterioration of adjacent finishes, or ongoing maintenance issues.

A suitably qualified contractor should be engaged to assess the affected area and replace the defective sealant as required. This item is considered a maintenance issue that should be attended to in the near future.

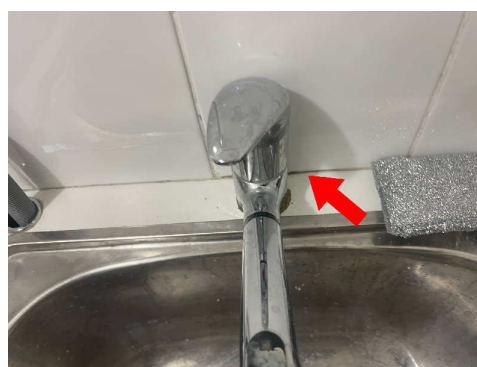
Finding 3.09

Finding: Cabinetry – Missing or Deteriorated Corner Sealant

Information: The cabinetry was observed to have missing or deteriorated sealant at the internal corners. In some areas, the sealant had not been applied, while in others it had broken down and no longer provided an effective seal.

Incomplete or deteriorated sealant can allow water, moisture, or debris to penetrate behind cabinetry panels, which may lead to swelling, staining, or damage to the cabinetry materials over time. It also detracts from the overall finish and appearance of the installation.

This matter is considered a maintenance defect. It is recommended that the affected cabinetry corners be re-sealed by a suitably qualified tradesperson to restore protection and appearance.

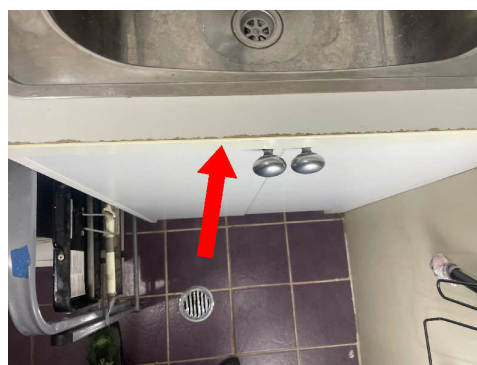
Finding 3.10

The observed staining and deterioration may be consistent with ongoing moisture exposure (splashing, minor leakage, or poor drying/ventilation) combined with normal use over time. Where laminated or painted finishes are scratched, worn, or water stained, the protective coating can be compromised, which may allow moisture absorption and lead to swelling, delamination, and progressive deterioration of the cabinet materials.

It is recommended that the client arrange further assessment and repair or replacement of the affected vanity components as required to restore function and reduce the risk of further deterioration. If water staining is active or worsening, it is also recommended that the plumbing and surrounding junctions (basin waste, taps, silicone seals, and adjacent wall/floor interfaces) be checked to confirm there is no ongoing leak contributing to the damage.

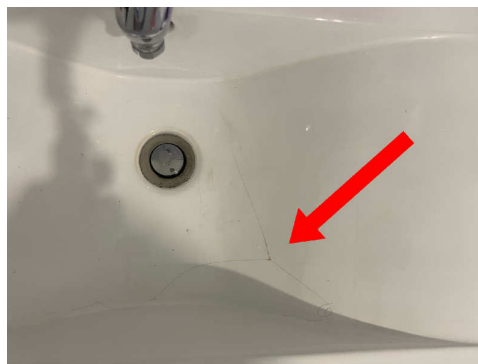
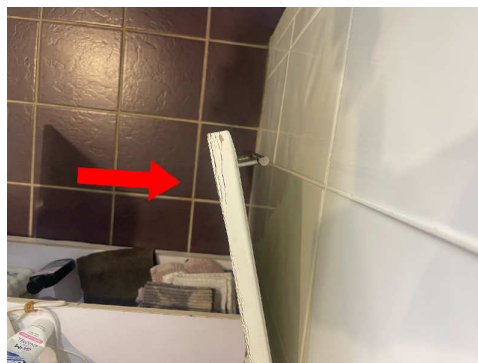
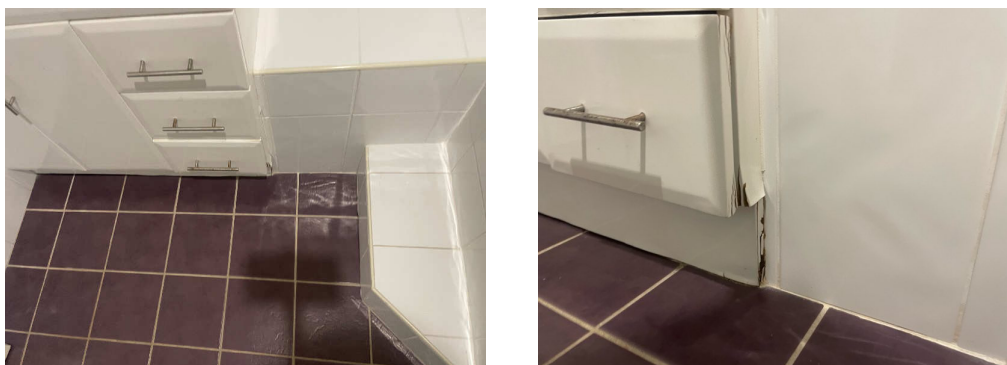
Finding 3.11

Building: Main Building
Location: Bathroom
Finding: Bathroom Vanity – Damaged (Scratches, Water Staining, Wear & Tear)

The observed staining and deterioration may be consistent with ongoing moisture exposure (splashing, minor leakage, or poor drying/ventilation) combined with normal use over time. Where laminated or painted finishes are scratched, worn, or water stained, the protective coating can be compromised, which may allow moisture absorption and lead to swelling, delamination, and progressive deterioration of the cabinet materials.

It is recommended that the client arrange further assessment and repair or replacement of the affected vanity components as required to restore function and reduce the risk of further deterioration. If water staining is active or worsening, it is also recommended that the plumbing and surrounding junctions (basin waste, taps, silicone seals, and adjacent wall/floor interfaces) be checked to confirm there is no ongoing leak contributing to the damage.

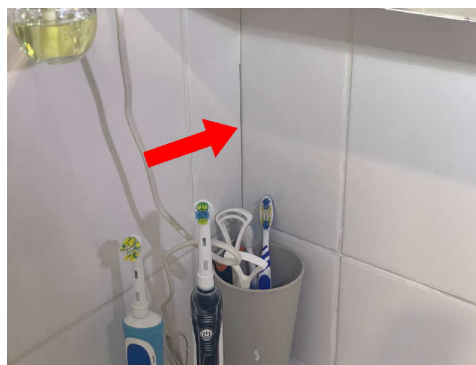
Finding 3.12

The deterioration has likely occurred over time due to general wear, building movement, or ongoing moisture exposure. Missing or damaged grout and sealant allow water to penetrate behind tiles, which can lead to staining, mould growth, or damage to the substrate and surrounding finishes.

It is recommended that the affected areas be re-grouted and re-sealed by a qualified tiler or trade as a short-term priority to maintain a watertight finish and prevent further deterioration.

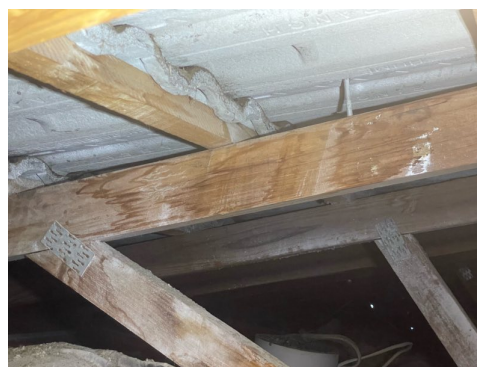
Finding 3.15

Building: Main Building
Location: Roof Void
Finding: Sarking - Missing

Although not a requirement at the time of construction, replacement of any missing building element is advisable (although this can be quite expensive to do after the time of construction). Where sarking is missing, regular inspections of the roof tiles for cracking and potential moisture penetration is required.

Sarking may be retrospectively fitted by a registered builder at the discretion of the client.

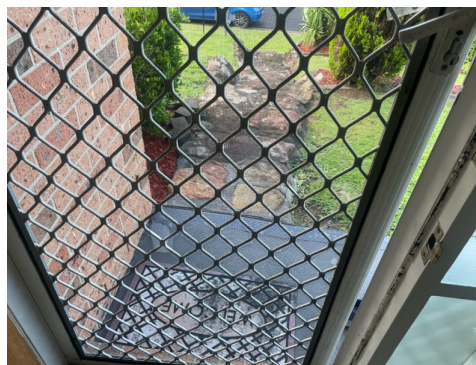
Finding 3.16

Building: Main Building
Location: Entry
Finding: Security Door - Deteriorated and Damaged Flyscreen

The combination of mechanical failure, damaged screen, and general deterioration means the door is not performing its intended function for security or ventilation. The defect also presents a minor safety and security concern due to the compromised locking mechanism.

It is recommended that a licensed tradesperson or security door specialist be engaged to repair or replace the damaged components. Replacement of the flyscreen and servicing or replacement of the top locking jack will restore the door's functionality, appearance, and safety.

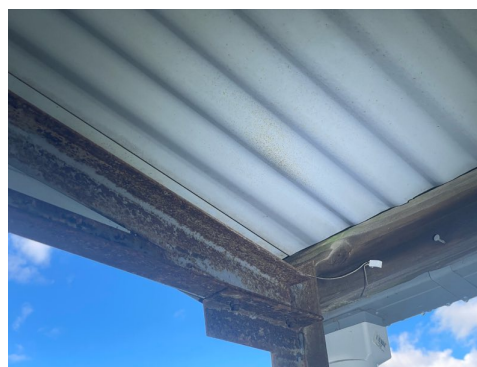
Finding 3.17

Building: Main Building
Location: Shed
Finding: Building element - Rusted or corroded

Where possible, the use of galvanized (treated) metals or aluminium coated metals aid in rust prevention, as does regular general maintenance. Rust formation can be controlled with coatings, such as paint, that isolate the iron from the environment.

Rusting and corrosion should be managed by ideally removing or limiting the affected surface from exposure to moisture. A registered builder may be appointed to replace any building elements that have been severely affected by rust or water damage.

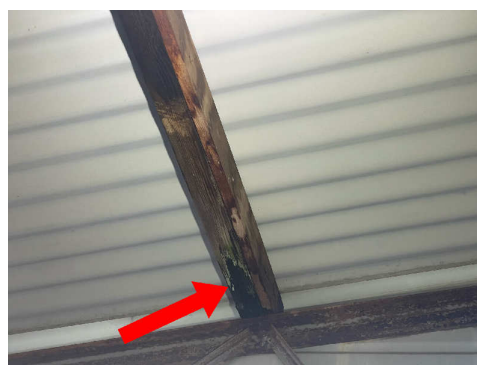
Finding 3.18

Building: Main Building
Location: Shed
Finding: Water leak - Active

Regardless of the location, even minor leaks that are left unmanaged can lead to serious damage of associated building elements and result in the need for replacement of building materials. Mould and other hazards such as electrical hazards may also arise if the leak is left to develop.

It is highly advised that the cause of the leak be identified and resolved immediately by a licensed plumber to prevent any further damage. Depending on the extent of the damage previously sustained, repair and/or replacement of any affected building materials may be required.

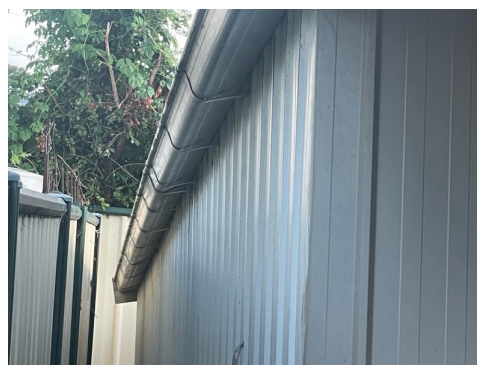
Finding 3.22

Finding: Sealant – Damaged / Displaced

Information: During the inspection, sections of sealant were noted to be damaged, deteriorated, or displaced from the joint. The sealant no longer appeared continuous or properly bonded along the affected junction, leaving parts of the joint insufficiently sealed.

Sealants are used to close and protect joints against the entry of water, moisture, dust, and air, and damaged or detached sealant can reduce the effectiveness of that junction over time. Where left unattended, this condition may contribute to moisture ingress, deterioration of adjacent finishes, or ongoing maintenance issues.

A suitably qualified contractor should be engaged to assess the affected area and replace the defective sealant as required. This item is considered a maintenance issue that should be attended to in the near future.

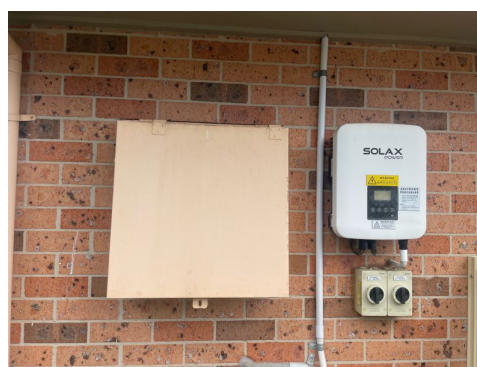
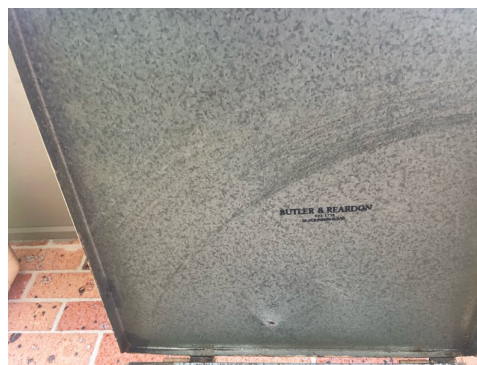
Finding 6.02

Finding: Termite Management – Durable Notice Missing

A post-construction chemical termite barrier is strongly recommended, particularly given the history of termite activity, to help protect timber building elements and reduce the risk of concealed termite damage.

It is recommended that a licensed pest controller confirm whether any termite protection exists and its condition, and if not, arrange installation as a short-term priority. Annual timber pest inspections are recommended in accordance with AS 4349.3 and ongoing termite management practices consistent with AS 3660.2.

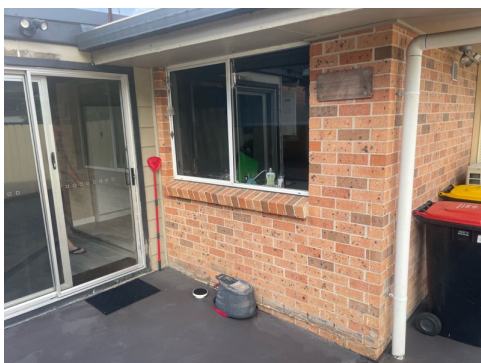
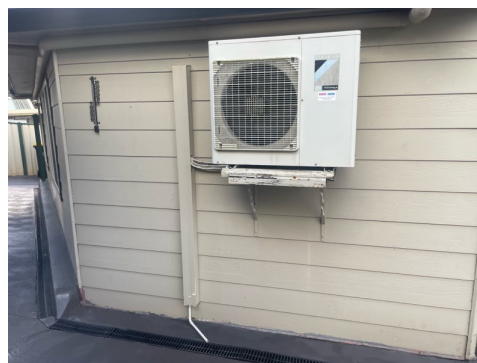
Finding 6.04

Building: Granny-Flat
 Location: All Areas
 Finding: Slab Edge - Exposure

If the slab edge is not properly exposed there is a high risk of termite attack. Sometimes, in order to determine the type of slab, a suitably qualified person such as an architect or builder may be required to consult the construction plans.

Where the slab edge cannot be properly inspected, it is highly recommended that termite or timber pest inspections be carried out every 6-12 months to aid protection of the property against infestation.

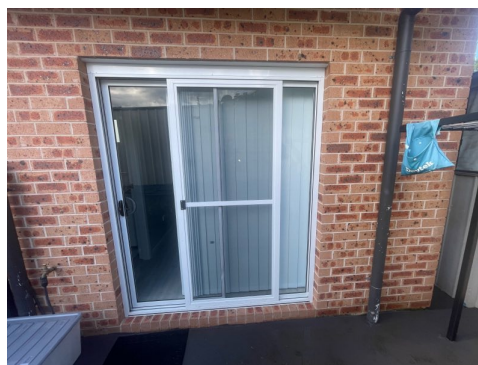
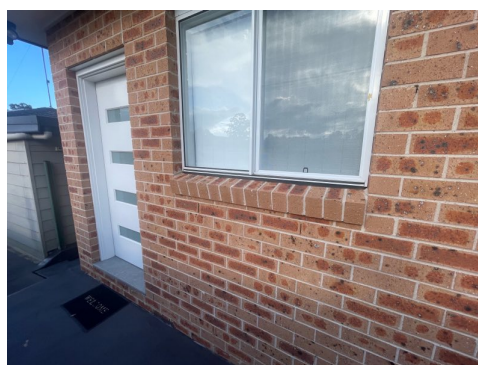
Finding 6.05

Information: The application of a post-construction chemical termite barrier is highly recommended for all properties, particularly if live termite activity has been found on the site previously. Such barriers are highly effective in preventing termite attack on any timber building elements throughout the property.

The client may consider gaining further advice from a pest controller as to the costs and procedures involved with this application. It is recommended that obtaining such advice be a short-term priority.

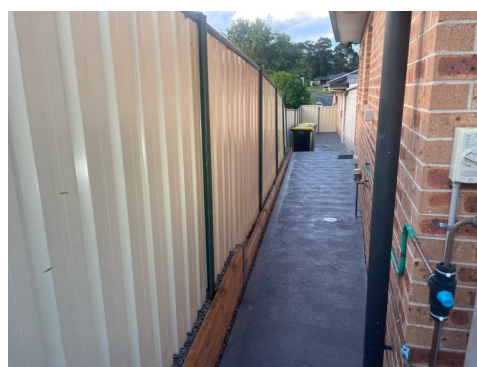
Finding 6.07

Information: The storing of timbers in the subfloor space or around the external property increases the risk of termite activity being present. As they are likely to come into contact with weather conditions or excessive moisture wood rot is likely to develop on timbers that are not treated.

It is highly recommended that any stored timbers be immediately removed from areas in which they may attract any termite / timber pest attack. Minimisation of risk / prevention of termite attack is far more adequate than dealing with the presence of termite activity.

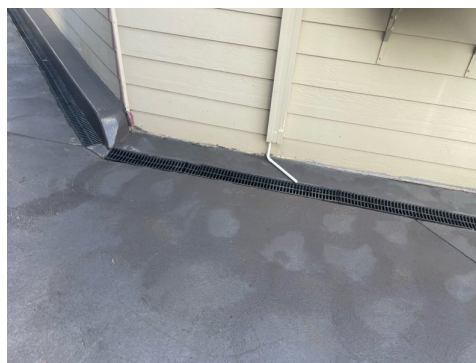
Finding 6.09

Building:	Granny-Flat
Location:	Hotwater Unit
Finding:	Overflows not plumbed to drainage
Information:	The overflow is not plumbed or connected to suitable drainage, which has resulted in the surrounding area becoming excessively damp.

These damp conditions can lead to secondary defects such as rot, rust or corrosion of associated building elements, the formation of fungal decay, or even the creation of potential slip hazards. When coupled with poor site drainage, pooling of water may also attract termite activity to this area.

It is highly recommended that a qualified plumber be appointed to install adequate drainage to the overflow. These works will ensure that the area remains dry and free of any secondary defects.

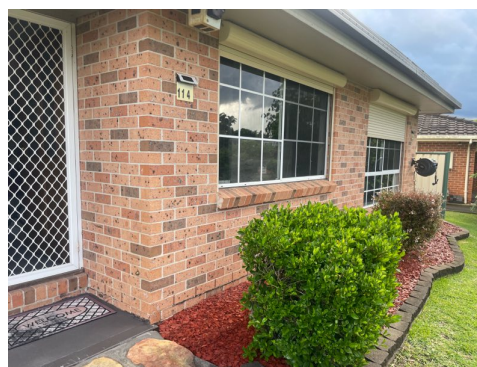
Finding 6.11

Building:	Main Building
Location:	Yard
Finding:	Large trees/stumps within 30m of house

There are a number of large trees/stumps within 30m of the house which may contain natural termite activity. It is important to monitor these areas to ensure no natural activity is allowed to progress into the main house.

Regular inspections are recommended. Consider test drilling any large trees. A pest controller can be contacted to carry out such testing at the owners discretion.

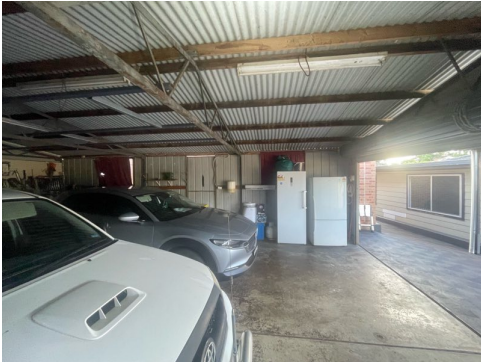
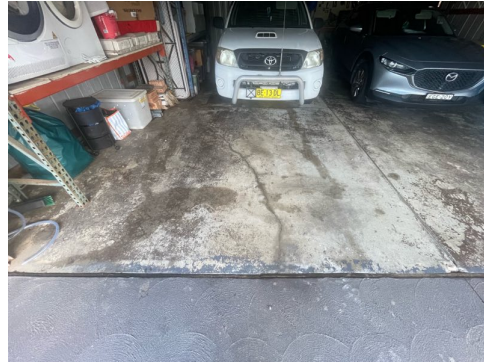
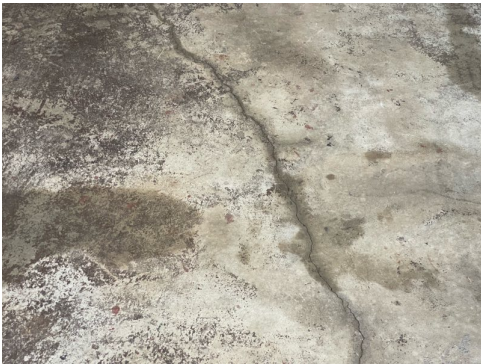
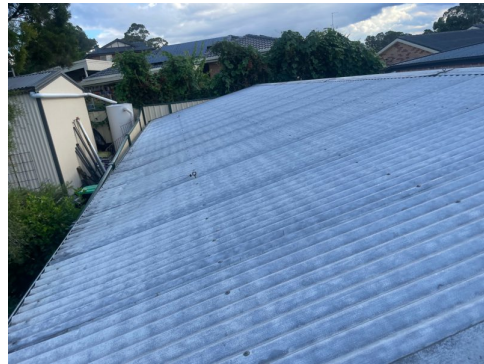
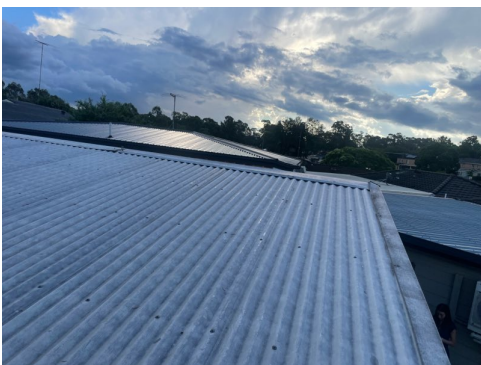
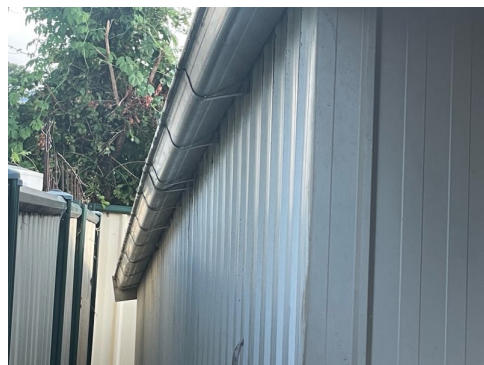
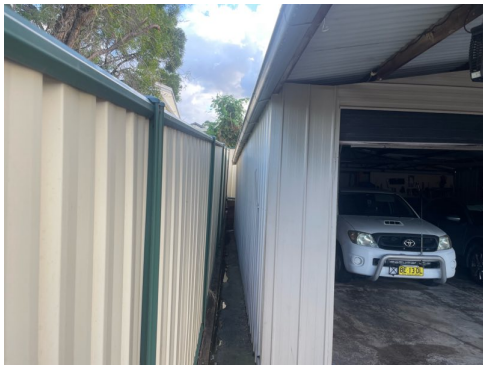
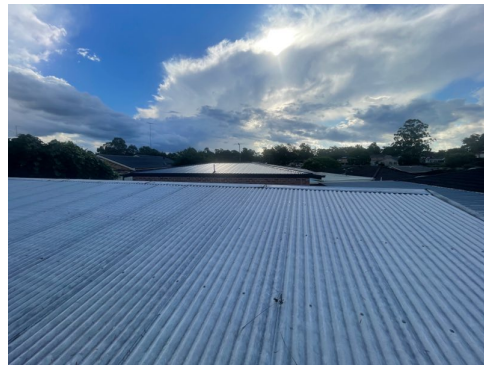
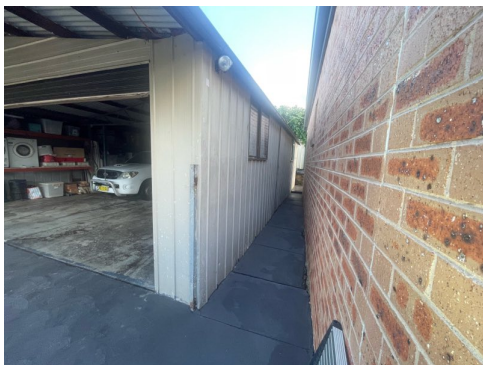
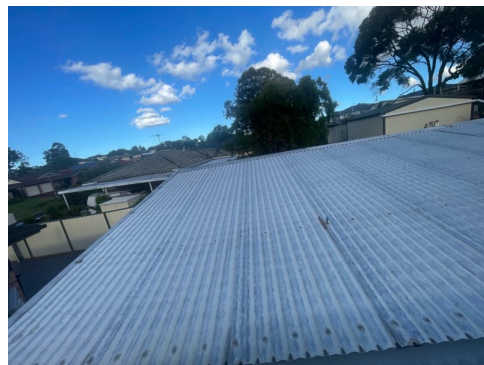
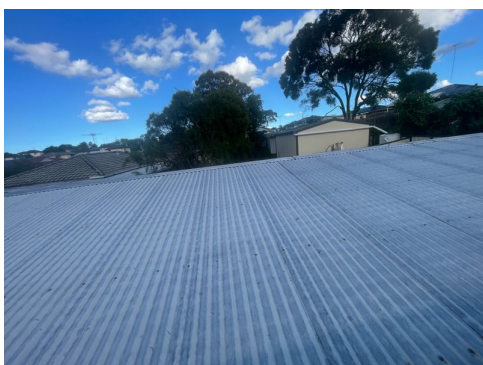
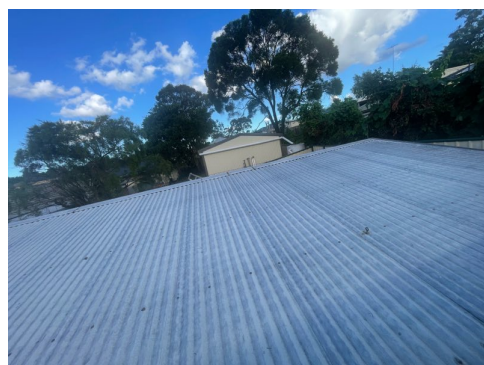
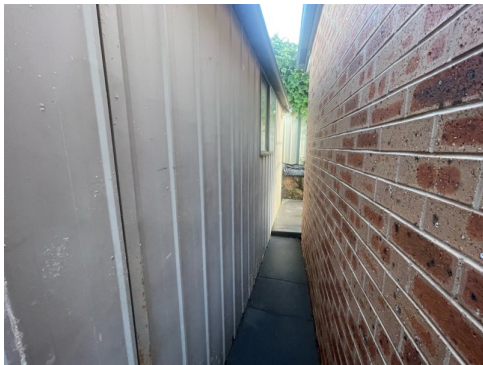
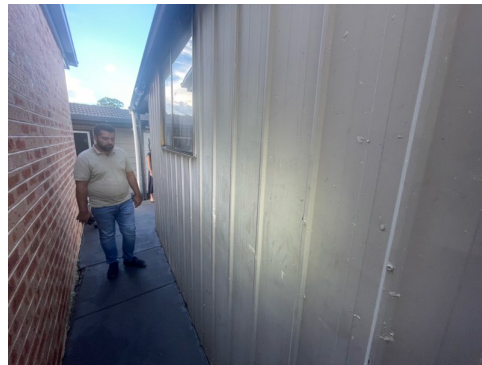
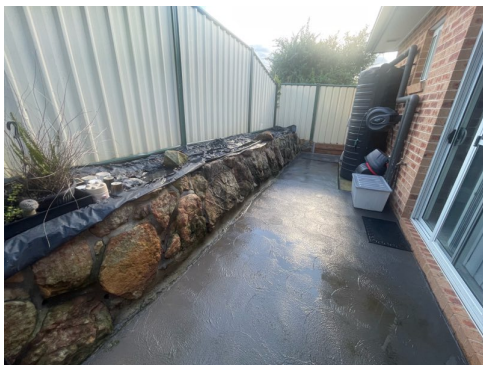
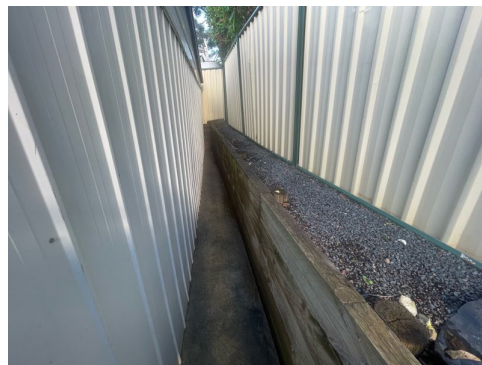
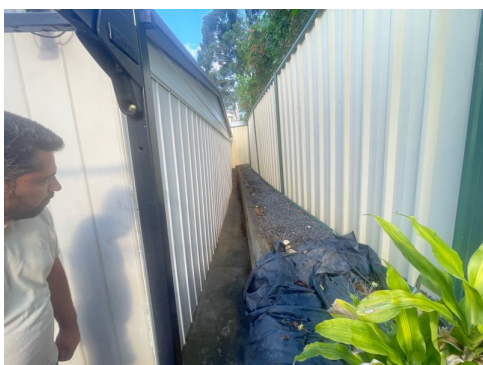
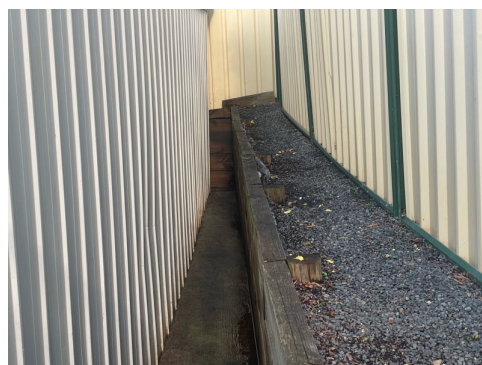
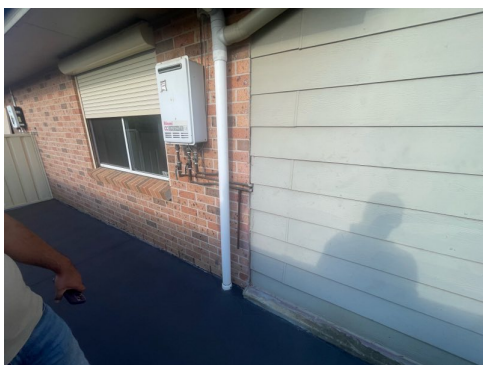
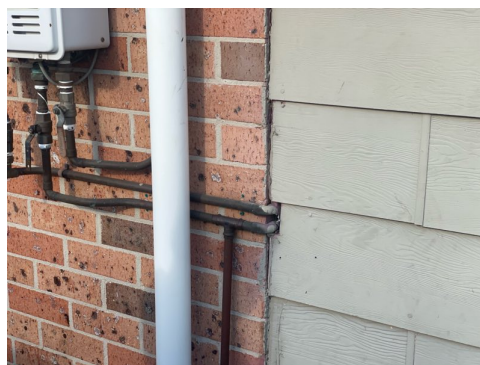
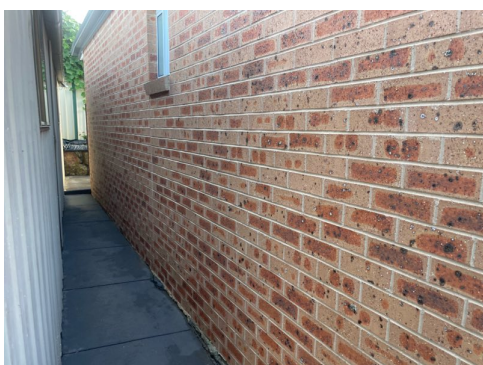
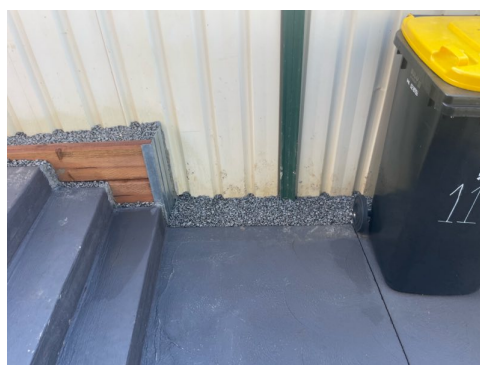
Noted Item

Building: Granny-Flat
Location: All Areas
Finding: Additional Photos – Access Limitations Due to Obstructions (Subfloor, Roof Void, Internal & External Areas)

Internally, some wall/floor junctions, corners, and sections behind furniture, stored items, and fixed joinery could not be fully viewed. This can limit the ability to identify localized defects, moisture impacts, or pest evidence in concealed areas.

The subfloor area (where applicable) was not fully accessible due to restricted clearance, limited entry points, and/or stored items and services within the subfloor. As a result, only accessible sections were inspected, and concealed timbers, bearers/joists, damp conditions, or evidence of pest activity may exist in areas that could not be entered or clearly viewed.

The roof void inspection was also limited due to restricted access and obstructions such as insulation, ducting, low head height, and the absence of safe walkways. Similarly, roof exterior inspection may be limited where pitch, height, weather conditions, or access constraints prevent safe close-up inspection. Accordingly, concealed roof framing, sarking, flashings, and roof drainage components may have defects that were not detectable at the time of inspection.
