Building and Timber Pest Inspection Report

Inspection Date: Thu, 19 Mar 2026

Property Address: 5/40 Liddiard St, Hawthorn VIC 3122,
Australia

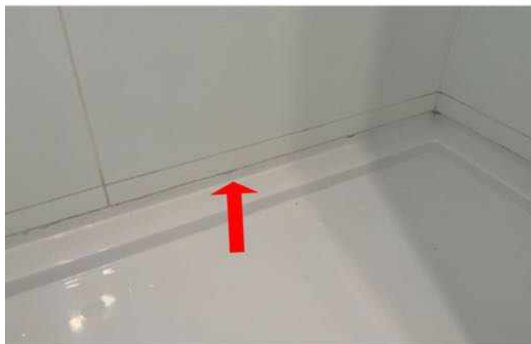
Finding: Grout and sealant - degraded within the bathroom area

Information: It was noted on inspection that grout or sealant is degraded to the shower and other areas within the bathroom.

Different materials move at different rates, generally causing cracking to grout at this point. Build up of moisture in the bathroom can also cause grout and sealants to degrade and become mouldy.

Any damaged or degraded materials should be scraped out and flexible and mould resistant materials should be applied to affected areas to prevent any subsequent water damage that may occur. Regular maintenance and replacement of damaged or missing grout/ sealant is highly recommended to the wet areas, as this is a regular wear and tear defect. Both grout and sealant in areas that come into regular contact with water should be maintained for the long term care of your property.

A bathroom specialist or tiling contractor should be appointed to complete these works as a priority.

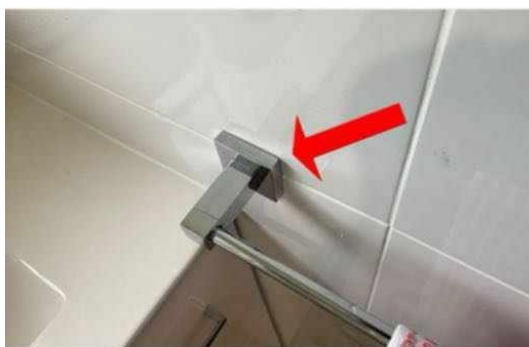
Finding 3.02

Finding: Towel rail loose

Information: At the time of inspection , the towel rail within the bathroom was loose and requires tightening.

This may be undertaken by a competent handyman.

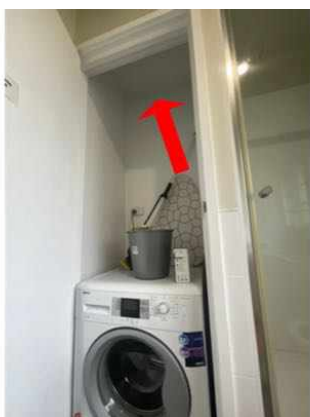
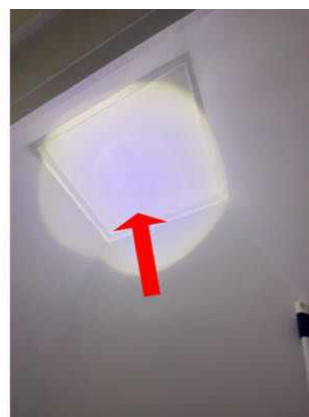
Finding 3.03

Information: It appeared that there was no exhaust fan or way of removing any hot, moist air caused by the drier in the laundry. This has the potential to cause excessive moisture within this area and allow condensation to build up causing potential mould issues and secondary defects.

It is recommended that some form of ventilation/ extraction method be introduced to ensure no moisture build up.

An electrician may be engaged to perform this task.

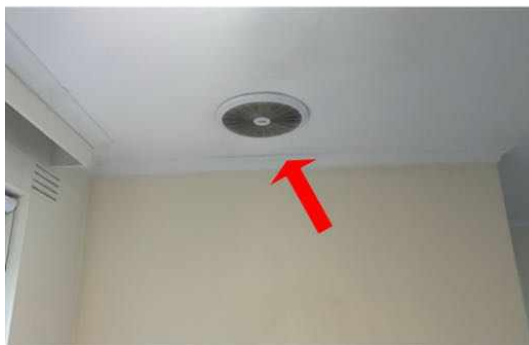
Finding: Rangehood missing

Rangehood extract steam and cooking vapours either through the roof void and outside or are filtered through charcoal filters back within the kitchen. The lack of a rangehood can cause condensation issues within the area and result in secondary moisture damage and a build up of cooking grease on ceilings

Even though this may be difficult and costly , the homeowner should look to have a rangehood installed by a licensed electrician.

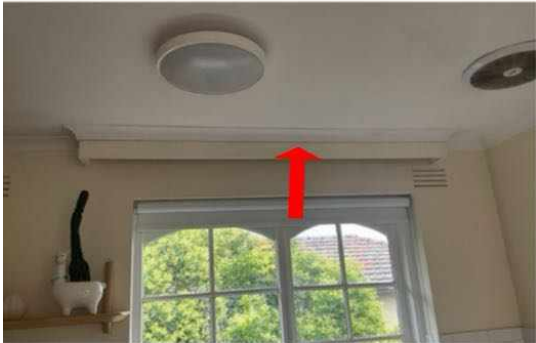
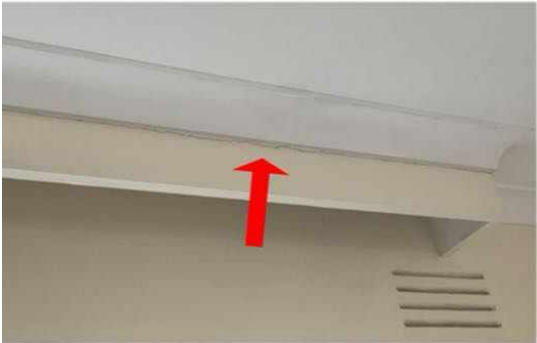
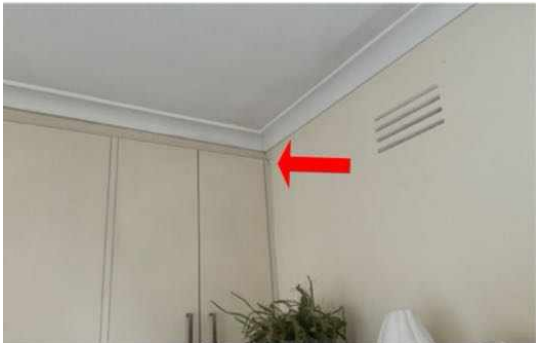
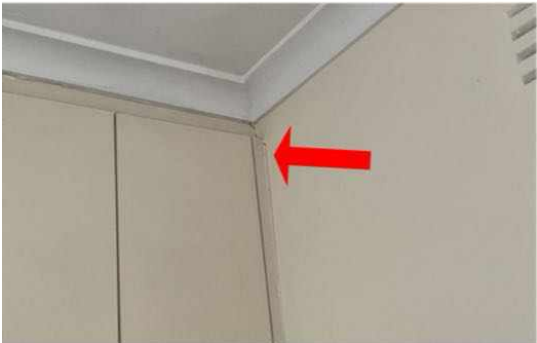
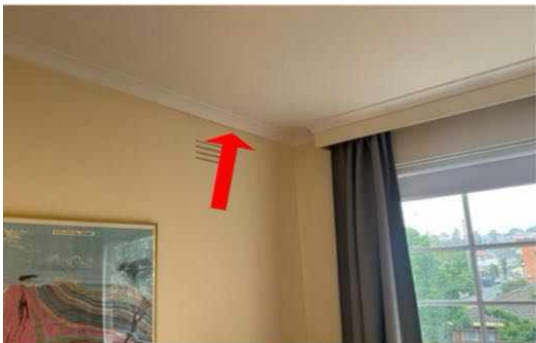
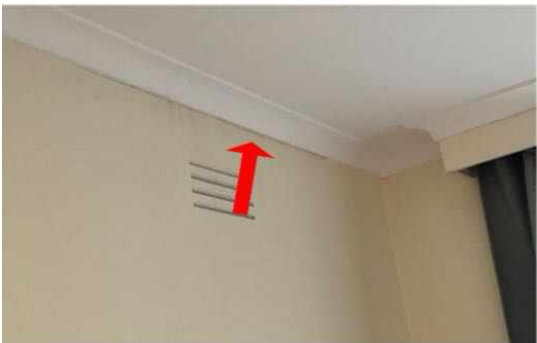
Finding 3.06

Finding: Cracking - fine

Information: Some fine cracking was noted throughout the property.

Although fine cracks are quite noticeable, they are often only considered to be an appearance defect, and usually do not indicate any structural damage. Generally, the cause of a fine crack is indicative of a separation between building materials and finishes (e.g. paint, plaster, etc.) along joints.

Cracking of this nature can generally be repaired with minor sanding, filling and/or repainting. Such works should be performed by a qualified painter or a general handyman.

Monitoring of all cracking should be conducted frequently. Always contact a building inspector should cracks widen, lengthen, or become more numerous.

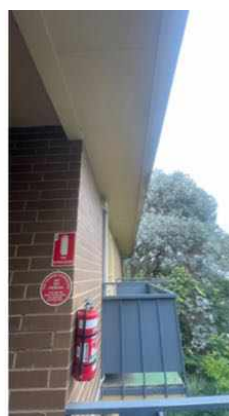
Building:
Location: Balcony
Finding: Area presented in a fair condition

Information: At the time of inspection, the area presented in a fair condition when compared with properties of a similar age.

There was some slight unevenness to the floor in this area.

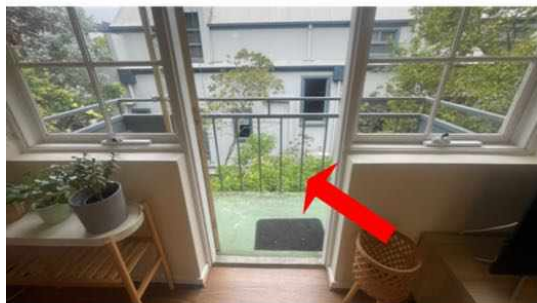
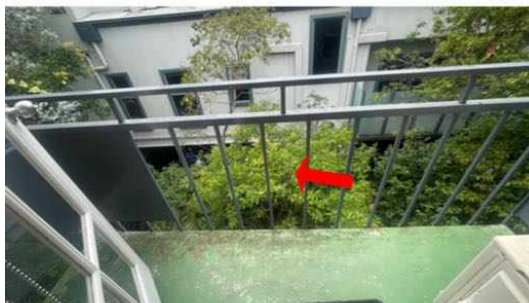
This item creates a potential safety hazard and caution should be taken around this area.

Please note: this item is listed for your information only as compliance with standards and codes is not covered within a pre purchase building inspection as per the Aust standards for residential pre purchase inspections (AS4349.1-2007)
