Building Inspection Report

Inspection Date: Wed, 1 Apr 2026

Property Address: 5/16-24 Merriwa St, GORDON, NSW, 2072,
Australia

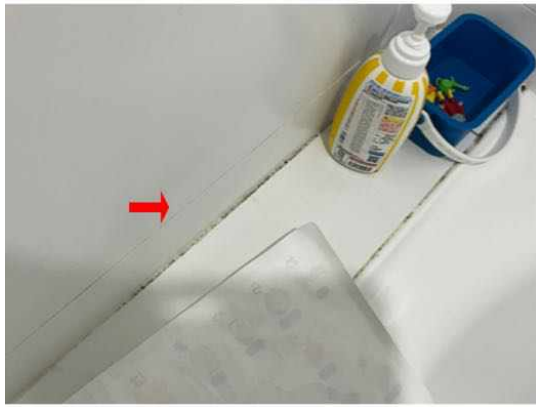
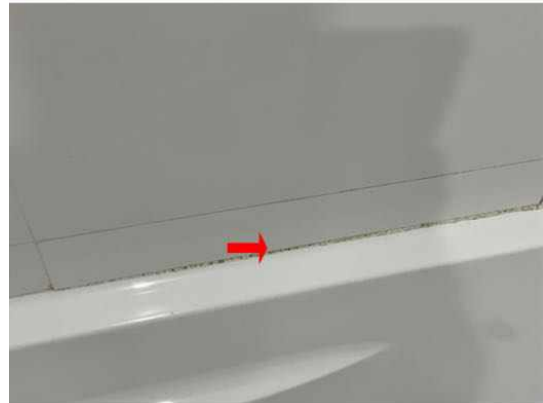
Defects 1.01

Building: Main Building
Location: Bathroom
Finding: Mould - Present
Information: Mold growth is present throughout the property, primarily due to inadequate ventilation. Poor airflow and moisture accumulation within the house have created ideal conditions for mold to thrive.

- **Health Hazards**: Mold growth can pose serious health risks to occupants, particularly those with allergies, asthma, or other respiratory conditions. Prolonged exposure to mold spores can cause respiratory issues, skin irritation, and other allergic reactions.
- **Structural Damage**: Mold can degrade building materials over time, leading to rot and weakening of the structural components such as timber, drywall, and insulation, which can result in costly repairs.
- **Decreased Property Value**: The presence of mold can significantly reduce the value of the property, as it indicates underlying moisture and ventilation issues that need addressing.

A licensed mold remediation specialist should be engaged to remove the mold and treat affected areas. In addition, a ventilation expert or builder should assess and improve the house's ventilation system, possibly installing exhaust fans, vents, or mechanical ventilation systems to ensure adequate airflow and prevent future mold growth.

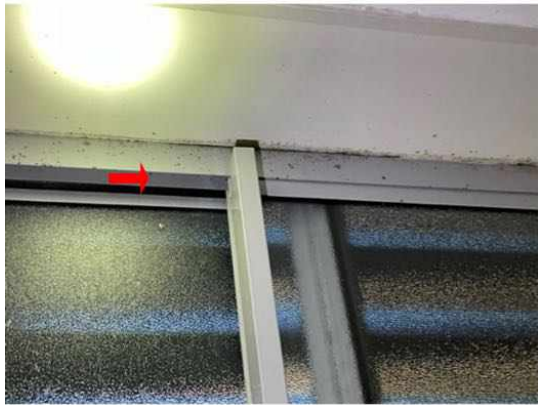
Defects 1.02

Building:	Main Building
Location:	Ensuite - Master
Finding:	Mould - Present
Information:	Mold growth is present throughout the property, primarily due to inadequate ventilation. Poor airflow and moisture accumulation within the house have created ideal conditions for mold to thrive.

- ****Health Hazards****: Mold growth can pose serious health risks to occupants, particularly those with allergies, asthma, or other respiratory conditions. Prolonged exposure to mold spores can cause respiratory issues, skin irritation, and other allergic reactions.
- ****Structural Damage****: Mold can degrade building materials over time, leading to rot and weakening of the structural components such as timber, drywall, and insulation, which can result in costly repairs.
- ****Decreased Property Value****: The presence of mold can significantly reduce the value of the property, as it indicates underlying moisture and ventilation issues that need addressing.

A licensed mold remediation specialist should be engaged to remove the mold and treat affected areas. In addition, a ventilation expert or builder should assess and improve the house's ventilation system, possibly installing exhaust fans, vents, or mechanical ventilation systems to ensure adequate airflow and prevent future mold growth.

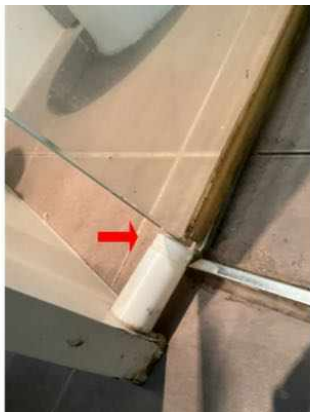
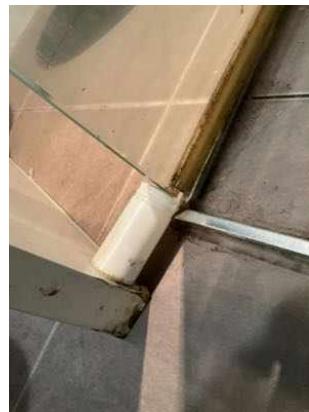
Defects 1.03

Building: Main Building
Location: Ensuite - Master
Finding: Door hitting shower screen
Information: The door swings open and directly contacts the glass shower screen, which poses a risk of damage to the screen over time due to repeated impact. This may result in cracking, chipping, or shattering of the glass, creating a potential safety hazard for occupants.

A qualified handyman or carpenter should install a doorstop or restrictor to prevent the door from swinging into the shower screen. Alternatively, repositioning the door swing or using a soft-close hinge may also be considered to reduce impact.

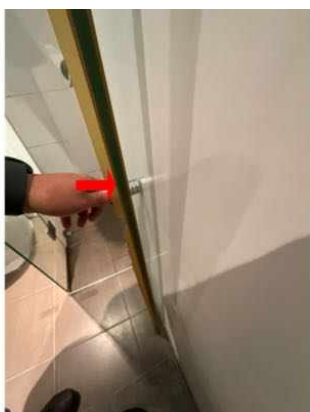
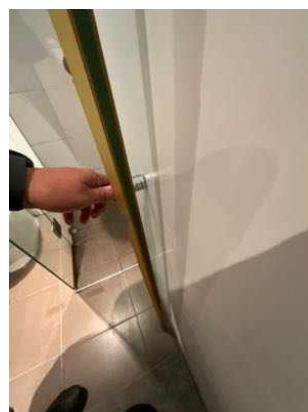
Defects 1.04

Building: Main Building
 Location: Ensuite - Master
 Finding: shower screen door hitting tiles
 Information: The shower screen door makes contact with the adjacent tiles when opened. This indicates inadequate clearance between the shower screen and the tiles. The door's operation is impeded and presents a safety concern.

- Potential for impact damage to the wall and shower screen.
- Increased risk of glass breakage, posing a personal injury hazard.
- Ongoing stress may lead to hardware failure or misalignment of the door.

This condition does not comply with the intent of AS 4349.1-2007, Appendix C – Significant Items, under “Defects in the condition of secondary and finishing elements,” specifically where normal use may cause failure or injury.

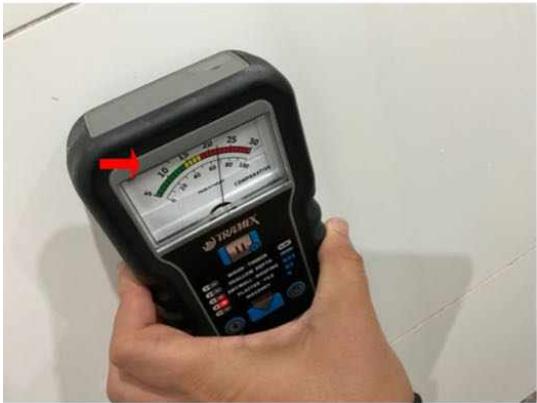
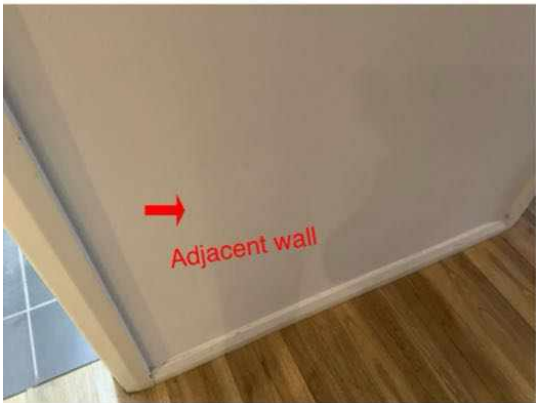
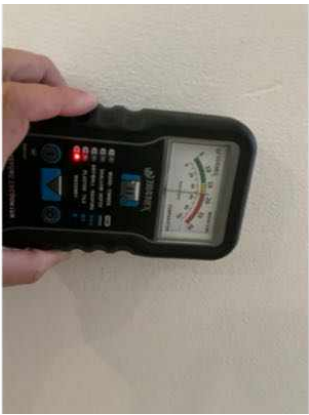
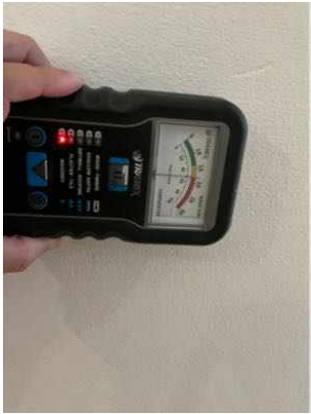
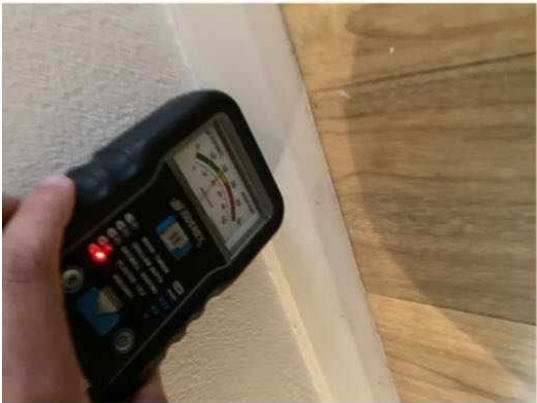
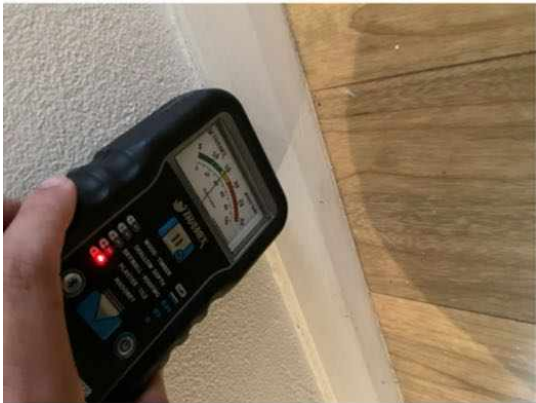
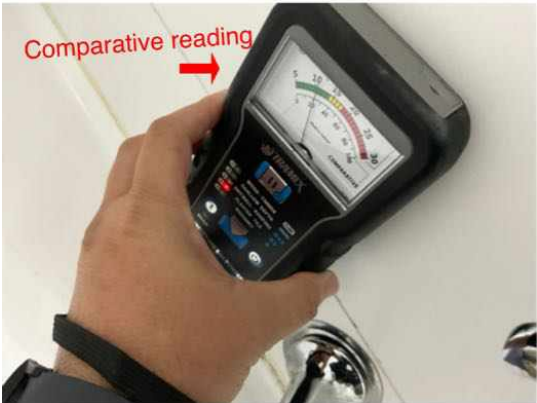
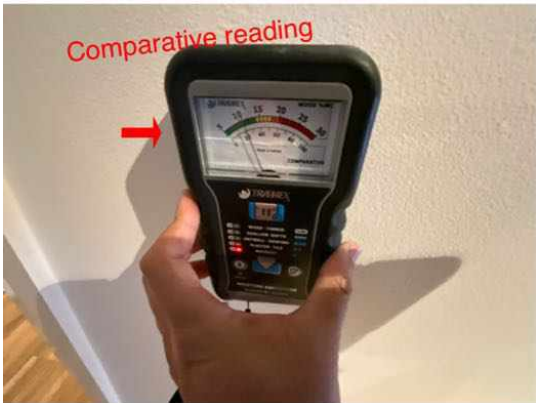
Defects 2.01

Building: Main Building
 Location: Bathroom
 Finding: Evidence of excessive moisture was present at the time of inspection
 Information: Excessive moisture is present behind the bathroom tiles, indicating a potential water leakage issue within the wall.

The prolonged presence of moisture can lead to mold growth, deteriorate the

structure, and create an environment conducive to health hazards. Additionally, it may compromise the adhesive holding the tiles, leading to their detachment.

A licensed plumber or a qualified contractor specializing in water damage remediation should investigate the source of the moisture, fix any leaks, and address the damage. Additionally, replacing affected tiles and ensuring proper waterproofing are crucial to preventing future issues.

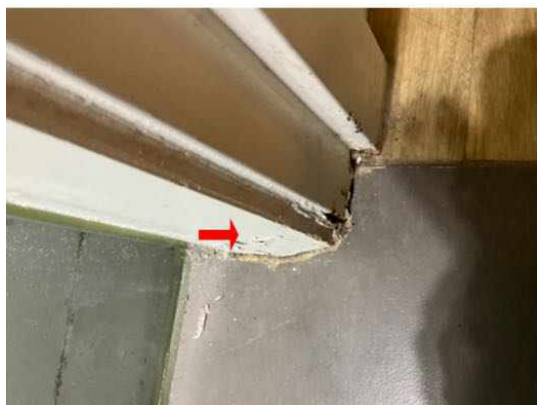
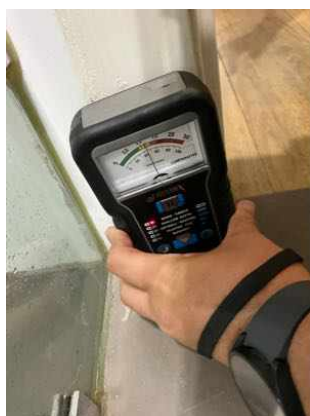
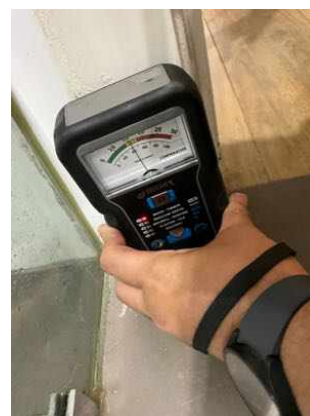
Defects 2.02

Building: Main Building
Location: Bathroom
Finding: Door Water damage
Information: The door in the area has sustained water damage, resulting in swelling and discoloration of the wood, as well as potential structural issues. This damage compromises both the aesthetic and functional aspects of the vanity."

1. **Carpenter or Woodworker:** They can assess and repair the damage to the vanity, potentially replacing any irreparable parts.
2. **Plumber:** If the water damage is due to plumbing issues, a plumber can fix leaks and ensure there are no further water-related problems.
3. **General Contractor:** If the damage is extensive and affects the surrounding area, a general contractor can coordinate the repair work, including both the vanity and any related structural or cosmetic repairs.

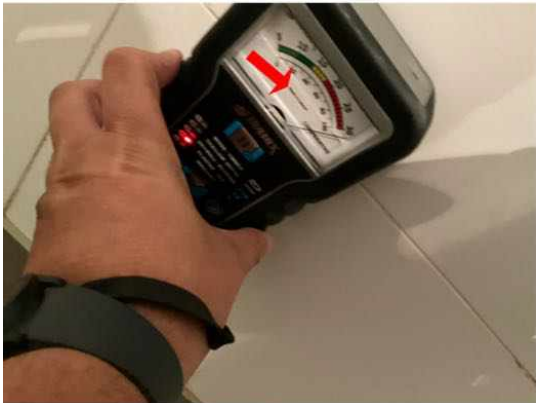
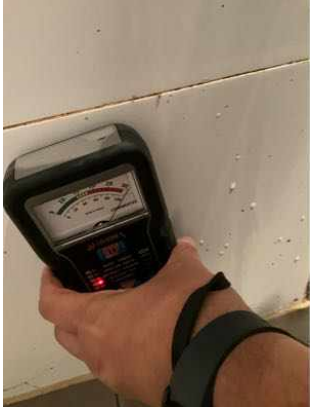
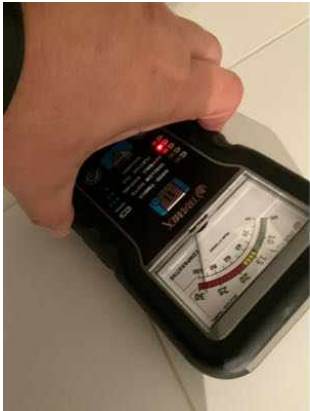
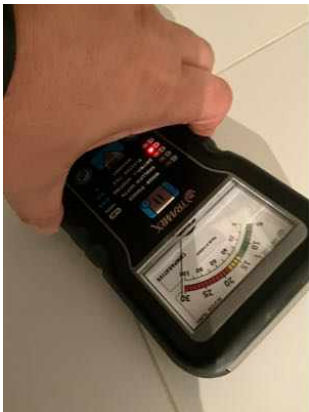
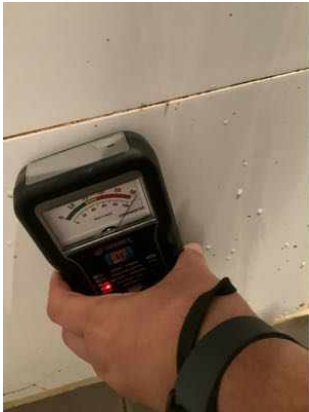
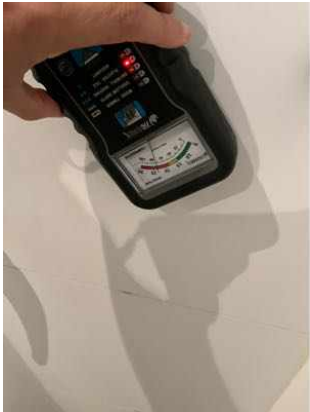
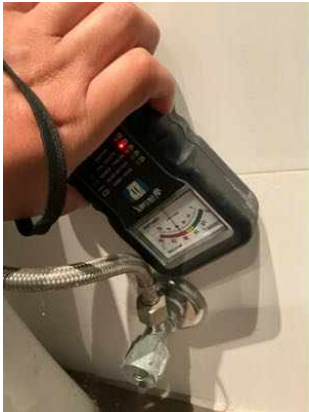
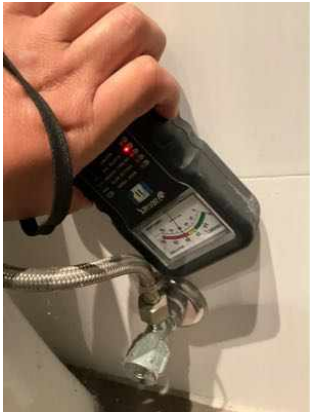
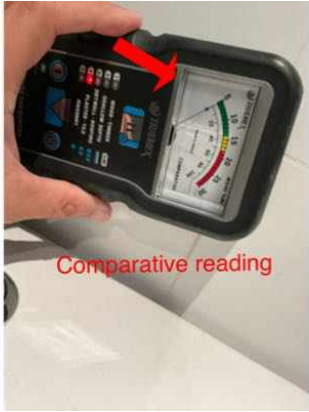
Defects 2.03

Building: Main Building
Location: Ensuite - Master
Finding: Evidence of excessive moisture was present at the time of inspection
Information: Excessive moisture is present behind the bathroom tiles, indicating a potential water leakage issue within the wall.

The prolonged presence of moisture can lead to mold growth, deteriorate the structure, and create an environment conducive to health hazards. Additionally, it may compromise the adhesive holding the tiles, leading to their detachment.

A licensed plumber or a qualified contractor specializing in water damage remediation should investigate the source of the moisture, fix any leaks, and address the damage. Additionally, replacing affected tiles and ensuring proper waterproofing are crucial to preventing future issues.

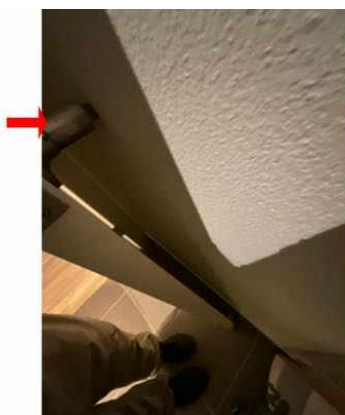
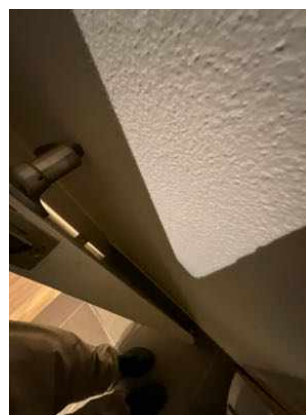
Defects 3.01

Building: Main Building
 Location: Toilet (WC)
 Finding: Missing Door Stopper
 Information: The door lacks a stopper, which is essential to prevent the door from swinging too far and potentially damaging the wall or the door handle. The absence of a door stopper increases the likelihood of impact damage to both the door and surrounding surfaces over time.

- **Damage Risk:** Moderate risk of damage to the door handle, wall, or door itself from repeated impacts when the door is opened forcefully or by a gust of wind.
- **Wear and Tear Risk:** Increased wear on door hardware and hinges due to the potential for abrupt stops without a dedicated stopper.

- **Engage a Handyperson or Carpenter:** A handyperson or carpenter should install a suitable door stopper to prevent excessive door movement. This could be a floor-mounted or wall-mounted stopper depending on the space and door design.

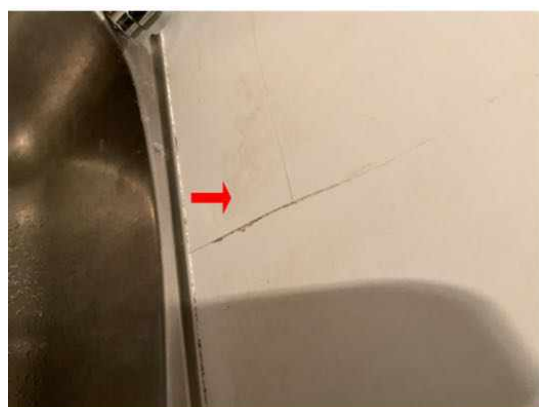
Defects 3.02

Building: Main Building
 Location: Laundry
 Finding: Tiles - Cracked or damaged
 Information: Cracking was evident to the tiling in this area at the time of inspection. While the

cracking appears to be minor, this area is frequently exposed to water, allowing potential for water penetration into adjoining sections of walls or flooring.

If left unmanaged, water penetration to these areas may lead to subsequent water damage, which is likely necessitate repair work to affected building elements.

A tiling contractor should be appointed to ensure that no further water damage occurs. The re-application of silicone and grouting throughout remaining tile work is also advised, to further protect the area against water penetration.

Where water penetration has led to water damage, appointment of a relevant tradesperson may be required to repair damaged building elements.

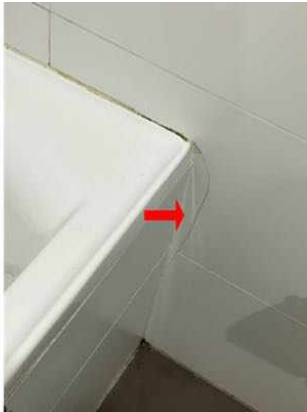
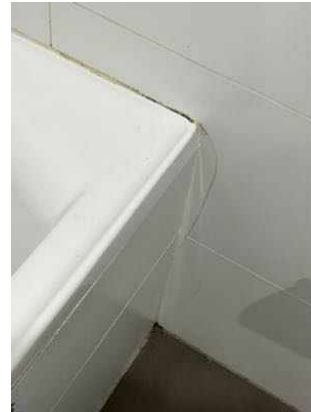
Defects 3.03

Building:	Main Building
Location:	Bathroom
Finding:	Tiles - Cracked or damaged
Information:	Cracking was evident to the tiling in this area at the time of inspection. While the cracking appears to be minor, this area is frequently exposed to water, allowing potential for water penetration into adjoining sections of walls or flooring.

If left unmanaged, water penetration to these areas may lead to subsequent water damage, which is likely necessitate repair work to affected building elements.

A tiling contractor should be appointed to ensure that no further water damage occurs. The re-application of silicone and grouting throughout remaining tile work is also advised, to further protect the area against water penetration.

Where water penetration has led to water damage, appointment of a relevant tradesperson may be required to repair damaged building elements.

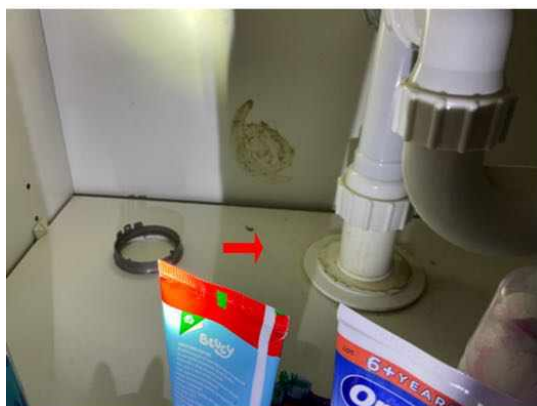
Defects 3.04

Building:	Main Building
Location:	Bathroom
Finding:	Water Stains in Vanity
Information:	“Water stains observed in the vanity area, compromising its appearance and potentially causing damage.”

Continued water exposure may lead to material damage, mold growth, and diminished aesthetic appeal.

A licensed plumber or maintenance professional should assess and fix any leaks contributing to the water stains, while a cleaning or restoration service may be needed to address the visible stains and prevent further damage.

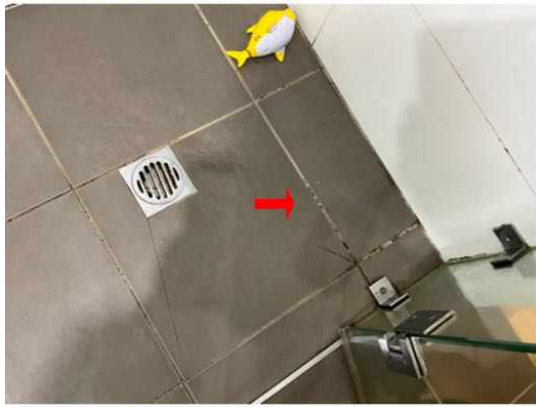
Defects 3.05

Building:	Main Building
Location:	Bathroom
Finding:	Sealant and grouting - Missing or damaged
Information:	It was noted on inspection that sealant or grout is degraded to the tiled shower alcove and or other areas of the bathroom.

Different materials and floor areas move at different rates, generally causing cracking to grout or sealant at this point. A flexible sealant is required to allow for expected expansion and contraction, while keeping the joint water tight and protective of all associated building materials.

There appears to be excessive mould to the sealant and grout which will likely require scraping out and replacement.

Flexible and mould resistant materials should be applied to affected areas to prevent any subsequent water damage that is likely to occur. Regular maintenance and replacement of damage or missing or damaged sealant and grout is highly recommended to the wet areas, as this is a regular wear and tear defect. Sealant and grouting in areas that come into regular contact with water should be maintained for the long term care of your property.

A sealant specialist or tiling contractor should be appointed to complete these works as soon as possible

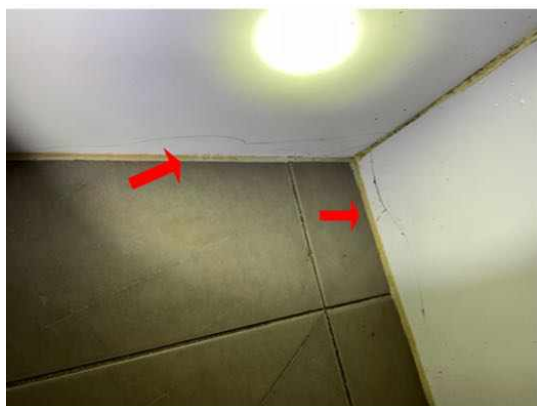
Defects 3.07

Building:	Main Building
Location:	Ensuite - Master
Finding:	Tiles - Cracked or damaged
Information:	Cracking was evident to the tiling in this area at the time of inspection. While the cracking appears to be minor, this area is frequently exposed to water, allowing potential for water penetration into adjoining sections of walls or flooring.

If left unmanaged, water penetration to these areas may lead to subsequent water damage, which is likely necessitate repair work to affected building elements.

A tiling contractor should be appointed to ensure that no further water damage occurs. The re-application of silicone and grouting throughout remaining tile work is also advised, to further protect the area against water penetration.

Where water penetration has led to water damage, appointment of a relevant tradesperson may be required to repair damaged building elements.

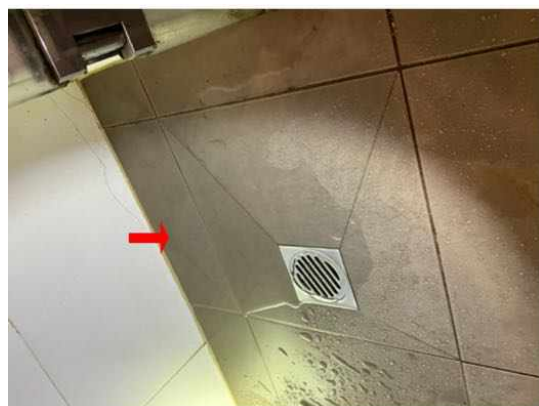
Defects 3.08

Building:	Main Building
Location:	Ensuite - Master
Finding:	Shower base - Water pooling
Information:	Evidence of water pooling around the floor waste in the shower recess was noticed at the time of inspection. It is suspected that this excessive moisture is attributed to insufficient fall in the shower floor tiles.

This pooling is minor overall but is still considered unsatisfactory, as standard tiling practices would not permit this situation to occur. Pooling water around floor wastes can create a slip hazard in extreme cases and create conditions that are conducive to mould growth over time. Where left unmanaged, the degradation of sealant and grouting is also likely to occur, possibly necessitating further repair works.

Remedial works may involve some sections of tiling and flooring repair and replacement. A tiling contractor or bathroom specialist should be appointed to provide further advice on reparation options and to perform works as necessary.

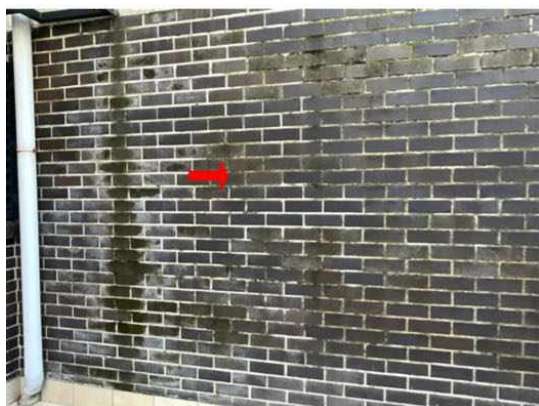
Defects 3.09

Building: Main Building
 Location: Courtyard Yard 1
 Finding: Water staining
 Information:

Water staining was evident in this area at the time of inspection. Water staining indicates that surfaces have been exposed to excessive moisture over time. The minerals and other elements in the water lead to staining, which may graduate to corrosion and deterioration if left unmanaged.

While mostly an appearance defect, water staining can be indicative of more serious defects, which may be currently concealed by other building elements.

Where water staining is active, a licensed plumber must be consulted to identify the cause of the staining and to provide advice on any reparation works that may be required. Replacement of any broken or damaged structures is advised.

Conversely, where water staining is old and inactive, affected building materials may be repaired or replaced at client discretion. A qualified carpenter or registered builder may be appointed to perform these works.

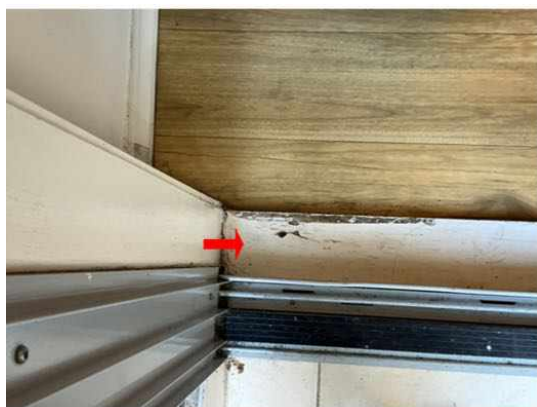
Defects 3.10

Building:	Main Building
Location:	Bedroom - Master
Finding:	Excessive Moisture in Timber Frame at Time of Inspection
Information:	The timber frame exhibits signs of excessive moisture during the inspection. This condition may result from leaks, condensation, poor sealing, or inadequate drainage around the area.
Risk:	<ul style="list-style-type: none"> • Structural Damage: Persistent moisture can lead to rot, warping, or deterioration of the timber, compromising the structural integrity and functionality of the window

- **Mold and Mildew Growth:** Excessive moisture promotes the growth of mold and mildew, which poses health risks to occupants and can require extensive and costly remediation efforts.
- **Energy Efficiency:** Damaged window frames can lead to gaps and air leaks, reducing the energy efficiency of the building and increasing heating and cooling costs.
- **Aesthetic Impact:** Moisture damage can cause discoloration, paint peeling, and an overall unsightly appearance, diminishing the visual appeal of the property.
- **Decreased Durability:** The lifespan of the window frame is significantly reduced when exposed to high moisture levels, leading to premature failure and higher maintenance costs.

- **Window Specialist:** A timber frame specialist can assess and repair the frame, ensuring proper sealing and drainage.
- **Carpenter or General Contractor:** For significant structural repairs or replacement of the timber window frame, a skilled carpenter or general contractor should be engaged.
- **Plumber:** If the moisture source is due to plumbing leaks, a licensed plumber should be consulted to address the issue.
- **Mold Remediation Specialist:** If mold or mildew is present, a mold remediation specialist should be contacted to safely treat and remove the mold.
- **Restoration Specialist:** For comprehensive drying and restoration services, a restoration specialist can provide professional solutions to dry out the timber window frame and prevent future moisture problems.

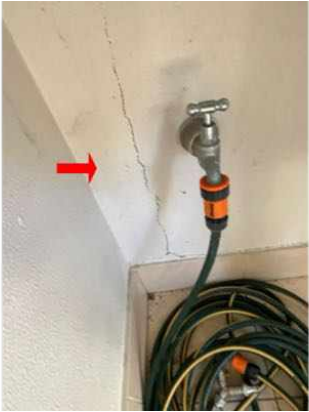
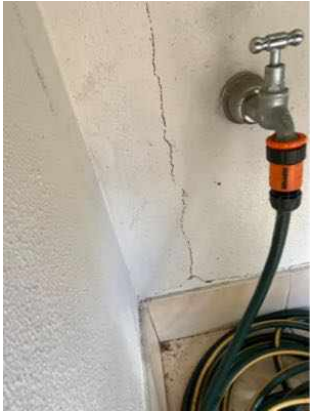
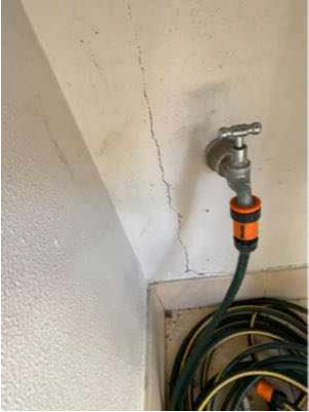
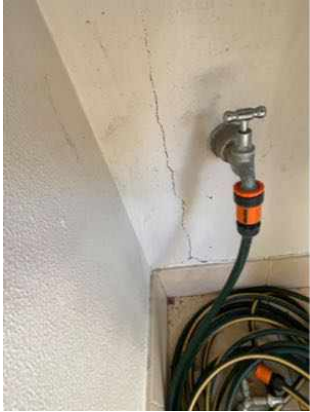
Defects 3.11

Building:	Main Building
Location:	Courtyard Yard 2
Finding:	Brickwork - Cracking [Repair required]
Information:	cracking was identified to the brickwork in this area. Cracks of this type are likely to have been caused by minor expected movement of building elements, but may also have a structural cause that is more significant.

A crack of this size may be repaired by extensive filling. Additionally, further remedial works to associated building elements, such as eave sheeting or external door frames, is likely to be required.

A qualified bricklayer should be contacted immediately to estimate and perform repair and restoration works. Consultation with a structural engineer may be required where structural instability is found to be the underlying cause of the cracking.

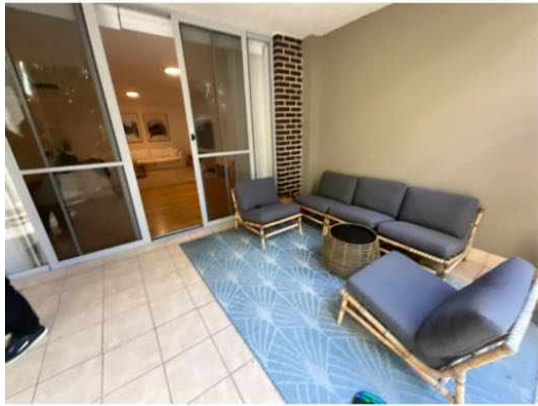
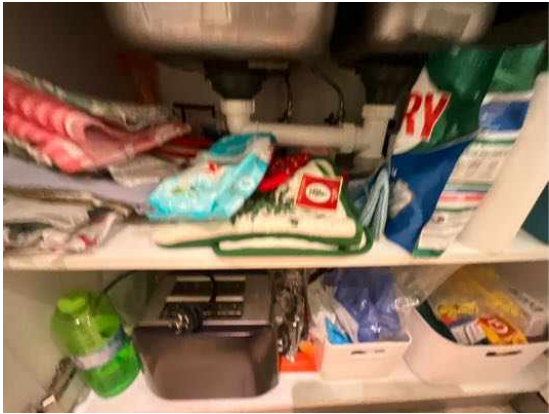
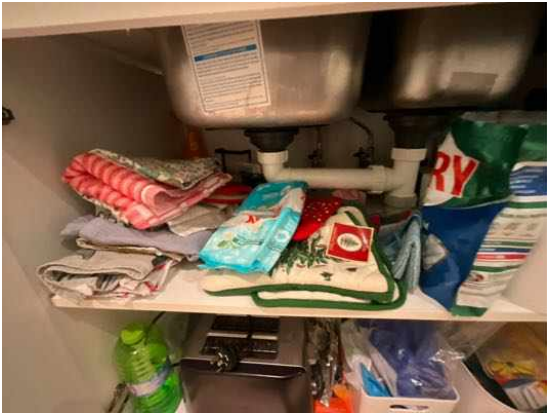
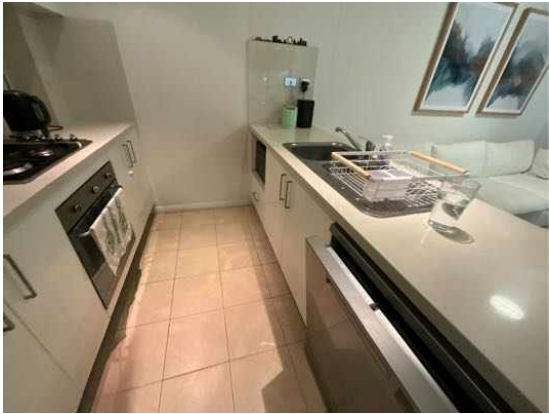
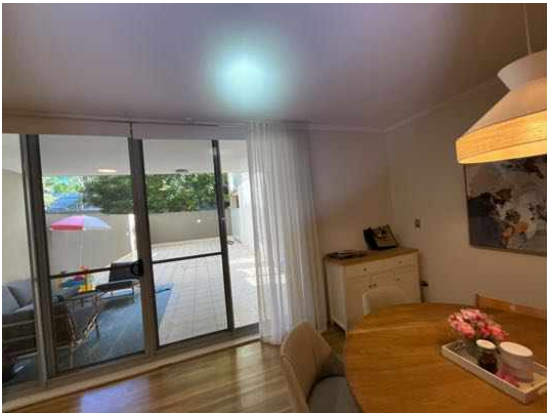
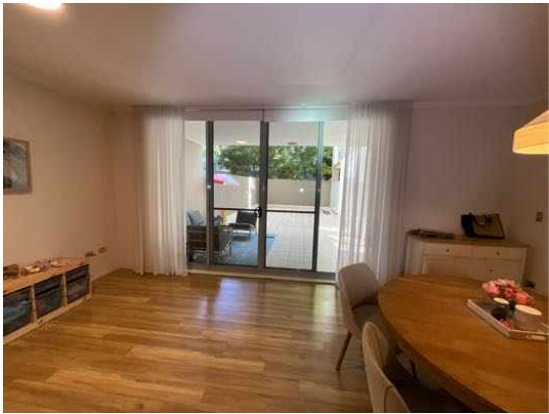
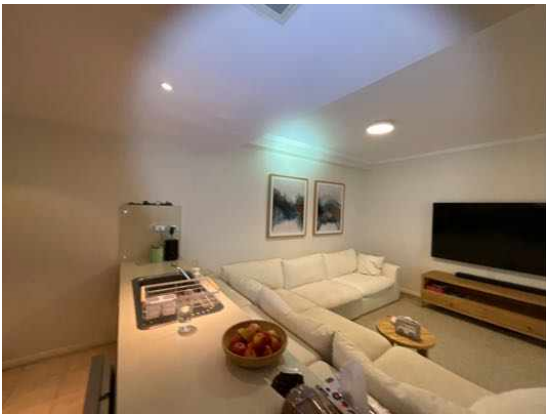
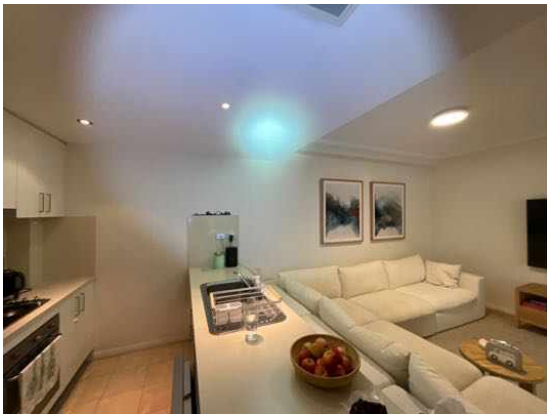
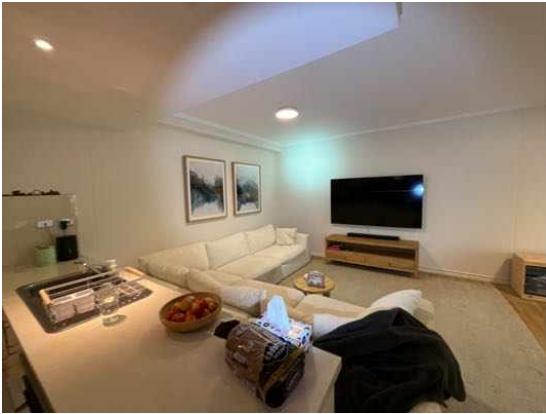
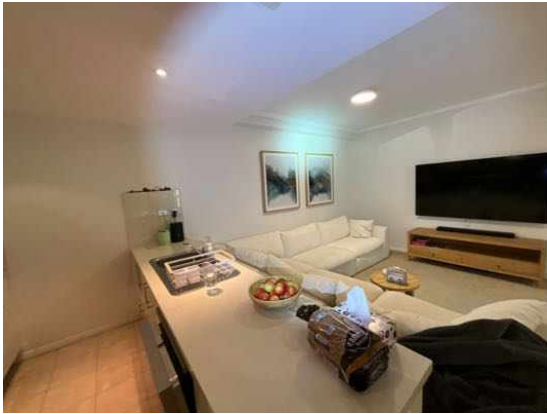
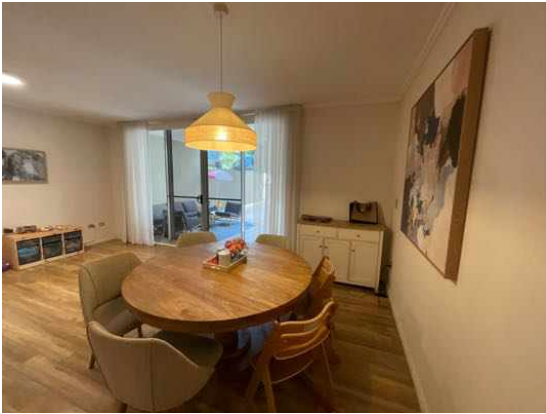
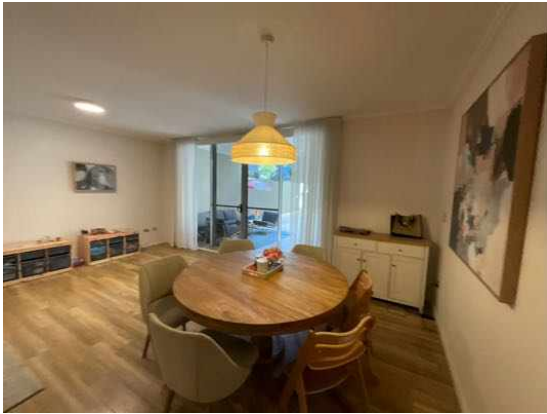
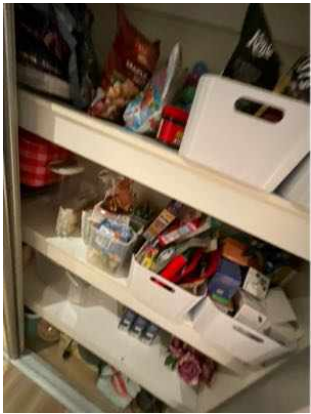
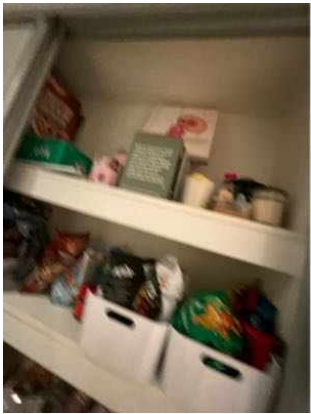
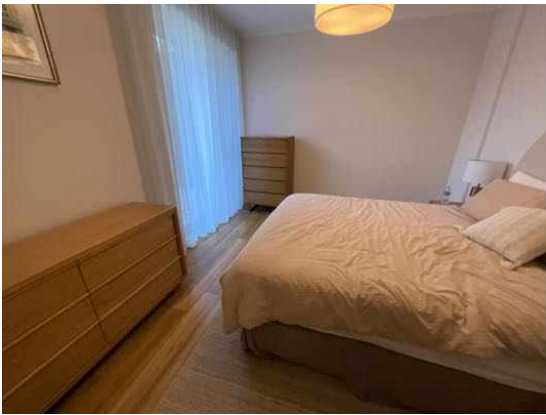
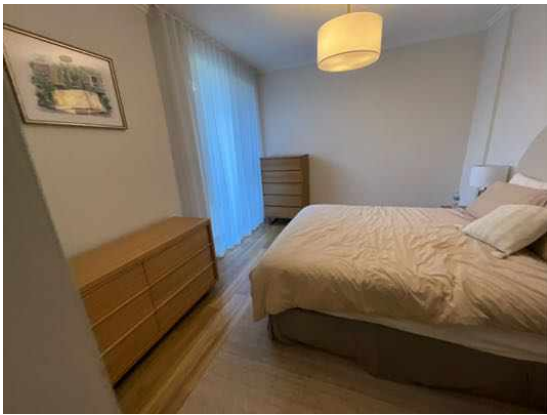
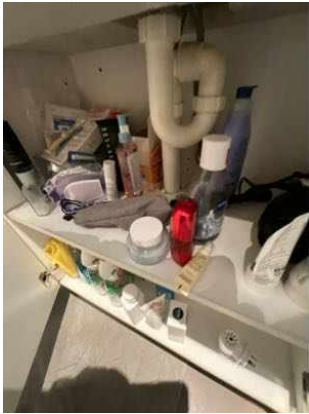
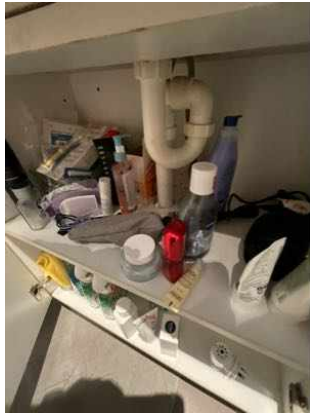
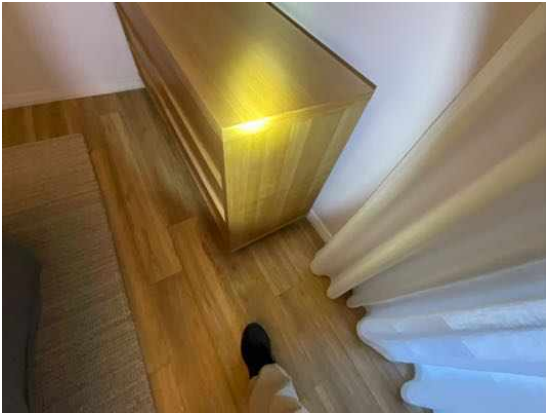
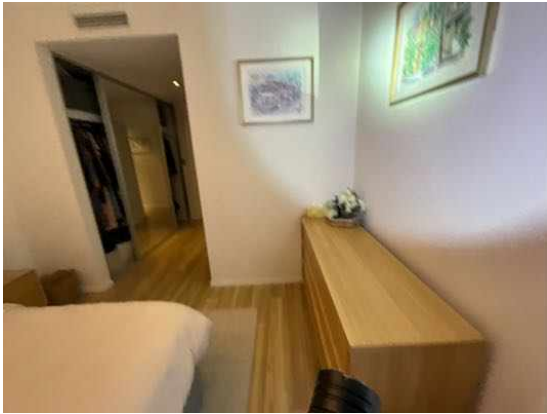
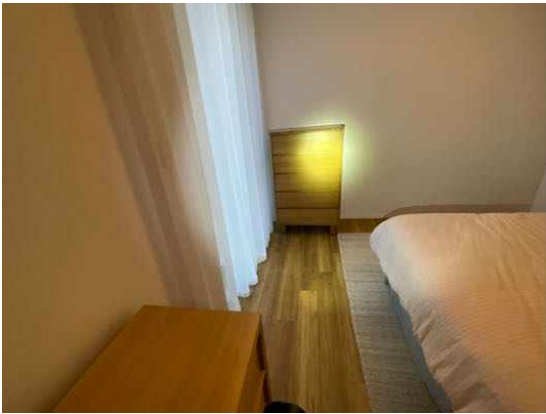
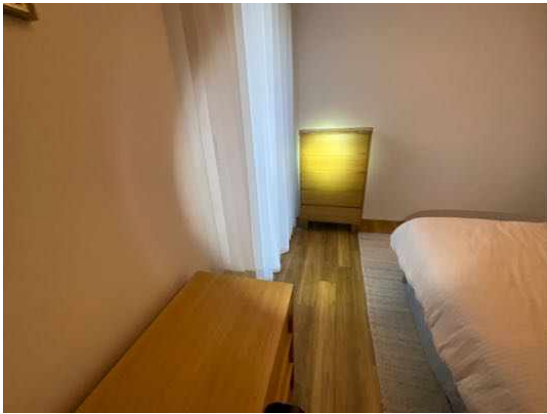
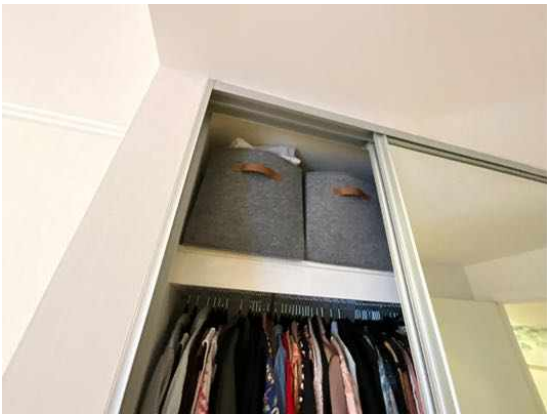
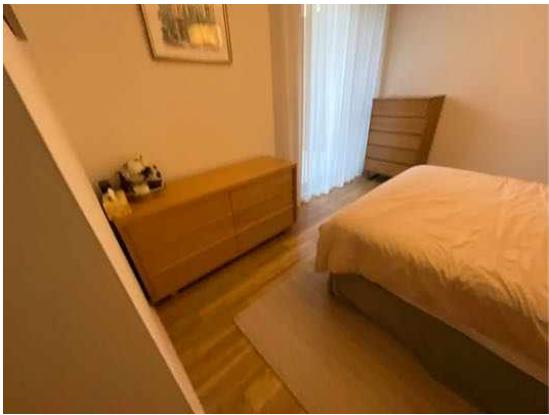
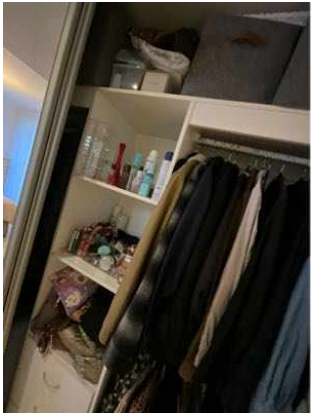
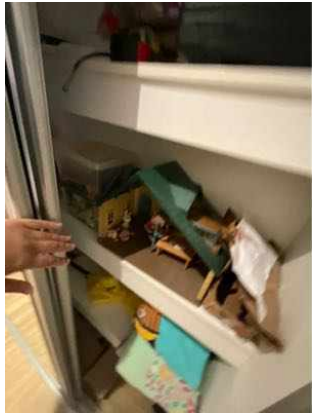
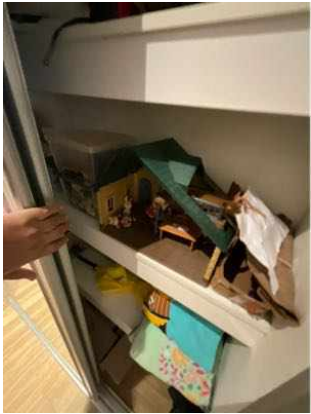
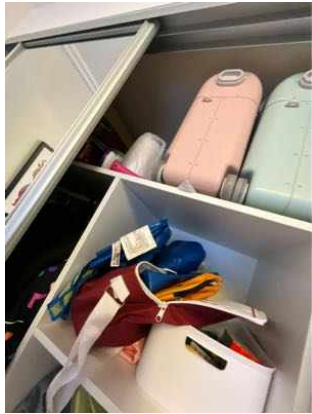
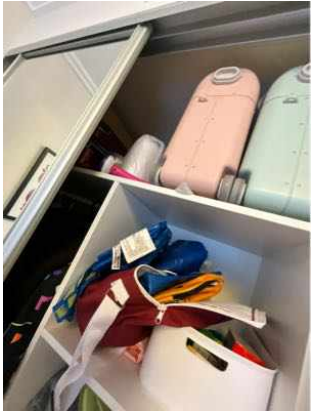
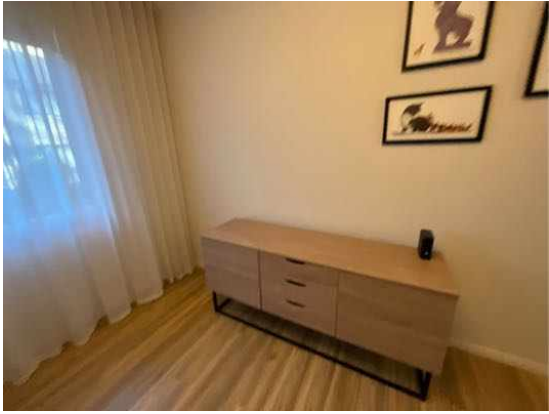
Noted Item

Building: Main Building
Location: All Areas
Finding: Additional Photos - Obstructions and Limitations
Information: These photographs are an indication of the obstructions and limitations which impeded full inspection of the property at the time of inspection. These obstructions can hide an array of defects and should be removed to allow full inspection to be carried out. A re-inspection is recommended once the areas are made accessible.
