Building and Timber Pest Inspection Report

Inspection Date: Tue, 17 Mar 2026

Property Address: 36 Simkin Dr, Benalla VIC 3672, Australia

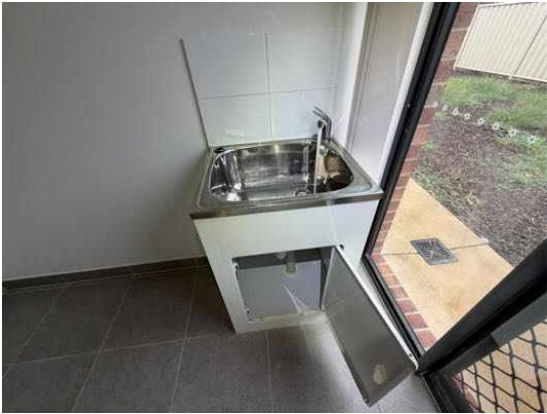
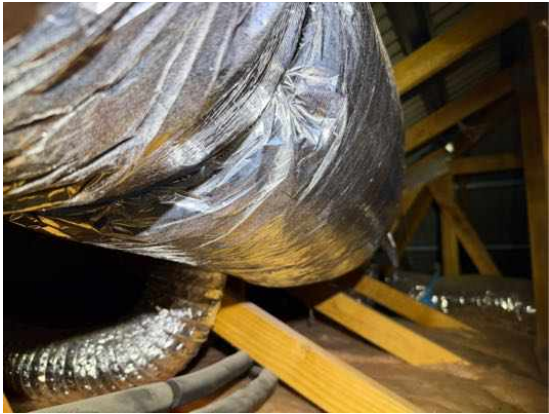
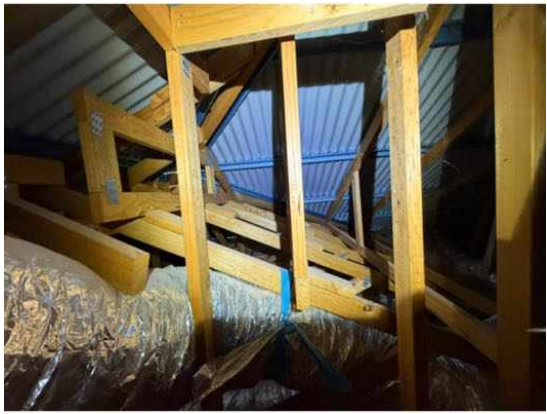
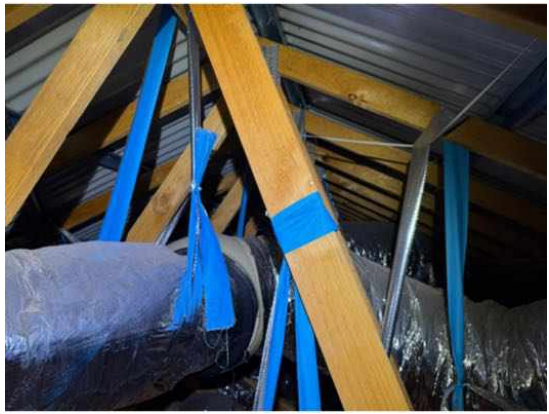
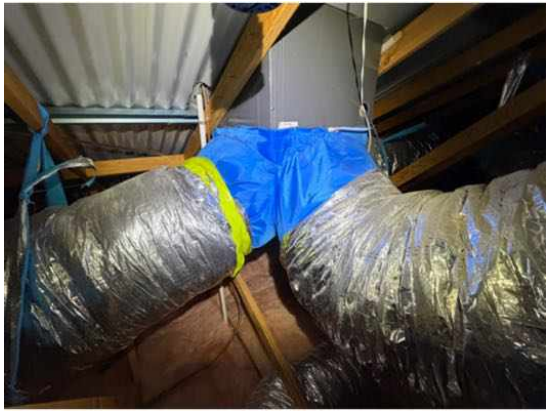
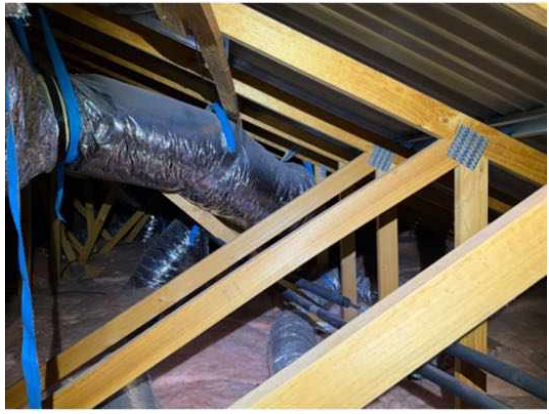
Building: Main Building
Location: All Areas
Finding: Additional Photos - Obstructions and Limitations
Information: These photographs are an indication of the obstructions and limitations which impeded full inspection of the property at the time of inspection. These obstructions can hide an array of defects and should be removed to allow full inspection to be carried out. A re-inspection is recommended once the areas are made accessible.
