Building and Timber Pest Inspection Report

Inspection Date: Wed, 25 Mar 2026

Property Address: 41 Murphy St, Blaxland NSW 2774,
Australia

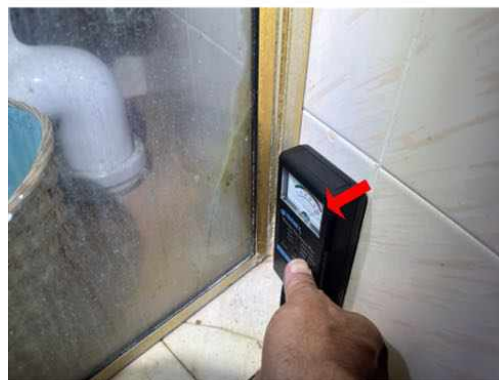
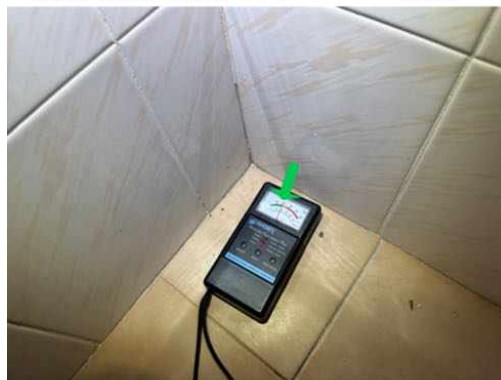
Location: Bathroom > Centre,Rear
Finding: Moisture meter: used in Shower area.
Information: A moisture meter was used during the inspection and isolated spots of excessive moisture was detected to accessible walls inside the property at the time of inspection.

It was noted on inspection that sealant or grout is in fair condition to most of the tiled shower alcove, with some areas requiring maintenance.

Different materials and floor areas move at different rates, generally causing cracking to grout or sealant at this point. A flexible sealant is required to allow for expected expansion and contraction, while keeping the joint water tight and protective of all associated building materials.

Flexible and mould resistant materials should be applied to affected areas to prevent any subsequent water damage that is likely to occur. Regular maintenance and replacement of damage or missing or damaged sealant and grout is highly recommended to the wet areas, as this is a regular wear and tear defect. Sealant and grouting in areas that come into regular contact with water should be maintained for the long term care of your property.

Monitoring the area is advised and if any visual signs of excessive moisture appear (peeling paint, mould) then consultation with a qualified plumber or bathroom specialist would be advised to identify the cause of damp and to perform remedial works as required.

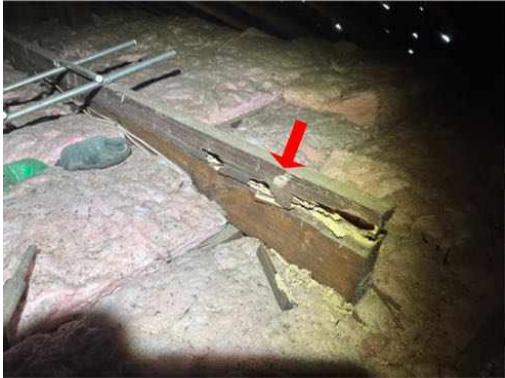
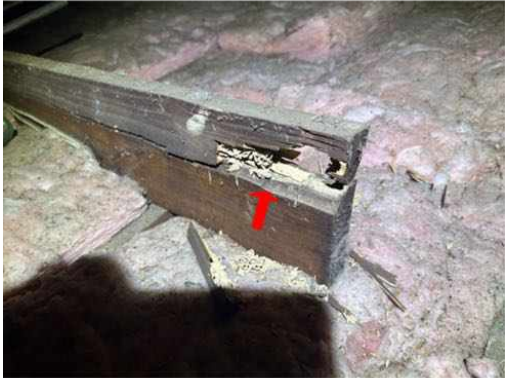
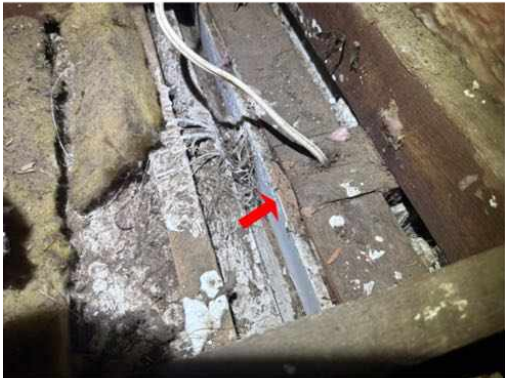
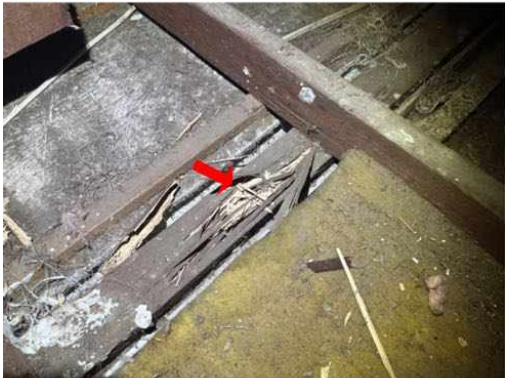
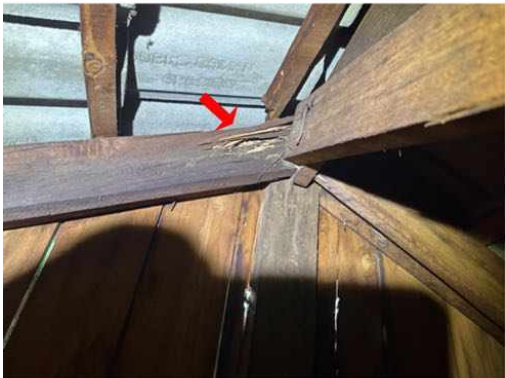
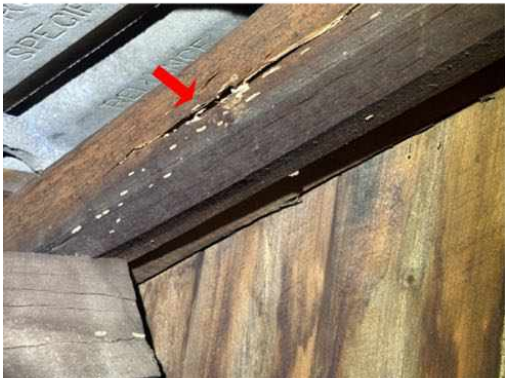
Finding 2.02

Building:	Main Building
Location:	Roof Void > All Areas
Finding:	Evidence of termite damage - structural
Information:	Despite no live termite or timber pest activity being identified, previous termite damage was found in this area. This damage is considered to be major and structural in nature. Such damage creates a potential safety hazard, and is likely to worsen and cause further damage to adjoining building materials.

If left unattended, this damage creates an unsafe environment and is likely to lead to the need for major structural works.

A building contractor should be appointed immediately to advise on options to prevent further damage and repair all affected building materials. Until such time, caution should be taken by all people coming into contact with these building elements and this area.

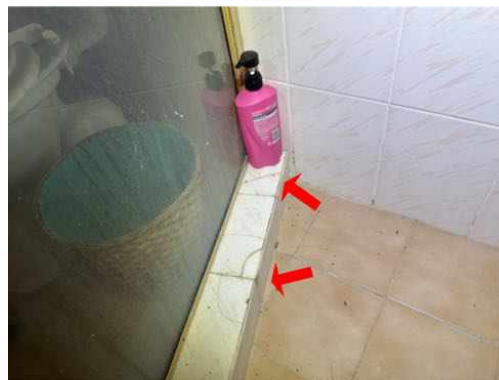
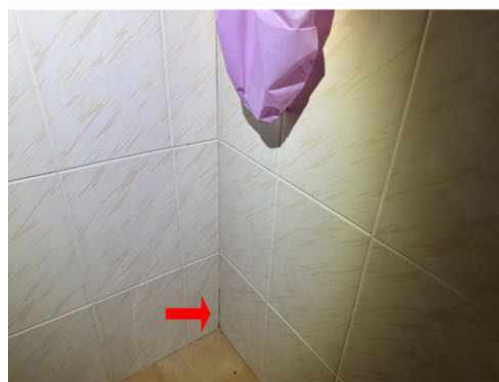
Building: Main Building
 Location: Bathroom > Centre,Rear
 Finding: Tiles - Cracked or damaged

Information: Cracking was evident to the tiling in this area at the time of inspection. While the cracking appears to be minor, this area is frequently exposed to water, allowing potential for water penetration into adjoining sections of walls or flooring.

If left unmanaged, water penetration to these areas may lead to subsequent water damage, which is likely necessitate repair work to affected building elements.

A tiling contractor should be appointed to ensure that no further water damage

occurs. The re-application of silicone and grouting throughout remaining tile work is also advised, to further protect the area against water penetration.

Where water penetration has led to water damage, appointment of a relevant tradesperson may be required to repair damaged building elements.

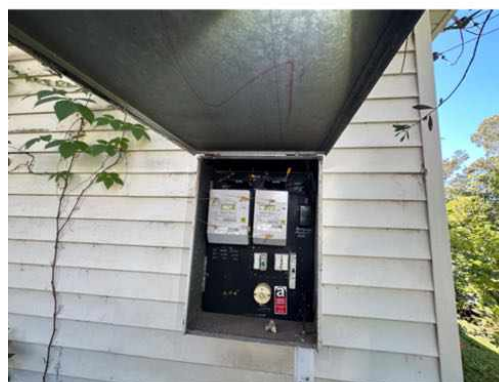
Building:	Main Building
Location:	Electrical circuit box > Front Left
Finding:	Termite Management System - no evidence of a chemical installation
Information:	The application of a post-construction chemical termite barrier is highly recommended for all properties, particularly if live termite activity has been found on the site previously. Such barriers are highly effective in preventing termite attack on any timber building elements throughout the property.

A durable notice should be placed in the switchboard unit to indicate current termite barriers. At the time of inspection, it appeared as though no termite management system has been installed, with no evidence to suggest preventative works taking place.

The client may consider gaining further advice from a pest controller as to the costs and procedures involved with this application. It is recommended that obtaining such advice be a short-term priority.

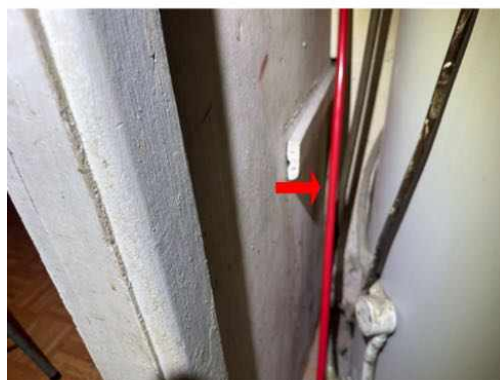
Finding 6.03

Building: Main Building
Location: Laundry/subfloor > Centre,Rear
Finding: HWS Overflow - Not Connected
Information:

The Hot Water System (HWS) overflow was found to be disconnected from storm water drainage and is creating excessive moisture in the surrounding area.

These damp conditions can lead to secondary defects such as rot, rust or corrosion of associated building elements, the formation of fungal decay, or even the creation of potential slip hazards. When coupled with poor site drainage, pooling of water may also attract termite activity to this area.

It is highly recommended that a licensed plumber be appointed to connect the HWS overflow in order to prevent such an environment from being created. These minor works should be carried out as soon as possible.

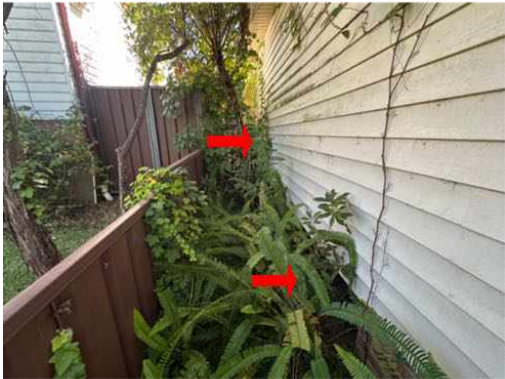
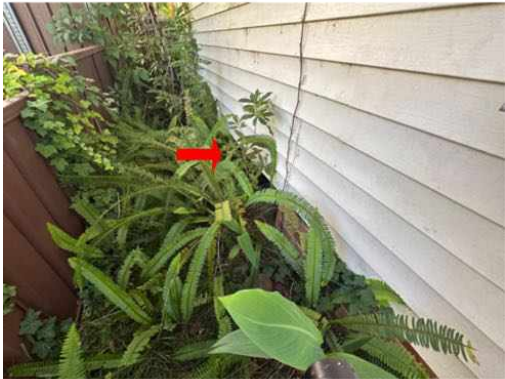
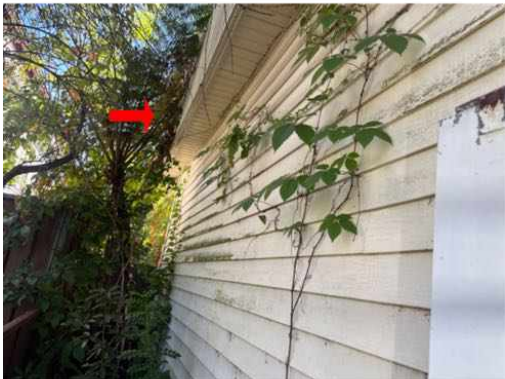
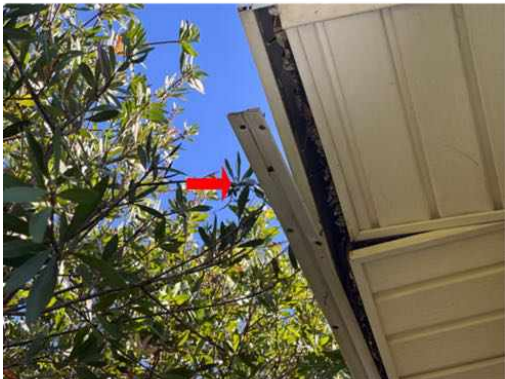
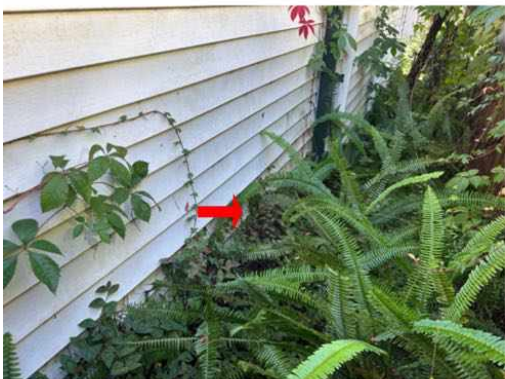
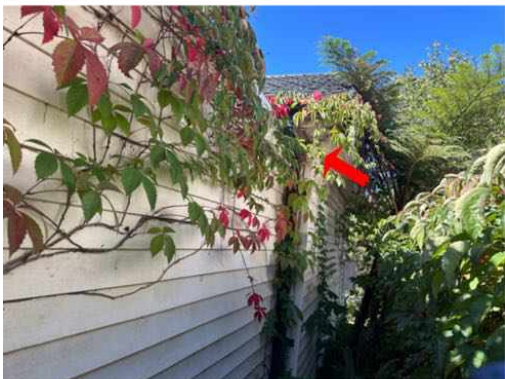
Wood rot is often associated with general damp problems and is evidenced by a 'musty' smell or mould and mildew occurring on surfaces. If left unmanaged, damp conditions can lead to further health problems and the decay of timbers will continue.

The removal and replanting of species that do not provide "cover" or cutting back of existing vegetation will assist greatly in preventing Bridging from occurring.

The removal of any such materials that may be conducive to termite activity should be carried out as soon as possible and arrange re inspection to minimize the risk of termite attack.

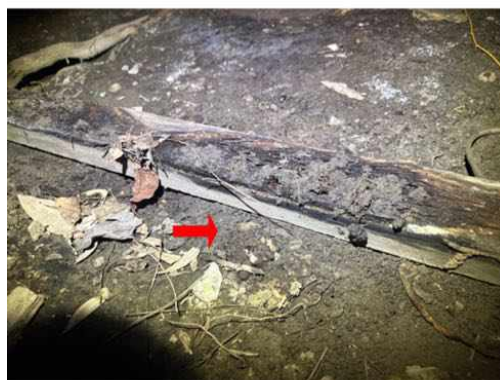
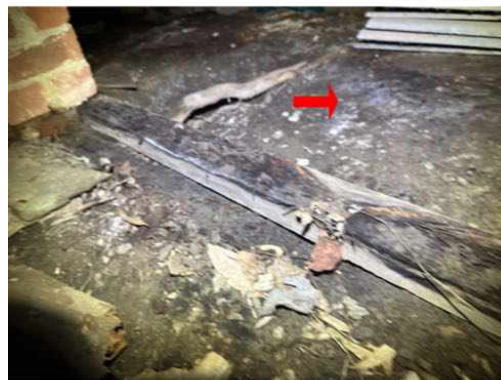
Finding 6.07

Building: Main Building
 Location: Subfloor > All Areas
 Finding: Subfloor: Damp.
 Information:

A well ventilated subfloor aids in maintaining dry conditions,

The client may also consider mechanical ventilation (powered fans) to improve subfloor airflow. Remedial works should be conducted as a matter of urgency to protect against the development of potentially harmful subfloor conditions.

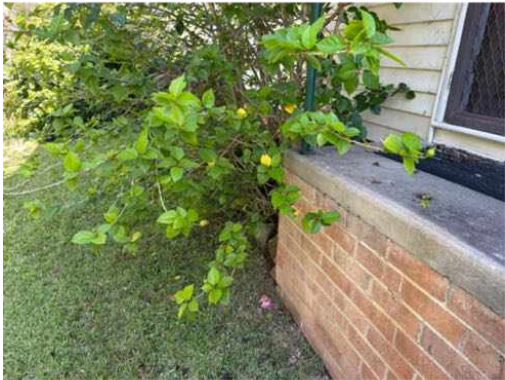
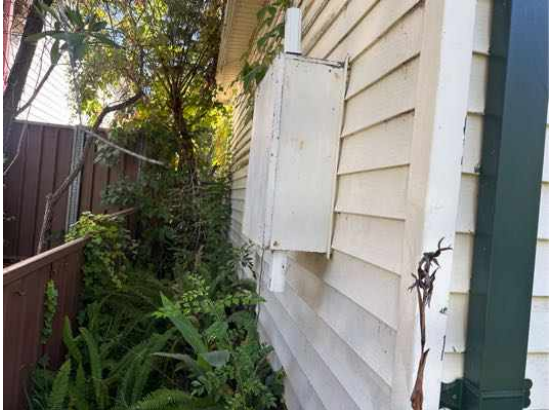
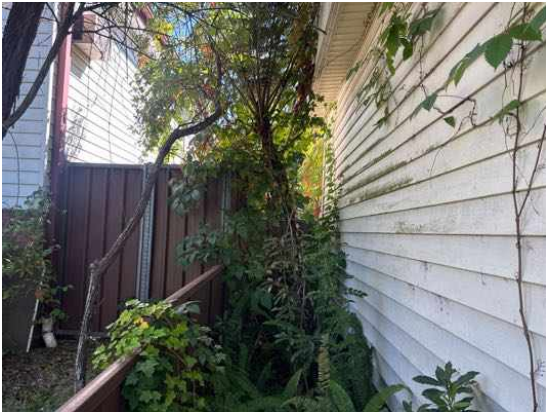
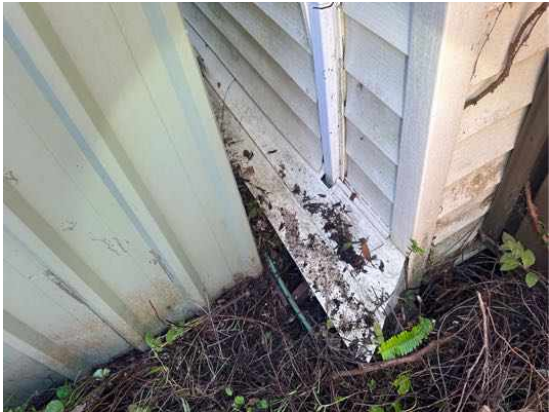
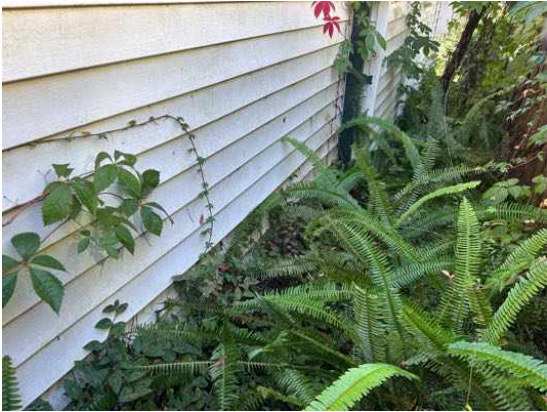
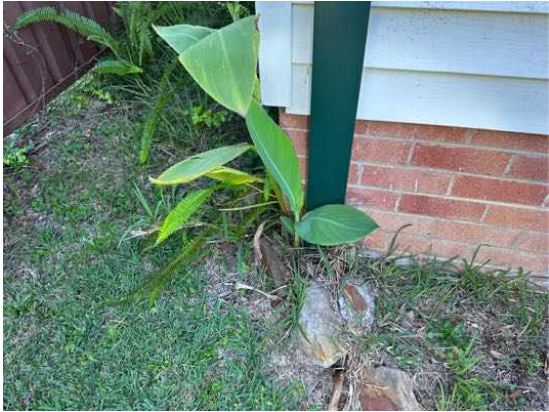
Building: Main Building
Location: All Areas > All Areas
Finding: Additional Photos - Obstructions and Limitations
Information: These photographs are an indication of the obstructions and limitations which impeded full inspection of the property at the time of inspection. These obstructions can hide an array of defects and should be removed to allow full inspection to be carried out. A re-inspection is recommended once the areas are made accessible.

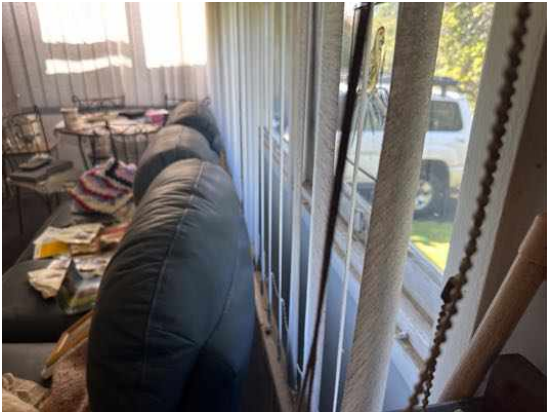
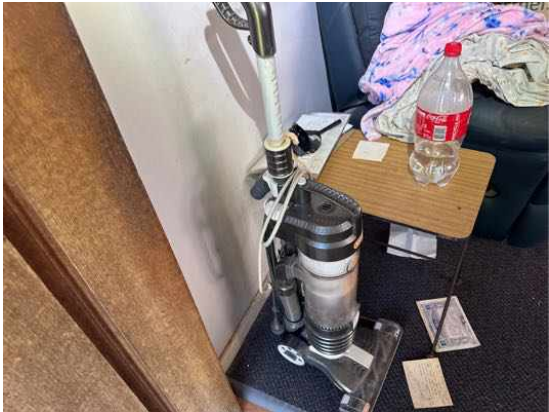
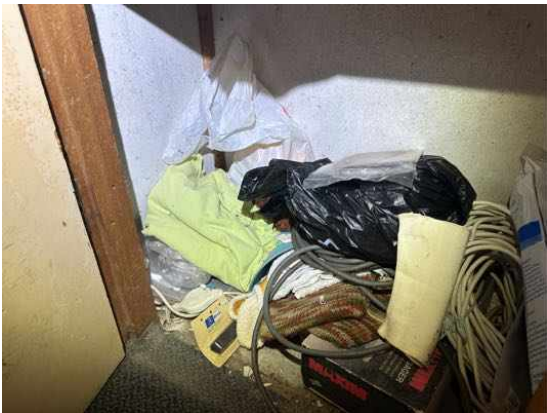
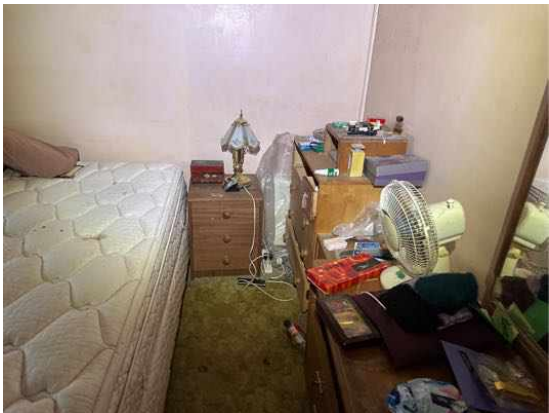
Building: Main Building
Location: All Areas > All Areas
Finding: Additional Photos - Obstructions and Limitations
Information: These photographs are an indication of the obstructions and limitations which impeded full inspection of the property at the time of inspection. These obstructions can hide an array of defects and should be removed to allow full inspection to be carried out. A re-inspection is recommended once the areas are made accessible.

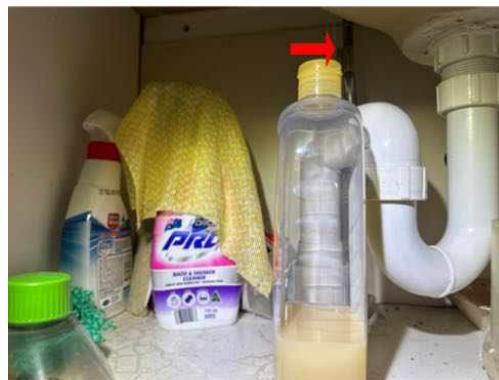
Building: Main Building
 Location: All Areas > All Areas
 Finding: Pipe: Flexible Braided pipes.
 Information: Braided Stainless Steel Flexi connector hose are popular in modern home fit outs because they can be bent into shape. They started to be installed in the early two thousands and their use is now extremely widespread in contemporary construction and renovations.

Flexible braided hoses accounted for more than one in five water damage claims lodged by Australian households according to research released by general insurer IAG.

It is recommended that the Flexi pipes to be replaced at the owners discretion to avoid an “escape water incident” which may lead to water damage to other building elements in the home.

This work can be undertaken by a licensed plumber, general handy person at the owners discretion.

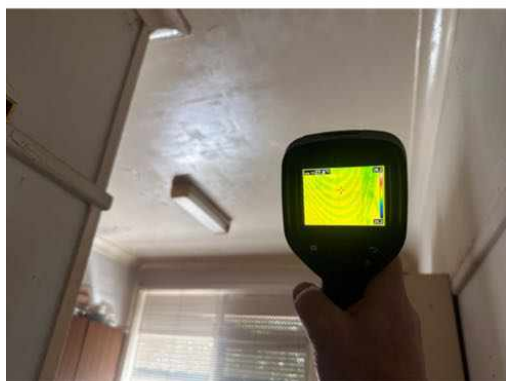
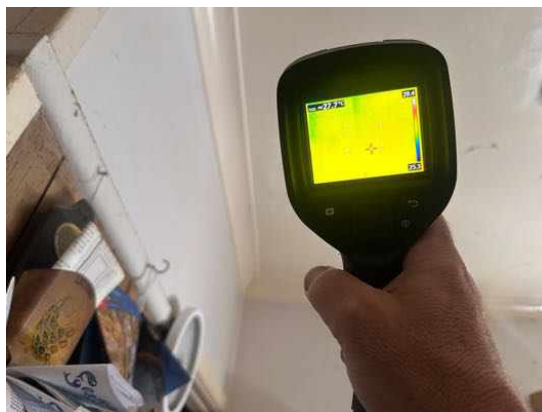
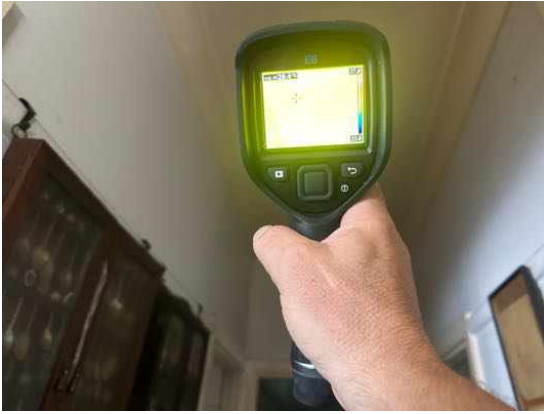
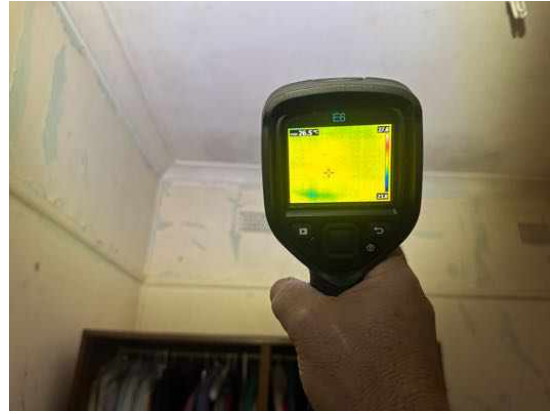
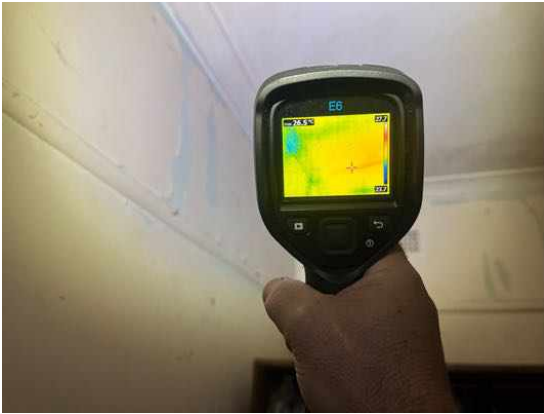
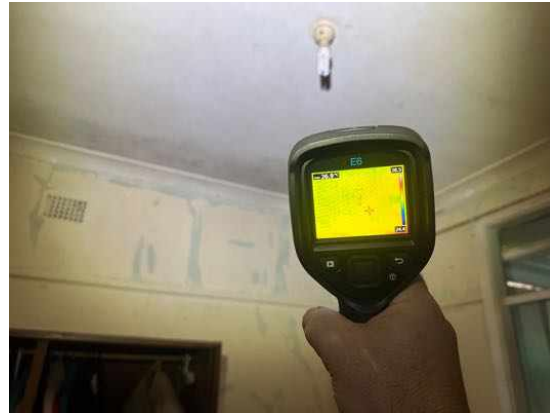
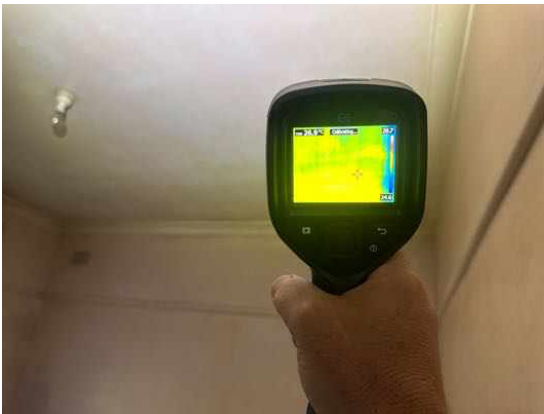
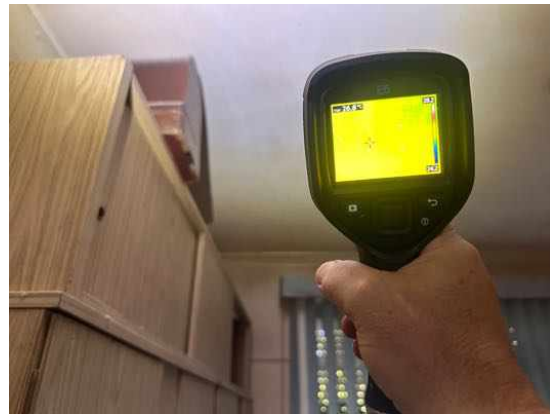
Building: Main Building
 Location: All Areas > All Areas
 Finding: Thermal imaging: No excessive moisture presentation.
 Information: At the time of inspection there appeared to be no excessive moisture presentation in this area.

NOTE: If the Property has been vacant for a period of time or wet areas not used, moisture levels or leaks may not be detectable at the time of the inspection because often only frequent use of water pipes (showers, taps etc) result in a leak being identifiable. We advise further testing on pipes and water susceptible areas (such as the bathroom and laundry) after more frequent use has occurred.

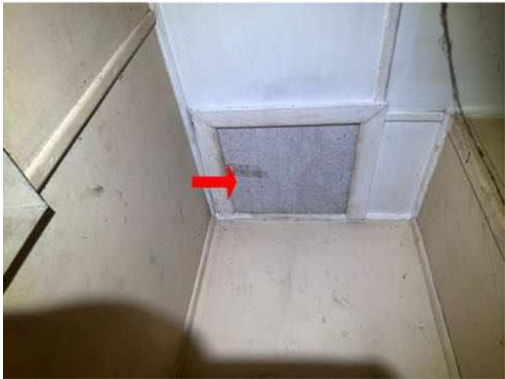
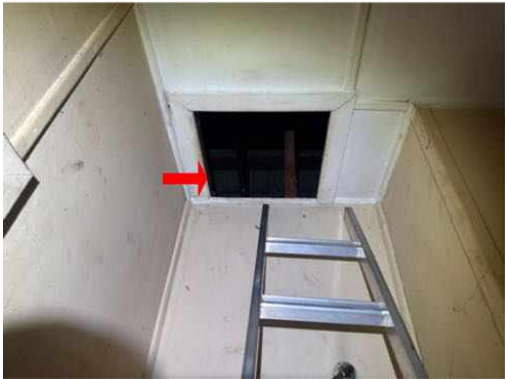
Building:	Main Building
Location:	All Areas > All Areas
Finding:	Roof void: limited access.
Information:	Limited access to the roof void was present due to facts including but not limited to access hatch size or placement, insulation, air conditioning ductwork, for this reason inspection to the roof void was minimal and a range of defect's from minor to major may not be visible at the time of inspection.
