# Building and Timber Pest Inspection Report

Inspection Date: Tue, 3 Mar 2026

Property Address: 7 The Island Court, Shell Cove NSW 2529,  
Australia

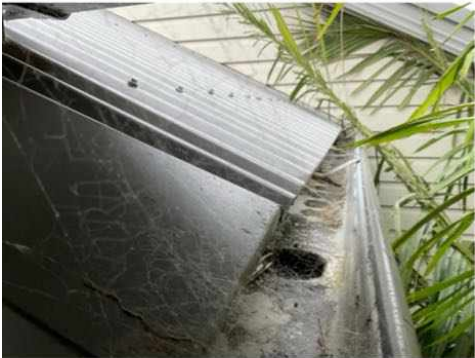
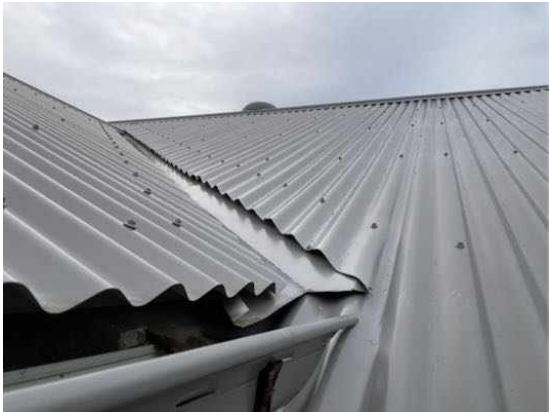
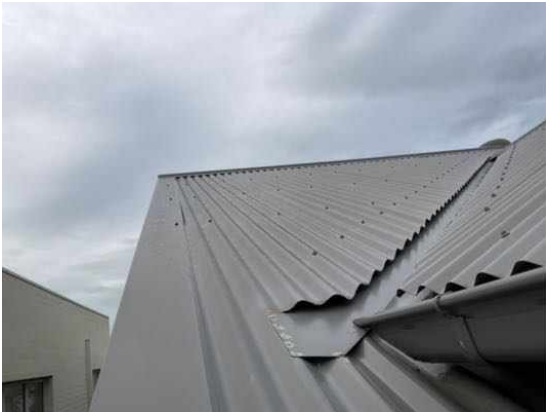
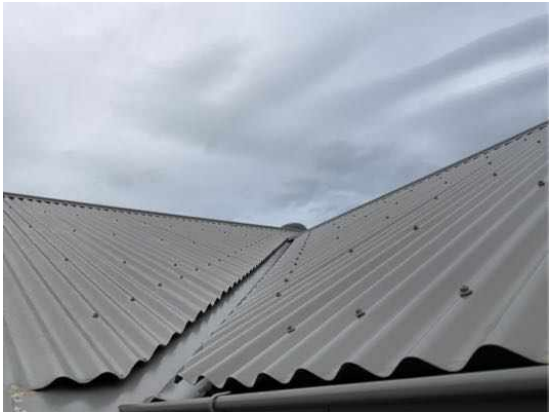
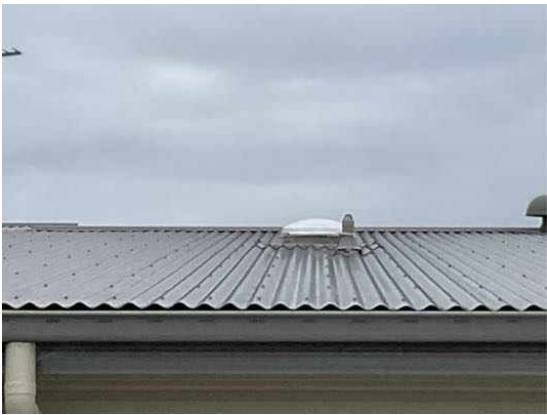
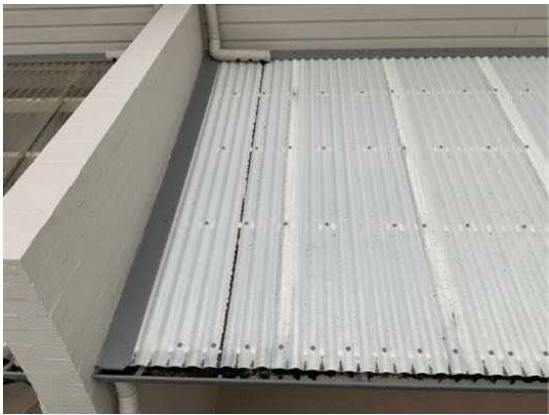
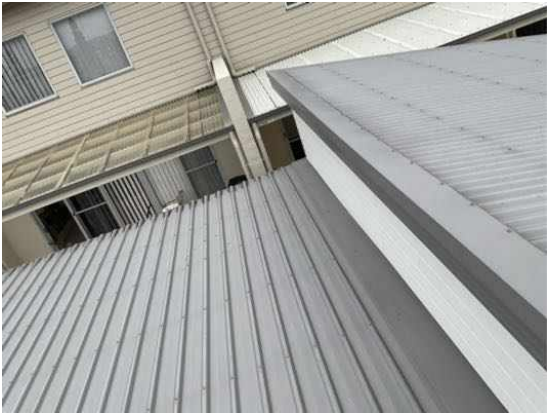
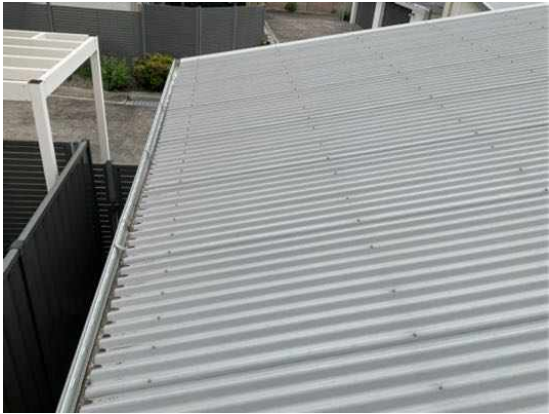
Building: Building 1  
Location: Roof Exterior  
Finding: Additional Photos  
Information: Additional photos are provided for your general reference

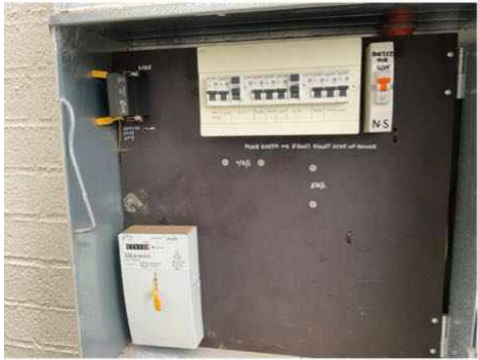
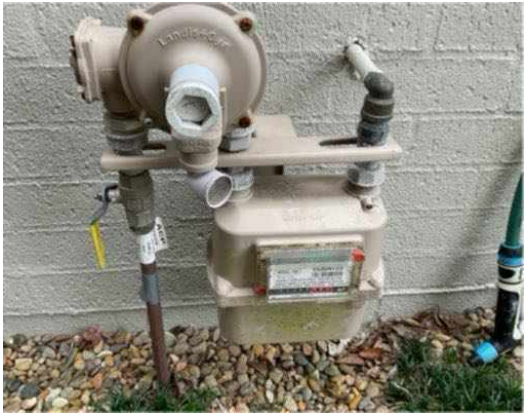
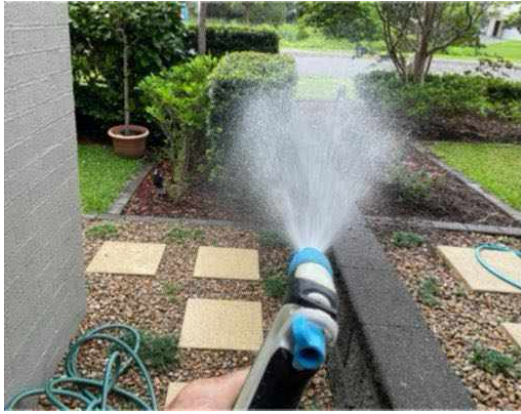
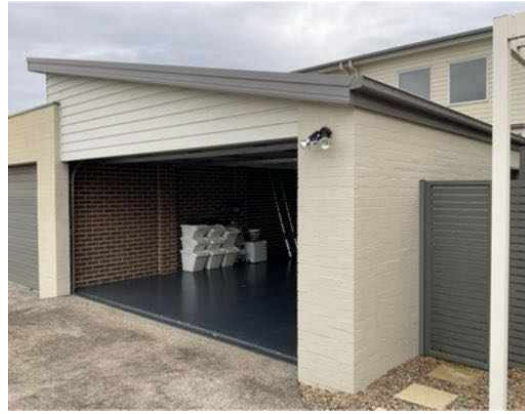
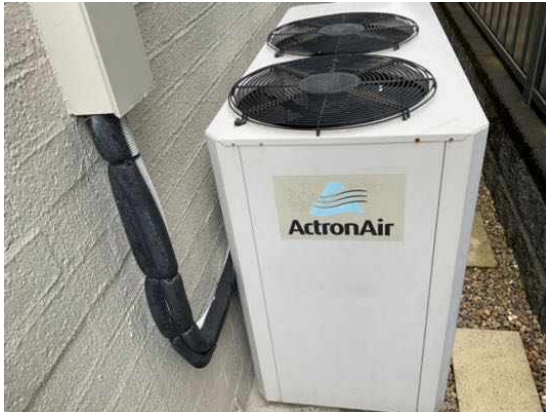
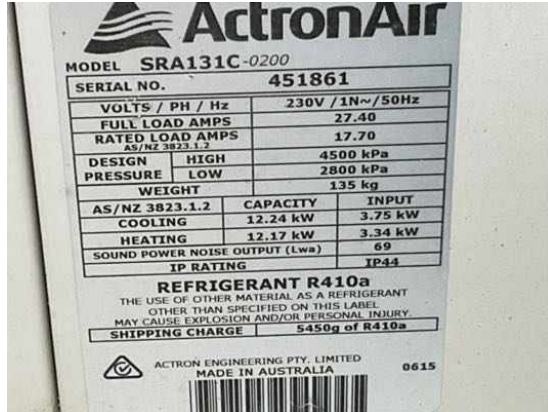
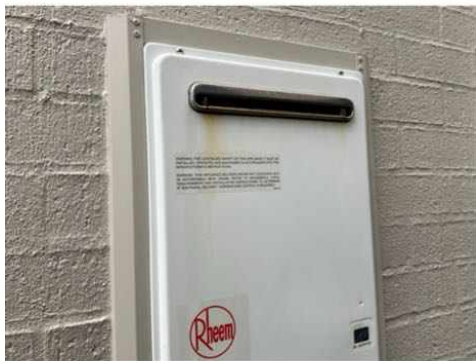
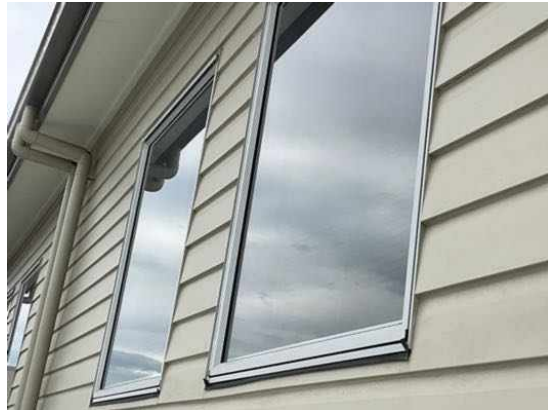
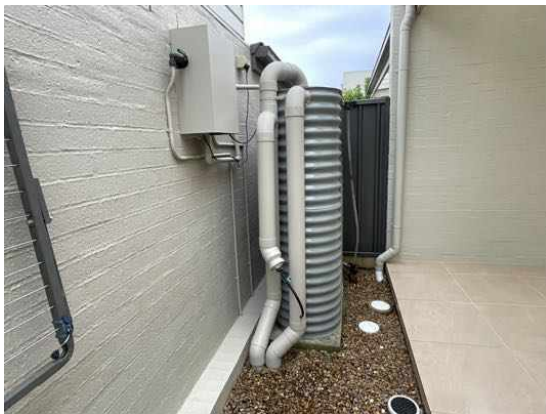
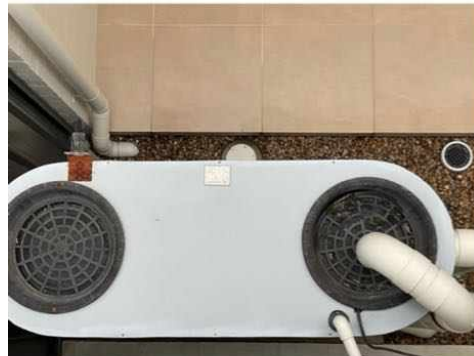
Building: Building 1  
Location: All External Areas  
Finding: Additional Photos  
Information: Additional photos are provided for your general reference

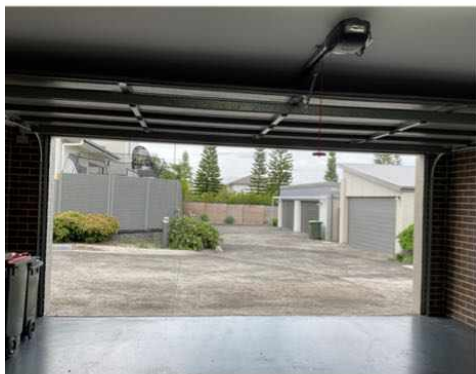
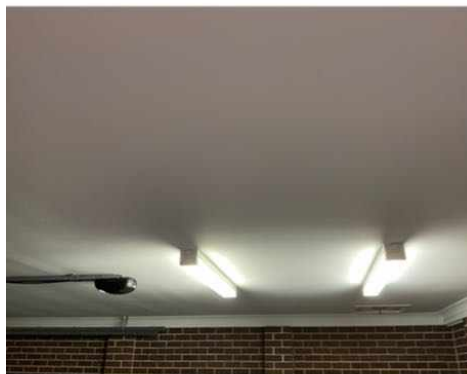
Building: Building 1  
 Location: All Internal Areas  
 Finding: Additional Photos  
 Information: Additional photos are provided for your general reference

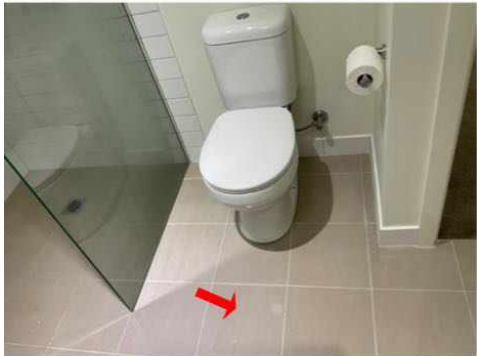
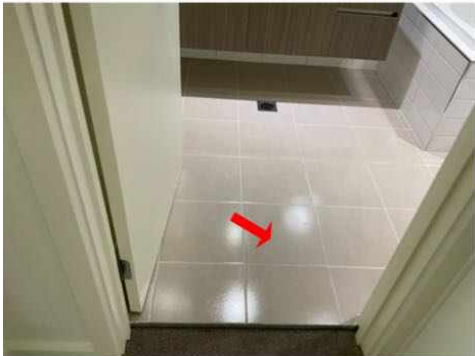
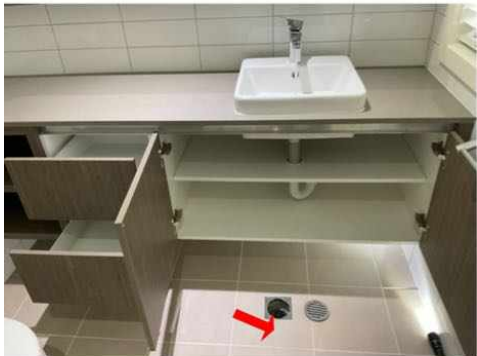
Building: Building 1  
 Location: Bathrooms and laundry  
 Finding: Waterproofing membranes - Information Only  
 Information: Internal Water Proofing Membranes, are crucial in preventing water ingress into the property is important to know that the Membrane System used is to Australian Standards and has been installed correctly.

With older property's where this information is unavailable all wet areas should be monitored. If any leaks, water staining, peeling or bubbling of the paint become evident to any adjacent walls or ceilings below a licensed builder or waterproofing specialist is recommended to investigate further.
