Building and Timber Pest Inspection Report

Inspection Date: Wed, 1 Apr 2026

Property Address: 6 Schubert Cres, Wodonga VIC 3690,
Australia

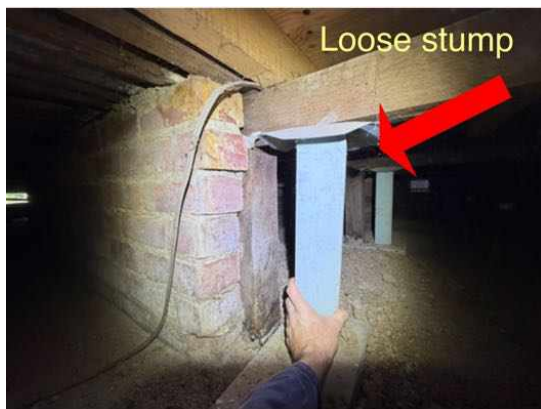
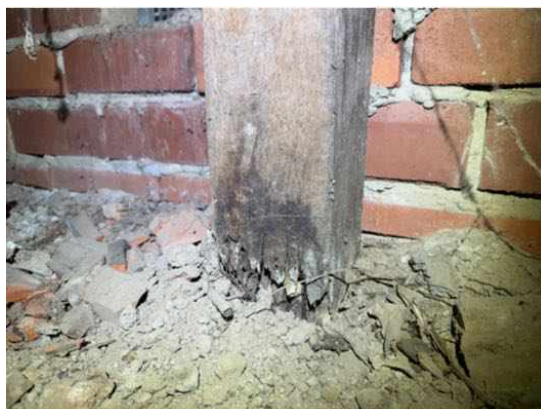
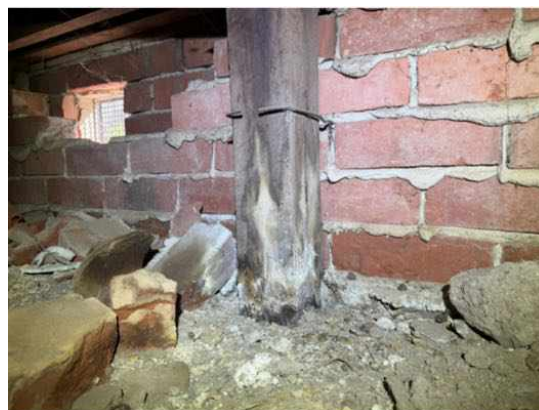
Building: Main Building
Location: Subfloor
Finding: Subfloor piers - Insufficient support / Fungal Decay & Termite Damage
Information: Some timber stumps at, but not limited to the right side of the subfloor, along the external wall appeared to be affected by fungal decay & termite damage. Some of the new timber stumps were also found to be loose and not fixed to the associated bearers. This affects the structural integrity of the subfloor structure in this area.

Recommend engaging a registered builder in the short term, to provide remedial works & replace any affected timbers, to ensure the subfloor structure is sufficiently supported.

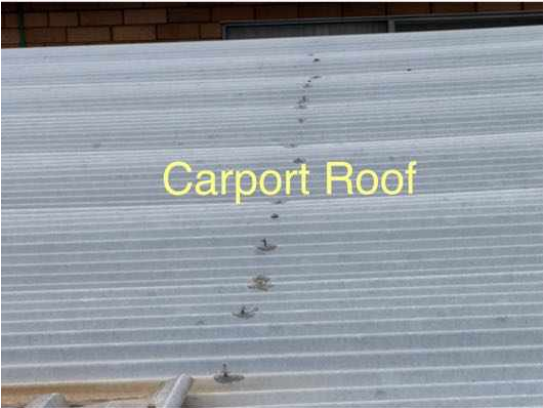
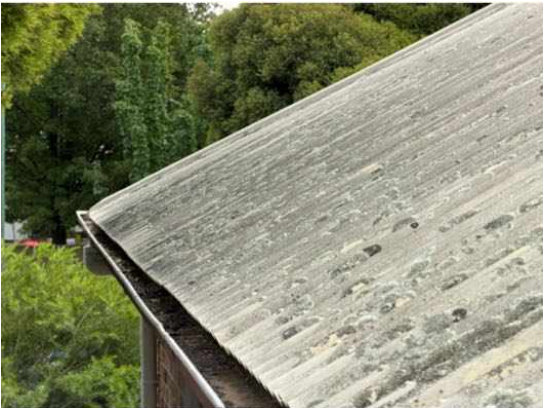
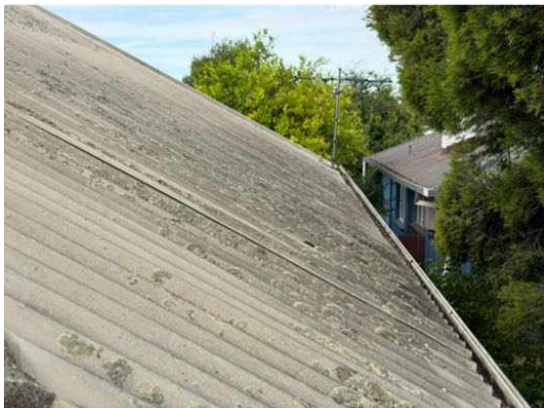
Building: Main Building
 Location: Roof Exterior
 Finding: Roof Exterior - Weathered, Rust
 Information: The roof exterior was found to be in a weathered condition evidenced by areas of rust, and general weathering. Some loose screws to the carport sheeting were also noted.

While weathering of the roof exterior is consistent with the age of the property, maintenance works are advised

Recommend consulting with a licensed roofing contractor at clients convenience, to provide further advice on maintenance works required and to ensure all roof sheeting is secure.

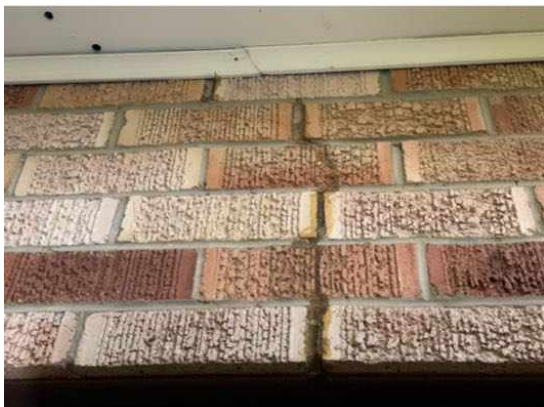
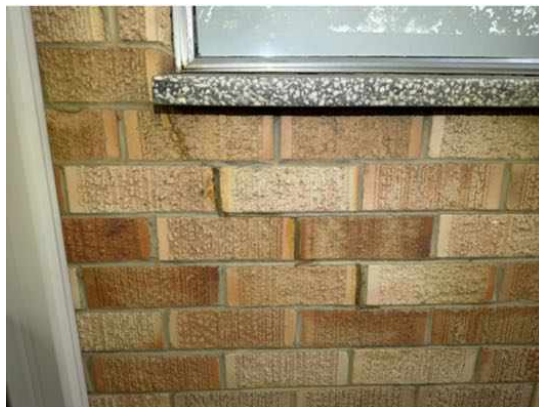
Finding 3.03

Building: Main Building
Location: External Brickwork
Finding: Brickwork - Step cracking

Information: Minor step cracking was identified to some areas of the brickwork at the time of inspection. Step cracking is a relatively common defect, and is most likely to occur adjacent to windows, doors and other openings.

The client should monitor the cracking. Should the step cracking lengthen, widen or become more numerous, a structural engineer should be engaged to provide further advice.

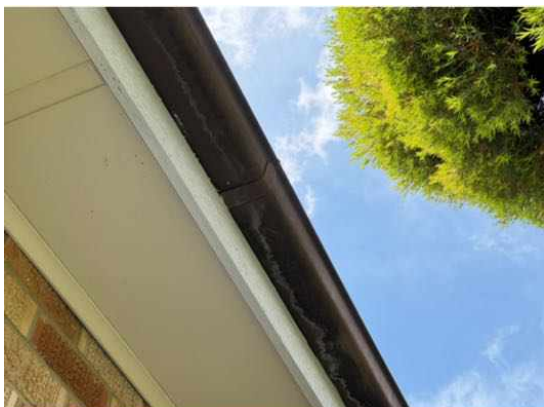
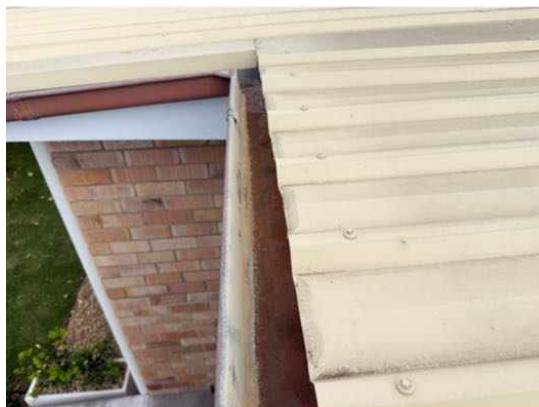
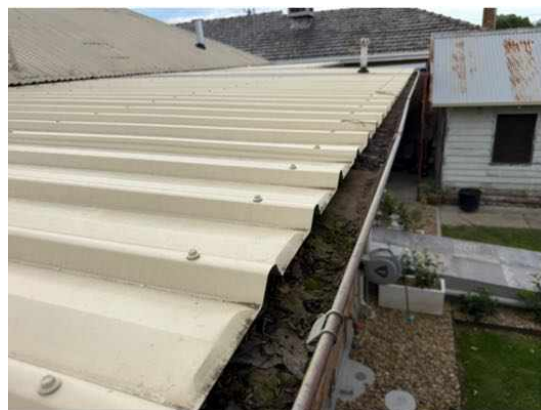
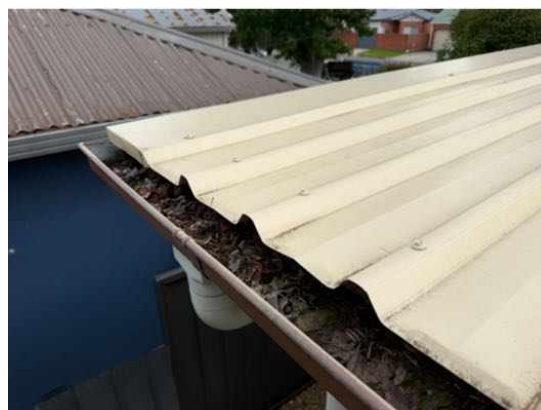
Finding 3.04

Finding: Gutters - Rust & Debris

Information: It appears that the gutters have areas of surface rust, a common finding in buildings of a similar age. Debris was also noted to some areas of the gutters.

Recommend engaging a licensed roof plumber, to provide further advice regarding maintenance works advised. All debris should be removed from the gutters, to avoid further accumulation & overflows.

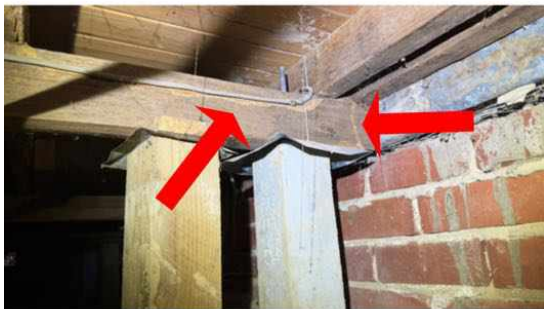
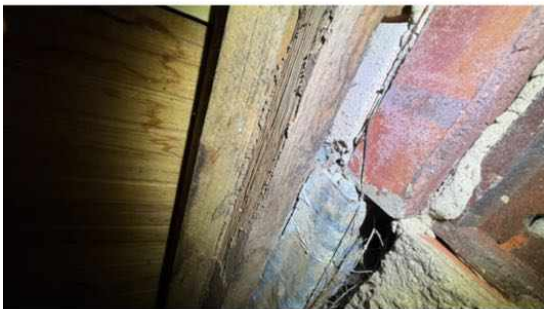
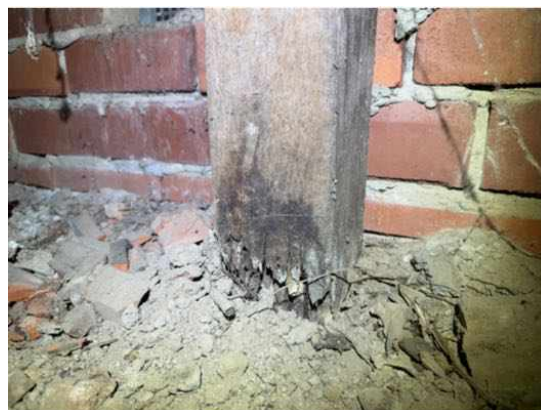
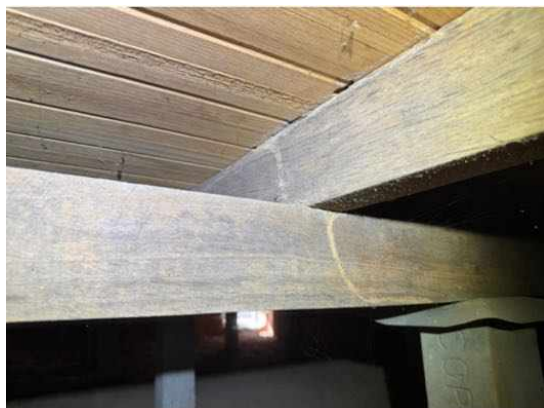
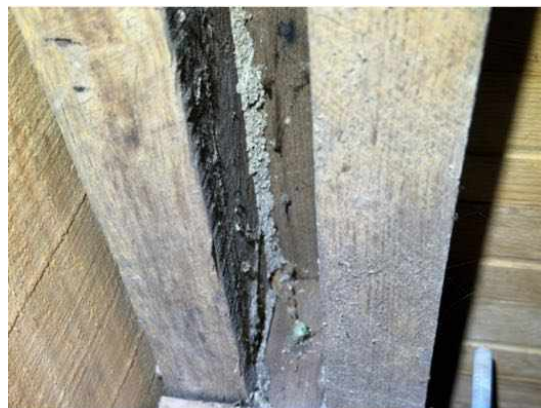
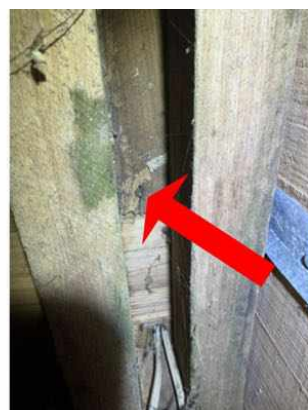
Building:	Main Building
Location:	Subfloor
Finding:	Evidence of termite workings & damage
Information:	Termite damage & workings were identified at, but not limited to, several areas throughout the subfloor. Although remedial works have been conducted, it appears some structural members (timber stumps) have been affected and should be replaced. It is also advised that a more invasive inspection be conducted to identify the extent of the damage.

Recommend engaging a licensed pest controller promptly, to provide further advice regarding installation of a termite treatment.

12 monthly ongoing termite inspections, conducted by a qualified termite inspector, are also recommended

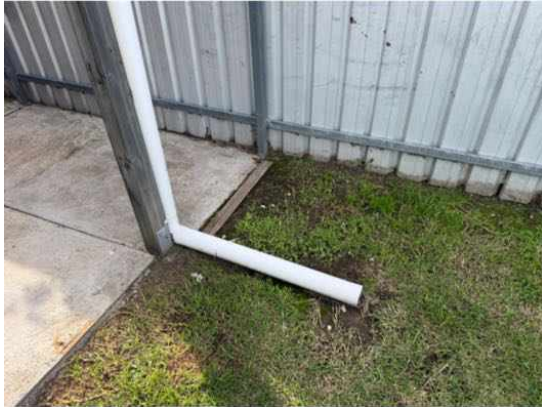
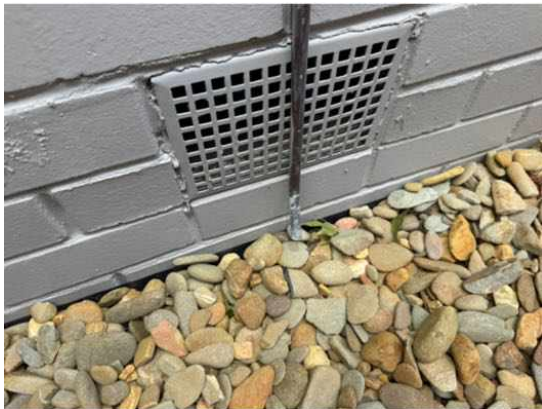
Information: It appears that there are potential areas around the perimeter of the property that could be susceptible to water pooling. Where insufficient drainage of roof plumbing, taps, hot water system & aircon overflows, and garden beds against the house are present, water pooling is likely to occur, and can create areas conducive to timber pests and moist conditions in the subfloor, if neglected.

Recommend consulting with a licensed plumber in the short term to further assess and provide remedial advice.

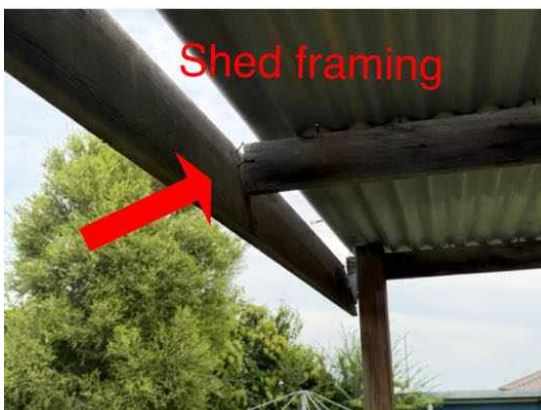
Building:	Main Building
Location:	Subfloor timbers, fascias, shed framing & cladding
Finding:	Fungal decay & weathering
Information:	Areas of fungal decay (wood rot) & weathering were identified at but not limited to some subfloor timbers, fascias, shed & carport framing & the weatherboard cladding.

For areas of fungal decay, the client can engage a licensed carpenter at their discretion to replace affected materials. For areas of general weathering, it is advised the client engage a licensed painter to apply protective sealant or coating to areas of weathered external timbers.

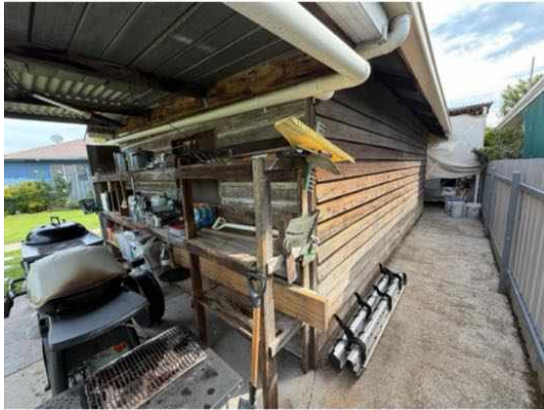
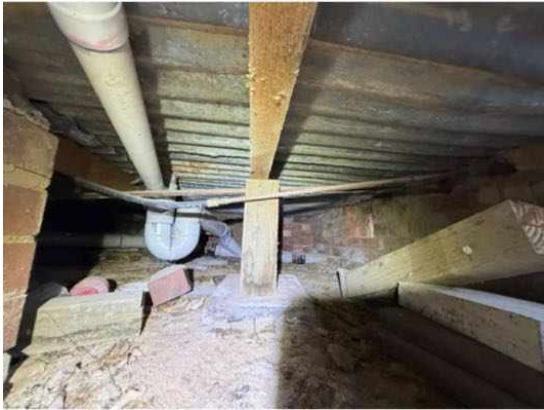
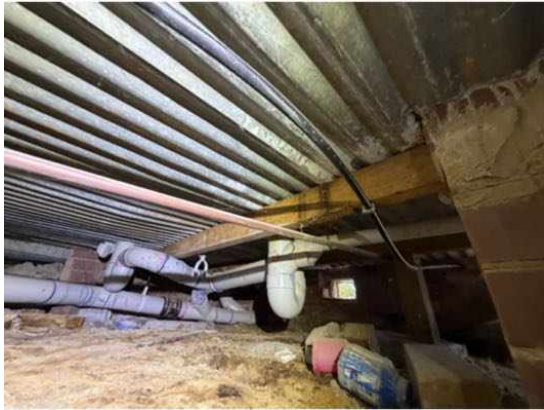
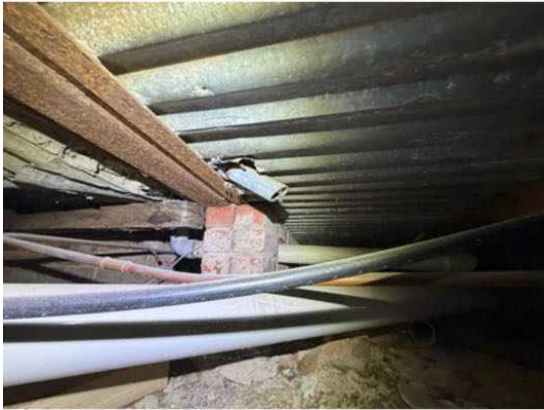
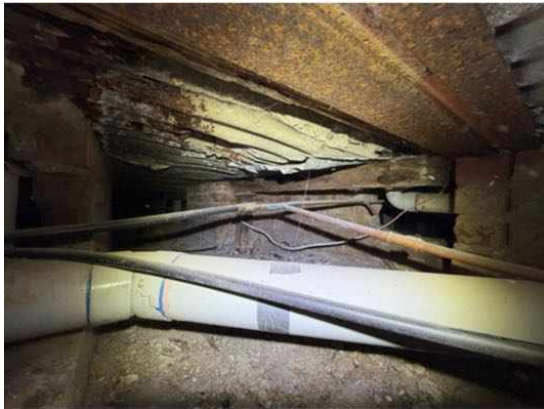
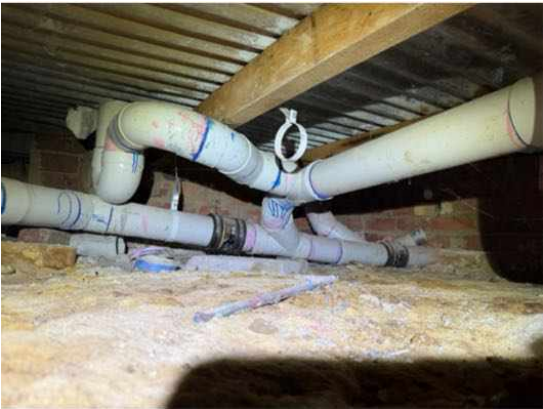
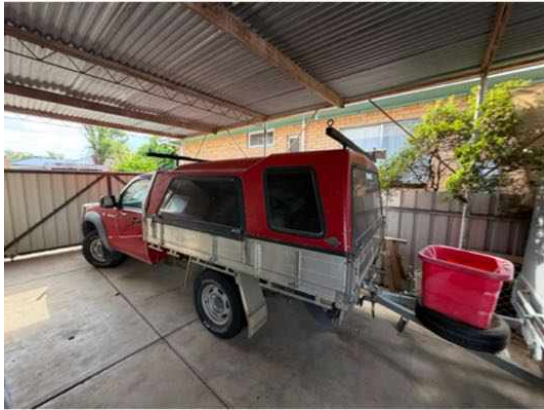
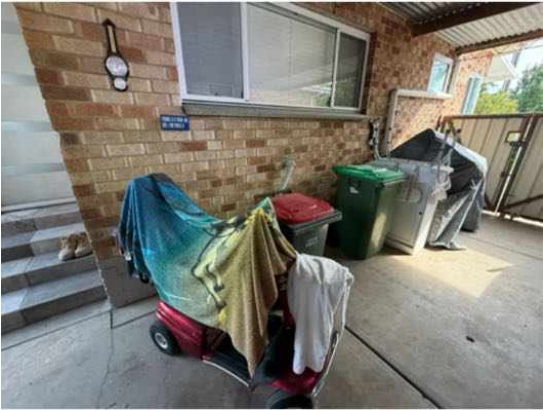
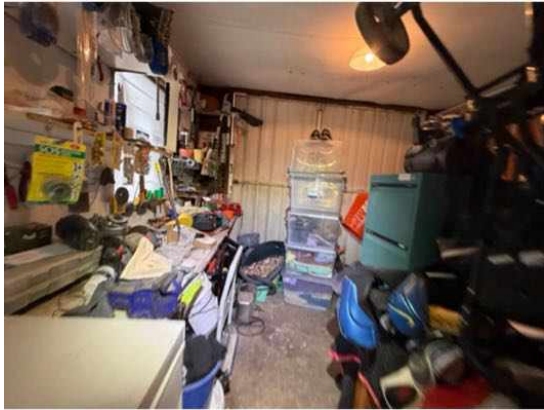
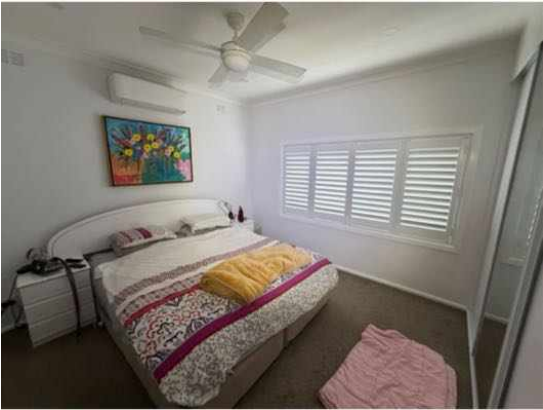
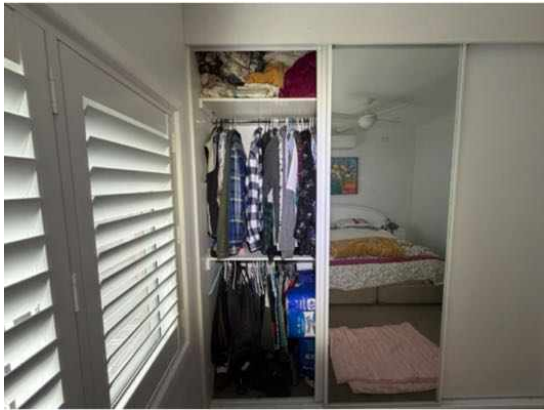
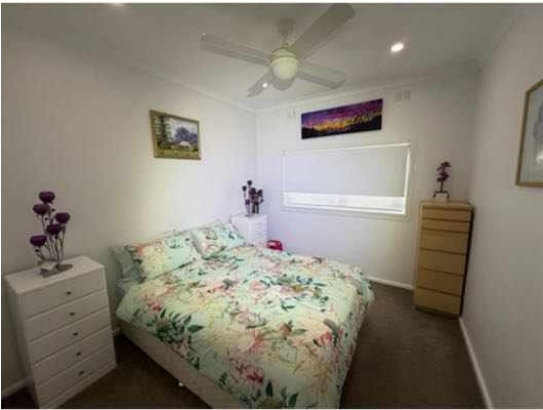
Building: Main Building
Location: All Areas
Finding: Additional Photos - Obstructions and Limitations
Information: These photographs are an indication of the obstructions and limitations which impeded full inspection of the property at the time of inspection. These obstructions can hide an array of defects and should be removed to allow full inspection to be carried out. A re-inspection is recommended once the areas are made accessible.
