Building and Timber Pest Inspection Report

Inspection Date: Mon, 16 Mar 2026

Property Address: 131 Merool Rd, Moama NSW 2731,
Australia cabin 81

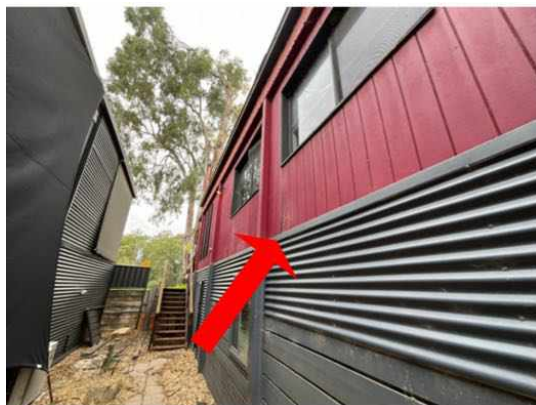
Finding: Cladding- deteriorated

Information: The external cladding shows signs of damage in several areas. Although not serious at this point, monitoring should be undertaken at intervals to ensure no further damage occurs.

A cladding specialist or handyman could be contacted as needed to patch any damage to prevent further deterioration.

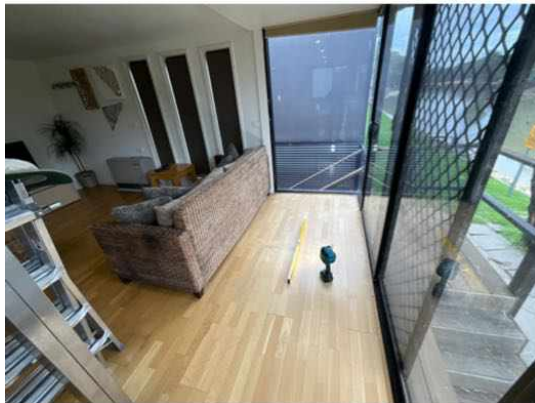
Finding 3.02

Building: Building 1
Location: All Internal Areas
Finding: Flooring - Uneven
Information: The internal flooring in this area is out of level and uneven. Uneven flooring is likely to indicate minor defects such as expected movement of the foundations of the property, but may also indicate subsidence of the associated subfloor support.

It is advised that the flooring be closely monitored to identify any further movement. Where flooring remains relatively unchanged for an extended period of time (i.e. several months), it is likely that this defect has been caused by expected movement of the foundations of the property.

Where flooring becomes increasingly uneven, a registered builder should be consulted to determine the extent of any needed works.

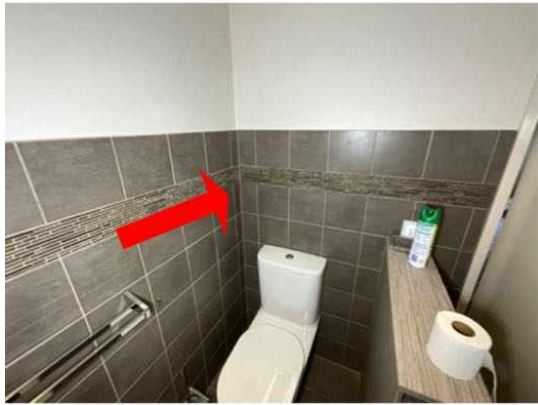
Finding 3.03

Building: Building 1
 Location: Ensuite
 Finding: Inadequate sealant or Grout
 Information: This area has a lack of effective Sealant or Grout. This is allowing the ingress of water to the structure inside the wall.

The presence of water encourages Termite attack, Mould and Fungal Decay.

A Tiler or General Handy person must be contacted as soon as possible to effect repairs and prevent further deterioration.

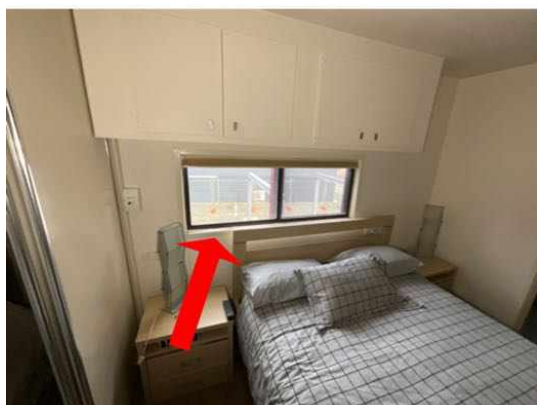
Finding 3.04

Building:	Building 1
Location:	Bedroom - Master
Finding:	MDF- Moisture affected
Information:	<p>The Particle board (MDF) in this area has been affected by excess moisture. This moisture has caused swelling of the material. A lack of effective paint or other coating has probably allowed the moisture to penetrate and deteriorate the material over time.</p> <p>In cases of minor swelling a painter or Handy person could re-paint and restore the area.</p> <p>In cases where the material is structurally compromised a carpenter or General handy</p>

person could be contacted to replace the damaged elements and complete all needed restoration.

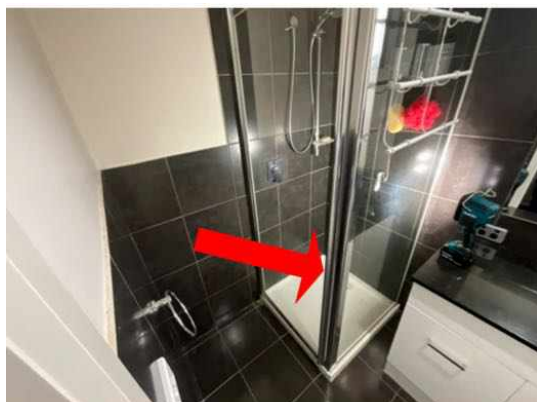
Finding 3.05

Building: Building 1
 Location: Bathroom
 Finding: Shower Door- jamming
 Information: The door to the shower alcove is sticking during normal operation. Poor operation of building elements is inconvenient and potentially dangerous to the elderly or younger members of the home.

A Handy person or bathroom specialist should be contacted soon to adjust the door to prevent any further deterioration.

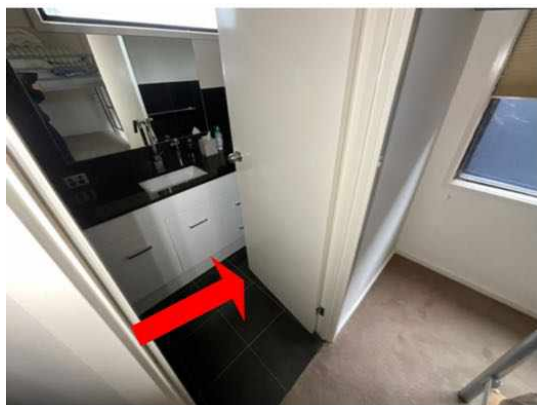
Finding 3.06

Building: Building 1
 Location: Bathroom
 Finding: Door- Binding/jamming
 Information: Binding and/or jamming of this door is evident during standard operation. This defect inhibits the functionality of the affected door as well as creating potential for secondary defects to associated building elements, such as damage to the floor covering.

A qualified carpenter or general handyperson should be appointed to perform minor rectification works at client discretion.

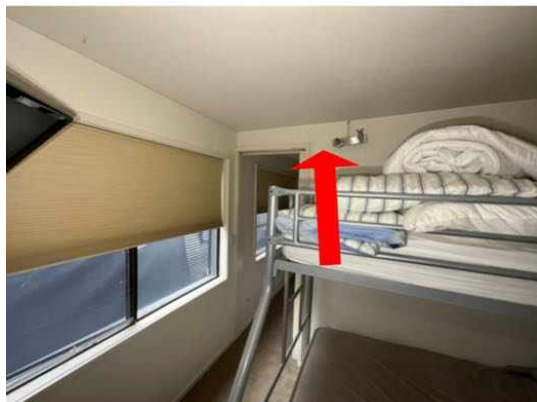
Building:	Building 1
Location:	Bedroom 3
Finding:	Cracking - Damage Category 1 - Fine (up to 1mm)
Information:	Although fine cracks are quite noticeable, they are often only considered to be an appearance defect, and usually do not indicate any structural damage. Generally, the

cause of a fine crack is indicative of a separation between building materials and finishes (e.g. paint, plaster, etc.) along joints.

Cracking of this nature can generally be repaired with minor sanding, filling and/or repainting. Such works should be performed by a qualified painter or a general handyman.

Monitoring of all cracking should be conducted frequently. Always contact a building inspector should cracks widen, lengthen, or become more numerous.

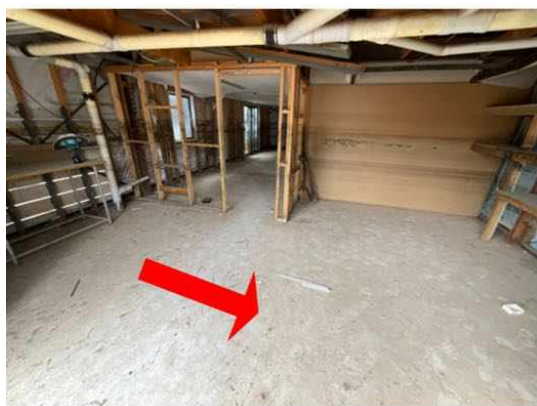
Finding 3.09

Building:	Building 1
Location:	Garage
Finding:	Crack in concrete slab - Category 1
Information:	A crack coded as Category 1 was identified in the slab. A Category 1 crack is described as a fine but noticeable crack, with the slab at an otherwise reasonable level.

To be considered Category 1, the approximate width of the crack is less than 1.0mm, or a less than 10mm change in offset when a 3m straight edge is placed over the defect.

Category 1 cracks should be monitored for a period of 12 months. At the end of the monitoring period, identified cracks that are rated greater than Category 2 are considered defects, and require rectification.

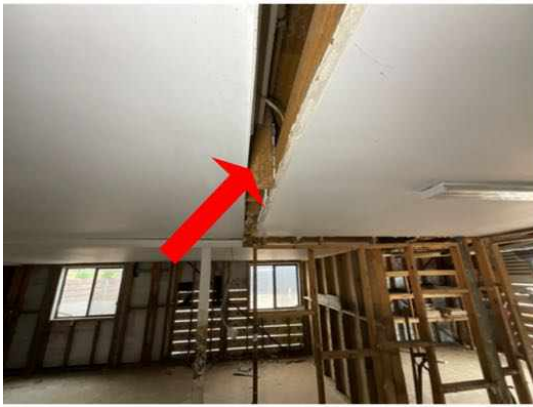
Building: Building 1
 Location: Previous laundry area
 Finding: Evidence of termite damage- not structural
 Information: Despite no live termite or timber pest activity being indicated, previous termite damage was found to have affected this area. This damage is considered to be inactive and is minor in nature.

It is advised that the area be visually inspected frequently to ensure that the condition of affected building materials does not worsen. At the time of inspection, damage is not structural and is only considered to be superficial.

A building contractor may be appointed to provide a further invasive inspection if further damage is evident.

A Pest control company should be consulted soon to initiate a termite management plan and prevent further damage.

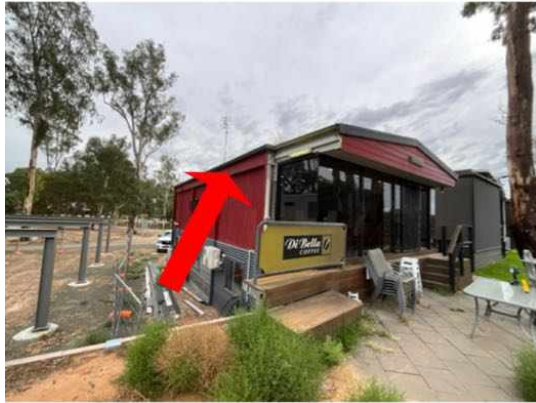
Finding 6.01

Blocked gutters are likely to lead to high levels of moisture in the affected areas. Such moisture will not only cause rust and decay of the associated building materials, but can also provide conditions that are conducive to termite and timber pest activity. Blockages in gutters should therefore be removed immediately to ensure dry conditions are maintained.

Consult a Licensed Plumber for further specific advice on remedial works that may be required. In the interim, it is highly advised that blocked gutters be removed by the homeowner or a general handyperson as a matter of urgency.

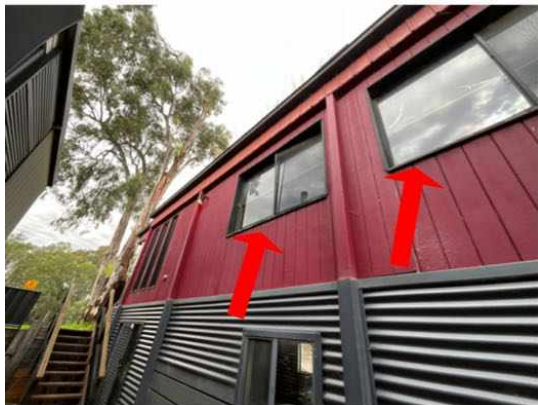
Finding 6.02

Building: Building 1
Location: External timber
Finding: Timber - exposed to weather
Information: External timbers that are frequently exposed to harsh weather conditions require adequate protection in order to maintain their condition. Where timbers have not been painted or treated adequately, general deterioration is likely to occur at an accelerated rate.

If left unattended, replacement of these timbers is likely to be necessary in the short-term future. Adequate treatment of these timbers is required as soon as possible by a painting contractor or general handyman.

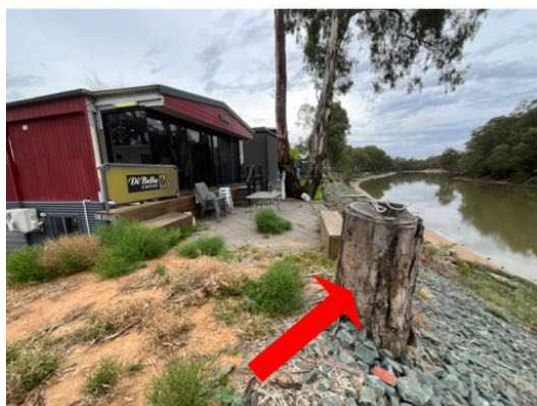
Finding 6.03

Building:	Building 1
Location:	River side
Finding:	Tree Stump in Ground
Information:	Any tree stumps in the yard not removed during the tree removal process provides the opportunity for Termite infestation and is likely to be subject to decay from damp conditions against the stump.

All tree stumps should be removed by professional tree removal services where possible. Meanwhile regular inspections are advised to identify any termite activity in the areas identified.

Services for tree stump removal should be contacted as soon as possible to reduce the risk of timber pest attack.

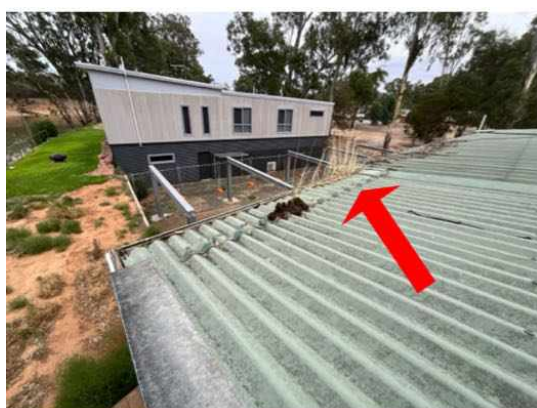
Finding 6.04

Building:	Building 1
Location:	All External Areas
Finding:	Termite Management System - no evidence of a chemical installation
Information:	The application of a post-construction chemical termite barrier is highly recommended for all properties, particularly if live termite activity has been found on the site previously. Such barriers are highly effective in preventing termite attack on any timber building elements throughout the property.

A durable notice should be placed in the switchboard unit to indicate current termite barriers. At the time of inspection, it appeared as though no termite management system has been installed, with no evidence to suggest preventative works taking place.

The client may consider gaining further advice from a pest controller as to the costs and procedures involved with this application. It is recommended that obtaining such advice be a short-term priority.

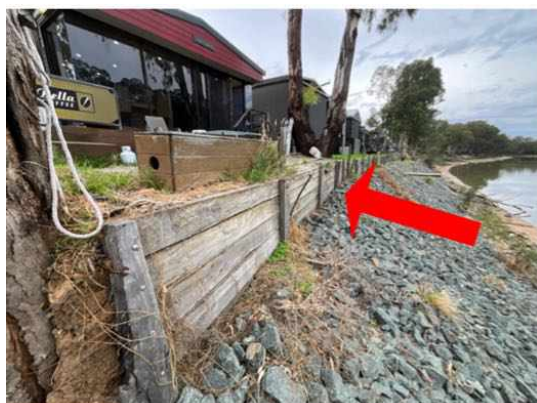
Finding 7.01

Building:	Building 1
Location:	Retaining wall
Finding:	Fungal decay - present (localised)
Information:	Fungal decay also known as wood decay or wood rot generally refers to the deterioration of timber elements when in contact with excessive levels of moisture for a prolonged period of time.

The development of fungal decay is accelerated by temperatures in the range of 5degreeC to 40degreeC as well as the presence of oxygen. Generally fungal decay develops on timber elements that are in use in an external environment which are exposed to rain penetration.

In this case although the affected timber element is in a decaying state the extent of any visible damage appears to be localised to a specific area and is yet to spread to other parts of the building element or affect adjoining structures. The fungal decay is therefore likely to be of a relatively superficial nature with minimal impact on the structural integrity or tensile strength of the timber element.

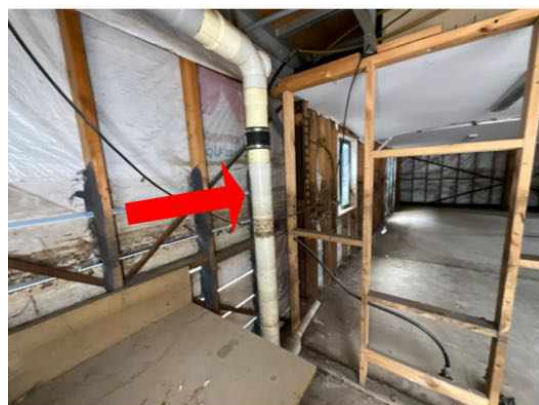
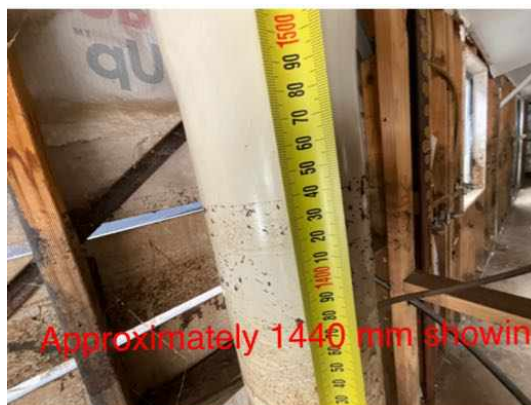
Building:	Building 1
Location:	Lower floor
Finding:	Flood level
Information:	The previous flood level can be seen as approximately 1440mm from the slab. Removal of damaged lining board has been undertaken.

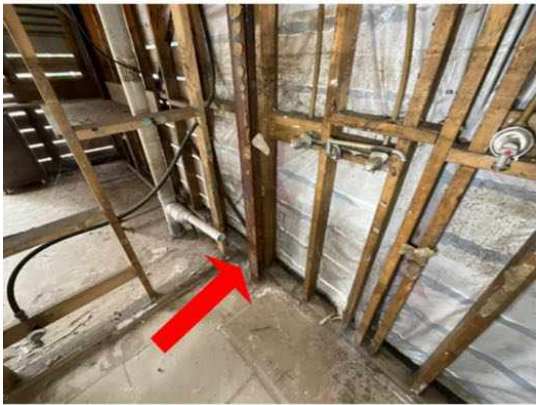
Building:	Building 1
Location:	Lower floor
Finding:	Steel- rust
Information:	The question of rust damaging the steel supporting uprights can be answered. The rust is generally superficial. No penetration through the material could be found at the time of inspection. Sounding of the steel revealed no weakened areas.

The structure has been built in separate sections brought together over time. The lack of cracking in the walls and flooring would indicate that no movement has occurred.

If further investigation is needed, a structural engineer should be consulted to determine potential improvements to the structure.

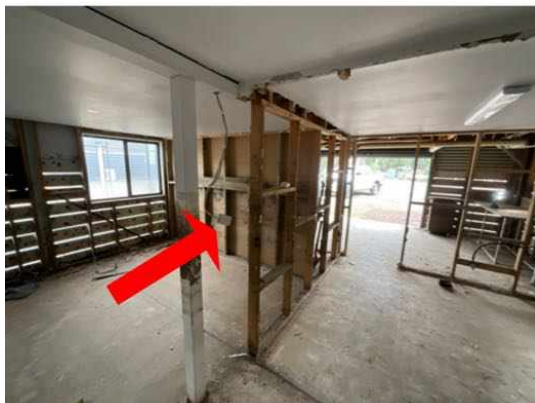
Building: Building 1
Location: Lower floor
Finding: Plumbing and Electrical
Information: Some installations appear of in finished/ poor quality. A plumber should be contacted at client discretion, to improve the installation and prevent further deterioration.

It is highly recommended that the client makes immediate arranges to have the gas appliances checked by a licensed gas plumber to ensure that the appliances are working safely and efficiently.

We recommend all other installations be checked also.

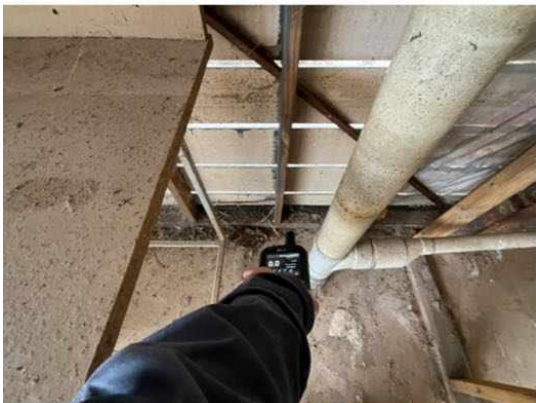
Building: Building 1
Location: Lower floor
Finding: Moisture levels
Information: The timber frame around the lower floor shows no signs of excess moisture.

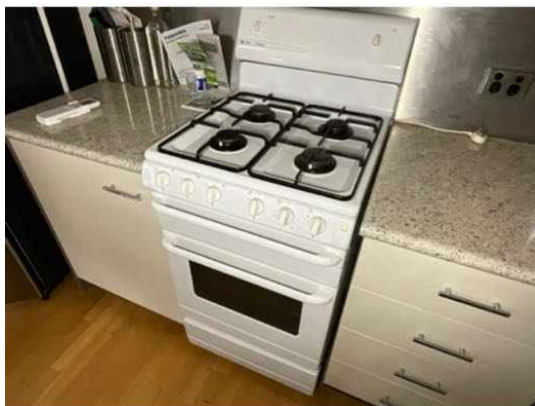
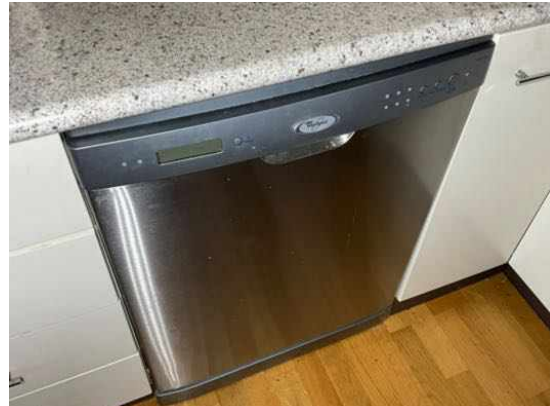
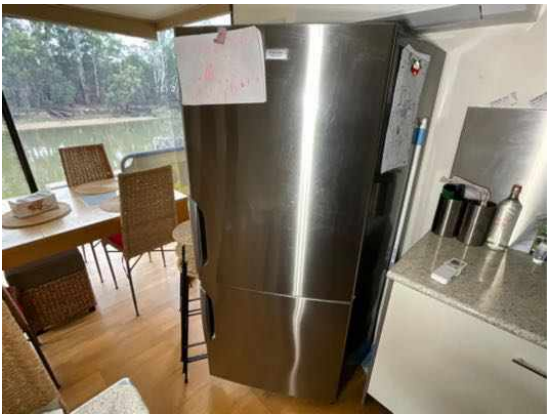
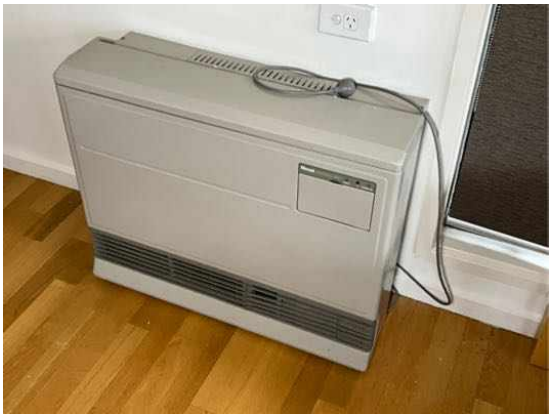
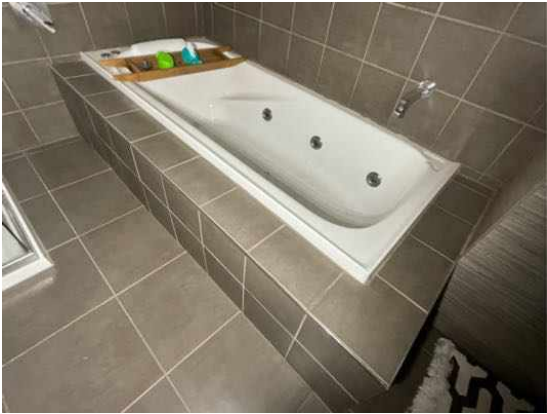
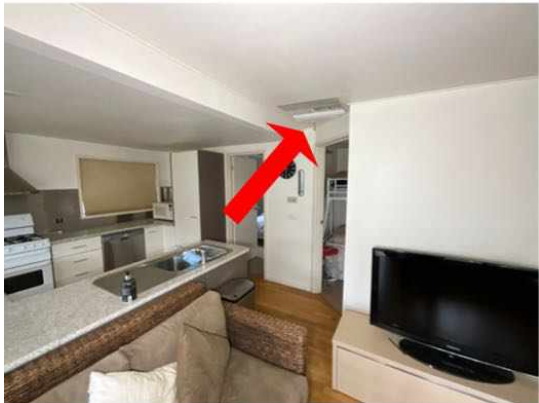
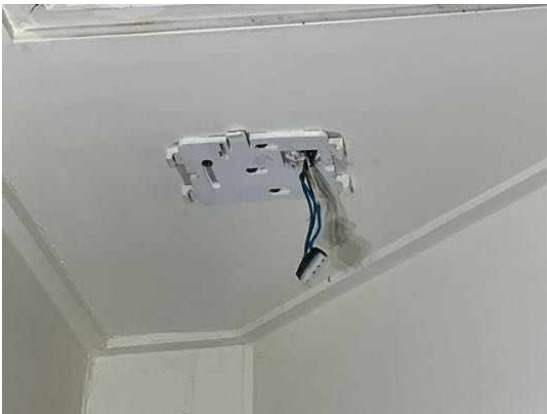
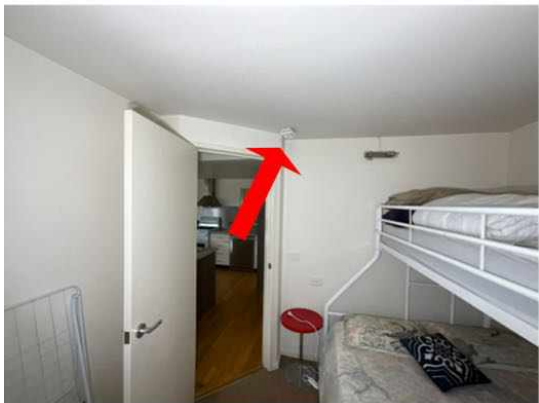
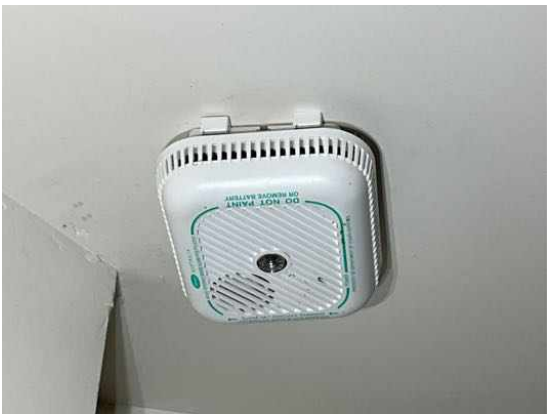
Building: Building 1
 Location: All Areas
 Finding: Additional Photos - Obstructions and Limitations
 Information: These photographs are an indication of the obstructions and limitations which impeded full inspection of the property at the time of inspection. These obstructions can hide an array of defects and should be removed to allow full inspection to be carried out. A re-inspection is recommended once the areas are made accessible.
