Building and Timber Pest Inspection Report

Inspection Date: Mon, 2 Feb 2026

Property Address: 2 Manhattan Dr, Eagleby QLD 4207,
Australia

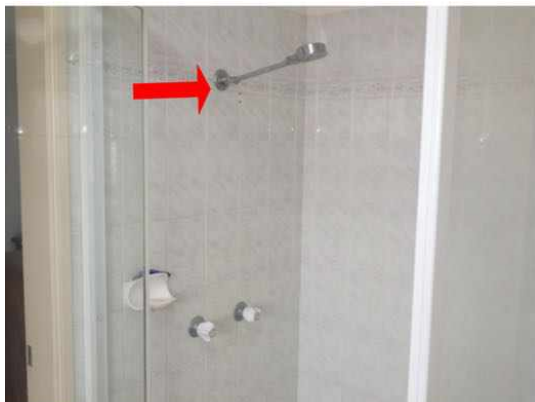
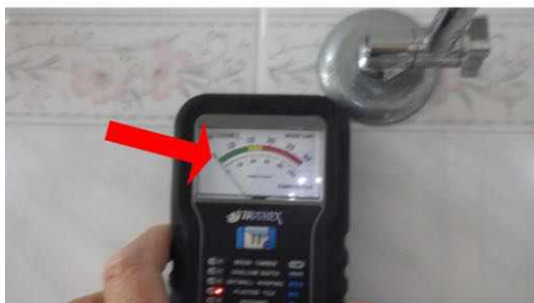
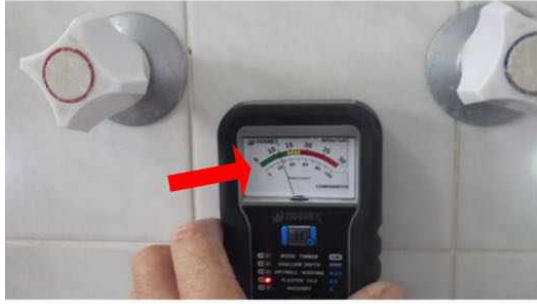
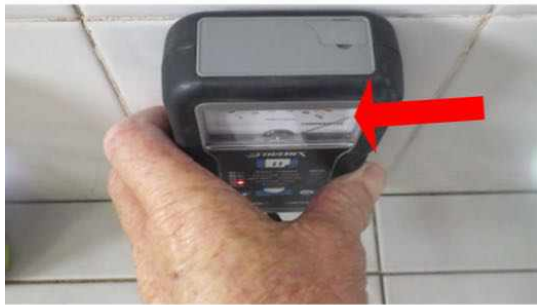
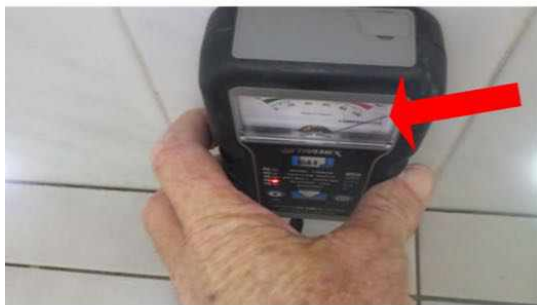
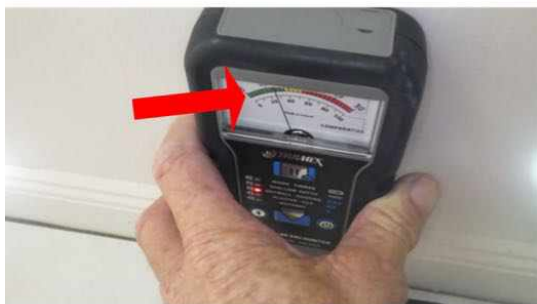
Building: Main Building
Location: Bathroom > Front Right
Finding: Shower - Leaking
Information: The bathroom shower registered elevated moisture level readings to the lower wall areas of the shower cubicle at the time of inspection, with the elevated moisture level readings transferring to the opposite side of the wall which would generally indicate the shower is leaking.

It is suspected that the leaking has occurred as a result of general ageing of the building elements (waterproofing Membrane) and/or deterioration of sealants and grout.

Leaking from the shower area, where left unattended, is likely to lead to water damage to adjoining flooring and walls. Such damage can necessitate extensive remedial works being required. Active water leaks may also create an environment that is susceptible to the formation and development of mould and /or timber termite activity.

A qualified plumber should be engaged to undertake a pressure test on the shower base and/or plumbing pipes. Additionally a licensed builder or shower area specialist may be required to repair or replace the shower cubicle. Such works should be performed as soon as possible to ensure that no damage occurs.

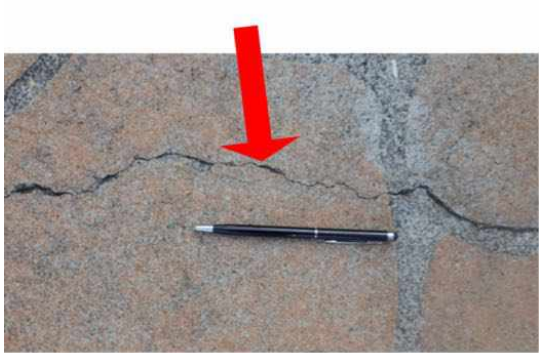
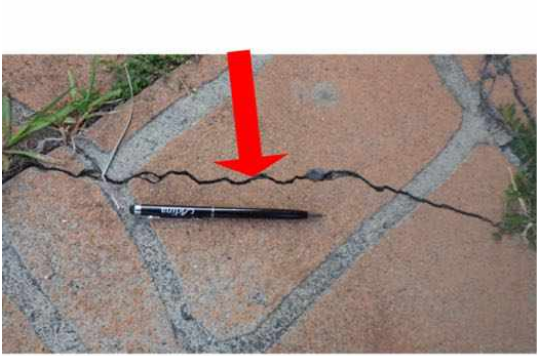
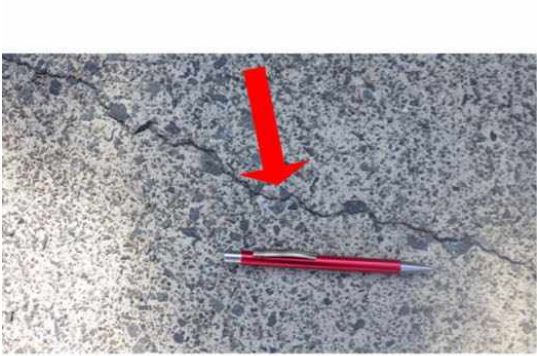
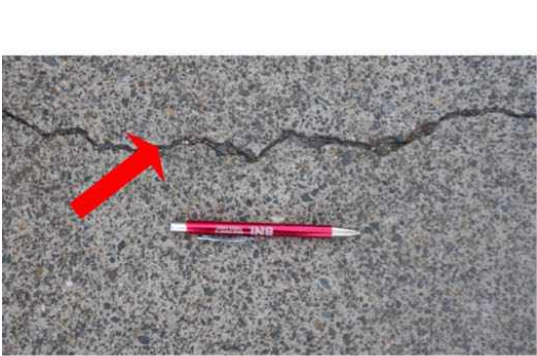
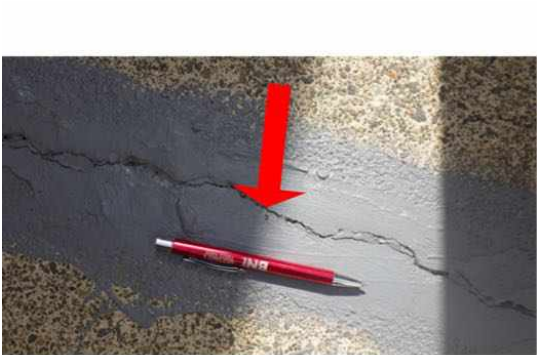
Finding 3.01

Building: Main Building
 Location: Driveway > Ground Level
 Finding: Cracking in concrete slab - Category 1
 Information: Cracking coded as Category 1 was identified in the driveway and footpaths concrete slabs (as pre example photos). A Category 1 crack is described as a fine but noticeable crack, with the slab at an otherwise reasonable level.

To be considered Category 1, the approximate width of the crack is less than 1.0mm, or a less than 10mm change in offset when a 3m straight edge is placed over the defect.

Category 1 cracks should be monitored for a period of 12 months. At the end of the monitoring period, identified cracks that are rated greater than Category 2 are considered defects, and require rectification.

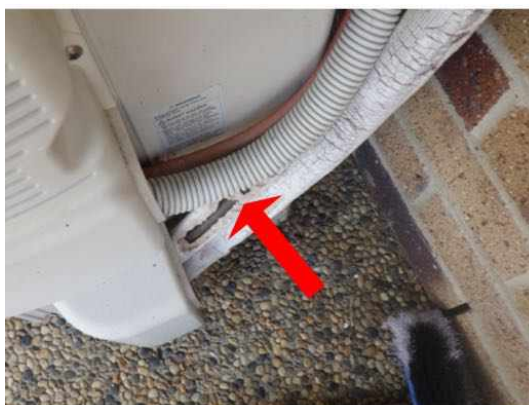
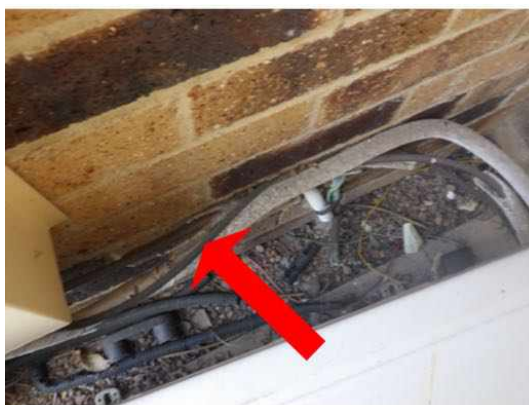
Finding 3.02

Building: Main Building
 Location: Exterior walls > Front Right,Rear Left
 Finding: Pipework - Insulation deteriorated
 Information: At the time of inspection sections of the air conditioning units pipe work insulation showed evidence of damage and deterioration. It is suspected that this deterioration has developed as a result of excessive exposure to weather, including UV exposure in daylight. Deteriorated insulation reduces the effectiveness of the material in helping to maintain the desired temperature and work most efficiently.

If left in an exposed position, it is likely that the deterioration will continue and worsen over time, potentially resulting in secondary building defects as well as a further loss in insulating properties.

Some areas of replacement of pipe insulation is likely to be required. Further preventative measures to remove or protect the material from future exposure are also advisable. Consultation with a licensed air conditioning installer is advised to gain quotes for the repair and/or replacement of deteriorated insulation.

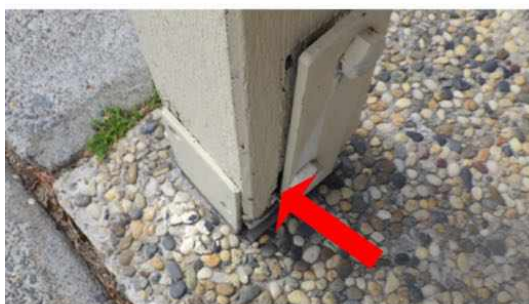
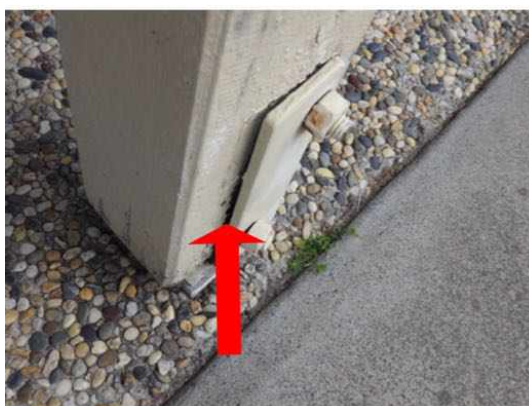
Finding 3.03

Building: Main Building
 Location: Alfresco > Rear Left
 Finding: Wood rot

Information: The timber support posts on the rear left side of the alfresco area show evidence of wood rot to the bottom edges. Wood rot, also known as Fungal Decay, occurs when timbers and other cellulose building materials are exposed to damp conditions on an ongoing basis. This could be the result of exposure to weathering over a prolonged period of time, or the attraction of excessive moisture from other abutting building materials.

A registered builder or qualified carpenter may be required to repair or replace the affected timber posts..

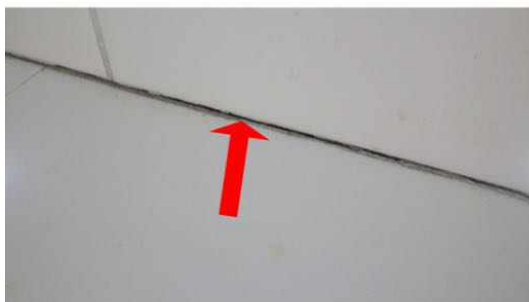
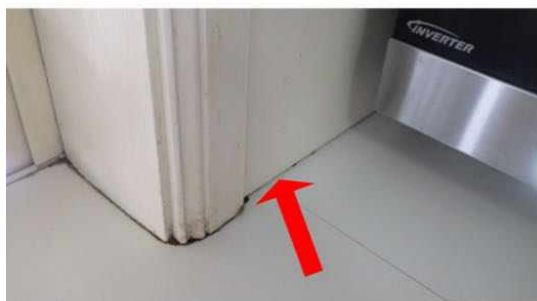
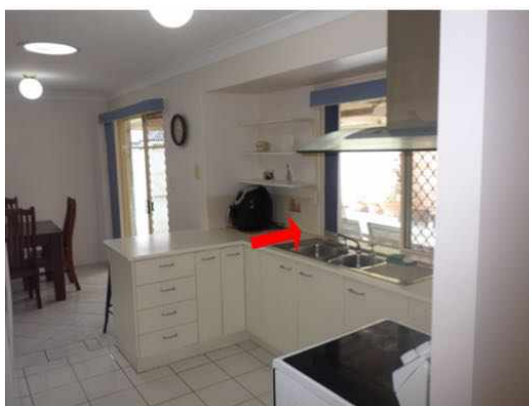
Finding 3.04

Building: Main Building
 Location: Kitchen > Centre Left
 Finding: Kitchen Bench -Sealant
 Information: It was noted on inspection that sealant is missing or deteriorated from the kitchen bench / tiled splash back intersection. It is important this area is sealed to prevent moisture or liquids penetrating the generally unsealed edges. Sealant also prevents vermin from accessing and or nesting in these areas.

A flexible sealant is required to allow for expected expansion and contraction, while keeping the joint water tight and protective of all associated building materials.

A sealant specialist or tiling contractor should be appointed to complete these works as soon as possible.

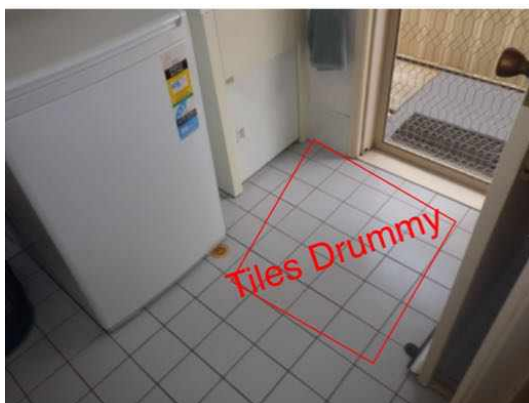
Finding 3.05

Building:	Main Building
Location:	Laundry > Centre,Rear
Finding:	Tiles - Drummy
Information:	Drummy tiled areas were identified in the Laundry area floor at the time of inspection. The term 'drummy' refers to tiles that despite being in relatively good condition have a hollow sound when tapped on and may be inclined to crack from heavy impact whether accidental or deliberate. Drummy tiled areas may be a direct result of poor workmanship during the construction process.

A tiling contractor could be appointed to perform works if necessary.

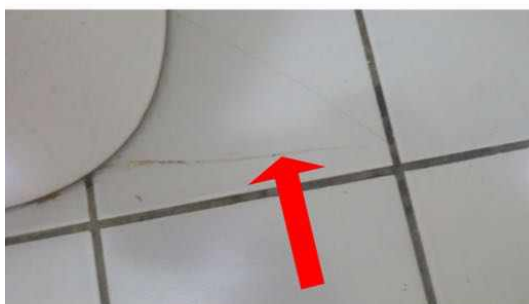
Finding 3.06

Building:	Main Building
Location:	Toilet (WC) > Centre
Finding:	Tile - Cracked
Information:	A cracked tile to the WC floor area was identified at the time of inspection. Such defects are generally caused by impact. Cracked or broken tiled areas may also be a direct result of poor workmanship during the construction process.

A tiling contractor could be appointed to perform repair works at the clients discretion.

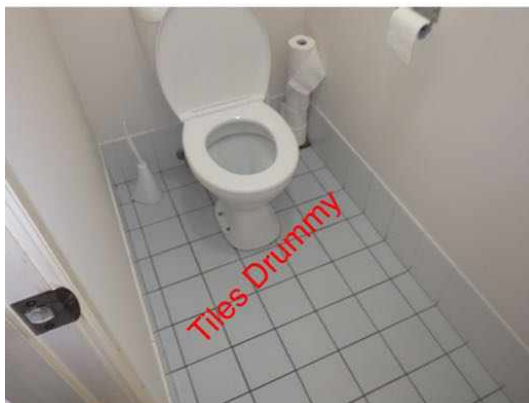
Finding 3.07

Building:	Main Building
Location:	Toilet (WC) > Centre
Finding:	Tiles - Drummy
Information:	Drummy tiled areas were identified in the WC area floor at the time of inspection. The term 'drummy' refers to tiles that despite being in relatively good condition have a hollow sound when tapped on and may be inclined to crack from heavy impact whether accidental or deliberate. Drummy tiled areas may be a direct result of poor workmanship during the construction process.

A tiling contractor could be appointed to perform works if necessary.

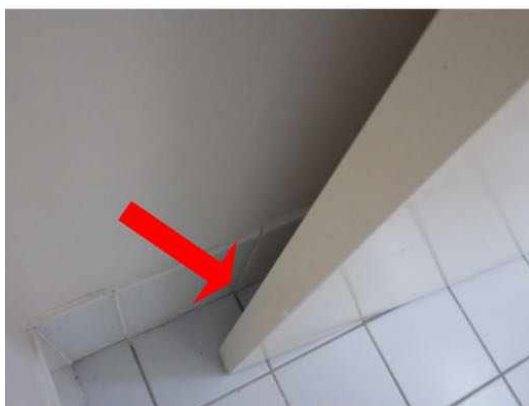
Finding 3.08

Building:	Main Building
Location:	Toilet (WC) > Front Right
Finding:	Door stop - Missing
Information:	The WC door stop is missing or is inadequate to stop the door handle from damaging the wall.

Re-installation or replacement of the door stop is advised to prevent any subsequent damage to the wall linings or associated structures.

A general handyman may be appointed to perform these works at client discretion.

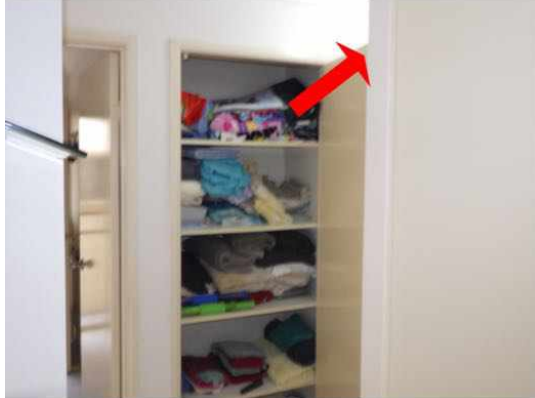
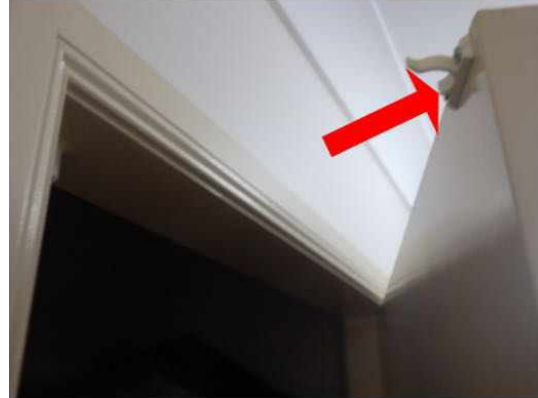
Finding 3.09

Building:	Main Building
Location:	Linen Cupboard > Front
Finding:	Door - Broken latch
Information:	The door latch to the linen cupboard door was found to be broken at the time of inspection. Breakage occurs generally when the building materials have aged and decayed, but may be indicative of impact damage (accidental or deliberate).

Replacement of the broken door catch is advised to improve the operational state of the associated door.

A general handyman could be appointed to replace the door latch at the client's discretion.

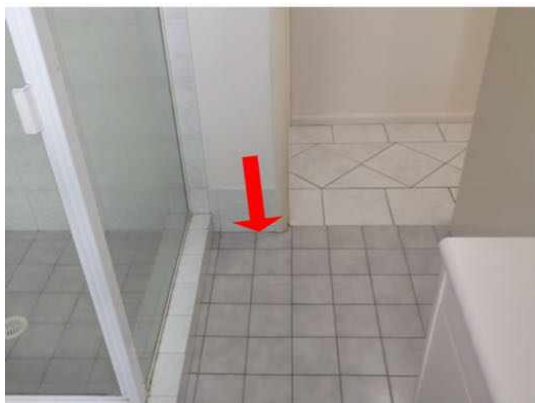
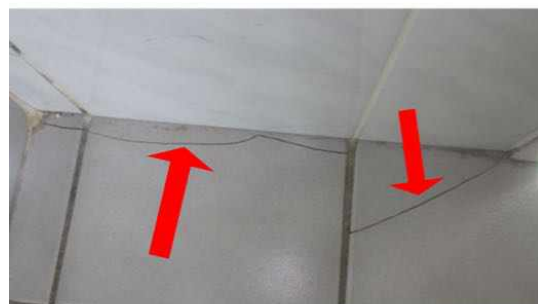
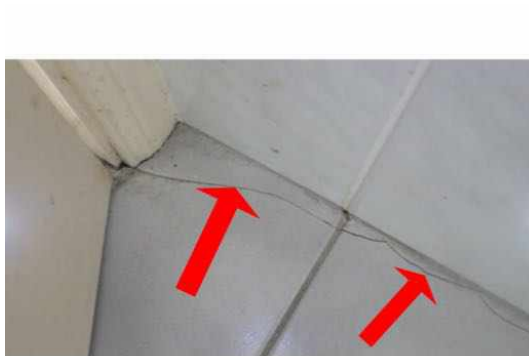
Finding 3.10

Building: Main Building
 Location: Bathroom > Front Left, Front Right
 Finding: Tiles - Cracked
 Information: Cracked tiles to the bathroom floor area were identified at the time of inspection. Such defects are generally caused by impact or moisture damage to the area. Cracked tiled areas may also be a direct result of poor workmanship during the construction process.

It is advised that a tiling contractor be appointed to perform repair works as necessary.

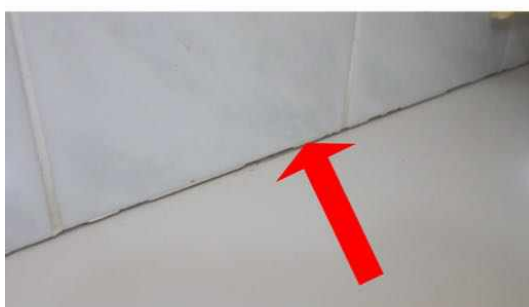
Finding 3.11

Building: Main Building
 Location: Bathroom > Centre Left
 Finding: Bathroom - Sealant
 Information: It was noted on inspection that sealant is missing or deteriorated from the bathroom vanity unit top / tiled splash back intersection. It is important this area is sealed to prevent moisture or liquids penetrating the generally unsealed edges. Sealant also prevents vermin from accessing and or nesting in these areas.

A flexible sealant is required to allow for expected expansion and contraction, while keeping the joint water tight and protective of all associated building materials.

A sealant specialist or tiling contractor should be appointed to complete these works as soon as possible.

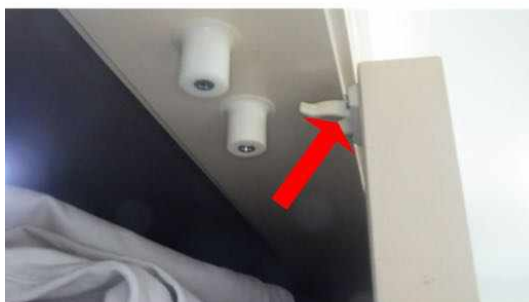
Finding 3.12

Building: Main Building
 Location: Bedroom - Master > Centre Left
 Finding: Door - Broken Catch
 Information: The door catches to the main bedroom cupboard doors were found to be broken at the time of inspection. Breakage occurs generally when the building materials have

aged and decayed, but may be indicative of impact damage (accidental or deliberate).

Replacement of the broken door catches is advised to improve the operational state of the associated doors.

A general handyman could be appointed to replace the door latches at the client's discretion.

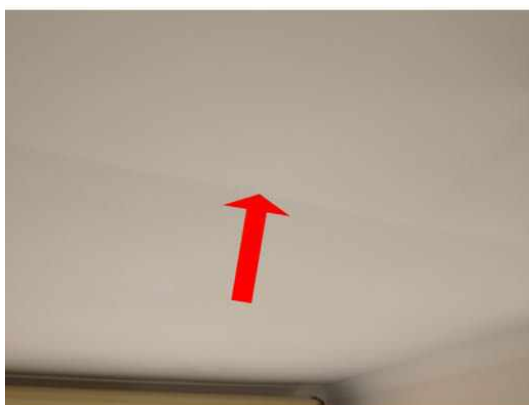
Finding 3.13

Building:	Main Building
Location:	Garage > Existing
Finding:	Ceiling - Sagging
Information:	The ceiling linings in the garage area showed signs of minor sagging at the time of inspection. Sagging to the fixed ceiling structure generally indicates that the building materials have swollen, due to exposure to moisture, or that fixings (e.g. nails or glue) have become loose and require reattachment.

Where minor sagging is evident, comparatively minor works, such as re-gluing and re-screwing of ceiling sheets, may be required.

Such works may be performed by relevant tradespeople, such as plasterers and painters.

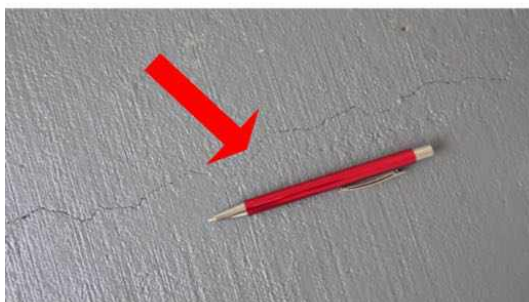
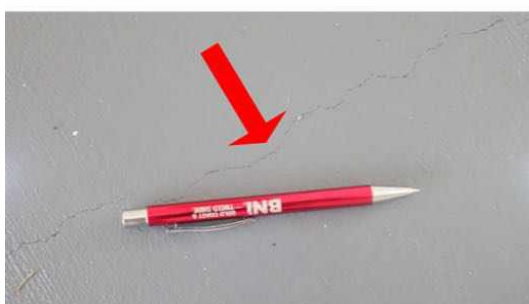
Finding 3.14

Building: Main Building
 Location: Garage > Ground Level
 Finding: Cracking in concrete slab - Category 1
 Information: Cracking coded as Category 1 was identified in the garage floor concrete slab. A Category 1 crack is described as a fine but noticeable crack, with the slab at an otherwise reasonable level.

To be considered Category 1, the approximate width of the crack is less than 1.0mm, or a less than 10mm change in offset when a 3m straight edge is placed over the defect.

Category 1 cracks should be monitored for a period of 12 months. At the end of the monitoring period, identified cracks that are rated greater than Category 2 are considered defects, and require rectification.

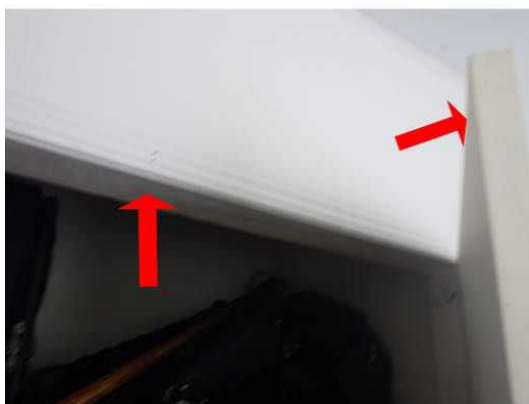
Finding 3.15

Building: Main Building
 Location: Garage > Rear Left
 Finding: Door Catches - Missing
 Information: It was noted that the door catches to the garage area cupboard doors were missing

at the time of inspection.

A general handyperson may be appointed to perform rectification works as necessary, at client discretion.

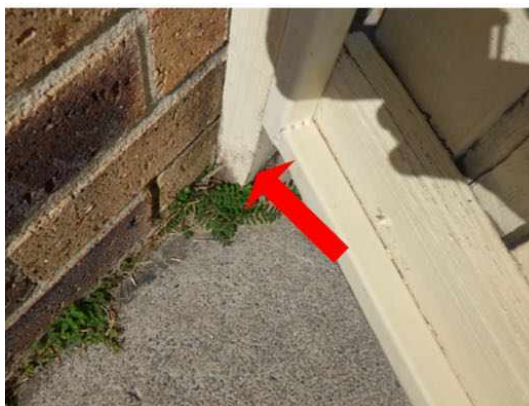
Finding 6.02

Building: Main Building
 Location: Exterior walls - left side > Front Left
 Finding: In ground contact
 Information: The timber gate post fixed to the exterior wall brickwork is in direct contact with the footpath concrete slab.

Any timbers in direct ground contact provide opportunity for concealed termite entry and are likely to be subject to premature rot and decay as the ground retains moisture

or damp conditions against the timbers.

Ideally these types of timber members would be clear of the ground area by a minimum of 50mm to provide a clear inspection zone.

Frequent pest inspections are advised to readily identify any termite activity in these areas.

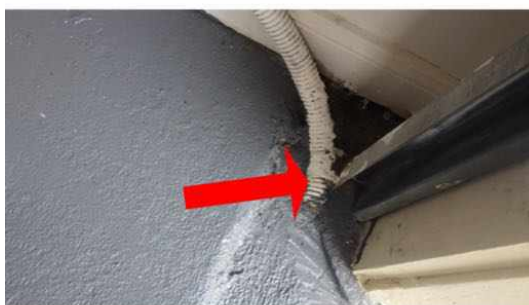
Finding 6.03

Building:	Main Building
Location:	Garage > Front Right
Finding:	Overflow - Not plumbed for drainage
Information:	The air conditioning unit overflow is not plumbed or connected to suitable drainage, which can result in the surrounding area becoming excessively damp. These damp conditions can lead to secondary defects such as rot, rust or corrosion of associated building elements, the formation of fungal decay, or even the creation of potential slip hazards. When coupled with poor site drainage, pooling of water may also attract termite activity to this area. It is highly recommended that a qualified plumber be appointed to install adequate drainage to the overflow. These works will ensure that the area remains dry and free of any secondary defects.

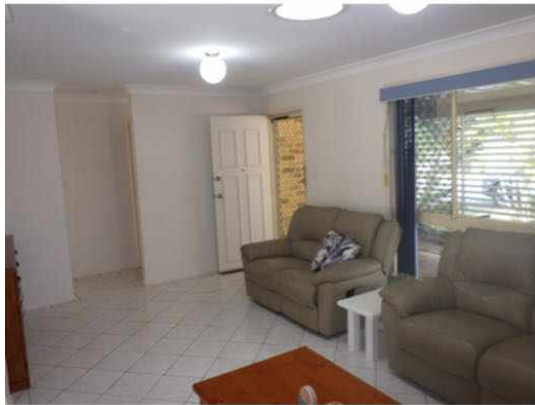
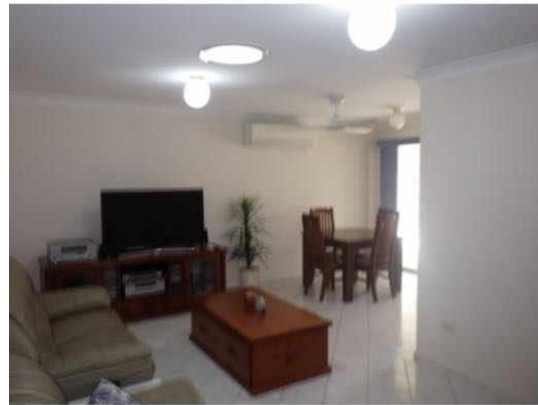
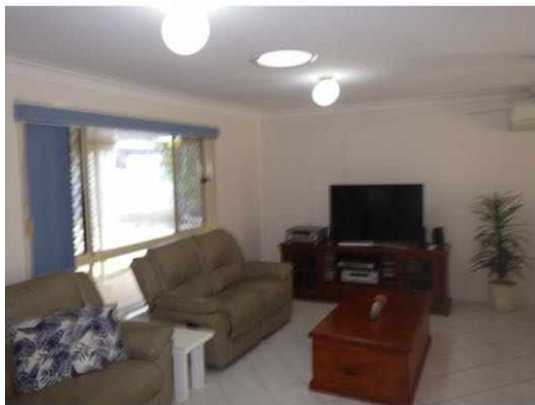
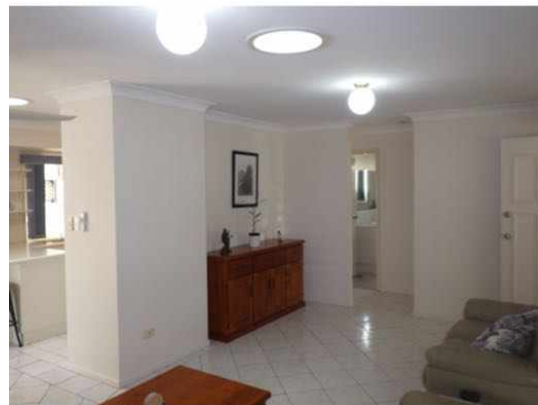
Building: Main Building
Location: Entry/Living Room > Existing
Finding: No obvious defect
Information: No obvious defects found at the time of inspection.

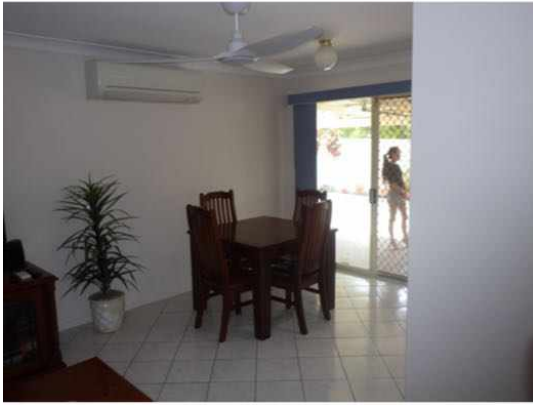
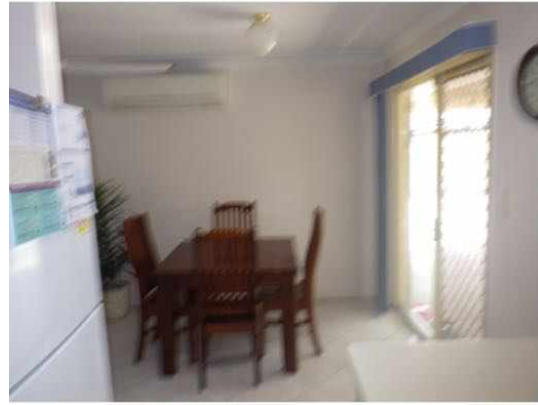
Building: Main Building
Location: Dining Room > Existing
Finding: No obvious defect
Information: No obvious defects found at the time of inspection.

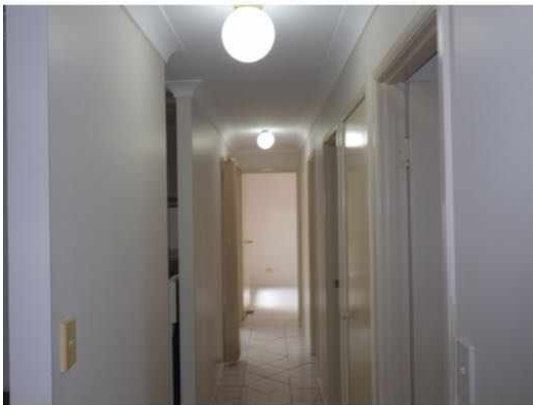
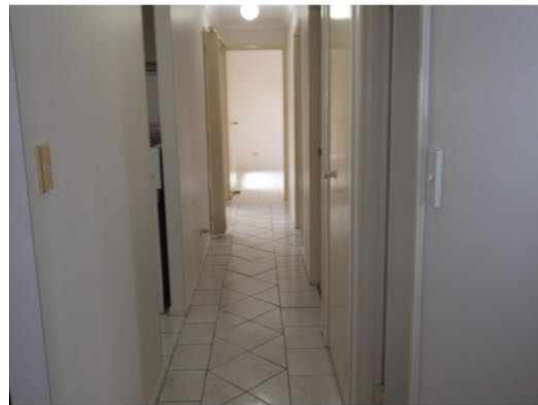
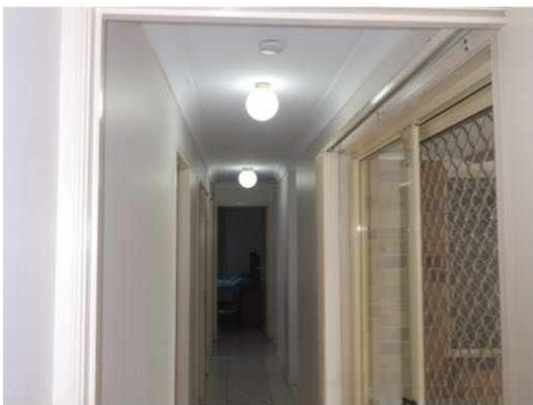
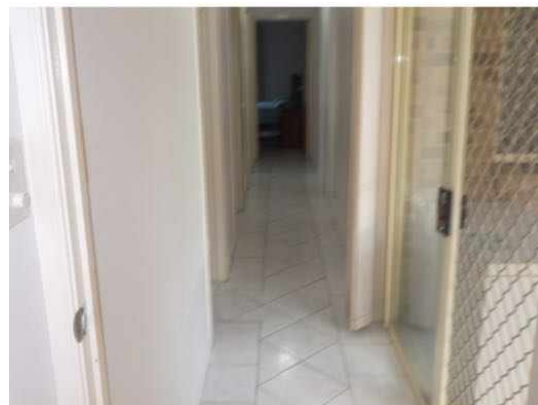
Building: Main Building
Location: Hallway > Existing
Finding: No obvious defect
Information: No obvious defects found at the time of inspection.

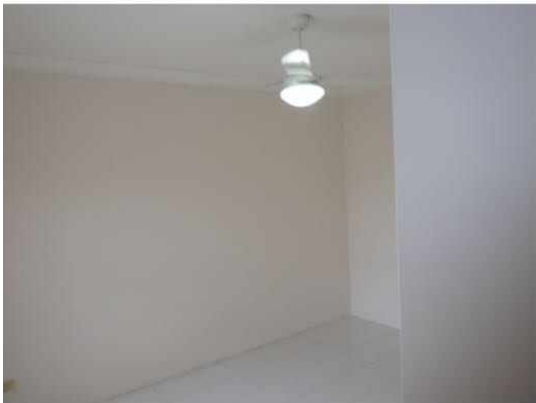
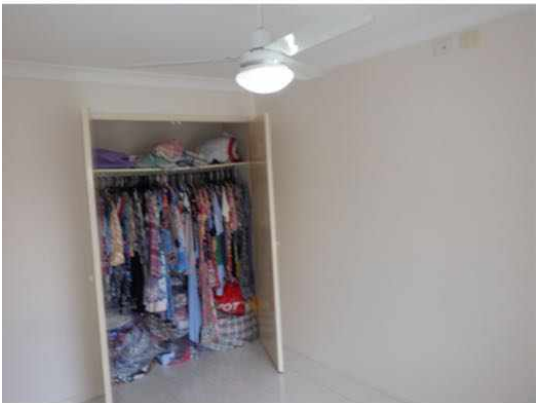
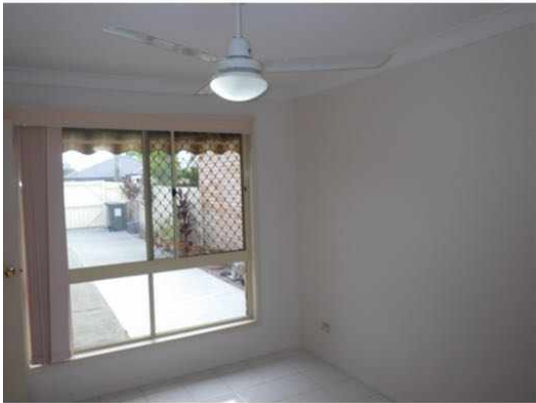
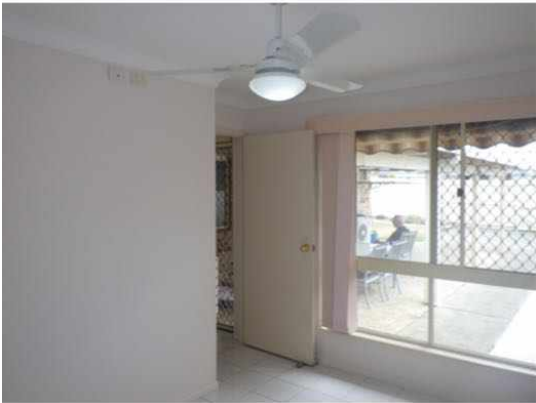
Building: Main Building
Location: Bedroom 3 > Existing
Finding: No obvious defect

Information: No obvious defects found at the time of inspection.

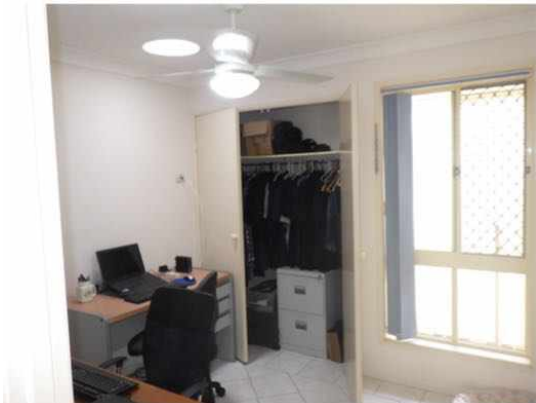
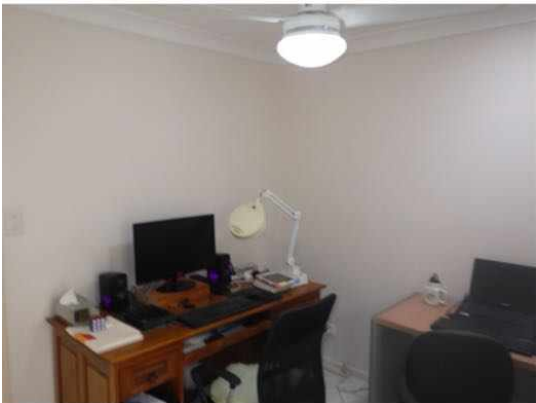
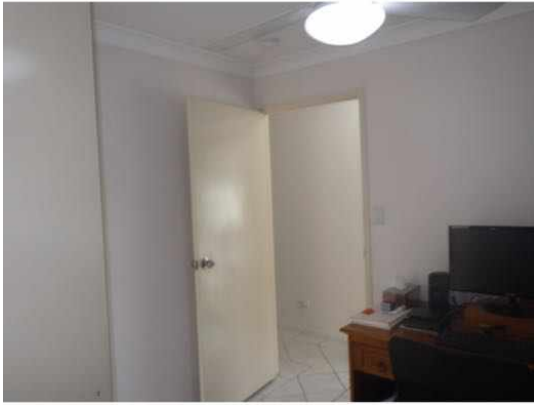
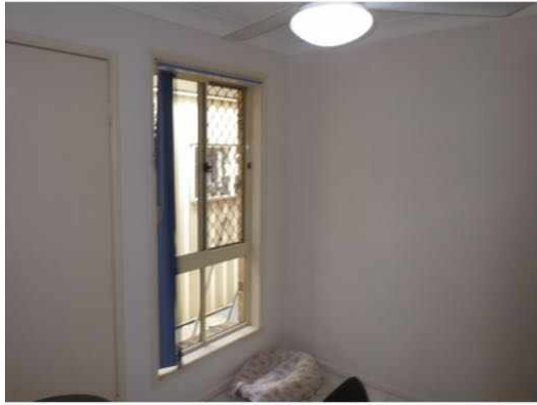
Building: Main Building
Location: Bedroom 2 > Existing
Finding: No obvious defect
Information: No obvious defects found at the time of inspection.

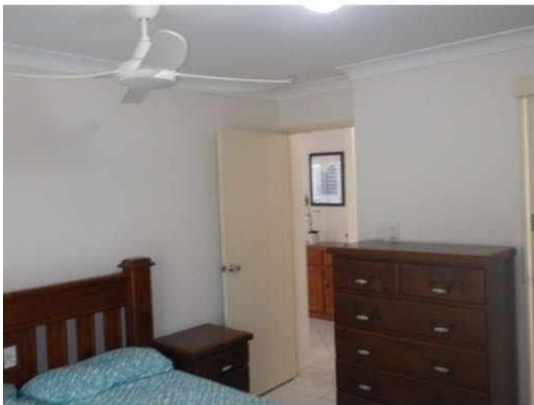
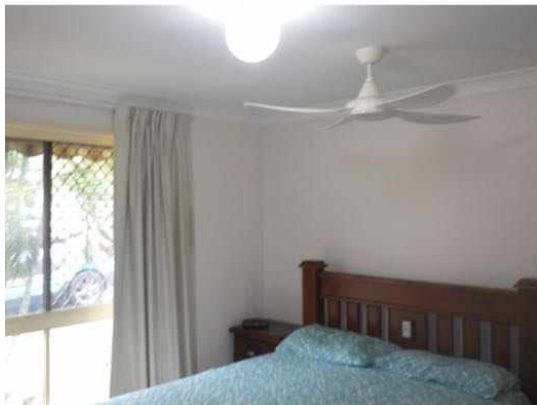
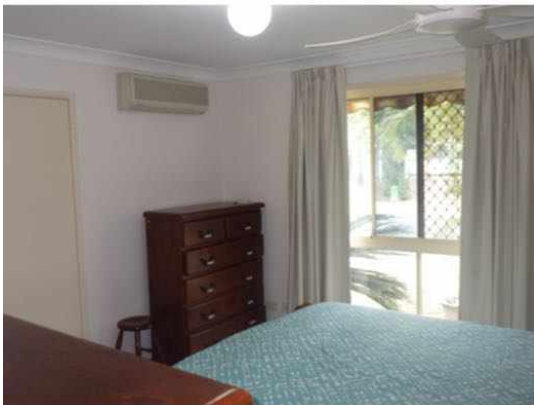
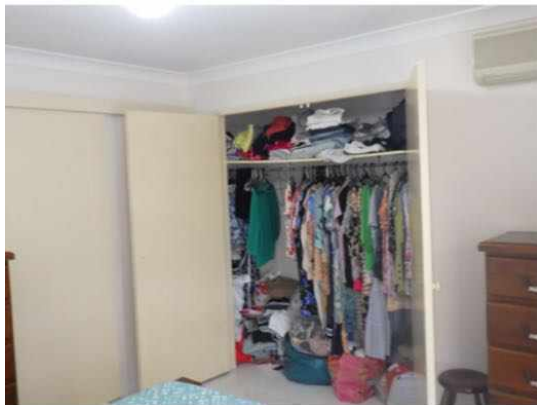
Building: Main Building
Location: Bedroom - Master > Existing
Finding: Additional Photos
Information: Additional photos are provided for your general reference

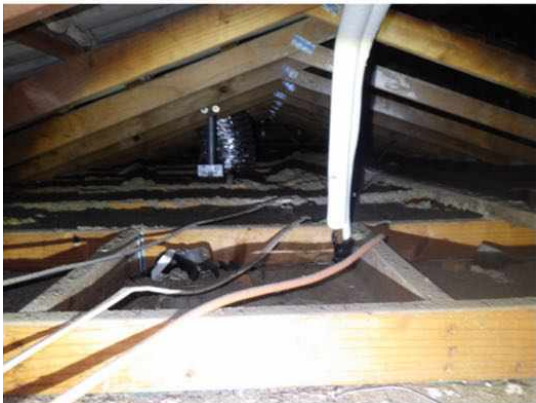
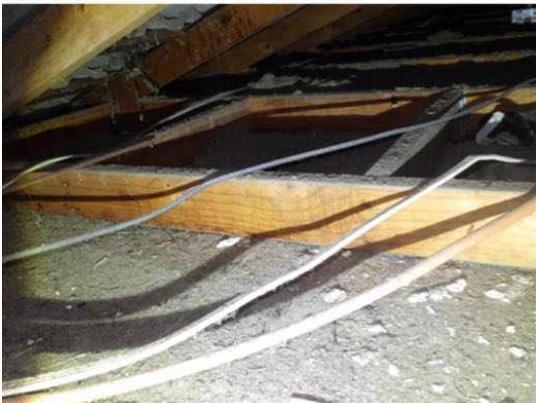
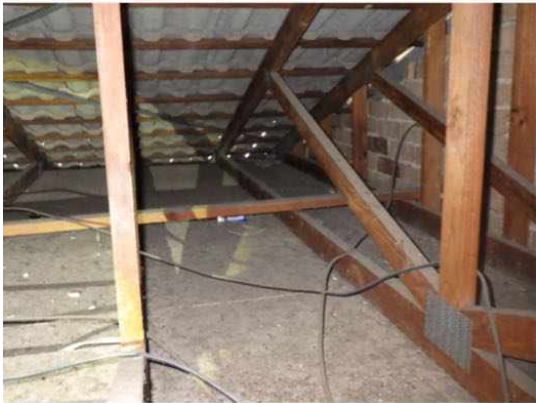
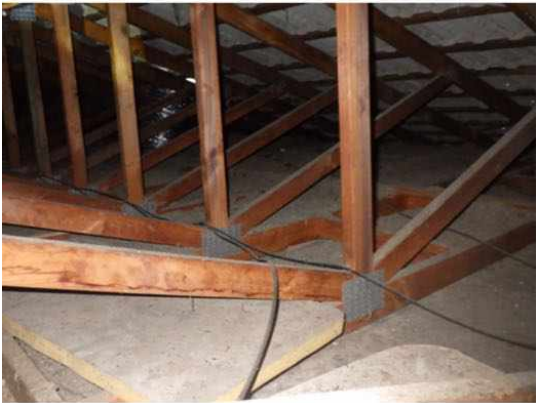
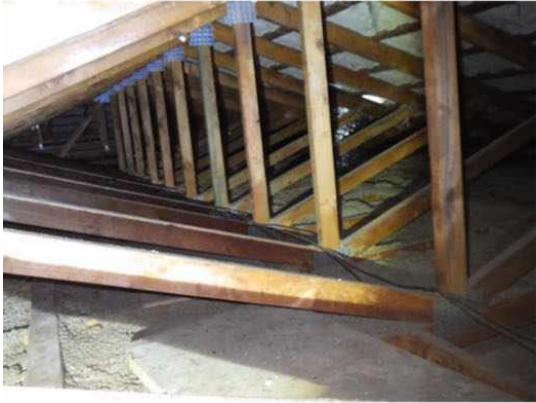
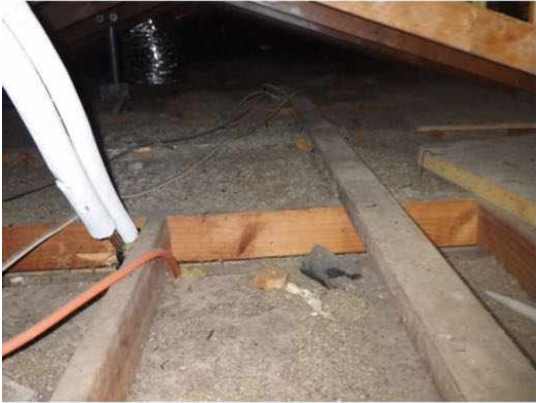
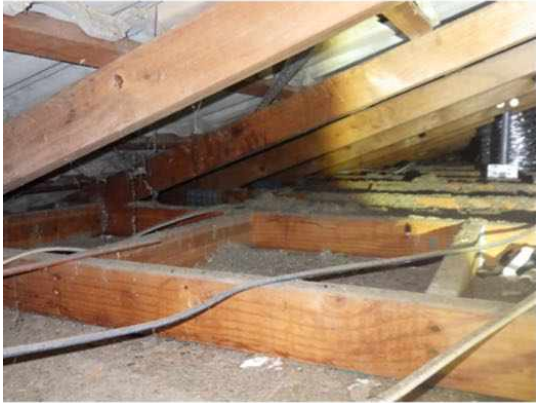
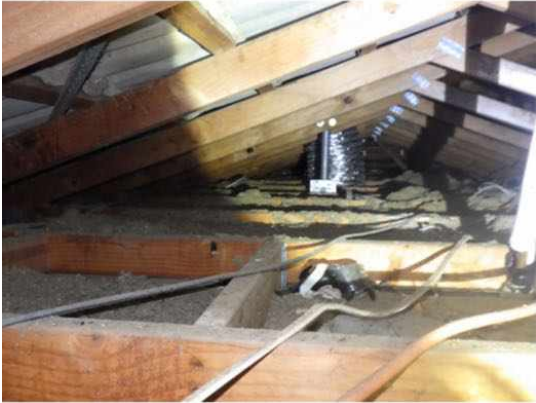
Building: Main Building
Location: Attic > Existing
Finding: Additional Photos

Information: Additional photos are provided for your general reference

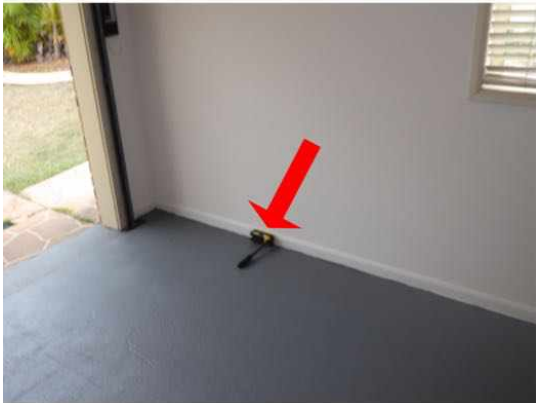
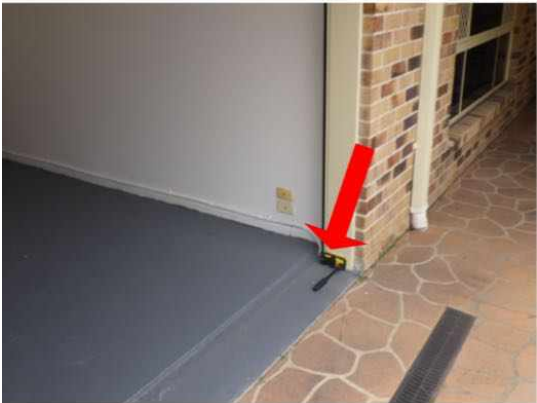
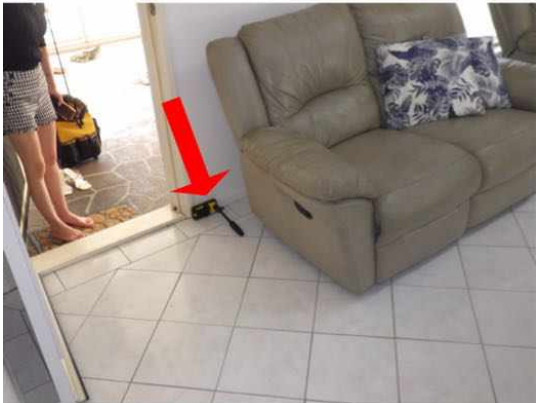
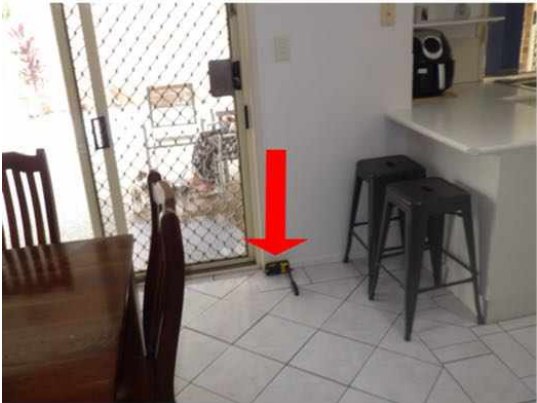
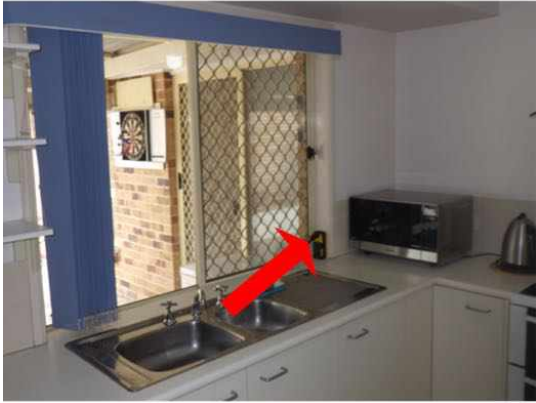
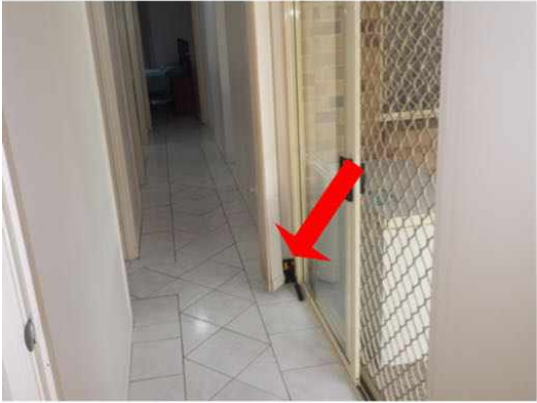
Building: Main Building
Location: Internal Areas > Existing
Finding: Termitracker
Information: The termitracker itracker was positioned randomly to internal wall, timber skirting and window frame areas checking for signs of termite activity.

No activity was recorded at the time of inspection.

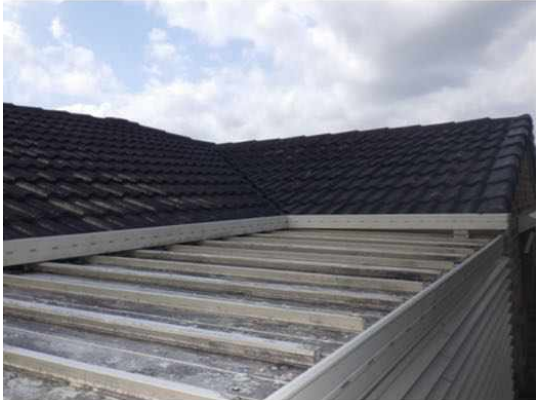
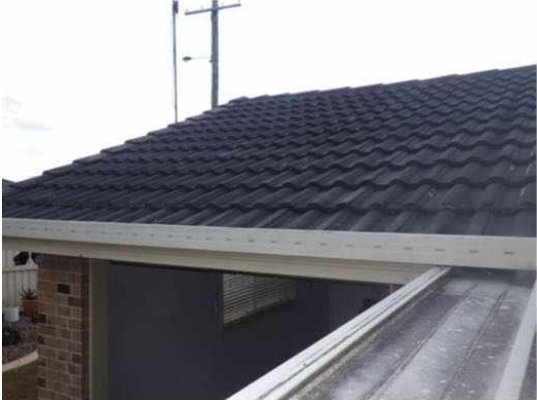
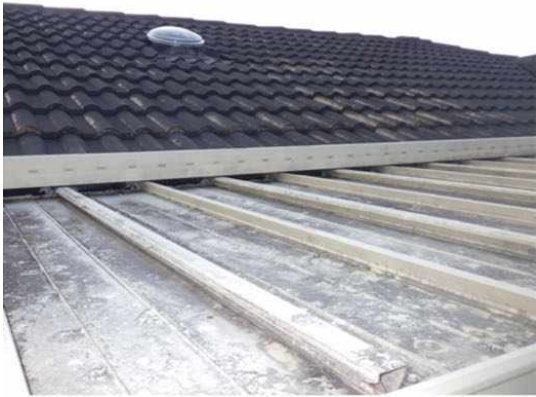
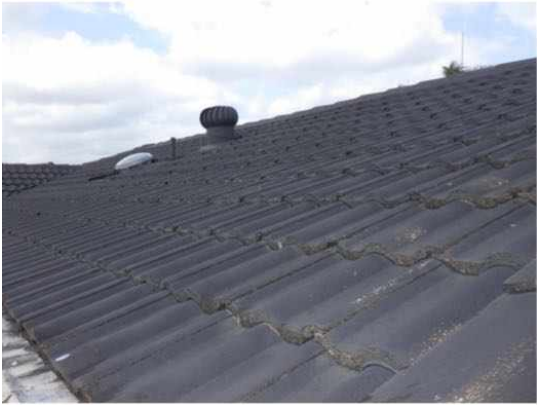
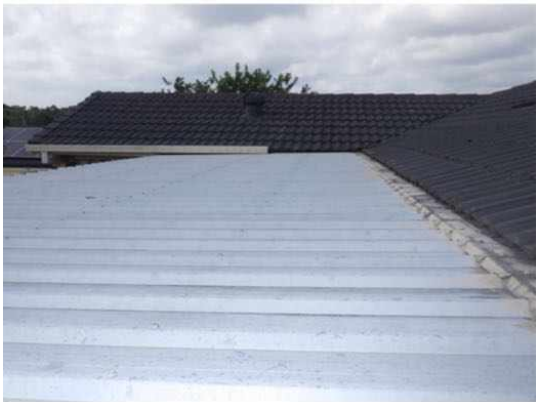
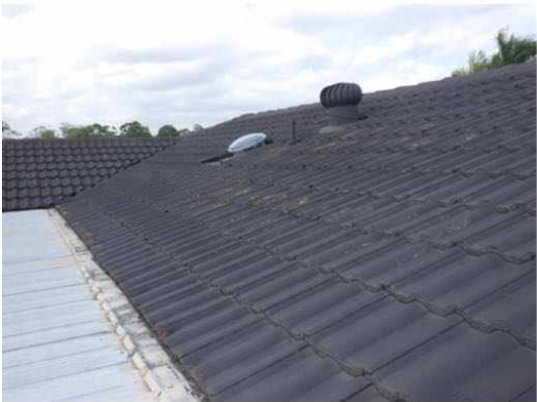
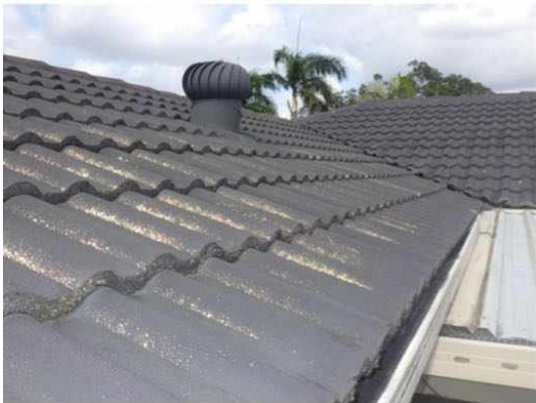
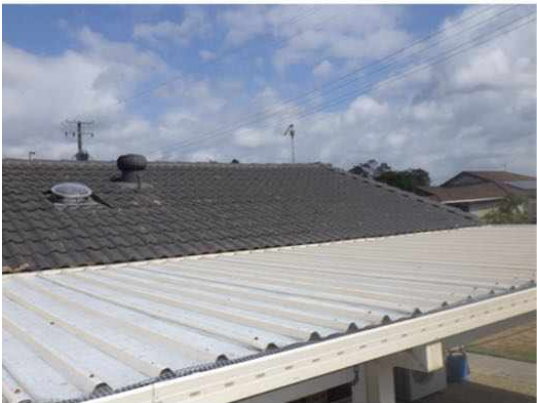
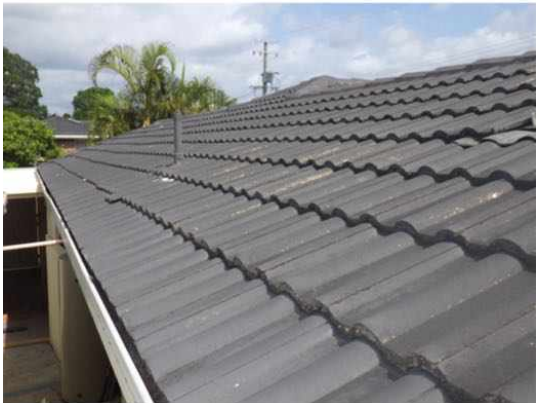
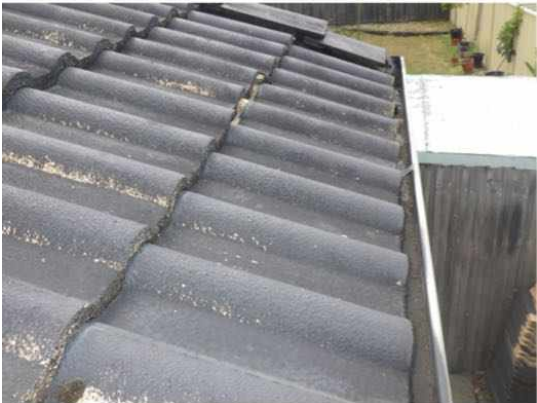
Building: Main Building
Location: Roof Exterior > Existing
Finding: Additional Photos
Information: Additional photos are provided for your general reference

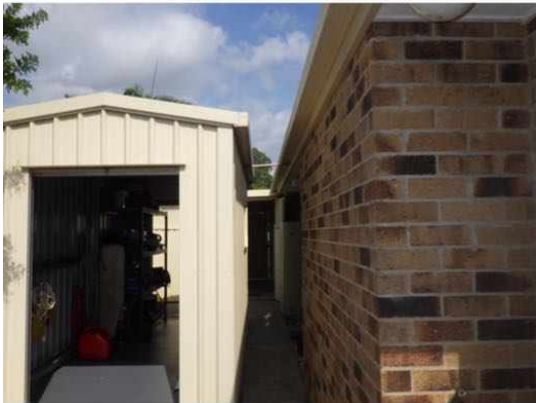
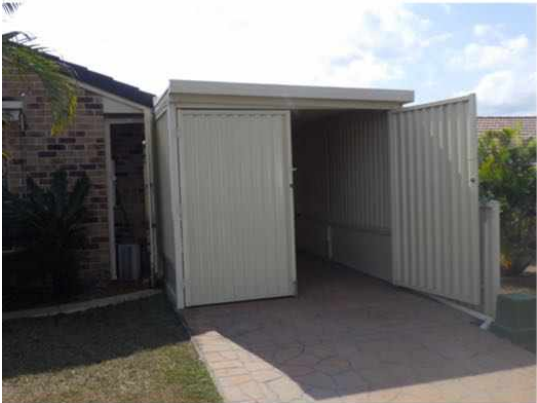
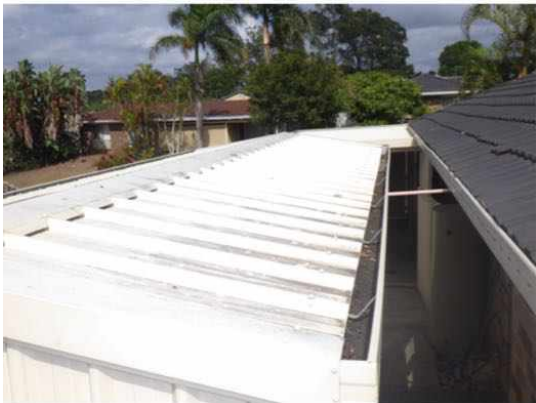
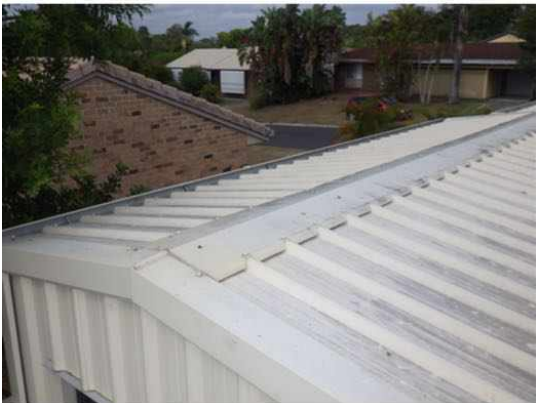
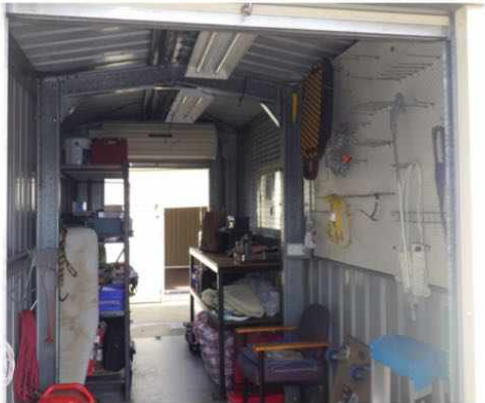
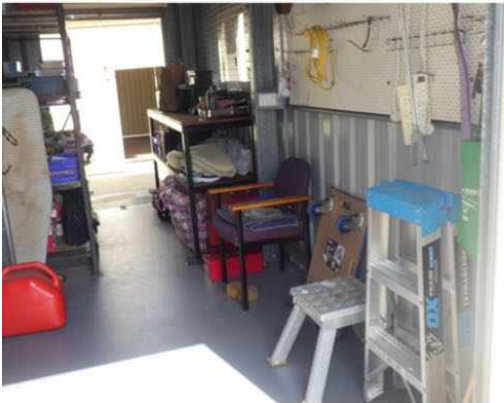
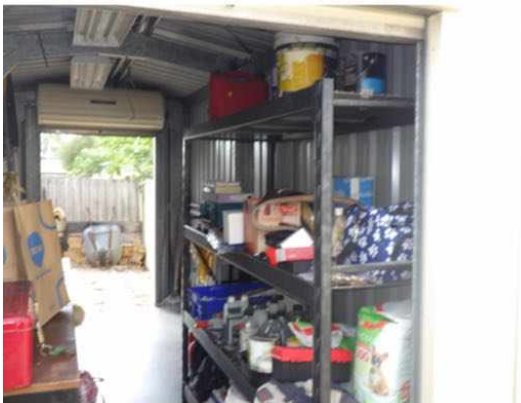
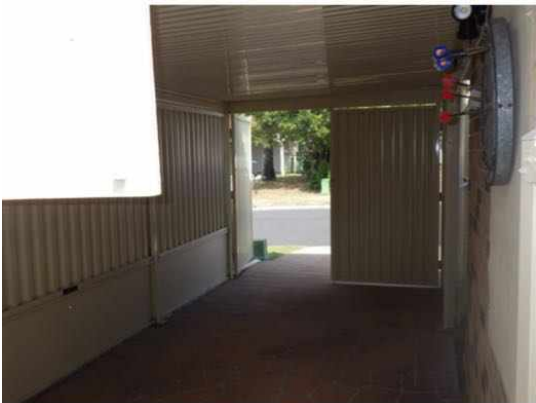
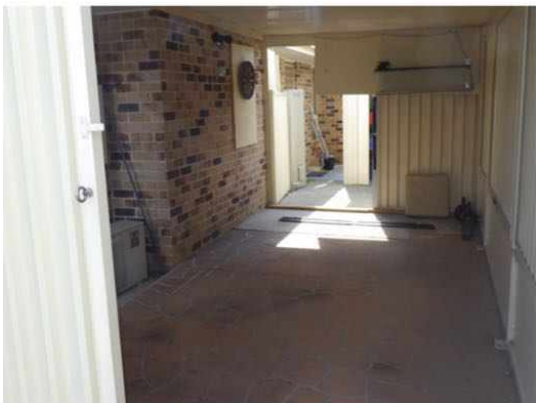
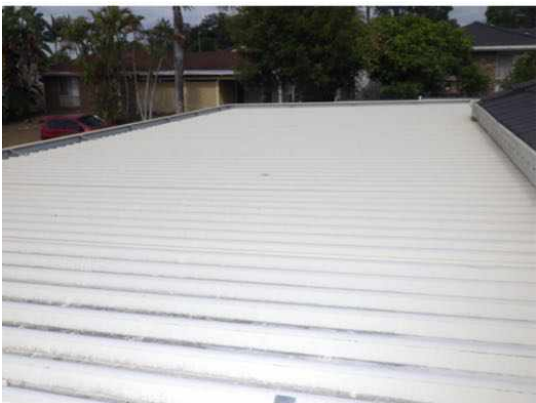
Building: Shed
Location: External Areas > Existing
Finding: Additional Photos
Information: Additional photos are provided for your general reference
